Site Accessibility Evaluation

Allmendinger Park
655 Pauline Blvd
Ann Arbor, MI 48104
ADA Only

Inspection Date: 07/11/2022

Report Date: 11/15/2022

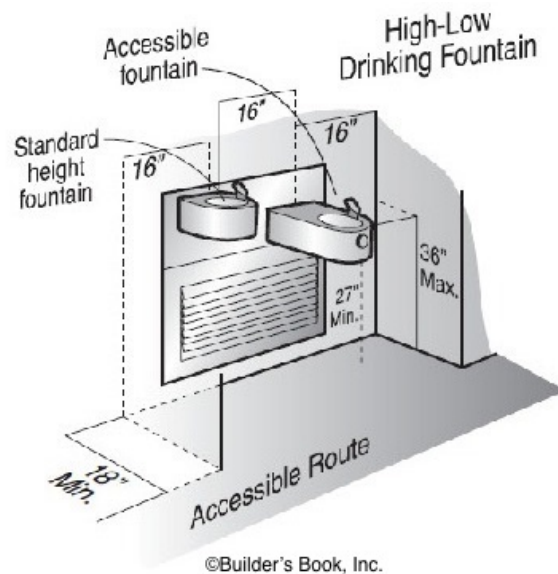
Missing high fountain

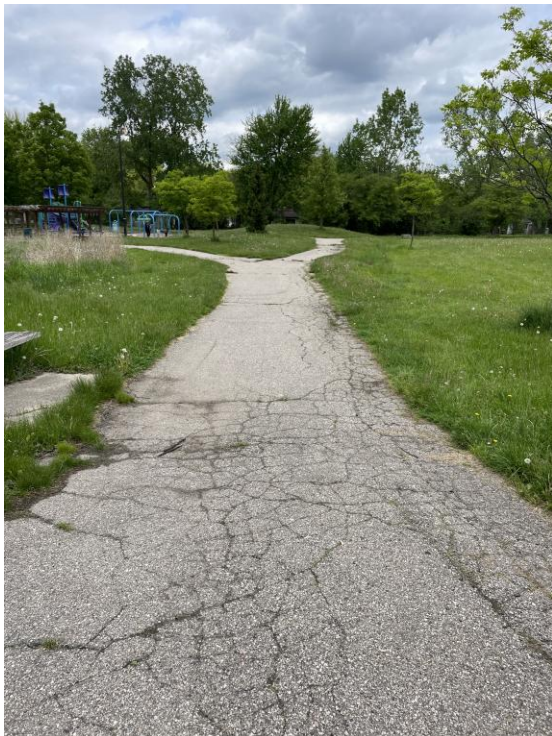
Asphalt with cracks and excessive cross slope

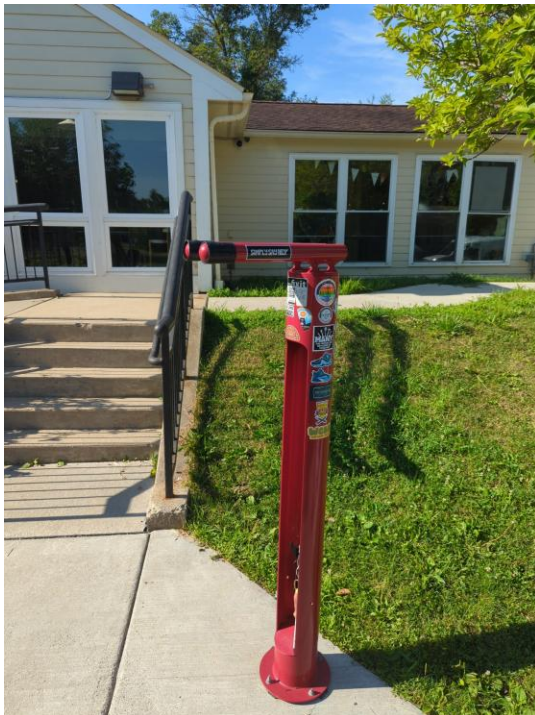
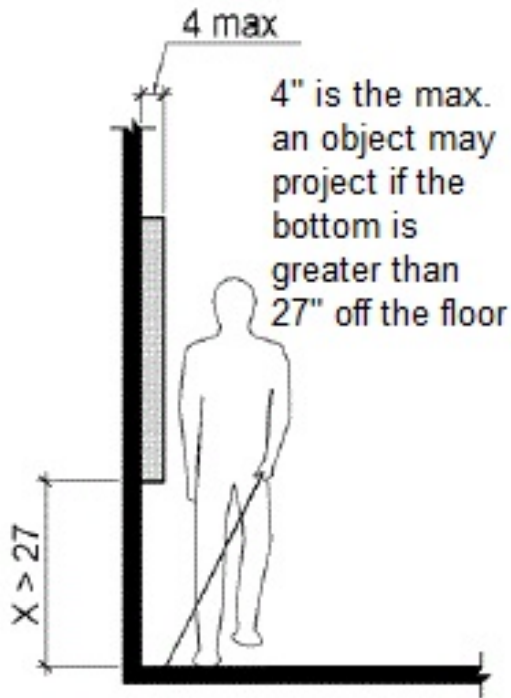
The bike repair station projects more than 4 inches into the circulation path.

Bike repair station protrudes 12 inches at 58 inches high

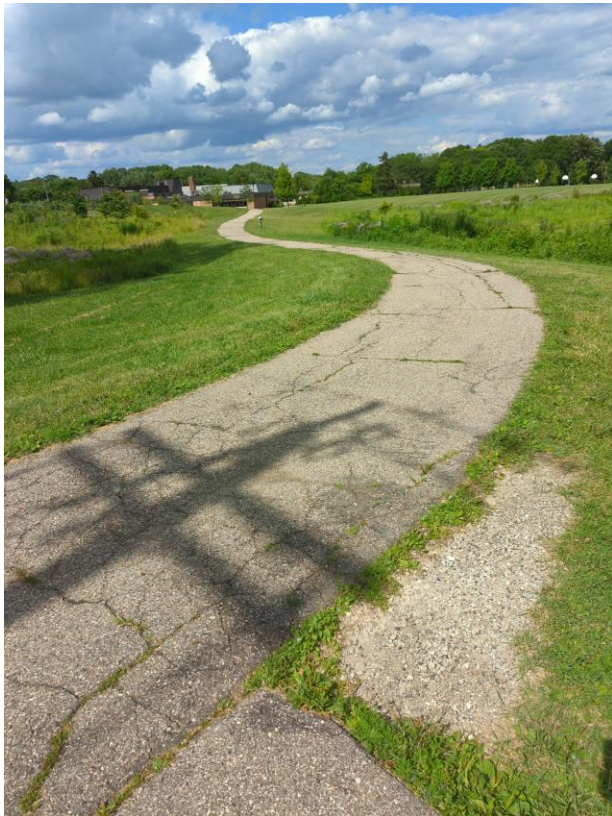
Path from Essex Rd to Allen Elementary School with broken asphalt

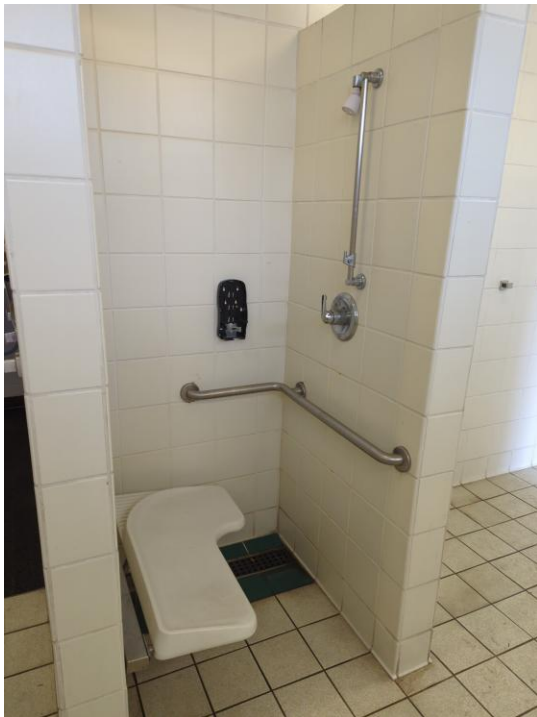
Fixed shower head provided, missing hand-held unit.

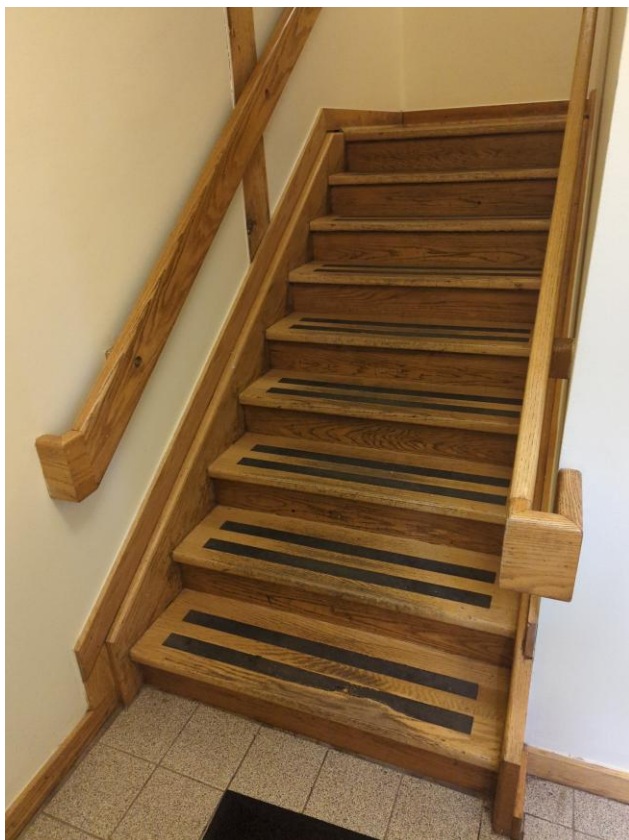
Finding #21 Continued

Compliant handrails are missing in the stairs connecting first and second floors

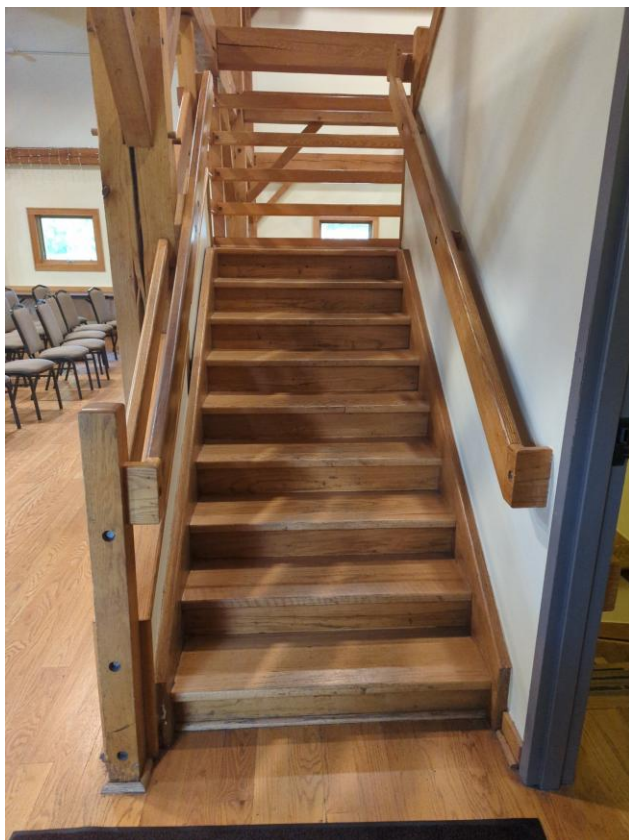
Finding #48 Continued

Compliant handrails are missing in the stairs connecting second floor and mezzanine

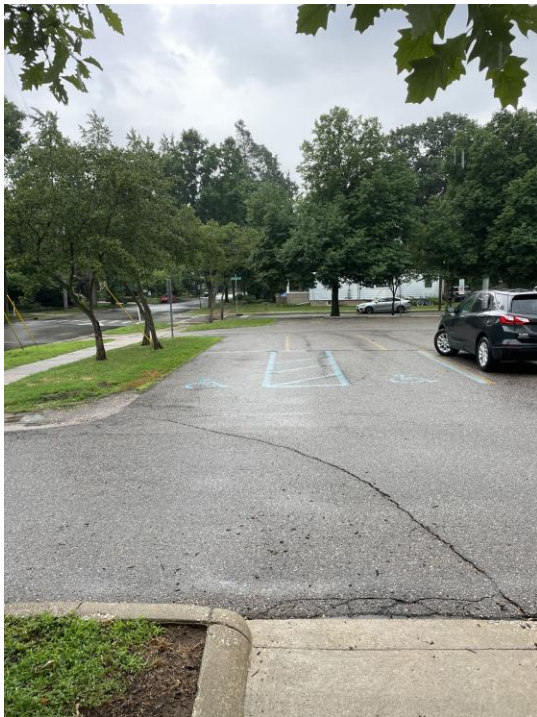
Missing two signs

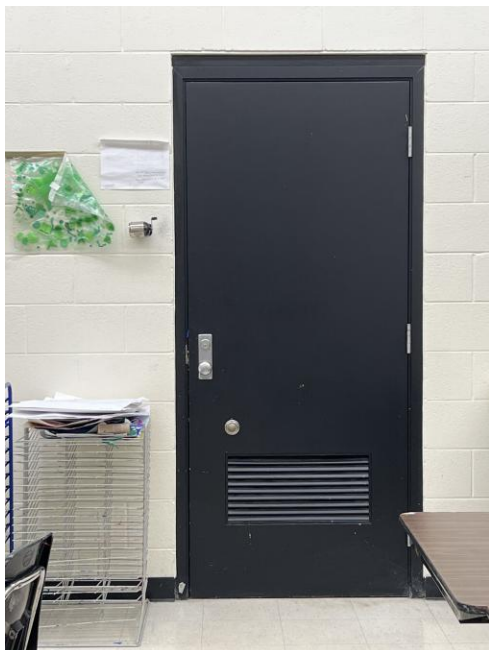
Door knobs found in classroom B

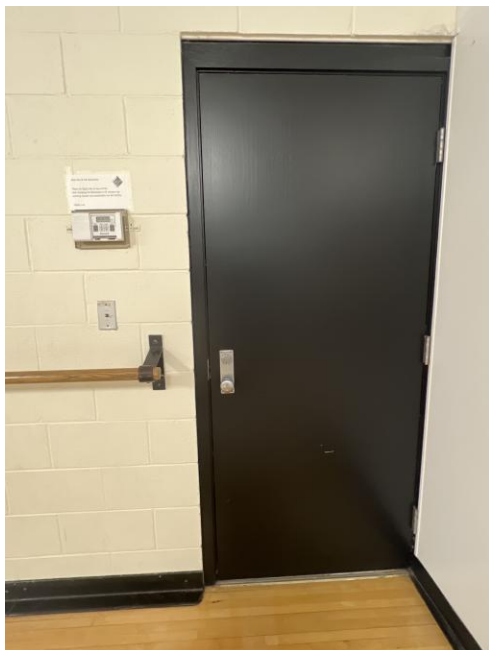
Door knobs found in the Dance classroom

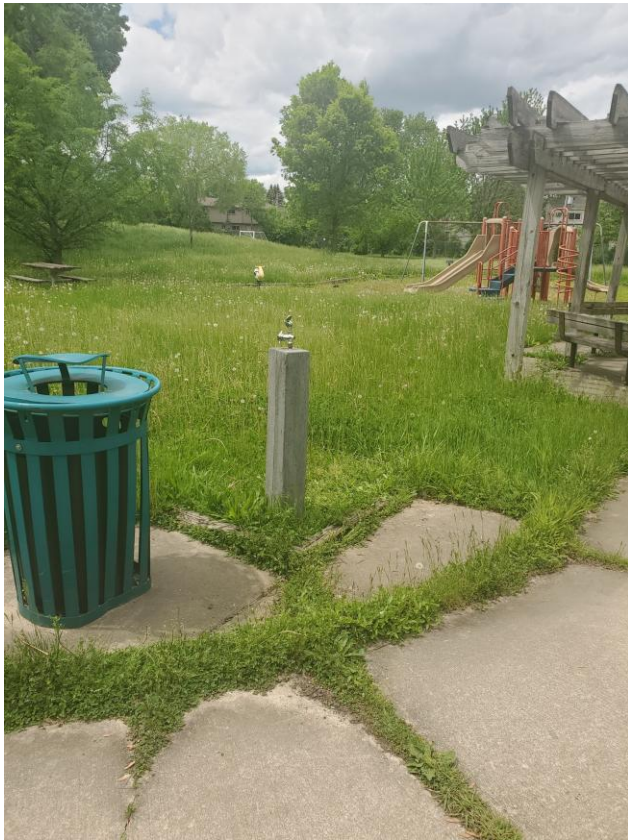
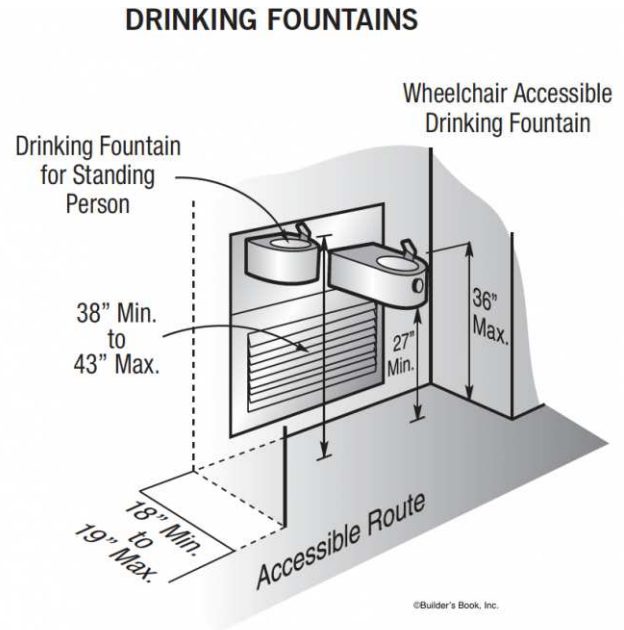
Finding #3 Continued

The drinking fountain has multiple violations including clear floor space, no high or low fountain, and operable parts.

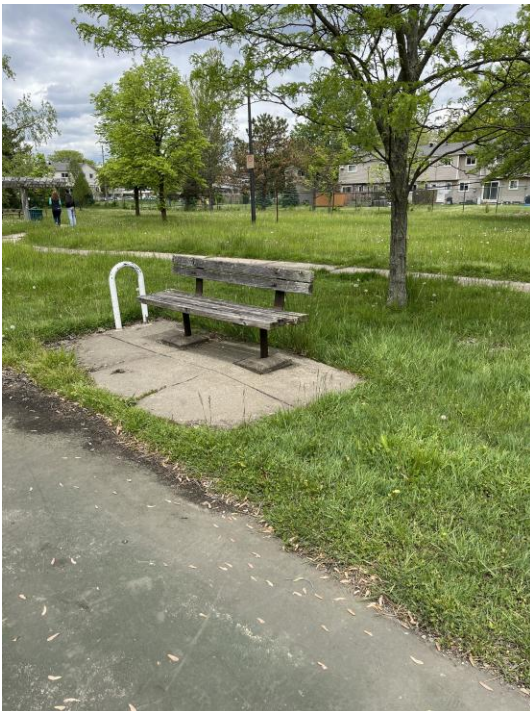
Accessible route to seating area is missing

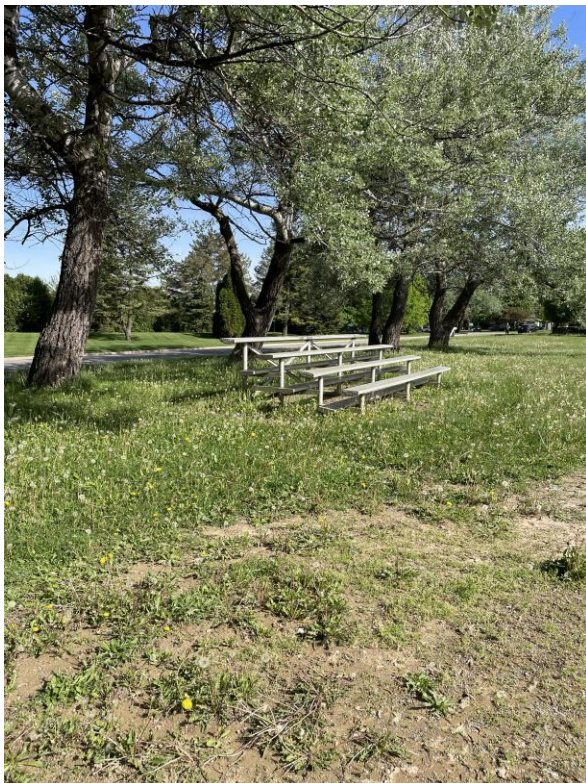
Accessible route missing

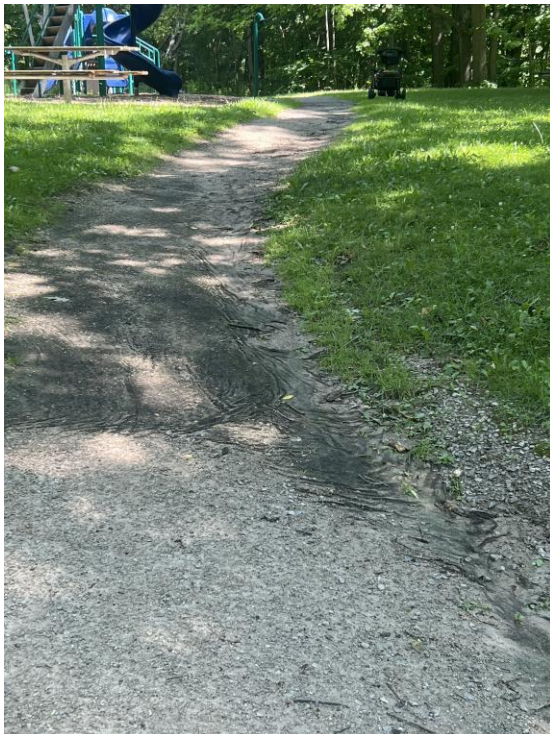
Surface has loose gravel and grass in cracks

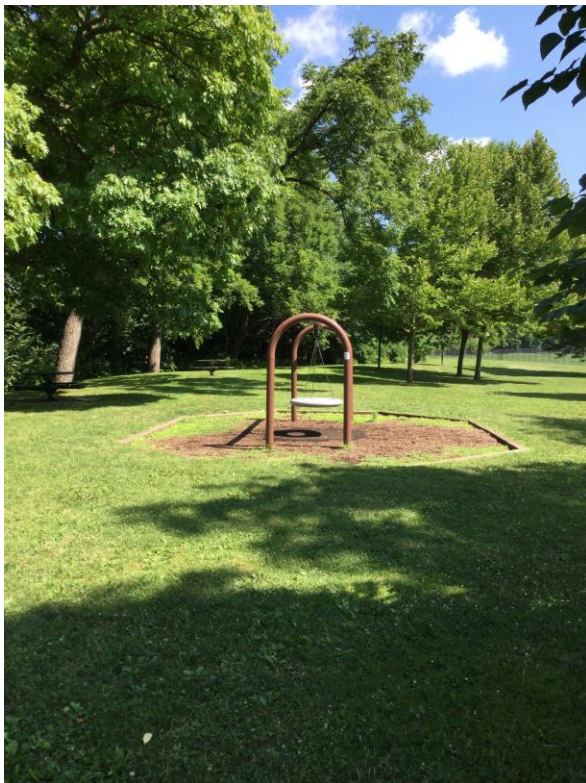
Accessible route to swing missing

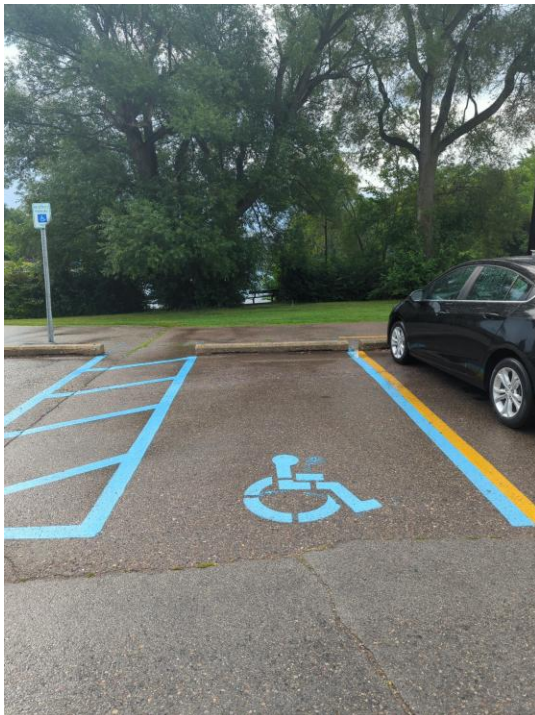
Missing sign on right accessible parking stall

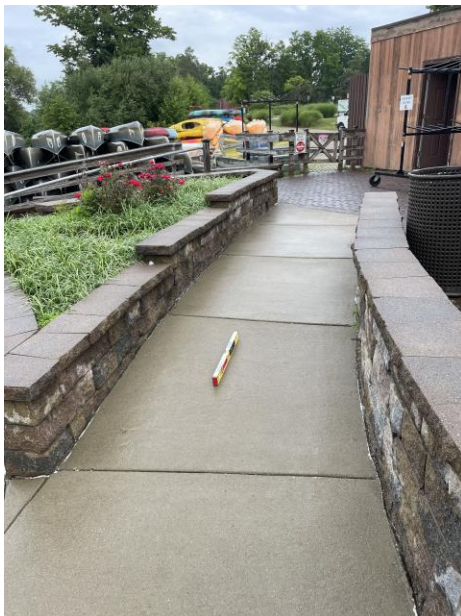
Missing on both sides

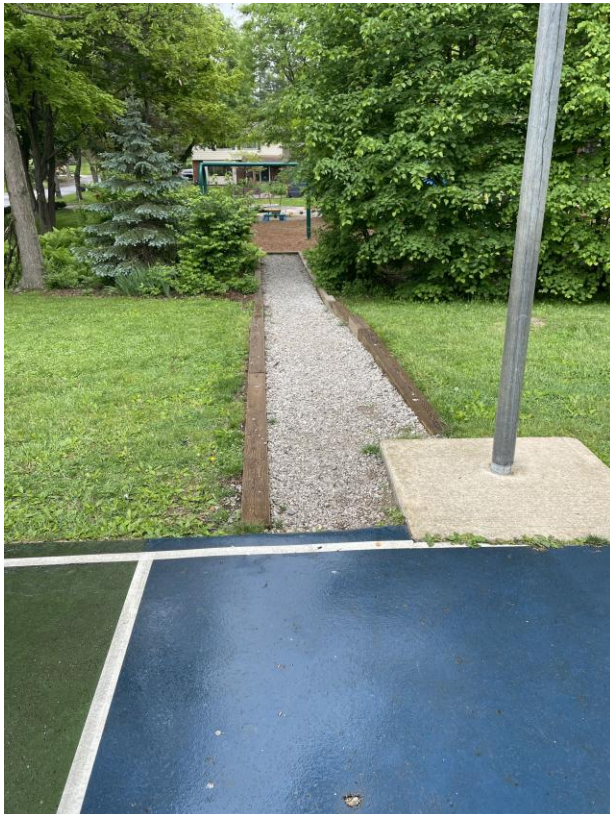
loose gravel

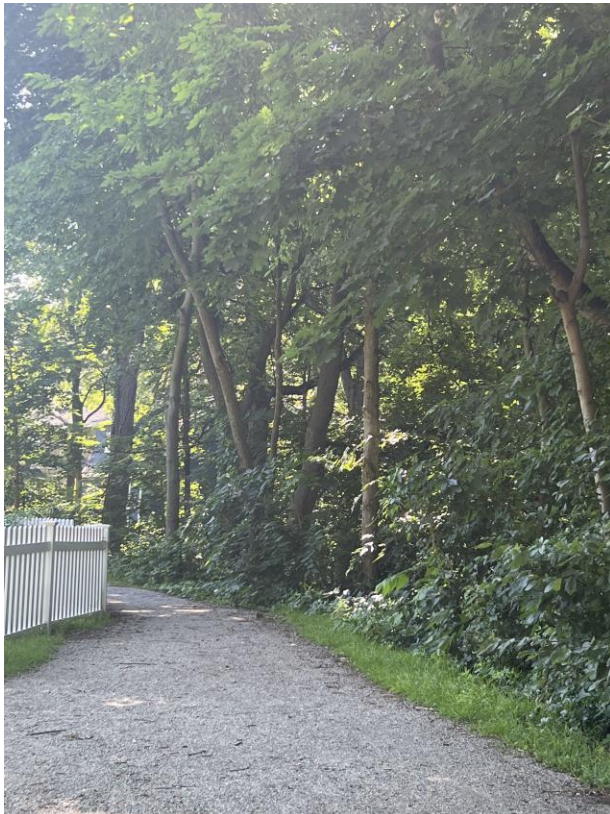
Loose gravel

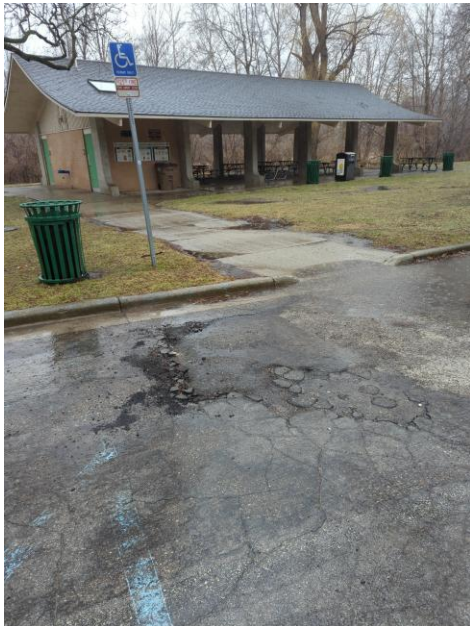
Asphalt on parking stall is broken on parking lot by restrooms

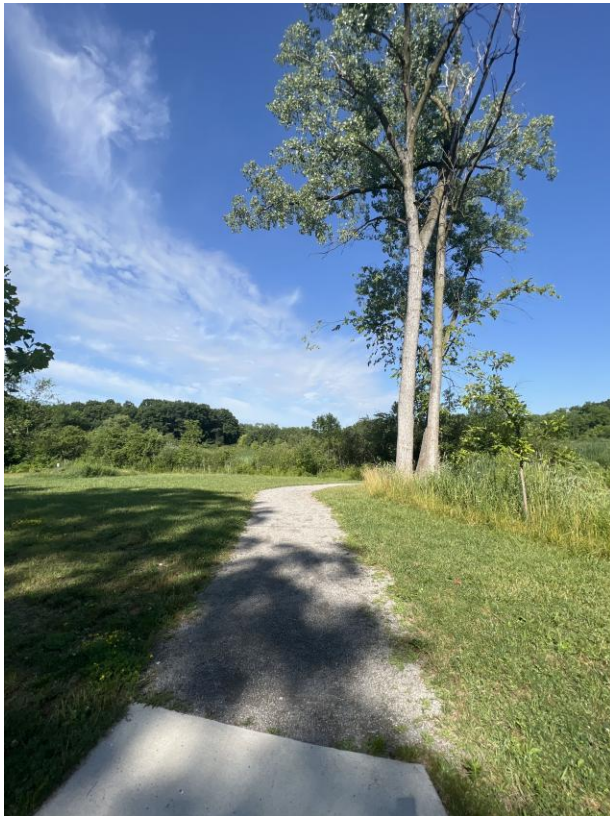
Loose gravel

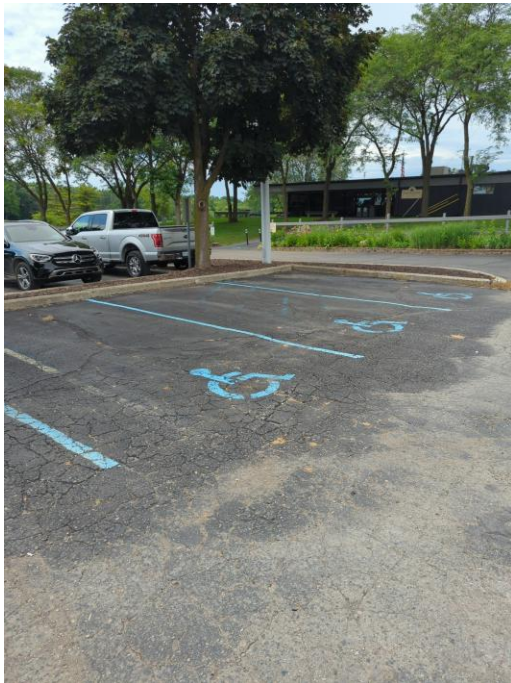
3 accessible parking stalls have broken and uneven asphalt.

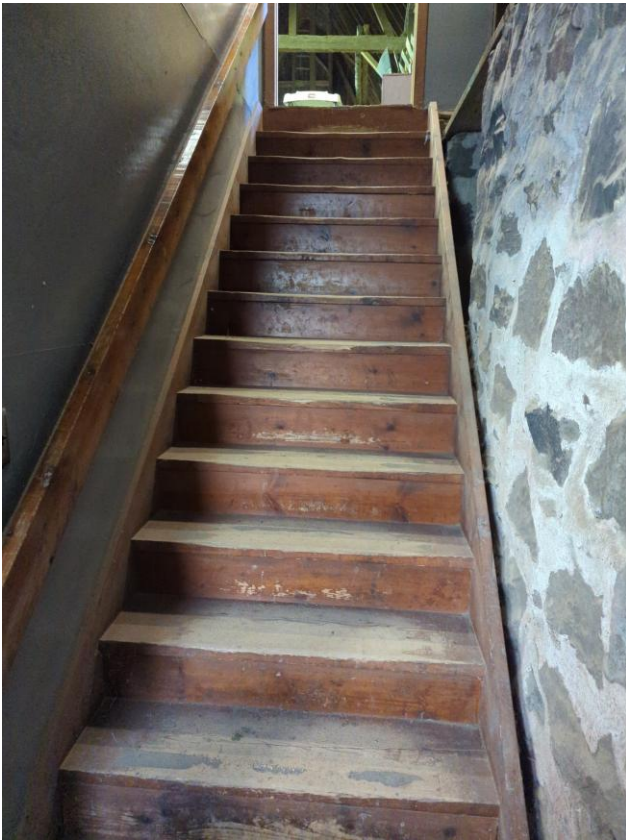
Finding #29 Continued

Stairs from basement to first floor is missing grab bars

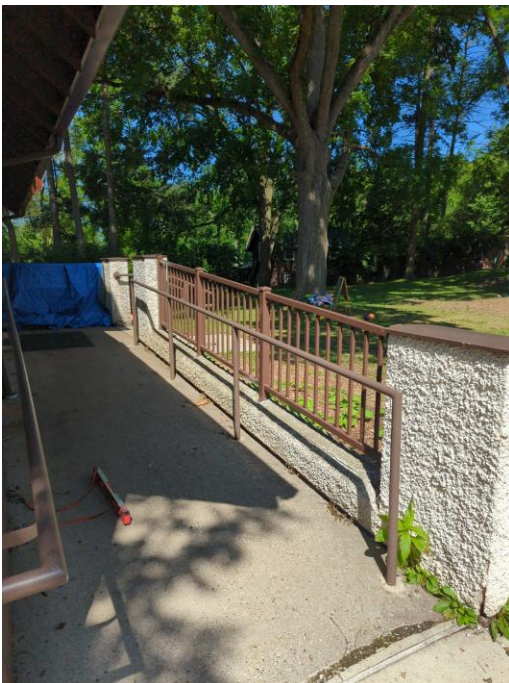
Top and bottom extensions missing on one side of ramp to Leslie House

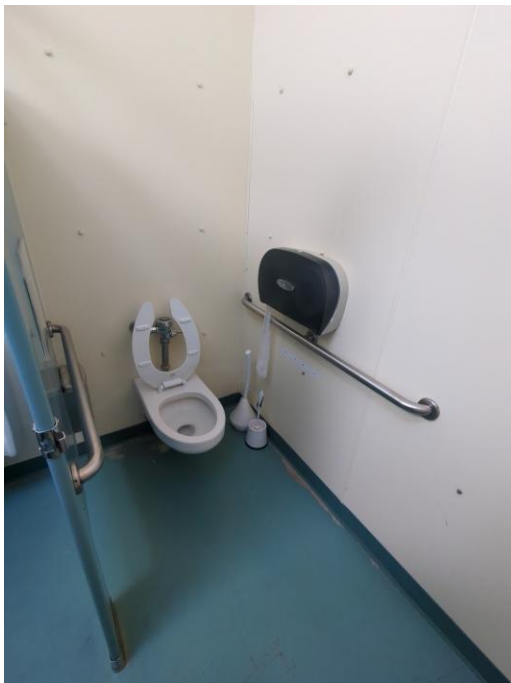
The toilet stall has multiple violations and does not meet all requirements

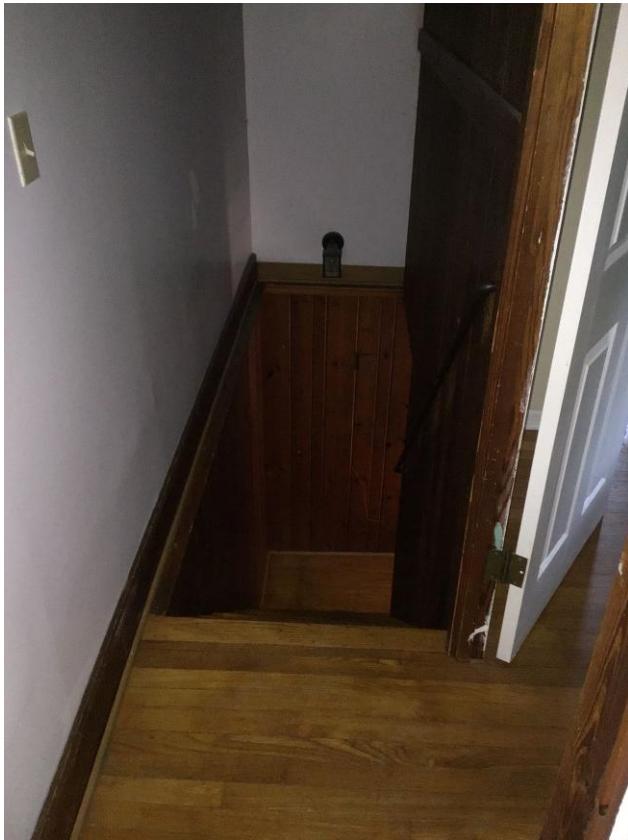
Finding #67 Continued

Handrail missing on one side. Stairs not compliant.

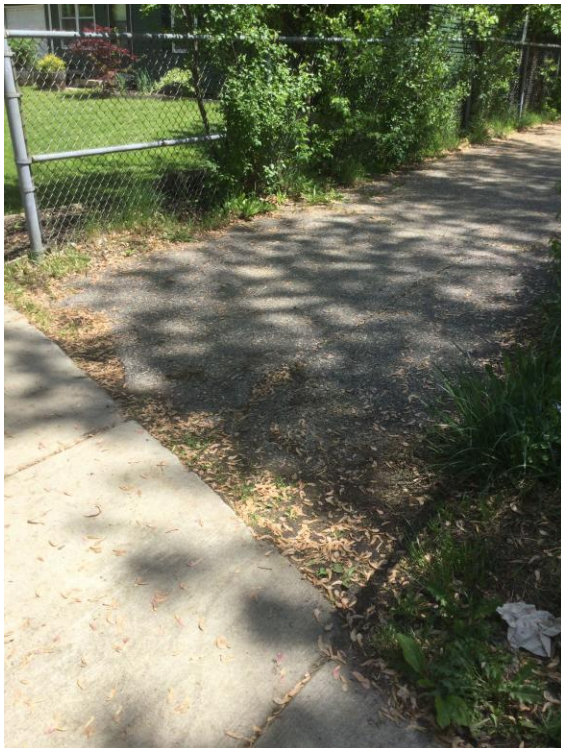
Accessible route has multiple violations

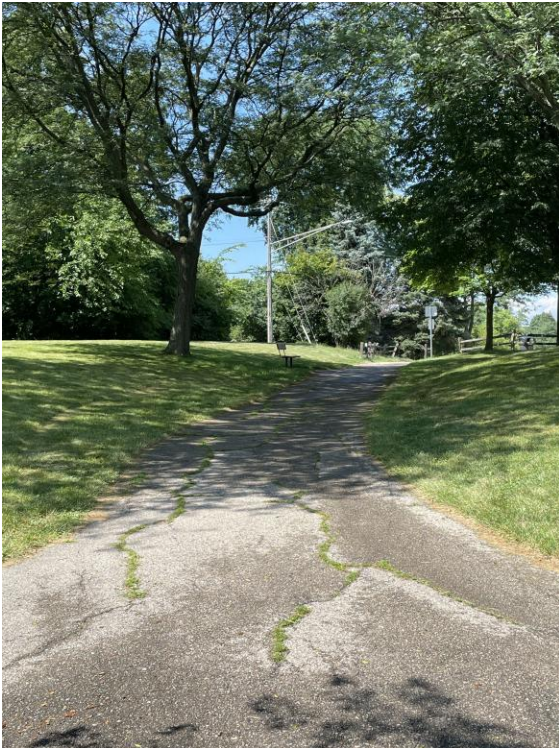
Cracks and vegetation along accessible route

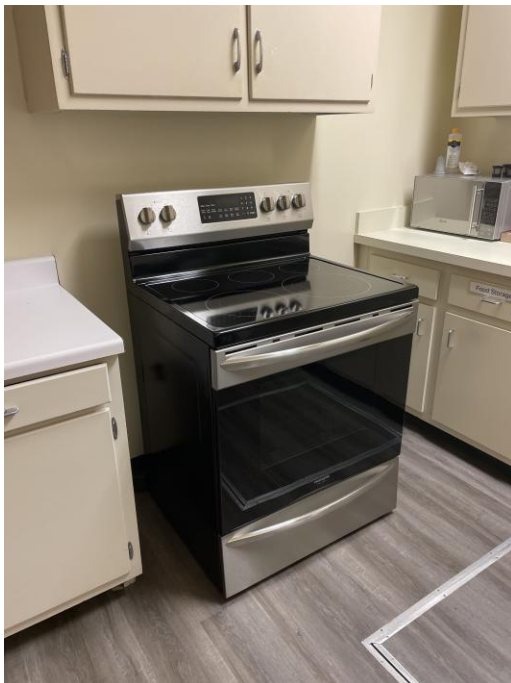
The stove controls are beyond reach range and require reaching across burners.

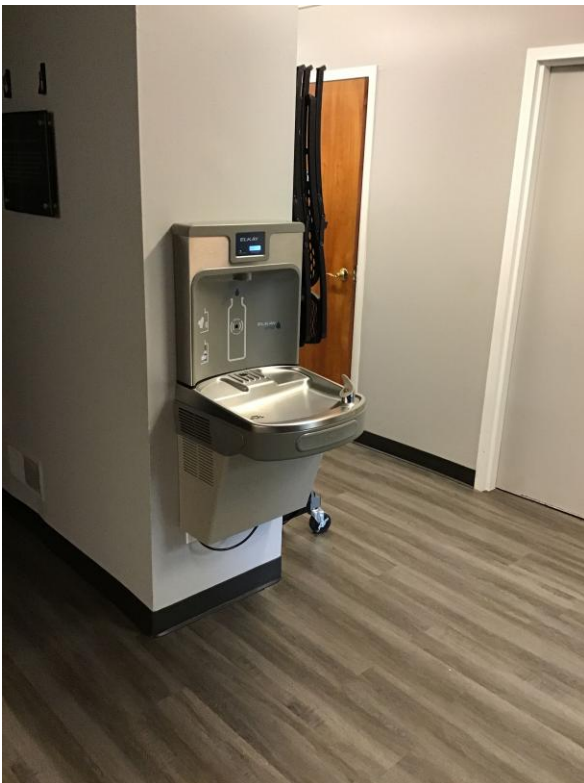
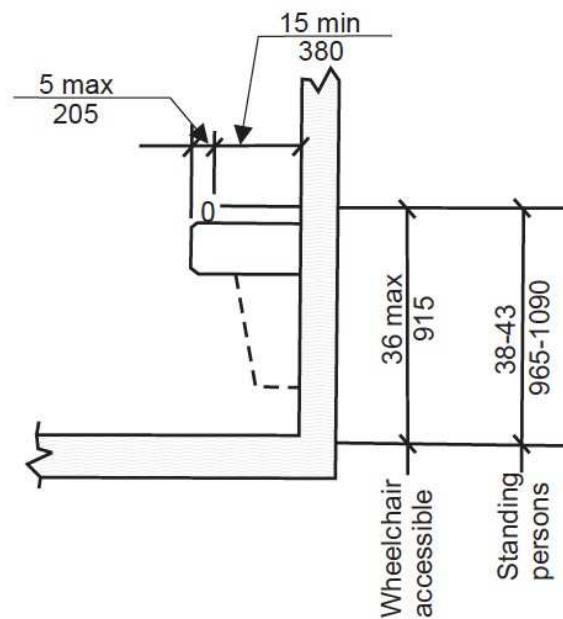
Missing high drinking fountain.

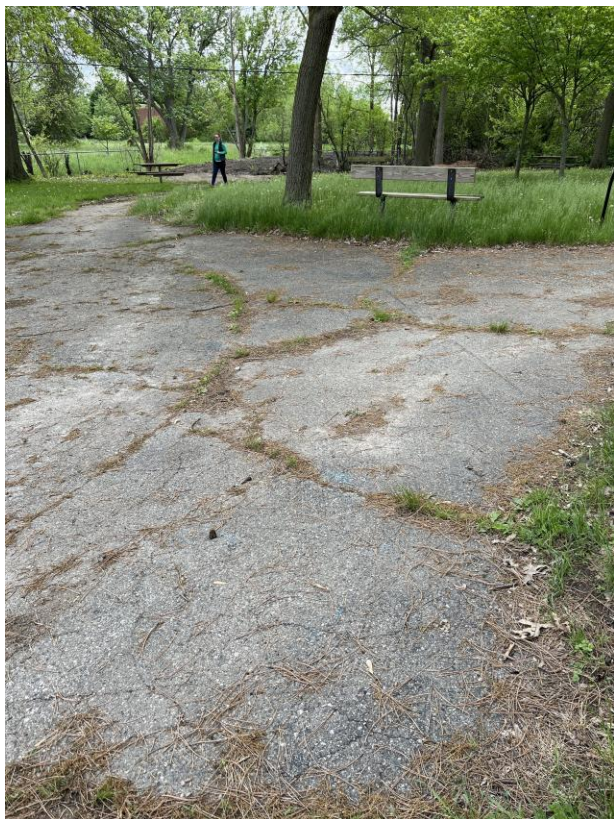
Surface is asphalt with cracks and excessive cross slope

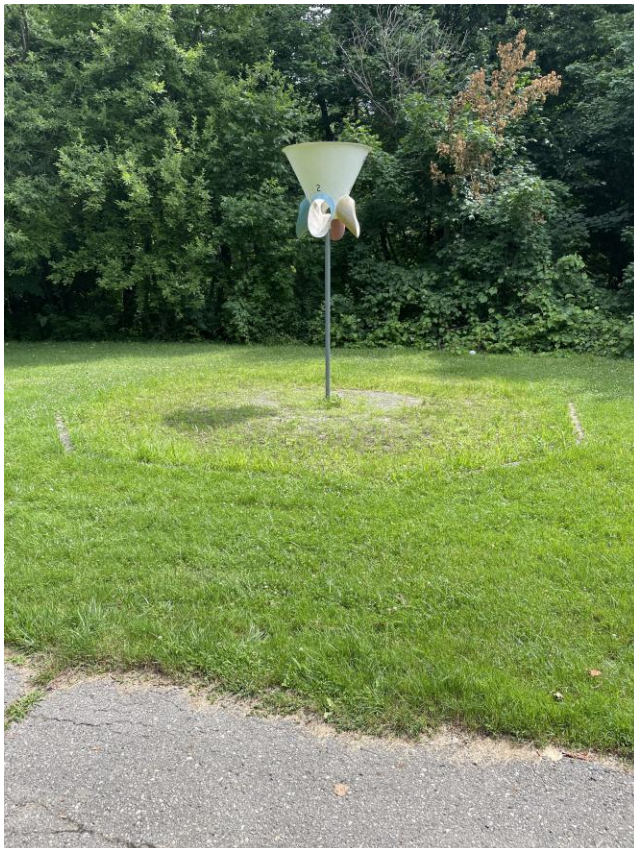
20 linear feet of accessible route is missing to play area

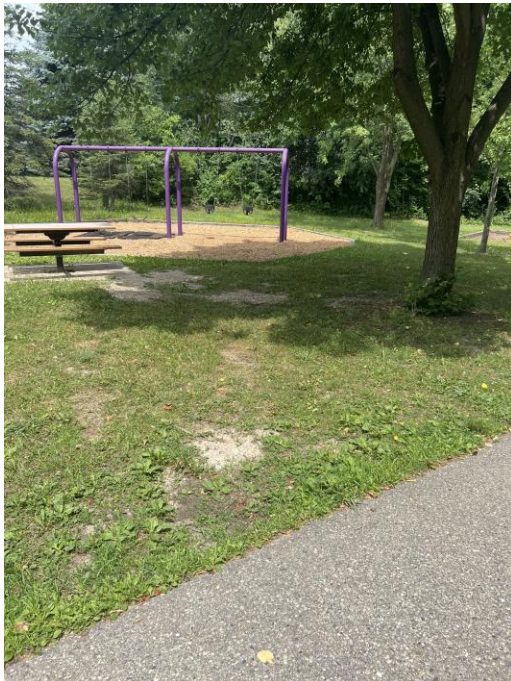
Accessible route is missing to swings

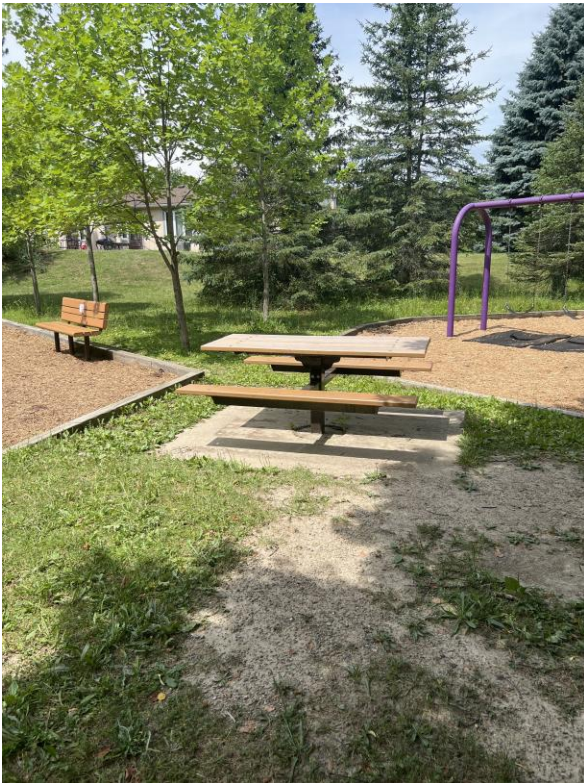
Accessible route is missing to picnic table

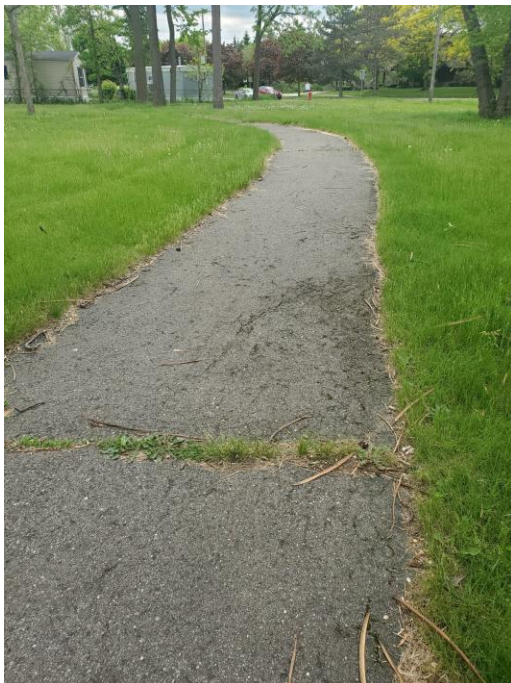
Accessible route has cracks where vegetation is growing, creating vertical changes in level greater than 1/4-inch or openings greater than 1/2-inch

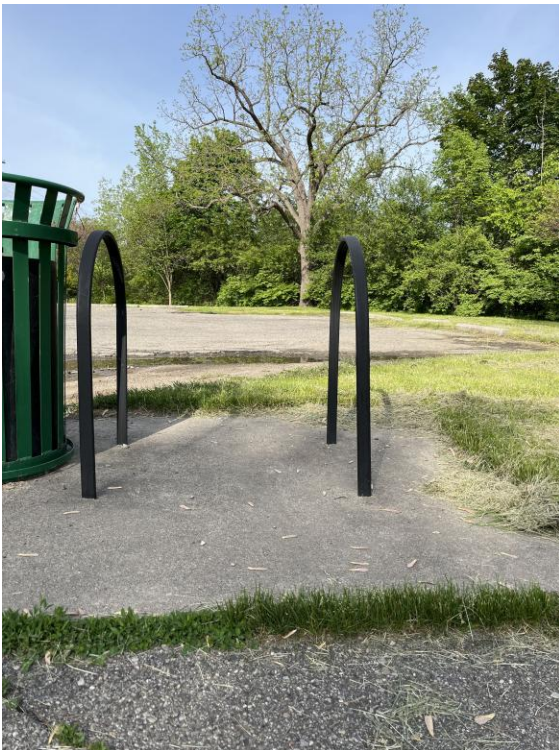
There is vegetation growing in the cracks of the sidewalk creating a vertical change in level greater than 1/4-inch to the trash bin.

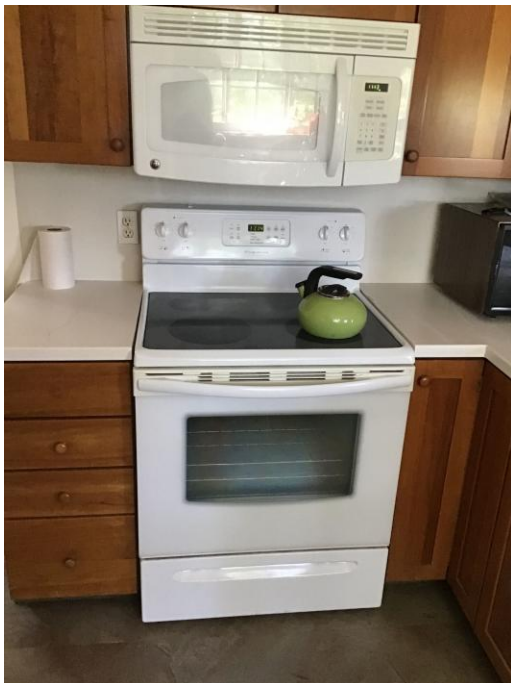
Controls past burners.

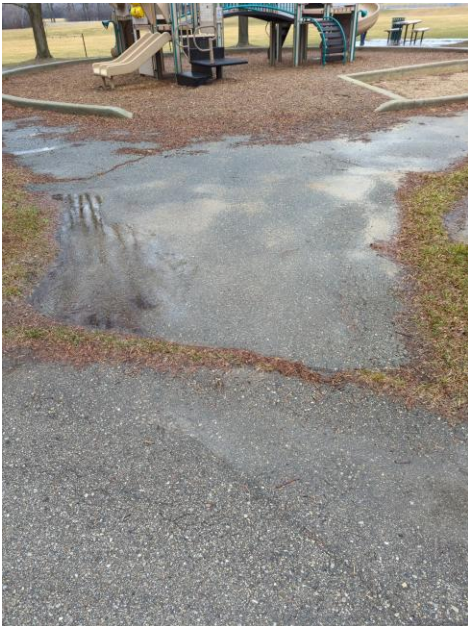
Vegetation on crack creates a change in level greater than 1/2 inch

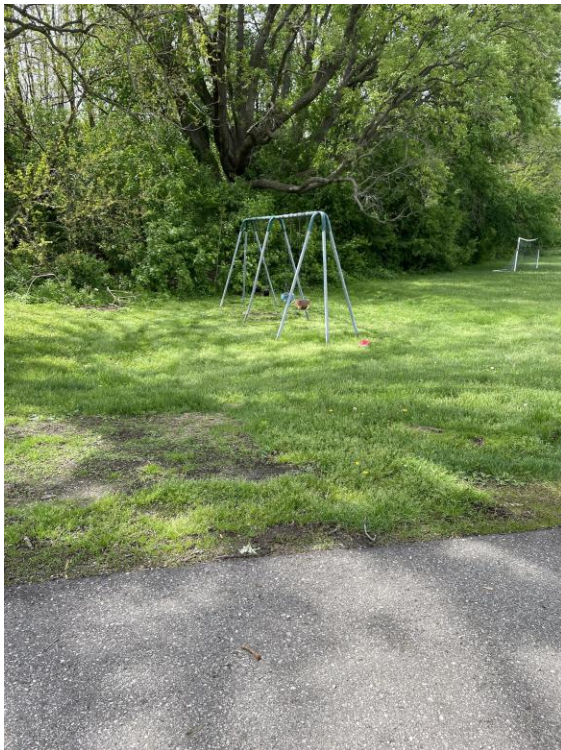
There is no accessible route provided to the swings; approximately 50 linear feet missing. Grass is not an accessible surface.

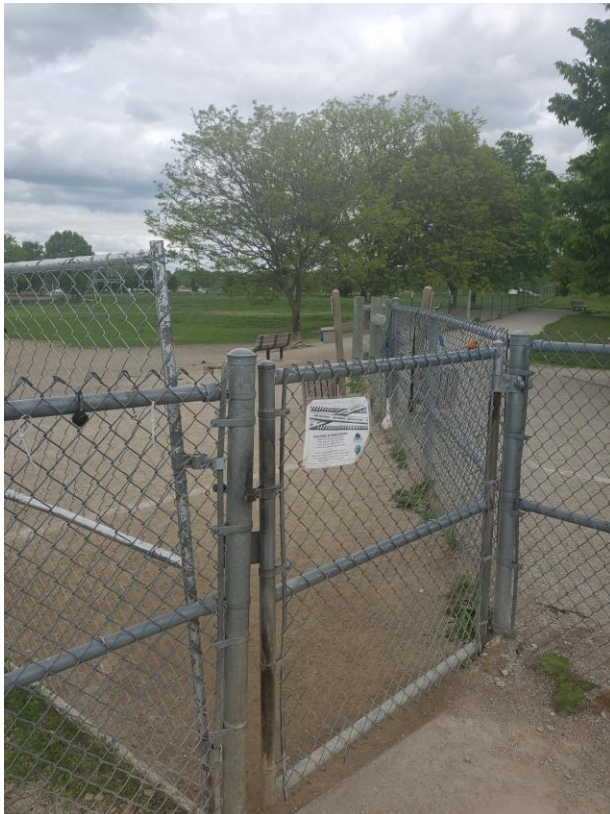
The accessible route to the gate has loose gravel which is not a compliant ground surface.

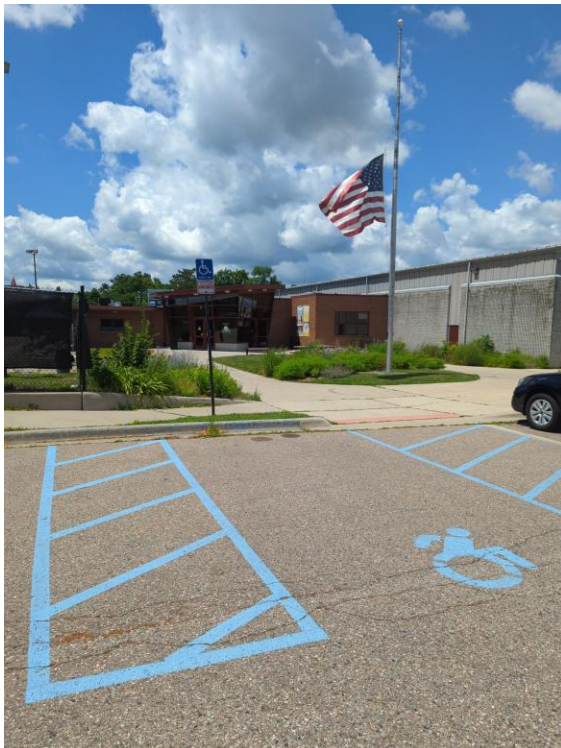
Two accessible parking stalls facing the pool, the right stall is "van accessible" but missing the sign.

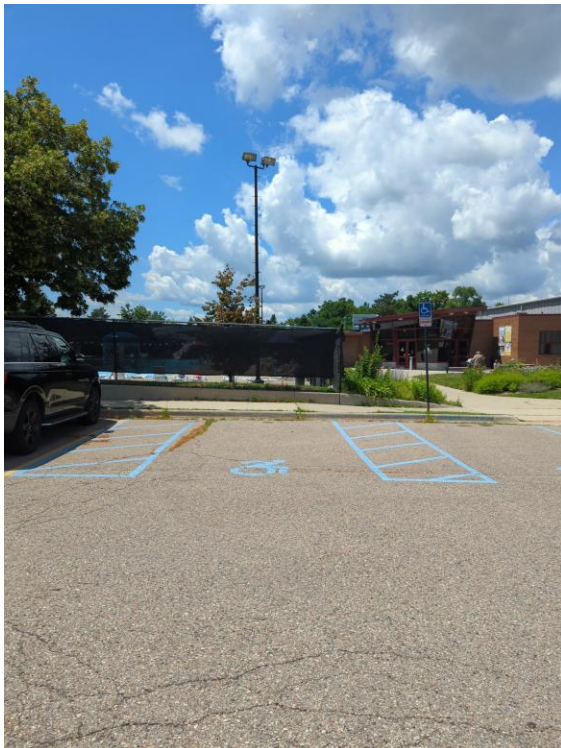
Two accessible parking stalls facing the pool, the left stall is missing the accessible sign.

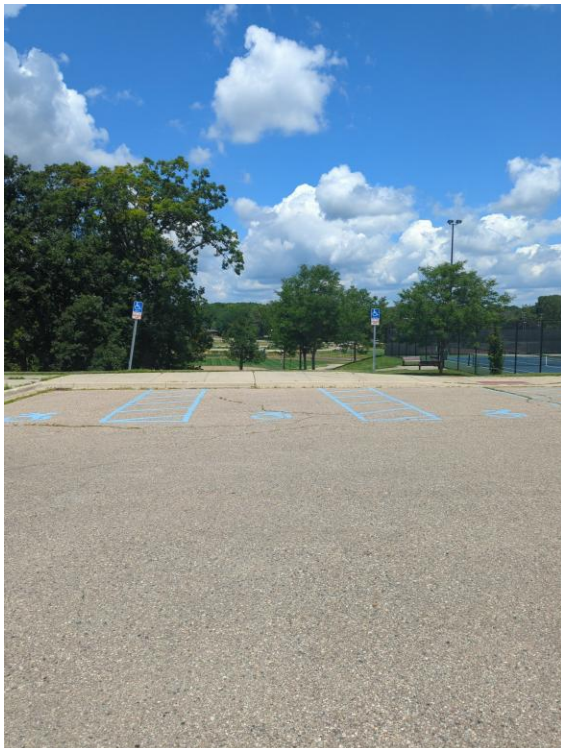
Three accessible parking stalls facing the park, the right stall is "van accessible" but missing the sign.

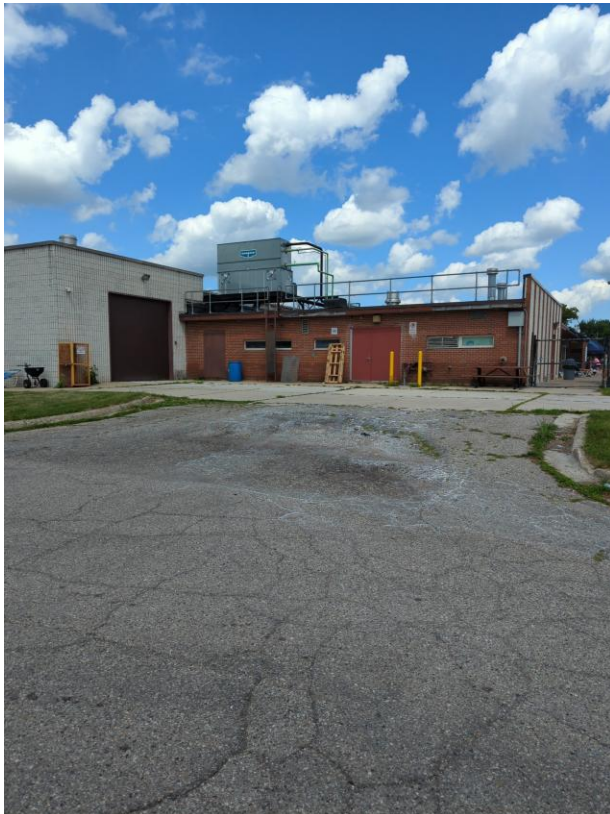
Asphalt is broken connecting west side parking lot with west side ice rink entrance

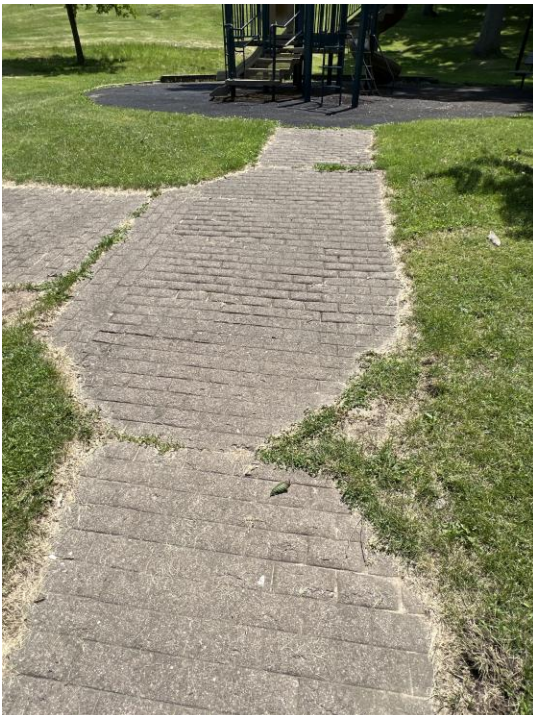
Sidewalk surfacing cracks/openings are too large and growing grass.

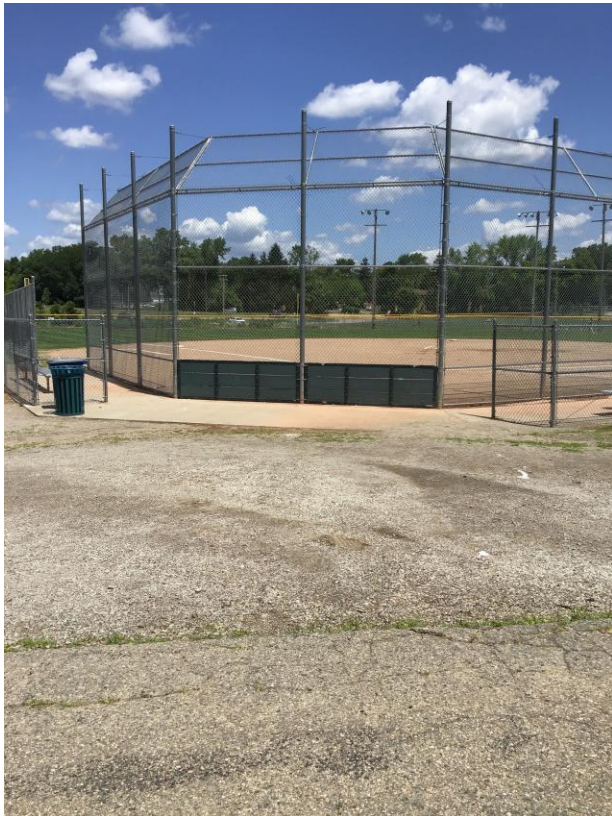
Fields 2 and 3 adjacent to the concessions building are missing accessible routes to asphalt path.

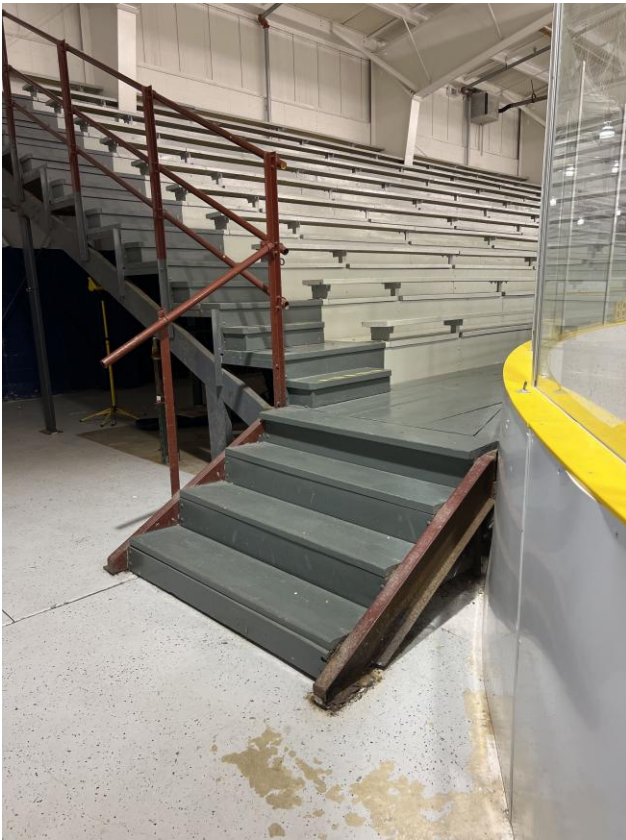
Finding #86 Continued

Missing handrail extension

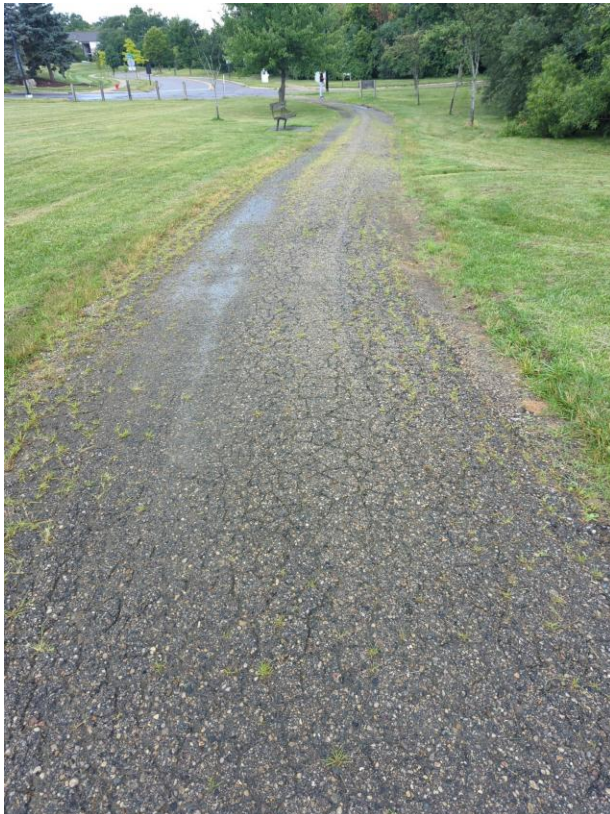
Asphalt is too broken up with vegetation growing between the cracks

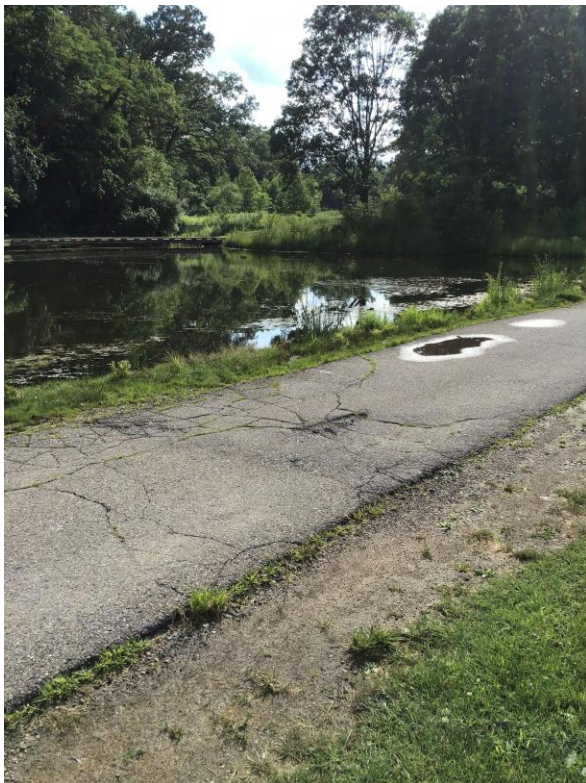
The trail surface is damaged and not accessible, with vertical changes in level and openings greater than 1/2-inch.

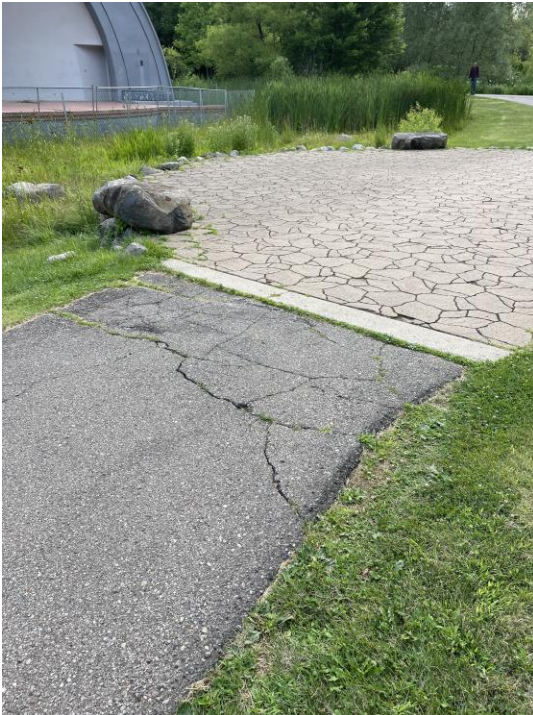
There are cracks on the trail that creates vertical changes in level greater than 1/4-inch and/or openings greater than 1/2-inch.
