Site Accessibility Evaluation

Allmendinger Park
655 Pauline Blvd
Ann Arbor, MI 48104
ADA Only

Inspection Date: 07/11/2022

Report Date: 11/15/2022

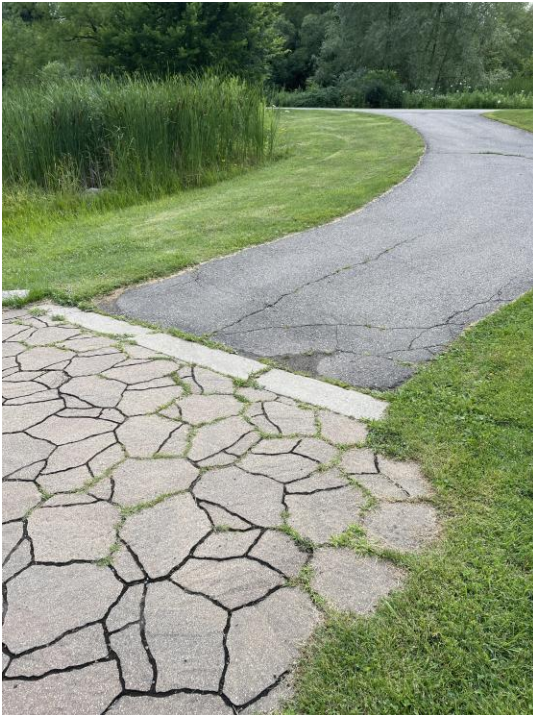
There are cracks on the trail that creates vertical changes in level greater than 1/4-inch and/or openings greater than 1/2-inch.

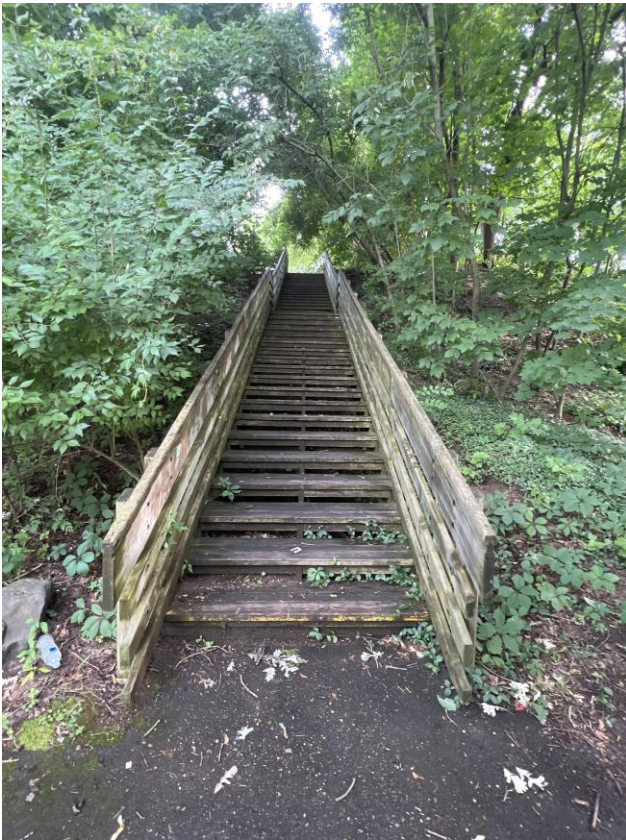
Finding #10 Continued

The stairway is missing accessible handrails

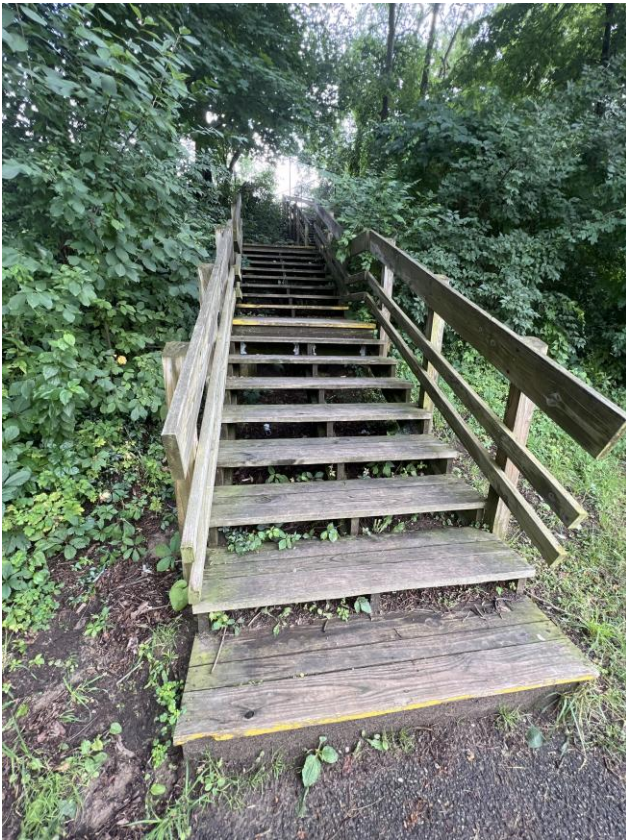
Finding #28 Continued

The stairway is missing accessible handrails

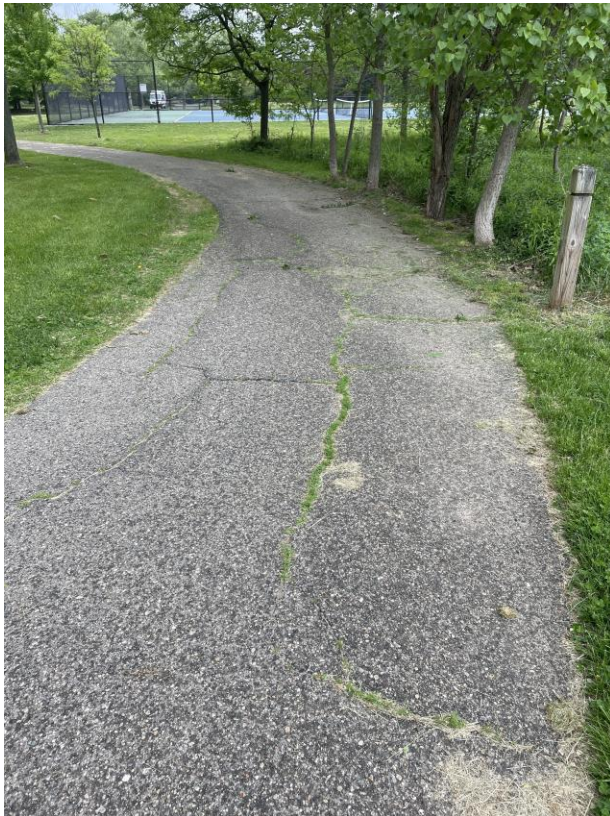
The sidewalk that forms part of the accessible route has loose gravel

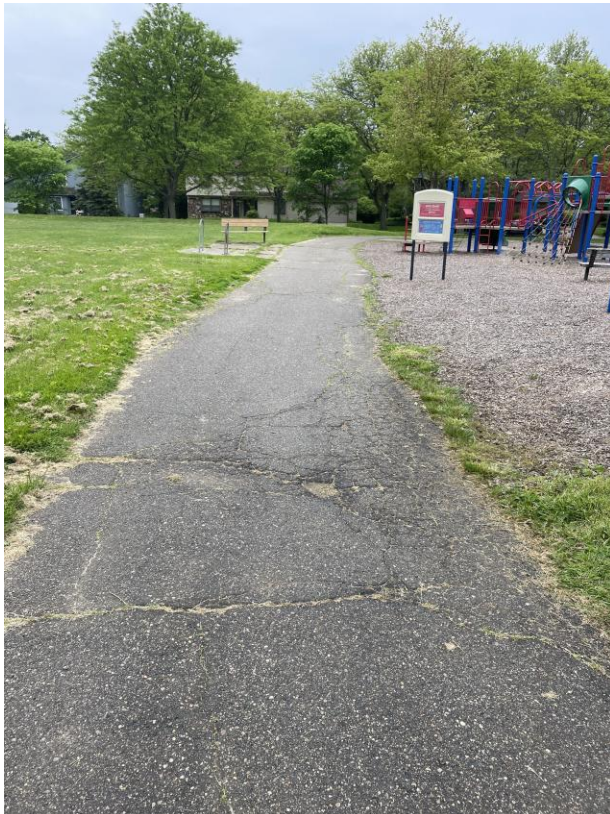
The sidewalk that forms part of the accessible route has loose gravel
