Report of Inspection / Test

Annual NFPA 25

2023-09-29

Baker Commons
106 Packard
Ann Arbor MI 48104
Tim Olivier
Print Date: 2023-10-02

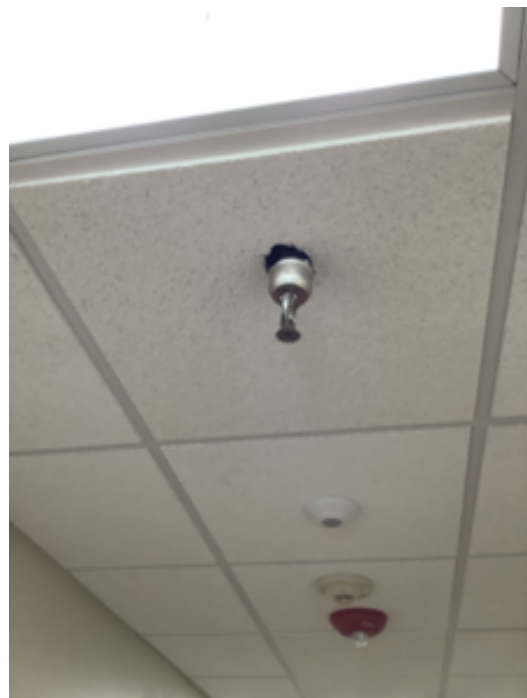
Deficiency #1 - Photo #1

Are all visible sprinkler heads properly adjusted with listed escutcheons in place?: No

Notes: 1st Floor hallway (ar2)
1st floor men's restroom (ar1)
1st floor women's restroom (ar1)
Outside of community room (ar1)
3rd floor hallway (adj1) conduit

Date Taken: August 21, 2019
Comments: 1st floor near room 110

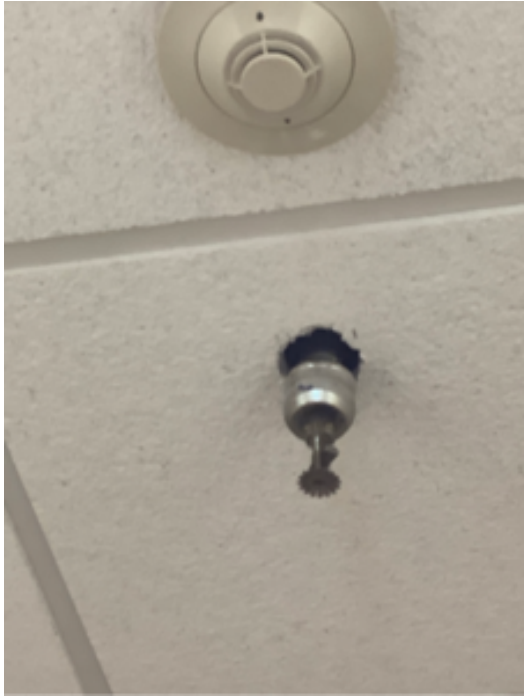
Deficiency #1 - Photo #2

Date Taken: August 21, 2019
Comments: 1st floor near room 103

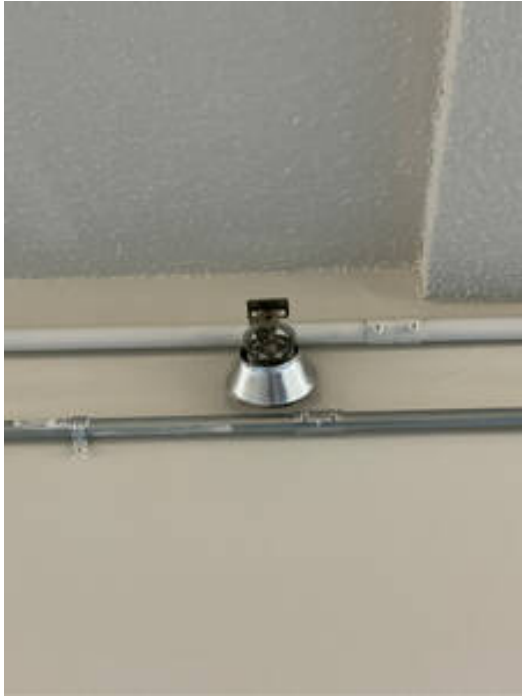
Deficiency #1 - Photo #3

Date Taken: September 29, 2023
Comments: 3rd floor adj 1 conduit in the way

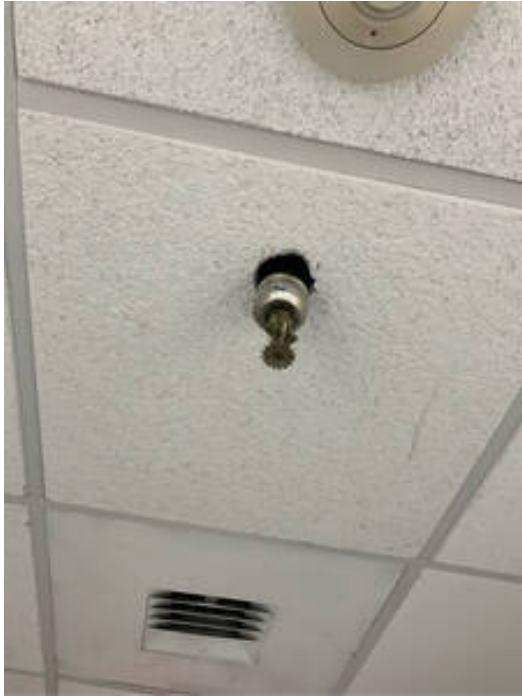
Deficiency #1 - Photo #4

Date Taken: September 29, 2023
Comments: 1st Floor hallway (ar1)

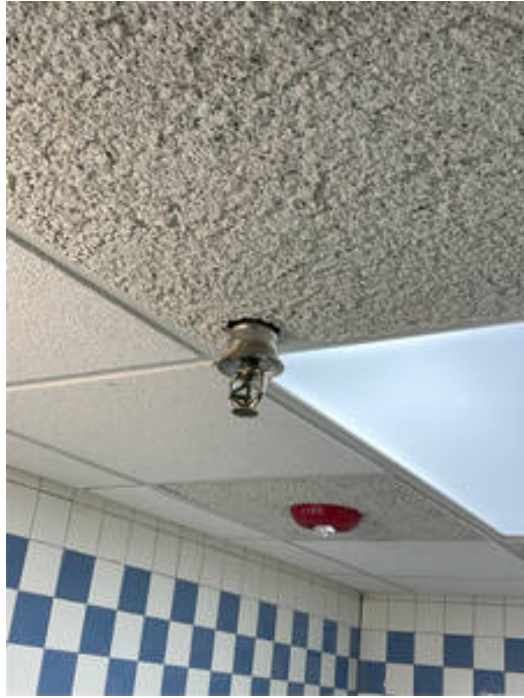
Deficiency #1 - Photo #5

Date Taken: September 29, 2023
Comments: 1st floor men's restroom

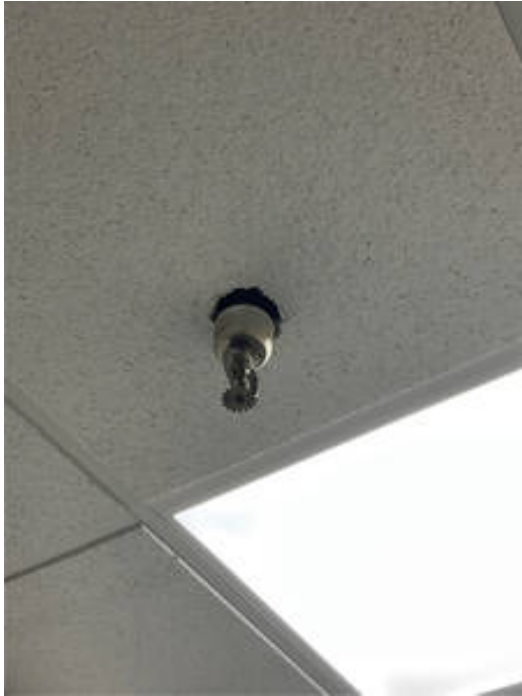
Deficiency #1 - Photo #6

Date Taken: September 29, 2023
Comments: 1st floor hallway

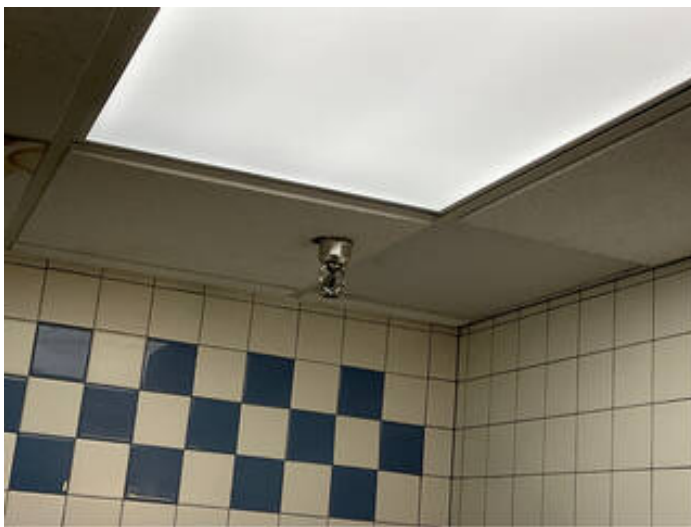
Deficiency #1 - Photo #7

Date Taken: September 29, 2023
Comments: 1st floor women's restroom

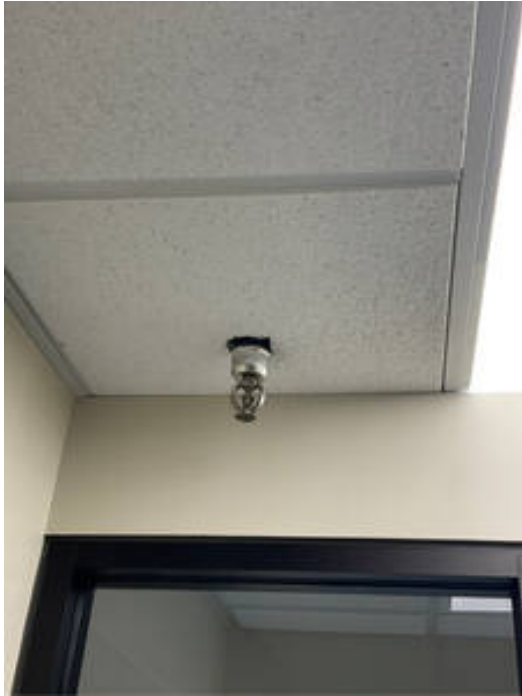
Deficiency #1 - Photo #8

Date Taken: September 29, 2023
Comments: Outside of Community Room (ar1)

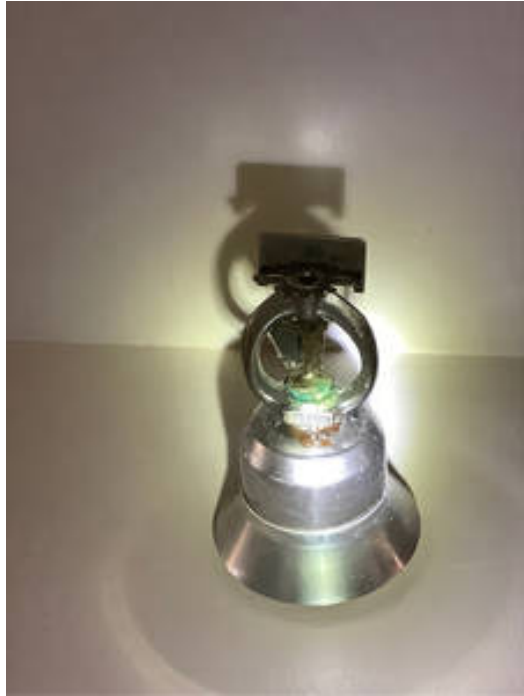
Deficiency #2 - Photo #1

Do all visible sprinkler heads appear to be free of damage/foreign materials?:

Notes: 5th Floor hallway (4) corroded
4th Floor hallway (1) corroded

Date Taken: September 24, 2021
Comments: 5th Floor hallway (4) corroded

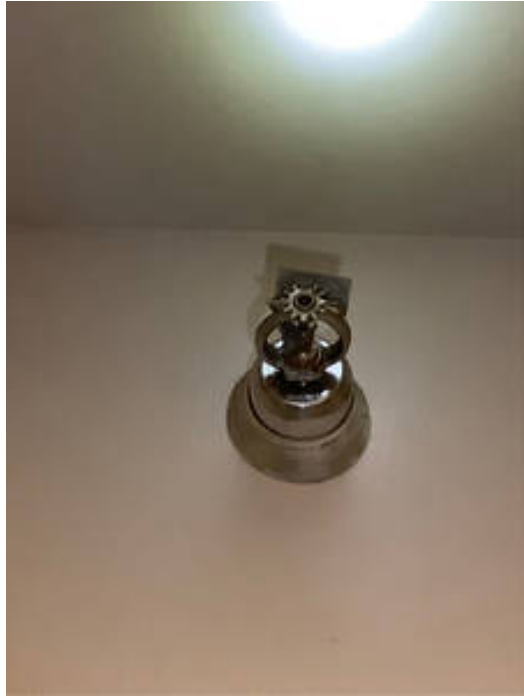
Deficiency #2 - Photo #2

Date Taken: September 24, 2021
Comments: 5th Floor at elevator bent deflector

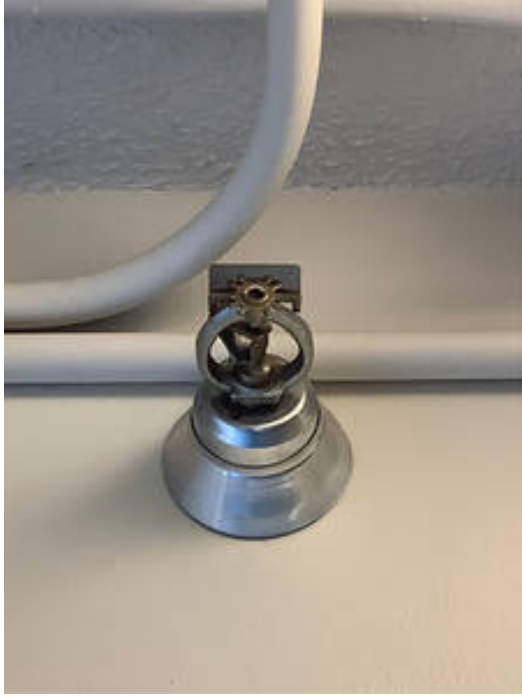
Deficiency #2 - Photo #3

Date Taken: September 24, 2021
Comments: 4th Floor bent deflector at 414

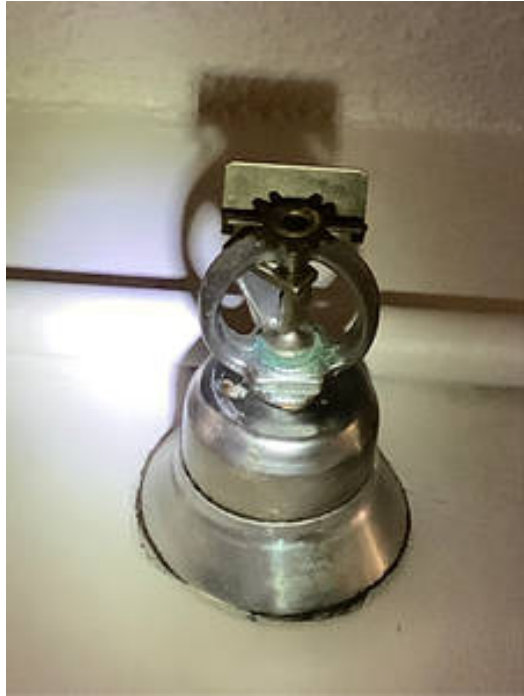
Deficiency #2 - Photo #4

Date Taken: September 24, 2021
Comments: 4th Floor hallway (1) corroded

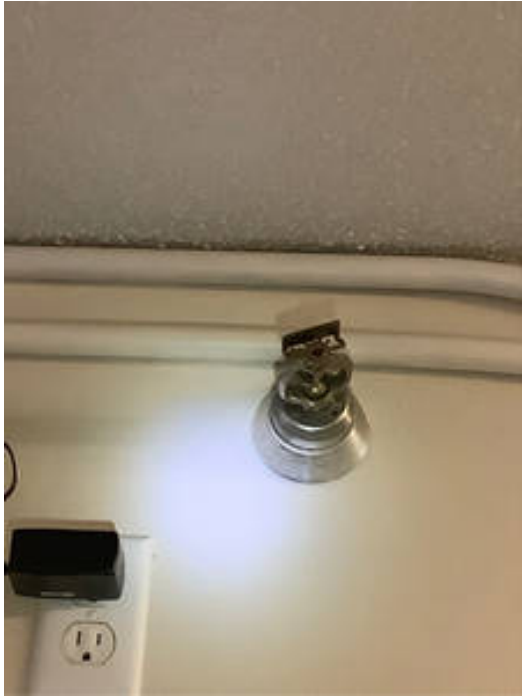
Deficiency #2 - Photo #5

Date Taken: September 24, 2021
Comments: 3rd floor hallway adjust

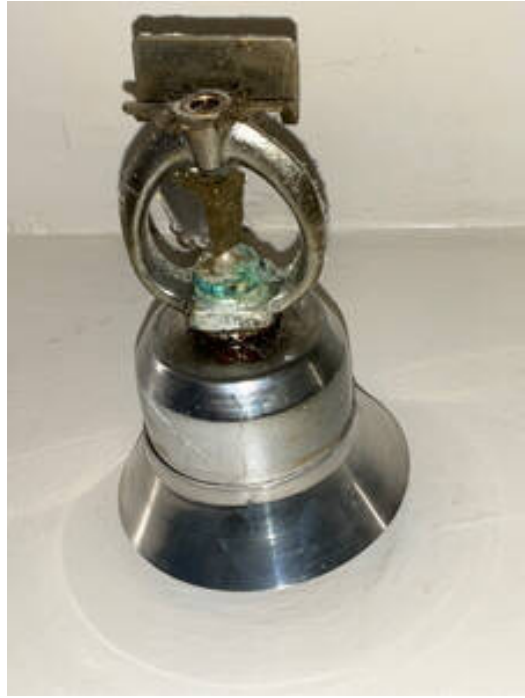
Deficiency #2 - Photo #6

Date Taken: September 29, 2023
Comments: 5th near 509

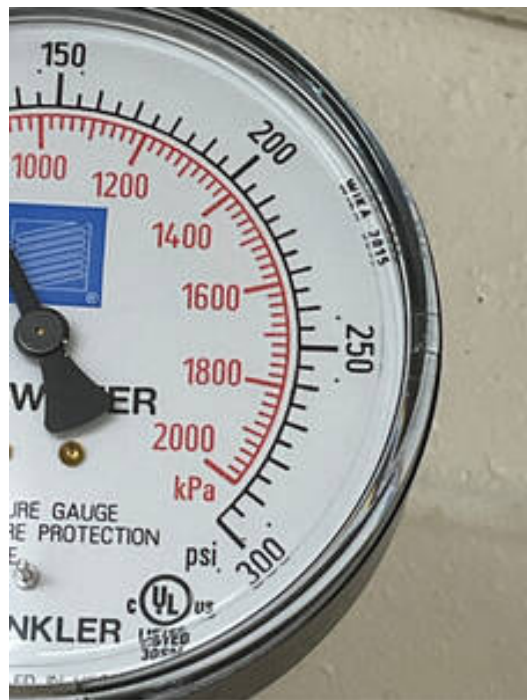
Deficiency #12 - Photo #1

Are gauge(s) in good condition and less than 5 years old? (Replacement required every 5 years): No

Notes: Replace (1) outdated gauge(s) as required.

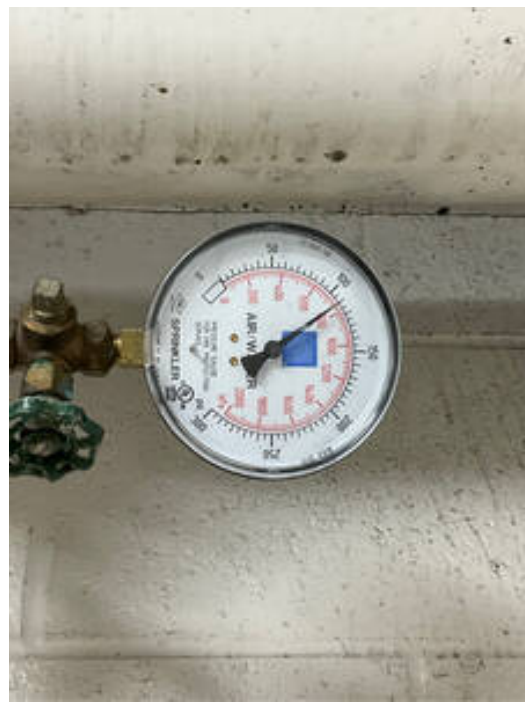
Deficiency #15 - Photo #1

Are gauge(s) in good condition and less than 5 years old? (Replacement required every 5 years): No

Notes: Replace (1) outdated gauge(s) as required.

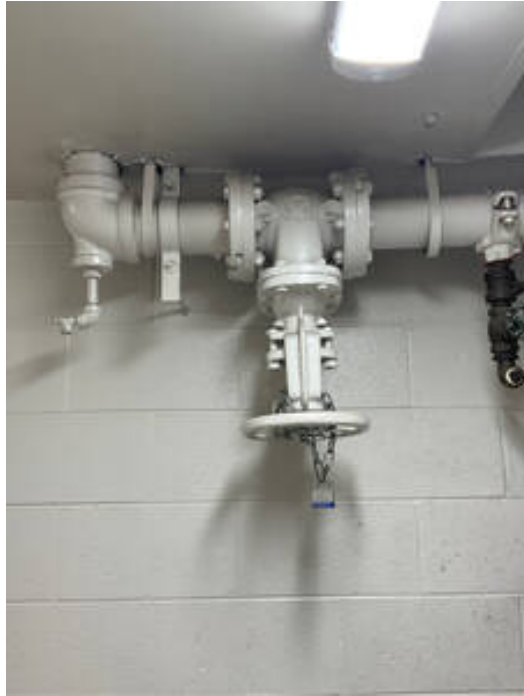
Deficiency #17 - Photo #1

| System | Description | Location | Valve Type | Size | Secured | Open | Easily Accessible | Signs | Exercised | Stems Lubricated | Flow Pass | Tamper Pass |
|---|---|---|---|---|---|---|---|---|---|---|---|---|
| Wet | Roof Header | 5th Stair | OS&Y | 4 " | Locked | No | Yes | No | No | Yes | N/A | N/A |
