Asbestos-Containing Materials Inspection
1474-1484 West Liberty Street
Ann Arbor, Michigan 48103

Ann Arbor Housing Development Corporation

April 4, 2023

ASTI Project No. 12703

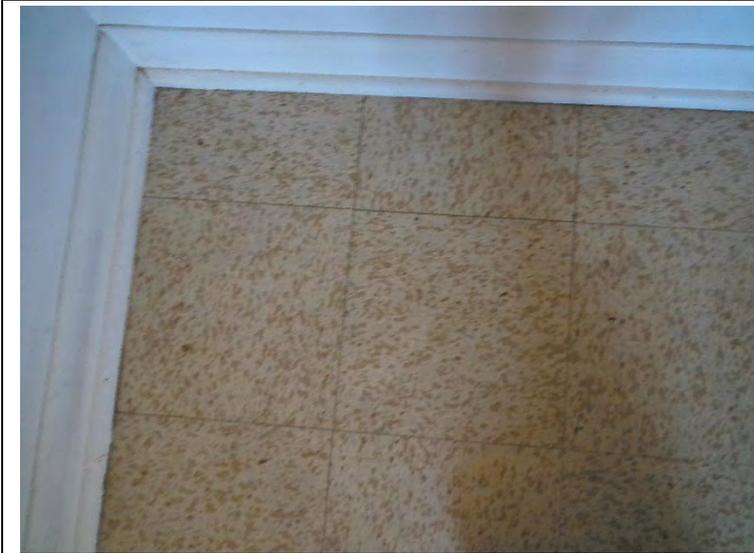
HA	Material/Description	Location	Asbestos Result
7	9" x 9" vinyl floor tile / Beige with tan spots	Throughout Buildings: 1474-1484 Some of the 9"x 9" floor tile is beneath carpet	1.25% Chrysotile (PC)
12	Linoleum / Brown & tan with pebble pattern	1474 Laundry room, 1484 2 nd floor landing	30% Chrysotile

According to classification guidelines set forth in NESHAP, the 9" x 9" vinyl floor tile and linoleum is classified as Category I non-friable ACMs. These materials in their current condition represents minimal risk of fiber release. If renovation or demolition would disturb these materials, ASTI recommends the ACMs be removed by a licensed abatement contractor prior to disturbance.

Photo 5. View of the asbestos-containing 9" x 9" floor tile

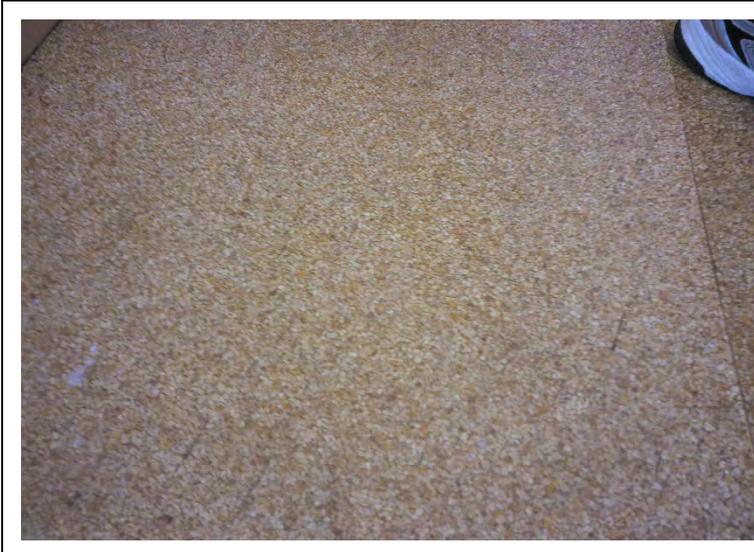
Photo 6. View of the asbestos-containing linoleum pebble pattern

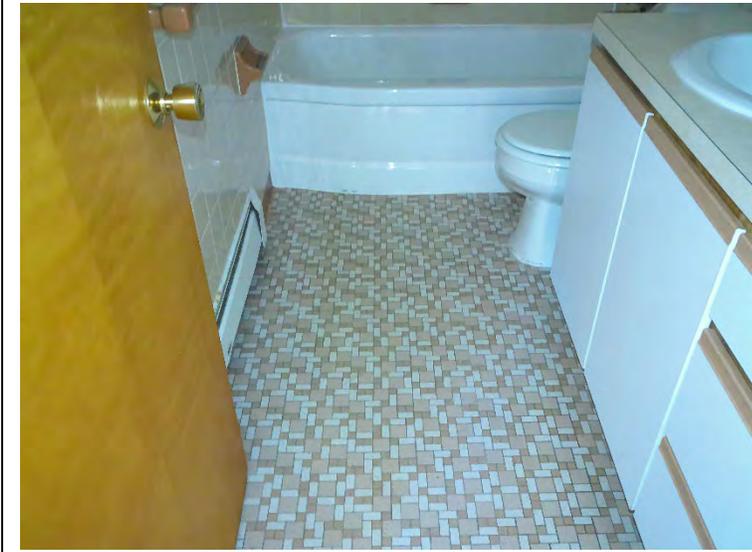
According to classification guidelines set forth in NESHAP, the bathtub undercoating and roofing materials are assumed to contain asbestos and are classified as Category II non-friable ACMs. Until testing of these materials is completed, they should be treated as Category II non-friable ACMs.

Photo 7. View of the bathtub with presumed undercoating
