Rental Assistance Demonstration (RAD): **PART 1: PHYSICAL CONDITION ASSESSMENT**

221-253 South Seventh Street, Ann Arbor, Michigan 48103

PROJECT # 8358E-1-96

DATE September 30, 2013
Revised September 15, 2014

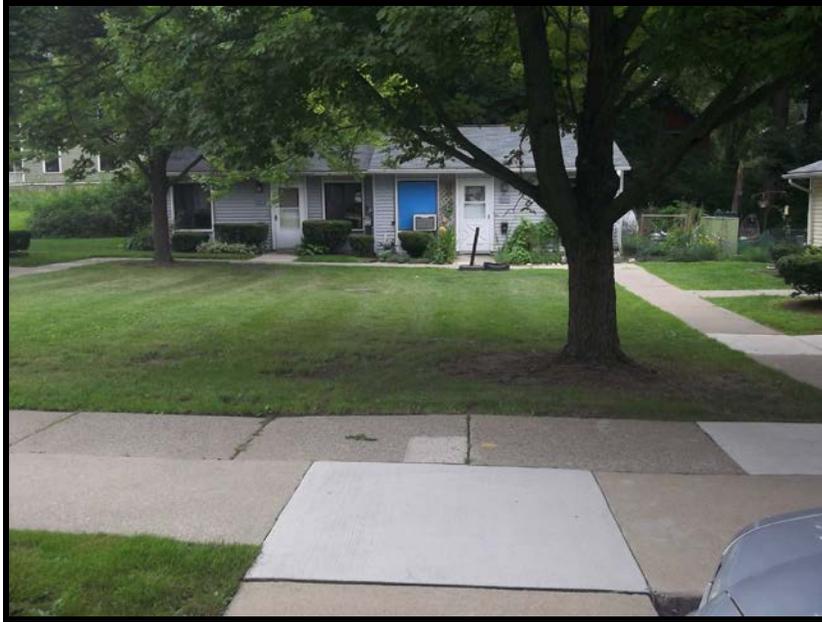
PHOTOGRAPH NO. 1: TYPICAL VIEW OF TENANT UNIT BUILDING

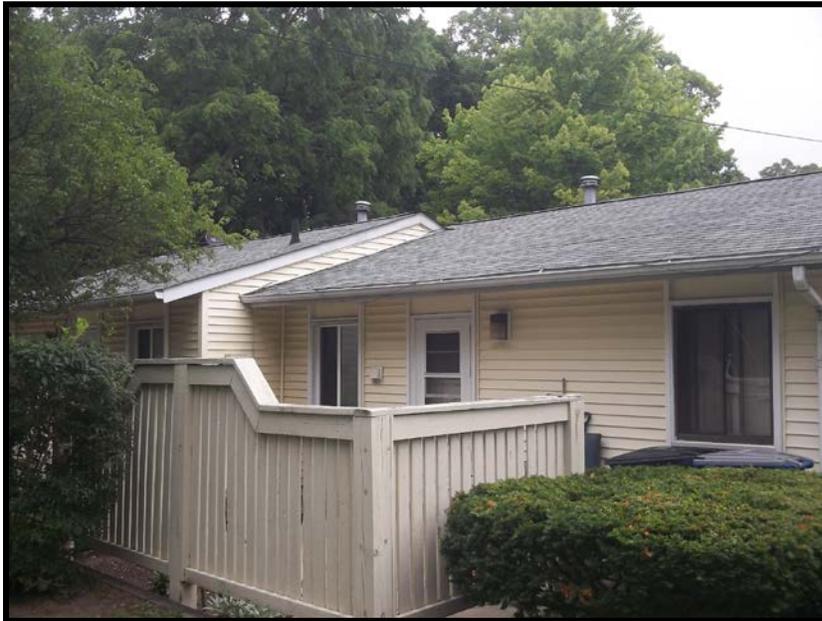
PHOTOGRAPH NO. 2: TYPICAL VIEW OF REAR OF TENANT BUILDING

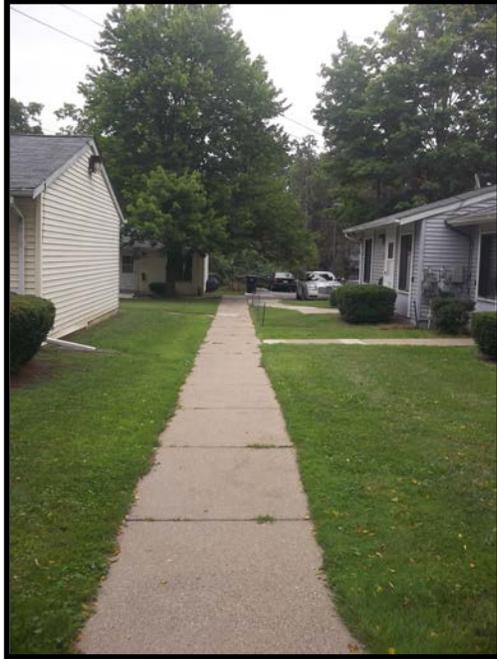
The flat work surrounding the building was observed to be in generally good condition. The steps at resident entries may not meet tread depth and riser height requirements and restrictions.

PHOTOGRAPH NO. 3: TYPICAL VIEW OF LANDSCAPING AND FLATWORK THROUGHOUT SUBJECT PROPERTY

Repair and maintain broken concrete walkways around the subject property to avoid continued degradation and possible trip hazards.

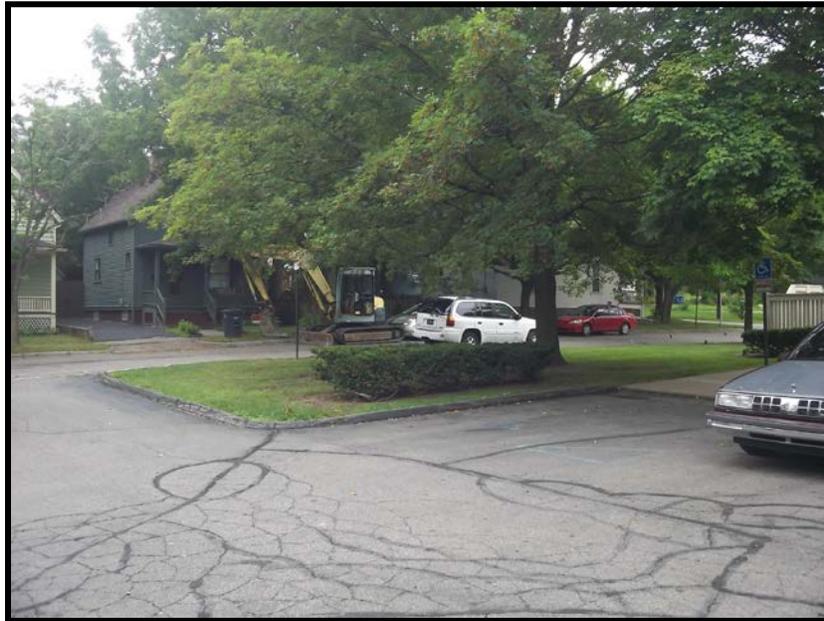
Overall, the asphalt and concrete paved areas appear to be in fair condition. However, longitudinal cracking and localized delamination was observed on the asphalt pavement drives and parking areas.

PHOTOGRAPH NO. 4: TYPICAL VIEW OF SUBJECT PROPERTY PARKING LOT

Longitudinal crack filling, seal coating, and re-striping of the asphalt pavement and sidewalk are recommended as a rehab item. Continued maintenance of paved areas is recommended. In addition, capital reserves should be considered for additional signage (accessibility, entry, and/or directional), future maintenance, and/or replacement and repair of paved areas. Please refer to the attached 20 Year Detail, 20 Year Schedule, and Capital Needs Input for additional information on condition, rehab costs and capital reserves.

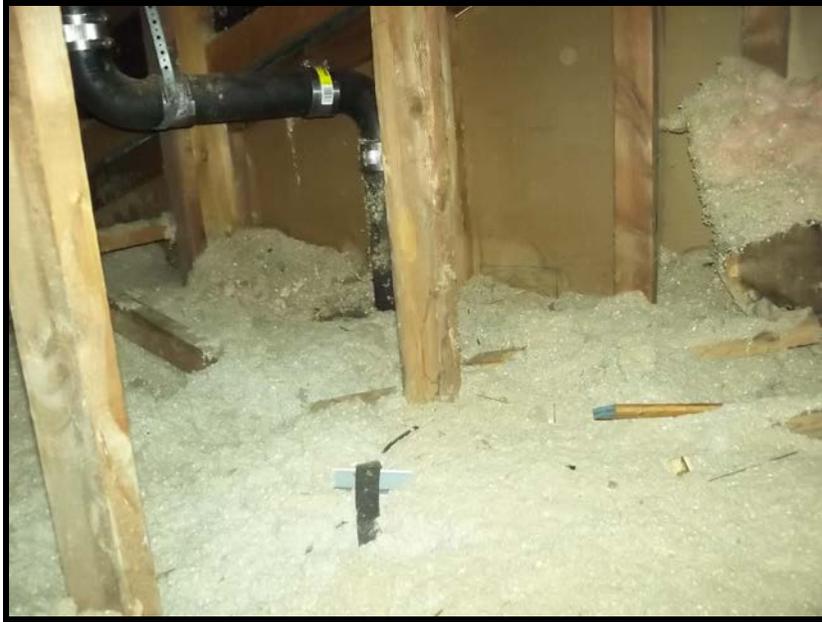
PHOTOGRAPH NO. 5: TYPICAL VIEW OF ATTIC INSULATION IN TENANT UNITS

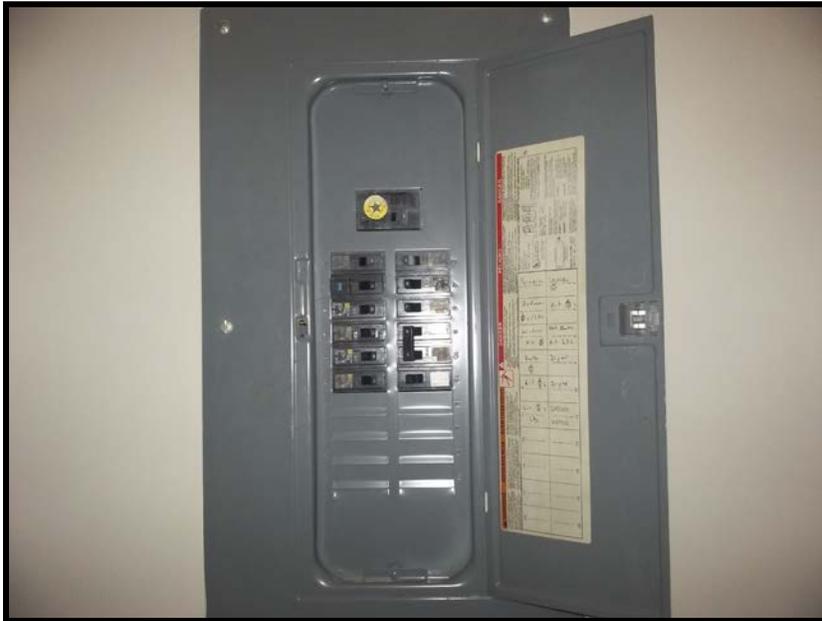
PHOTOGRAPH NO. 6: TYPICAL VIEW OF ELECTRICAL PANELS IN TENANT UNITS

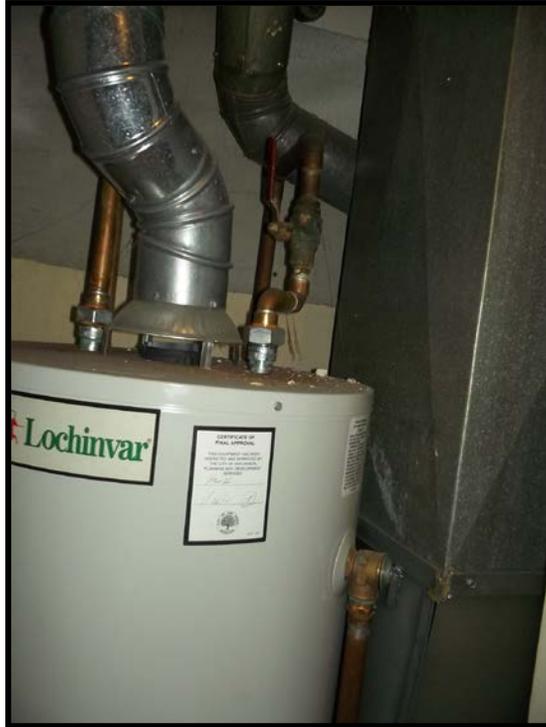
PHOTOGRAPH NO. 7: TYPICAL VIEW OF HOT WATER HEATERS IN TENANT UNITS

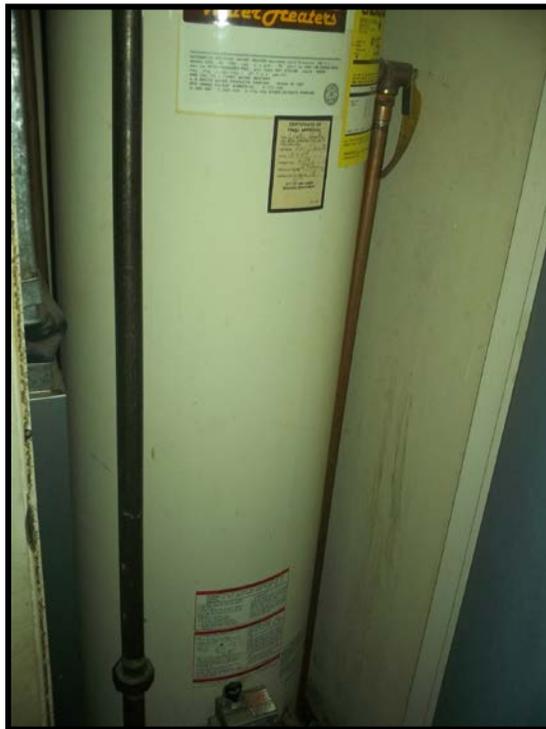
PHOTOGRAPH NO. 8 VIEW OF HOT WATER HEATER IN UNIT 221

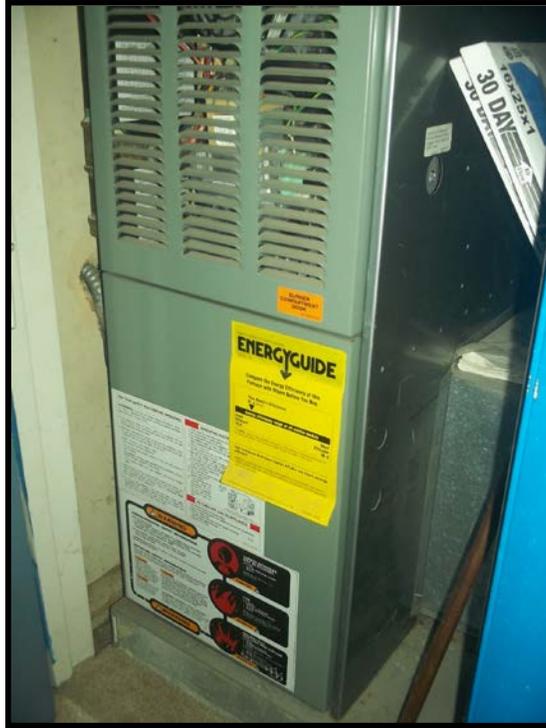
PHOTOGRAPH NO. 9: TYPICAL VIEW OF FURNACES IN TENANT UNITS

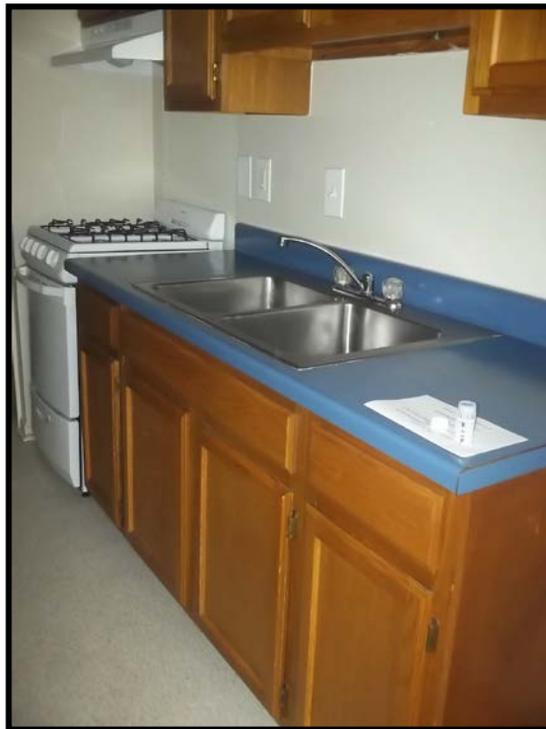
PHOTOGRAPH NO. 10: TYPICAL VIEW OF TENANT UNIT KITCHEN

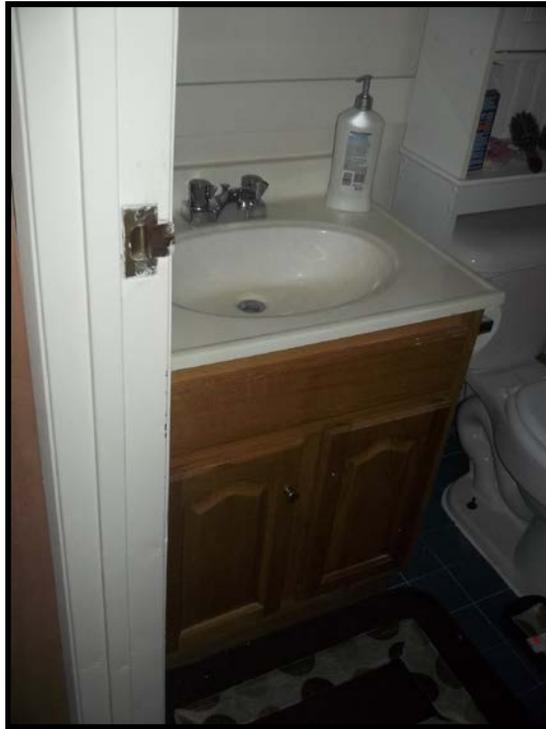
PHOTOGRAPH NO. 12: TYPICAL VIEW OF TENANT UNIT BATHROOM

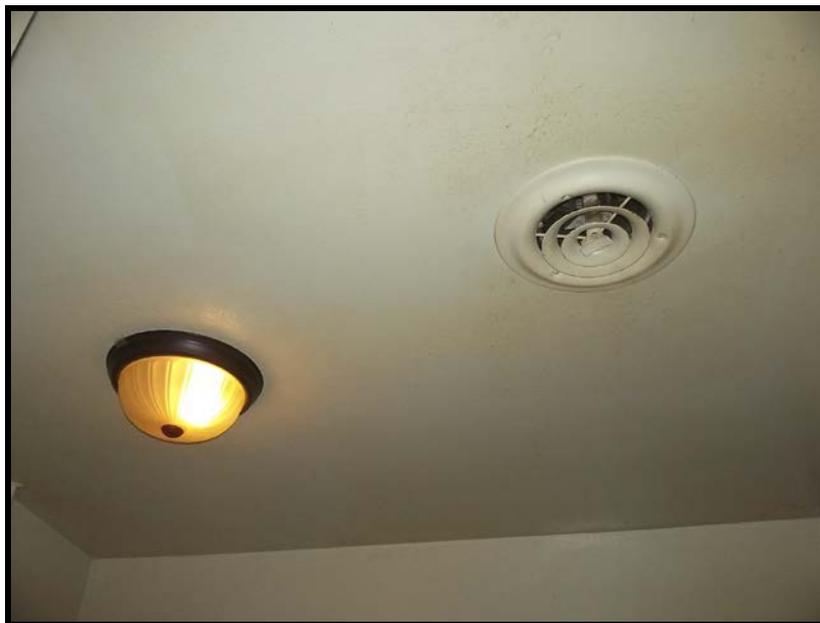
PHOTOGRAPH NO. 13: TYPICAL VIEW OF TENANT UNIT LIGHT FIXTURES

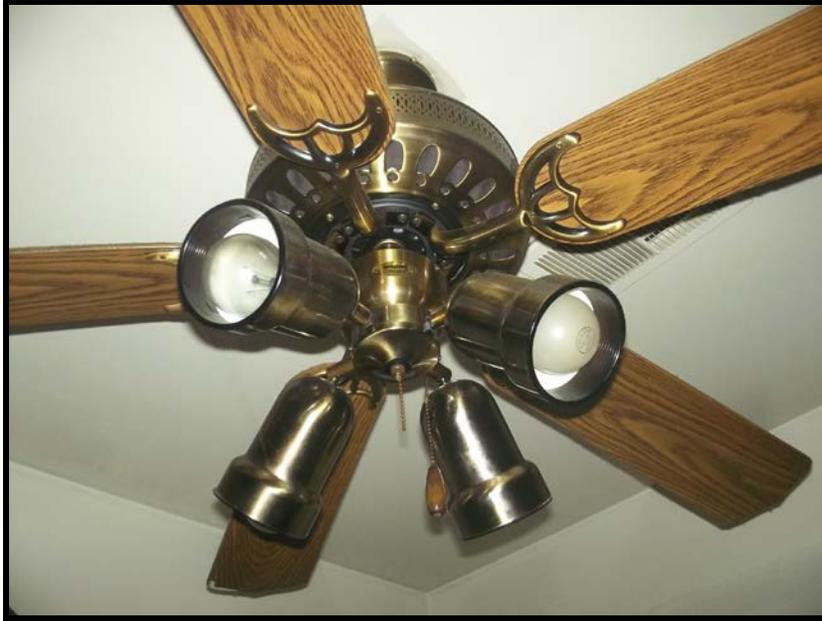
PHOTOGRAPH NO. 15: TYPICAL VIEW OF TENANT UNIT CEILING FANS

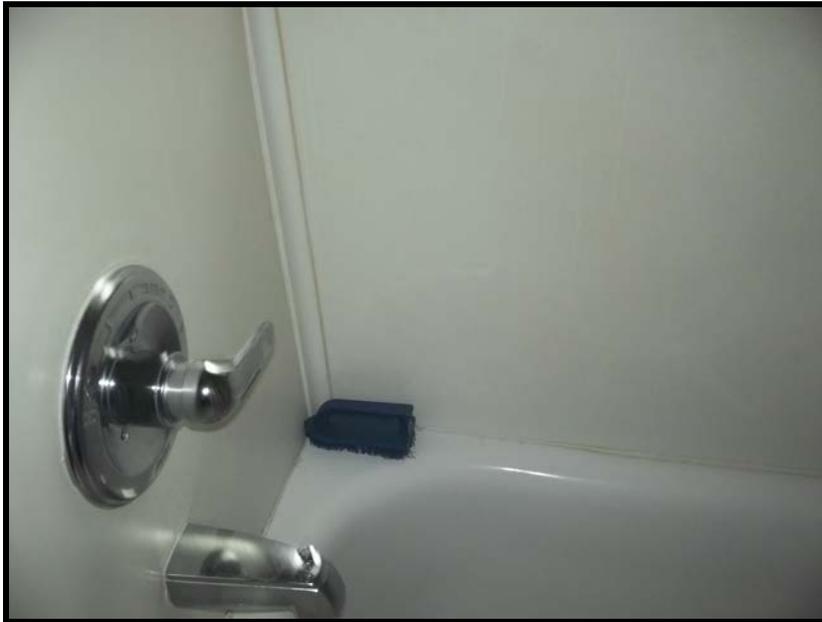
PHOTOGRAPH NO. 16: TYPICAL VIEW OF TENANT UNIT TUB AND ASSOCIATED VINYL ENCLOSURE

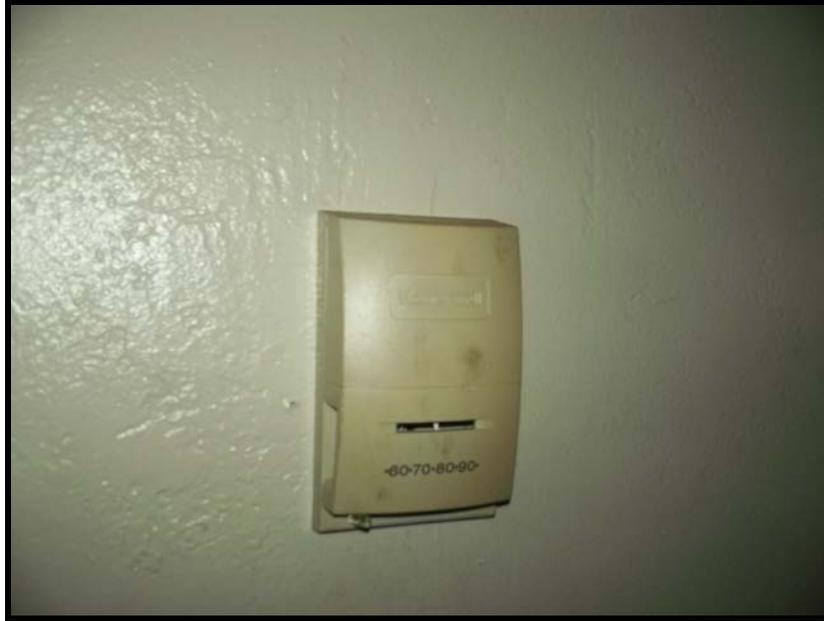
PHOTOGRAPH NO. 17: TYPICAL VIEW OF TENANT UNIT THERMOSTAT

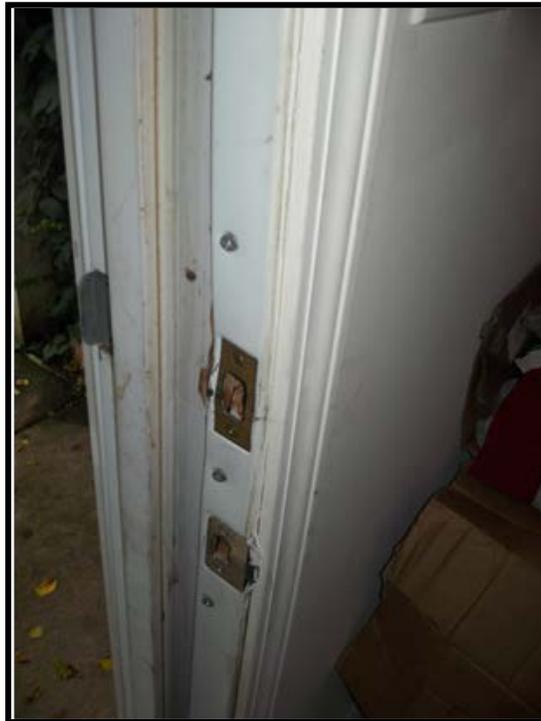
The vinyl siding, decorative wood, screen doors, and steel entry doors generally appeared to be in good condition. However, the windows are beyond their EUL. New double-paned, low E windows were installed in October 2013. In addition, the door frame associated with the rear door on Unit 241 was observed to be damaged.

PHOTOGRAPH NO. 18: VIEW OF DAMAGED DOOR FRAME IN TENANT UNIT 241

Replacement of damaged doors is recommended as a rehab item. Continued maintenance of siding, soffits, fascia, gutters and downspouts, windows and doors is recommended. In addition, capital reserves should be considered for future, cleaning and/or re-caulking of the building exteriors.

- replace the rear entry door and hardware associated with Unit 241
- replace or repair 100-percent of the tenant unit flooring, as appropriate
- paint Units 221, 233, 241, 243, and 251
- replace 100-percent of the bathroom fans with high-efficiency fixtures and vent through roof
- miscellaneous carpentry for unit repairs
- placement of additional attic insulation
- install soundproofing between tenant units
- install radon mitigation system in tenant unit 223 building
- integrate a pest management policy

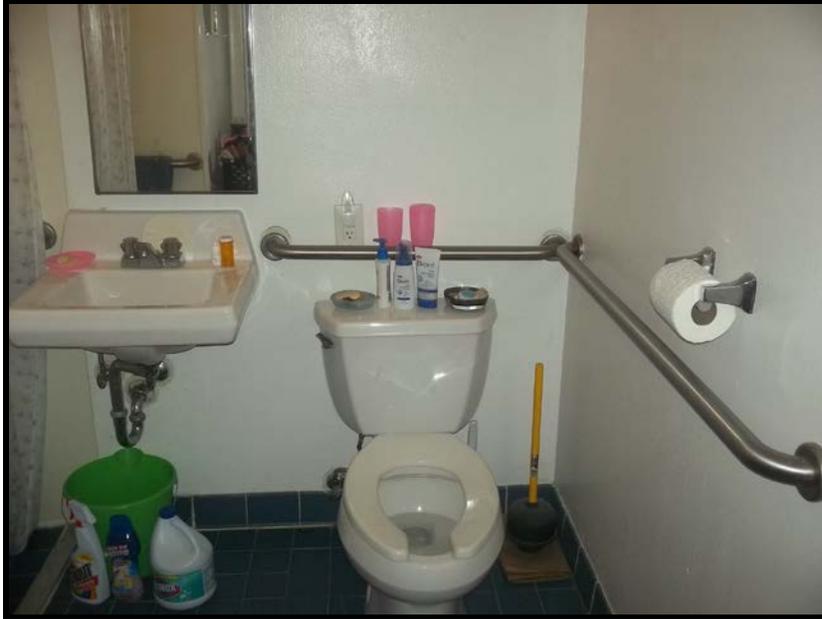
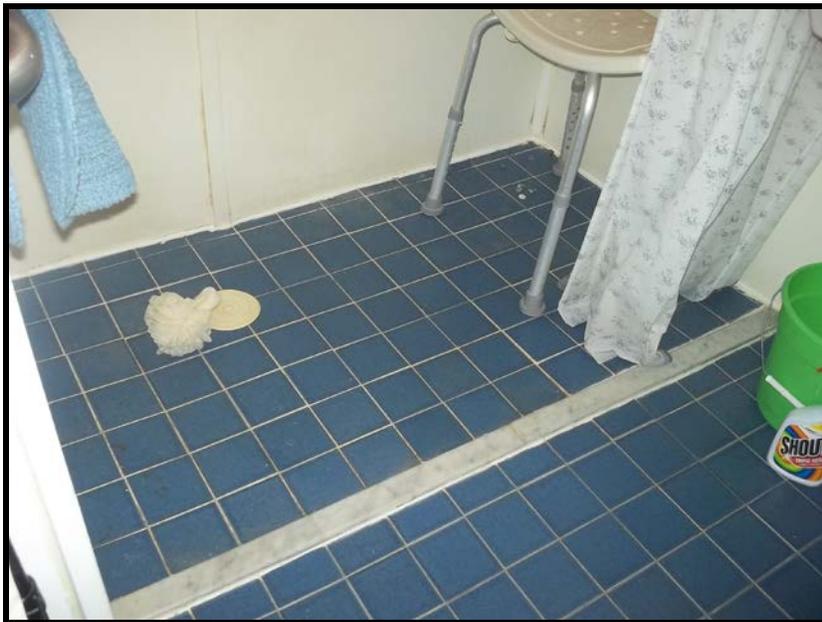
PHOTOGRAPH NO. 19: VIEW OF ADA UPGRADES TO UNIT 251
