Asbestos-Containing Materials Inspection
528 Virginia Avenue
Ann Arbor, Michigan 48103

Ann Arbor Housing Development Corporation

April 4, 2023

ASTI Project No. 12703

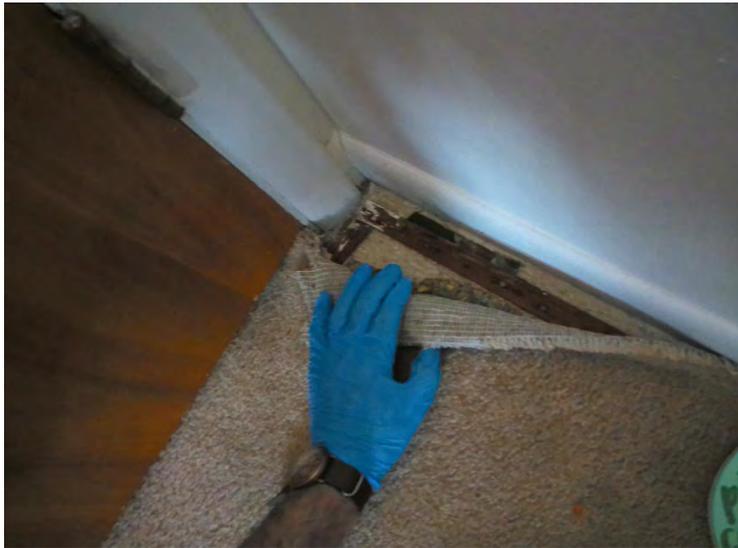
HA	Material/Description	Location	Asbestos Result
10	9" x 9" vinyl floor tile / Beige	Beneath carpet in bedroom 3 and likely throughout 528 - unit 1	1.75% Chrysotile (PC)

According to classification guidelines set forth in NESHAP, the 9" x 9" vinyl floor tile is classified as a Category I non-friable ACM. This material in it's current condition represents minimal risk of fiber release. If renovation or demolition would disturb this material, ASTI recommends the ACM be removed by a licensed abatement contractor prior to disturbance.

Photo 3. View of the asbestos-containing floor tile beneath the carpet
