Asbestos-Containing Materials Inspection
1540-1582 Siller Terrace
Ann Arbor, Michigan 48103

Ann Arbor Housing Development Corporation

April 4, 2023

ASTI Project No. 12703

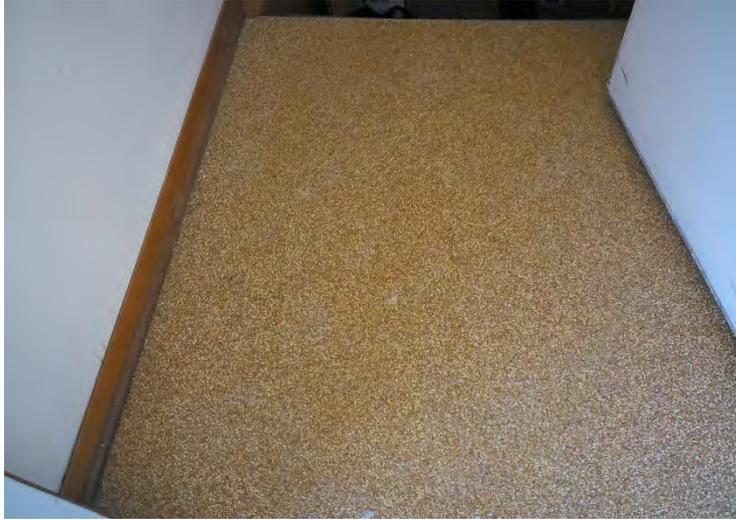
According to classification guidelines set forth in NESHAP, the linoleum is classified as Category I non-friable ACM. This material in its current condition represents minimal risk of fiber release. If renovation or demolition would disturb this material, ASTI recommends the ACM be removed by a licensed abatement contractor prior to disturbance.

Photo 4. View of the asbestos-containing linoleum in the entry area

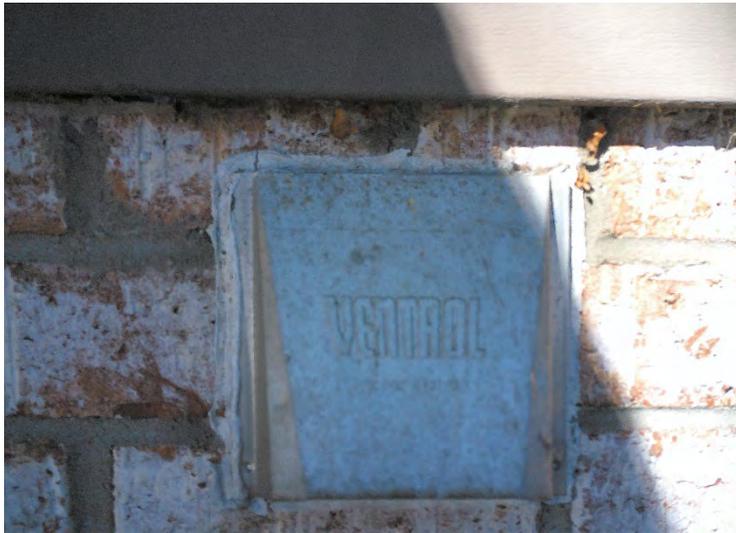
According to classification guidelines set forth in NESHAP, the dryer vent caulk is classified as Category II non-friable ACM. This material appeared to be in good condition and presents minimal risk of fiber release. If renovation or demolition would disturb this material, ASTI recommends it be removed by a licensed abatement contractor prior to disturbance.

Photo 5. View of the asbestos-containing dryer vent caulk

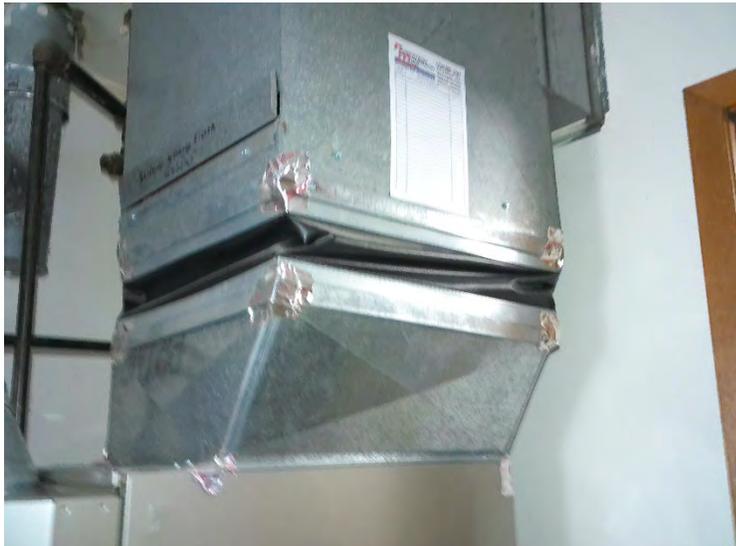
According to classification guidelines set forth in NESHAP, the vibration dampener, bathtub undercoating and/or surround adhesive and roofing materials are assumed to contain asbestos and are classified as Category II non-friable ACMs. Until testing of these materials is completed, they should be treated as Category II non-friable ACMs.

Photo 6. View of the presumed asbestos-containing vibration dampener

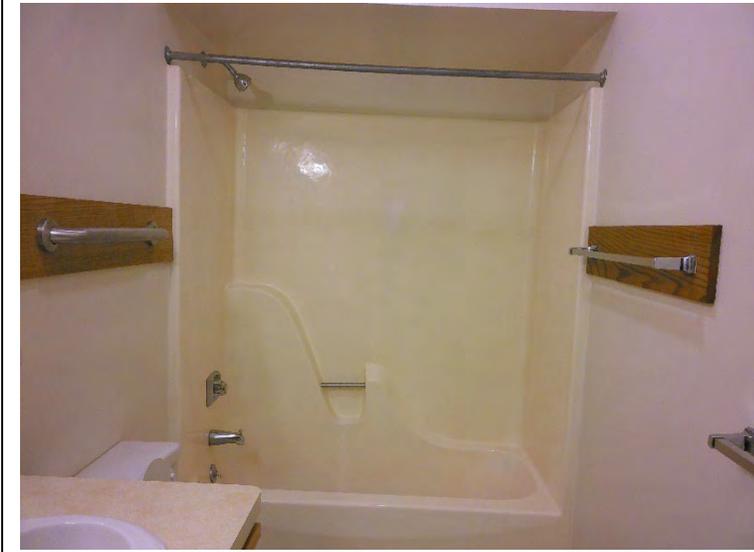
Photo 7. View of the presumed asbestos-containing bathtub undercoating and surround adhesive
