**PHASE I ENVIRONMENTAL SITE ASSESSMENT  
LURIE TERRACE APARTMENTS  
600 WEST HURON STREET AND 3 PARKVIEW PLACE  
ANN ARBOR, WASHTENAW COUNTY, MICHIGAN**

**D3G PROJECT NUMBER:  
2020-0252**

**REPORT ISSUE DATE:  
AUGUST 17, 2020**

**INSPECTION DATE:  
MARCH 10, 2020**

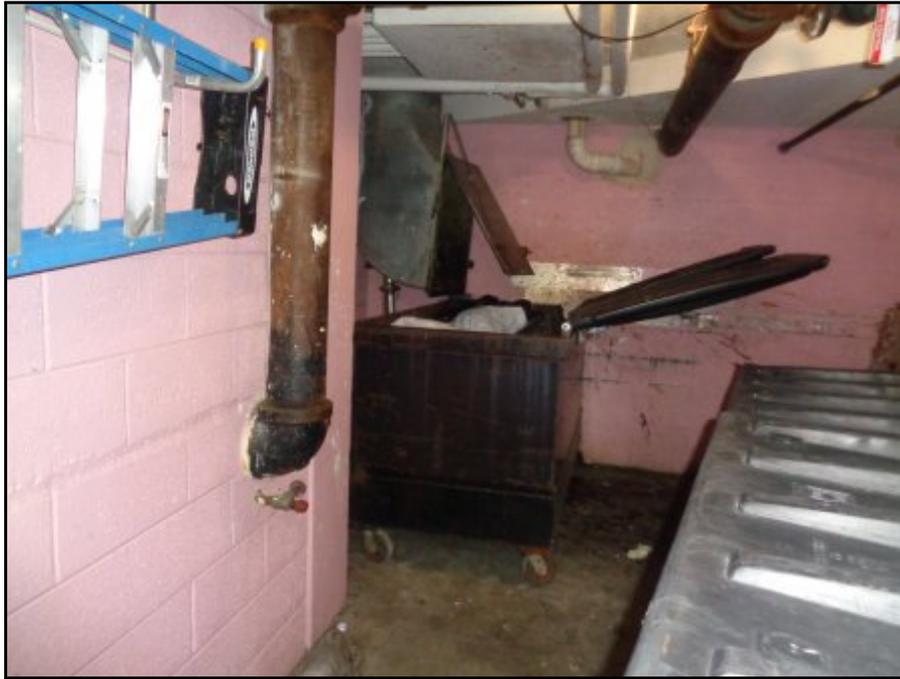
Located in designated areas of the property are various solid waste dumpsters. No staining and/or visual signs of spillage were observed in the vicinity of the dumpsters during the subject property visit.

17 : View of trash room and dumpsters

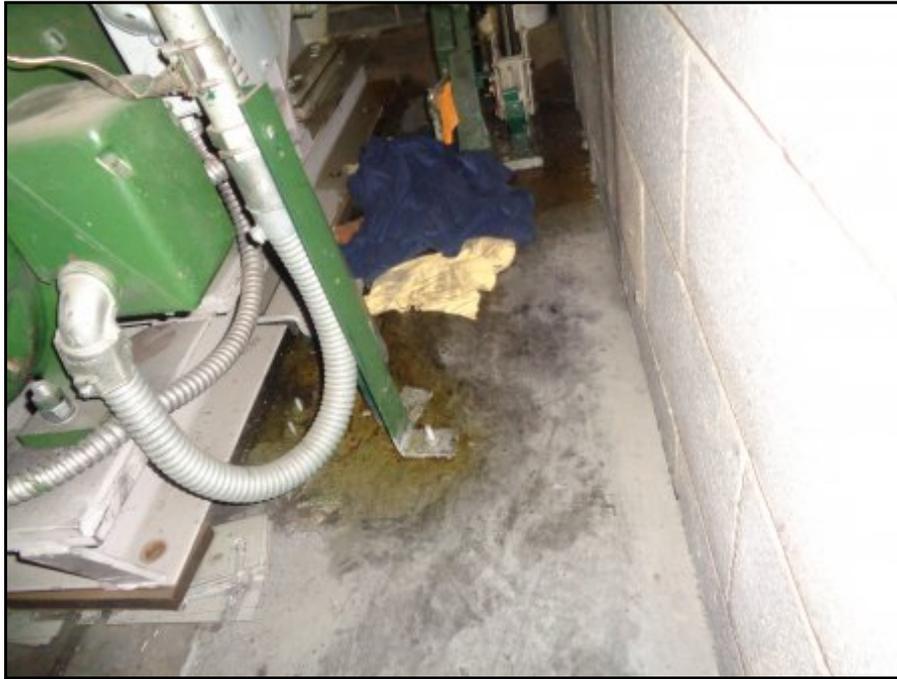
Two (2) hoist elevators are located at the subject property. Significant leakage was observed on the concrete surface surrounding the elevator equipment and in a bucket within the elevator equipment room. Based on the observed conditions, the on-site hoist elevator oil leakage is considered an environmental condition for which further action is recommended. Recommendations are listed in Section 11.0 of this report.

21 : View of elevator equipment leakage and staining

(3) D3G recommends that the leaking hoist elevator equipment be repaired to proper working order and that the spilled oil is disposed of in accordance with applicable regulations.

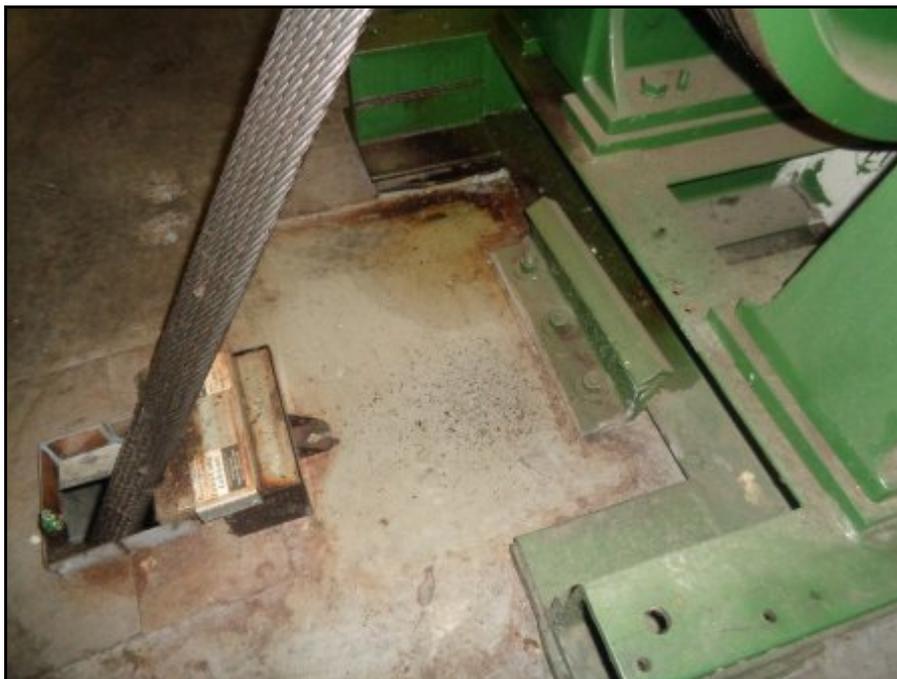
22 : View of elevator equipment leakage and staining

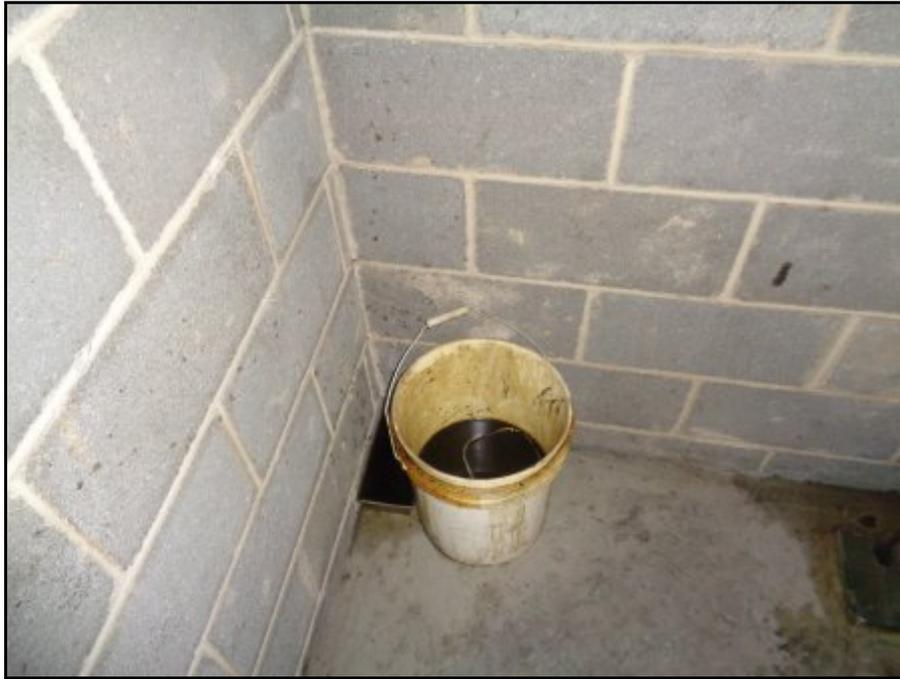
23 : View of elevator equipment leakage

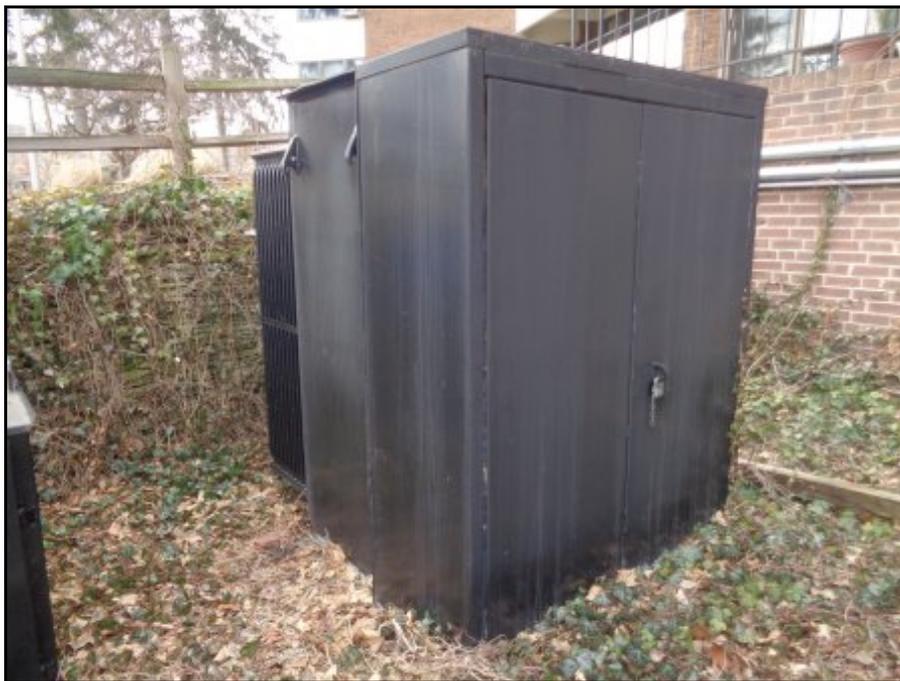
Located at an exterior location of the property is one (1) pad-mounted electrical transformer, which is owned and maintained by DTE Energy. The on-site electrical transformer was not affixed with a "Non-PCB" sticker and is therefore assumed to contain regulated levels of PCBs. However, leakage was not visually observed on or around the transformer and in its current physical condition it is not believed to present environmental concerns to the subject property.

28 : View of pad-mounted electrical transformer
