January 15, 2014

Re: Pre-Demolition Asbestos, Lead-Based Paint, and Universal and Hazardous Materials Survey Report

PARCEL TAX IDENTIFICATION NUMBER H-08-012-360-027
 3013 WEST HURON RIVER DRIVE, ANN ARBOR, WASHTENAW COUNTY, MI

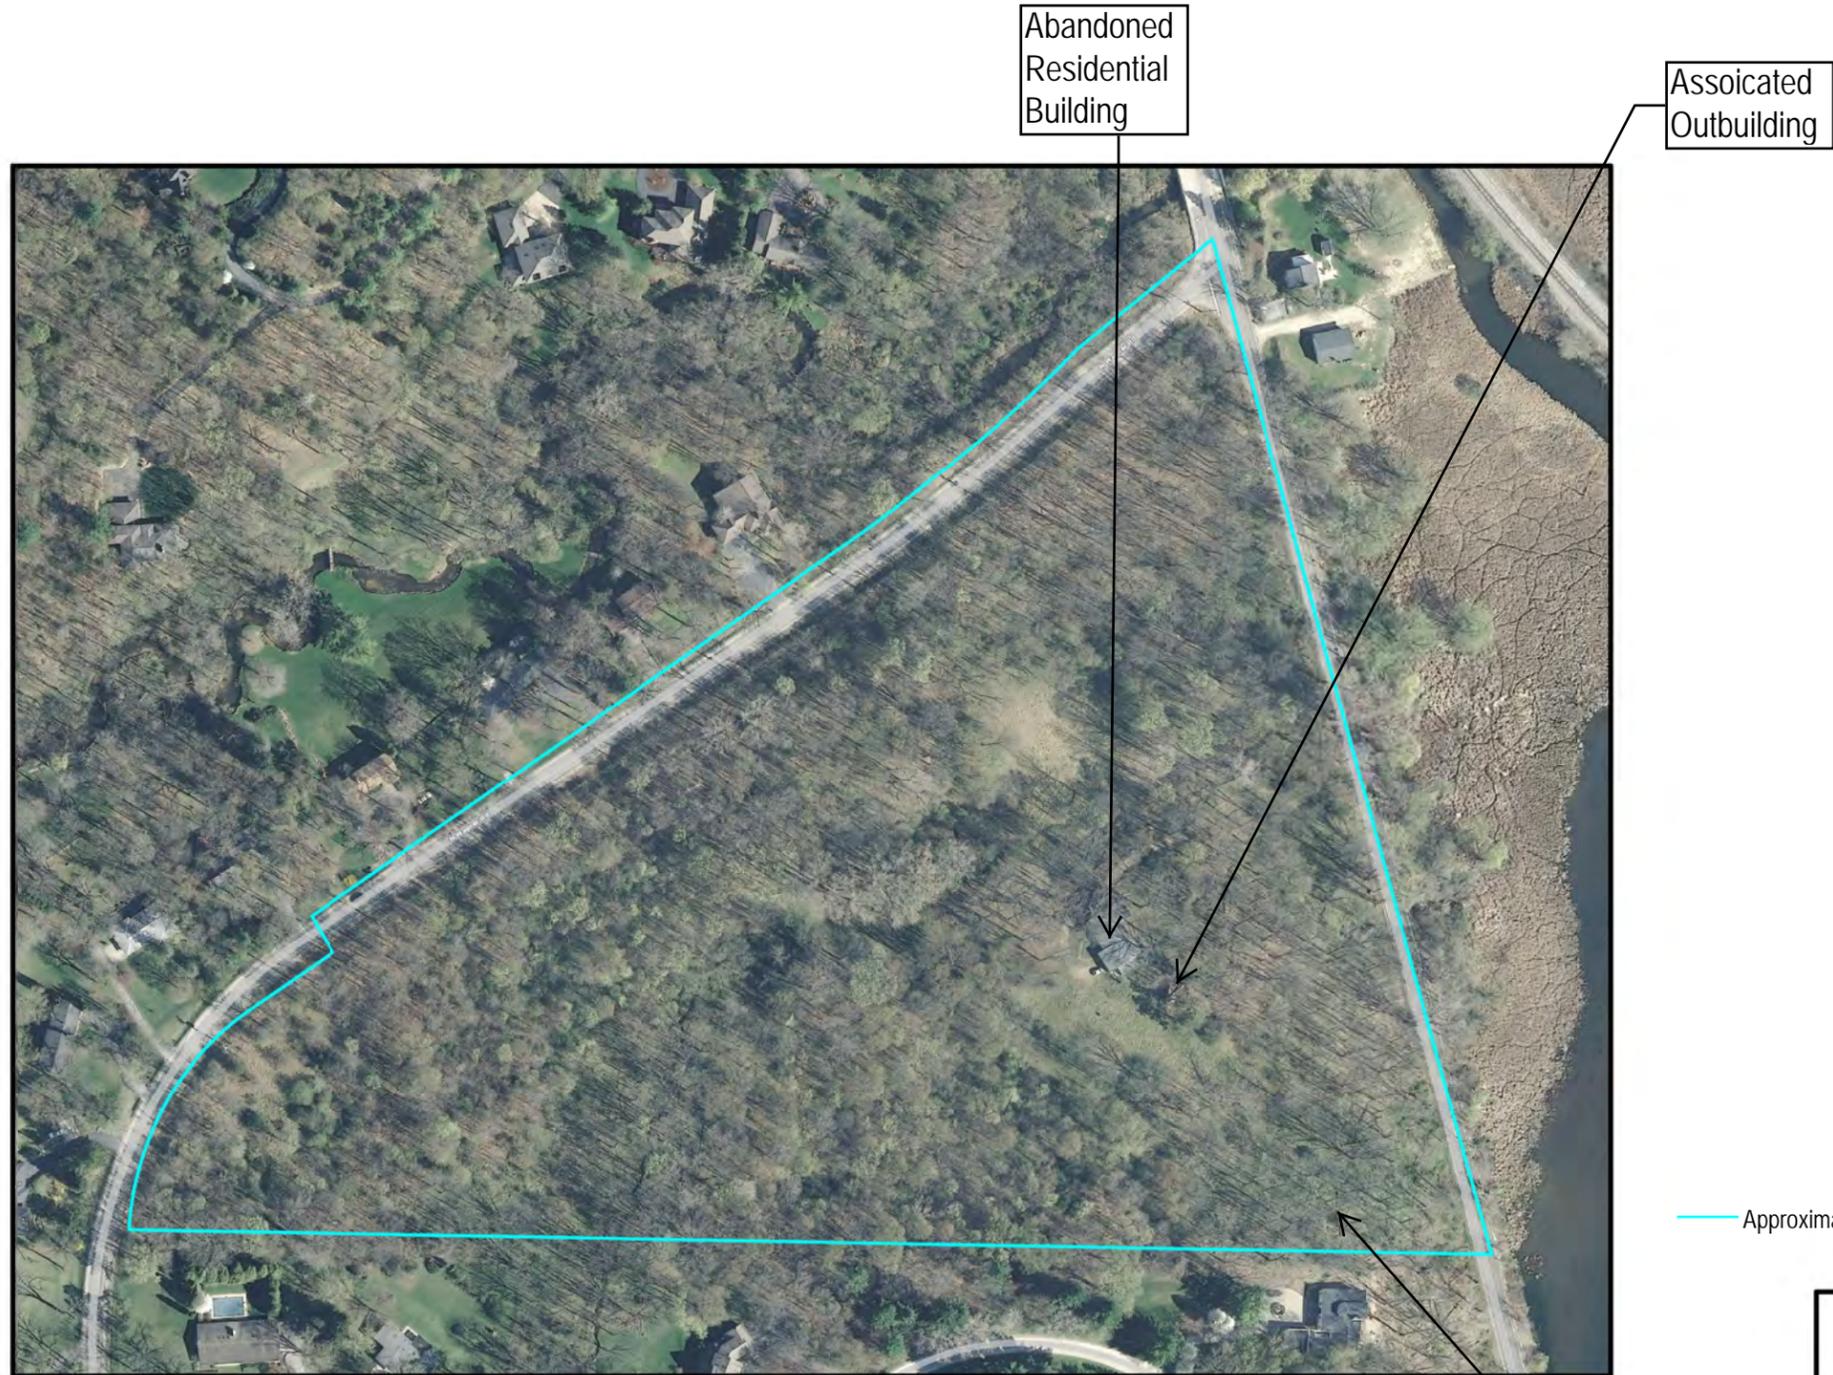
FIGURE 2
SITE SCHEMATIC MAP

Based on this survey, lead containing paint was not identified within the functional areas. Functional areas are depicted on *Figure 2*. Test results for this building can be found in *Table 2, Paint Sample Results (XRF Method)*.

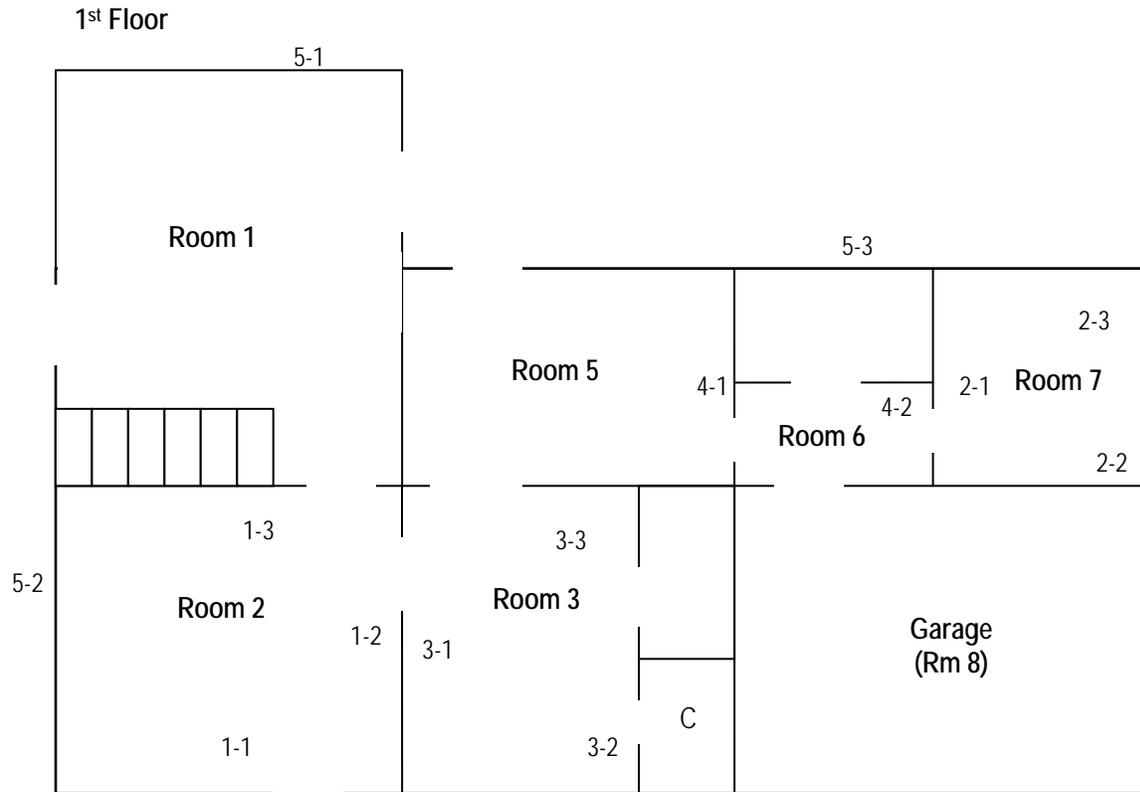
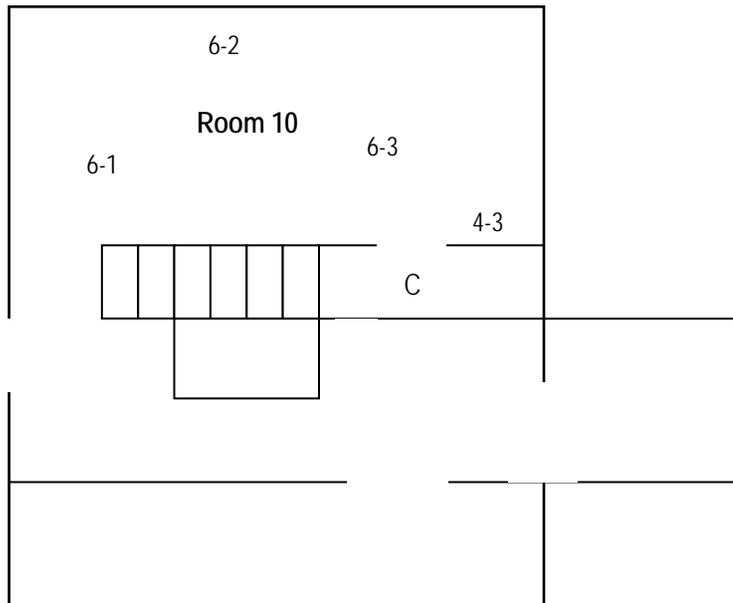
Figure 3, Abandoned Residential Building and Associated Outbuilding Asbestos Sample Locations

Functional areas and ACBM sample locations are depicted on *Figure 3, Abandoned Residential Building and Associated Outbuilding Asbestos Sample Locations*. See *Table 1, Asbestos Sampling Results* for a listing of homogeneous materials identified by MSG during this survey. A copy of the analytical report including chain of custody is attached in *Attachment B, Analytical Report and Chain of Custody*.

Based on this pre-demolition asbestos survey; sampled materials in the abandoned residential building were found to contain greater than 1% asbestos which will require abatement by an accredited asbestos worker prior to demolition activities. Notification according to the procedure described by the NESHAP, Title 40 of the Code of Federal Regulations, Part 61, Subpart M, for renovation and demolition projects should be followed. Notification of demolition/renovation should be made to the Michigan Department of Environmental Quality Air Quality Division (MDEQ-AQD) prior to demolition or renovation. A copy of a notification form is provided in *Attachment D, Notification of Intent to Renovate/Demolish*. This form should be completed by the contractor who completes the demolition. Prior to beginning a demolition or renovation project, the contractor must make the proper notifications to the Michigan Department of Licensing and Regulatory Affairs (LARA) and MDEQ and complete pre-demolition abatement activities.

Functional Area	Homogenous Material Group	Approximate Quantity (SF/LF)	Sample ID	Condition	Type	Result (% Type)
Room 7	9x9 gray floor tile	200 SF	AS-2-1	Good	Non-Friable	5% Chrysotile

Proven demolition methodologies and/or use of respirator protection should be utilized to prevent unacceptable worker exposures during demolition activities. The ACBM shall be disposed of in accordance with Parts 111 or 115 of Michigan Public Act 451 of 1994, as amended.
