Asbestos-Containing Materials Inspection
Lurie Terrace Apartments
600 West Huron Street
Ann Arbor, Michigan

Ann Arbor Affordable Housing Corporation

June 1, 2023

ASTI Project No. 12793

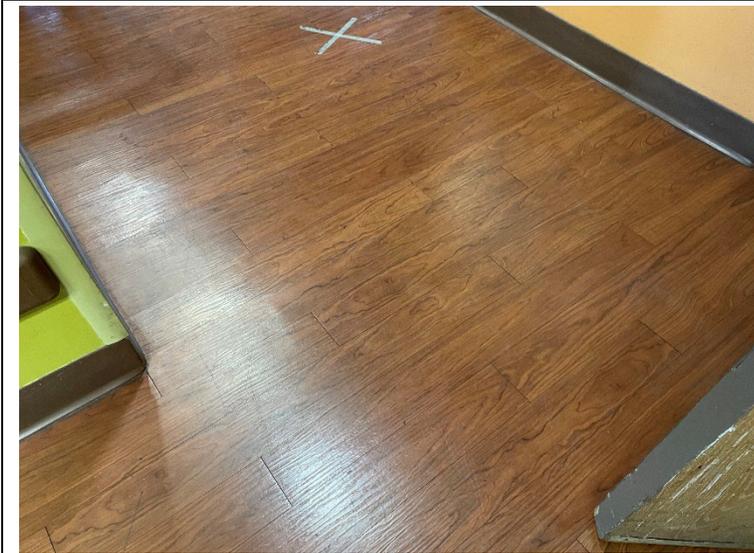
Photo 2. A view of the 8th floor plank flooring with the asbestos-containing brown floor tile underneath

According to classification guidelines set forth in NESHAP, the flooring samples are classified as Category I non-friable ACMs. These materials in their current condition represent minimal risk of fiber release. If renovation or demolition would disturb these materials, ASTI recommends the ACMs be removed by a licensed abatement contractor prior to disturbance.

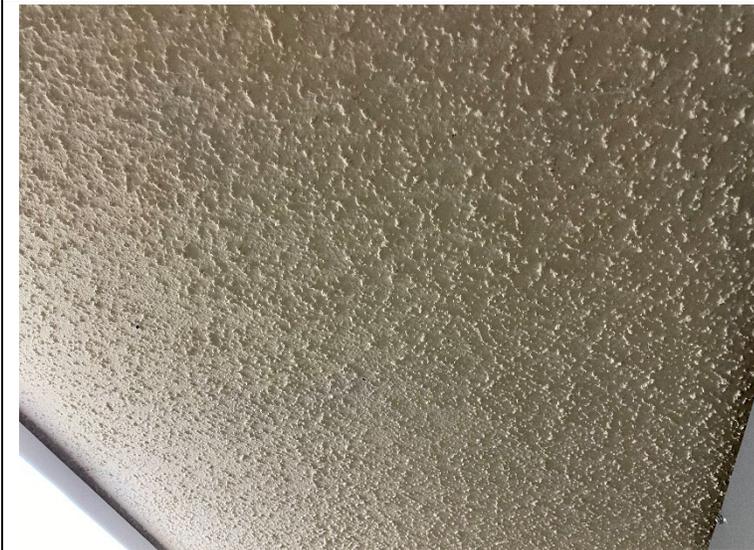
Photo 3. A view of the asbestos-containing ceiling texture

According to classification guidelines set forth in NESHAP, the ceiling texture, drywall joint compound, sink undercoat, foundation tar, & old door caulk samples are classified as Category I non-friable ACMs. These materials in their current condition represent minimal risk of fiber release. If renovation or demolition would disturb these materials, ASTI recommends the ACMs be removed by a licensed abatement contractor prior to disturbance.

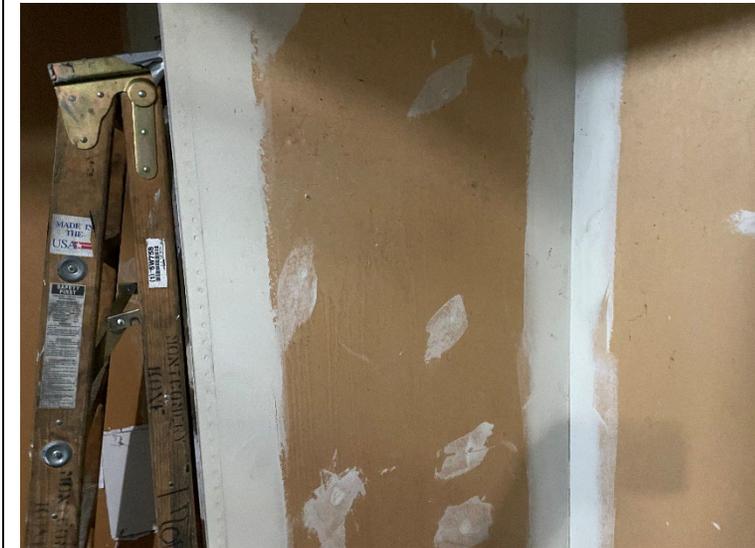
Photo 4. A view of the asbestos-containing drywall joint compound

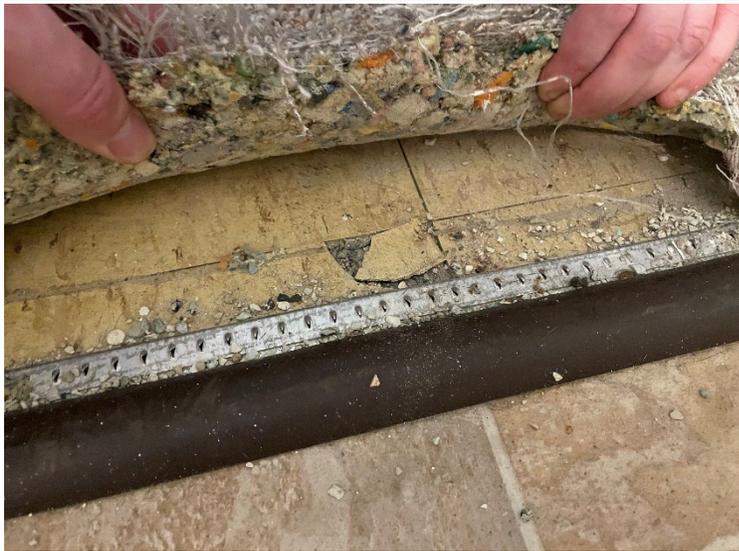
| MATERIAL | LOCATION | ESTIMATED QUANTITY |
|---|---|---|
| 9x9 Floor Tile – Cream w/ Tan & Brown | Unit 222 Entry | 350 ft ² observed |

Photo 5. A view of the asbestos-containing cream with tan & brown streaks 9x9 floor tile

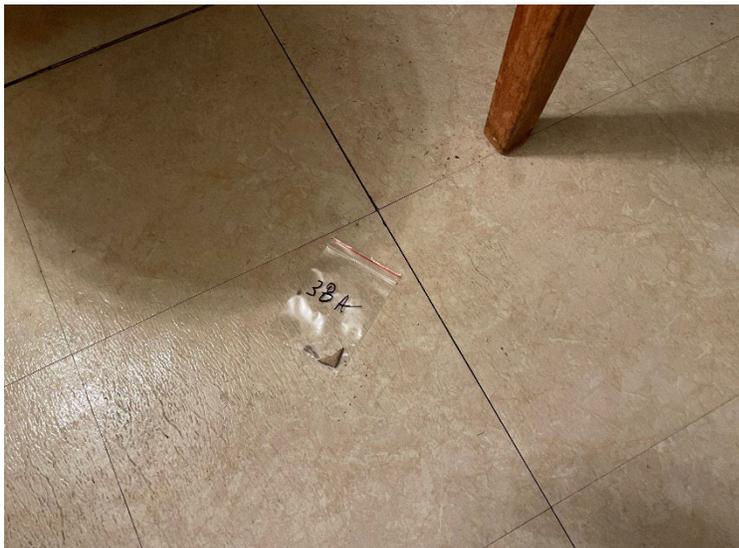
| MATERIAL | LOCATION | ESTIMATED QUANTITY |
|---|---|---|
| Floor Tile – Beige | Unit 611 Bathroom | 100 ft ² observed |

Photo 6. A view of the 12x12 white and tan floor tile with the asbestos-containing beige floor tile underneath

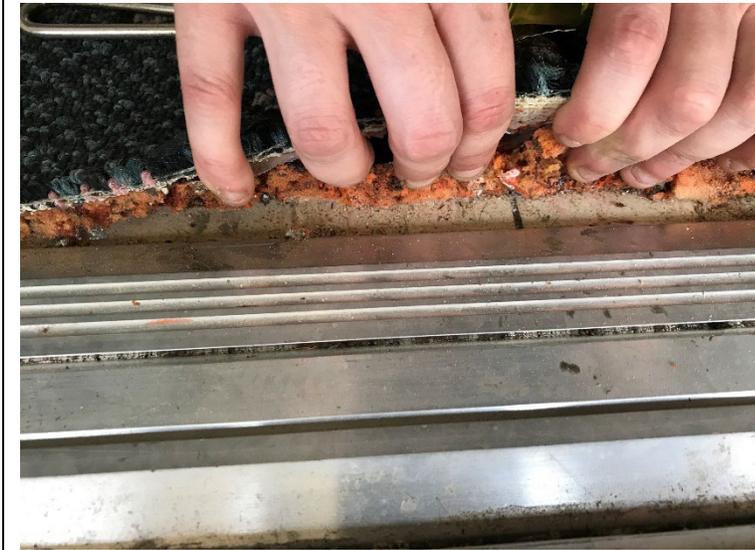
Photo 7. A view of the asbestos-containing floor tile with white spots

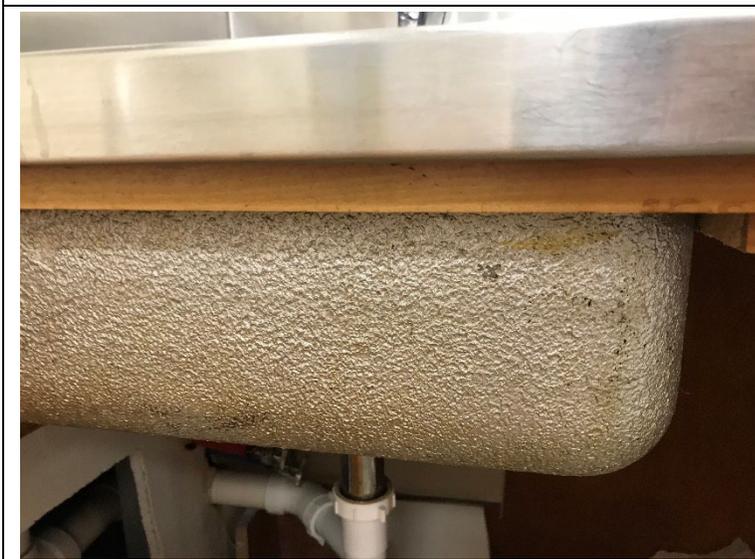
Photo 8. A view of the asbestos-containing silver & black sink undercoat

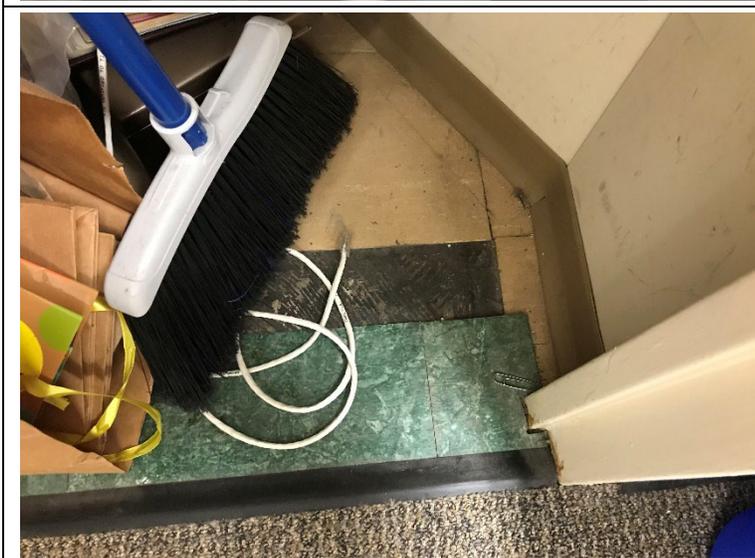
Photo 9. A view of the asbestos-containing beige 9x9 floor tile

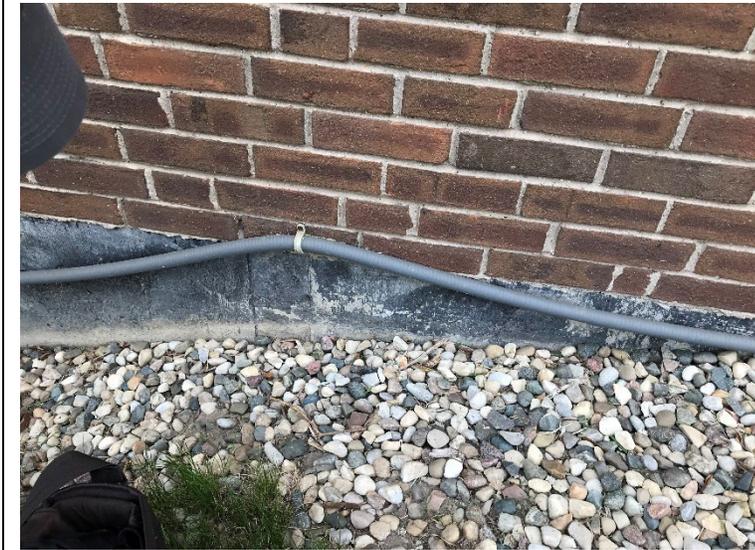
| MATERIAL | LOCATION | ESTIMATED QUANTITY |
|---|---|---|
| Foundation Tar – Black | Foundation | 3,000 ft ² |

Photo 10. A view of the asbestos-containing foundation tar

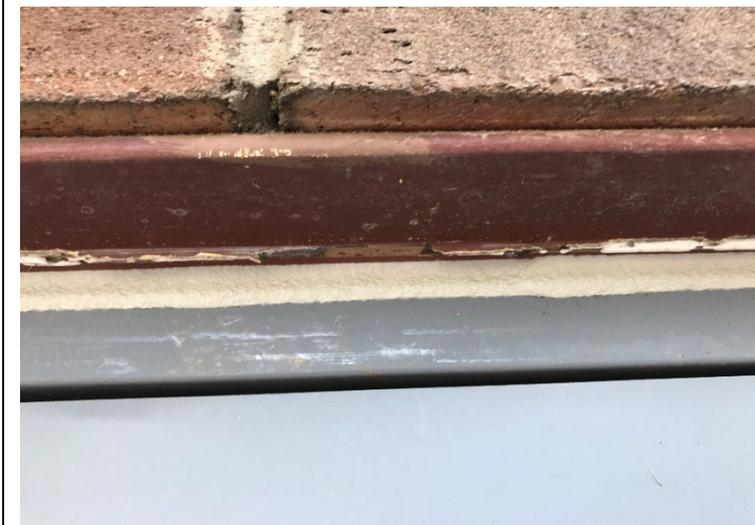
Photo 11. A view of the asbestos-containing old door caulk

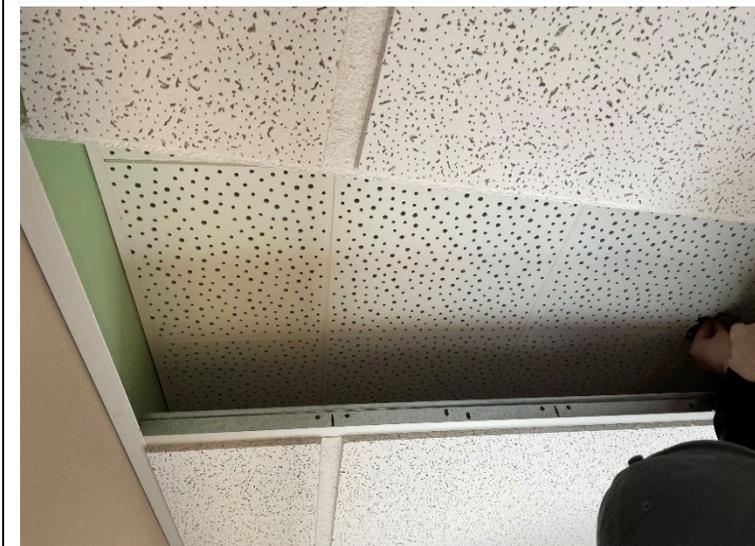
Photo 12. A view of the 1x1 ceiling tile with associated glue pods containing less than 1% asbestos
