**RENTAL ASSISTANCE DEMONSTRATION (RAD):**

# **PART 1: PHYSICAL CONDITION ASSESSMENT**

3681-3689 Platt Road, Ann Arbor, Michigan 48108

**PROJECT #** 8357E-1-196

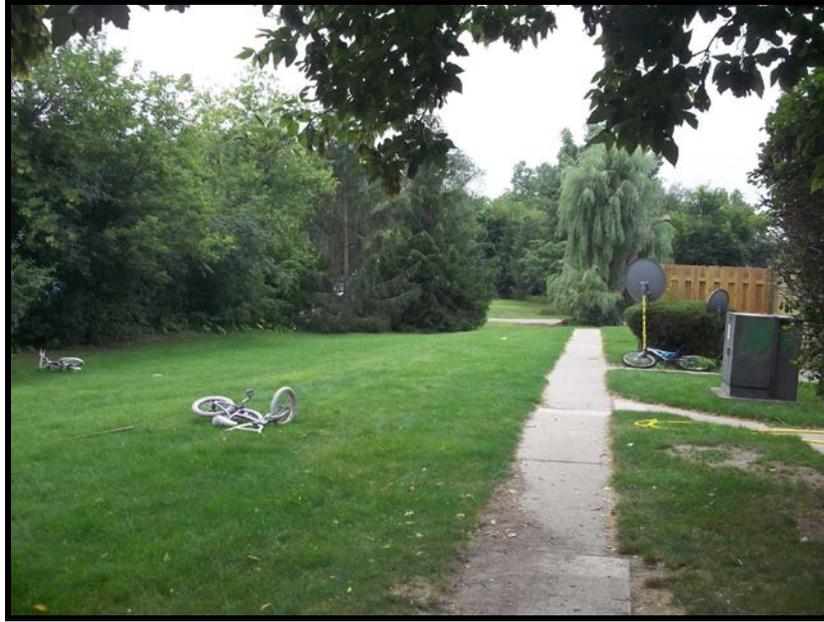
The flat work surrounding the building was observed to be in fair condition with some cracking and separation at engineered seams observed. The steps at resident entries may not meet tread depth and riser height requirements and restrictions. In addition, the concrete step associated with the rear entrance to Unit 3689 was observed to be at its EUL. AAHC has repaired the concrete step following the original site visit.

*PHOTOGRAPH NO. 3: TYPICAL VIEW OF LANDSCAPING AND FLATWORK BEHIND TENANT BUILDING*

Replacement of damaged concrete steps was originally recommended as a rehab item, but it was repaired in 2014. Please refer to the attached Capital Needs Input, 20 Year Detail, 20 Year Schedule and Rehab Specifications for additional information on condition, rehab costs and capital reserves.

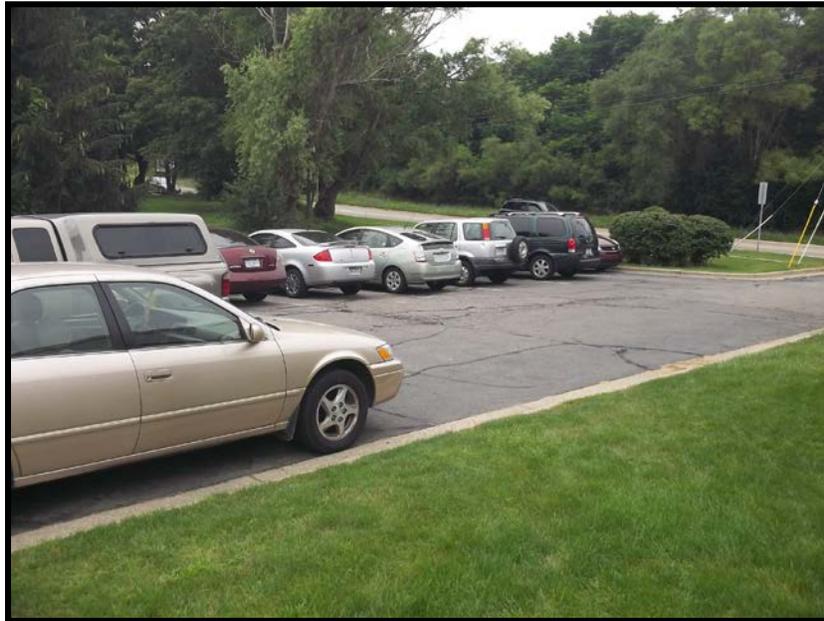
Overall, the asphalt and concrete paved areas appear to be in fair condition. However, longitudinal cracking and localized delamination was observed on the asphalt pavement drives and parking areas. Longitudinal cracking and movement along engineered seams was also observed on the concrete paved sidewalk. The concrete curbing and concrete approach were observed to be in good condition.

The amount of parking appears to be deficient for the type and use of the property. The subject property is equipped with approximately 8 parking spaces. The subject property is not equipped with any handicap accessible parking spaces.

*PHOTOGRAPH NO. 4: TYPICAL VIEW OF SUBJECT PROPERTY PARKING LOT*

Longitudinal crack filling, seal coating, and re-striping of the asphalt pavement and sidewalk are recommended as a rehab item. Continued maintenance of paved areas is recommended. In addition, capital reserves should be considered for additional signage (accessibility, entry, and/or directional), future maintenance, and/or replacement and repair of paved areas. Please refer to the attached Capital Needs Input, 20 Year Detail, 20 Year Schedule and Rehab Specifications for additional information on condition, rehab costs and capital reserves.

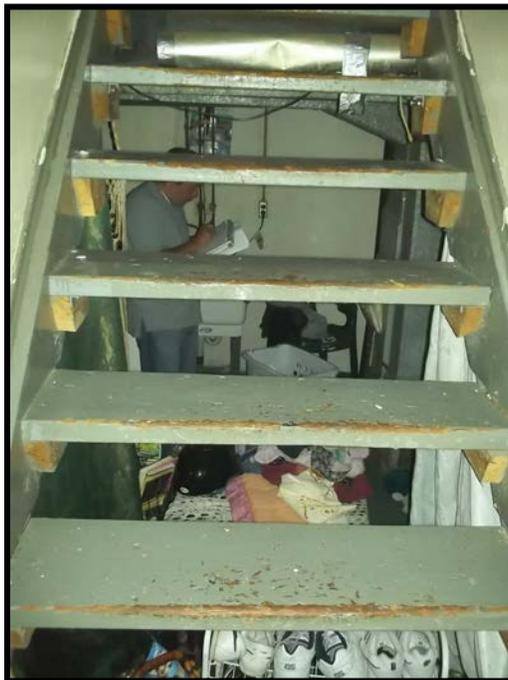
*PHOTOGRAPH NO. 8 TYPICAL VIEW OF BASEMENT STAIRS IN TENANT UNITS*

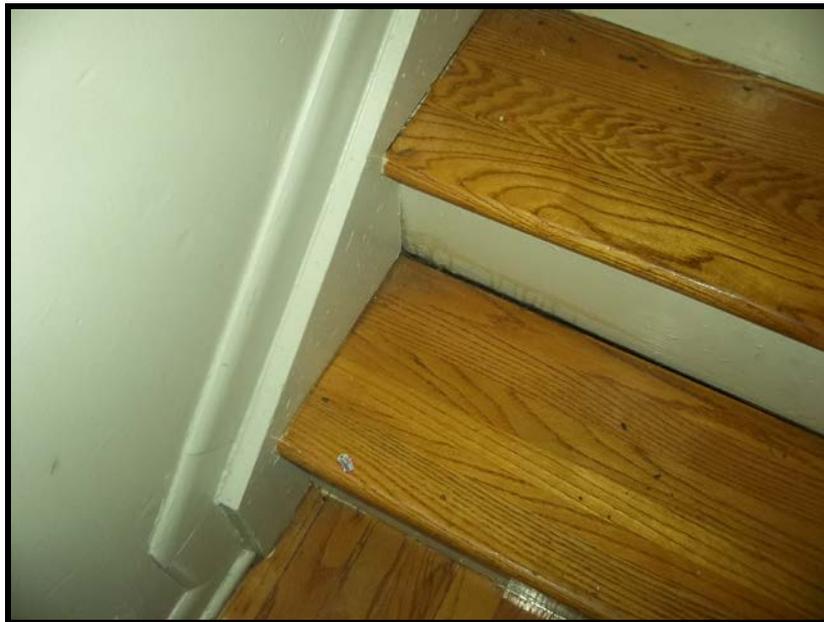
In general, interior stairs appeared to be in fair condition; however, the stairs between the first and second story in Unit 3687 were observed to need repair and rehabilitation. Treads and risers may need

to be replaced or repaired and secured in places required. AAHC has replaced the stairs between the first and second floor following the site visit.

*PHOTOGRAPH NO. 18: VIEW OF DAMAGED SECOND STORY STAIRS IN TENANT UNIT 3687*

Replacement of exterior railings is recommended as a rehab item. The repair of second story stairs in Unit 3687 was originally recommended as a rehab item, but this has been replaced by AAHC. Continued maintenance of stairways is recommended. In addition, capital reserves should be considered for future maintenance of interior stairwells. Please refer to the attached Capital Needs Input, 20 Year Detail, 20 Year Schedule and Rehab Specifications for additional information on condition, rehab costs and capital reserves.

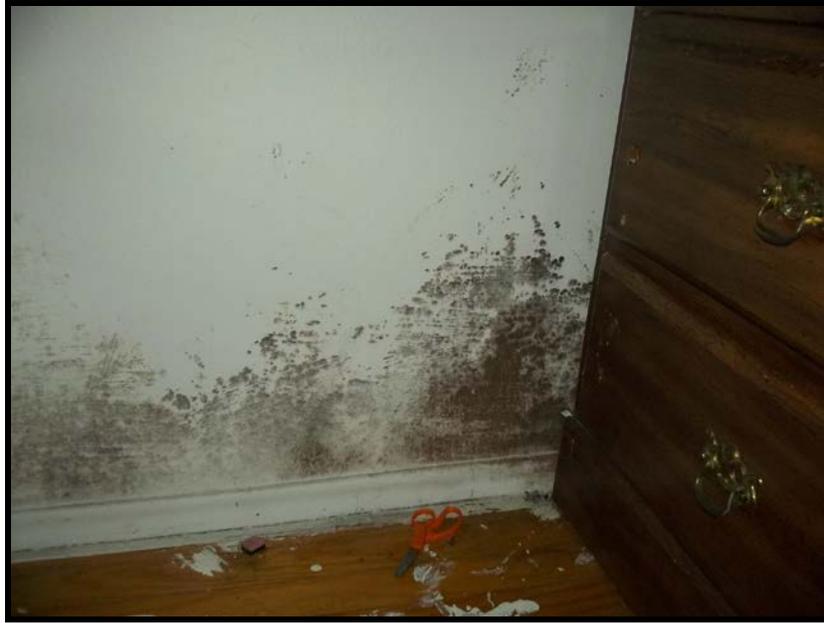
AKT Peerless conducted a limited visual survey during the walk-through and no directly observed potential on-site environmental hazards were observed. However, limited mold conditions were noted in Unit 3681. A lead based paint (LBP) survey of the subject property was completed in 1996. Results indicated LBP was not identified at the property, except for on the exterior wood siding. AKT Peerless' August 2013 site reconnaissance did not identify wood siding on the subject building. It is unknown whether this siding was removed or exists beneath the current aluminum siding. No documented asbestos testing had been identified prior to conducting this PCA.

*PHOTOGRAPH NO. 19: TYPICAL VIEW OF MOISTURE INTRUSION OBSERVED IN TENANT UNIT 3681*

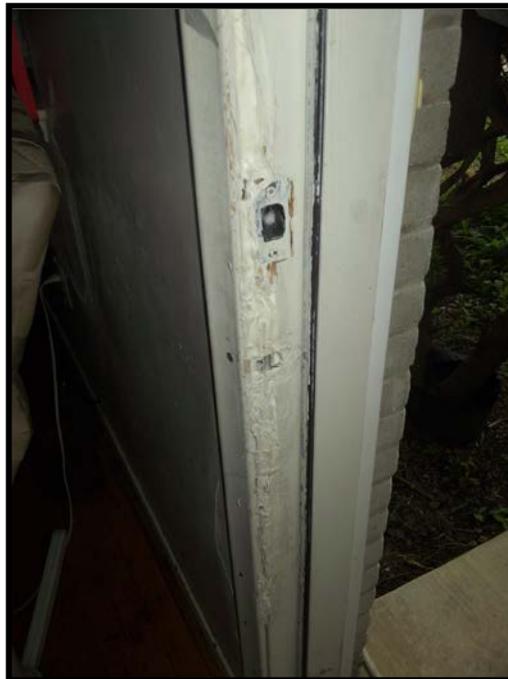
The decorative wood, screen doors, and steel entry doors generally appeared to be in good condition. However, the vinyl siding and windows are beyond their EUL. New double-paned, low E windows were installed in October 2013. In addition, the door frame associated with the front door on Unit 3681 was observed to be damaged.

*PHOTOGRAPH NO. 20: VIEW OF DAMAGED ENTRY DOOR FRAME IN TENANT UNIT 3681*

Replacement of vinyl siding, aluminum downspouts and the front door at Unit 3681 are recommended as a rehab item. Placement of rigid insulation beneath new siding and additional tuck pointing of the masonry veneer should be considered. Continued maintenance of soffits, fascia and gutters is recommended. In addition, capital reserves should be considered for future re-caulking of the building exterior.
