Rental Assistance Demonstration (RAD): **PART 1: PHYSICAL CONDITION ASSESSMENT**

2670 – 2680 South Main Street, Ann Arbor, Michigan 48103

DATE October 11, 2013
Revised September 15, 2014
Revised November 20, 2014

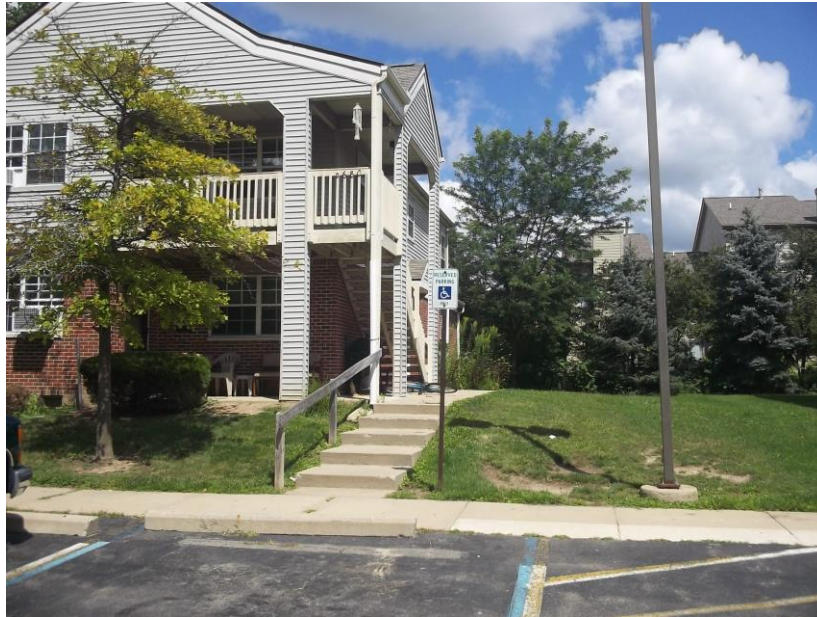
PHOTOGRAPH NO. 1: TYPICAL VIEW OF TENANT UNIT BUILDING

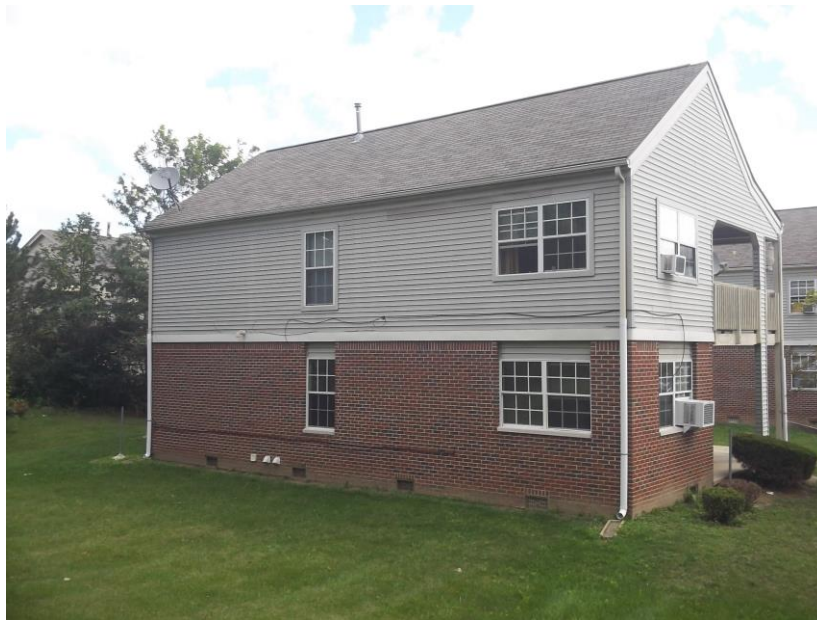
PHOTOGRAPH NO. 2: TYPICAL VIEW OF SIDE OF TENANT BUILDING

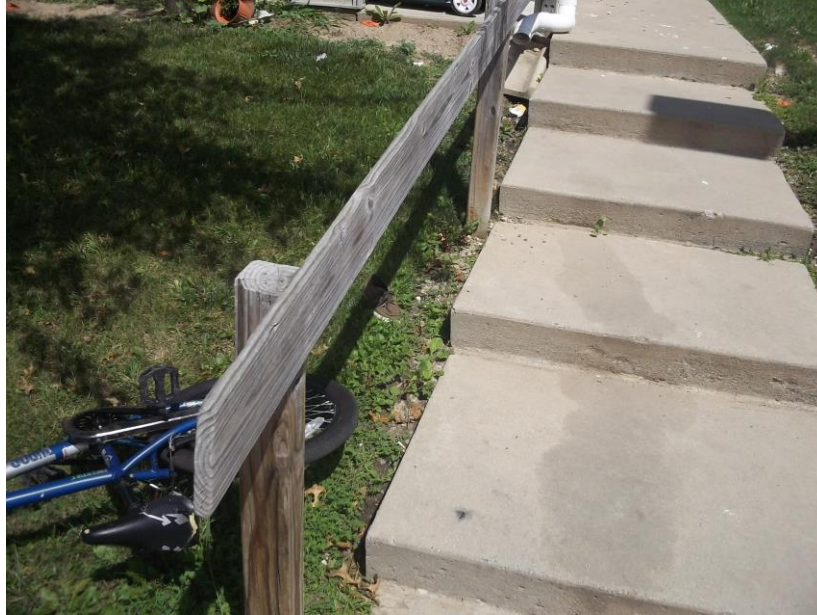
The flat work surrounding the building was observed to be in fair condition. Handrails appear to need repair or replacement. Sidewalk handrails have been replaced by AAHC following the site visit.

PHOTOGRAPH NO. 3: TYPICAL VIEW OF LANDSCAPING AND FLATWORK THROUGHOUT SUBJECT PROPERTY

Approximately 20% of the existing flatwork is recommended for patching and repair. Repair and maintain broken concrete walkways around the subject property to avoid continued degradation and possible trip hazards.

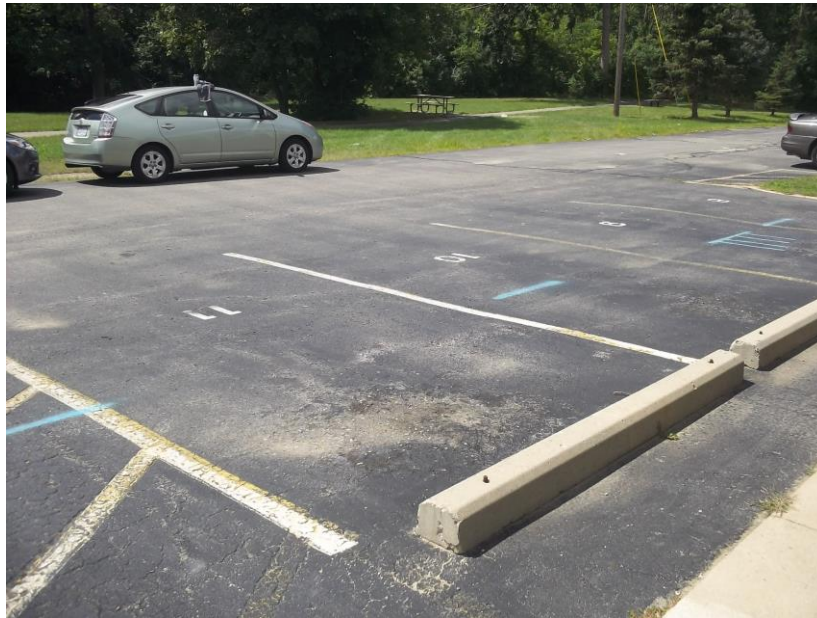
Overall, the asphalt drive and parking spaces are in fair condition. There are some surface cracks and surface deterioration.

PHOTOGRAPH NO. 4: TYPICAL VIEW OF SUBJECT PROPERTY PARKING LOT

Approximately 33% of the asphalt parking area is in need of patching and repair. Seal coating and re-striping of the entire asphalt pavement area is recommended as a rehab item. Continued maintenance of paved areas is recommended. In addition, capital reserves should be considered for future expansion, maintenance, and/or replacement and repair of paved areas. Please refer to the attached Capital Needs Input, 20 Year Detail, 20 Year Schedule and Rehab Specifications for additional information on condition, rehab costs and capital reserves.

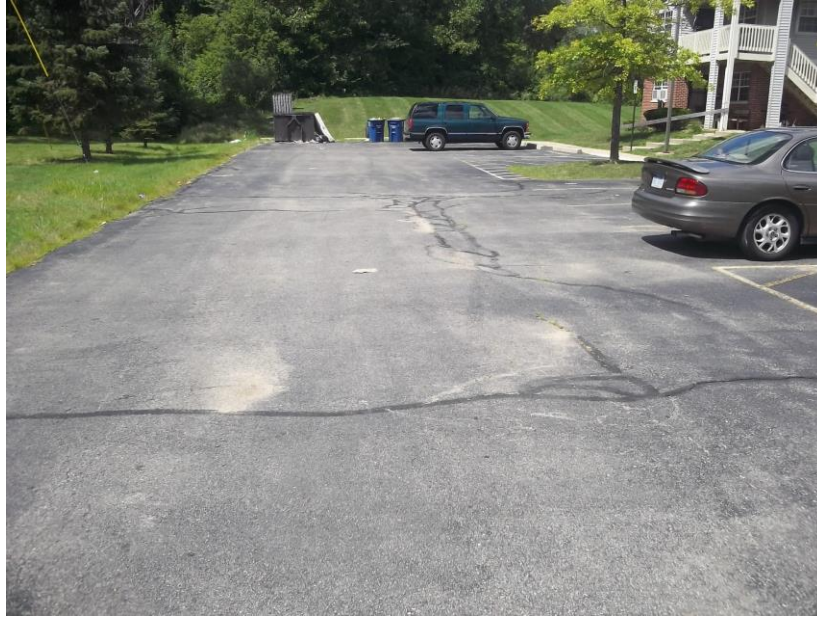
PHOTOGRAPH NO. 5: SECOND VIEW OF PARKING LOT

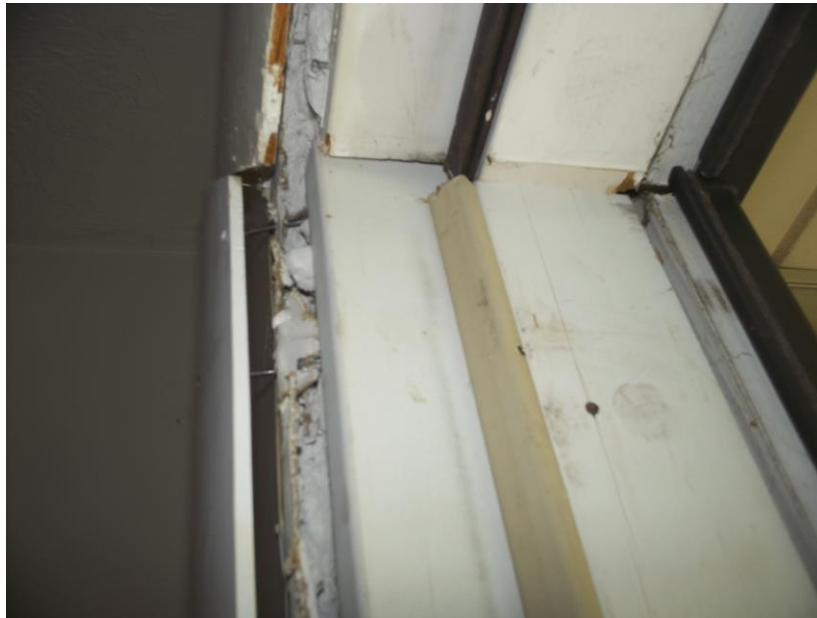
The vinyl siding and brick veneer generally appeared to be in fair condition. The majority of the window screens are torn or missing. New double-paned, low E windows were installed in October 2013. The exterior doors were determined to be in fair condition, with the exception of the main entry doors on units 2672 and 2674 which are in poor condition. At least 40% of the aluminum and PVC downspouts appear to need repair and replacement.

PHOTOGRAPH NO. 6: ISSUES AT ENTRY DOOR

Caulk and seal openings at vinyl siding/exterior envelope is recommended as a rehab item. Replacement of main entry doors on units 2672 and 2674 and 40% of the downspouts are recommended as a rehab item. Control air leakage through air sealing, as specified in the Energy Audit, is recommended as a rehab item.

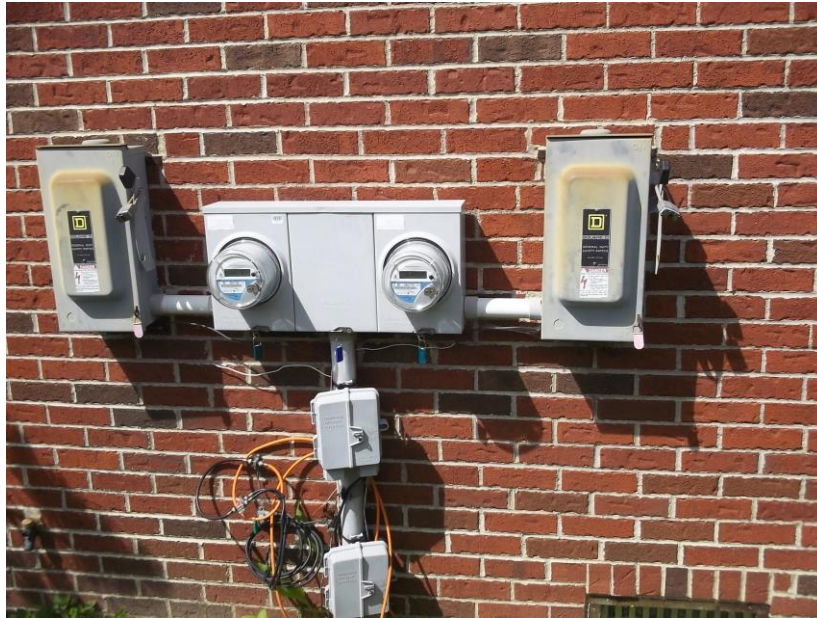
PHOTOGRAPH NO. 7: ELECTRICAL DIS-CONNECT LOCATED BY METER

It is recommended that main breakers are added to the electrical panels that are located in the tenant units. Continued maintenance of utilities associated with the subject property as part of normal facility operations is recommended.

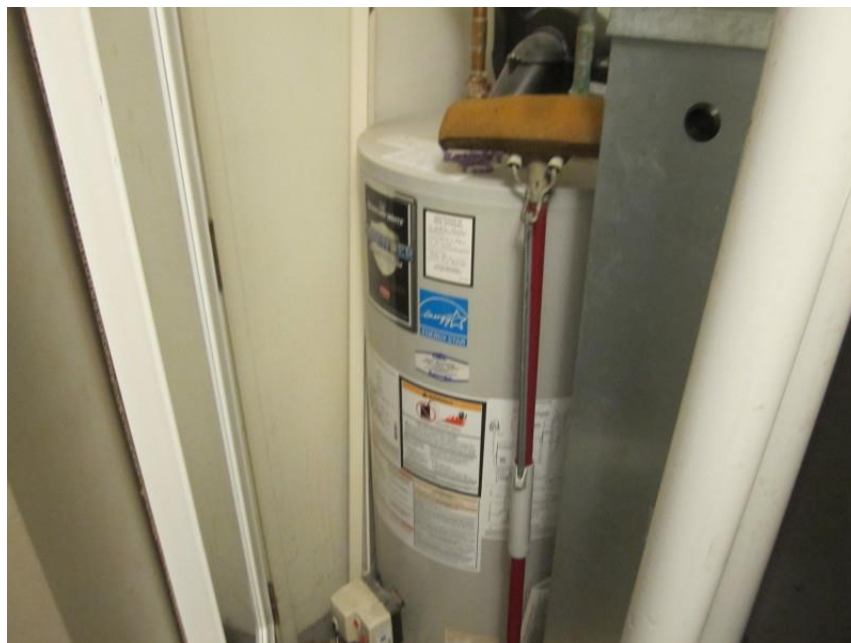
Domestic hot water is supplied by individual, gas-fired, 40-gallon, hot water tanks located in the mechanical rooms of the tenant units. These tanks have been replaced as necessary from approximately the mid-2000s to present, and replacements are typically power vent models.

PHOTOGRAPH NO. 8 VIEW OF HOT WATER HEATER IN UNIT

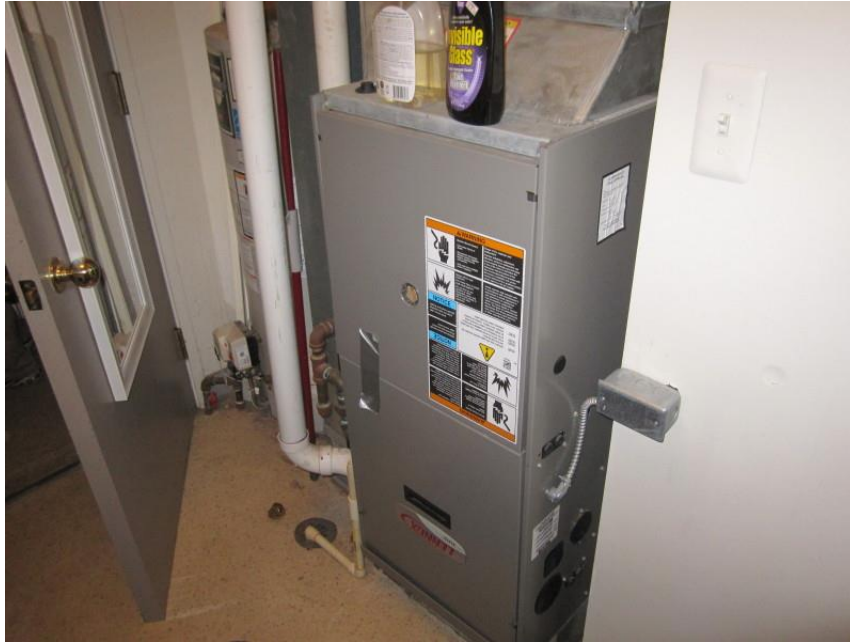
PHOTOGRAPH NO. 9: TYPICAL VIEW OF FURNACES IN TENANT UNITS

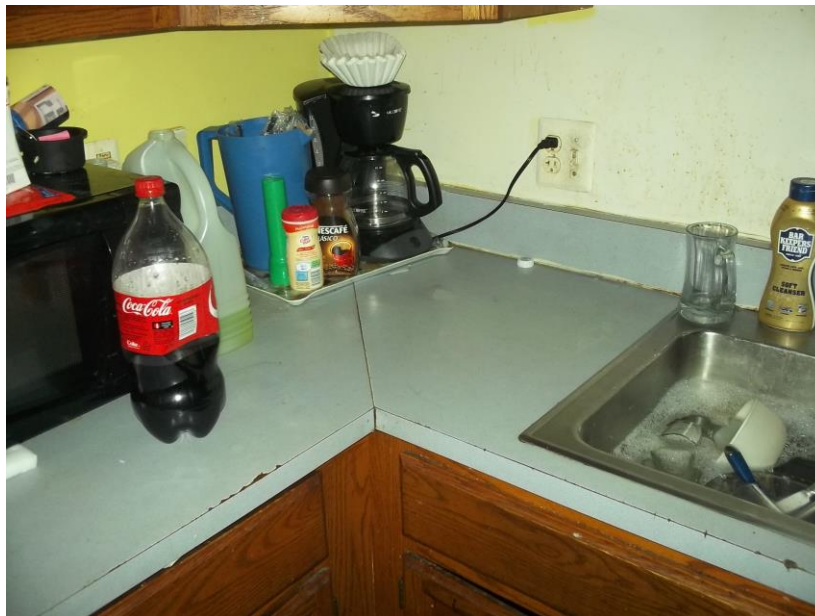
PHOTOGRAPH NO. 10: LAMINATE COUNTERTOP (TYPICAL)

- Counter Tops, Sinks + plumbing attachments (Units 2672, 2674, 2676)
- Kitchen floor covering (2670, 2674) - 167 SF each
- Range Hood - recirculating (2670, 2672, 2674, 2678, 2680)
- Natural Gas Range (2670, 2672, 2674)
- Bath Counter Tops and Sinks (2672, 2674, 2676)
- Bathroom Ceramic Floor Tile (2678) - 44 SF each
- Bath Vanities (2674, 2676)
- Bath Tub Surround (2670)
- Replace existing bathroom exhaust fans with high-efficiency exhaust fans in each unit
- Plastic Medicine Cabinet (x2)
- Living Room Carpets (2670) - 216 SF each - Hall 102 SF ea
- Living Area Resilient Floor Tile (2674) - 318 SF each
- Prep and paint surfaces in Units 2670 and 2674
- Bedroom Resilient Floor Tile (2670, 2672) - 400 SF each unit
- Laundry Room Floorcovering – all units, 58 SF each
- Hardware and track replacement for 12 bi-fold closet doors

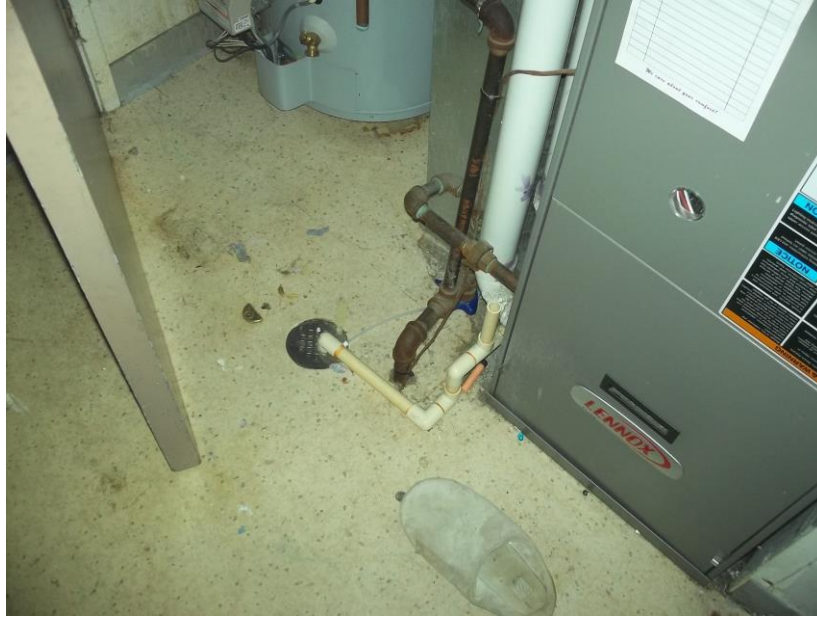
PHOTOGRAPH NO. 11: LAUNDRY ROOM FLOOR (TYPICAL)

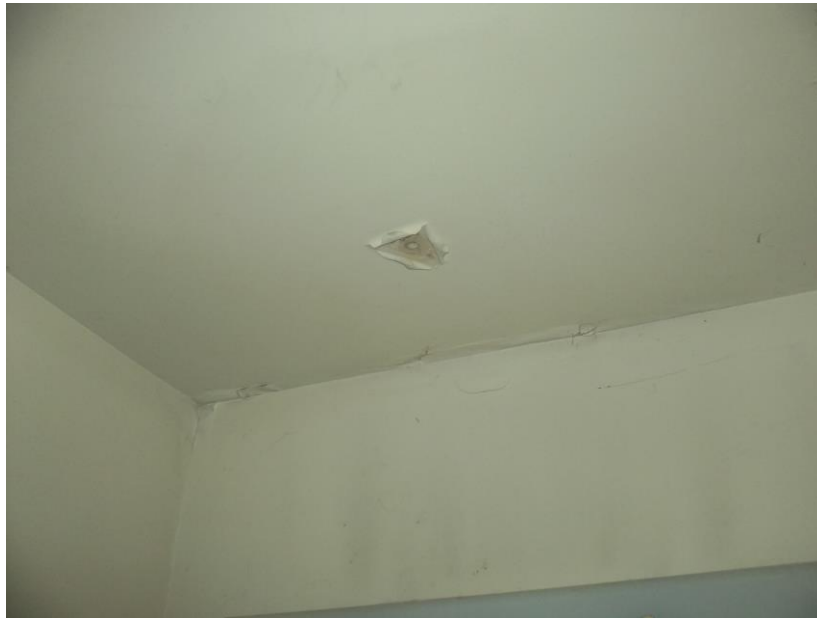
PHOTOGRAPH NO. 12: CEILING MOISTURE PROBLEM (UNIT 2674)

- Repair / replace bathroom ceiling in unit #2670 and resolve moisture issue.
- Tenant Unit Cabinets - Wall and Base (2674)
- Tenant Unit Cabinets - Base (2670, 2680)

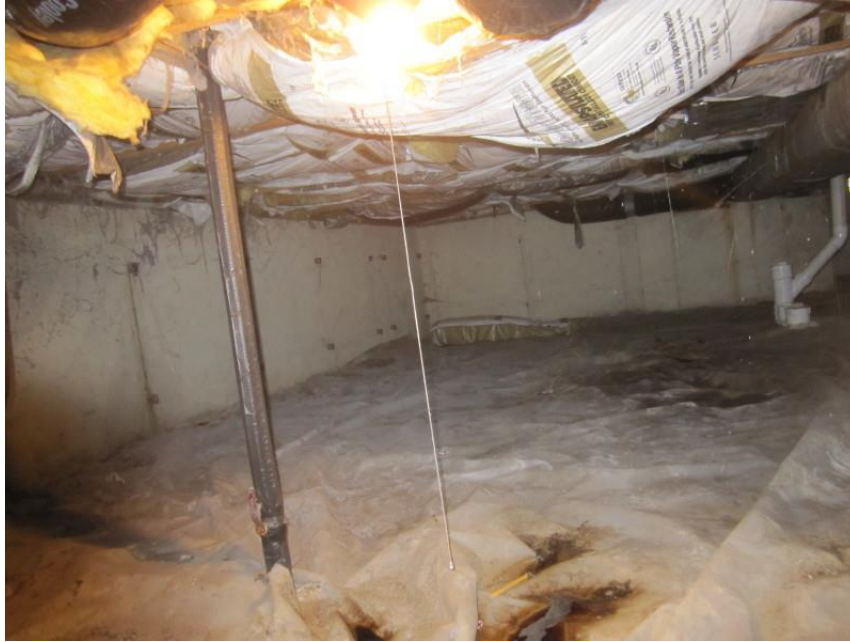
Observations of the subject property indicate the foundations of the subject buildings consists of a poured concrete foundation walls. There are also CMU piers on spread footings that support a beam in the middle of the building. The piers were noted to not be grouted solid.

PHOTOGRAPH NO. 13: TYPICAL VIEW OF CRAWL SPACE

The CMU piers should be grouted solid as specified in the original construction documents. The building foundations should be observed as routine building operations.

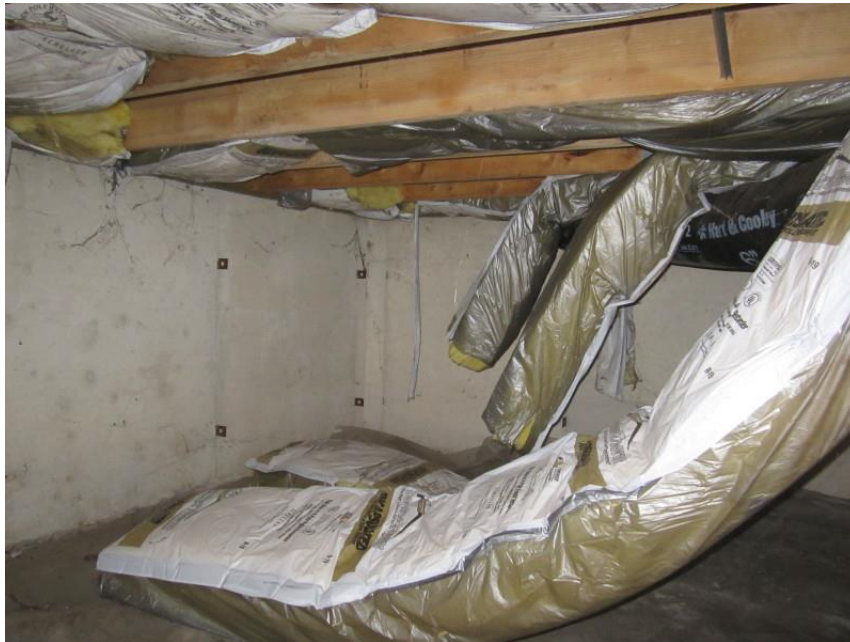
PHOTOGRAPH NO. 14: EXAMPLE OF DROPPED INSULATION IN CRAWL SPACE

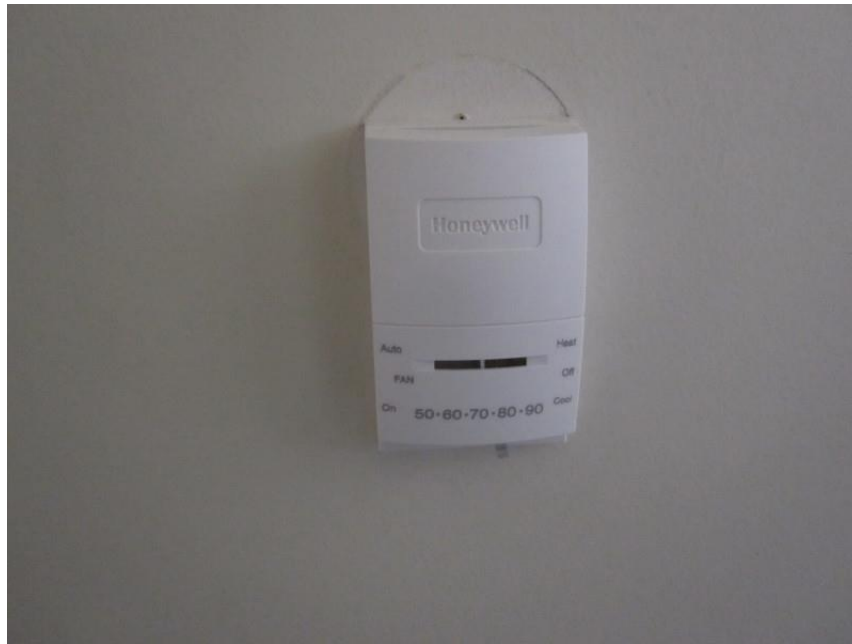
PHOTOGRAPH NO. 15: TYPICAL VIEW OF TENANT UNIT THERMOSTAT

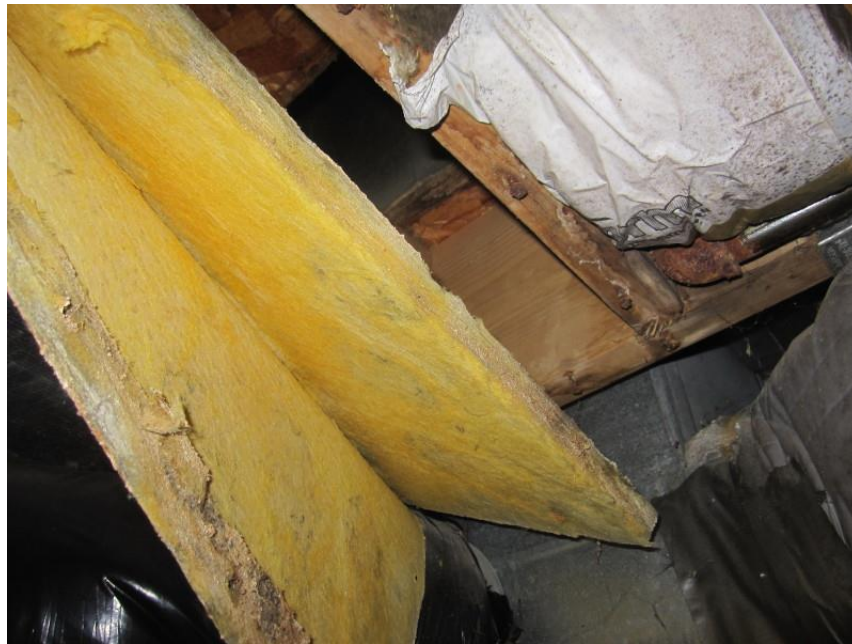
PHOTOGRAPH NO. 16: VIEW OF OPEN RETURN AIR CHASE (TYPICAL)
