Limited Asbestos-Containing Materials Inspection
1514-1520 White, 1521 State, 701-719 Henry
Ann Arbor, Michigan

Ann Arbor Housing Commission

November 11, 2013

ASTI Project 8563

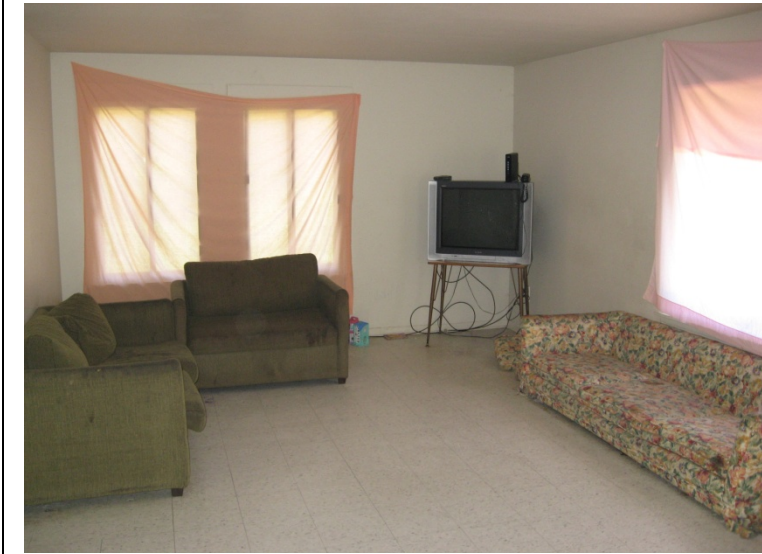
Photo 1. Example of apartment unit drywall with asbestos-containing joint compound.

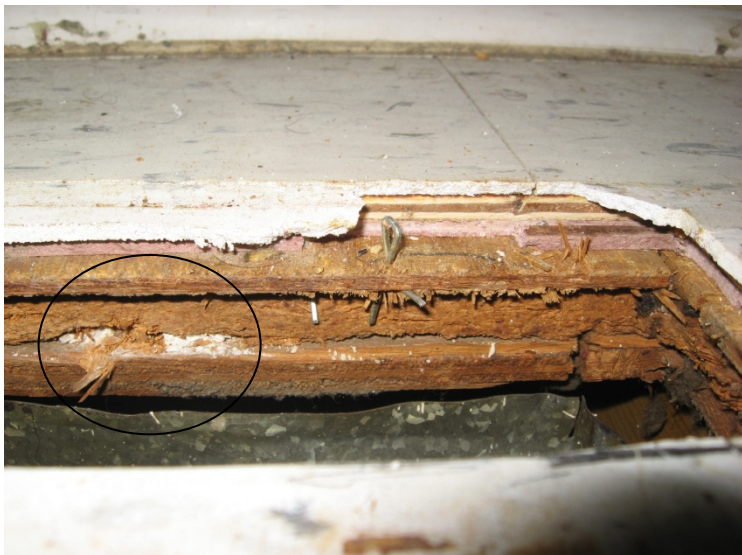
Photo 2. Asbestos-containing floor tile observed in apartment unit 3451 second floor bedroom sub-floor layers. Observed by removing floor vent. Similar floor tile was not observed in any of the other units.
