Appendix K – Wildlife Site Visit

At the request of Mr. Steve Houtteman, Michigan Department of Transportation (MDOT) and yourself, the US Department of Agriculture Wildlife Services (WS) signed an agreement to perform a Formal Site Visit at Ann Arbor Municipal Airport (KARB). This letter summarizes the findings of the two-day Site Visit and provides recommendations for KARB in dealing with the wildlife found to be utilizing the site.

Ann Arbor Municipal Airport Landscape

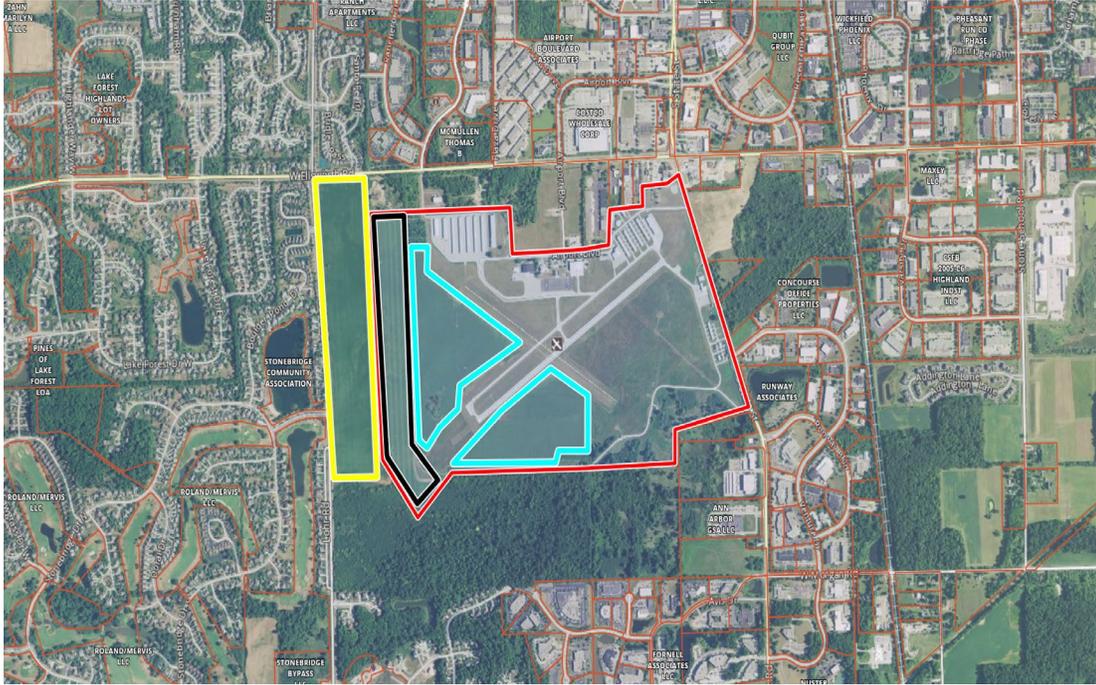
Red line = Ann Arbor perimeter fence

Turquoise line = Fallow field (too wet for planting)

Black line = Soybean field

Yellow line = Cornfield outside AOA

3. Look into to phasing out agriculture on airport property. Start with agriculture inside the AOA and move to outside AOA if/when possible. Corn should never be planted inside the AOA. If agriculture continues, soybeans are the least attractive of the conventional agriculture products. Immediately upon harvest the farmer should be required to plow field under to cover as much of the left over beans as possible.

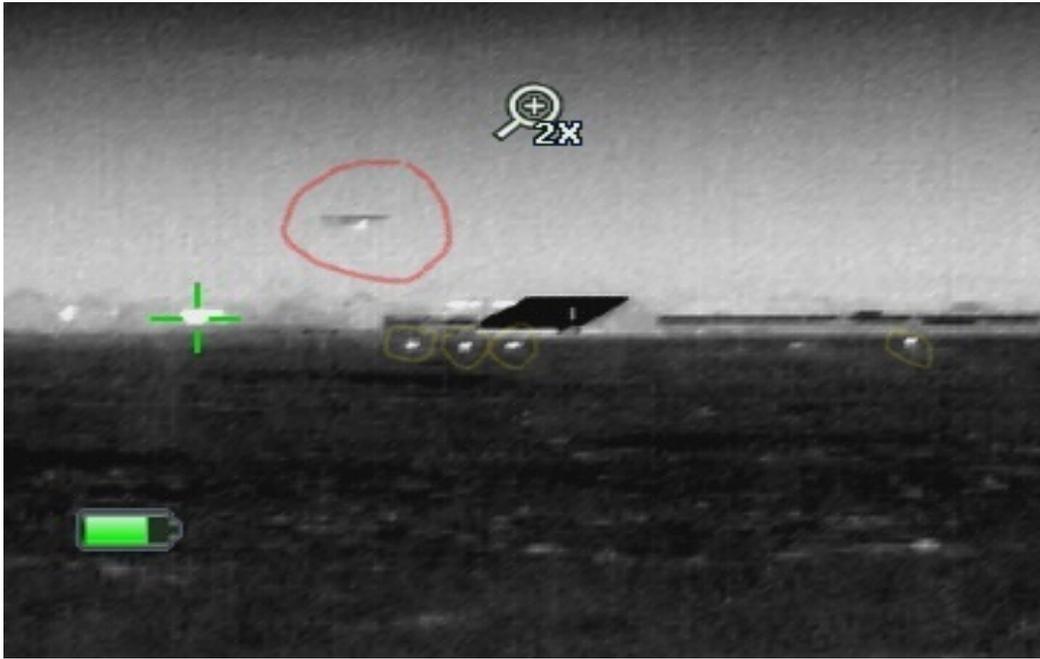
Figure 1. Four deer foraging near runway with plane taking off.

During the SV a FLIR (Forward Looking Infrared) unit was used to observe wildlife activity at night. At least eleven different deer were confirmed on the airfield. More deer could be present on the airfield. Six deer were near the runway and observed spooking from a landing aircraft. It is very likely that more deer are present on the airfield.

The six deer observed near the runway came from far south-east corner of the airport and traveled to the soybean field to the west. Three additional deer traveled from the south-east corner of the airport to the soybean field. Two more deer were observed bedding in the woods on the north-west side of the airfield close to the soybean field.

2. Aggressively cull deer from the airfield until a deer proof fence can be constructed. Deer culling requires a permit from the DNR which must be obtained prior to any lethal control work involving deer.

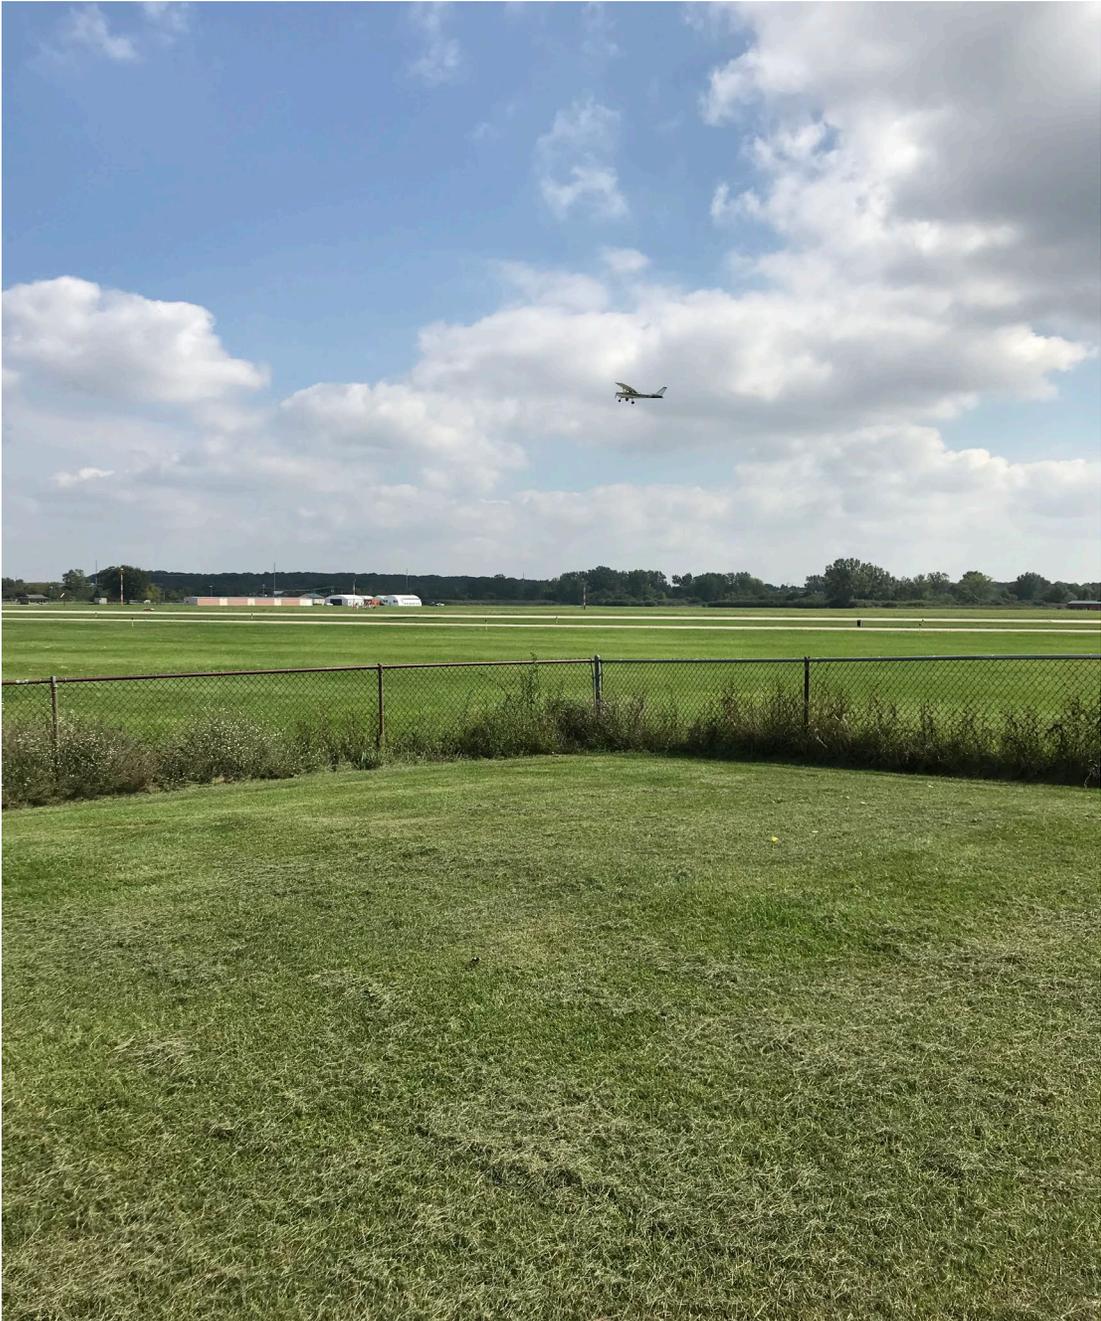
Fencing is the number one way to keep deer off the airfield. KARB contains a mix of chain-link fencing that ranges in height from 4foot to 10foot. In addition to fencing, drainage culverts and gates need to be addressed to prevent deer from access the airfield. Below are some examples of the entrance points deer may use to access KARB's airfield.

Figure 2. Four foot fence NE KARB

Deer are crepuscular animals, most active at dawn and dusk. But deer are also active at night. KARB is very quiet at night, during these times deer will wander into areas around the airfield that they are not normally seen. This is when a deer would most likely jump the four foot fence on the north-east of airfield. During the rut, bucks will chase does and deer become frantic and can lose their fear of humans. When this happens, a four foot fence would not pose a significant barrier. KARB also has two large concrete drainage culverts that are four foot tall. They are located on the north-west and south-west side of the airfield. Both of these culverts lead into woods. Neither of the culverts have any type of grate to prevent deer or coyotes from accessing the airfield. Deer can be drawn to walk

1. The perimeter of the airfield should be enclosed with a deer proof fence, as outlined in FAA CertAlert 04-16:

*“Proper fencing is the best way of keeping deer off aircraft movement areas. The FAA recommends a 10-12 foot chain link fence with 3-strand barbed wire outriggers. In some cases an airport may be able to use an 8-foot chain link fence with a 3-strand barbed outriggers, depending upon the amount of deer activity in a local area. All fencing must be properly installed and maintained. A 4-foot skirt of chain link fence material, attached to the bottom of the fence and buried at a 45 degree angle on the outside of the fence will prevent animals from digging under the fence and reduce the chance of washouts. This type of fencing also greatly increases airport security and safety. **The fence line right-of-way must be kept free of excess vegetation.** The fence line should be patrolled at least daily, and any washouts, breaks or other holes in the fence repaired as soon as they are discovered. Gates should close with less than 6-inch gaps to prevent entry by deer.”*

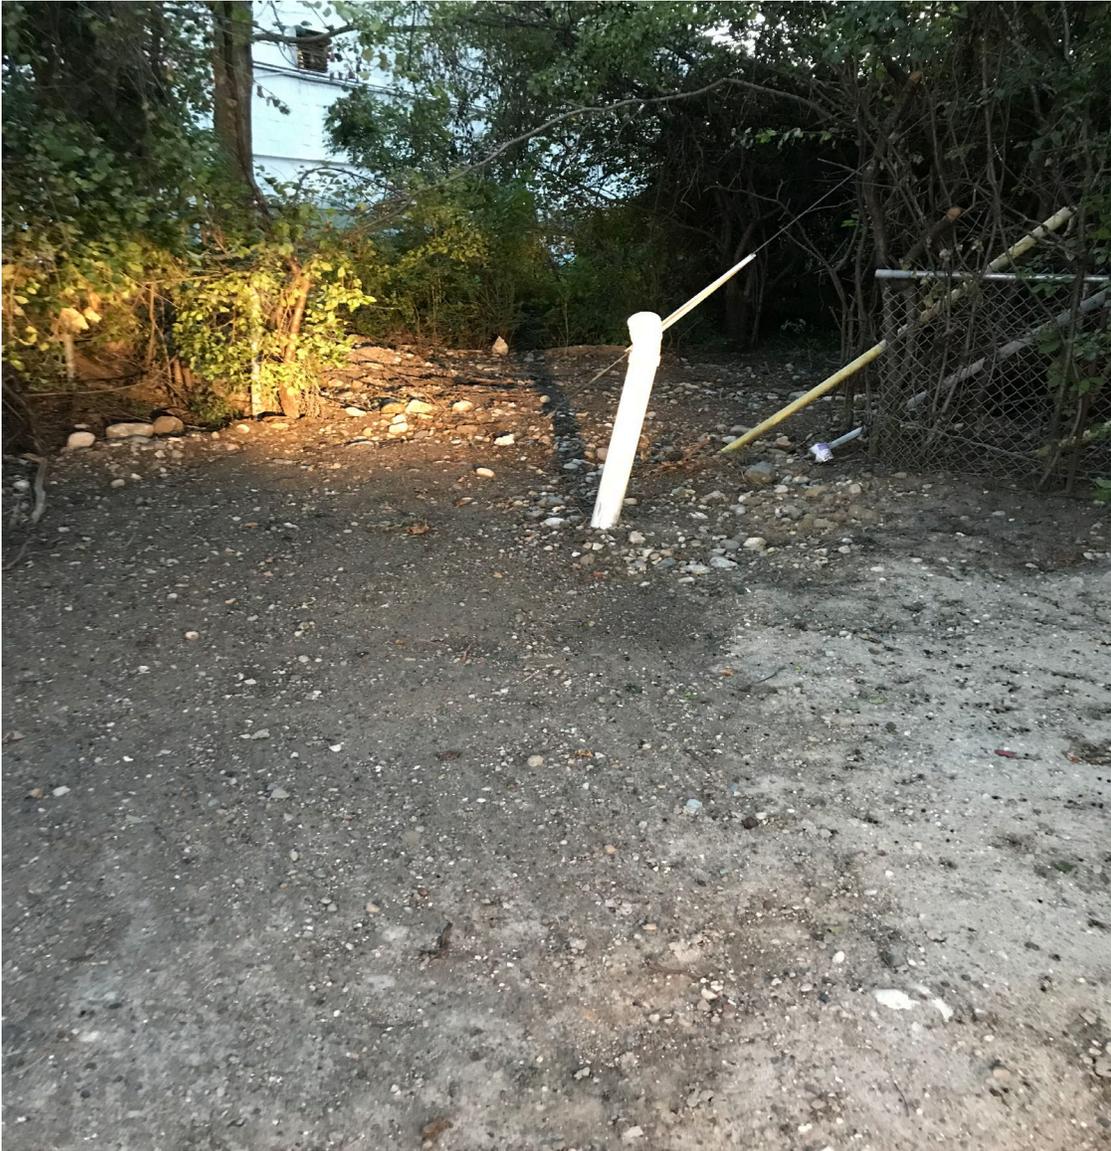
Figure 3. Open fence under construction NE KARB

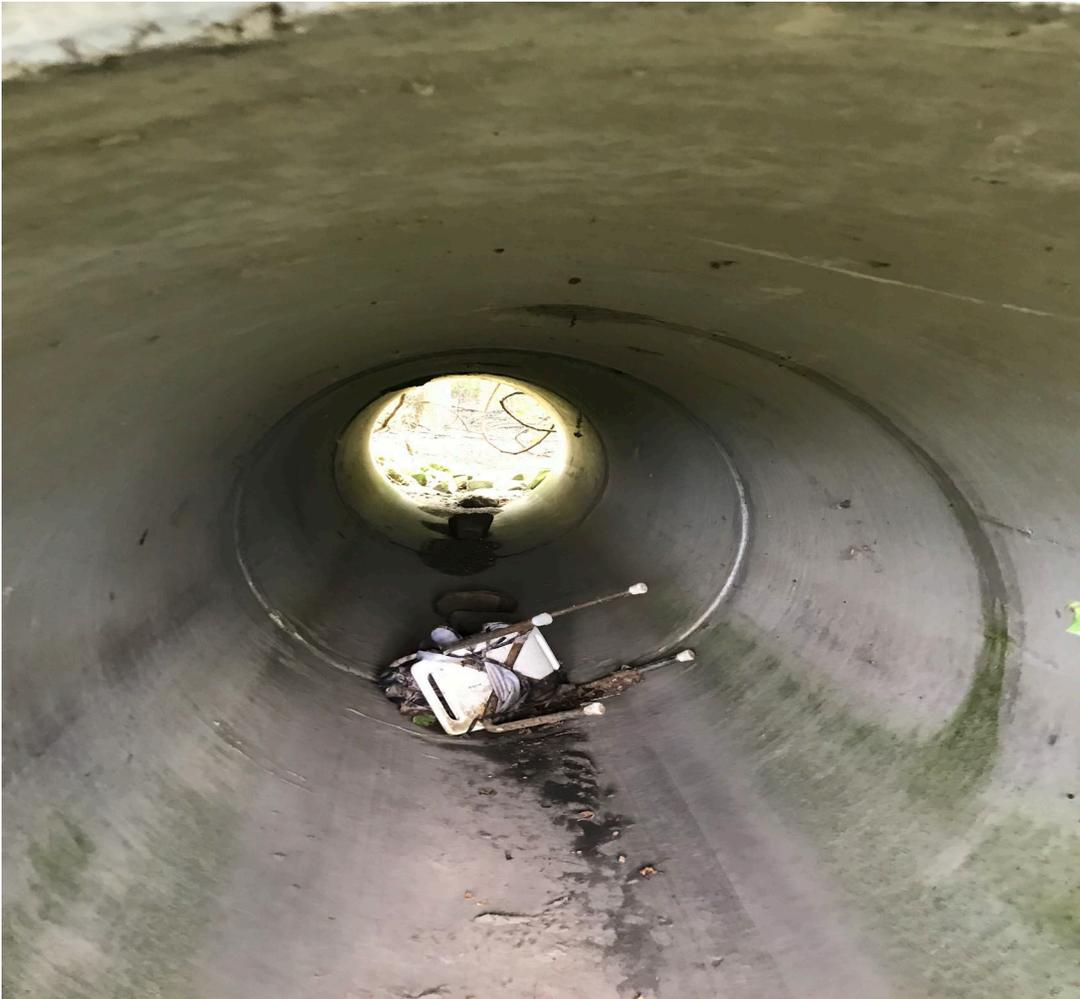
Figure 4. Four foot tall culvert leading off AOA into woods SW KARB

through these culverts by the smell of soybeans on the airfield or from the scent of other deer.

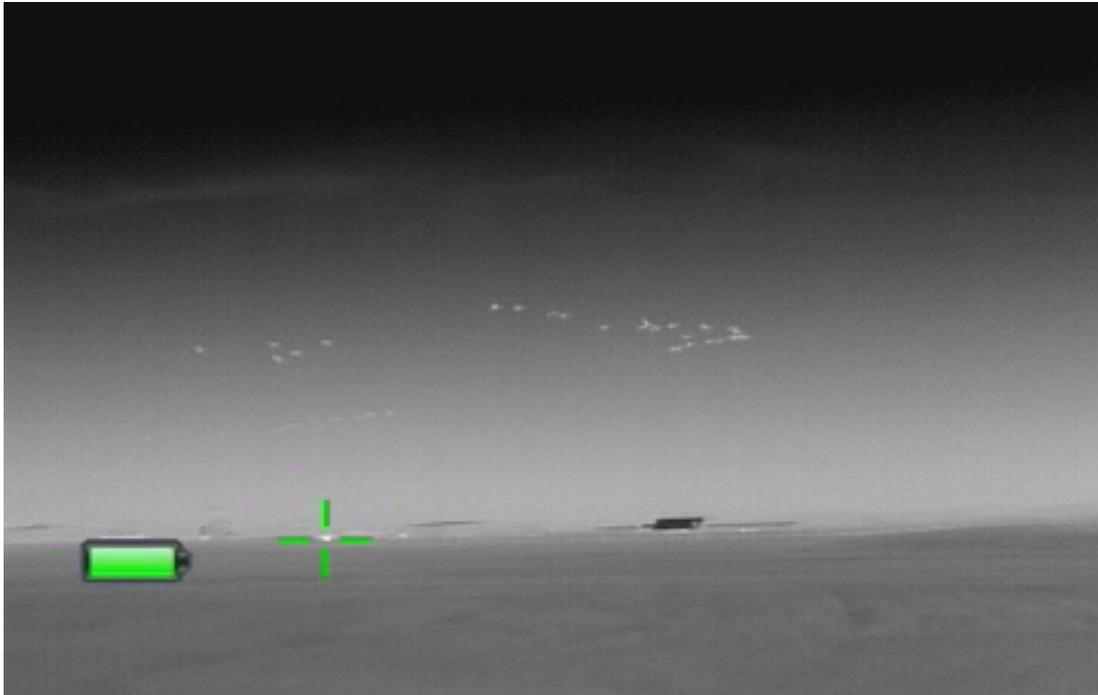
Figure 5. Canada geese leaving KARB in the dark

Morning, afternoon and evening wildlife surveys were conducted during the SV at KARB. During the morning and evening surveys 75-100 Canada geese were observed feeding in the tilled fallow field just north of the approach of runway 9. During the evening survey the geese occupied the approach of runway 9 from 18:30 until ten minutes after dark. During this time flocks of 5 to 15 geese arrived on the airfield at different times. When leaving, the geese took flight and circled the airfield by first heading east before turning west into the approach airspace for runway 9. Figure 5 shows geese leaving the airfield heading east before heading west. Geese were also observed feeding within 10 yards of the runway.

Avian hazards should not be overlooked either. Canada geese are a real and present danger, and will need to be managed for the foreseeable future. KARB is surrounded by ideal resident/migratory Canada goose habitat.
