Preservation Briefs: 9

The Repair of Historic Wooden Windows

John H. Myers

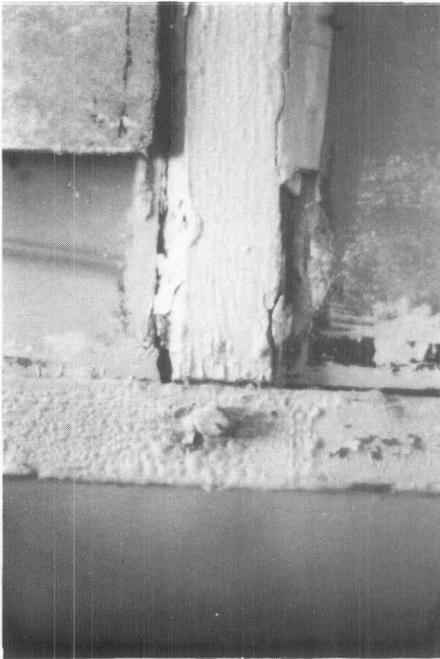
Figure 4a. The following series of photographs of the repair of a historic double-hung window use a unit which is structurally sound but has many layers of paint, some cracked and missing putty, slight separation at the joints, broken sash cords, and one cracked pane. Photo: John H. Myers

The routine maintenance required to upgrade a window to "like new" condition normally includes the following steps: 1) some degree of interior and exterior paint removal, 2) removal and repair of sash (including reglazing where necessary), 3) repairs to the frame, 4) weatherstripping and reinstallation of the sash, and 5) repainting. These operations are illustrated for a typical double-hung wooden window (see figures 4a-f), but they may be adapted to other window types and styles as applicable.

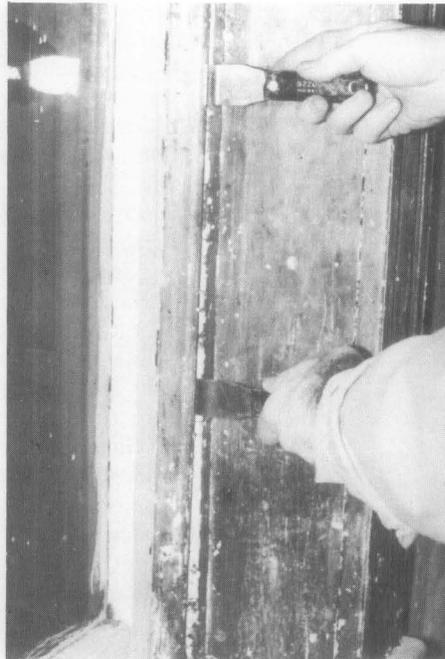
Figure 4b. After removing paint from the seam between the interior stop and the jamb, the stop can be pried out and gradually worked loose using a pair of putty knives as shown. To avoid visible scarring of the wood, the sash can be raised and the stop pried loose initially from the outer side. Photo: John H. Myers

Paint removal should begin on the interior frames, being careful to remove the paint from the interior stop and the parting bead, particularly along the seam where these stops meet the jamb. This can be accomplished by running a utility knife along the length of the seam, breaking the paint bond. It will then be much easier to remove the stop, the parting bead and the sash. The interior stop may be initially loosened from the sash side to avoid visible scarring of the wood and then gradually pried loose using a pair of putty knives, working up and down the stop in small increments (see figure 4b). With the stop removed, the lower or interior sash may be withdrawn. The sash cords should be detached from the sides of the sash and their ends may be pinned with a nail or tied in a knot to prevent them from falling into the weight pocket.

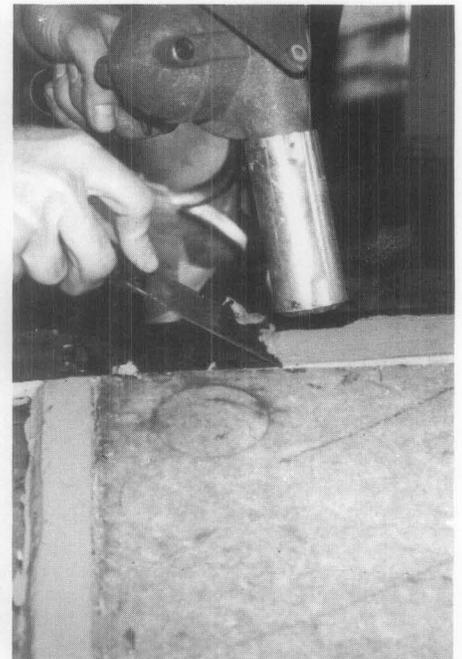
Figure 4c. Sash can be removed and repaired in a convenient work area. Paint is being removed from this sash with a hot air gun while an asbestos sheet protects the glass from sudden temperature change. Photo: John H. Myers

The sash can be stripped of paint using appropriate techniques, but if any heat treatment is used (see figure 4c), the glass should be removed or protected from the sudden temperature change which can cause breakage. An

overlay of aluminum foil on gypsum board or asbestos can protect the glass from such rapid temperature change. It is important to protect the glass because it may be historic and often adds character to the window. Deteriorated putty should be removed manually, taking care not to damage the wood along the rabbet. If the glass is to be removed, the glazing points which hold the glass in place can be extracted and the panes numbered and removed for cleaning and reuse in the same openings. With the glass panes out, the remaining putty can be removed and the sash can be sanded, patched, and primed with a preservative primer. Hardened putty in the rabbets may be softened by heating with a soldering iron at the point of removal. Putty remaining on the glass may be softened by soaking the panes in linseed oil, and then removed with less risk of breaking the glass. Before reinstalling the glass, a bead of glazing compound or linseed oil putty should be laid around the rabbet to cushion and seal the glass. Glazing compound should only be used on wood which has been brushed with linseed oil and primed with an oil based primer or paint. The pane is then pressed into place and the glazing points are pushed into the wood around the perimeter of the pane (see figure 4d). The final glazing compound or putty is applied and beveled to complete the seal. The sash can be refinished as desired on the inside and painted on the outside as soon as a "skin" has formed on the putty, usually in 2 or 3 days. Exterior paint should cover the beveled glazing compound or putty and lap over onto the glass slightly to complete a weathertight seal. After the proper curing times have elapsed for paint and putty, the sash will be ready for reinstallation.

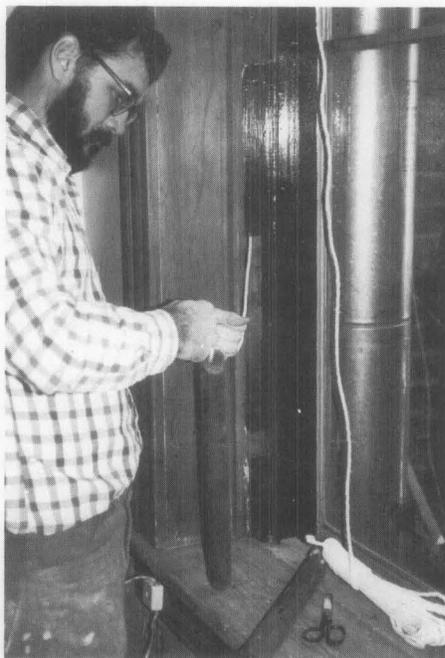
Figure 4e. A common repair is the replacement of broken sash cords with new cords (shown) or with chains. The weight pocket is often accessible through a removable plate in the jamb, or by removing the interior trim. Photo: John H. Myers

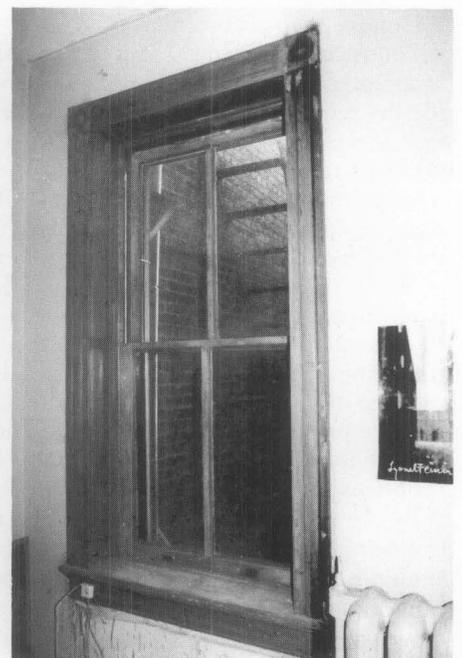
Figure 4f. Following the relatively simple repairs, the window is weathertight, like new in appearance, and serviceable for many years to come. Both the historic material and the detailing and craftsmanship of this original window have been preserved. Photo: John H. Myers

The operations just discussed summarize the efforts necessary to restore a window with minor deterioration to "like new" condition (see figure 4f). The techniques can be applied by an unskilled person with minimal training and experience. To demonstrate the practicality of this approach, and photograph it, a Technical Preservation Services staff member repaired a wooden double-hung, two over two window which had been in service over ninety years. The wood was structurally sound but the window had one broken pane, many layers of paint, broken sash cords and inadequate, worn-out weatherstripping. The staff member found that the frame could be stripped of paint and the sash removed quite easily. Paint, putty and glass removal required about one hour for each sash, and the reglazing of both sash was accomplished in about one hour. Weatherstripping of the sash and frame, replacement of the sash cords and reinstallation of the sash, parting bead, and stop required an hour and a half. These times refer only to individual operations; the entire proc-

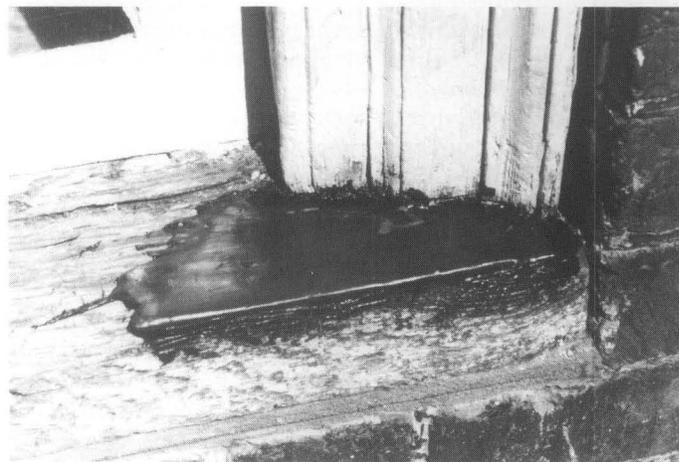
Figure 5. This illustrates a two-part epoxy patching compound used to fill the surface of a weathered sill and rebuild the missing edge. When the epoxy cures, it can be sanded smooth and painted to achieve a durable and waterproof repair. Photo: John H. Myers

Wood may also be strengthened and stabilized by consolidation, using semi-rigid epoxies which saturate the porous decayed wood and then harden. The surface of the consolidated wood can then be filled with a semi-rigid epoxy patching compound, sanded and painted (see figure 5). Epoxy patching compounds can be used to build up
