Newport Creek Area Drainage Study

FOR THE CITY OF ANN ARBOR

Draft: October 4, 2021
HRC Job No. 20200315

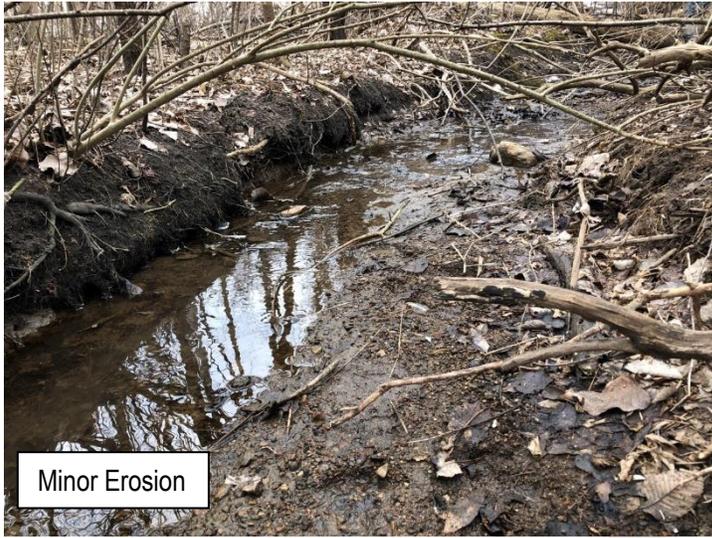
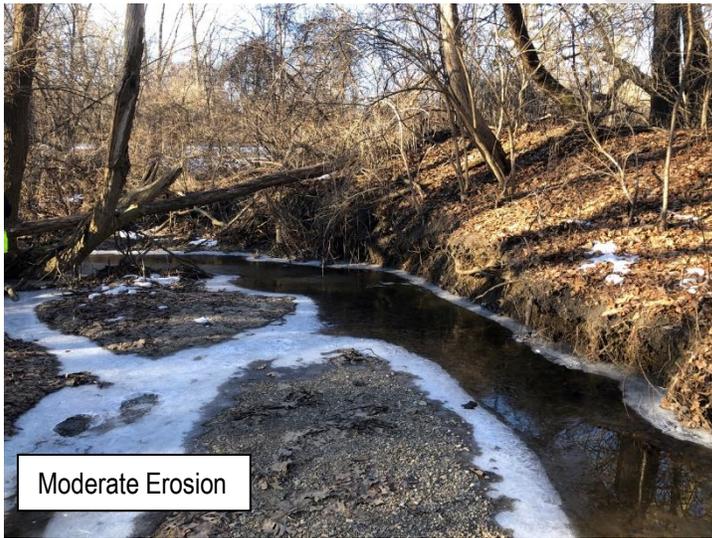
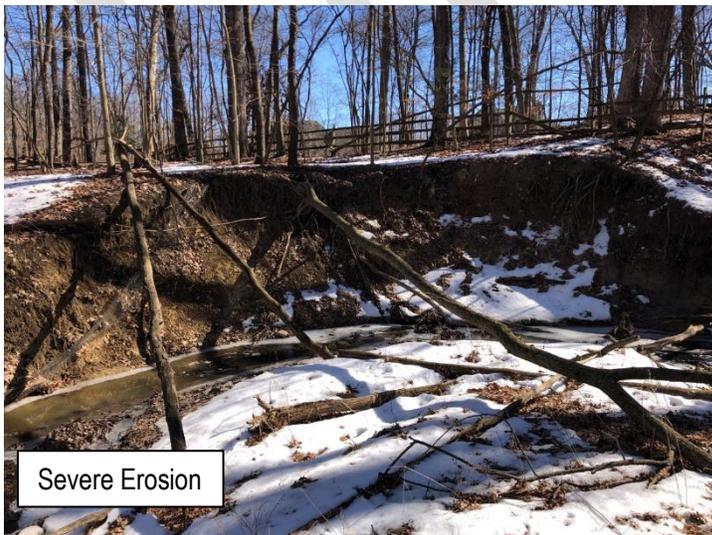
Figure 2. Examples of erosion severity seen along Newport Creek.

When examined closer, almost half of the eroding streambanks were considered severe (Table 2). Erosion condition scores were a qualitative assessment, generally determined by both the height and the level of exposed, unvegetated streambanks. Measurements were not taken to classify these categories, but the HRC team has experience with stream assessments, and the field personnel were calibrated to each other. Figure 2 shows examples of the difference in erosion severity seen along Newport Creek. Of the eroding banks, over 85% were considered either severe or moderate (Table 2). Therefore, while the total percentage (22.4%) of eroding streambanks within the system is not particularly surprising, the severity of the eroding areas should be noted for additional consideration. Table 3 further details the erosion severity within each section of Newport Creek. While each section has roughly the same percentage of eroding banks (20-25%), the erosion severity can differ quite a bit.

Streambank stabilization measures can be employed where the banks of Newport Creek are experiencing erosion. These measures can range from planting vegetation to armoring the streambank with rock or stone. However, it should be advised that streambanks with more than just minor erosion likely will not stabilize themselves with vegetation alone. More severe erosion is a symptom of a larger problem that should be addressed with qualified licensed engineers and contractors. It is important that any remedy is not merely a band-aid that either will not last or shifts the problem to another location within the creek. Figure 14 shows a potential streambank stabilization method. Permits will be required by the Michigan Department of Environment, Great Lakes, and Energy (EGLE) to do any work on the creek. There are some fast-track and less onerous permit processes for homeowners or projects that require less work. These would fall under the General or Minor permit categories for bioengineering streambanks (https://www.michigan.gov/egle/0,9429,7-135-3313_71520_24403-539378--,00.html).

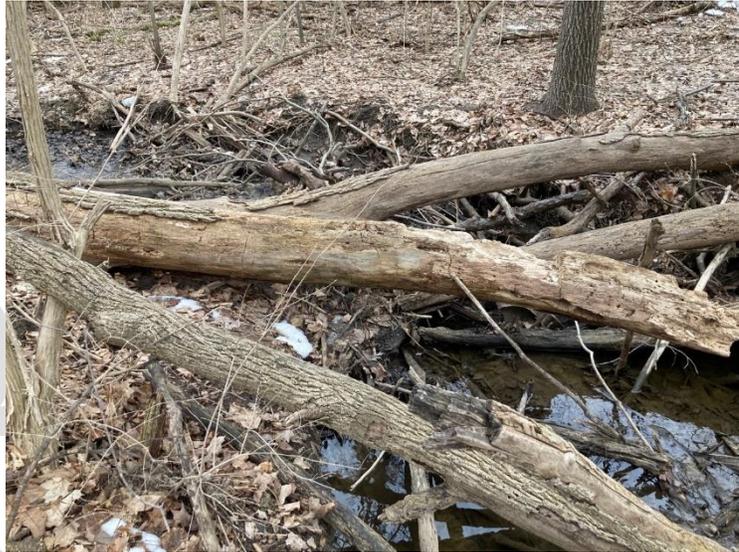
Figure 4. Additional barriers found in Newport Creek.

Also noted throughout the creek were other barriers (weir, check dams, failed culvert crossing) that range in their influence and impact to the movement of water throughout the system (Figure 4).

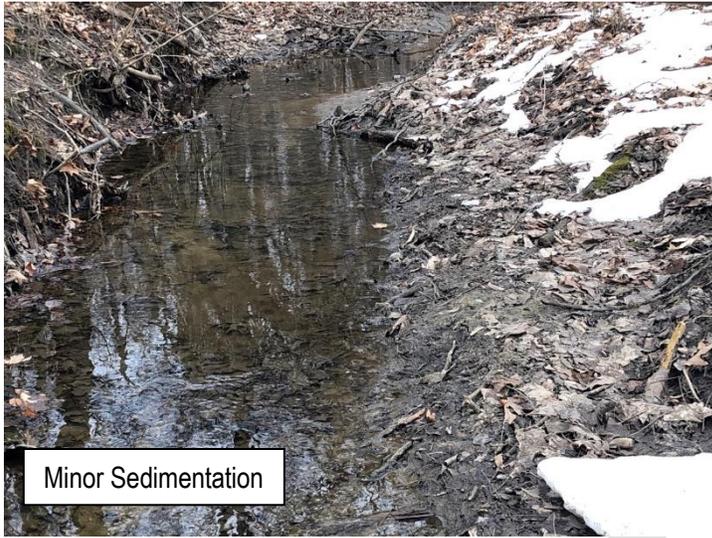
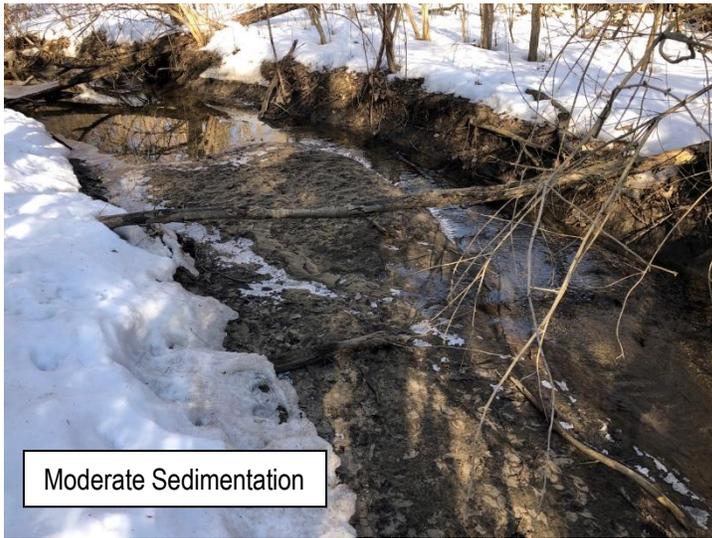
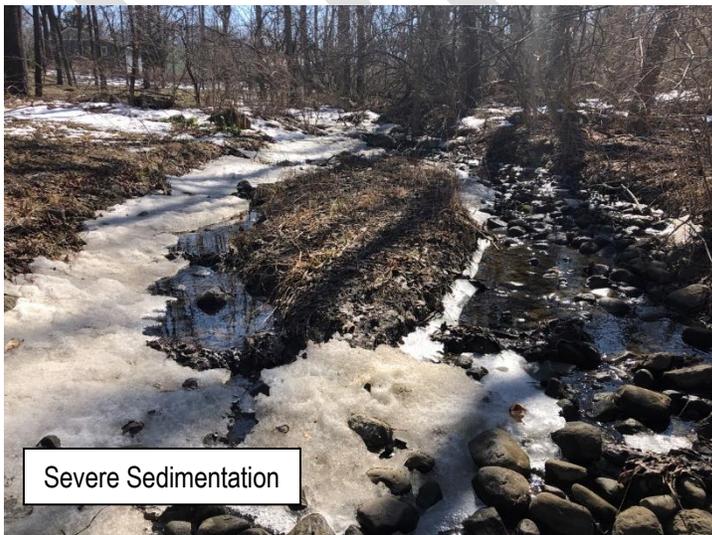
Figure 5. Examples of sediment severity seen within Newport Creek.

As mentioned previously, sedimentation was noted as a type of obstruction when performing the stream inspection. Similar to the streambank condition erosion assessments, sedimentation was categorized by severity on a qualitative basis. Severity was determined by both the amount of sediment in the stream and its impact to the functioning of the creek. Figure 5 shows an example of each sediment severity classification found in Newport Creek. Given the extent of erosion along the creek, it is reasonable to also find sediment deposition. Just as erosion is a natural element of streams, sediment deposition is also a natural process. However, this deposition can become problematic when it starts to impact the functionality of the natural system and movement of water through it. Sediment only physically impacted roughly 5% of the length of Newport Creek and the majority of that was considered minor or moderate, 36% and 38% respectively (Table 5). This indicates that although there is a fair amount of erosion occurring throughout the system, the sediment is being transported and mostly deposited into the Huron River. A natural, self-sustaining system would balance the amount of erosion and sediment deposition. It would appear that Newport Creek has a sediment deficit, but this would have to be confirmed from actual quantitative analyses.

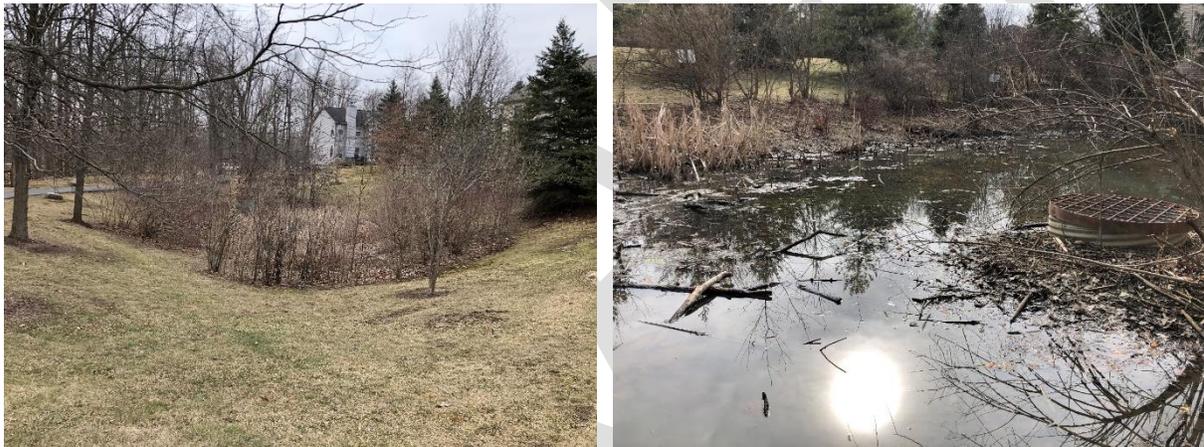
Figure 7. Excessive vegetation.

The most common maintenance issue seen throughout the pilot study was excessive vegetation that has likely decreased a basin's original design capacity. Several basins also showed some sediment accumulation. The most common issues encountered included:

Several of the stormwater basins within the Newport Creek drainage area were assessed and recommended for maintenance, see Section 2.2. Removing excess vegetation and sediment will increase the storage capacity of several impacted basins. This will allow more water to be detained during rain events and help reduce the peak flow into Newport Creek. However, while this may help reduce the frequency of flooding, this is unlikely to solve all flooding concerns. HRC recommends locating the Maintenance Agreements for each of the basin's which could help determine a follow up protocol based on the outcome of these evaluations. If there are not Maintenance Agreements, the City could mail a notice to the HOAs or private owners with information on the existing conditions of their basin(s) and suggestions for maintenance.

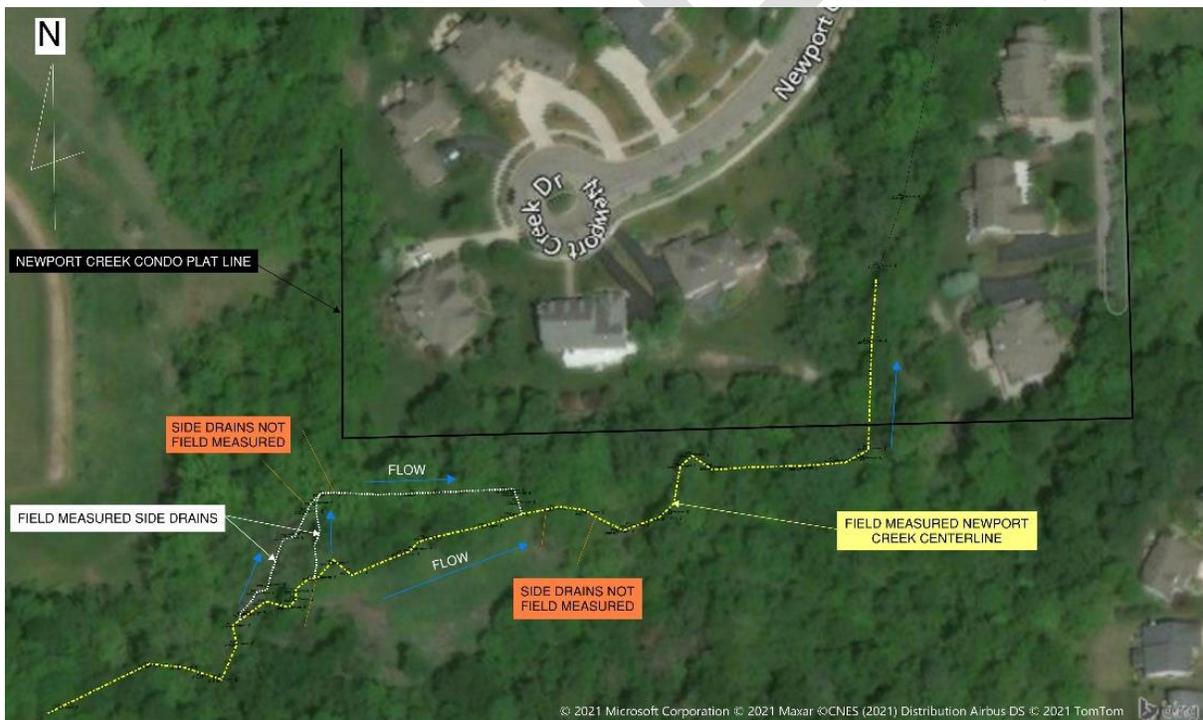
Figure 13. Braided area of Newport Creek.

HRC identified, surveyed, and described the existing route and course for Newport Creek as part of this study (Appendix C). The route and course description and exhibit define the centerline of the existing stream. Most of Newport Creek is a single channel system except for the area between Skyline High School and Newport Creek Drive (Figure 13). This area has multiple channels, no clearly defined main channel, and has been cited by several residents to experience regular flooding. If Newport Creek becomes a County Drain, this area would need to be further investigated. HRC's surveyed route and course determined the main channel within this braided system to be the southernmost braid. This was established based on where the channel likely was or should be rather than where most of the water is currently going. It is likely that as a County Drain, this area would need to be clearly defined. This stretch was also indicated as an area with high potential for new stormwater detention, either as an offline basin or as a shallow wetland complex (Figure 11). If a project were to proceed, this route and course could be amended to correlate with the improvements.

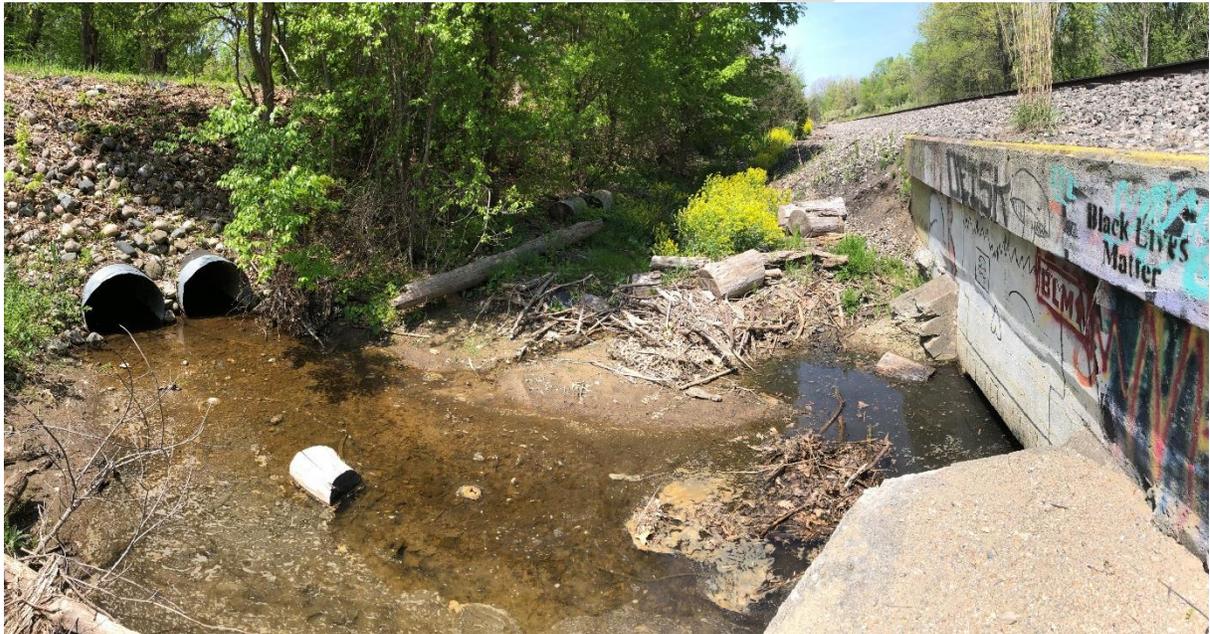
Figure 16. Culverts under Huron River Drive and the railroad.

Field inspections during the creek assessment identified pinch points along the drain. The most obvious pinch point in the system was noticed between Huron River Drive and the culverts under the railroad near the outlet at Barton Pond. The railroad culvert is almost entirely filled with sediment, a condition which is not accounted for in the EPA SWMM model. This is an additional reason the model does not show flooding where flooding is known to occur. To

address the railroad culvert that is filled with sediment, MDOT will need to be involved in further communications.

Cost estimate: \$250,000 (Not including MDOT costs)
