Millers Creek Watershed Improvement Plan

Prepared by:
Ayres, Lewis, Norris, & May, Inc.
Huron River Watershed Council
Tilton and Associates, Inc.

Ann Arbor, MI
April 20, 2004

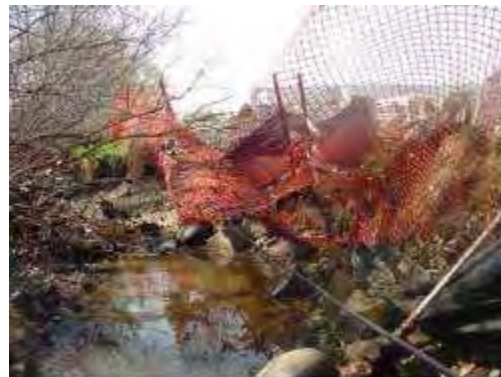
Figure 1.1 Damage on Pfizer Campus Along Millers Creek

This project was prompted by flooding and bank erosion on Pfizer's Ann Arbor campus (See **Figure 1.1**). Pfizer decided to investigate the problems and develop a solution by looking at their campus in the context of the Miller Creek watershed. With assistance from the Washtenaw County Drain Commissioner (WCDC) and the Huron River Watershed Council (HRWC), Pfizer initiated MCAT and this project. Concern for the creek coalesced in the middle to early 1990s when an earlier version of MCAT, led by the Environmental Research Institute of Michigan (ERIM), the HRWC and the WCDC began investigating possible watershed-wide improvements.

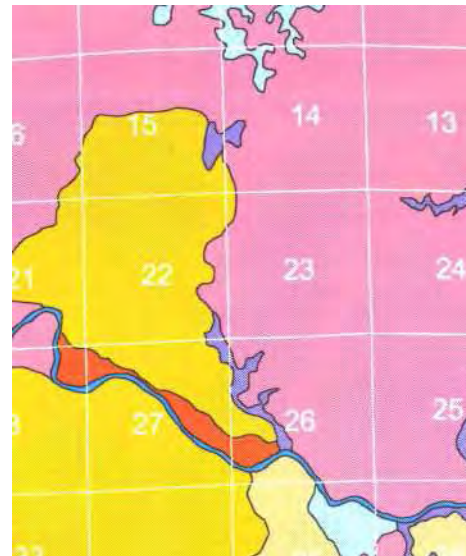
Figure 2.4. Presettlement Vegetation (pink area represents oak-hickory forest)

The European pre-settlement vegetation within the Millers Creek watershed was primarily oak-hickory and mixed oak forest (**Figure 2.4**). Oak-hickory forest covered the watershed east of the creek while mixed oak forest occupied the western half of the watershed. A large area of wet prairie once existed in the area that is now Thurston Pond and Nature Area. Another linear area of wet prairie once extended along Millers Creek from the mouth to Glazier Way (Cormer, et al., 1995).

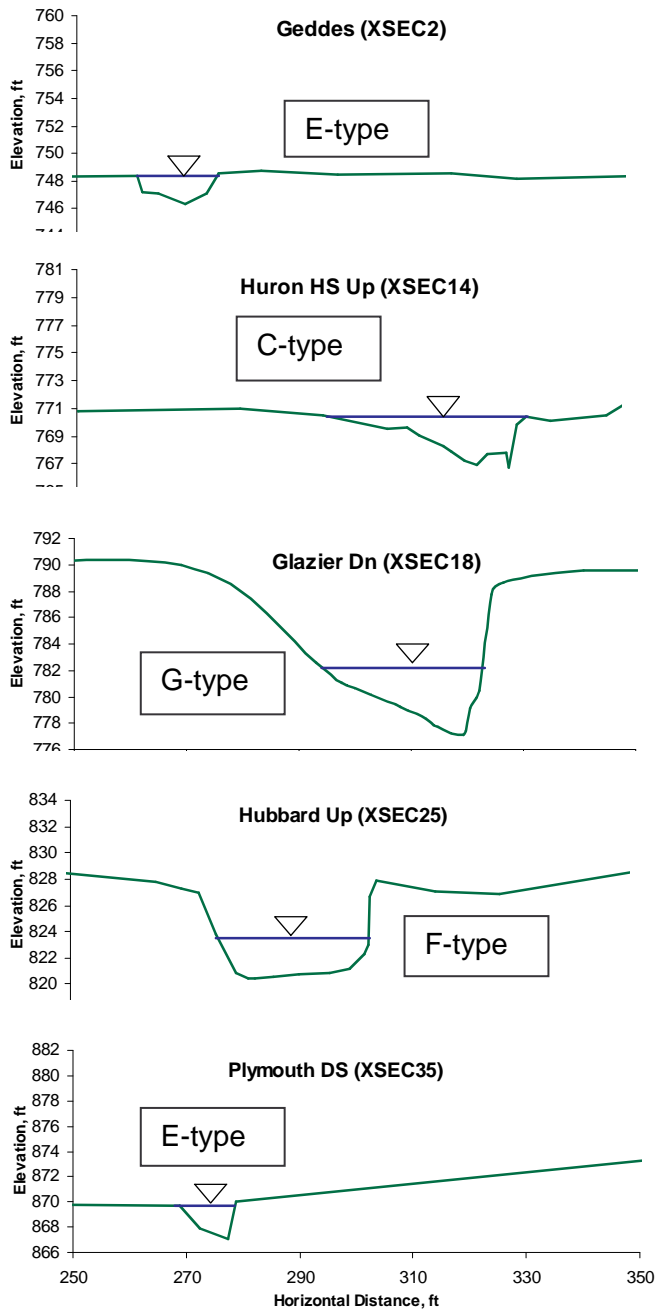
Figure 2.8 Millers Creek Cross-sections (left) and an Example of Channel Evolution (right), modified from Rosgen (1996)

- e. Meandering creates a C-type stream within the confines of the original channel.
- f. Additional settling out of solids builds up a new, active floodplain, and a new E-stream type within the original channel. The old floodplain is perched above the active stream and is now referred to as a terrace.

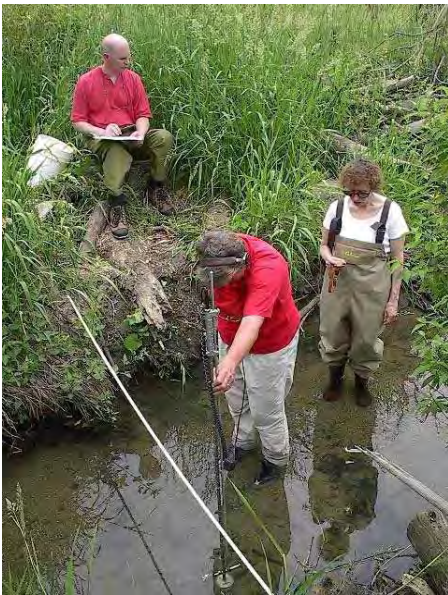
Figure 3.2. Volunteers measure flow at the study site near Huron High School.

HRWC developed rating curves for staff gages at seven study sites and for pressure transducers (water level recorders), at three of those study sites (Plymouth, Glazier and Meadows) by measuring flow with a current meter during a variety of flow periods from June 2002 until November 2002 (See **Figures 3.2 and 3.3 and Appendix G**). Due to the rapidity

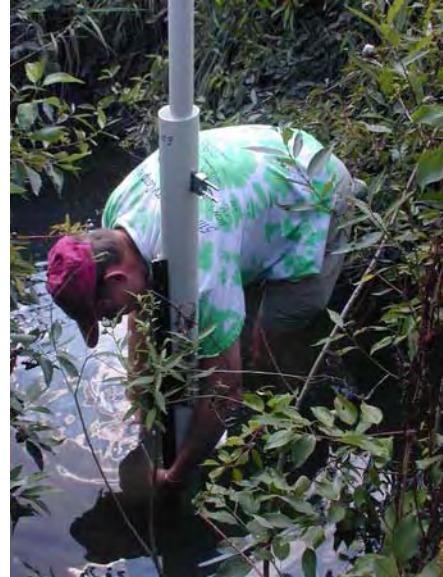
Figure 3.4 A volunteer installs a transducer at the Meadows study site.

A bed profile and cross-section survey of the main channel of Millers Creek was conducted (See **Appendices E and I** for data). The survey started at the Plymouth Road culvert near Green Road and extended to the creek mouth at Geddes Road. Traditional surveying methods were used and tied into USGS vertical benchmarks (NGVD29). Horizontal location of the stream centerline was located by GPS and by aerial photography. The profile survey included cross sections at 500 to 1,000 foot intervals. ALNM provided the benchmarks for the HRWC geomorphology study. Huron River water surface elevations were interpolated from the 1983 FEMA study. Where needed, additional elevations were interpolated from the City of Ann Arbor GIS 5-foot contour topographic map. The Project Team also provided vertical control survey for the staff gage and transducer locations (see **Fig. 3.4 and Appendix G**).

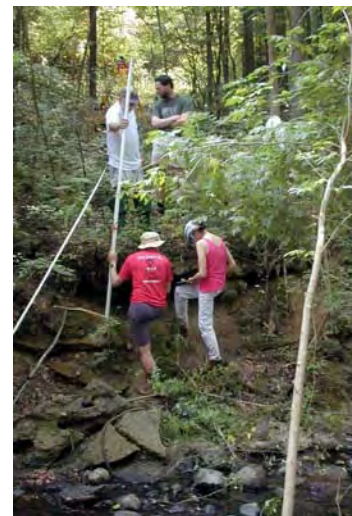
Figure 3.5. Volunteers measure geomorphology at the Hubbard Site

Using a level and rod, HRWC teams measured the geomorphic characteristics of the channel along three permanently marked cross-sections at five study sites (Plymouth, Hubbard, Glazier, Huron HS and Meadows) in June through November 2002. The teams located bankfull, edge of the water, thalweg (lowest elevation) and, inflection points at each cross-section. They also measured the slope of the stream in the surveyed stretch. Team accuracy was demonstrated by repeating measurements at each transect by a different team at least once during the summer (**Figure 3.5 and 3.6**).

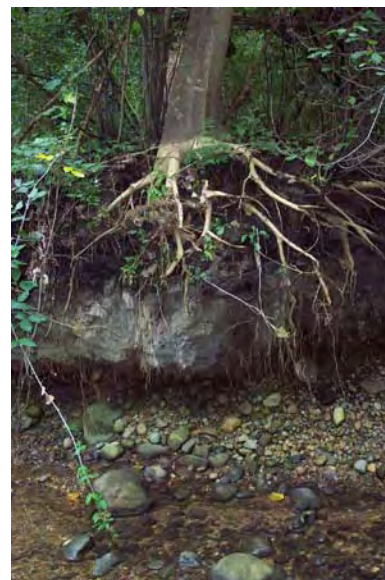
Figure 3.7 Elevated Plant Root Zone

The bed of Millers Creek has eroded due to channelization and increased peak flows. Consequently, the plant root zone is elevated above Millers Creek in many areas (See Figure 3.7). Because plant roots are important in stabilizing soils, this condition makes streambanks more susceptible to erosion. The portion of the streambank that is exposed to flowing water does not contain a dense plant root matrix. The degree of bed downcutting varies throughout the watershed. Therefore, the height of the bank between the bed and rooted zone also varies. Streambanks become more susceptible to erosion as this distance increases.

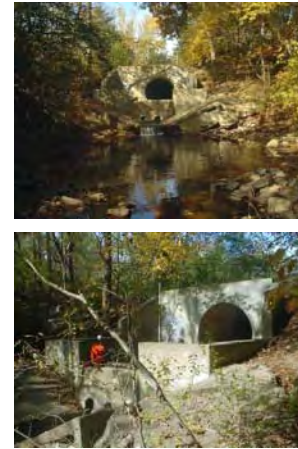
Figures 3.8 (a) and (b) Examples of Large Concrete Culverts in Millers Creek

Flow velocity in Millers Creek is dependent upon many natural geomorphic variables but is primarily controlled by bed slope. The most important human-induced factor affecting flow velocity in Millers Creek is channel constriction, including enclosures or culverts (See **Figures 3.8 (a) and (b)**). Large sections of Millers Creek are enclosed in culverts where it is crossed or encroached upon by roads and other infrastructure. These culverts constrict flow and increase velocity. Artificially high flow velocities in Millers Creek cause bed and bank erosion. Typically, frequent flow velocities greater than 3 feet per second (fps) can begin to degrade the bed and banks of Millers Creek. In addition to culverts, contributing storm sewers discharge at high velocity into Millers Creek. This criteria was evaluated by averaging the velocities at each model node within a given reach as computed by the SWMM hydraulic model (refer to **section 4.2**).

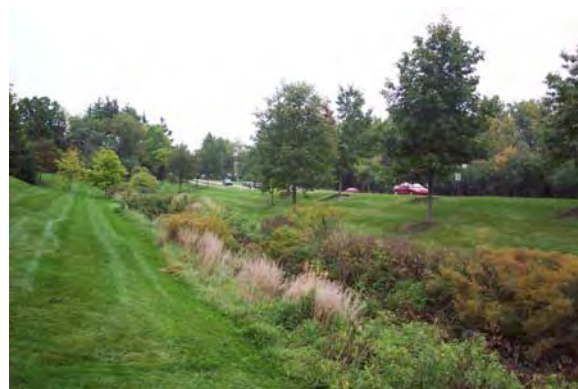
Figure 3.9 Example of the Vegetative Cover along a stretch of Millers Creek where trees are lacking

Vegetated streambanks have a good root matrix that helps bind soil particles together and resists erosion. The type, density, and depth of the root matrix depend on the presence and type of vegetation growing on the bank. The ideal vegetative cover contains plants from the three community types: trees, shrubs, and forbs (wildflowers and grasses). A blend of these community types is present along streambanks throughout much of Millers Creek. However, the tree and shrub communities are lacking in some areas (See **Figure 3.9**). Reaches with turf grasses have the highest potential for erosion. Reaches dominated by the tree-shrub communities have the lowest erosion potential.

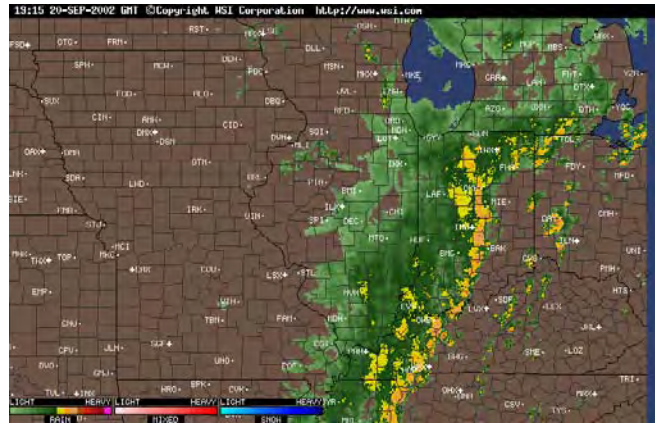
Figure 3.10 Radar Image of 9-20-02 Rainfall

Two dry weather surveys and three wet weather water quality surveys were conducted between August and October 2002. Successful wet weather capture was facilitated by real-time rainfall forecast data available via the internet (See **Figure 3.10**). Water quality grab samples and staff gage readings were taken at six of the study sites during these surveys. A Quality Assurance Protection Plan (QAPP) preceded data collection to provide assurance that all data was

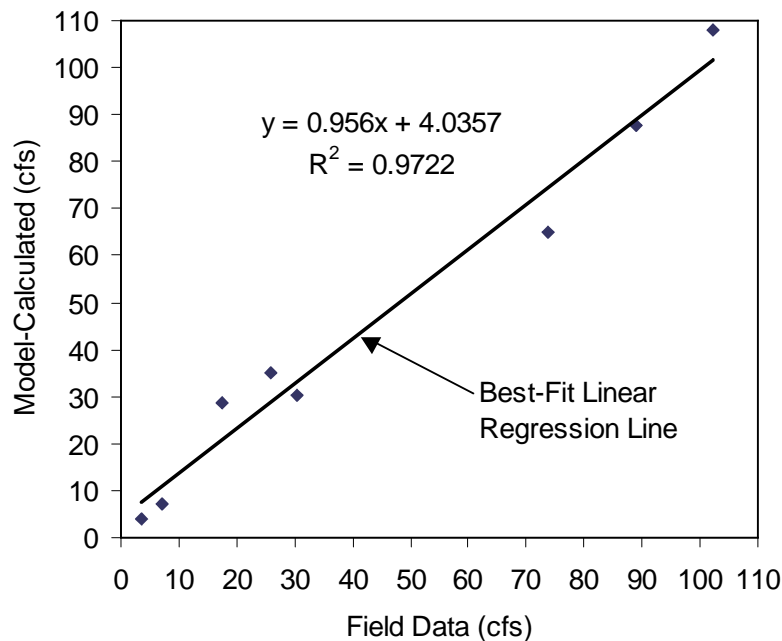
Figure 4.2 Comparison of Model-Calculated and Measured (by transducer) Peak Flow Rates for the three calibration events at the Plymouth, Glazier and Meadows Sites

Note: Meadows flow estimated for comparison purposes using Huron HS site stage-discharge relationship

Examples of the calibration fits are shown in **Figures 4.2-4.4** below. In **Figure 4.2** event peak flow observations are plotted against model calculations and a best-fit regression line drawn through the points. Note that a line slope of 1 translates into an exact match between the model estimates and data, and the r^2 value (correlation coefficient) represents the strength of the regression comparison. The peak flow regression slope is 0.96 and the $r^2 = 0.97$. The total volume fit regression slope is 1.17 with an $r^2 = 0.99$. Note also that the model slightly under-predicts peak flow and slightly over-predicts total volume. Final calibration was a compromise between matching peak flows but not excessively over-predicting total flow through the system. In **Figure 4.3**, calculations are plotted for the first calibration event at Glazier.

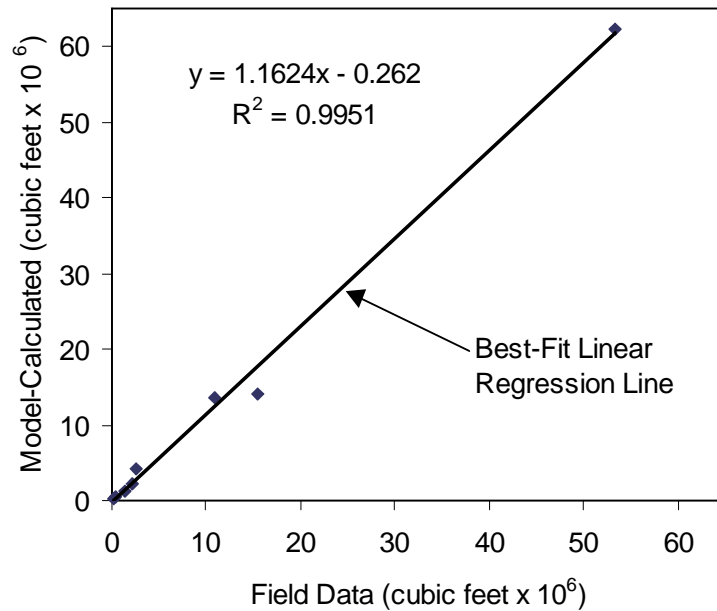
Figure 4.3 Comparison of Model-Calculated and Measured (by Transducer) Total Event Volume for the three calibration events at the Plymouth, Glazier and Meadows Sites

Note: Meadows total event volume estimated for comparison purposes using Huron HS site stage-discharge relationship

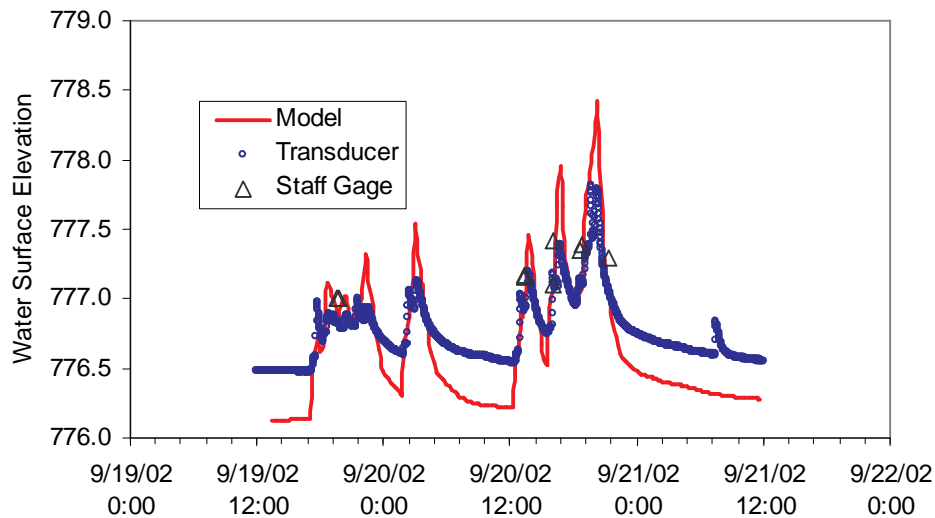
Figure 4.5 Example Water Surface Elevation Calibration Fit Event 1 (Sept.19-21, 2002) at the Glazier Site

At low flows (< 10 cfs), the model under-predicts flow depths, while at high flows (>50 cfs), the model over-predicts flow depths (See **Figure 4.5** below). We found that the discrepancies between model flow depths and observations at low flow depths were less than 6 inches. At the highest observed calibration flows the discrepancies could be slightly higher than 6 inches.

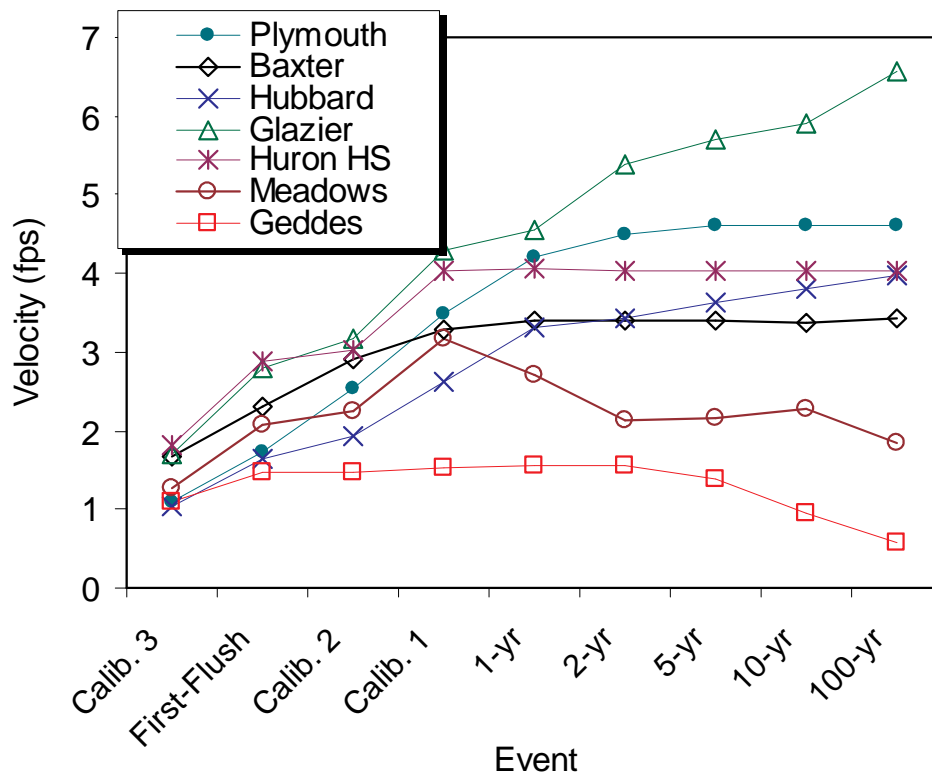
Figure 4.7 Model-Estimated Peak Velocities* for all Existing Conditions Events (model velocity defined as the average across the channel)

Model calculations for peak flow, average cross-section velocity and the 100-year floodplain for the main channel of Millers Creek are summarized in this section. **Figures 4.6 and 4.7** below summarize the calibrated model peak flow and peak velocity estimates for existing conditions. Glazier and Hubbard, the most geomorphically unstable sites, show consistently increasing velocities with increasing flows. Meadows and Geddes, the sites experiencing the most overbank flow, show decreasing velocities with increasing flows for events larger than the 1-year and 2-year storms. During larger storm events backwater from the Huron River is likely contributing to overbank flows and decreasing velocities at these downstream stations.

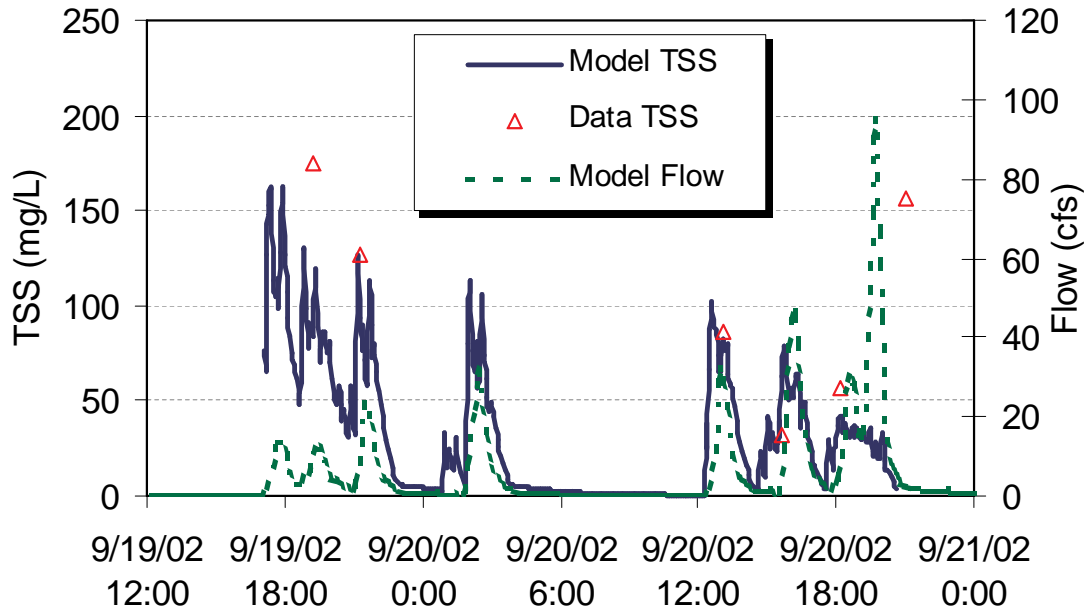
Figure 4.8 Comparison of Model-Calculated and Field Data Total Suspended Solids Concentration at the Hubbard Station for Event 1, Sept.19-21, 2002

Examples of the water quality calibration for TSS and TP are shown in **Figures 4.8** and **4.9** below.

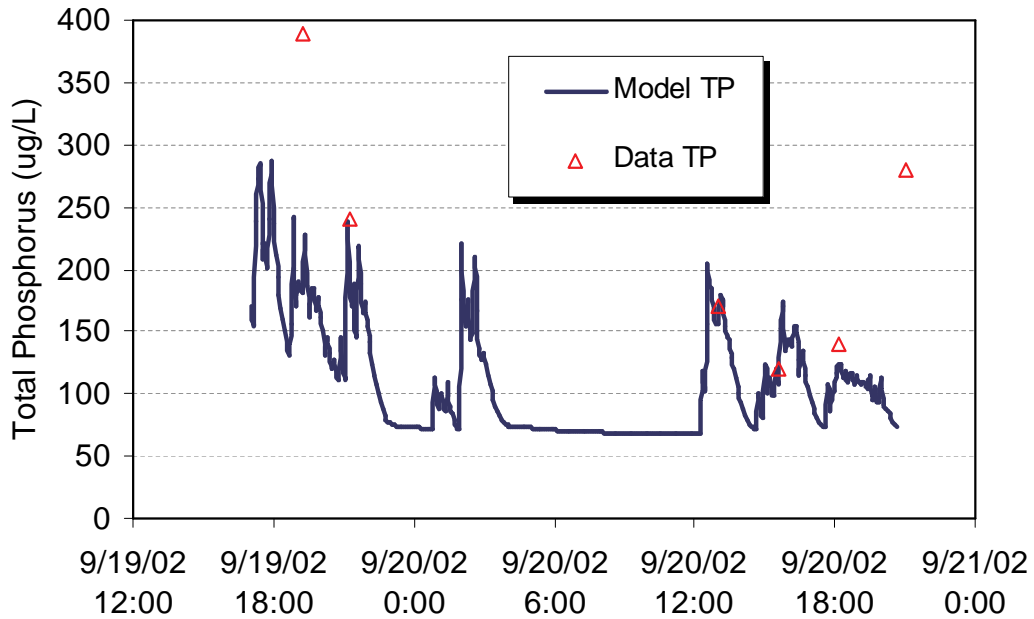
Figure 4.9 Comparison of Model-Calculated and Filed Data Total Phosphorus Concentration at the Hubbard Station for Event 1, Sept.19-21, 2002
