ADDENDUM No. 1

ITB No. 4680

City of Ann Arbor WWTP Clear Well Improvements

**Ann Arbor Wastewater Treatment Plant
Tertiary Filter Building
Filter Clear Well Investigation Summary and Recommendations**

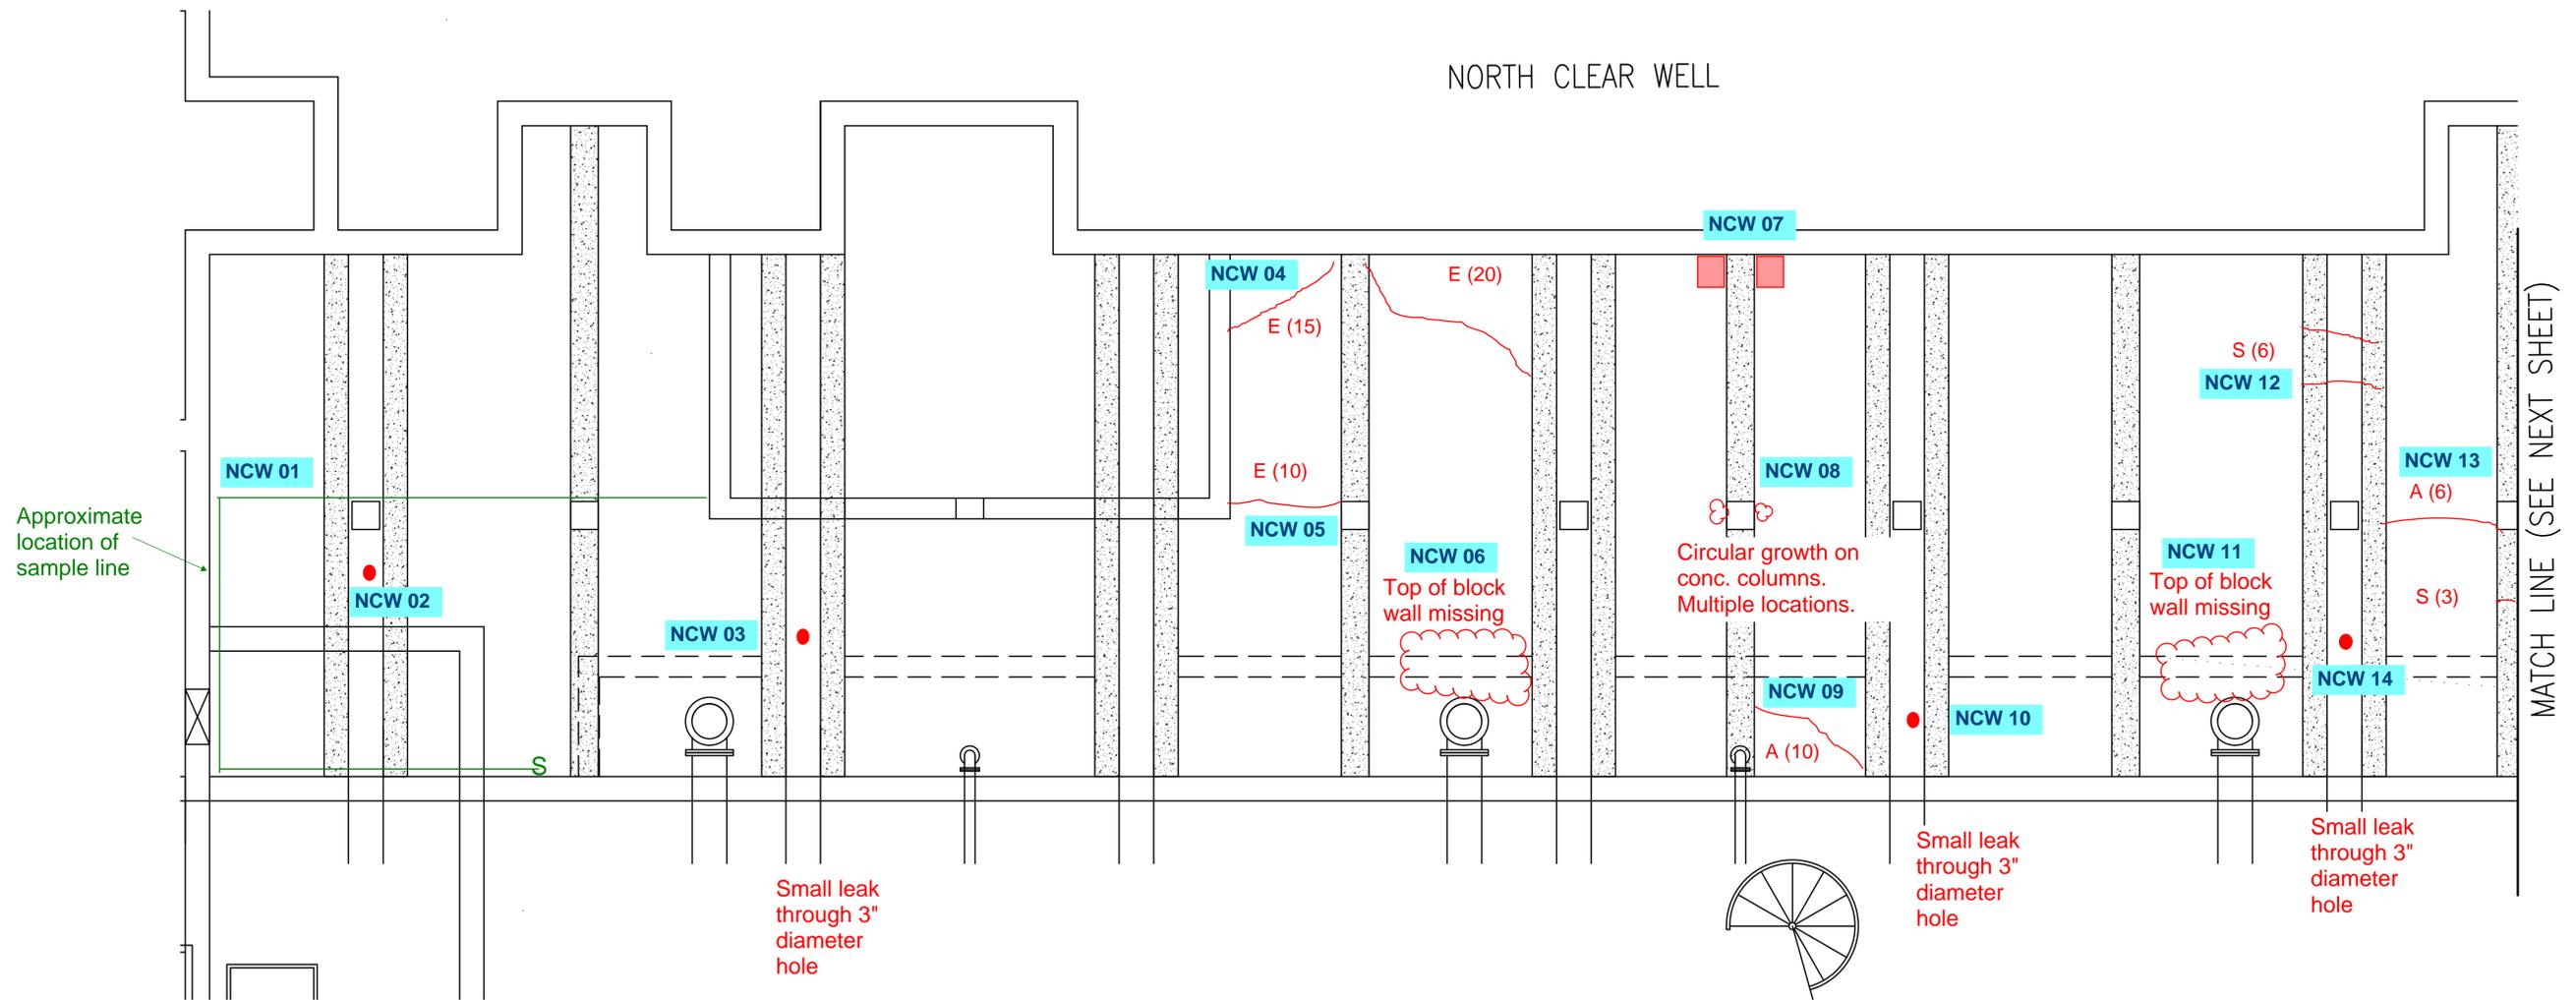
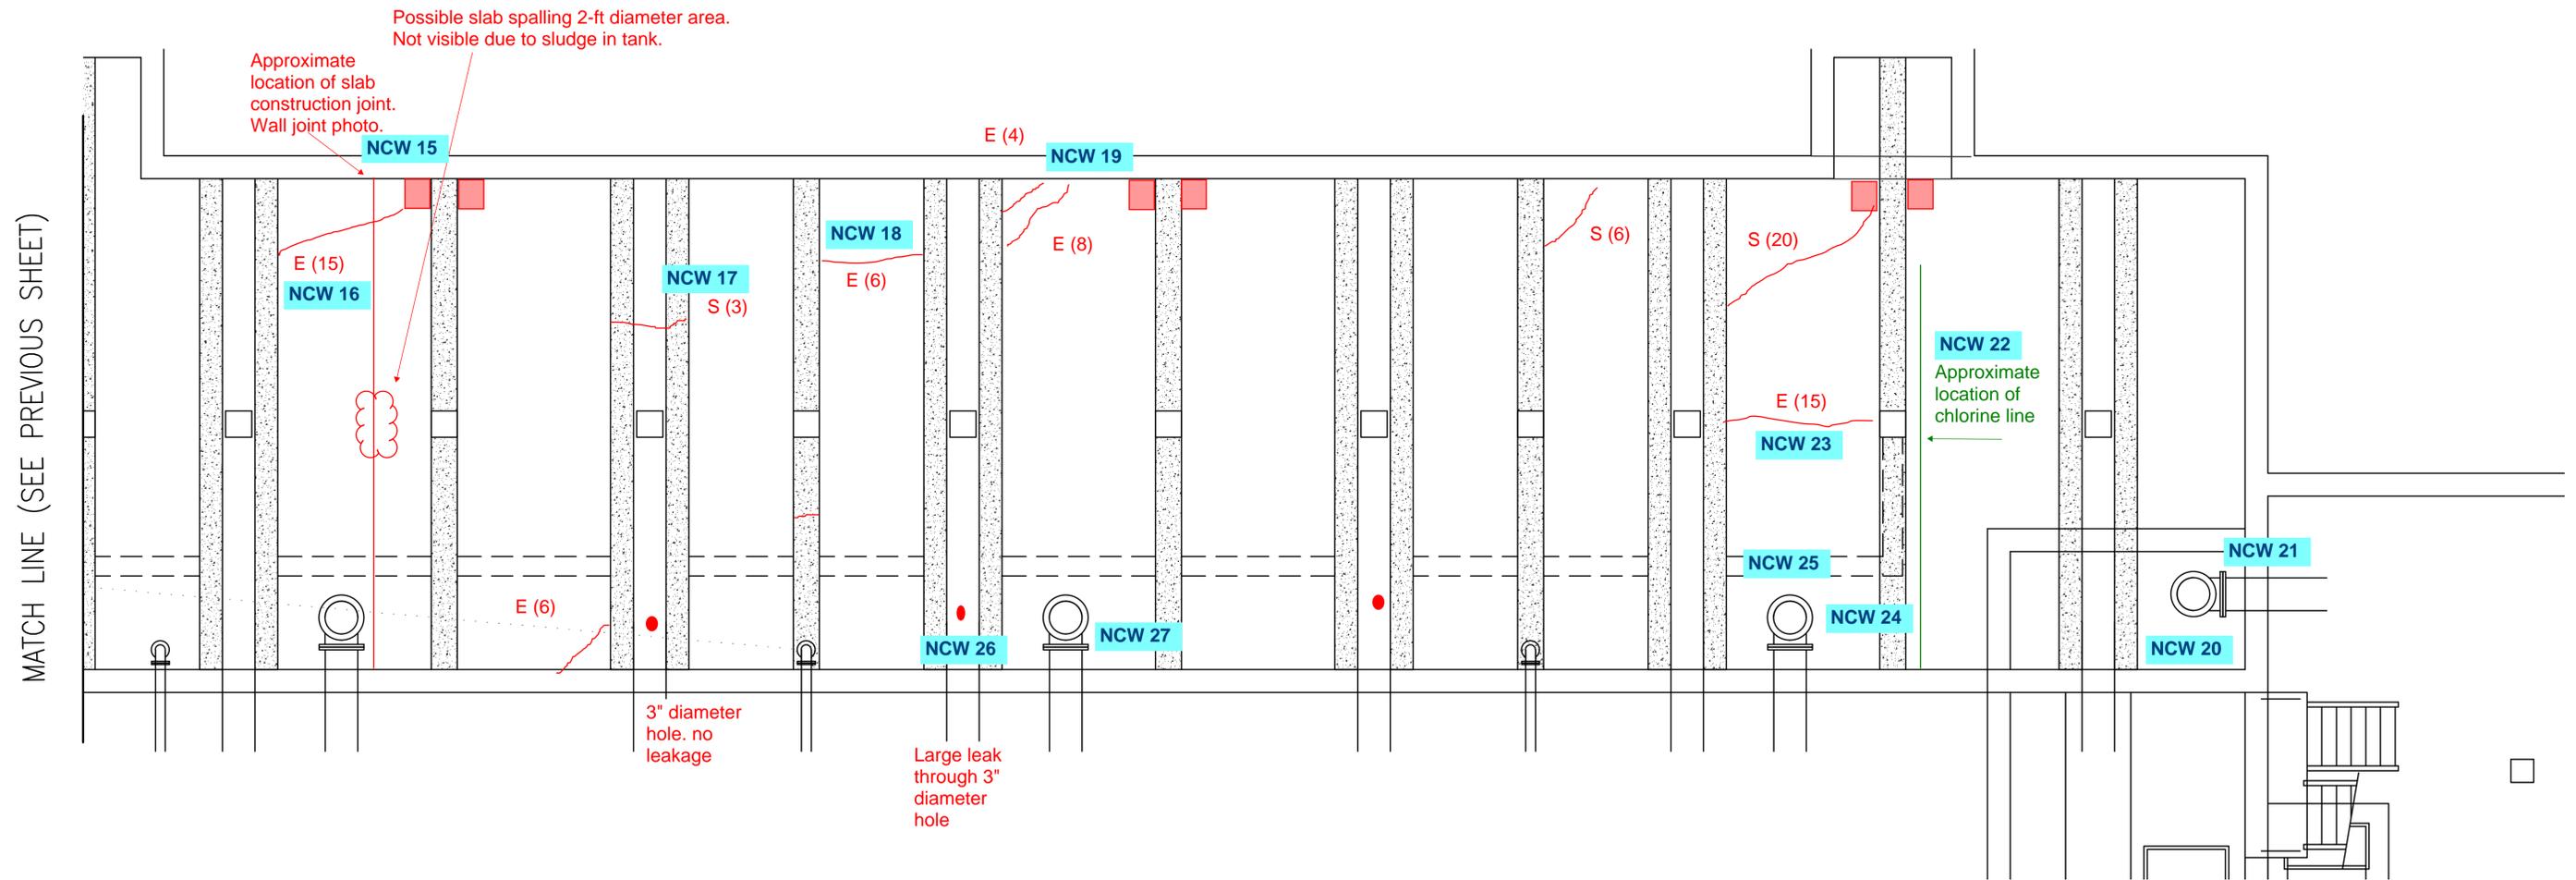
NORTH CLEAR WELL

- There are no expansion joints in this clear well.
- The ceiling is in good condition and not stained as it is above the operating water level.
- There were circular areas on the underside of the wide beams/ troughs at the bottom of the filter cells that require concrete restoration. Several small holes that appeared to be tie- holes from the original construction, or possibly the location that the vertical resteel was anchored for the Westech supports for the 1997 underdrains. Several of these areas were actively leaking which would have been water remaining in the underdrain troughs from the shutdown. These areas will need to be dried and patched.
- There was intermittent cracking along the ceiling of the structure and efflorescence was visible. The efflorescence is produced when the free lime in the concrete reacts with water. The water causing the

efflorescence may be from condensation inside the tank or possibly from infiltration from the filters above. These items are noted in the attached annotated plan of the clear wells.

- The CMU baffle wall was deteriorating primarily at the location of the Filter Effluent discharge bells near the ceiling of the clear well. Recommend complete removal of the baffle wall. The interfaces to the base slab and ceiling to be patched. The requirement of a new baffle wall and design to be explored as part of the alternatives analysis.

- Galvanized steel plates with clips. (typical)
- Approximately 3-inch diameter hole in the bottom of beam.
- A = Crack actively leaking
- E = Crack with efflorescence
- S = Stress crack
- ~ Crack with estimate length
- NCW XX Photo reference number

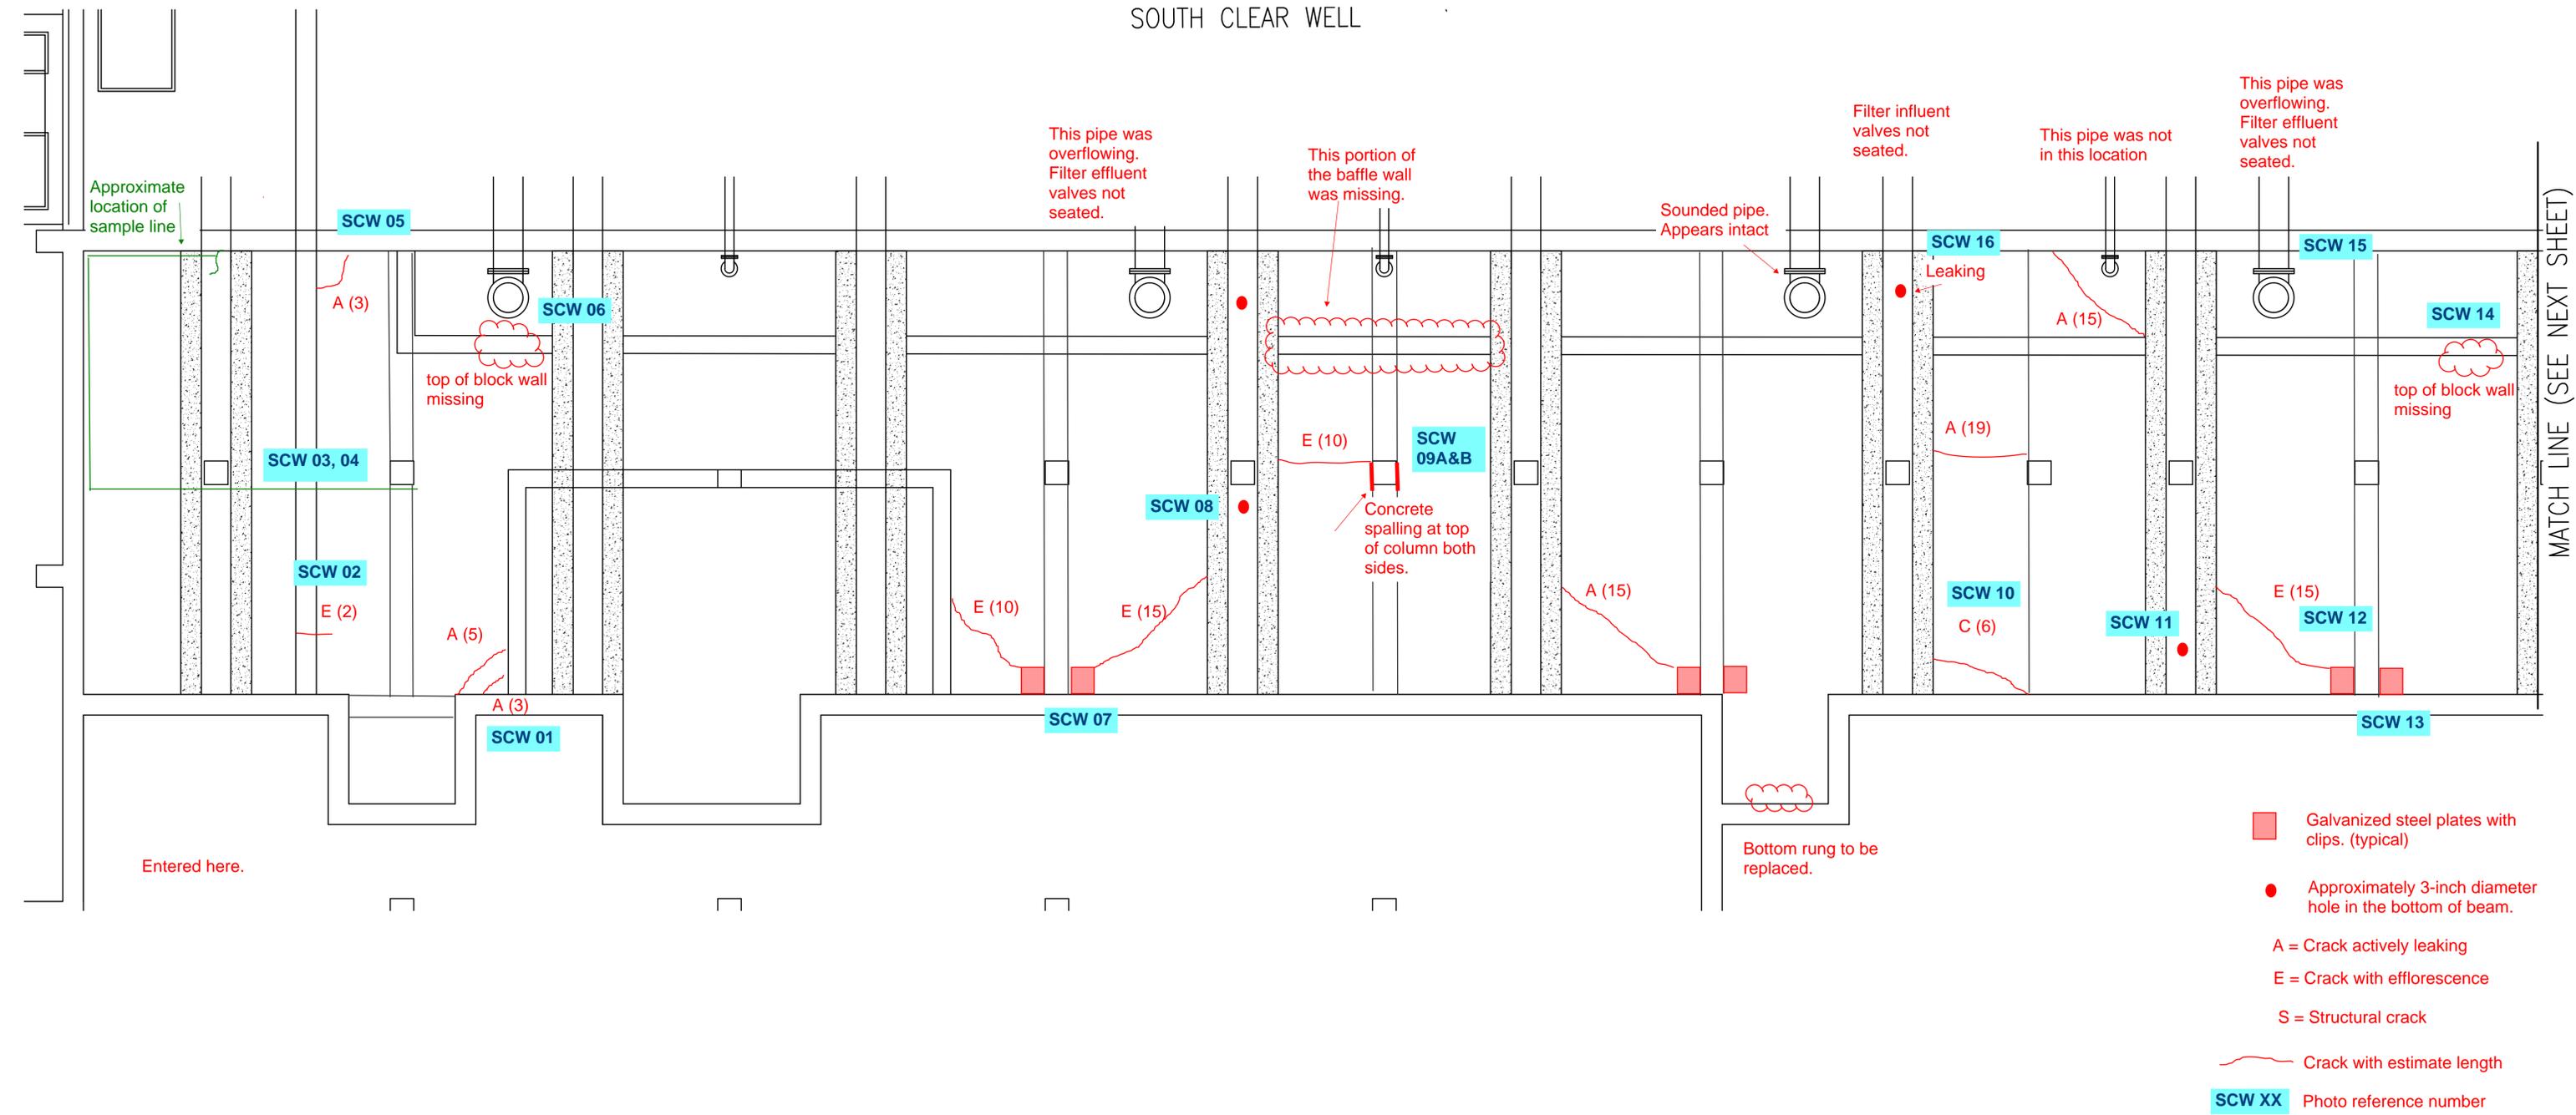
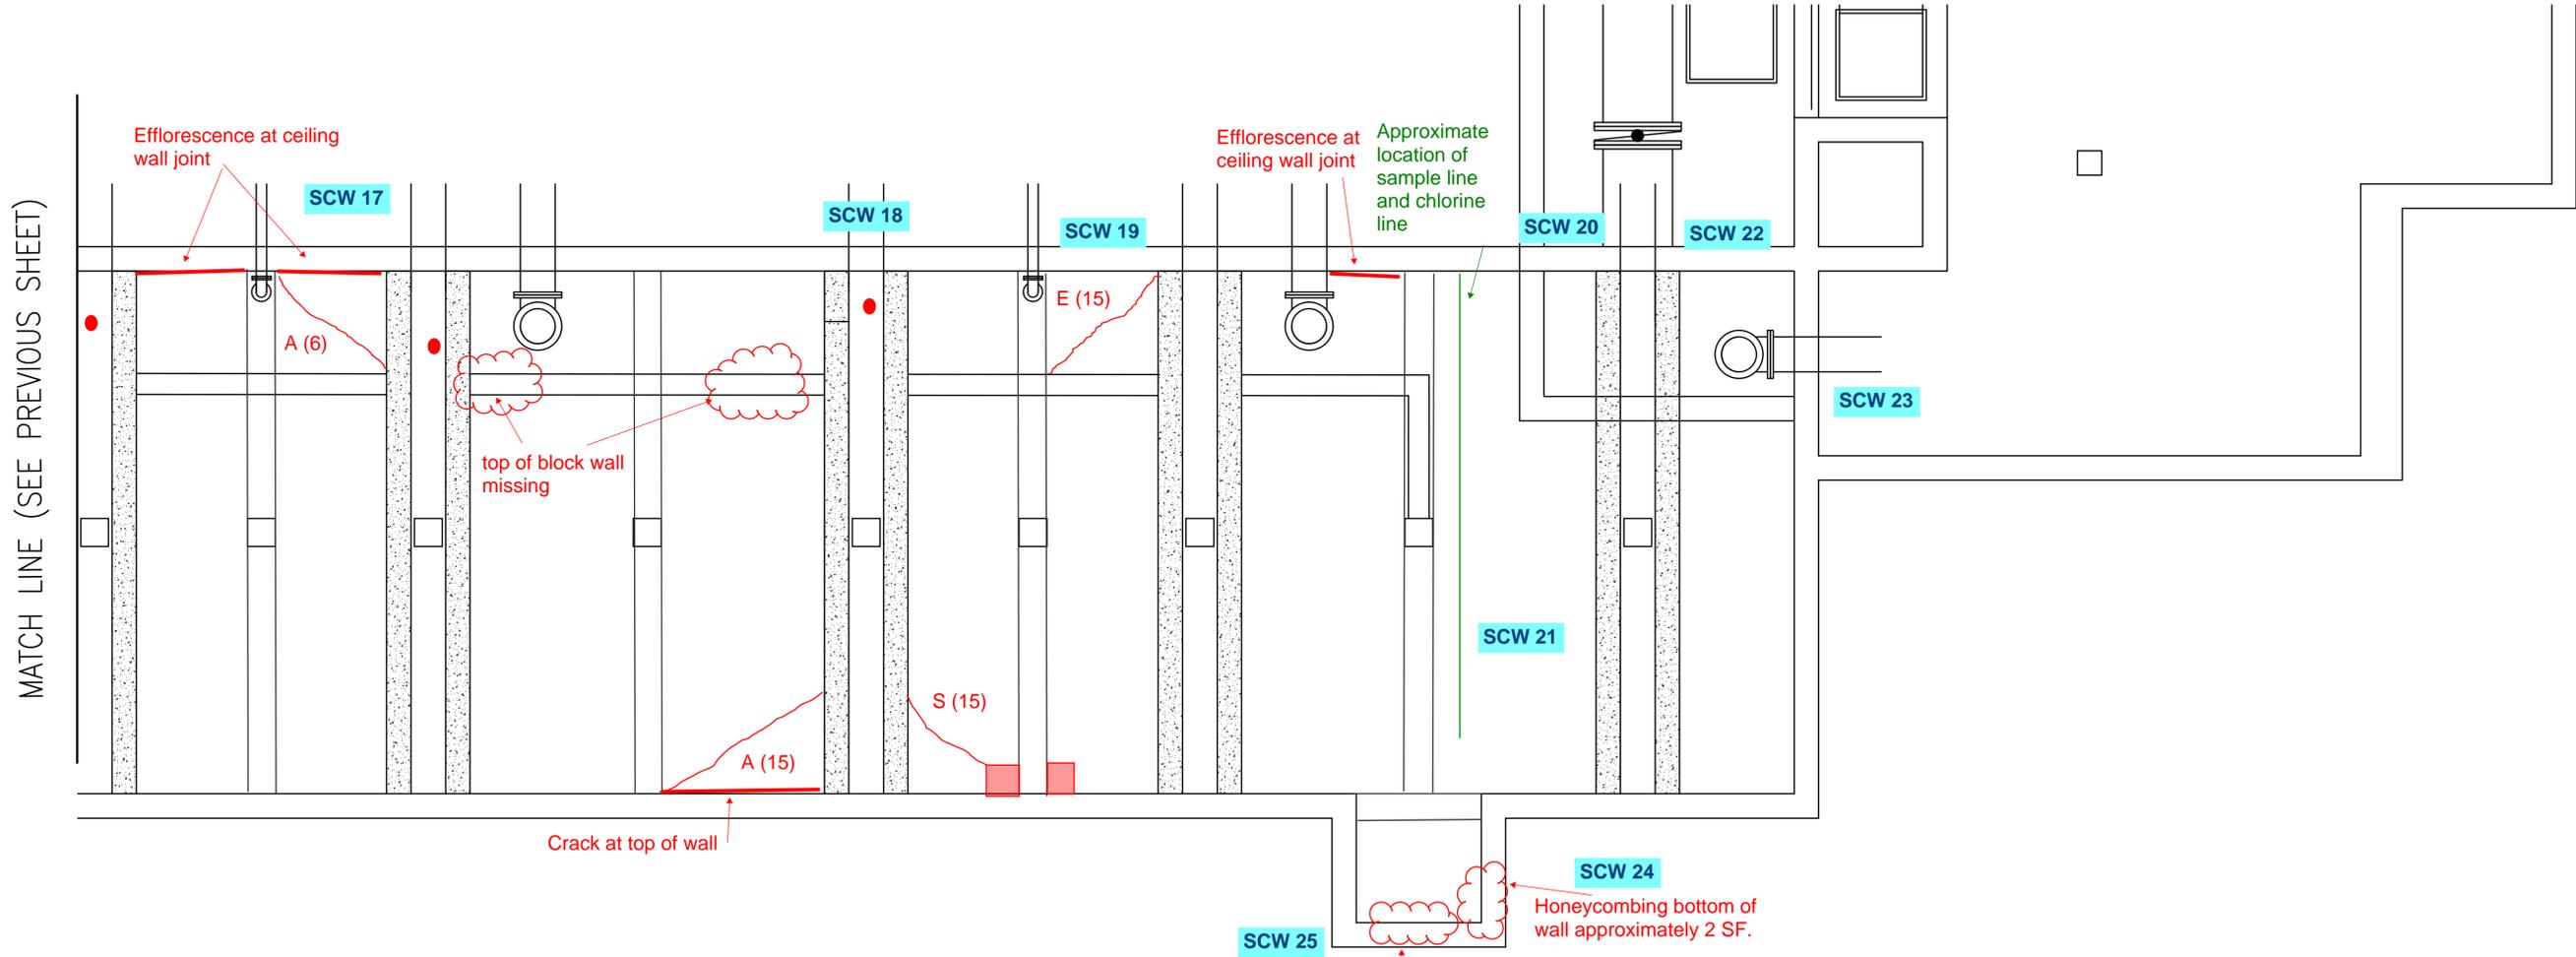
SOUTH CLEAR WELL

- There are no expansion joints in this clear well.
- The ceiling is in good condition and not stained as it is above the operating water level.
- There were circular areas on the underside wide beams/ troughs at the bottom of the filter cells that require concrete restoration. Several small holes that appeared to be tie- holes from the original construction, or possibly the location that the vertical resteel was anchored for the Westech supports for the 1997 underdrains. Several of these areas were actively leaking which would have been water remaining in the underdrain troughs from the shutdown. These areas will need to be dried and patched.

- There was intermittent cracking along the ceiling of the structure and efflorescence was visible. The efflorescence is produced when the free lime in the concrete reacts with water. The water causing the efflorescence may be from condensation inside the tank or possibly from infiltration from the filters above. These items are noted in the attached annotated plan of the clear wells.

- We noted concrete spalling at the top of one column as noted on the plan in Attachment 3 and photo SCW 9A and 9B that requires patching.
- The walls and columns require no structural action at this time.

- Isolation gates were leaking which will also need to be addressed for construction.
- Several ladder rungs for the clear well were missing as noted in the plan in Attachment 3. Recommend replacement of the missing rungs.

- Galvanized steel plates with clips. (typical)
- Approximately 3-inch diameter hole in the bottom of beam.
- A = Crack actively leaking
- E = Crack with efflorescence
- S = Structural crack
- Crack with estimate length
- SCW XX Photo reference number
