**PHASE I ENVIRONMENTAL SITE ASSESSMENT  
LURIE TERRACE APARTMENTS  
600 WEST HURON STREET AND 3 PARKVIEW PLACE  
ANN ARBOR, WASHTENAW COUNTY, MICHIGAN**

**D3G PROJECT NUMBER:  
2020-0252**

**REPORT ISSUE DATE:  
AUGUST 17, 2020**

**INSPECTION DATE:  
MARCH 10, 2020**

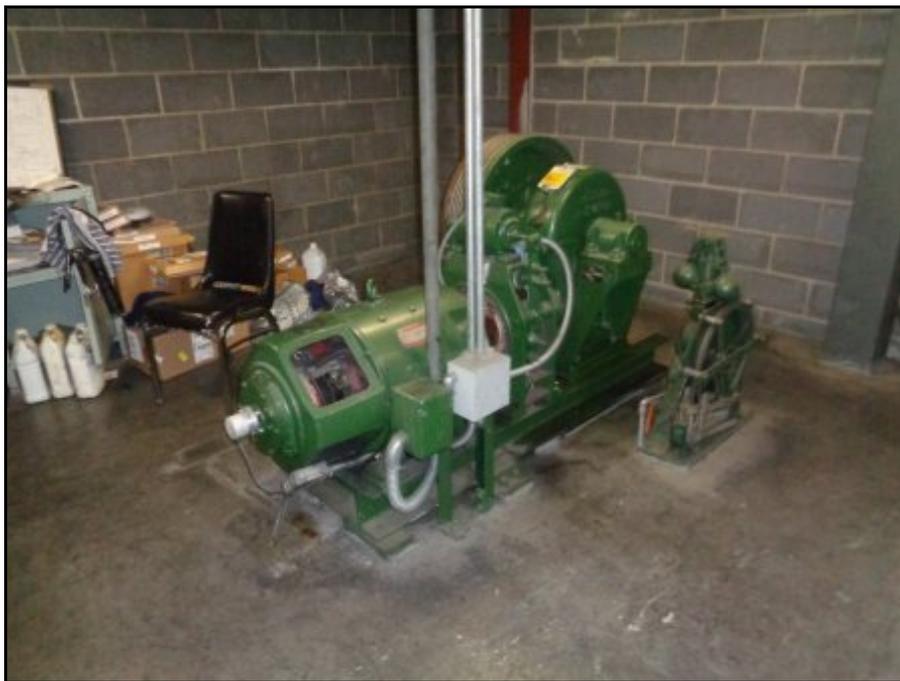
20 : View of elevator equipment

(3) D3G recommends that the leaking hoist elevator equipment be repaired to proper working order and that the spilled oil is disposed of in accordance with applicable regulations.
