**Re: Lead Based Paint Inspection and Risk Assessment
805-807 West Washington
Ann Arbor, Michigan
ECS Project A108-0001**

LEAD BASED PAINT INSPECTION AND RISK ASSESSMENT

FOR THE PROPERTY LOCATED AT

805-807 West Washington St.
Ann Arbor, Michigan 48103

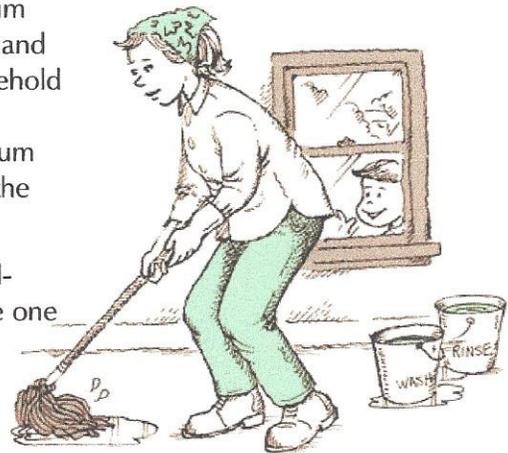
1. Vacuum the surface with a HEPA filter-equipped vacuum cleaner. This special type of vacuum will trap lead particles and prevent them from being released back into the air. A household vacuum will not do this. Remember—when you finish vacuuming—carefully empty the dust collected in the vacuum cleaner, being sure to dampen it with water first to control the spread of collected dust.
2. Wet clean exposed areas with a solution of water and an all-purpose cleaner or a cleaner made specifically for lead. Use one bucket for the cleaning solution and one bucket for rinsing. Change the rinse water frequently (at least once for each room being cleaned) and replace rags, sponges, and mops often. Clean the surface until no dust is visible. After cleaning, rinse the surface with clean water and a new sponge or cloth.

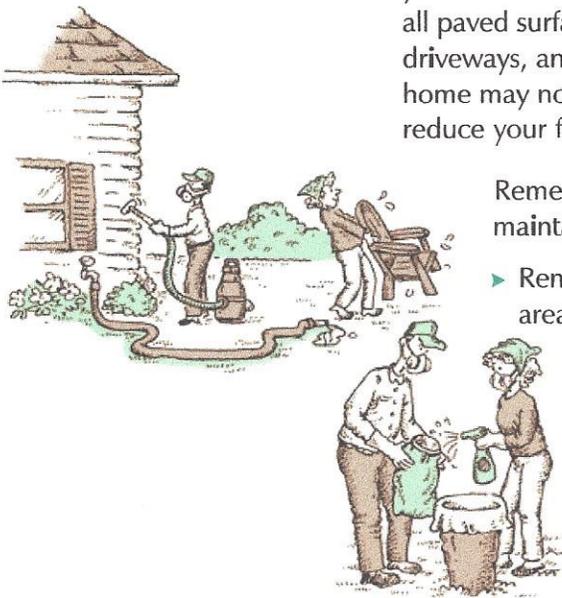
Lead in exterior dust can be dangerous because it can be tracked inside your home. You need to remove as much dust and dirt as possible from all paved surfaces on your property (such as sidewalks, patios, driveways, and parking areas). Removing all lead dust outside your home may not be possible, but by following some simple steps you can reduce your family's exposure to exterior lead dust.

- ▶ Remove all large items, such as outdoor furniture, from the areas you are going to clean. Dampen the areas with water to control the spread of lead dust.
- ▶ Vacuum all hard surfaces with a HEPA filter-equipped vacuum cleaner. Clean all surfaces continuously until no visible dirt or dust is present.
- ▶ Carefully empty the dust collected in the vacuum cleaner, being sure to dampen it with water first to control the spread of the collected dust.

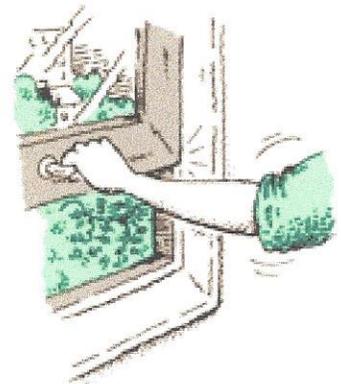
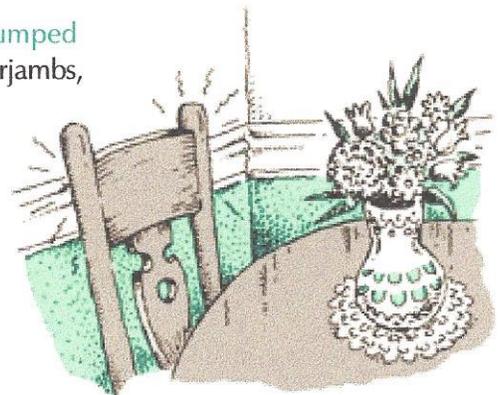
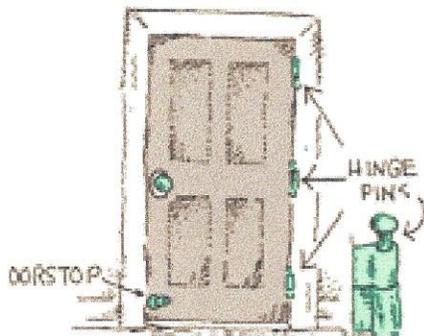
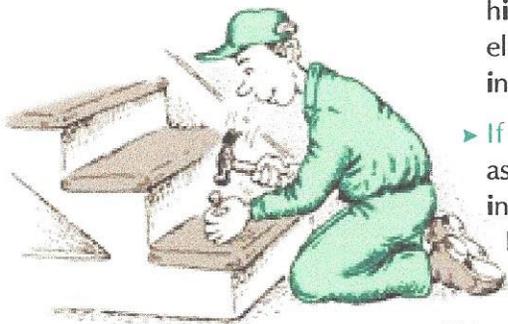
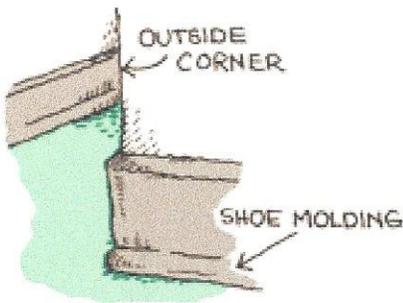
Friction surfaces are surfaces that are subject to abrasion, that is, rubbing or friction actions that cause wear on a surface. Common examples of friction surfaces are the parts of a window that rub when opened and closed, tight-fitting doors, cabinet doors and drawers, stairs and hand railings, and floors. When covered with lead-based paint, friction surfaces subject to abrasion can disturb lead-based paint. Friction surfaces may be treated by fixing the areas that rub together. For example, if you replace a tight-fitting door with a loose-fitting one, you will reduce the chances that the door will create lead dust.

Impact surfaces are surfaces that stick out and tend to be bumped or banged. The most common impact surfaces are doors and doorjamb, door trim, doorstops, outside corners of walls, baseboards, shoe moldings, chair rails, and stair risers. Repeated impacts can cause small chips of paint to fall to the floor and contaminate dust. You can reduce impact surface problems by placing barriers in front of the surfaces. For example, put a new chair rail on a lead-painted wall. This will lessen the damage done to the wall when a chair bumps against the rail.
