Radon Measurement Assessment Report

Colonial Oaks, LLC – West Washington 805-807 West Washington Street Ann Arbor, MI 48103

MI22-707

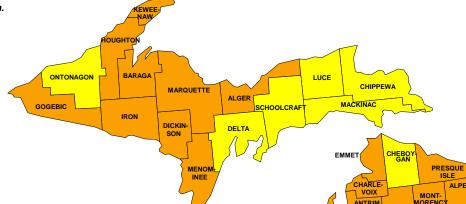
This map is not intended to determine if a home in a given zone should be tested for radon. Homes with elevated levels of radon have been found in all three zones.

All homes should be tested, regardless of zone designation.

IMPORTANT: Consult the publication entitled "Preliminary Geologic Radon Potential Assessment of Michigan" (USGS Open-file Report 93-292-E) before using this map. http://energy.cr.usgs.gov/radon/grpinfo.html This document contains information on radon potential variations within counties. EPA also recommends that this map be supplemented with any available local data in order to further understand and predict the radon potential of a specific area.
