BROMLEY PARK
2785 BRIARCLIFF STREET, ANN ARBOR, MI

client
CITY OF ANN ARBOR
PARKS & RECREATION DEPT.
301 East Huron Street
Ann Arbor, MI 48104
734.794.6230

sheet name
PLAY AREA
UPGRADES
OPTION 3

OPTION THREE

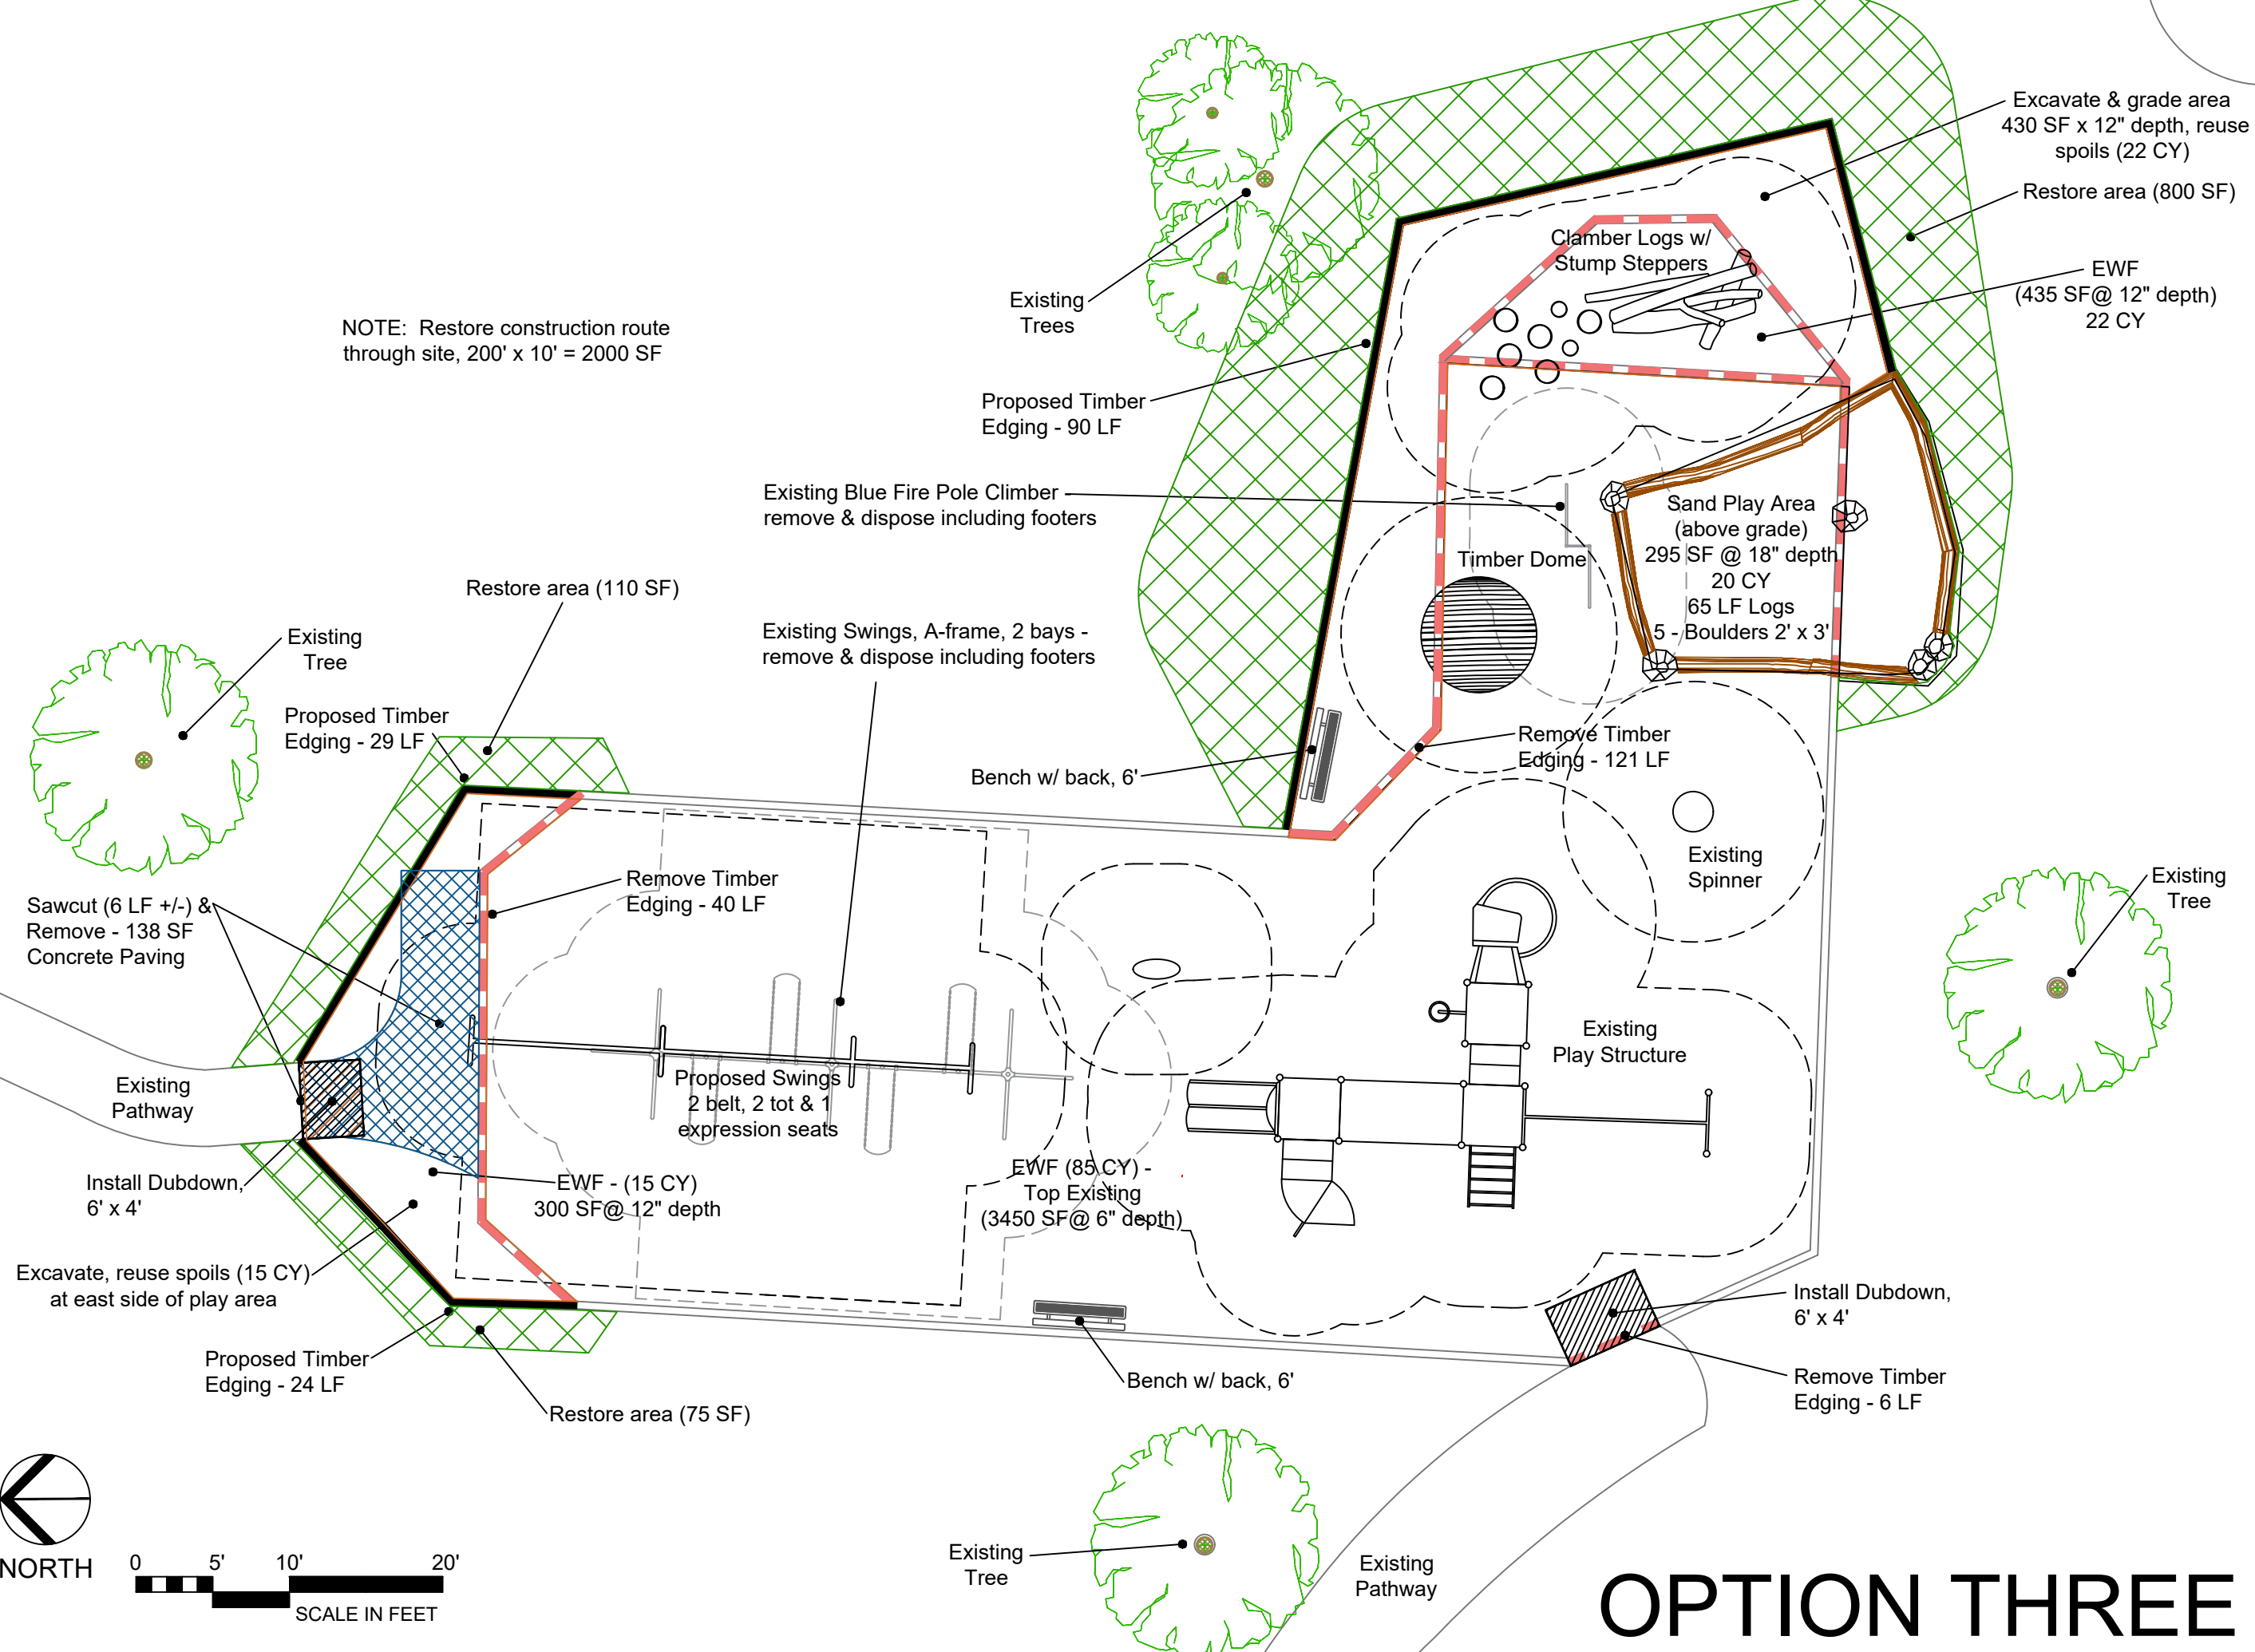
sheet number
1 of 1

NOTE: Restore construction route through site, 200' x 10' = 2000 SF

Excavate & grade area
430 SF x 12" depth, reuse
spoils (22 CY)

Restore area (800 SF)

EWF
(435 SF@ 12" depth)
22 CY

Sand Play Area
(above grade)
295 SF @ 18" depth
20 CY
65 LF Logs
5 - Boulders 2' x 3'

Remove Timber
Edging - 40 LF

EWF - (15 CY)
300 SF@ 12" depth

EWF (85 CY) -
Top Existing
(3450 SF@ 6" depth)

Install Dubdown,
6' x 4'

Proposed Timber
Edging - 24 LF

Excavate, reuse spoils (15 CY)
at east side of play area

Sawcut (6 LF +/-) &
Remove - 138 SF
Concrete Paving

Existing Swings, A-frame, 2 bays -
remove & dispose including footers

Existing Blue Fire Pole Climber
remove & dispose including footers

Proposed Timber
Edging - 90 LF

Clamber Logs w/
Stump Steppers

Timber Dome

Remove Timber
Edging - 121 LF
