Site Accessibility Evaluation

Allmendinger Park
655 Pauline Blvd
Ann Arbor, MI 48104
ADA Only

Inspection Date: 07/11/2022

Report Date: 11/15/2022

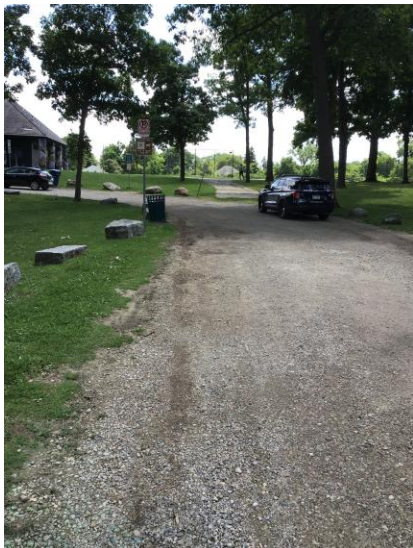
Parking: Parking Lot

Finding: 1 - ADA Parking Space

There are no accessible parking stalls.

No accessible parking provided. Need one van accessible stall.

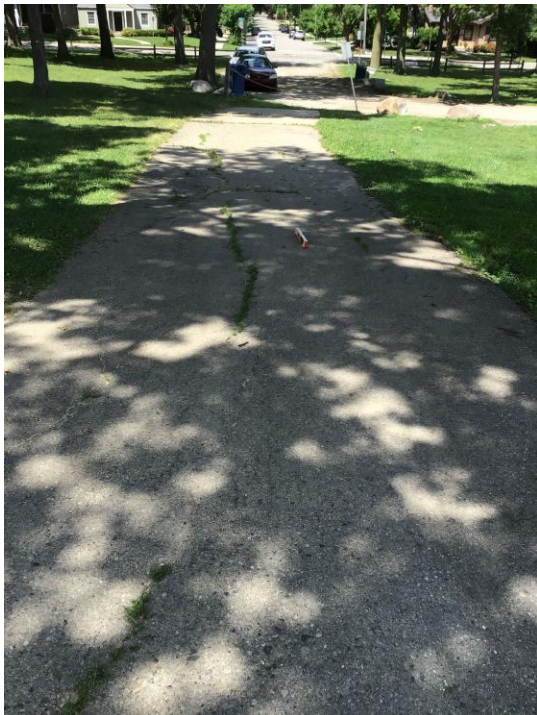
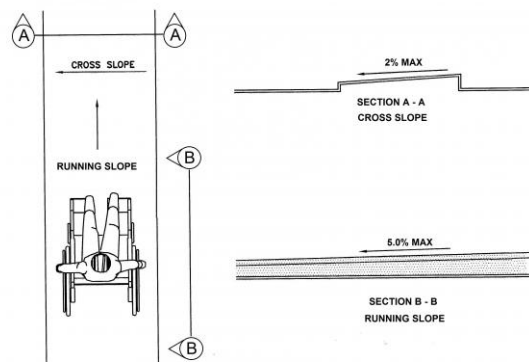
Trail System: Trail

Paved trail from parking into park is up to 9% runners slope.

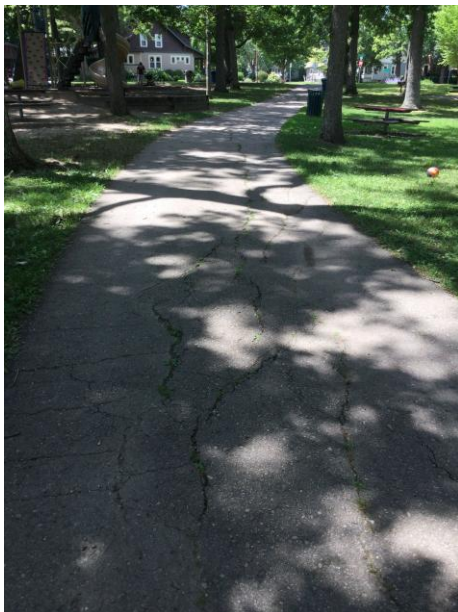
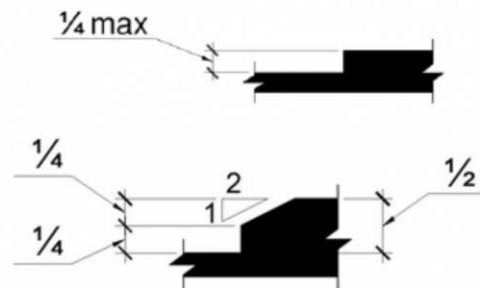
Trail System: Trail

Asphalt trail surface cracks and subgrade sinking areas greater than 1/2" depth.

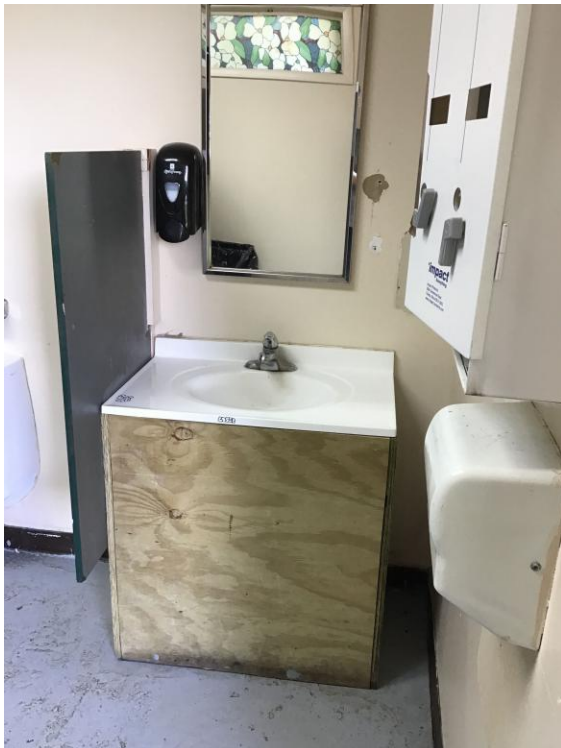
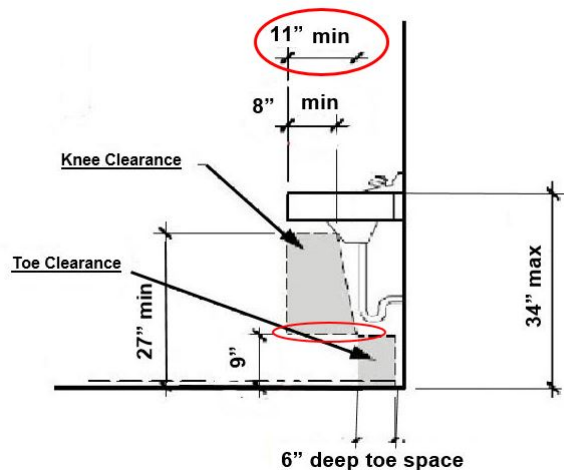
Restrooms: Men's

Lavatory has no knee clearance.

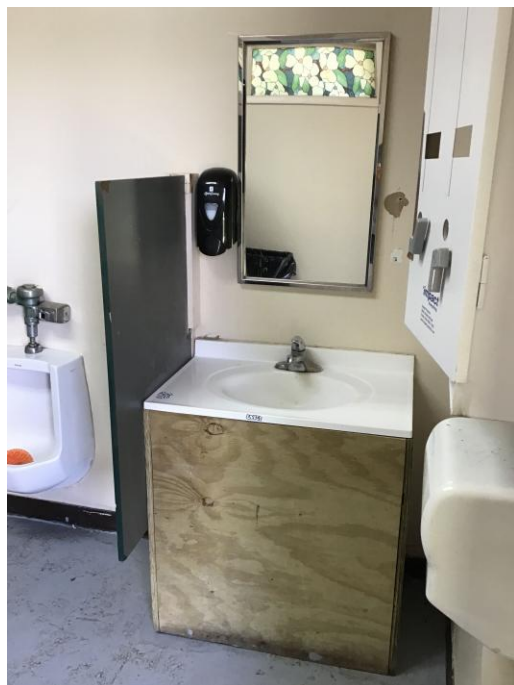
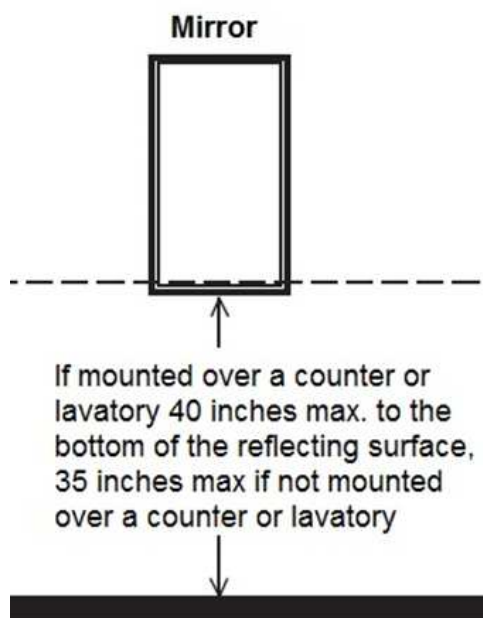
Restrooms: Men's

The mirror is at 44 inches.

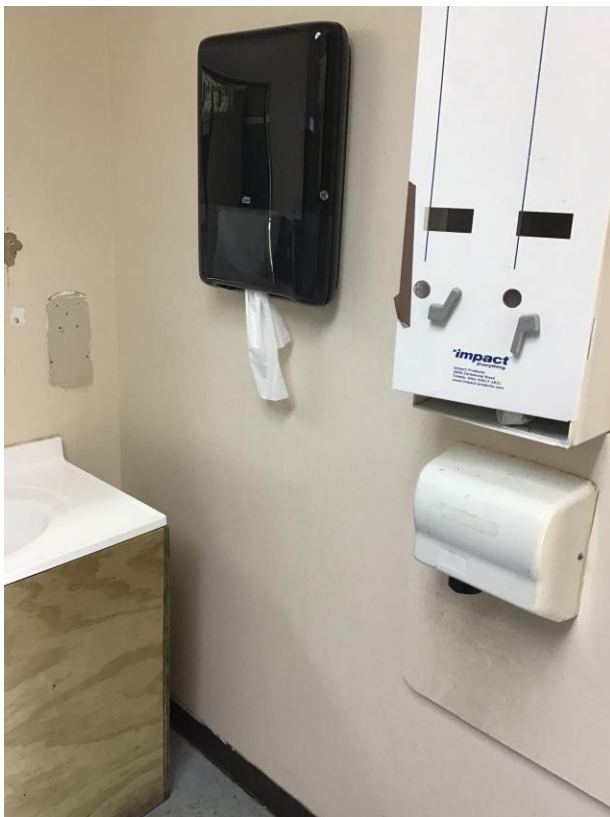
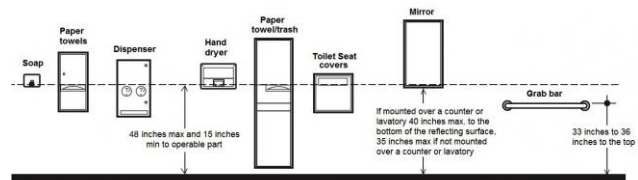
Restrooms: Men's

Paper towel dispenser height at 52 inches.

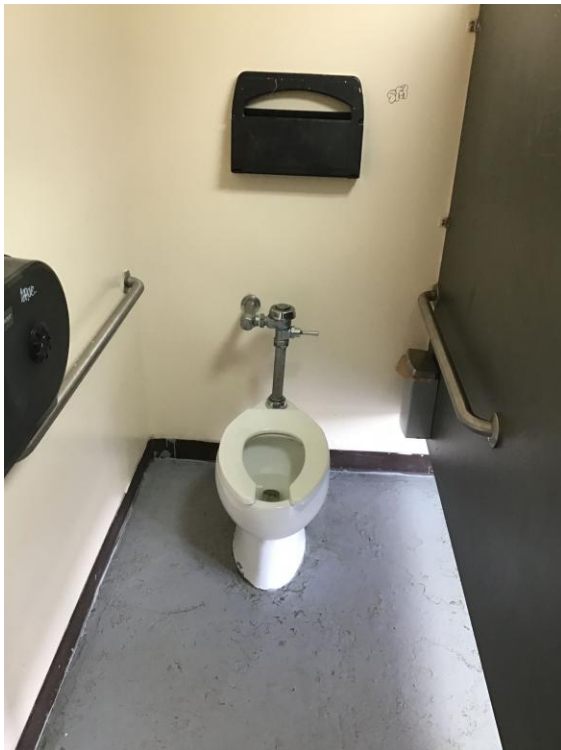
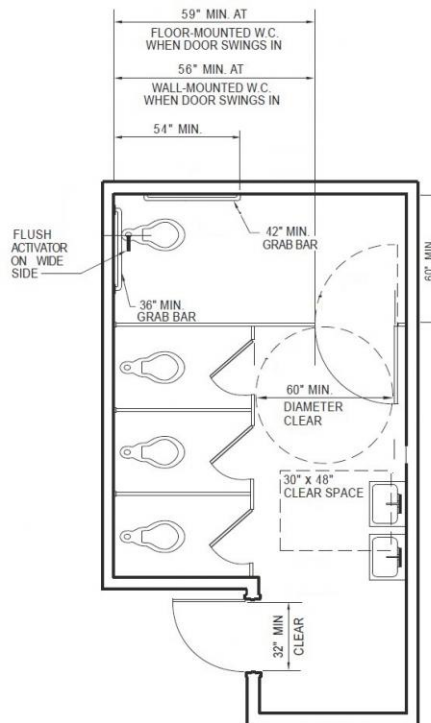
Restrooms: Men's

The stall does not have the required minimum clear floor space or maneuvering clearances for the toilet, Grab bars are missing and/or incorrectly installed, accessories, such as toilet seat covers, toilet paper holders, and garbage cans are either too high, without clear floor space or both, the floor level changes greater than a 1/2 inch at the floor drains.

Stall width at 42 inches with multiple barriers.

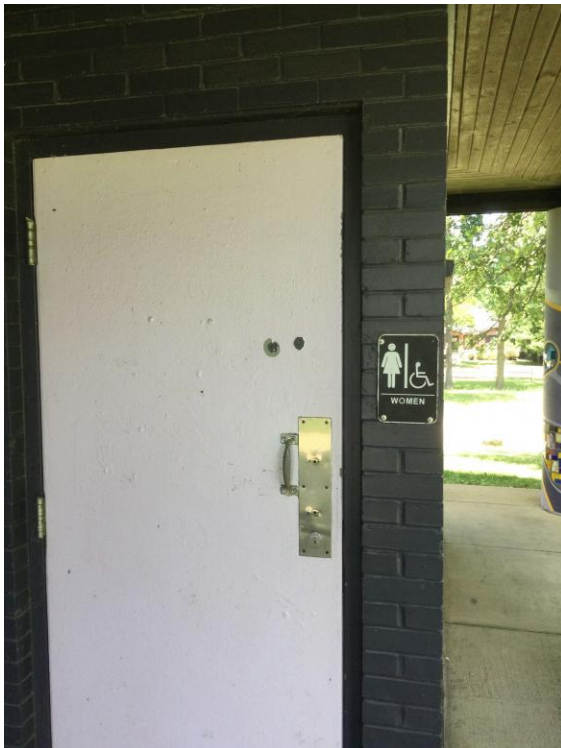
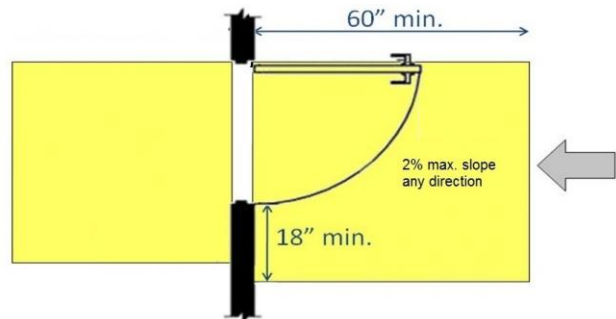
Restrooms: Women's

Pull side clearance is 10"

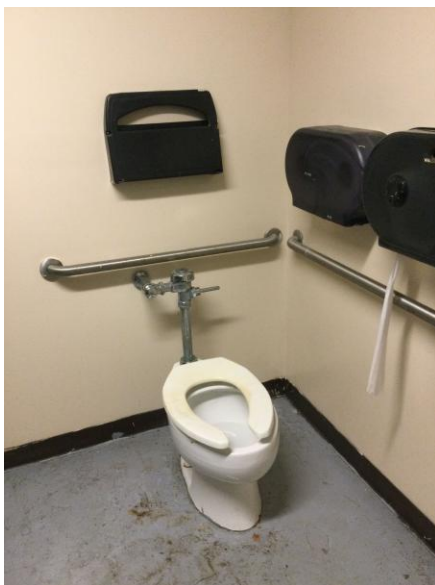
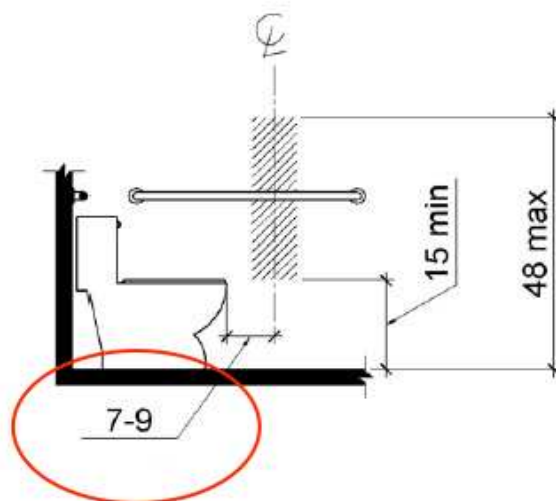
Restrooms: Women's

Toilet paper dispenser is less than 12" above grab bar

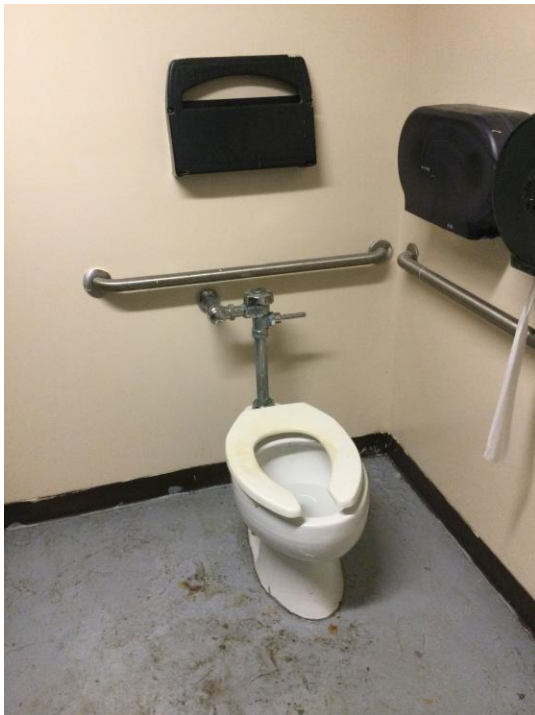
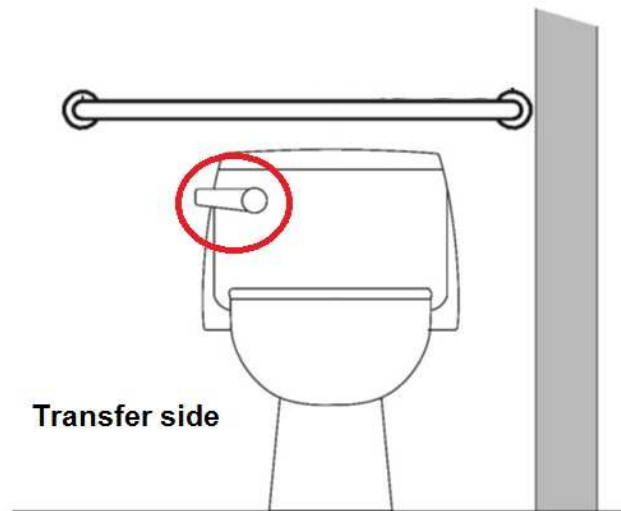
Restrooms: Women's

Flush handle on wrong side

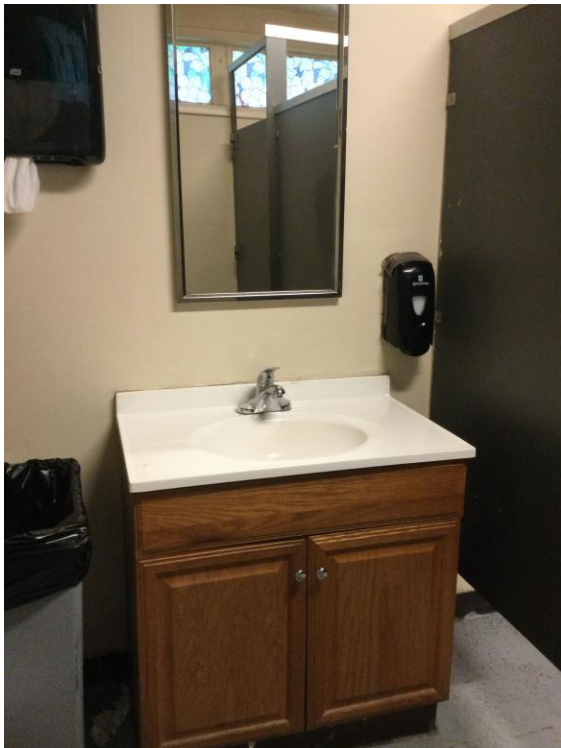
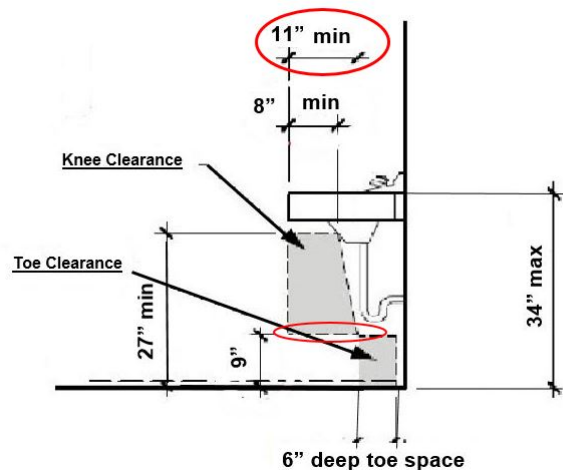
Restrooms: Women's

Lavatory sink not accessible

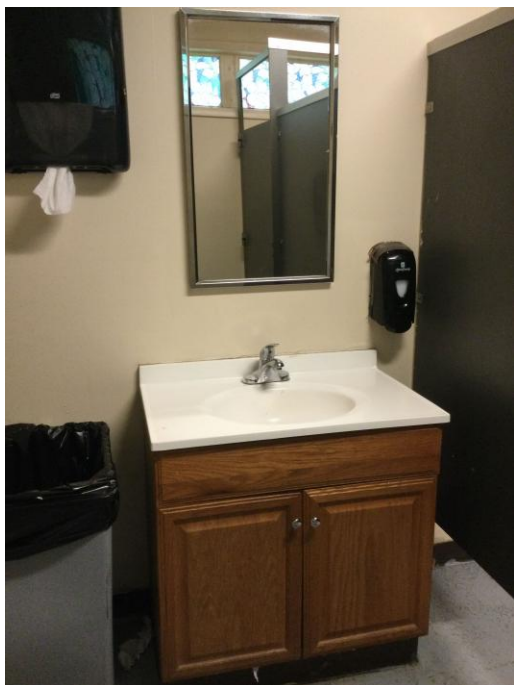
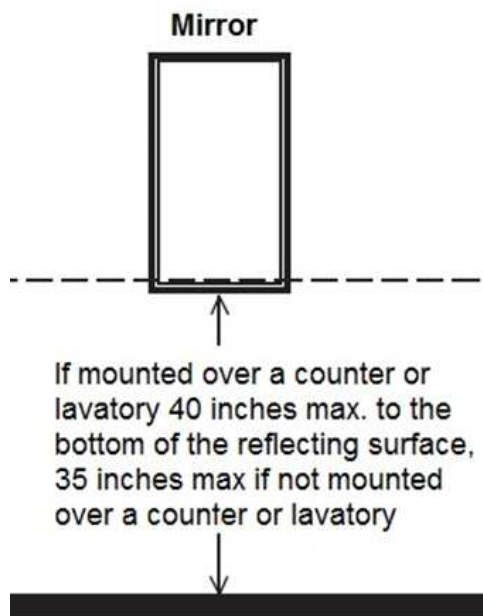
Restrooms: Women's

Mirror height is 46"

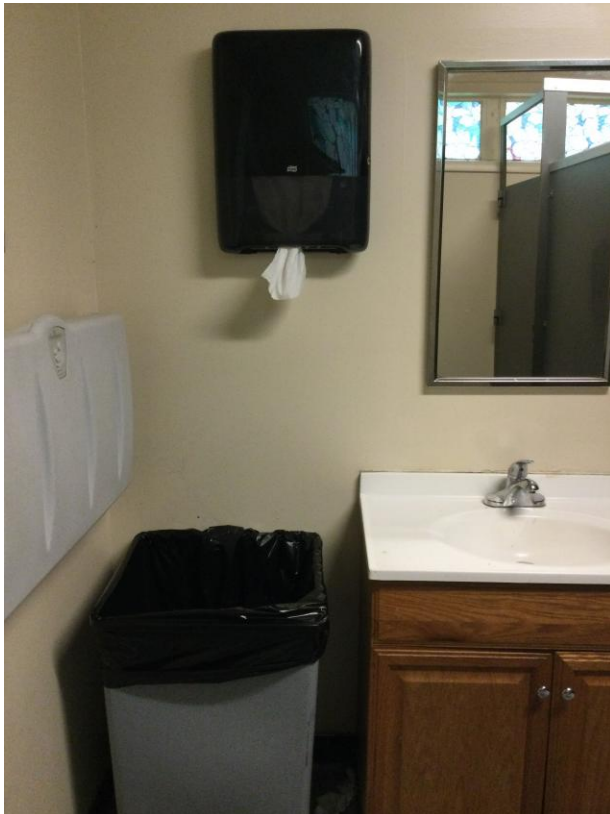
Restrooms: Women's

Dispenser mounting height is greater than 48"

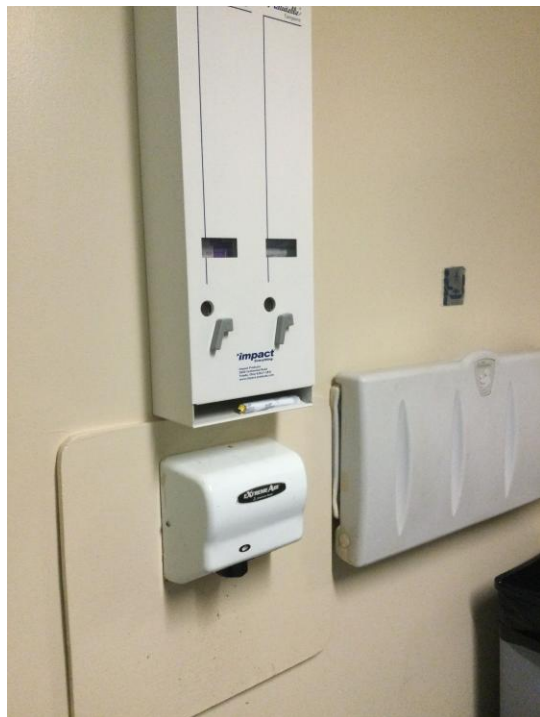
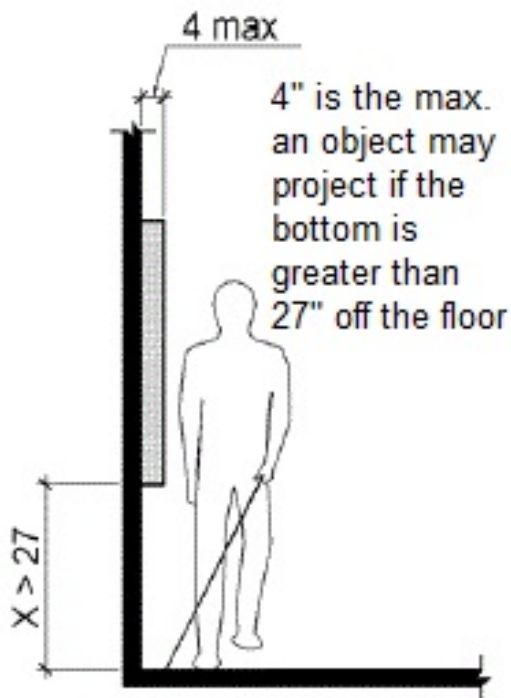
Restrooms: Women's

Wall-mounted objects that have leading edges between 27 inches and 80 inches from the floor must not project more than 4 inches into the circulation path. Protruding objects that extend to the floor or within 27 inches of the floor are cane detectable and are therefore not hazardous. Where it is necessary or desirable to have objects protrude from the wall, a manner of cane detection must be provided.

Dispenser protrudes 6" from wall

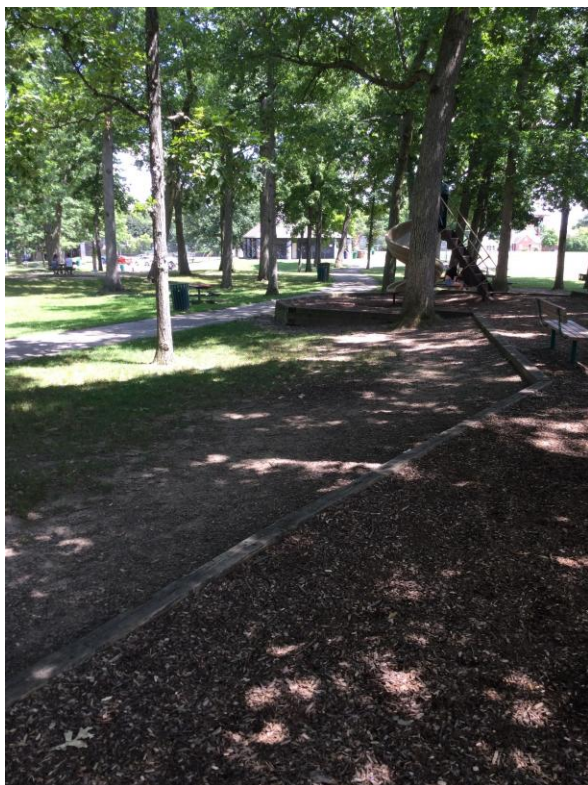
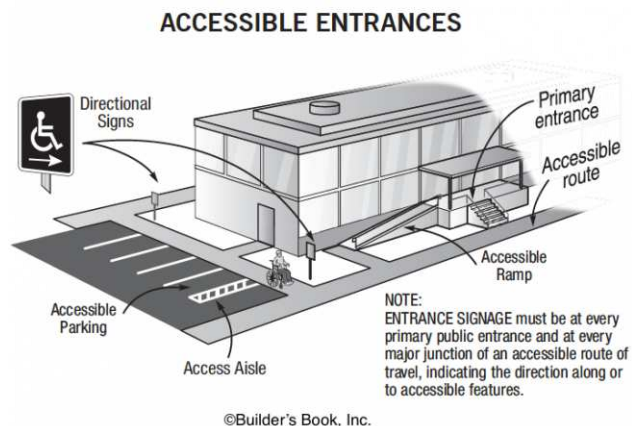
Play Area: Large Playground

Grass and gravel surface to play elements

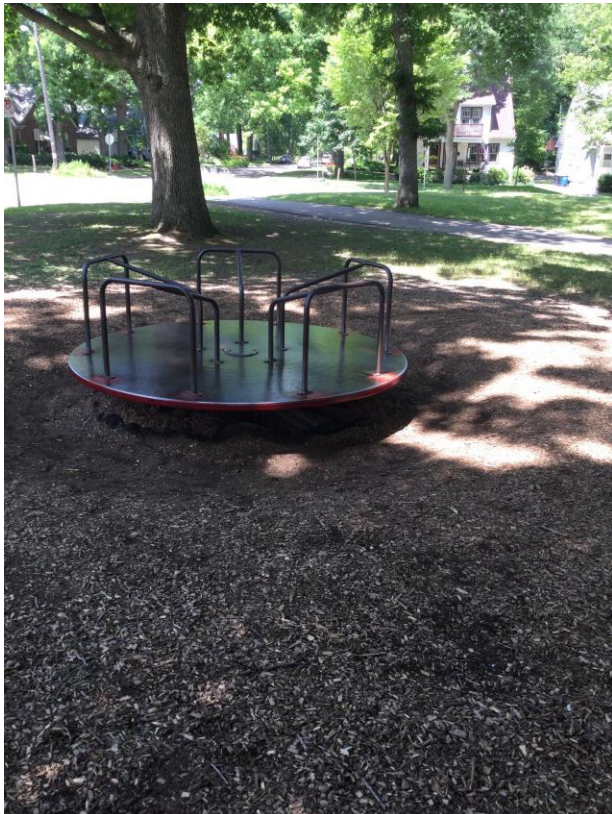
Play Area: Large Playground

Playground surfacing does not meet standards. Needs maintenance.

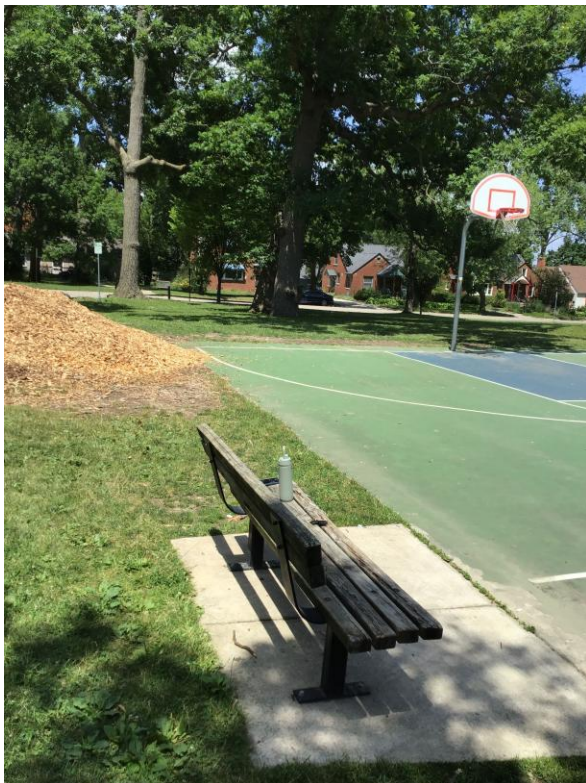
Basketball Court: Basketball Court

No accessible route to basketball court.

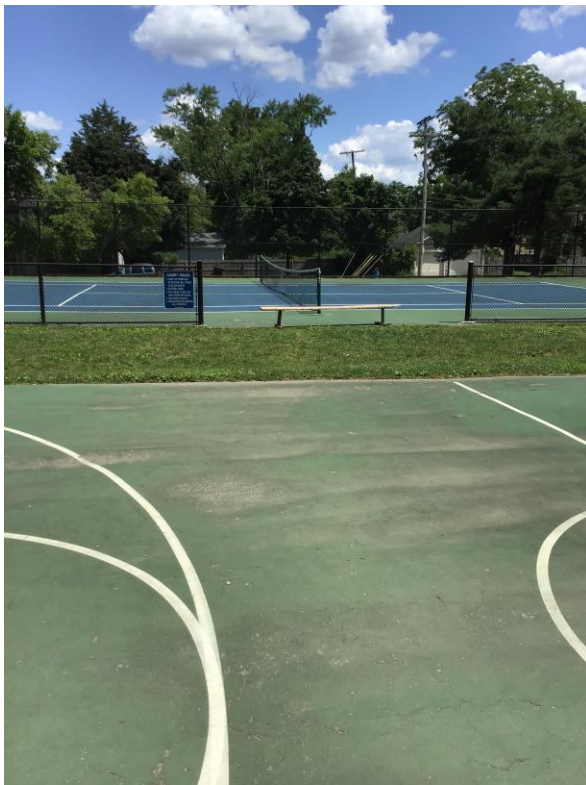
Tennis Court: Entrance

No accessible route to tennis court entrance.

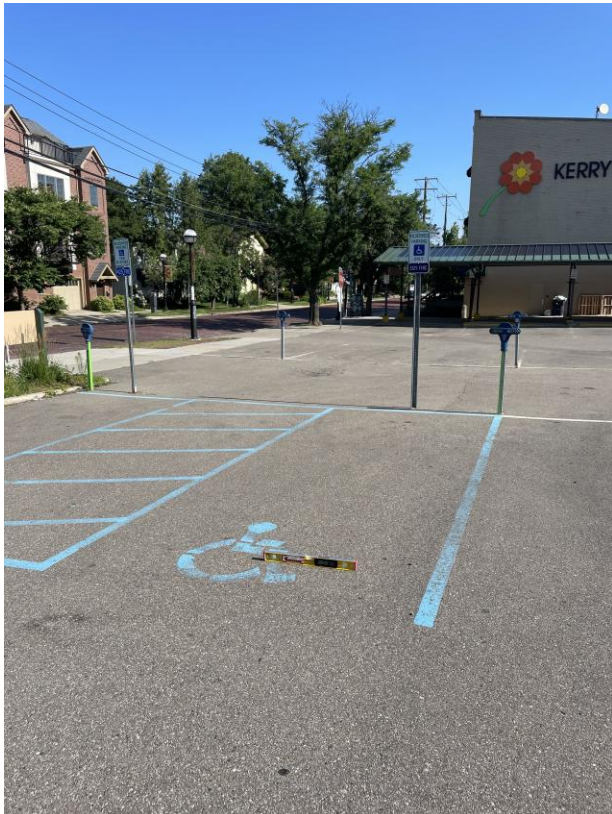
The cross slope is at 4% for both the parking space and the access aisle.

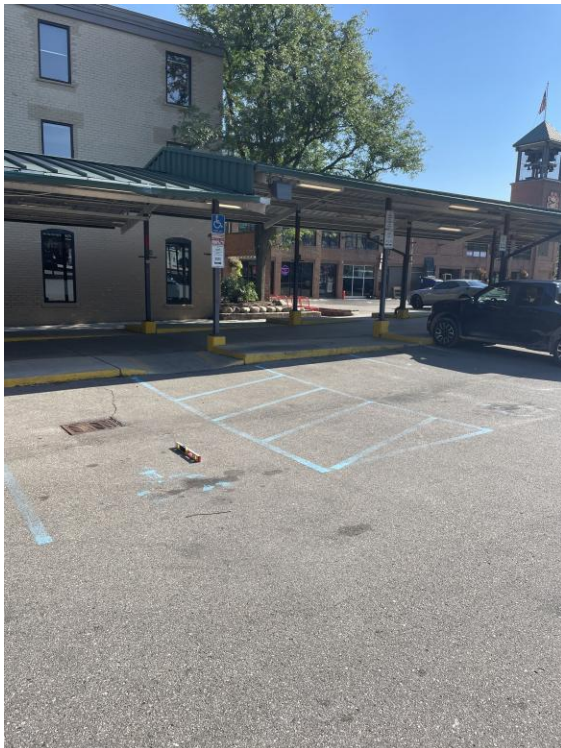
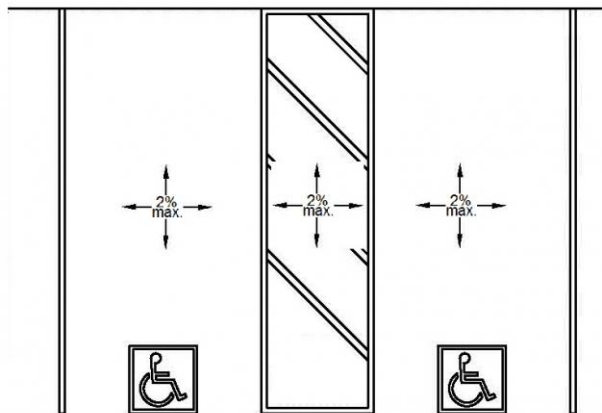
The cross slope is at 3% for both accessible parking spaces.

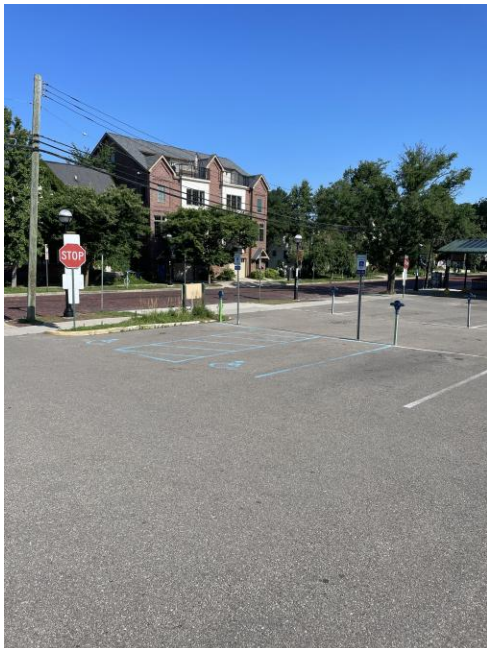
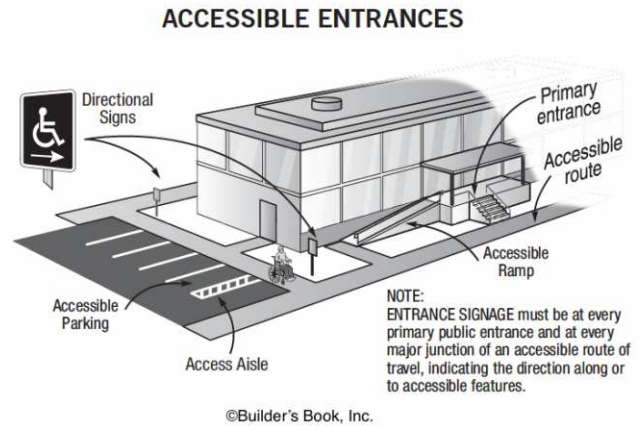
The 2 accessible spaces are not on the shortest route to the Farmer's Market.

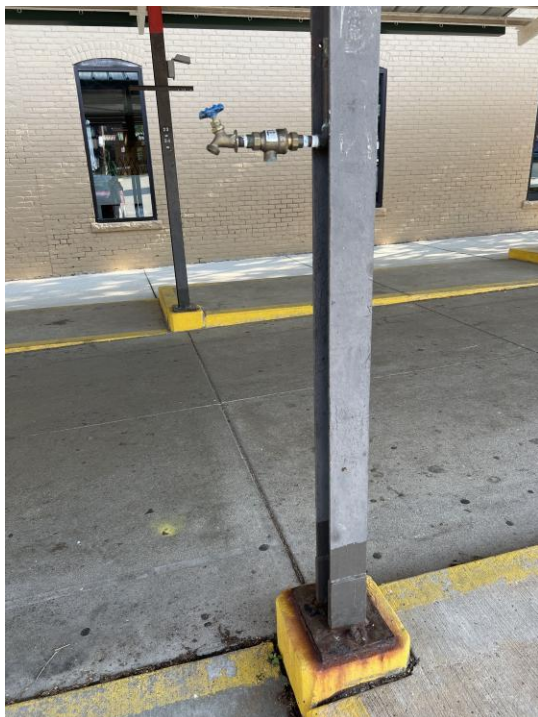
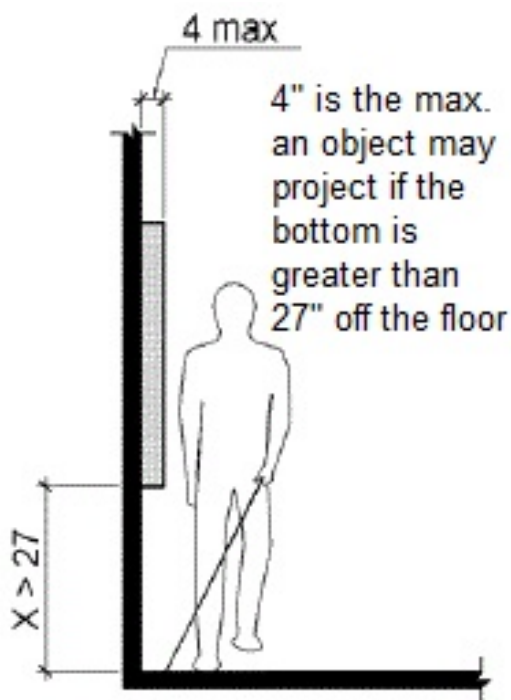
The water spout is between 27 inches and 80 inches from the floor and is protruding more than 4 inches.

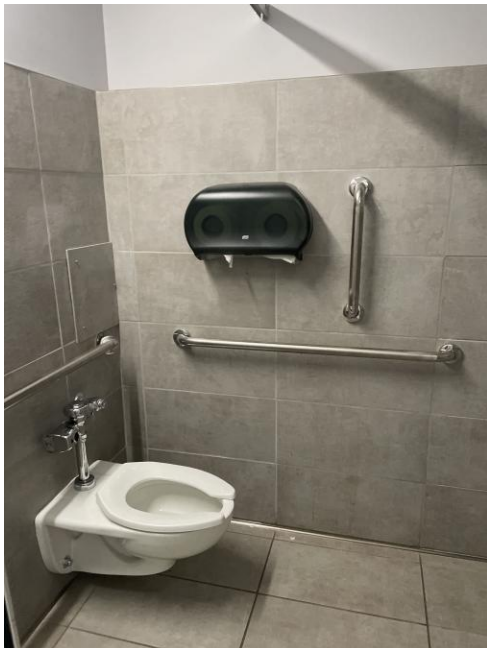
The toilet paper dispenser is installed 7"-9" in front of the water closet.

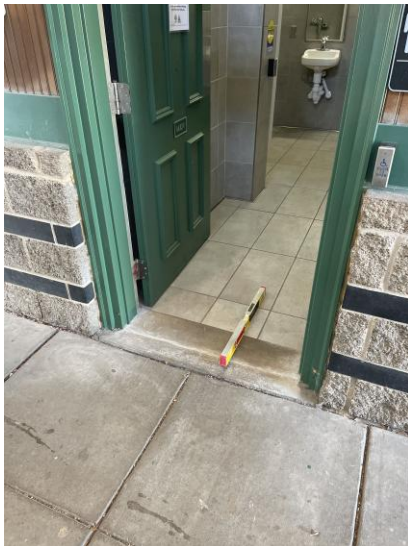
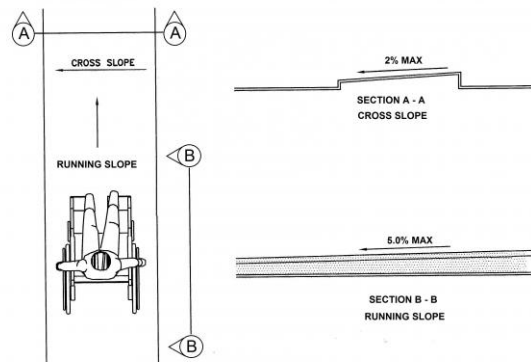
The running slope is 9% at door entrance to the Farmer's Market Office.

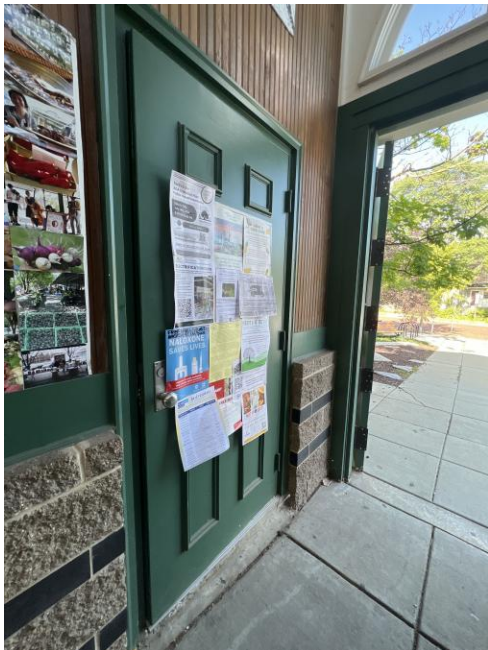
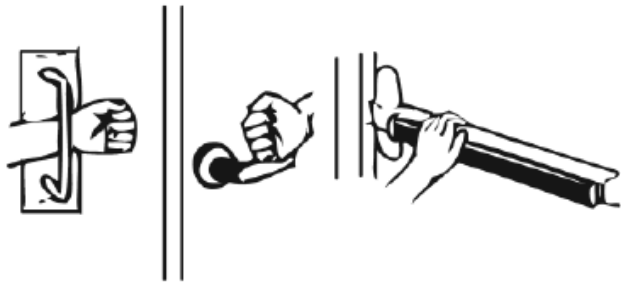
There are 2 door knobs in the breezeway near the office of the Famer's Market.

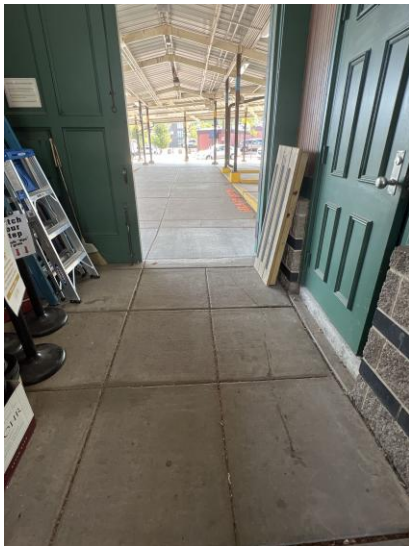
The running slope from the office to the Farmer's Market is greater than 5%.

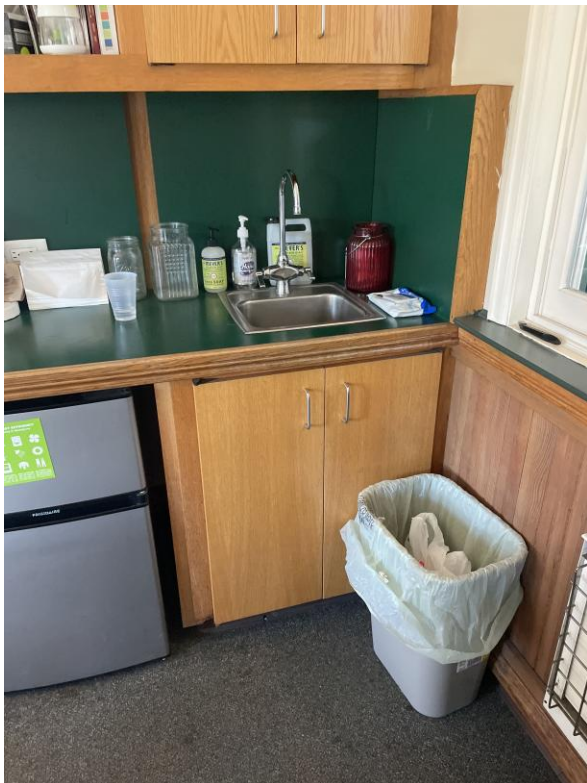
The sink height is 36 inches.

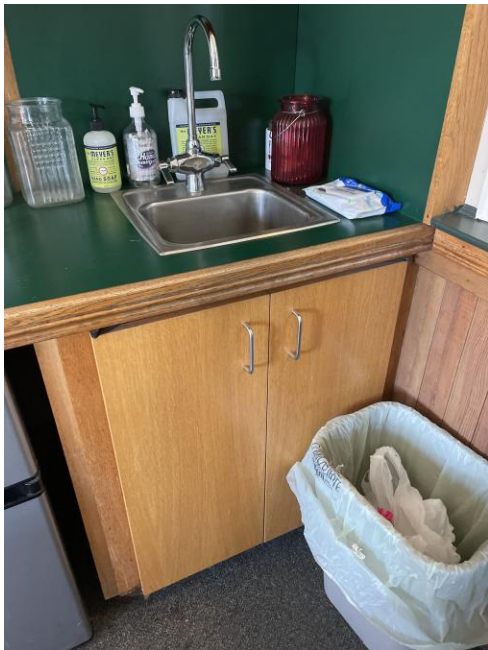
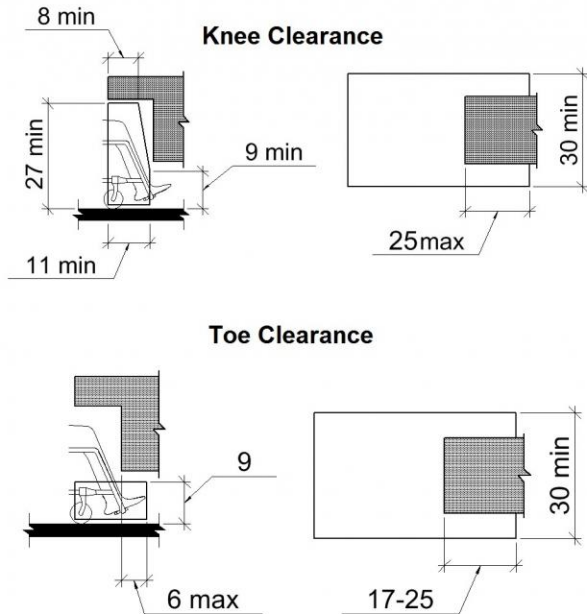
No knee and toe clearance provided due to cabinets.

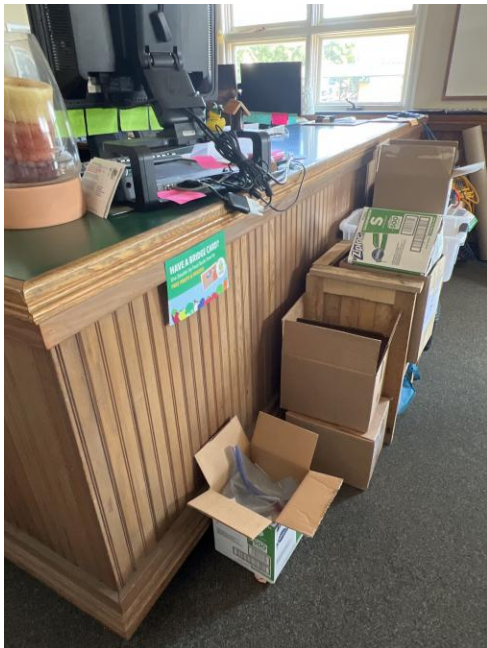
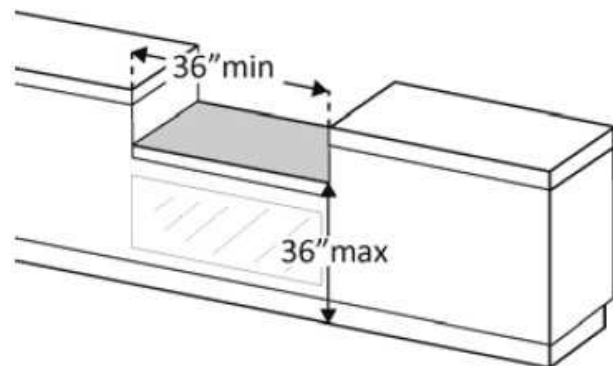
The counter is greater than 36 inches.

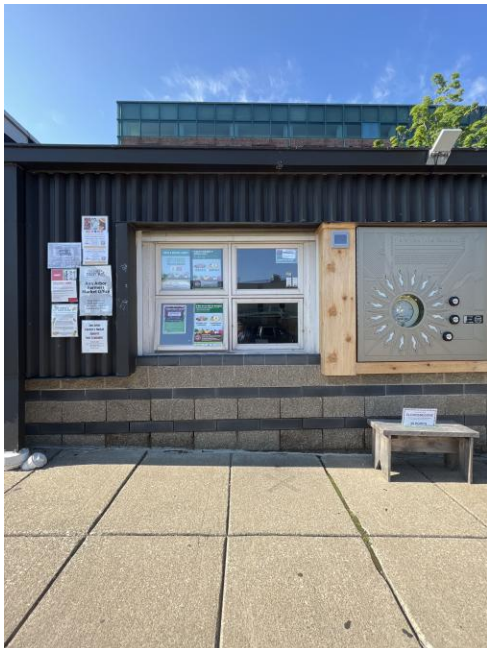
The window sales counter height is 40 inches and greater due to the slope of the sidewalk.

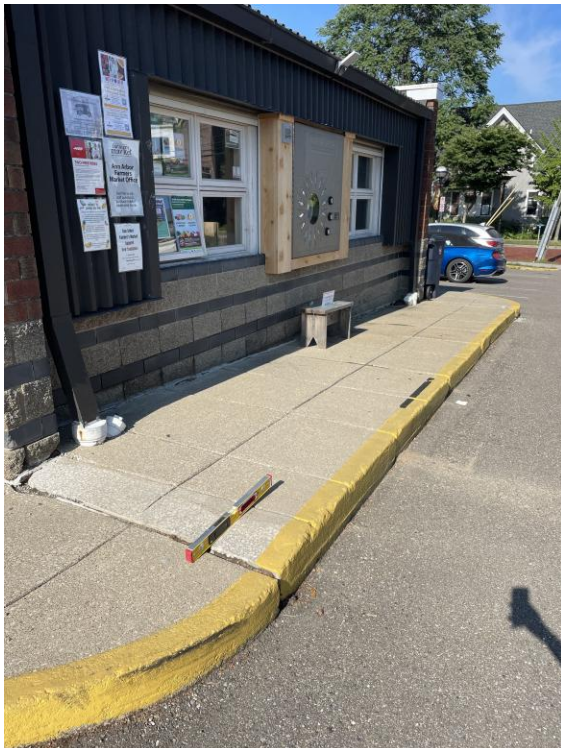
The route around the building to the sales counters is not compliant.

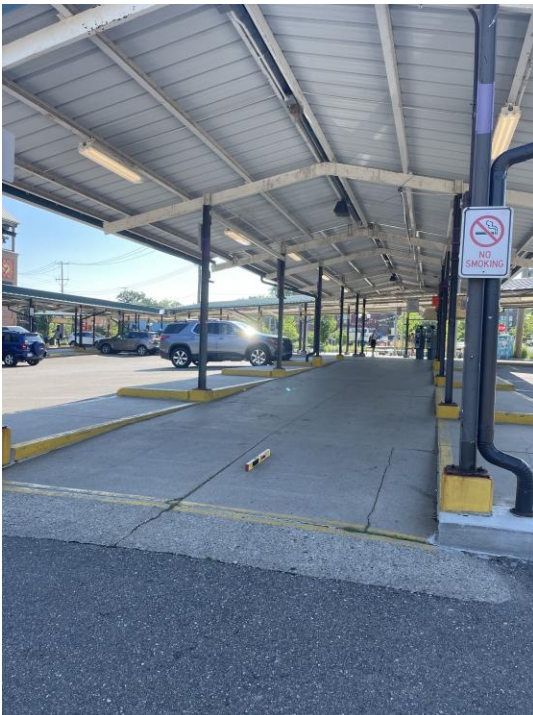
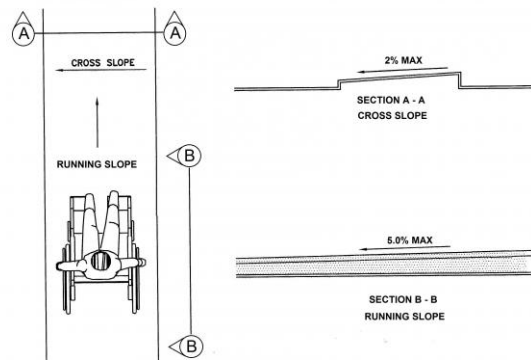
The Farmer's Market route has a running slope of 5.5%.

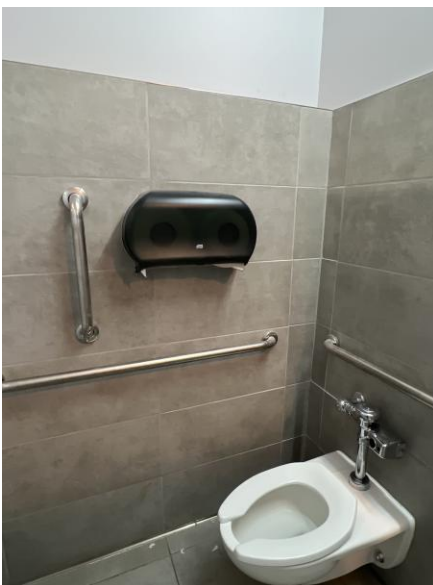
The toilet paper dispenser is out of reach range from the water closet.

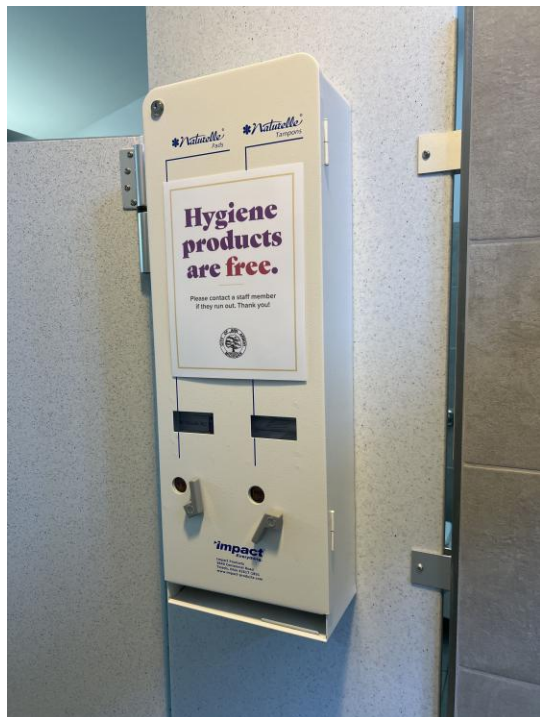
The hygiene dispenser is protruding more than 4 inches.

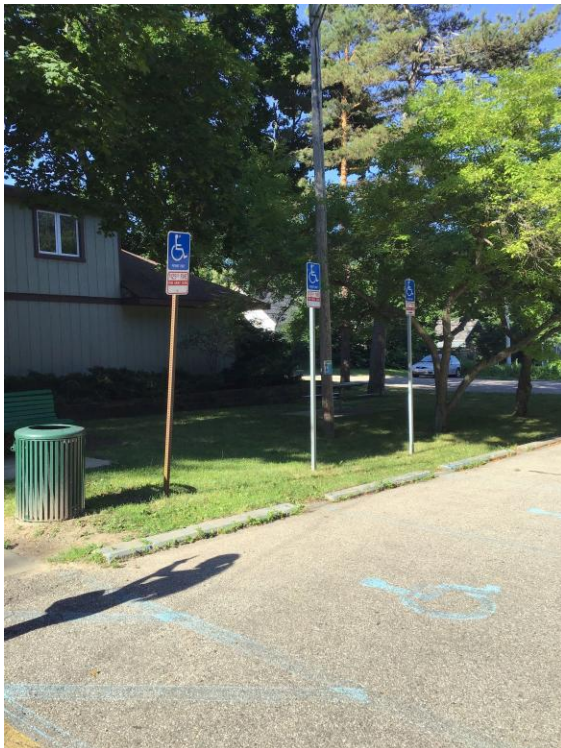
Slopes approximately 3.1%.

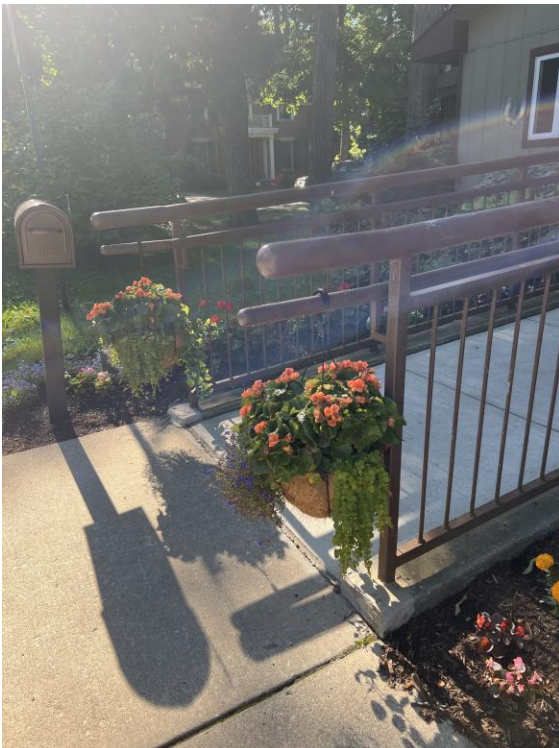
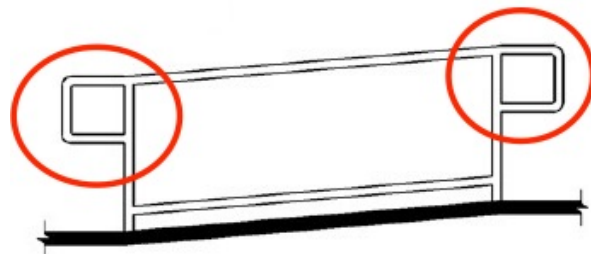
Handrail does not return

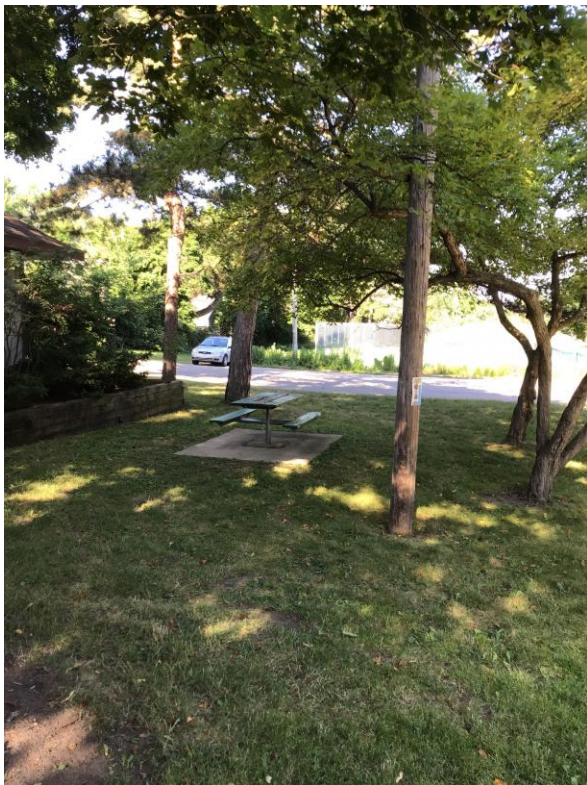
Exterior: Picnic Area

No accessible route to picnic table.

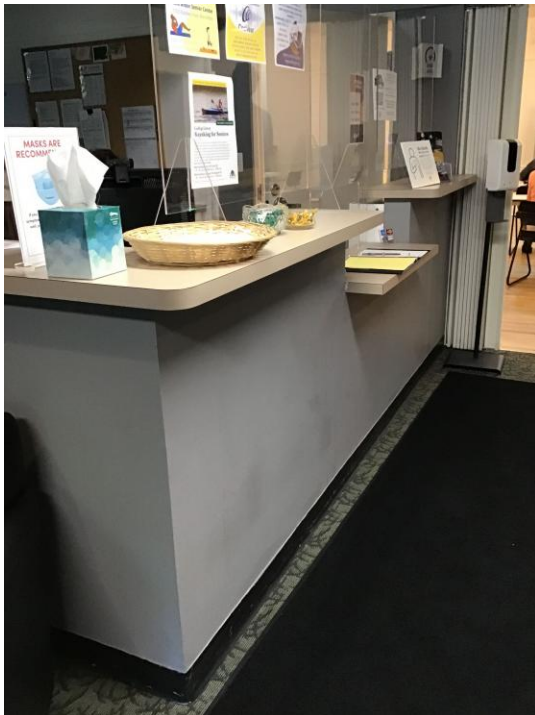
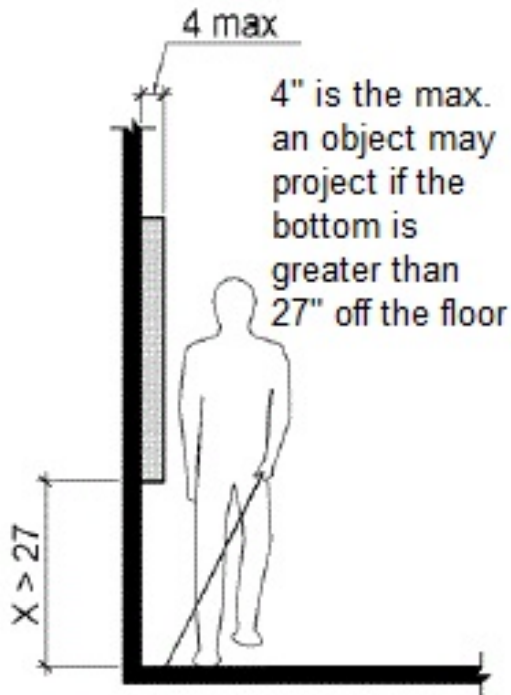
Lobby: Reception Area

Wall-mounted objects that have leading edges between 27 inches and 80 inches from the floor must not project more than 4 inches into the circulation path. Protruding objects that extend to the floor or within 27 inches of the floor are cane detectable and are therefore not hazardous. Where it is necessary or desirable to have objects protrude from the wall, a manner of cane detection must be provided.

Counter is a protruding object.

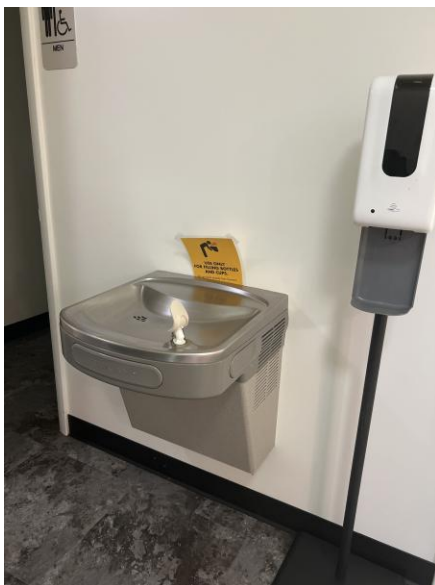
Hallway Area: Hallway

Missing high fountain

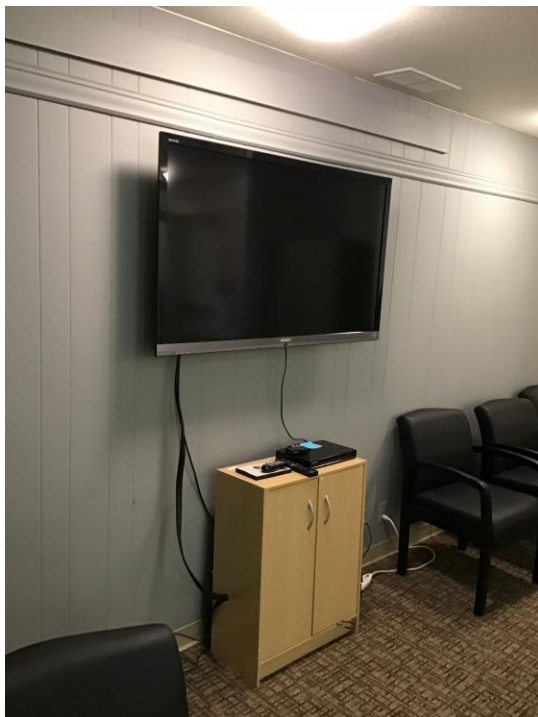
Office Space: Office

Wall-mounted objects that have leading edges between 27 inches and 80 inches from the floor must not project more than 4 inches into the circulation path. Protruding objects that extend to the floor or within 27 inches of the floor are cane detectable and are therefore not hazardous. Where it is necessary or desirable to have objects protrude from the wall, a manner of cane detection must be provided.

Digital monitoring is protruding.

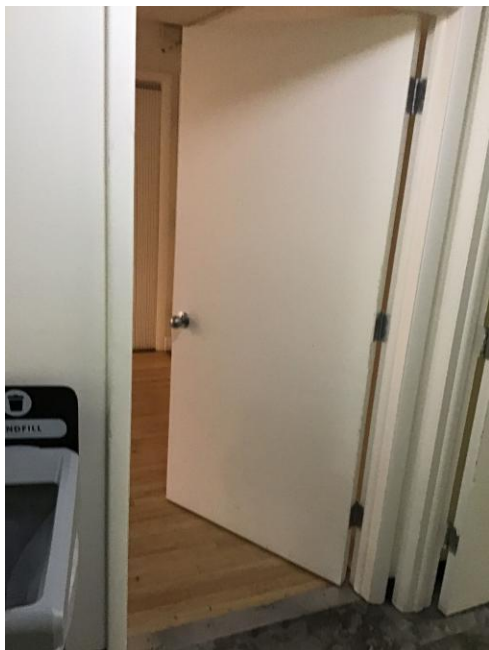
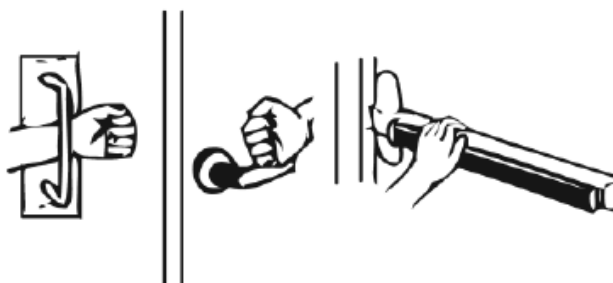
Office Space: Office

Door knobs on doors.

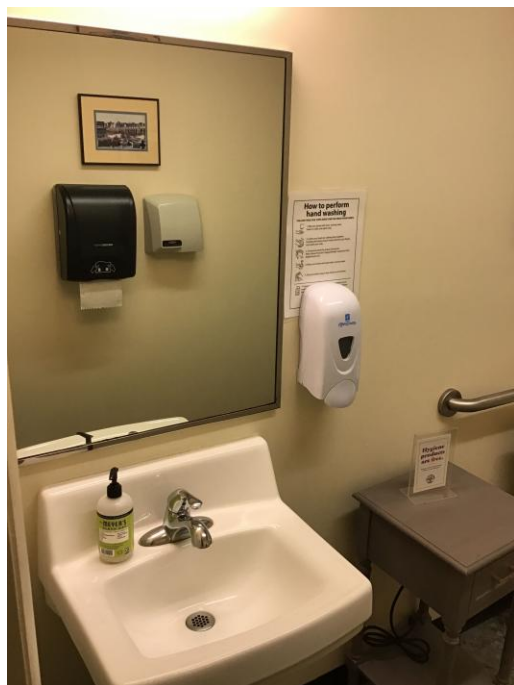
Office Space: Women's Restroom

Mirror above 40".
