Site Accessibility Evaluation

Allmendinger Park
655 Pauline Blvd
Ann Arbor, MI 48104
ADA Only

Inspection Date: 07/11/2022

Report Date: 11/15/2022

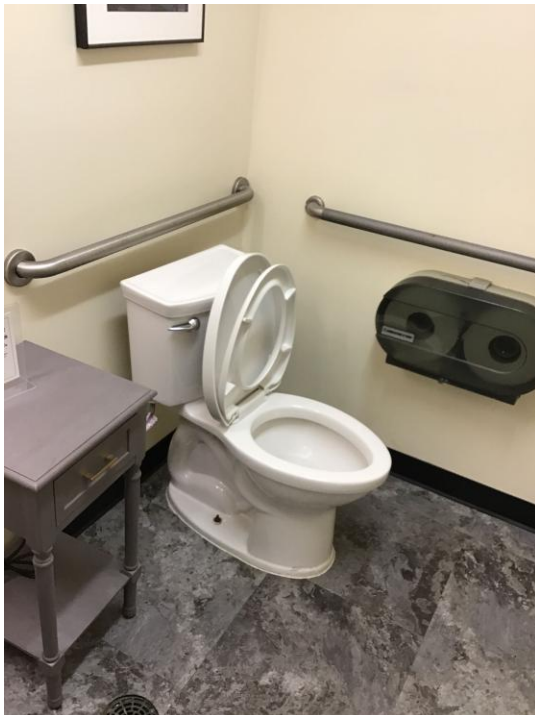
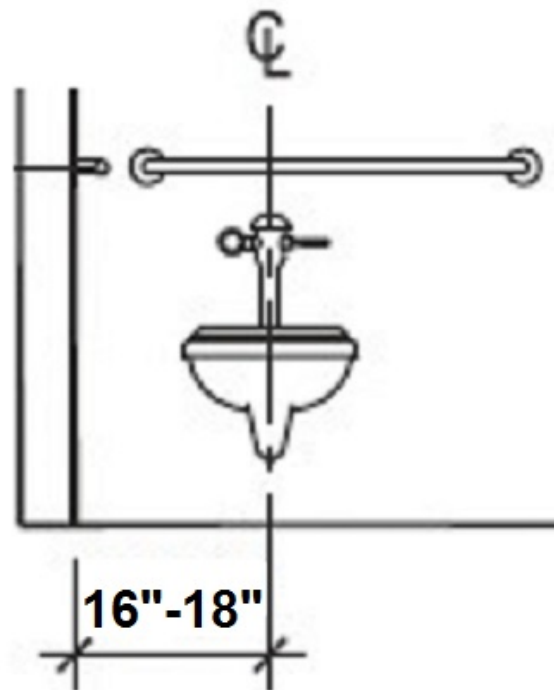
Office Space: Women's Restroom

Water closet approximately 20" from side wall.

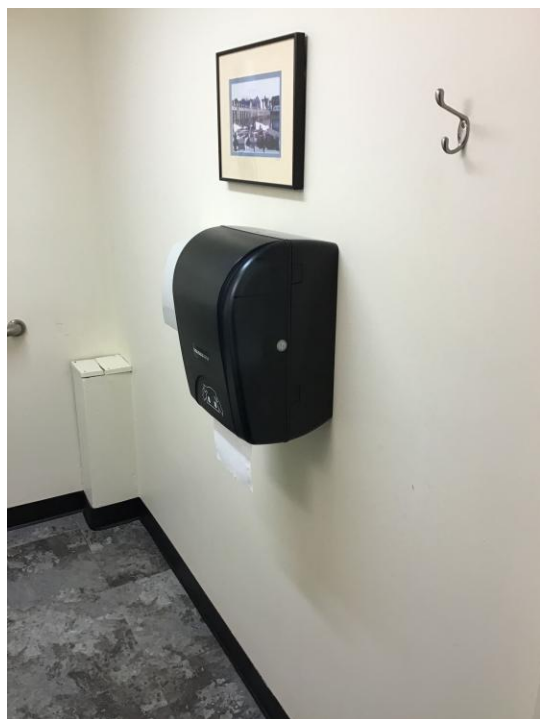
Office Space: Women's Restroom

Wall-mounted objects that have leading edges between 27 inches and 80 inches from the floor must not project more than 4 inches into the circulation path. Protruding objects that extend to the floor or within 27 inches of the floor are cane detectable and are therefore not hazardous. Where it is necessary or desirable to have objects protrude from the wall, a manner of cane detection must be provided.

Paper towel dispenser is protruding.

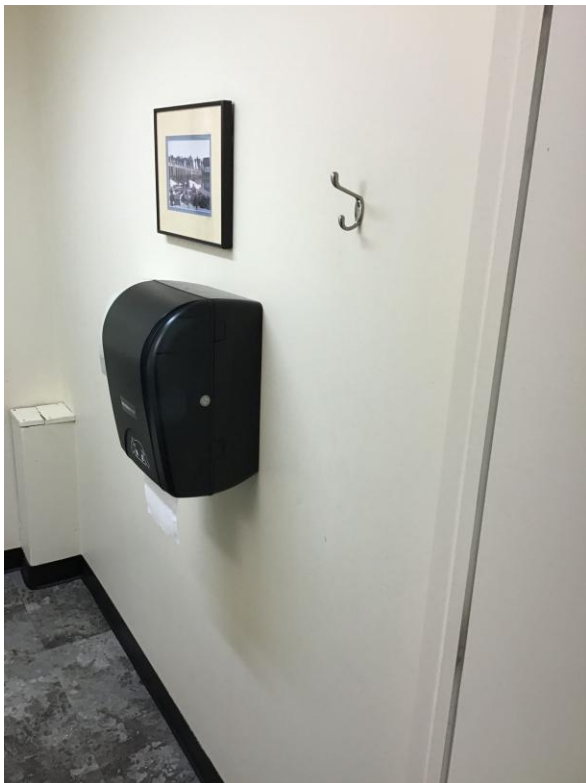
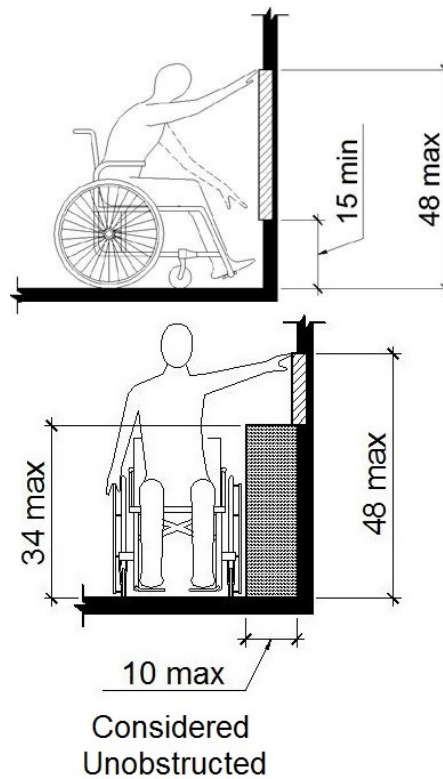
Office Space: Women's Restroom

Coat hook at 62".

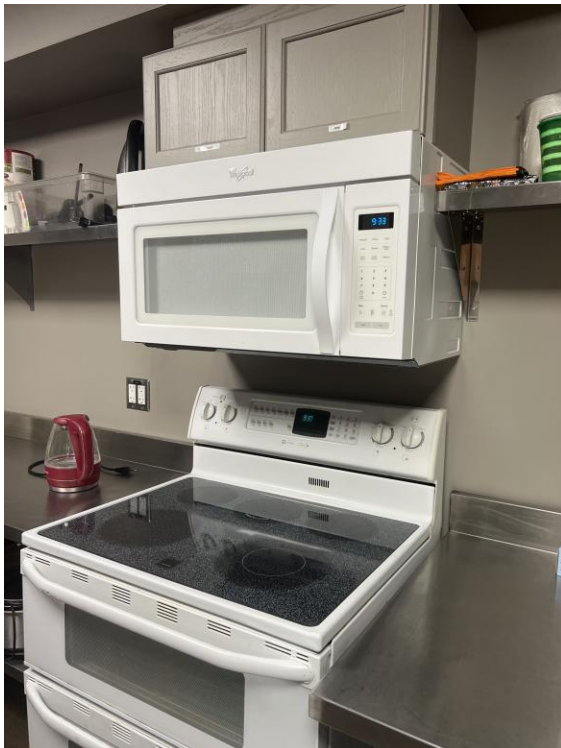
Kitchen: Kitchen Area

Microwave

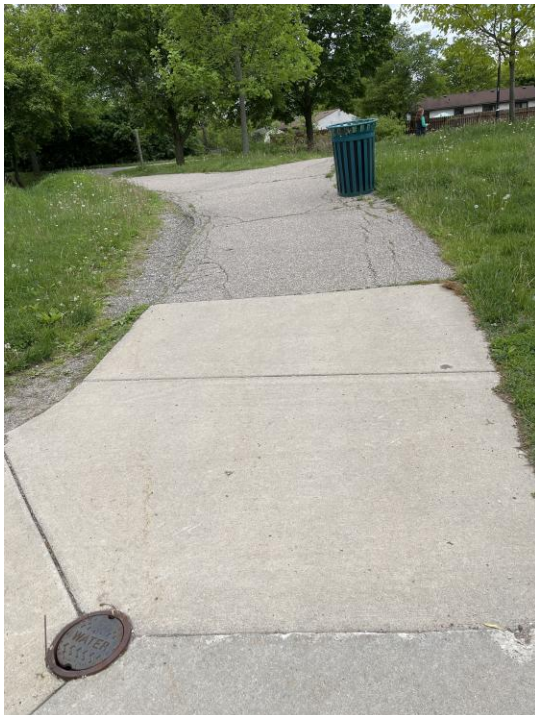
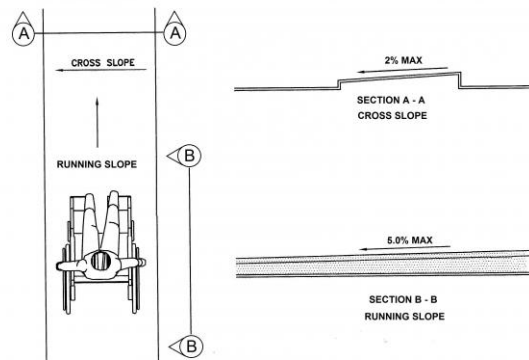
Running slope is 8.5 %

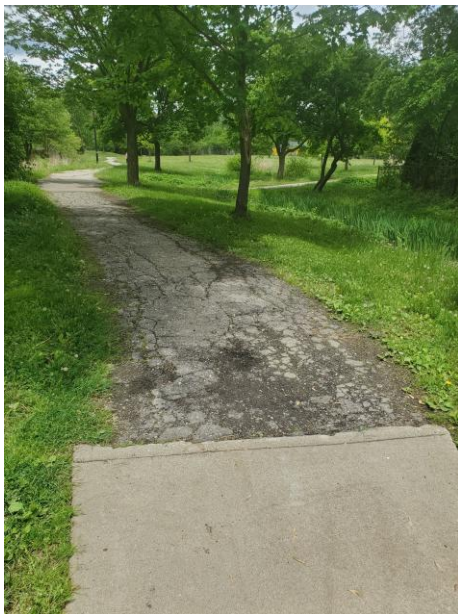
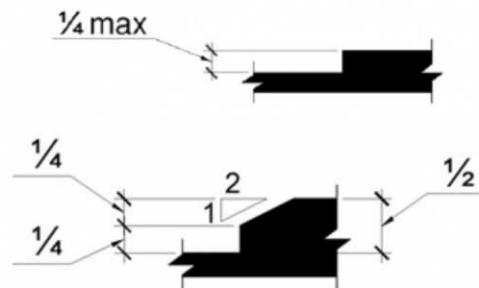
asphalt/ concrete connection

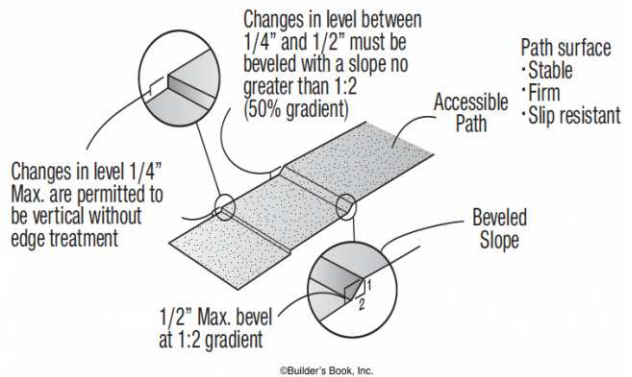
The accessible route contains loose gravel and/or surface materials that do not provide for a stable, firm slip resistant surface.

Asphalt with cracks and excessive cross slope

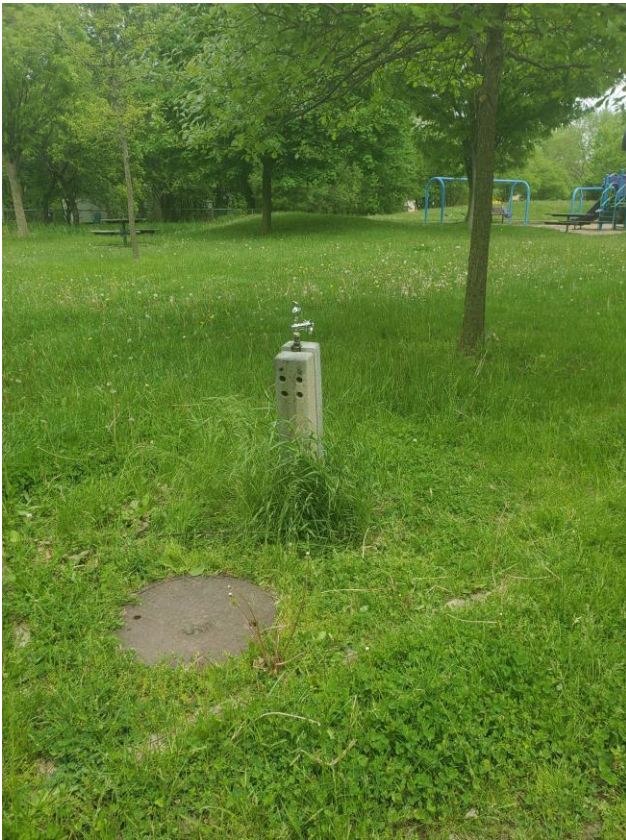
Finding #7 Continued

The drinking fountain has multiple violations.

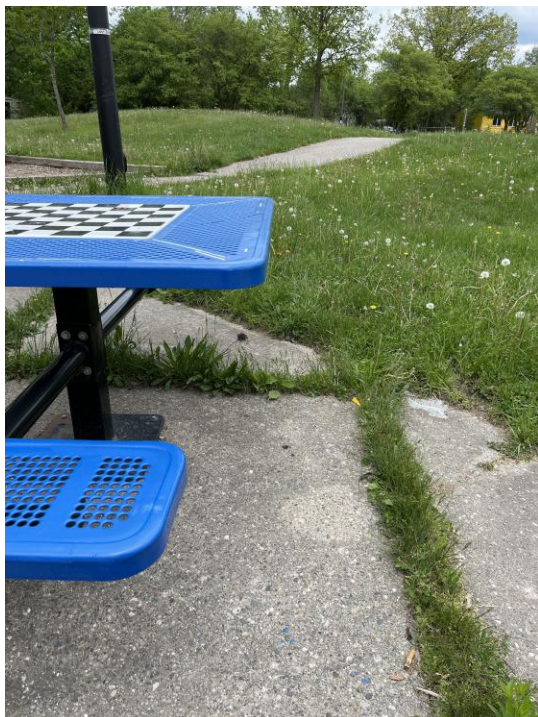
Wall-mounted objects that have leading edges between 27 inches and 80 inches from the floor must not project more than 4 inches into the circulation path. Protruding objects that extend to the floor or within 27 inches of the floor are cane detectable and are therefore not hazardous. Where it is necessary or desirable to have objects protrude from the wall, a manner of cane detection must be provided.

Picnic table is a protruding object

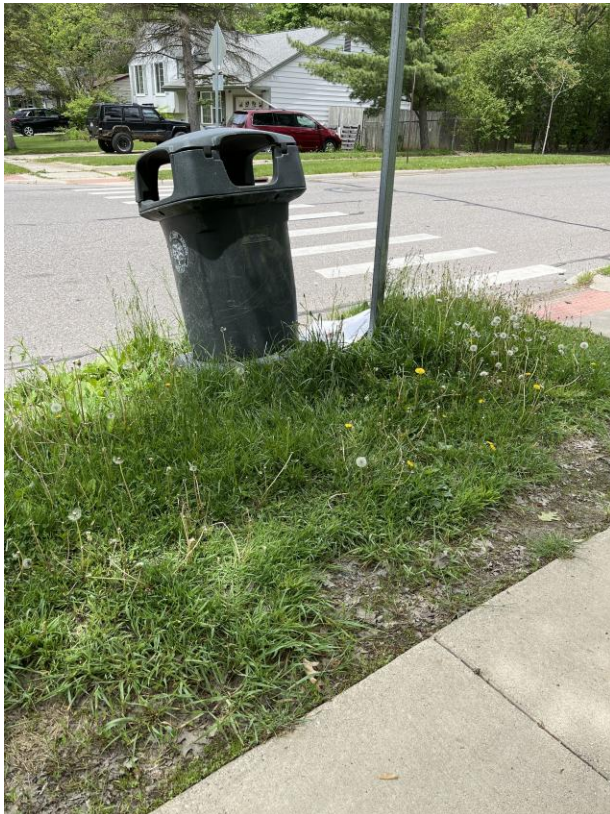
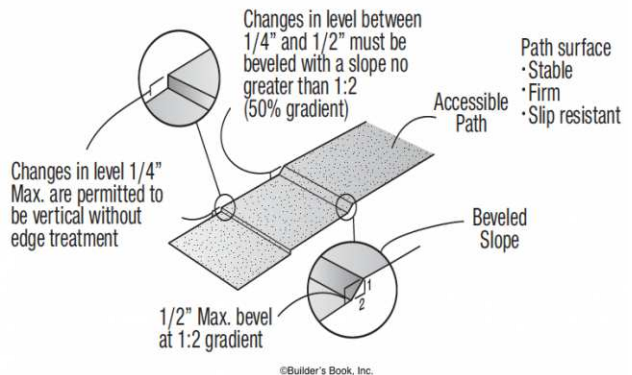
The accessible route contains loose gravel and/or surface materials that do not provide for a stable, firm slip resistant surface.

Surface is grass

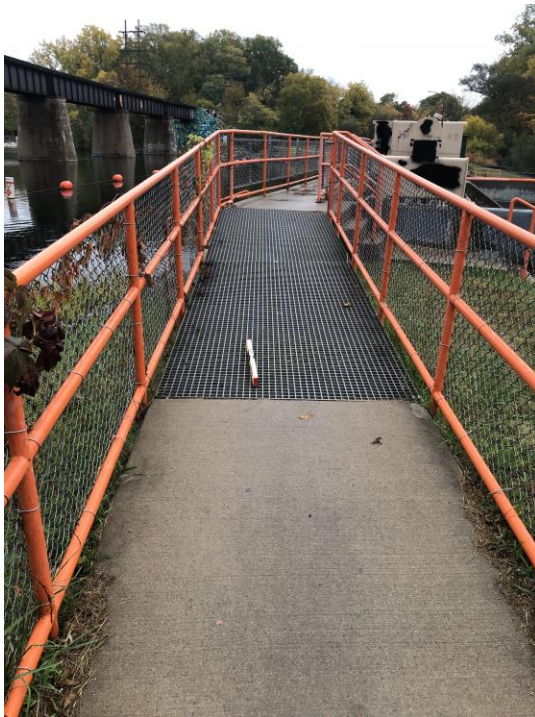
Metal grate surface slope at 7.1%.

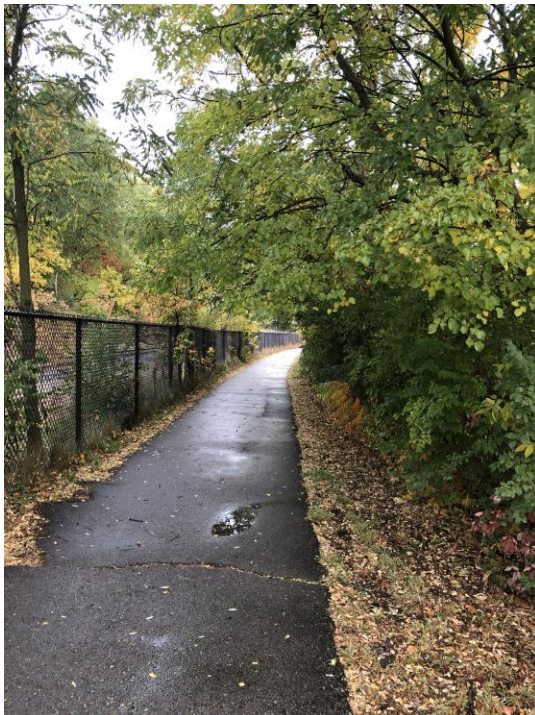
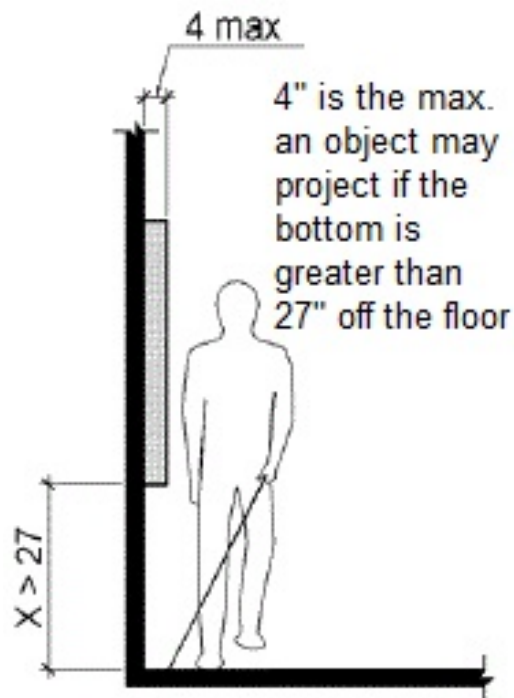
Wall-mounted objects that have leading edges between 27 inches and 80 inches from the floor must not project more than 4 inches into the circulation path. Protruding objects that extend to the floor or within 27 inches of the floor are cane detectable and are therefore not hazardous. Where it is necessary or desirable to have objects protrude from the wall, a manner of cane detection must be provided.

Trees are protruding objects.

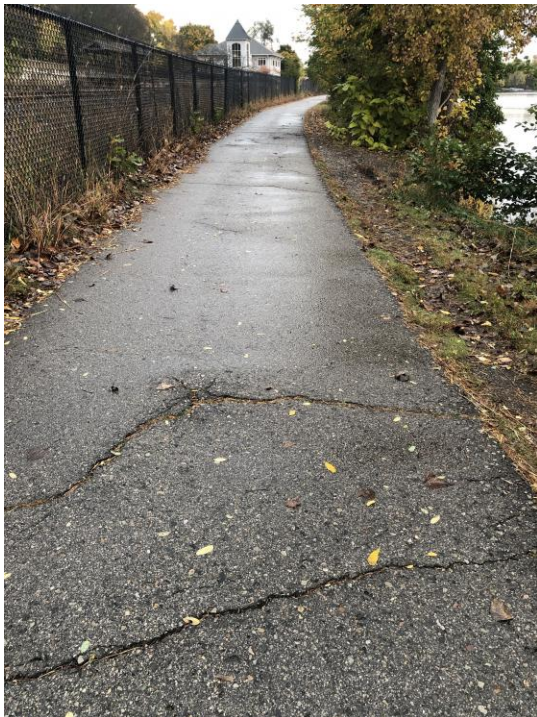
Asphalt surface has openings.

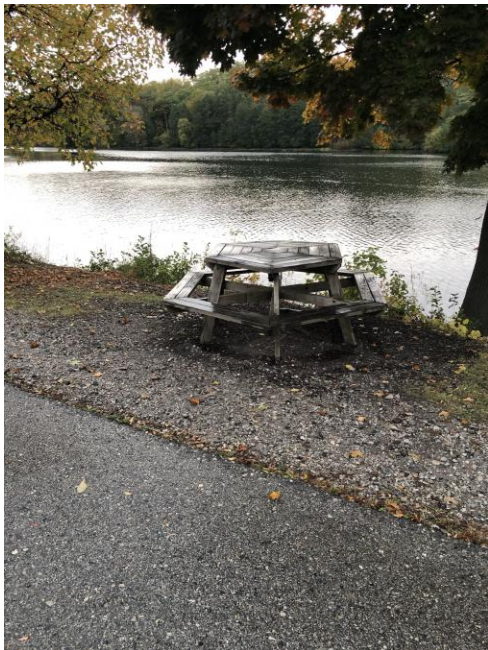
Bench with non-compliant seating and No accessible route.

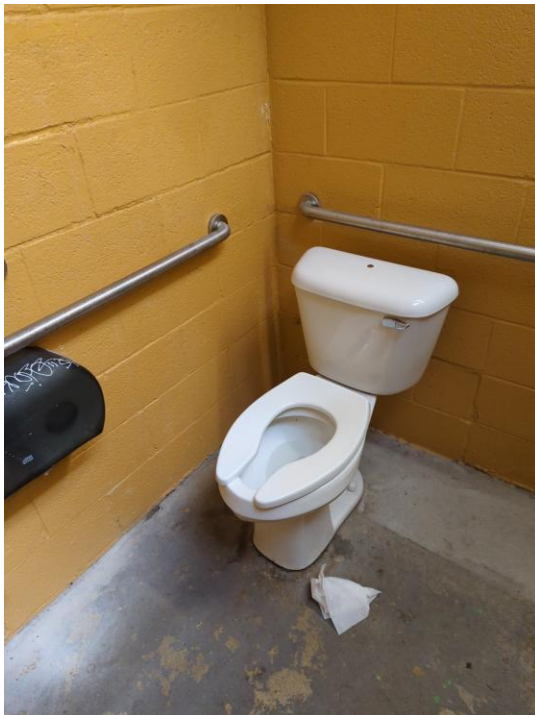
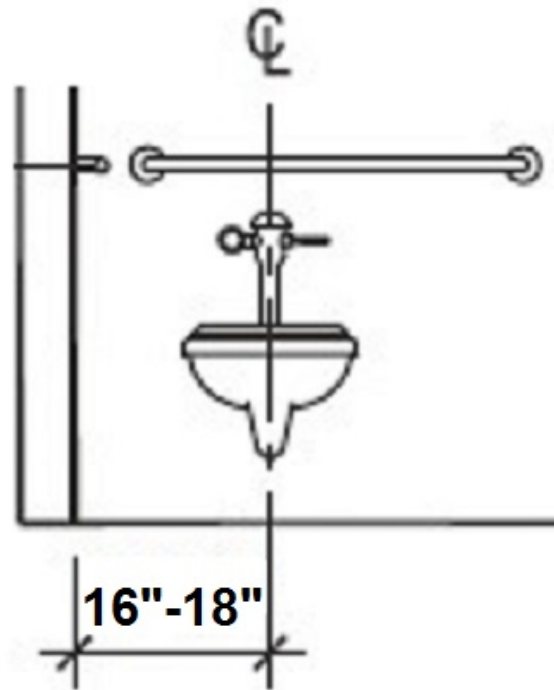
Water closet is centered at 19 inches

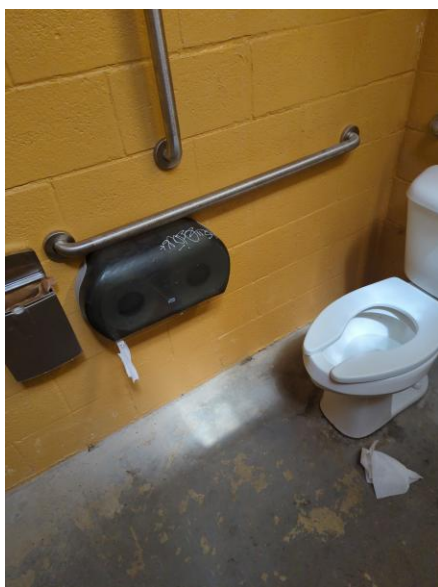
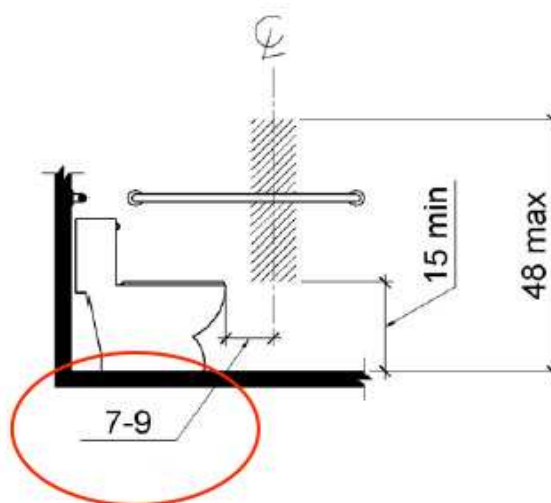
Dispenser is 12 inches in front of toilet

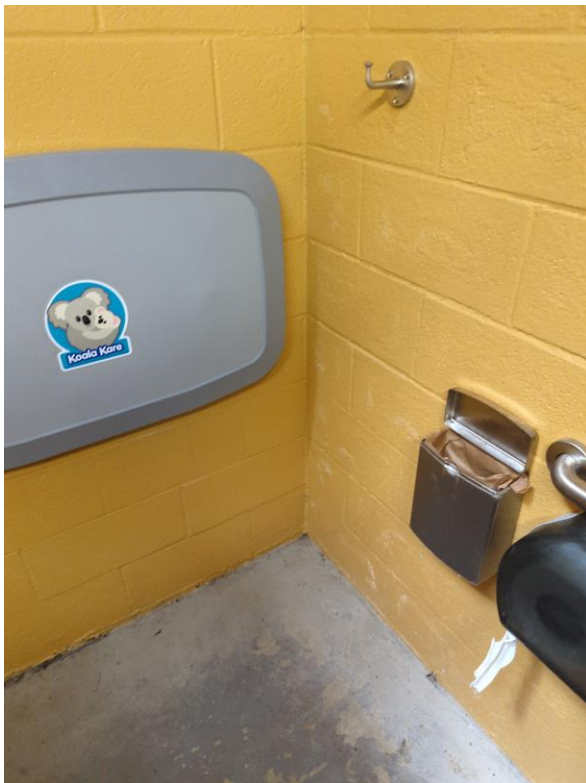
Coat hook is 54 inches high

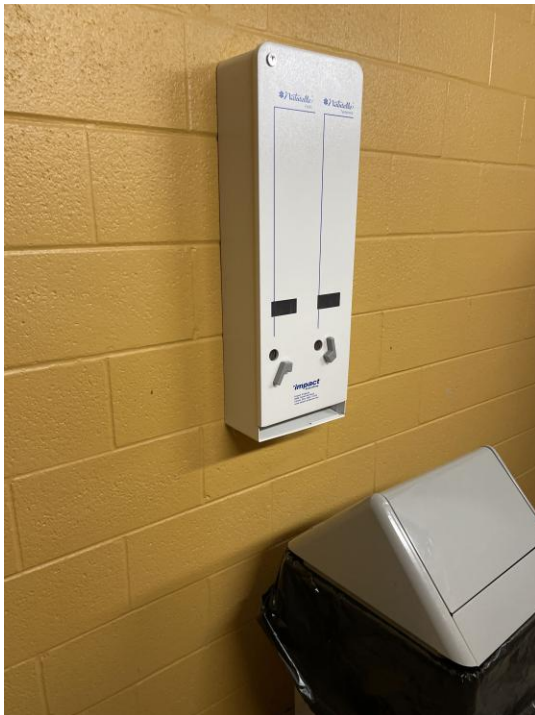
Wall-mounted objects that have leading edges between 27 inches and 80 inches from the floor must not project more than 4 inches into the circulation path. Protruding objects that extend to the floor or within 27 inches of the floor are cane detectable and are therefore not hazardous. Where it is necessary or desirable to have objects protrude from the wall, a manner of cane detection must be provided.

6"

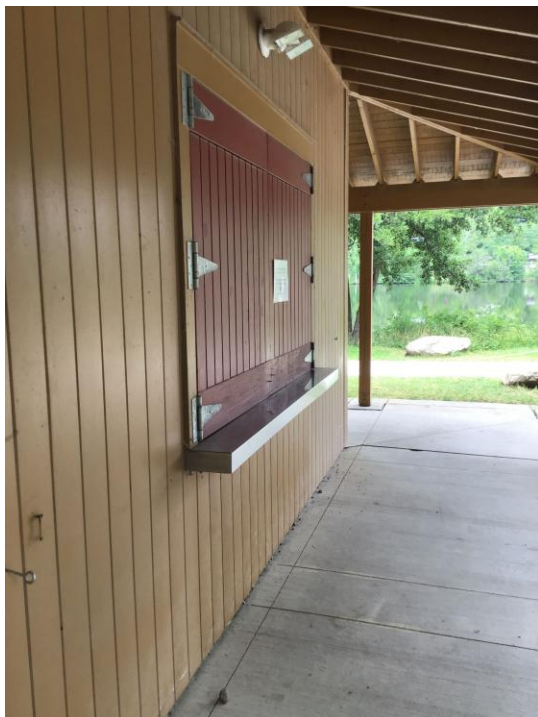
Wall-mounted objects that have leading edges between 27 inches and 80 inches from the floor must not project more than 4 inches into the circulation path. Protruding objects that extend to the floor or within 27 inches of the floor are cane detectable and are therefore not hazardous. Where it is necessary or desirable to have objects protrude from the wall, a manner of cane detection must be provided.

The counter facing the gazebo is a protruding objects.

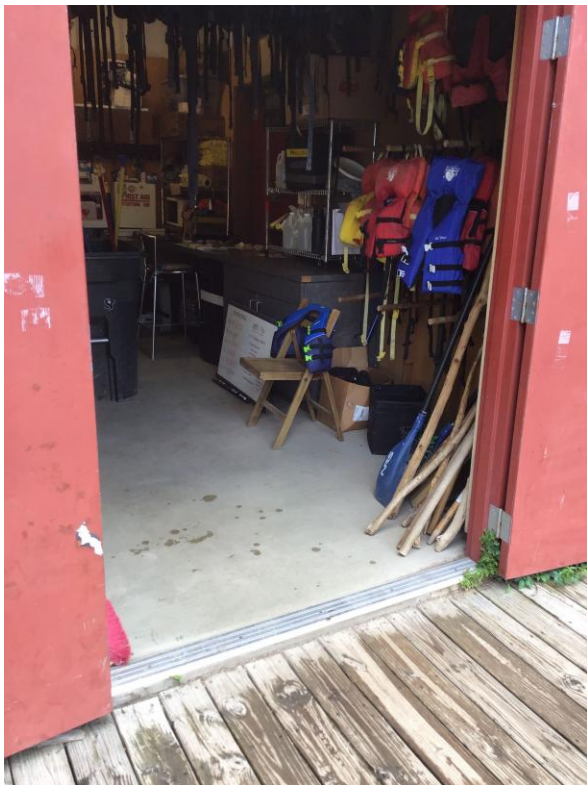
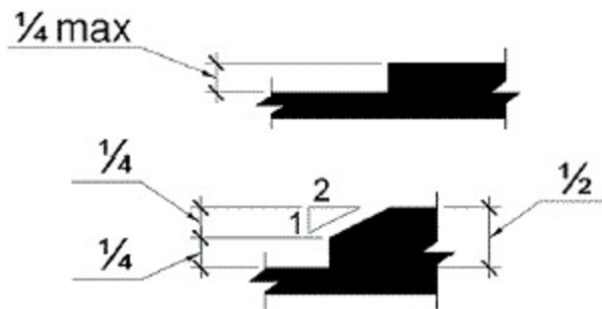
The double doors to the wooden deck have a threshold at 2 inches high.

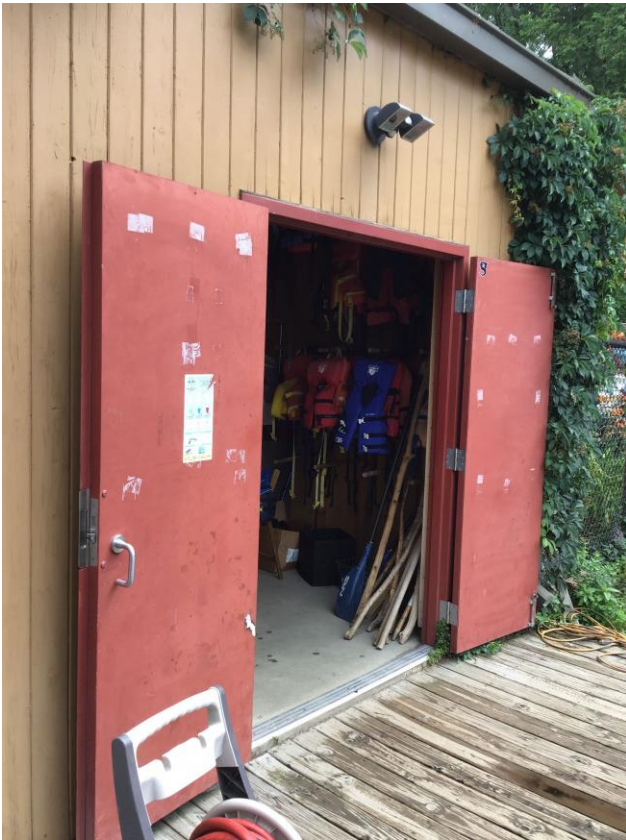
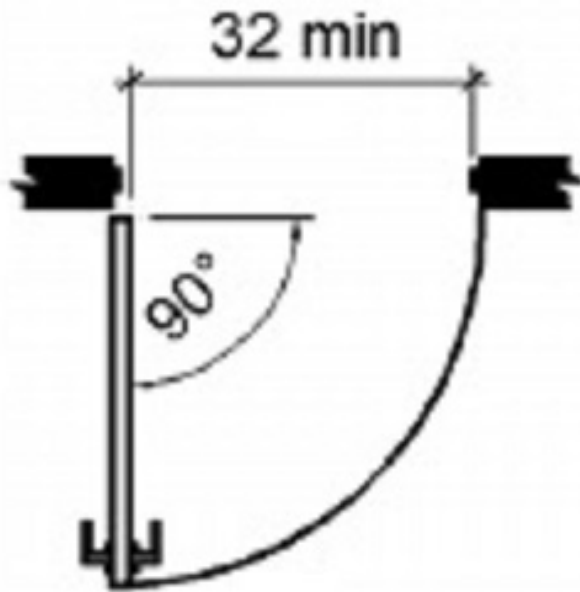
Finding #14 Continued

The double doors to the wooden deck do not provide the clear width for a single leaf.

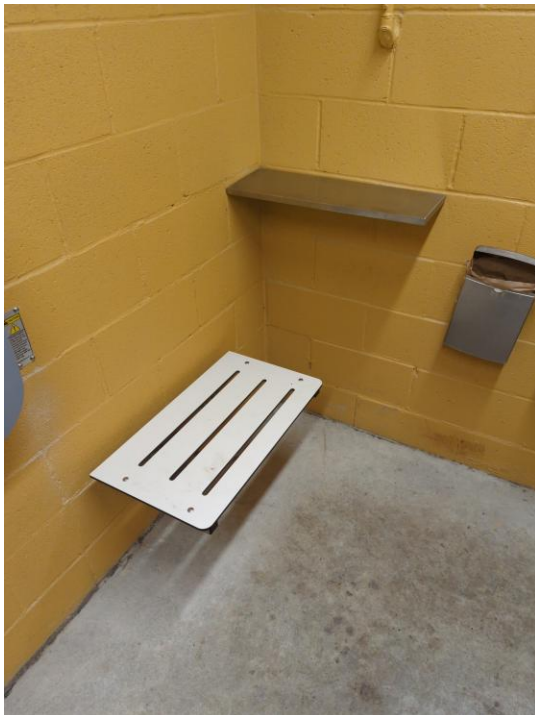
Bench is 15x25 inches

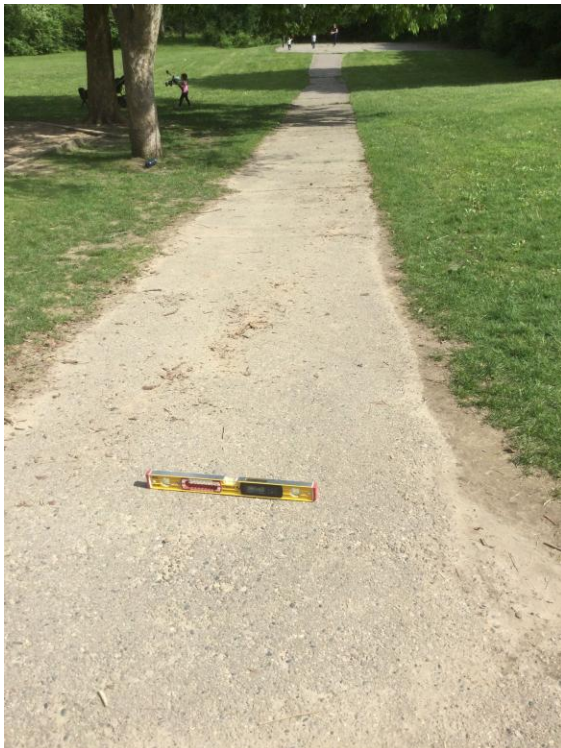
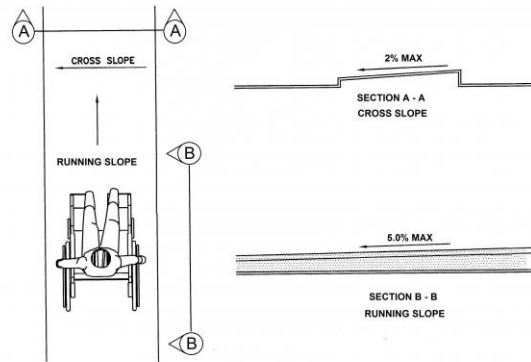
Asphalt surface

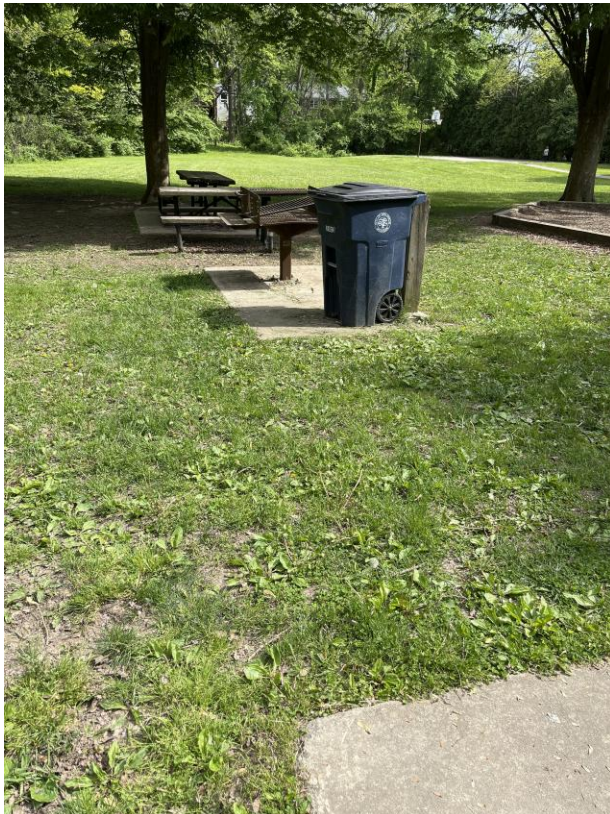
The accessible route contains loose gravel and/or surface materials that do not provide for a stable, firm slip resistant surface.

Surface is grass

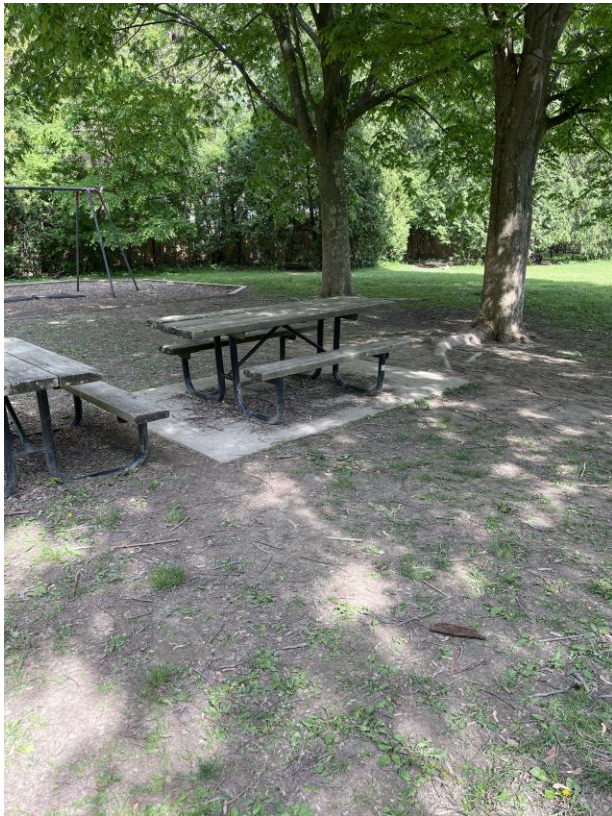
The accessible route contains loose gravel and/or surface materials that do not provide for a stable, firm slip resistant surface.

Surface is grass

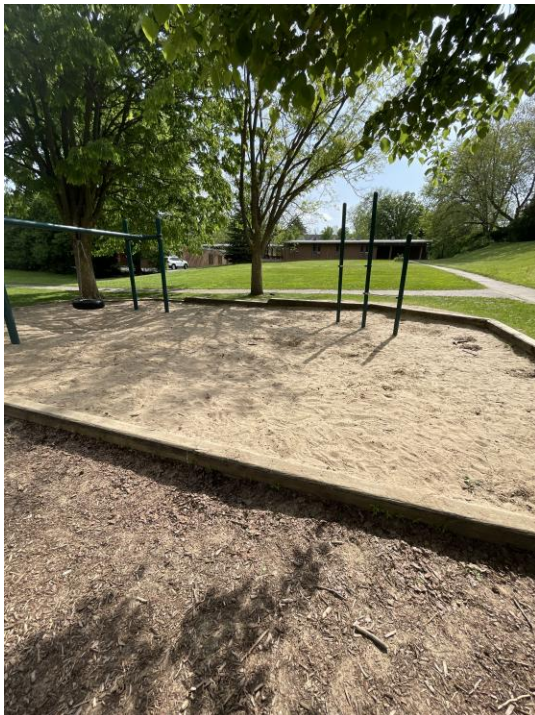
Sand

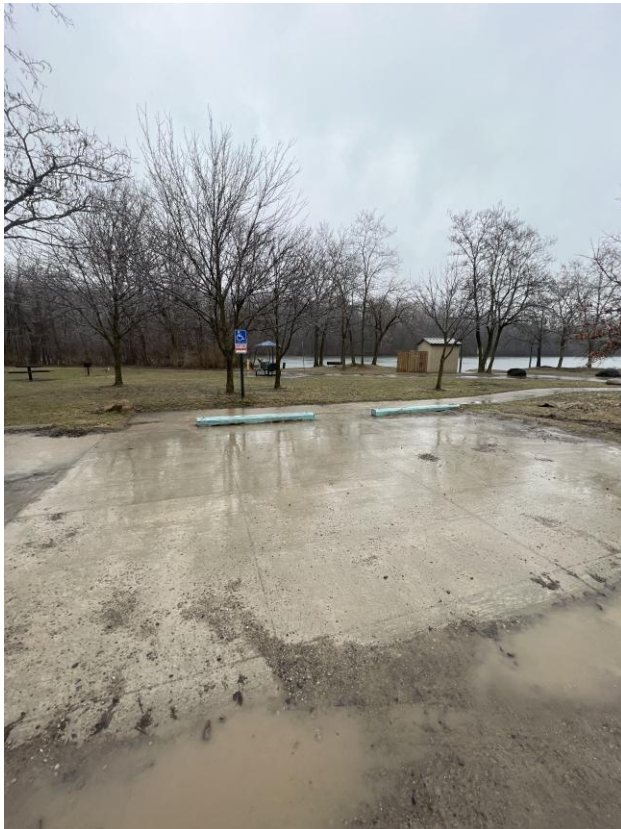
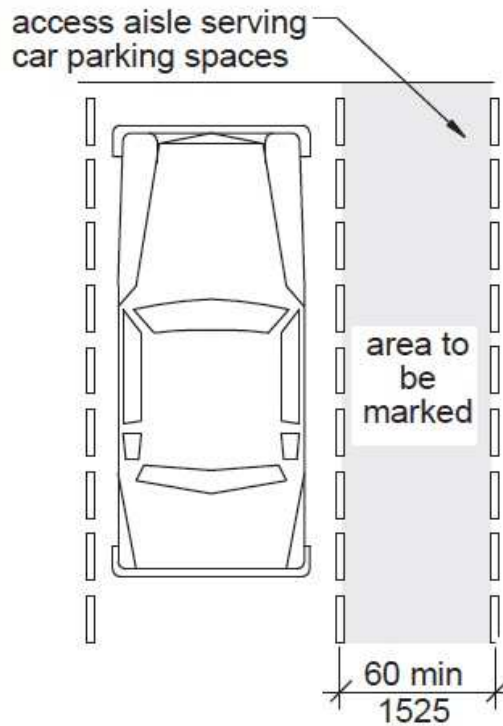
Parking: Parking Lot

The access aisle is missing at the accessible parking stall.

No markings for access aisle or parking

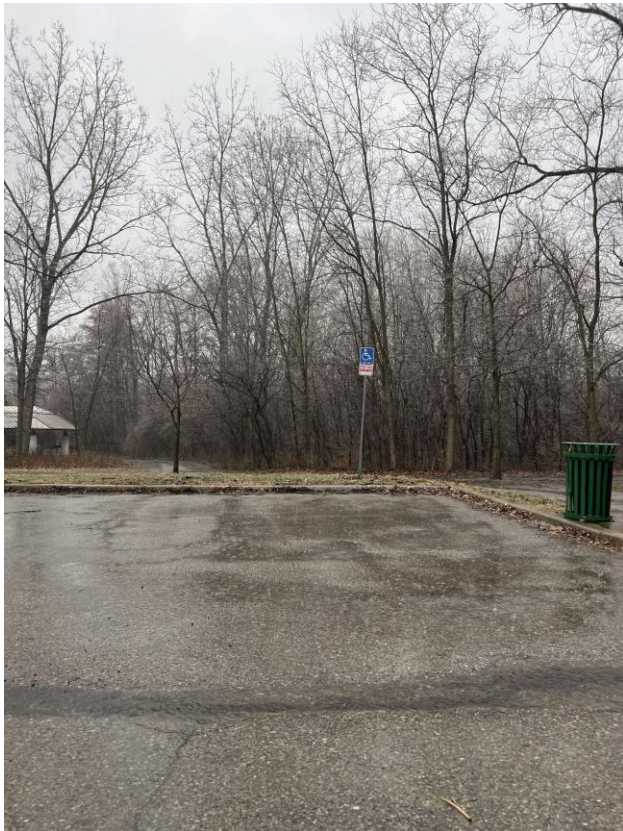
Parking: Parking Lot

The access aisle is missing at the accessible parking stall.

No markings for access aisle or parking

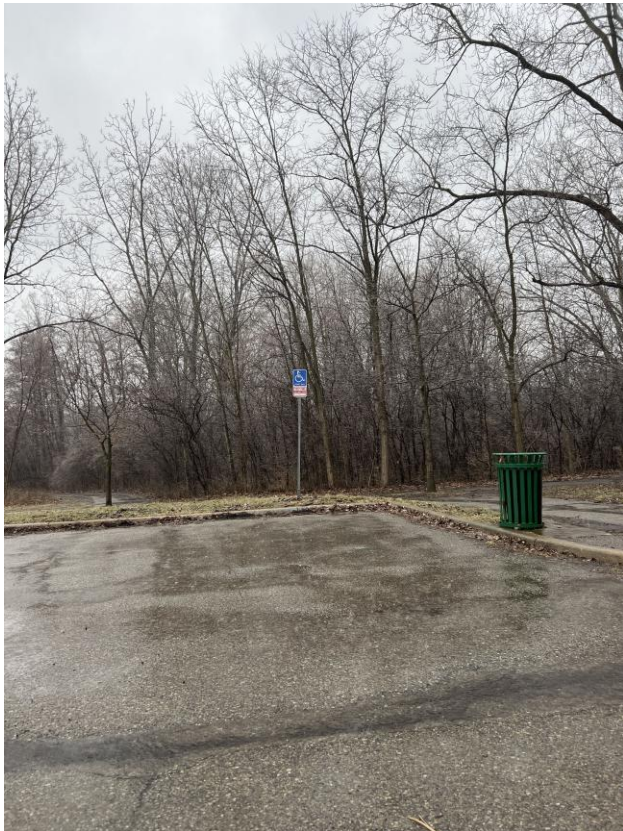
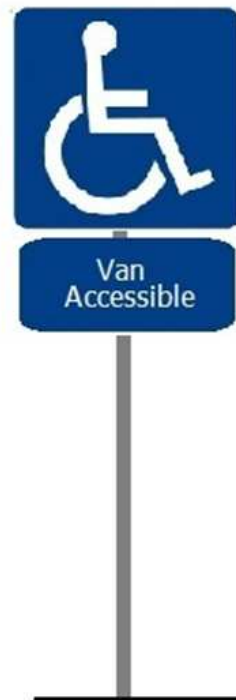
Parking: Parking Lot

The van stall is missing a sign identifying it as a van accessible stall.

No markings for van stall

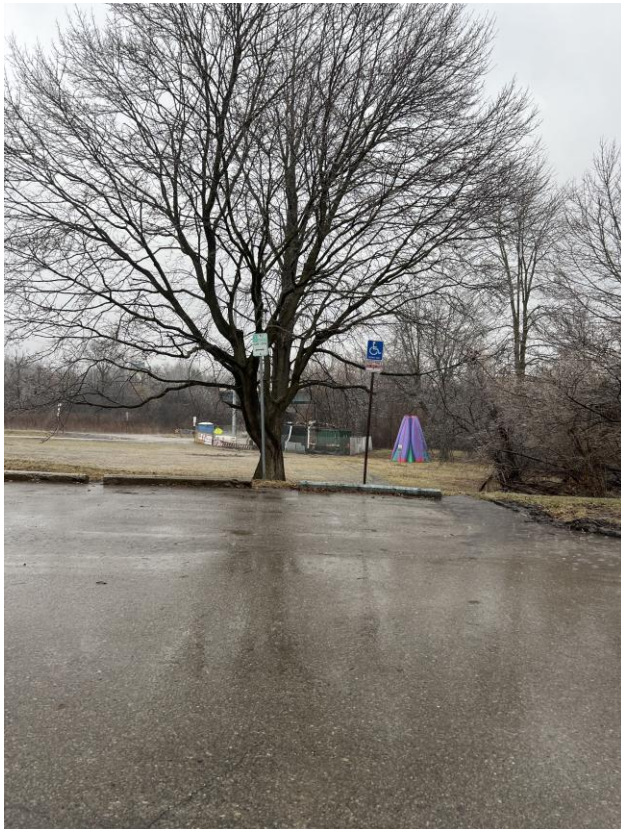
Parking: Parking Lot

The van stall is missing a sign identifying it as a van accessible stall.

No markings for van stall

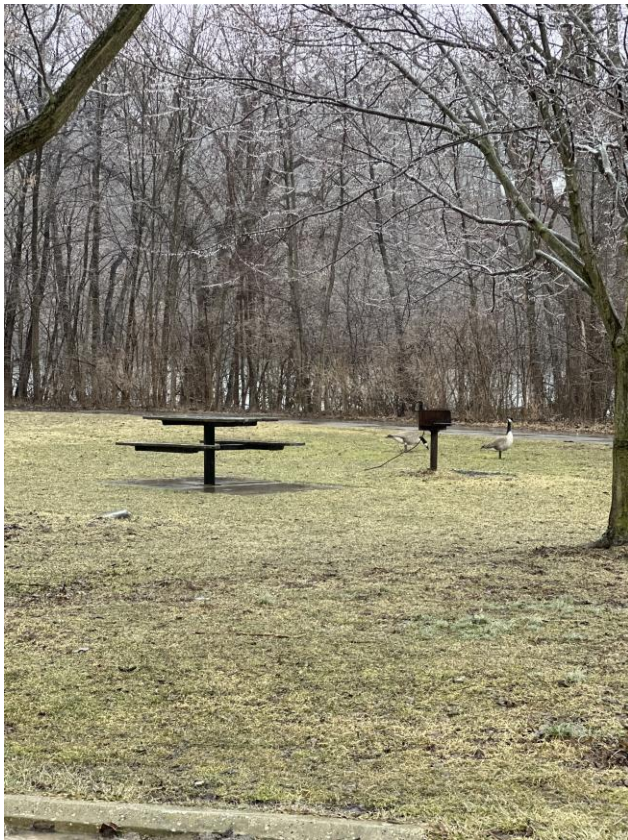
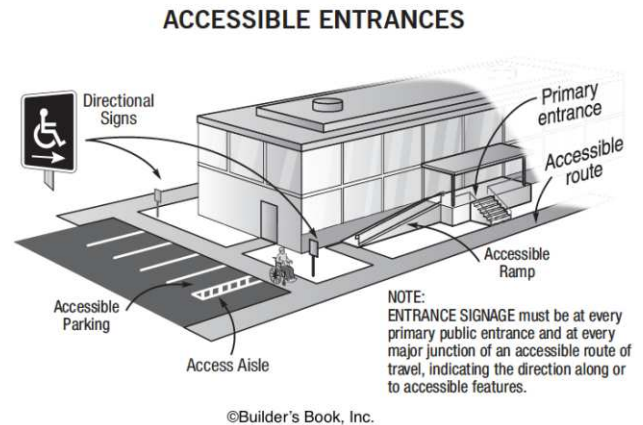
Trail System: Trail

No route to 3 picnic tables and a grill

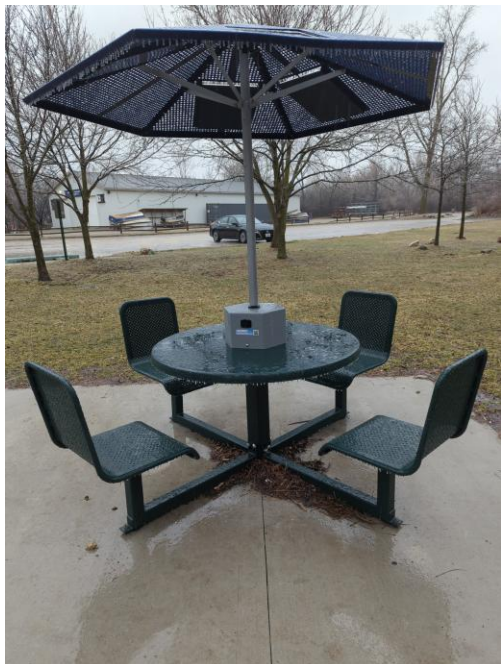
Green Space: Picnic Area

The charging station picnic table does not have an accessible seating space

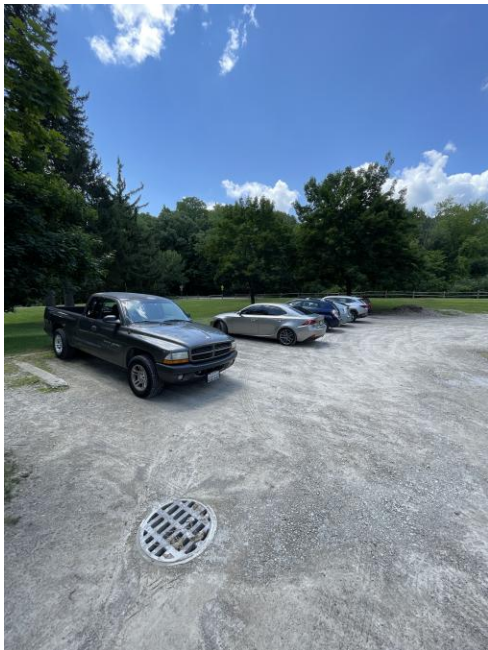
No accessible spaces are provided. Gravel parking lot

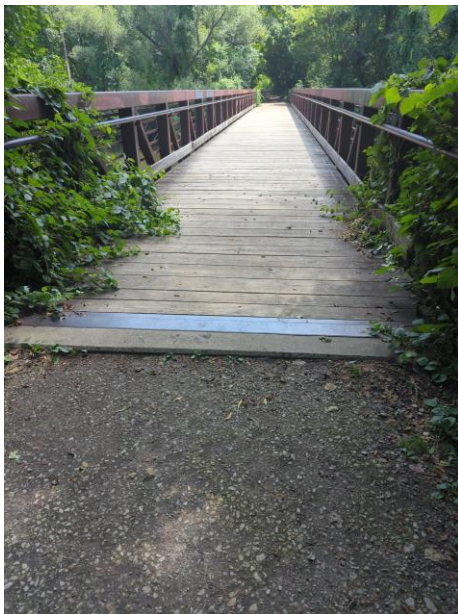
Trail System: Trail

Both ends of bridge have a vertical change in level of up to 2 inches

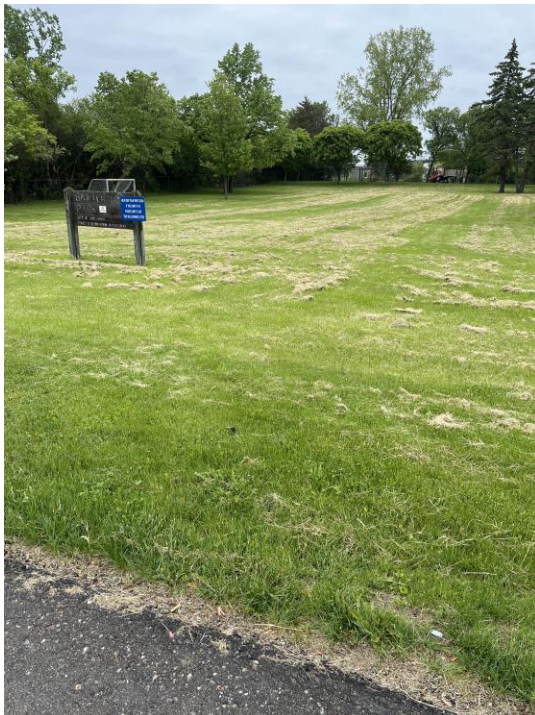
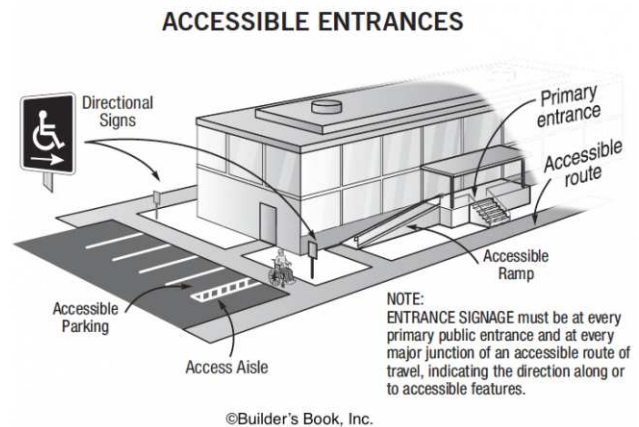
Surface is grass and excessive slope

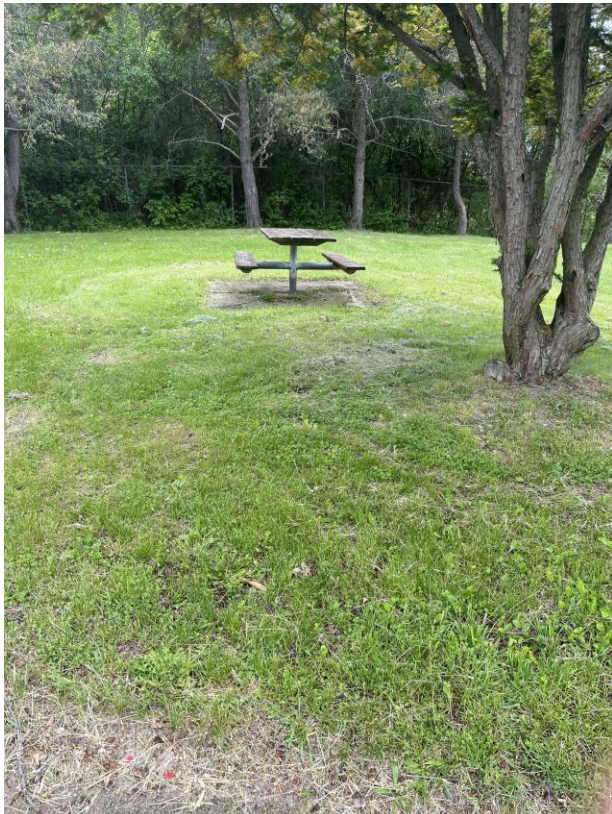
Green Space: Picnic Area

The accessible route contains loose gravel and/or surface materials that do not provide for a stable, firm slip resistant surface.

Surface is grass for 40 feet from trail

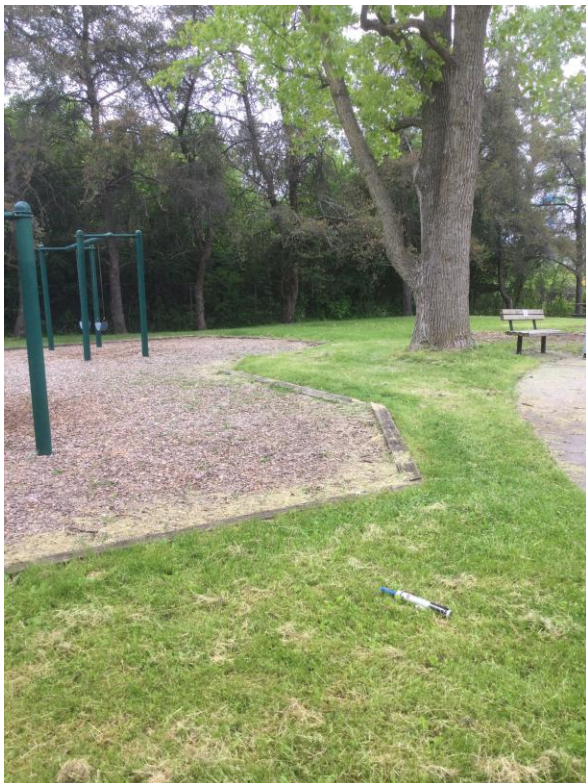
Play Area: Swings

Grass surface

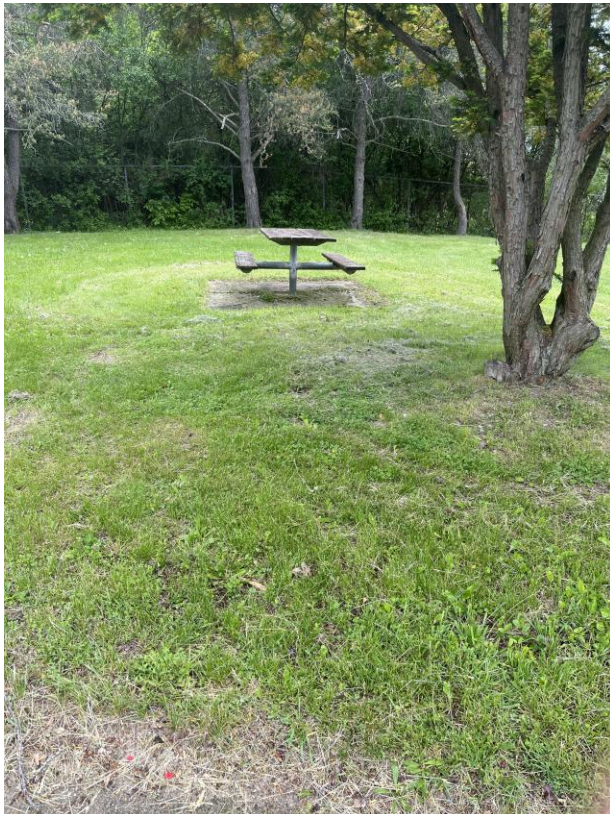
Soccer Field: Route

The accessible route contains loose gravel and/or surface materials that do not provide for a stable, firm slip resistant surface.

Surface is grass

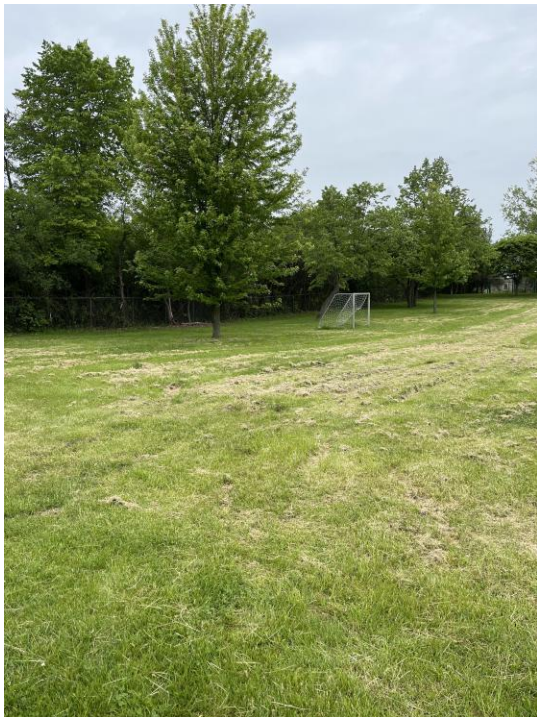
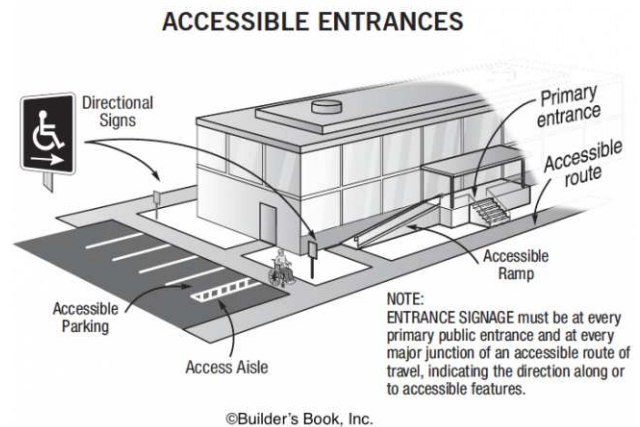
Soccer Field: Route

Surface is grass and excessive slope

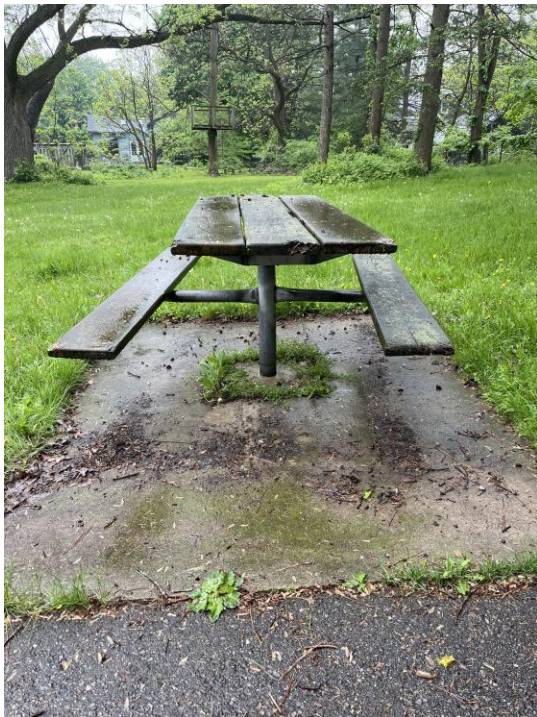
Green Space: Picnic Area

Opening on transition from trail to picnic area

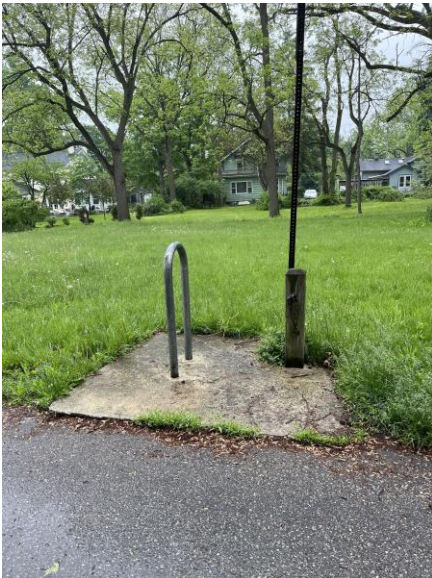
Green Space: Bike Rack

change in level in transition between trail and bike rack area

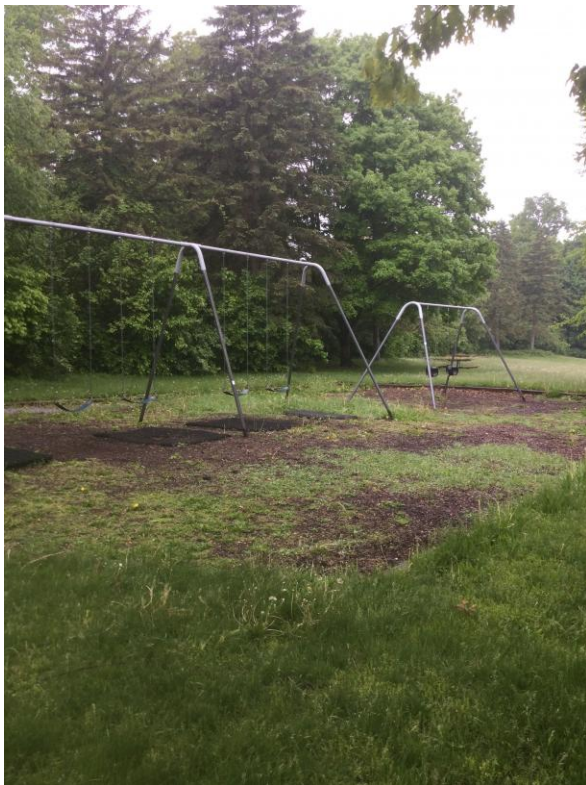
Play Area: Swings

Grass surface
