Site Accessibility Evaluation

Allmendinger Park
655 Pauline Blvd
Ann Arbor, MI 48104
ADA Only

Inspection Date: 07/11/2022

Report Date: 11/15/2022

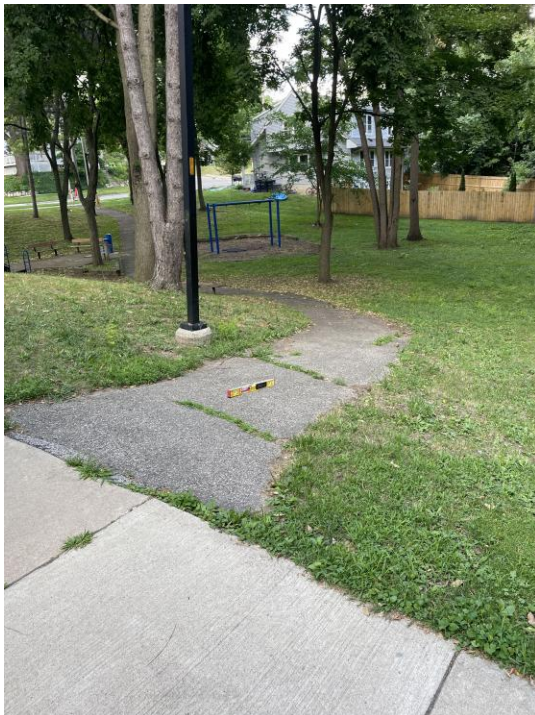
Excessive running and cross slope from public sidewalk to drinking fountain

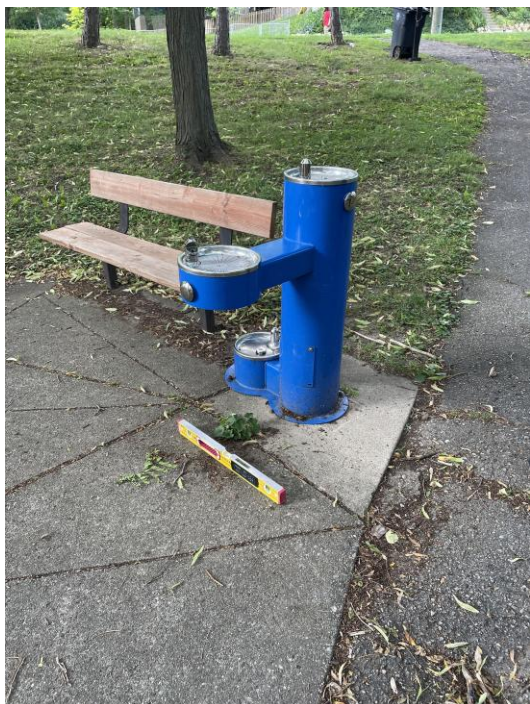
Green Space: Drinking Fountain

Clear floor space slope is 2.9%

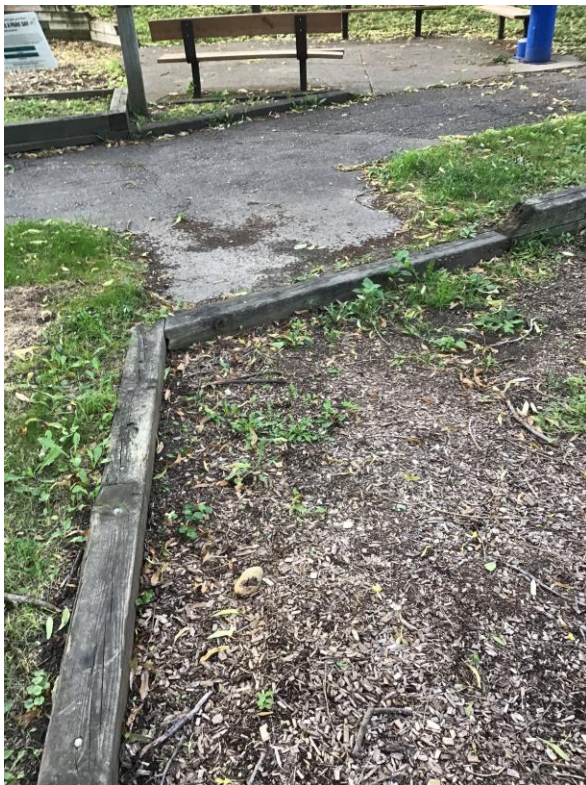
Play Area: Swings

No accessible route to swings.

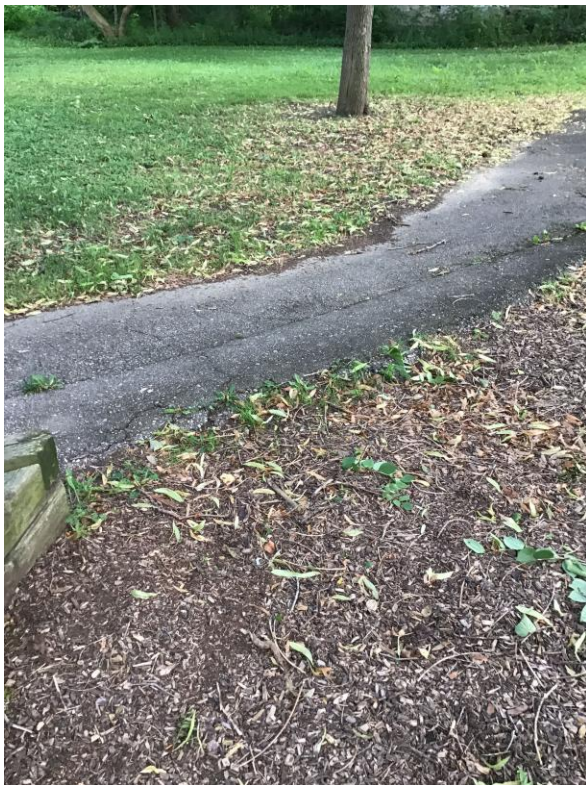
Play Area: Play Area

No accessible route to play area.

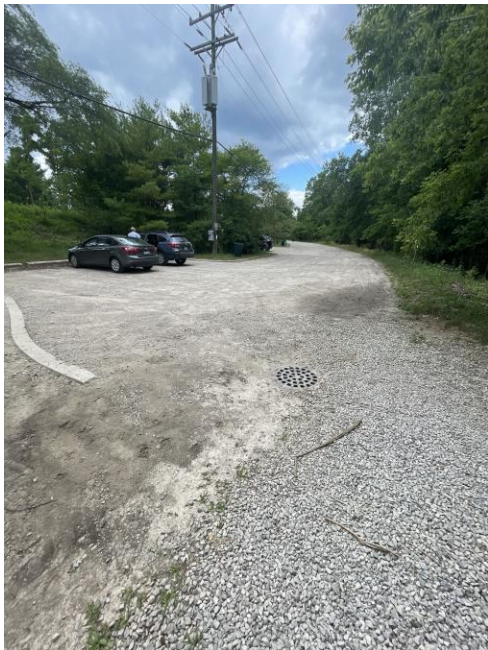
No accessible parking spaces are provided

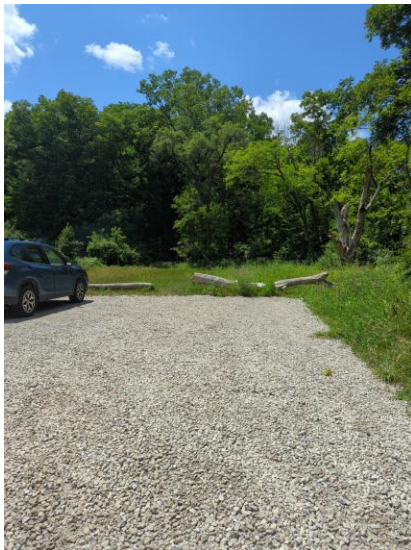
No accessible parking space; no compliant ground surface

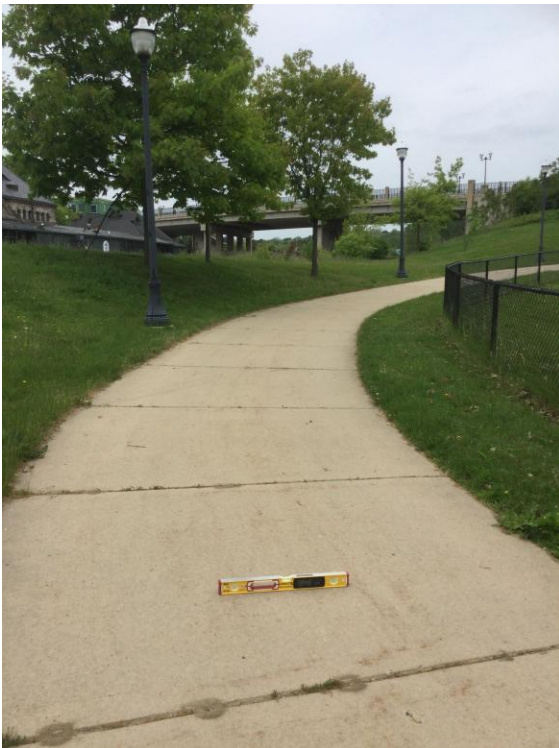
2.7

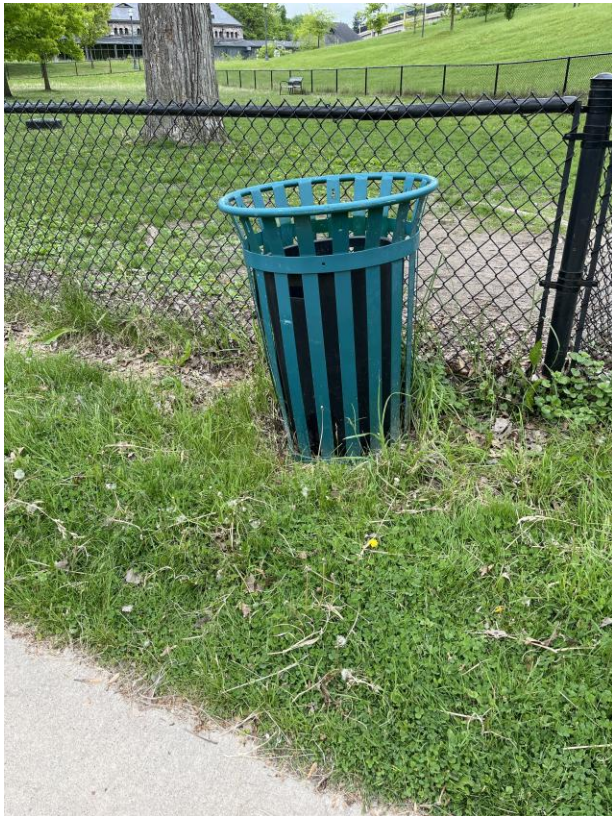
The accessible route contains loose gravel and/or surface materials that do not provide for a stable, firm slip resistant surface.

N/A

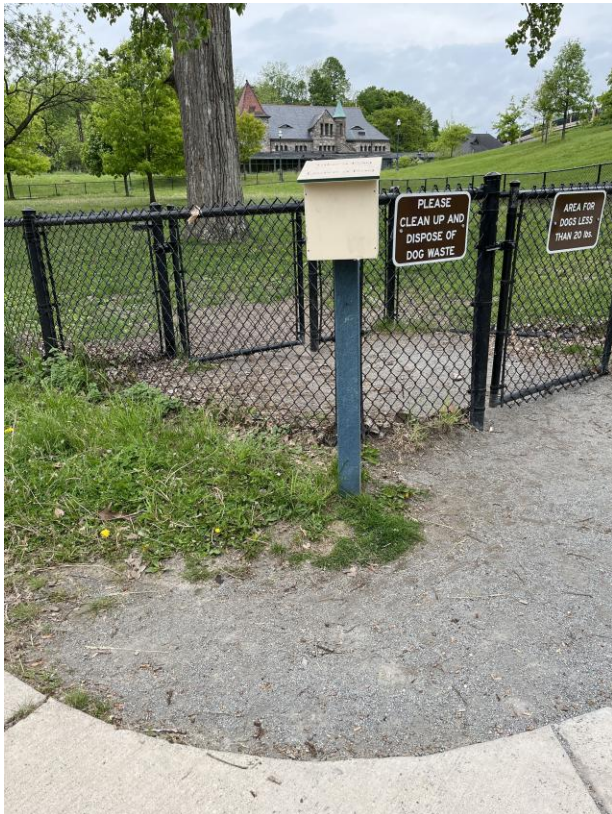
The accessible route contains loose gravel and/or surface materials that do not provide for a stable, firm slip resistant surface.

N/A

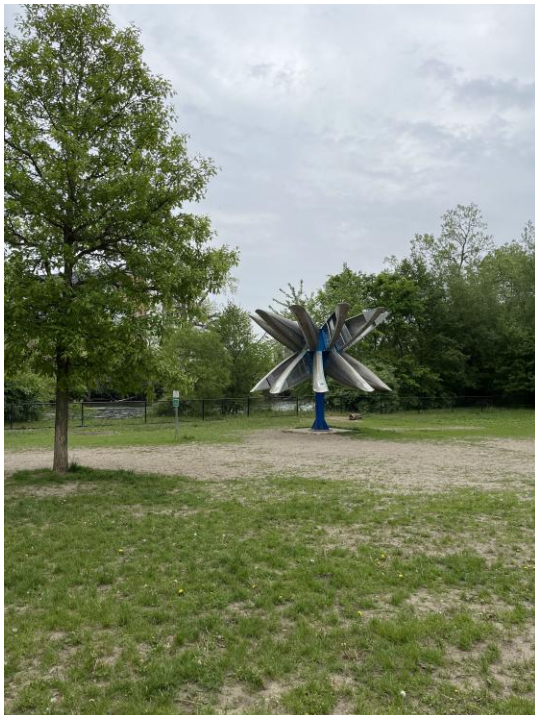
Wall-mounted objects that have leading edges between 27 inches and 80 inches from the floor must not project more than 4 inches into the circulation path. Protruding objects that extend to the floor or within 27 inches of the floor are cane detectable and are therefore not hazardous. Where it is necessary or desirable to have objects protrude from the wall, a manner of cane detection must be provided.

Sculpture is protruding

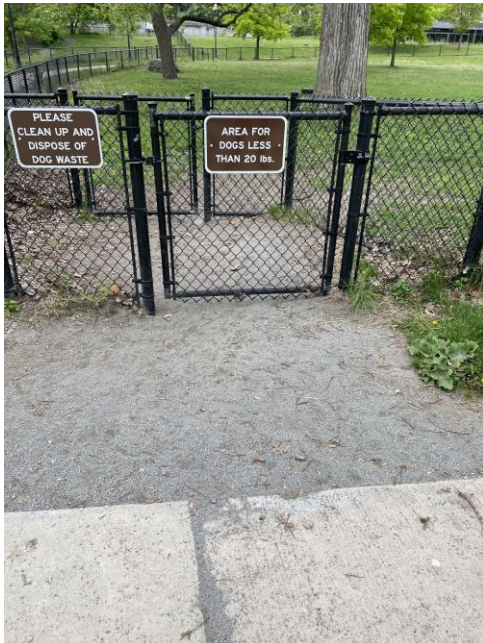
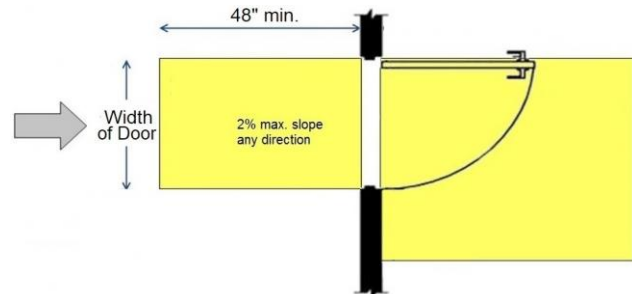
Gravel

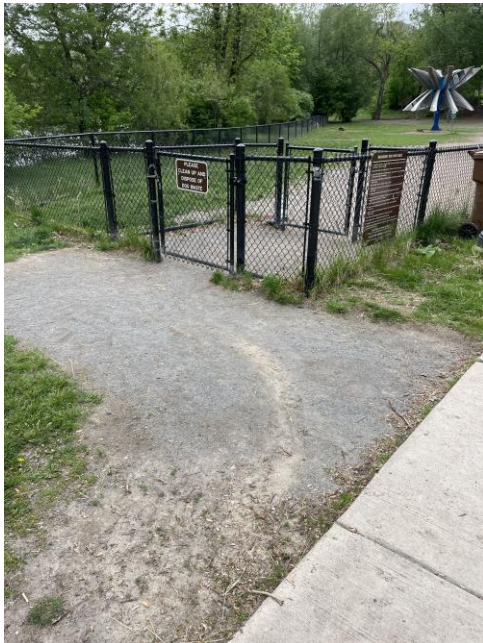
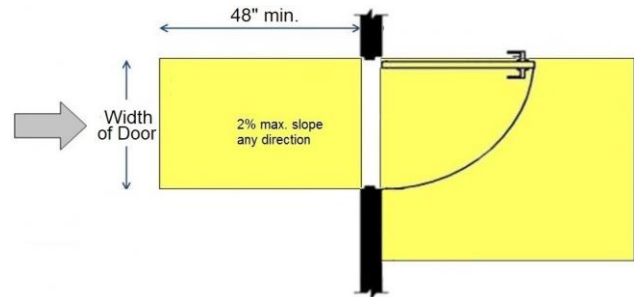
**2010 ADAS Section: 404.2.4.4, 404.2.4.4
Exception 1**

**As Built:
Gravel**

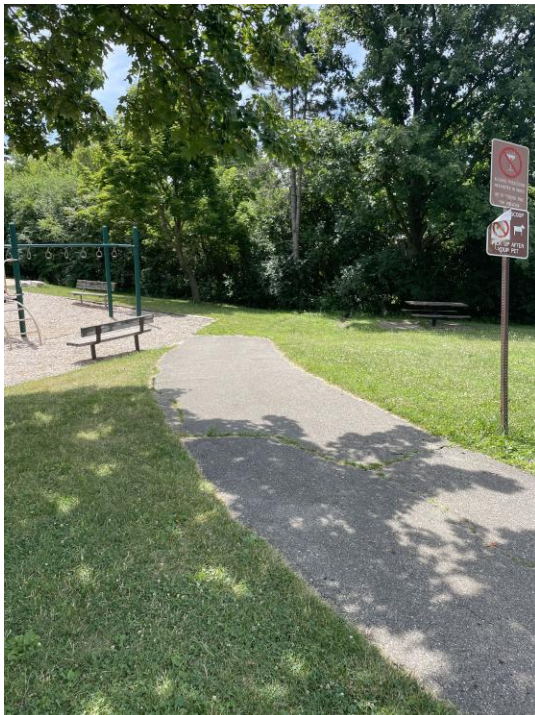
40 LF

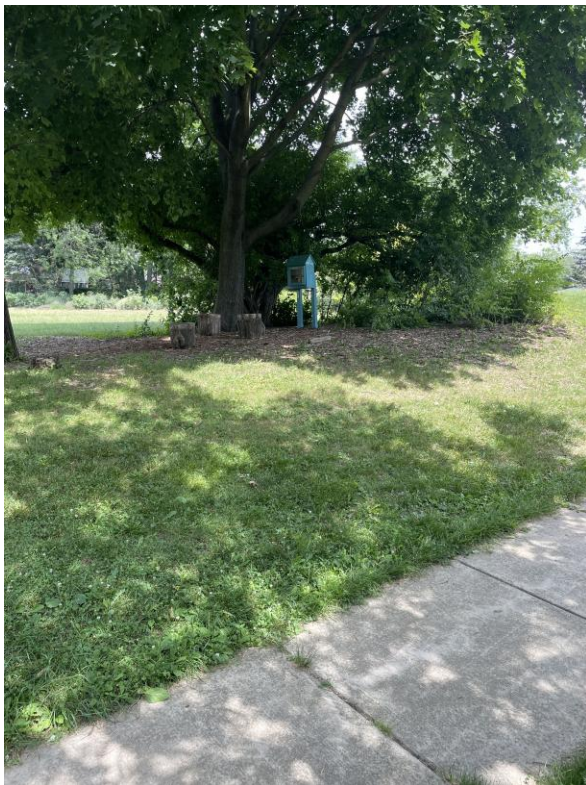
30 LF

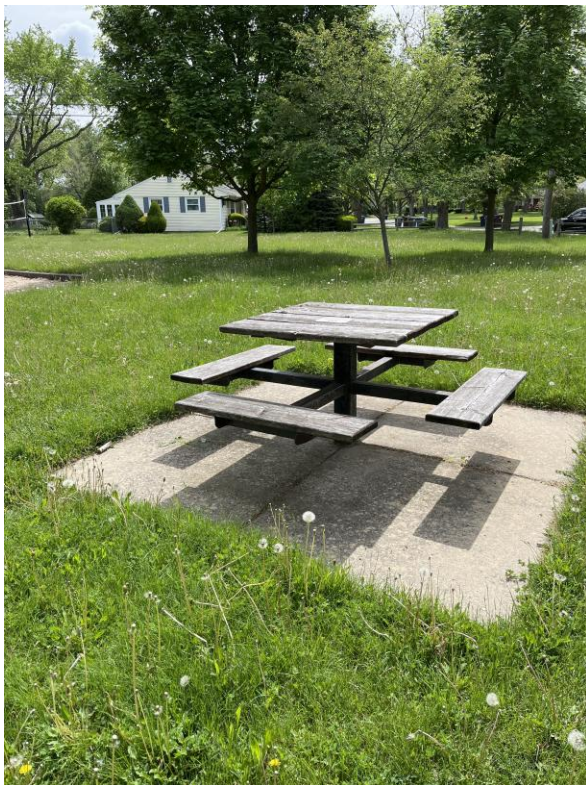
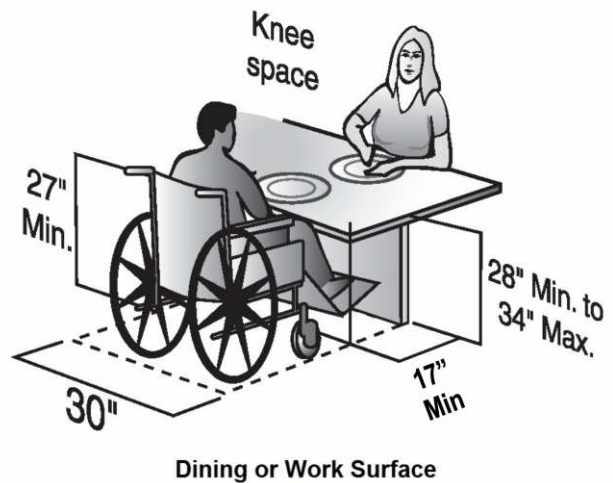
There is no knee or toe clearance at the picnic table.

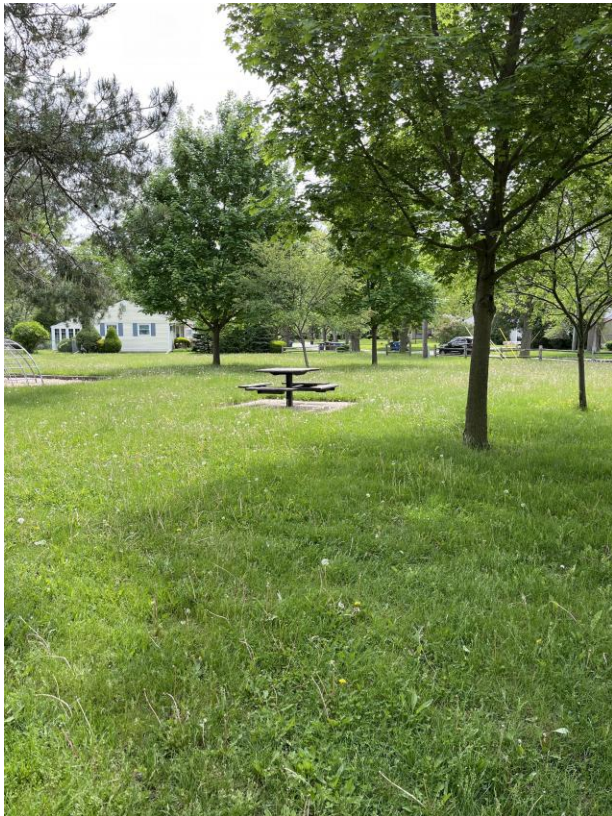
The accessible route contains loose gravel and/or surface materials that do not provide for a stable, firm slip resistant surface.

The surface is grass.

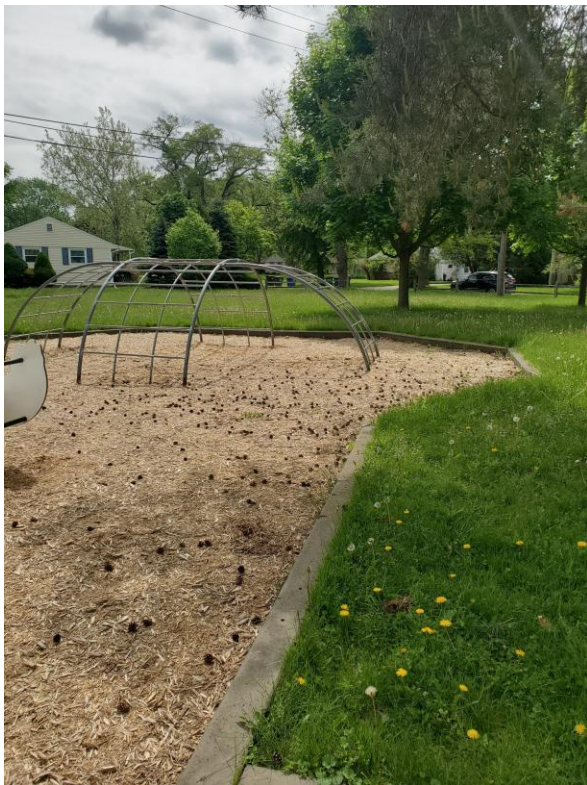
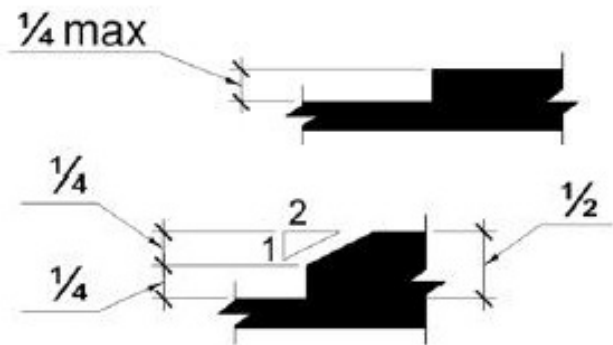
There is a change in level greater than 1/4 at the entrance to the playground.

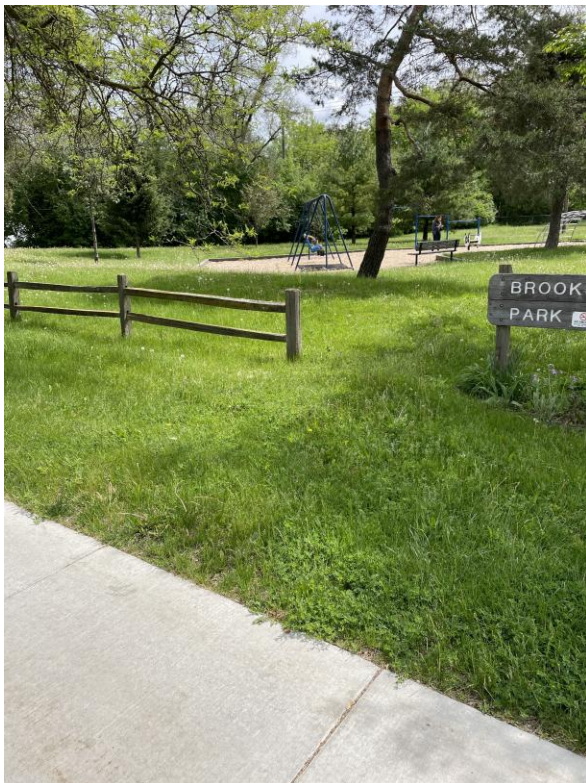
There is no accessible route to the playground (about 75 linear feet).

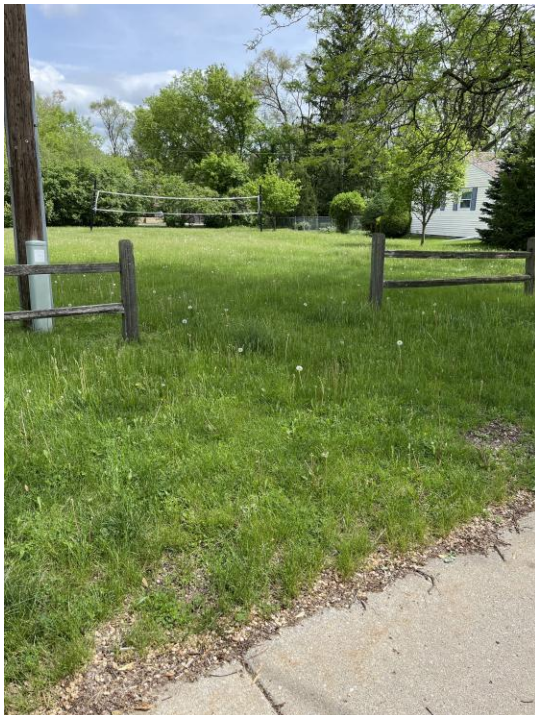
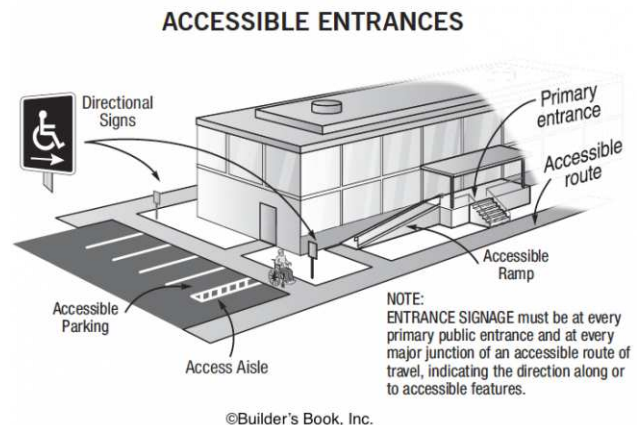
The surface is grass.

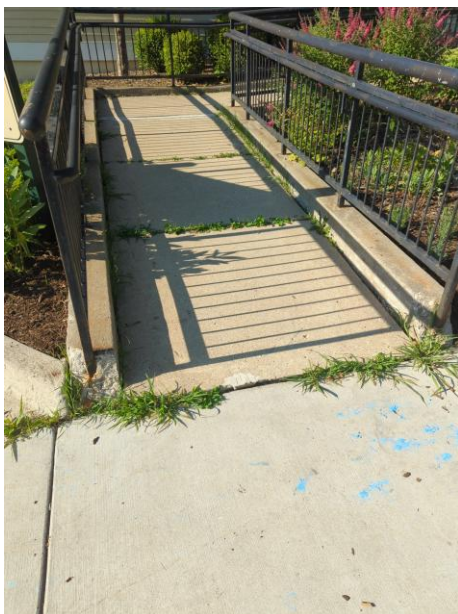
Bottom of ramp has a 1-1/2 inch vertical change in level

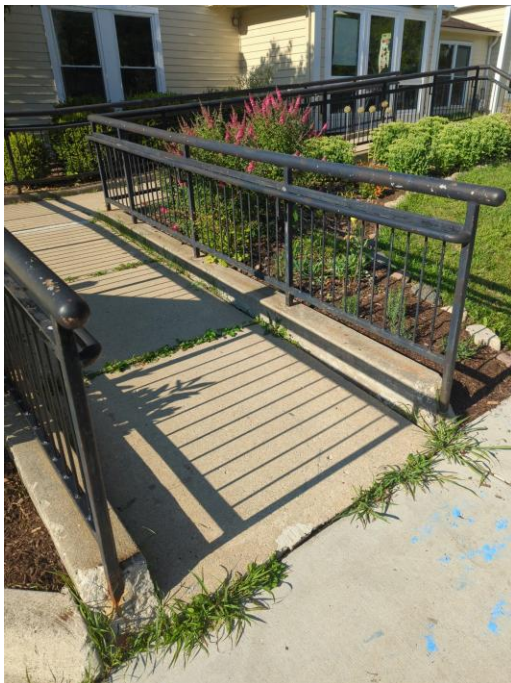
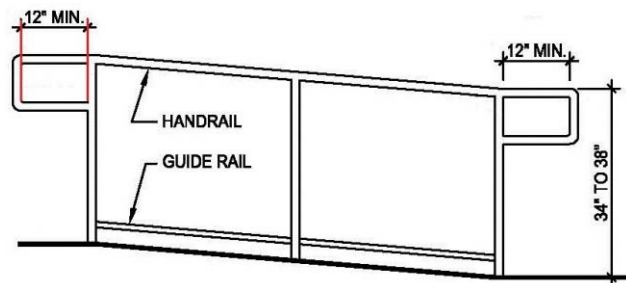
Ramp handrails do not have top nor bottom extensions

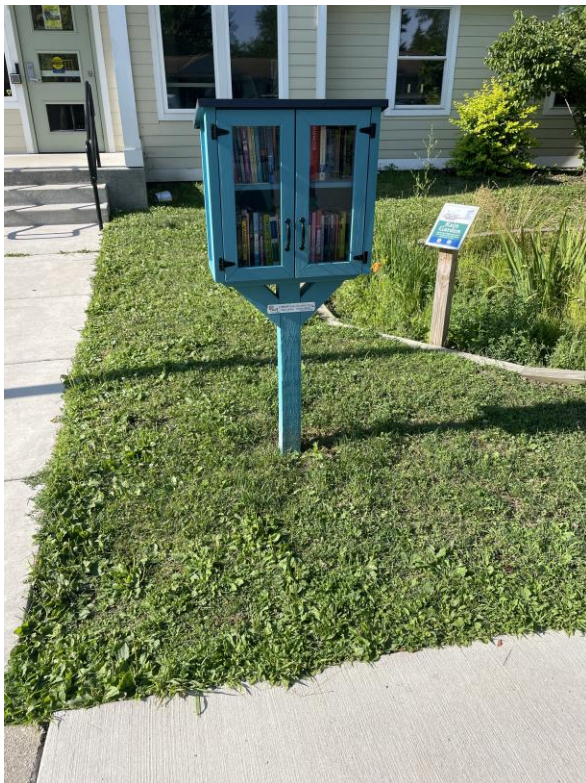
No route provided to little library

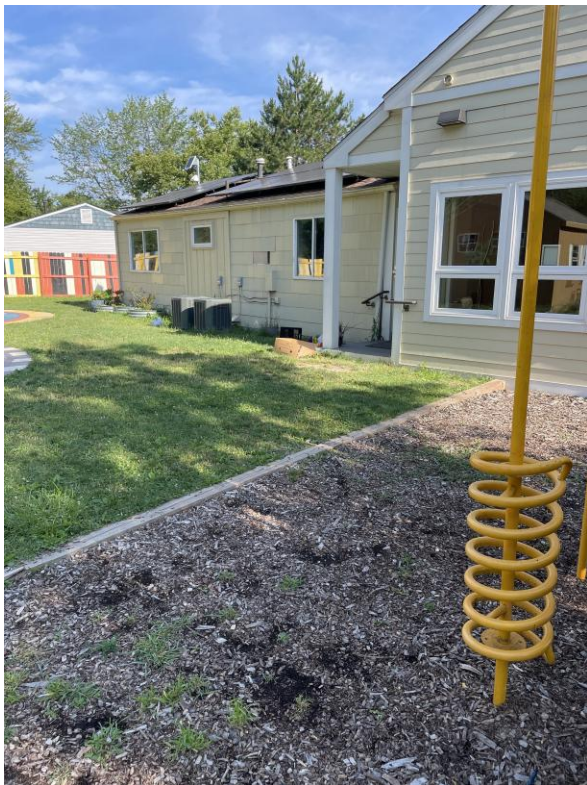
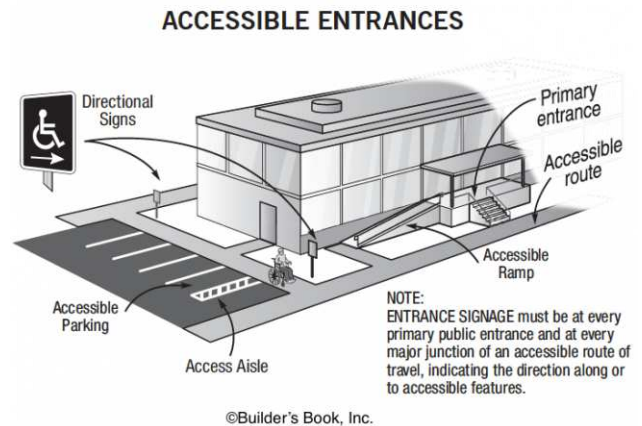
No accessible route provided to the playground

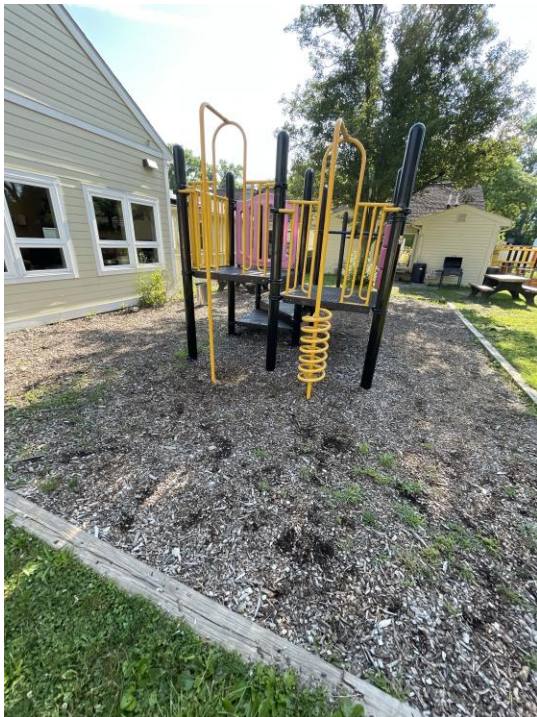
Need to add more mulch

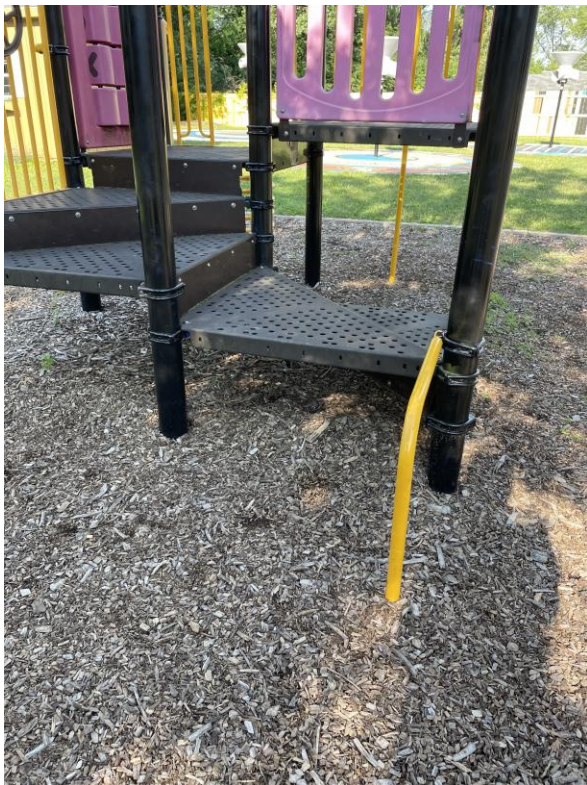
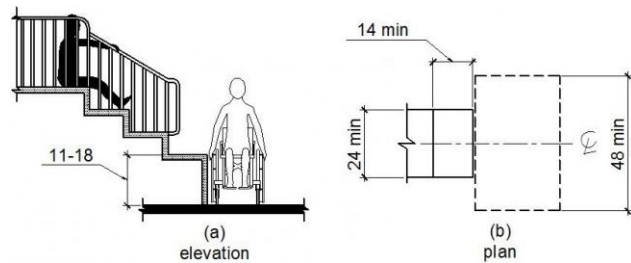
21" above ground

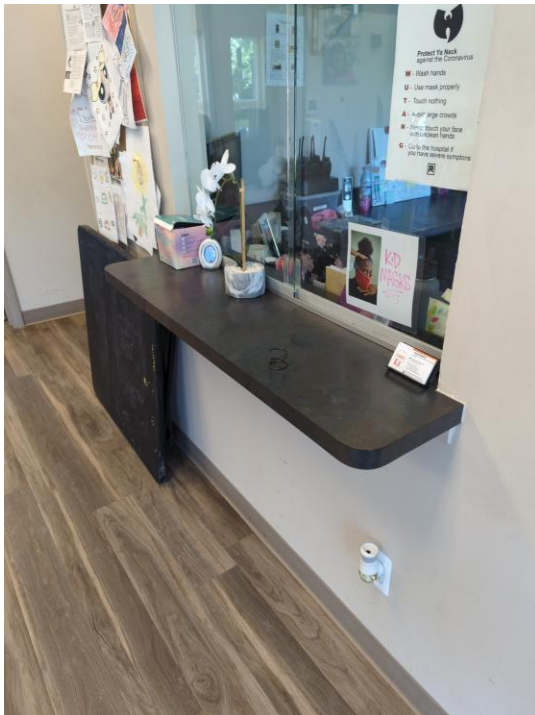
Wall-mounted objects that have leading edges between 27 inches and 80 inches from the floor must not project more than 4 inches into the circulation path. Protruding objects that extend to the floor or within 27 inches of the floor are cane detectable and are therefore not hazardous. Where it is necessary or desirable to have objects protrude from the wall, a manner of cane detection must be provided.

Counter protrudes 9 inches

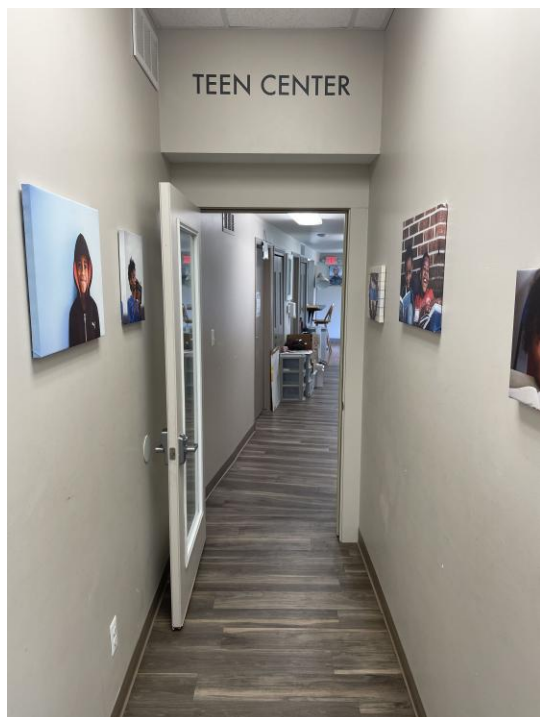
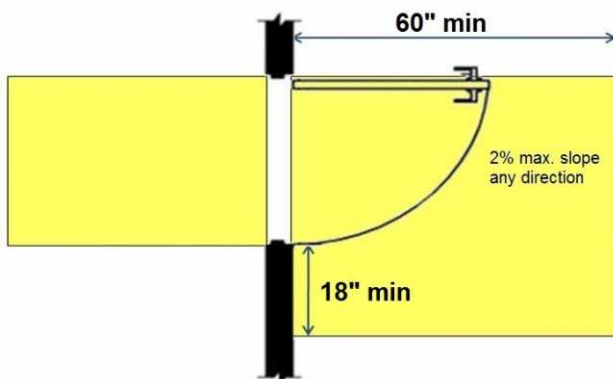
Clearance extends 4”

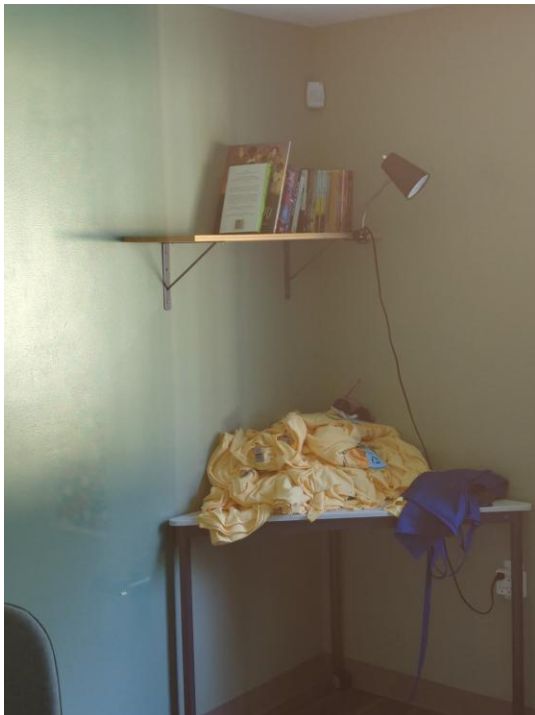
Wall-mounted objects that have leading edges between 27 inches and 80 inches from the floor must not project more than 4 inches into the circulation path. Protruding objects that extend to the floor or within 27 inches of the floor are cane detectable and are therefore not hazardous. Where it is necessary or desirable to have objects protrude from the wall, a manner of cane detection must be provided.

Office by kitchen has a shelf that protrudes 10 inches

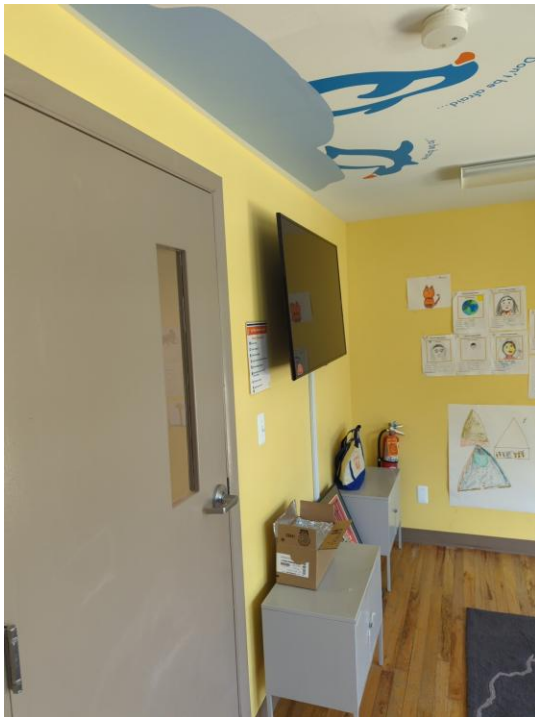
Wall-mounted objects that have leading edges between 27 inches and 80 inches from the floor must not project more than 4 inches into the circulation path. Protruding objects that extend to the floor or within 27 inches of the floor are cane detectable and are therefore not hazardous. Where it is necessary or desirable to have objects protrude from the wall, a manner of cane detection must be provided.

Wall-mounted TV in Global Room protrudes 6 inches

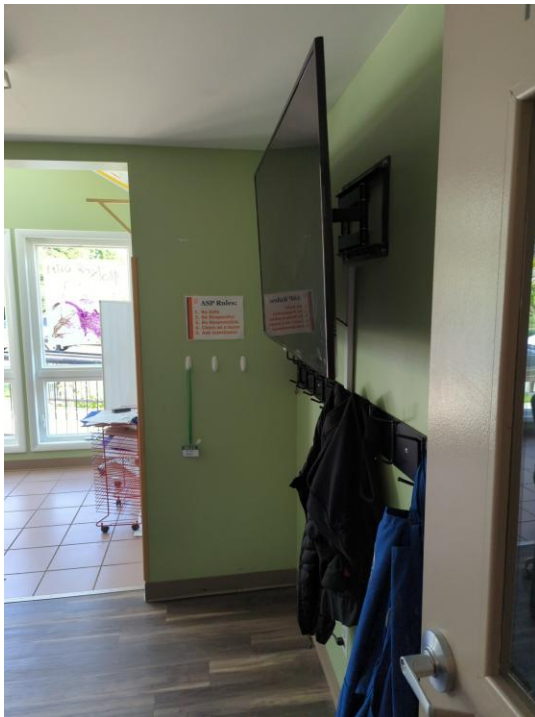
Wall-mounted objects that have leading edges between 27 inches and 80 inches from the floor must not project more than 4 inches into the circulation path. Protruding objects that extend to the floor or within 27 inches of the floor are cane detectable and are therefore not hazardous. Where it is necessary or desirable to have objects protrude from the wall, a manner of cane detection must be provided.

Wall-mounted TV in Nature Room protrudes 10 inches

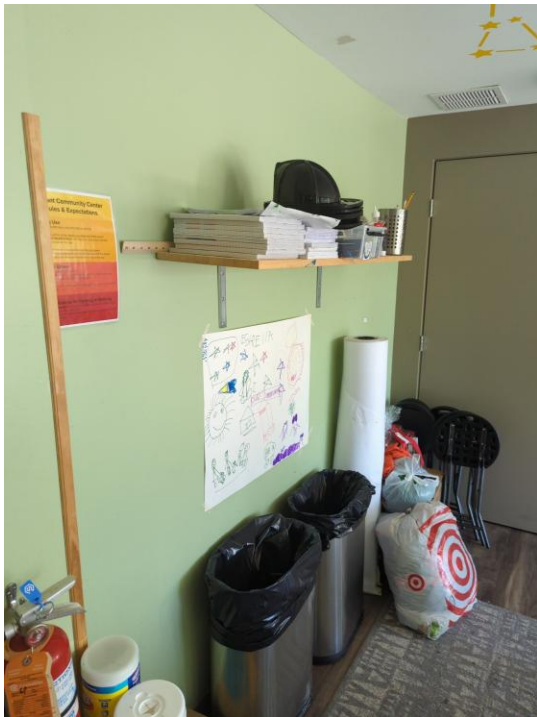
Wall-mounted objects that have leading edges between 27 inches and 80 inches from the floor must not project more than 4 inches into the circulation path. Protruding objects that extend to the floor or within 27 inches of the floor are cane detectable and are therefore not hazardous. Where it is necessary or desirable to have objects protrude from the wall, a manner of cane detection must be provided.

Shelf in Nature Room protrudes 12 inches

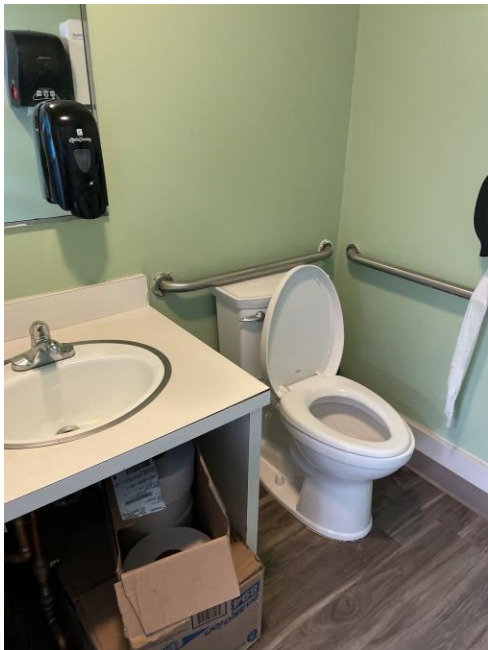
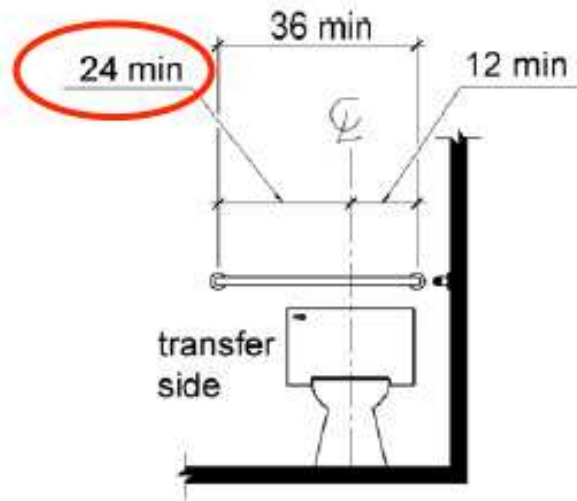
The grab bar is less than 36" long

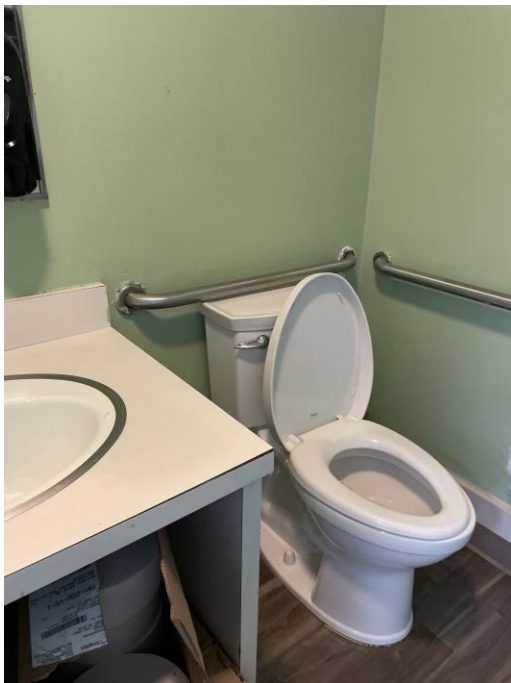
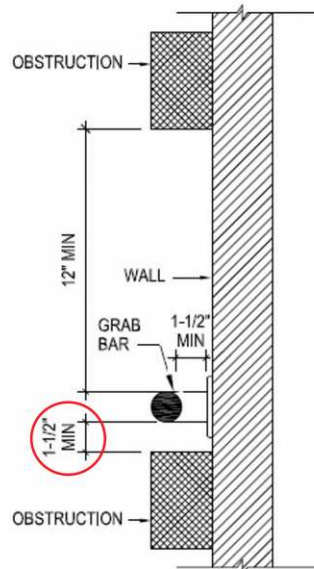
The water closet is less than 1 1/2” below the grab bar

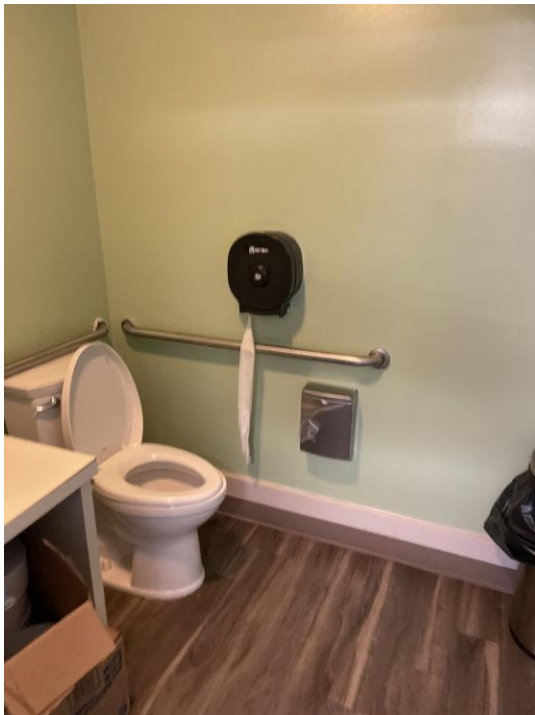
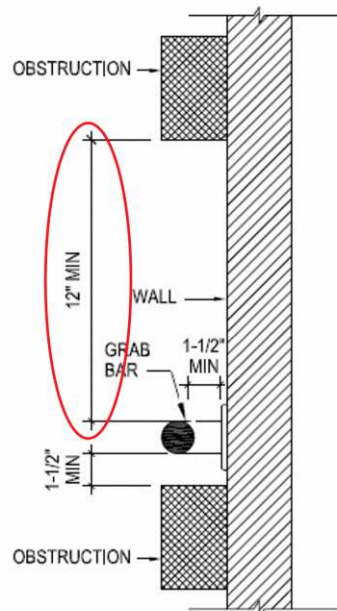
The dispenser is less than 12" above the side bar

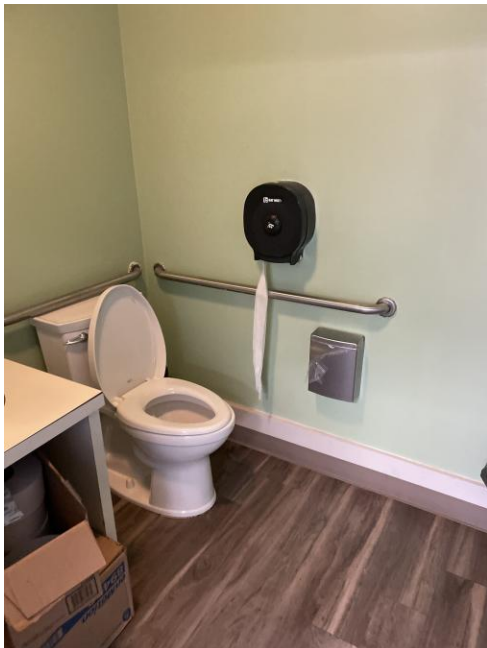
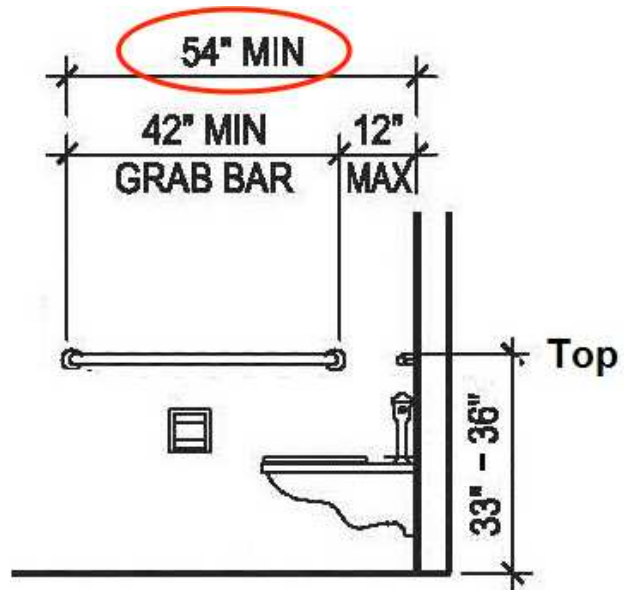
46" from rear wall

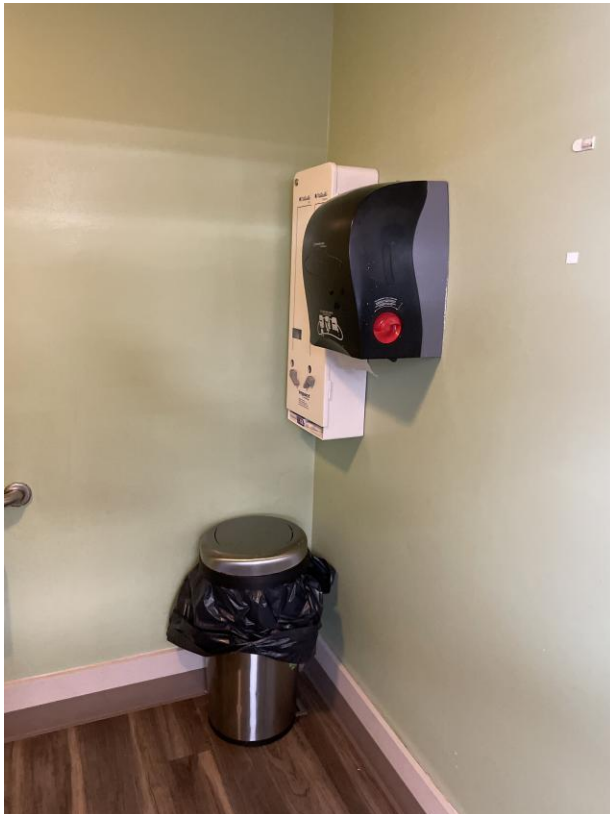
More than 49" from floor. It is also a protruding object

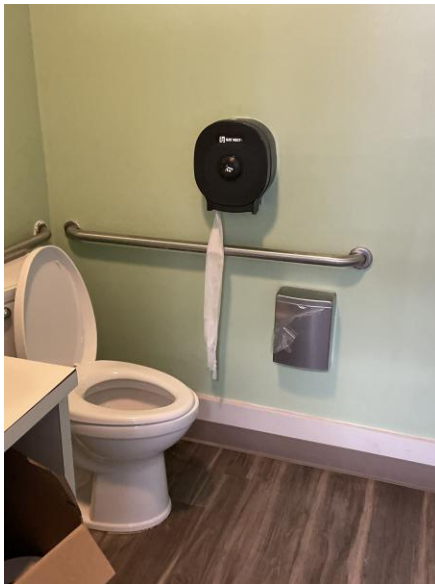
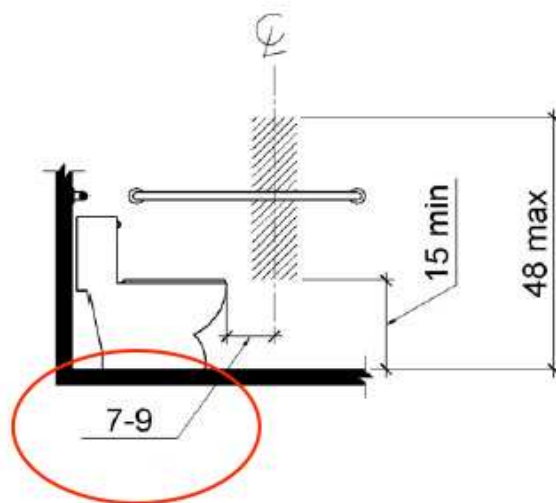
Less than 7” in front LF the water closet

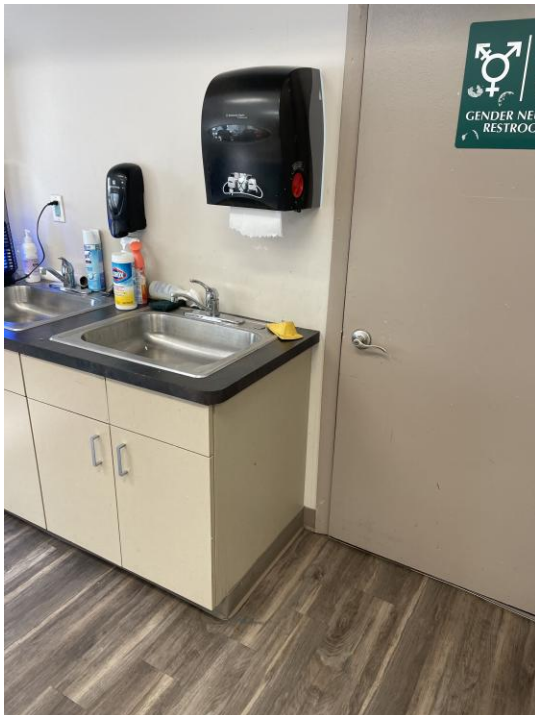
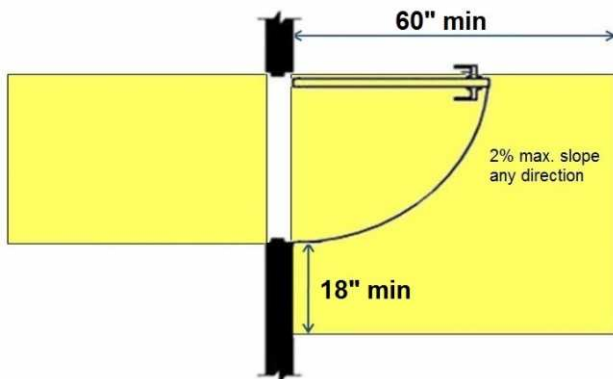
Clearance does extends 3” on latch side

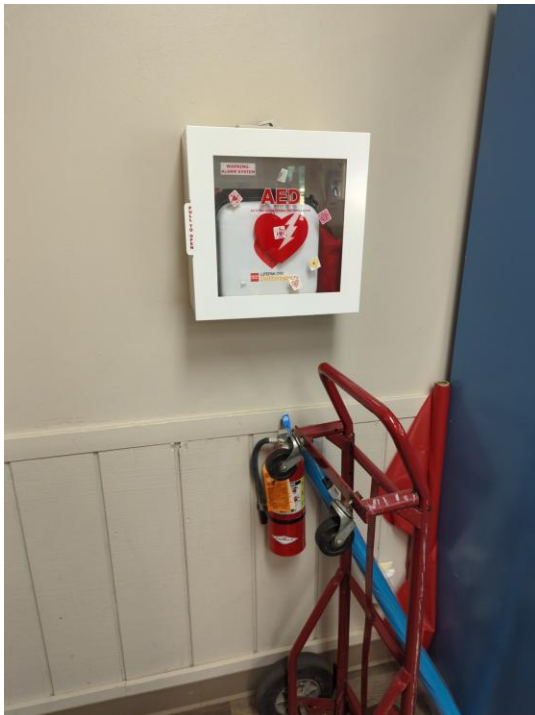
Wall-mounted objects that have leading edges between 27 inches and 80 inches from the floor must not project more than 4 inches into the circulation path. Protruding objects that extend to the floor or within 27 inches of the floor are cane detectable and are therefore not hazardous. Where it is necessary or desirable to have objects protrude from the wall, a manner of cane detection must be provided.

AED box protrudes 6 inches

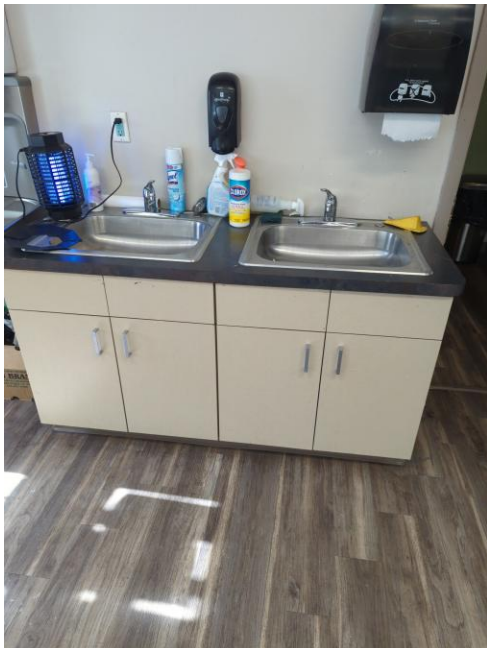
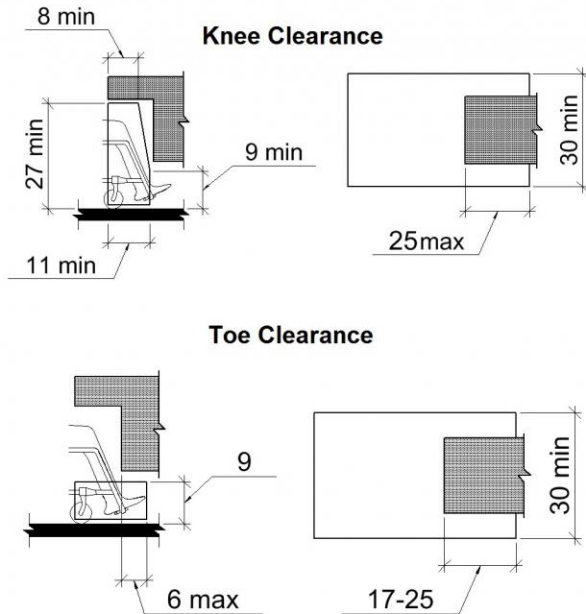
The sink in the conference room does not have a knee and toe clearance

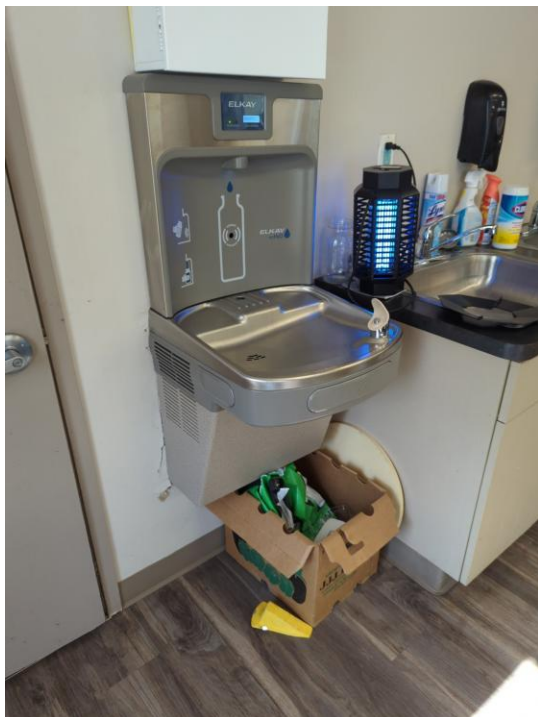
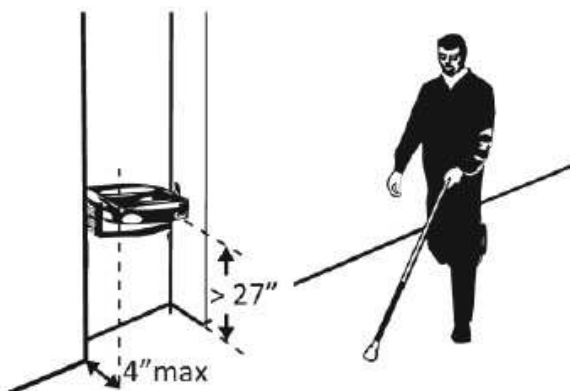
Low drinking fountain products 8 inches at 30 inches high

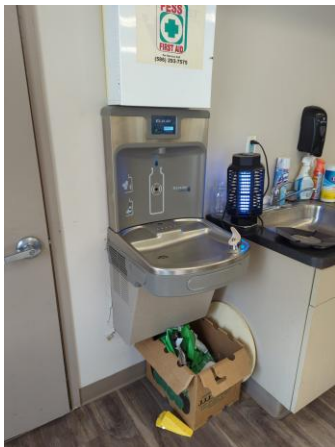
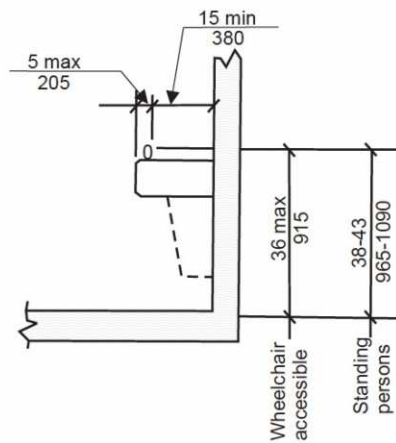
There is no high drinking fountain provided

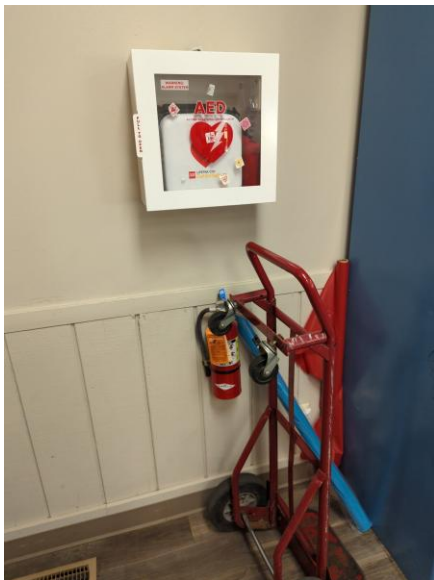
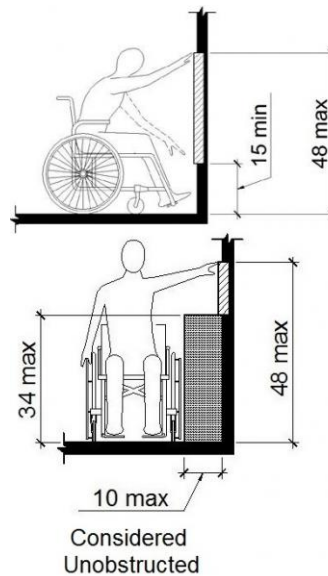
AED box is 58 inches high

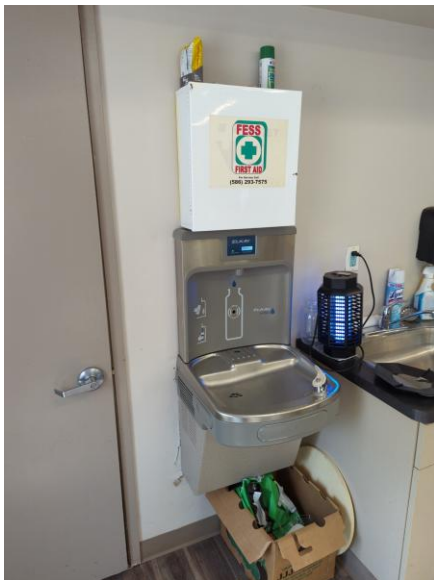
First aid box is 63 inches high

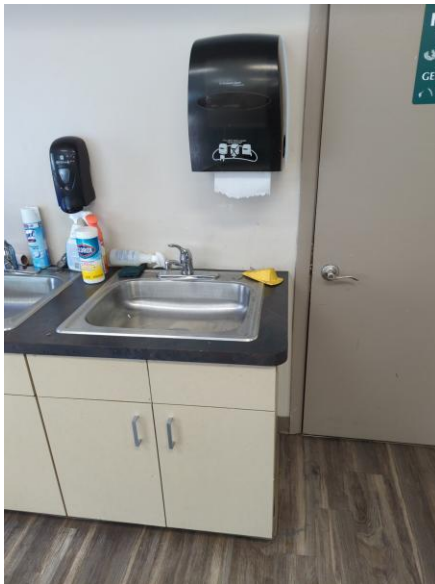
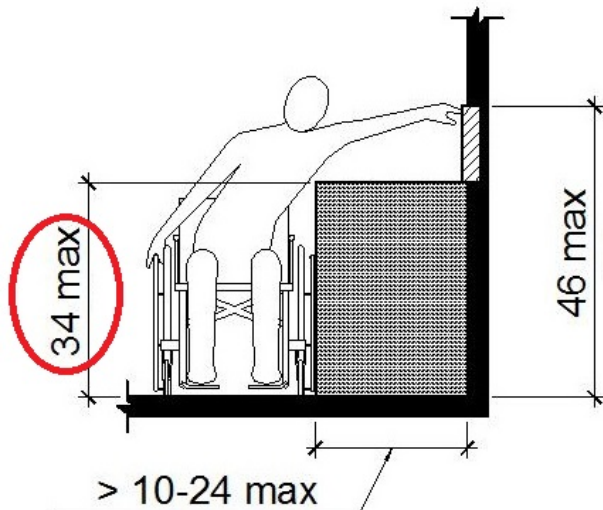
Paper towel dispenser is 54 inches high
