Site Accessibility Evaluation

Allmendinger Park
655 Pauline Blvd
Ann Arbor, MI 48104
ADA Only

Inspection Date: 07/11/2022

Report Date: 11/15/2022

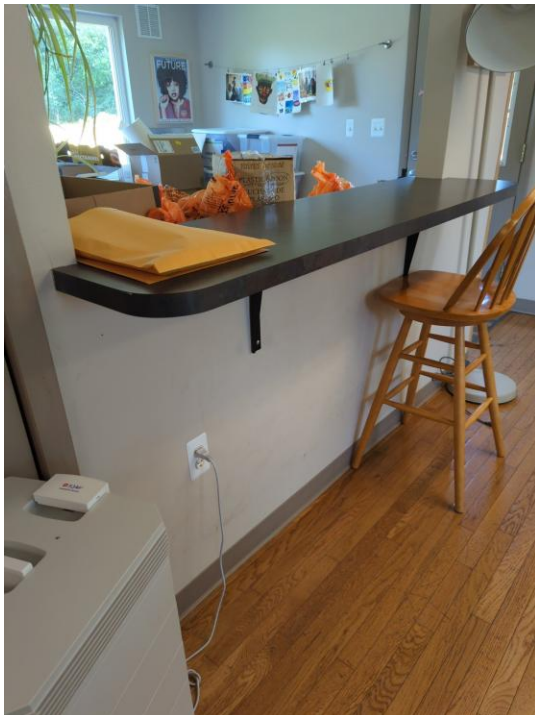
Wall-mounted objects that have leading edges between 27 inches and 80 inches from the floor must not project more than 4 inches into the circulation path. Protruding objects that extend to the floor or within 27 inches of the floor are cane detectable and are therefore not hazardous. Where it is necessary or desirable to have objects protrude from the wall, a manner of cane detection must be provided.

Kitchen passthrough counter protrudes 12 inches at 41 inches high

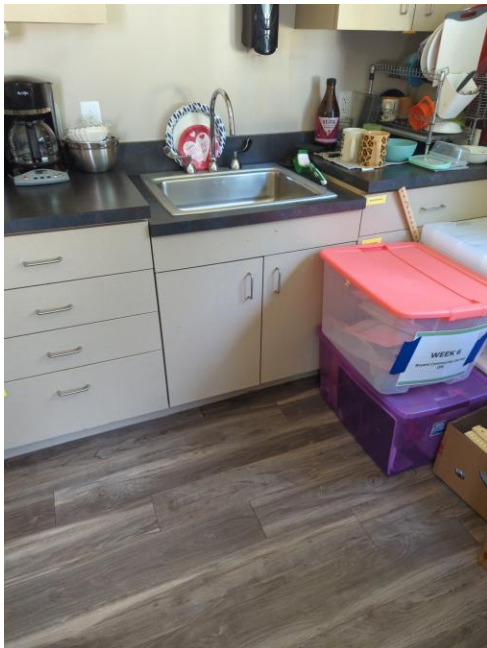
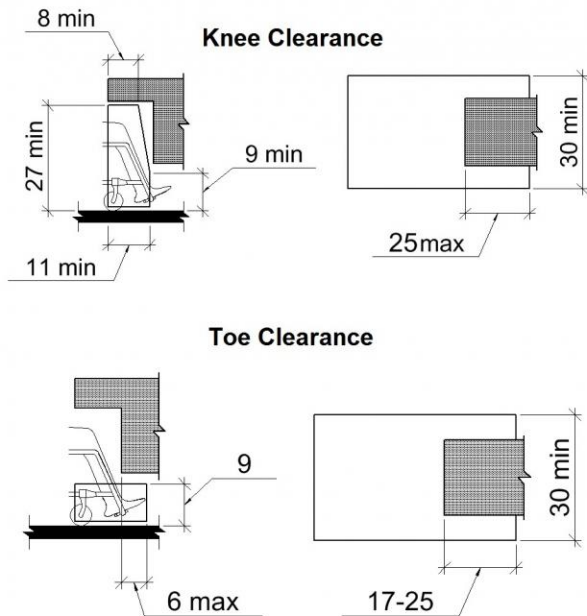
Kitchen sink does not have a knee and toe clearance

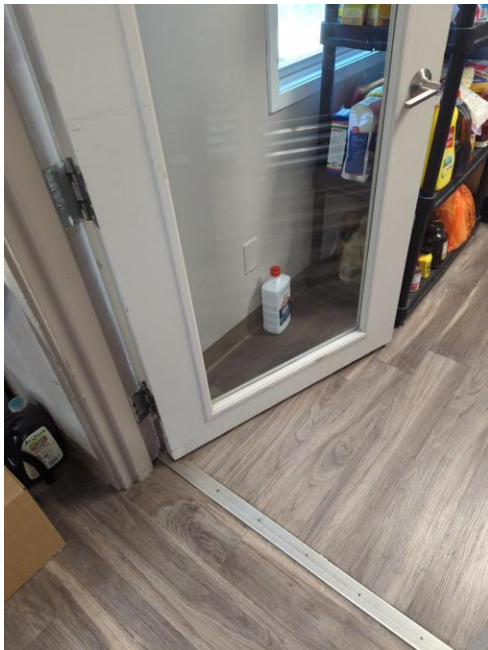
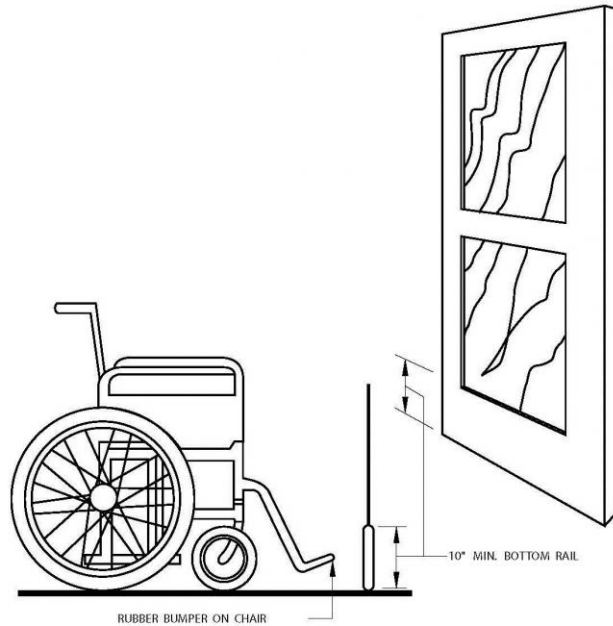
Door to kitchen has 5 inches of smooth surface

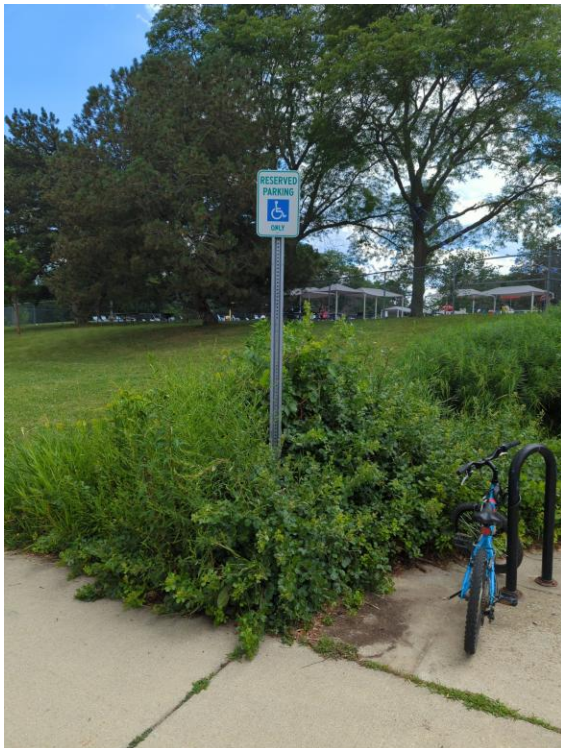
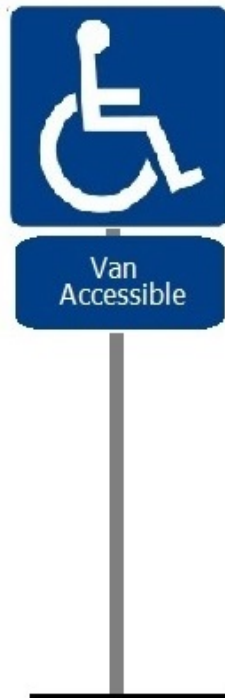
The van stall is missing a sign identifying it as a van accessible stall.

No van sign provided; at least one with a van access aisle must have a van sign

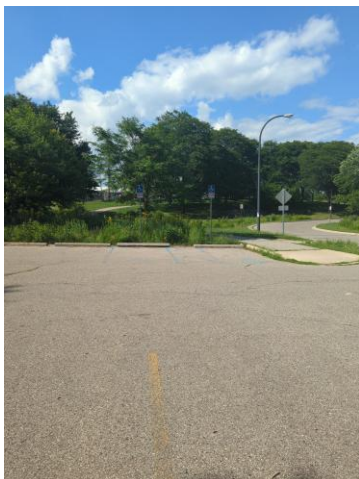
Parking by tennis courts - 2 accessible stalls without a van accessible

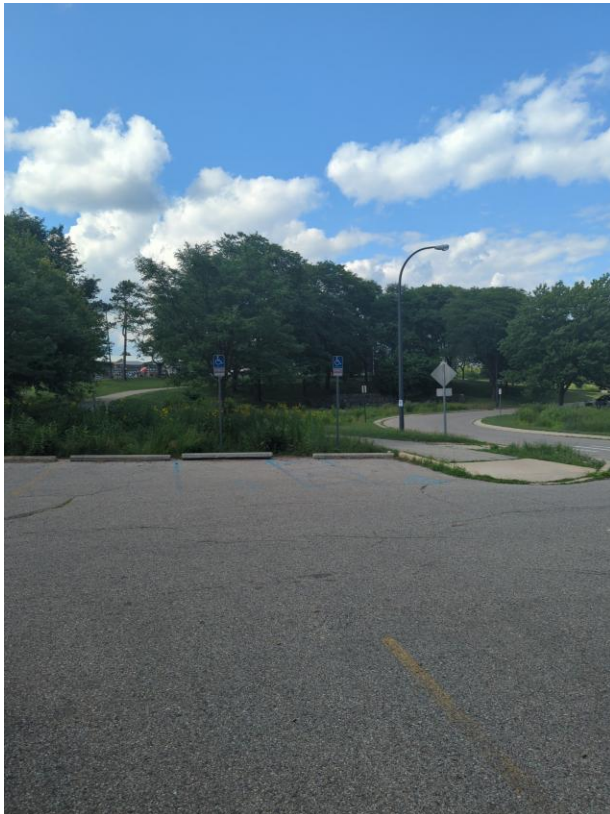
Parking by tennis courts - 2 accessible stalls with up to 4% slope

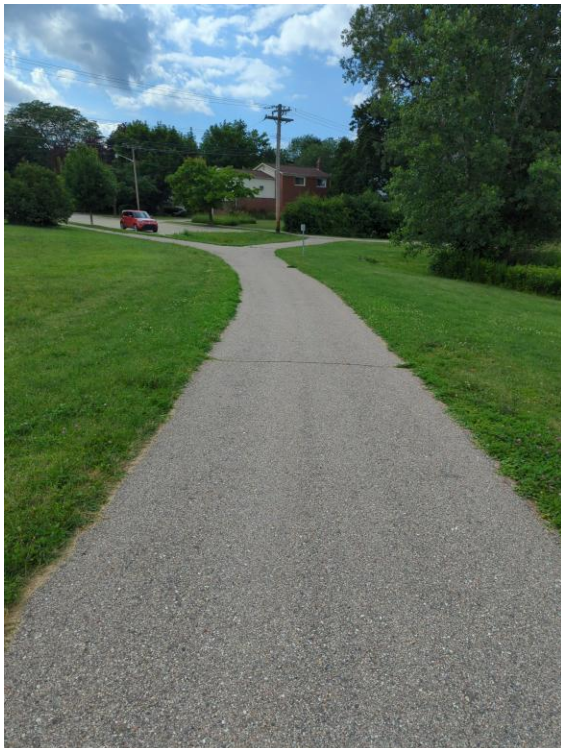
Path from Buhr Park to Essex Rd with cross slope of 3.5%

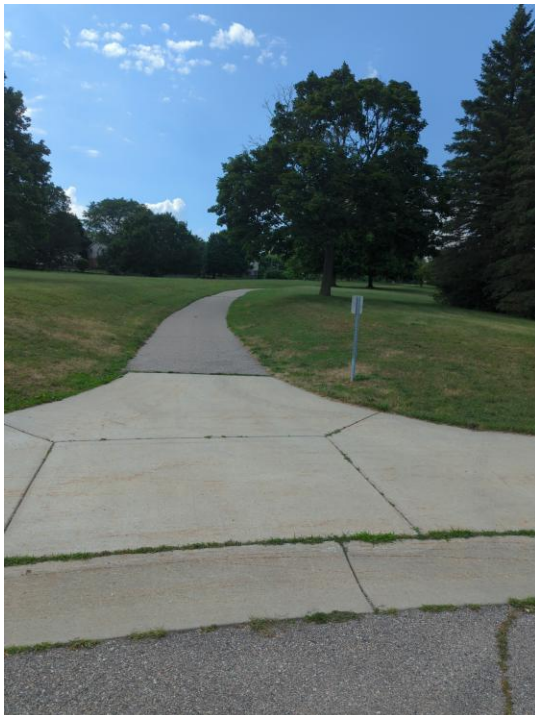
Path from Buhr Park to Essex Rd with a running slope of up to 6.7%

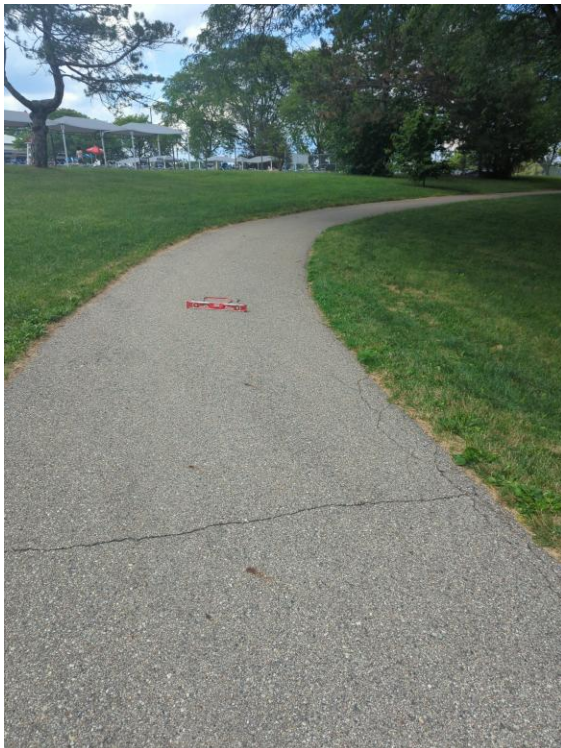
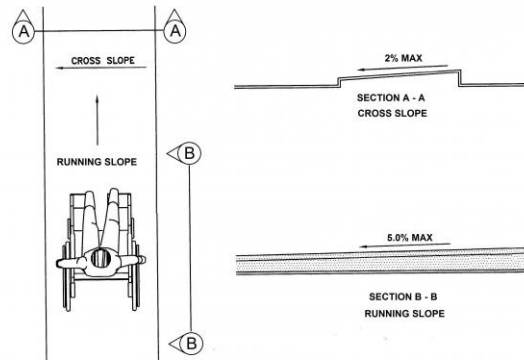
Where the path from playground to pool has a turn, cross slope is up to 7%

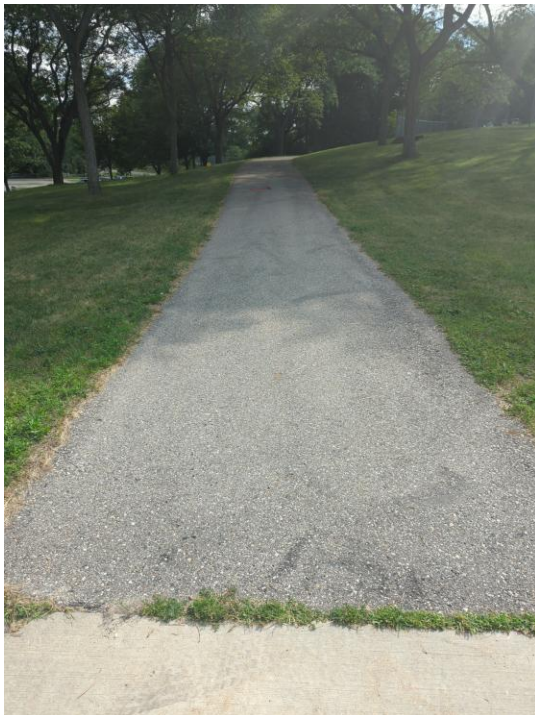
Where the path from pool parking to playground has a turn, running slope of up to 7%

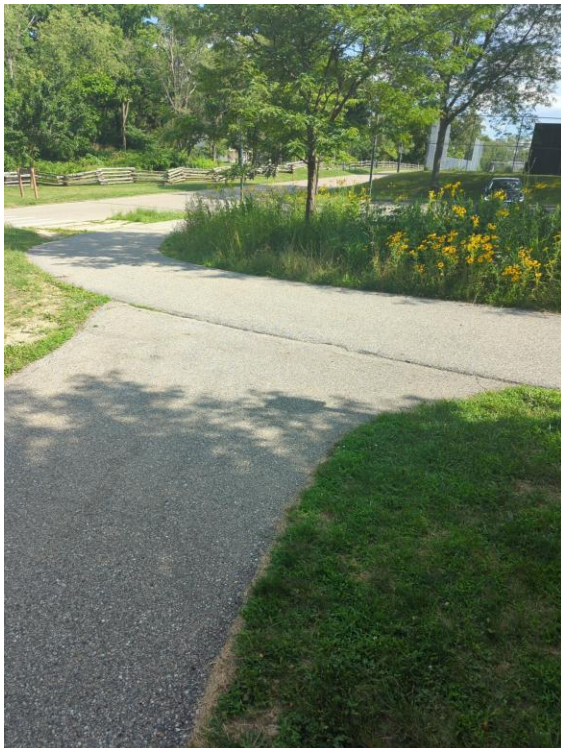
Where paths intersect by playground parking, cross slope is up to 5%

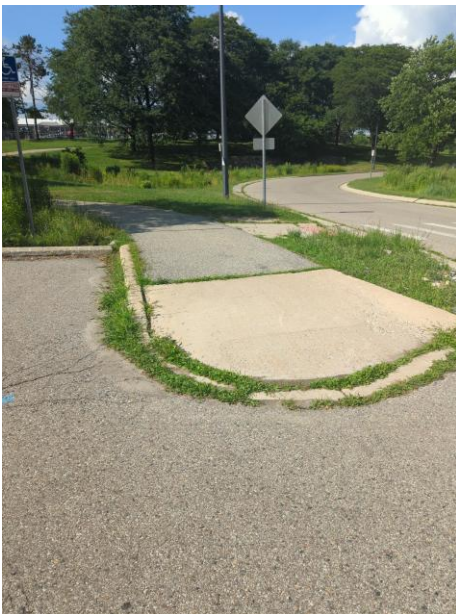
Curb ramp by playground parking has a vertical change in level greater than 1/2 inch

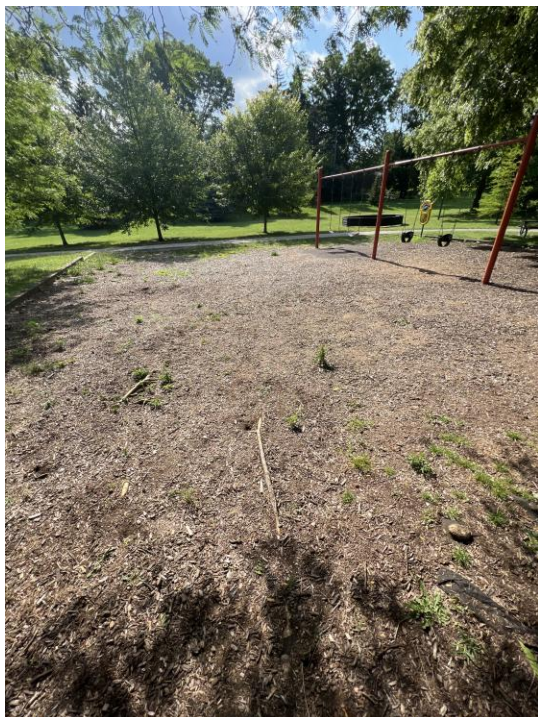
Ground surface is dirt and wood chips

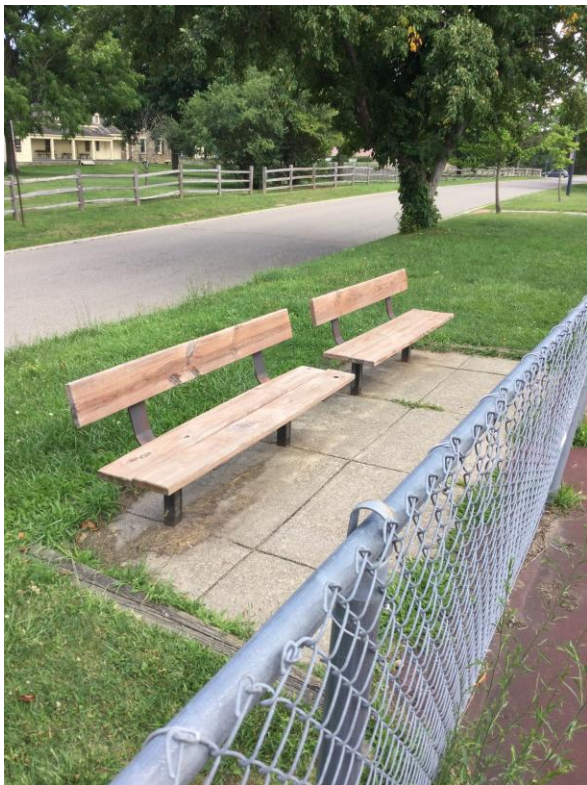
Two benches with no route

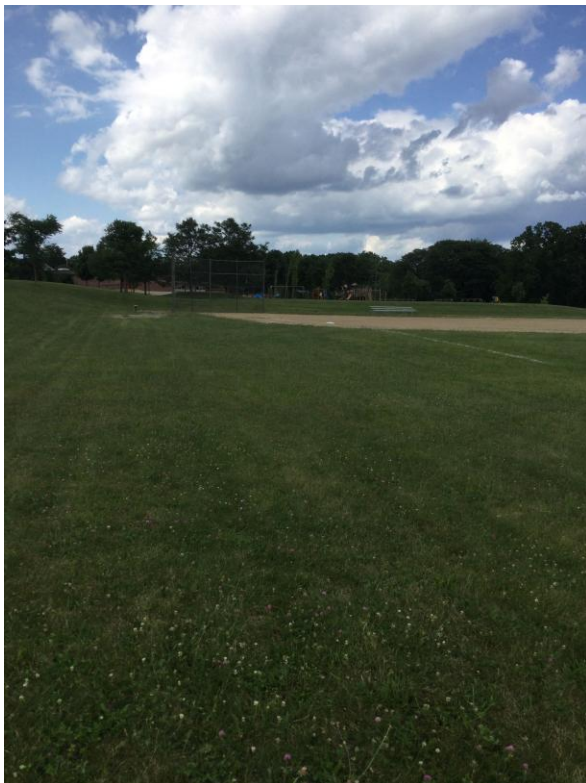
Field 4 has no accessible route

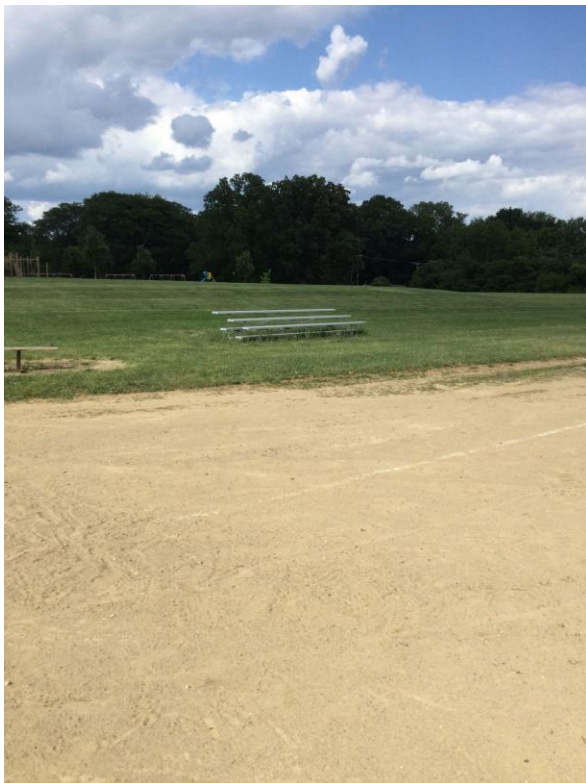
Field 4 Spectator Route not provided

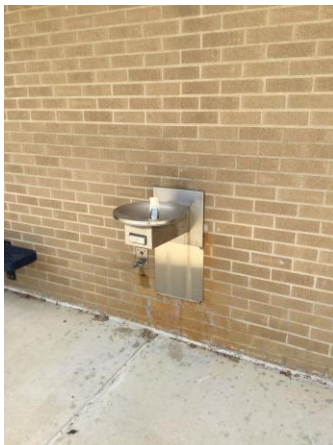
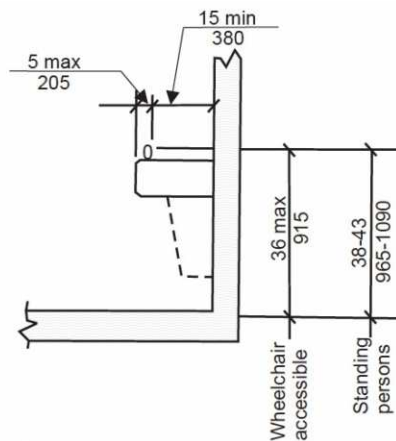
No high drinking fountain

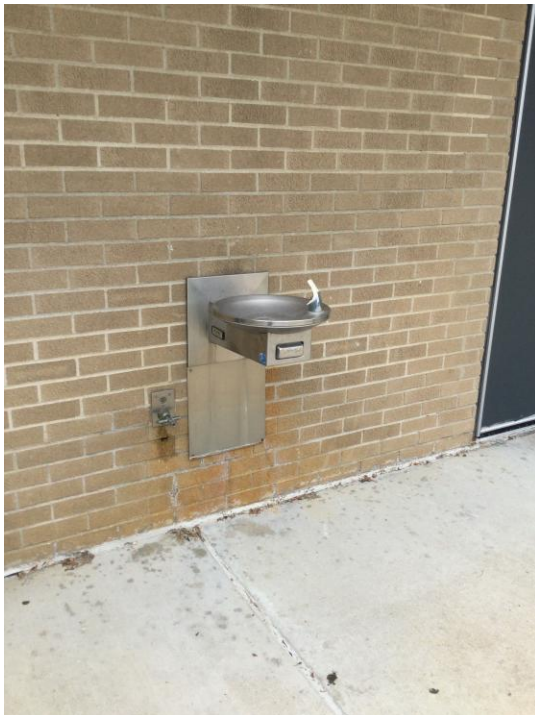
Wall-mounted objects that have leading edges between 27 inches and 80 inches from the floor must not project more than 4 inches into the circulation path. Protruding objects that extend to the floor or within 27 inches of the floor are cane detectable and are therefore not hazardous. Where it is necessary or desirable to have objects protrude from the wall, a manner of cane detection must be provided.

Pool drinking fountain is protruding

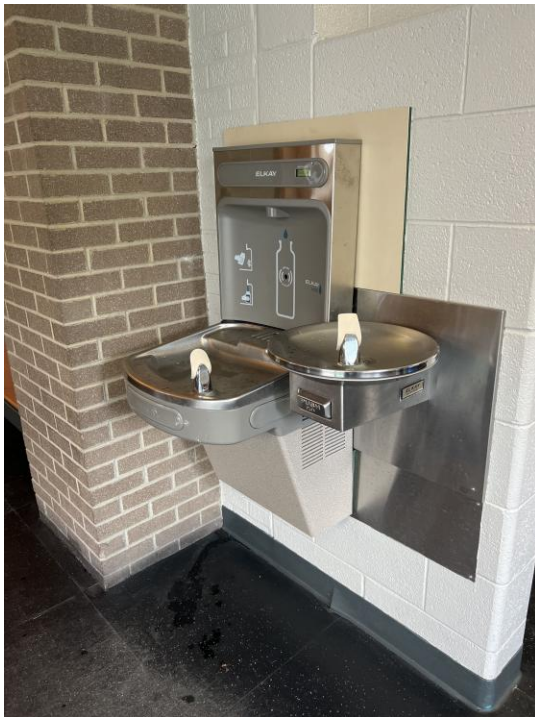
Wall-mounted objects that have leading edges between 27 inches and 80 inches from the floor must not project more than 4 inches into the circulation path. Protruding objects that extend to the floor or within 27 inches of the floor are cane detectable and are therefore not hazardous. Where it is necessary or desirable to have objects protrude from the wall, a manner of cane detection must be provided.

Drinking fountain on the corner of the lobby hallway

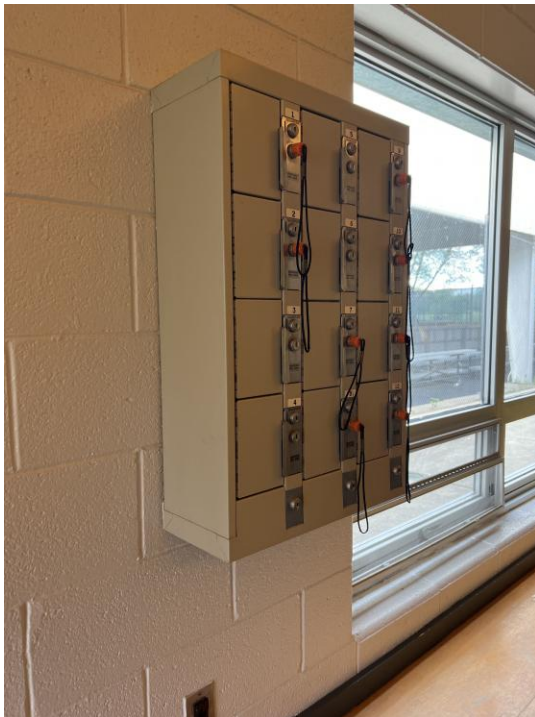
Wall-mounted objects that have leading edges between 27 inches and 80 inches from the floor must not project more than 4 inches into the circulation path. Protruding objects that extend to the floor or within 27 inches of the floor are cane detectable and are therefore not hazardous. Where it is necessary or desirable to have objects protrude from the wall, a manner of cane detection must be provided.

Lockers are protruding

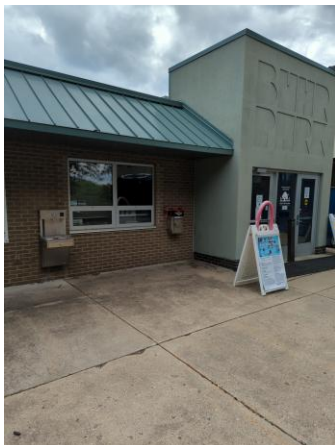
There is no high drinking fountain by the main entrance

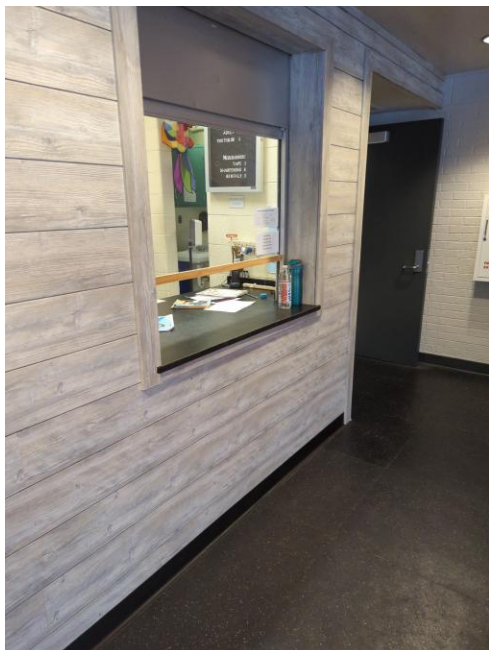
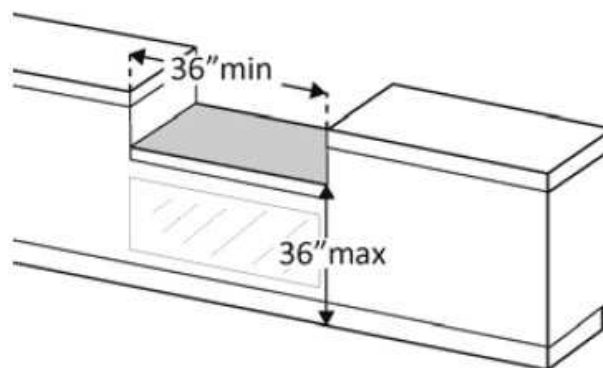
Counter is 37 inches high

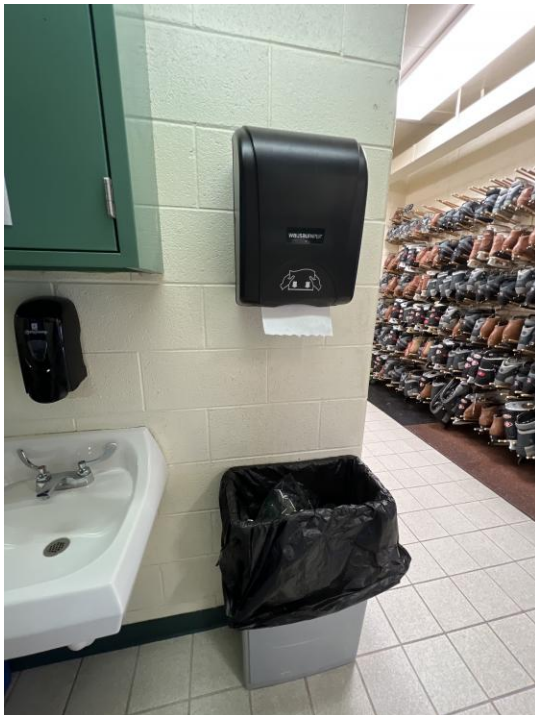
Wall-mounted objects that have leading edges between 27 inches and 80 inches from the floor must not project more than 4 inches into the circulation path. Protruding objects that extend to the floor or within 27 inches of the floor are cane detectable and are therefore not hazardous. Where it is necessary or desirable to have objects protrude from the wall, a manner of cane detection must be provided.

The paper towel dispenser is protruding

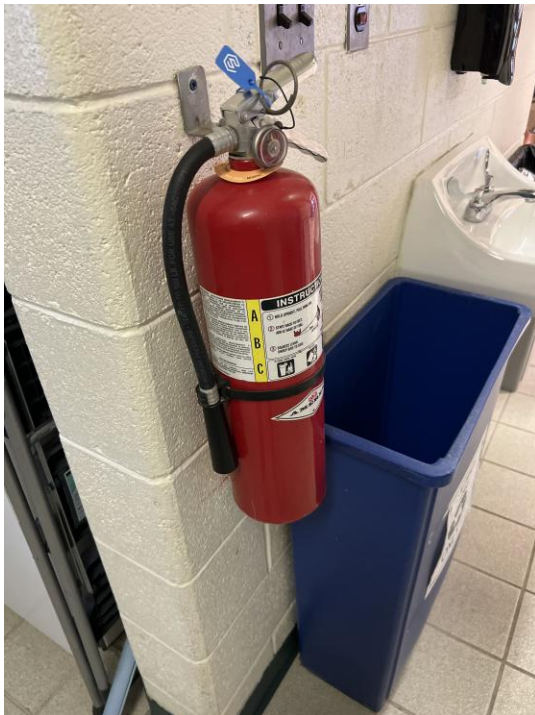
Wall-mounted objects that have leading edges between 27 inches and 80 inches from the floor must not project more than 4 inches into the circulation path. Protruding objects that extend to the floor or within 27 inches of the floor are cane detectable and are therefore not hazardous. Where it is necessary or desirable to have objects protrude from the wall, a manner of cane detection must be provided.

The fire extinguisher is protruding

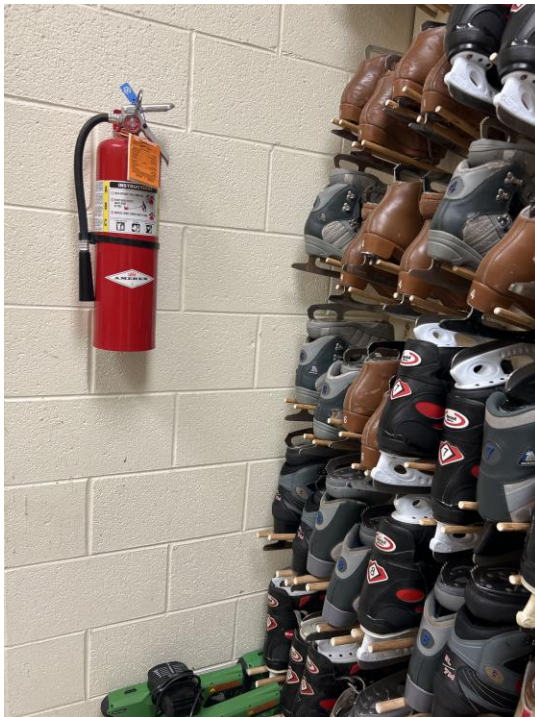
Wall-mounted objects that have leading edges between 27 inches and 80 inches from the floor must not project more than 4 inches into the circulation path. Protruding objects that extend to the floor or within 27 inches of the floor are cane detectable and are therefore not hazardous. Where it is necessary or desirable to have objects protrude from the wall, a manner of cane detection must be provided.

The fire extinguisher is protruding

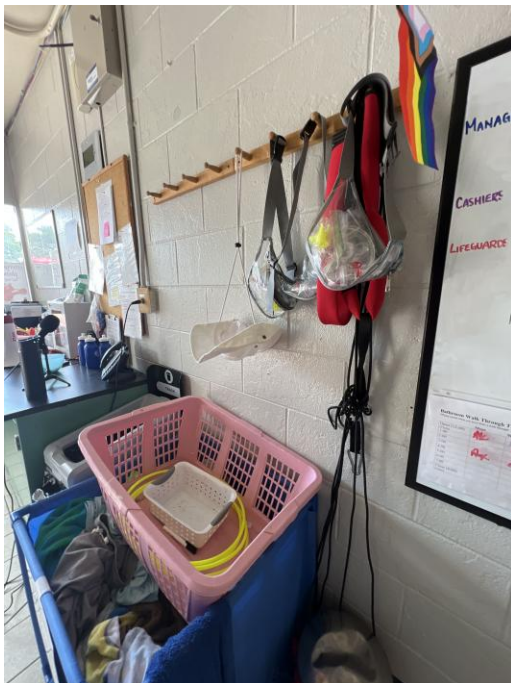
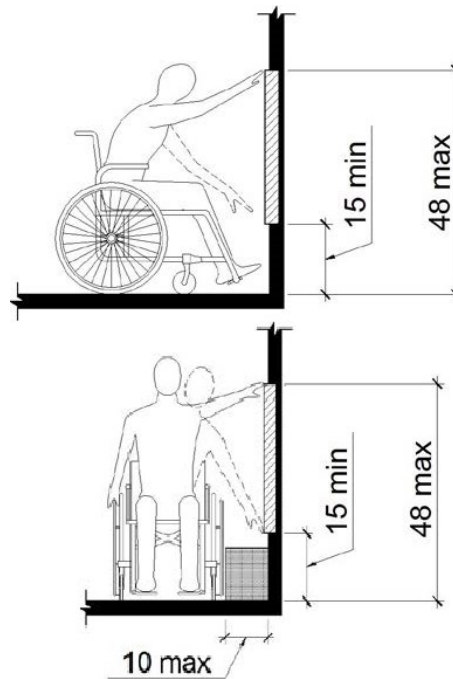
The coat hooks are mounted high

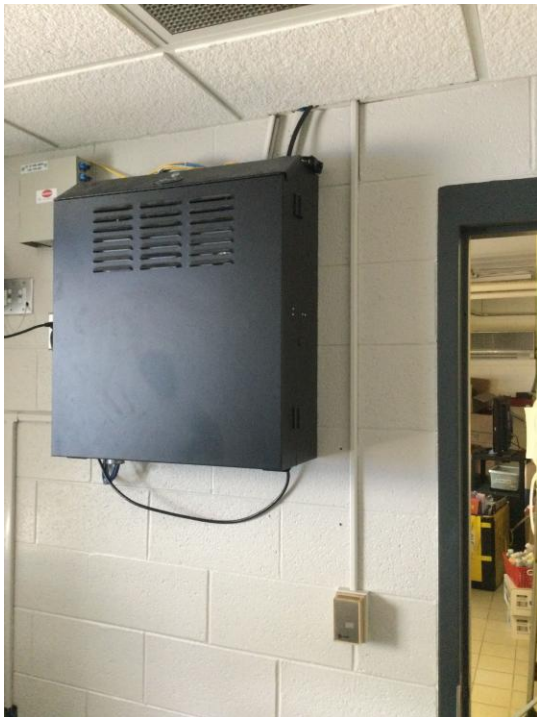
Wall-mounted objects that have leading edges between 27 inches and 80 inches from the floor must not project more than 4 inches into the circulation path. Protruding objects that extend to the floor or within 27 inches of the floor are cane detectable and are therefore not hazardous. Where it is necessary or desirable to have objects protrude from the wall, a manner of cane detection must be provided.

The office electrical box is protruding

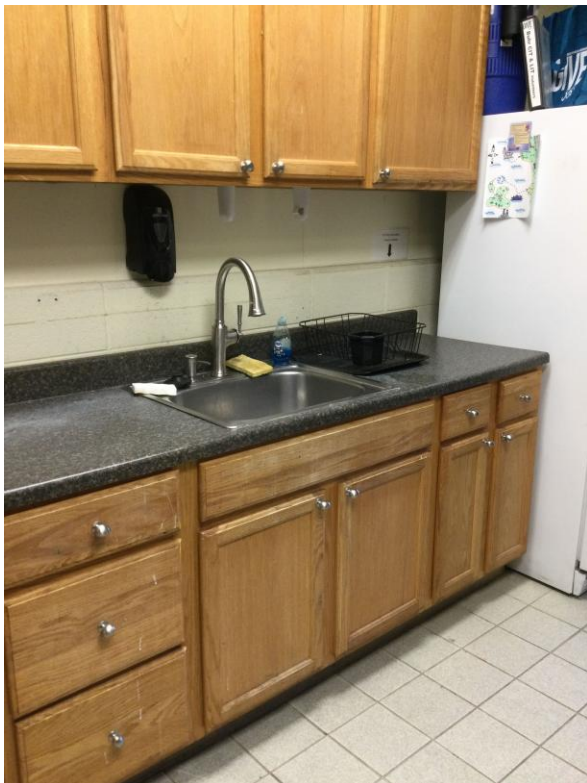
The top the sink is at 36”

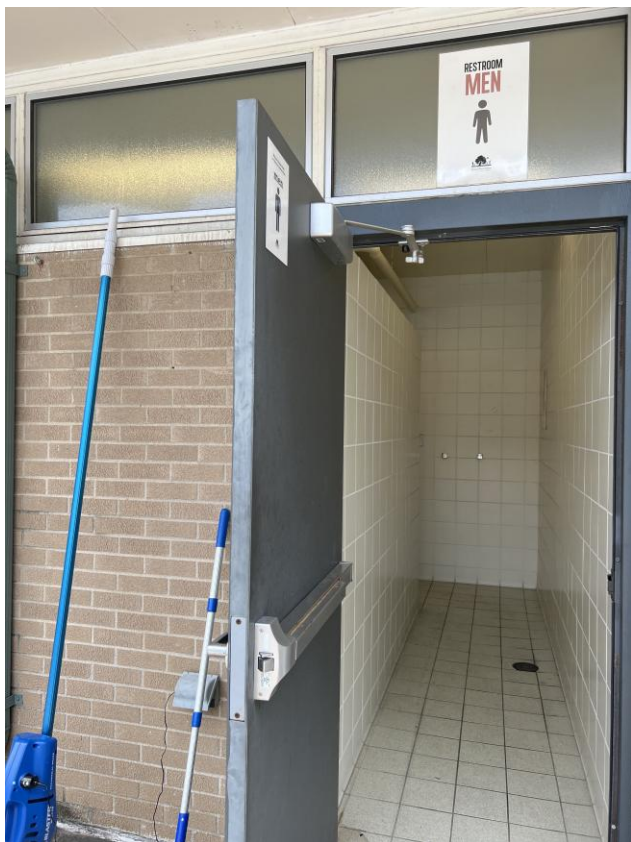
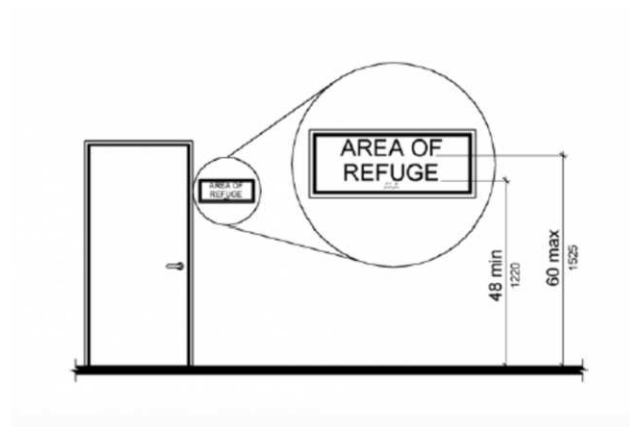
Finding #40 Continued

The Men's Lockerroom/Restroom sign is not compliant

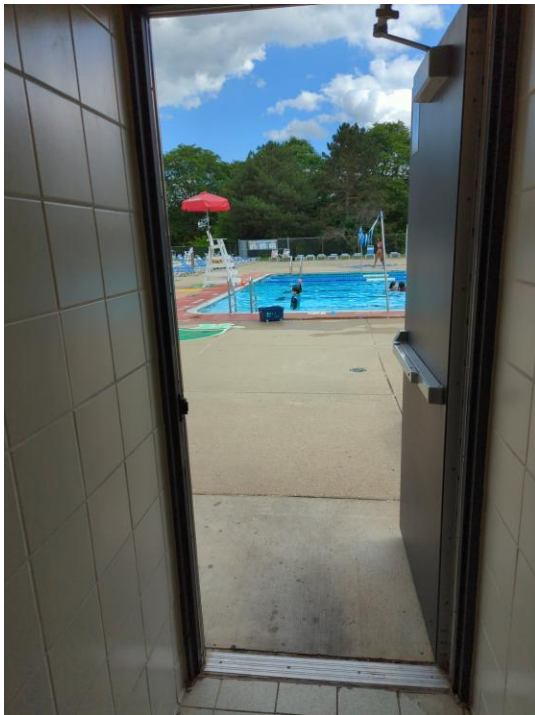
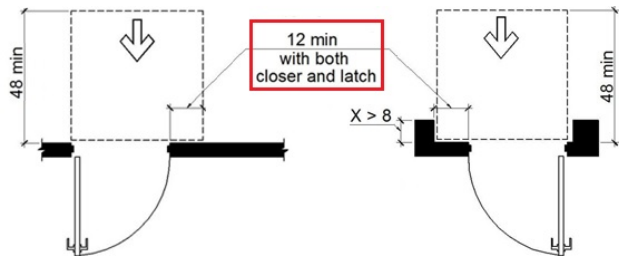
Door from men's locker room to pool has 1 inch on the push side

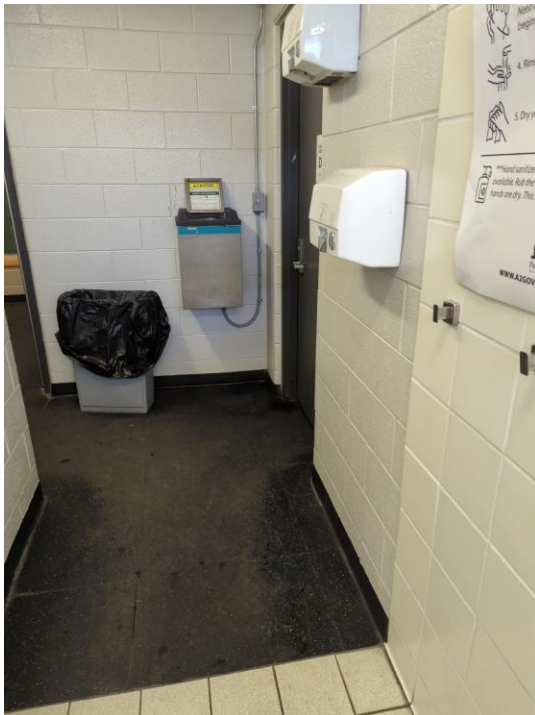
Wall-mounted objects that have leading edges between 27 inches and 80 inches from the floor must not project more than 4 inches into the circulation path. Protruding objects that extend to the floor or within 27 inches of the floor are cane detectable and are therefore not hazardous. Where it is necessary or desirable to have objects protrude from the wall, a manner of cane detection must be provided.

Hand dryer from shower to locker room protrudes 7 inches

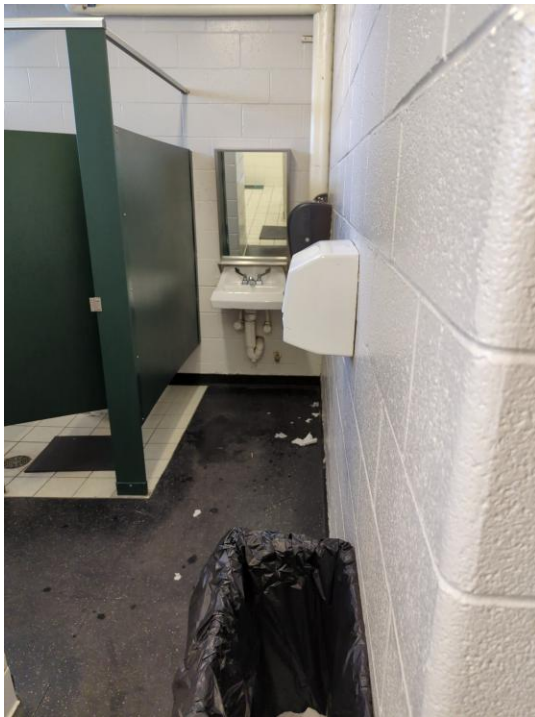
Wall-mounted objects that have leading edges between 27 inches and 80 inches from the floor must not project more than 4 inches into the circulation path. Protruding objects that extend to the floor or within 27 inches of the floor are cane detectable and are therefore not hazardous. Where it is necessary or desirable to have objects protrude from the wall, a manner of cane detection must be provided.

Hand dryer from shower to restroom protrudes 7 inches

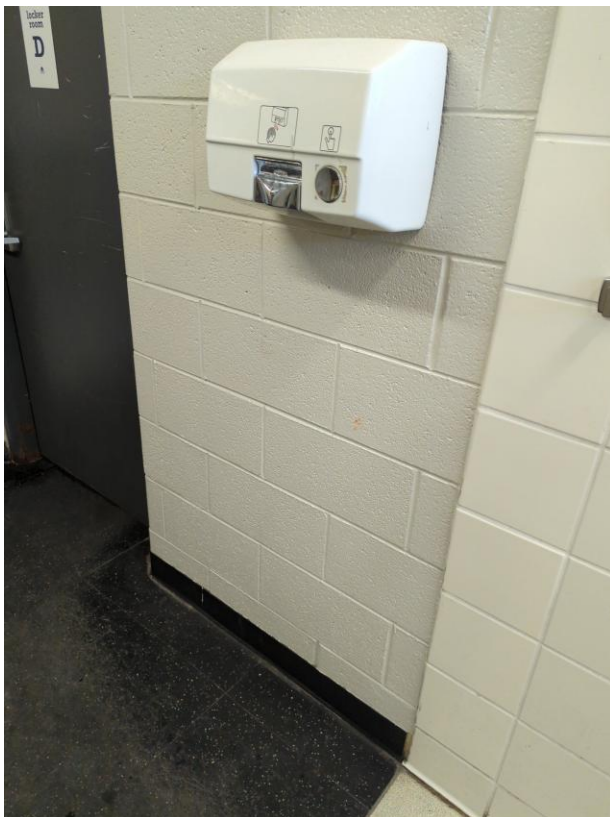
Hand dryer from the shower to the locker room is 52 inches high to the operable part

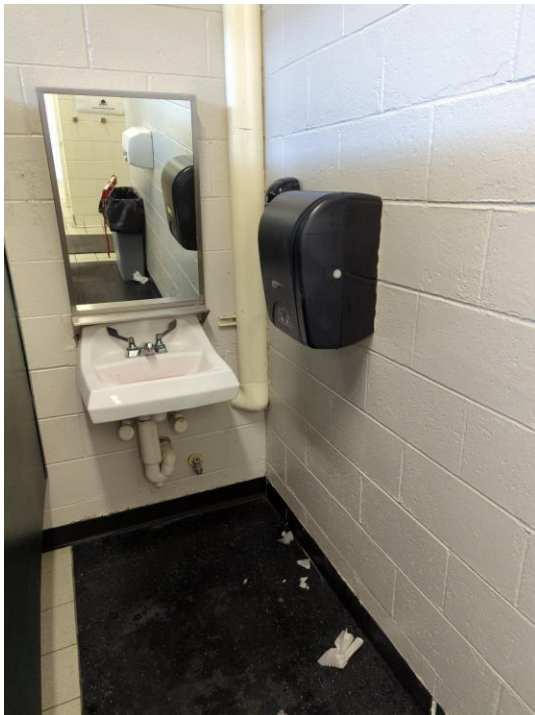
Wall-mounted objects that have leading edges between 27 inches and 80 inches from the floor must not project more than 4 inches into the circulation path. Protruding objects that extend to the floor or within 27 inches of the floor are cane detectable and are therefore not hazardous. Where it is necessary or desirable to have objects protrude from the wall, a manner of cane detection must be provided.

Paper towel dispenser in men's restroom protrudes 10 inches

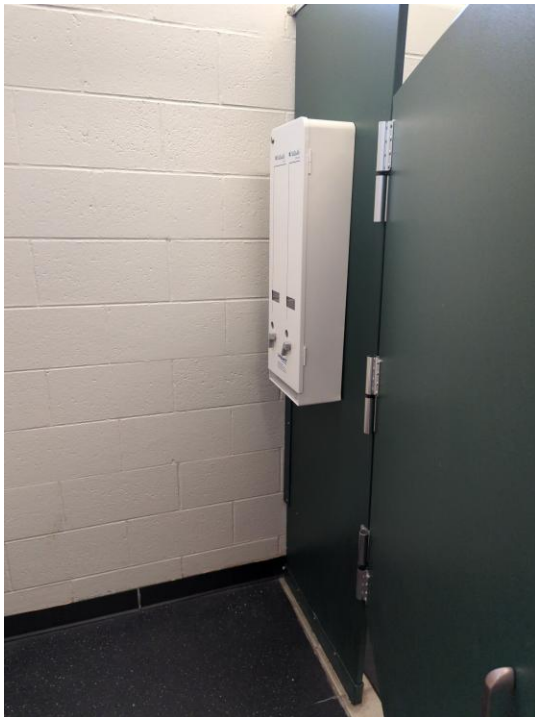
Wall-mounted objects that have leading edges between 27 inches and 80 inches from the floor must not project more than 4 inches into the circulation path. Protruding objects that extend to the floor or within 27 inches of the floor are cane detectable and are therefore not hazardous. Where it is necessary or desirable to have objects protrude from the wall, a manner of cane detection must be provided.

Feminine product dispenser in men's restroom protrudes 6 inches

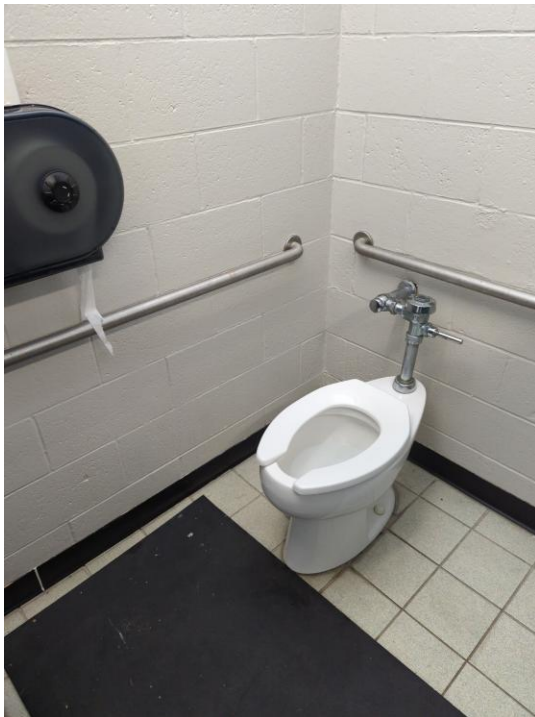
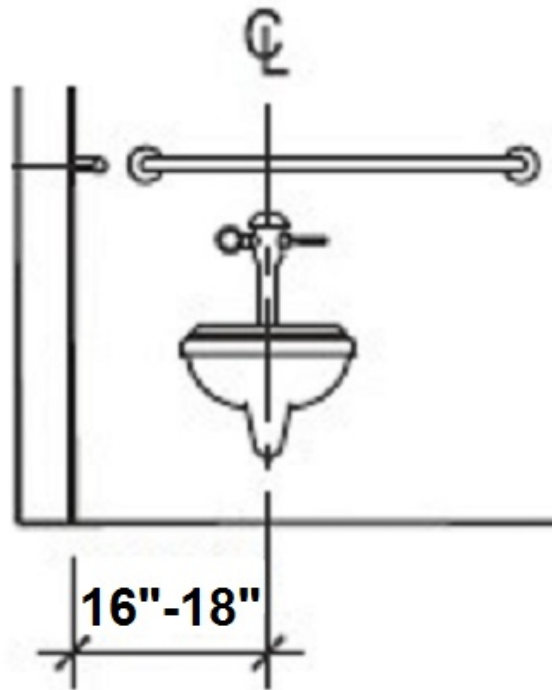
Toilet centerline is 19 inches from side wall

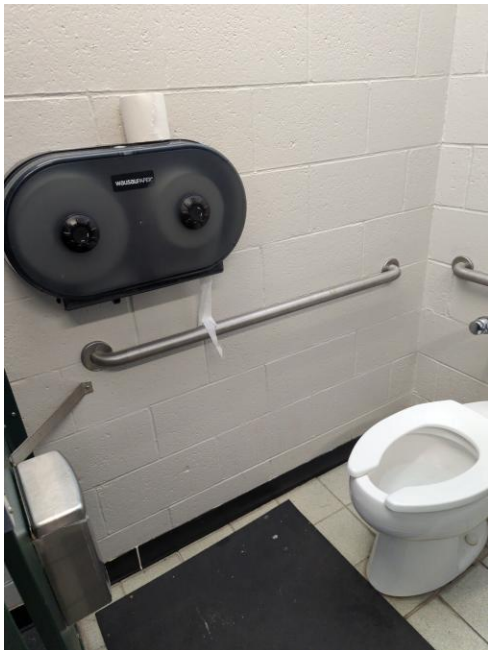
Side grab bar extends 50 inches from back wall

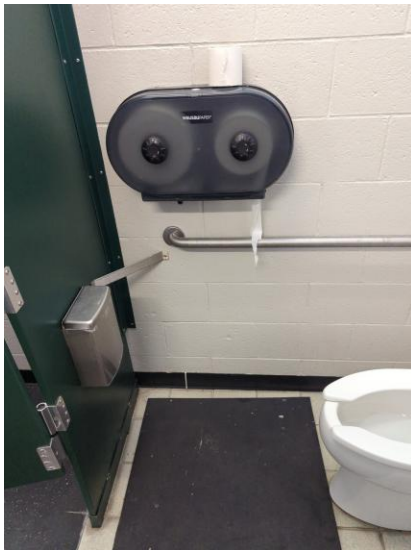
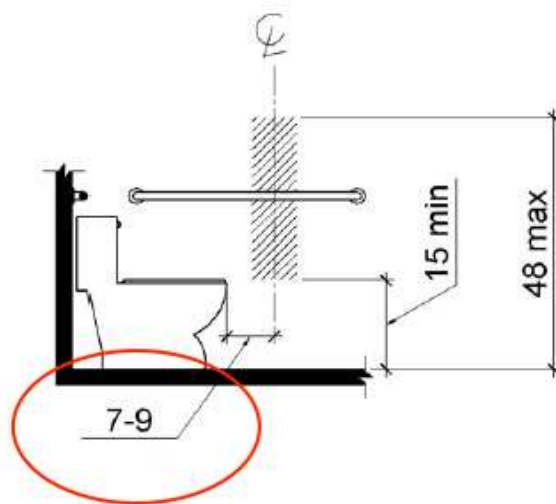
Toilet paper dispenser is centered 15 inches in front of water closet, and is only 7 inches above the side grab bar

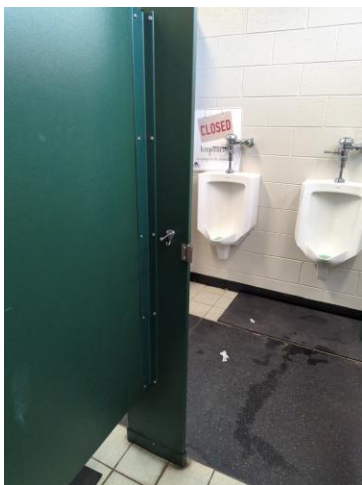
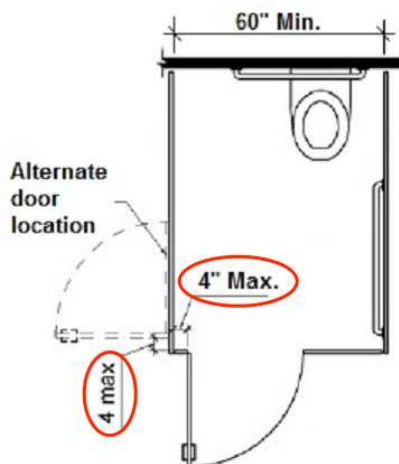
Partition door is located 6 inches away from partition door

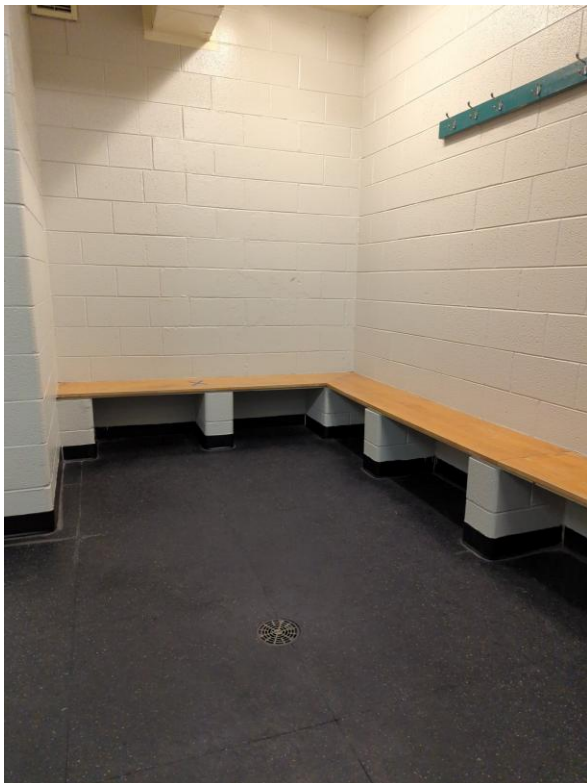
There is no clear floor space provided at the end of the bench

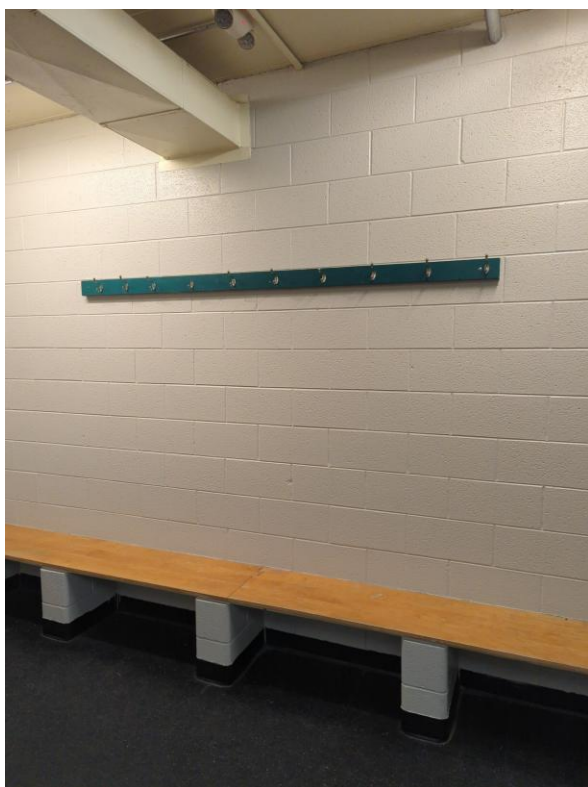
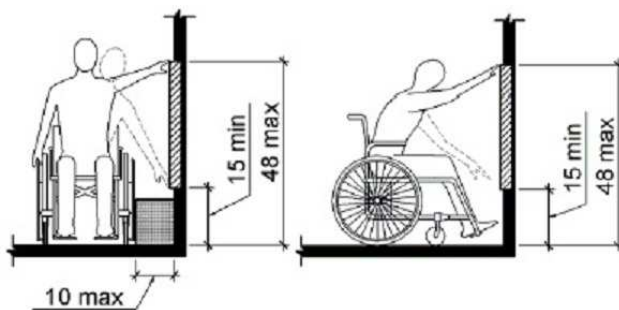
Coat hooks are 80 inches high

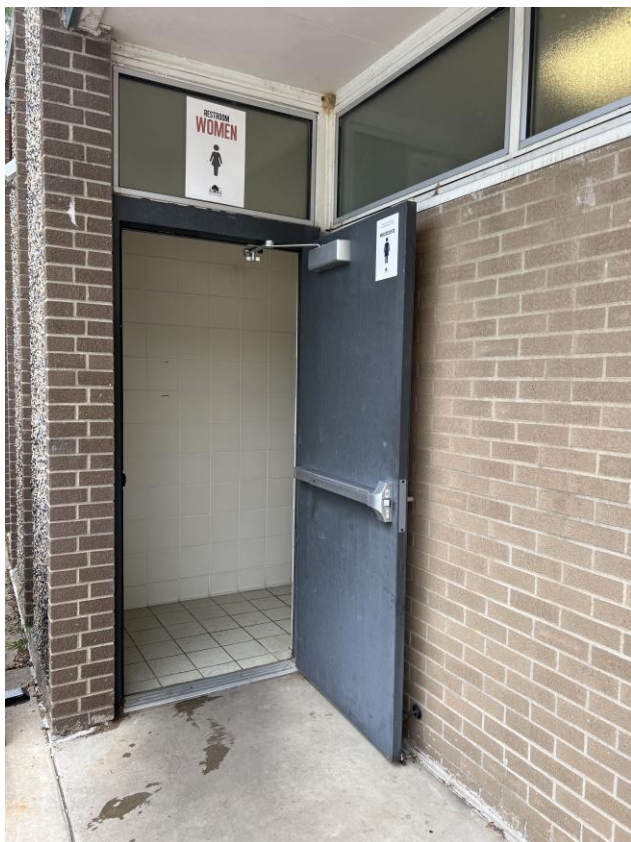
Finding #55 Continued

The women's lockerroom/restroom identification sign is not compliant

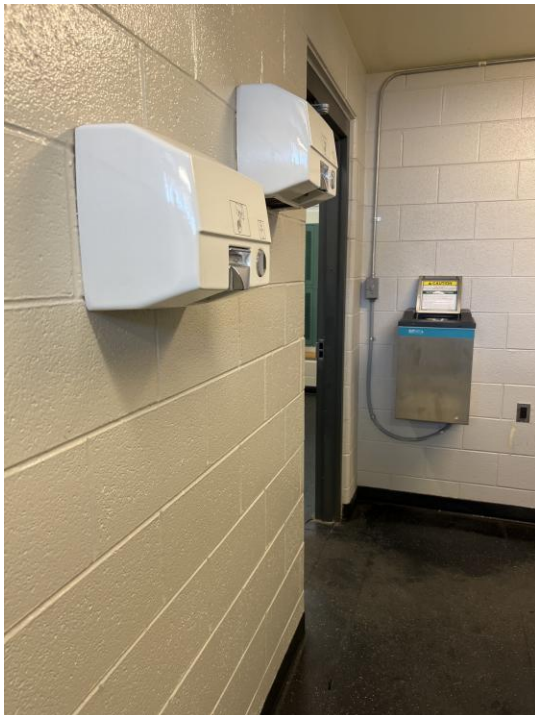
Wall-mounted objects that have leading edges between 27 inches and 80 inches from the floor must not project more than 4 inches into the circulation path. Protruding objects that extend to the floor or within 27 inches of the floor are cane detectable and are therefore not hazardous. Where it is necessary or desirable to have objects protrude from the wall, a manner of cane detection must be provided.

The dispenser is more than 4 inches from the wall

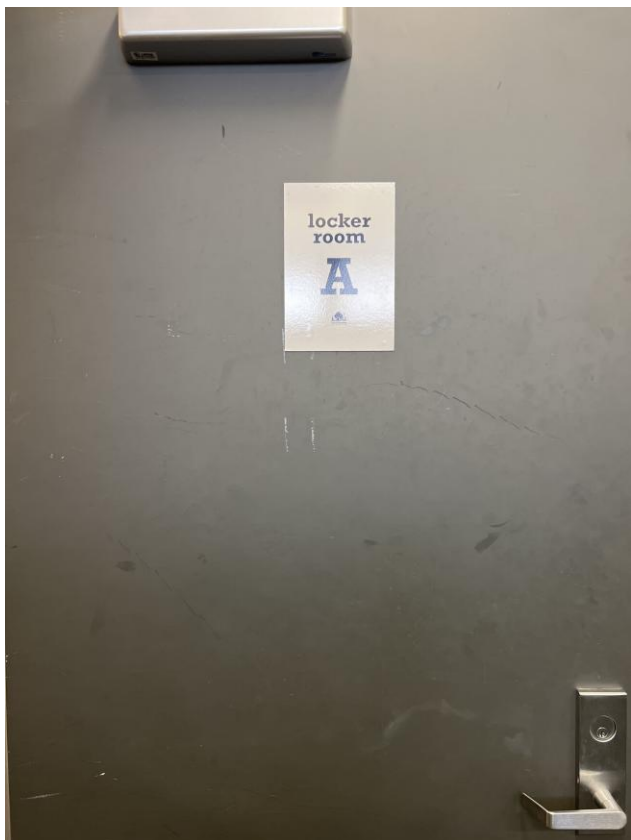
Finding #57 Continued

The Locker Room A sign is not compliant

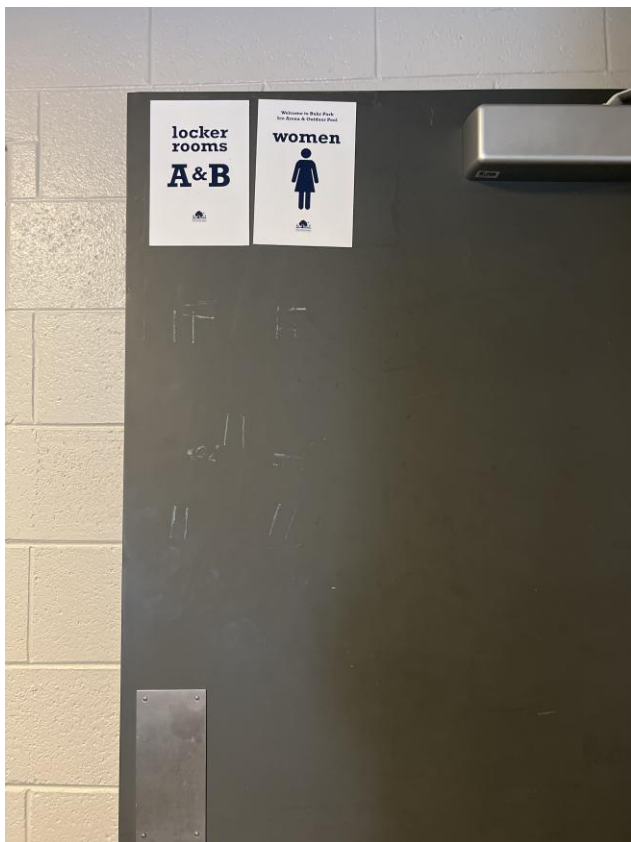
Finding #58 Continued

The Room Sign Identification for the Locker Rooms and Women's Restroom is not compliant
