Site Accessibility Evaluation

Allmendinger Park
655 Pauline Blvd
Ann Arbor, MI 48104
ADA Only

Inspection Date: 07/11/2022

Report Date: 11/15/2022

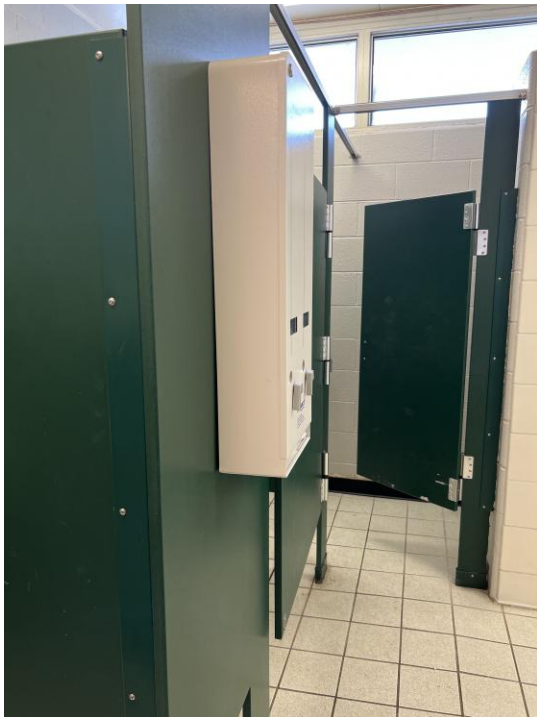
Wall-mounted objects that have leading edges between 27 inches and 80 inches from the floor must not project more than 4 inches into the circulation path. Protruding objects that extend to the floor or within 27 inches of the floor are cane detectable and are therefore not hazardous. Where it is necessary or desirable to have objects protrude from the wall, a manner of cane detection must be provided.

The dispenser is protruding

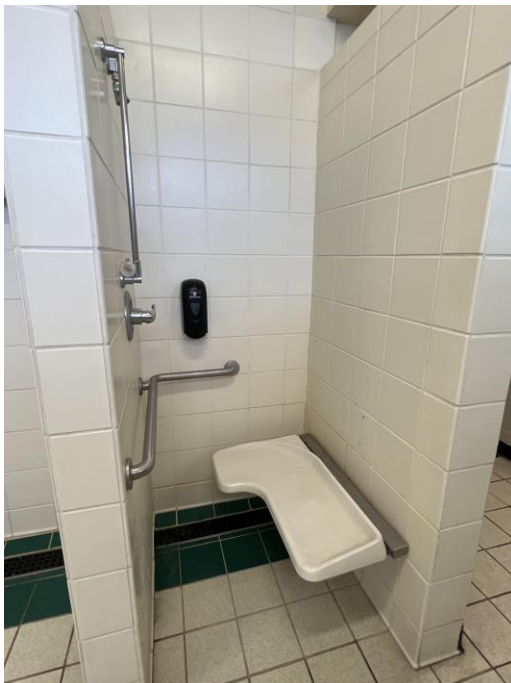
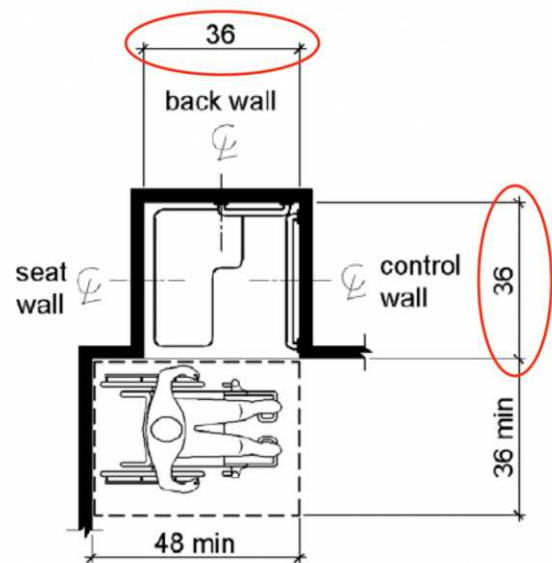
The transfer shower size is too small

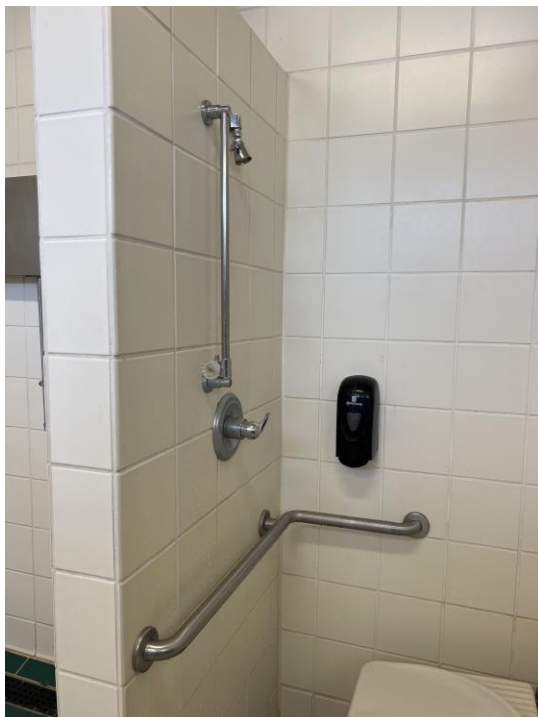
The shower is missing the hand-held spray unit.

Fixed shower head

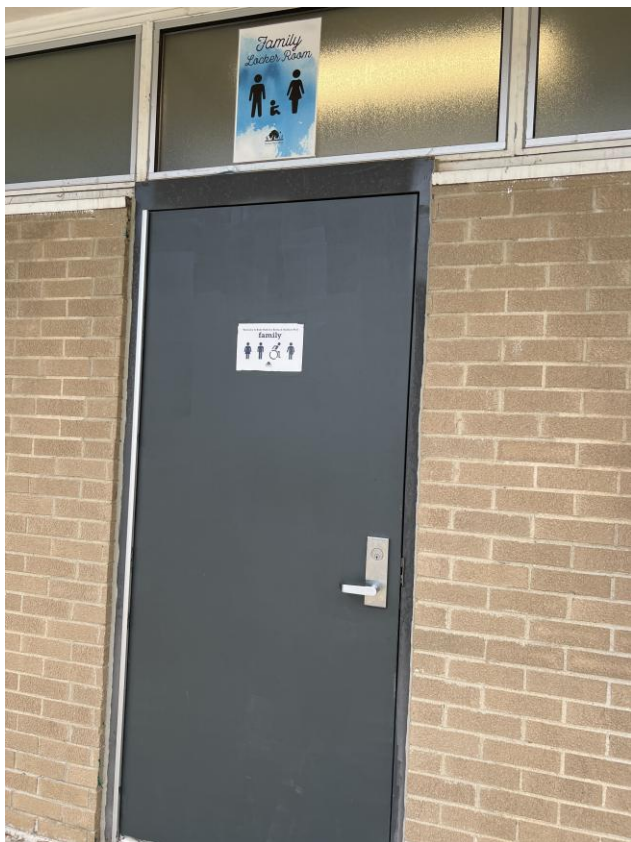
Finding #62 Continued

The Family Restroom sign is not compliant

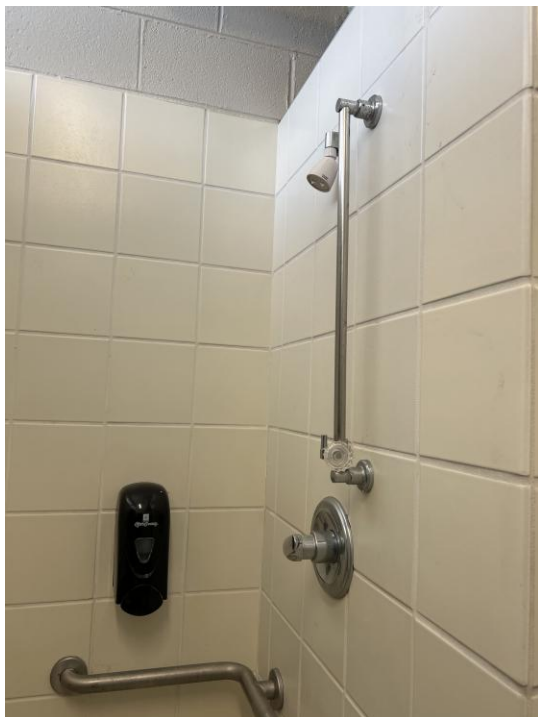
The shower is missing the hand-held spray unit.

There is a fixed shower head

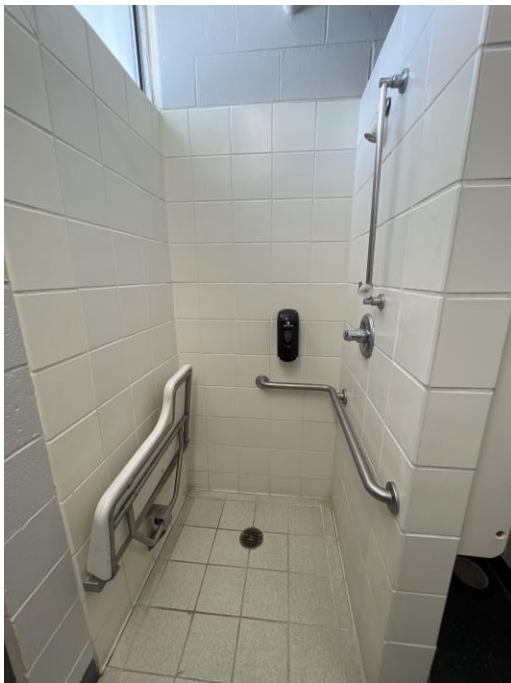
The transfer shower size is too small

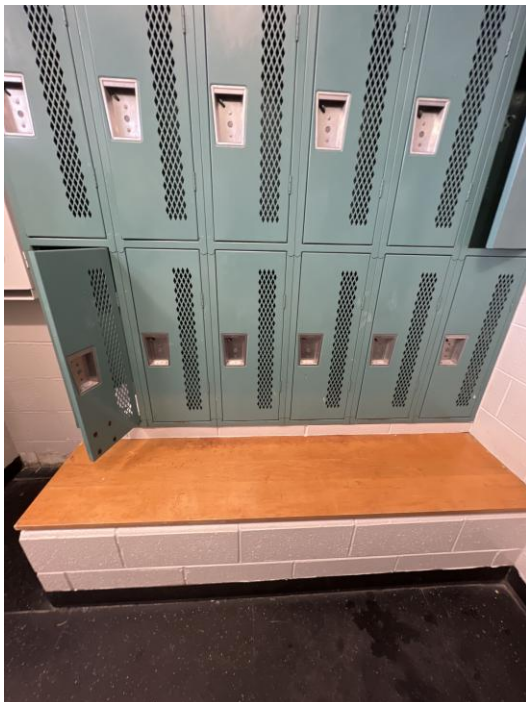
The bench depth is not compliant

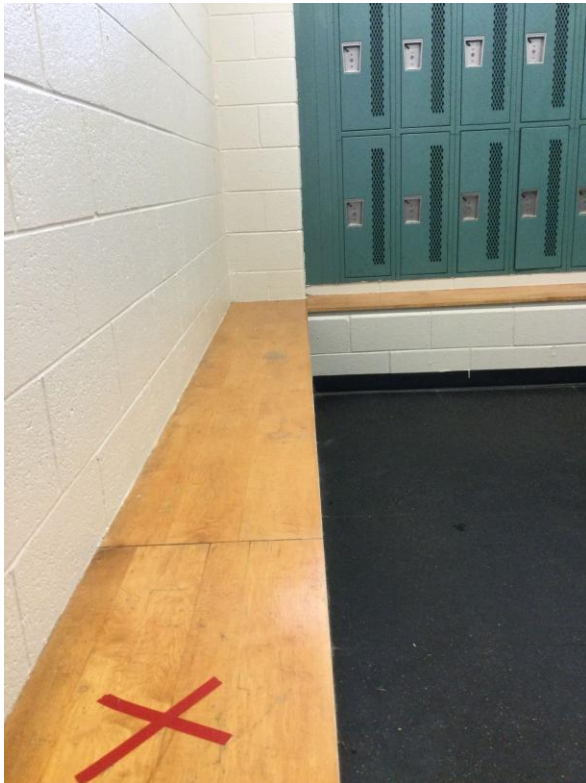
The Bench depth is at 16"

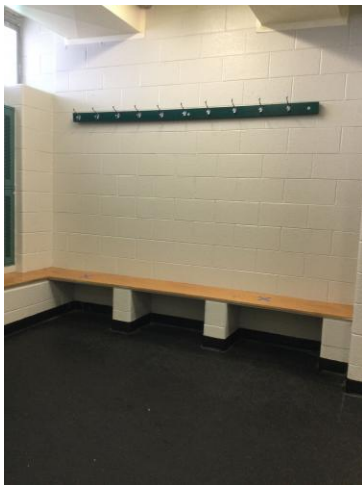
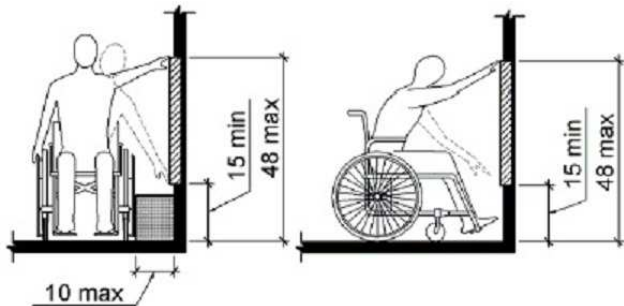
The changing room hooks are 72" tall

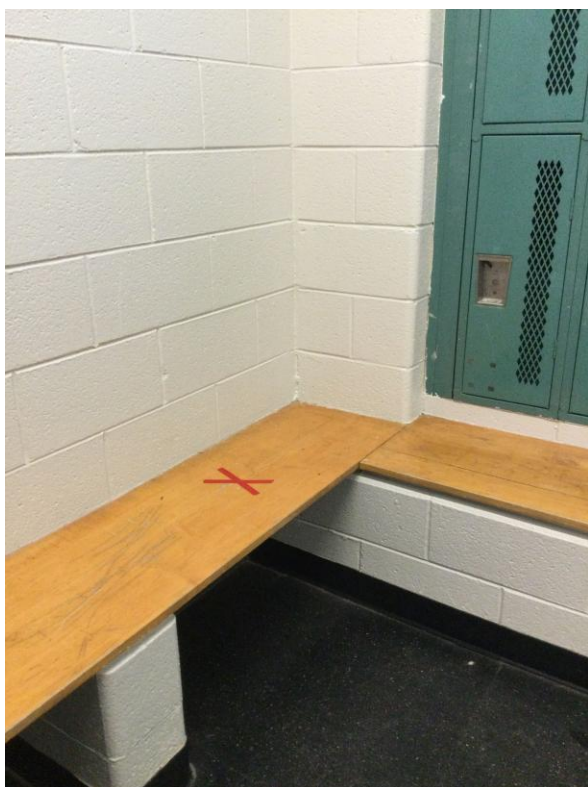
16" depth

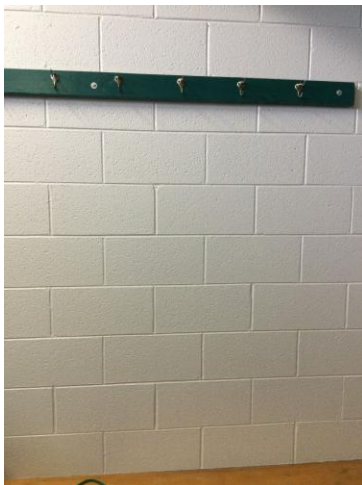
72" tall

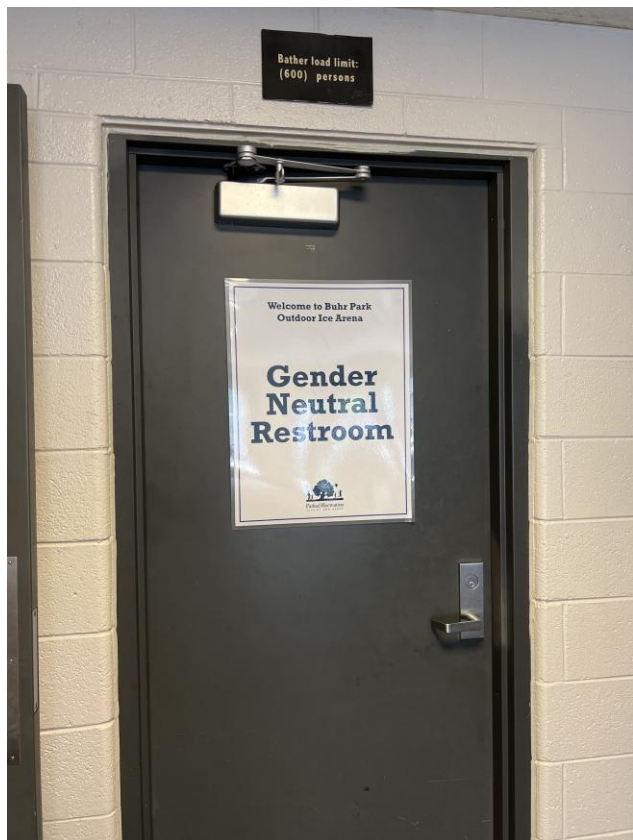
Finding #70 Continued

The room identification sign for the Gender Neutral Restroom is not compliant

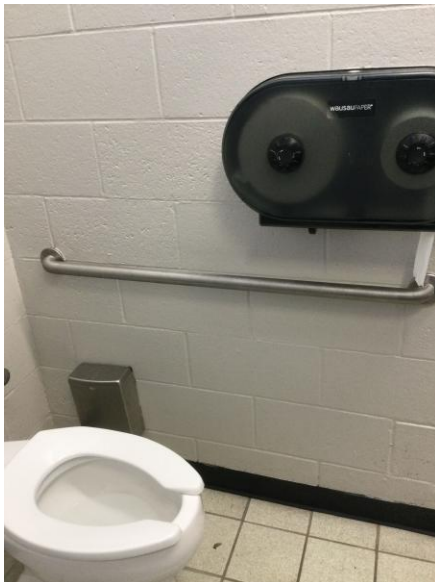
Out of range

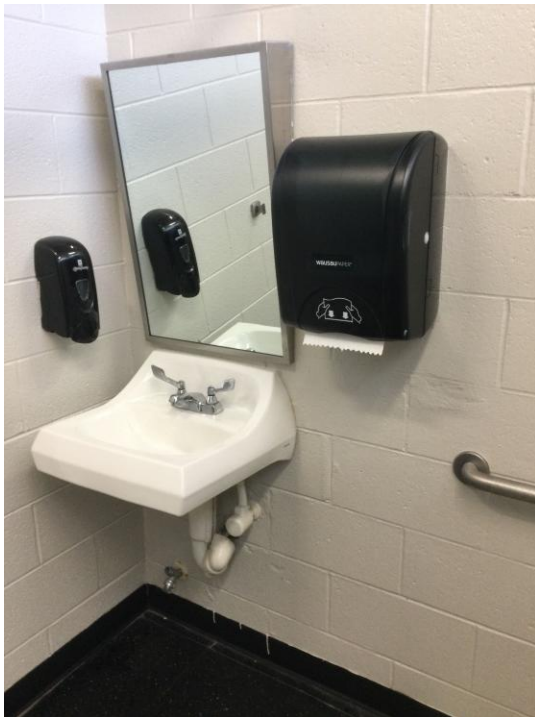
Wall-mounted objects that have leading edges between 27 inches and 80 inches from the floor must not project more than 4 inches into the circulation path. Protruding objects that extend to the floor or within 27 inches of the floor are cane detectable and are therefore not hazardous. Where it is necessary or desirable to have objects protrude from the wall, a manner of cane detection must be provided.

The paper towel dispenser protrudes more than 4 inches

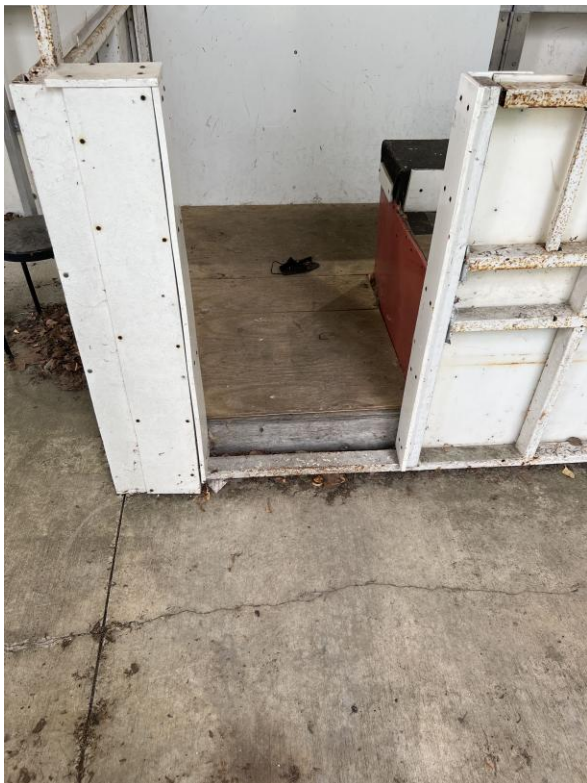
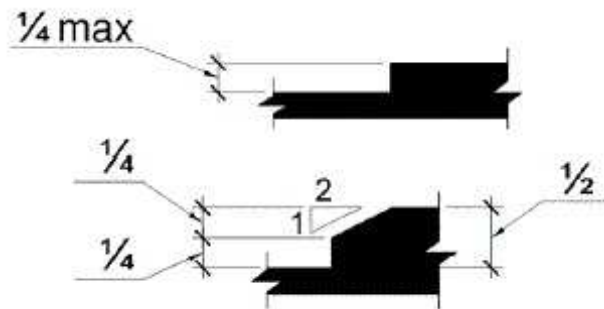
There is a change in level for the entrance to the hockey rink

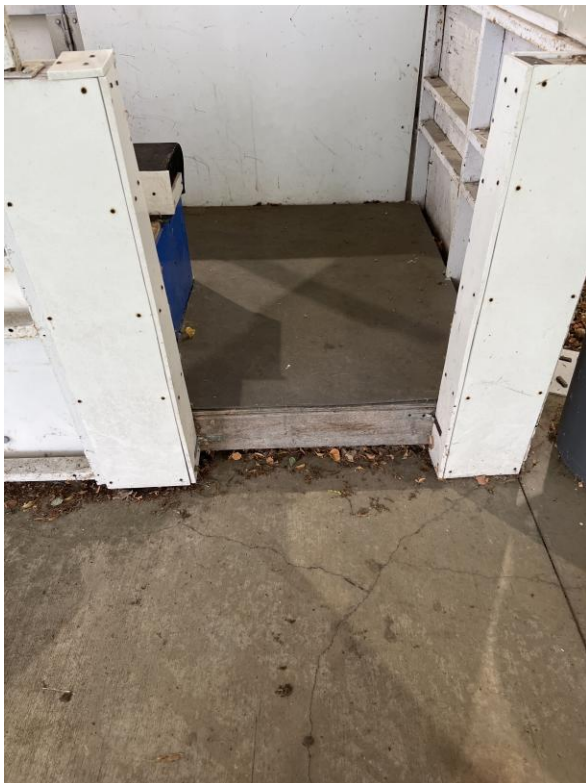
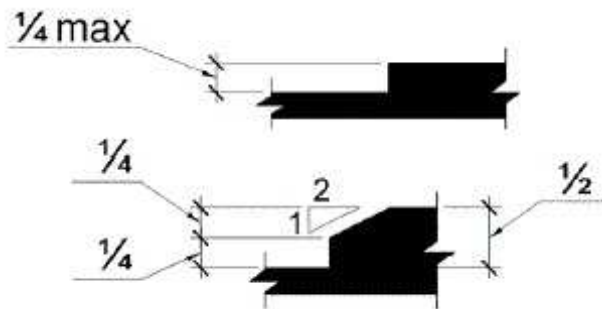
There is a change in level at multiple entrances to the hockey rink

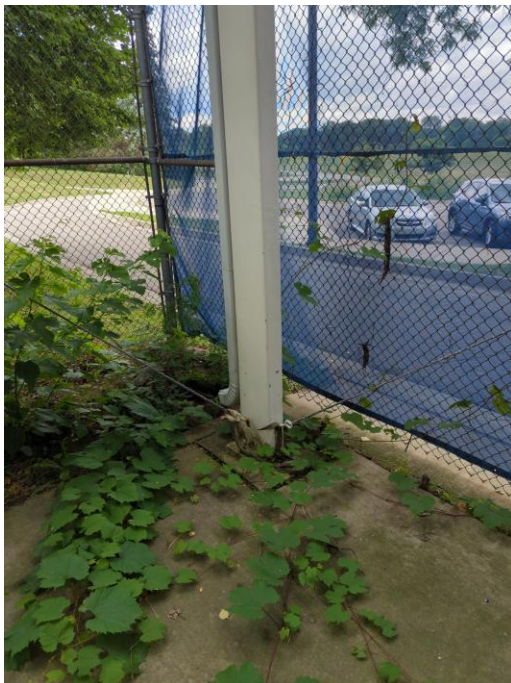
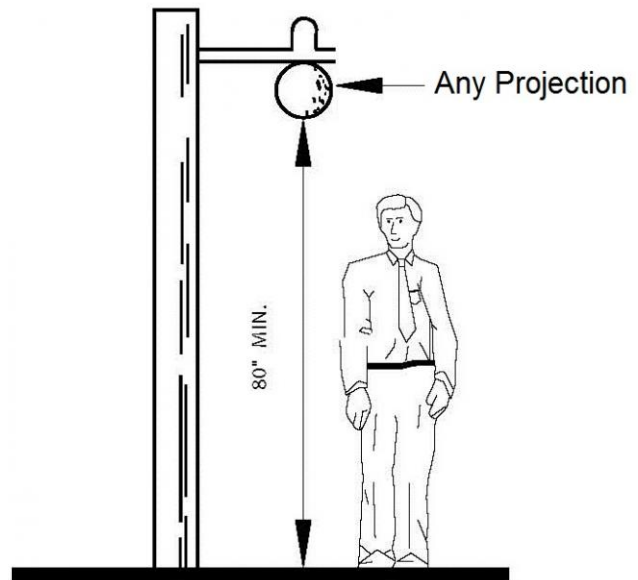
Support cables at each corner

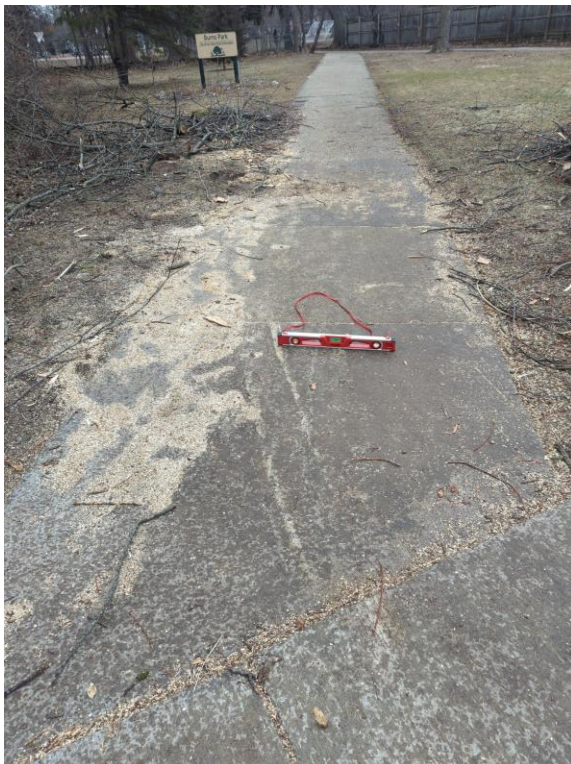
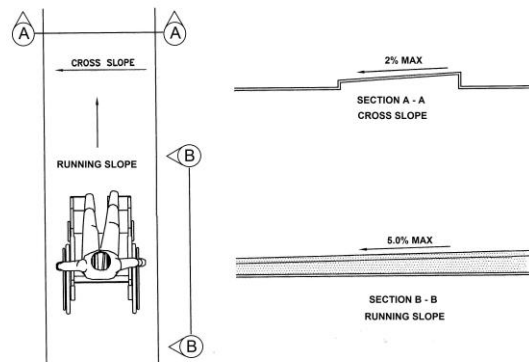
SW entrance on Granger Ave cross slope up to 5% 15 linear feet

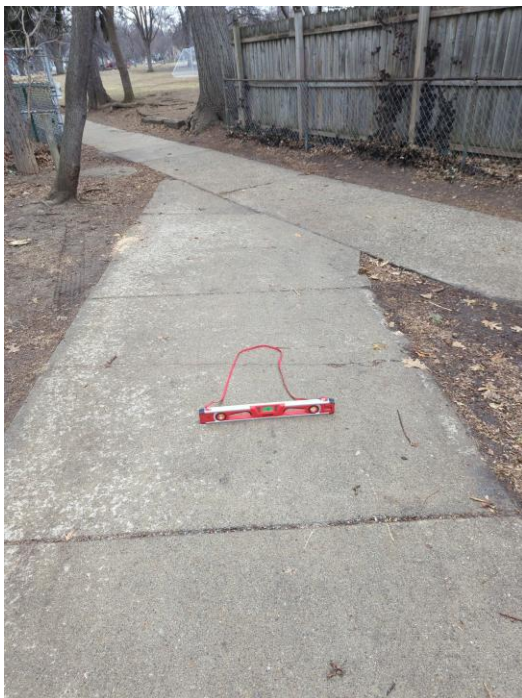
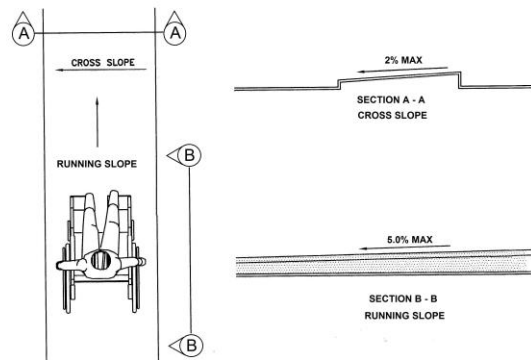
Where the two sidewalks from Granger Ave meet, sidewalk on left has cross slope of up to 3.2%

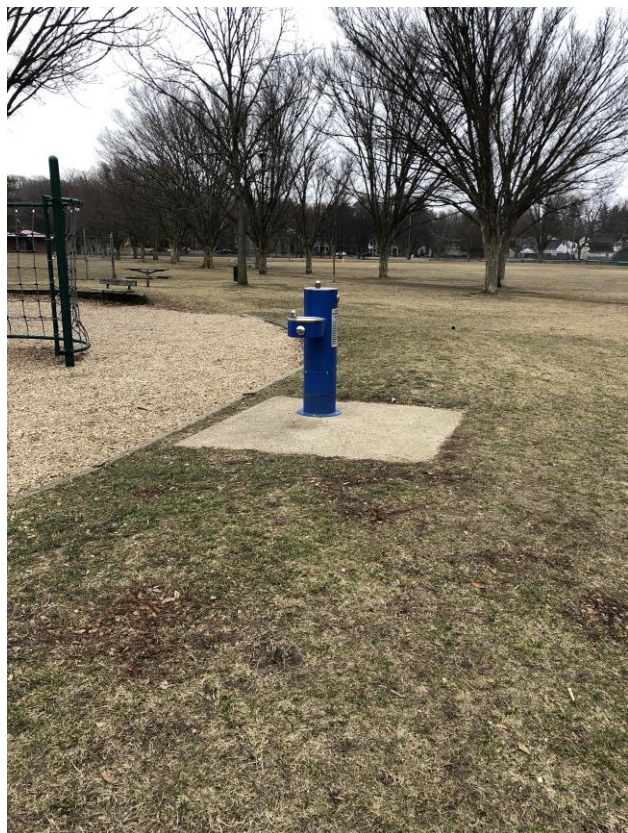
No accessible route to drinking fountain.

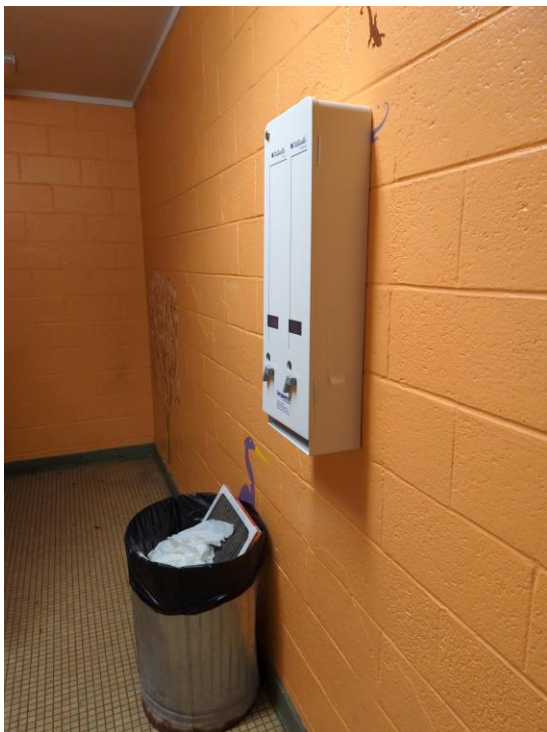
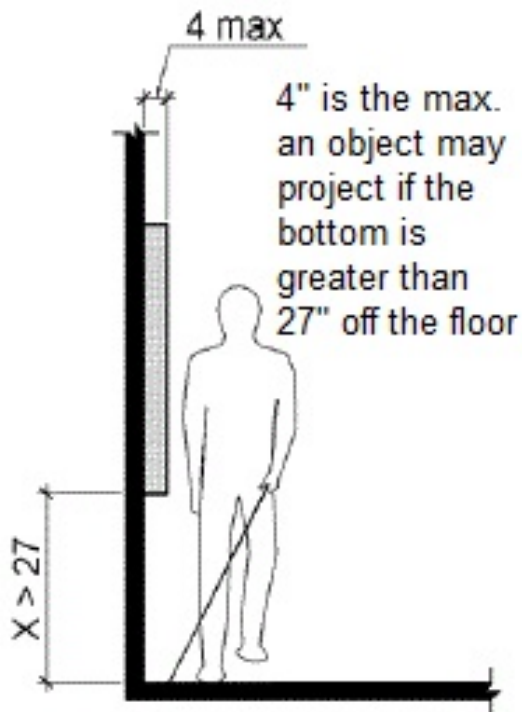
Wall-mounted objects that have leading edges between 27 inches and 80 inches from the floor must not project more than 4 inches into the circulation path. Protruding objects that extend to the floor or within 27 inches of the floor are cane detectable and are therefore not hazardous. Where it is necessary or desirable to have objects protrude from the wall, a manner of cane detection must be provided.

The sanitary napkin dispenser protrudes 5-1/2 inches at 47 inches high

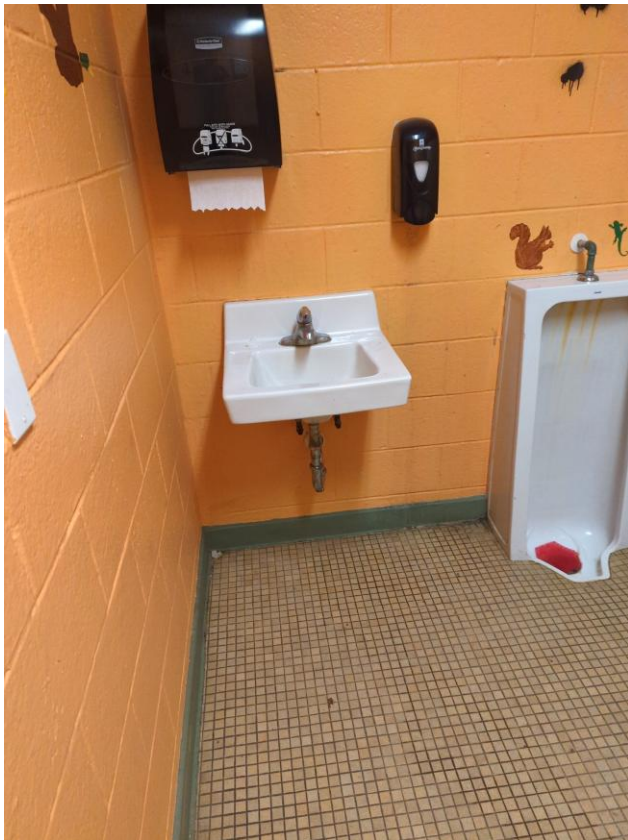
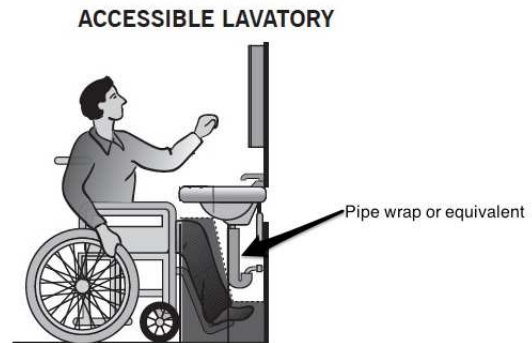
Lavatory pipes are not insulated

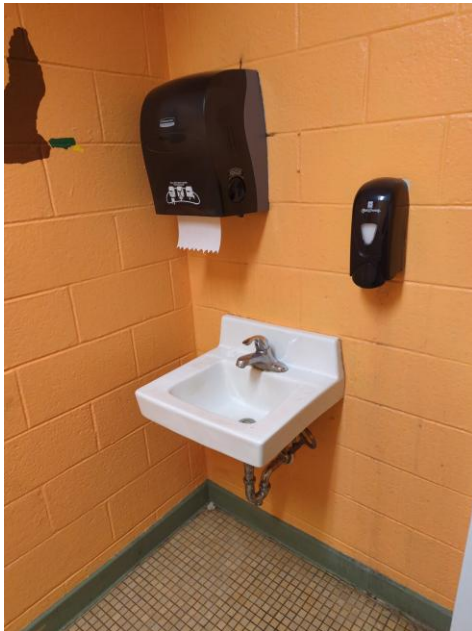
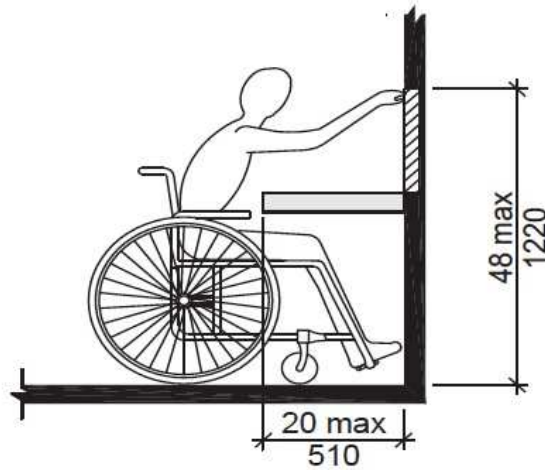
The paper towel dispenser is mounted at 56 inches high to the operable part (knob on side)

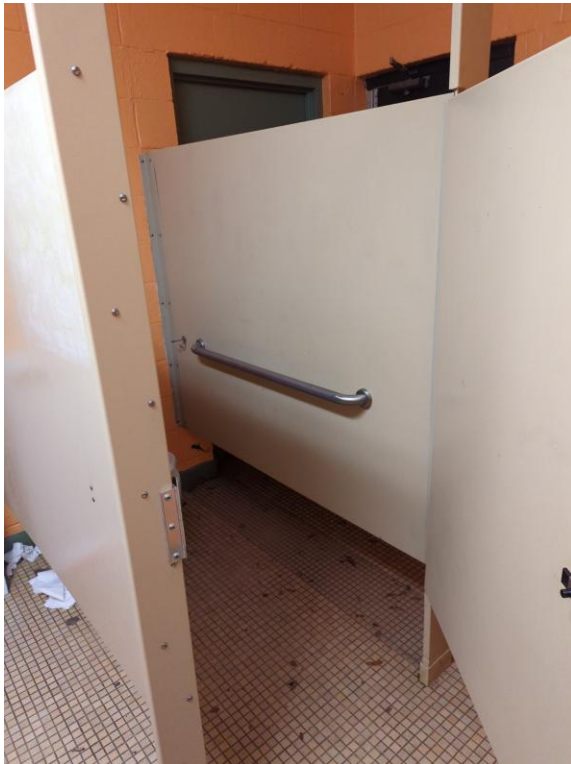
Restrooms: Men's

There is no accessible stall provided

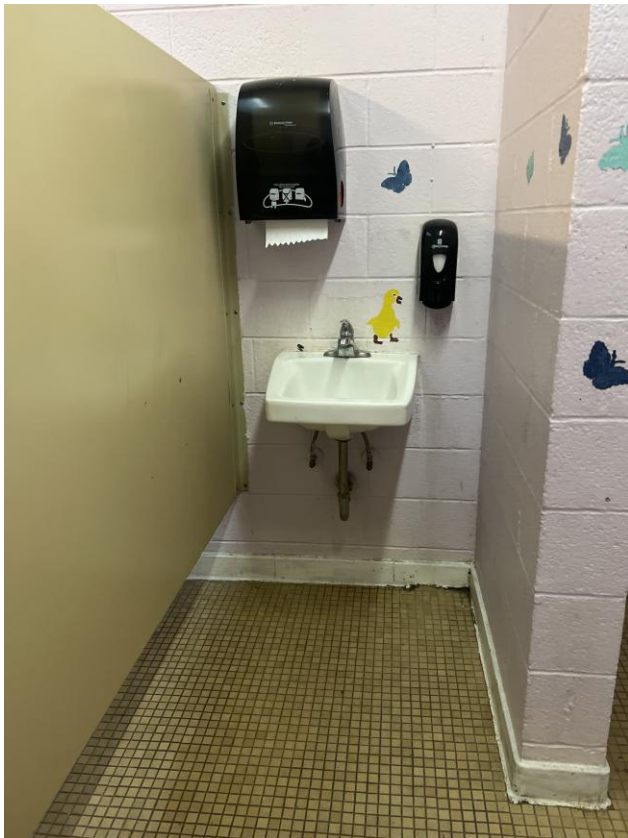
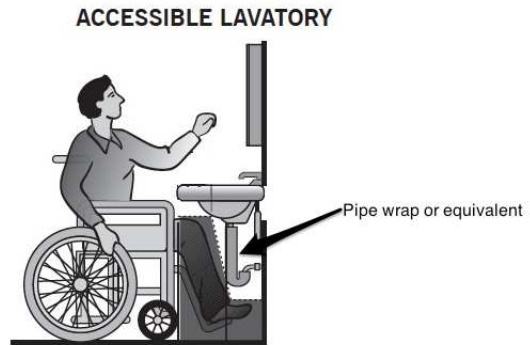
Restrooms: Women's

Pipes are not insulated

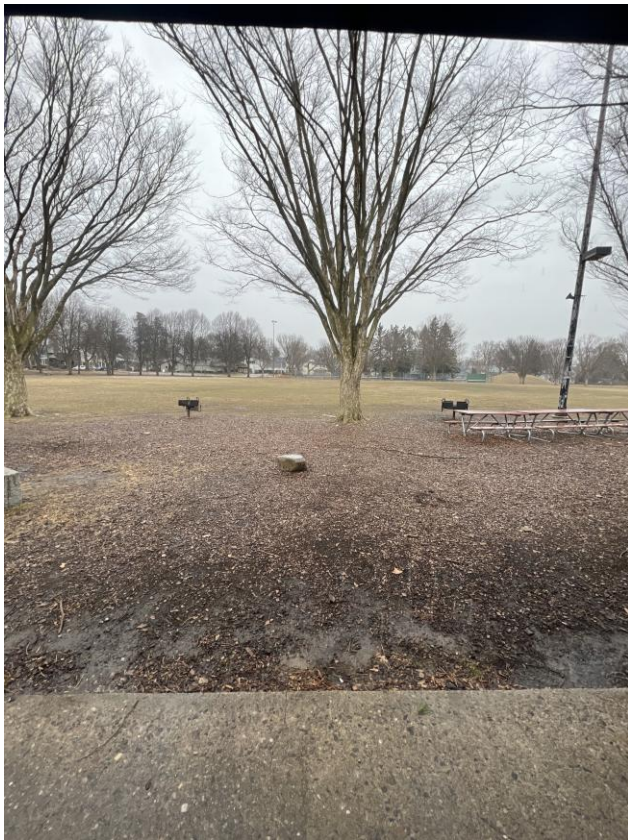
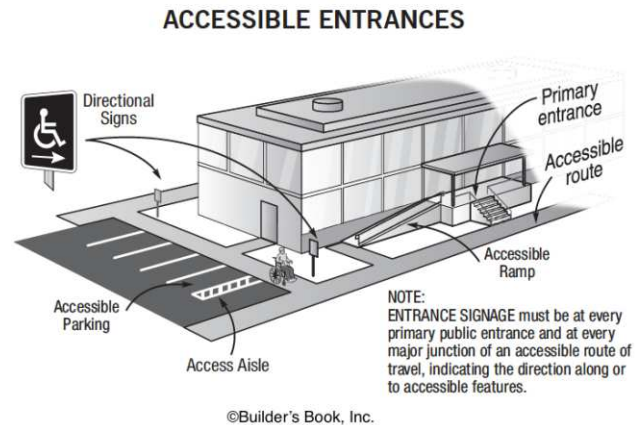
Play Area: Field Near Restrooms

No accessible route to grill and seating area

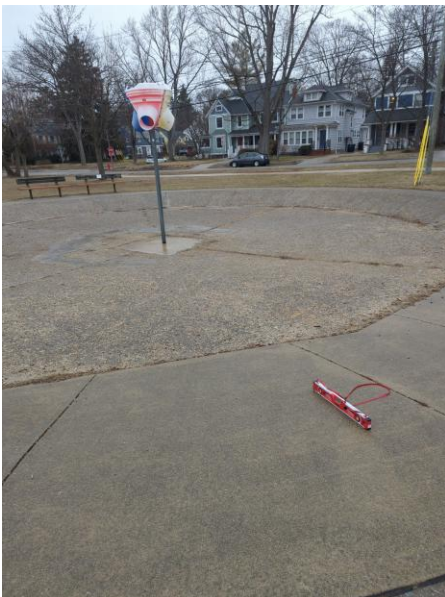
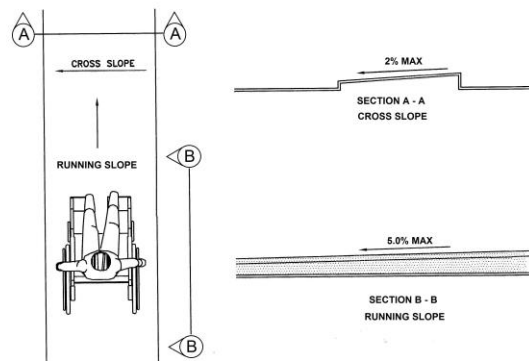
Play Area: Ball Game

The entrance to the play area has a running slope of up to 11%. The maximum slope for a walking surface is 5%, and for a ramp compliant with 405 is 8.33%

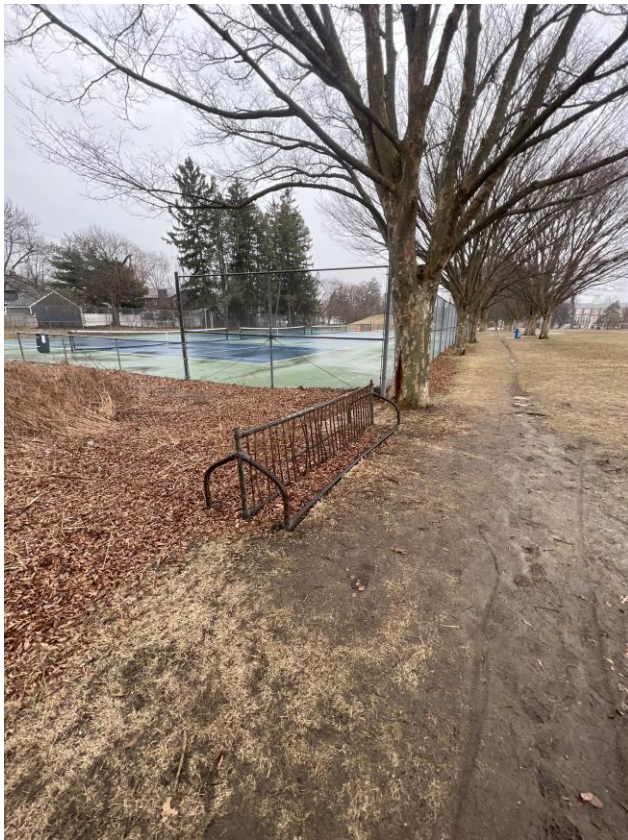
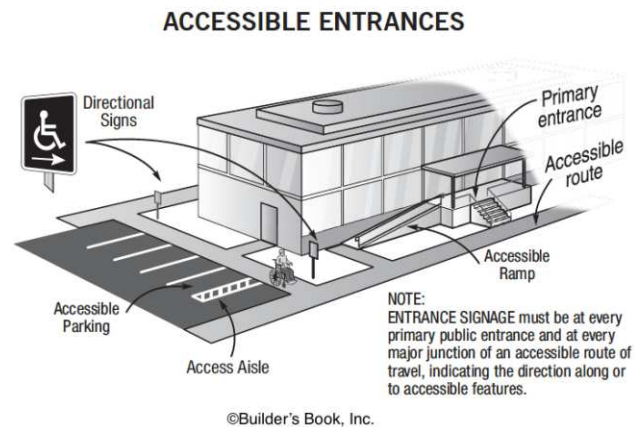
Tennis Court: Entrance

No accessible route to bike rack

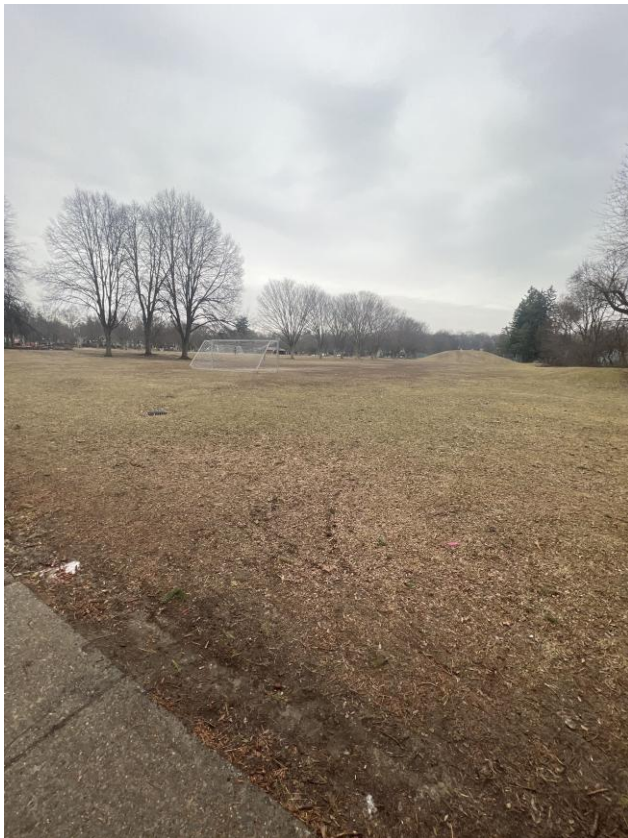
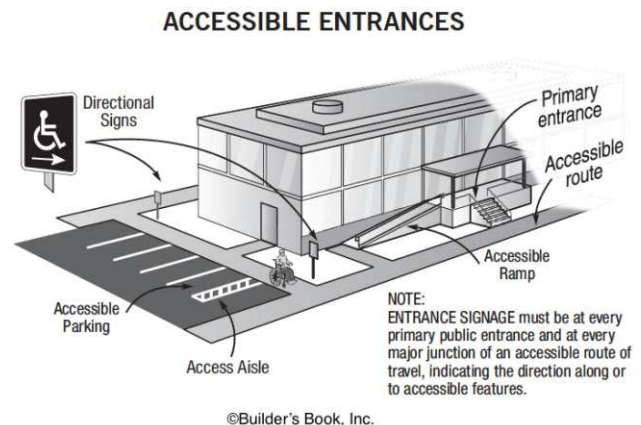
Soccer Field: Seating

No accessible route to soccer field

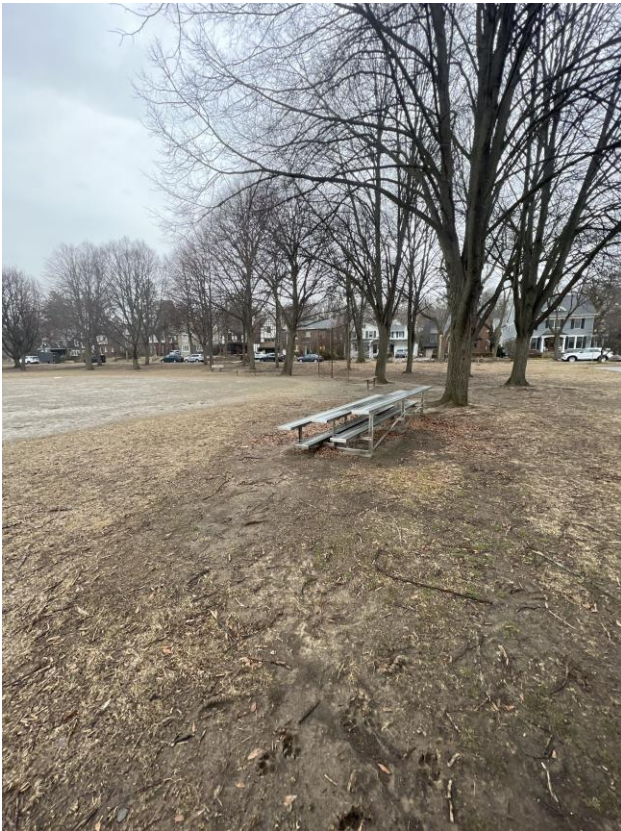
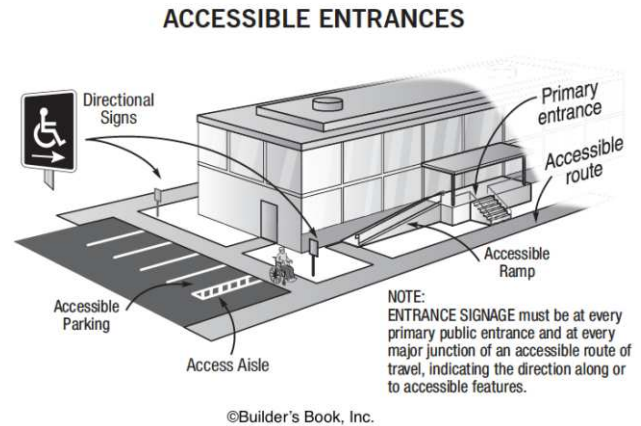
Baseball Field: Seating

No accessible route to baseball field seating and dugouts

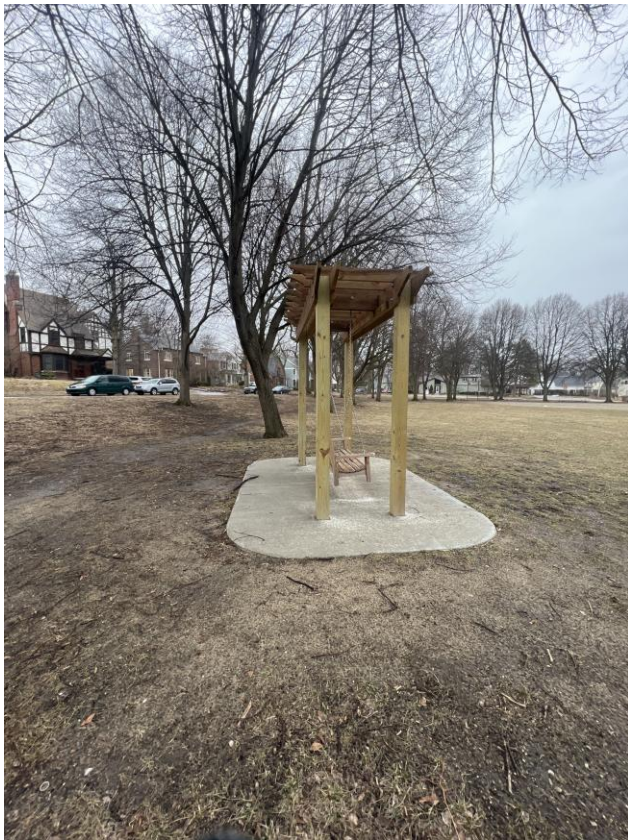
Baseball Field: Seating

No accessible route to swing

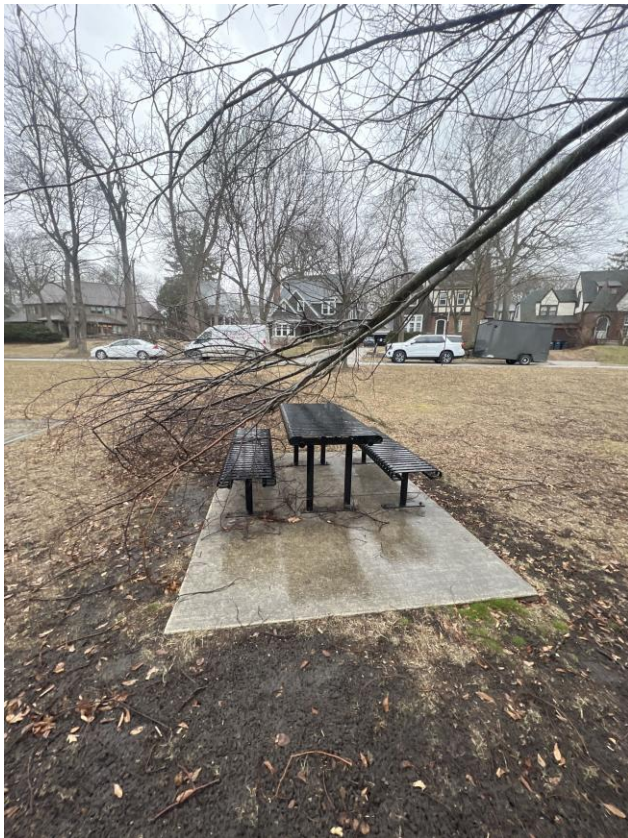
Baseball Field: Seating

No accessible route to table

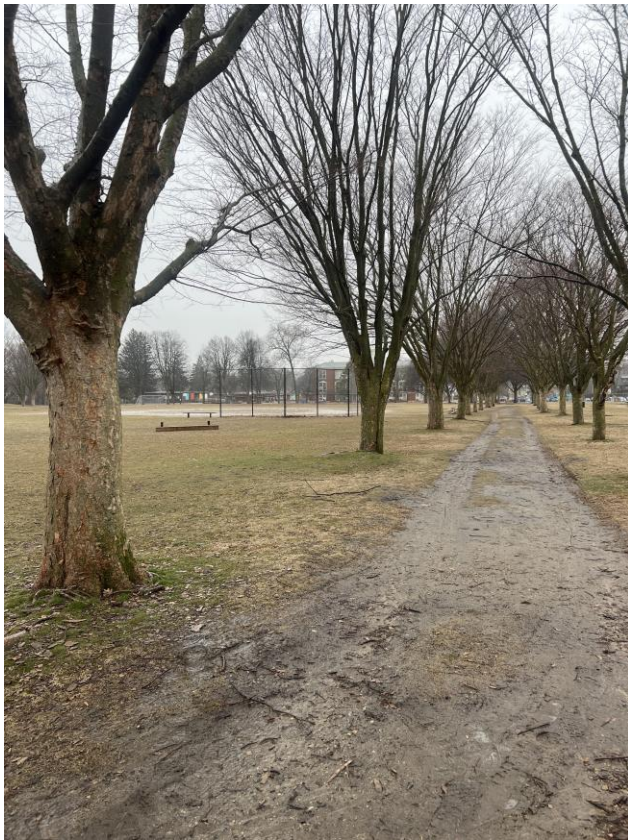
Baseball Field: Seating

No accessible route to baseball fields

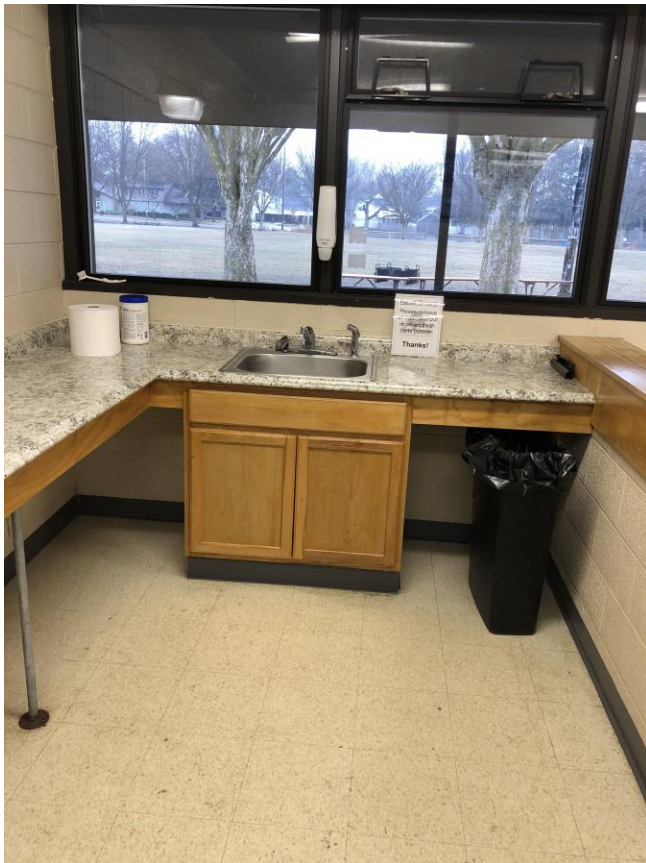
Assembly Area: Community Space

Height at 37 inches. No knee space provided.

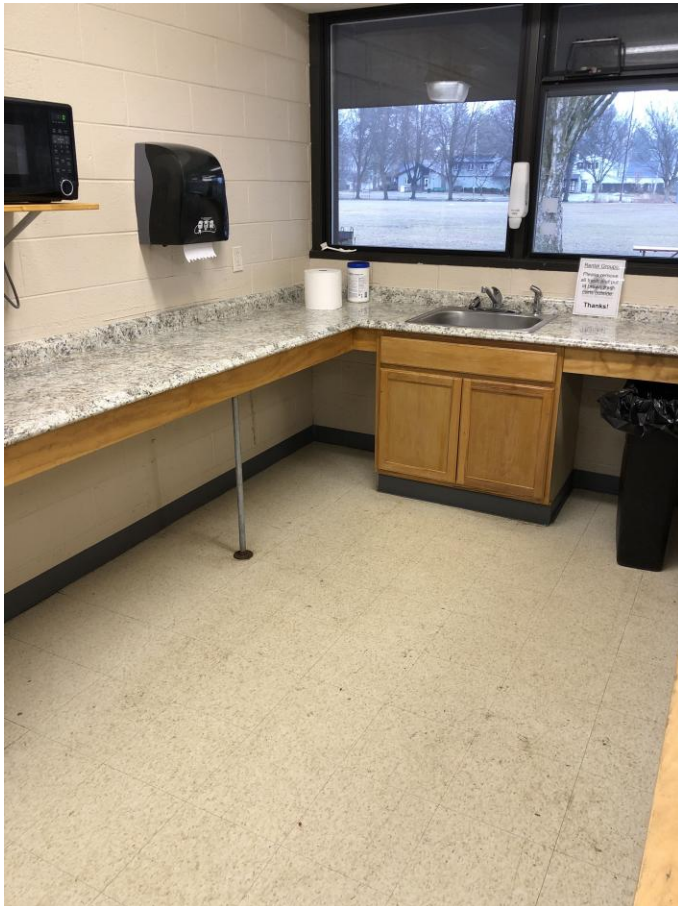
Assembly Area: Community Space

Counters at 37 inches.

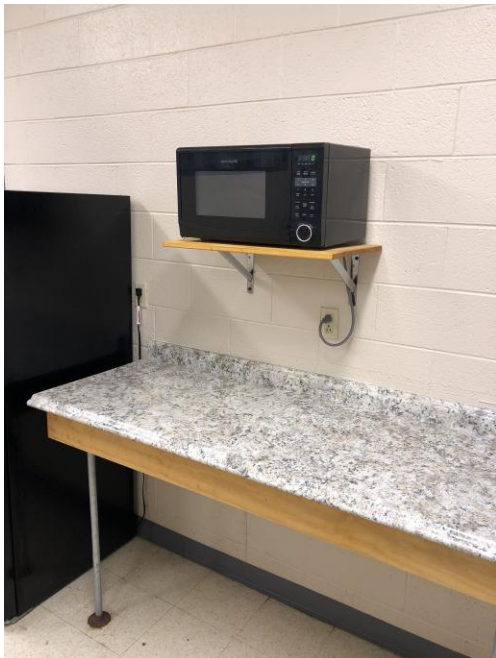
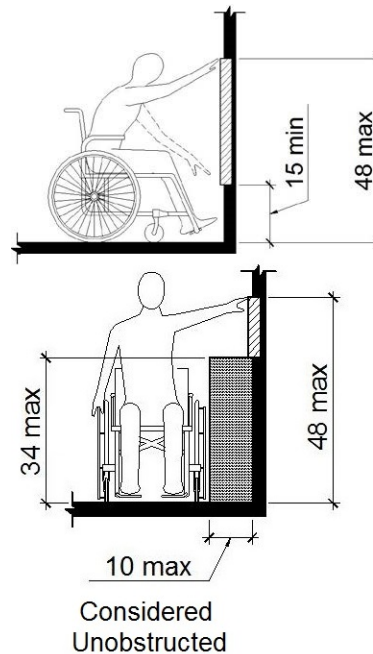
Assembly Area: Community Space

Microwave controls at 68 inches.

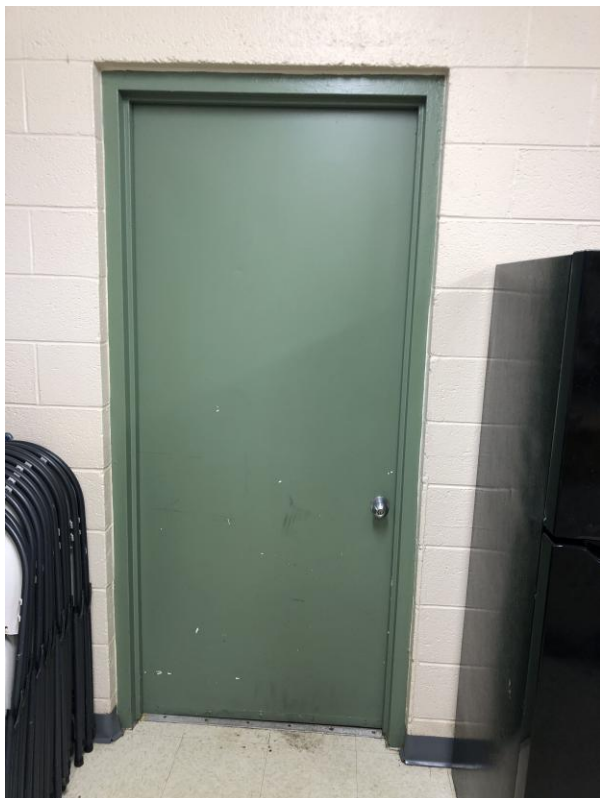
Assembly Area: Community Space

Knob at door to maintenance storage area near kitchen.

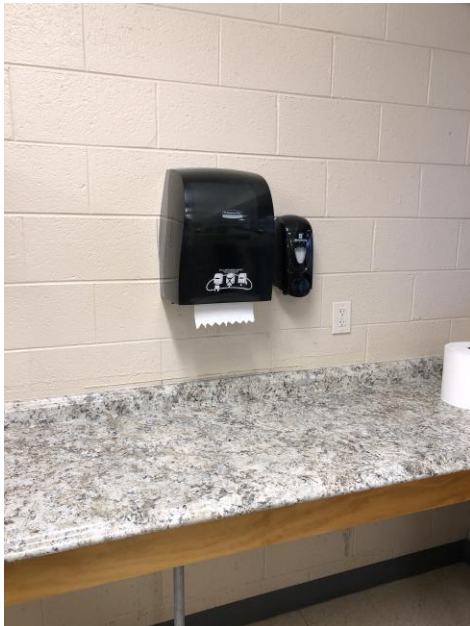
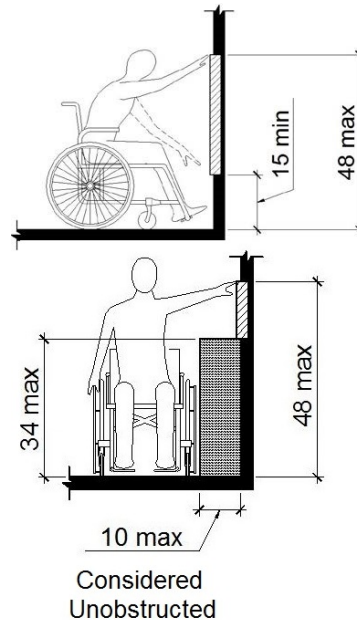
Assembly Area: Community Space

Towel and soap dispensers at 55 inches high.

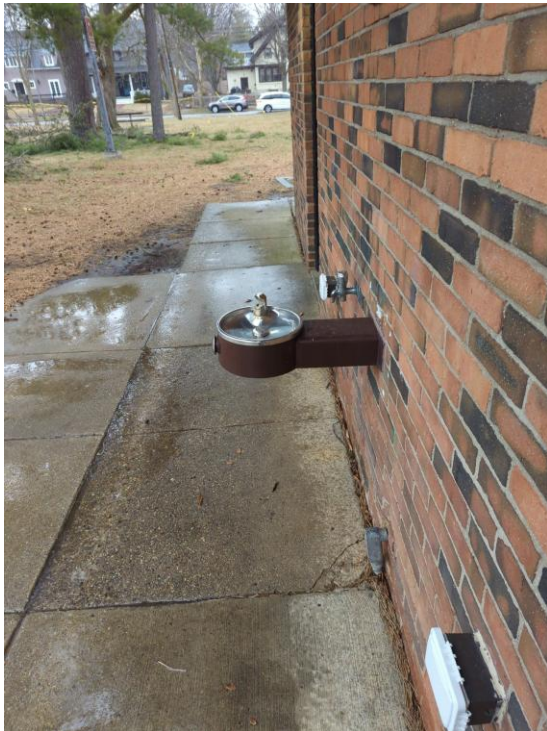
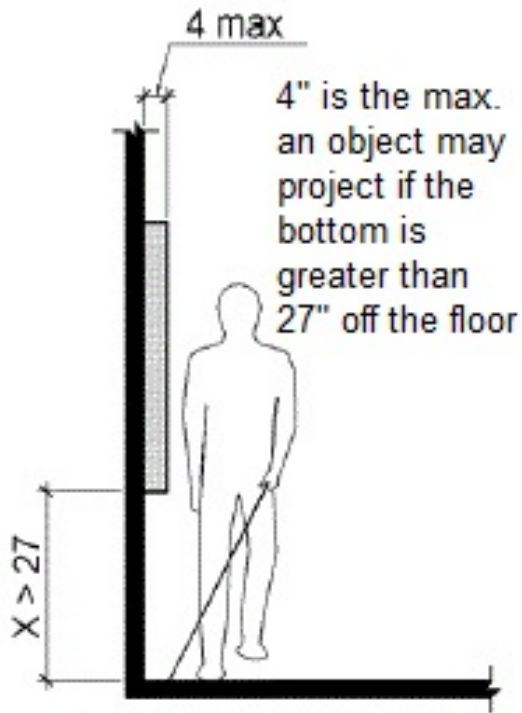
Assembly Area: Exterior

Wall-mounted objects that have leading edges between 27 inches and 80 inches from the floor must not project more than 4 inches into the circulation path. Protruding objects that extend to the floor or within 27 inches of the floor are cane detectable and are therefore not hazardous. Where it is necessary or desirable to have objects protrude from the wall, a manner of cane detection must be provided.

The "low" drinking fountain protrudes 22 inches at 28 inches high

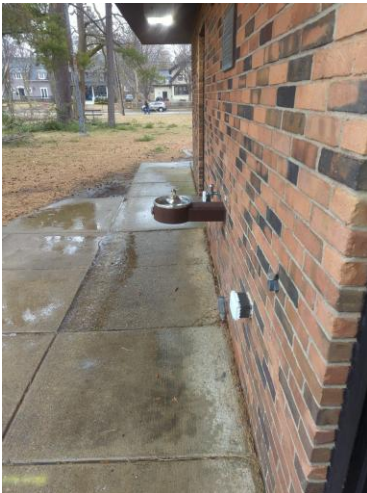
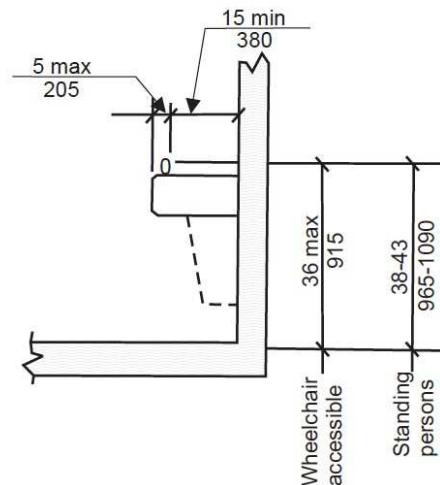
Assembly Area: Exterior

There is no high drinking fountain provided

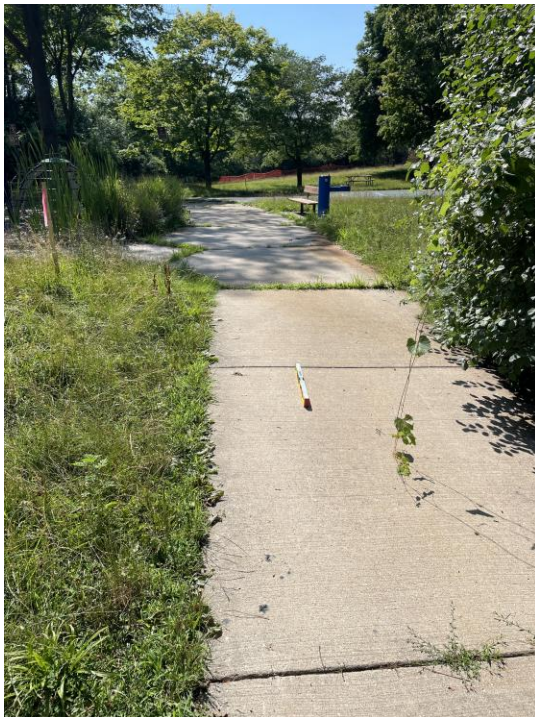
As Built:

6.5% running slope
