Site Accessibility Evaluation

Allmendinger Park
655 Pauline Blvd
Ann Arbor, MI 48104
ADA Only

Inspection Date: 07/11/2022

Report Date: 11/15/2022

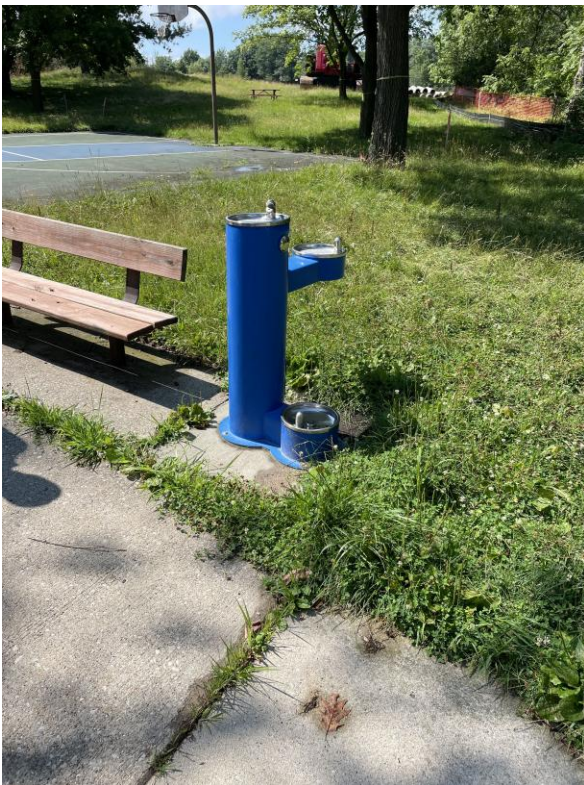
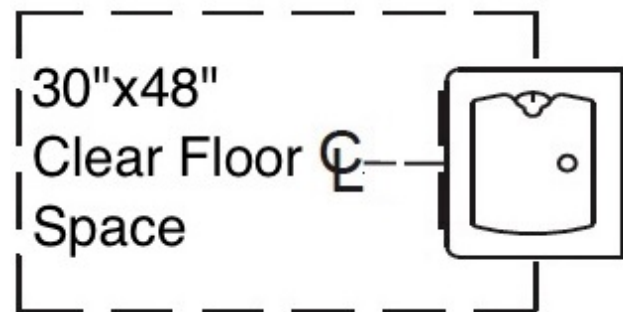
Green Space: Drinking Fountain

As Built:

Approach not provided

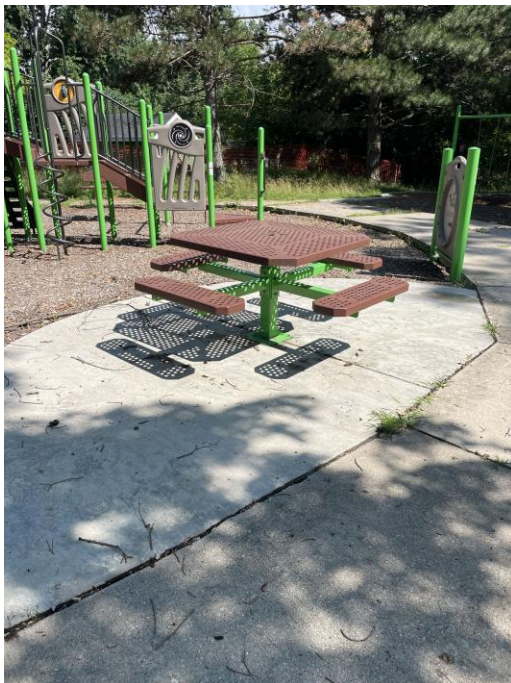
Green Space: Picnic Area

As Built:

No wheelchair space provided

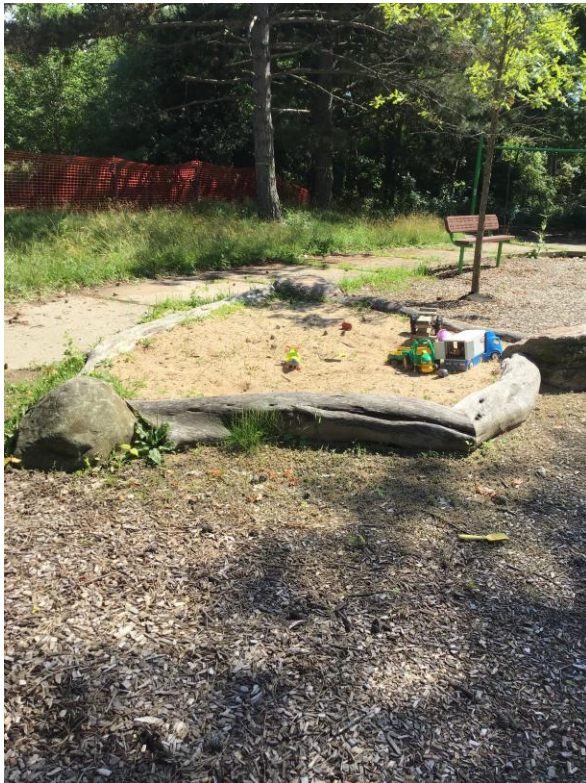
Play Area: Sand Pit

As Built:

No accessible route to sand pit.

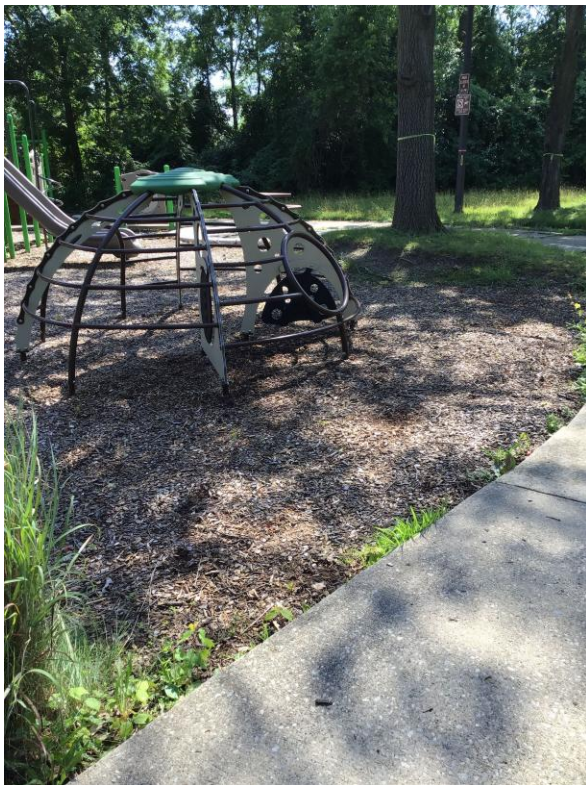
Play Area: Play Area

As Built:

No accessible route to play area.

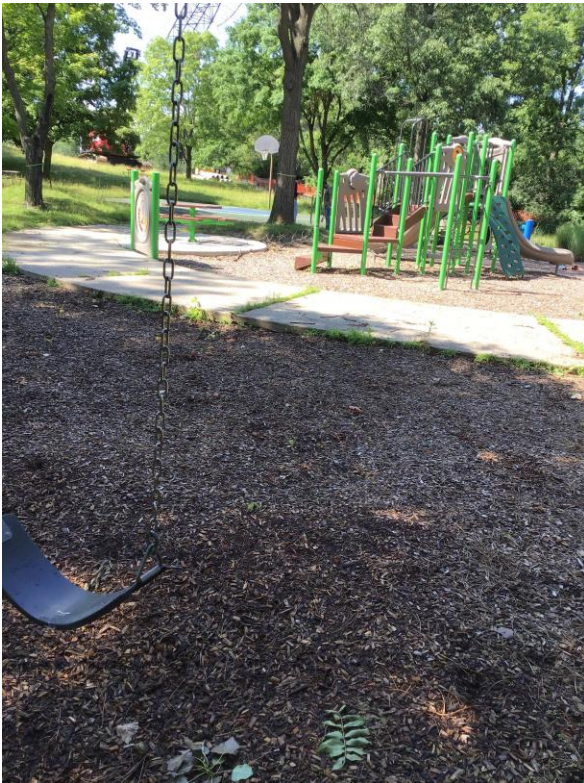
Play Area: Swing Set

As Built:

No accessible route to swing set.

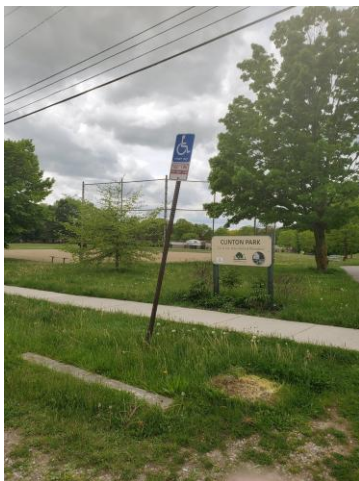
Parking: Parking LOt

As Built:

gravel parking lot

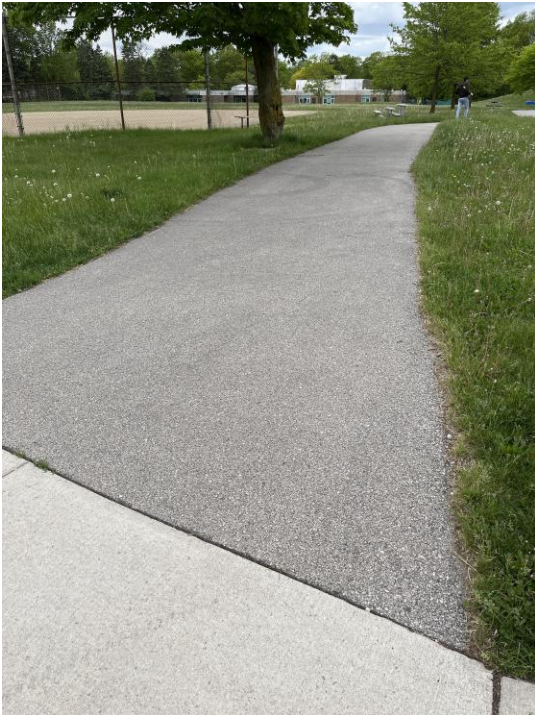
Green Space: Sidewalks

As Built:

horizontal opening

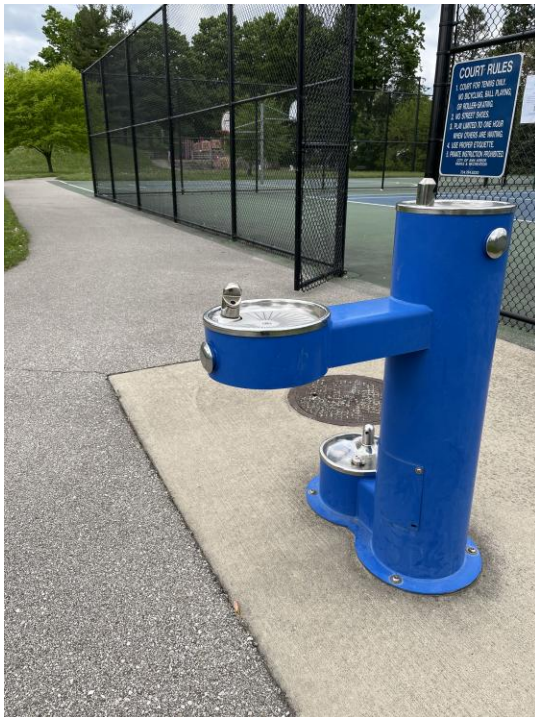
Green Space: Drinking Fountain

As Built:

Lower fountain is 27 1/2 high

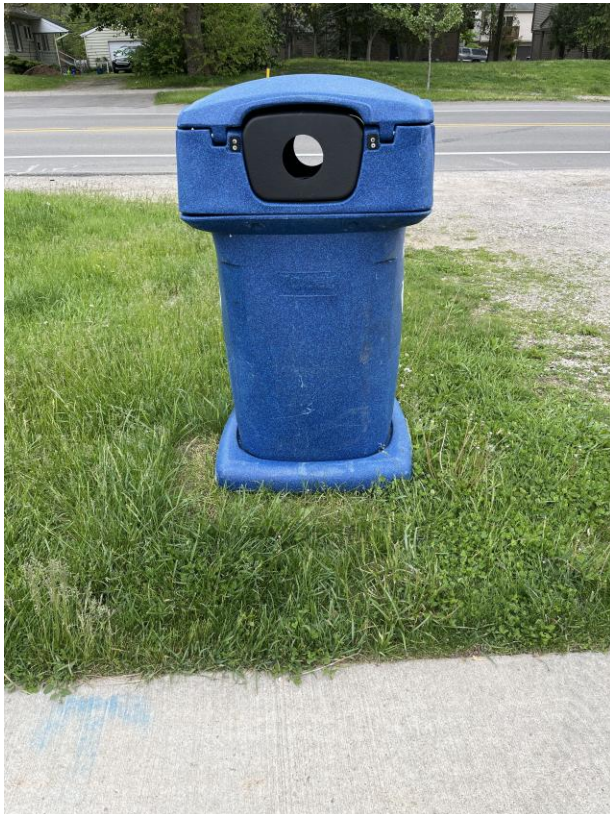
Green Space: Receptacle

The accessible route contains loose gravel and/or surface materials that do not provide for a stable, firm slip resistant surface.

As Built:

Surface is grass

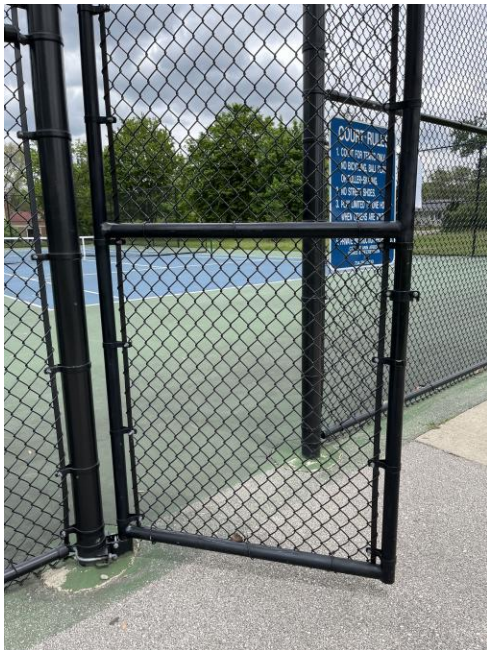
Tennis Court: Entrance

As Built:

gate has no smooth surface

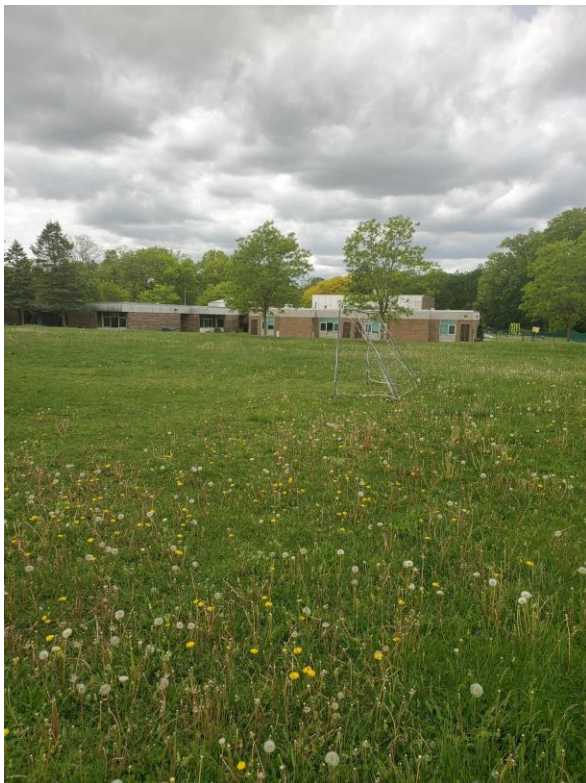
Soccer Field: Route

As Built:

grass surface

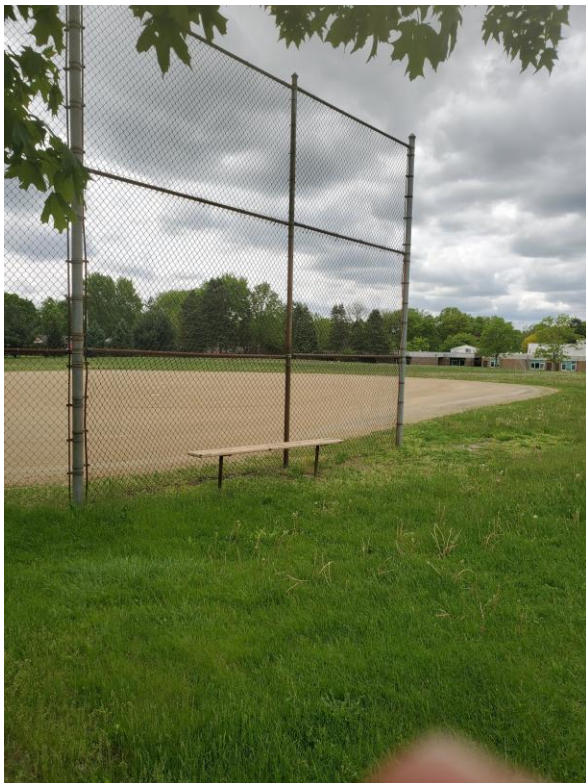
Baseball Field: Dugouts

As Built:

grass surface

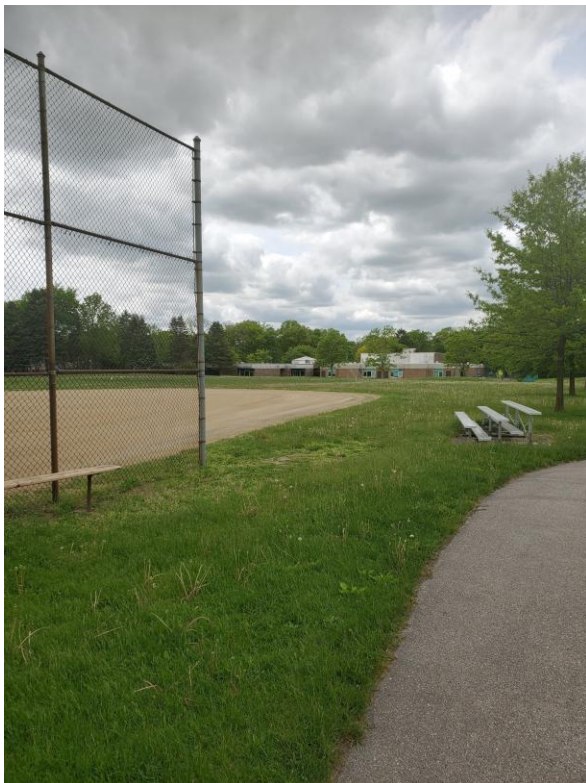
Baseball Field: Route

As Built:

grass surface

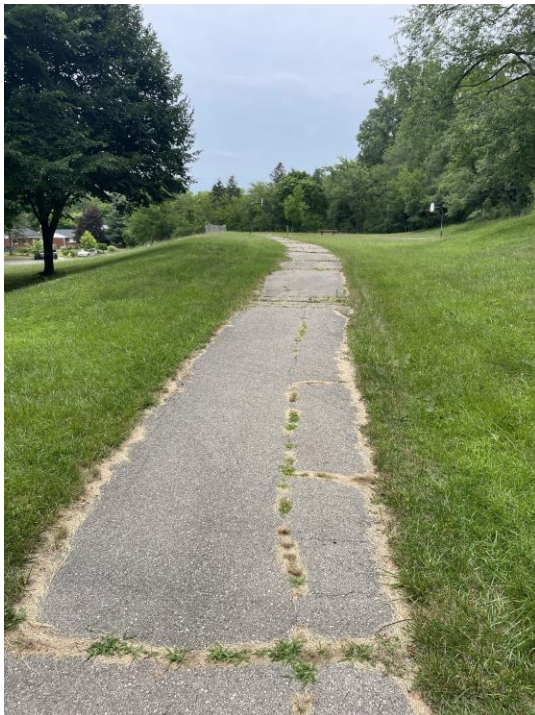
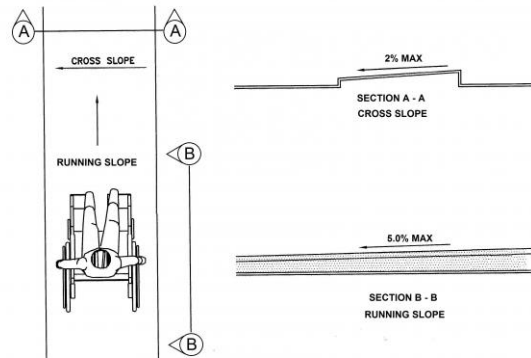
150 LF

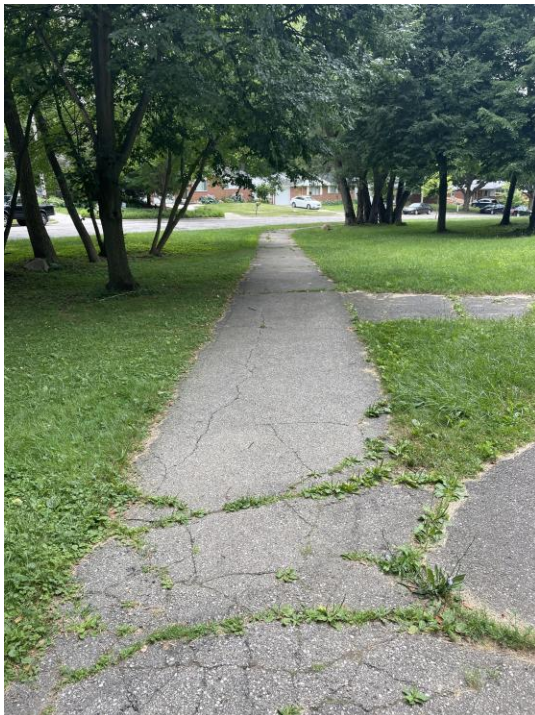
300 LF

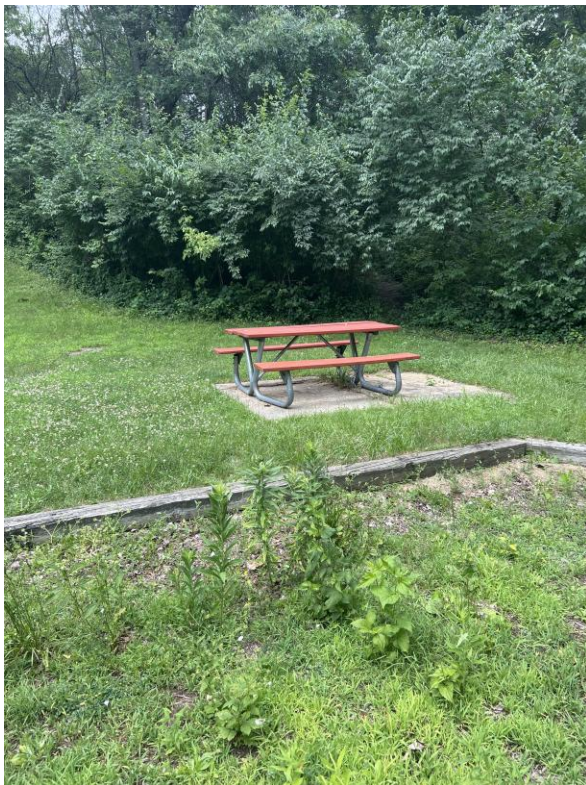
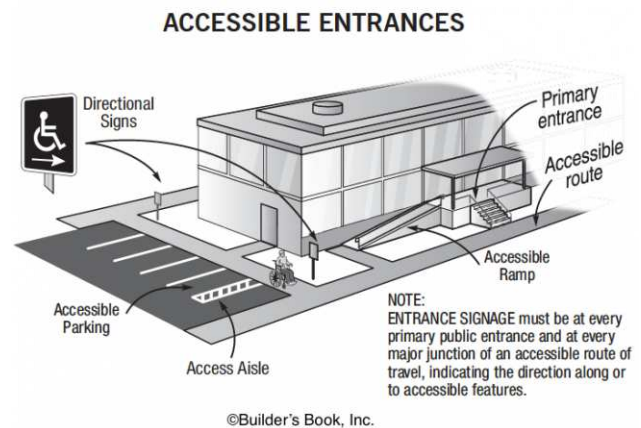
No accessible route to the picnic table.

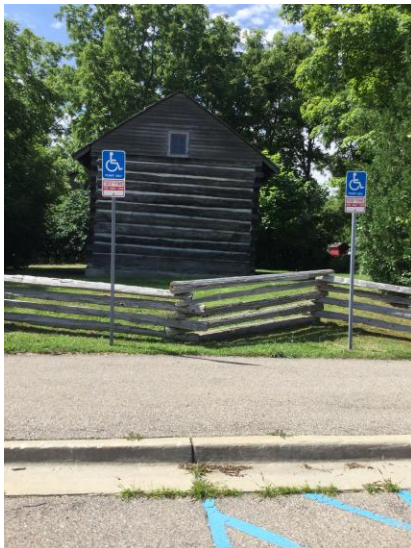
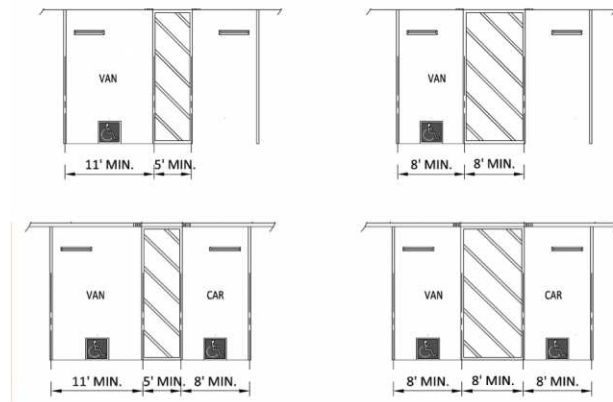
Finding: 1 - Van Stall Missing

10' stall width

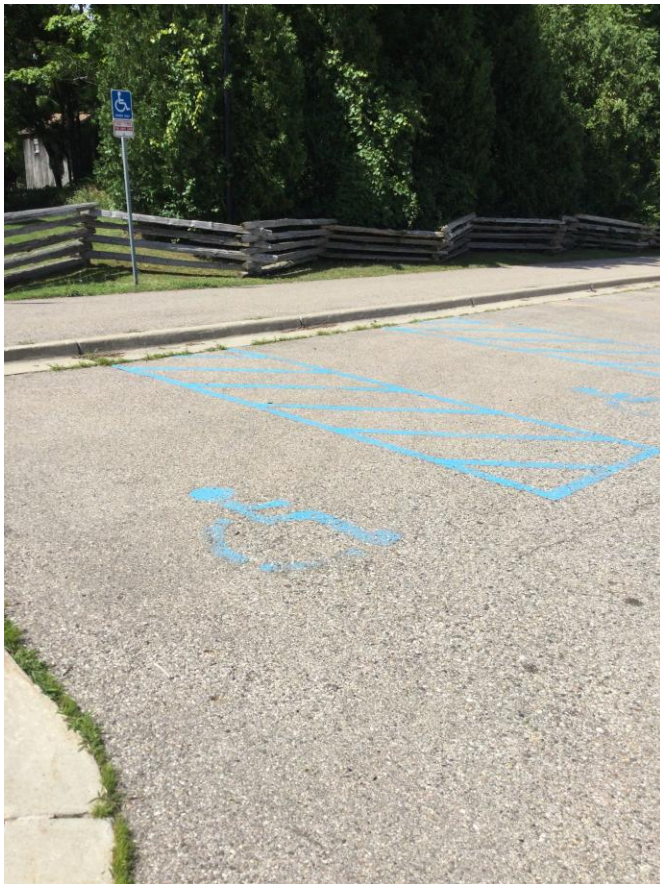
The striping and markings for the accessible parking stall, loading/unloading access aisle are dilapidated and in need of repair and/or maintenance.

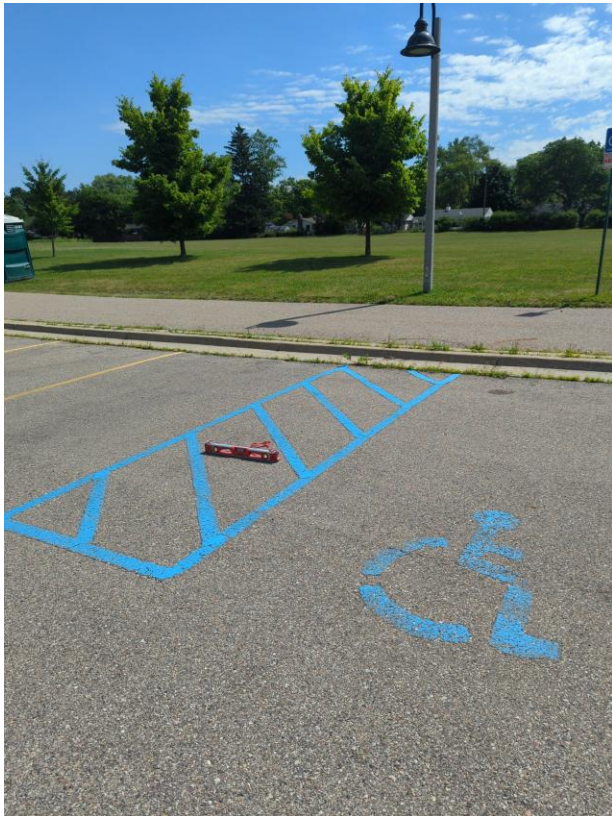
Cross slope is up to 3% on the left space facing the baseball field

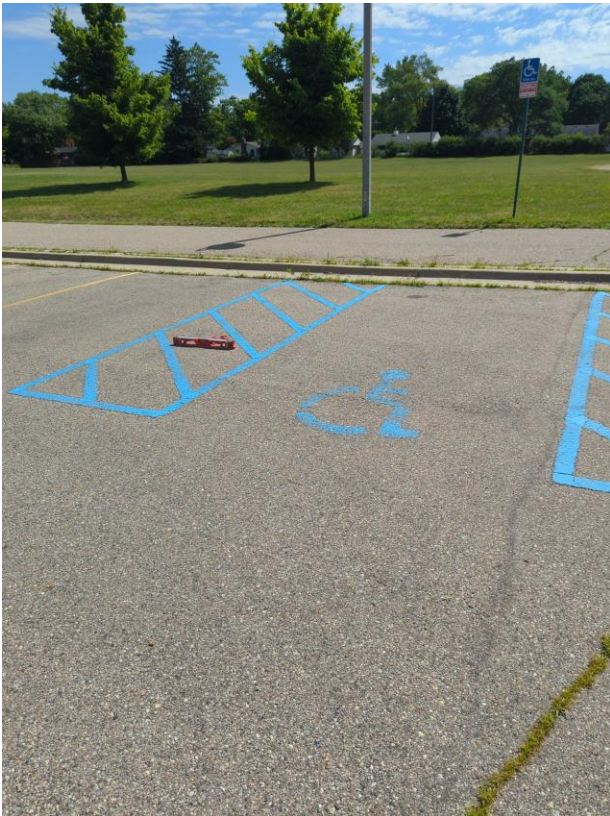
Cross slope is up to 4% on the left space facing the baseball field

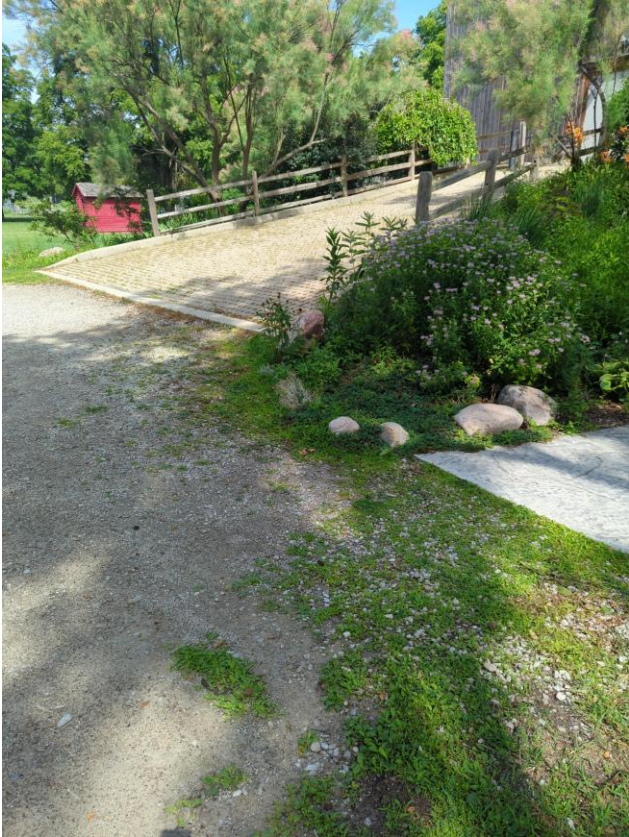
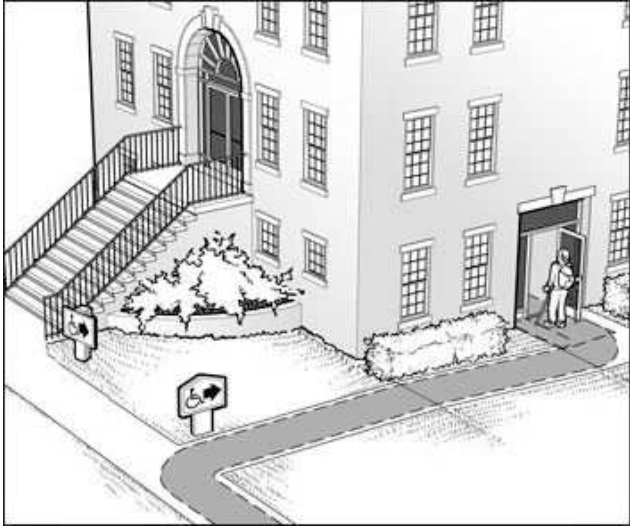
Finding #5 Continued

No accessible route to access ramp from parking lot

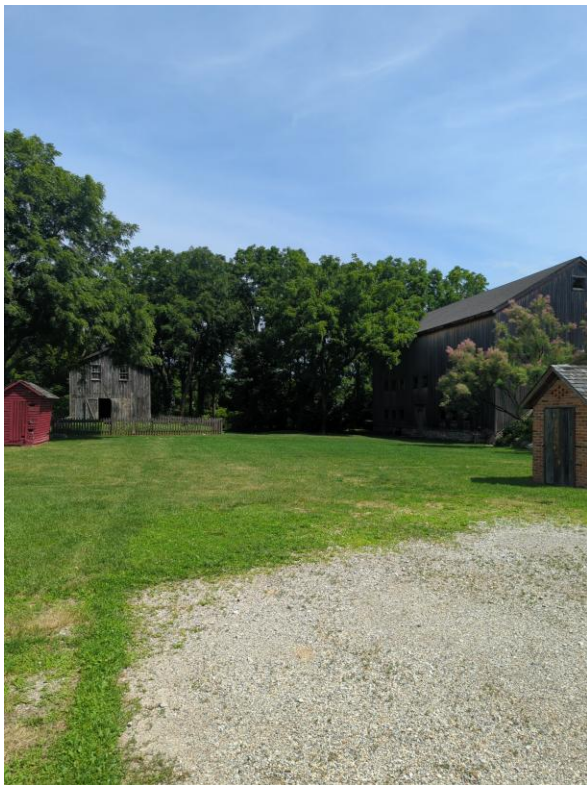
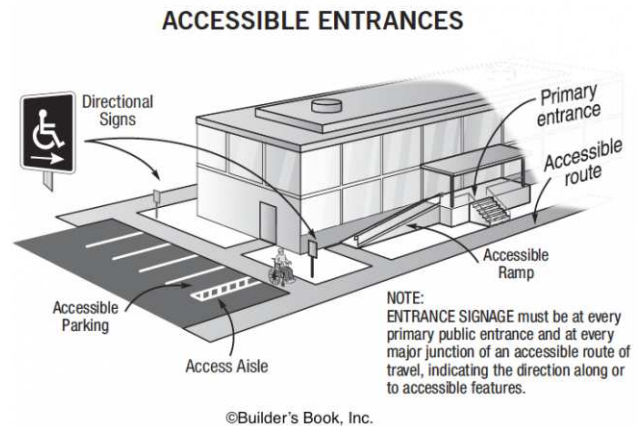
No accessible route connecting multiple buildings and elements located at the site

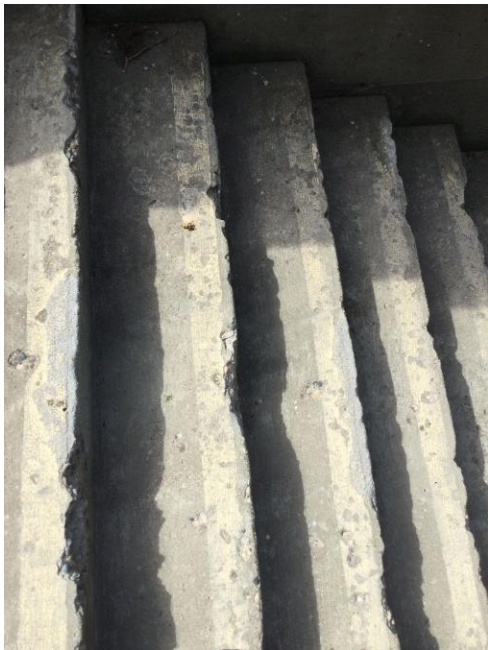
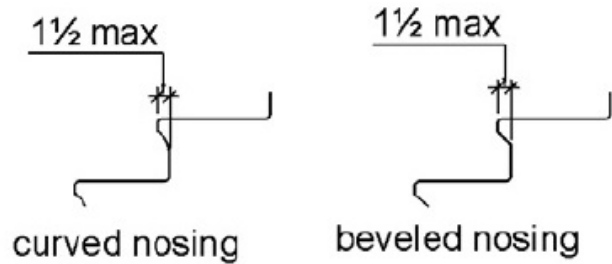
Nosing is not uniform

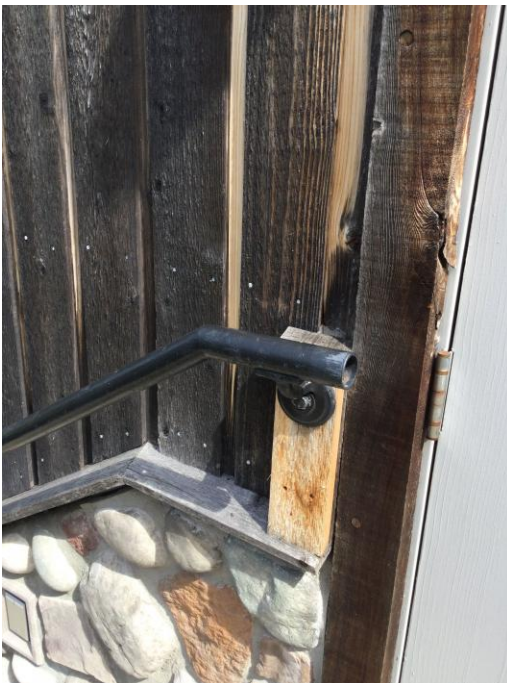
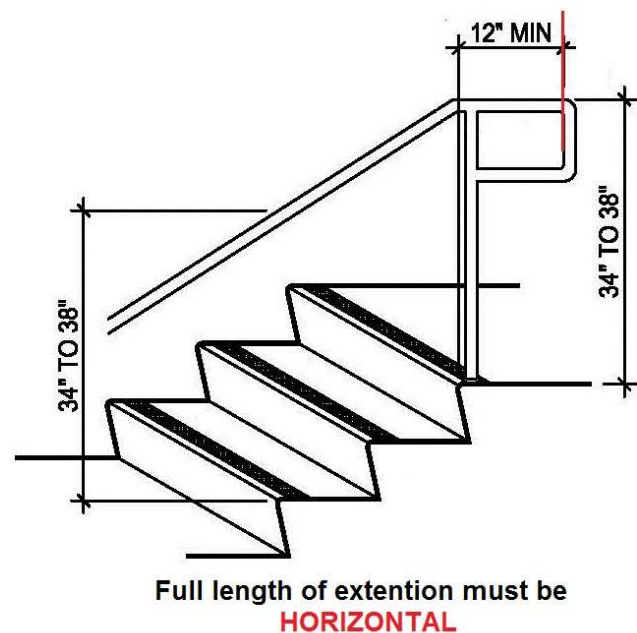
10" extension

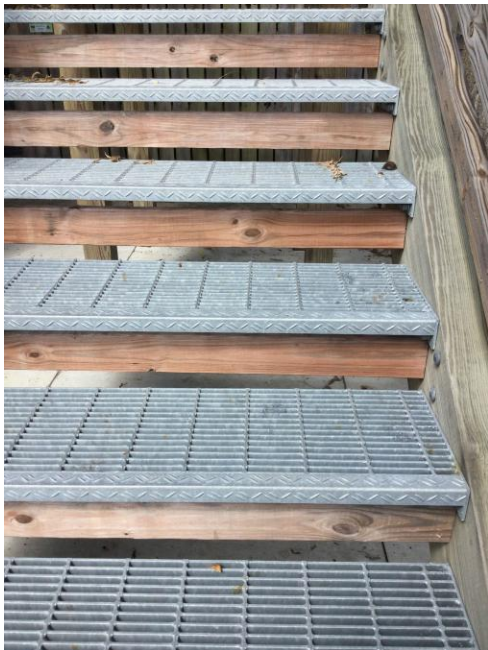
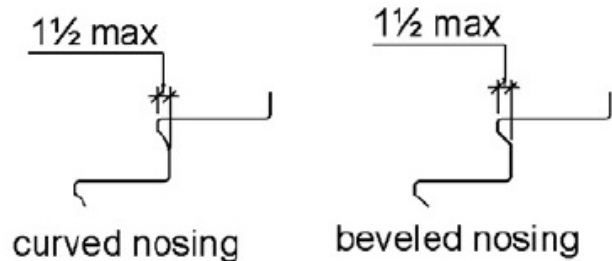
Square nosing

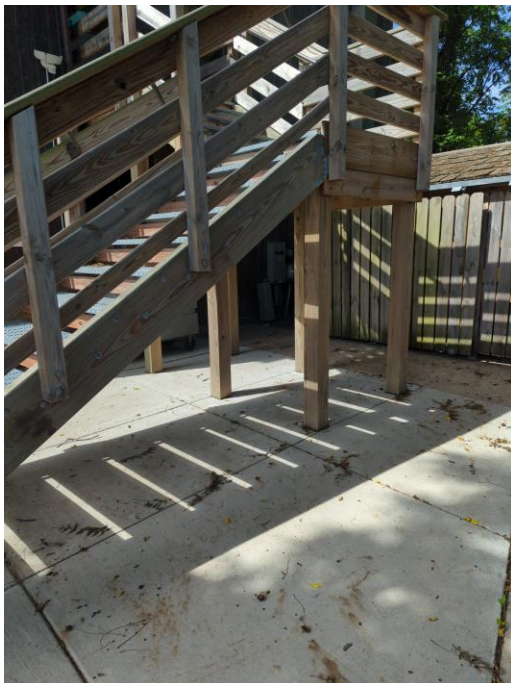
Bottom of stairs is not closed

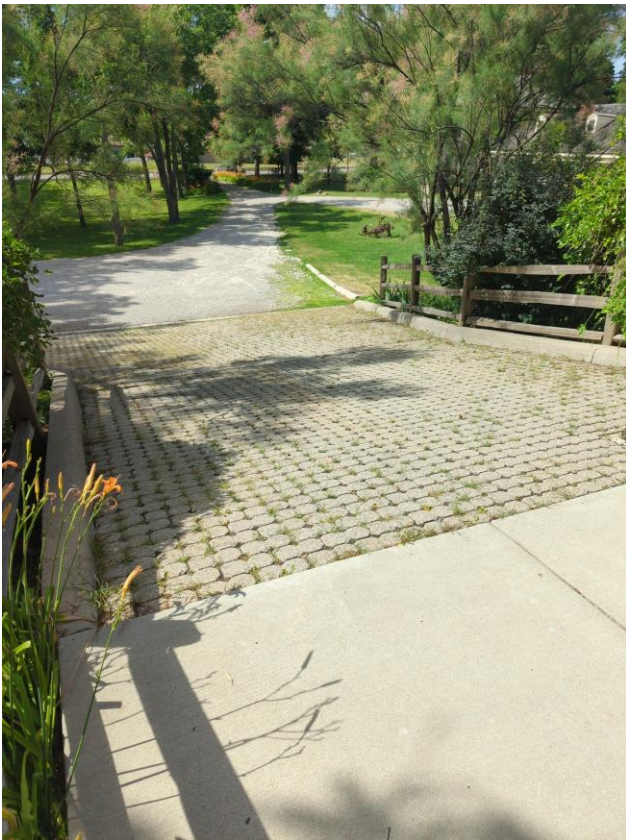
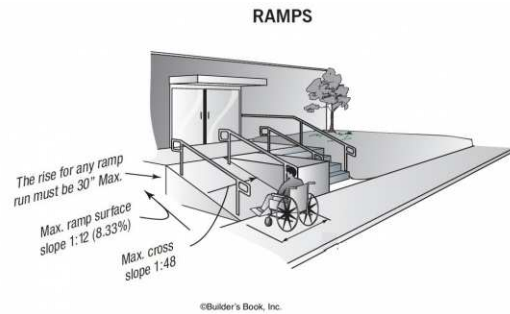
Exterior access ramp to 2nd floor space has a slope of 20%

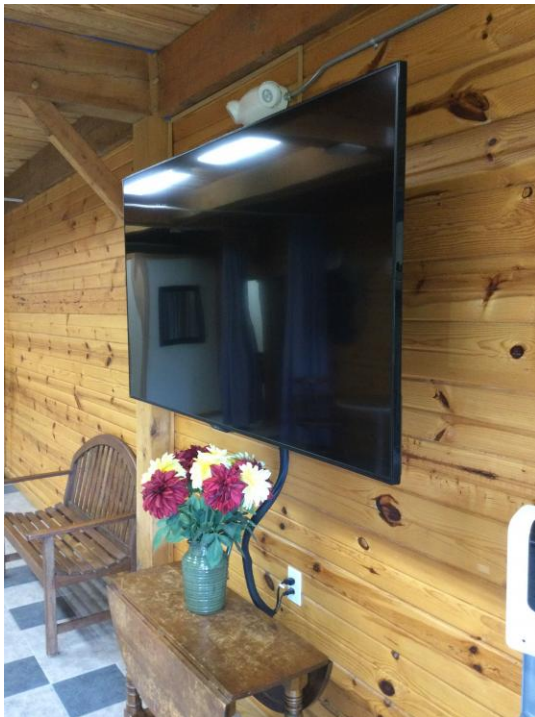
Wall-mounted objects that have leading edges between 27 inches and 80 inches from the floor must not project more than 4 inches into the circulation path. Protruding objects that extend to the floor or within 27 inches of the floor are cane detectable and are therefore not hazardous. Where it is necessary or desirable to have objects protrude from the wall, a manner of cane detection must be provided.

Protruding 16"

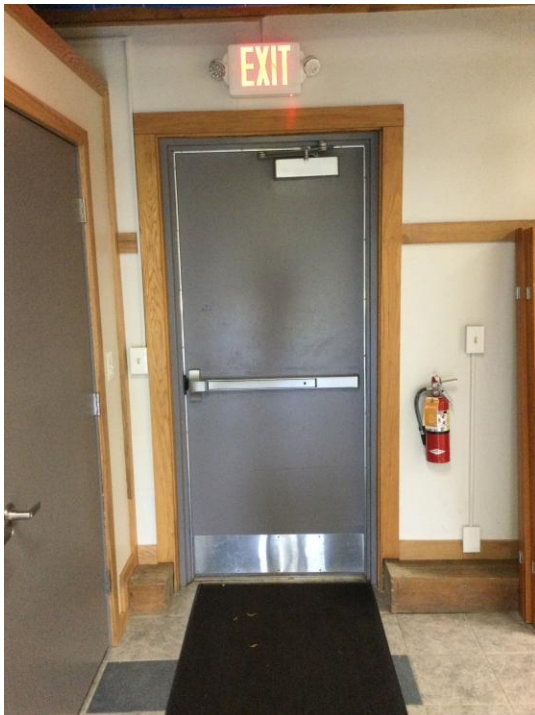
Strike clearance 10"

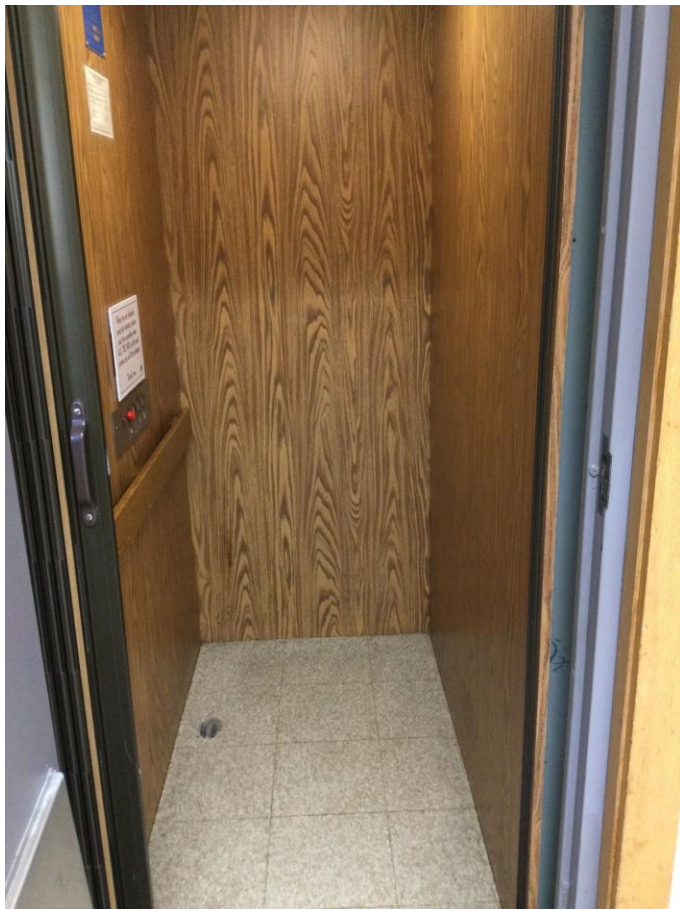
Finding #15 Continued

Opening 28"

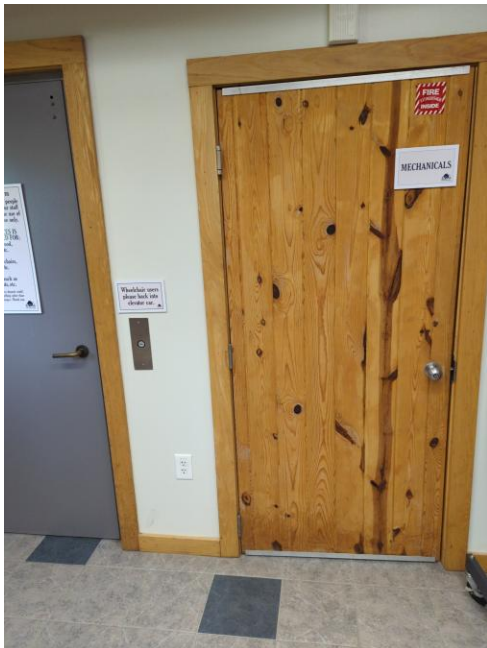
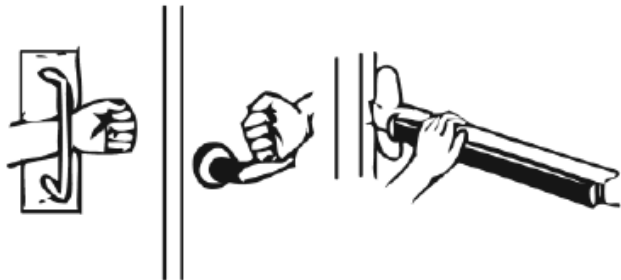
Elevator equipment door has knob-type hardware

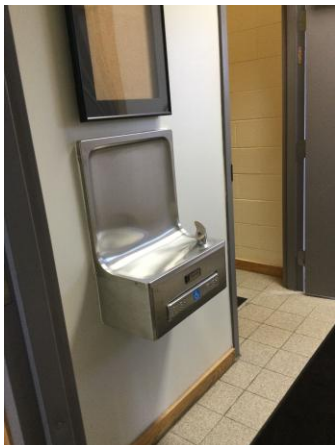
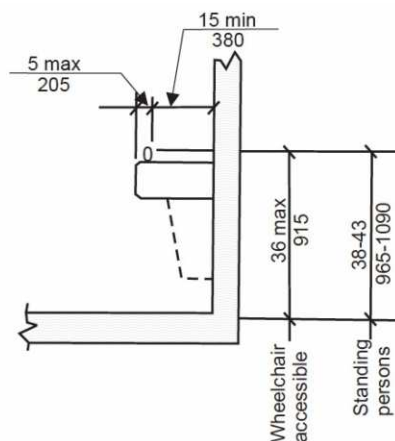
Low provided

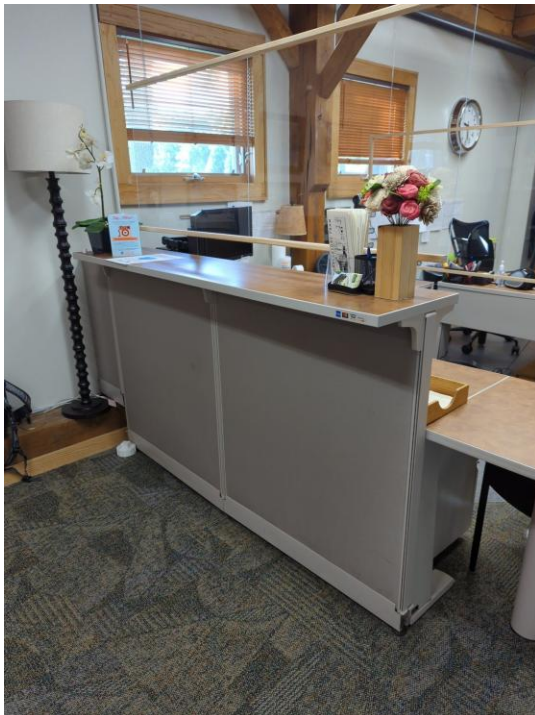
Wall-mounted objects that have leading edges between 27 inches and 80 inches from the floor must not project more than 4 inches into the circulation path. Protruding objects that extend to the floor or within 27 inches of the floor are cane detectable and are therefore not hazardous. Where it is necessary or desirable to have objects protrude from the wall, a manner of cane detection must be provided.

Counter protrudes 7-1/2 inches from partition

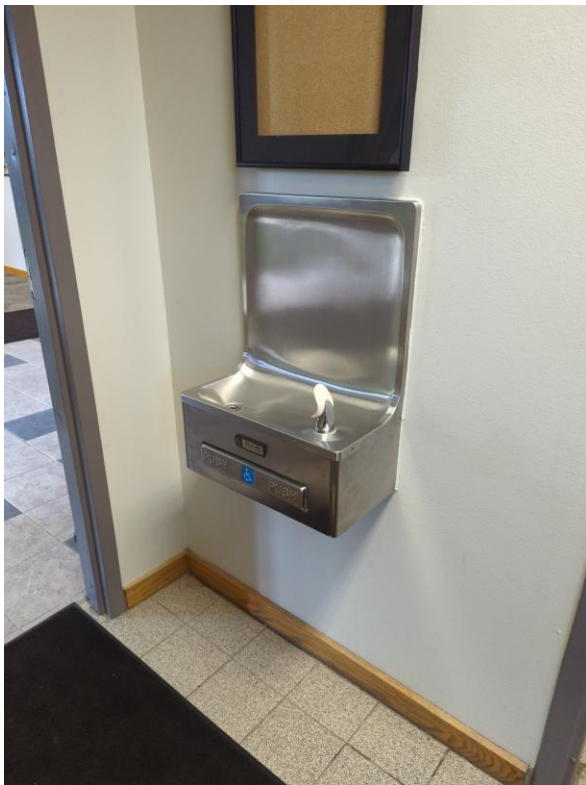
Low drinking fountain does not have the required depth or height for a forward approach

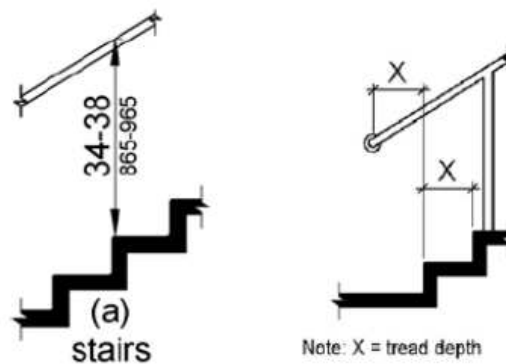
Finding #21 Continued

Compliant handrails are missing in the stairs connecting first and second floors

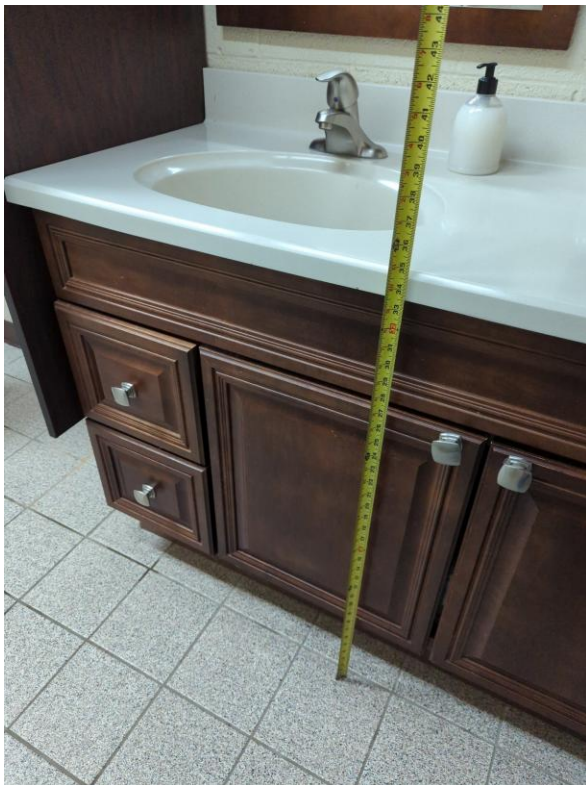
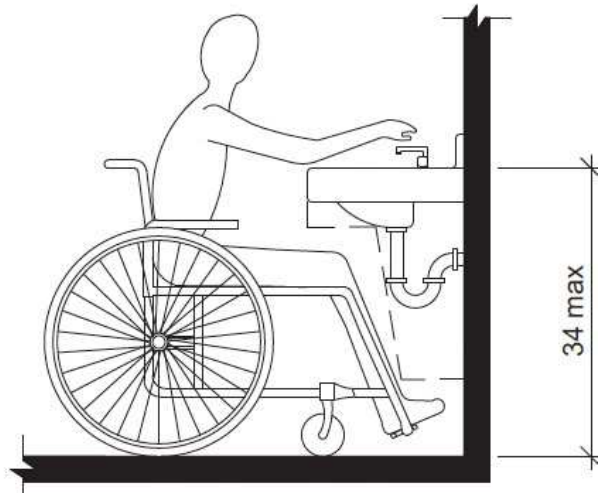
Lavatory height is 35 inches

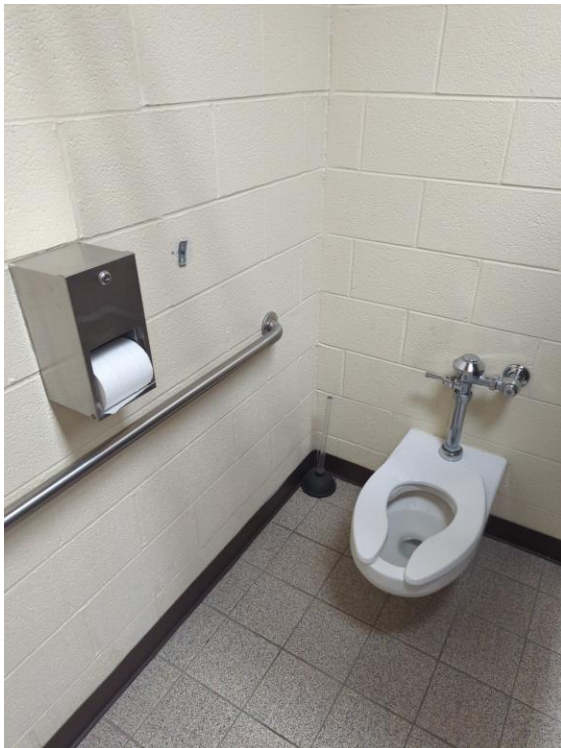
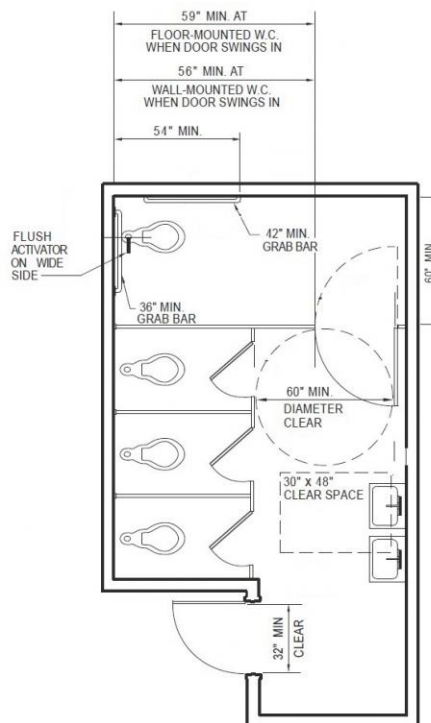
The stall does not have the required minimum clear floor space or maneuvering clearances for the toilet, Grab bars are missing and/or incorrectly installed, accessories, such as toilet seat covers, toilet paper holders, and garbage cans are either too high, without clear floor space or both, the floor level changes greater than a 1/2 inch at the floor drains.

Toilet stall is not compliant

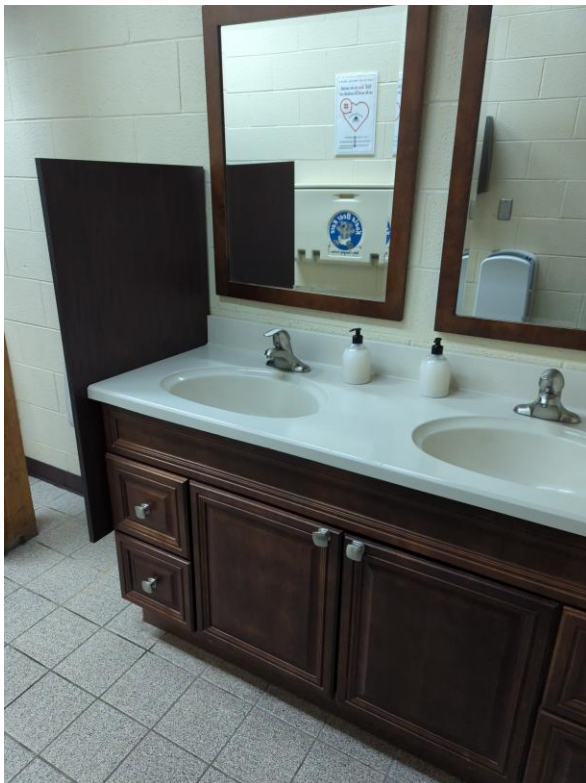
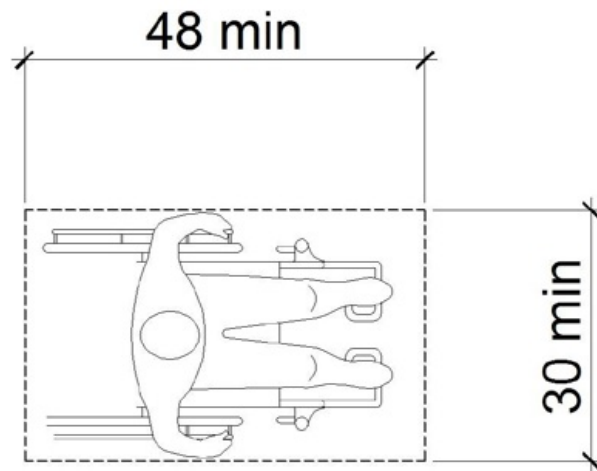
Clear floor space is not provided for a forward approach; only one is required.

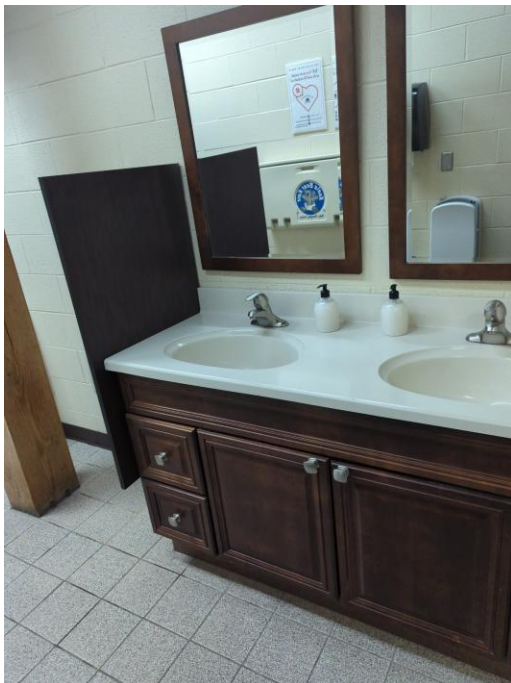
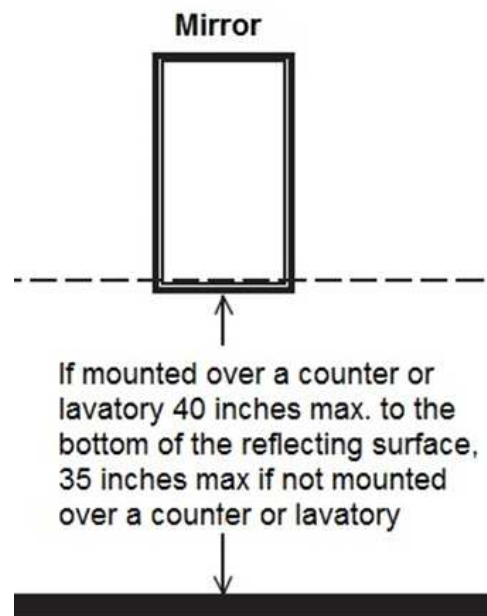
Mirror is 43 inches high to the reflective surface

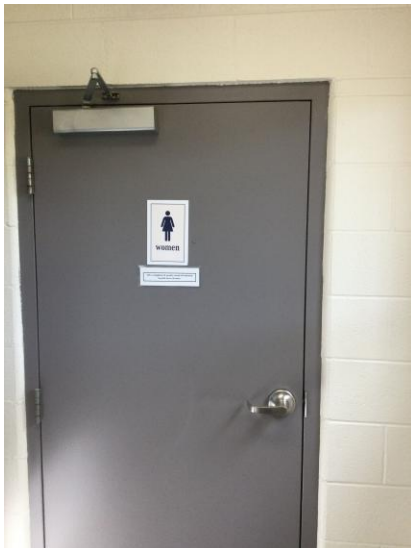
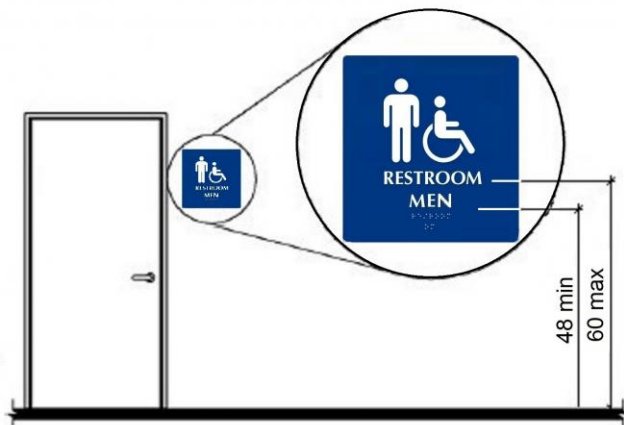
A compliant room identification sign is missing on the strike side of the door.

Located on door

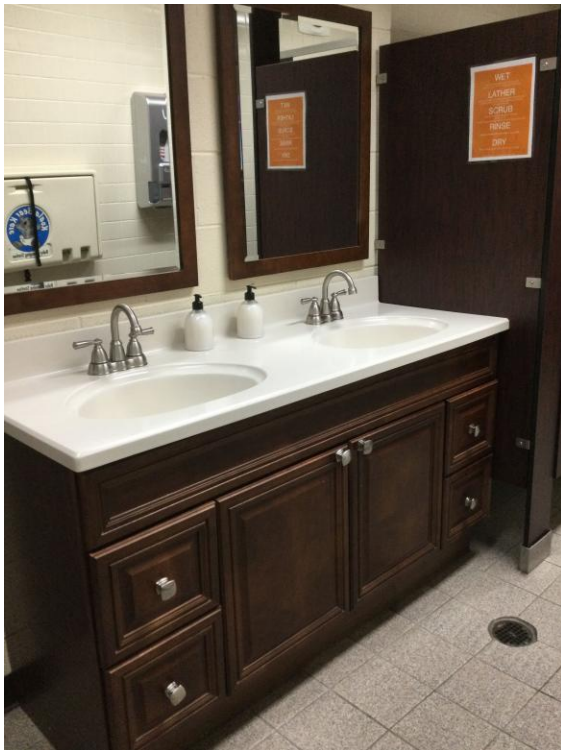
Cabinet under sinks

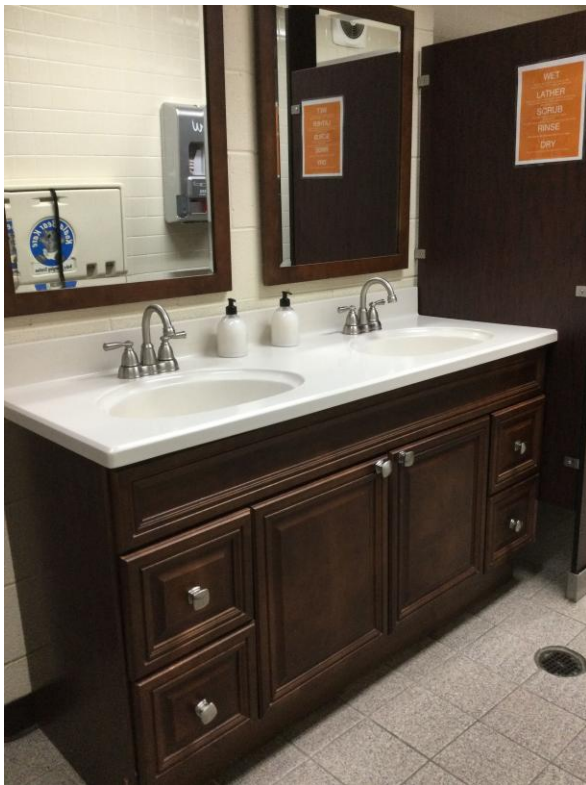
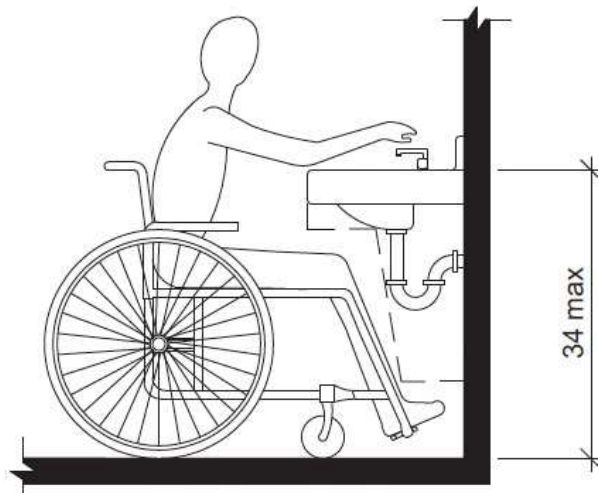
Rim 35"

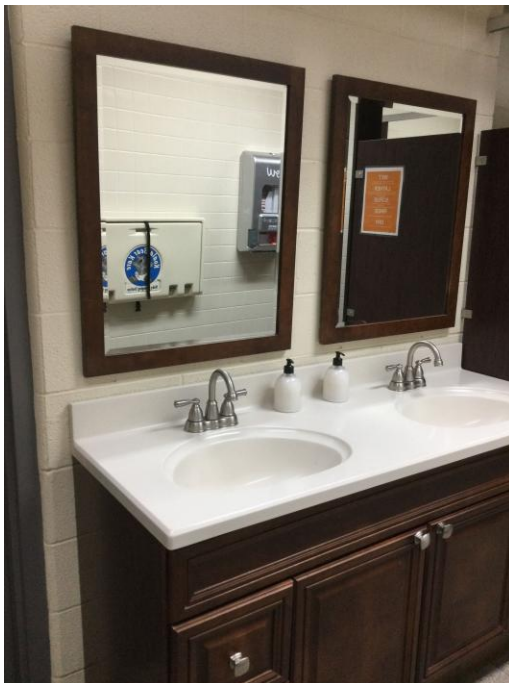
Mounted 44"

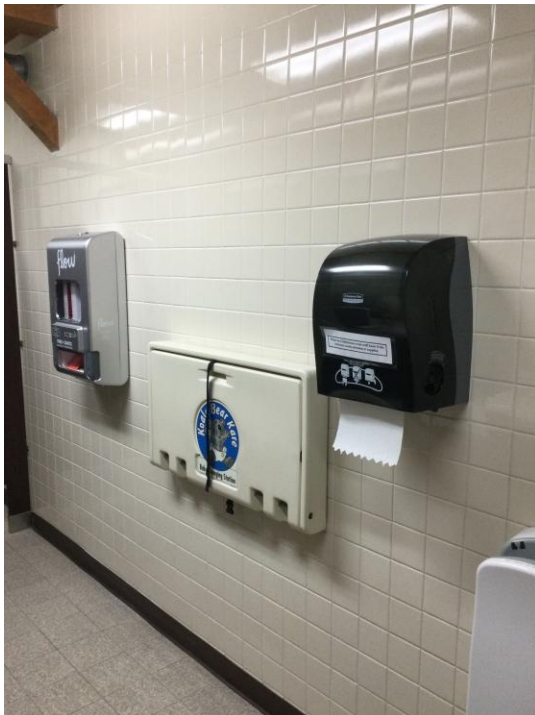
9" protruding
