Site Accessibility Evaluation

Allmendinger Park
655 Pauline Blvd
Ann Arbor, MI 48104
ADA Only

Inspection Date: 07/11/2022

Report Date: 11/15/2022

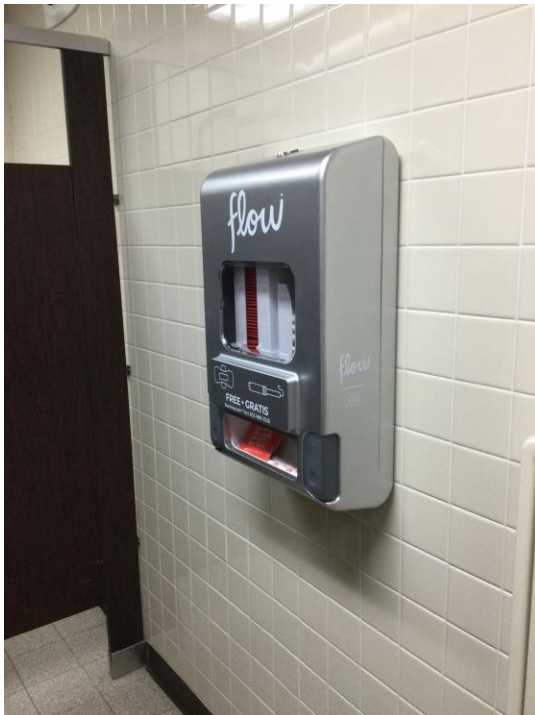
7" protruding

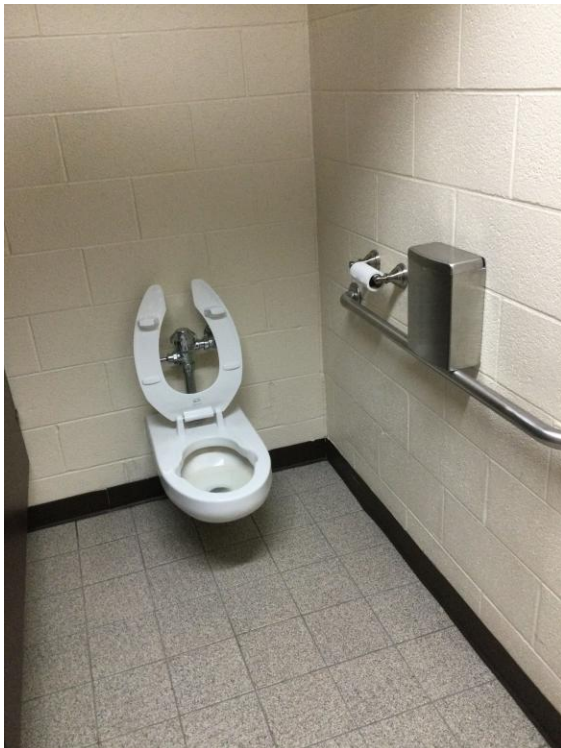
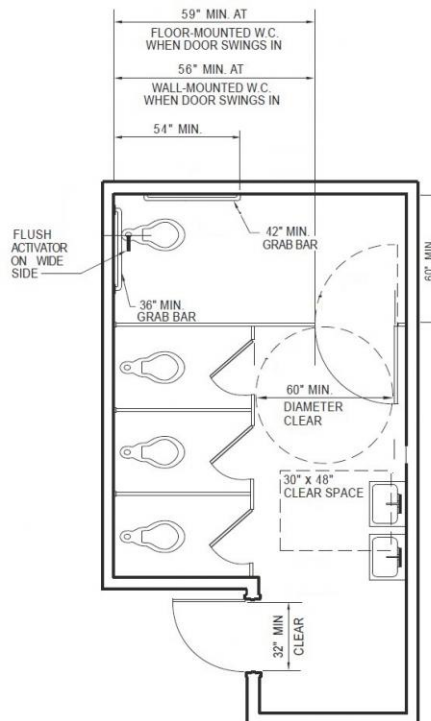
The stall does not have the required minimum clear floor space or maneuvering clearances for the toilet, Grab bars are missing and/or incorrectly installed, accessories, such as toilet seat covers, toilet paper holders, and garbage cans are either too high, without clear floor space or both, the floor level changes greater than a 1/2 inch at the floor drains.

Not compliant

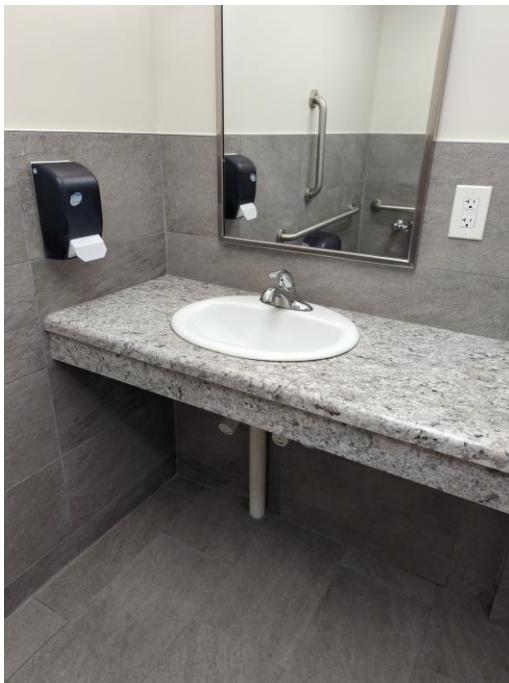
Mirror is 41 inches high to the reflective surface

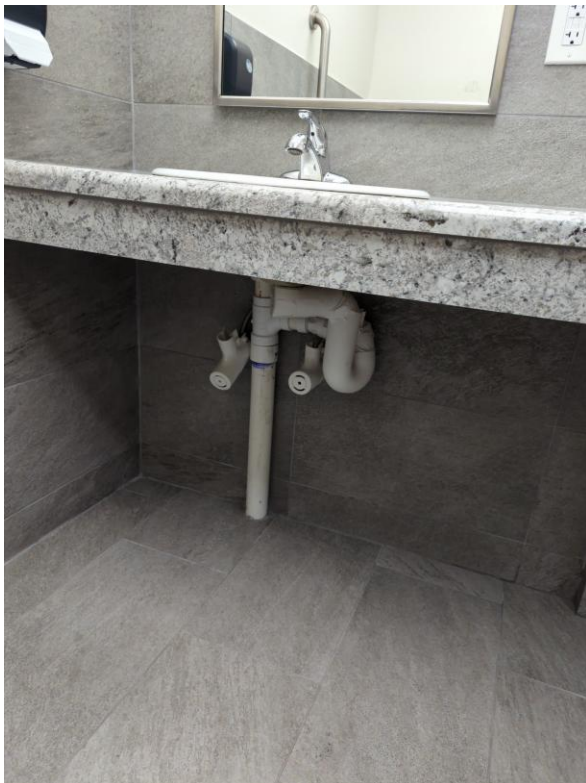
Vertical pipe is not insulated

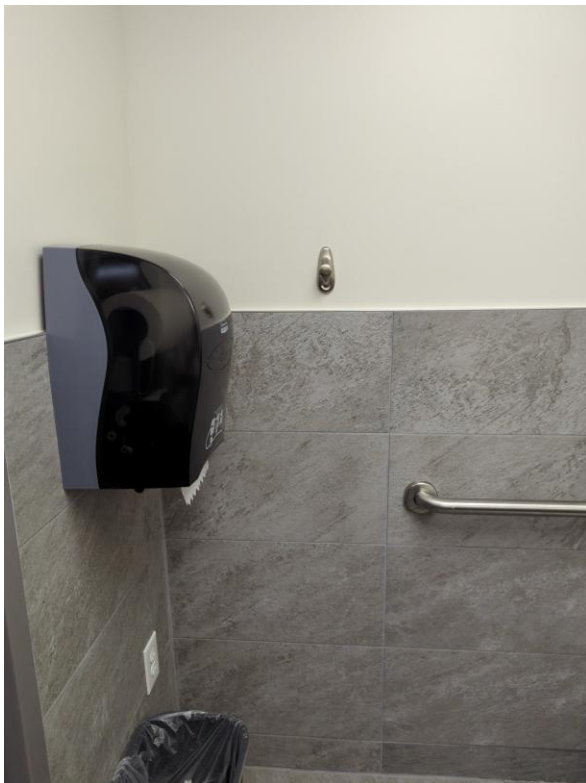
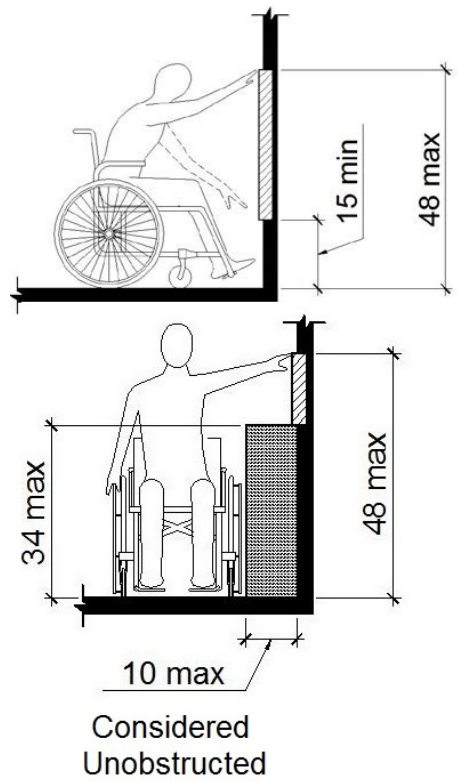
Coat hook is 56 inches high

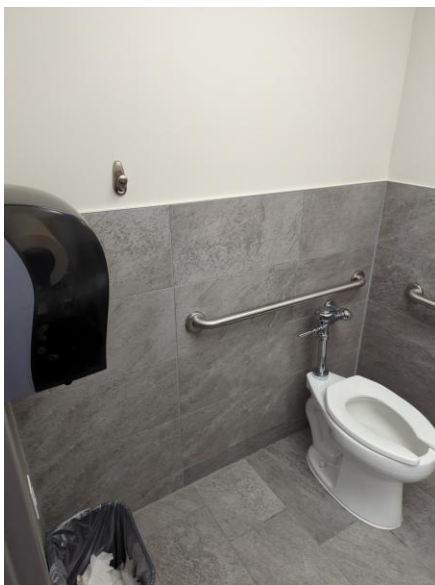
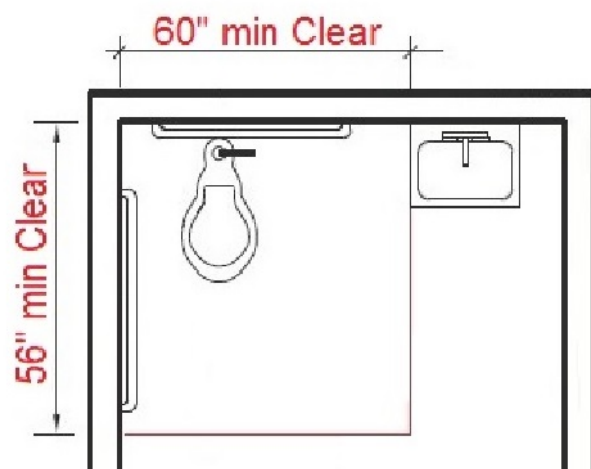
Paper towel dispenser inside clear floor space, 57 inches from side wall

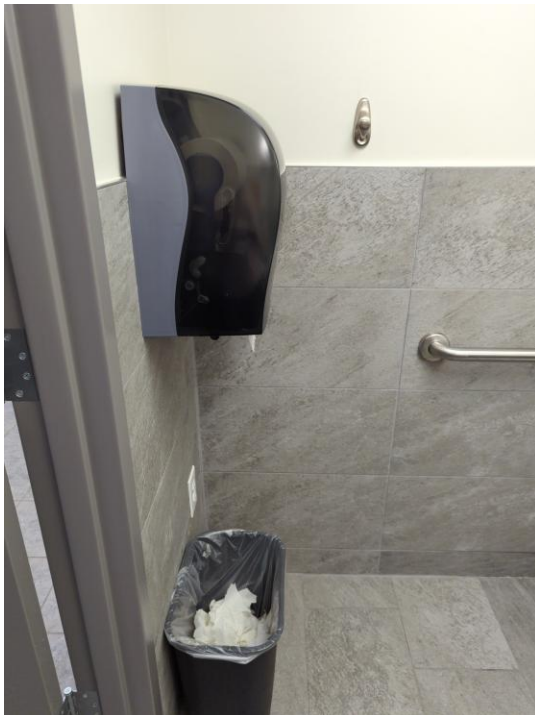
Paper towel dispenser protrudes 10 inches

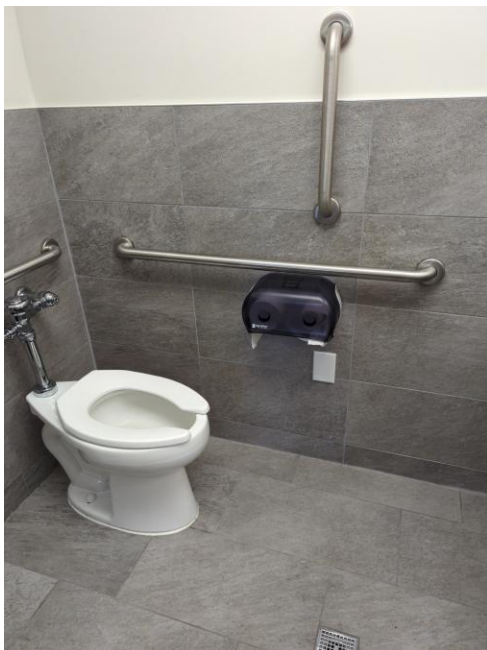
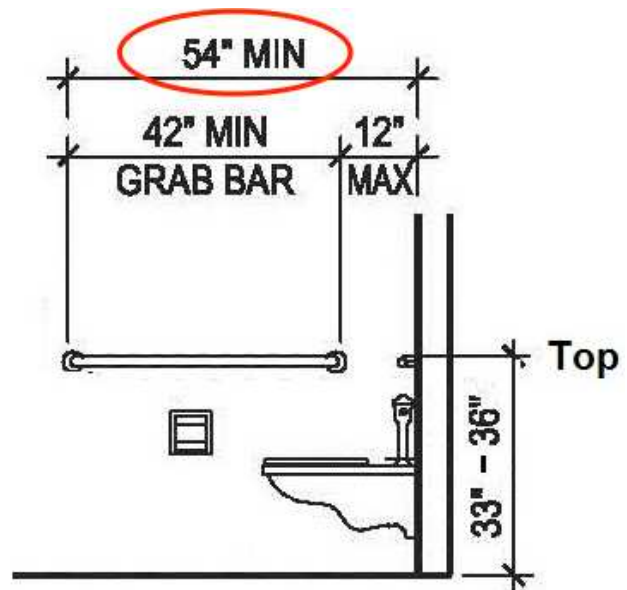
Side grab bar is 10 inches from back wall, and extends to 52 inches.

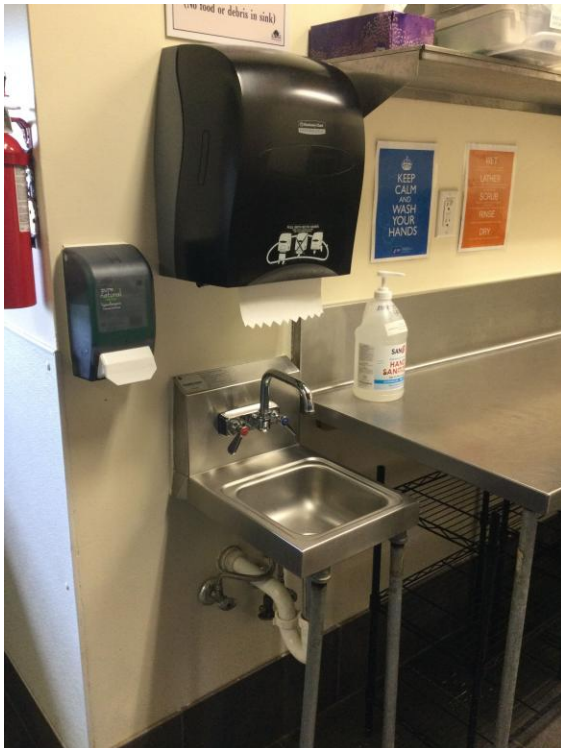
53" to operable part

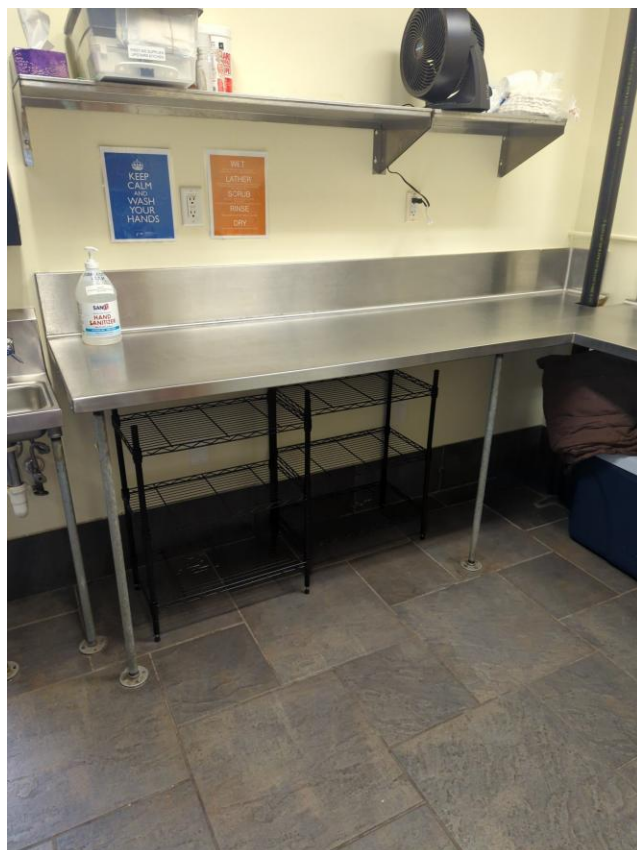
The work counter is 38 inches high

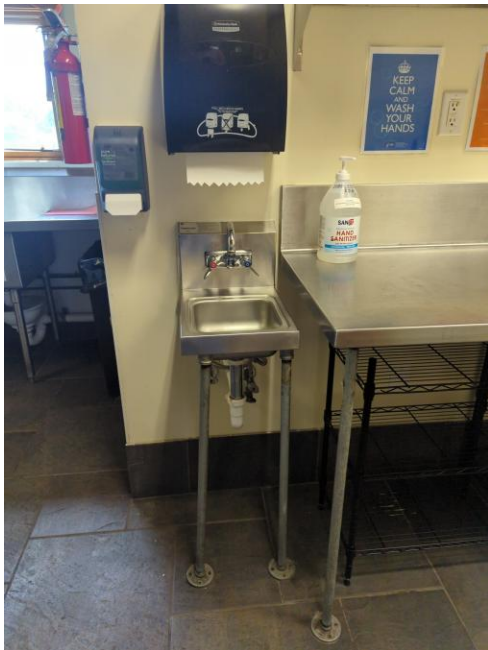
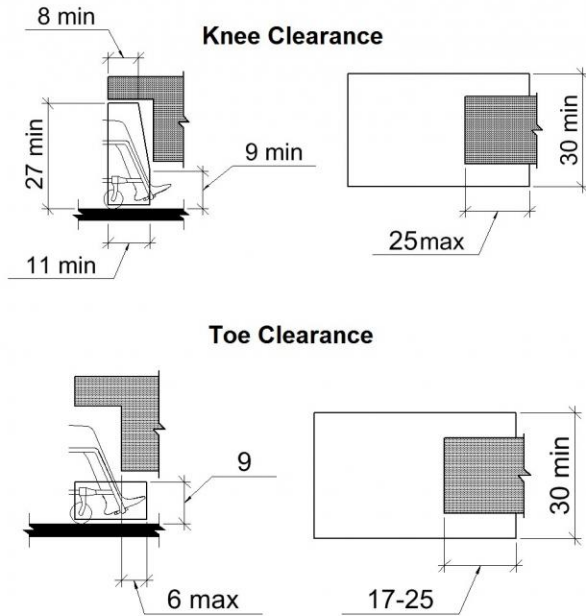
Hand sink does not have a required clear floor space

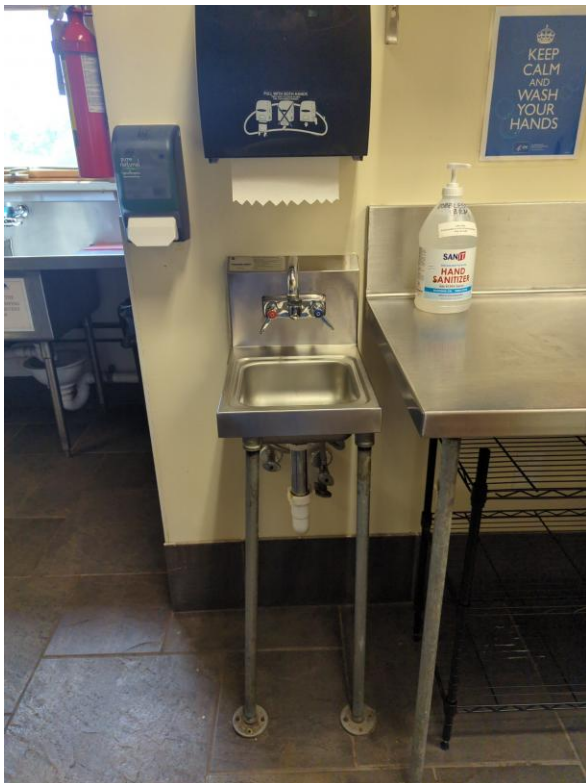
Hand sink does not have insulated pipe covers

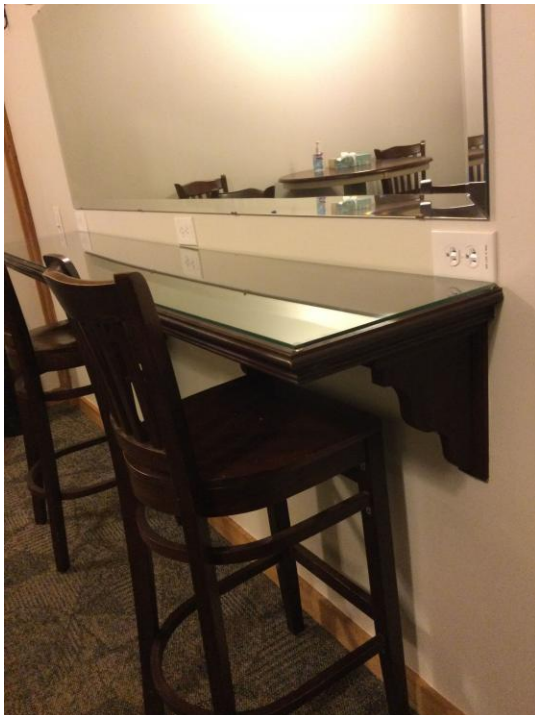
Ledge protrudes 15"

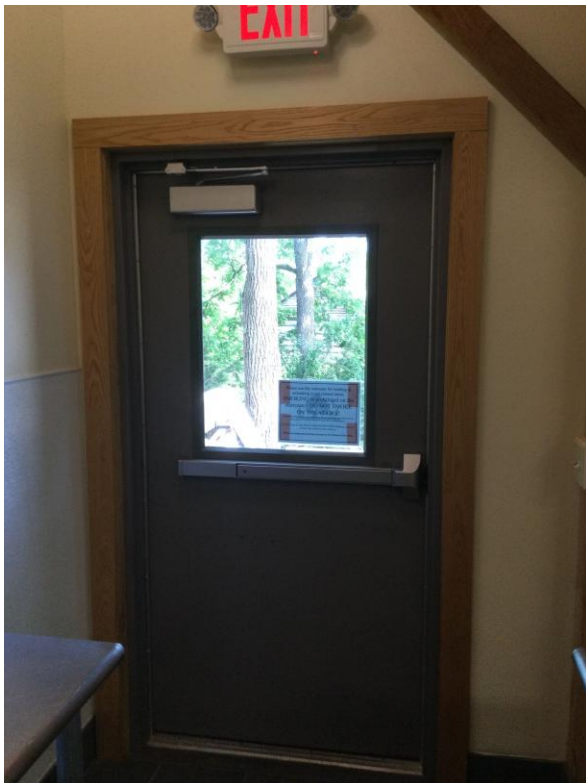
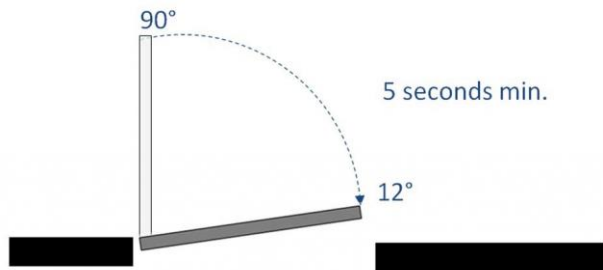
Too fast

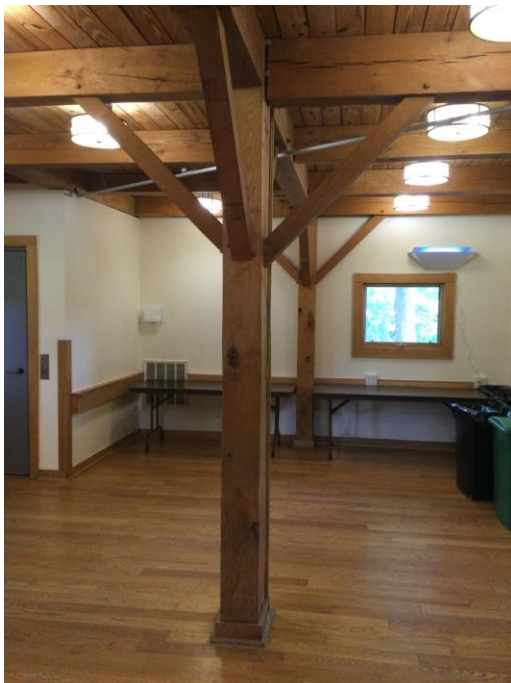
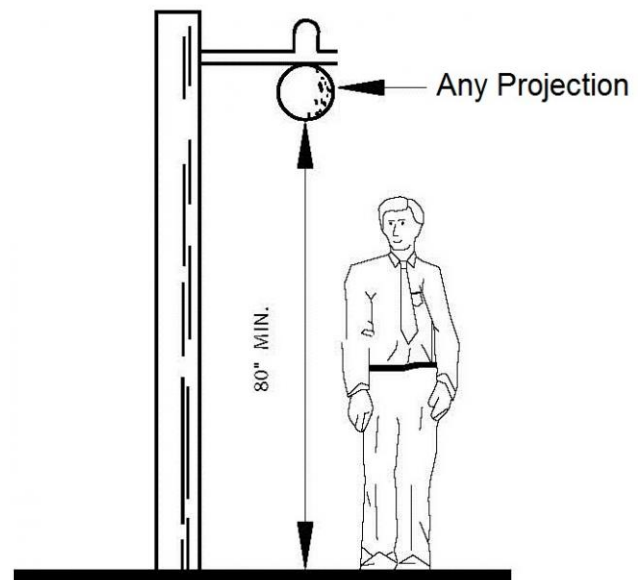
Bracing structure 73"

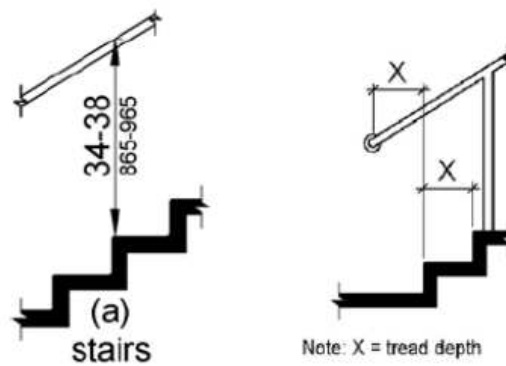
Finding #48 Continued

Compliant handrails are missing in the stairs connecting second floor and mezzanine

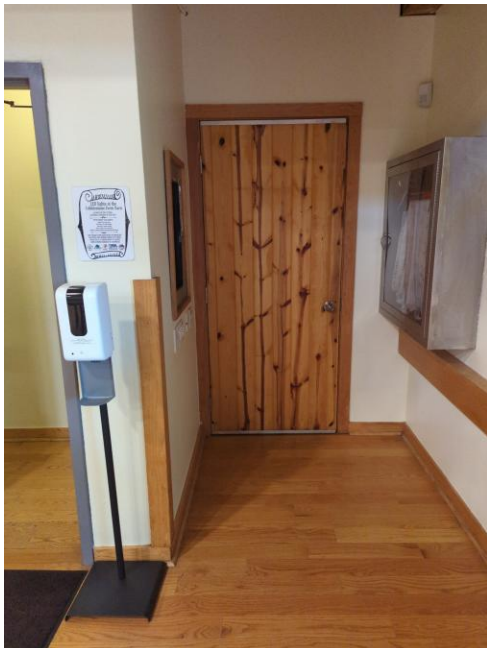
Door to storage from by stairs has knob-type hardware

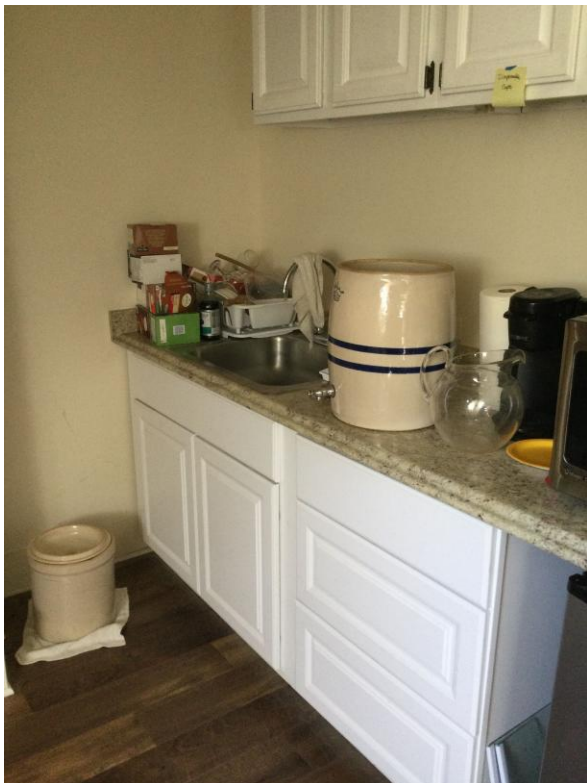
Rim height 36"

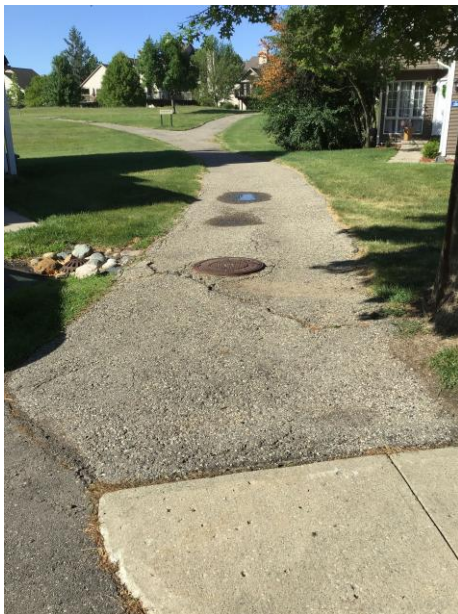
At trail entrance, the trail surface has changes in level due to surface cracks.

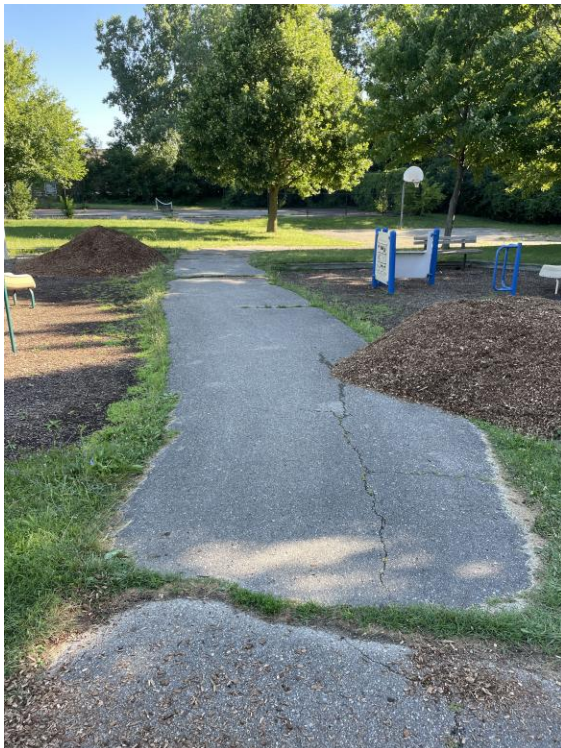
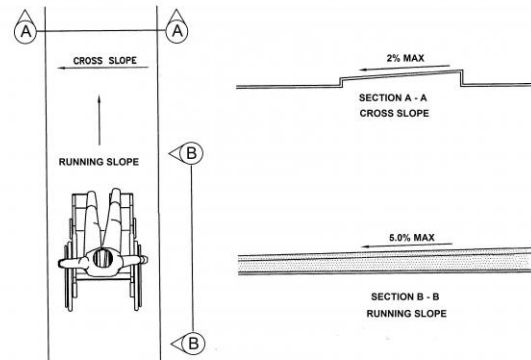
Excessive cross slope and changes in level

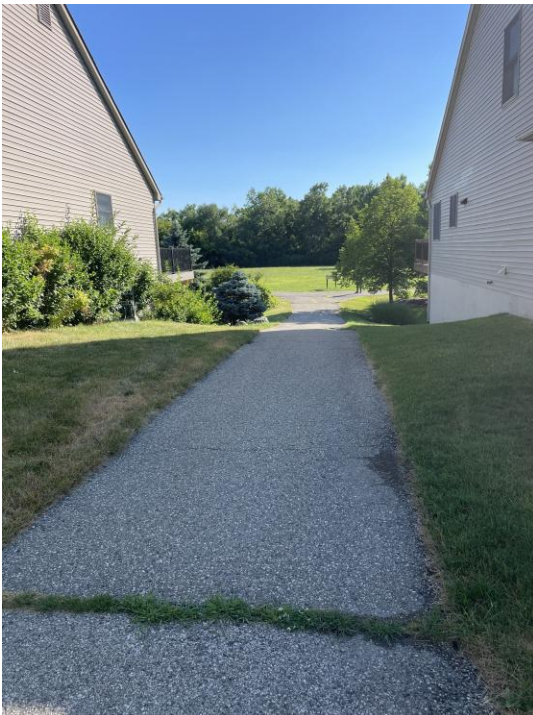
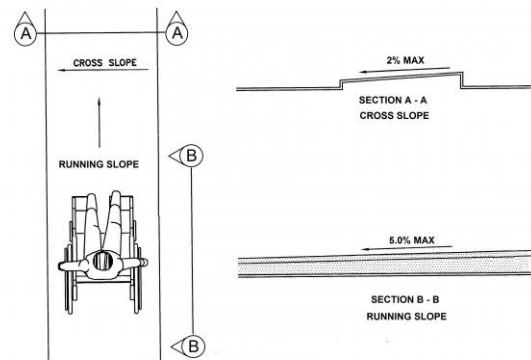
Excessive running and cross slope

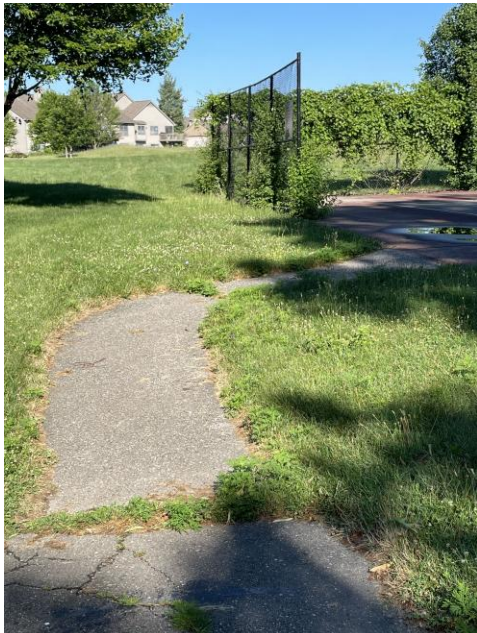
Excessive running and cross slope

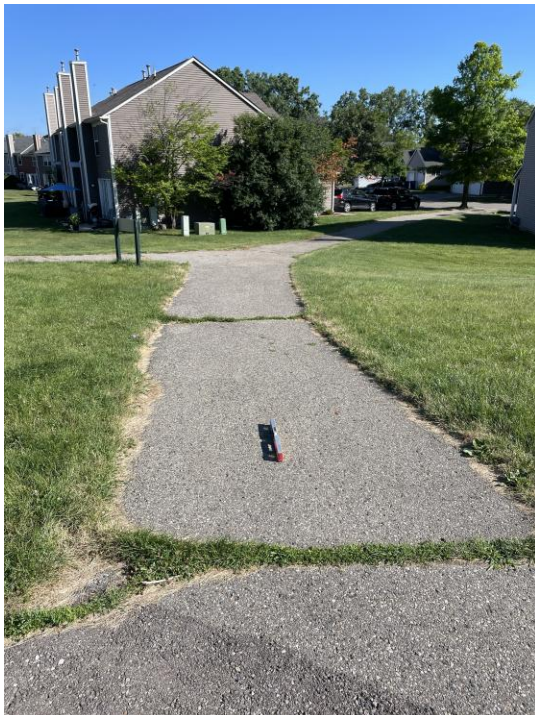
Excessive running slope and changes in level

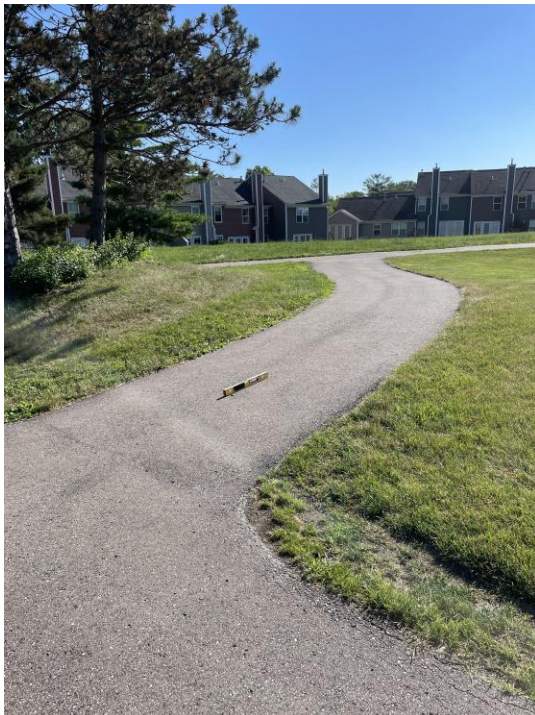
Excessive running slope

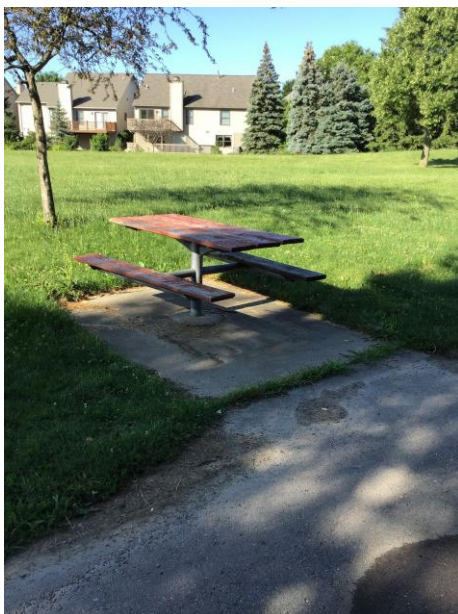
Route from trail to table has a change in level due to vegetation.

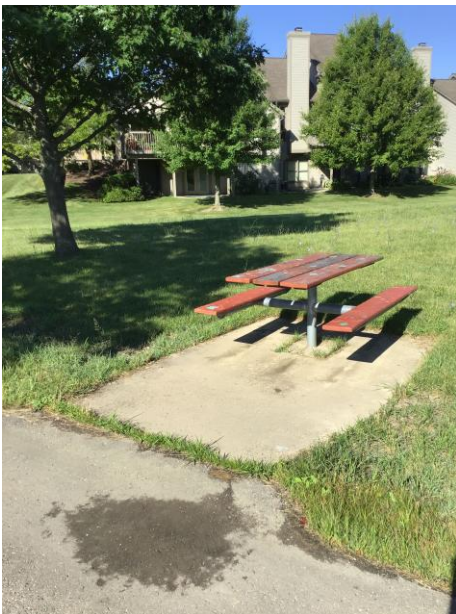
Route from trail to table has vertical change due to vegetation.

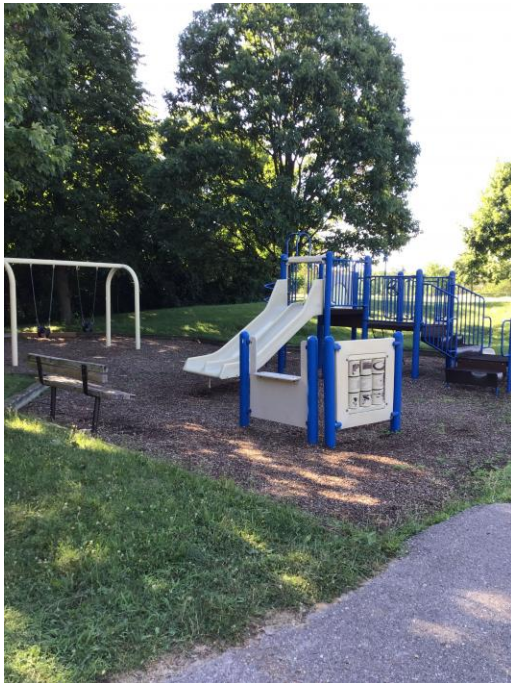
No accessible route into play area is provided.

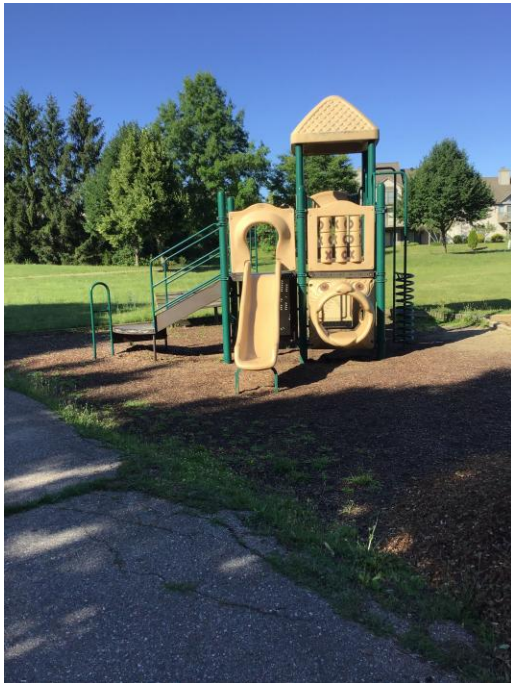
Accessible route is not provided to play area.

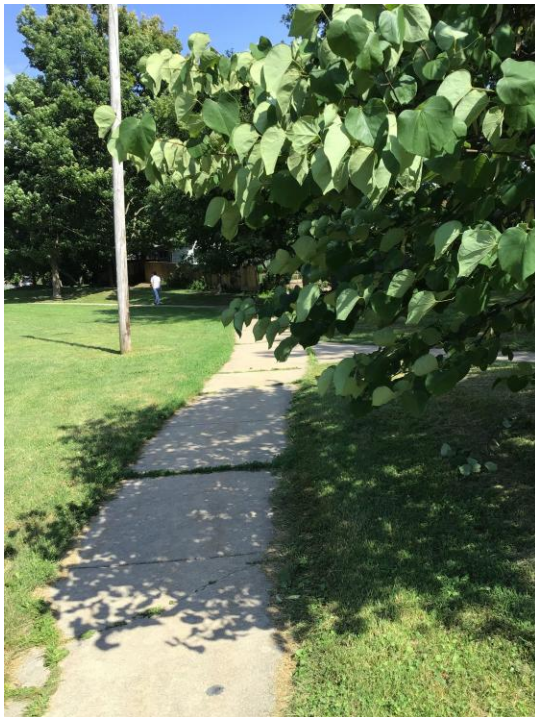
Wall-mounted objects that have leading edges between 27 inches and 80 inches from the floor must not project more than 4 inches into the circulation path. Protruding objects that extend to the floor or within 27 inches of the floor are cane detectable and are therefore not hazardous. Where it is necessary or desirable to have objects protrude from the wall, a manner of cane detection must be provided.

Tree is protruding object.

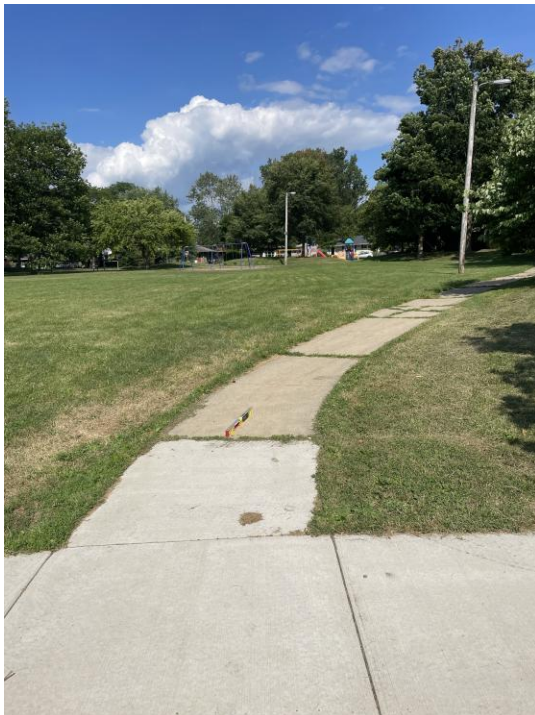
Excessive running and cross slope

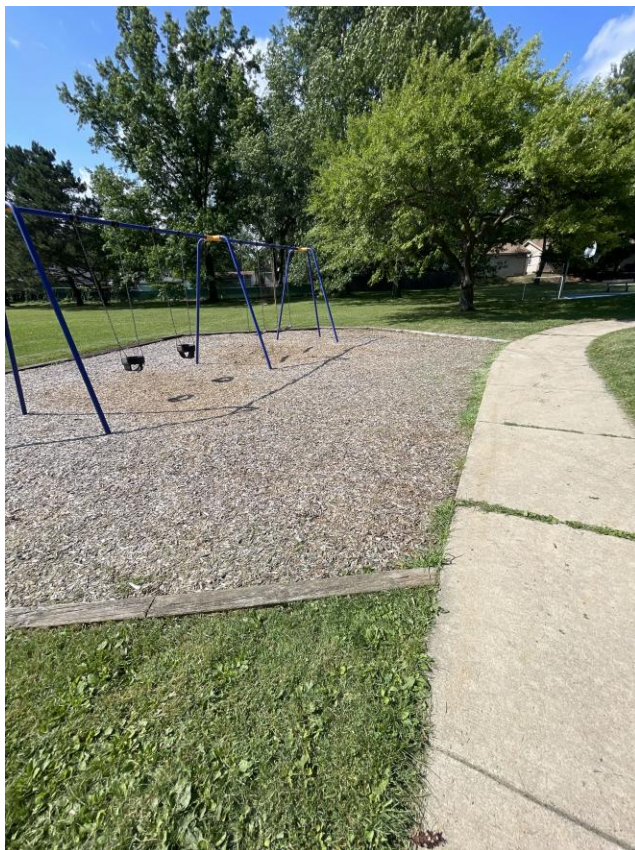
No ramp provided into swings area

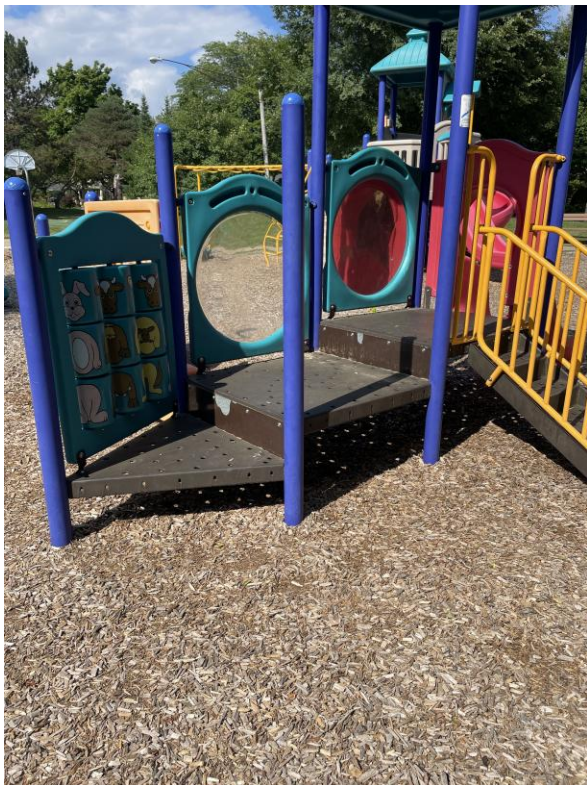
No transfer support is provided

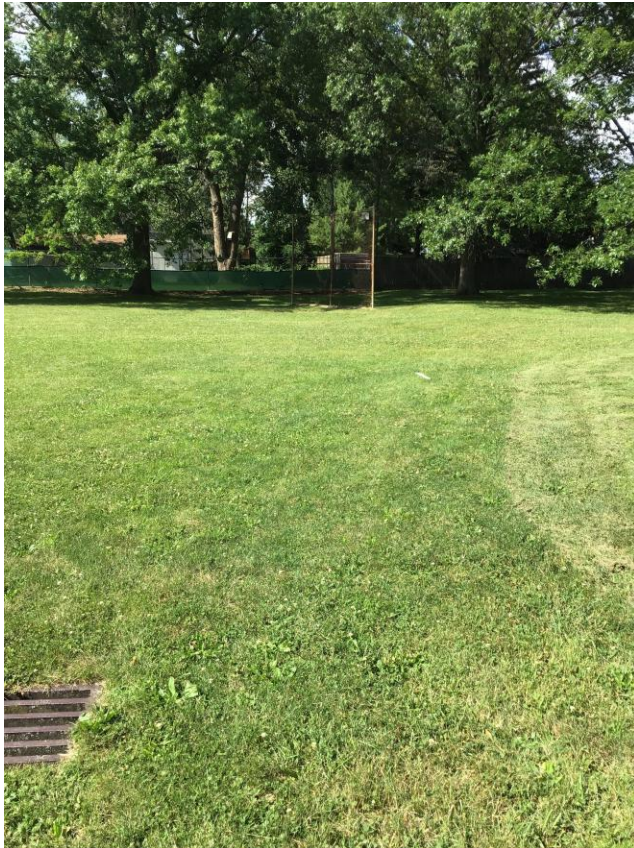
No accessible route to baseball field.

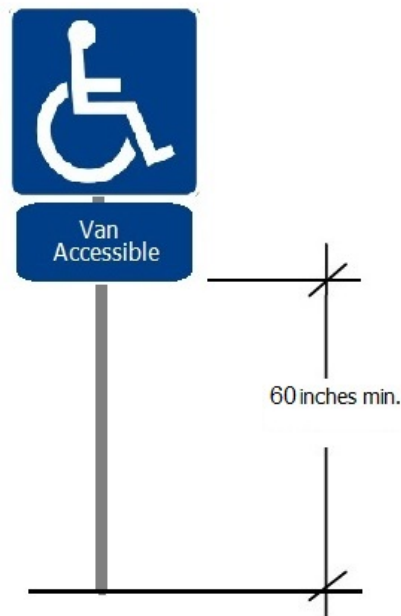
The required parking signage is missing.

Missing two signs

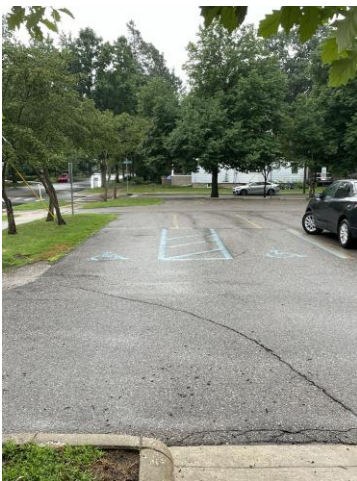
Need to provide one van stall. Existing stalls do not meet required dimensions

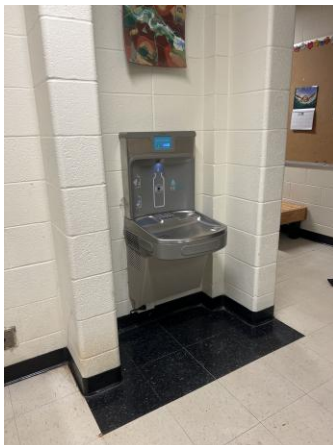
No tall drinking fountain

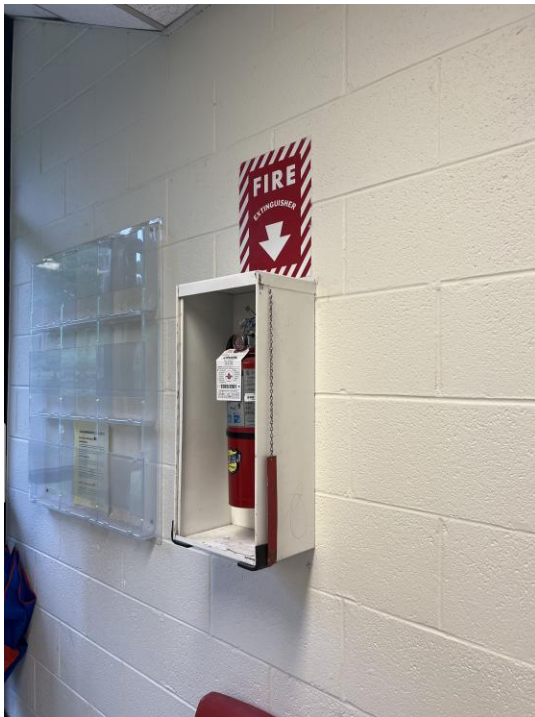
Wall-mounted objects that have leading edges between 27 inches and 80 inches from the floor must not project more than 4 inches into the circulation path. Protruding objects that extend to the floor or within 27 inches of the floor are cane detectable and are therefore not hazardous. Where it is necessary or desirable to have objects protrude from the wall, a manner of cane detection must be provided.

Fire Extinguisher protrudes more than 4 inches

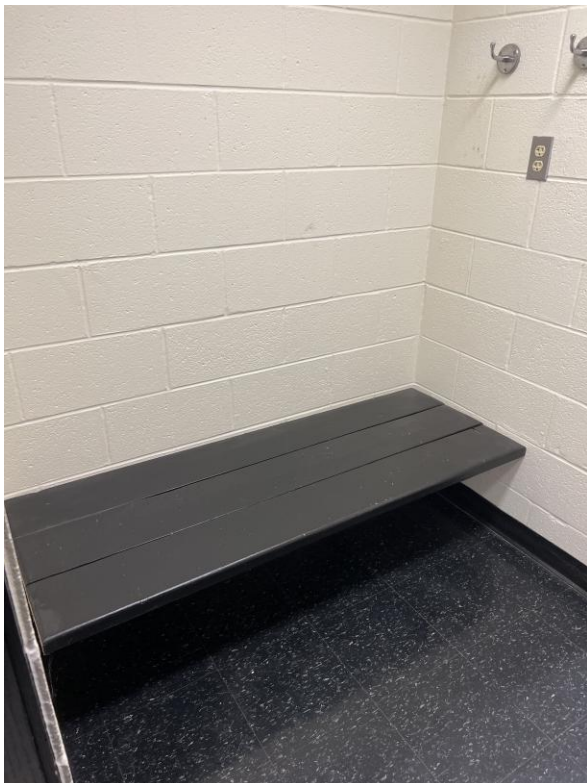
Clear floor space adjacent to the bench has not been provided.

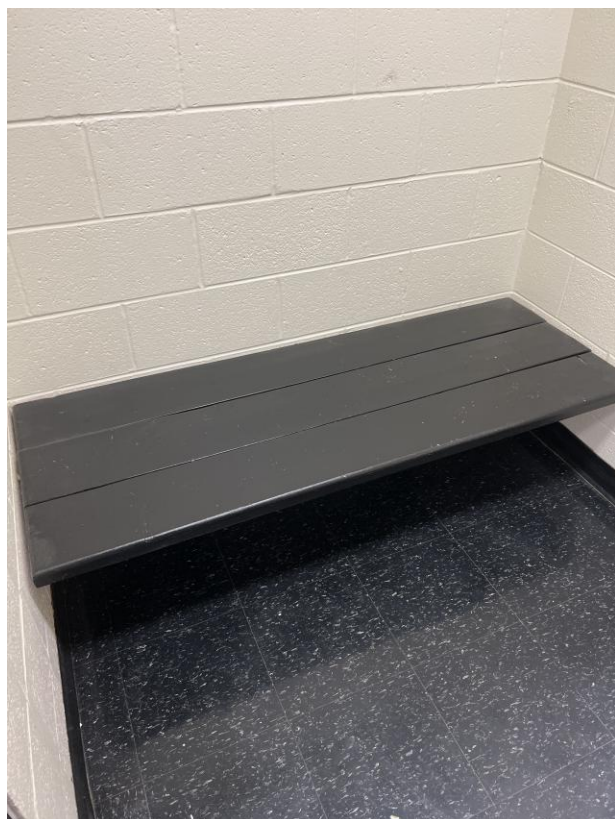
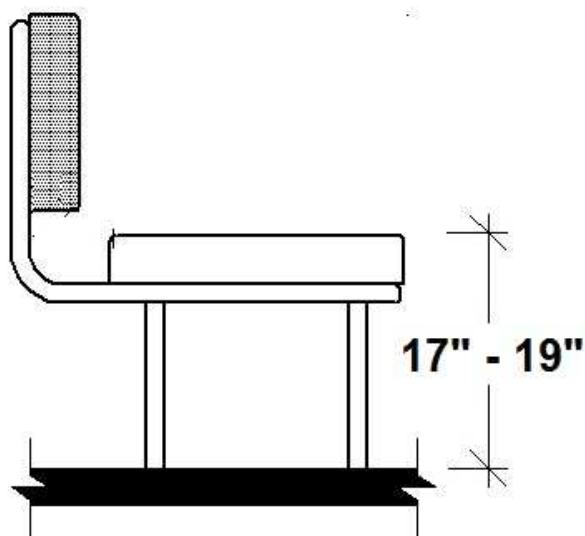
Bench seat is not compliant.

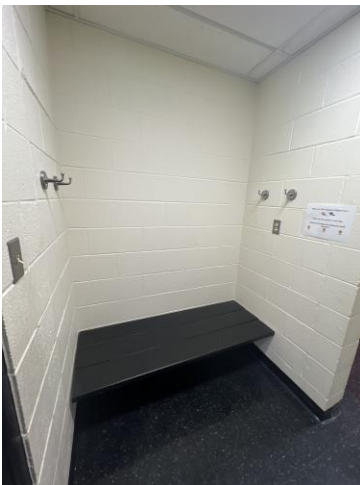
Coat hooks are too high

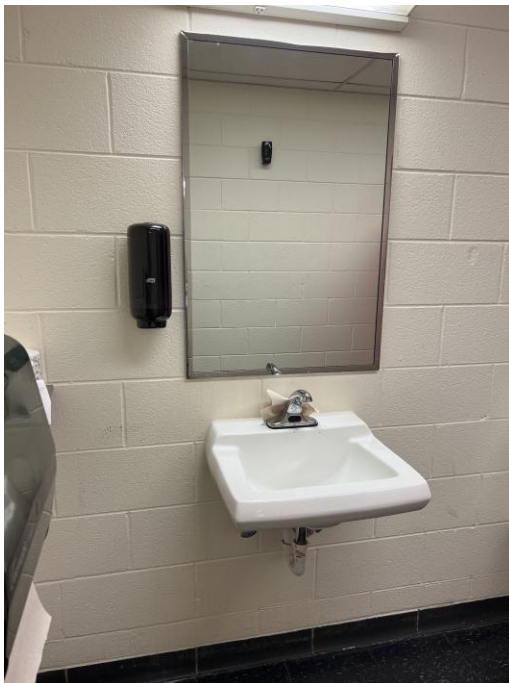
Mirror is mounted too high.

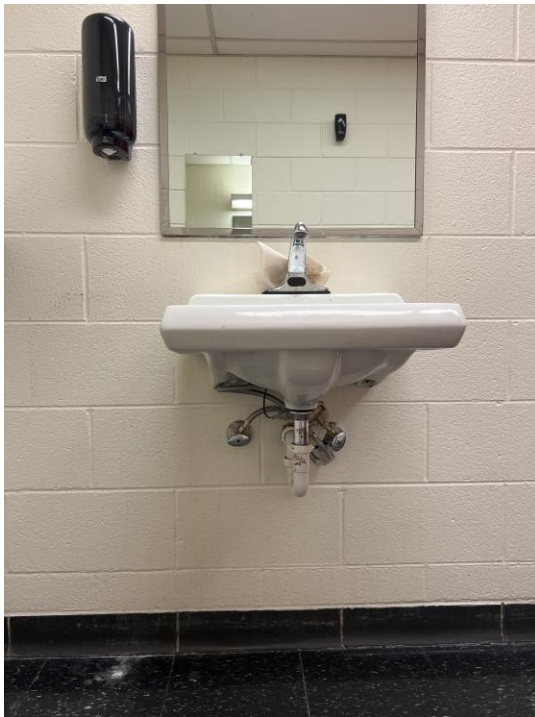
Wall-mounted objects that have leading edges between 27 inches and 80 inches from the floor must not project more than 4 inches into the circulation path. Protruding objects that extend to the floor or within 27 inches of the floor are cane detectable and are therefore not hazardous. Where it is necessary or desirable to have objects protrude from the wall, a manner of cane detection must be provided.

The dispenser projects more than 4 inches into the circulation path.

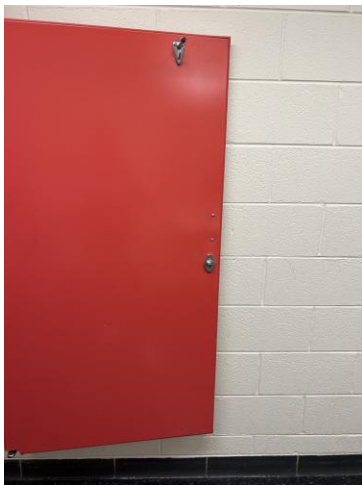
The coat hook is installed greater than 48 inches above the finished floor.

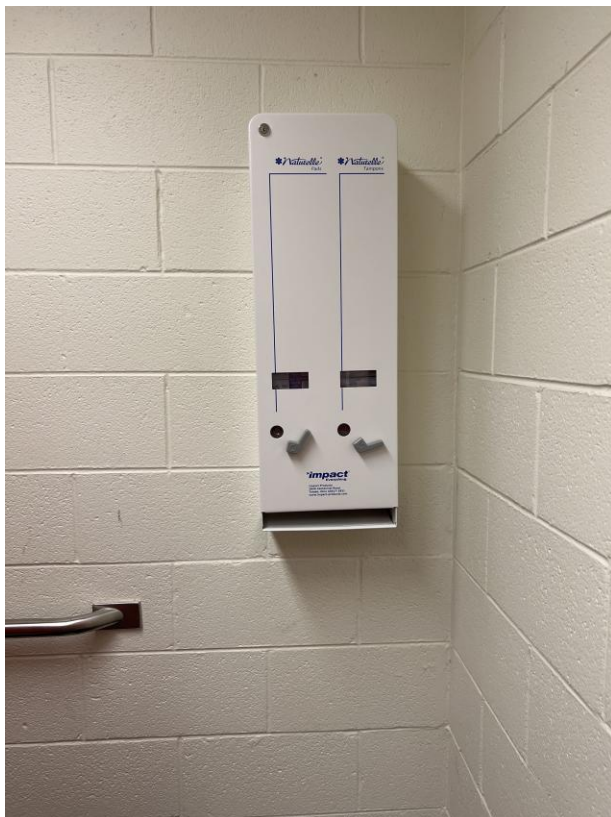
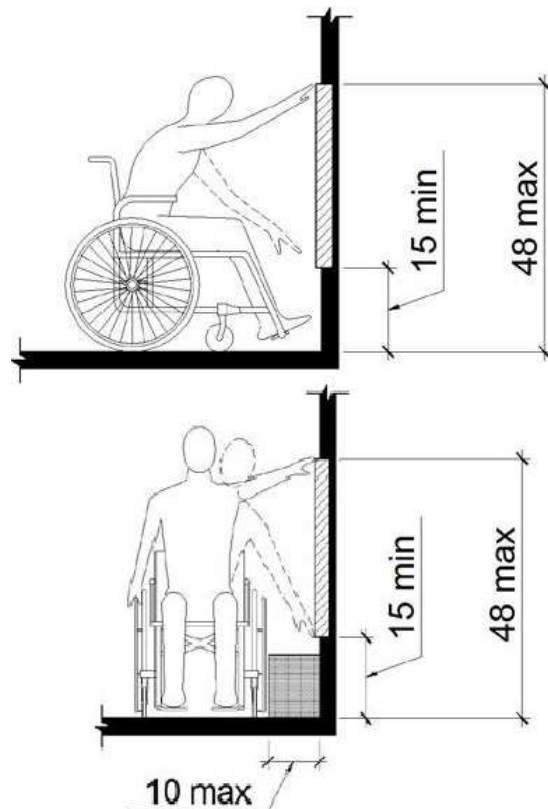
The dispenser's operation mechanism is too high off the floor.

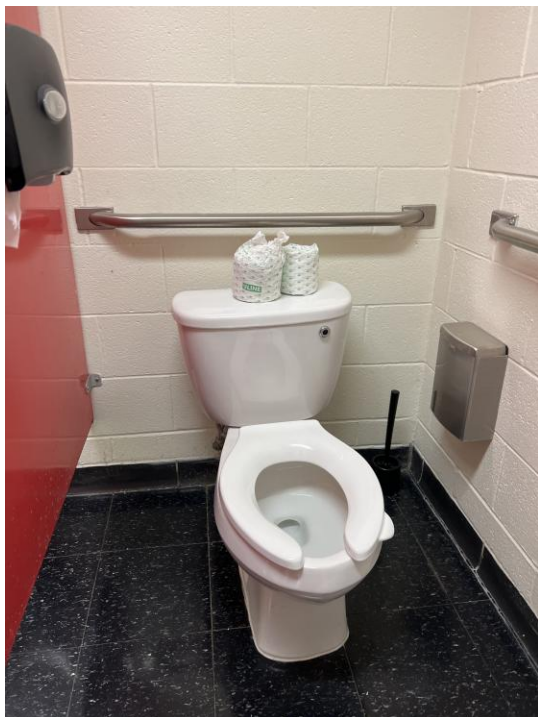
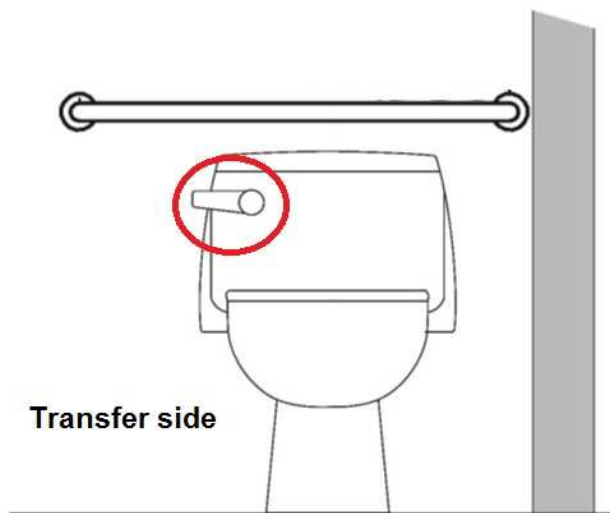
The flush handle is located on the wrong side of the toilet.

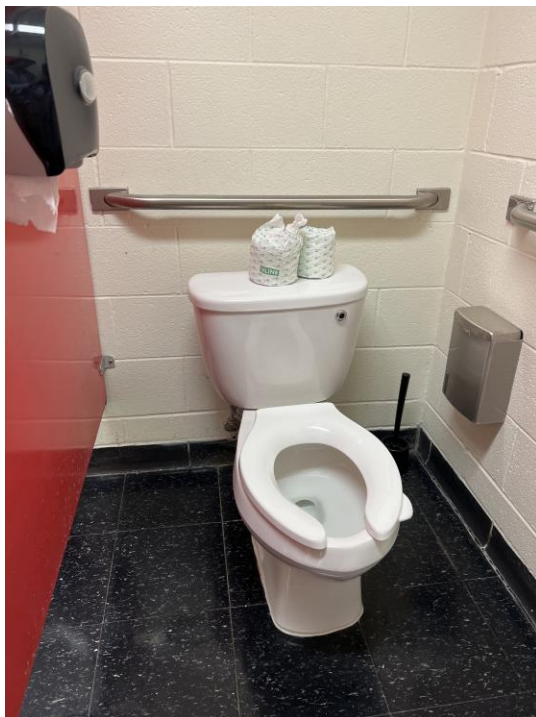
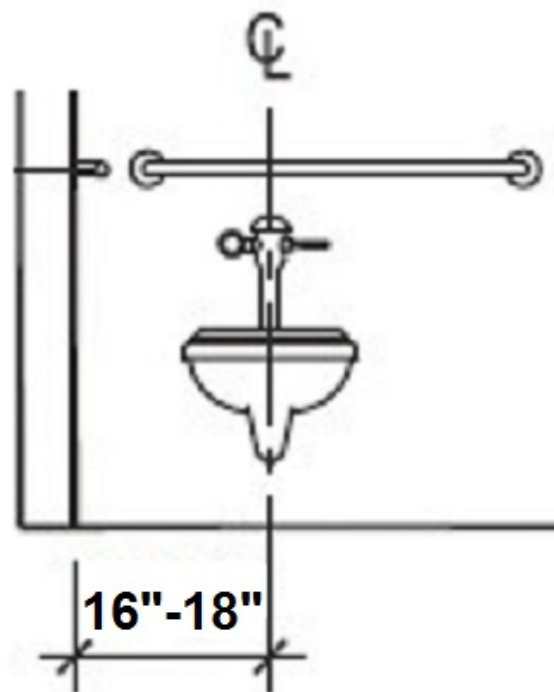
19 inches

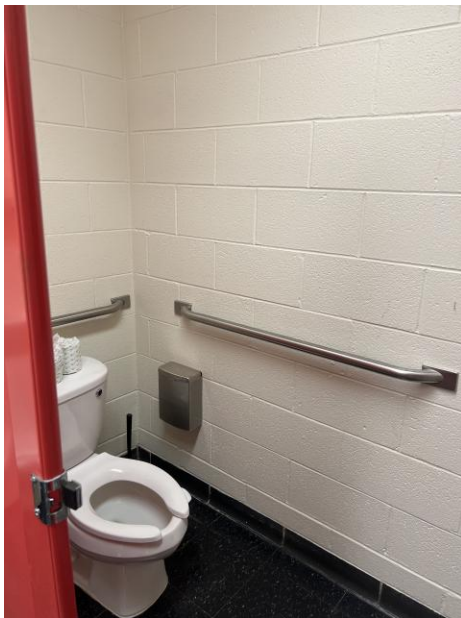
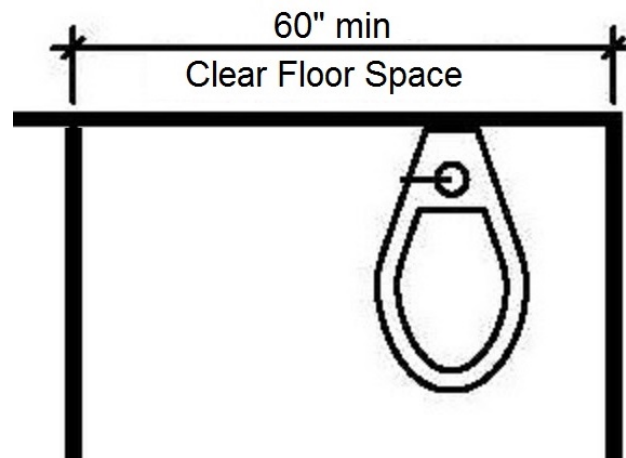
The toilet compartment is too small.

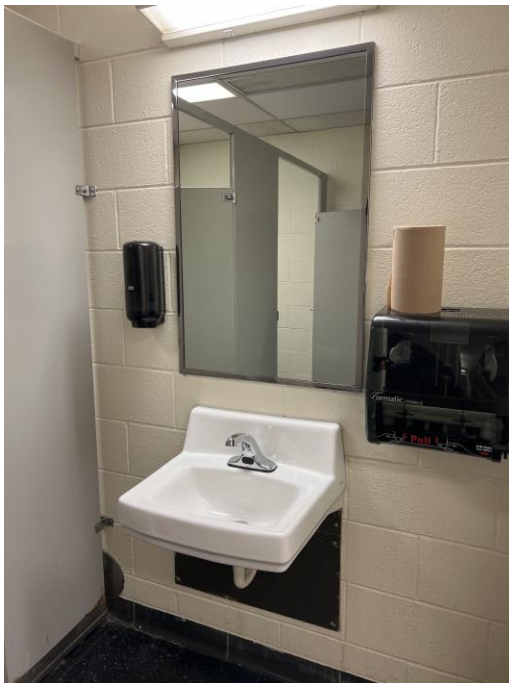
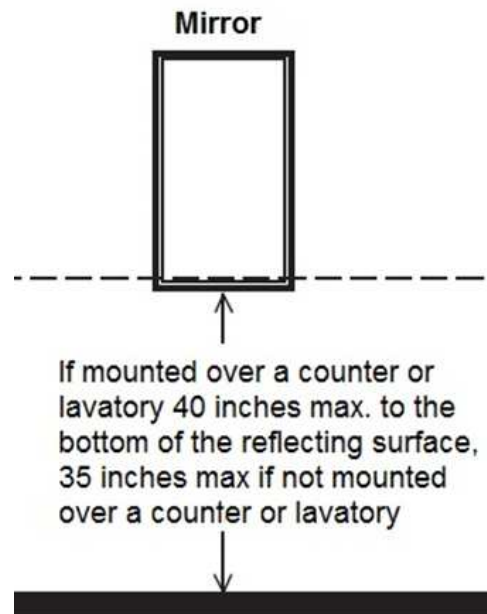
The mirror is mounted too high.
