Site Accessibility Evaluation

Allmendinger Park
655 Pauline Blvd
Ann Arbor, MI 48104
ADA Only

Inspection Date: 07/11/2022

Report Date: 11/15/2022

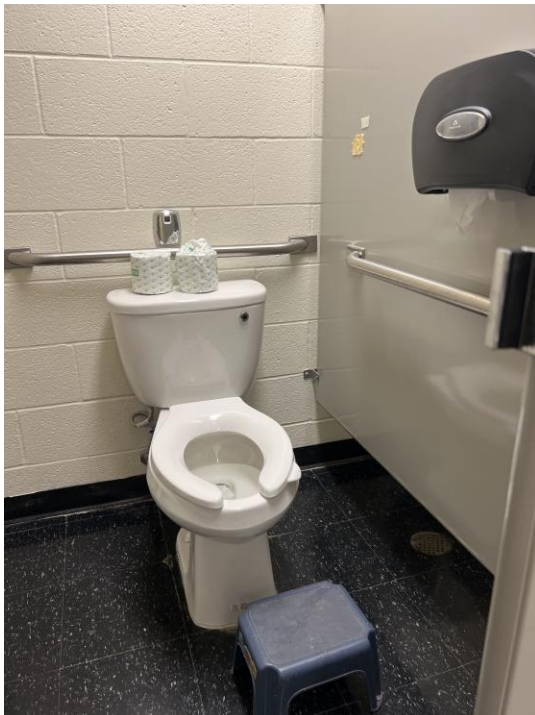
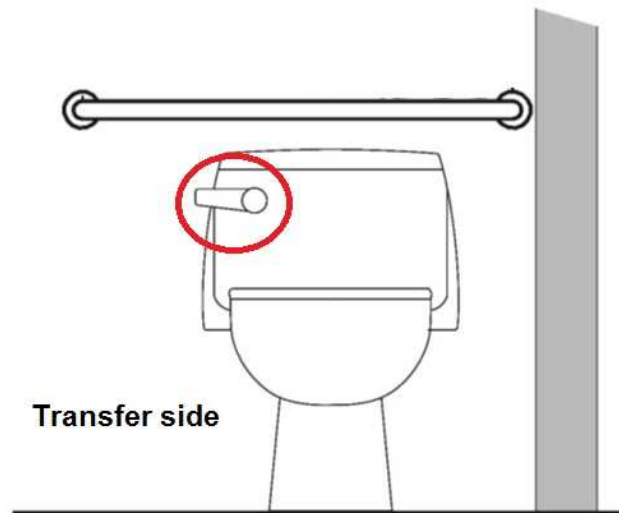
The flush handle is located on the wrong side of the toilet.

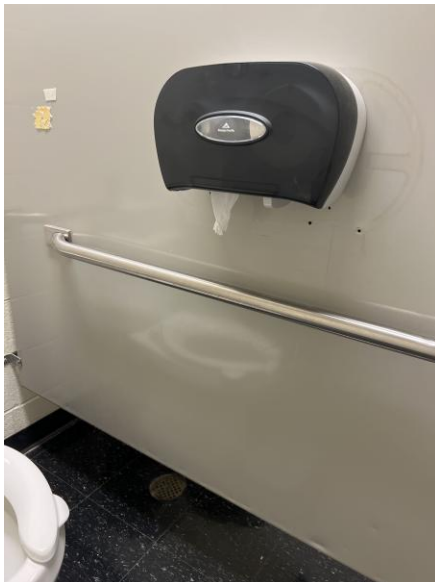
The toilet paper is not installed within the compliant range.

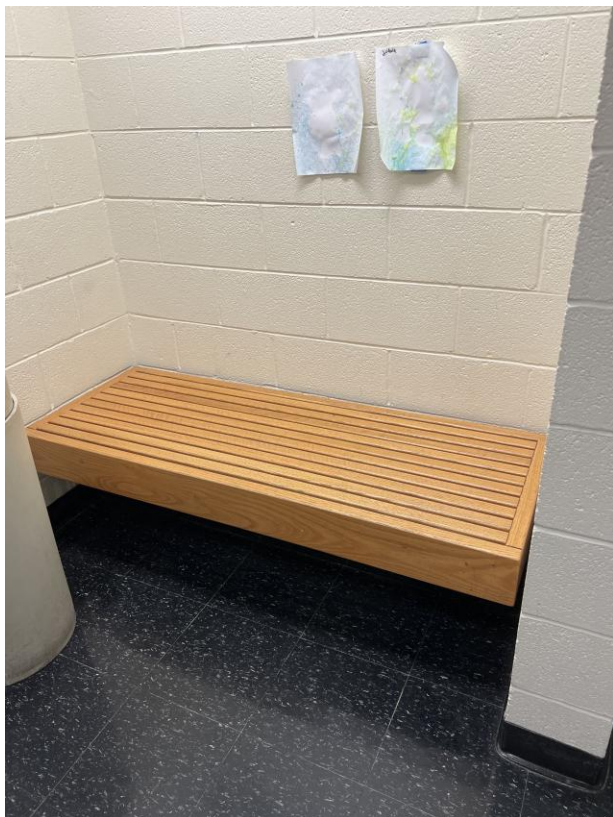
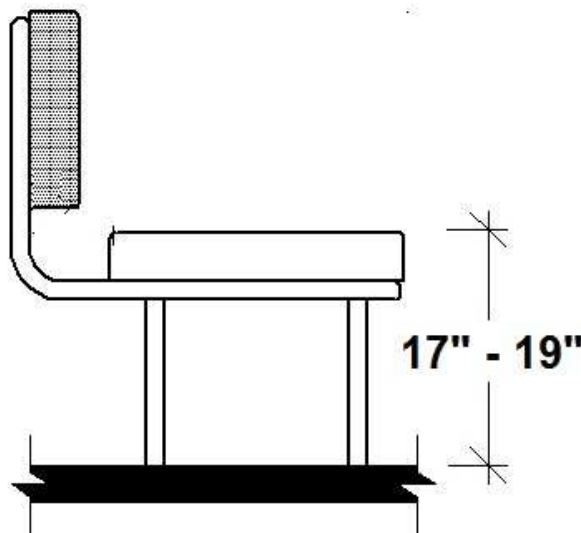
The bench seat is not within compliant height range.

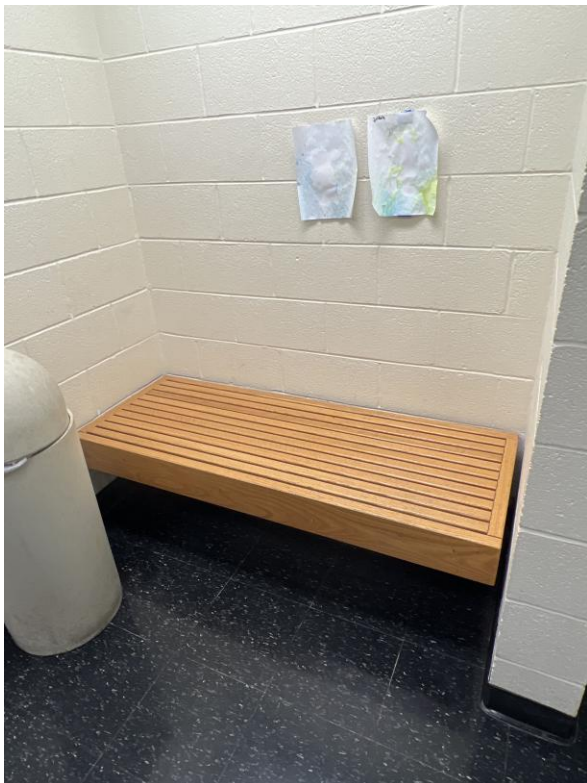
The clear floor space is not provided.

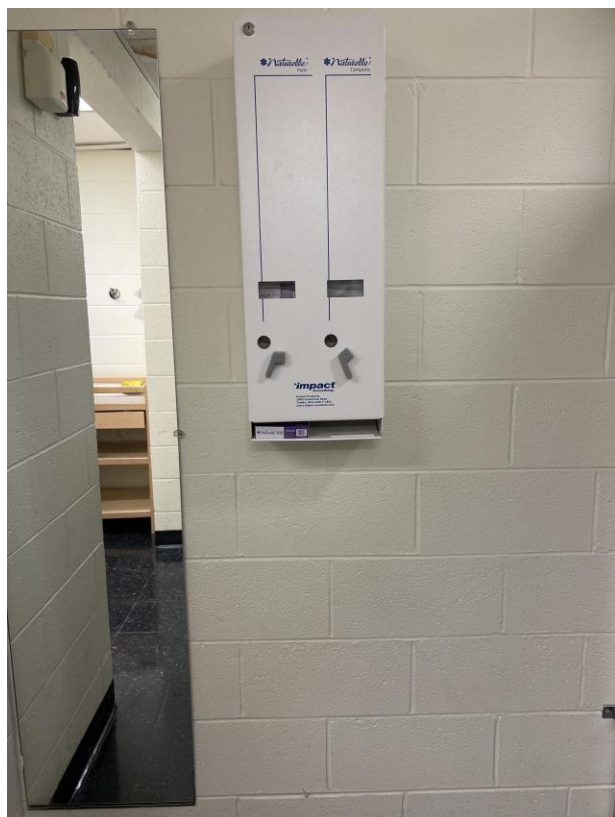
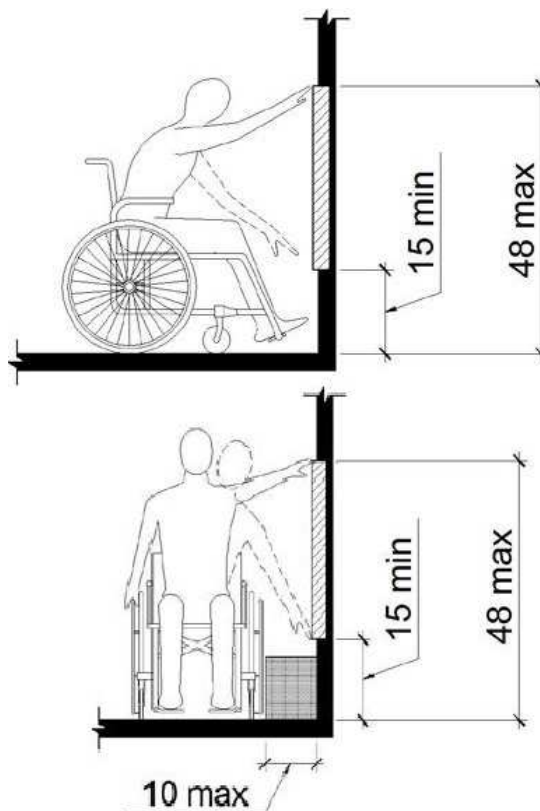
The dispenser is out of reach range.

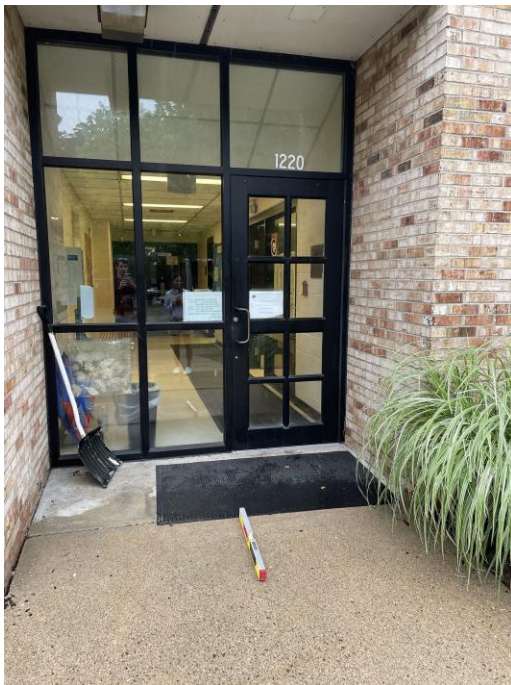
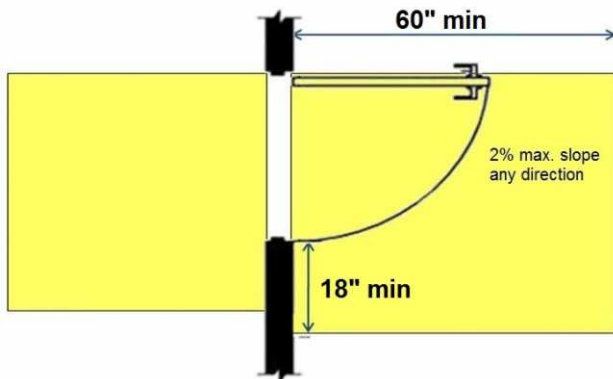
5.6%

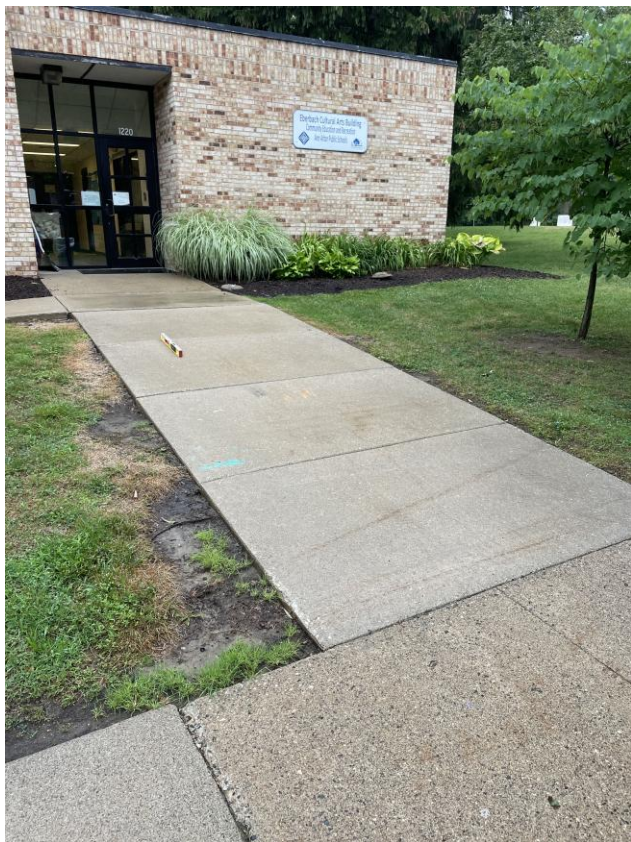
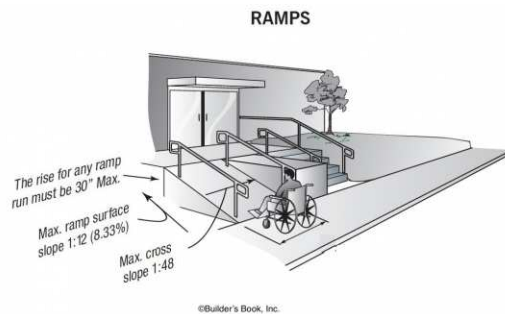
12%

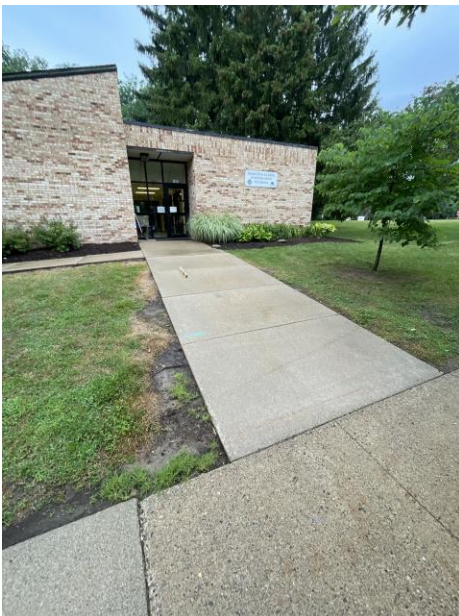
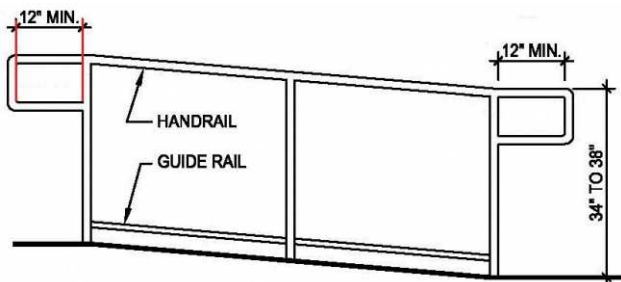
Missing handrails on both sides

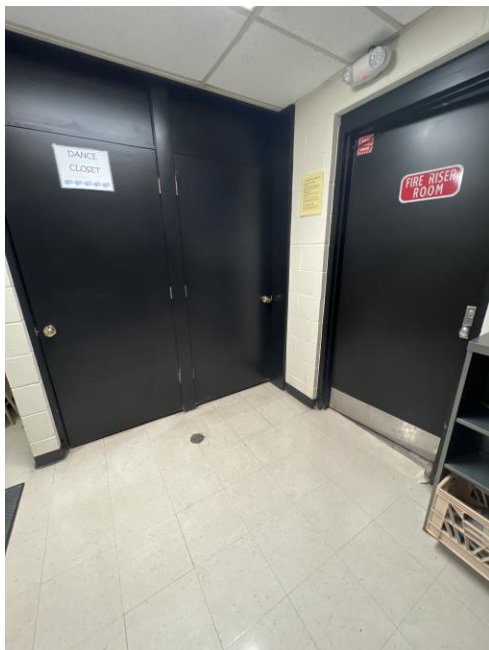
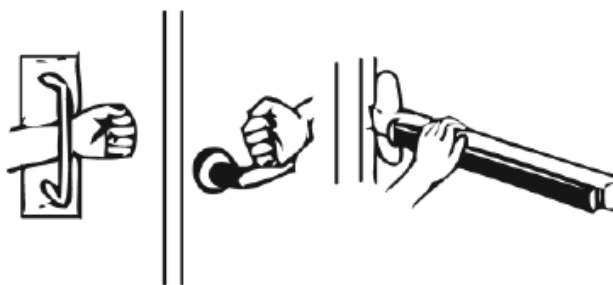
3 door knobs in the hallway

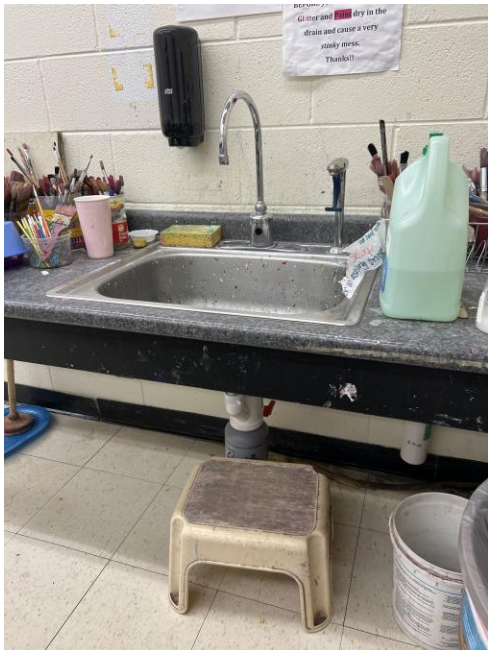
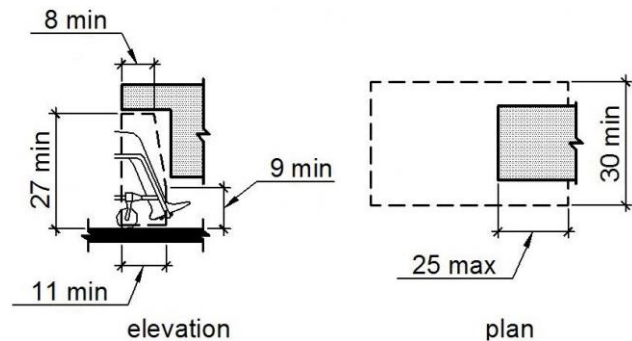
There is not enough knee clearance

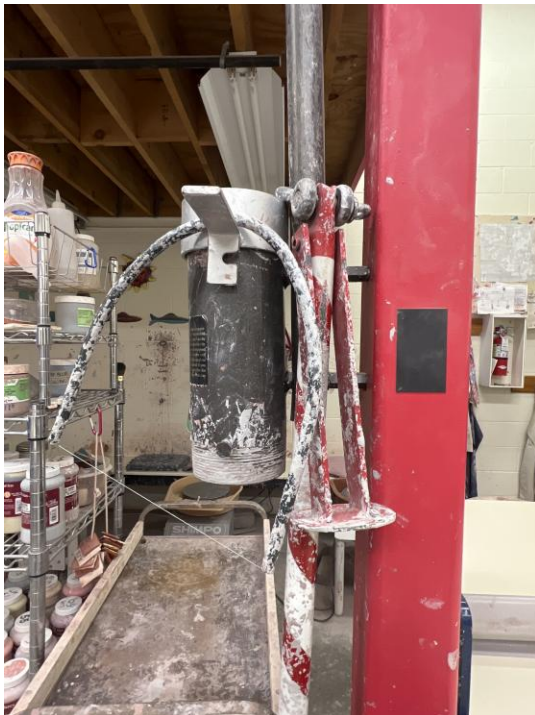
Wall-mounted objects that have leading edges between 27 inches and 80 inches from the floor must not project more than 4 inches into the circulation path. Protruding objects that extend to the floor or within 27 inches of the floor are cane detectable and are therefore not hazardous. Where it is necessary or desirable to have objects protrude from the wall, a manner of cane detection must be provided.

The clay extruder projects more than 4 inches into the circulation path.

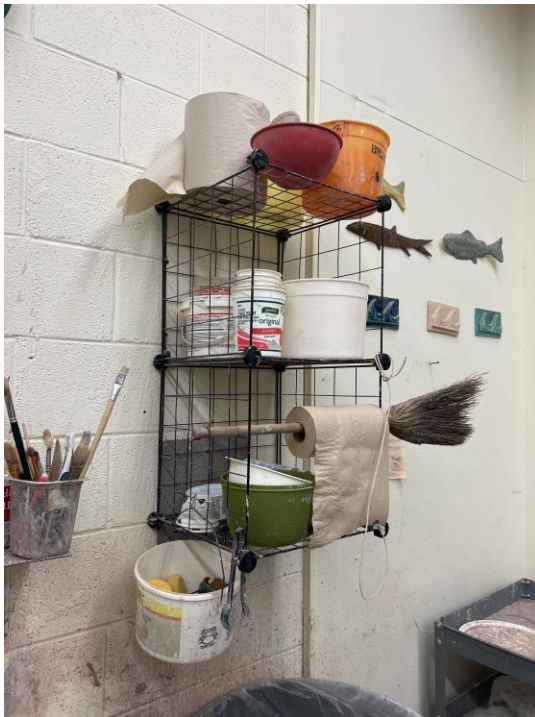
Wall-mounted objects that have leading edges between 27 inches and 80 inches from the floor must not project more than 4 inches into the circulation path. Protruding objects that extend to the floor or within 27 inches of the floor are cane detectable and are therefore not hazardous. Where it is necessary or desirable to have objects protrude from the wall, a manner of cane detection must be provided.

The shelf projects more than 4 inches into the circulation path.

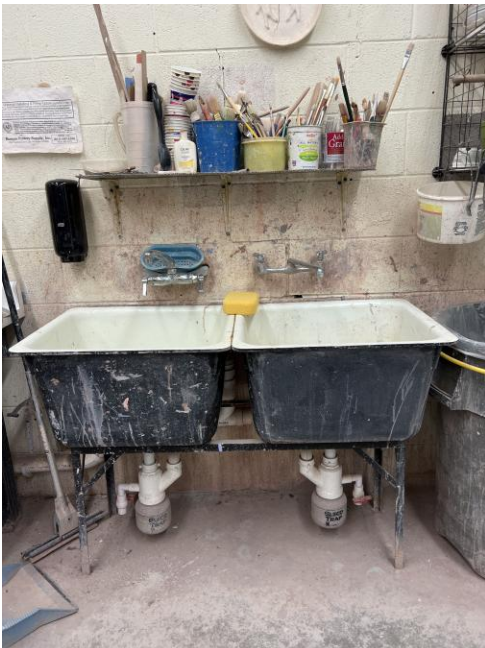
There is no knee clearance

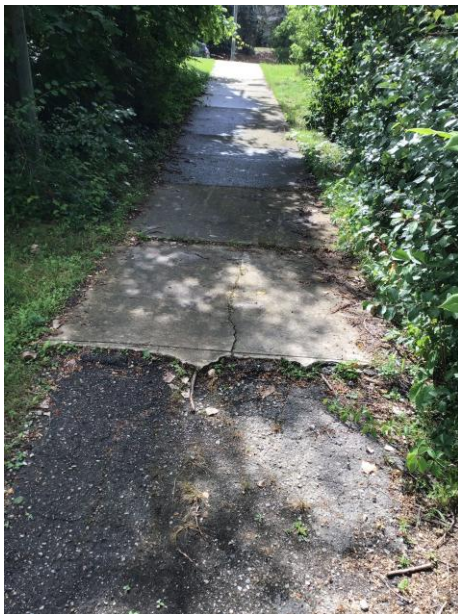
Vertical change of 2 inches.

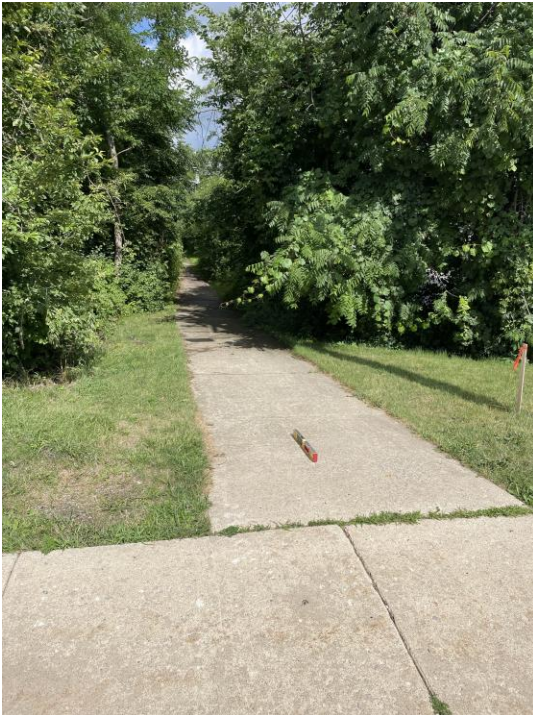
11%

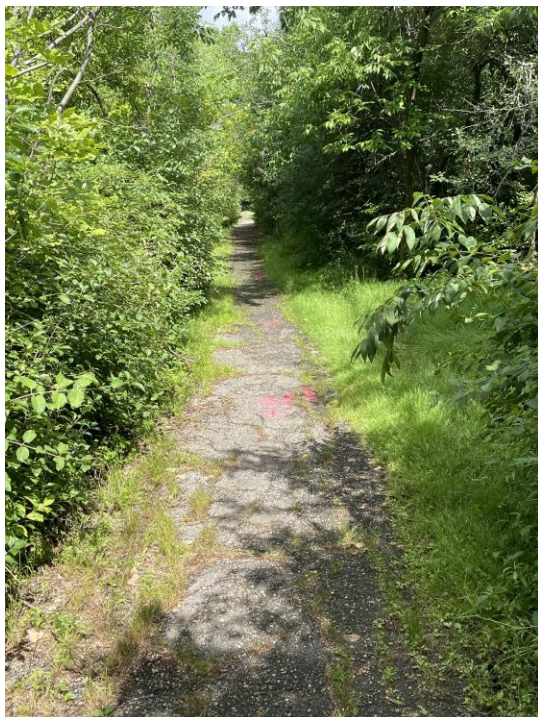
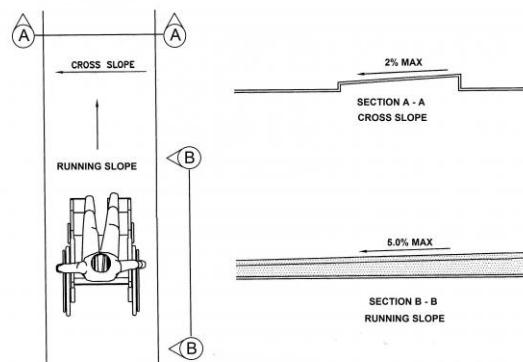
All route is not compliant

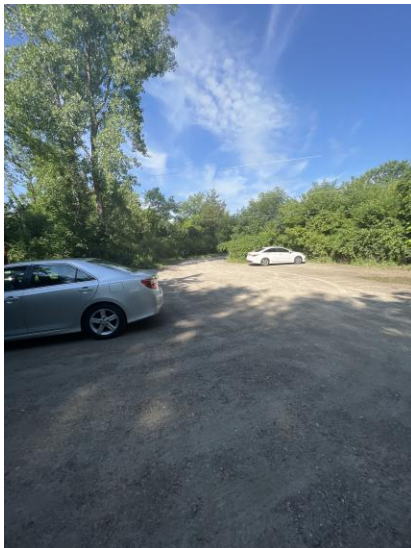
Parking lot undeveloped

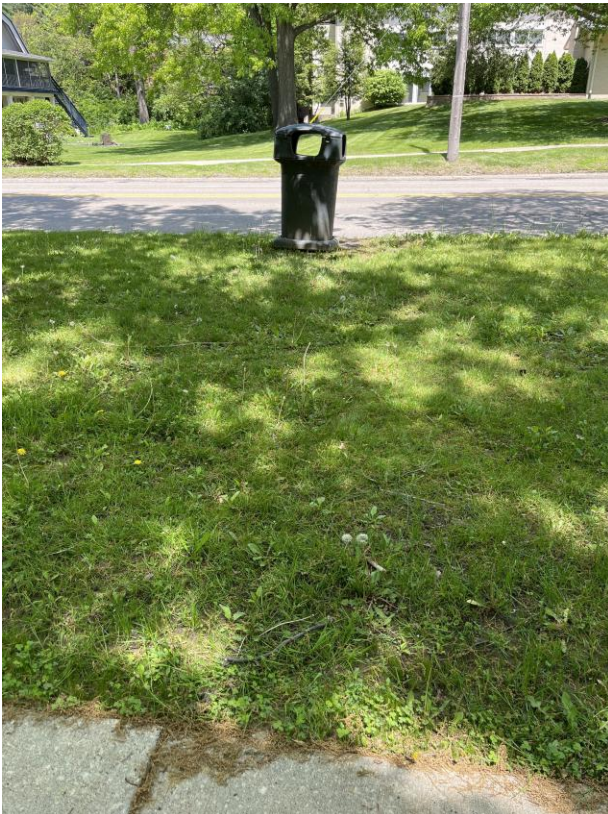
The accessible route contains loose gravel and/or surface materials that do not provide for a stable, firm slip resistant surface.

Surface is grass

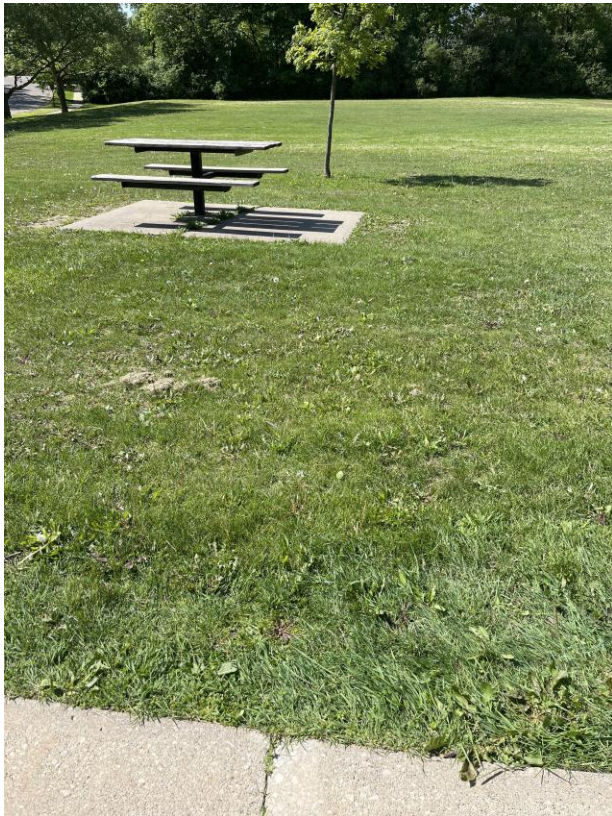
The accessible route contains loose gravel and/or surface materials that do not provide for a stable, firm slip resistant surface.

Surface is grass

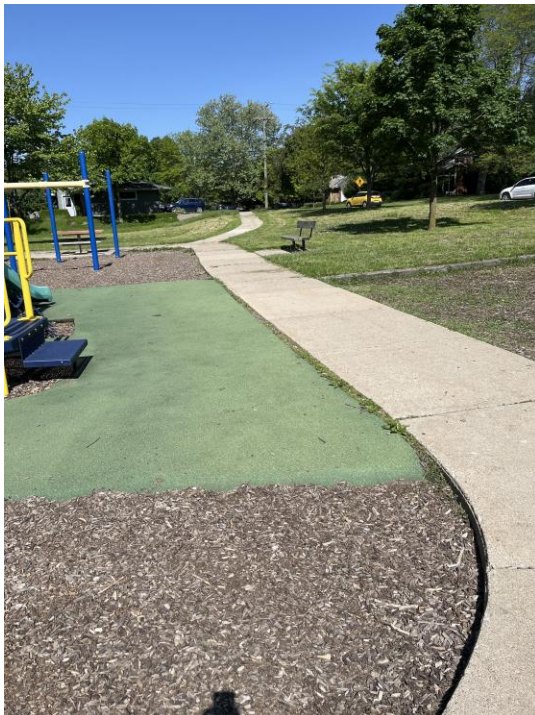
Opening between sidewalk and access ramp to the playground

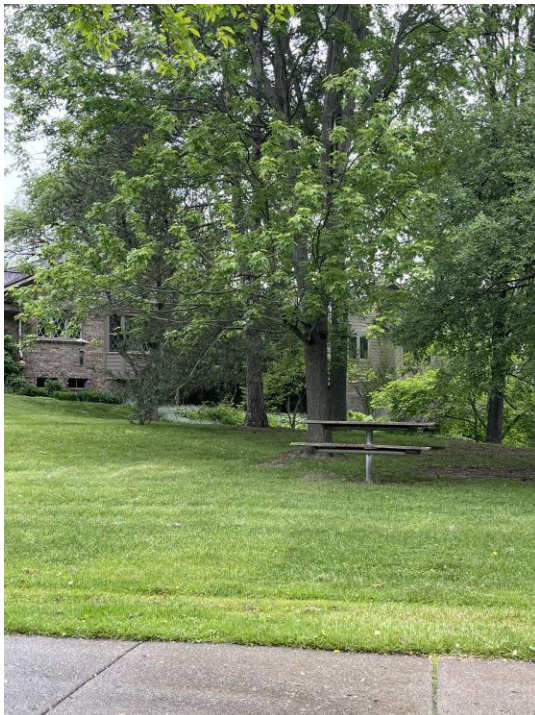
Surface is grass

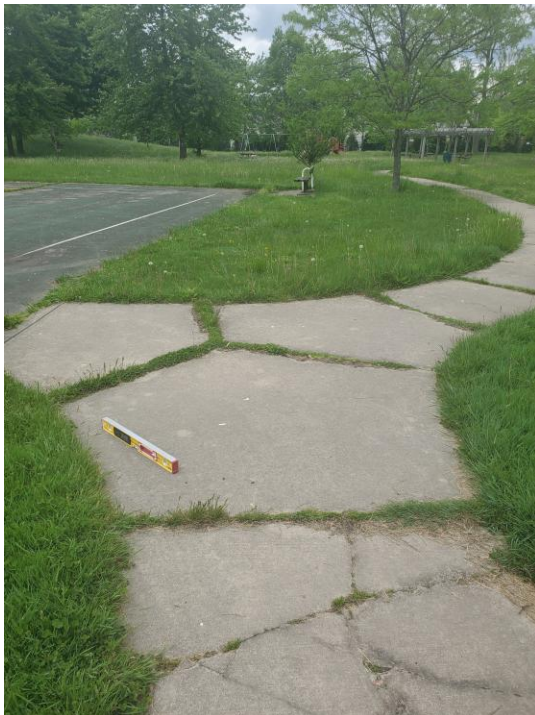
The route contains openings greater than 1/2 inch.

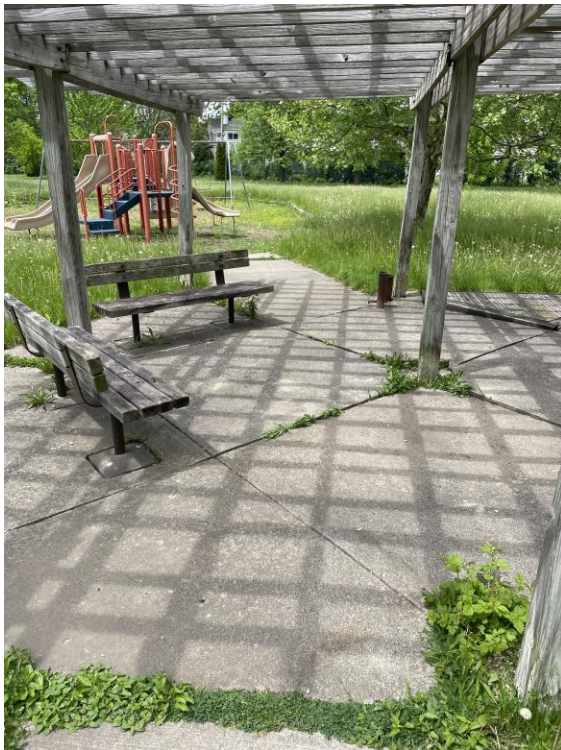
The path of contains multiple issues including cross and running slope and is not accessible.

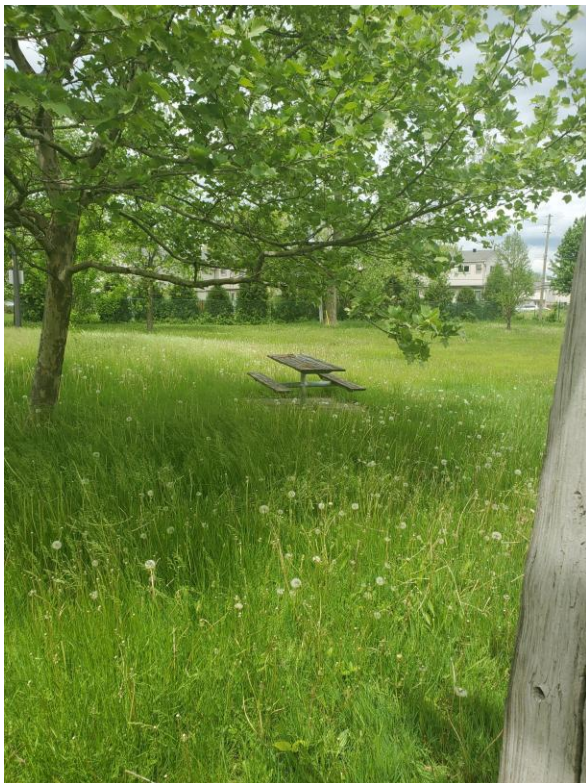
Grass Surface

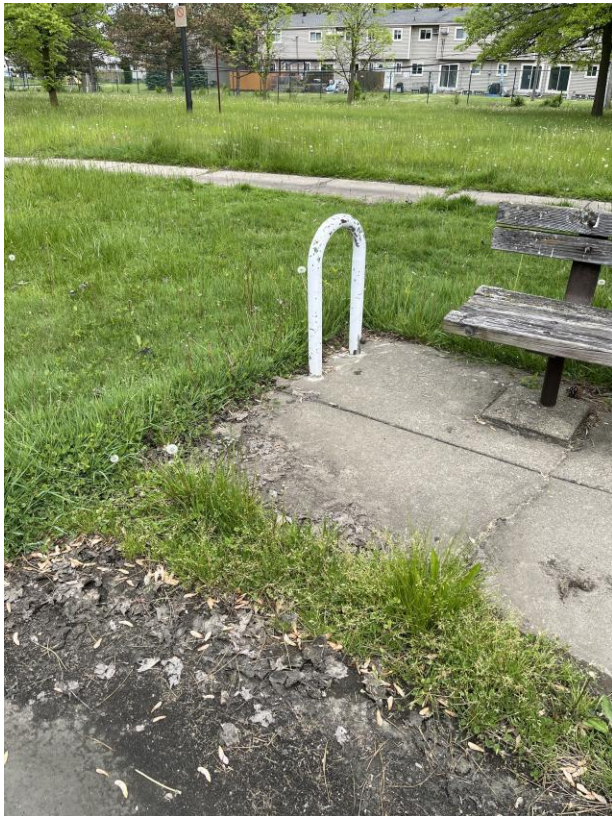
Grass and excessive slope

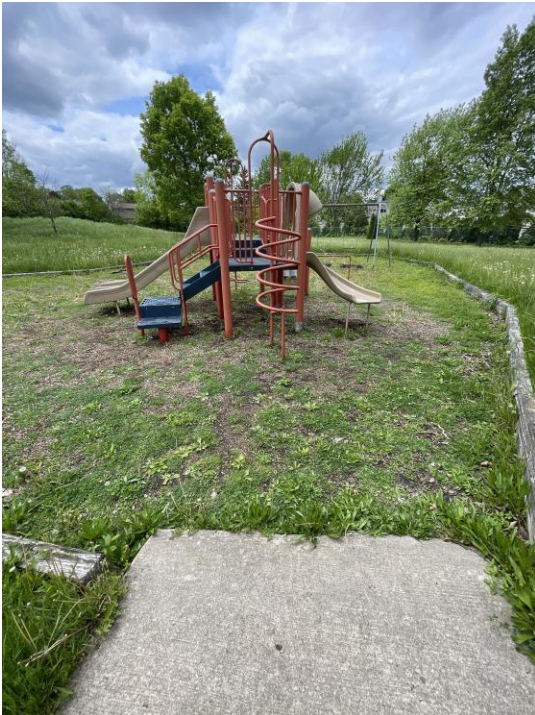
The ground surface is not compliant.

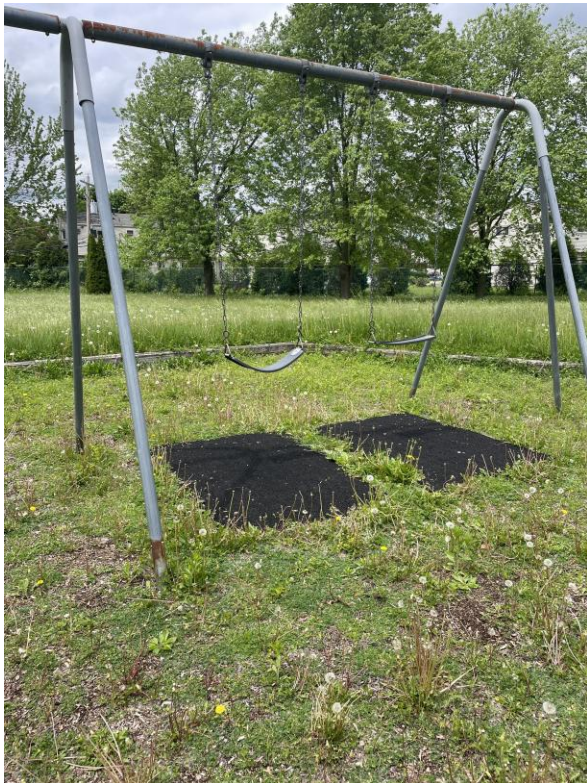
There is no accessible way to use the swings.

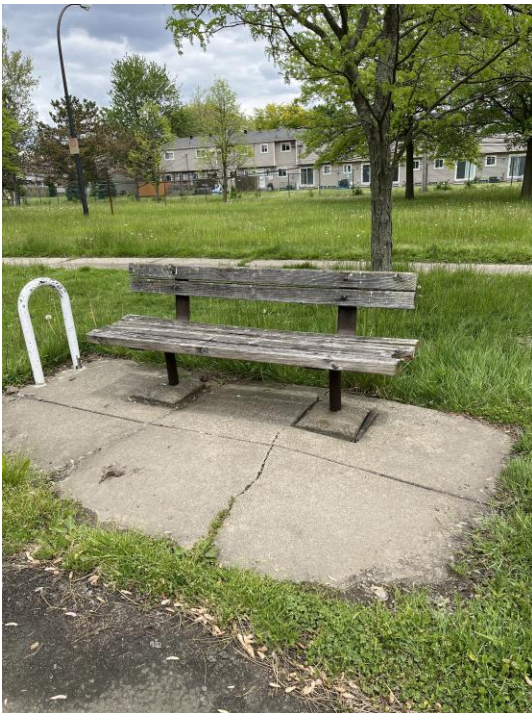
Surface is not stable: grass and excessive slope

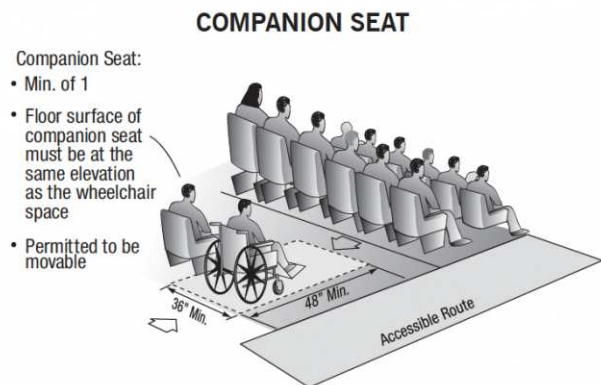
Accessible route to seating area is missing

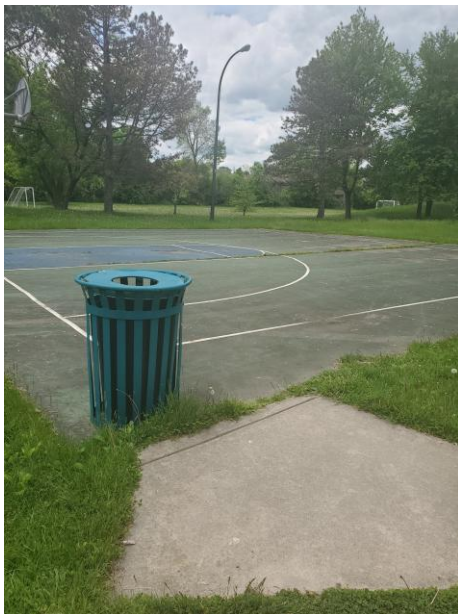
Change in level, Opening in surface with vegetation, and receptacle blocking court access

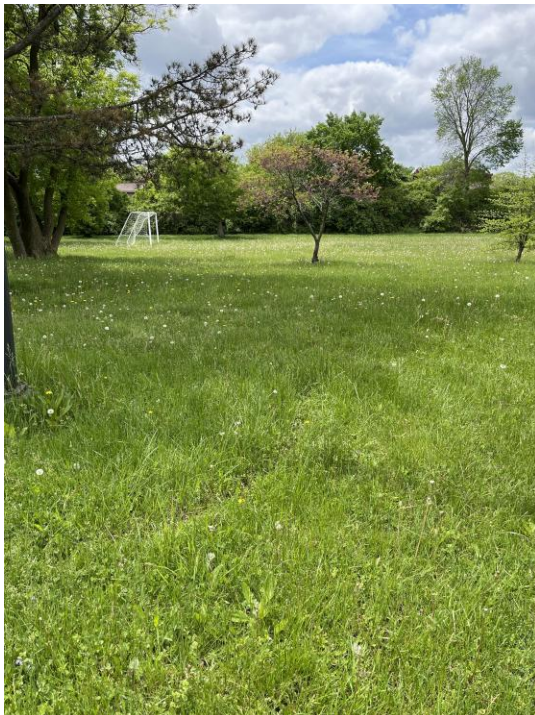
Grass

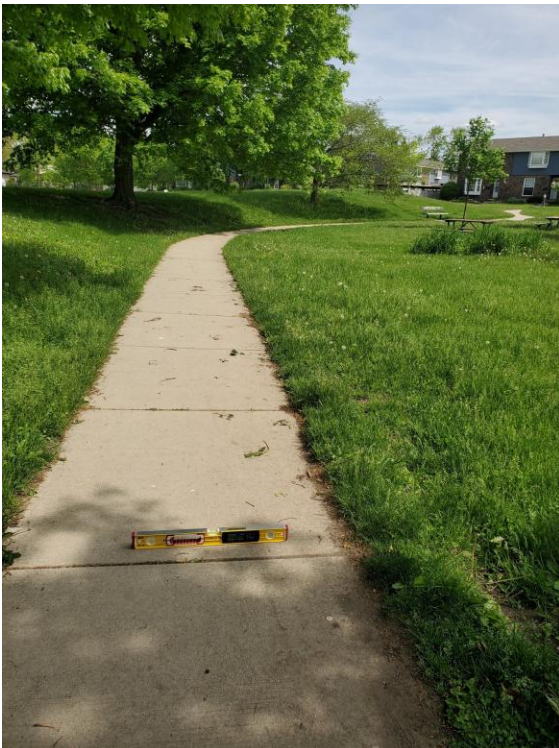
Cross slope exceeds 2%

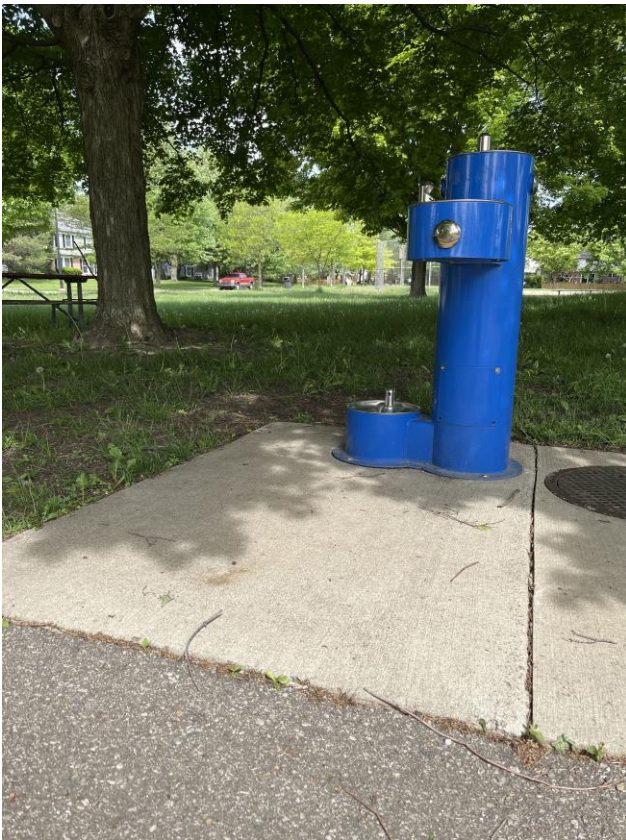
Change in level & no clear floor space

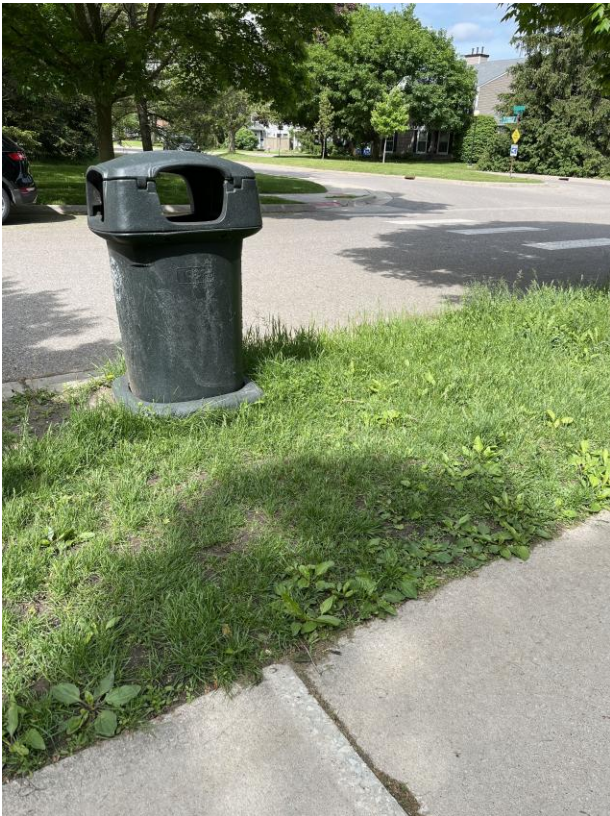
Grass

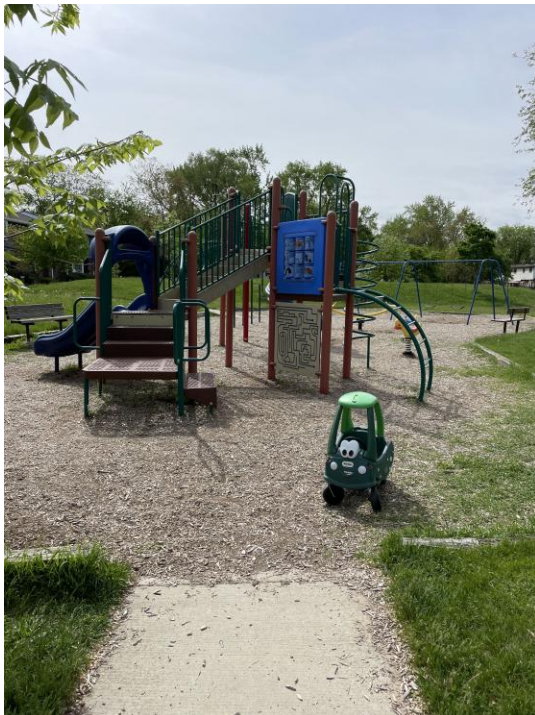
Playground ground surface has wood chips

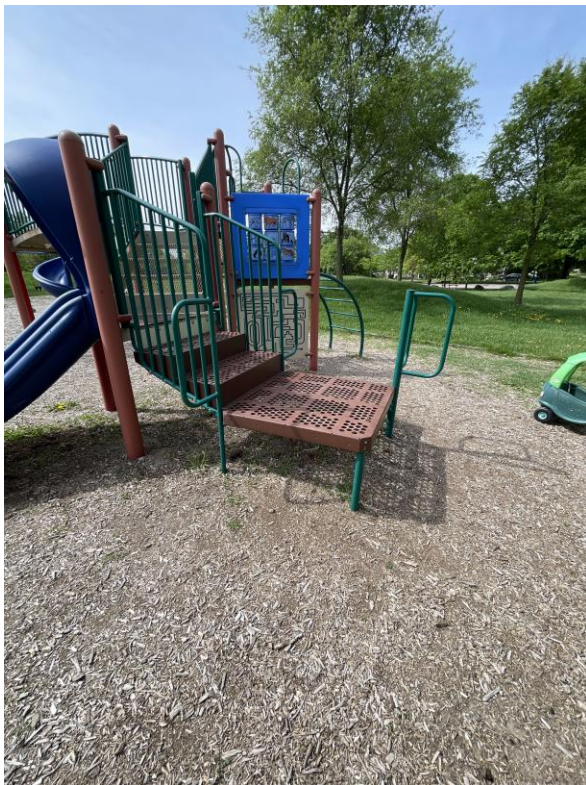
21" above ground

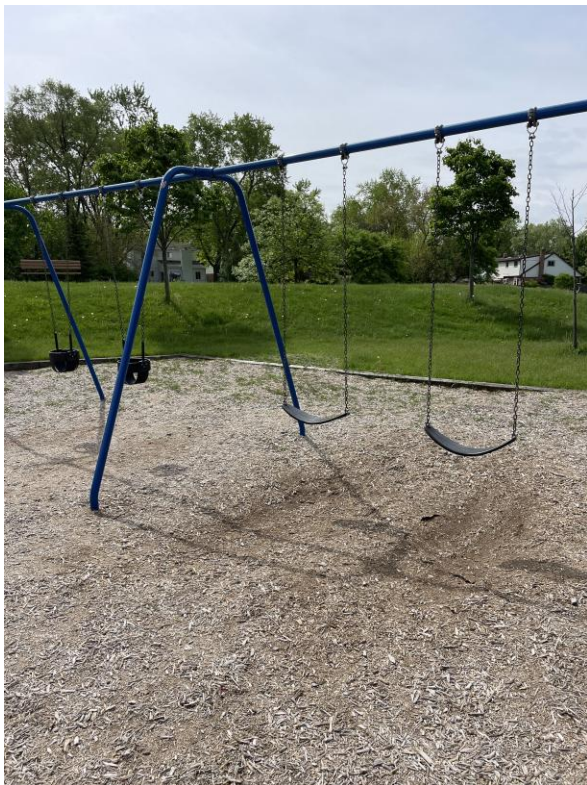
Swing seats at 28" above ground

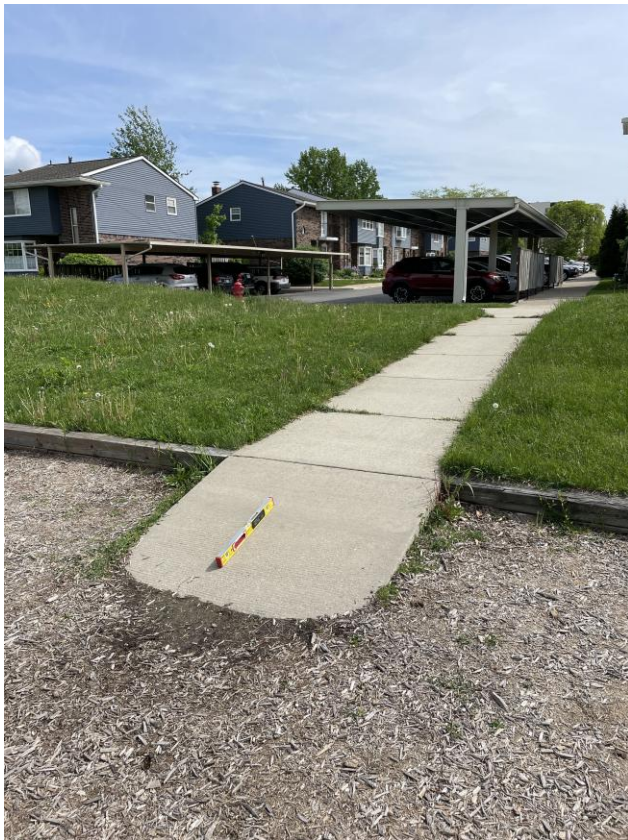
Ramp slope too steep

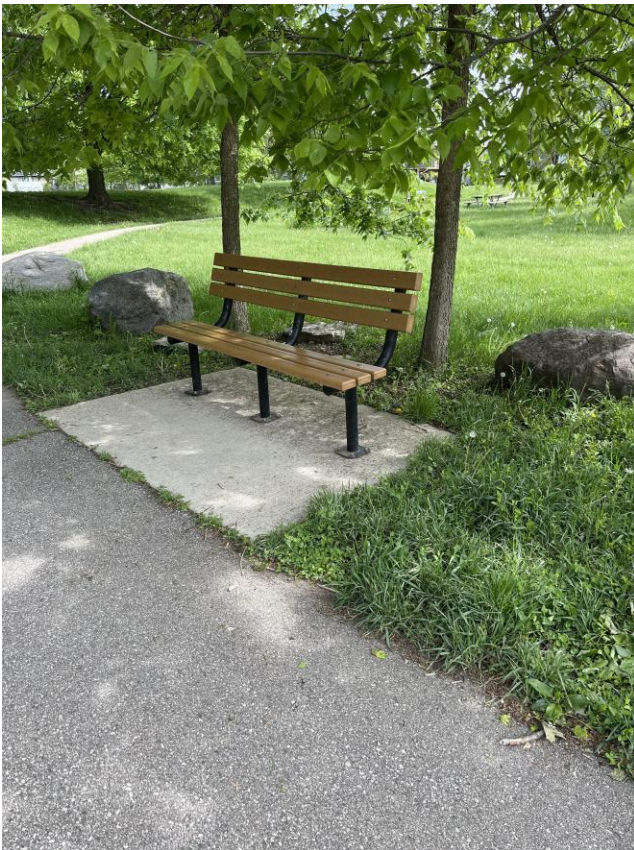
Grass next to the bench

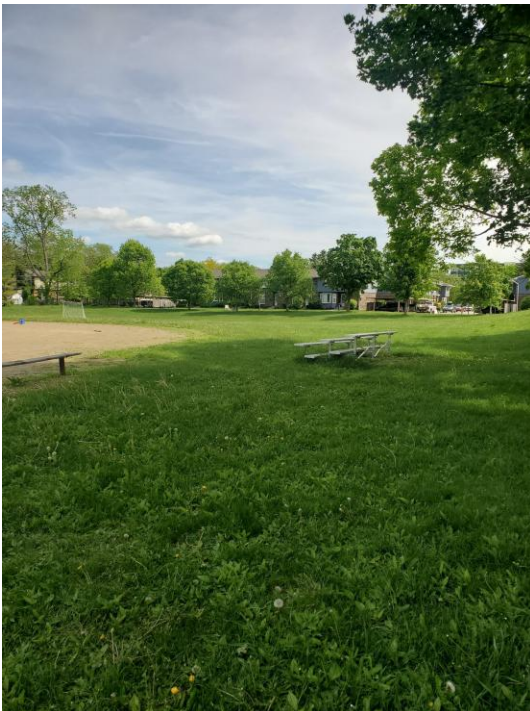
Grass surface

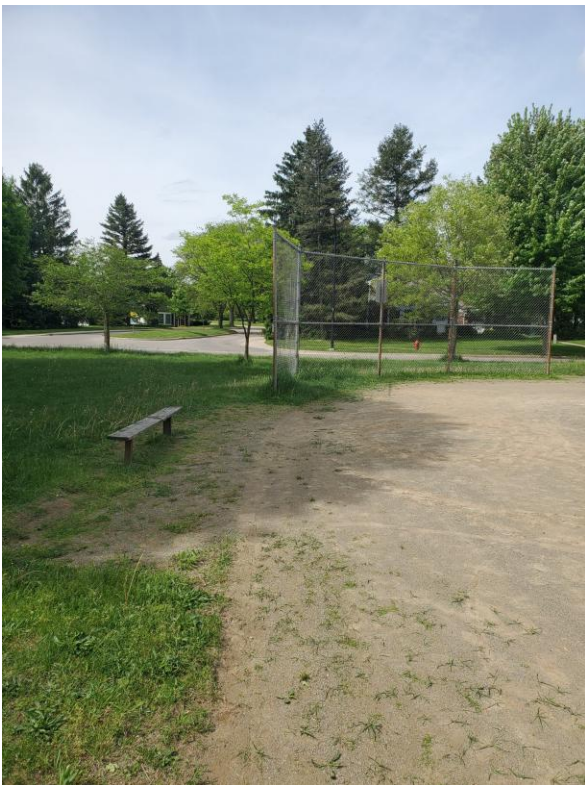
Grass surface

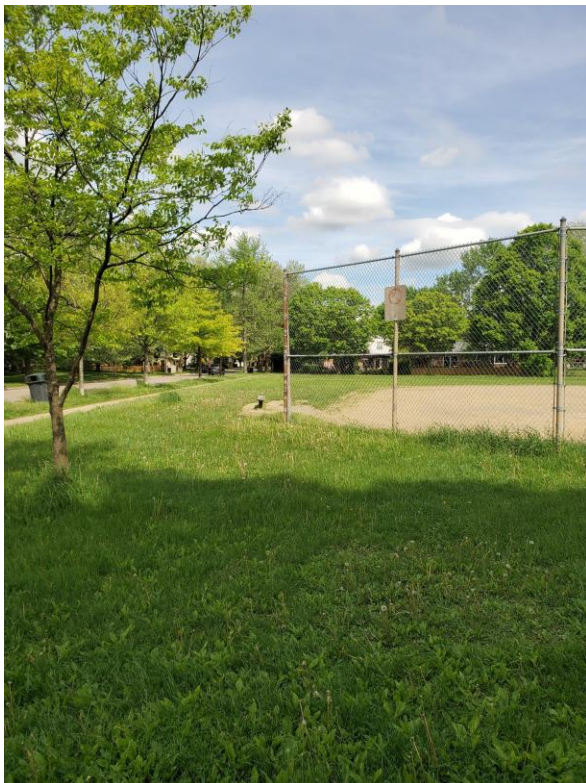
No accessible route

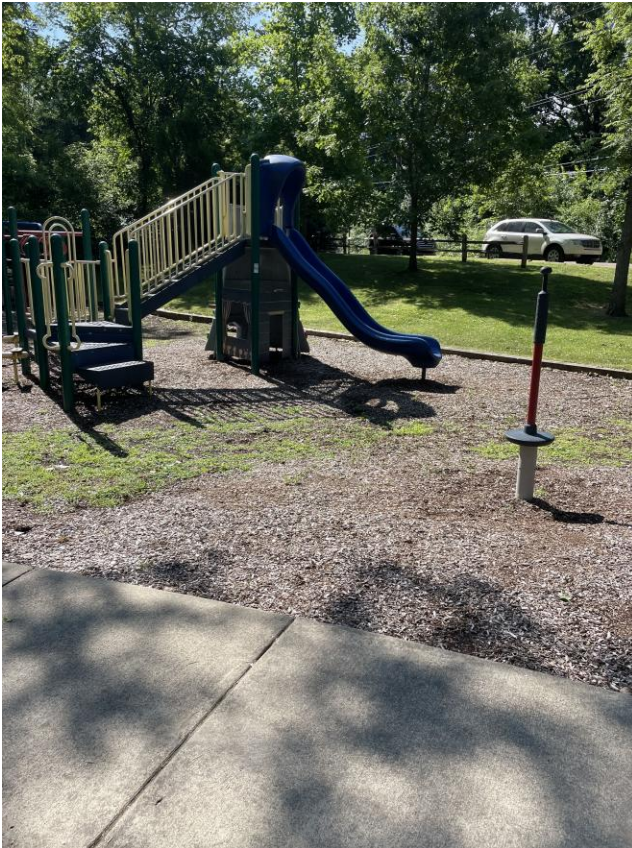
No ramp into playground

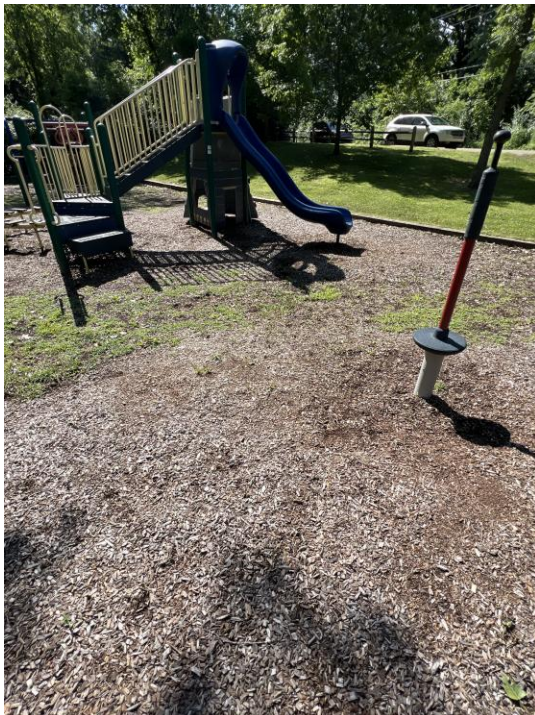
Wood chips

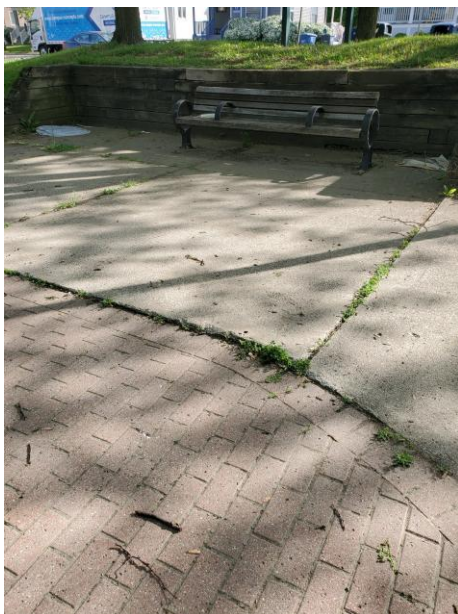
Changes in level

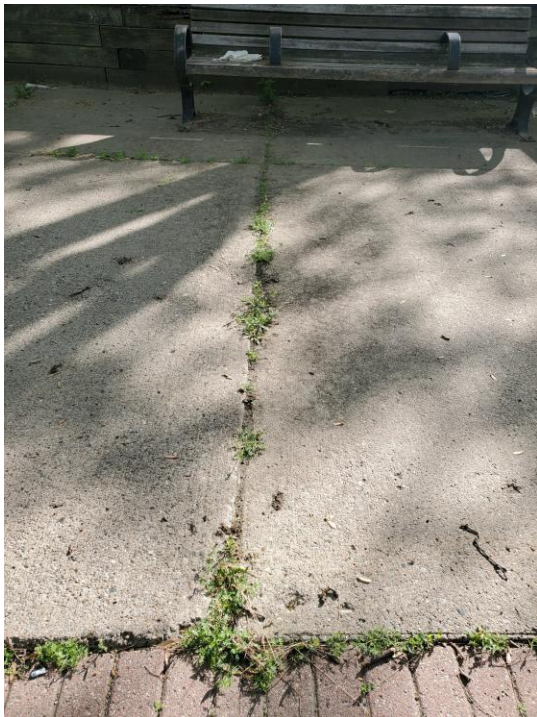
brick paver and concrete plaza

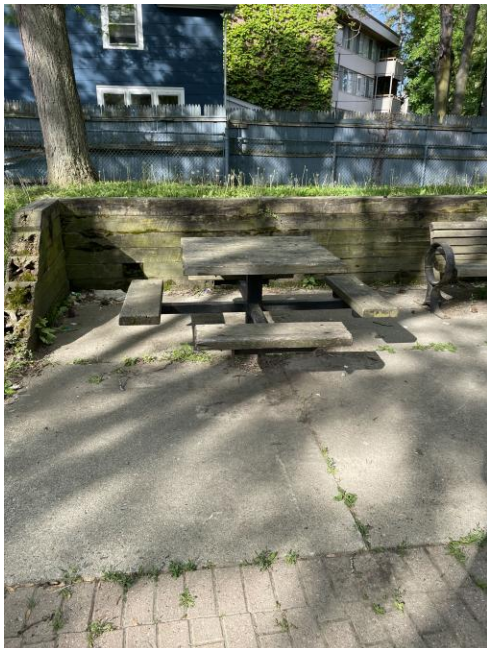
Not provided

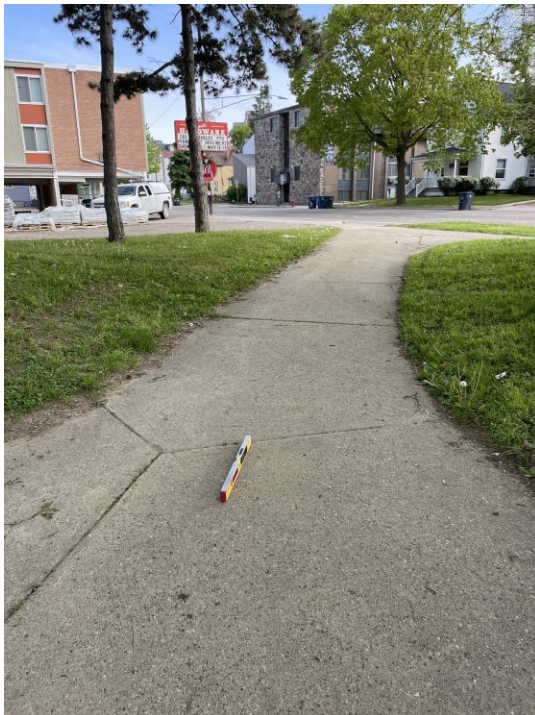
Slope greater than 5%

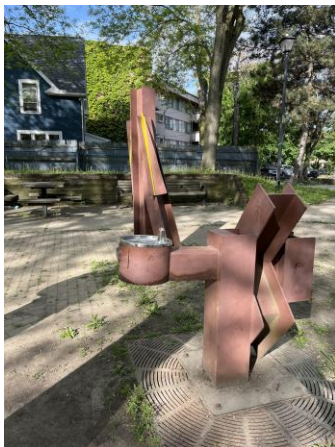
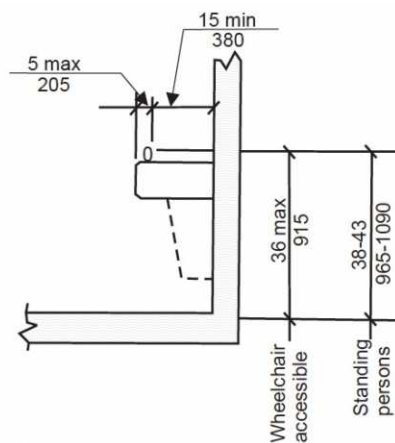
Only low fountain

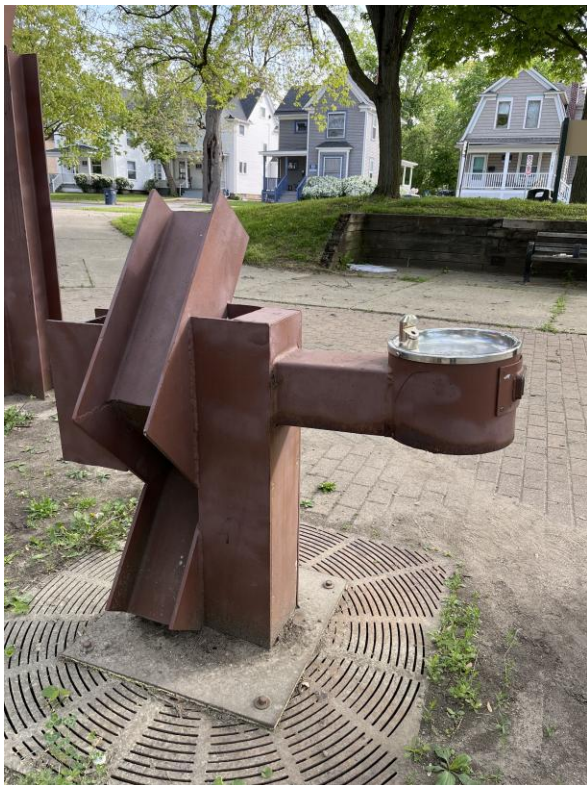
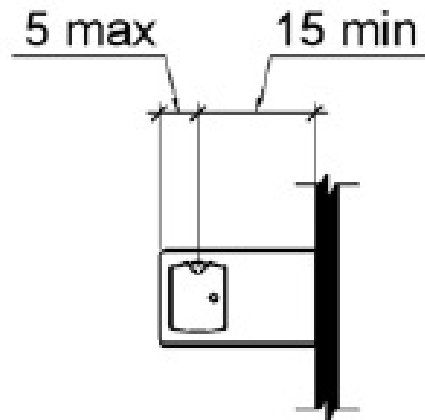
Green Space: Drinking Fountain

Spout at 11 1/2 inches distance from vertical support
