Site Accessibility Evaluation

Allmendinger Park
655 Pauline Blvd
Ann Arbor, MI 48104
ADA Only

Inspection Date: 07/11/2022

Report Date: 11/15/2022

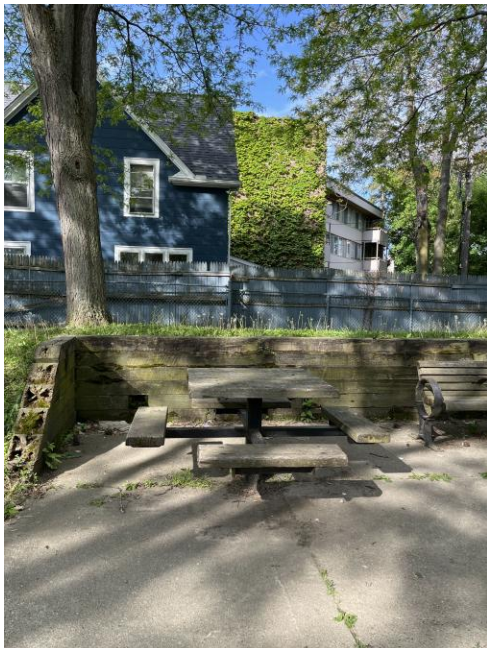
Green Space: Picnic Area

Non-compliant picnic table

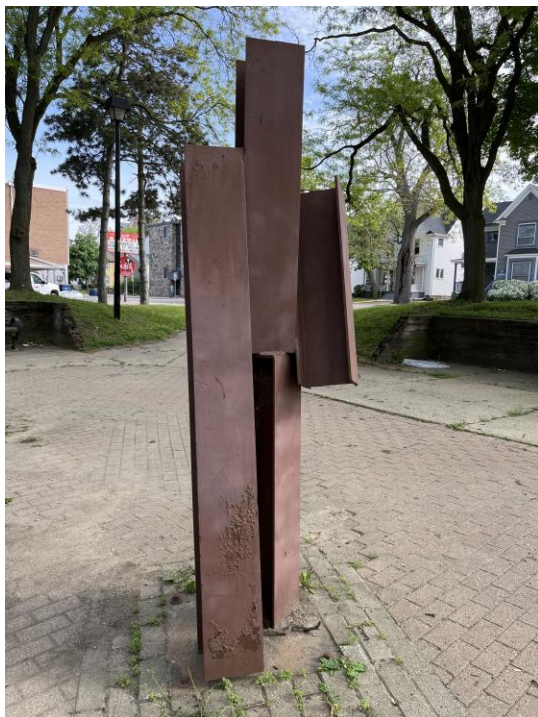
Green Space: Sculpture

Wall-mounted objects that have leading edges between 27 inches and 80 inches from the floor must not project more than 4 inches into the circulation path. Protruding objects that extend to the floor or within 27 inches of the floor are cane detectable and are therefore not hazardous. Where it is necessary or desirable to have objects protrude from the wall, a manner of cane detection must be provided.

Sculptures are protruding

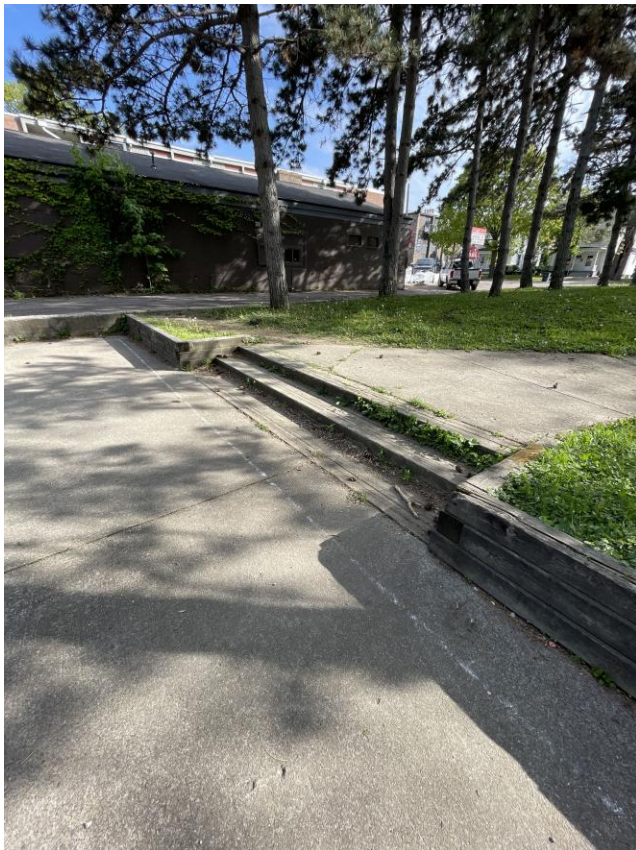
Basketball Court: Route

Changes in level

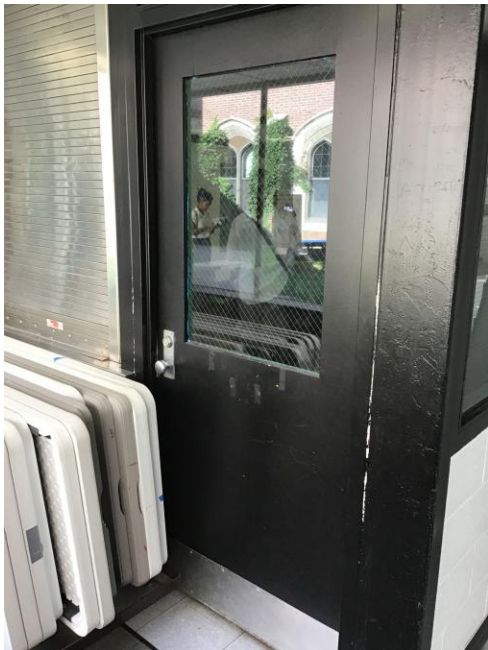
There are 3 doors with knobs.

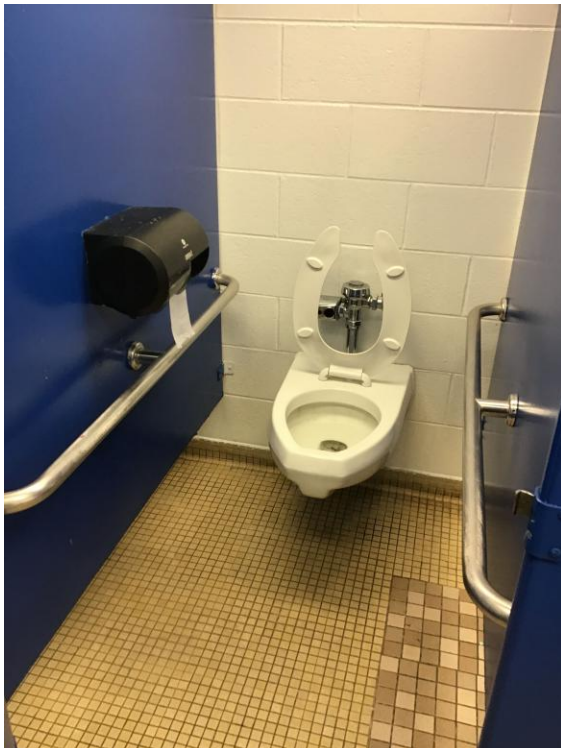
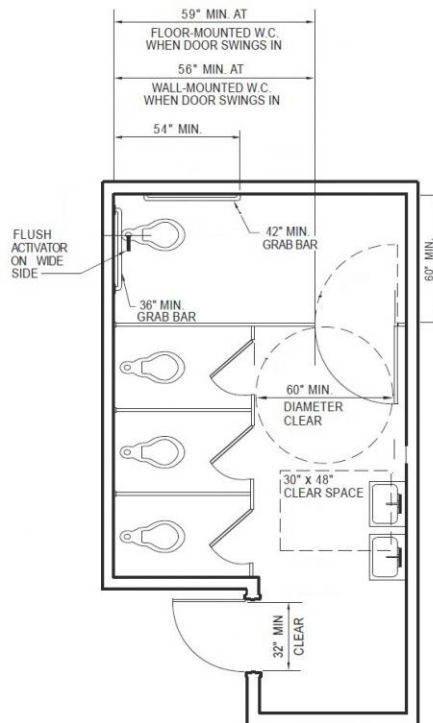
Lobby: Men's Restroom

The stall does not have the required minimum clear floor space or maneuvering clearances for the toilet, Grab bars are missing and/or incorrectly installed, accessories, such as toilet seat covers, toilet paper holders, and garbage cans are either too high, without clear floor space or both, the floor level changes greater than a 1/2 inch at the floor drains.

Compartment width is 36 inches among other barriers.

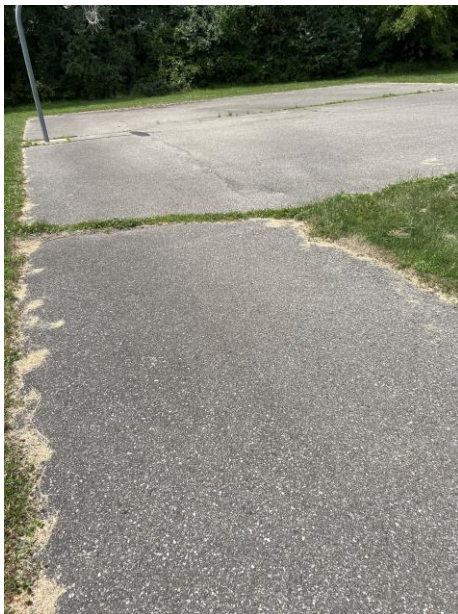
Changes in level

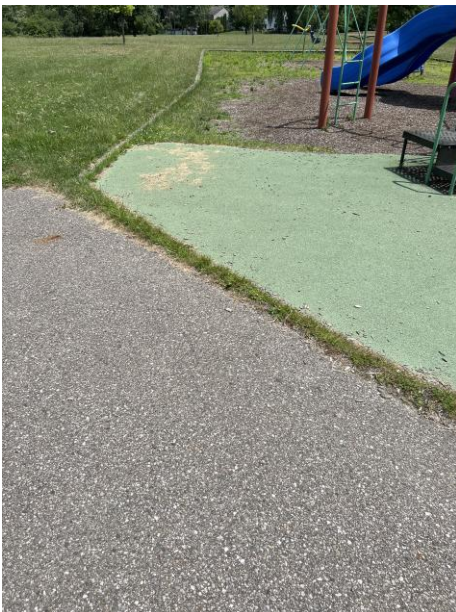
Trail System: Trail

Change in elevation

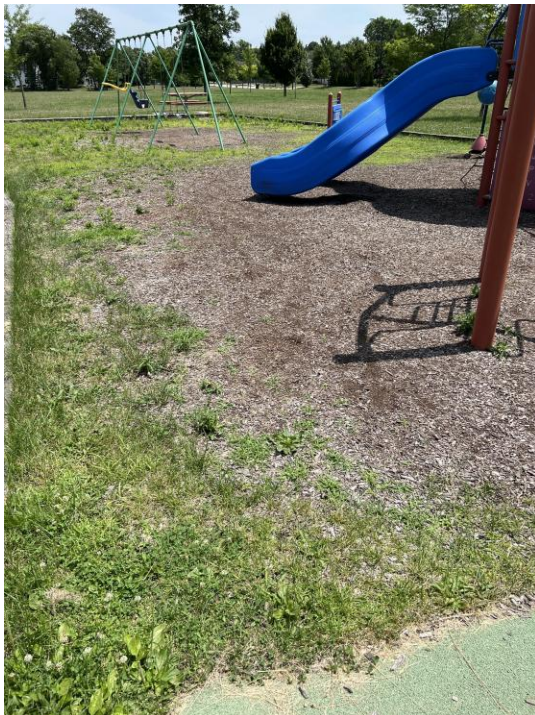
Play Area: Playground

Wood chips

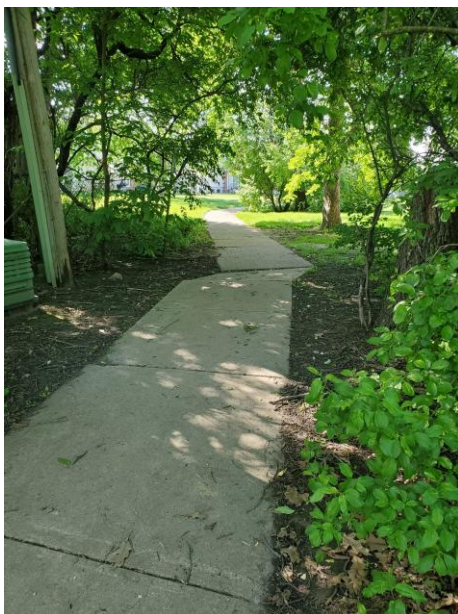
trail from neighborhood

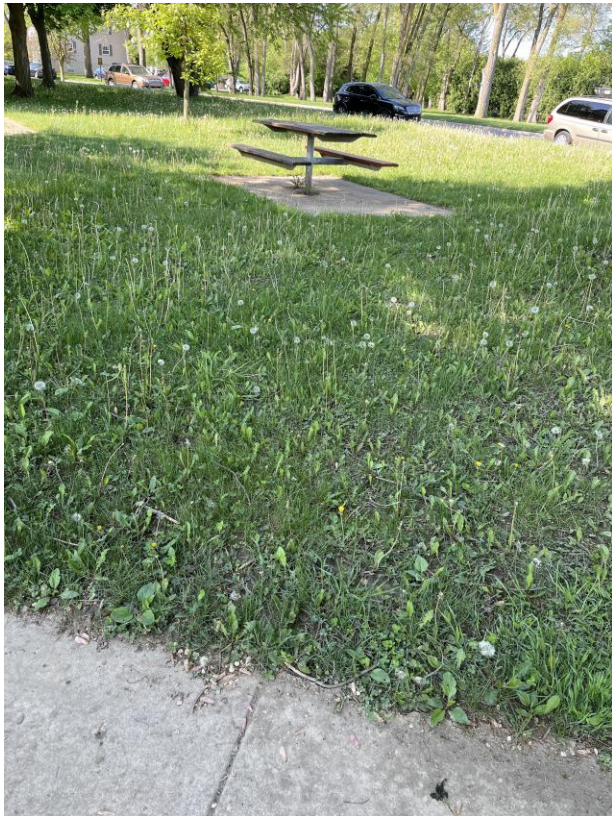
Green Space: Picnic Area

The accessible route contains loose gravel and/or surface materials that do not provide for a stable, firm slip resistant surface.

Surface is grass

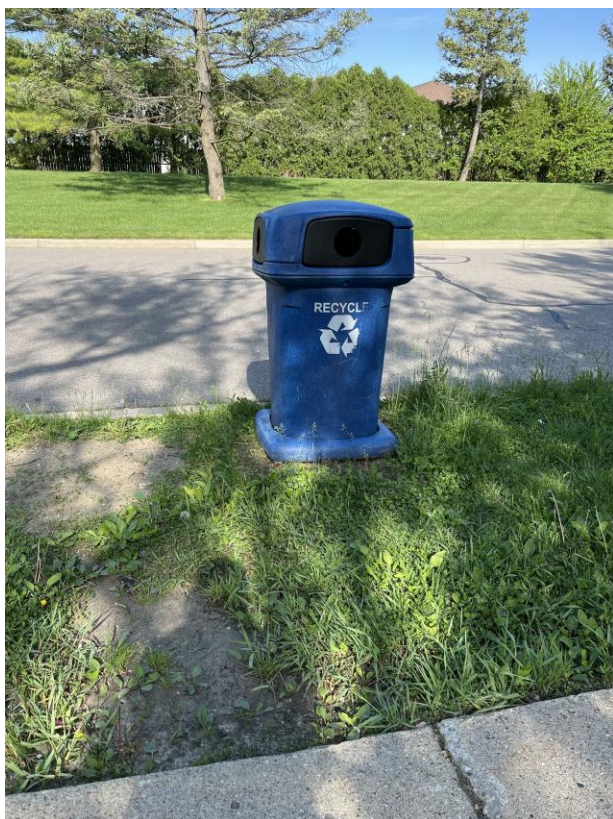
Green Space: Receptacle

The accessible route contains loose gravel and/or surface materials that do not provide for a stable, firm slip resistant surface.

Surface is grass

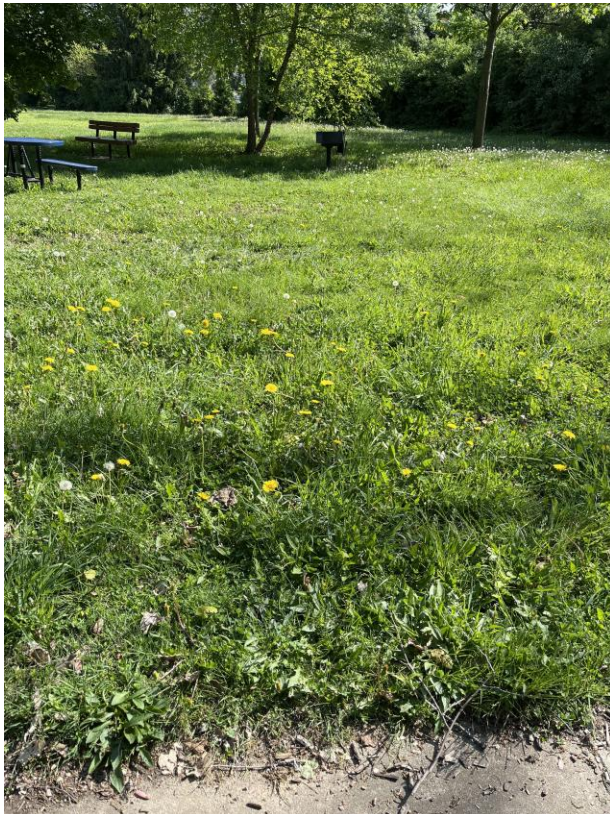
Green Space: Grill

The accessible route contains loose gravel and/or surface materials that do not provide for a stable, firm slip resistant surface.

Surface is grass

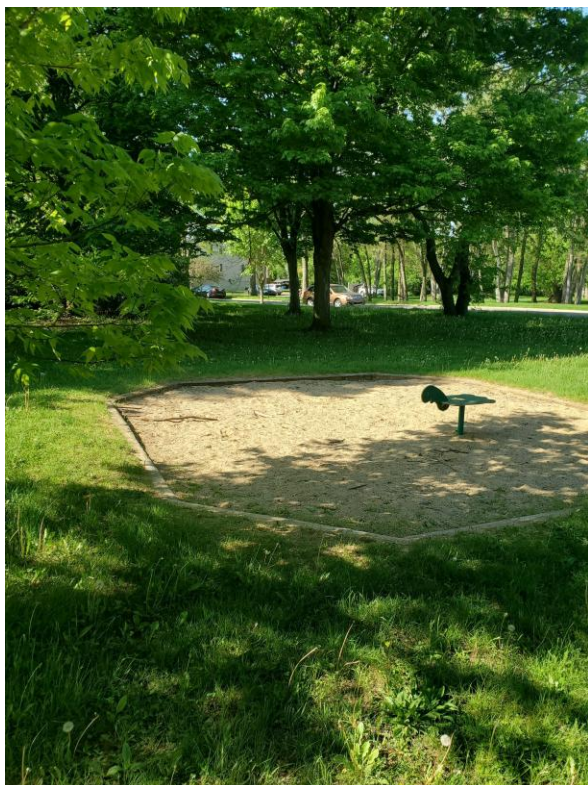
Play Area: Small Play

grass route

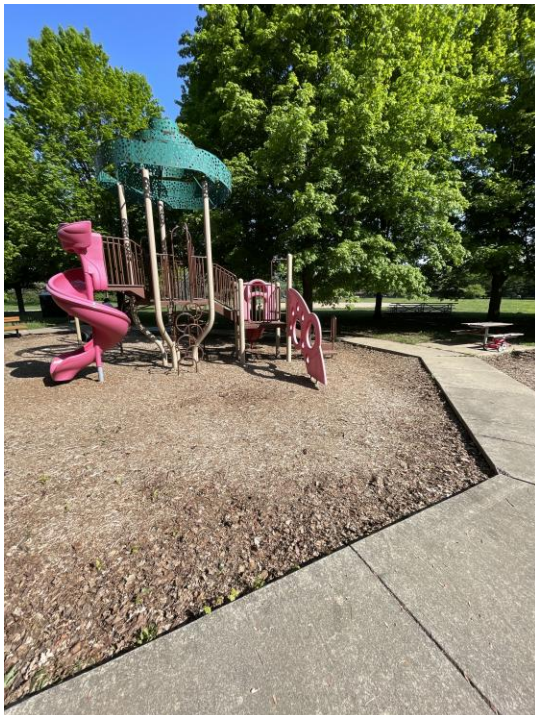
Play Area: Playground

Wood chips

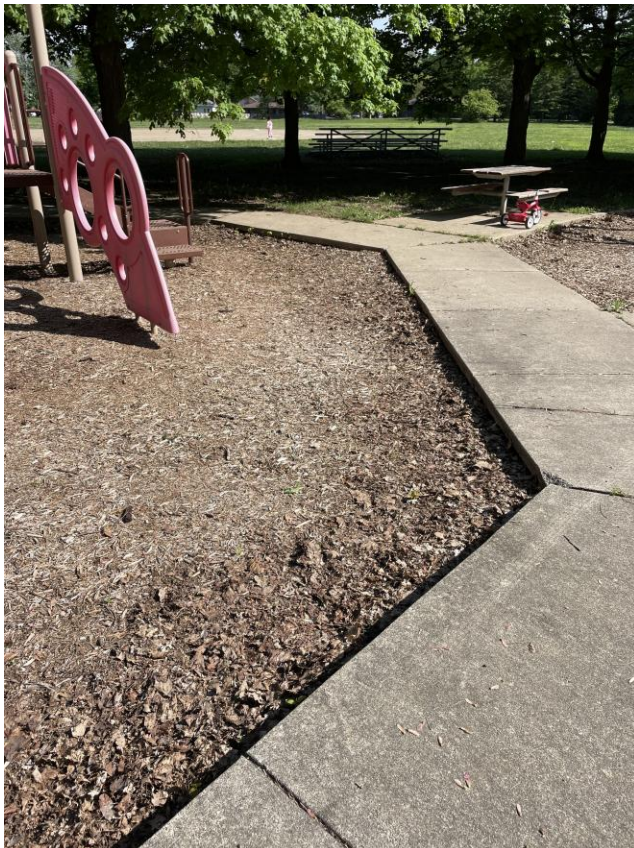
Play Area: Playground

No ramp - change in level

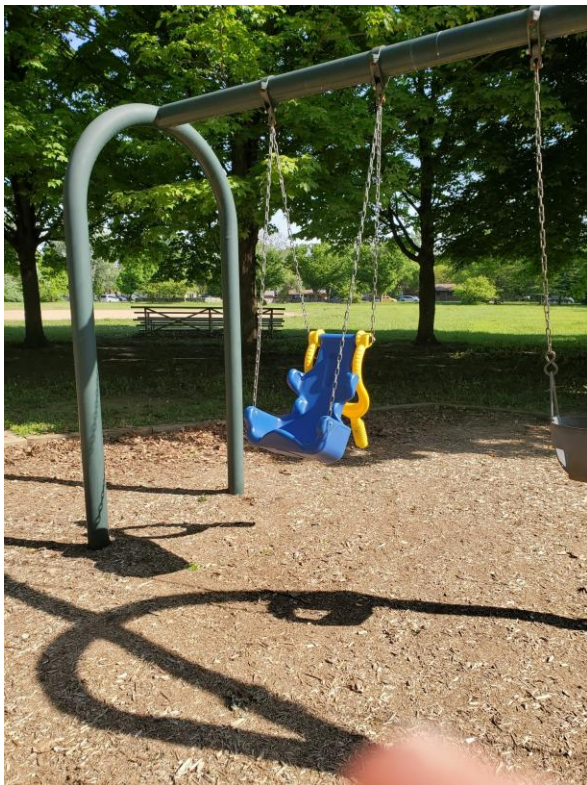
Play Area: Swing

Seat too high off ground

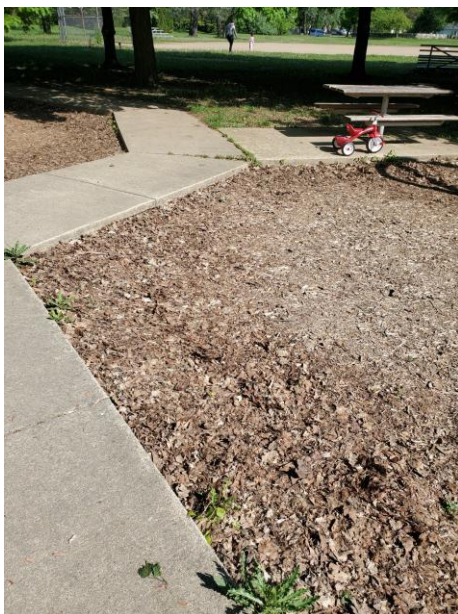
Play Area: Swing

Change in level

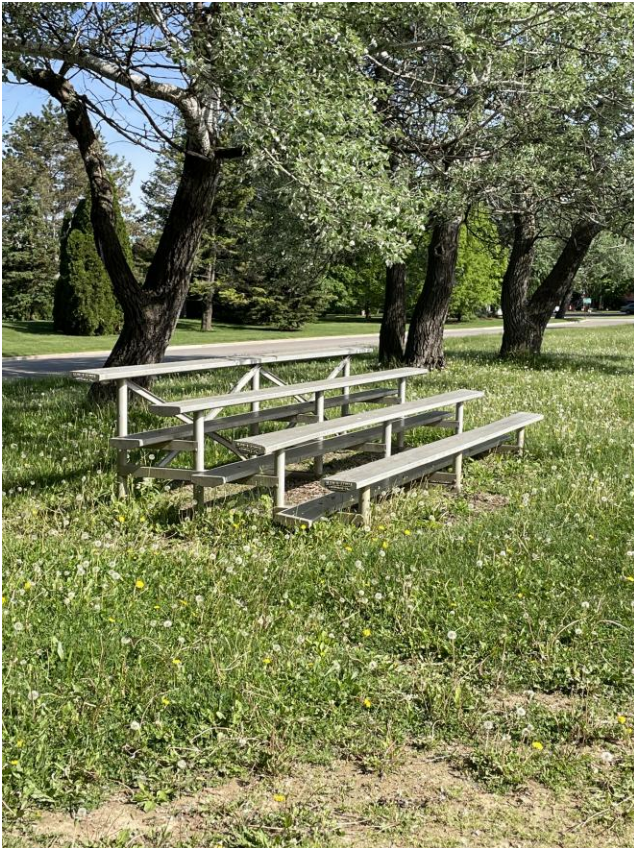
Baseball Field: Seating

Accessible route missing

Surface is grass

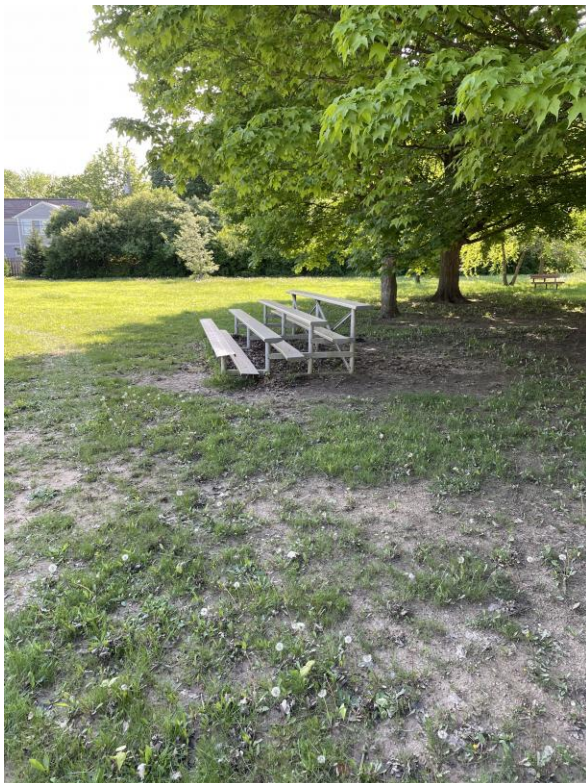
Baseball Field: Seating

No accessible route

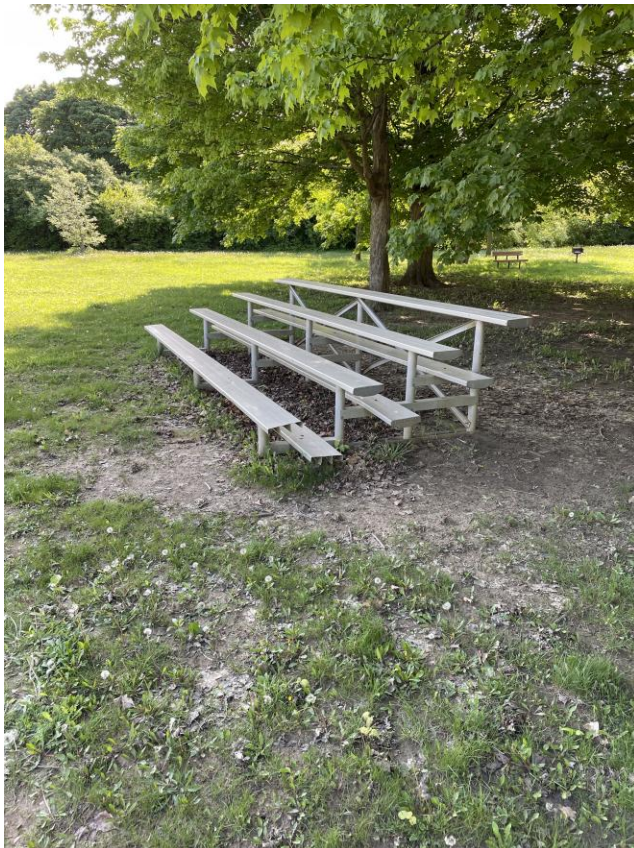
Baseball Field: Seating

Surface is grass

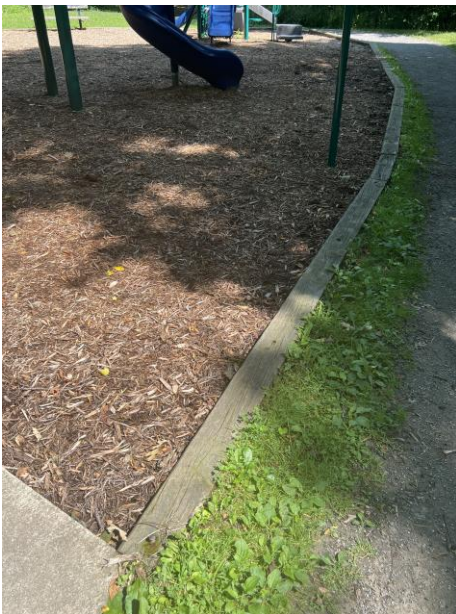
Change in level

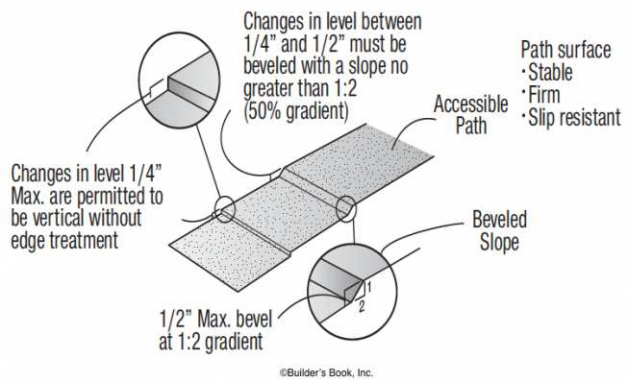
Play Area: Playground

The accessible route contains loose gravel and/or surface materials that do not provide for a stable, firm slip resistant surface.

Surface has loose gravel and grass in cracks

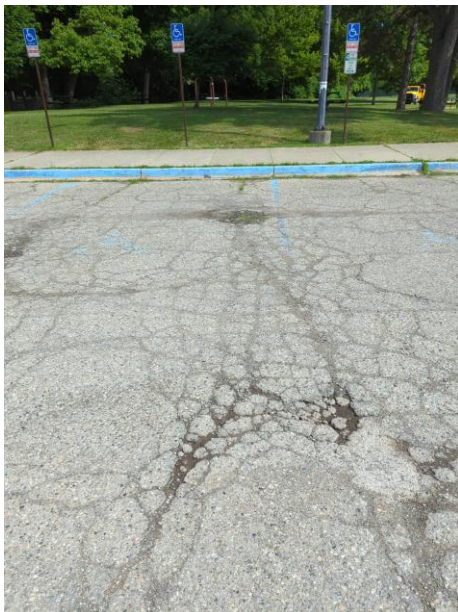
No accessible van parking stalls

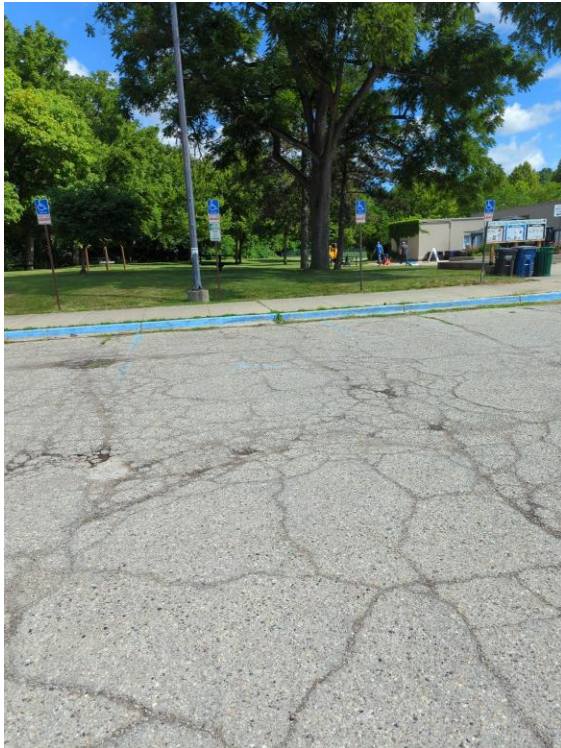
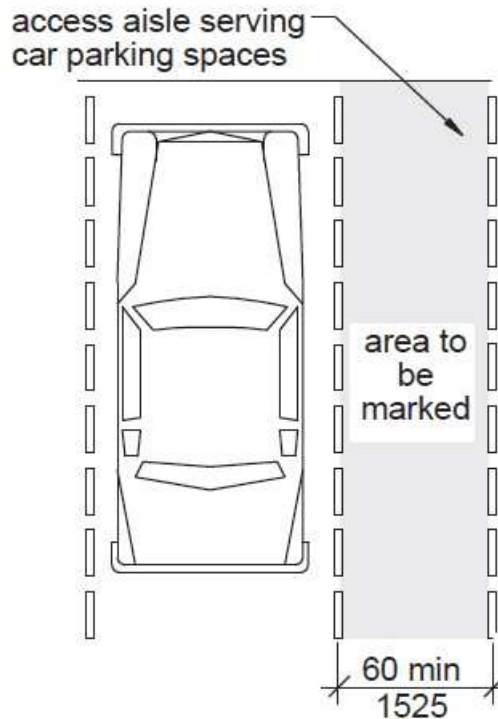
The access aisle is missing at the accessible parking stall.

None of the 5 accessible stalls have an access aisle

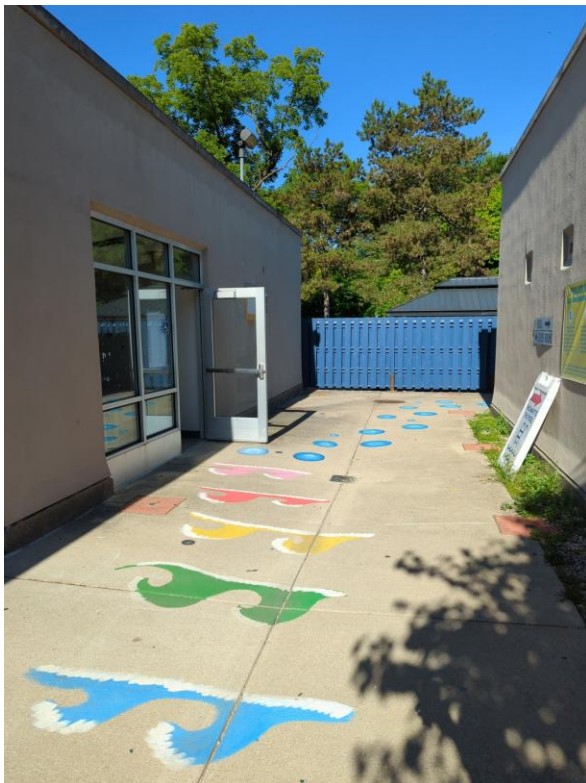
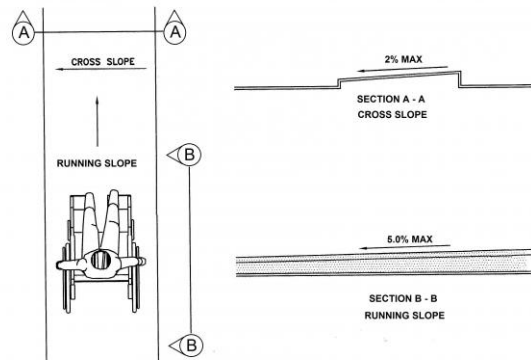
Accessible route from main pool building to rest of the facility has a cross slope of up to 7% at the floor drain in front of entrance

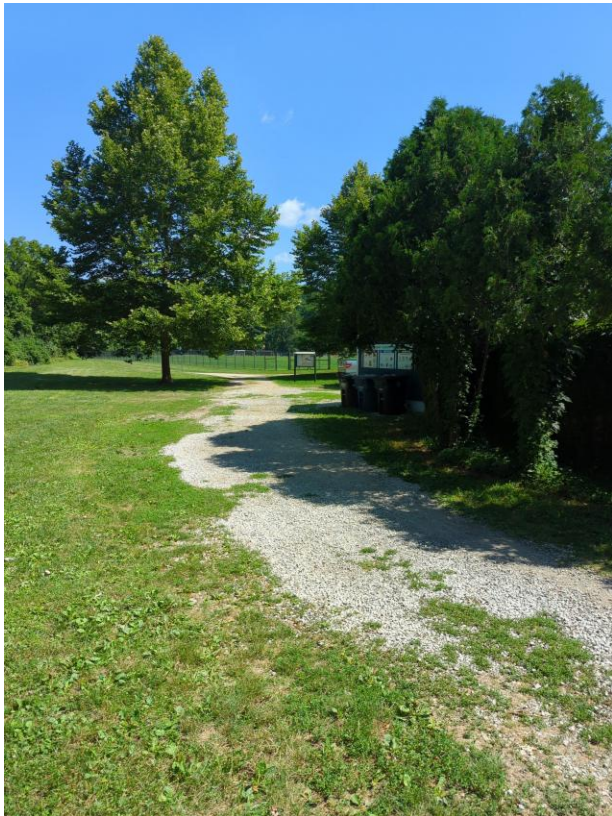
The accessible route contains loose gravel and/or surface materials that do not provide for a stable, firm slip resistant surface.

There is no accessible route connecting the pool and playground to each of the soccer fields

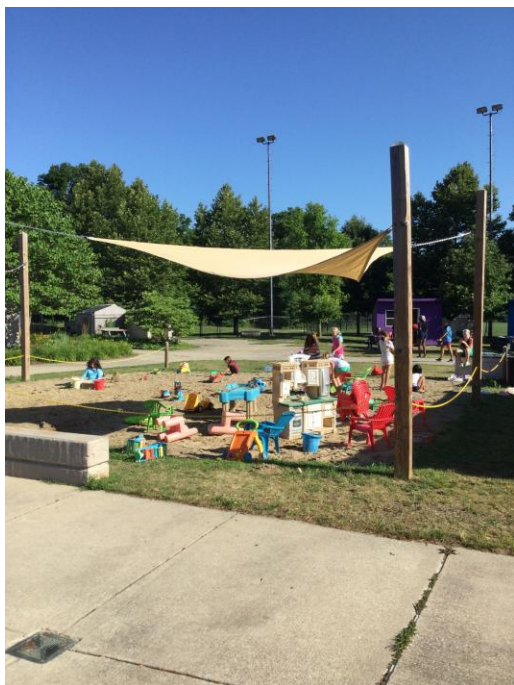
No accessible route

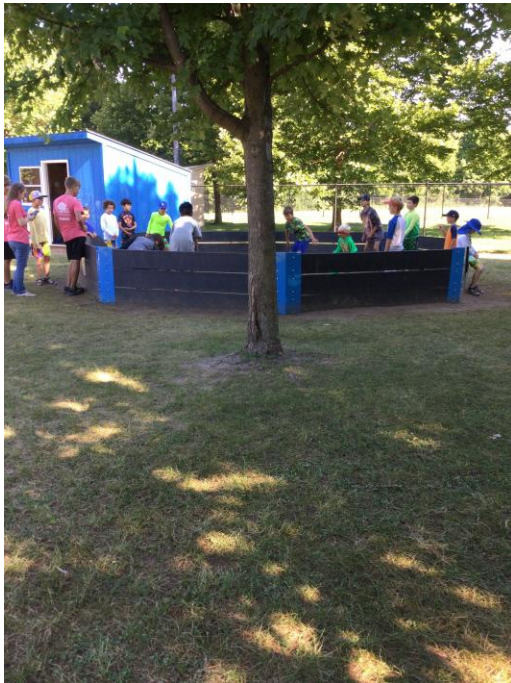
Accessible route

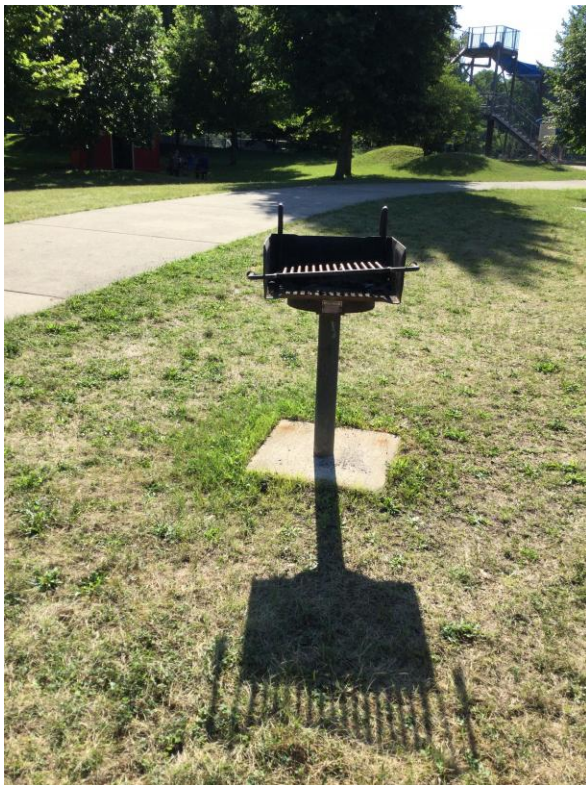
No accessible route to the grill

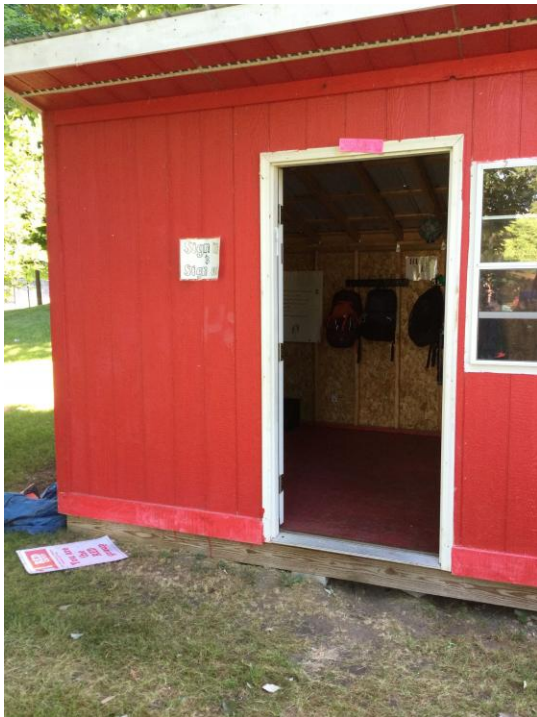
Change in level

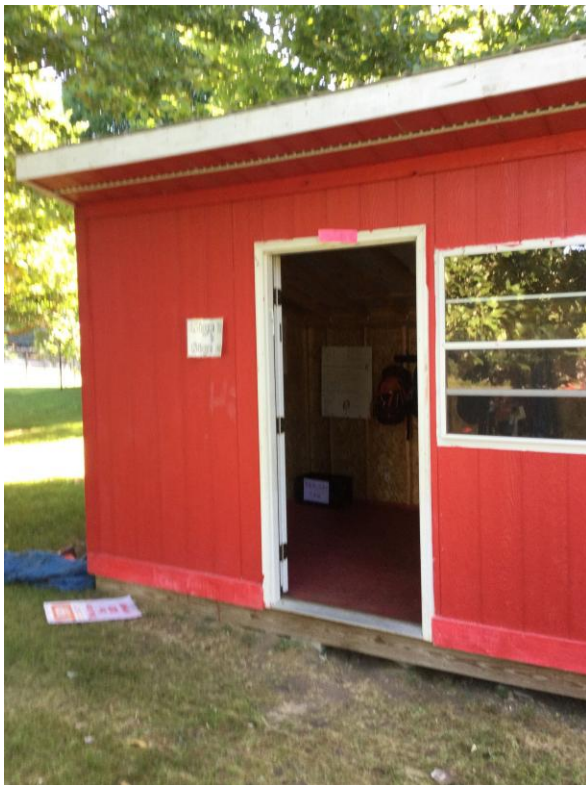
No accessible route

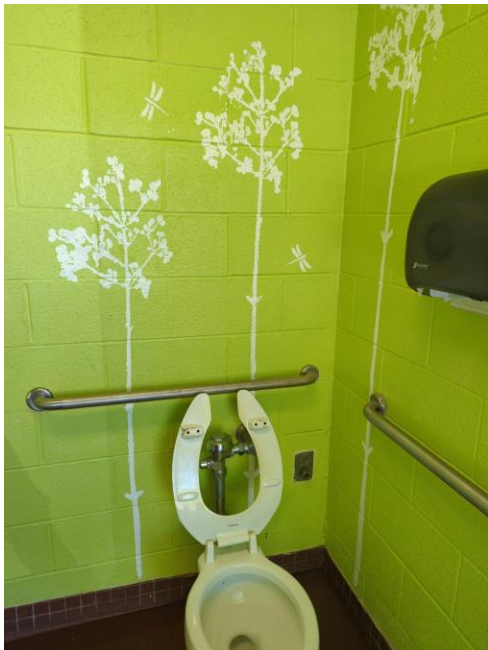
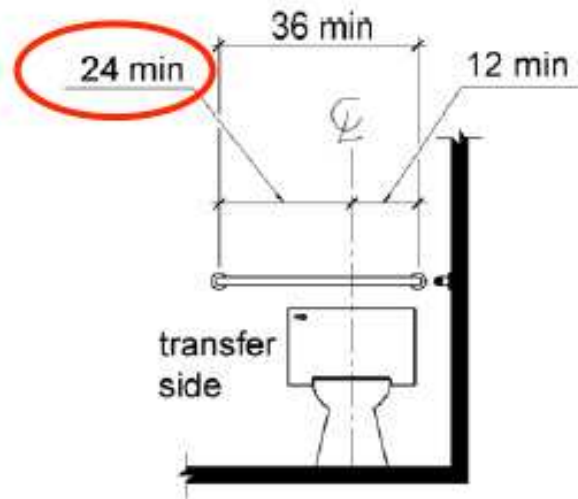
Rear grab bar extends 22 inches from the centerline of the water closet

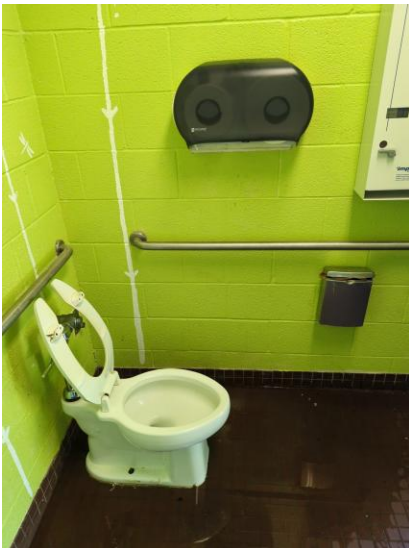
The centerline of the toilet paper dispenser is aligned with the front edge of the water closet and is 50 inches high

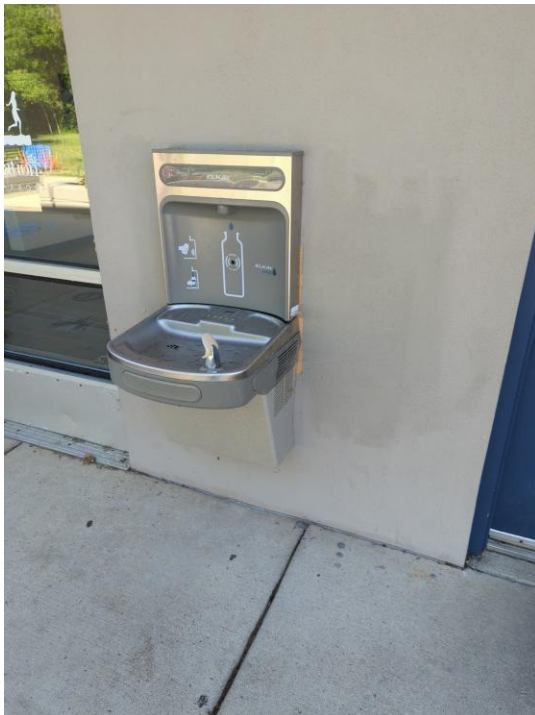
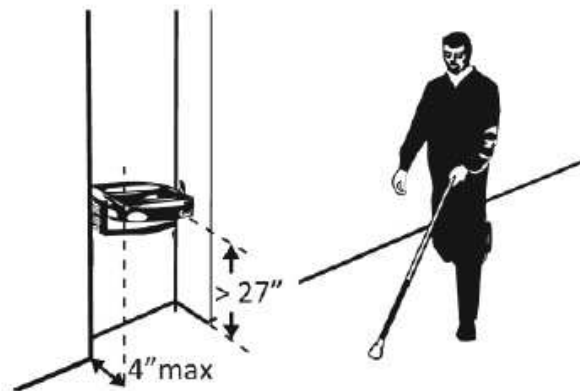
Low drinking fountain has the apron at 28 inches high

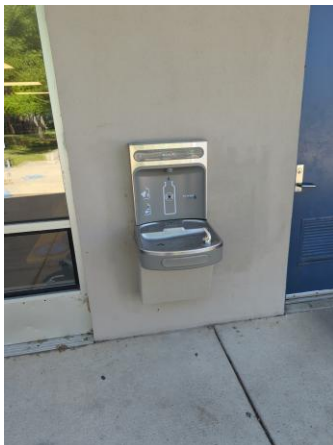
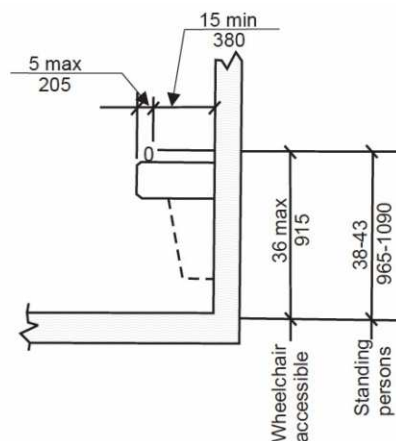
There is no high drinking fountain provided

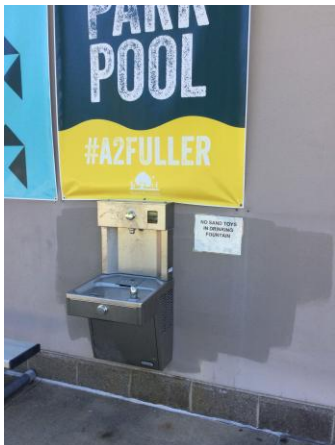
No high drinking fountain

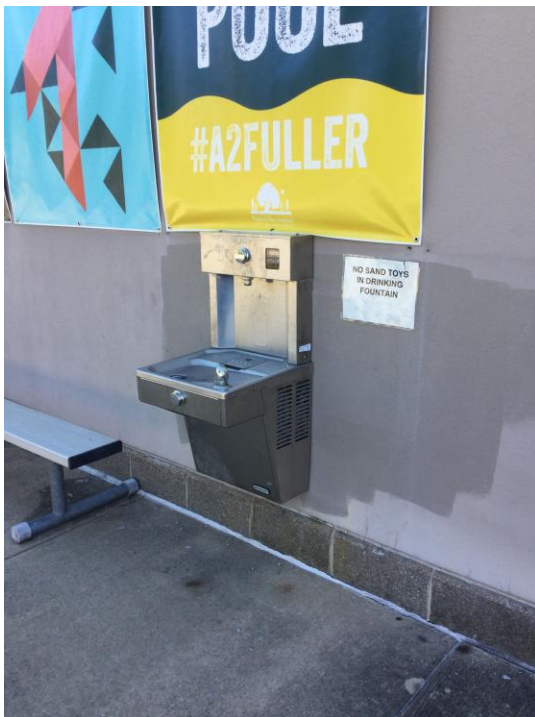
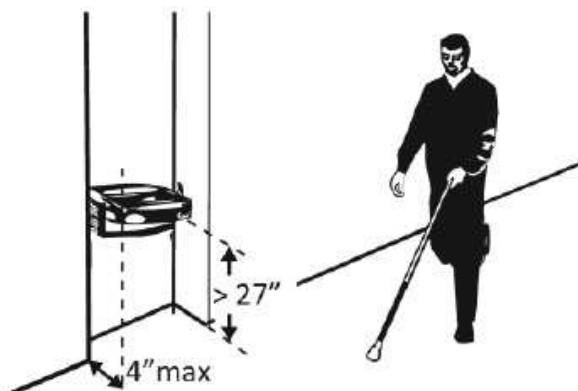
Drinking fountain is protruding

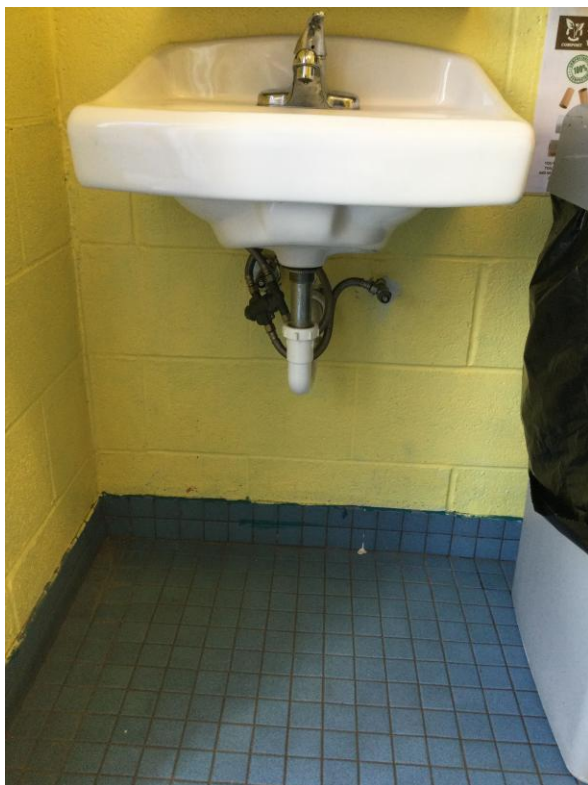
Not fully insulated

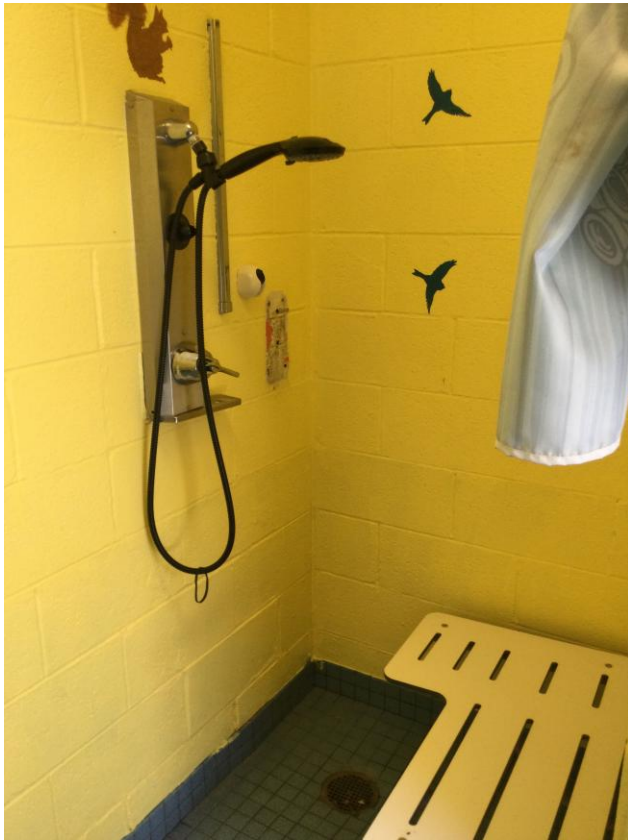
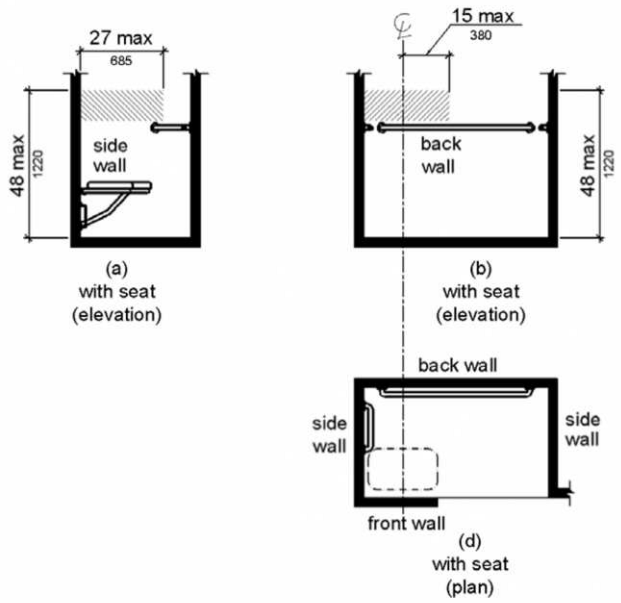
Finding #18 Continued

56" shower head

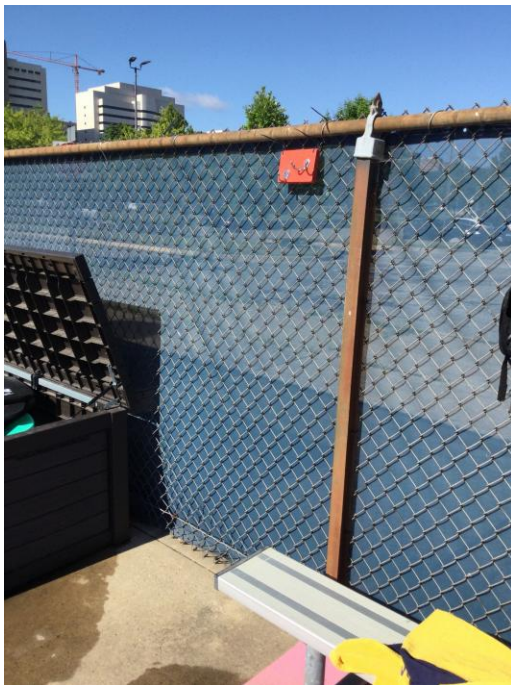
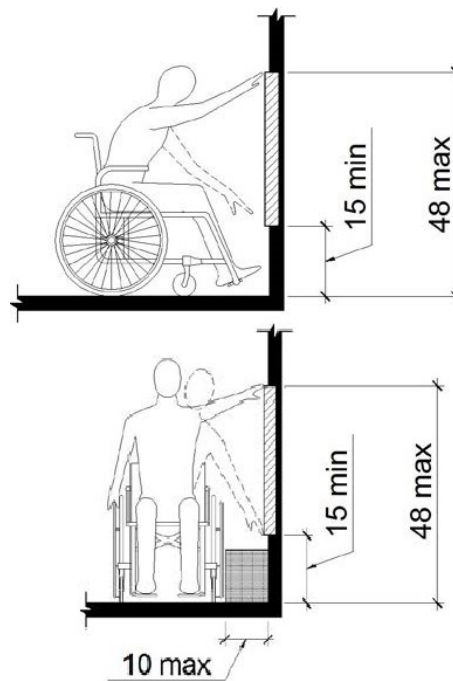
Fence hooks are too high

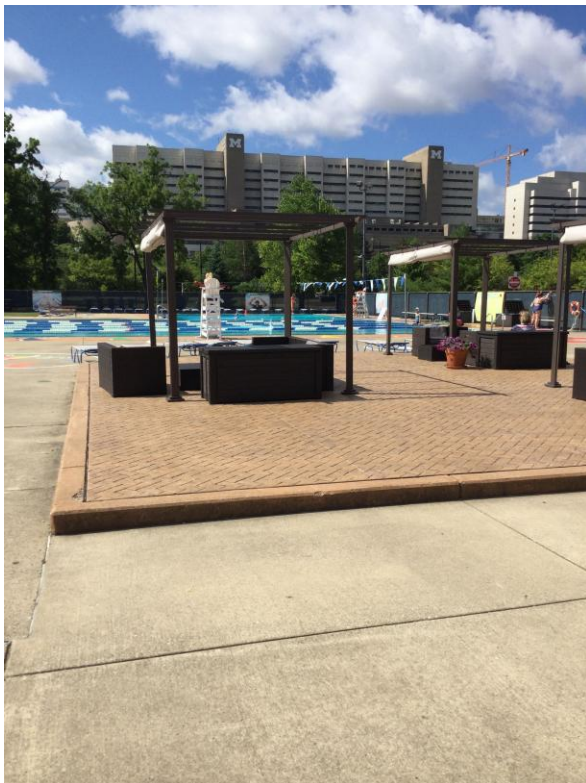
6" raised slab

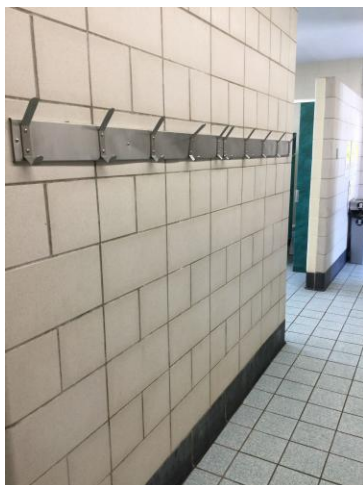
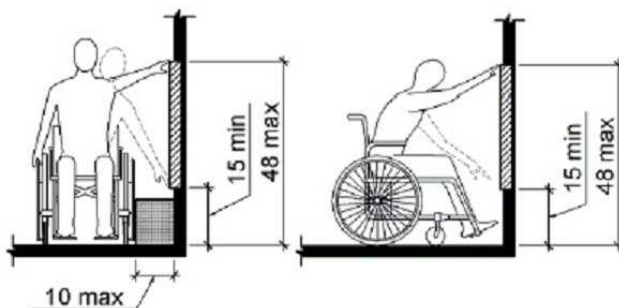
Hooks are too high

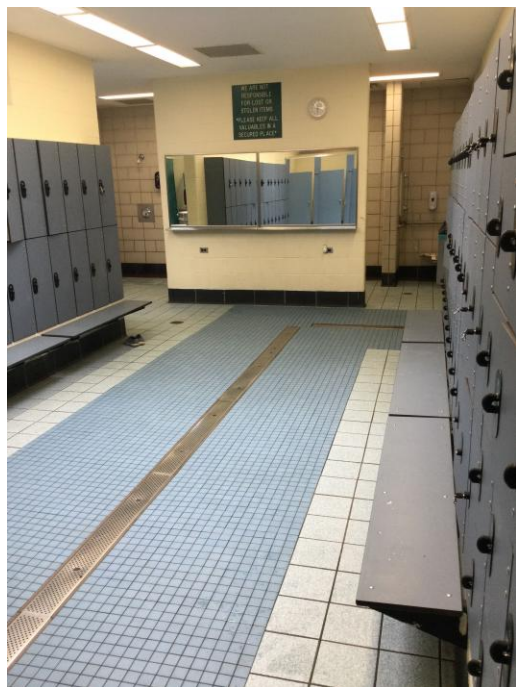
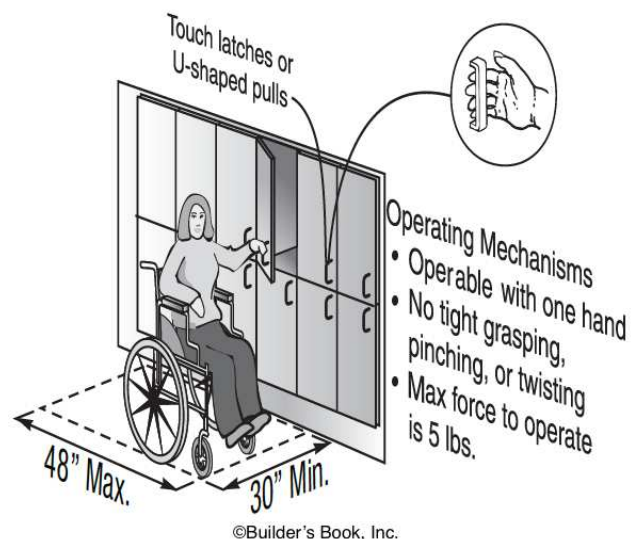
No accessible lockers

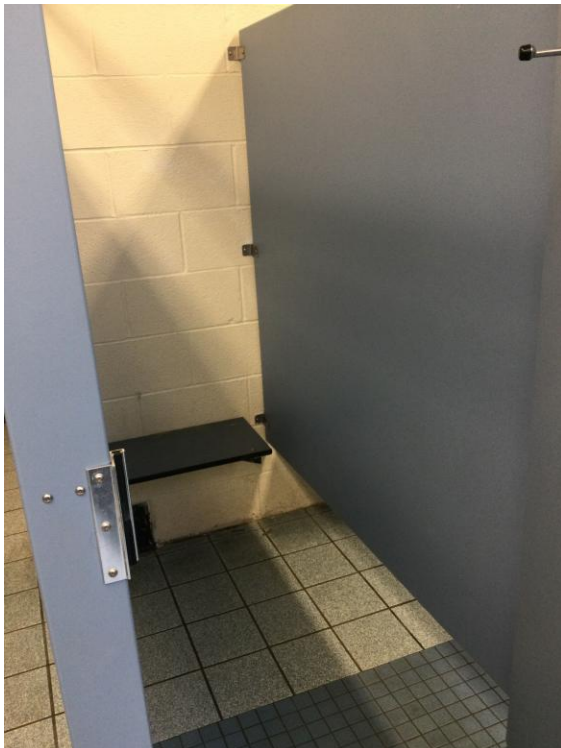
No accessible changing rooms

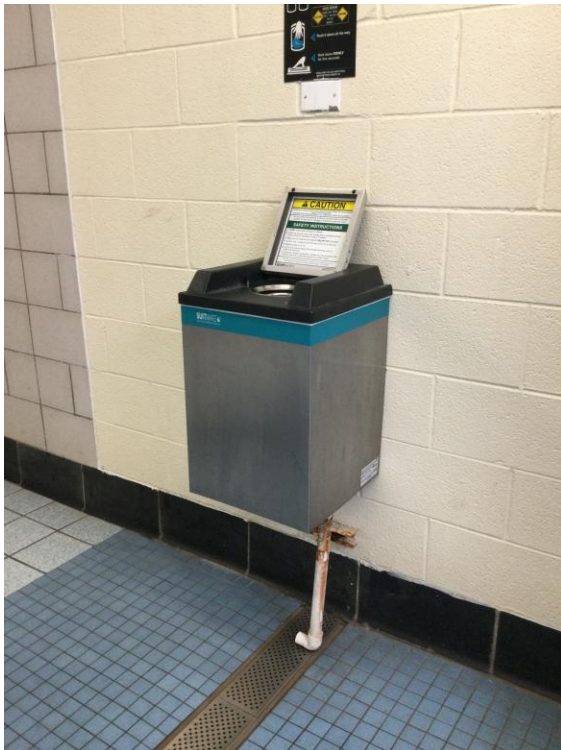
43"

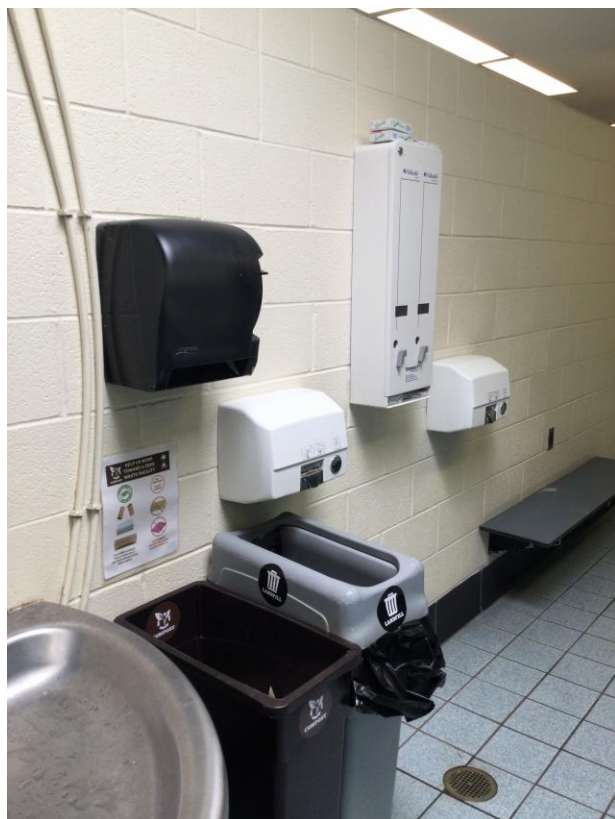
52"

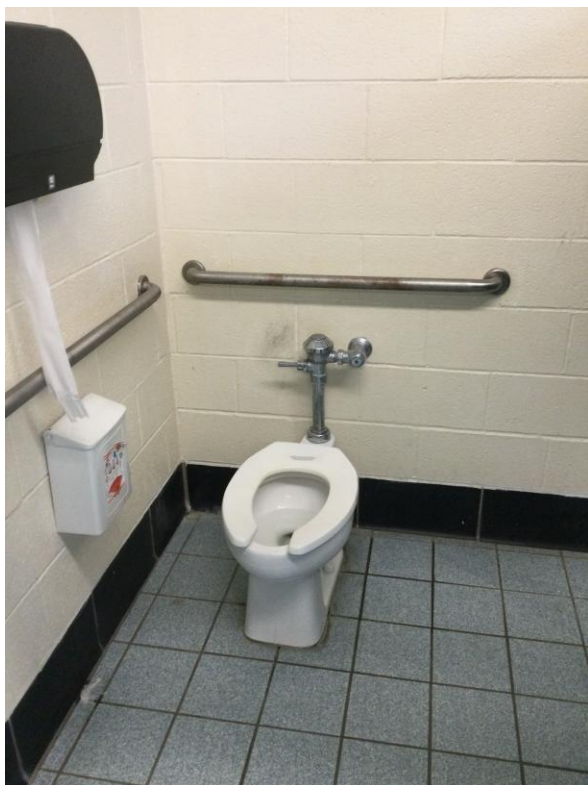
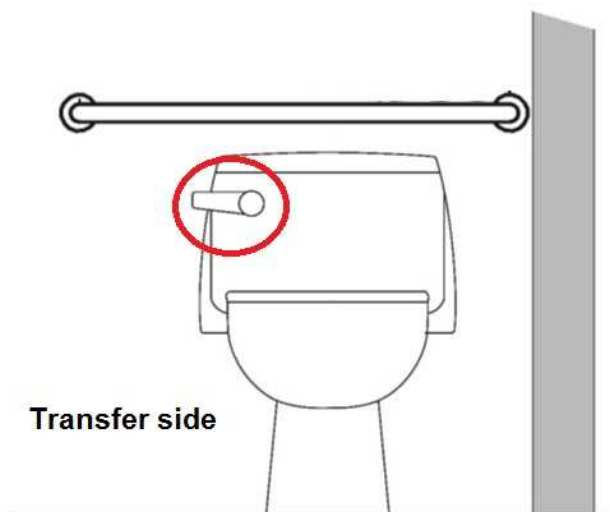
The flush handle is located on the wrong side of the toilet.

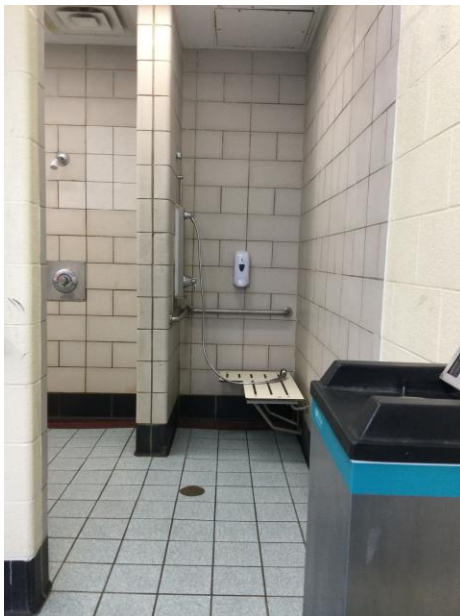
70" top of mount bar

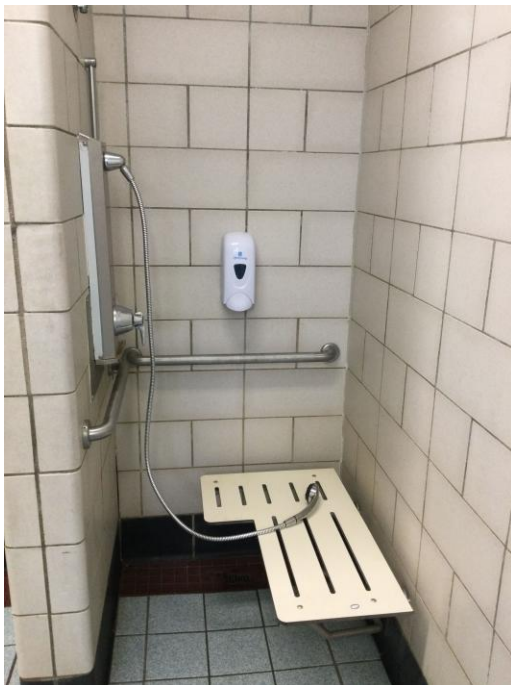
32" x 36"
