Site Accessibility Evaluation

Allmendinger Park
655 Pauline Blvd
Ann Arbor, MI 48104
ADA Only

Inspection Date: 07/11/2022

Report Date: 11/15/2022

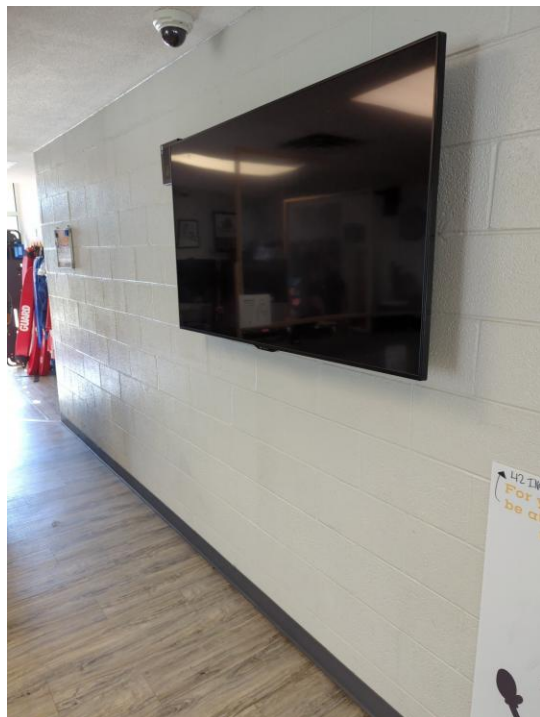
Wall-mounted objects that have leading edges between 27 inches and 80 inches from the floor must not project more than 4 inches into the circulation path. Protruding objects that extend to the floor or within 27 inches of the floor are cane detectable and are therefore not hazardous. Where it is necessary or desirable to have objects protrude from the wall, a manner of cane detection must be provided.

Wall-mounted TV protrudes 5-1/2 inches from the wall

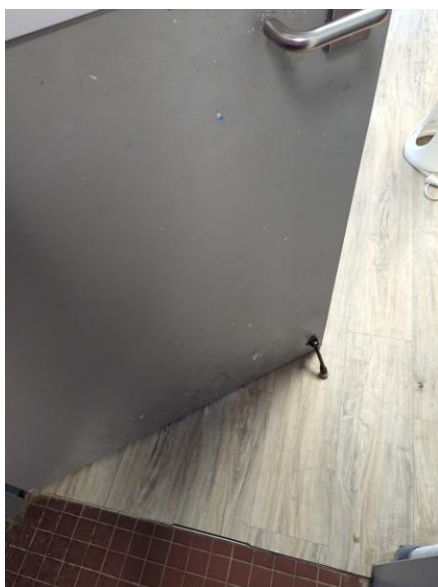
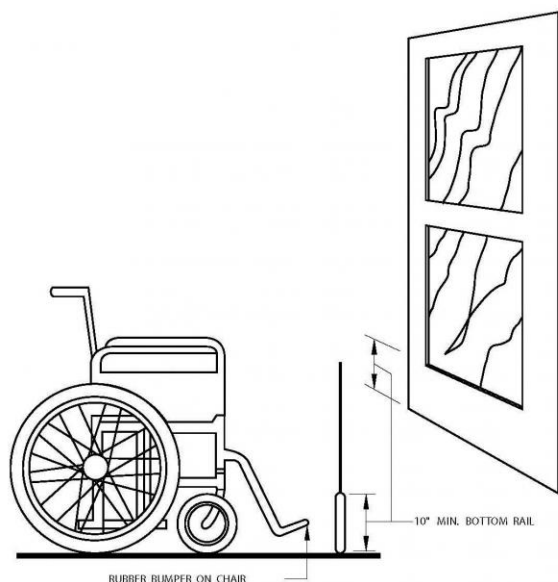
Door stopper

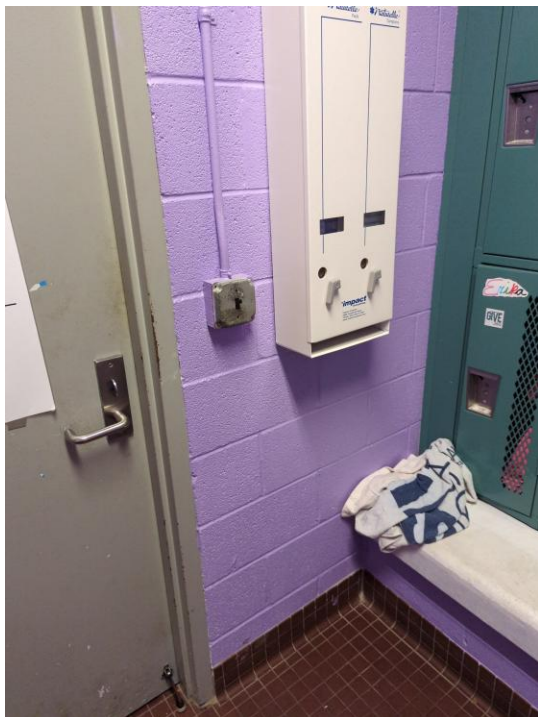
Wall-mounted objects that have leading edges between 27 inches and 80 inches from the floor must not project more than 4 inches into the circulation path. Protruding objects that extend to the floor or within 27 inches of the floor are cane detectable and are therefore not hazardous. Where it is necessary or desirable to have objects protrude from the wall, a manner of cane detection must be provided.

Feminine product dispenser protrudes 6 inches

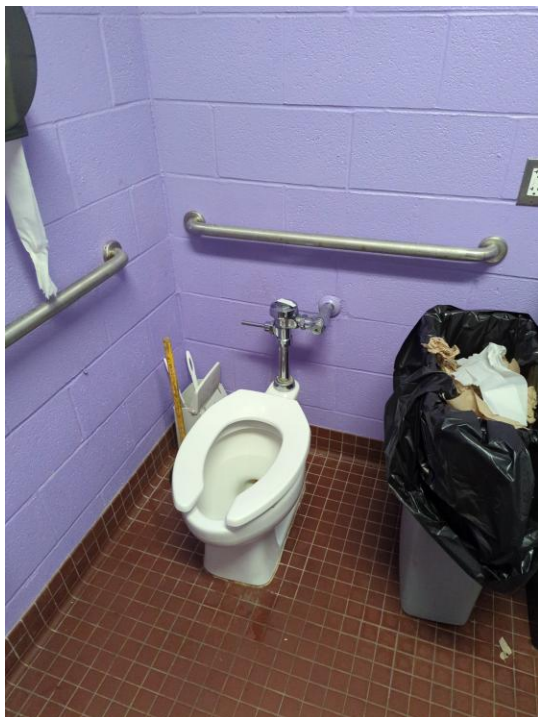
Flush handle is towards the side wall

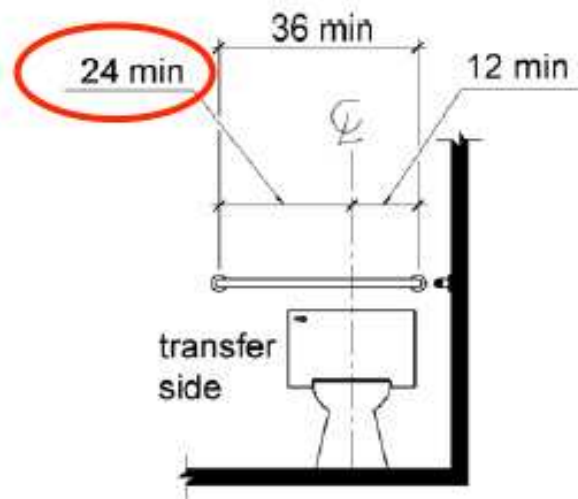
Rear grab bar extends 22 inches from the centerline of the water closet

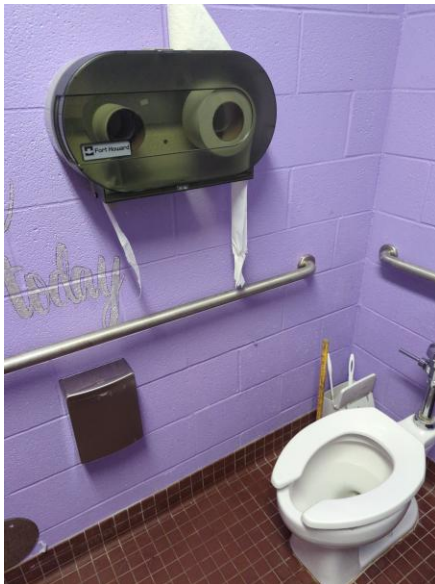
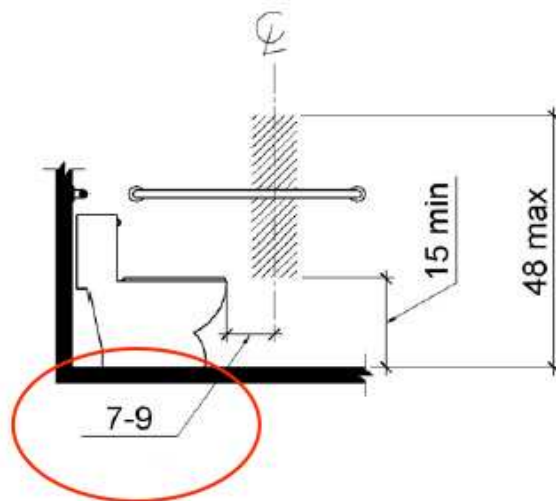
Toilet paper dispenser is 4 inches in front of the water closet to the centerline, and is 49 inches high

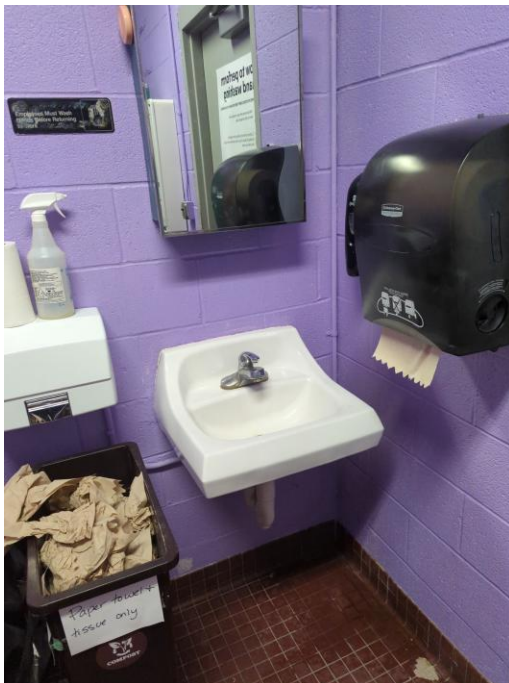
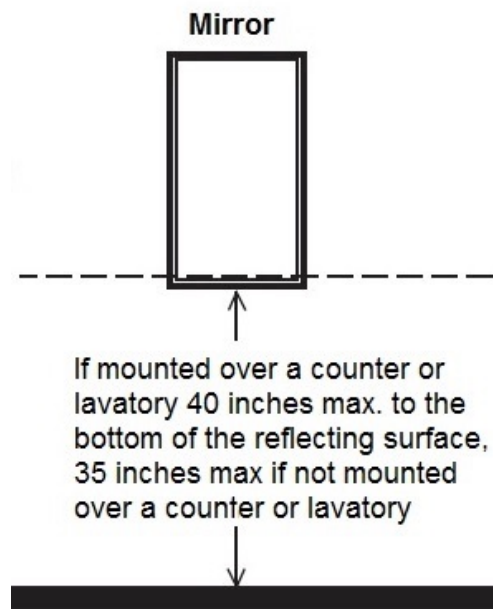
Mirror is 52 inches high

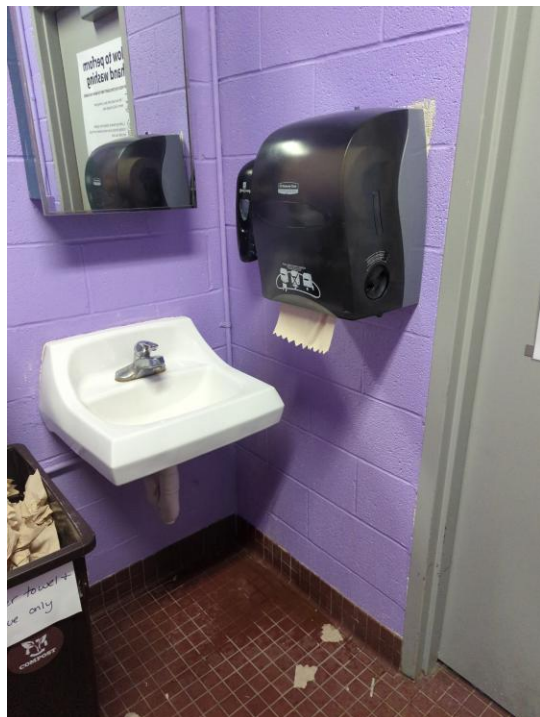
Wall-mounted objects that have leading edges between 27 inches and 80 inches from the floor must not project more than 4 inches into the circulation path. Protruding objects that extend to the floor or within 27 inches of the floor are cane detectable and are therefore not hazardous. Where it is necessary or desirable to have objects protrude from the wall, a manner of cane detection must be provided.

paper towel dispenser protrudes 10 inches

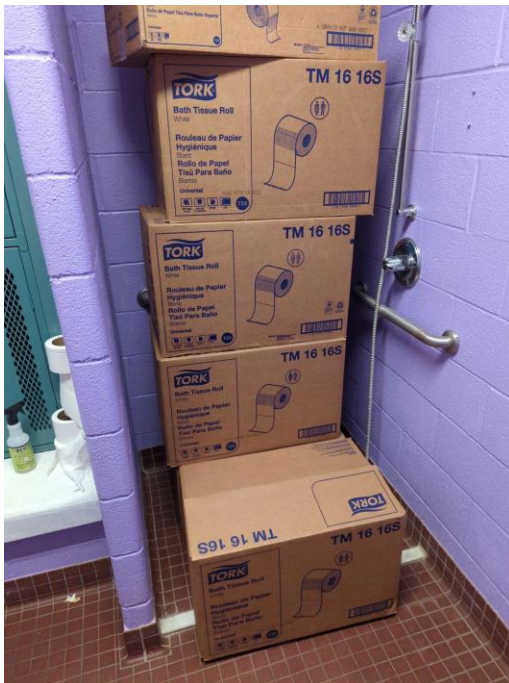
The transfer shower is 40x36 inches

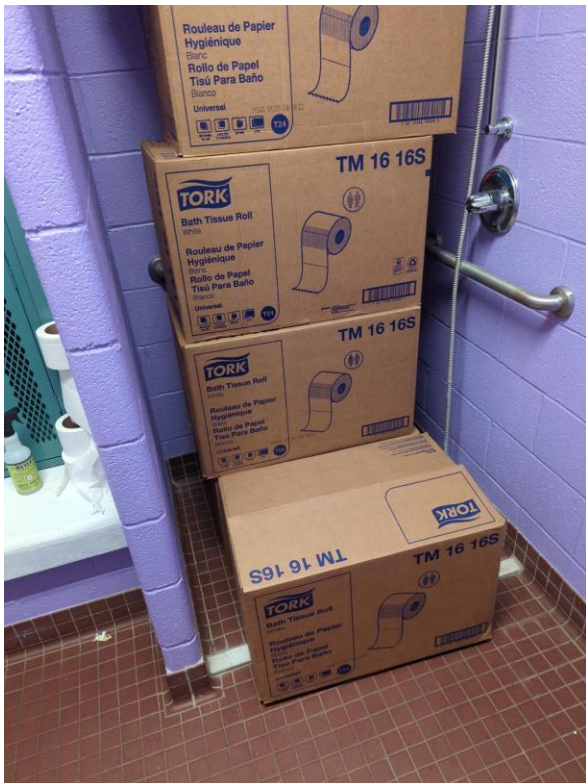
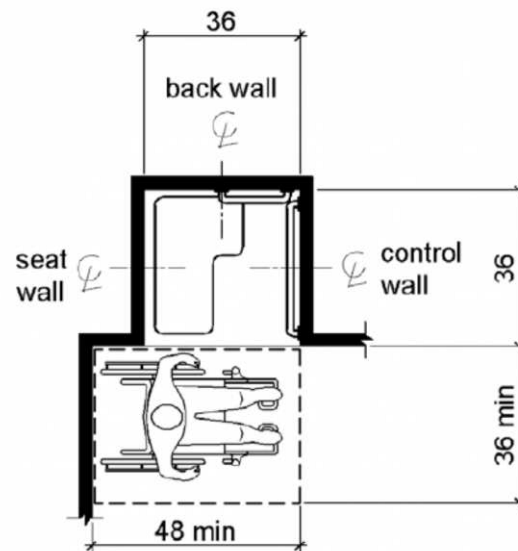
The shower compartment is missing a seat.

The transfer shower does not have a seat

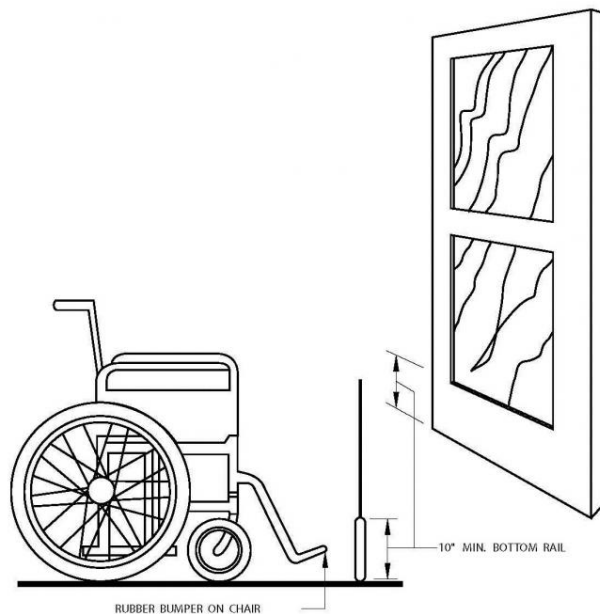
Both doors at the camp office area in the main building have a bottom smooth surface of only 9 inches high

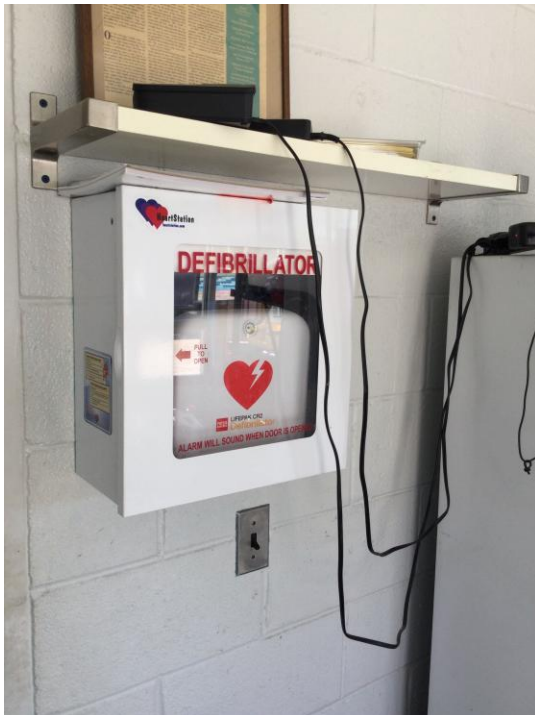
Wall-mounted objects that have leading edges between 27 inches and 80 inches from the floor must not project more than 4 inches into the circulation path. Protruding objects that extend to the floor or within 27 inches of the floor are cane detectable and are therefore not hazardous. Where it is necessary or desirable to have objects protrude from the wall, a manner of cane detection must be provided.

9"

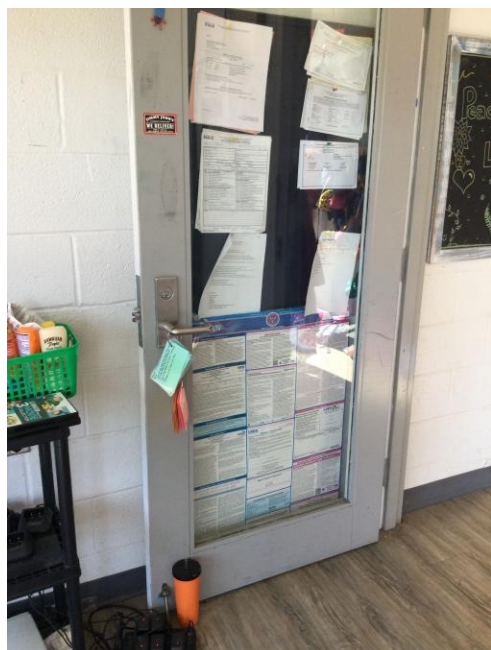
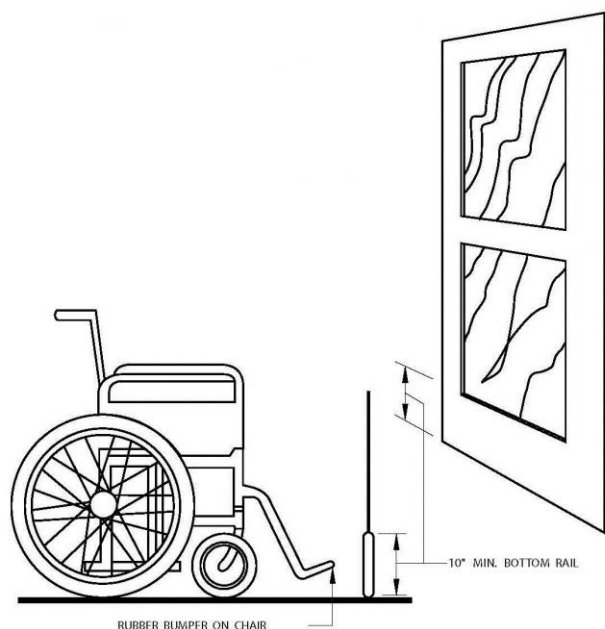
Glass doors

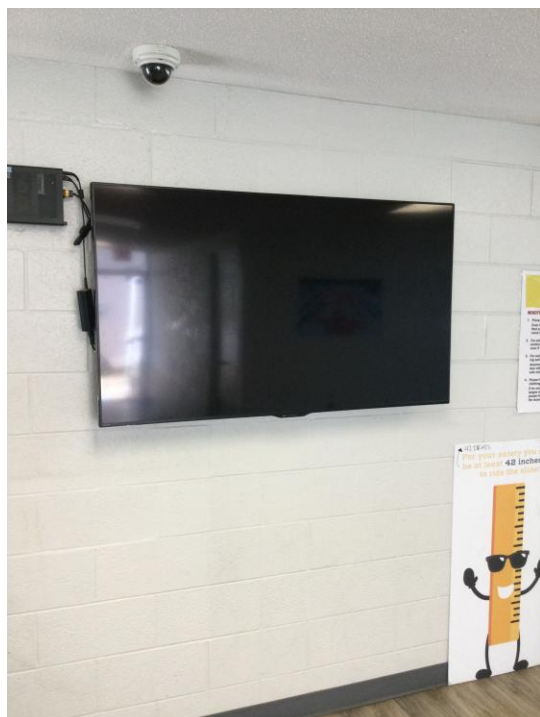
Wall-mounted objects that have leading edges between 27 inches and 80 inches from the floor must not project more than 4 inches into the circulation path. Protruding objects that extend to the floor or within 27 inches of the floor are cane detectable and are therefore not hazardous. Where it is necessary or desirable to have objects protrude from the wall, a manner of cane detection must be provided.

6"

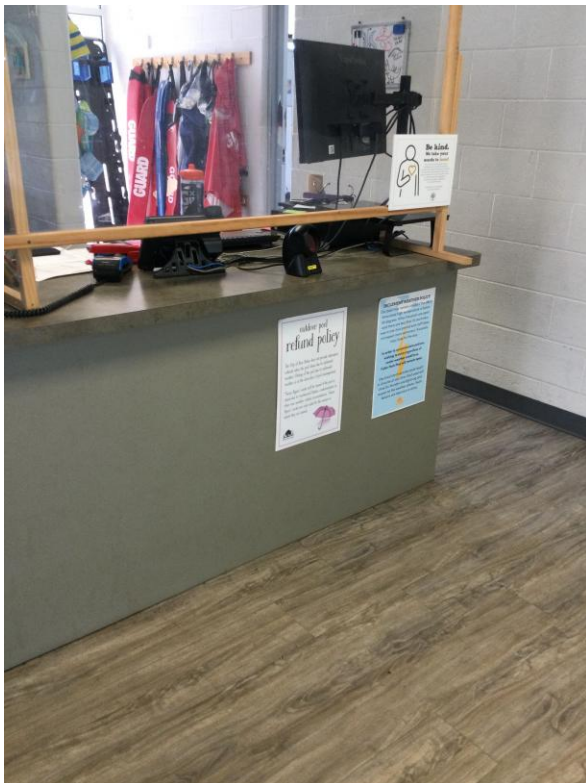
3"

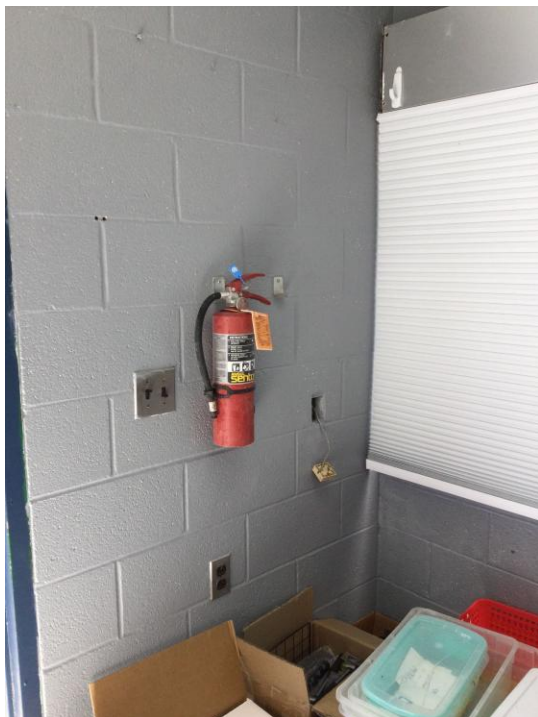
Wall-mounted objects that have leading edges between 27 inches and 80 inches from the floor must not project more than 4 inches into the circulation path. Protruding objects that extend to the floor or within 27 inches of the floor are cane detectable and are therefore not hazardous. Where it is necessary or desirable to have objects protrude from the wall, a manner of cane detection must be provided.

6"

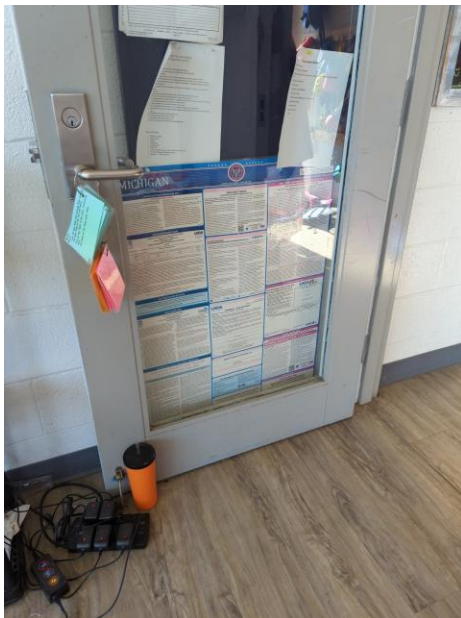
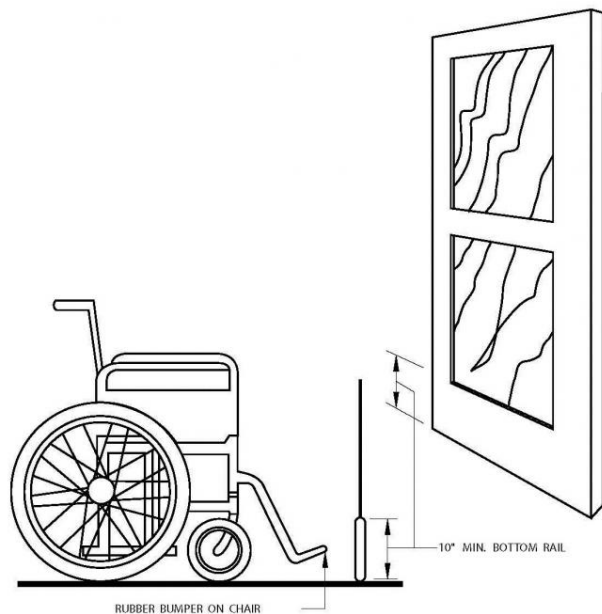
Both doors at the break room area in the main building have a bottom smooth surface of only 9 inches high

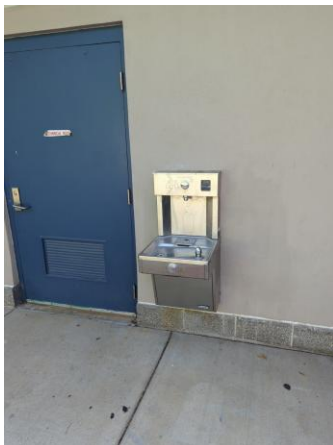
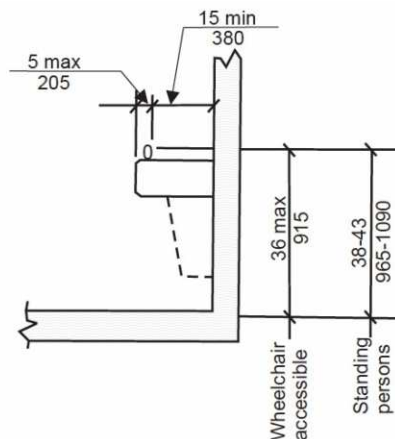
There is no high drinking fountain provided

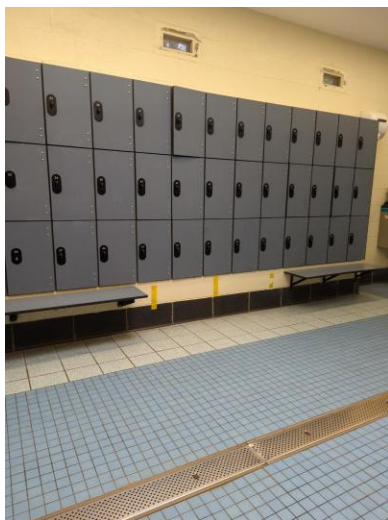
There is no accessible bench provided; bench is only 12 inches deep

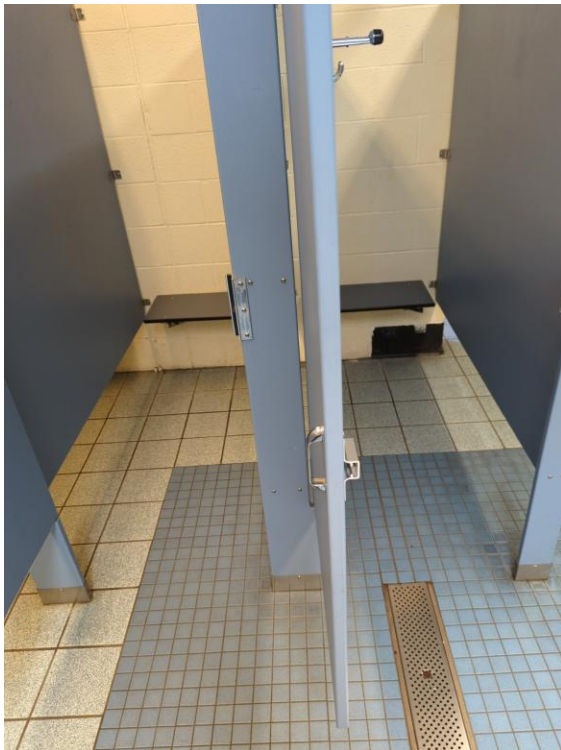
Three changing stalls provided, no accessible changing stall

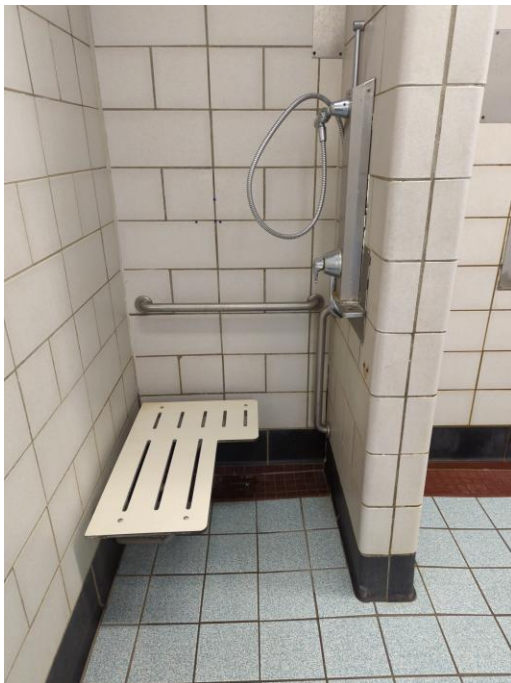
Transfer shower is 32x36 inches

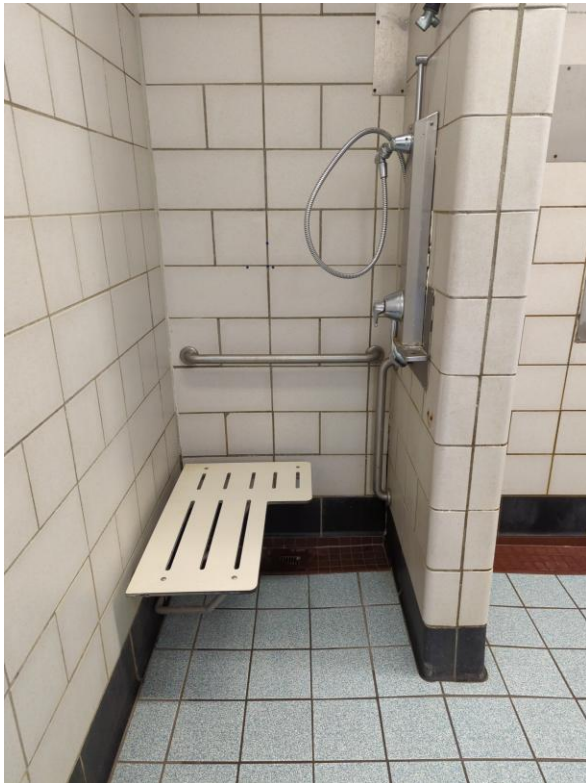
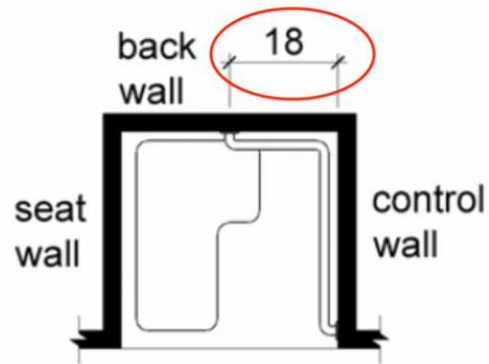
Back wall grab bar is over the shower seat

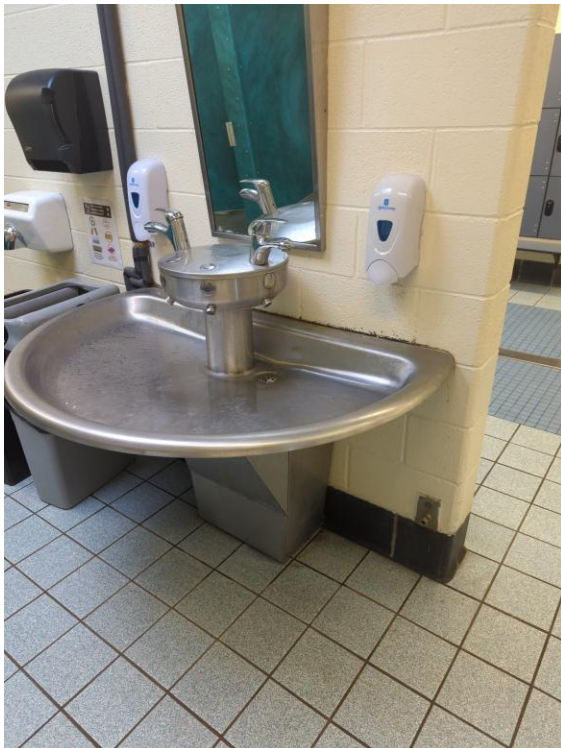
Lavatory faucet is 48 inches high with an obstruction of 24 inches for a forward approach

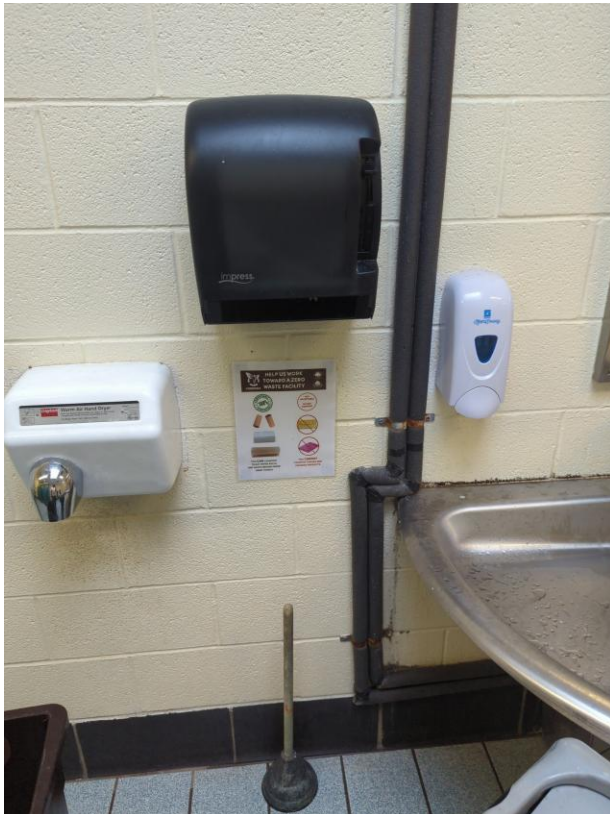
Paper towel dispenser is 60 inches high to the operable part

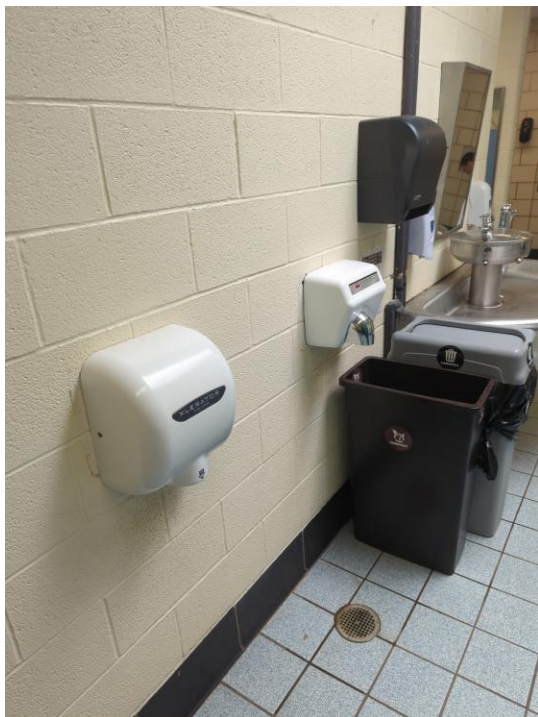
Two hand dryers and one paper towel dispenser protrude 7-9 inches from the wall

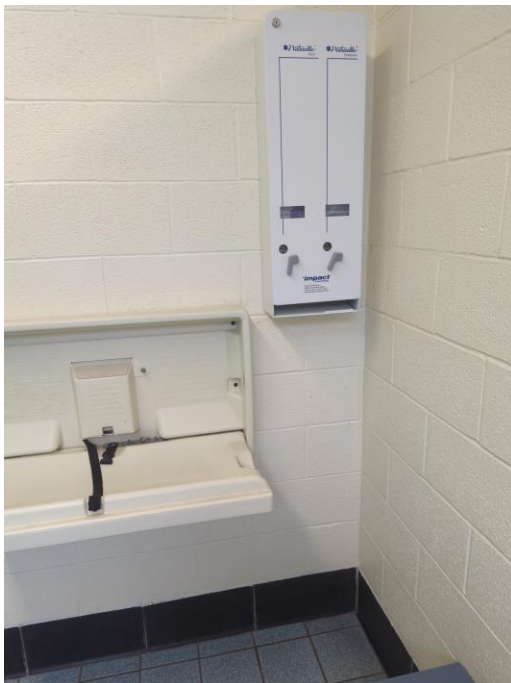
Locker Room: Men's Locker Room

The feminine product dispenser in the men's locker room is 55 inches high to the operable part

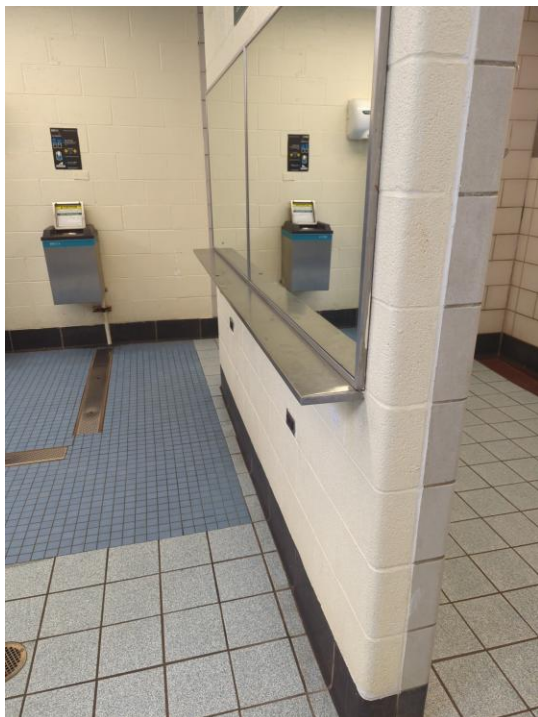
Locker Room: Men's Locker Room

Mirror shelf protrudes 6 inches

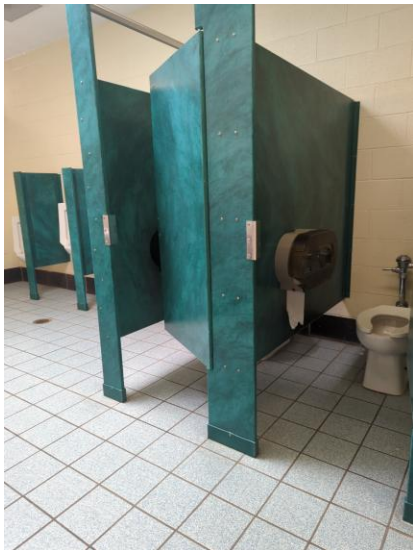
Locker Room: Men's Locker Room

A total of 7 fixtures (4 urinals and 3 water closets) are provided; one ambulatory stall is required

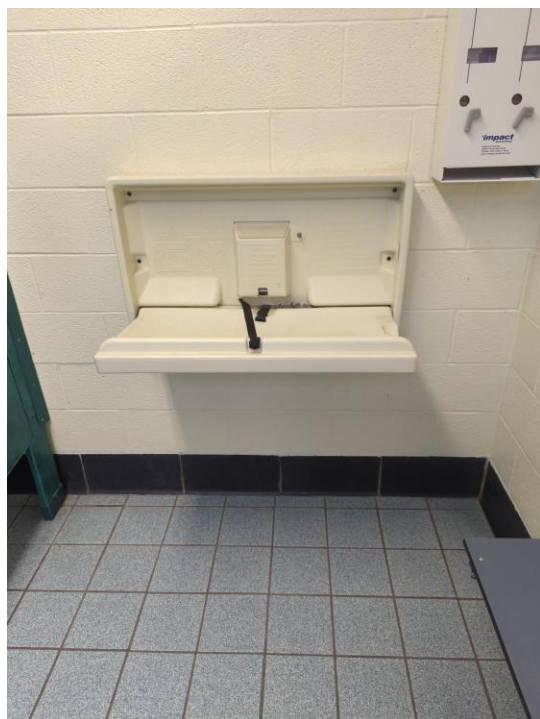
Locker Room: Men's Locker Room

The baby changing table projects 20 inches from the wall when open

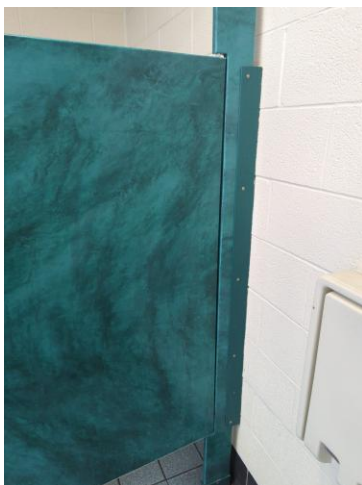
Locker Room: Men's Locker Room

Door is 5 inches from the wall

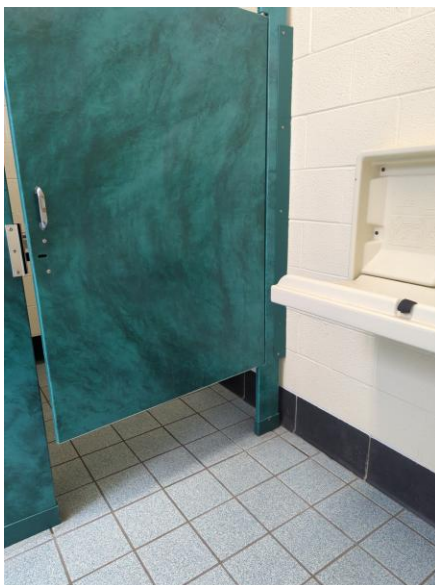
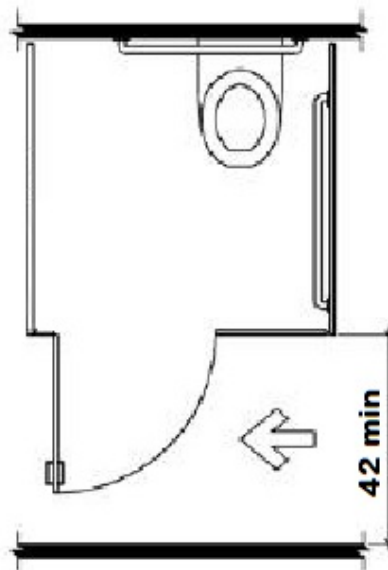
Locker Room: Men's Locker Room

Baby changing table does not start closed, obstructs the partition stall door maneuvering clearance

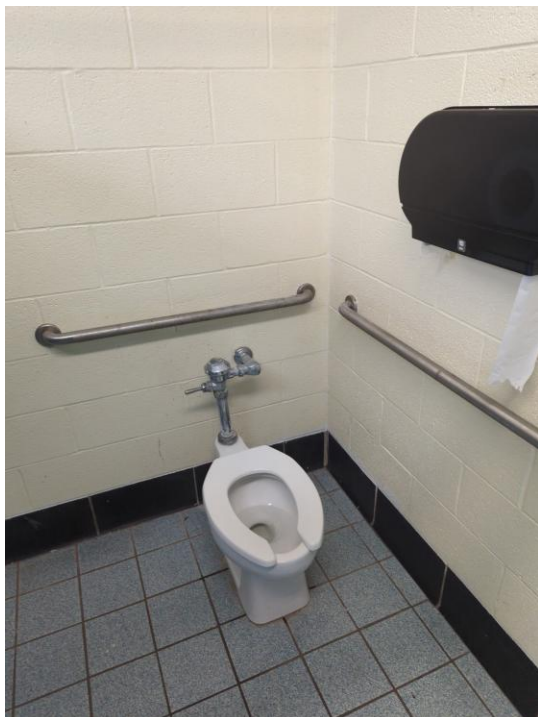
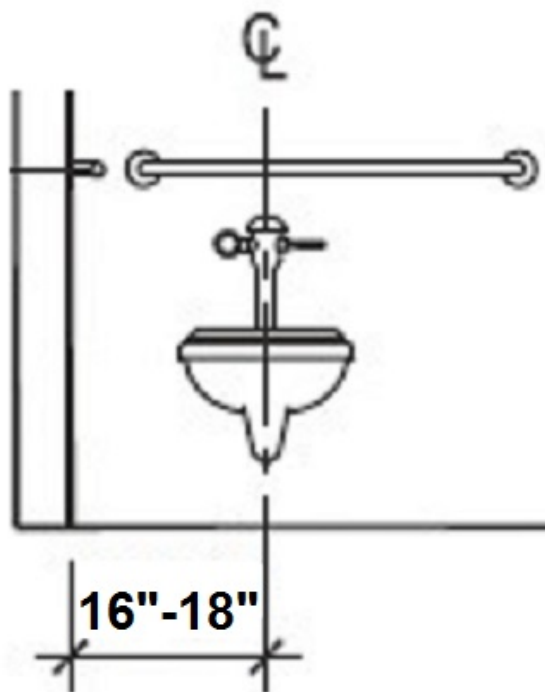
Locker Room: Men's Locker Room

Water closet is 19 inches from the side wall to the centerline

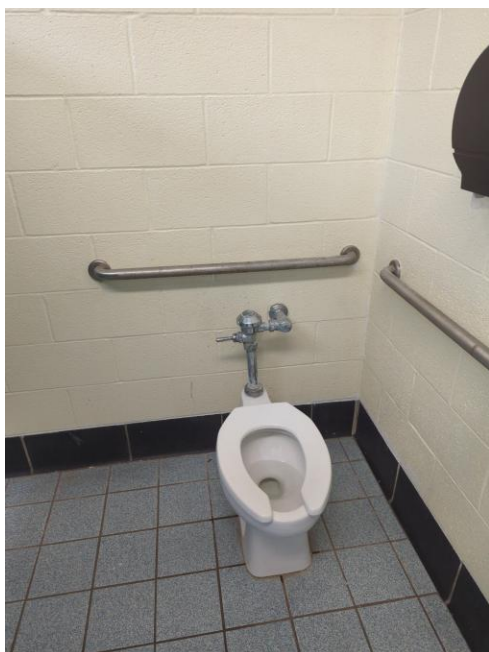
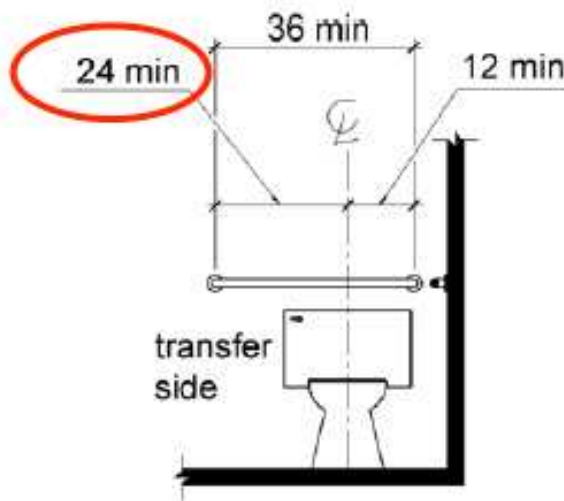
Locker Room: Men's Locker Room

Rear grab bar extends 22 inches from the centerline

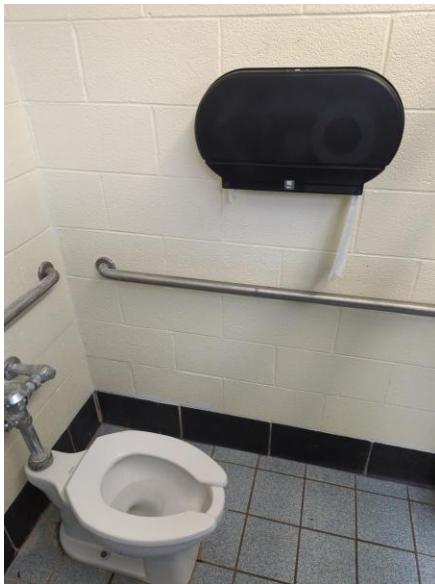
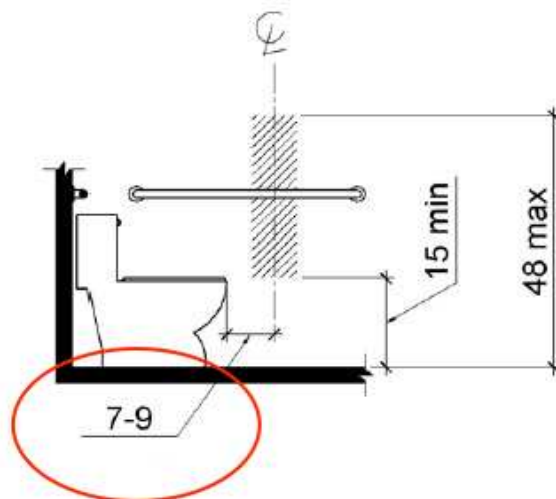
Locker Room: Men's Locker Room

Toilet paper dispenser is 4 inches from the front of the water closet and is 49 inches high

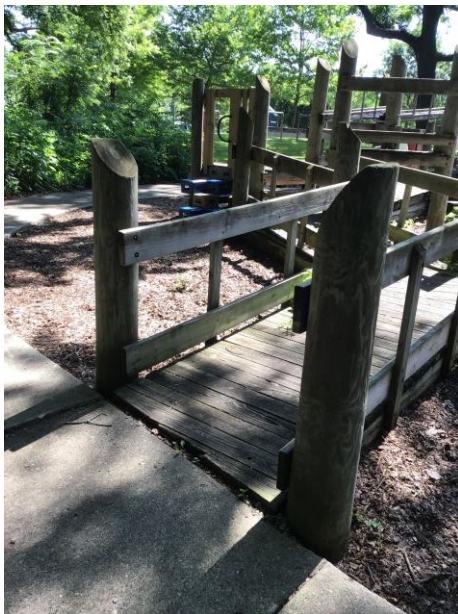
Connection from sidewalk to wooden ramp is 2 inches.

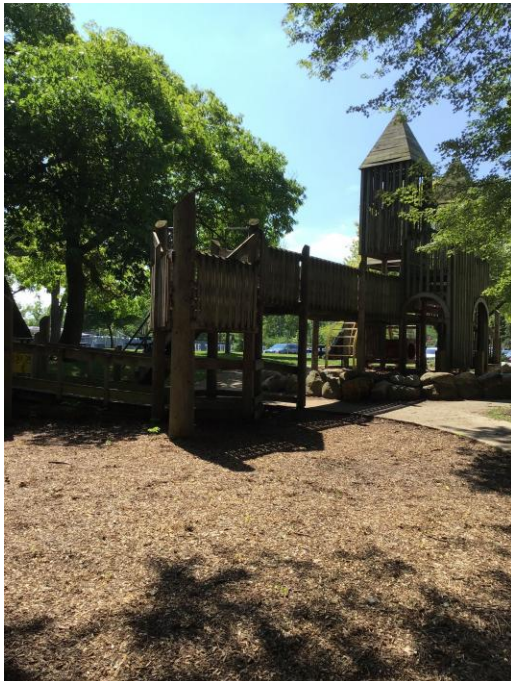
Play Area: Large Playground

No accessible route to elevated play components.

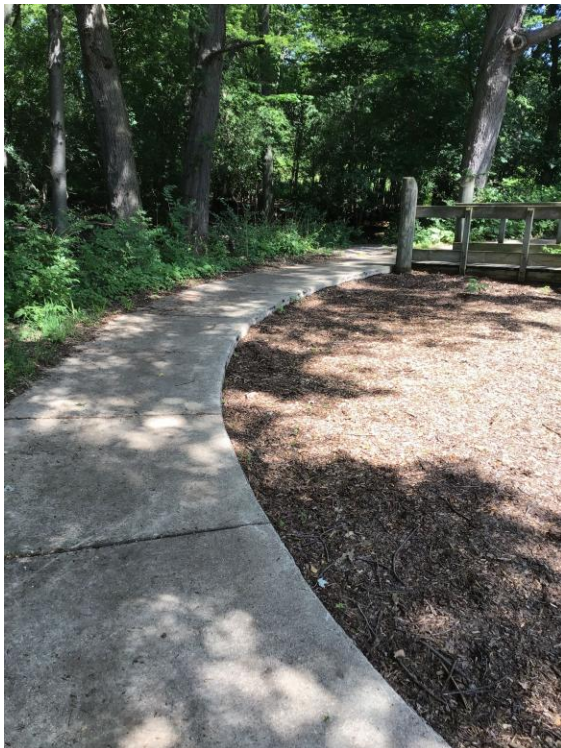
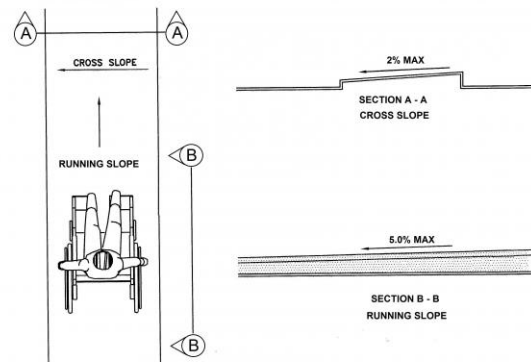
Play Area: Large Playground

Sidewalk to play area exceeds 2%.

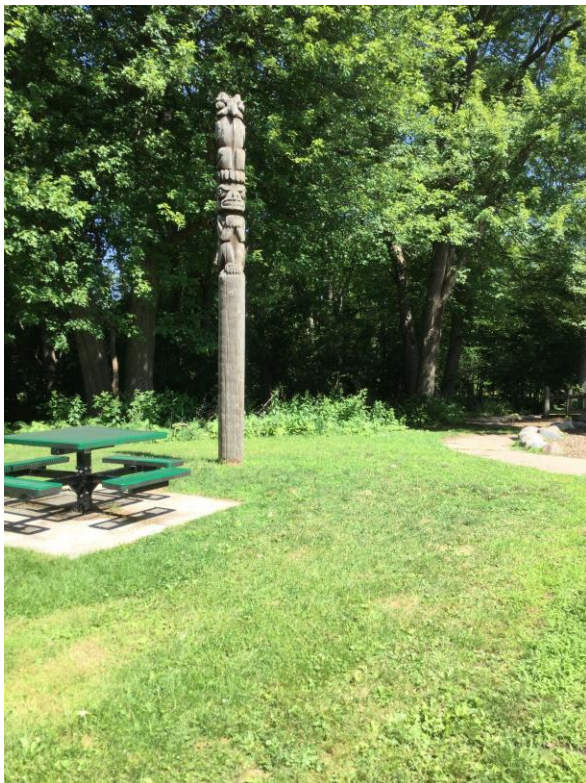
Play Area: Swing

Accessible route to swing missing

No accessible route

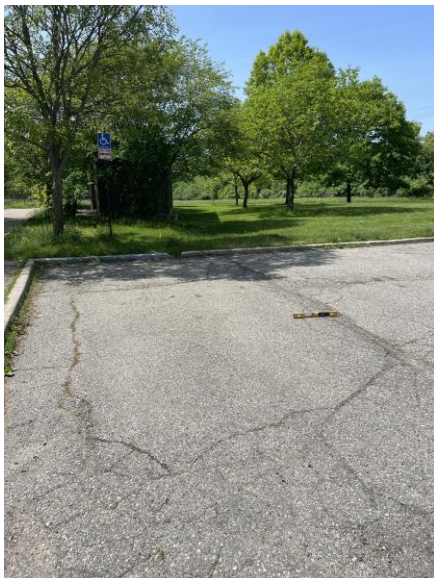
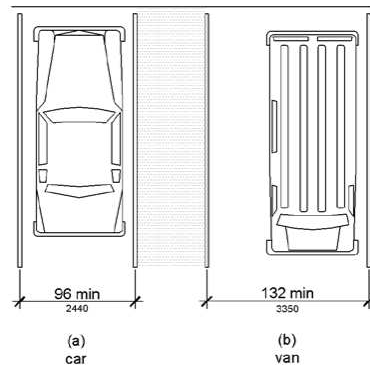
The parking space the minimum width. The floor or ground surface is not firm stable or slip resistant. The parking space contains changes in level and/or gaps that exceed the maximum allowable requirements. The parking space does not have the proper identifications signs or the signs are not installed at the correct height. The parking space is missing an adjacent access aisle.

Slope greater than 2%, changes in level, not marked

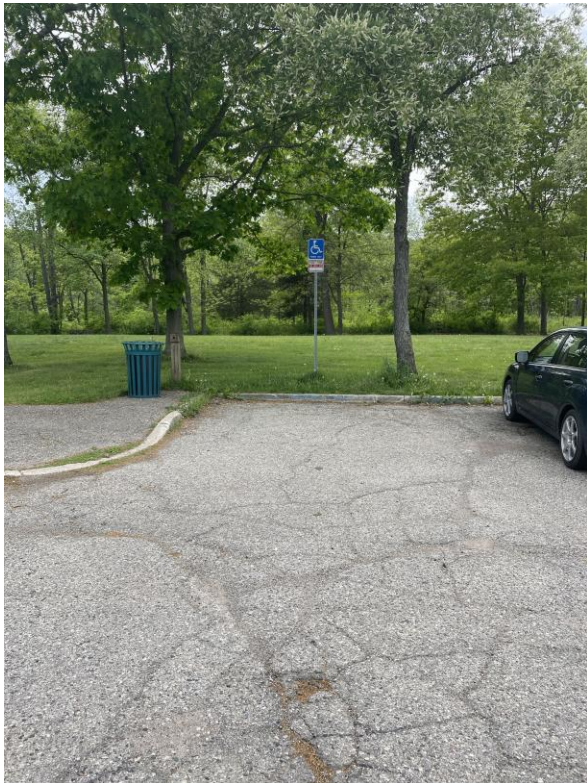
Parking: Parking Lot

The accessible parking space is missing the required markings.

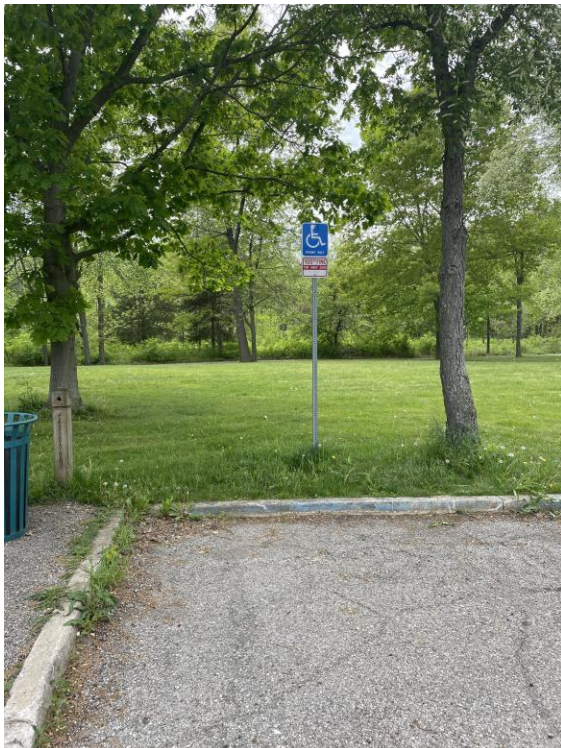
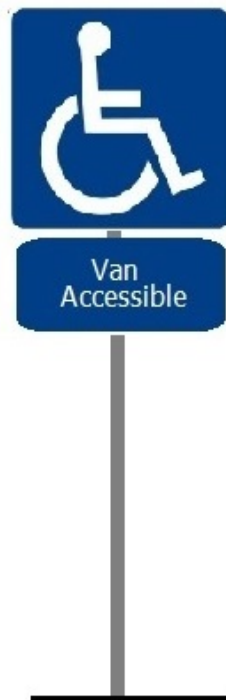
Parking: Parking Lot

The van stall is missing a sign identifying it as a van accessible stall.

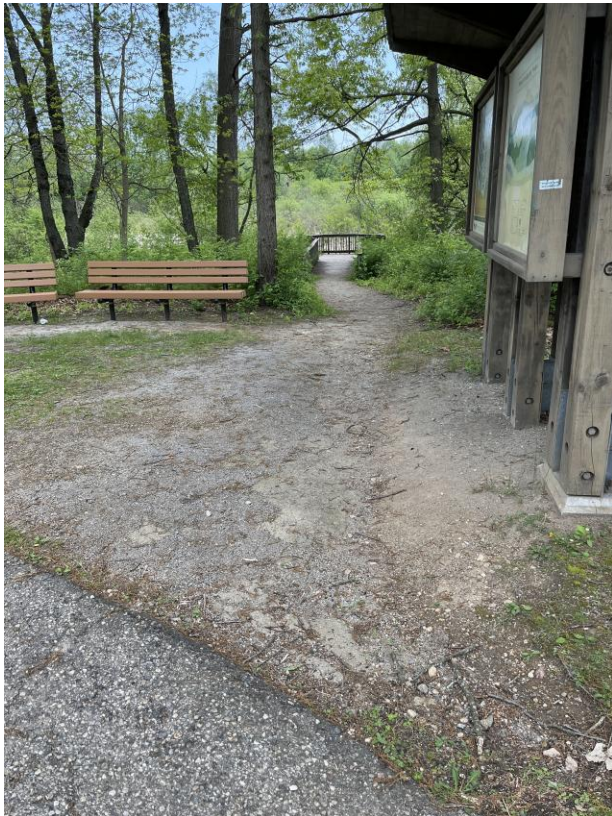
Trail System: Trail

The accessible route contains loose gravel and/or surface materials that do not provide for a stable, firm slip resistant surface.

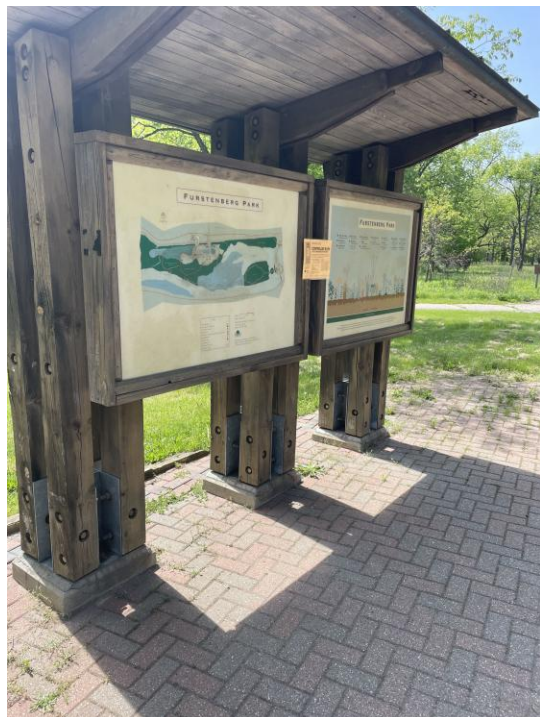
Trail System: Trail

Wall-mounted objects that have leading edges between 27 inches and 80 inches from the floor must not project more than 4 inches into the circulation path. Protruding objects that extend to the floor or within 27 inches of the floor are cane detectable and are therefore not hazardous. Where it is necessary or desirable to have objects protrude from the wall, a manner of cane detection must be provided.

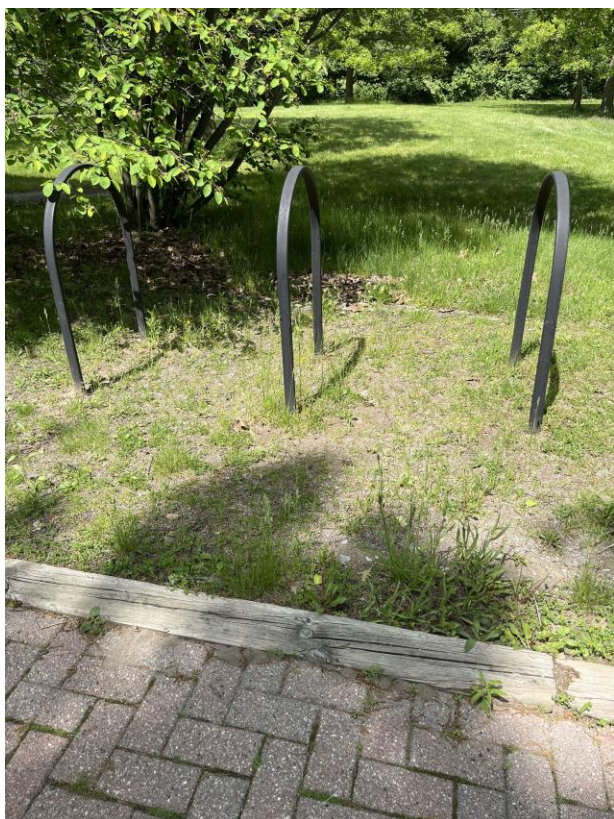
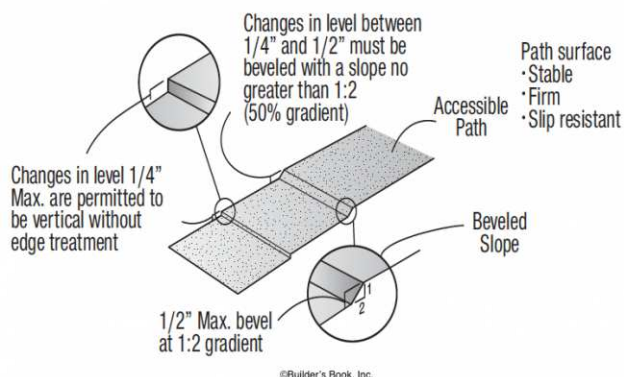
The accessible route contains loose gravel and/or surface materials that do not provide for a stable, firm slip resistant surface.

Surface is grass

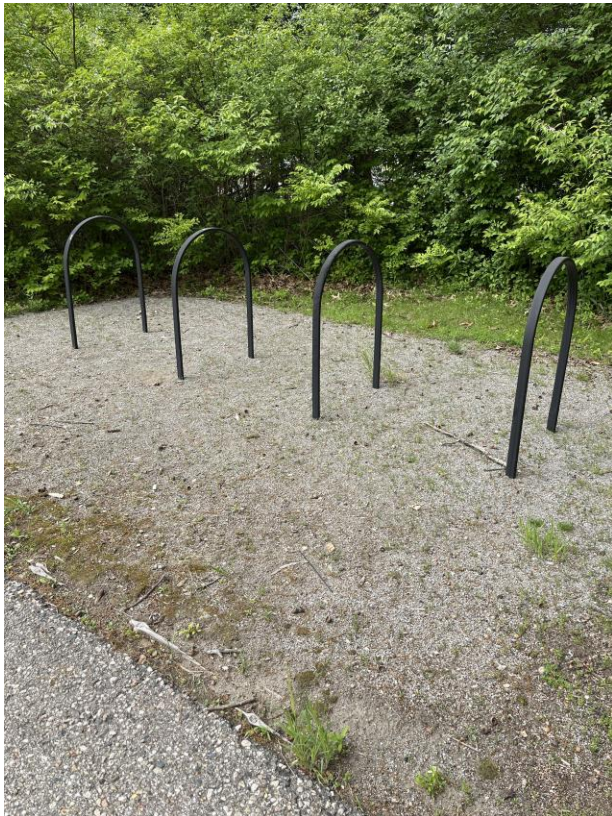
The accessible route contains loose gravel and/or surface materials that do not provide for a stable, firm slip resistant surface.

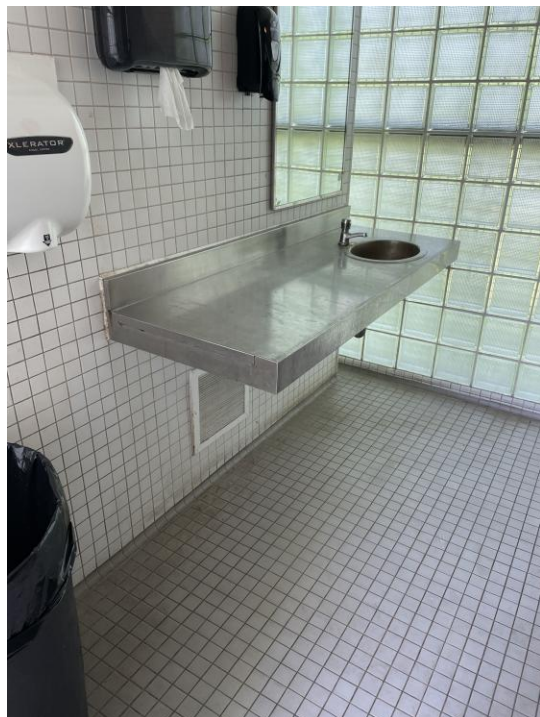
Wall-mounted objects that have leading edges between 27 inches and 80 inches from the floor must not project more than 4 inches into the circulation path. Protruding objects that extend to the floor or within 27 inches of the floor are cane detectable and are therefore not hazardous. Where it is necessary or desirable to have objects protrude from the wall, a manner of cane detection must be provided.
