Site Accessibility Evaluation

Allmendinger Park
655 Pauline Blvd
Ann Arbor, MI 48104
ADA Only

Inspection Date: 07/11/2022

Report Date: 11/15/2022

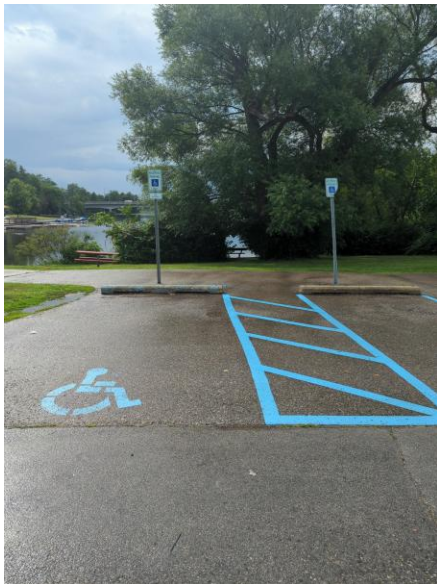
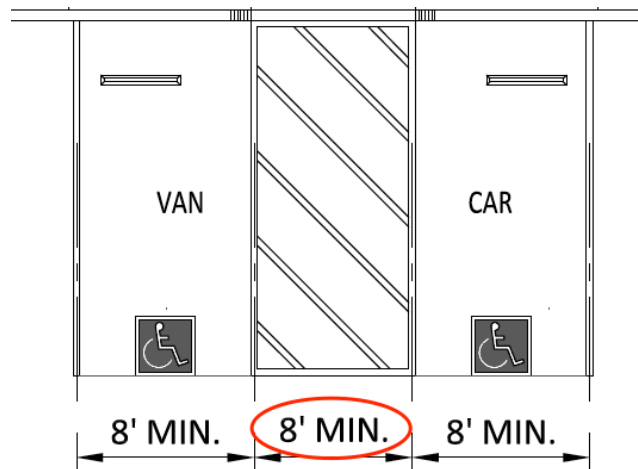
Van accessible parking space is 9 feet wide with an access aisle of 5 feet

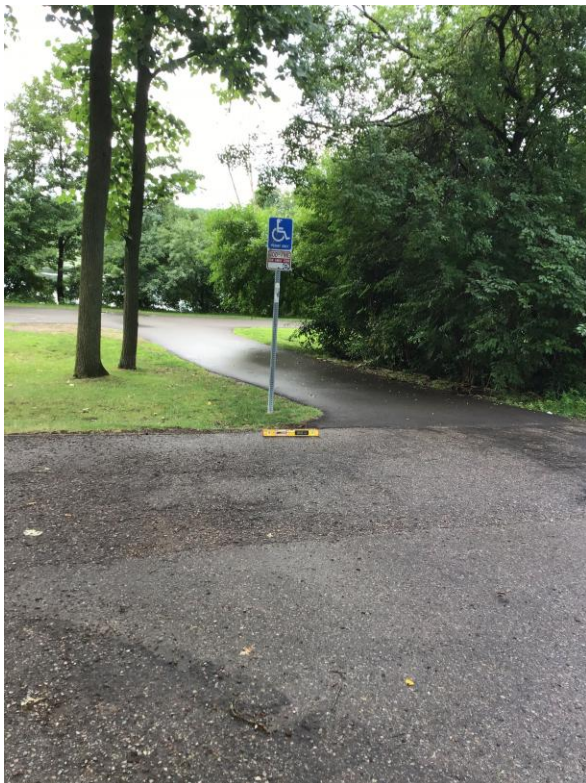
The accessible parking space is missing the required markings.

No markings at boat launch parking lot stall.

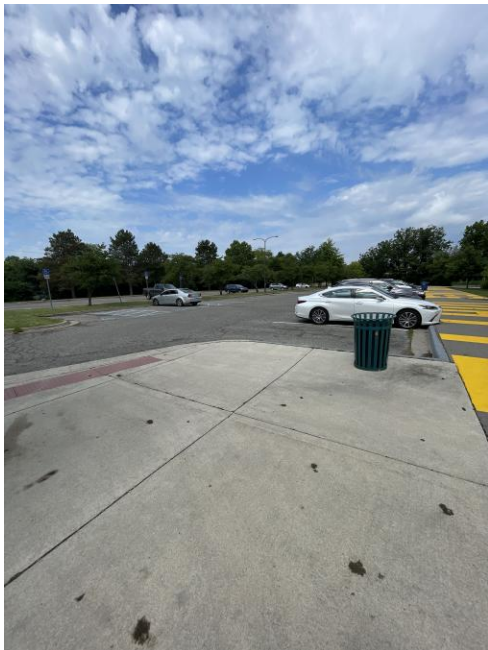
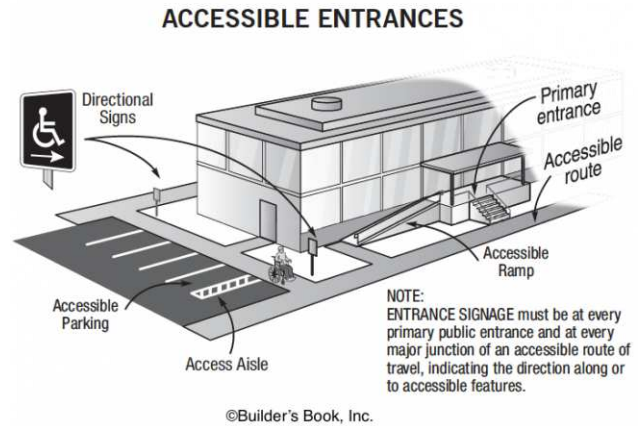
All accessible parking spaces not location on shortest accessible route to park

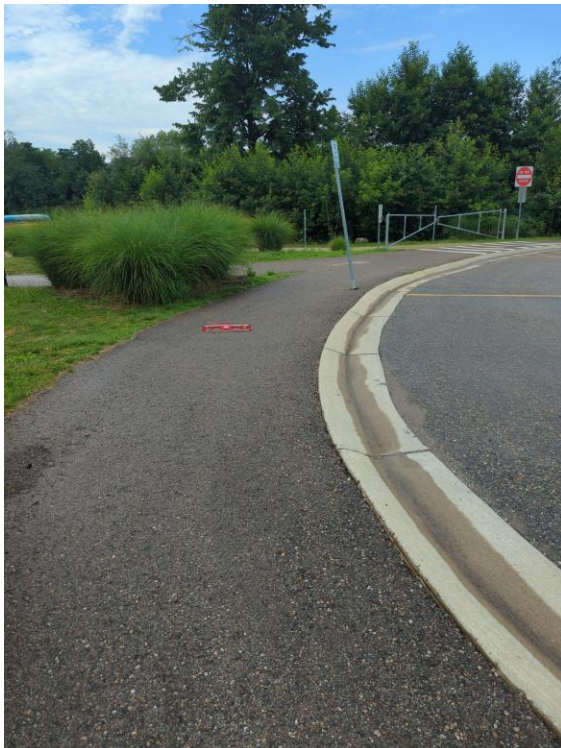
Sidewalk - curb ramp to maintenance entrance 3.5% cross slope

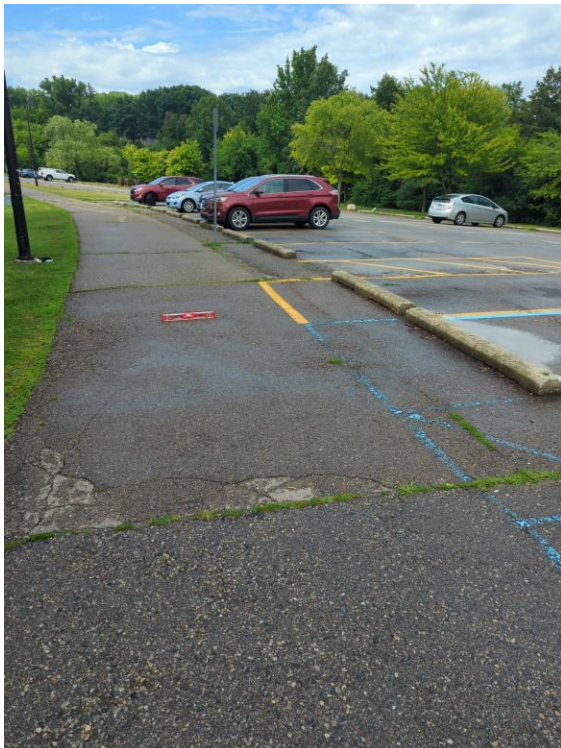
Path in front of parking stalls has a cross slope of up to 4.5%

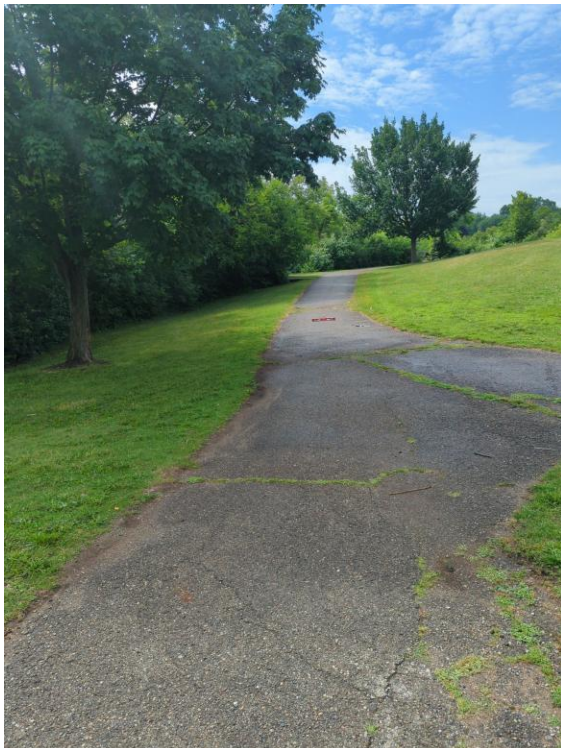
Path from parking stalls to pedestrian bridge has a cross slope of up to 5.4%

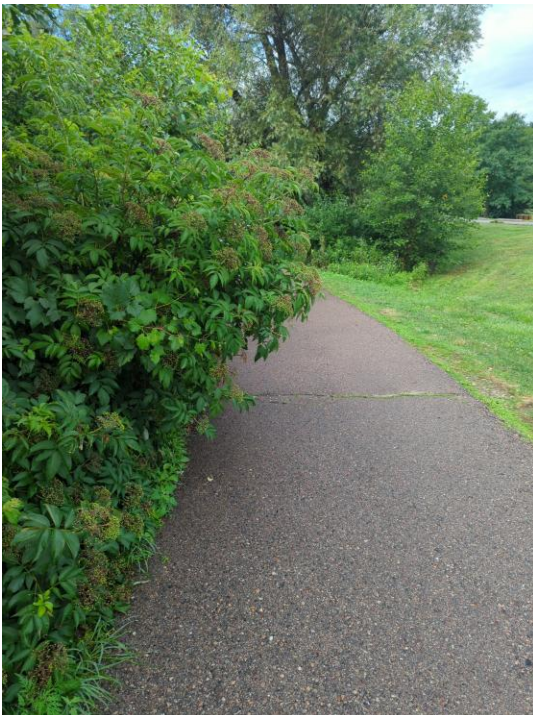
Vegetation protrudes into sidewalk

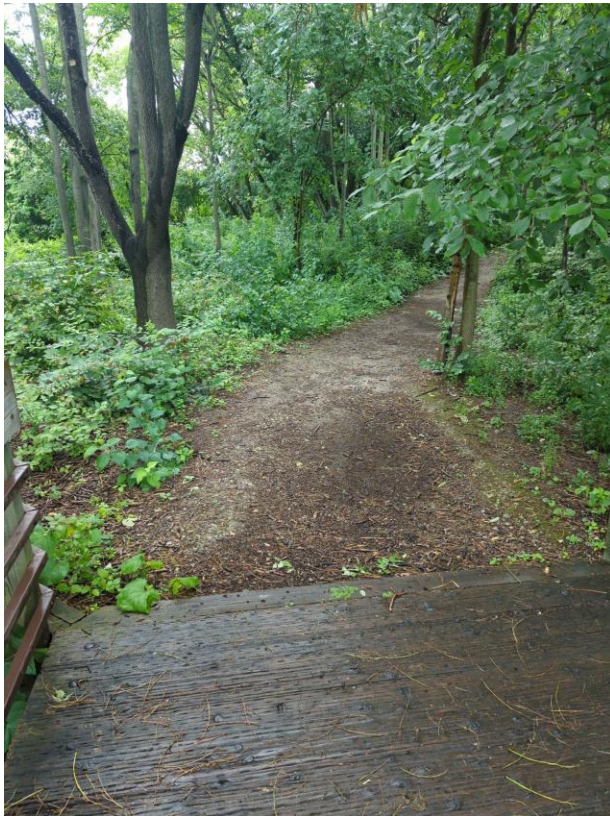
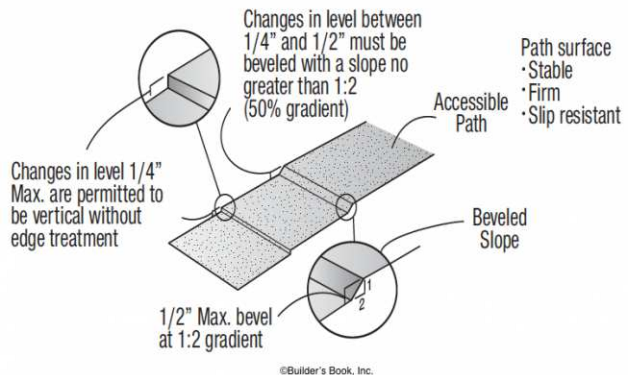
No accessible path past the pedestrian bridge

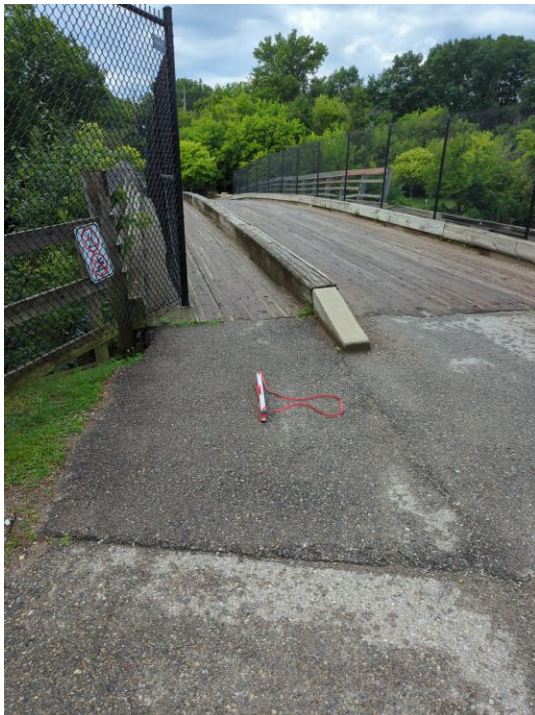
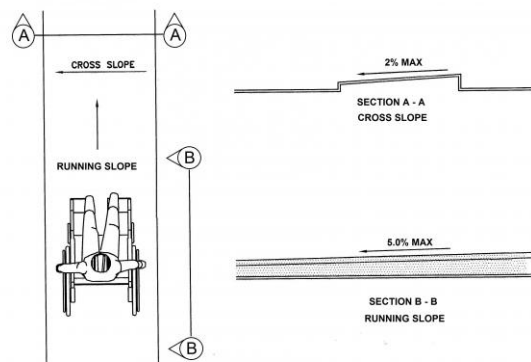
Path to cross vehicular bridge has a running slope of 6%

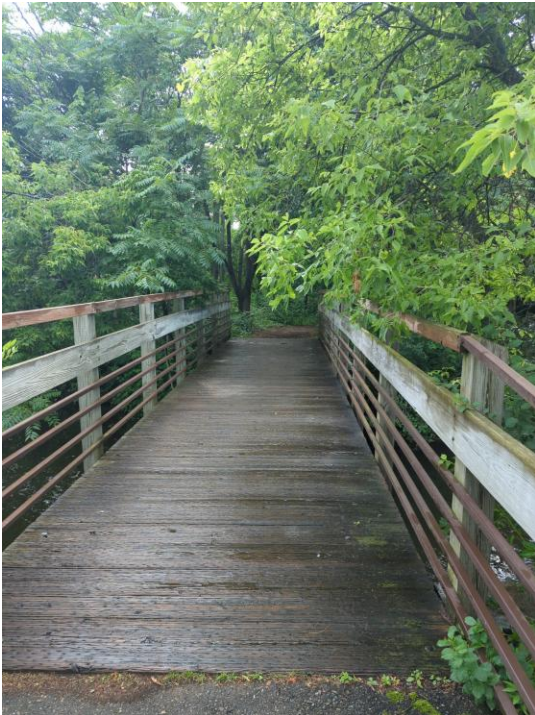
Objects that have leading edges between 27 inches and 80 inches from the floor must not project more than 4 inches into the circulation path. Protruding objects that extend to the floor or within 27 inches of the floor are cane detectable and are therefore not hazardous. Where it is necessary or desirable to have objects protrude from the wall, a manner of cane detection must be provided.

Vegetation protrudes into the pedestrian bridge

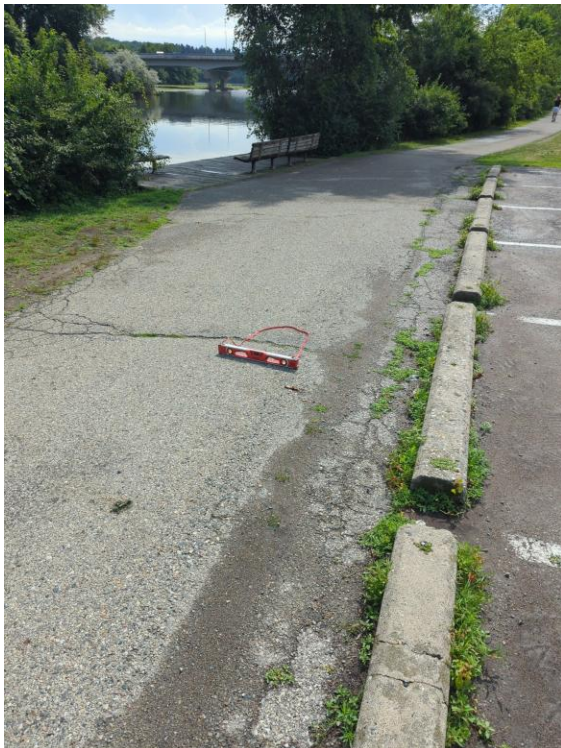
Path from parking to fishing pier with 6.3% cross slope

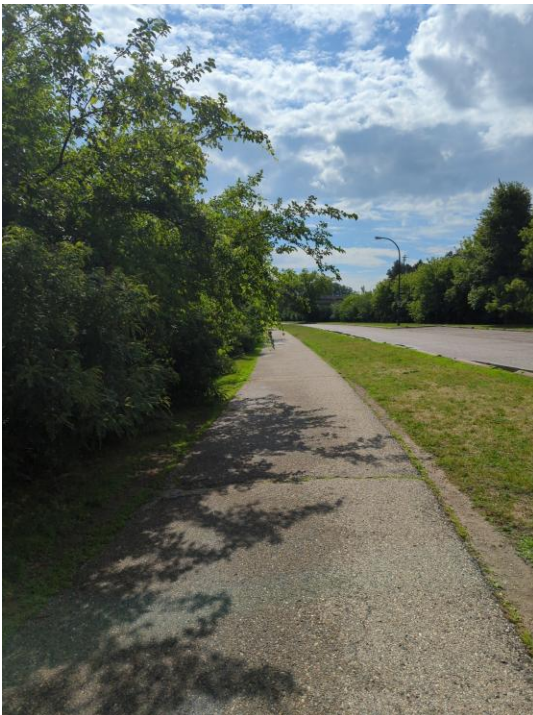
Objects that have leading edges between 27 inches and 80 inches from the floor must not project more than 4 inches into the circulation path. Protruding objects that extend to the floor or within 27 inches of the floor are cane detectable and are therefore not hazardous. Where it is necessary or desirable to have objects protrude from the wall, a manner of cane detection must be provided.

Vegetation protrudes into the path in front of parking stalls

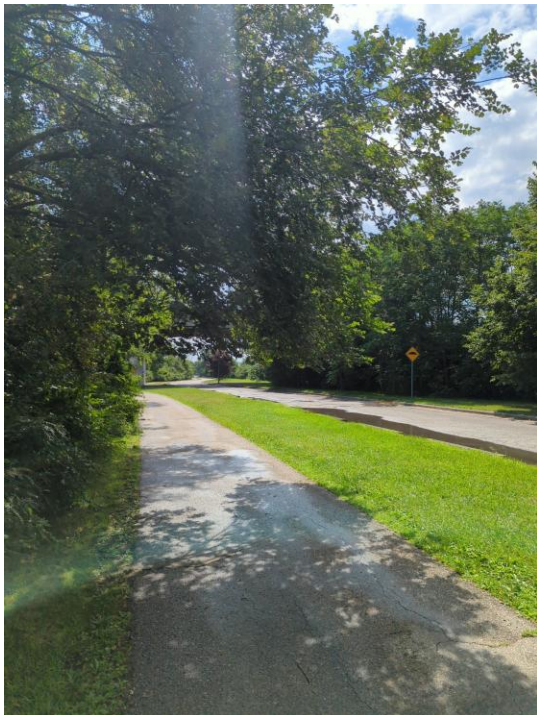
Objects that have leading edges between 27 inches and 80 inches from the floor must not project more than 4 inches into the circulation path. Protruding objects that extend to the floor or within 27 inches of the floor are cane detectable and are therefore not hazardous. Where it is necessary or desirable to have objects protrude from the wall, a manner of cane detection must be provided.

Vegetation protrudes into the path by overhead bridge

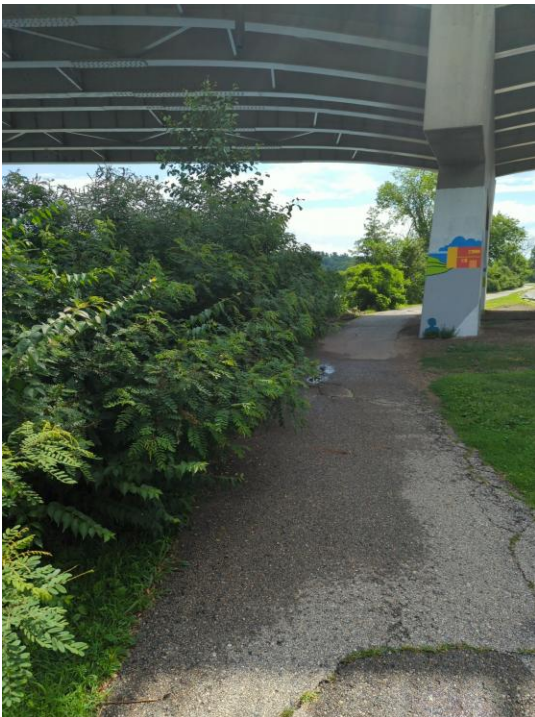
Objects that have leading edges between 27 inches and 80 inches from the floor must not project more than 4 inches into the circulation path. Protruding objects that extend to the floor or within 27 inches of the floor are cane detectable and are therefore not hazardous. Where it is necessary or desirable to have objects protrude from the wall, a manner of cane detection must be provided.

Vegetation protrudes into the path by overhead bridge

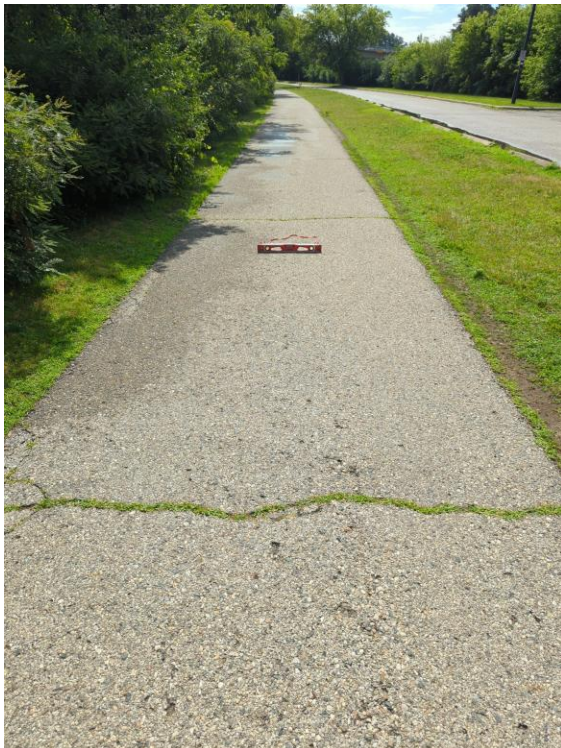
Path in front of parking stall towards overhead bridge has 5% cross slope

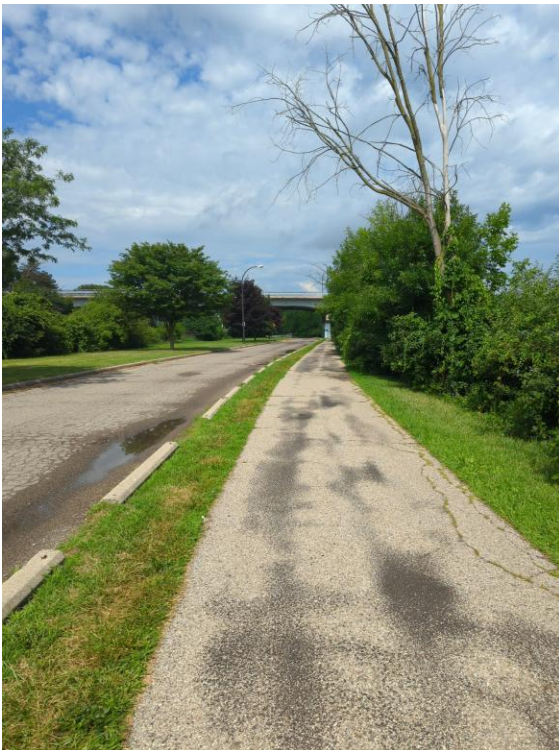
Path parallel to street from overhead bridge to all-access playground has a cross slope of up to 8%

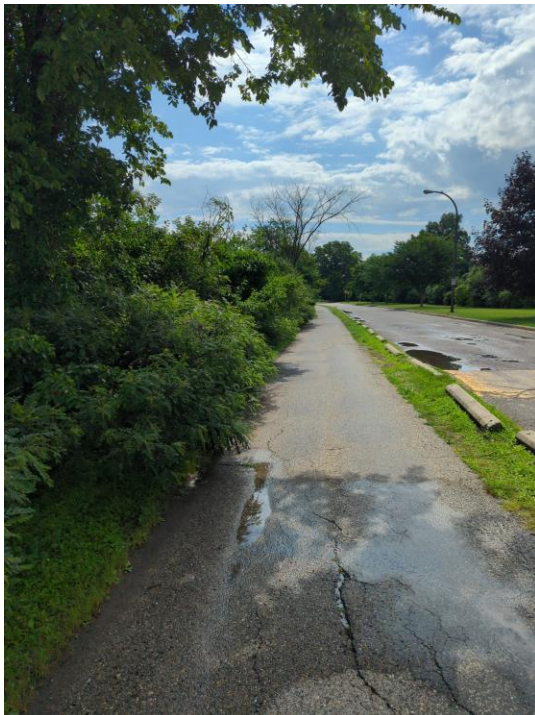
Objects that have leading edges between 27 inches and 80 inches from the floor must not project more than 4 inches into the circulation path. Protruding objects that extend to the floor or within 27 inches of the floor are cane detectable and are therefore not hazardous. Where it is necessary or desirable to have objects protrude from the wall, a manner of cane detection must be provided.

Vegetation protrudes into the path by overhead bridge

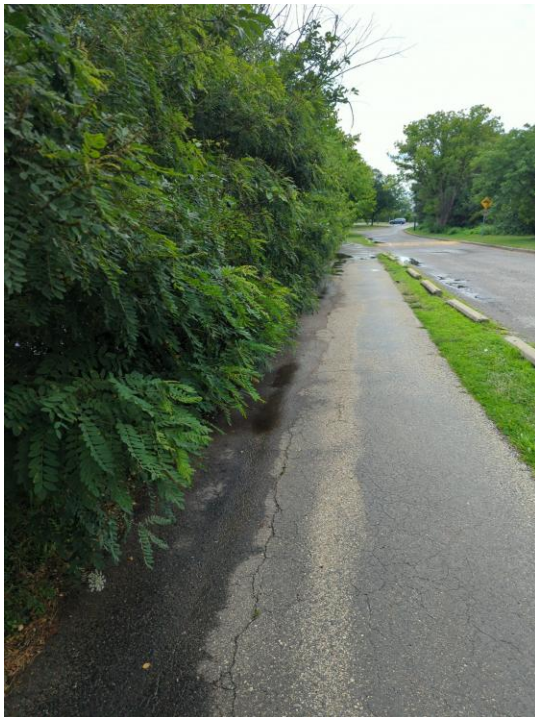
Objects that have leading edges between 27 inches and 80 inches from the floor must not project more than 4 inches into the circulation path. Protruding objects that extend to the floor or within 27 inches of the floor are cane detectable and are therefore not hazardous. Where it is necessary or desirable to have objects protrude from the wall, a manner of cane detection must be provided.

Vegetation protrudes into the path by overhead bridge towards all-access playground

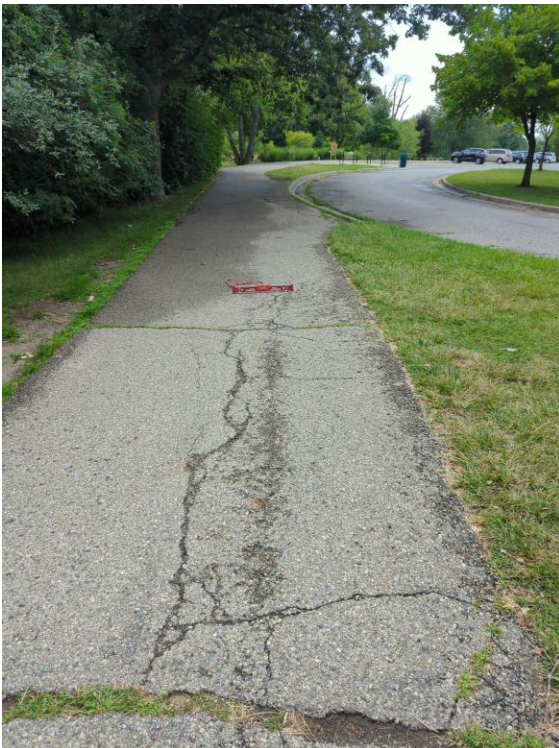
Path by all-access playground has 4.3% cross slope

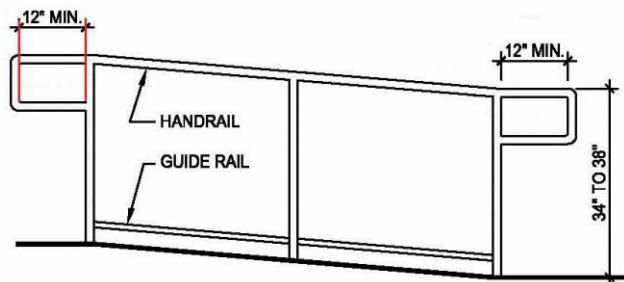
Missing on both sides

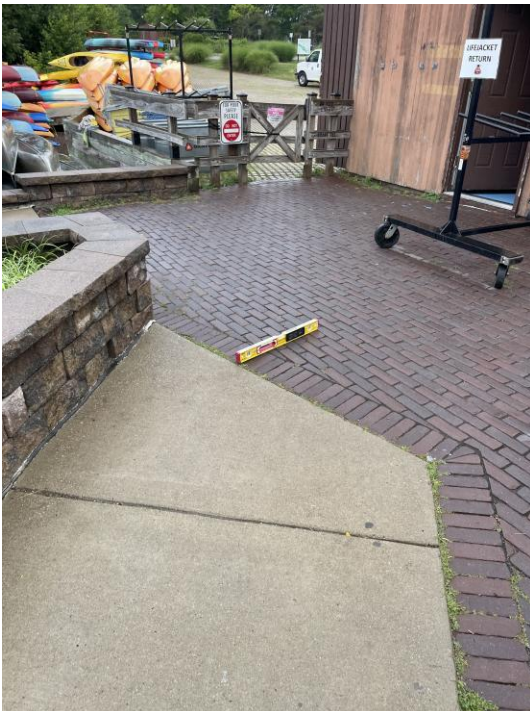
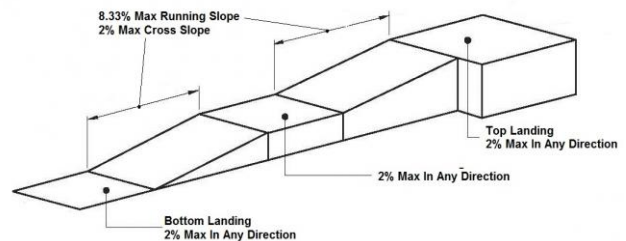
5% and greater

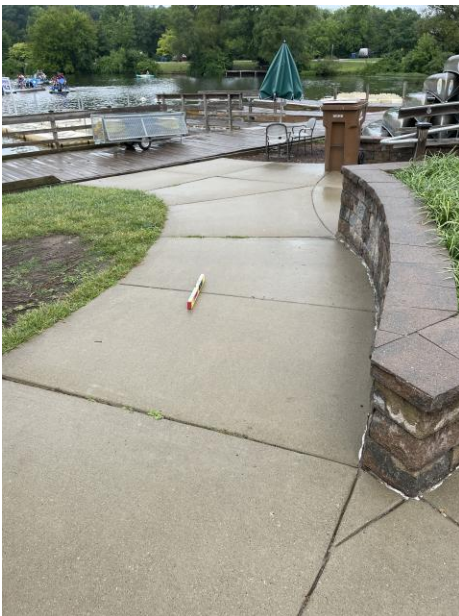
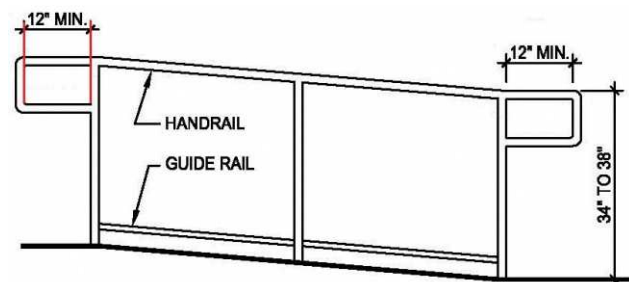
Missing on both sides

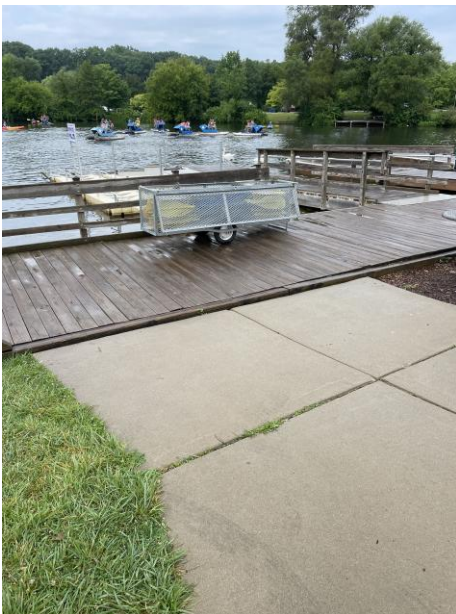
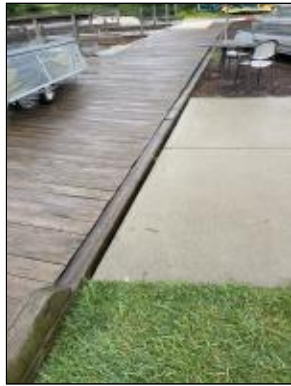
Finding #24 Additional Finding Photos

Excessive vertical change in level and opening at transition between sidewalk and pier

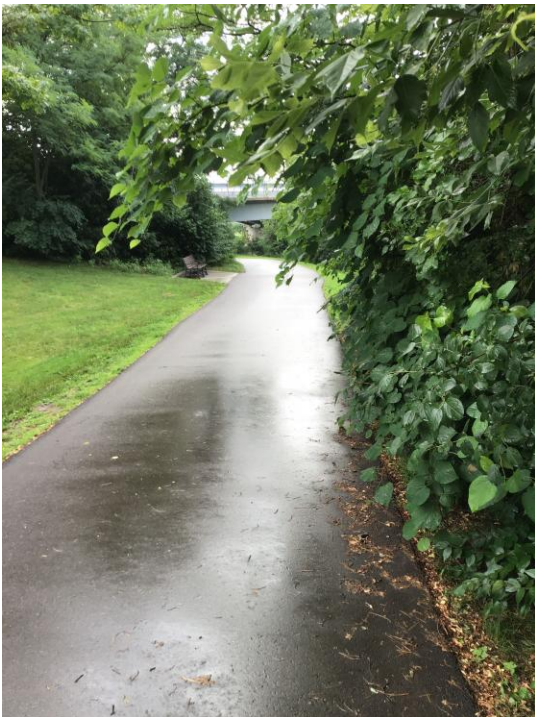
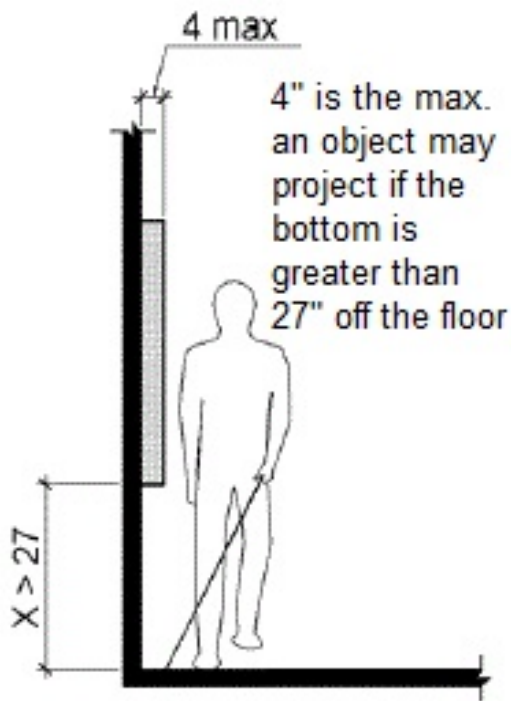
Wall-mounted objects that have leading edges between 27 inches and 80 inches from the floor must not project more than 4 inches into the circulation path. Protruding objects that extend to the floor or within 27 inches of the floor are cane detectable and are therefore not hazardous. Where it is necessary or desirable to have objects protrude from the wall, a manner of cane detection must be provided.

Trees are protruding objects.

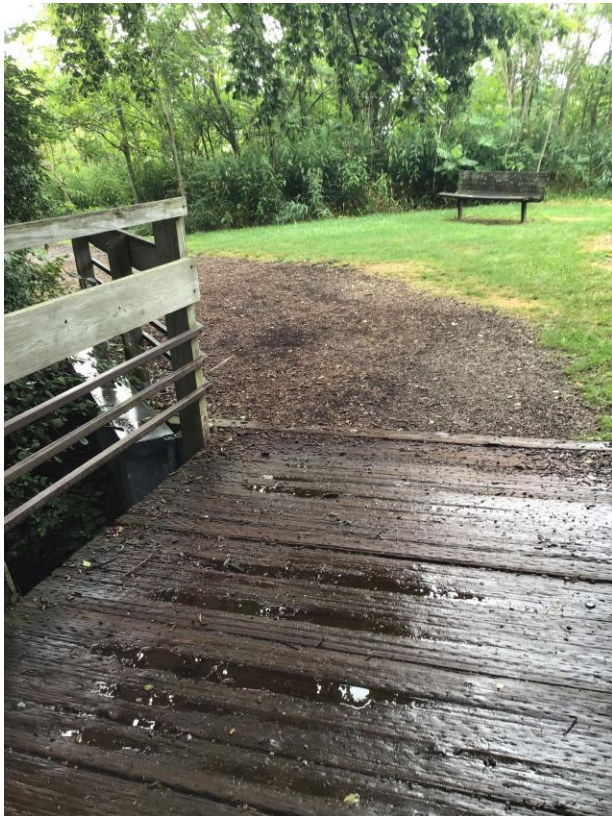
The accessible route contains loose gravel and/or surface materials that do not provide for a stable, firm slip resistant surface.

Trail surface is mulch.

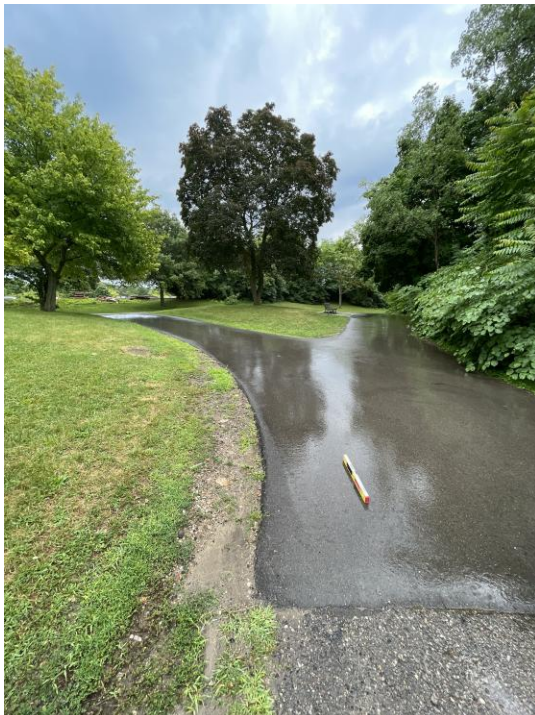
6% and greater

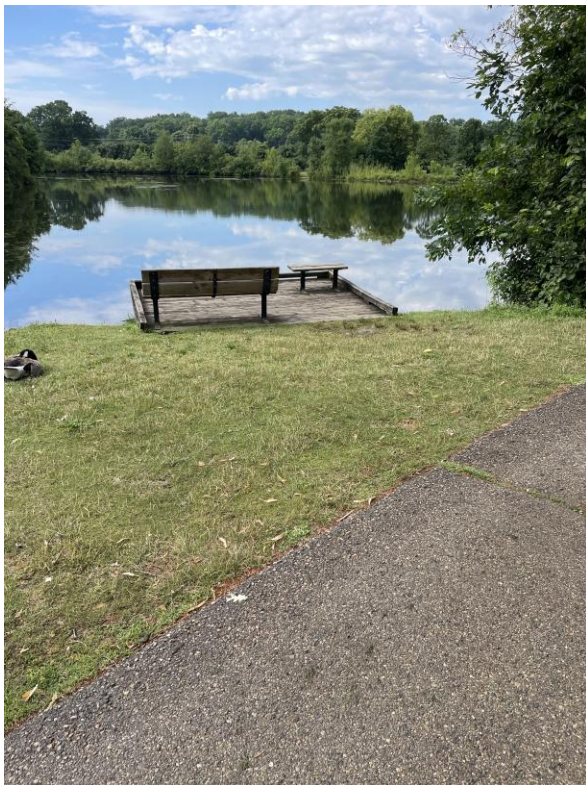
No route provided to fishing pier

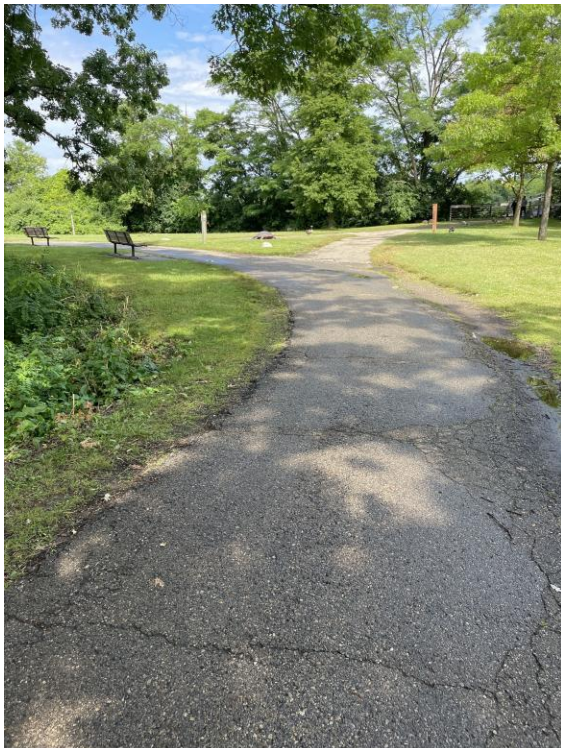
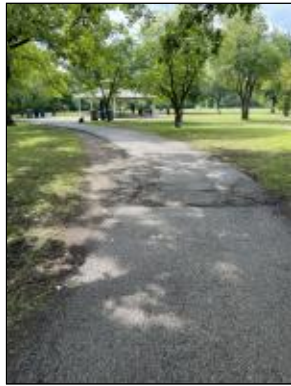
Finding #29 Additional Finding Photos

Excessive cross slope, changes in level and openings

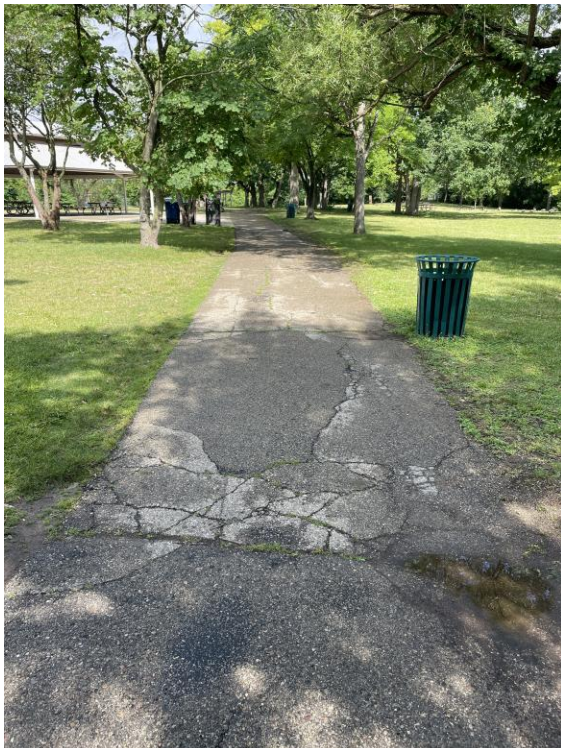
Excessive cross slope, changes in level and openings

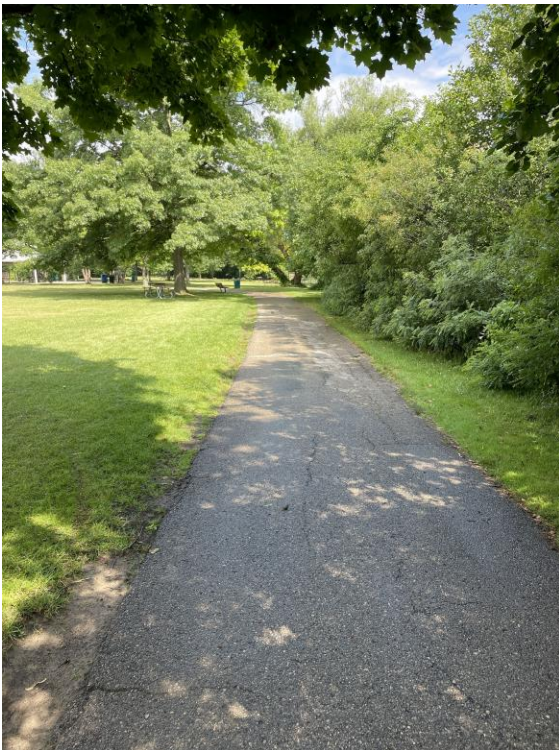
Excessive cross slope, changes in level and openings

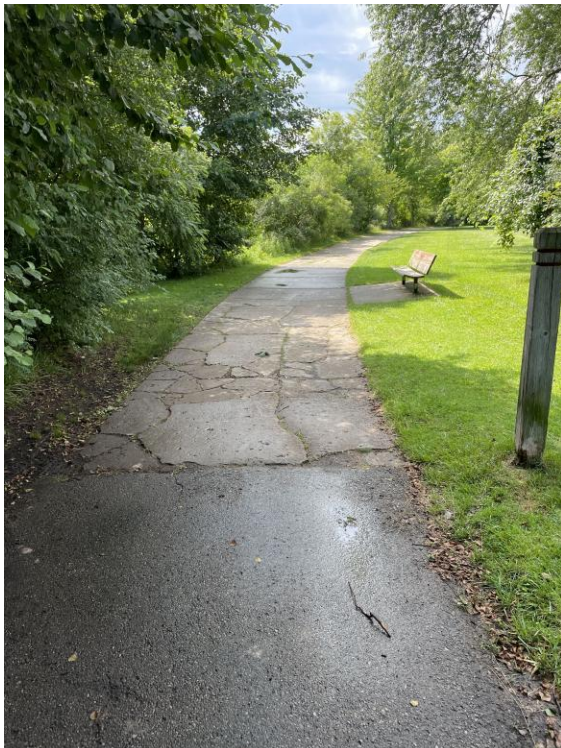
Excessive cross slope, changes in level and openings

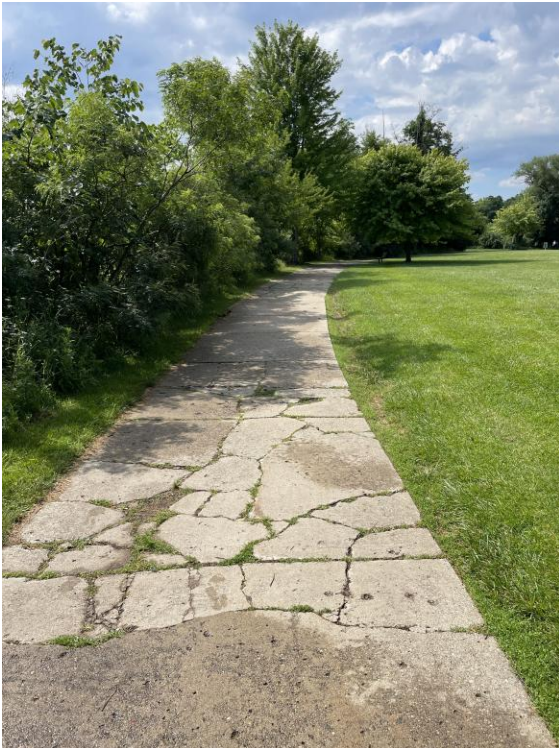
Excessive cross slope, changes in level and openings

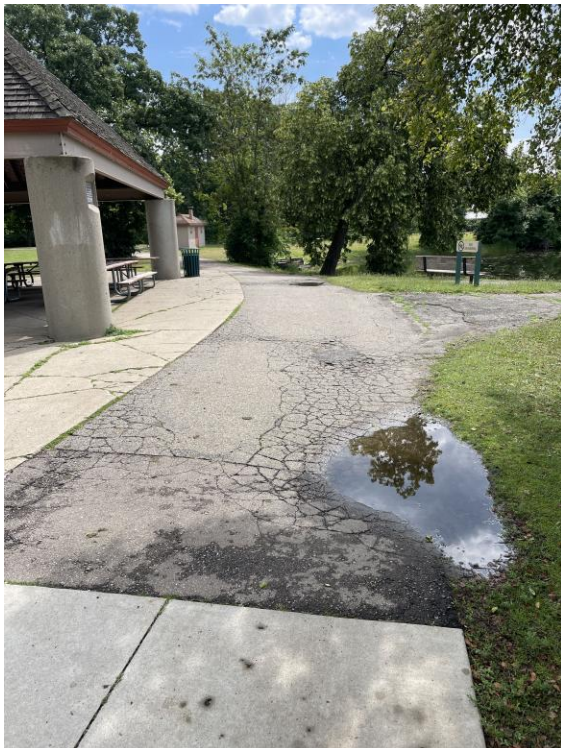
Excessive cross slope, changes in level and openings

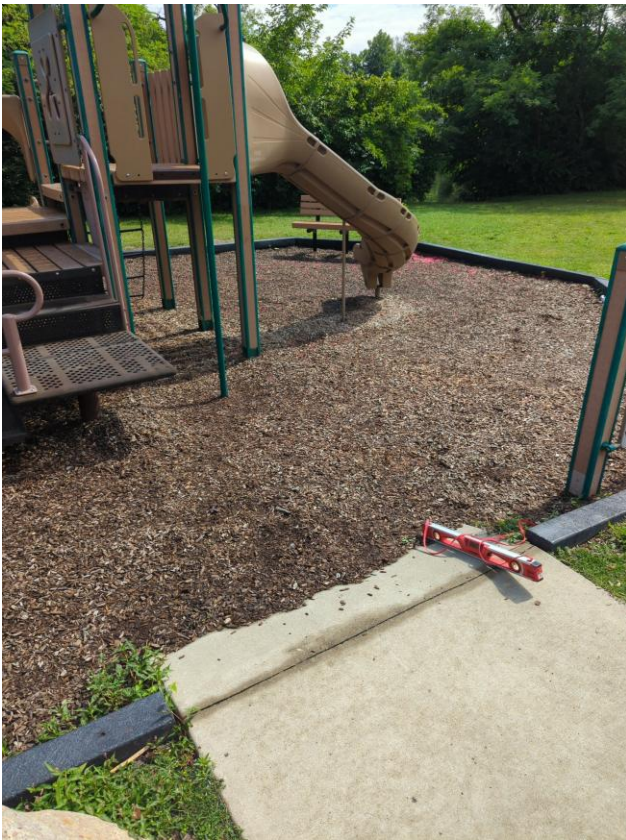
Ramp to playground with 29% slope

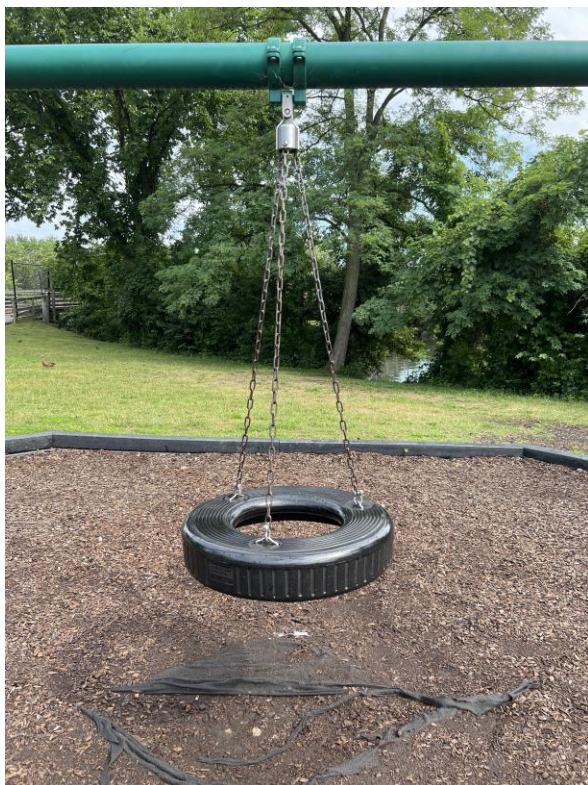
Tire swing is too high

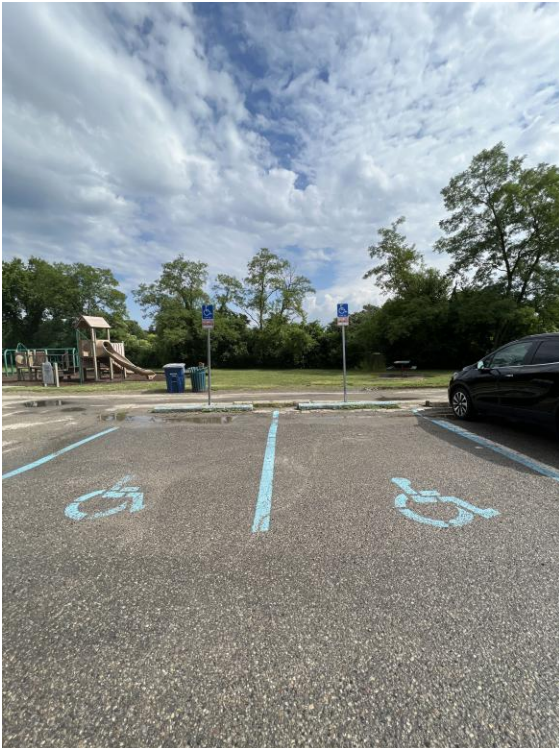
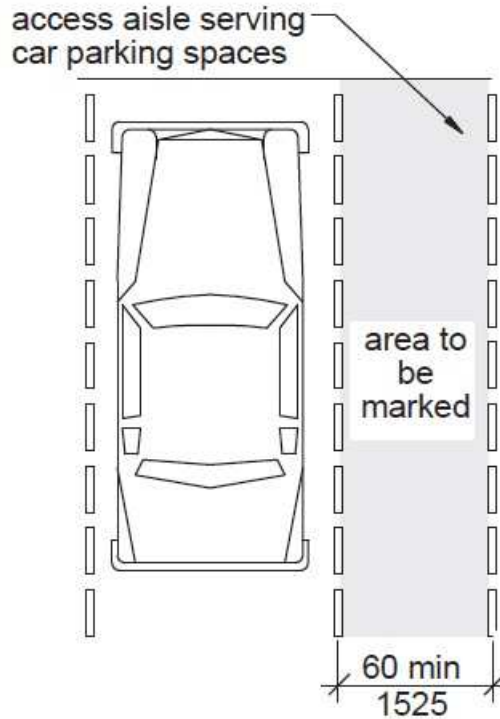
The access aisles are missing at the accessible parking stall.

No access aisle

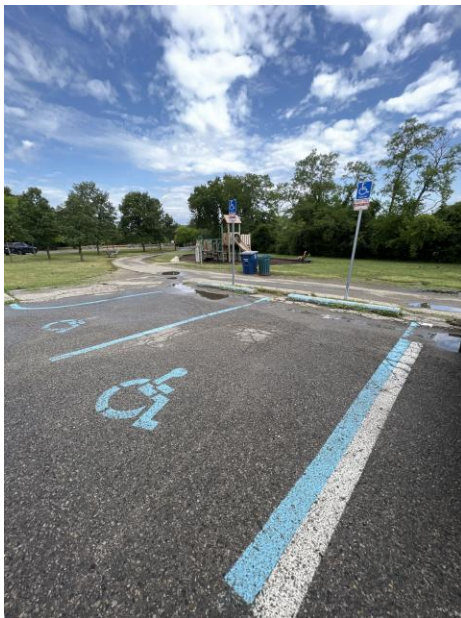
Not enough accessible parking stalls

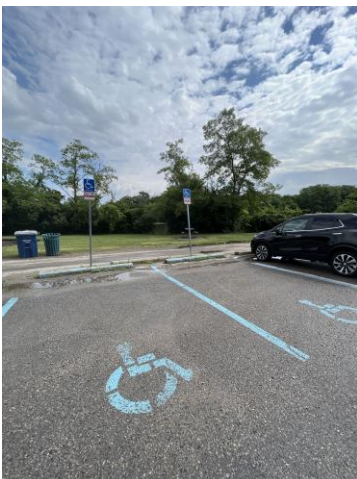
No van accessible stalls

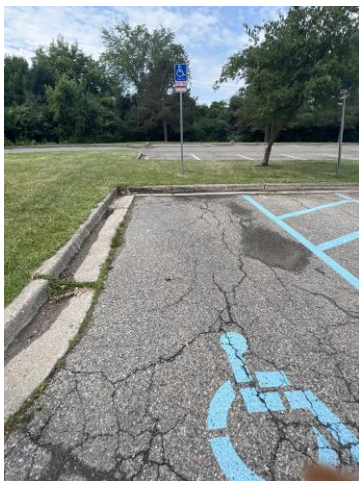
8 accessible spaces

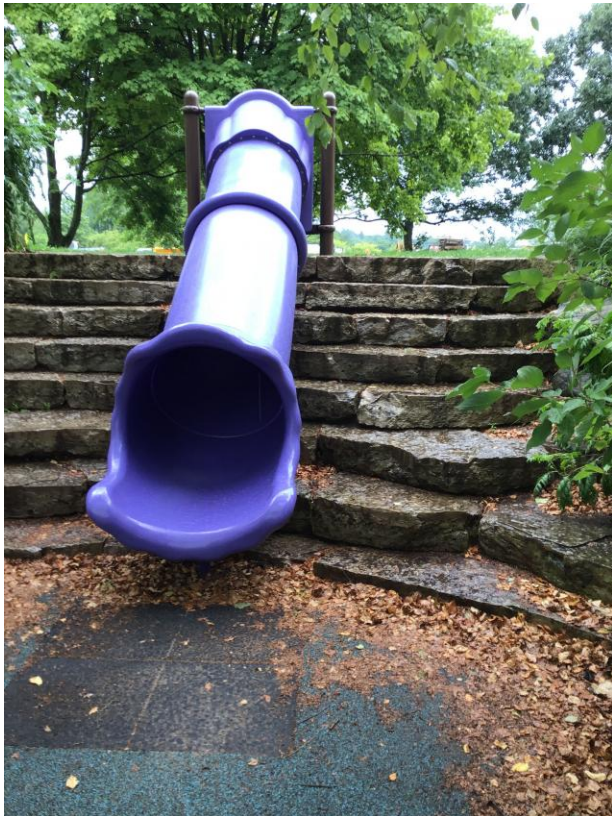
The transfer platform of stones do not meet dimensional requirements.

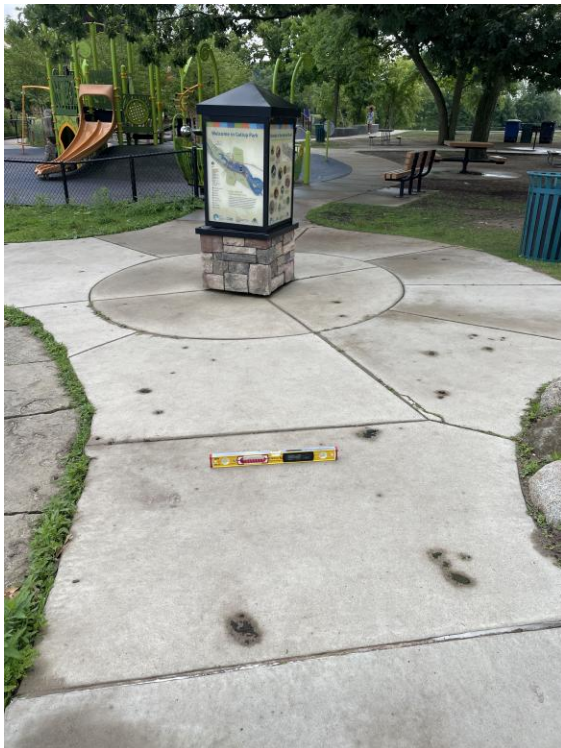
Route around informational sign is greater than 2%

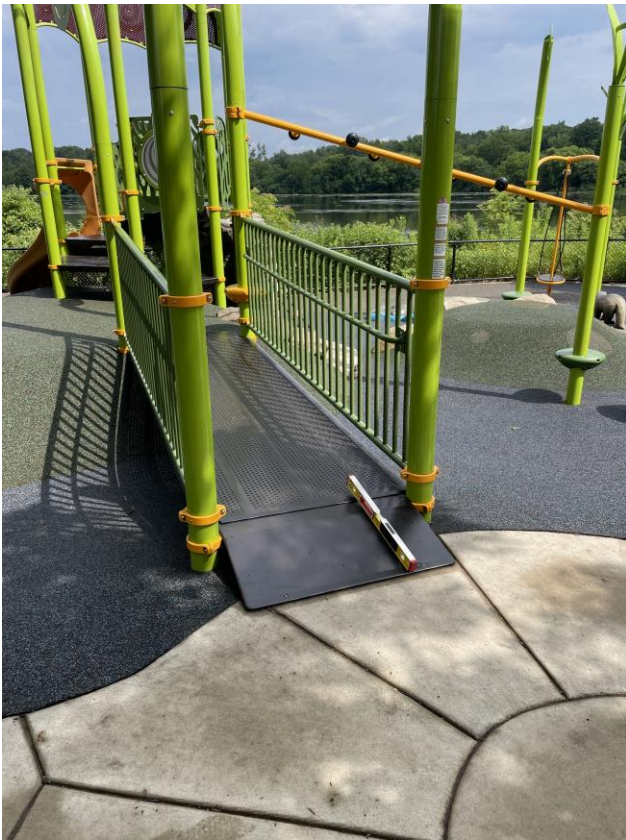
Ramp into playground bridge is 25% and has no top landing

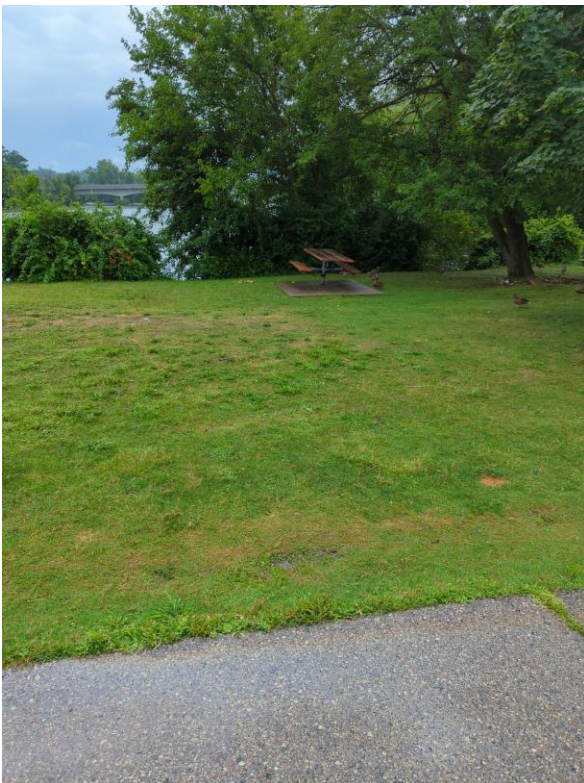
No route to the picnic table in front of accessible parking stalls

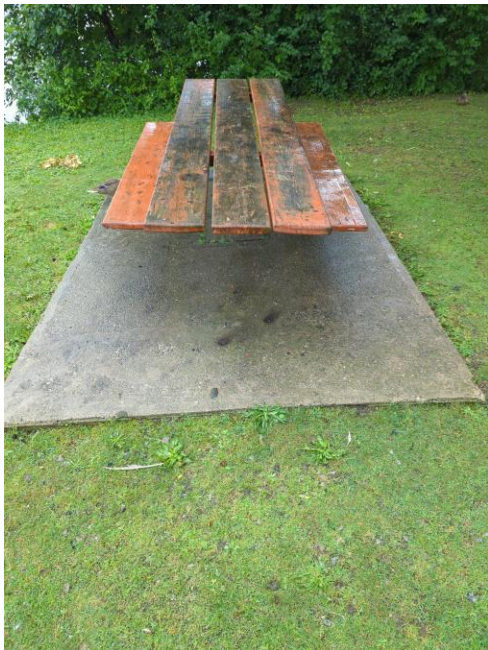
Accessible dining surface is 29 inches wide

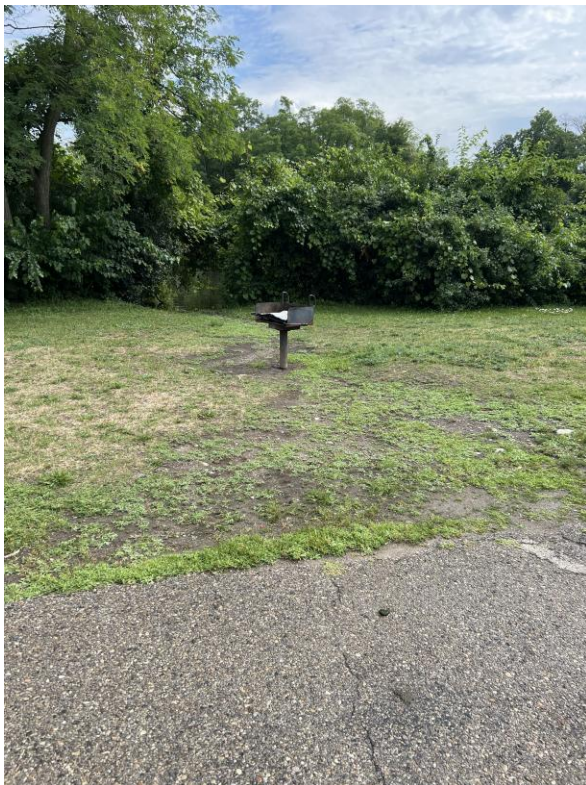
No accessible route

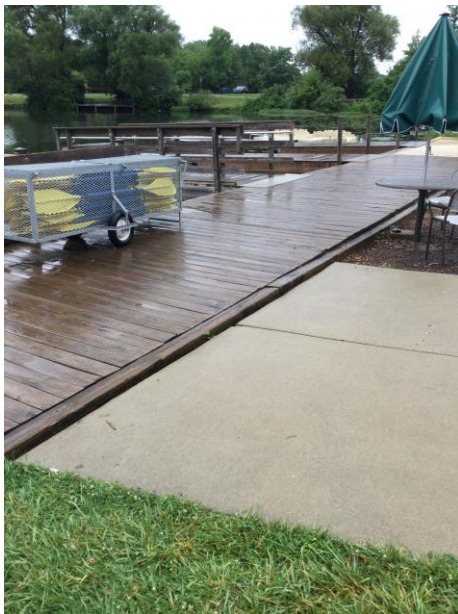
2"

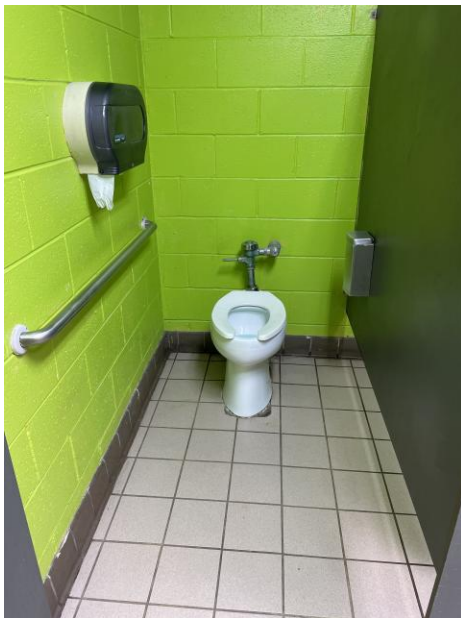
42"

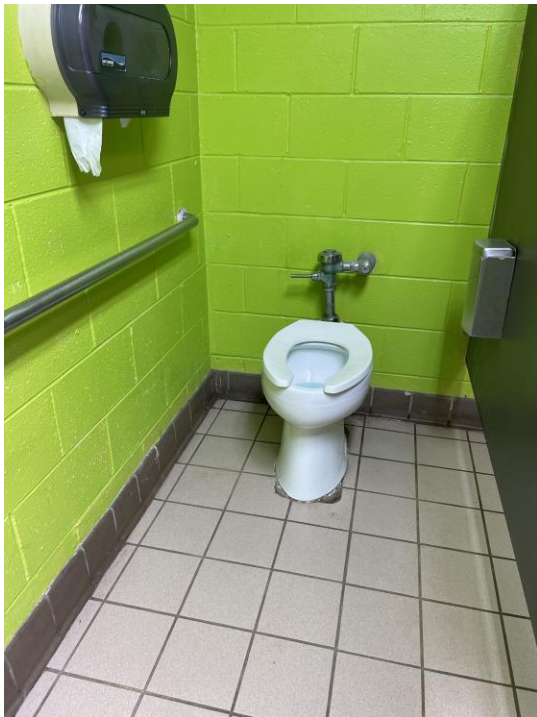
Not on open side

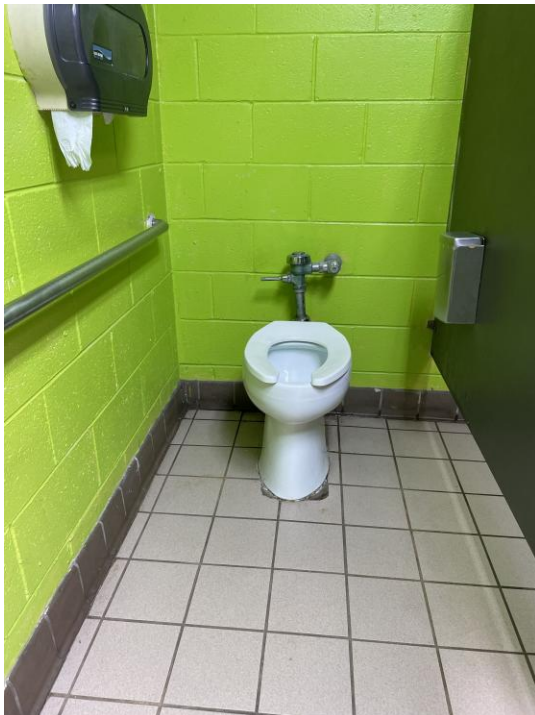
20" from side wall

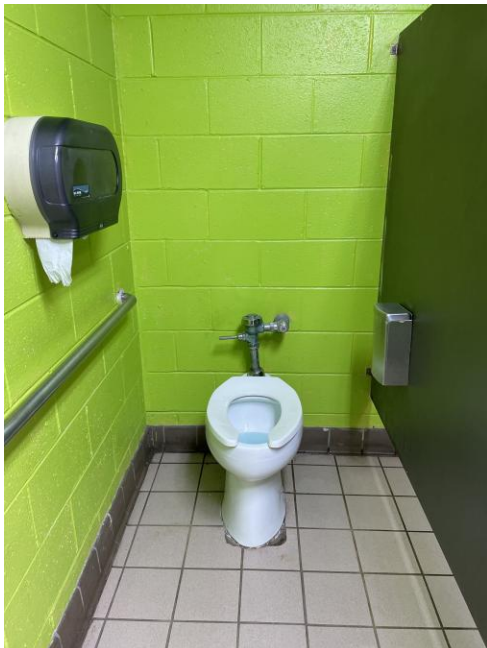
The rear grab bar is missing.

Rear grab bar not provided
