Site Accessibility Evaluation

Allmendinger Park
655 Pauline Blvd
Ann Arbor, MI 48104
ADA Only

Inspection Date: 07/11/2022

Report Date: 11/15/2022

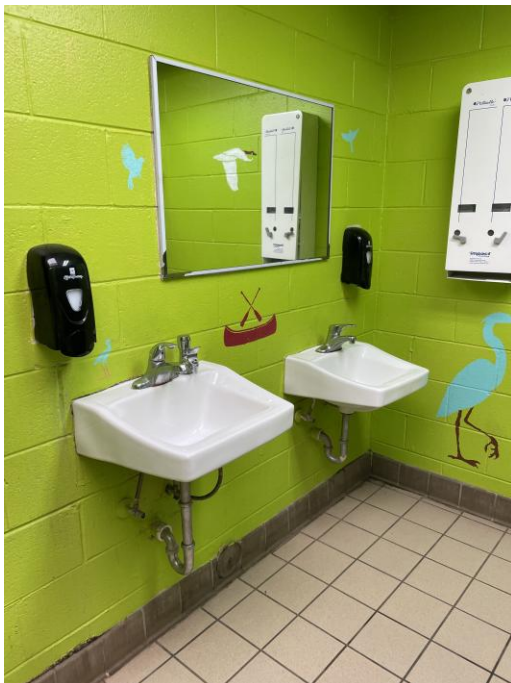
48" above finish floor

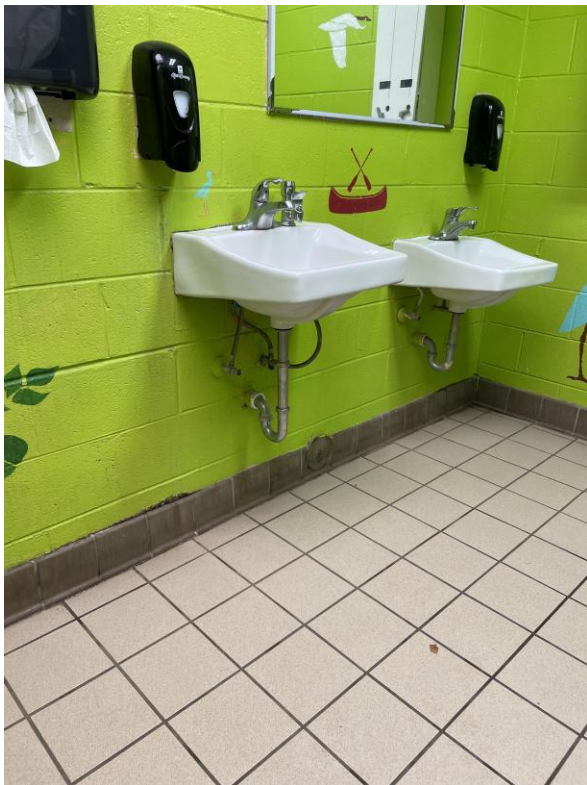
Pipes are not insulated

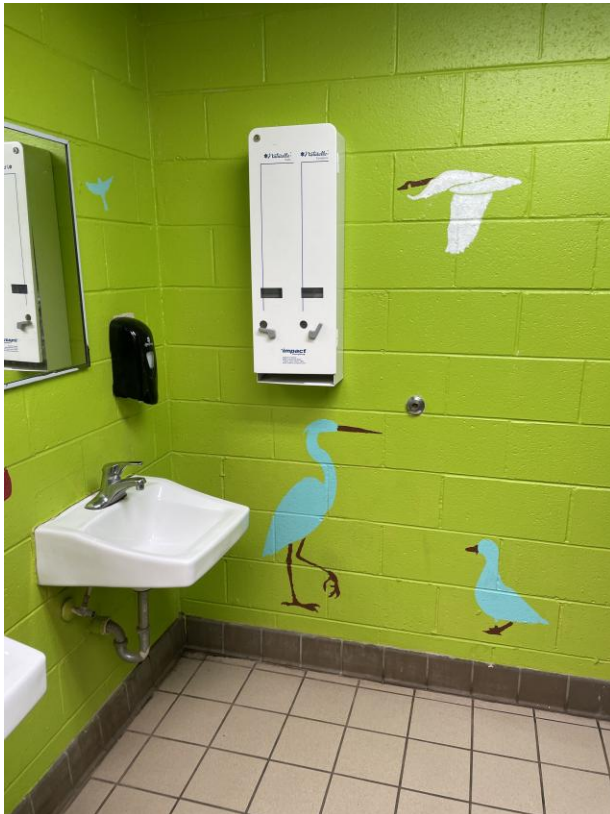
Dispenser is not installed within reach range

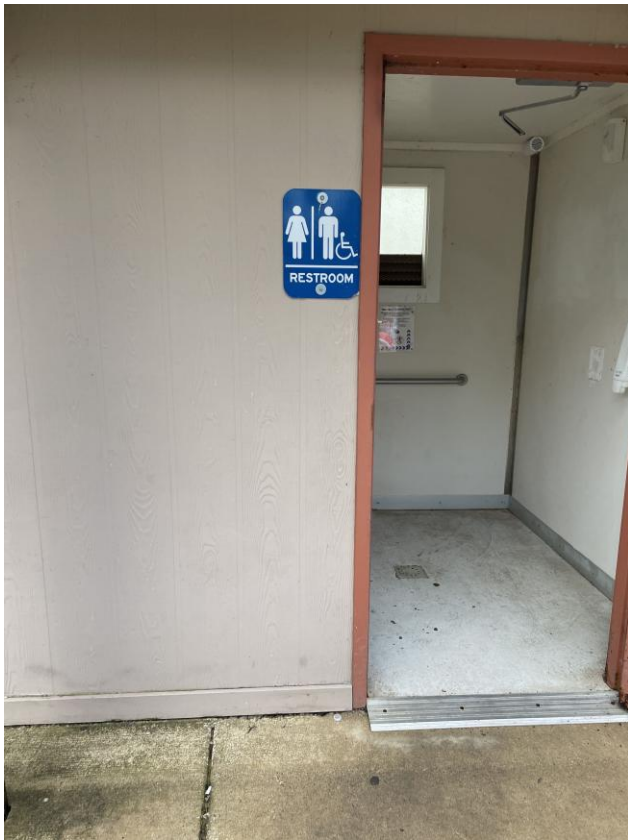
No braille provided

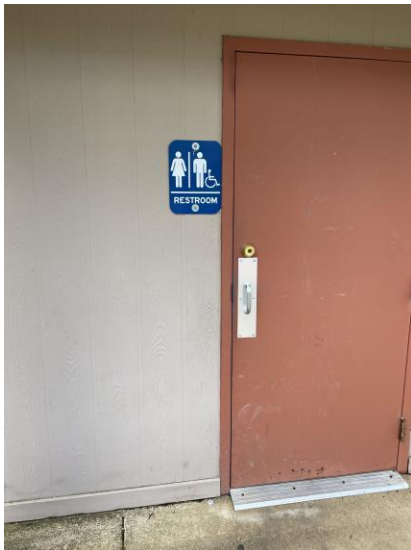
No braille provided

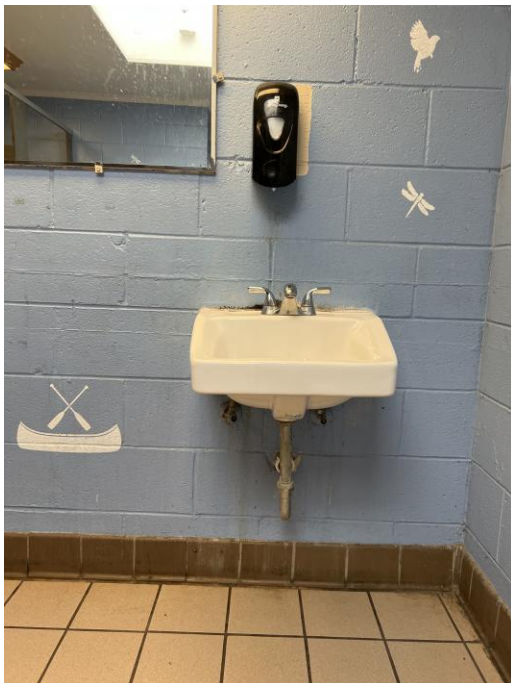
Mirror is mounted too high

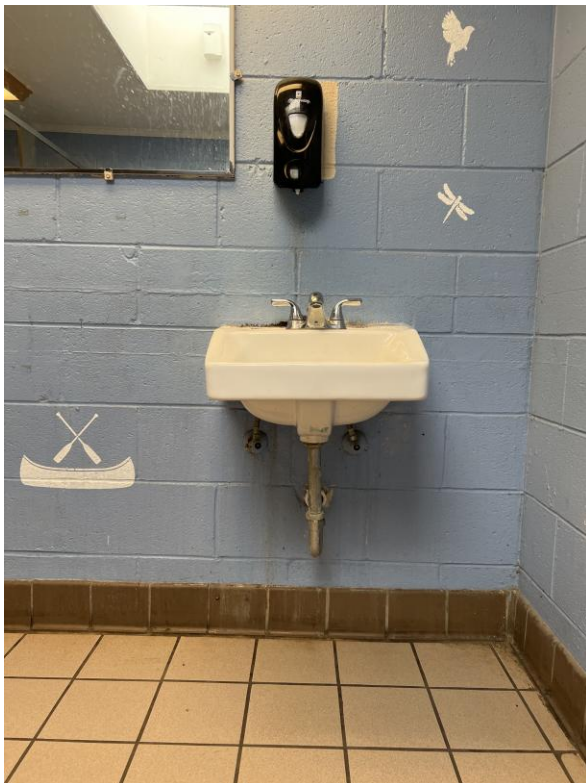
Pipes are not insulated

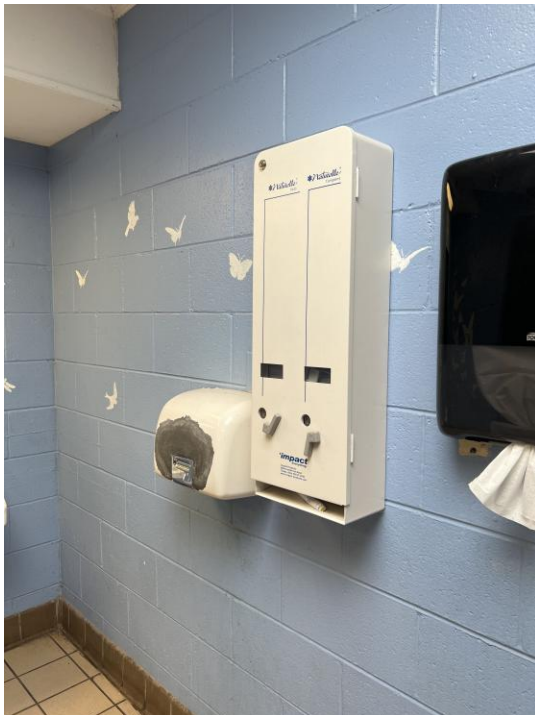
Wall-mounted objects that have leading edges between 27 inches and 80 inches from the floor must not project more than 4 inches into the circulation path. Protruding objects that extend to the floor or within 27 inches of the floor are cane detectable and are therefore not hazardous. Where it is necessary or desirable to have objects protrude from the wall, a manner of cane detection must be provided.

Protruding

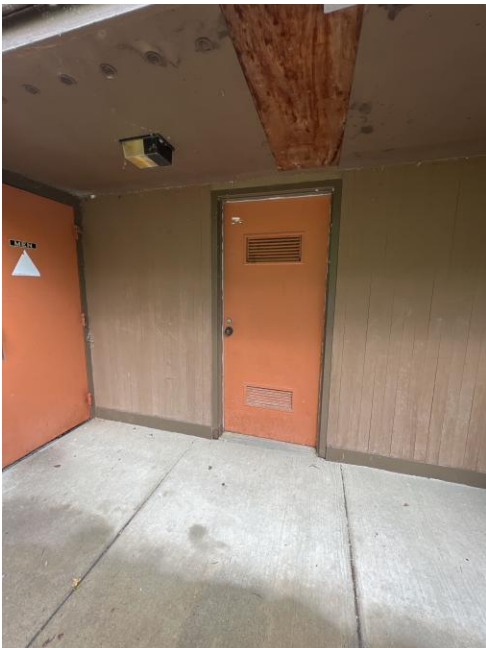
Door knobs

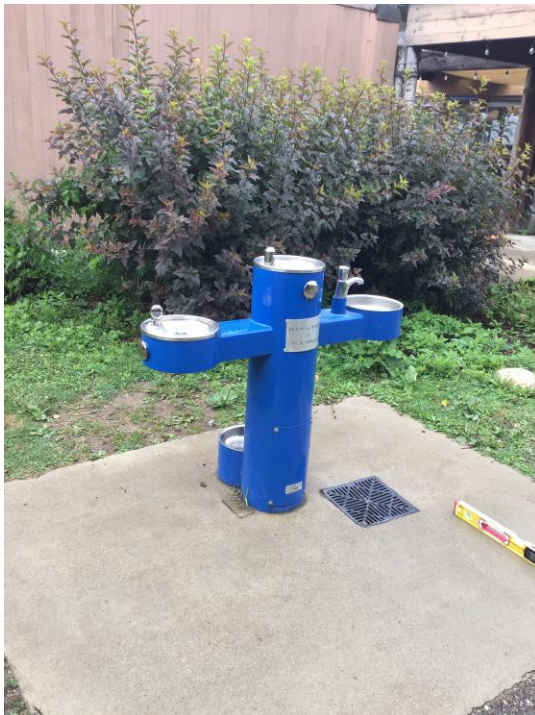
Drinking fountain by facility entrance is a protruding object.

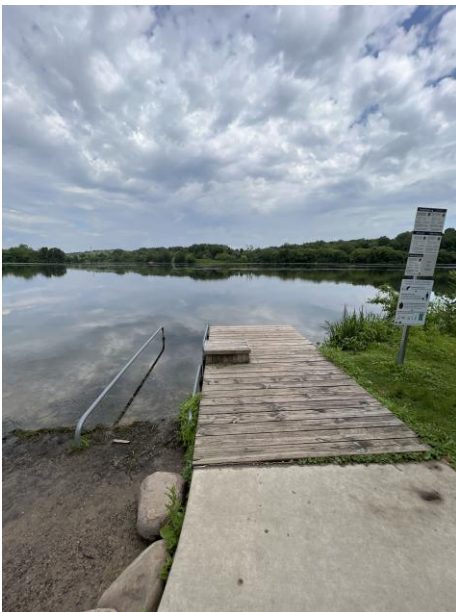
Changes in level

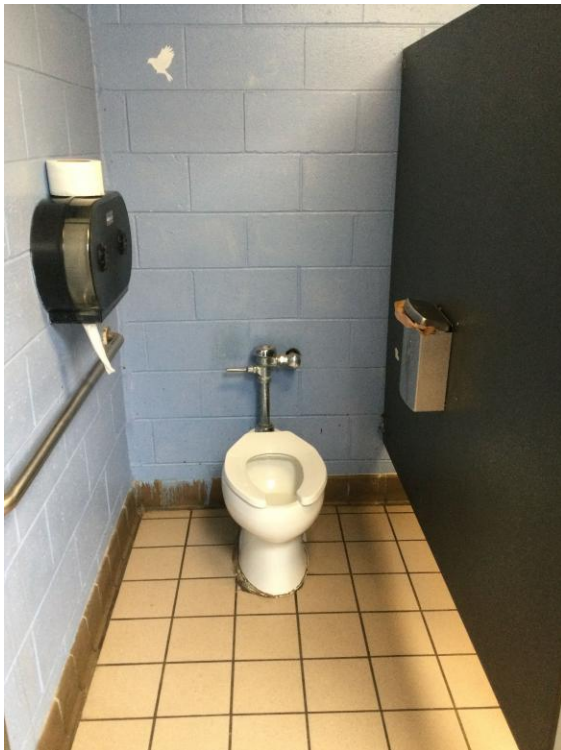
The stall does not have the required minimum clear floor space or maneuvering clearances for the toilet, Grab bars are missing and/or incorrectly installed, accessories, such as toilet seat covers, toilet paper holders, and garbage cans are either too high, without clear floor space or both, the floor level changes greater than a 1/2 inch at the floor drains.

Redo

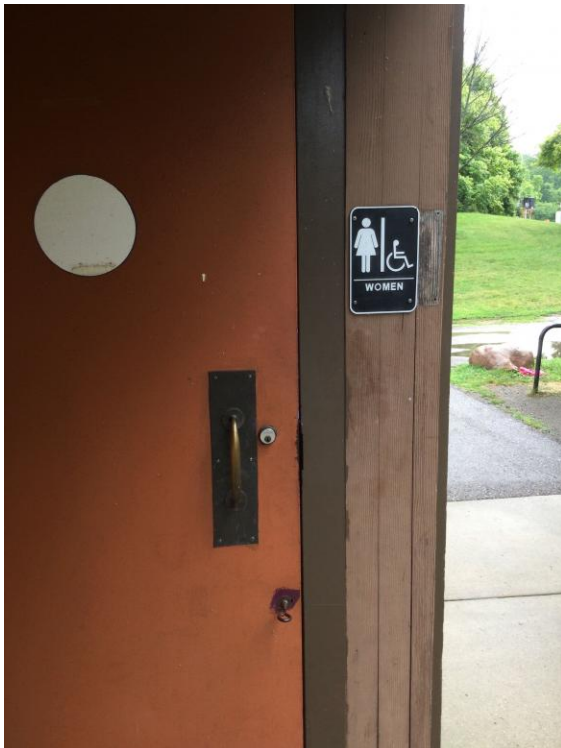
14"

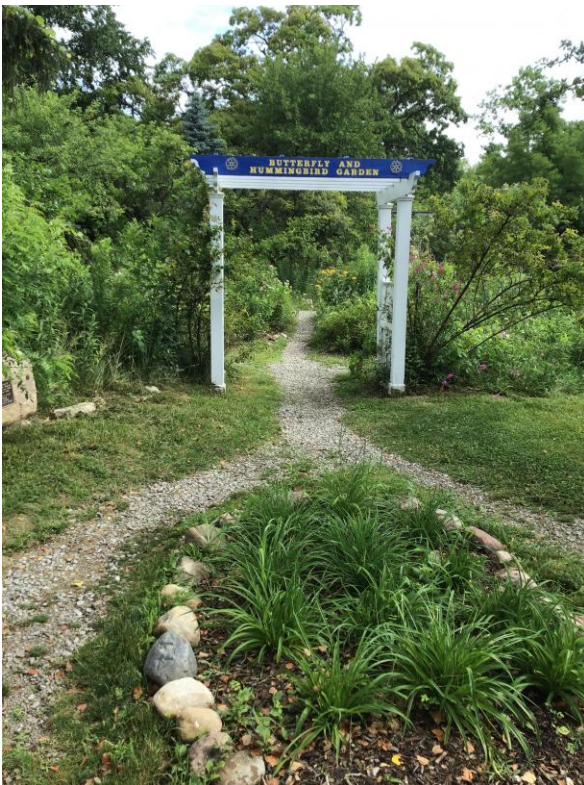
No accessible route into or within the garden

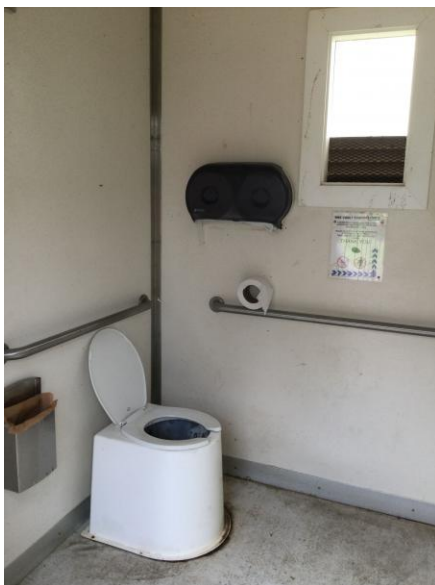
Too close

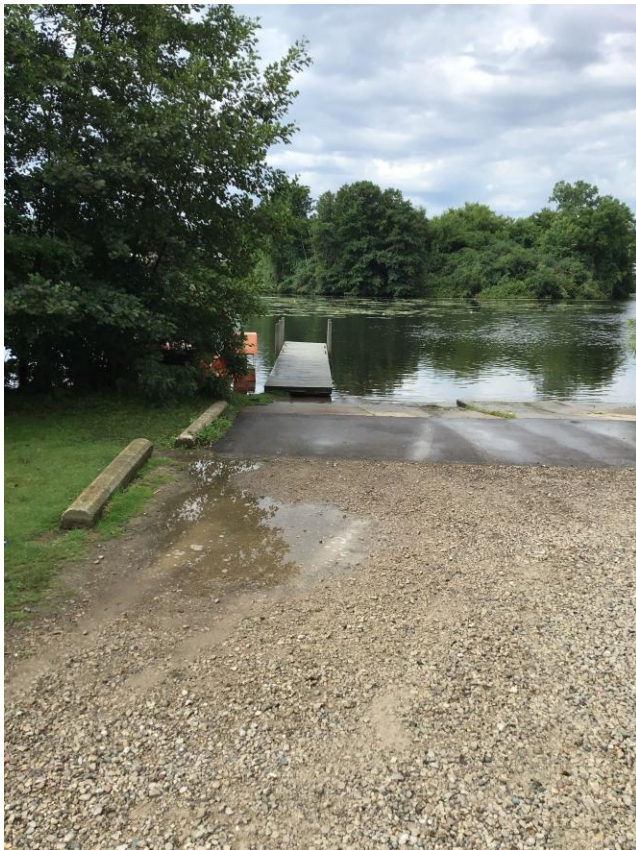
Route to boardwalk has vertical change of 7 inches.

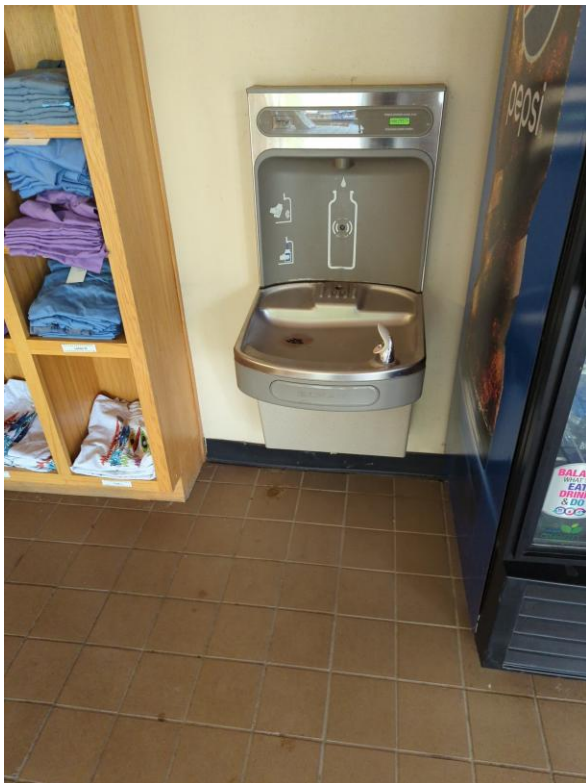
Knee clearance is 22 inches

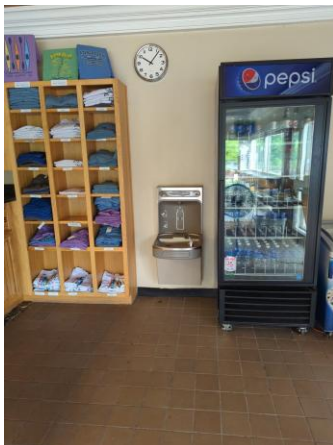
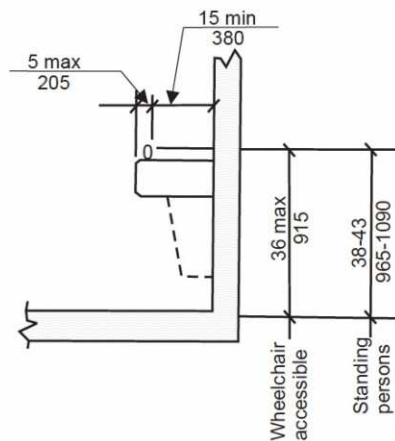
No high drinking fountain

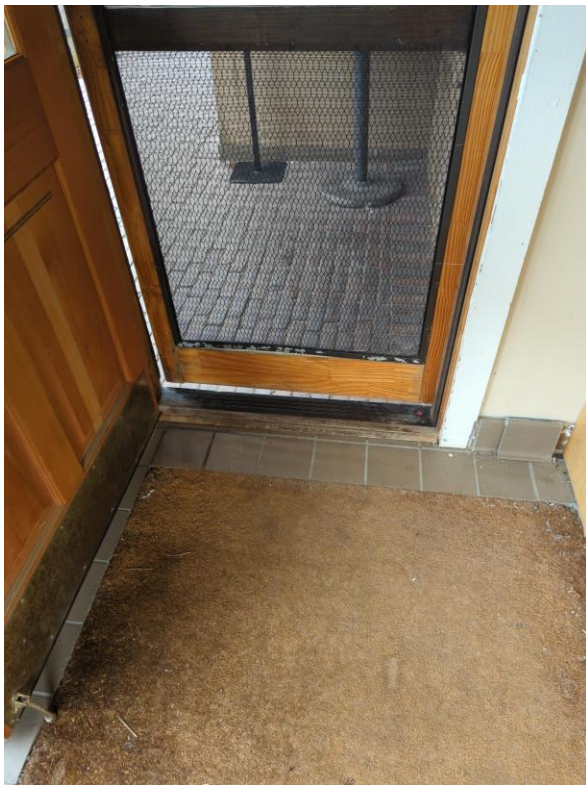
Threshold is 1-1/4 inches high

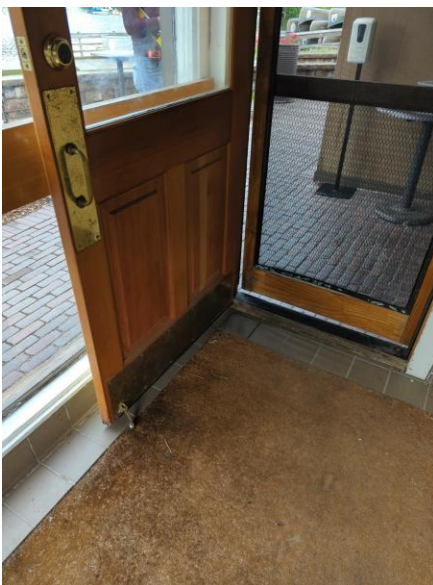
Hold open device on smooth surface

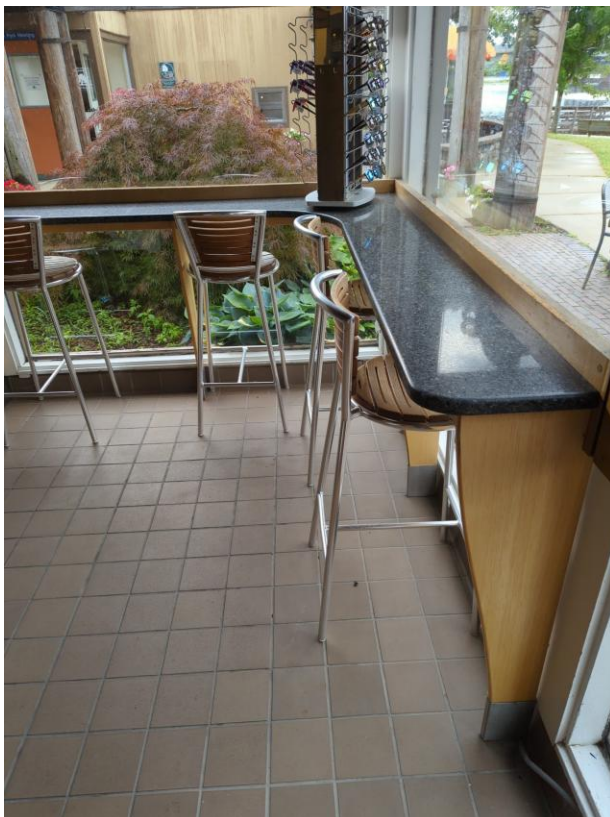
Dining surface is 39 inches high

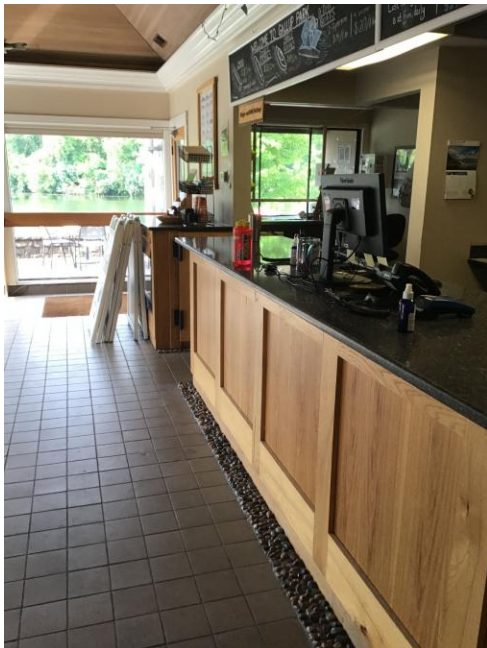
Counter height at 43 inches.

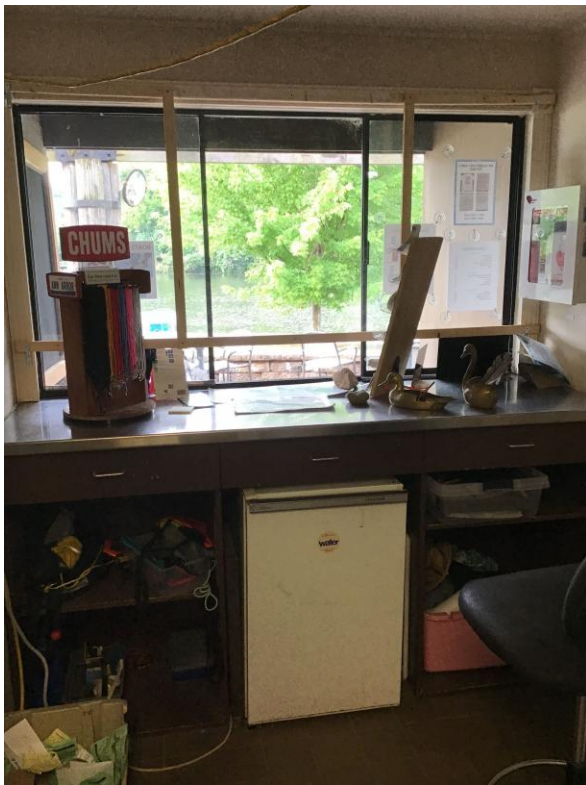
Interior side of customer service window is 42 inches.

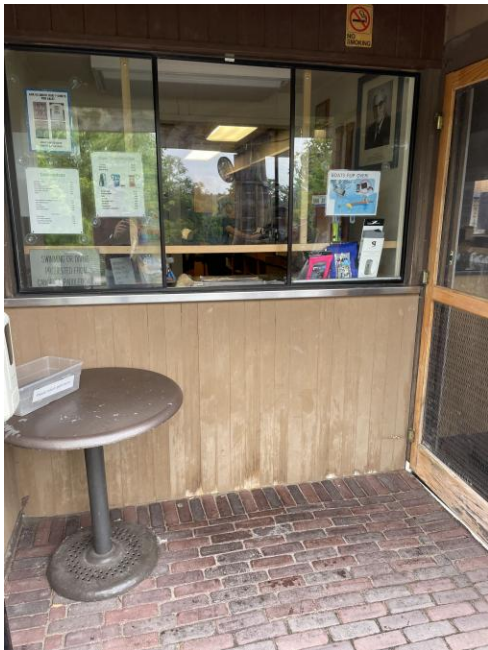
42"

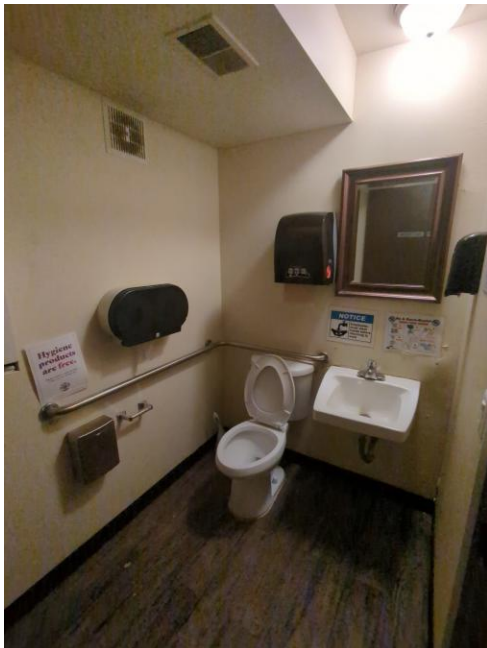
The restroom does not have the required minimum clear floor space or maneuvering clearances for the toilet. The restroom does not have the required minimum clear floor space or maneuvering clearances for the lavatory. The entry door does not contain the required minimum maneuvering spaces on the pull/push sides. The entry door encroach into the required clear floor space for fixtures. Grab bars are missing and/or incorrectly installed. Accessories, such as toilet seat covers, paper towel holders, garbage cans, hand dryers, and mirrors are either too high or without clear floor space or both.

Non-accessible staff restroom

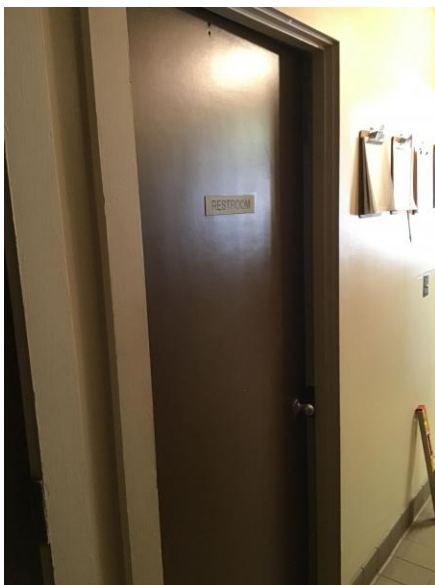
Staff restroom missing signage.

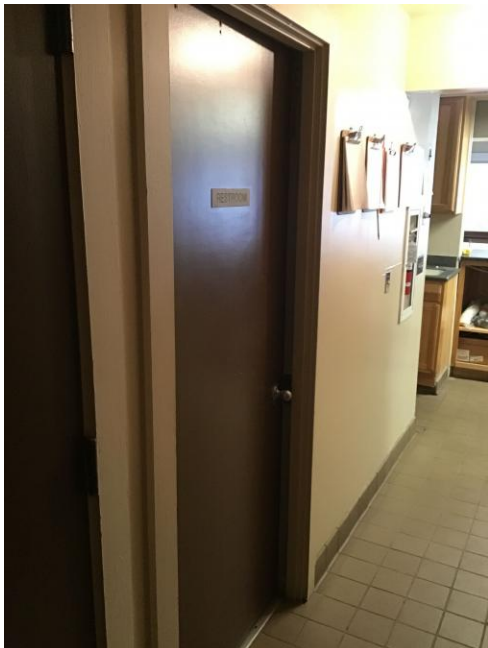
Staff restroom and other doors have knob.

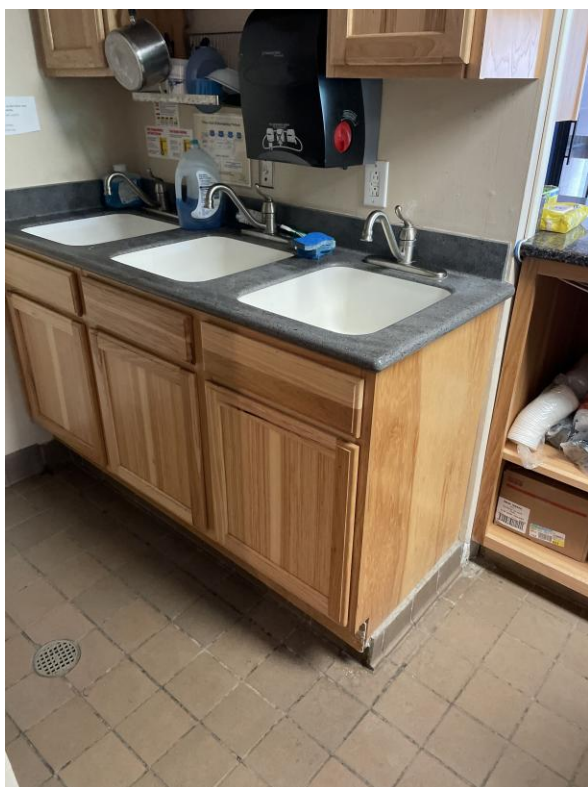
40" above floor

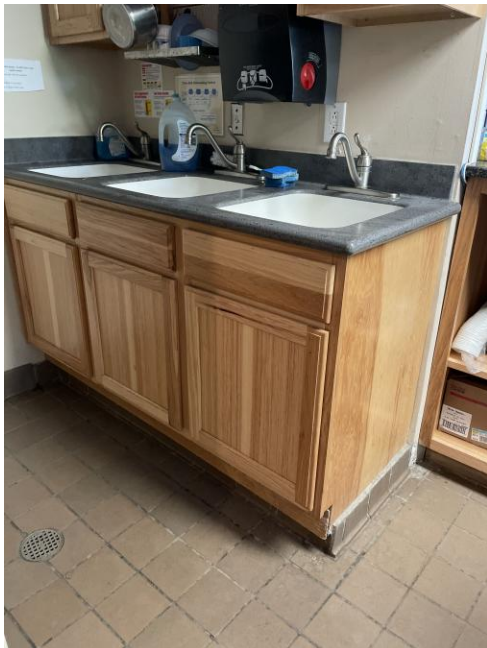
Cabinets are provided

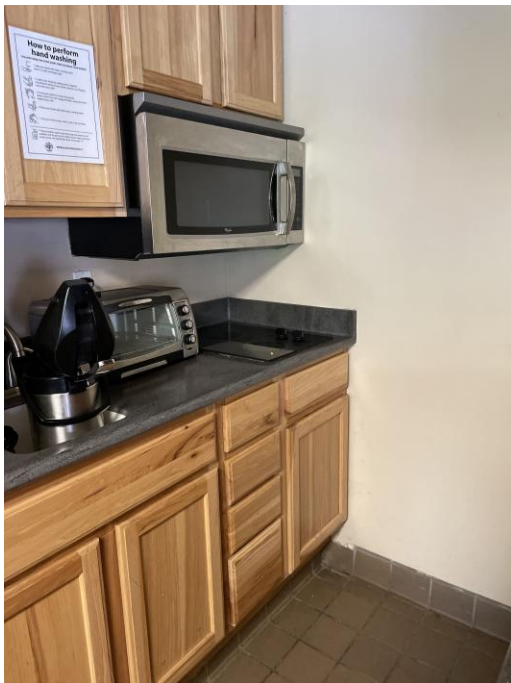
Microwave not installed within reach range

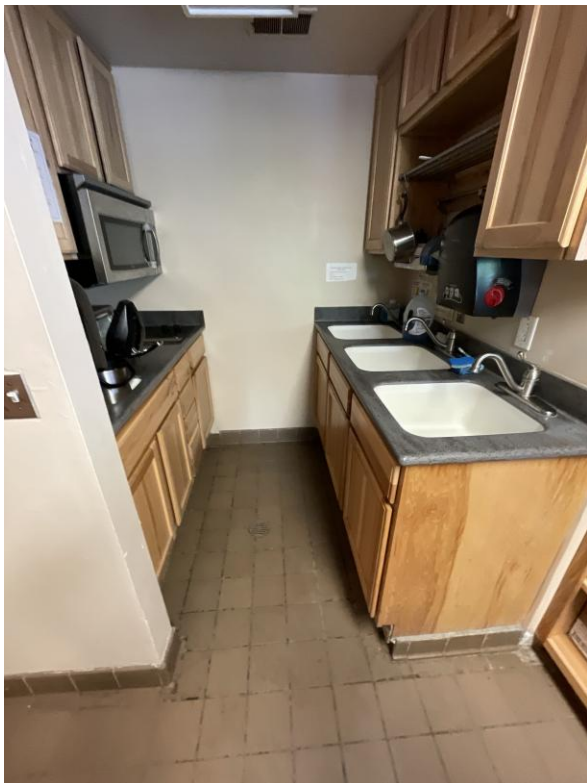
32" wide

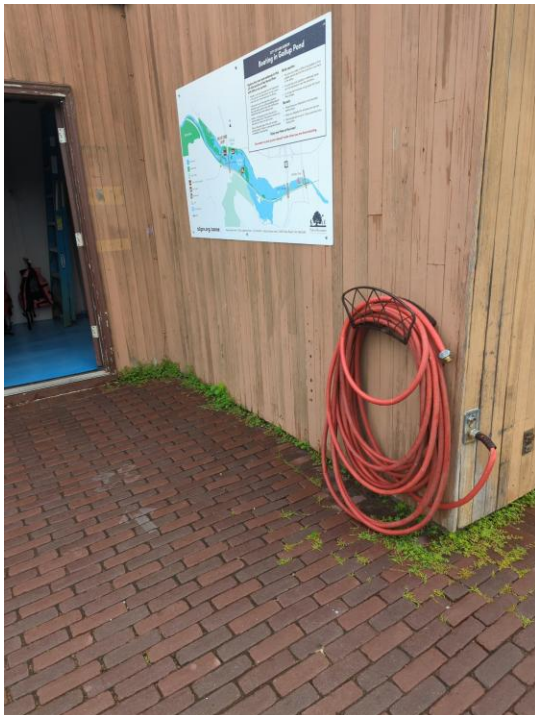
Wall-mounted objects that have leading edges between 27 inches and 80 inches from the floor must not project more than 4 inches into the circulation path. Protruding objects that extend to the floor or within 27 inches of the floor are cane detectable and are therefore not hazardous. Where it is necessary or desirable to have objects protrude from the wall, a manner of cane detection must be provided.

Water hose rack protrudes 6-1/2 inches

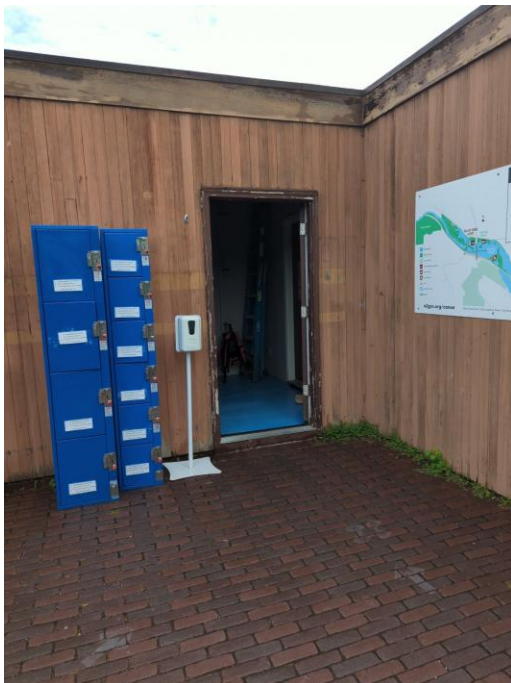
Door has a 4 inch step

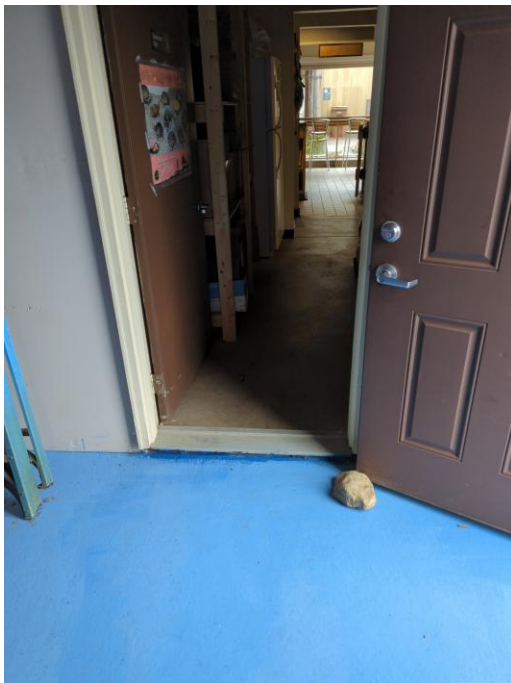
Door has a 2 inch step from vest storage to main building

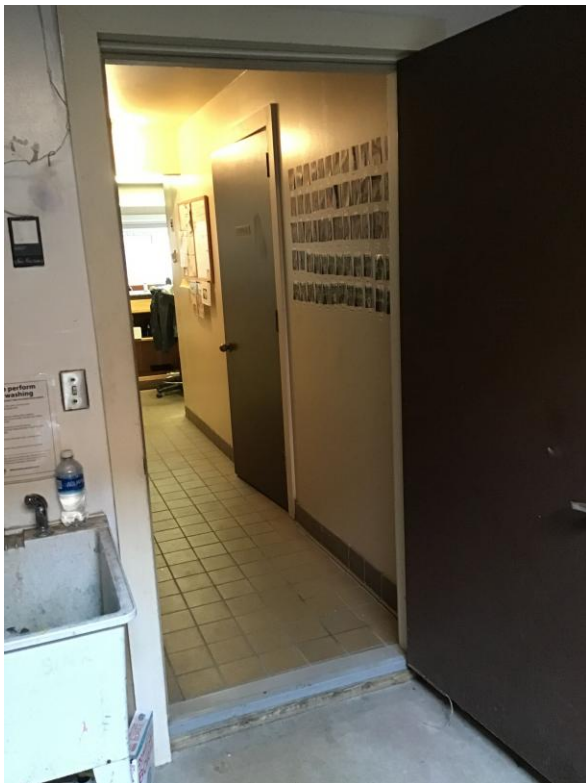
Threshold at 3 inches.

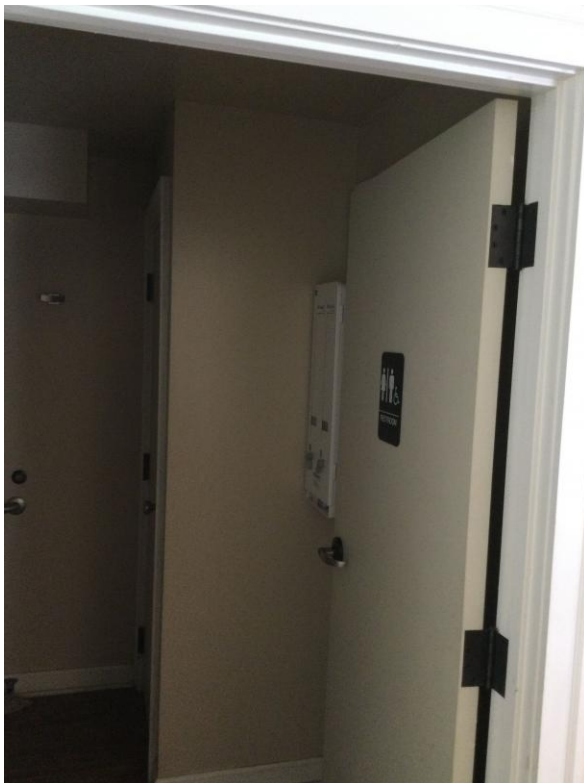
No closer

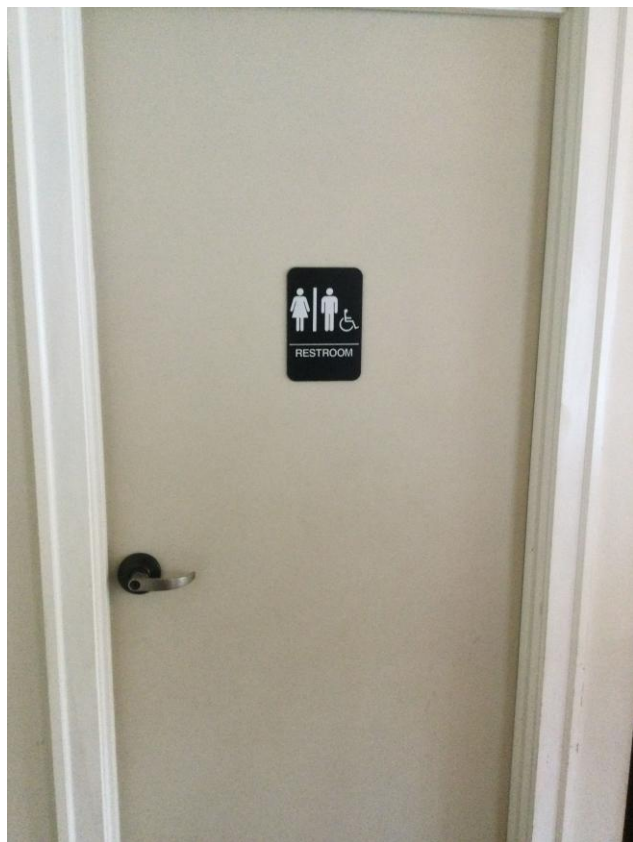
The restroom is missing the International Symbol of Accessibility (ISA).

Wrong location

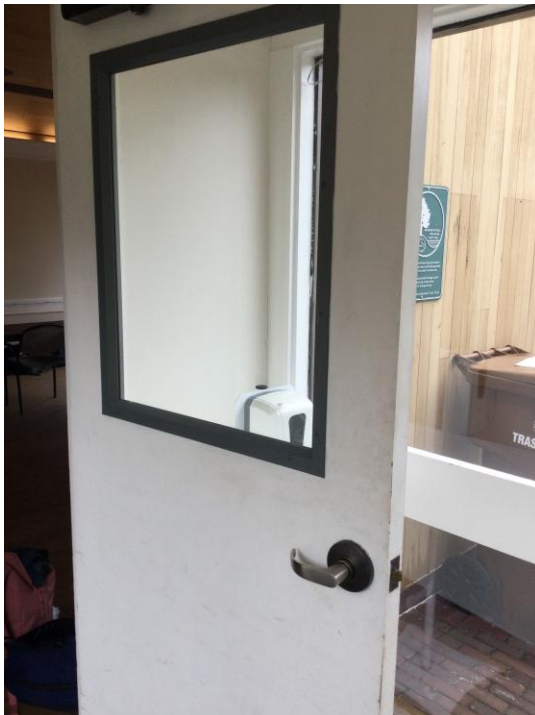
48"

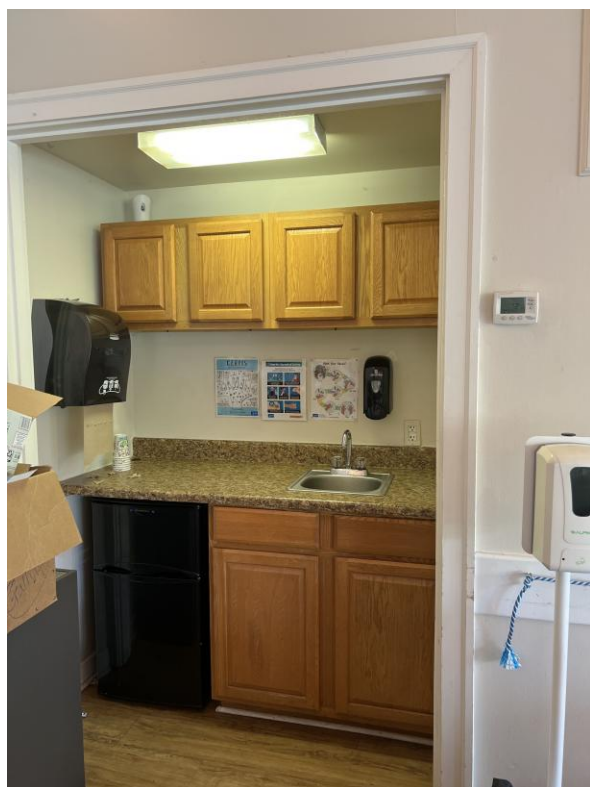
Sink is too heigh

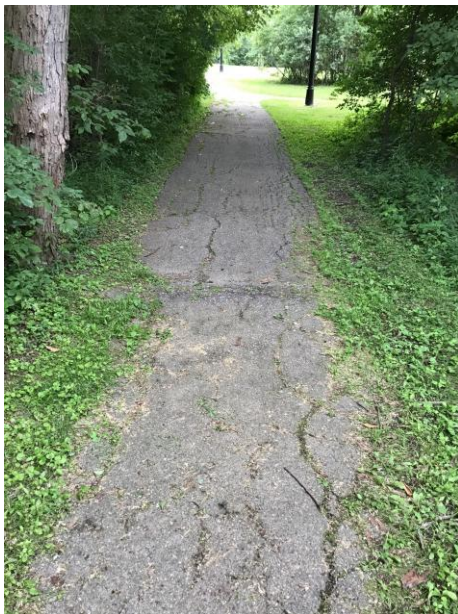
Vertical changes in the paved trail.

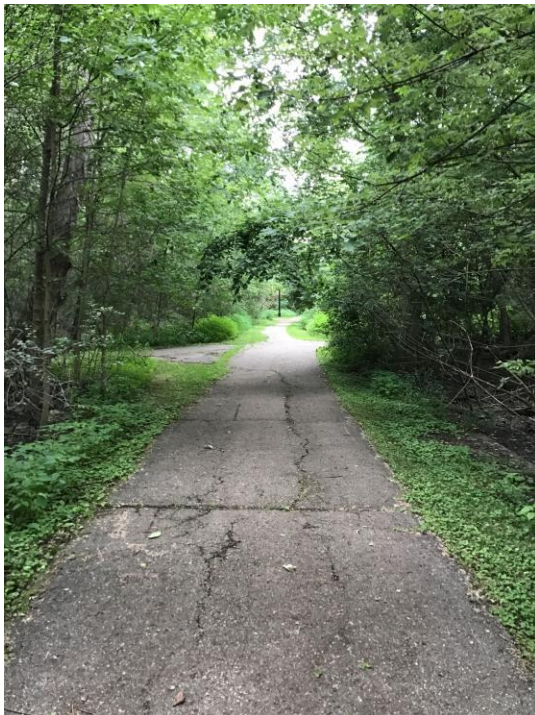
Wall-mounted objects that have leading edges between 27 inches and 80 inches from the floor must not project more than 4 inches into the circulation path. Protruding objects that extend to the floor or within 27 inches of the floor are cane detectable and are therefore not hazardous. Where it is necessary or desirable to have objects protrude from the wall, a manner of cane detection must be provided.

Trees are protruding objects.

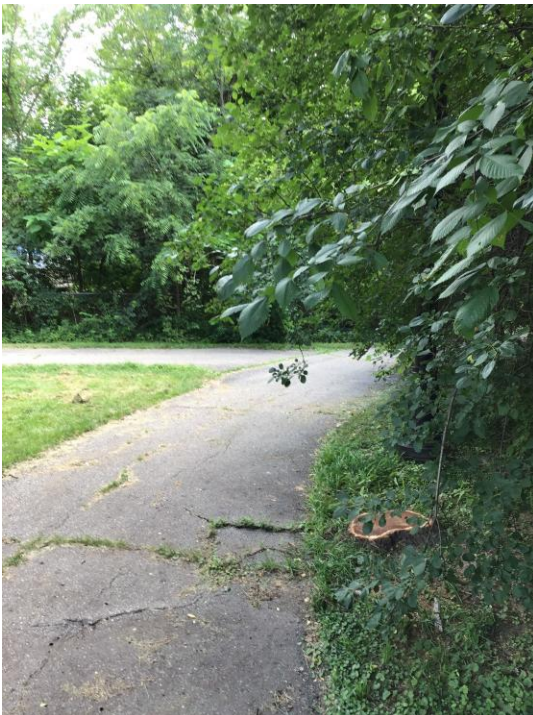
Wall-mounted objects that have leading edges between 27 inches and 80 inches from the floor must not project more than 4 inches into the circulation path. Protruding objects that extend to the floor or within 27 inches of the floor are cane detectable and are therefore not hazardous. Where it is necessary or desirable to have objects protrude from the wall, a manner of cane detection must be provided.

Trees are protruding objects.

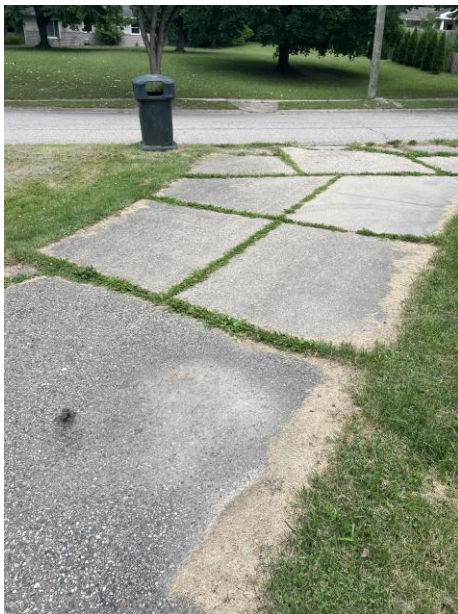
Change in elevation

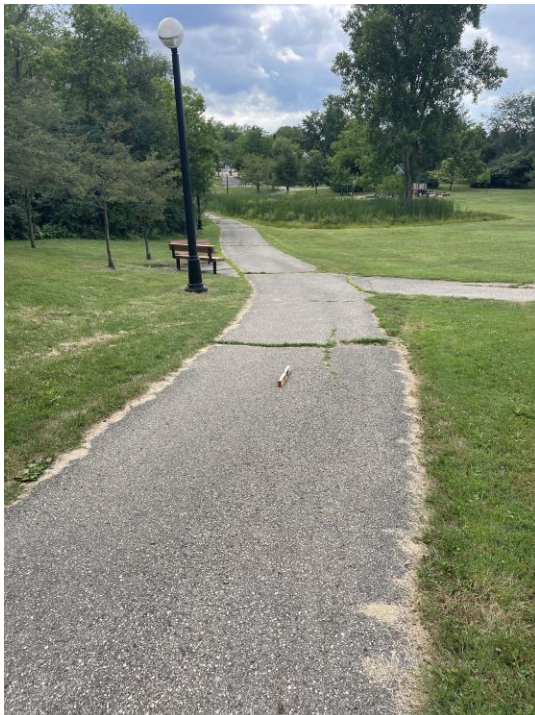
5.9%

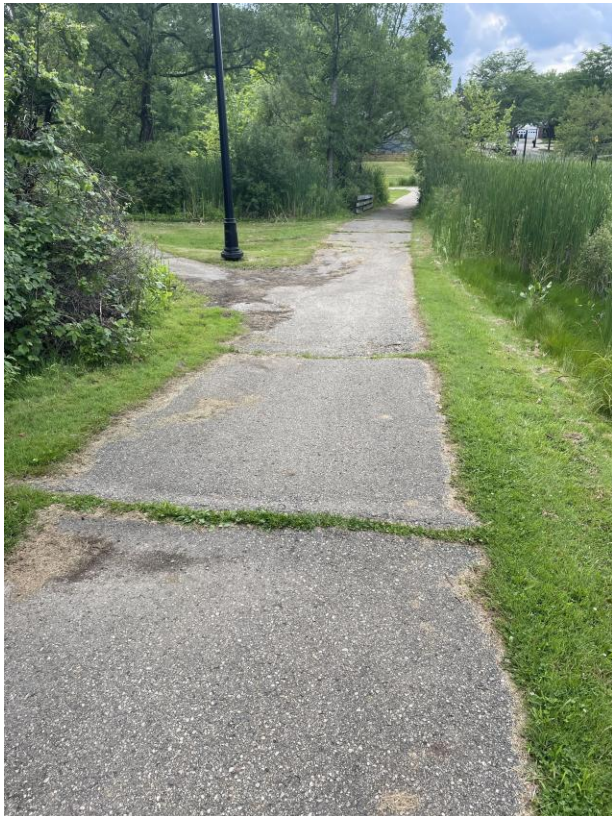
The accessible route contains loose gravel and/or surface materials that do not provide for a stable, firm slip resistant surface.

Multiple openings and vertical changes in level

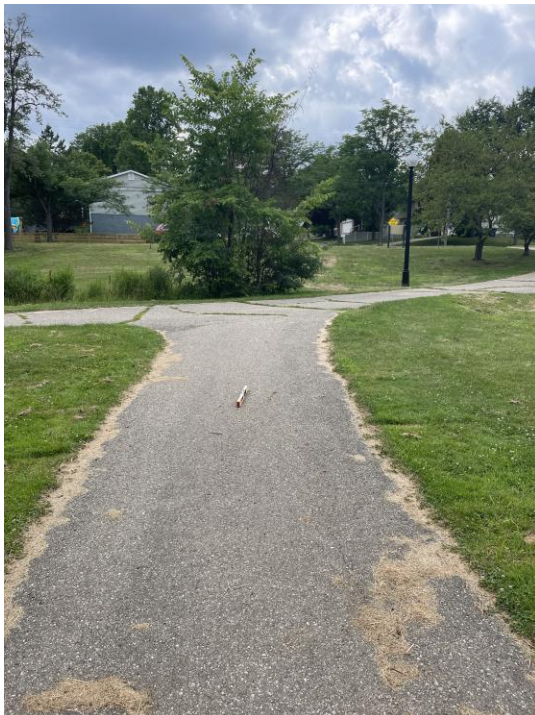
6.6%

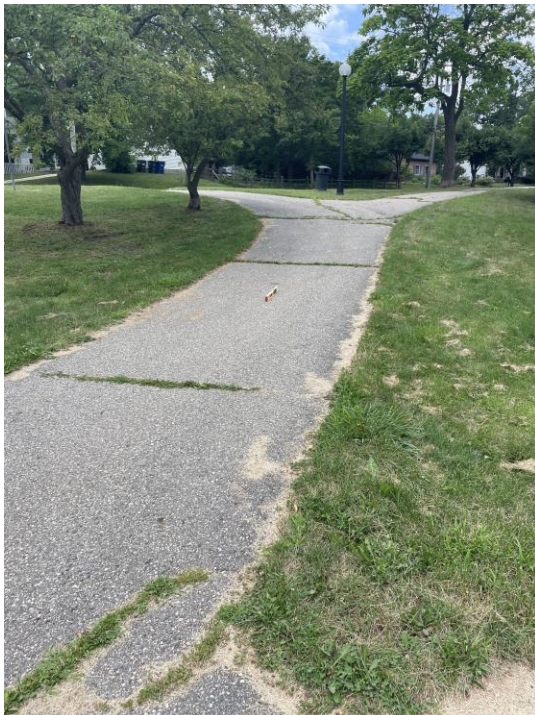
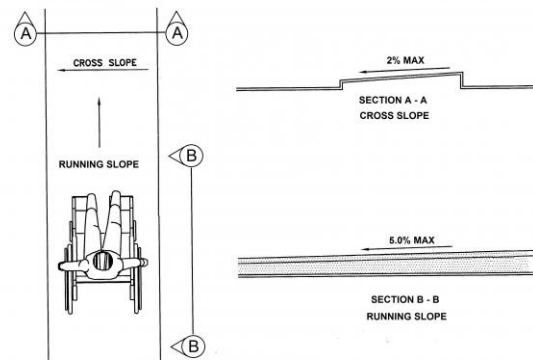
As Built:

8% and greater

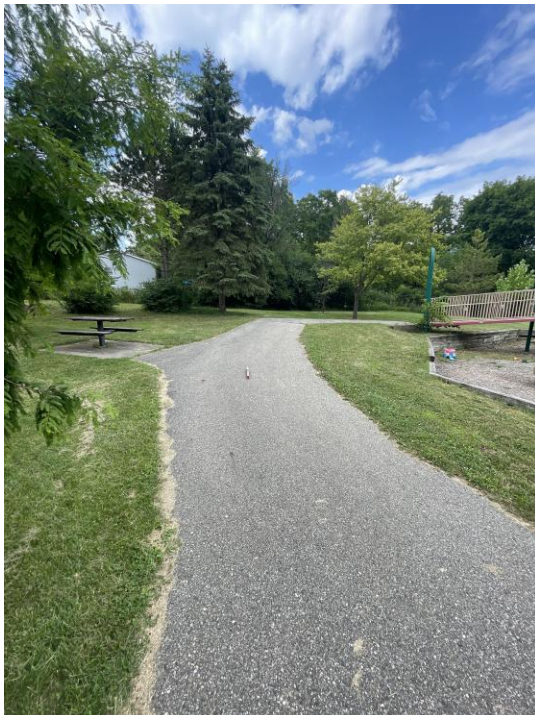
As Built:

6.5% and greater

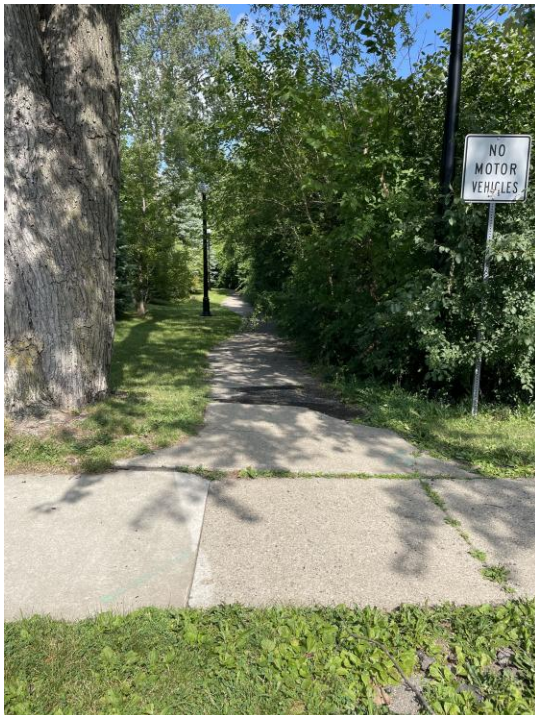
As Built:

7.5% and greater

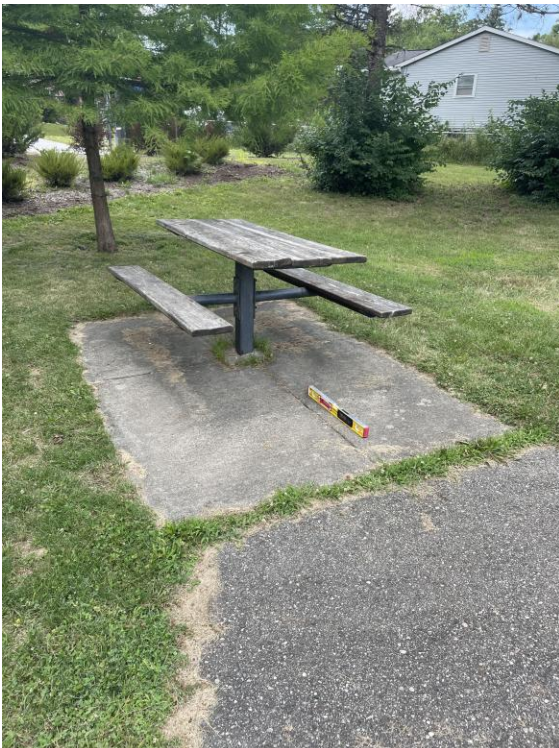
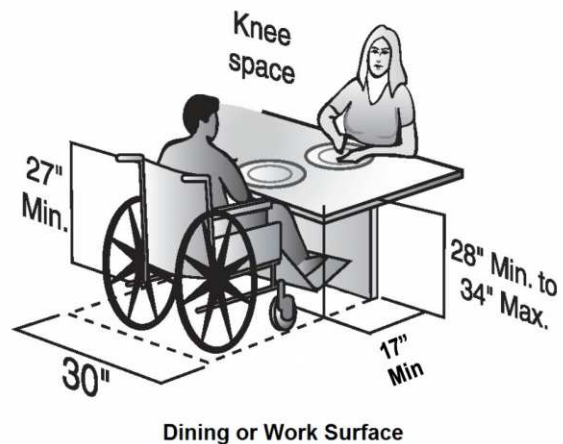
As Built:

Slope of clear floor space is 3.4%

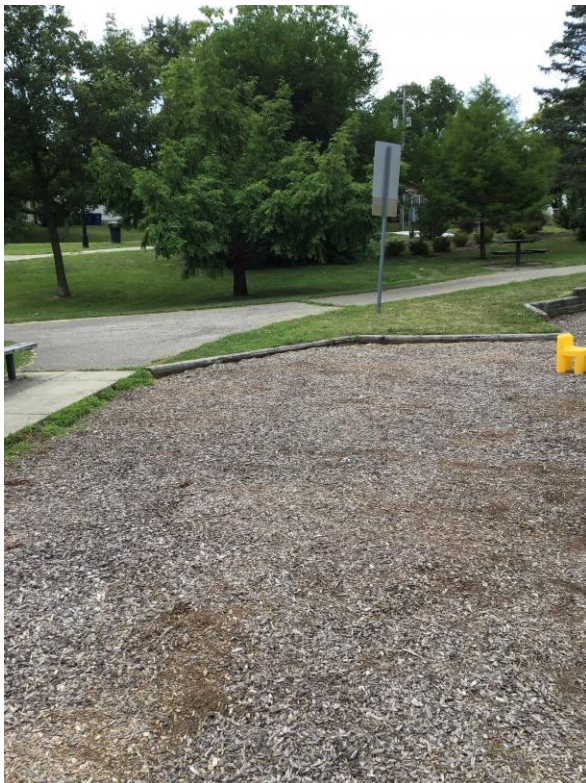
No accessible route to play area.

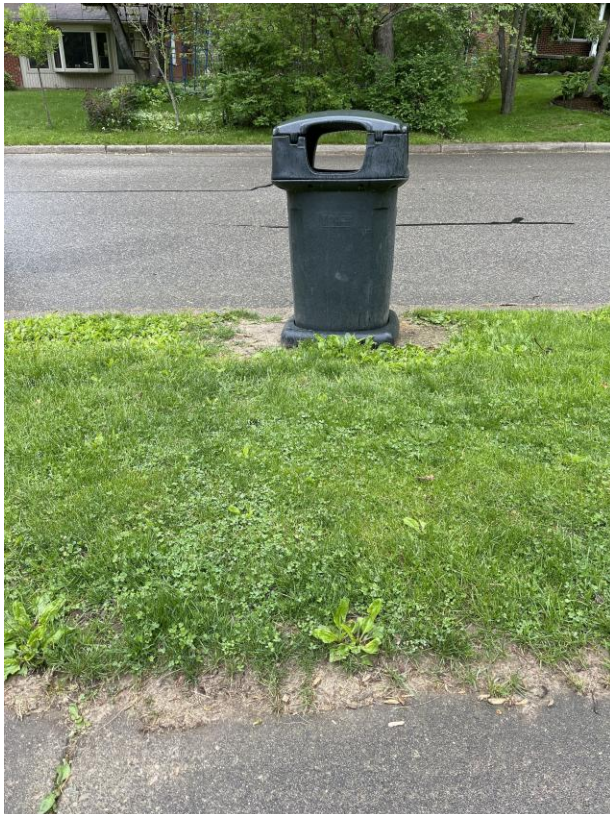
The accessible route contains loose gravel and/or surface materials that do not provide for a stable, firm slip resistant surface.

Surface is grass

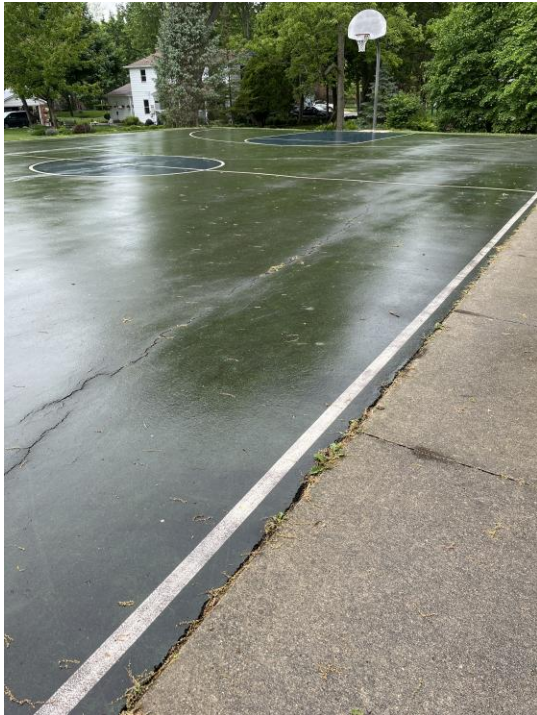
opening on transition between sidewalk and basketball court

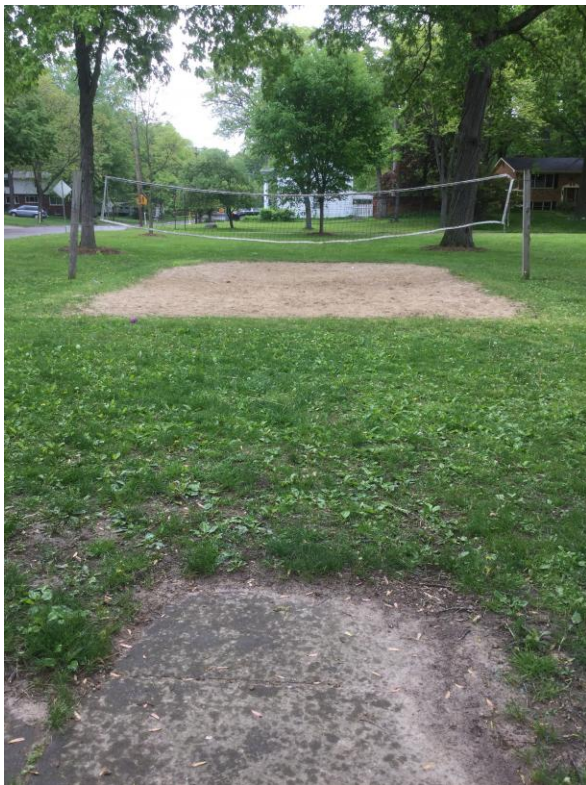
Grass surface
