Site Accessibility Evaluation

Allmendinger Park
655 Pauline Blvd
Ann Arbor, MI 48104
ADA Only

Inspection Date: 07/11/2022

Report Date: 11/15/2022

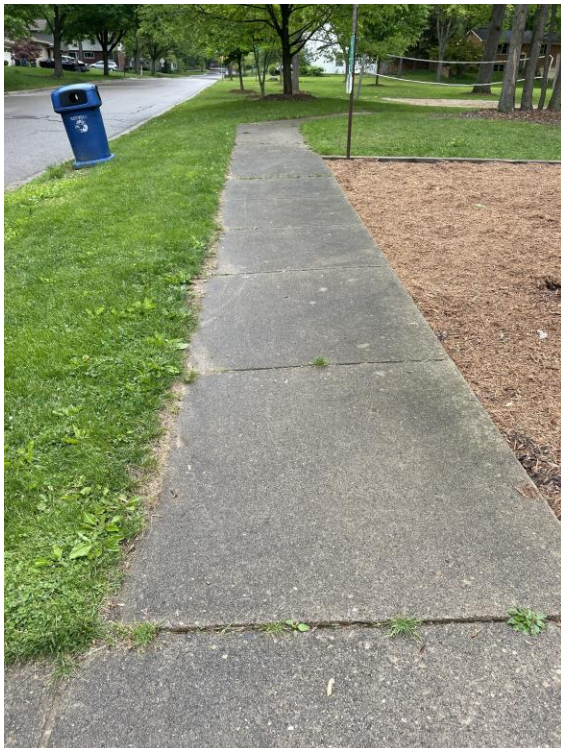
Cross slope greater than 2% for 75 feet

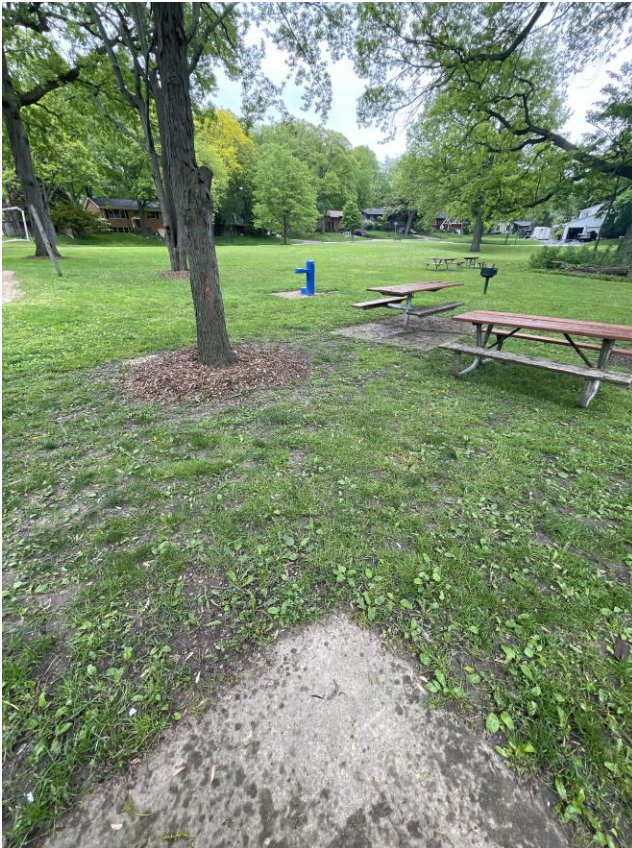
Drinking fountain is in the grass

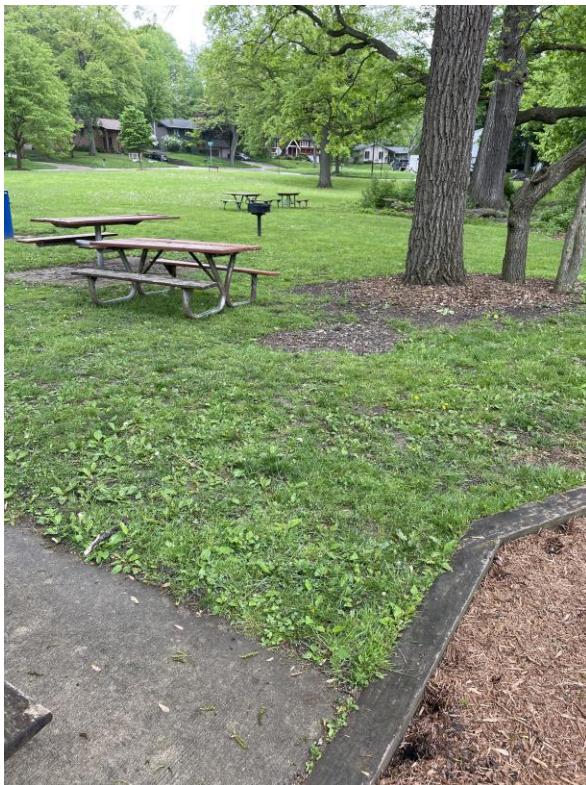
No accessible route to grill

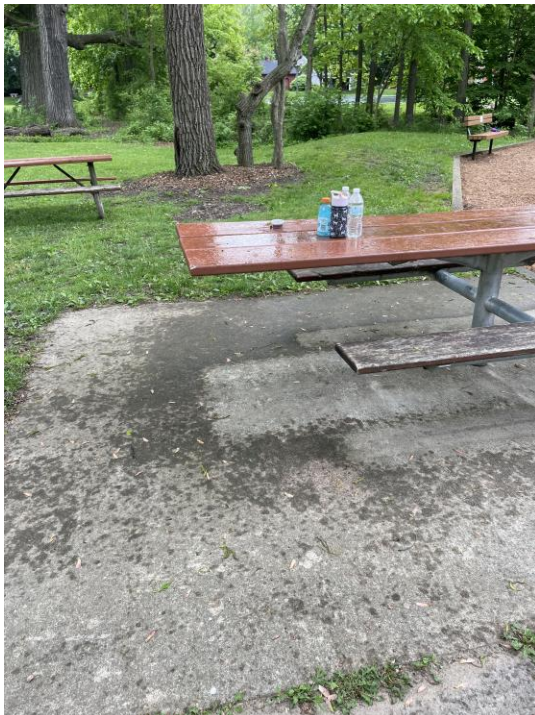
Wall-mounted objects that have leading edges between 27 inches and 80 inches from the floor must not project more than 4 inches into the circulation path. Protruding objects that extend to the floor or within 27 inches of the floor are cane detectable and are therefore not hazardous. Where it is necessary or desirable to have objects protrude from the wall, a manner of cane detection must be provided.

Table is protruding

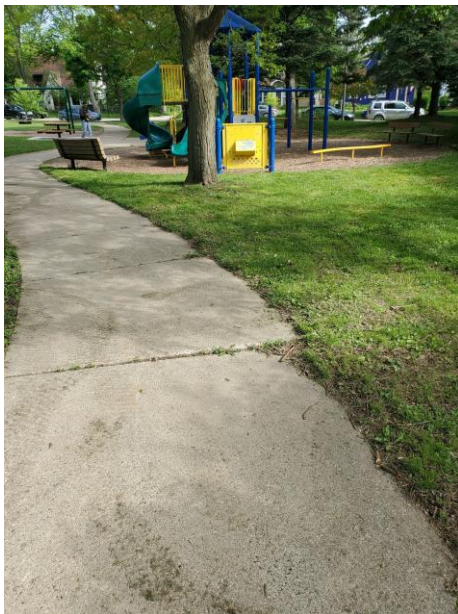
Change in elevation

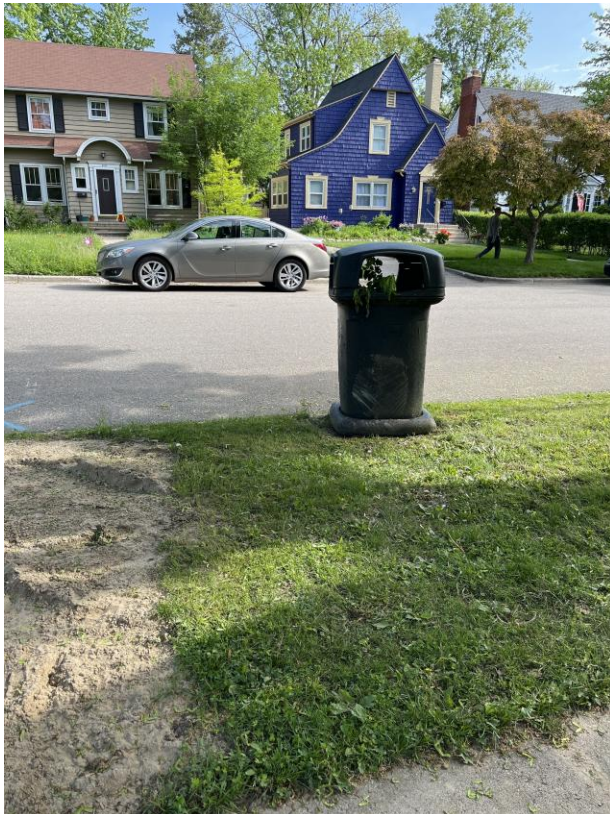
The accessible route contains loose gravel and/or surface materials that do not provide for a stable, firm slip resistant surface.

Surface is grass

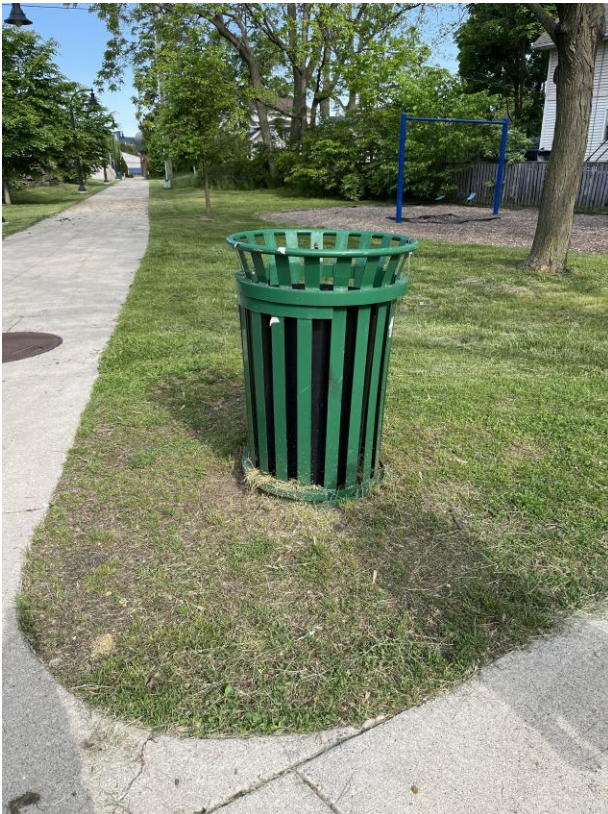
The accessible route contains loose gravel and/or surface materials that do not provide for a stable, firm slip resistant surface.

Surface is grass

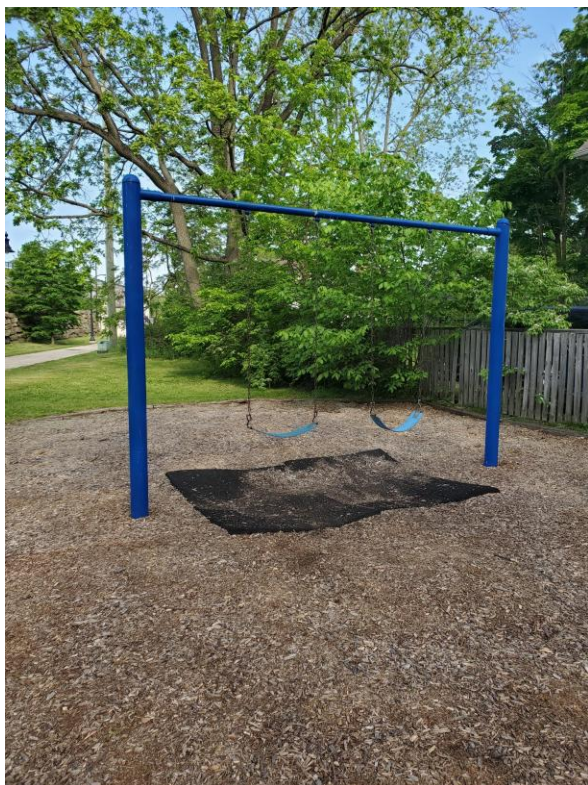
Swing is too high

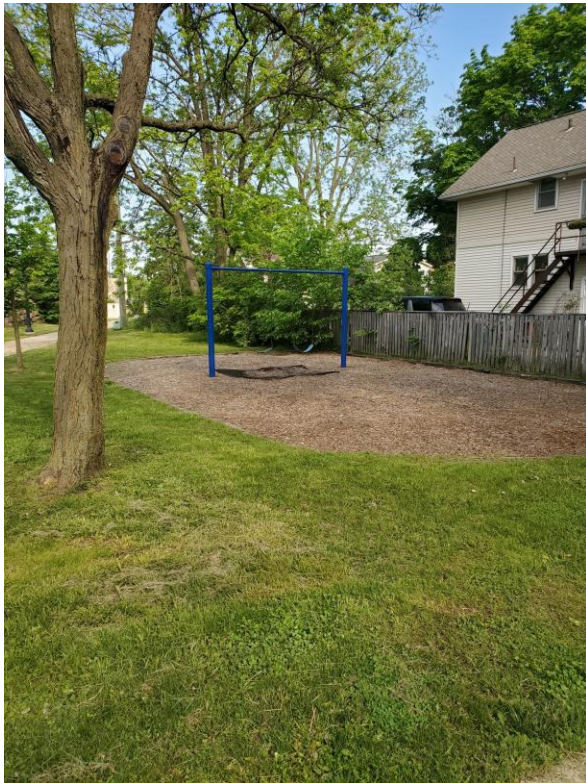
grass surface

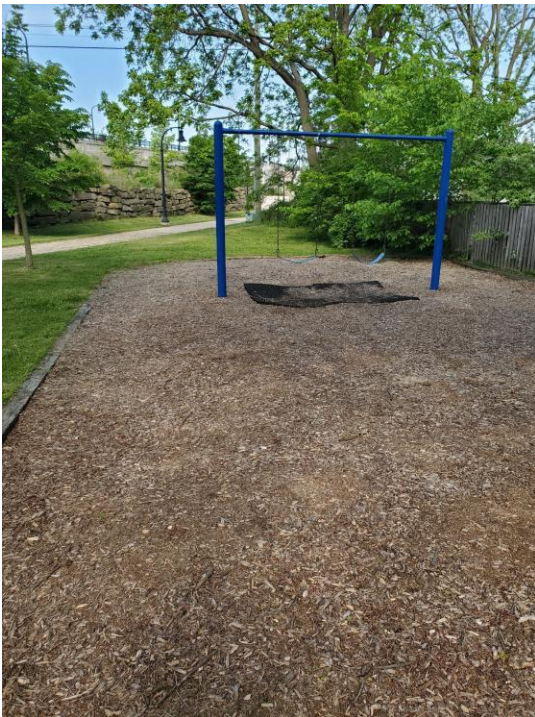
surface is wood chips

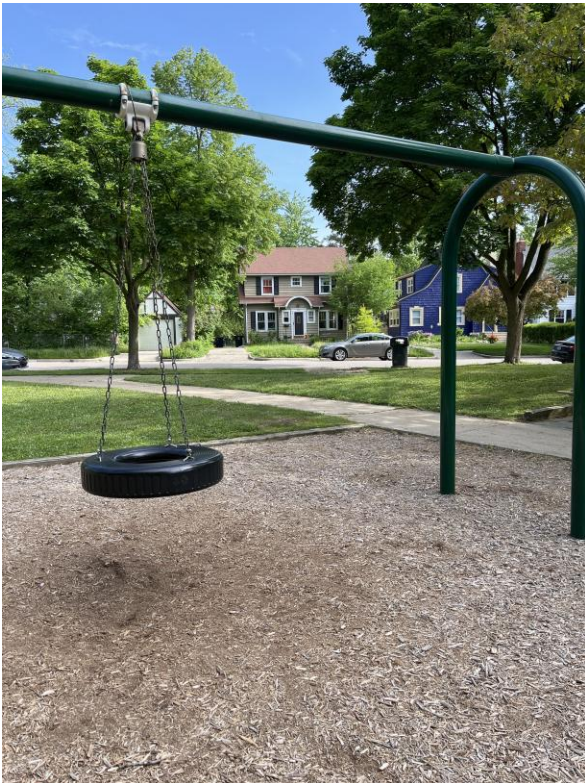
Swing at 30 inches height

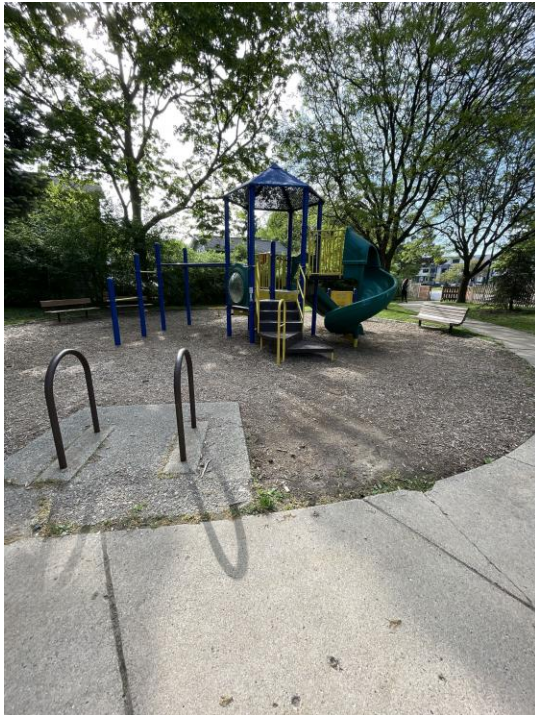
Wood chips

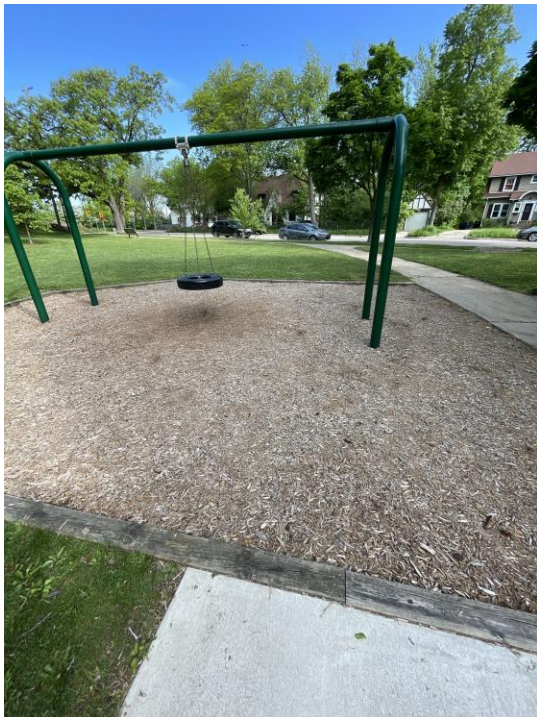
wood chips

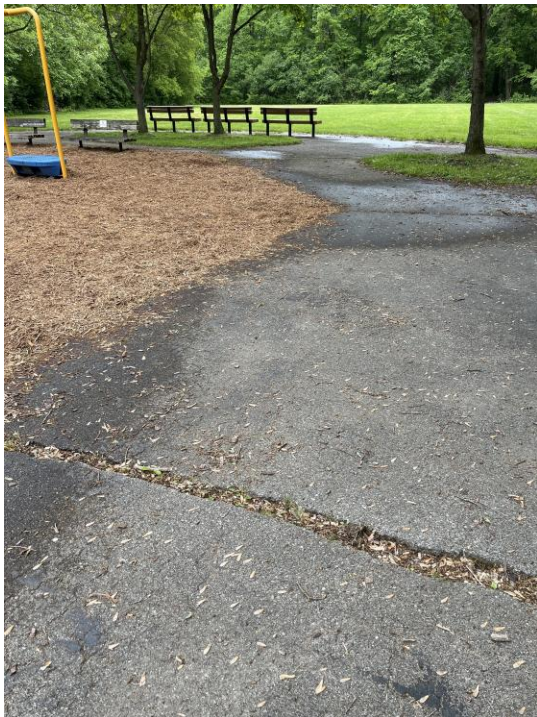
horizontal opening

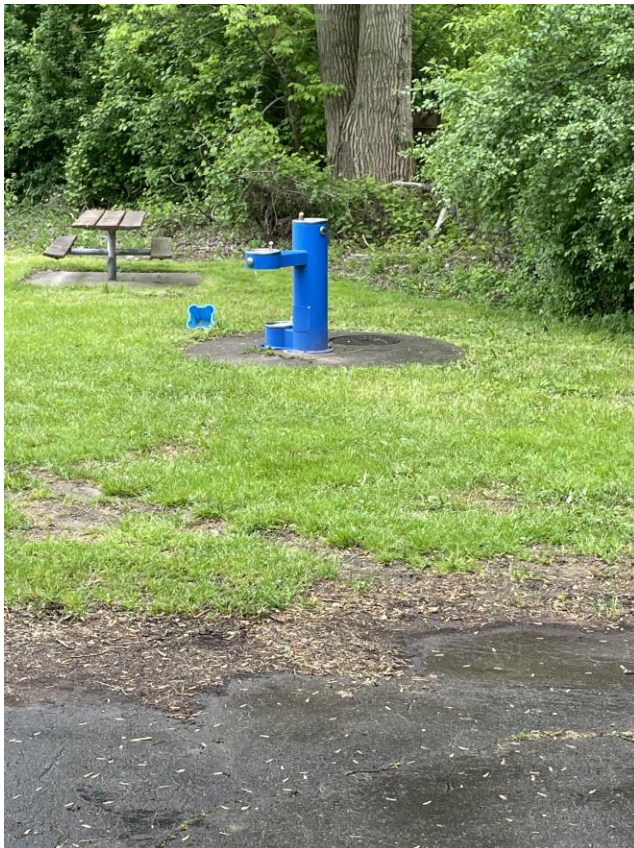
No accessible route

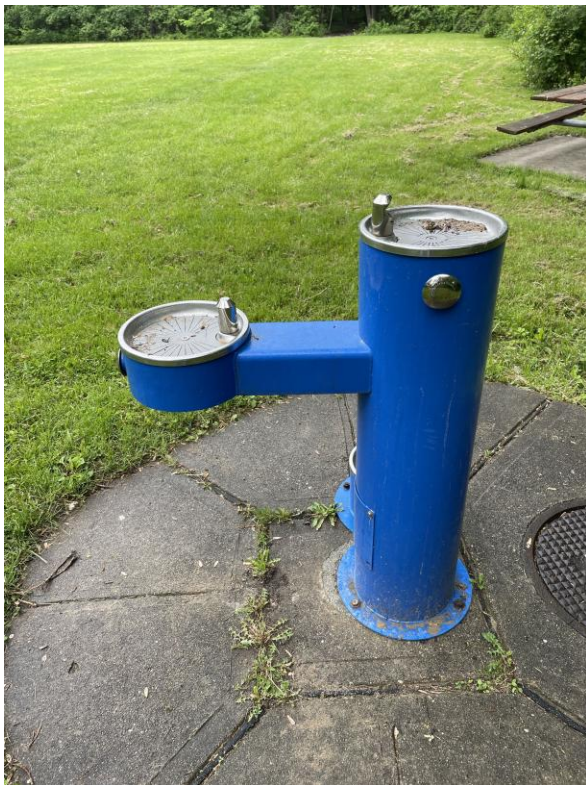
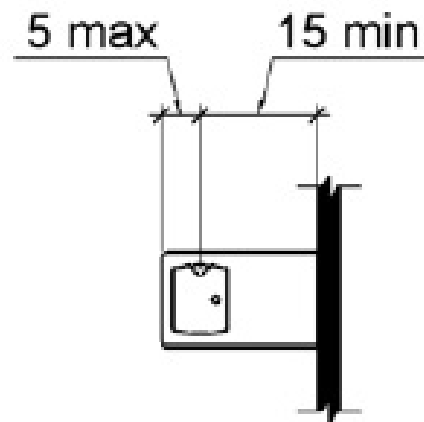
N/A

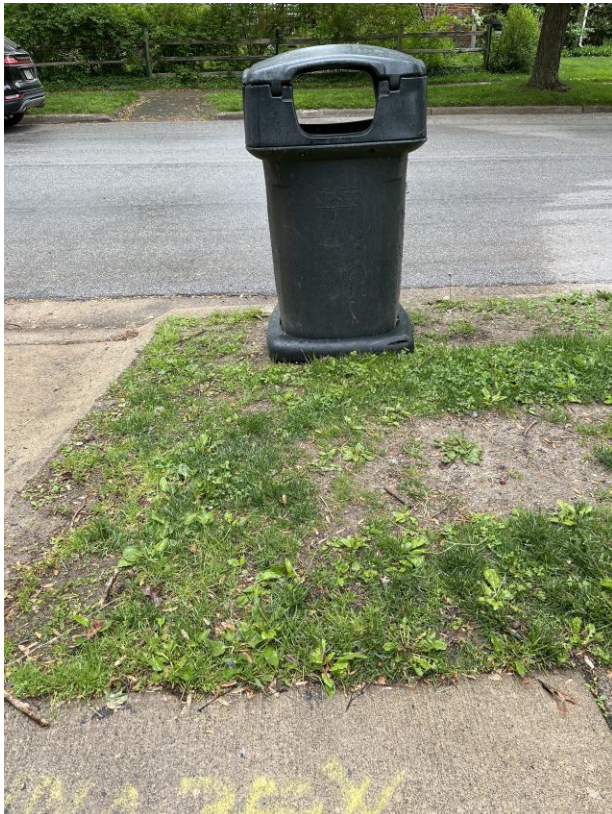
Green Space: Receptacle

The accessible route contains loose gravel and/or surface materials that do not provide for a stable, firm slip resistant surface.

Surface is grass

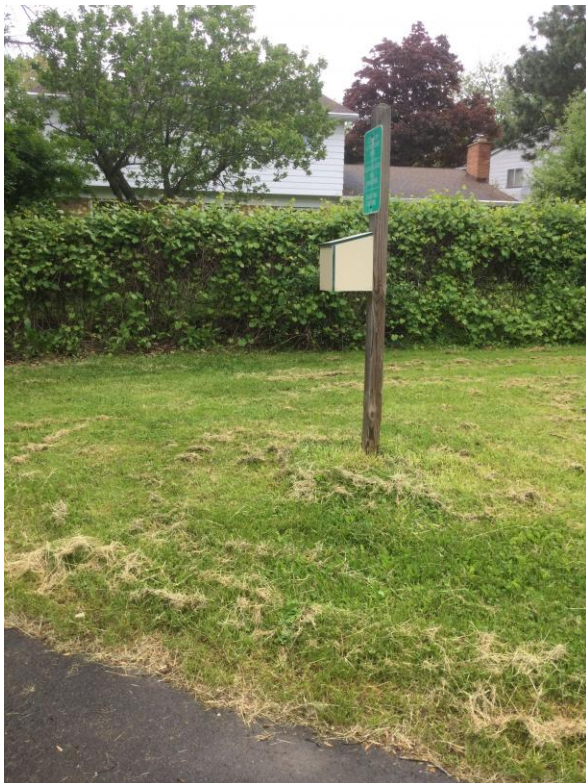
Green Space: Dog Station

No accessible route

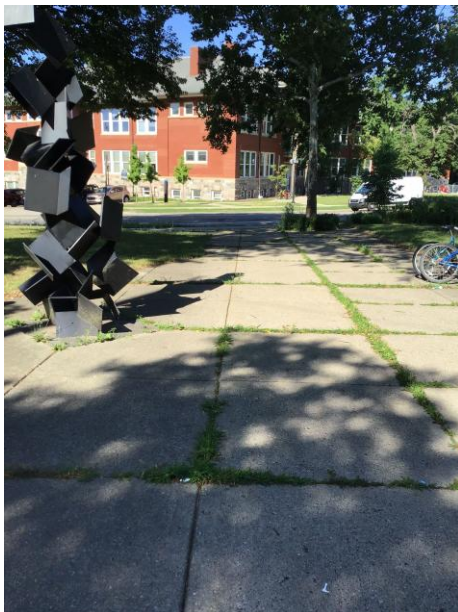
All joints in concrete have changes in level. in level

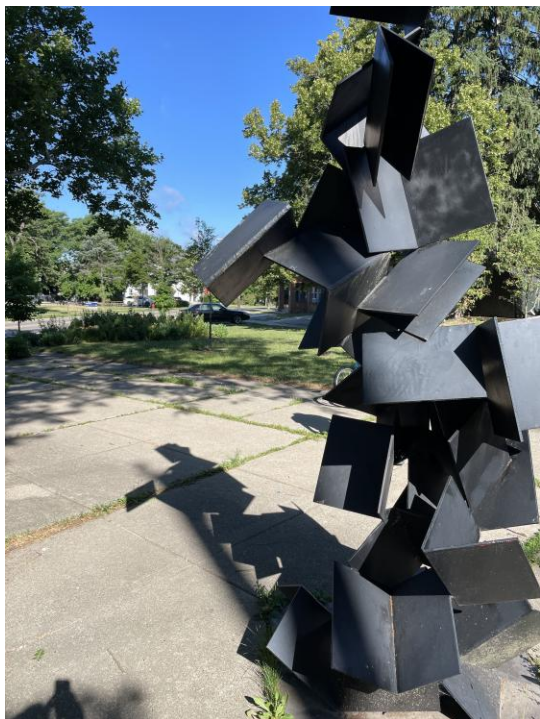
Trail System: Trail

Wall-mounted objects that have leading edges between 27 inches and 80 inches from the floor must not project more than 4 inches into the circulation path. Protruding objects that extend to the floor or within 27 inches of the floor are cane detectable and are therefore not hazardous. Where it is necessary or desirable to have objects protrude from the wall, a manner of cane detection must be provided.

Protruding sculpture

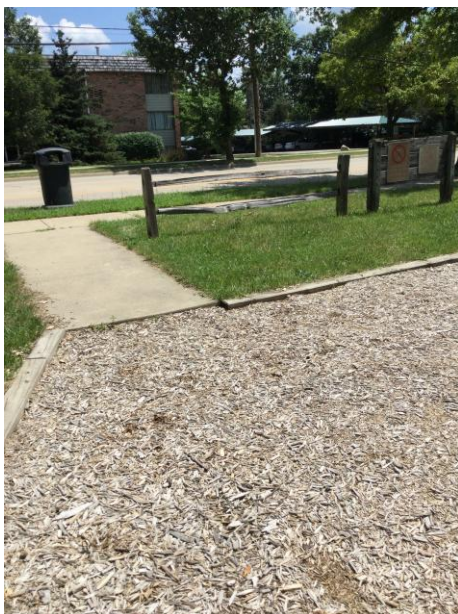
Change in level

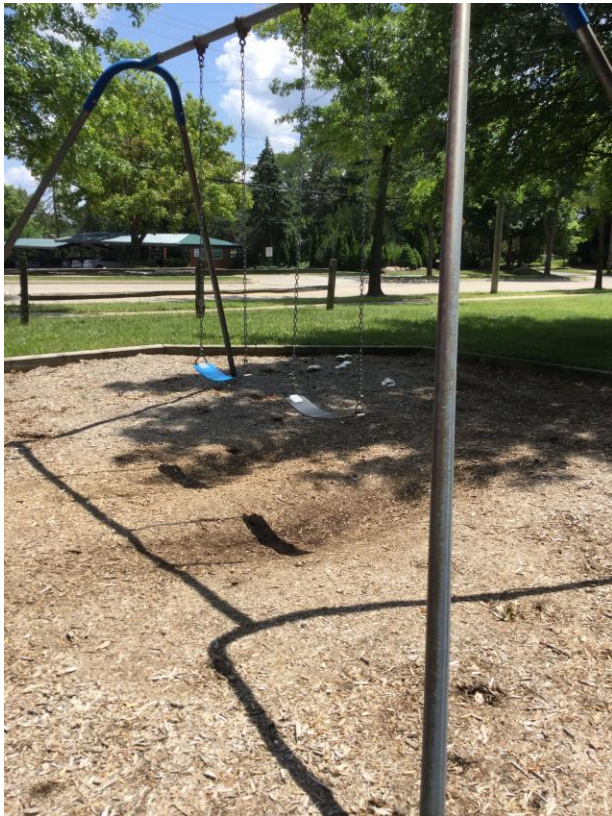
Play Area: Playground

Wood chips

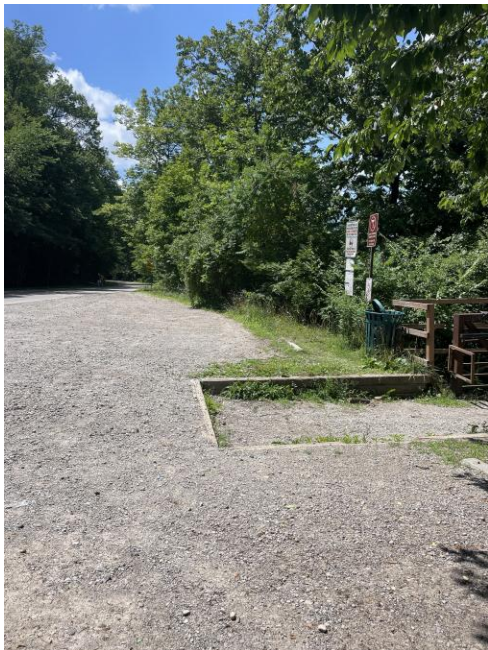
Gravel parking lot

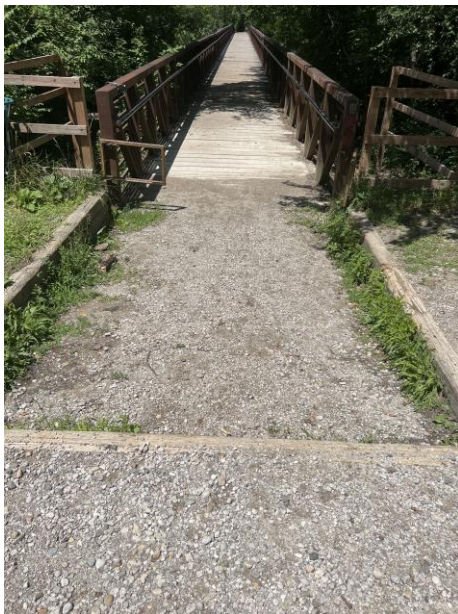
Trail System: Trail

Abrupt change in level

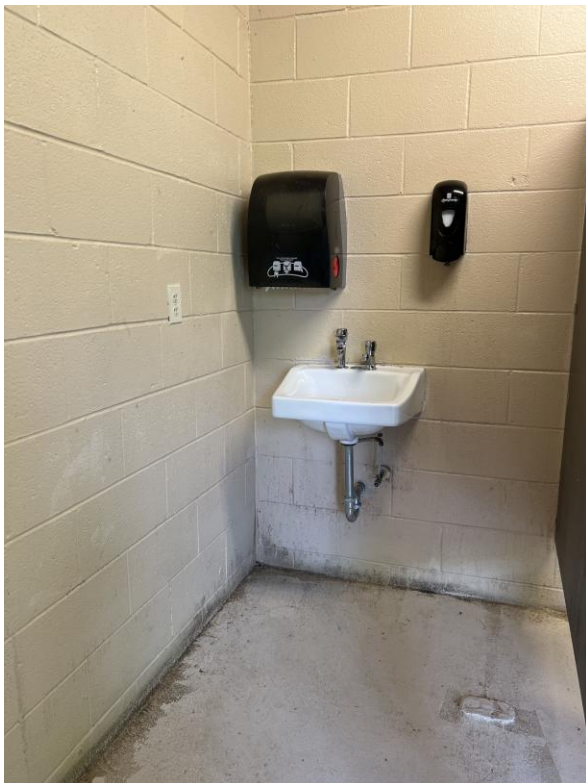
Pipes are not insulated

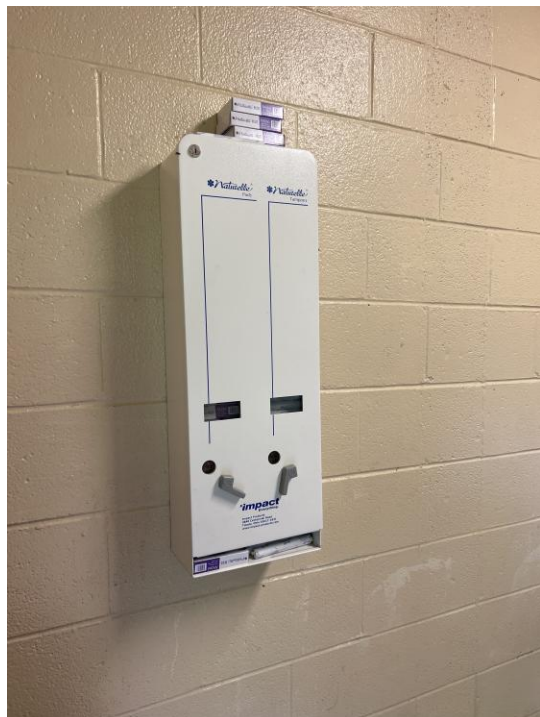
Restrooms: Men's

Wall-mounted objects that have leading edges between 27 inches and 80 inches from the floor must not project more than 4 inches into the circulation path. Protruding objects that extend to the floor or within 27 inches of the floor are cane detectable and are therefore not hazardous. Where it is necessary or desirable to have objects protrude from the wall, a manner of cane detection must be provided.

Protruding

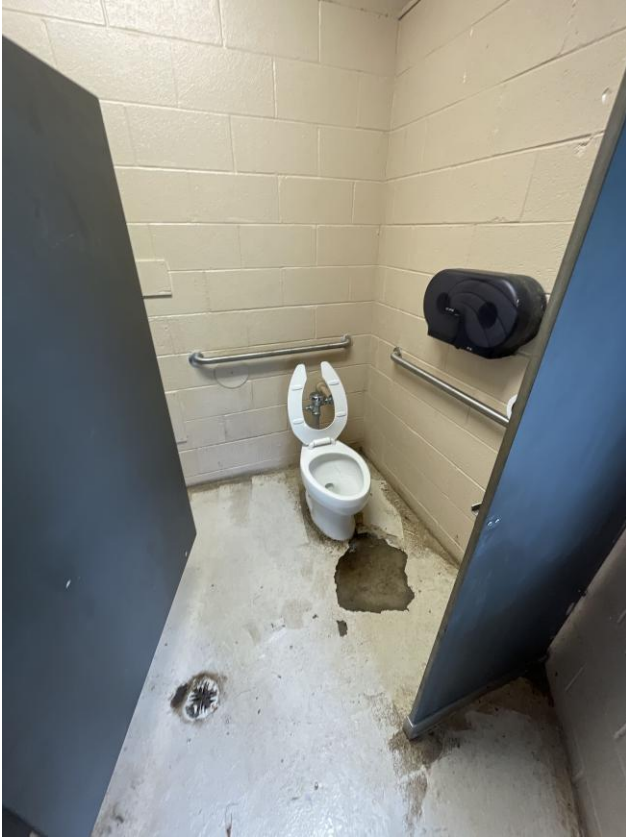
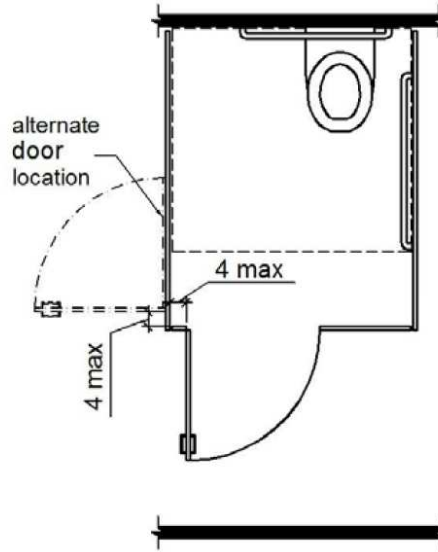
Finding #3 Continued

Door swings into the water closet clearance

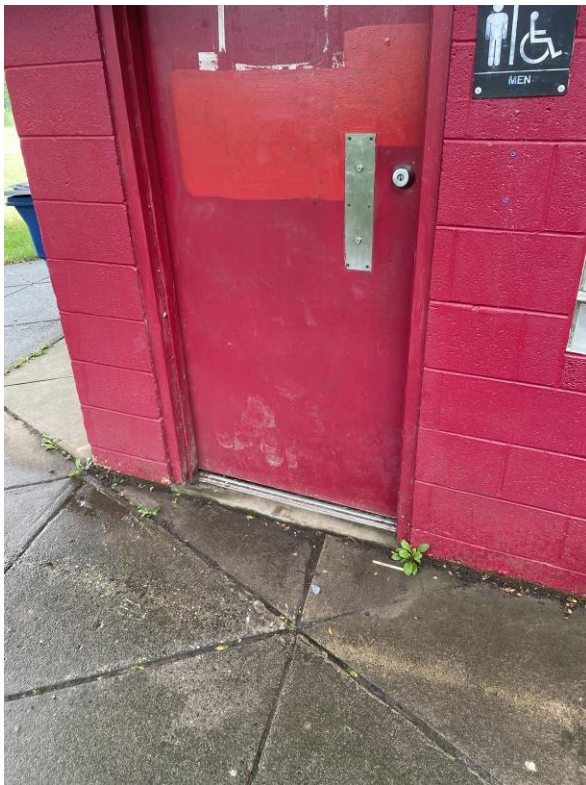
Restrooms: Men's

Vertical change in level of 1"

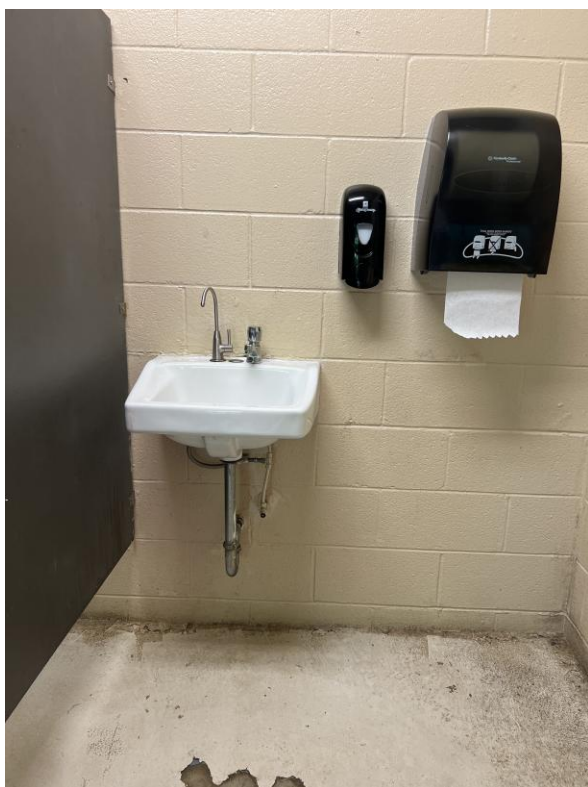
Restrooms: Women's

Pipes are not covered

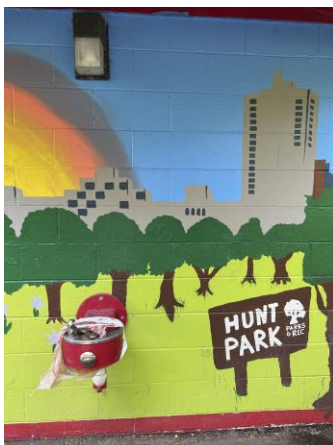
Restrooms: Women's

There is no high drinking fountain

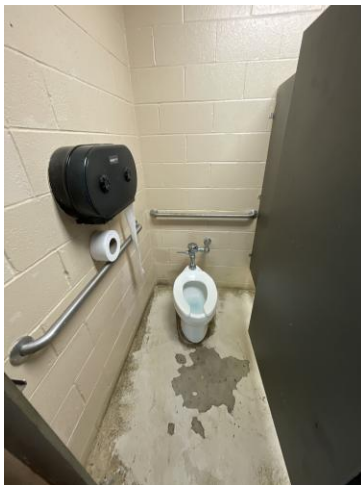
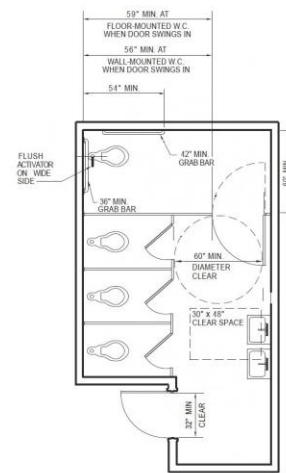
Restrooms: Women's

The stall is not accessible. Multiple violations

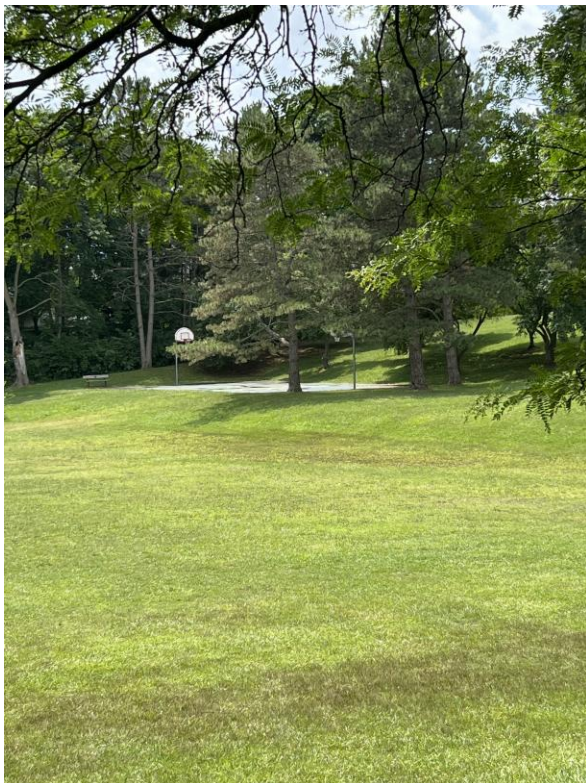
Basketball Court: Seating

No accessible route

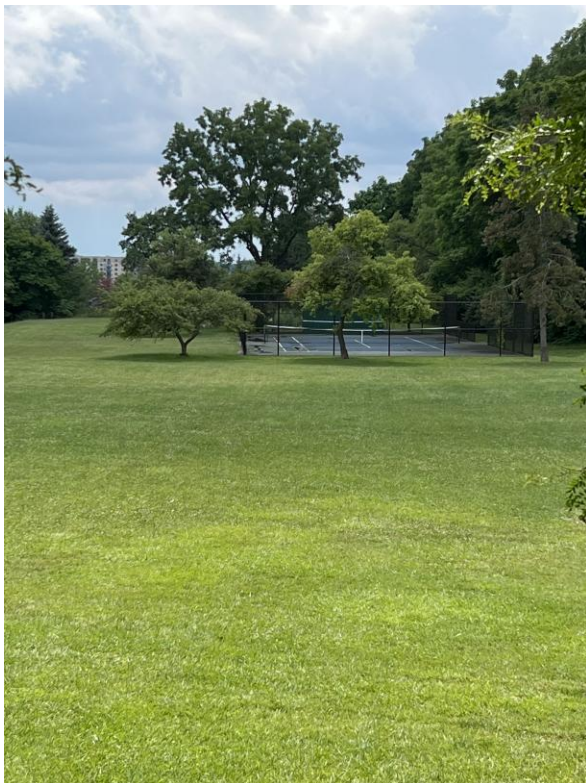
Tennis Court: Entrance

No accessible route

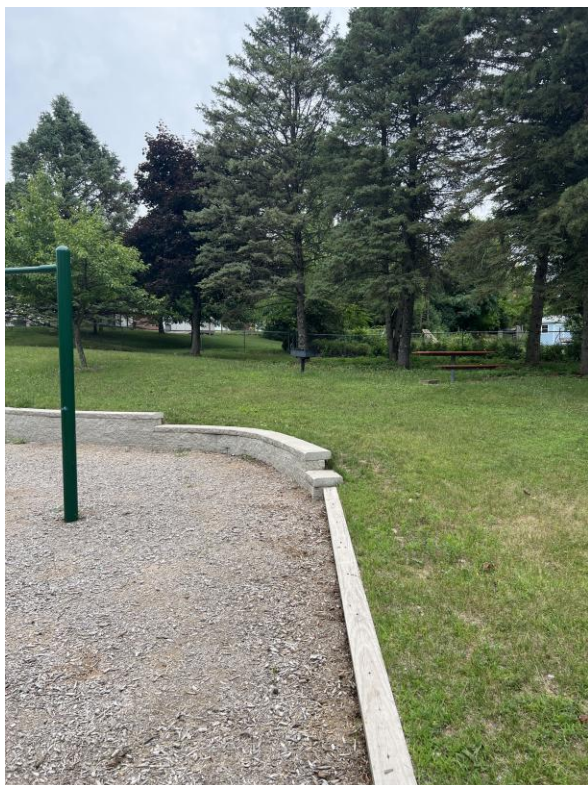
No route to grill and picnic table

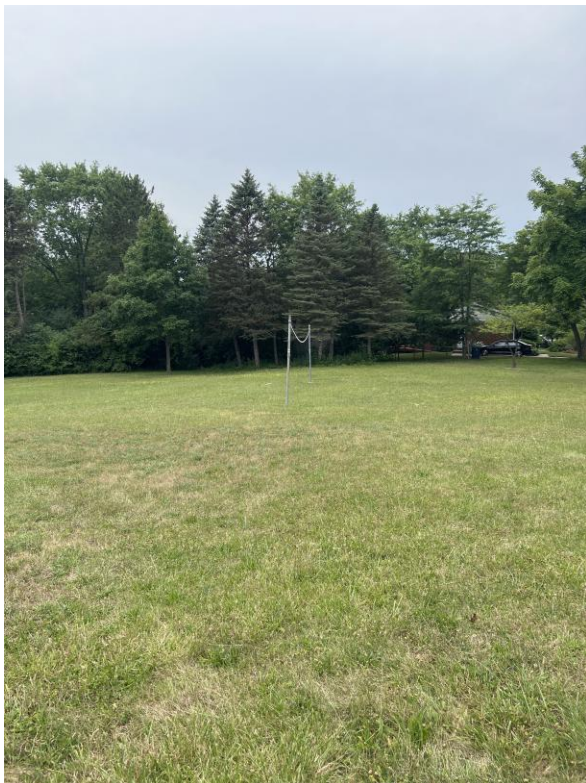
Play Area: Playground

No route to volleyball court

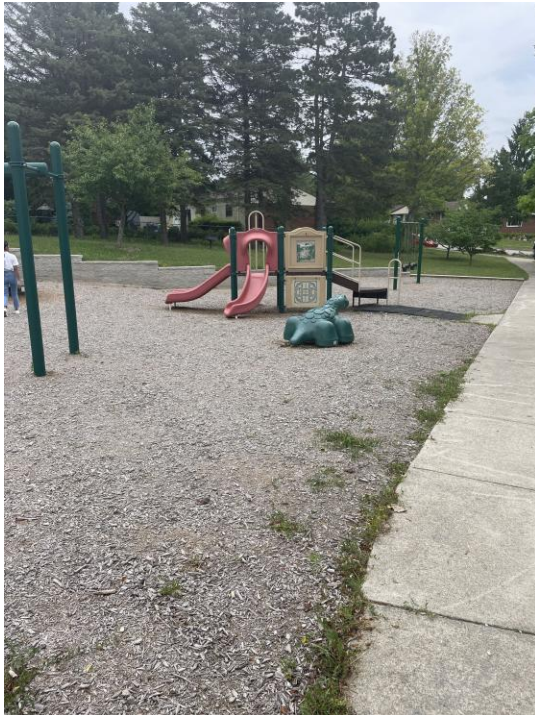
Play Area: Playground

Wood chips

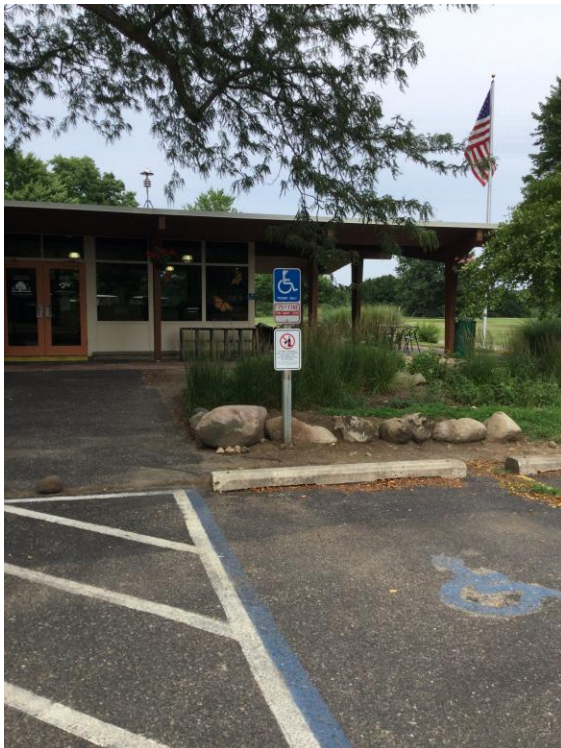
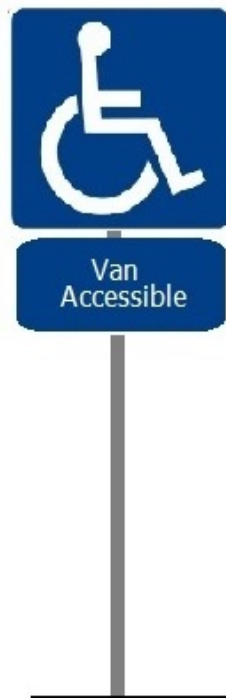
The van stall is missing a sign identifying it as a van accessible stall.

Missing

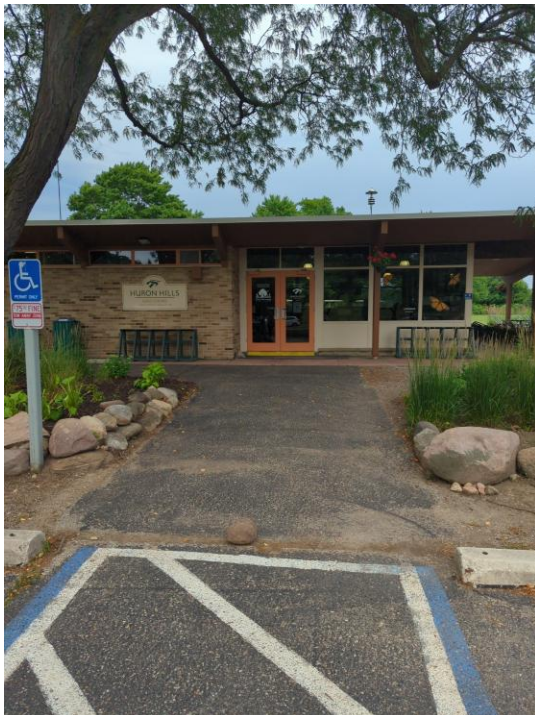
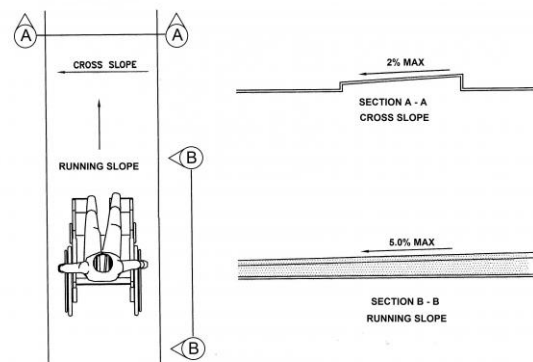
As Built:

Sidewalk from accessible parking to building entrance has a running slope of up to 9%

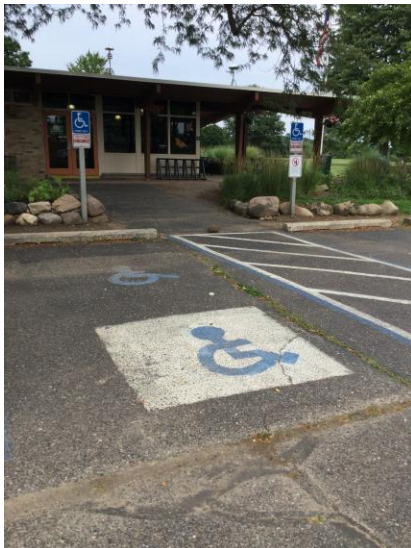
As Built:

10' wide

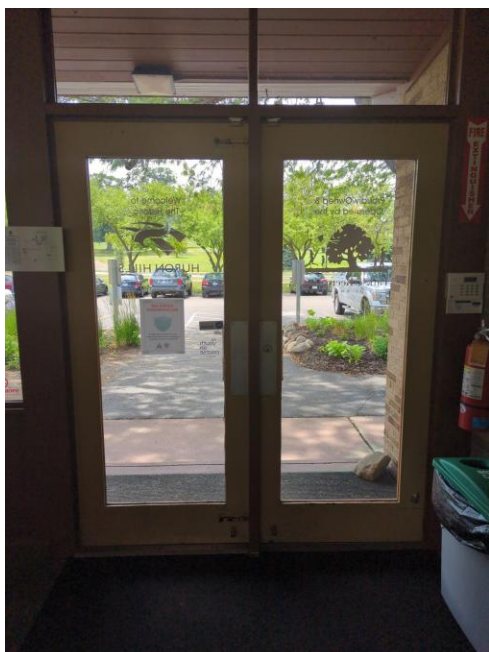
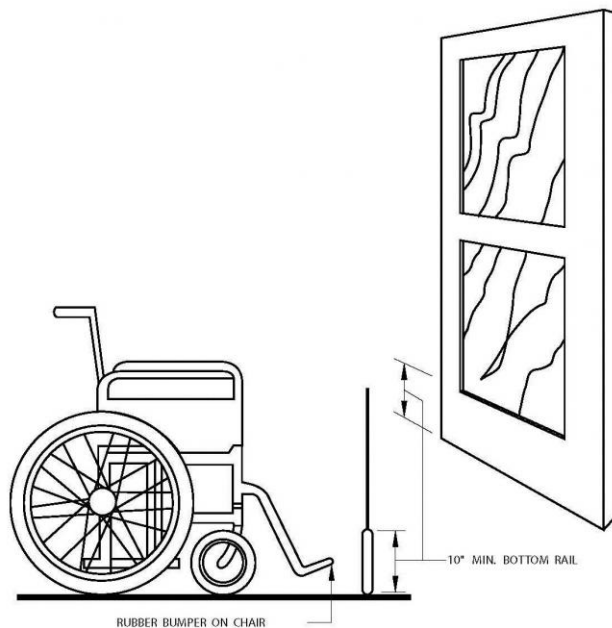
As Built:

Door smooth surface on all 4 entrance doors is 9 inches with hold-open devices

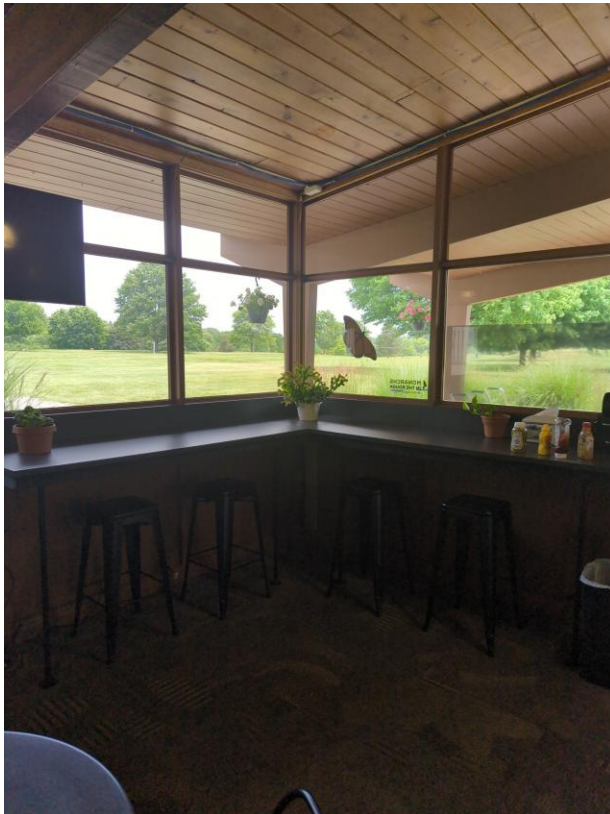
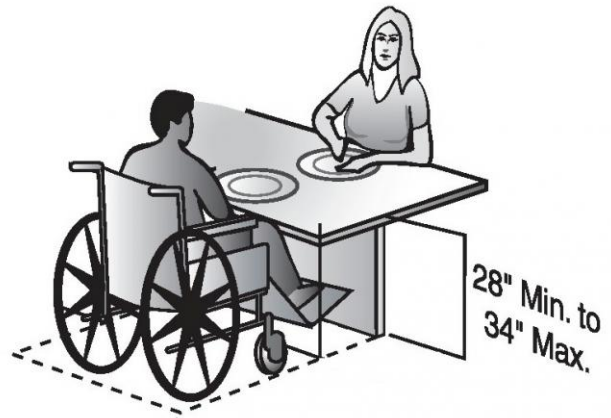
As Built:

Fixed dining surface is 43 inches high

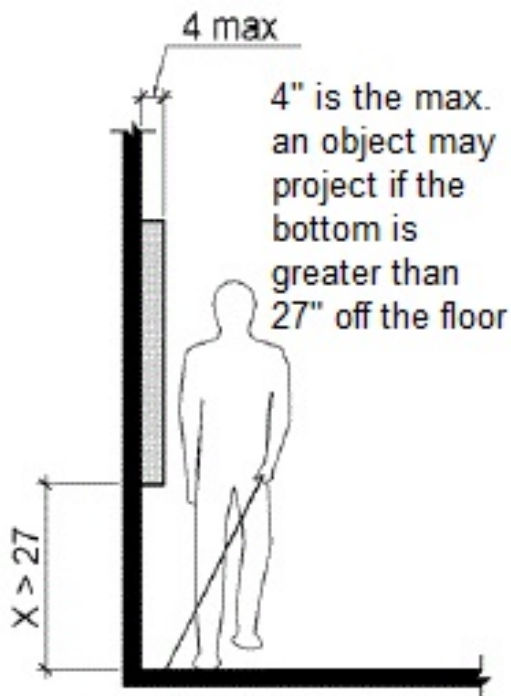
Wall-mounted objects that have leading edges between 27 inches and 80 inches from the floor must not project more than 4 inches into the circulation path. Protruding objects that extend to the floor or within 27 inches of the floor are cane detectable and are therefore not hazardous. Where it is necessary or desirable to have objects protrude from the wall, a manner of cane detection must be provided.

As Built:

Fixed dining surface protrudes 26 inches from the wall

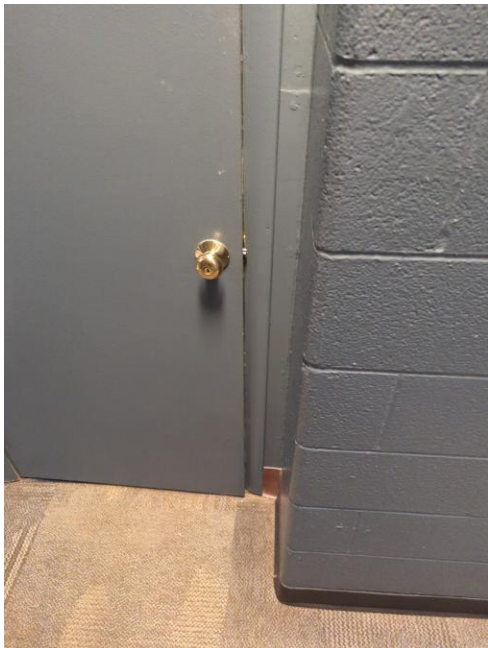
As Built:

Door to janitor closet has a knob

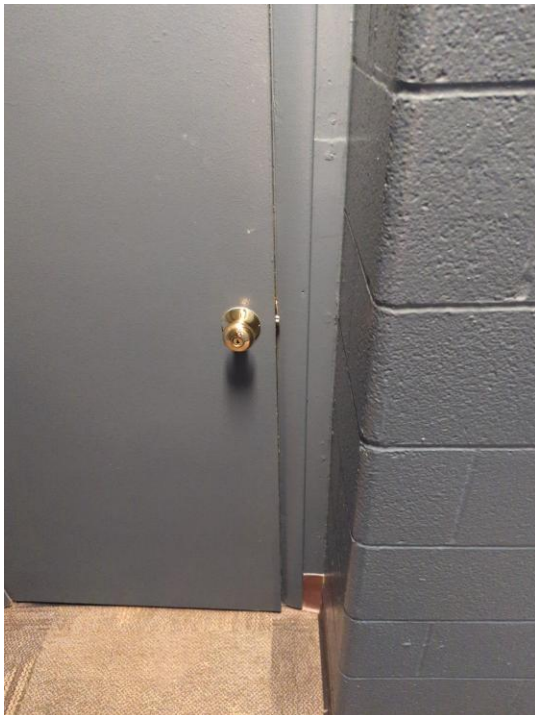
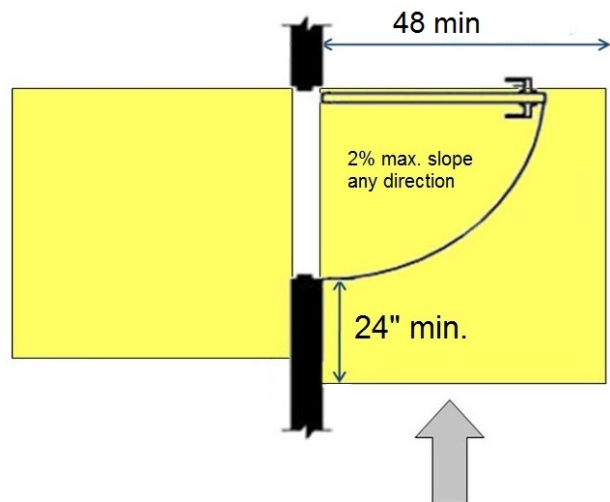
As Built:

Door maneuvering clearance is only 5 inches

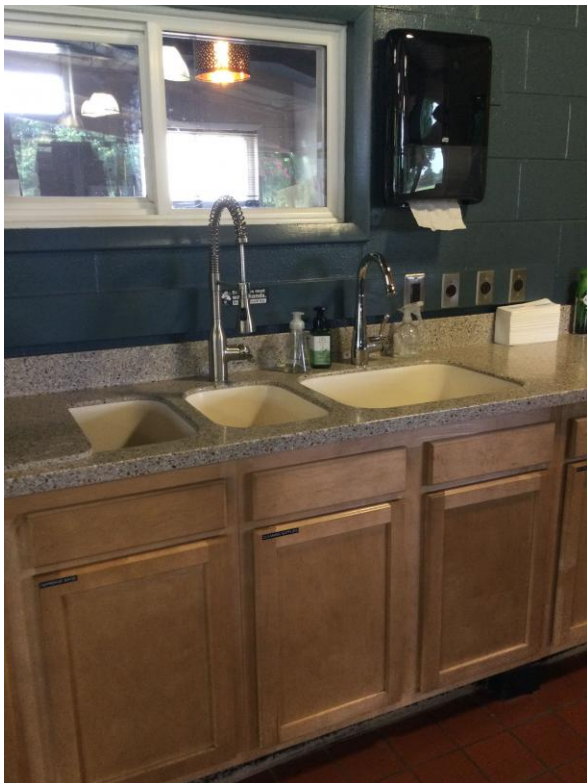
As Built:

38" rim height

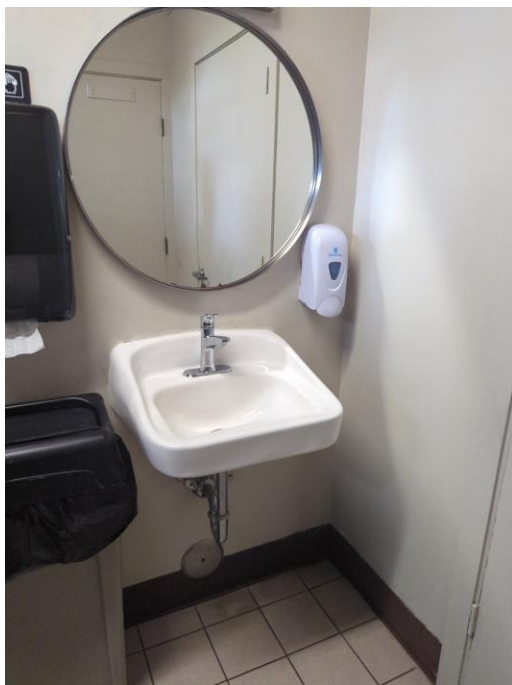
As Built:

Mirror is 45 inches high to the reflective surface

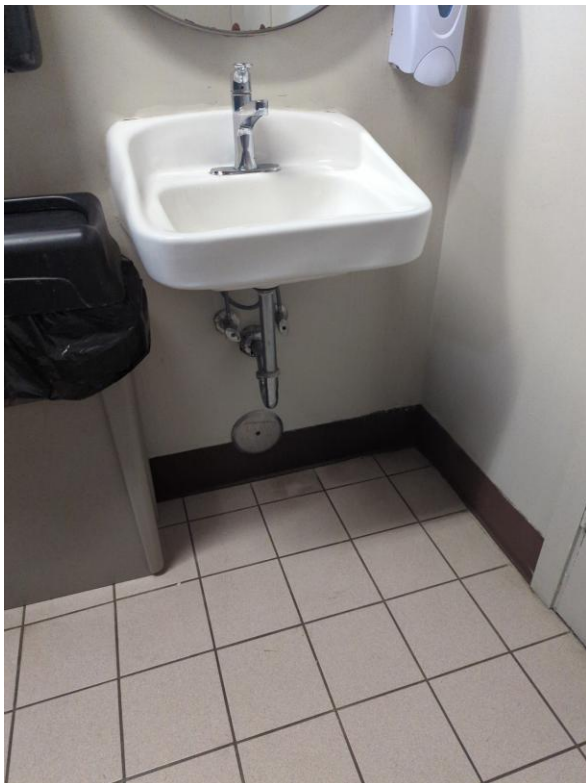
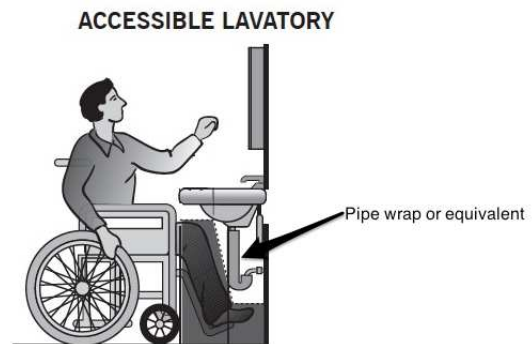
As Built:

Lavatory does not have pipe insulation

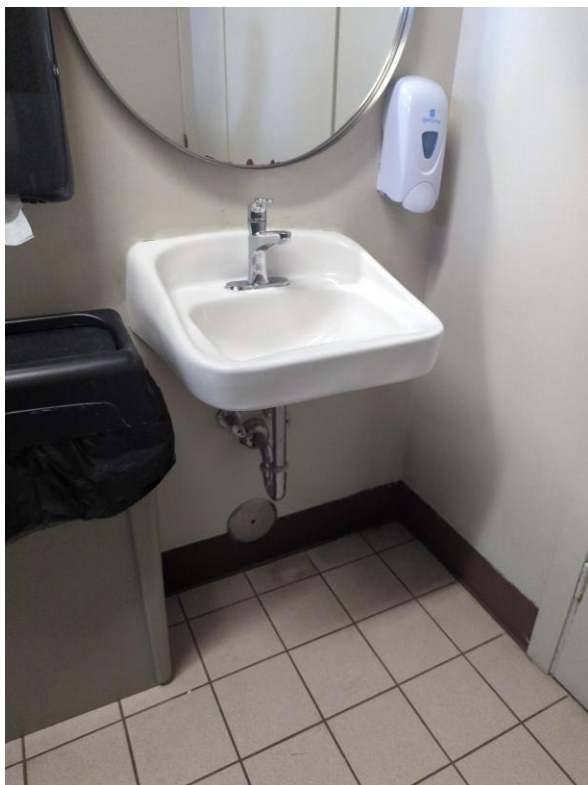
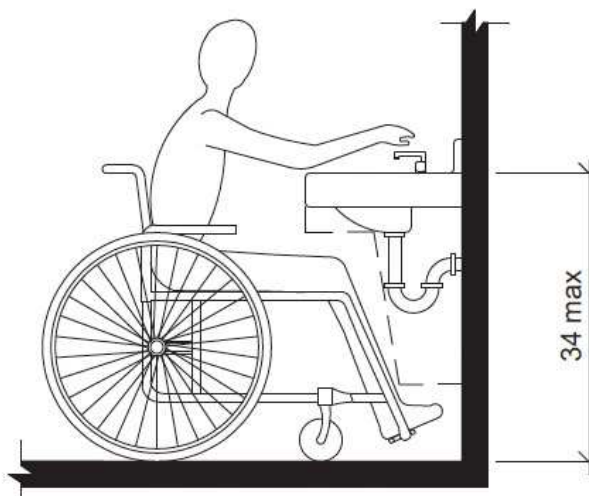
As Built:

Lavatory rim is 35 inches high

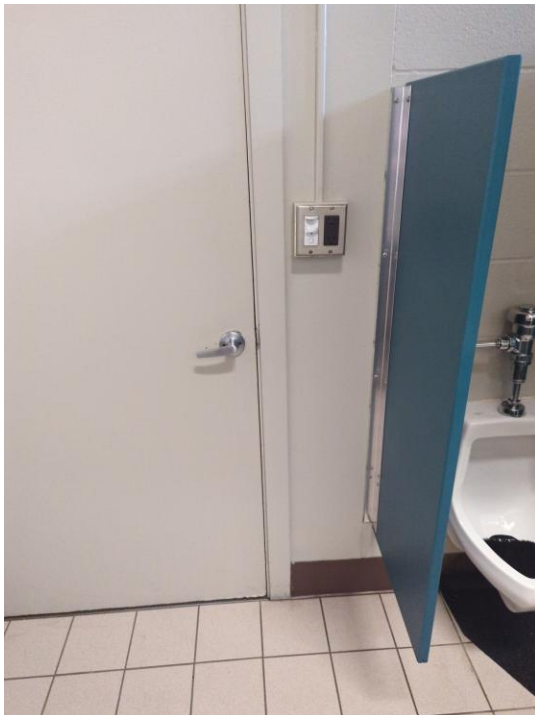
As Built:

Restroom door only has 13 inches on the pull side
