Site Accessibility Evaluation

Allmendinger Park
655 Pauline Blvd
Ann Arbor, MI 48104
ADA Only

Inspection Date: 07/11/2022

Report Date: 11/15/2022

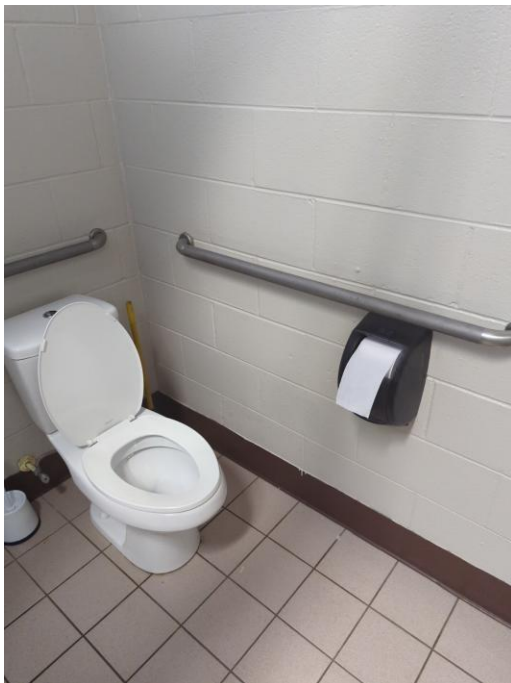
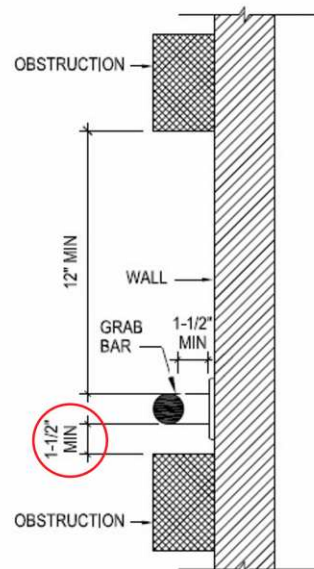
As Built:

Toilet paper dispenser is 1 inch below the grab bar

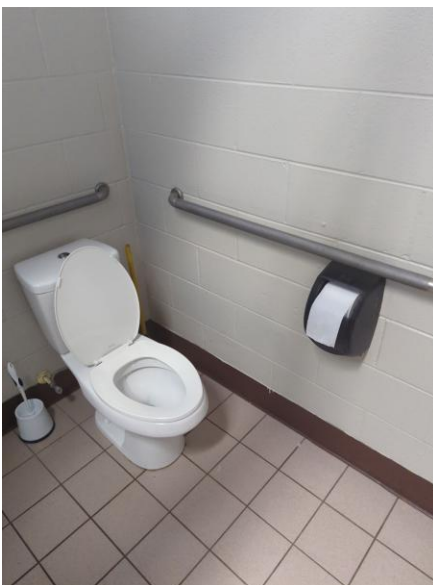
As Built:

Toilet paper dispenser is 11 inches in front of the water closet

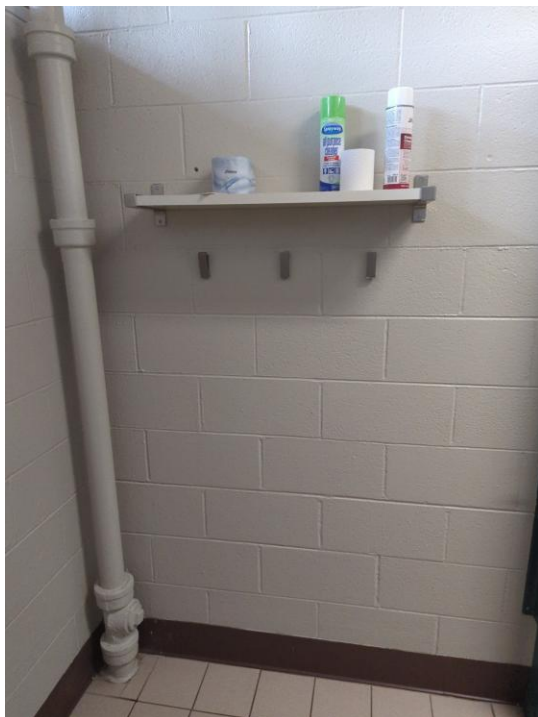
Wall-mounted objects that have leading edges between 27 inches and 80 inches from the floor must not project more than 4 inches into the circulation path. Protruding objects that extend to the floor or within 27 inches of the floor are cane detectable and are therefore not hazardous. Where it is necessary or desirable to have objects protrude from the wall, a manner of cane detection must be provided.

As Built:

The wall-mounted shelf protrudes 8 inches at 65 inches high

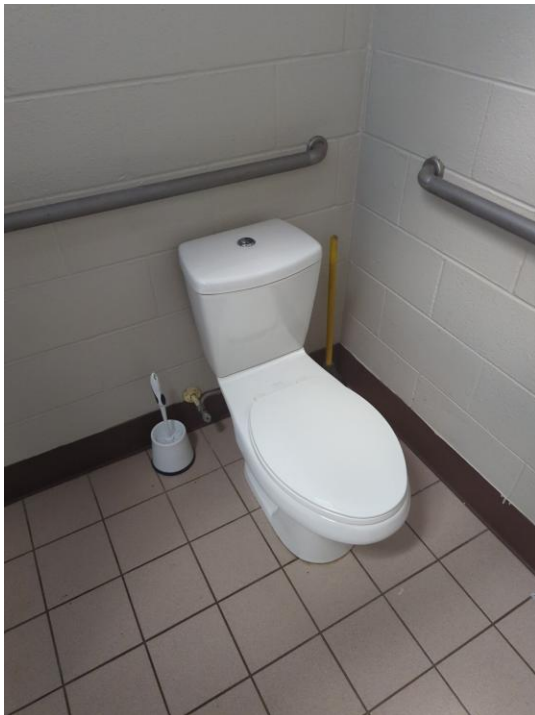
As Built:

The flush valve is on the top of the tank

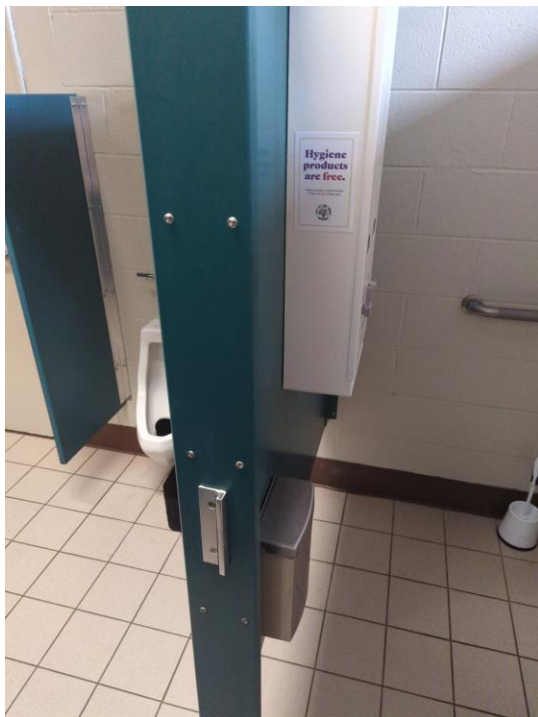
Wall-mounted objects that have leading edges between 27 inches and 80 inches from the floor must not project more than 4 inches into the circulation path. Protruding objects that extend to the floor or within 27 inches of the floor are cane detectable and are therefore not hazardous. Where it is necessary or desirable to have objects protrude from the wall, a manner of cane detection must be provided.

As Built:

Feminine product dispenser inside the men's restroom protrudes 5-1/2 inches

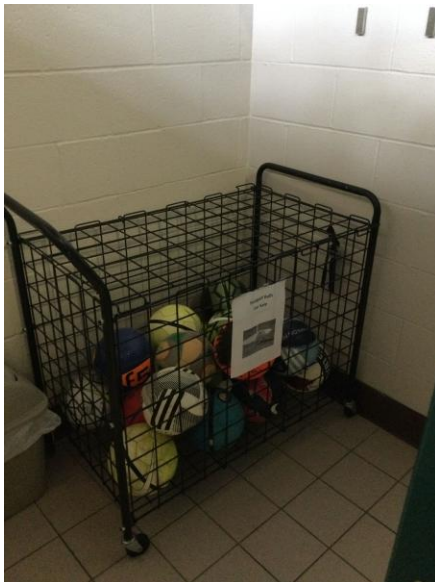
As Built:

Missing

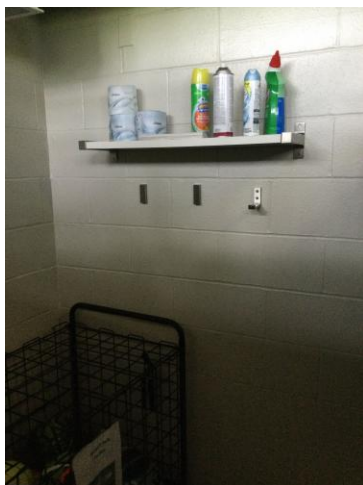
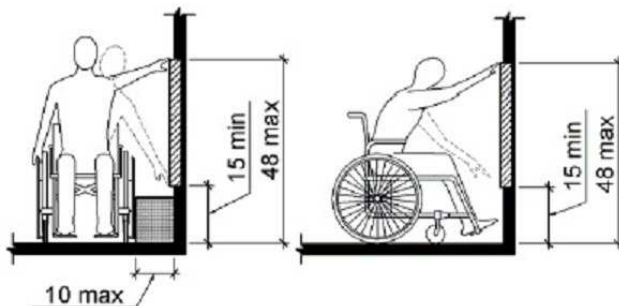
As Built:

56"

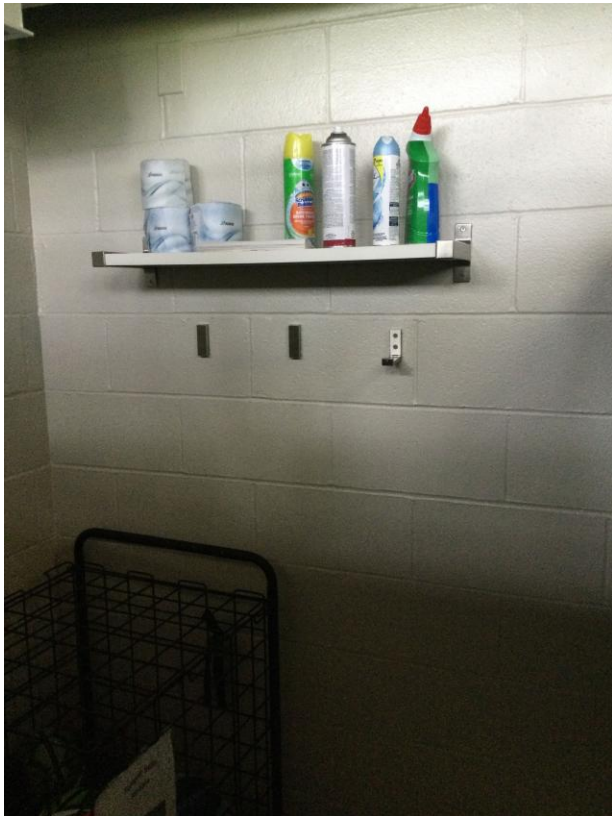
As Built:

67"

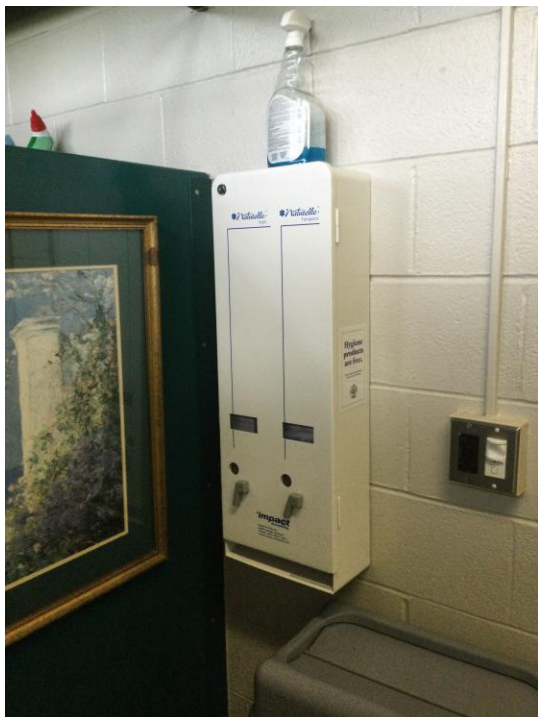
Wall-mounted objects that have leading edges between 27 inches and 80 inches from the floor must not project more than 4 inches into the circulation path. Protruding objects that extend to the floor or within 27 inches of the floor are cane detectable and are therefore not hazardous. Where it is necessary or desirable to have objects protrude from the wall, a manner of cane detection must be provided.

As Built:

Protruding object

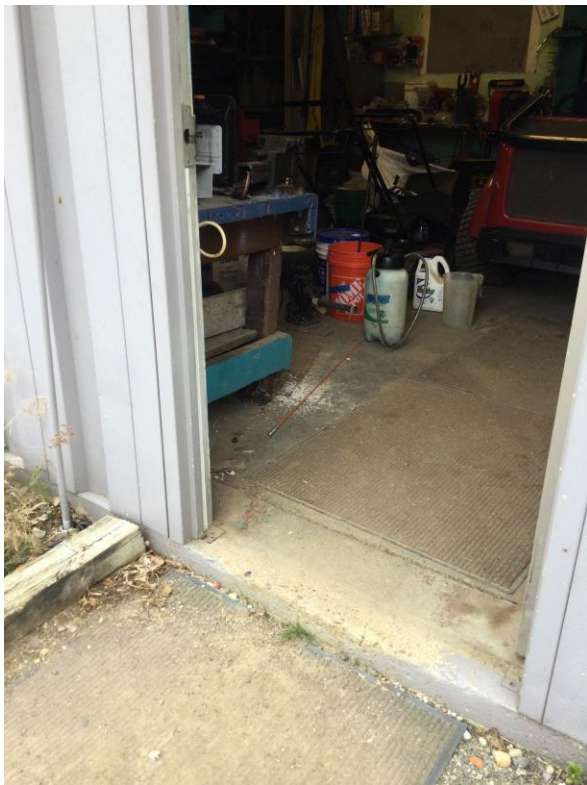
As Built:

3" threshold

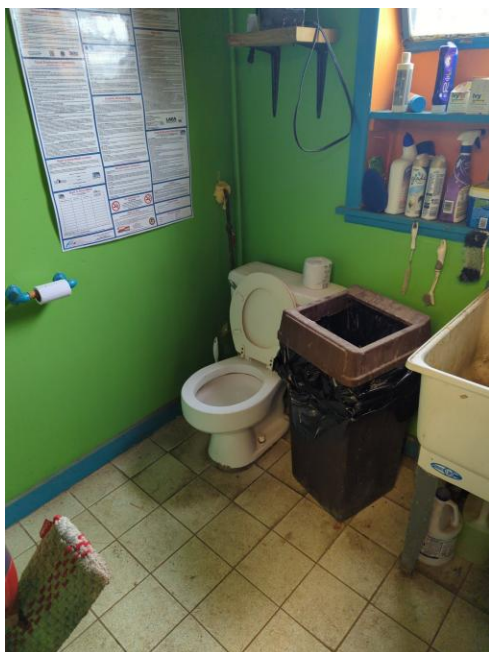
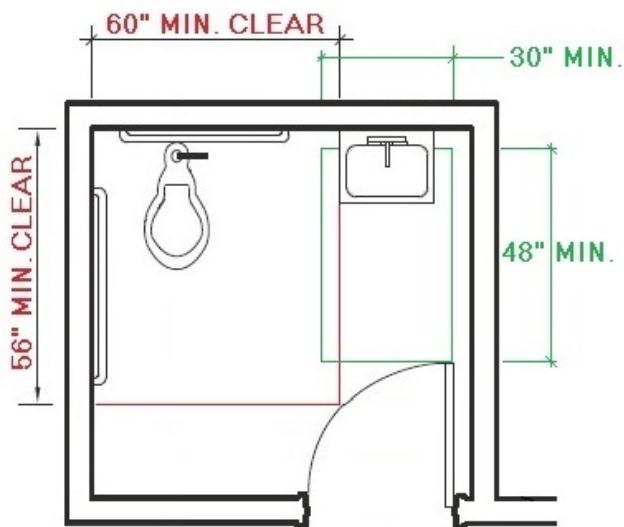
The restroom does not have the required minimum clear floor space or maneuvering clearances for the toilet. The restroom does not have the required minimum clear floor space or maneuvering clearances for the lavatory. The entry door does not contain the required minimum maneuvering spaces on the pull/push sides. The entry door encroach into the required clear floor space for fixtures. Grab bars are missing and/or incorrectly installed. Accessories, such as toilet seat covers, paper towel holders, garbage cans, hand dryers, and mirrors are either too high or without clear floor space or both.

Restroom inside workshop is not compliant, does not have any compliant elements

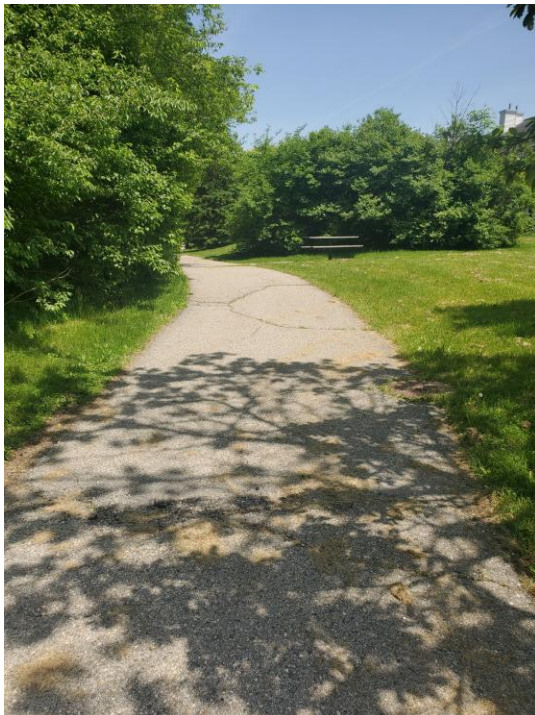
Trail contains openings

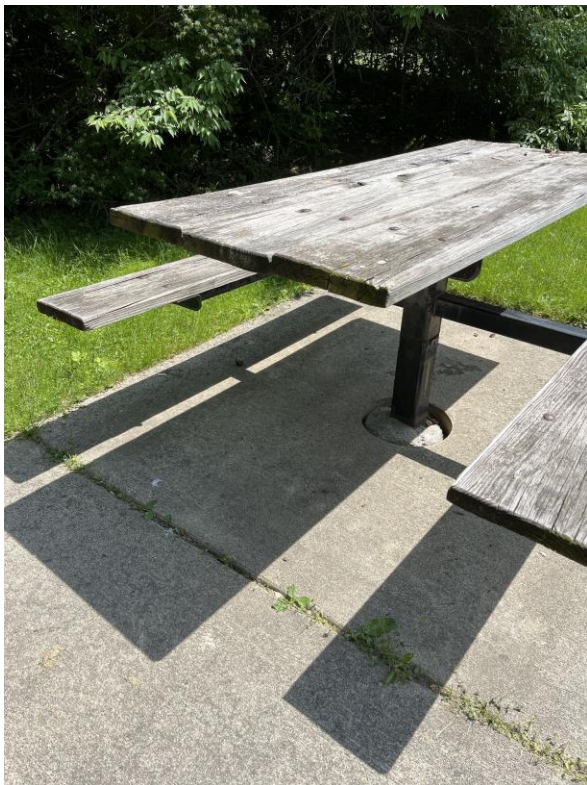
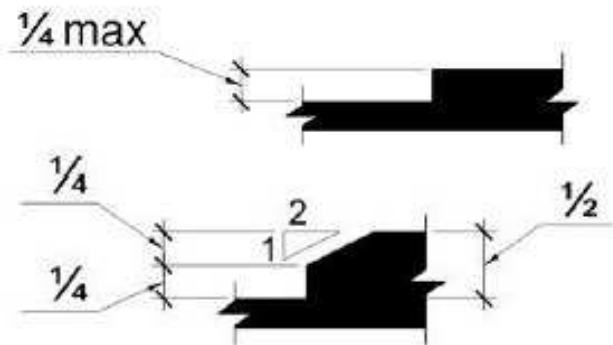
opening on the clear floor space

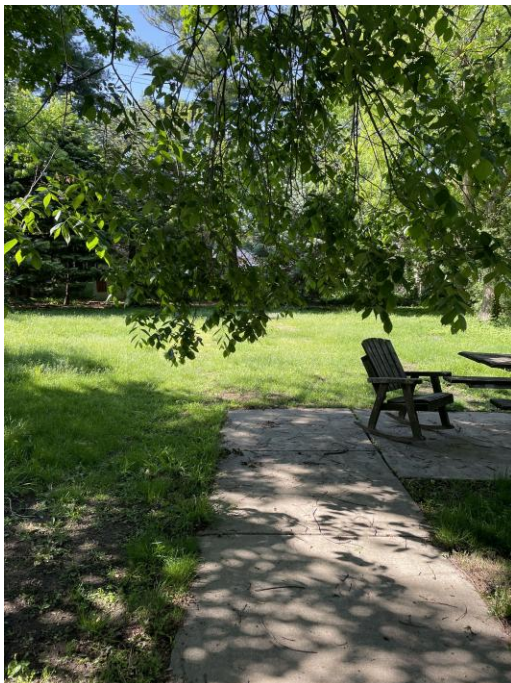
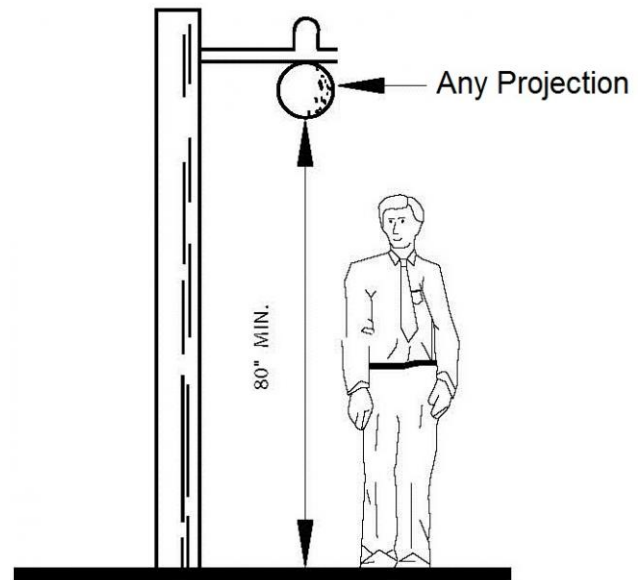
Vegetation

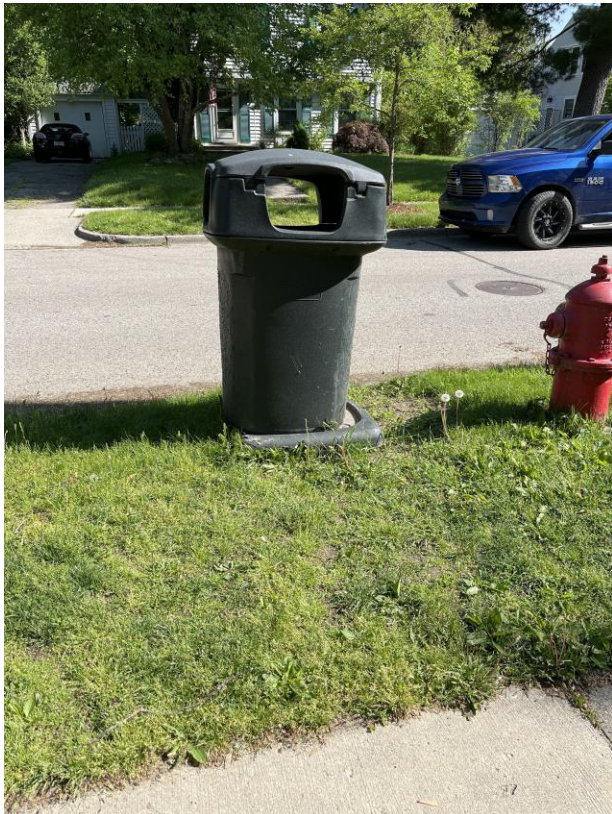
The accessible route contains loose gravel and/or surface materials that do not provide for a stable, firm slip resistant surface.

Surface is grass

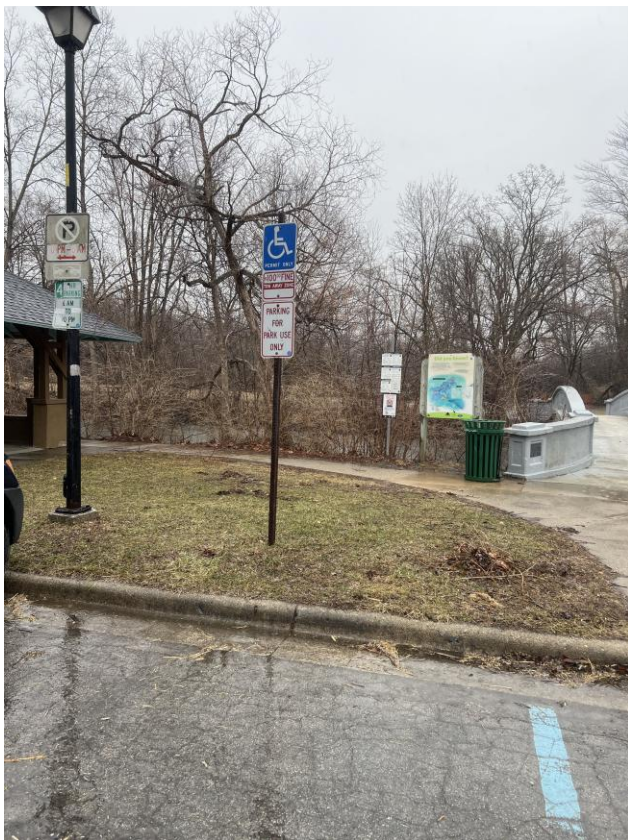
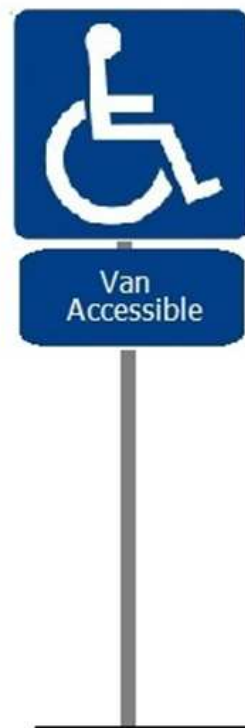
The van stall is missing a sign identifying it as a van accessible stall.

No van accessible sign

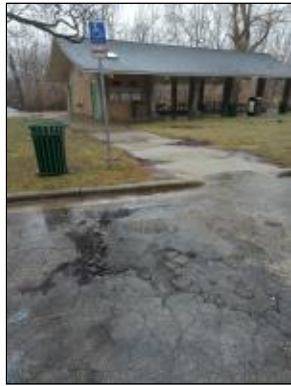
Finding #2 Additional Finding Photos

Asphalt on parking stall is broken on parking lot by restrooms

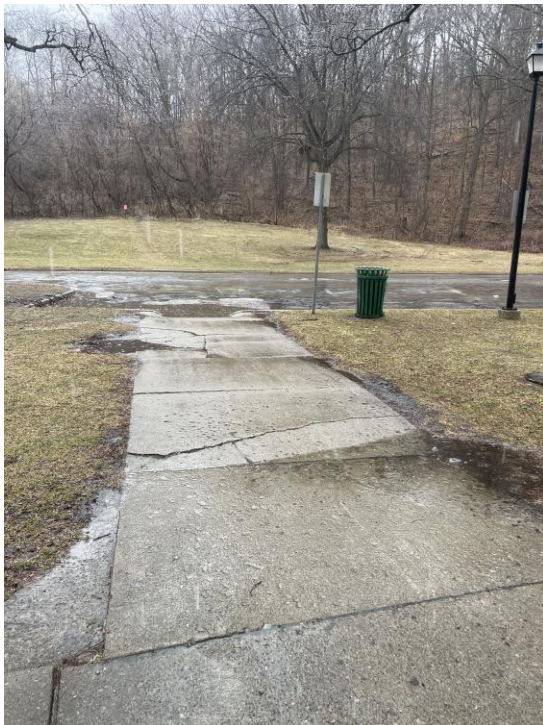
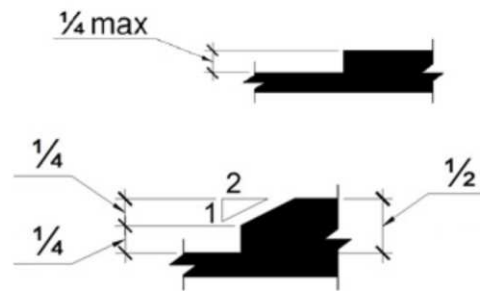
Multiple holes on route

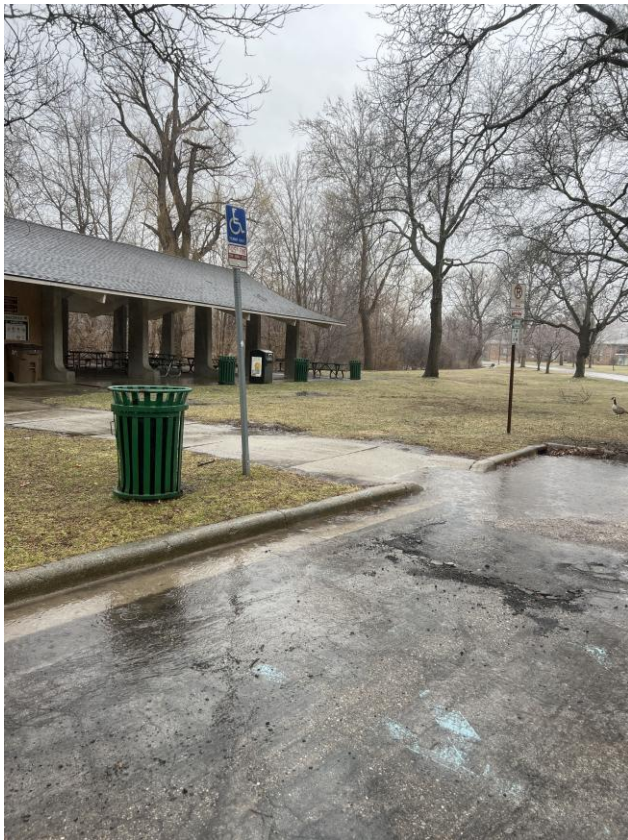
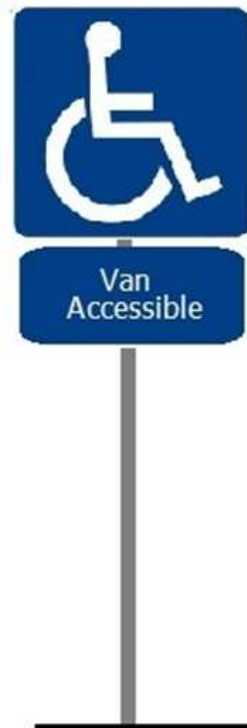
The van stall is missing a sign identifying it as a van accessible stall.

No van accessible sign

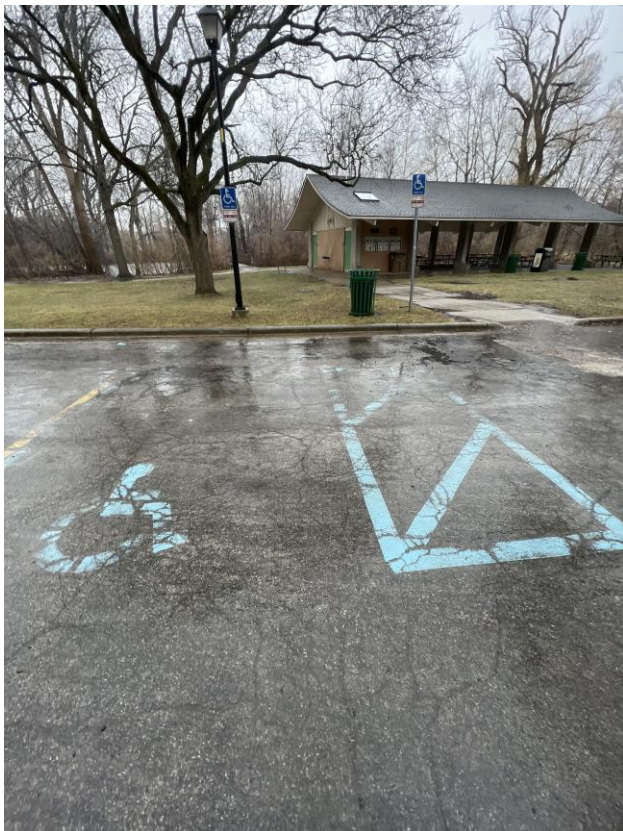
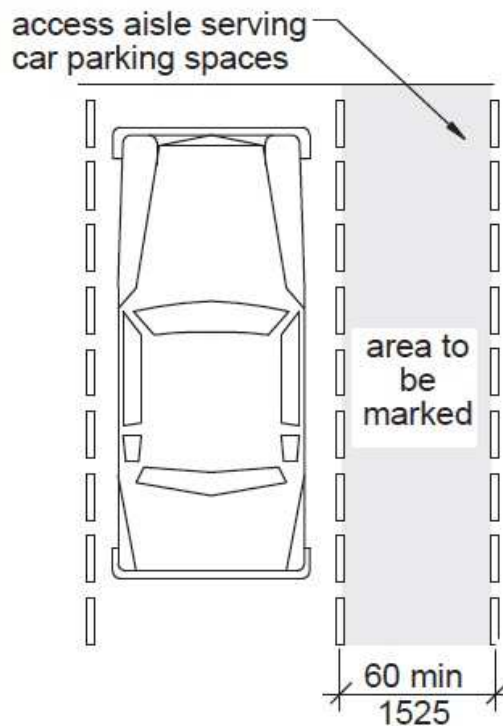
The access aisle is missing at the accessible parking stall.

11 foot spot or 8 foot access aisle

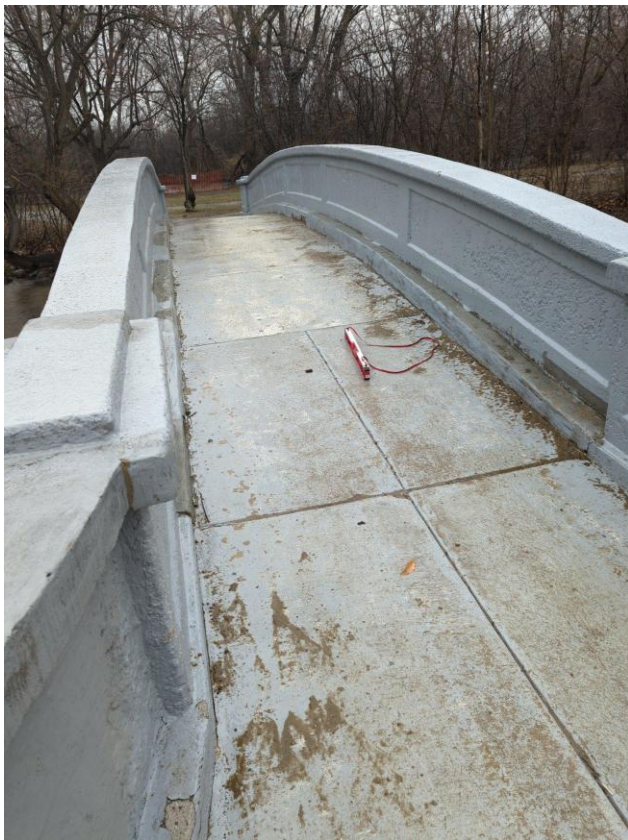
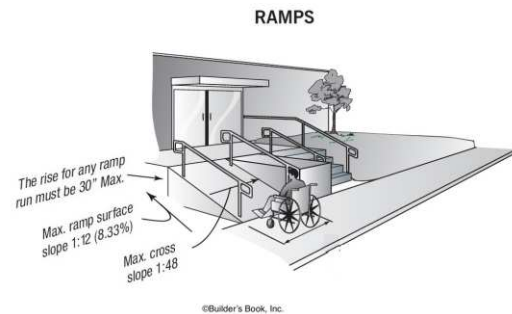
Bridge has a running slope of up till 12%

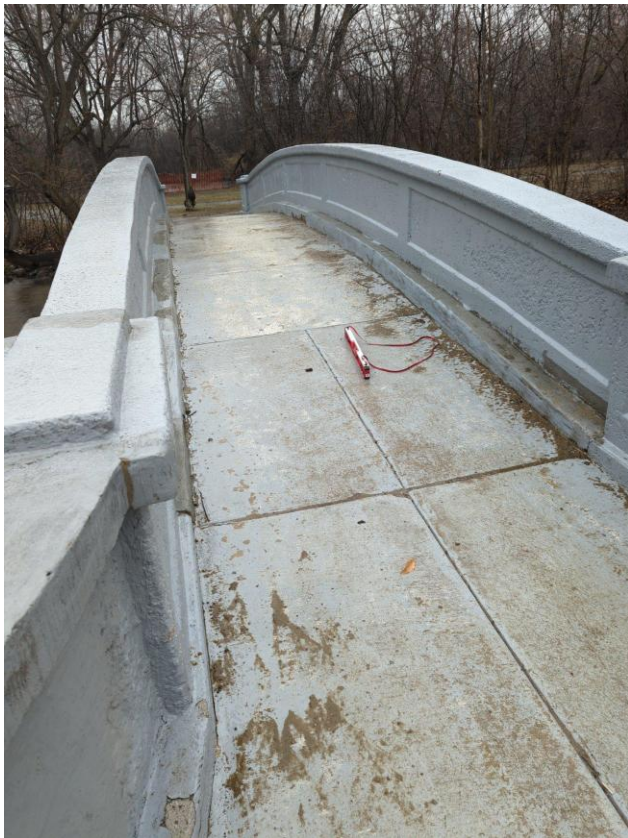
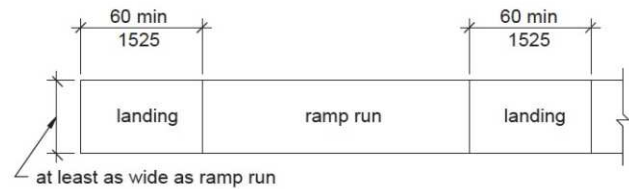
The ramp is missing the required top landing.

The ramps on the bridge do not have a top landing

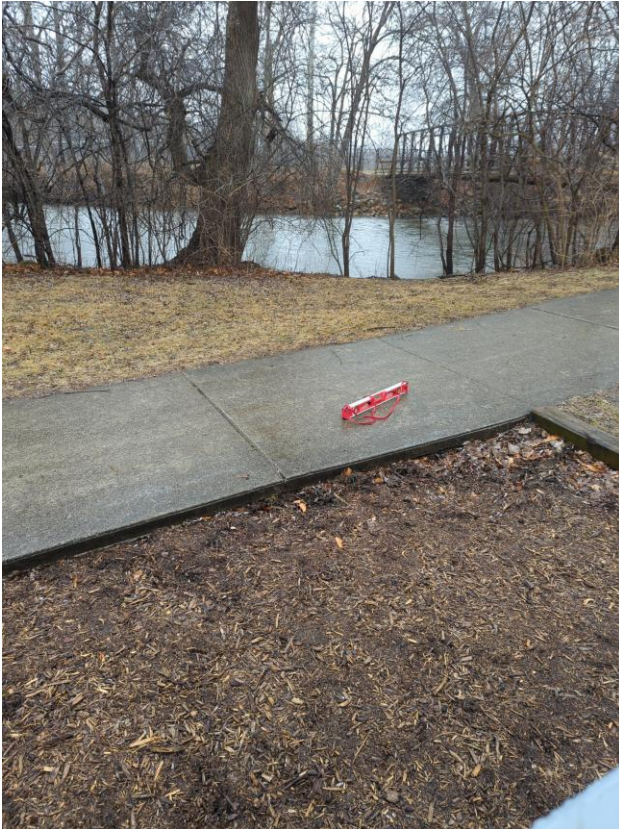
**Entrance to
playground equipment
has a change in level
of 3 inches without a
ramp**

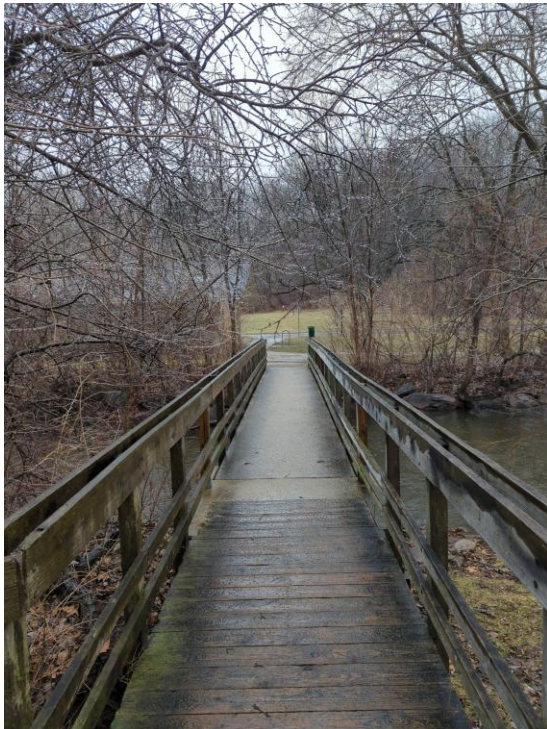
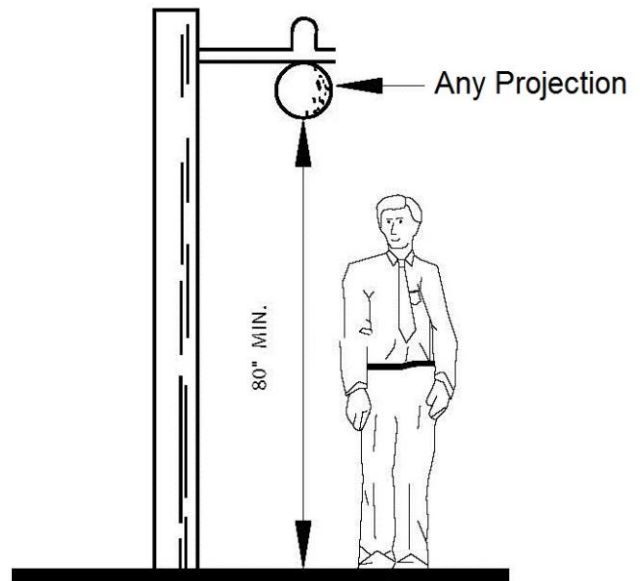
Tree branches are less than 80 inches high above the bridge

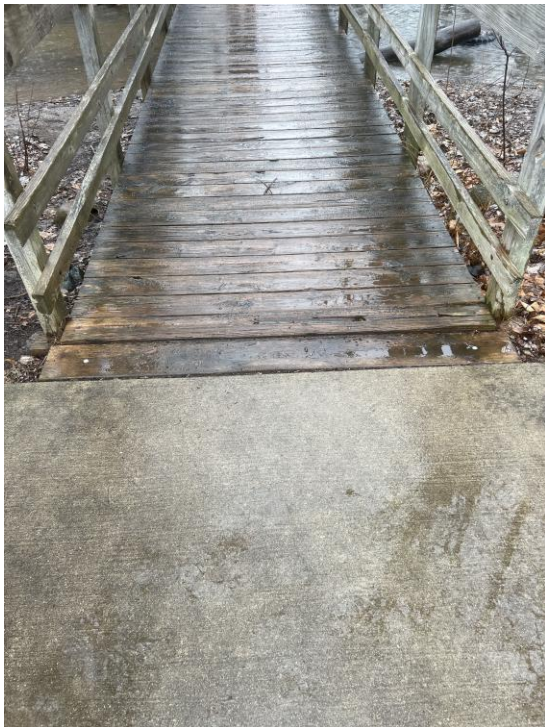
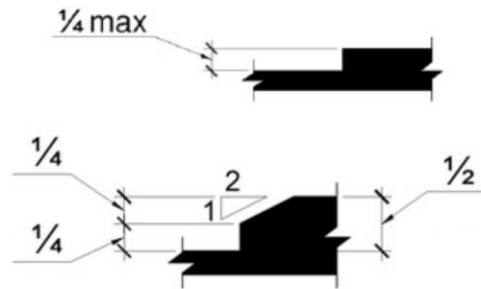
To bridge

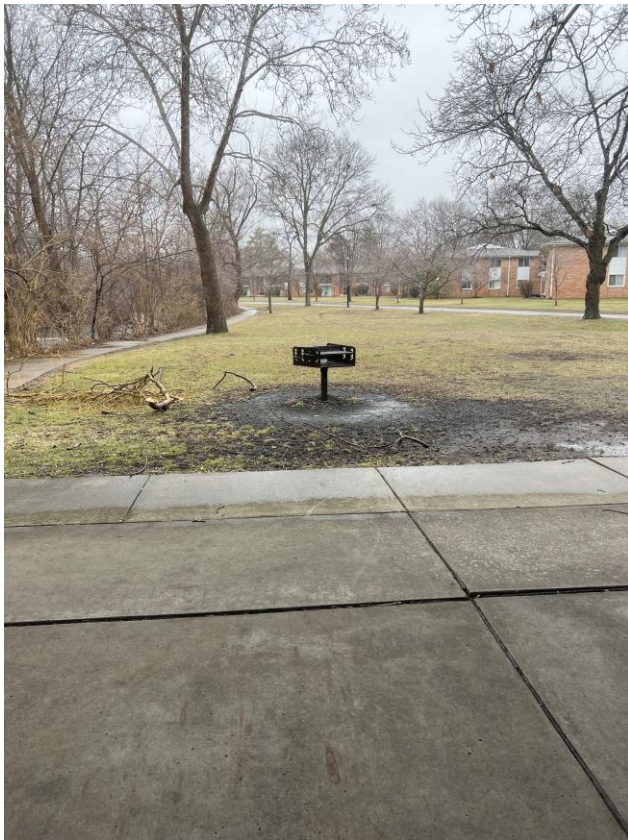
No accessible route to grill

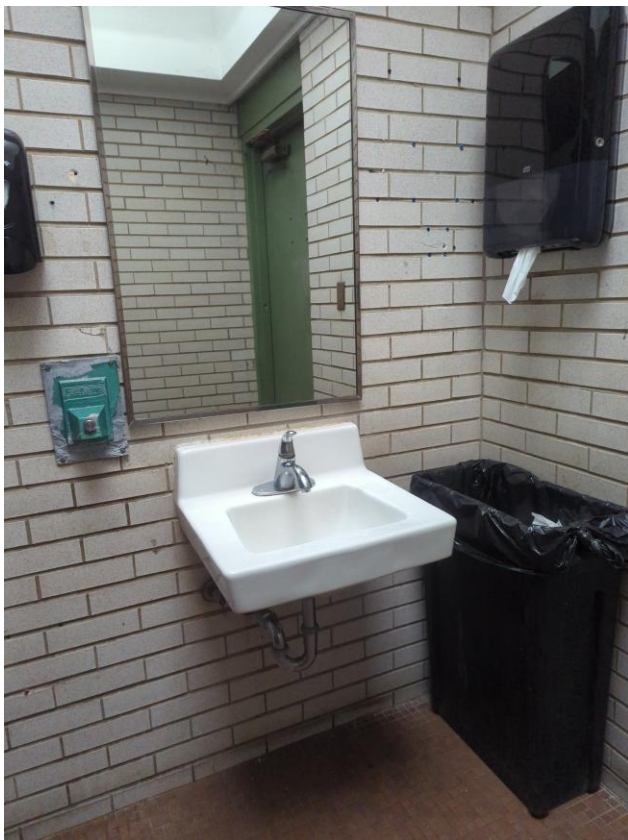
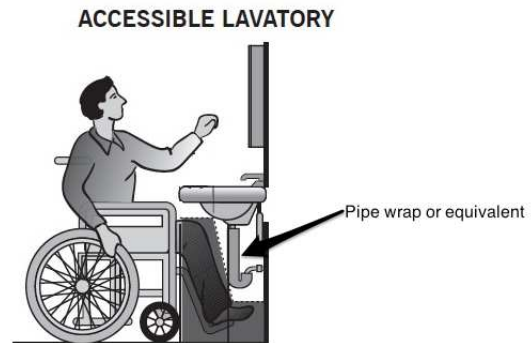
Lavatory does not have pipe insulation

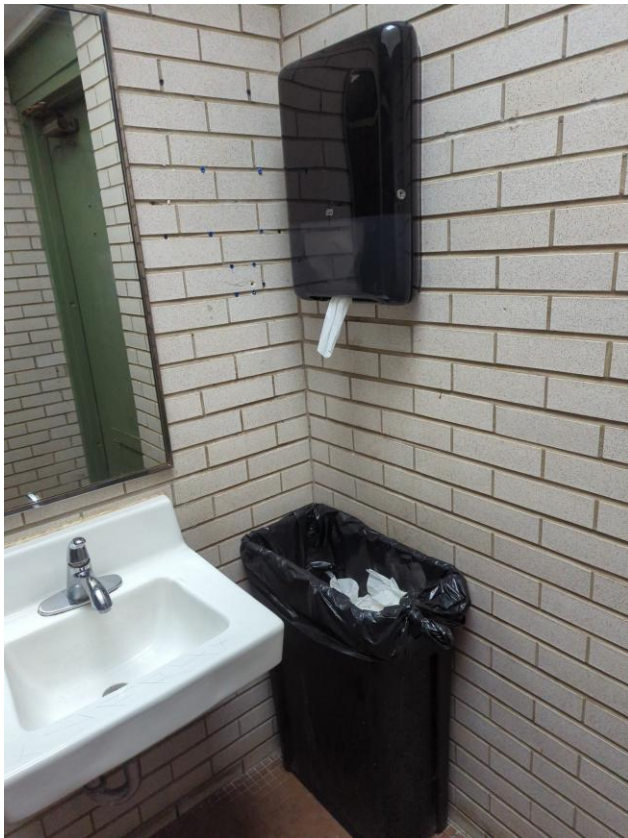
Paper towel dispenser is 54 inches high

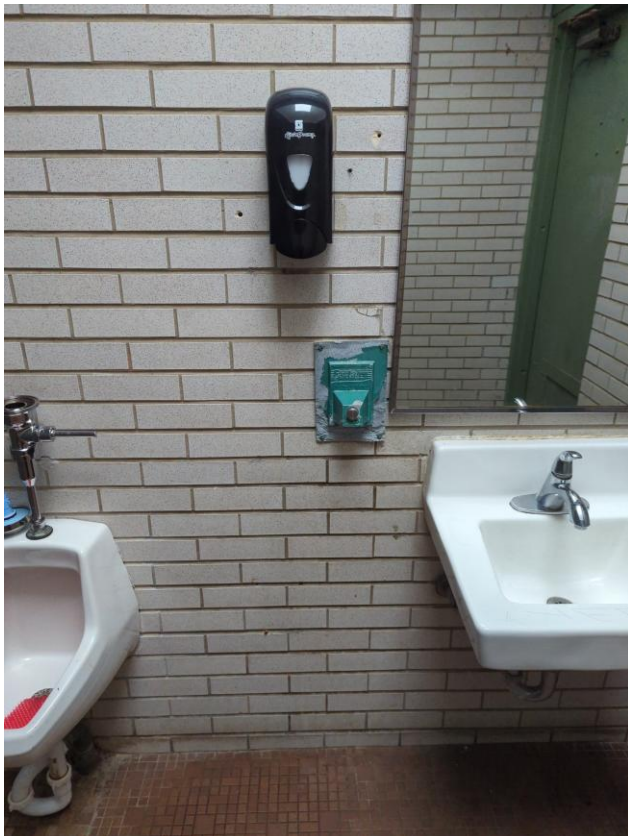
Soap dispenser is 54 inches high

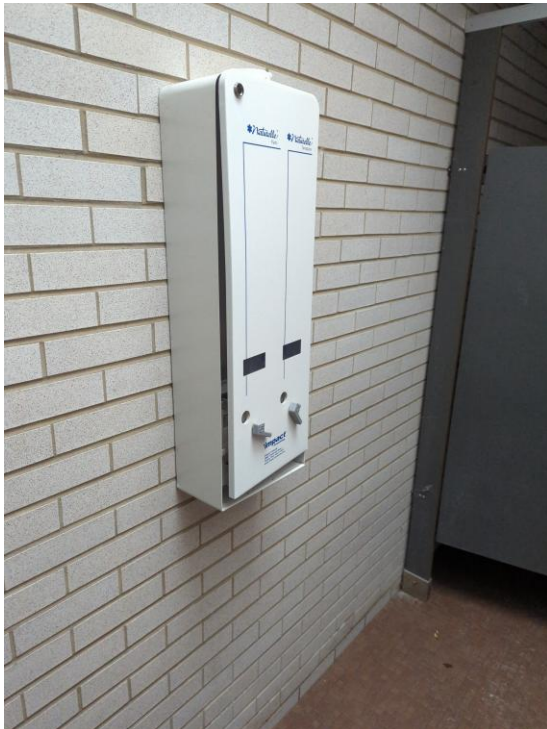
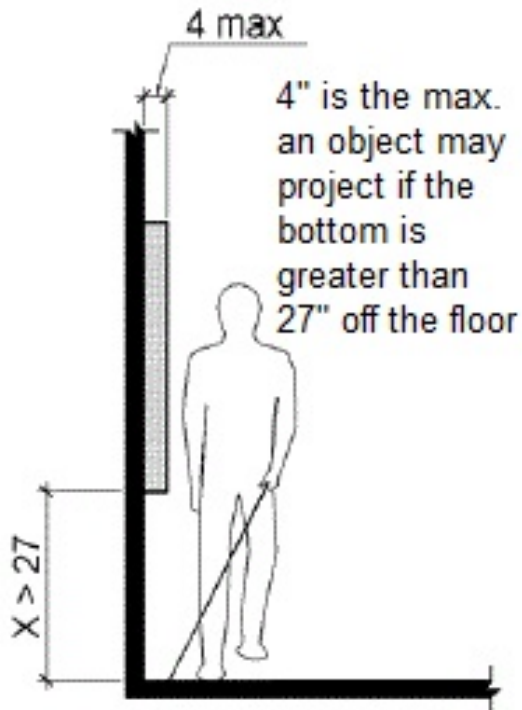
Sanitary napkin dispenser protrudes 5-1/2 inches at 39-1/2 inches high

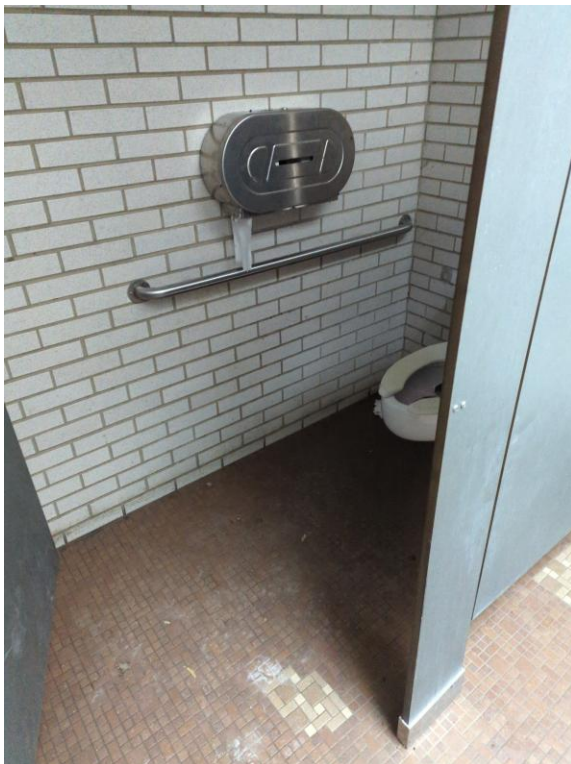
There is no accessible stall provided

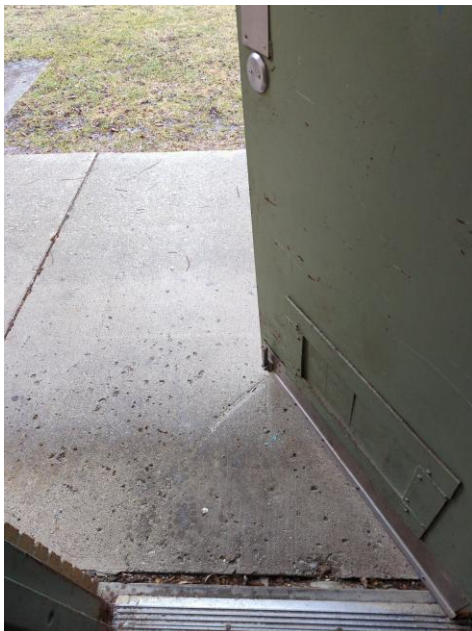
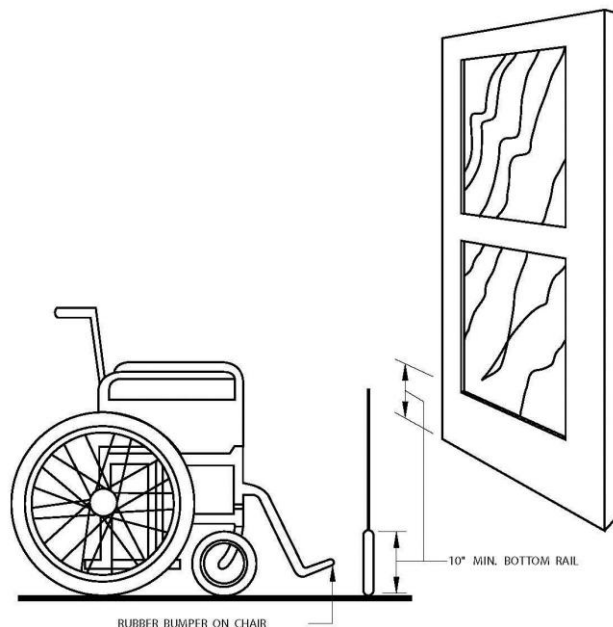
Door has a door stop within the bottom 10 inches

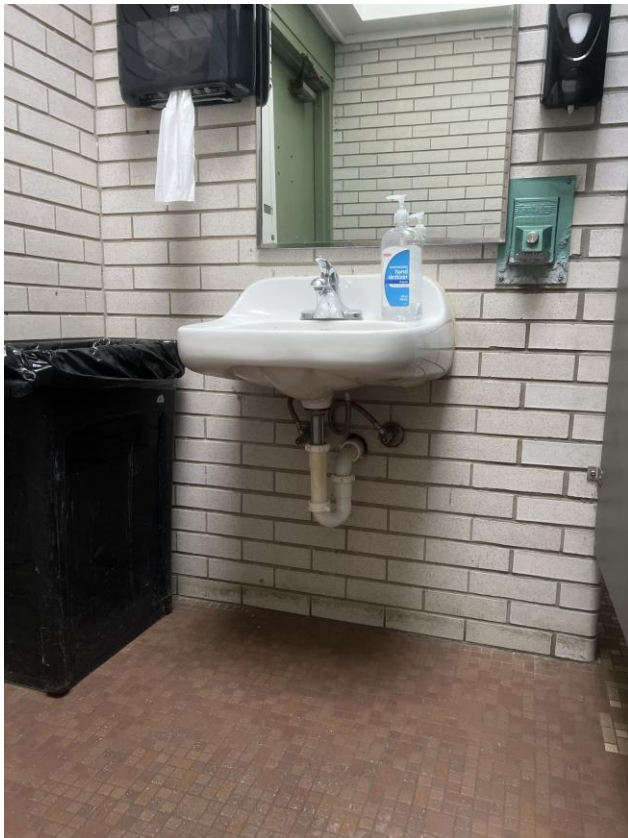
Not fully insulated

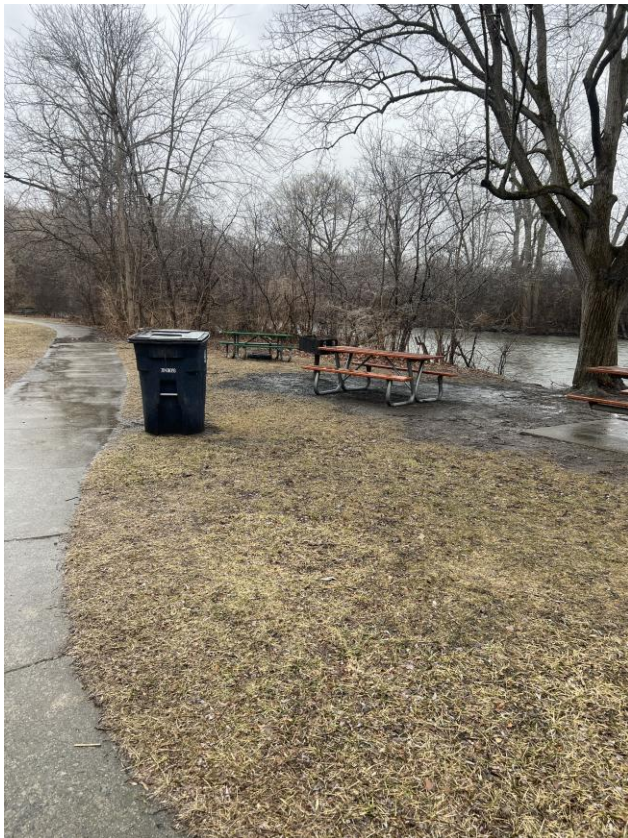
No accessible route to picnic table

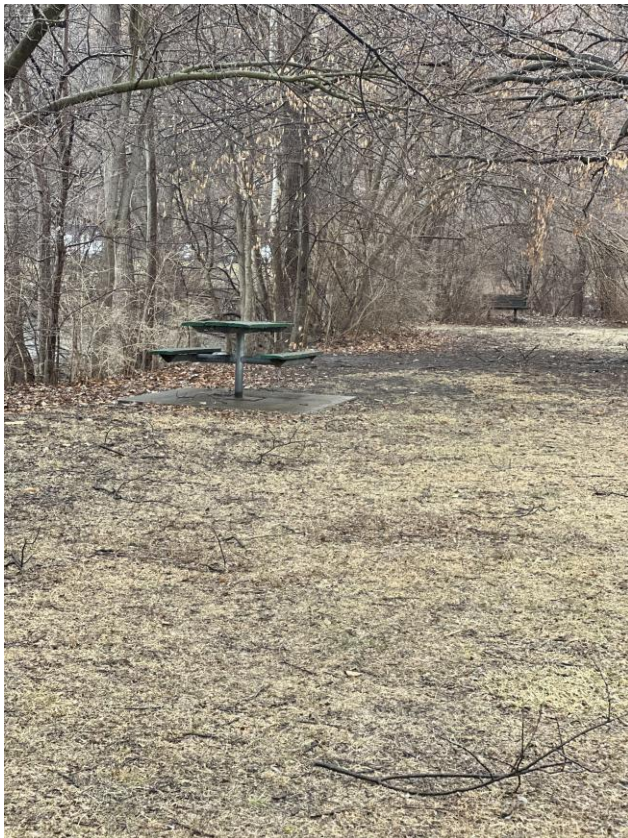
No accessible route to picnic table

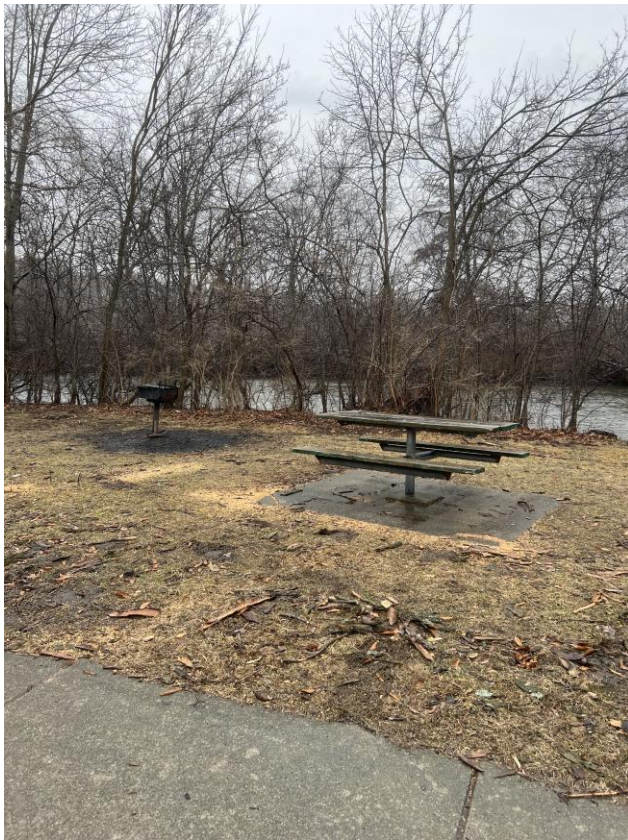
No accessible route to picnic table or grill

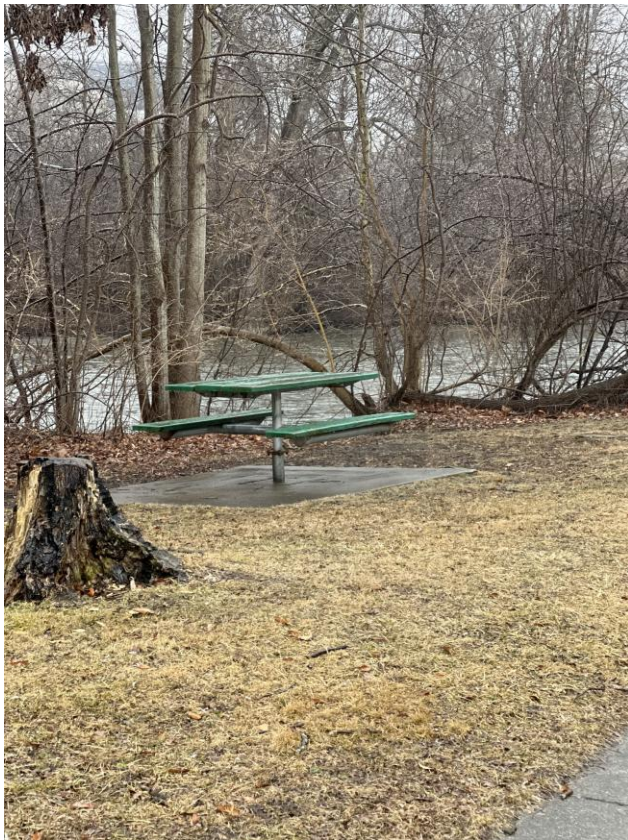
No accessible route to picnic table

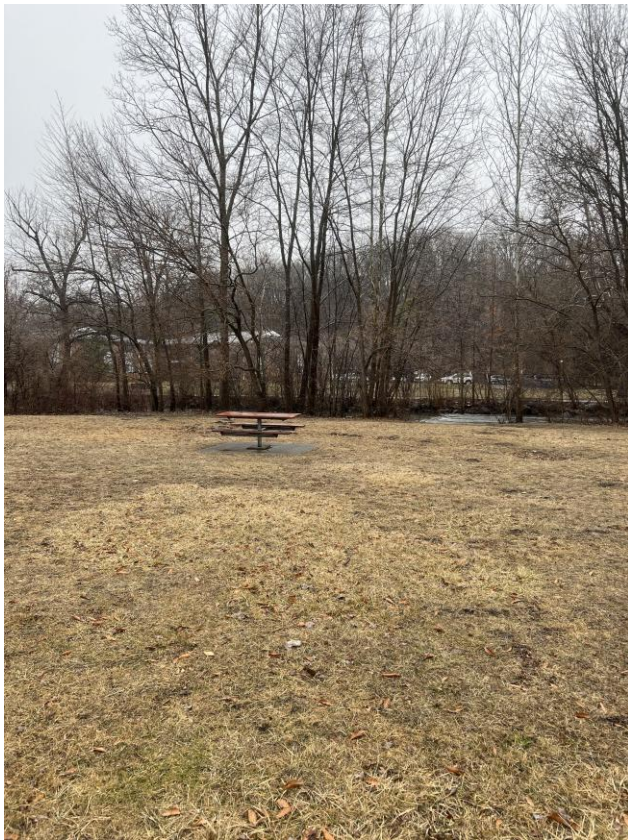
No accessible route to picnic table

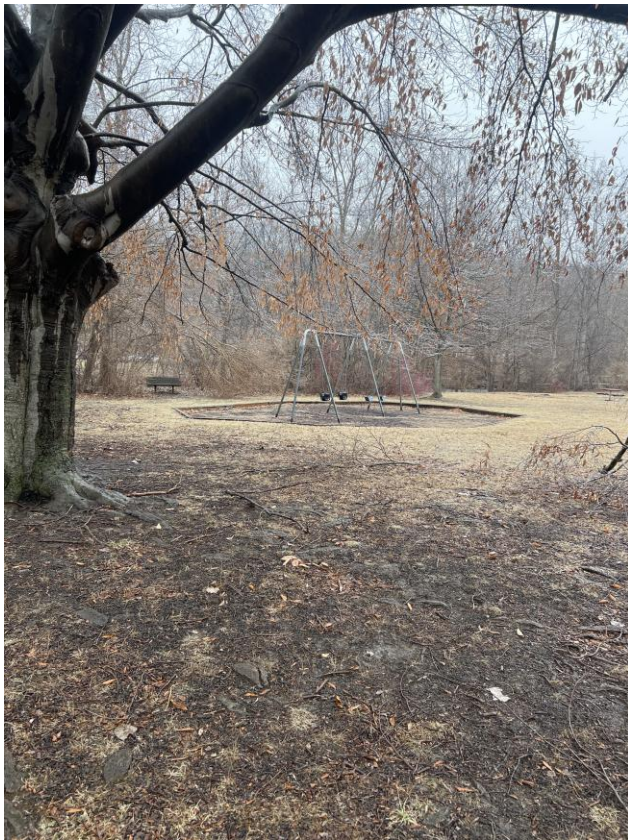
No accessible route to swings & bench

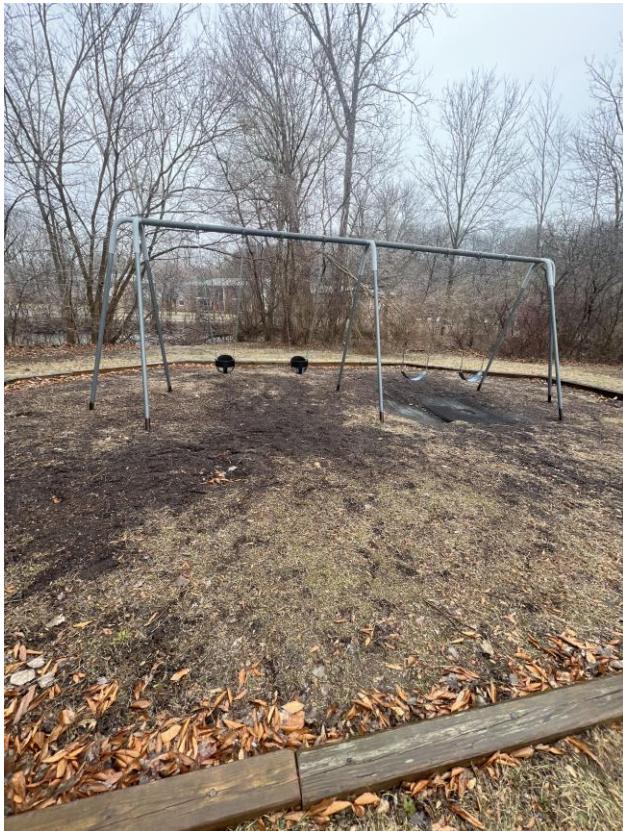
Grass and dirt

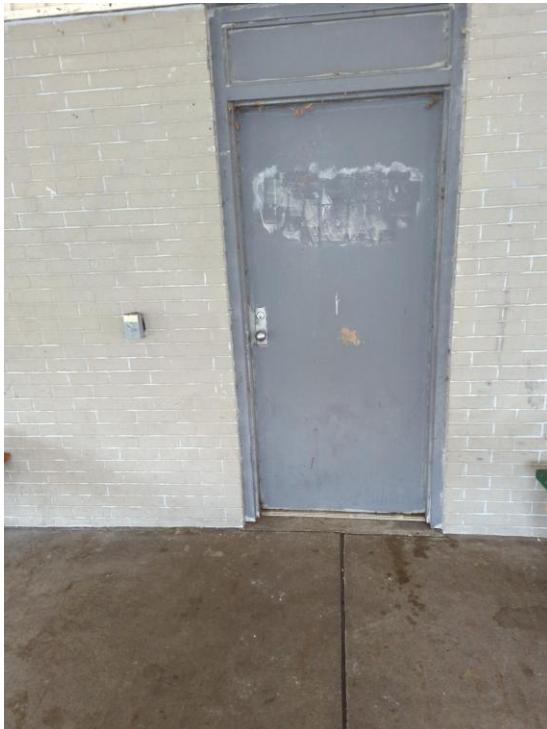
Door to storage room
has a knob

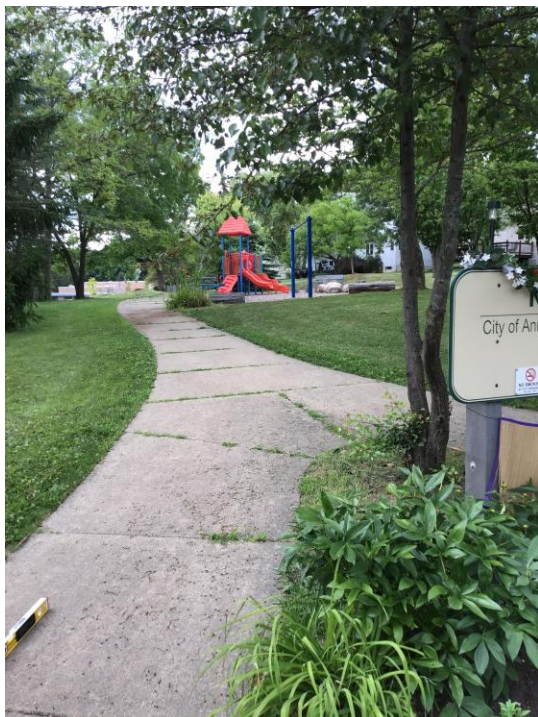
Tree at entrance is a protruding object.
