Site Accessibility Evaluation

Allmendinger Park
655 Pauline Blvd
Ann Arbor, MI 48104
ADA Only

Inspection Date: 07/11/2022

Report Date: 11/15/2022

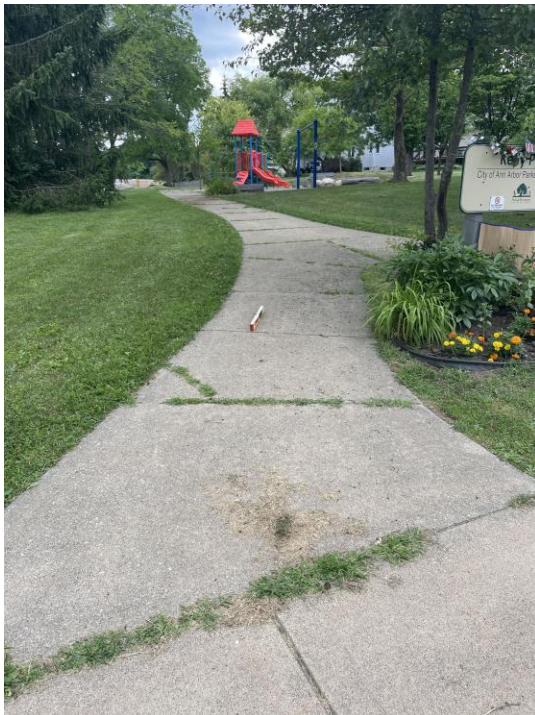
Running slope is 7.9%

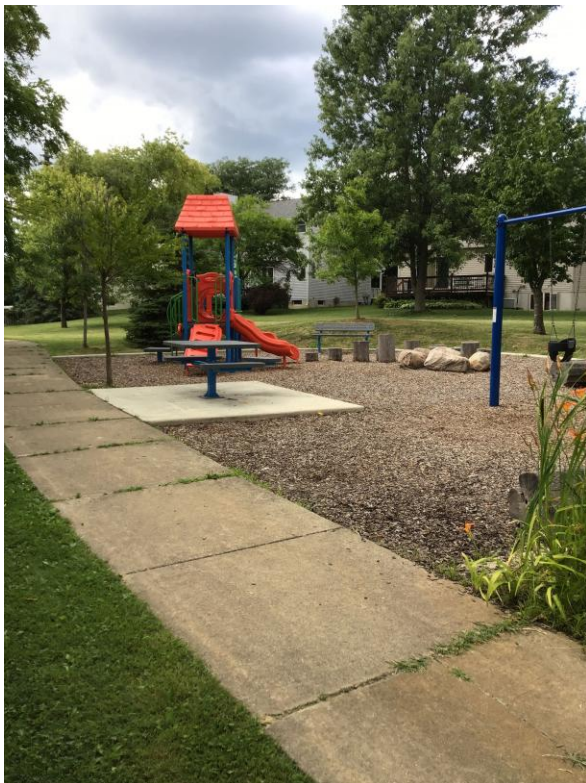
No accessible route to play area.

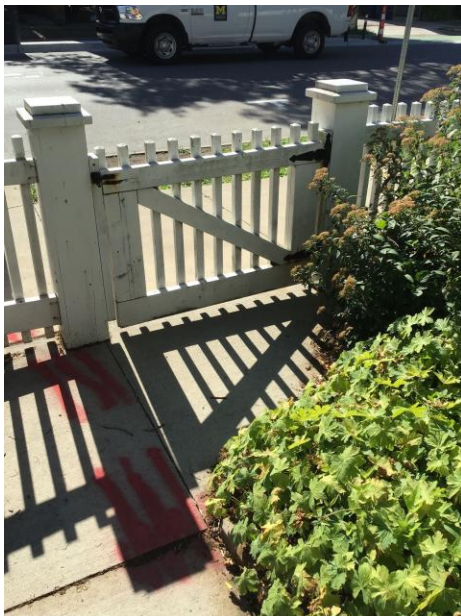
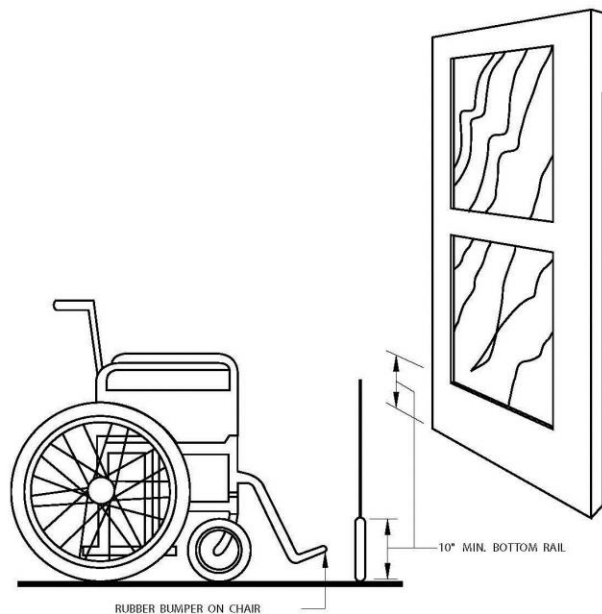
The exterior gate does not have a smooth 10” surface.

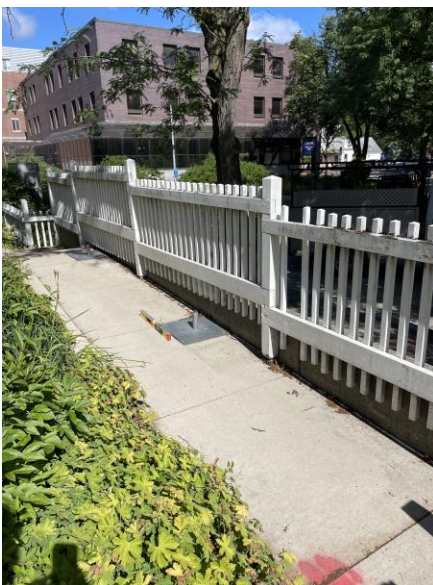
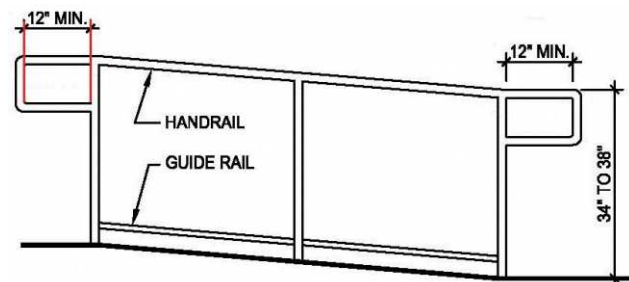
Walking surface with a running slope greater than 5% must be treated as a ramp. Handrails not provided on ramp.

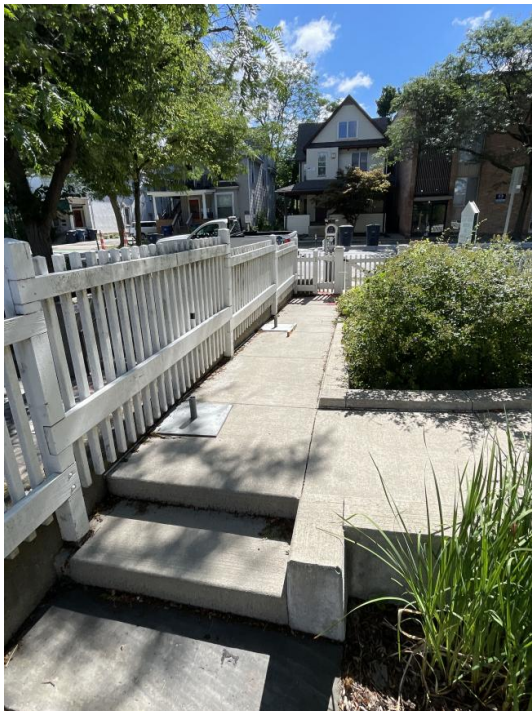
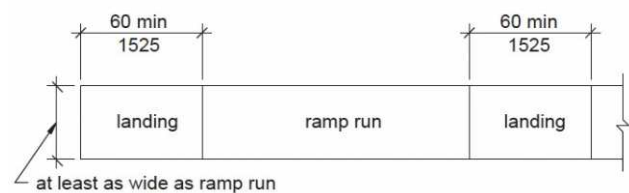
Landing is not 60" long

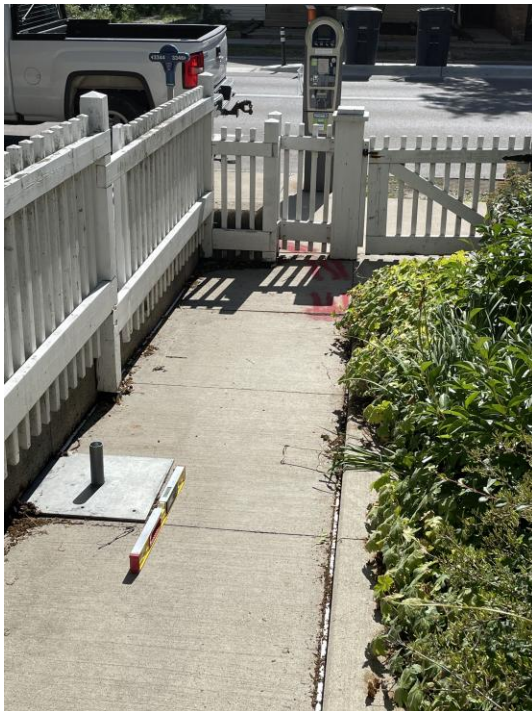
Landing is not 60" long

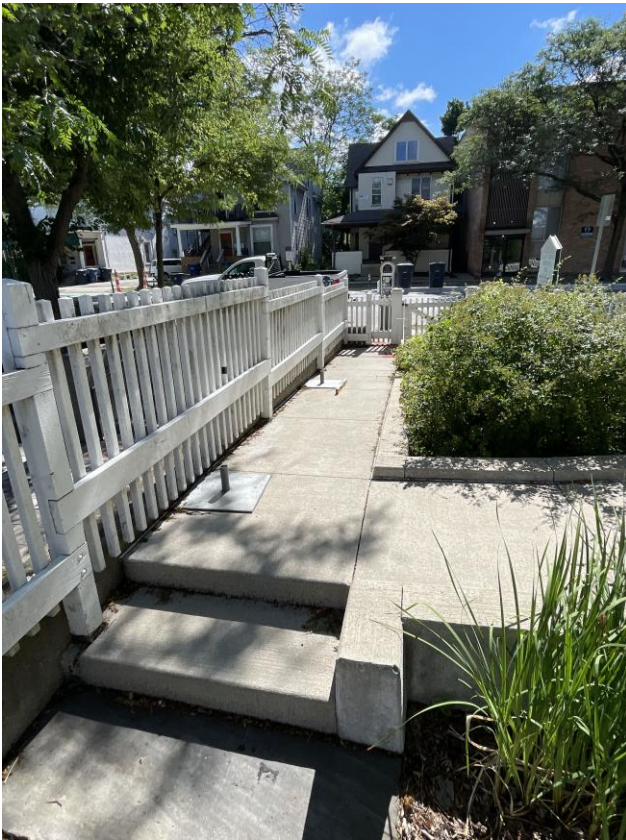
Finding #5 Continued

Handrails not provided on exterior stairway with two steps leading to entrance.

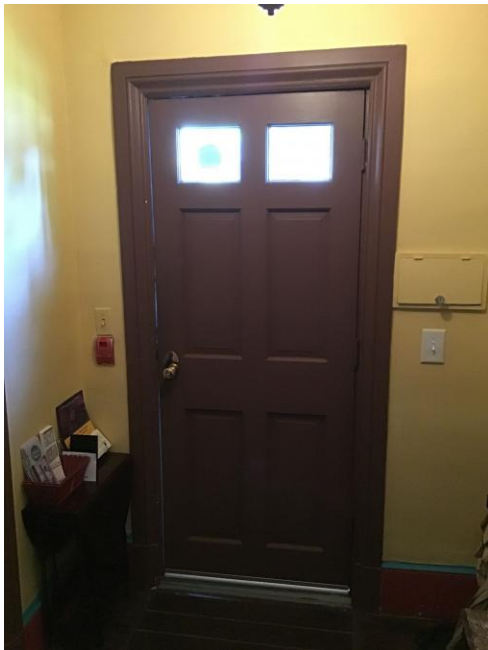
Entrance door has a knob.

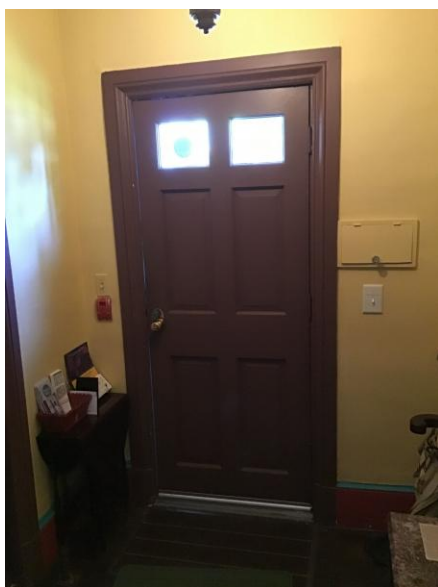
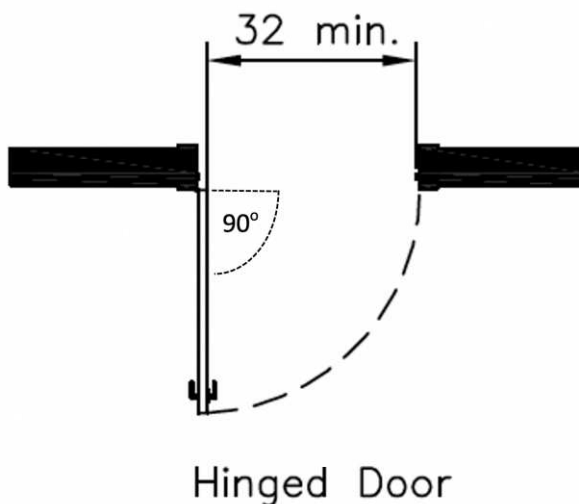
Clear width at 29".

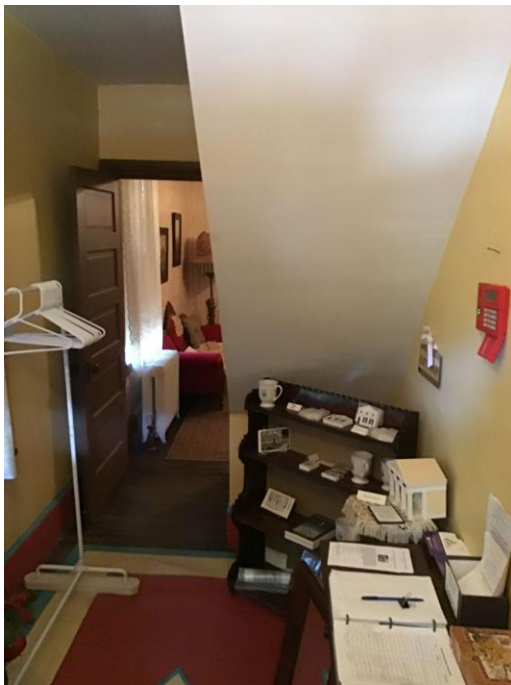
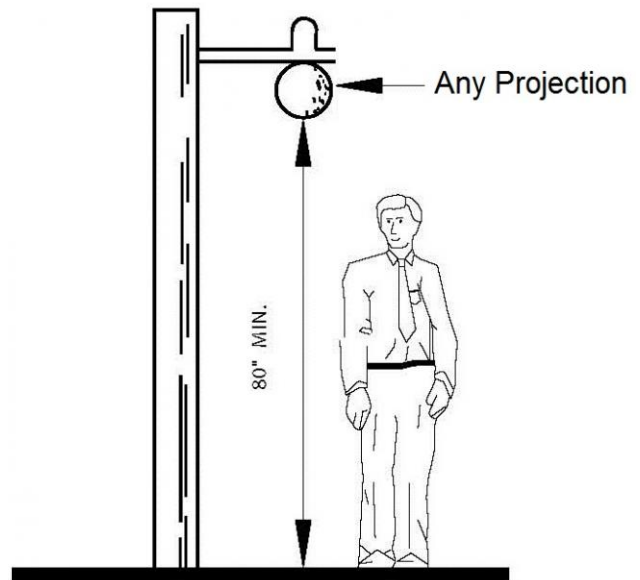
No came detection is provided under stair case.

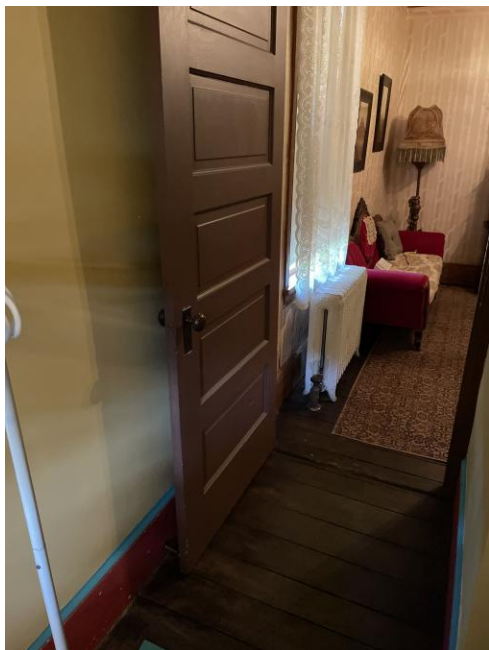
5 doors along accessible route have knobs

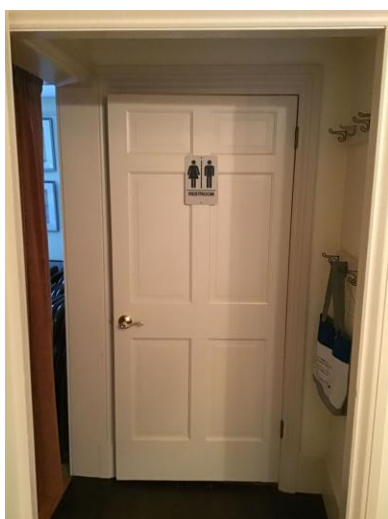
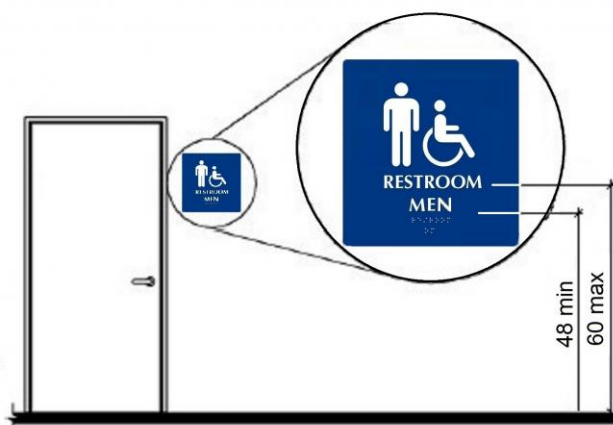
A compliant room identification sign is missing on the strike side of the door.

Sign not located on latch side wall.

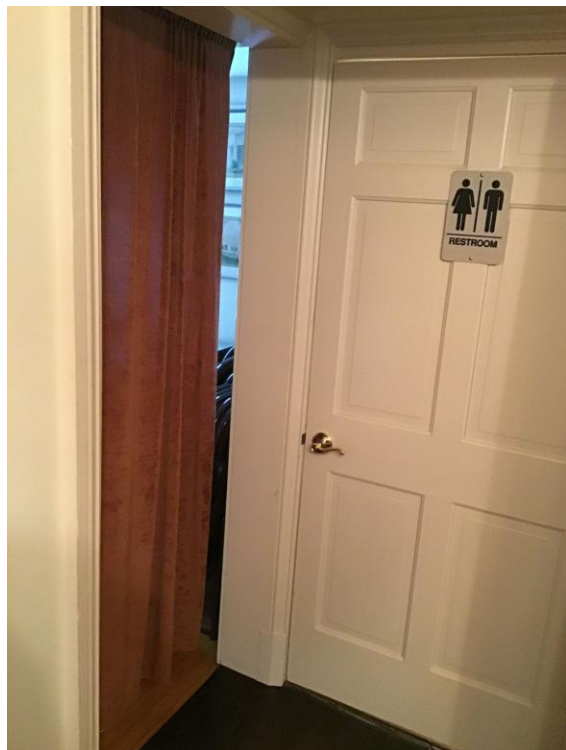
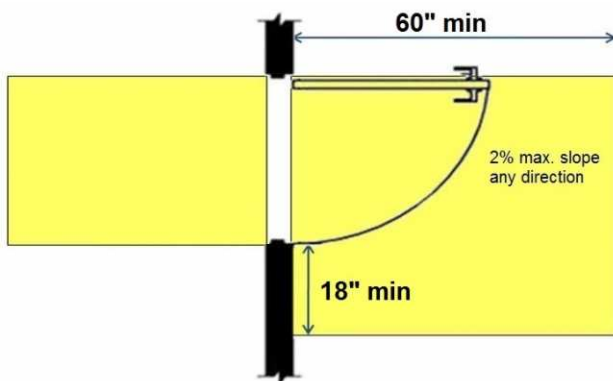
The restroom door does not have the required clearance.

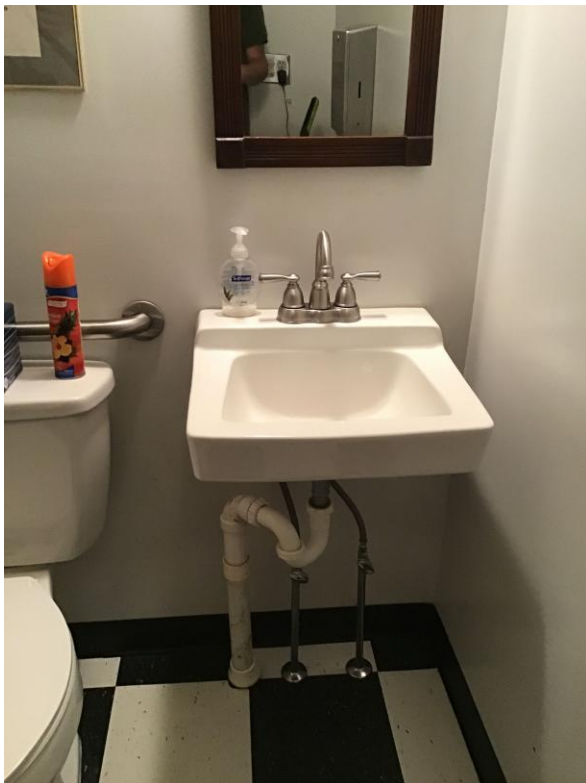
Exposed pipes in restroom lavatory.

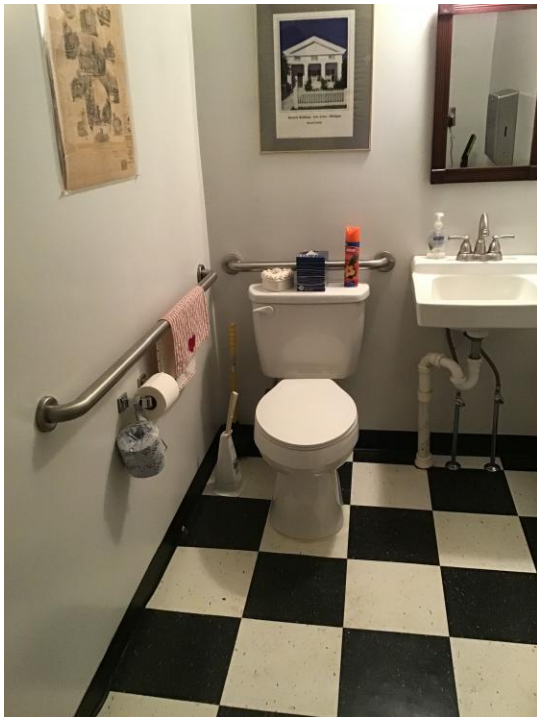
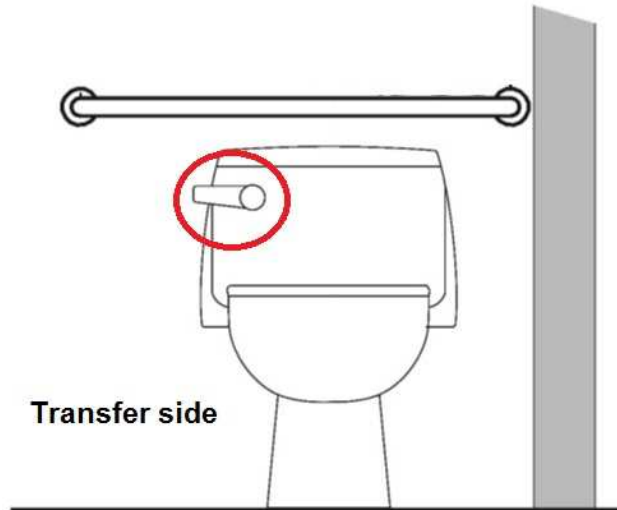
Control not on the open side.

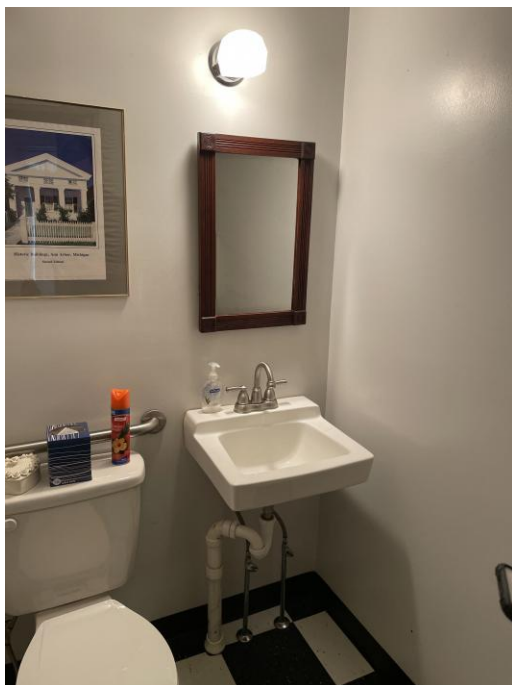
Reflective surface more than 40" above the finish floor

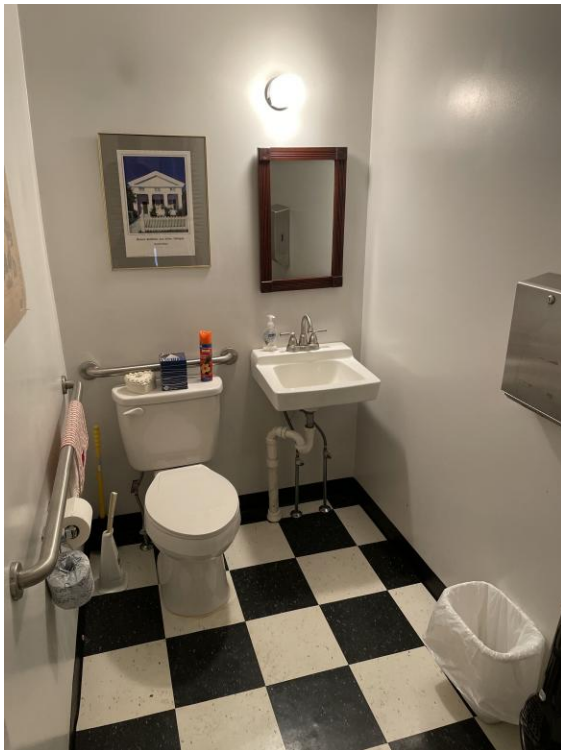
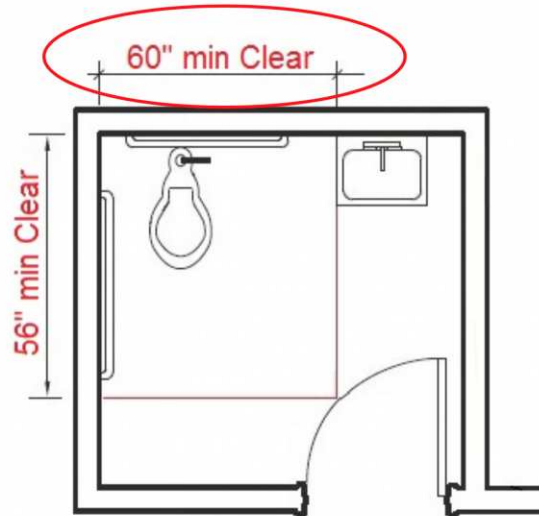
Restroom is not 60" wide

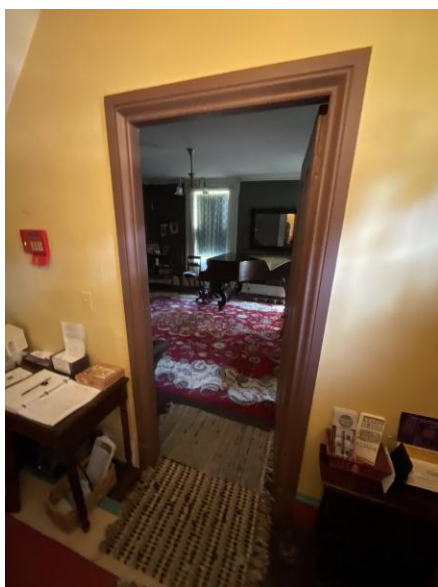
Doorway into piano room is not 32" wide

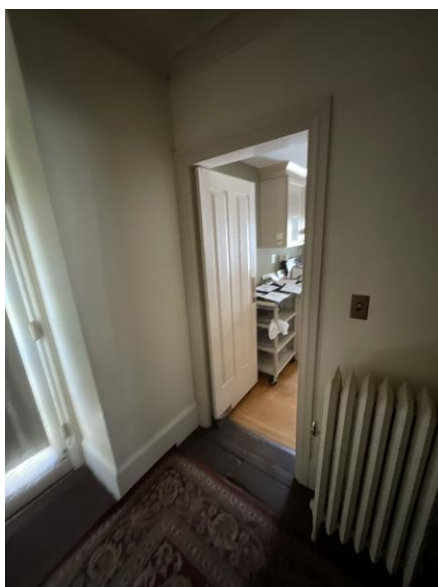
Door opening is not 32" wide

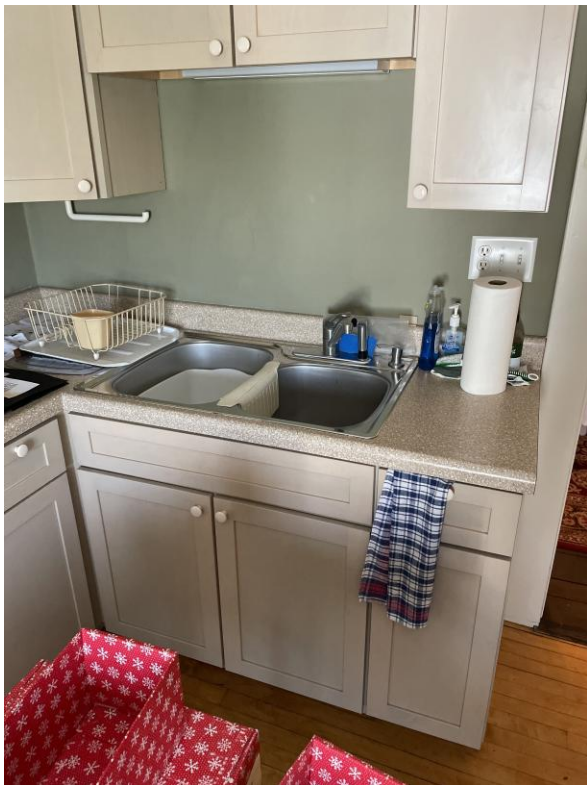
Rim above 34” and no knee and toe clearance are provided

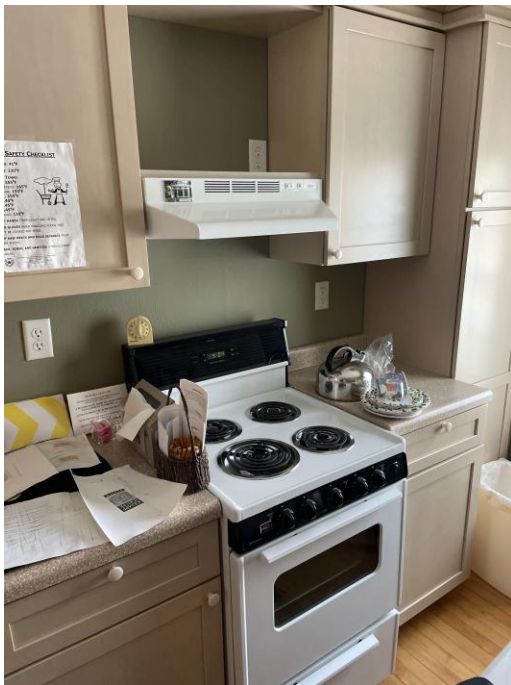
Vent hood not installed within reach range

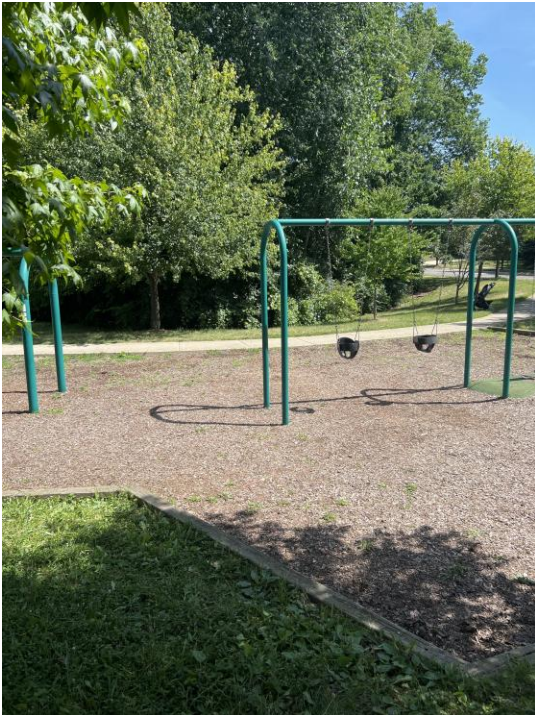
Existing pre-engineered wood mulch needs maintenance.

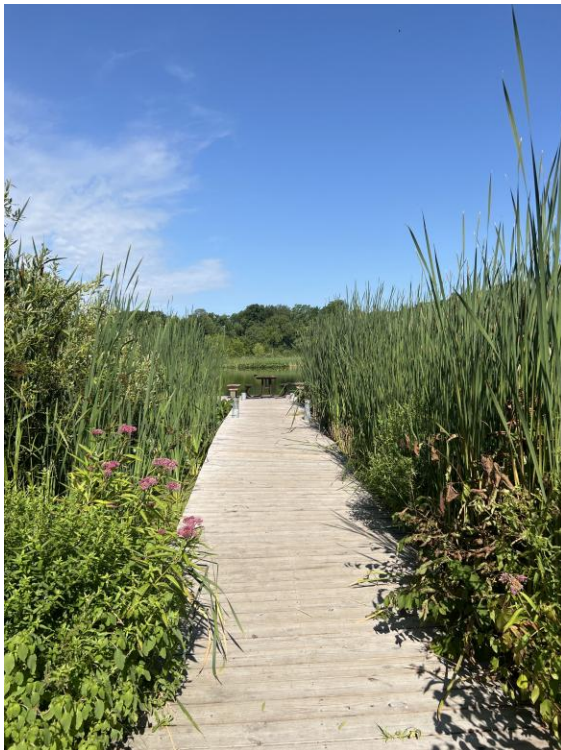
Greater than 2%

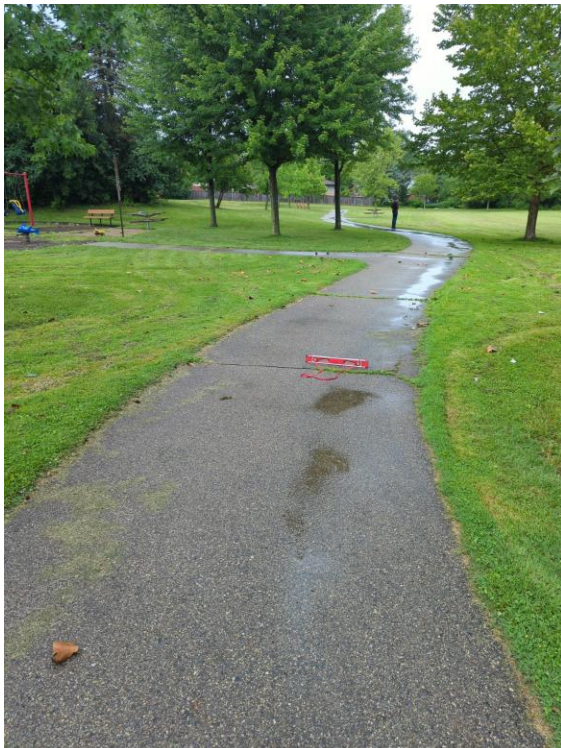
Path from Land Way to playground has a cross slope of up to 3.5%

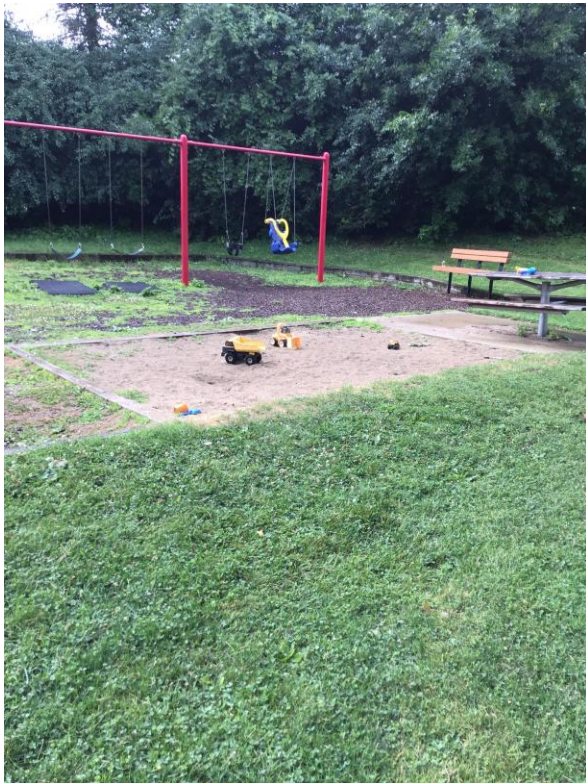
No accessible route to sand pit.

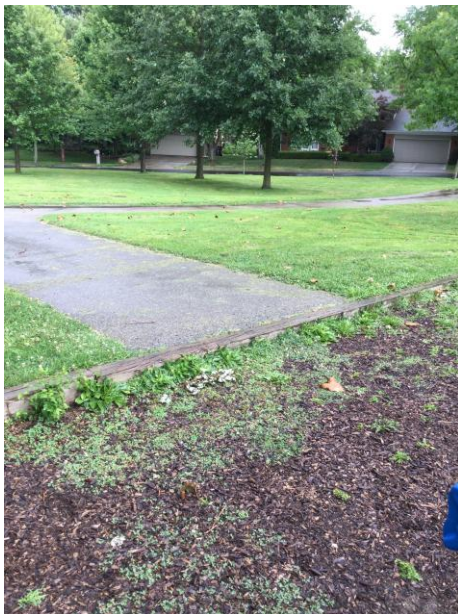
4" change in level from sidewalk to playground surface.

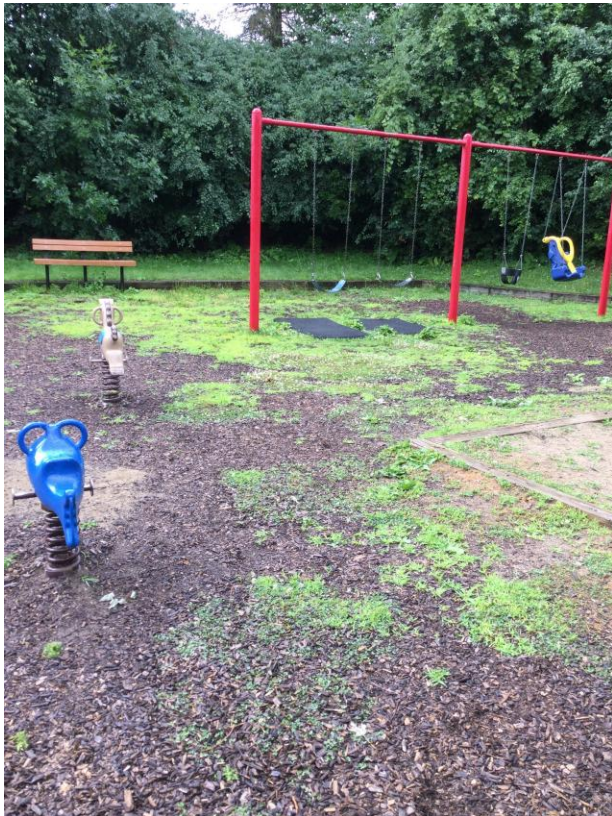
Existing pre-engineered wood mulch needs maintenance.

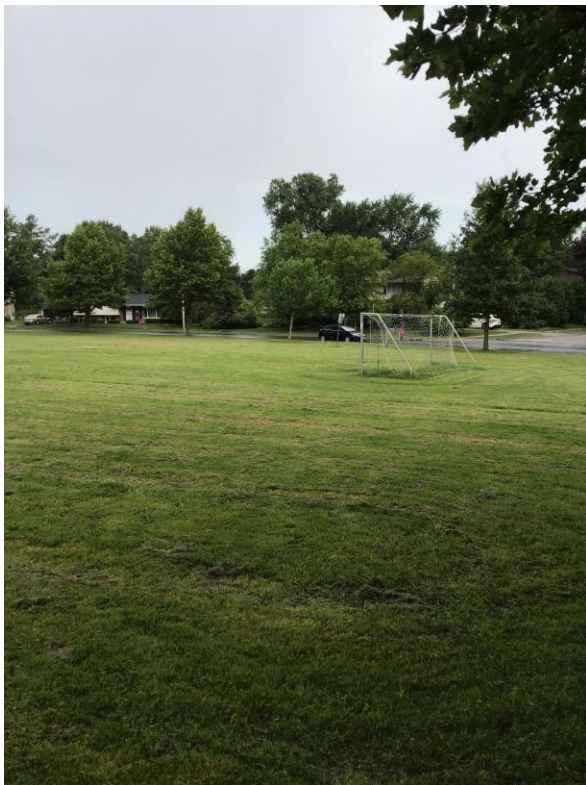
No accessible route to soccer field.

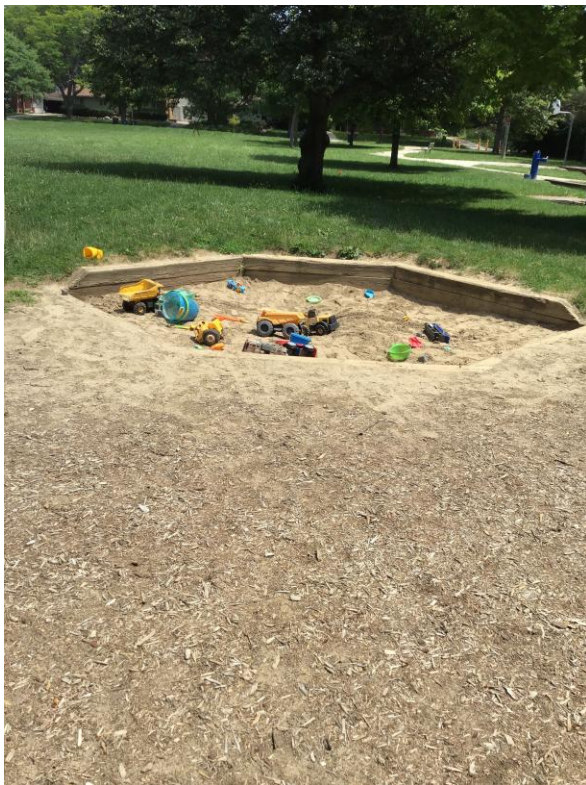
No accessible route to sand pit.

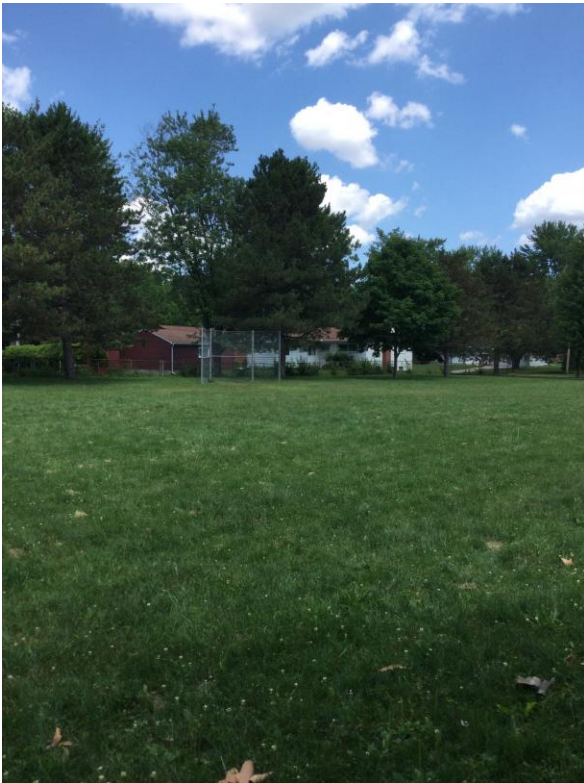
No accessible route to baseball field.

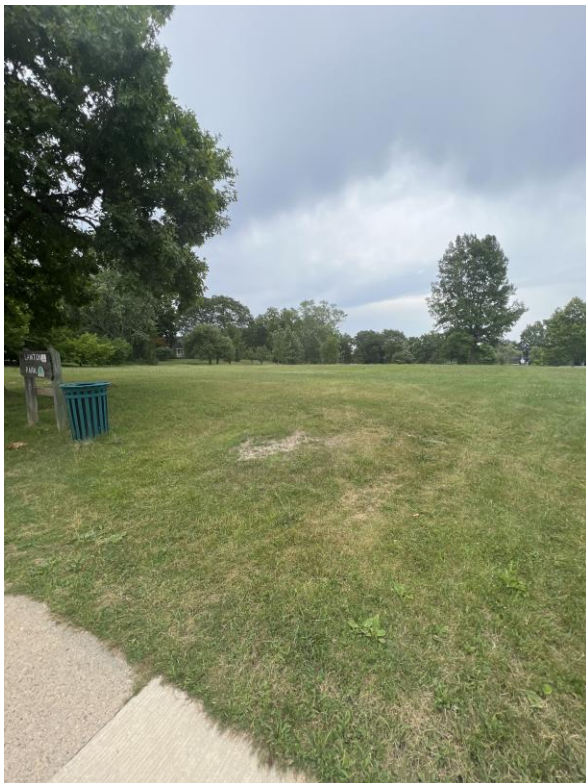
No accessible route to play area.

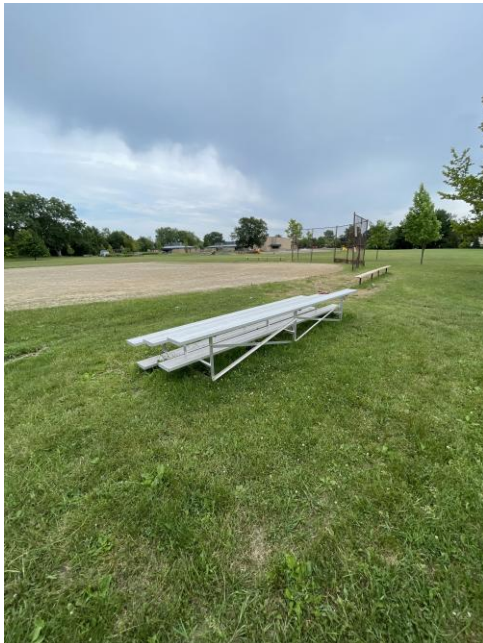
No wheelchair area adjacent to bleachers.

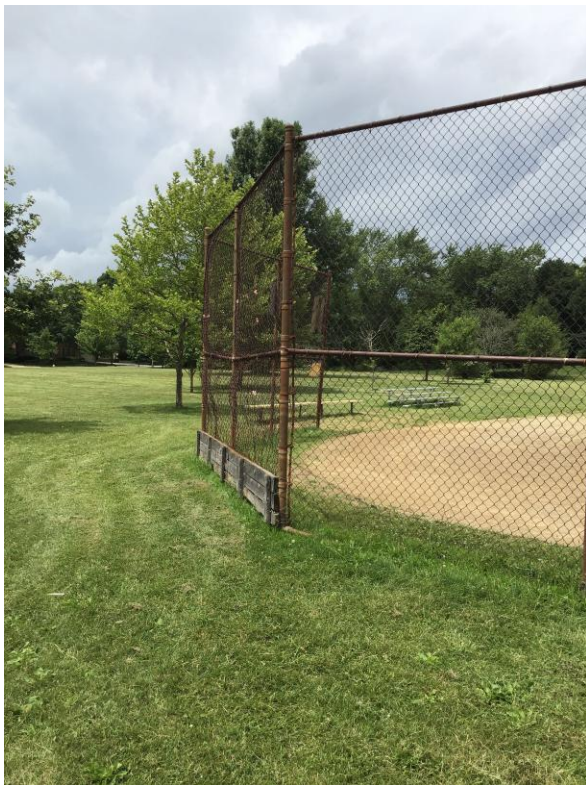
No accessible route to baseball field, dugouts, or seating.

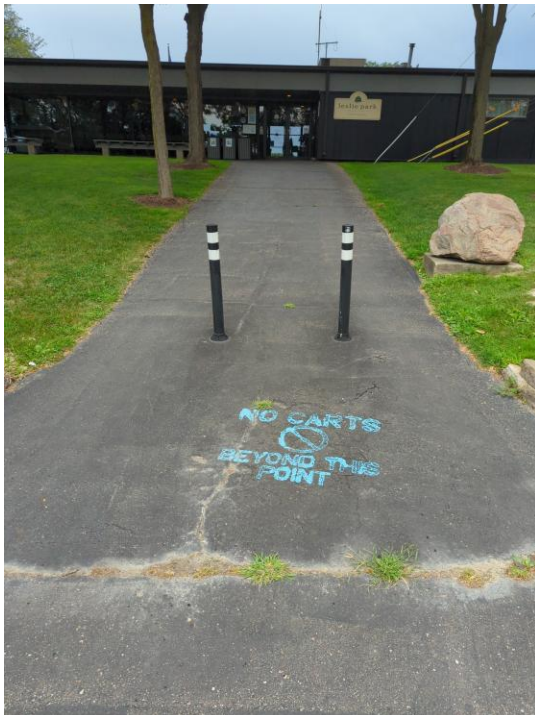
Accessible route from the accessible parking to the main entrance has a running slope of up to 13.5%

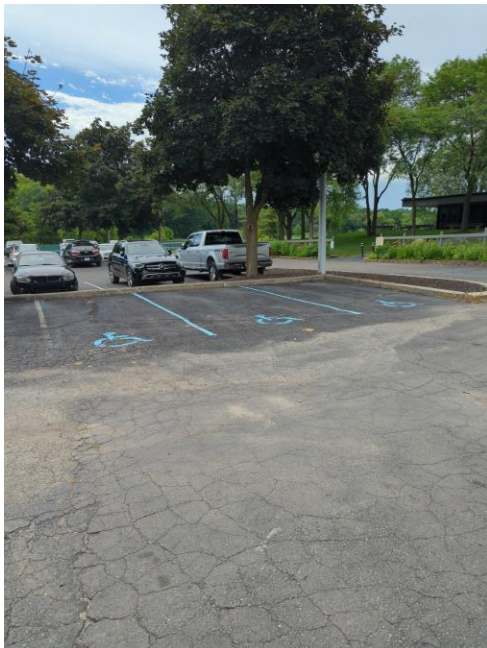
104 total parking space require 5 accessible stalls with one van accessible space

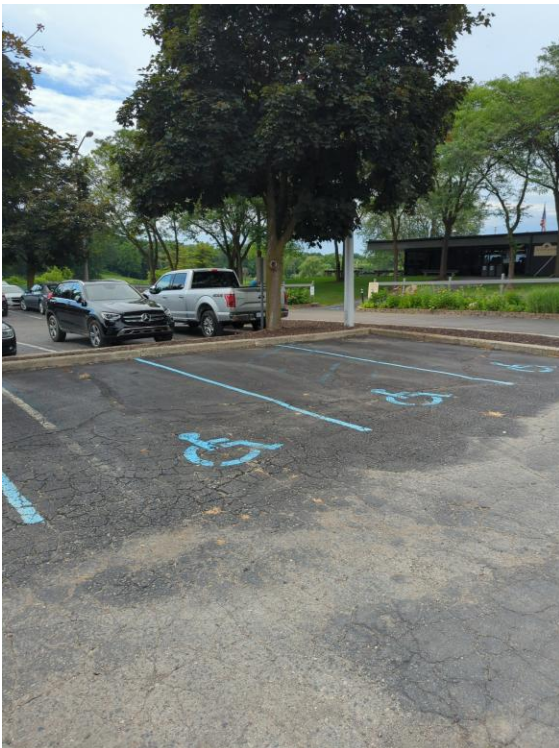
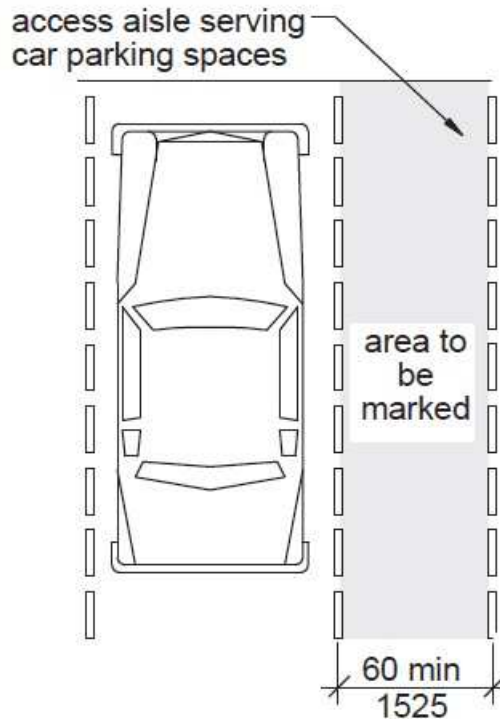
The access aisle is missing at the accessible parking stalls.

None of the 4 accessible parking stalls have an access aisle

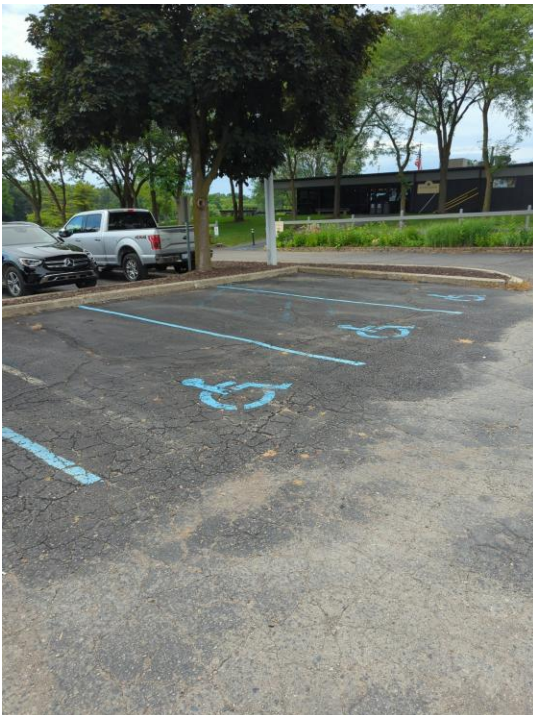
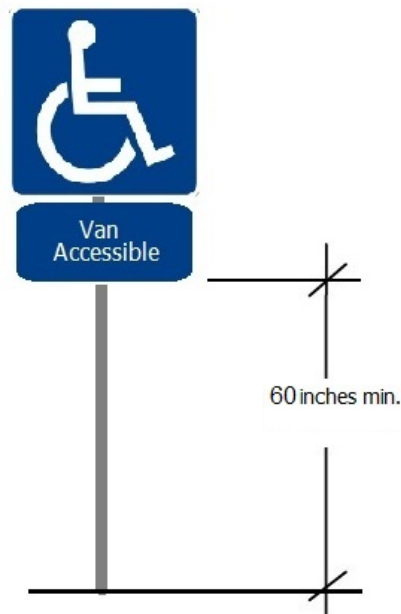
The required parking signage is missing.

None of the 4 accessible parking stalls have an accessible parking sign

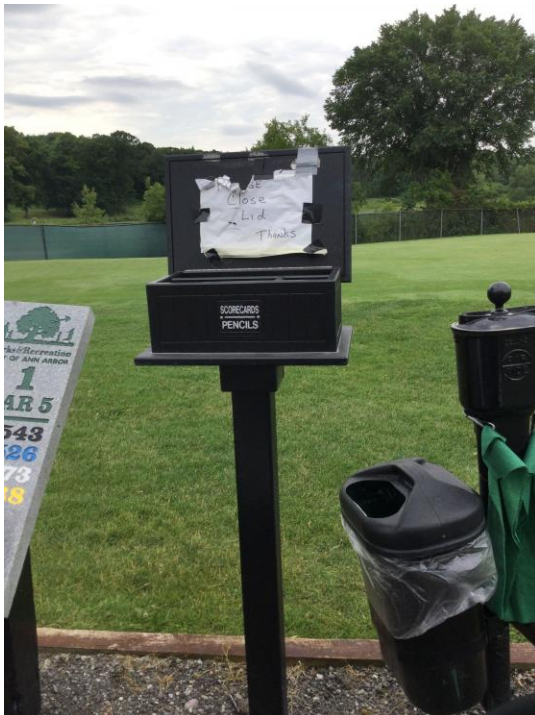
The scorecard and pencil box and the golf ball cleaner are higher than 48”

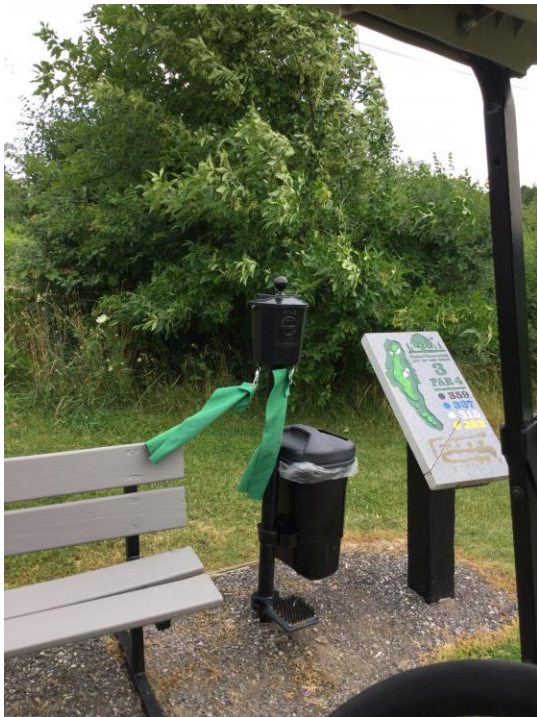
The golf ball cleaner is higher than 48”

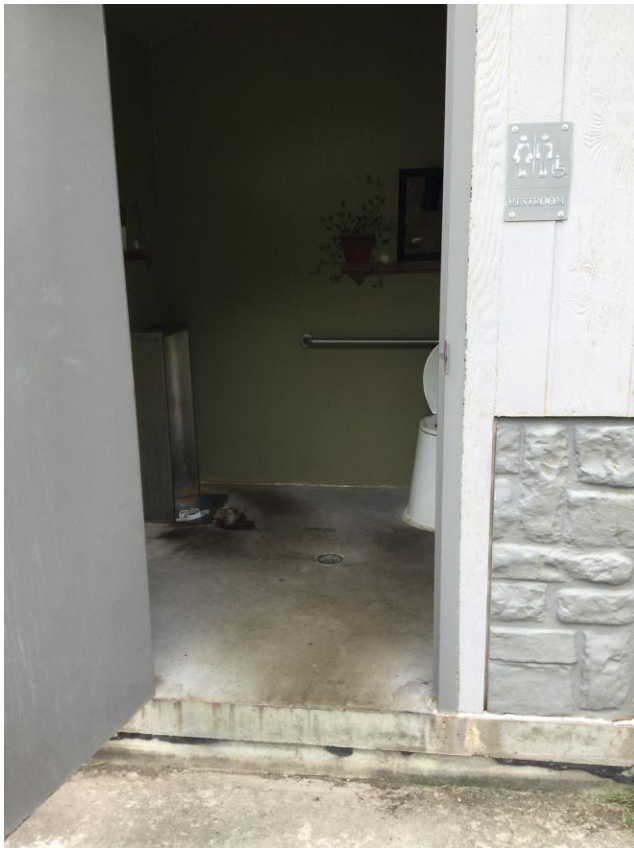
10" step up to the restroom in the golf course

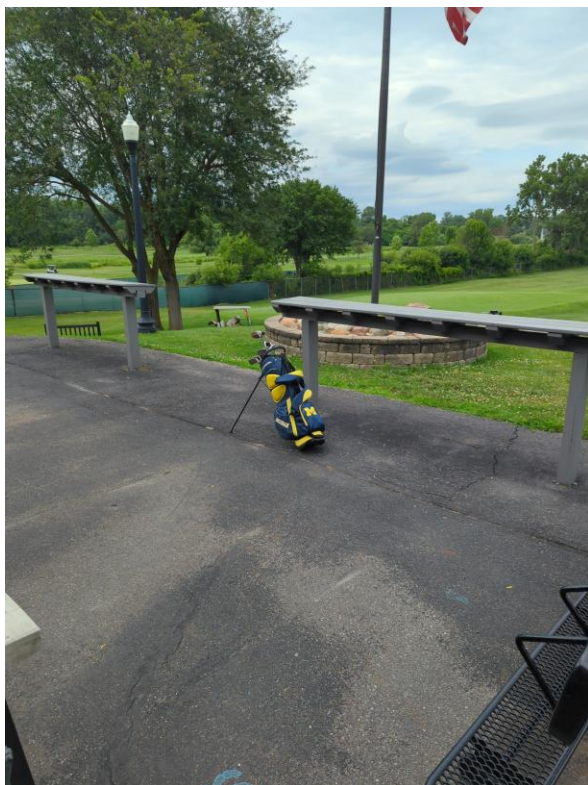
2 exterior bar ledge are 43 inches high

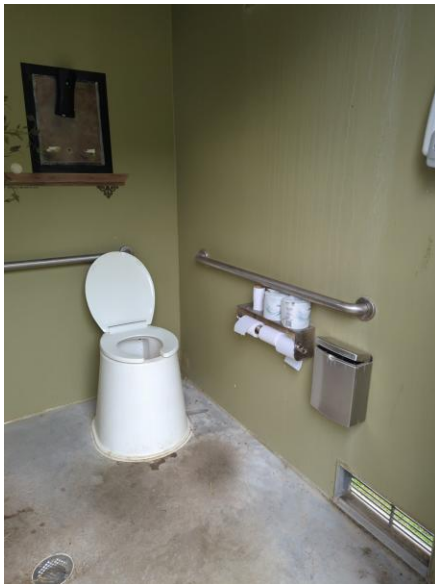
Toilet paper dispenser is 11 inches in front of water closet

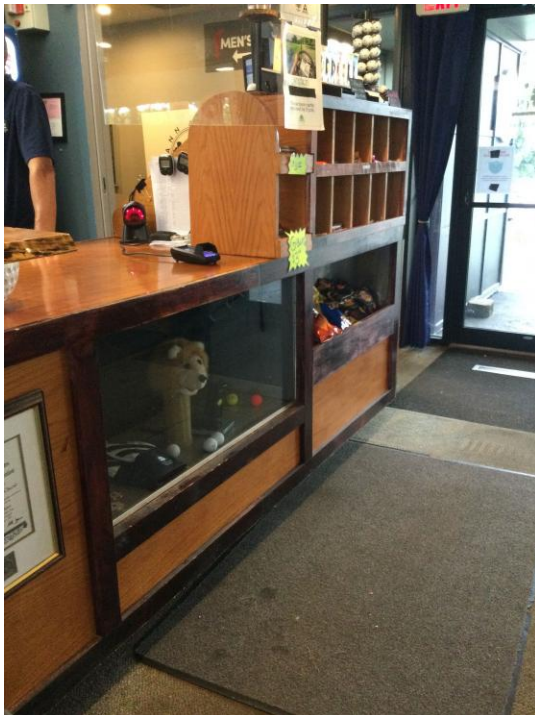
The sales counter is 37" high

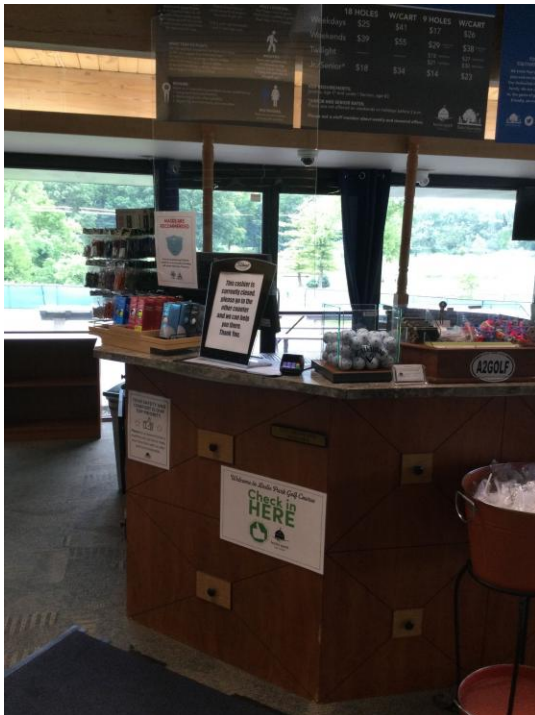
Service counter is 48" high

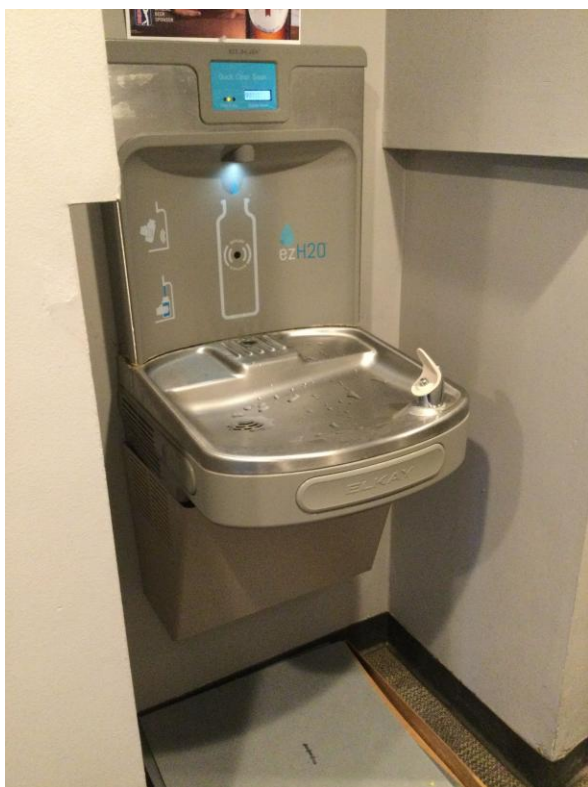
Drinking fountain does not have clear floor space

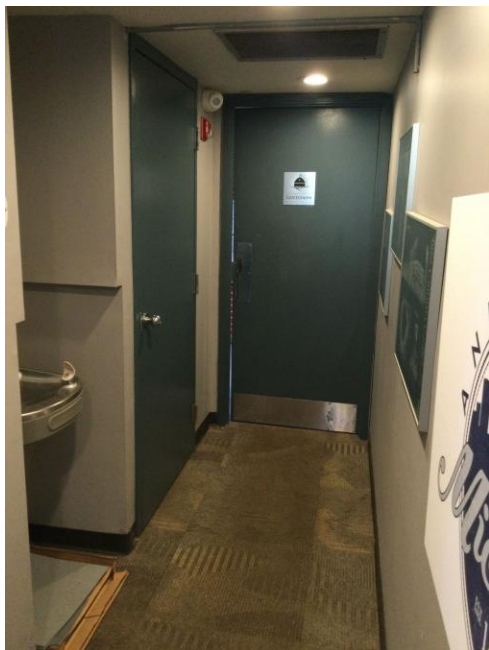
Non-compliant door knob

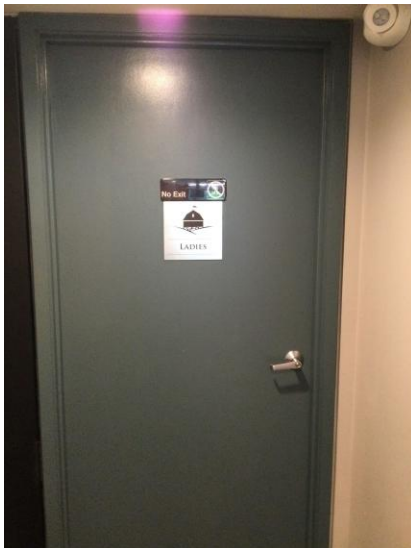
A compliant room identification sign is missing on the strike side of the door.

Door sign located not on wall adjacent to the latch side of the door.

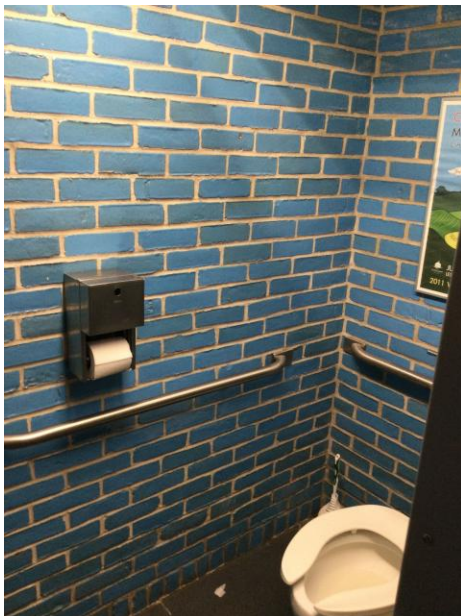
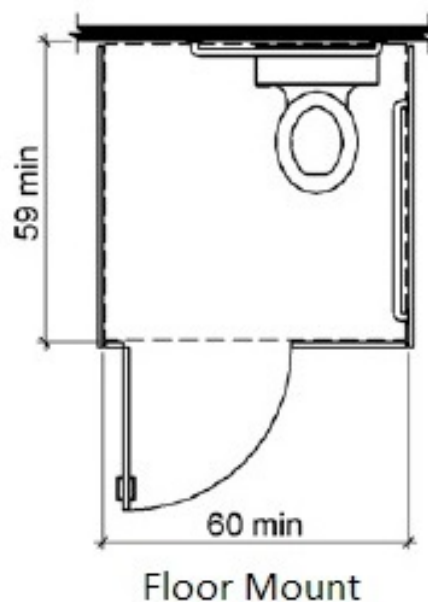
Accessible toilet compartment is 43" wide

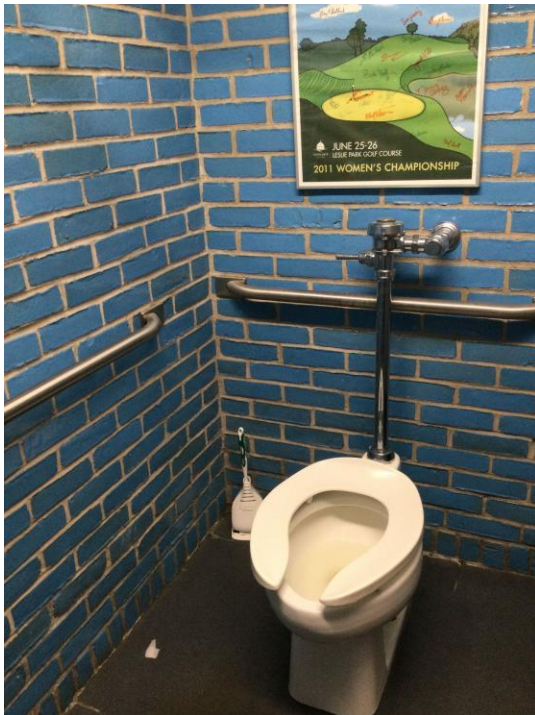
Toilet is centered at 24" from the side wall.

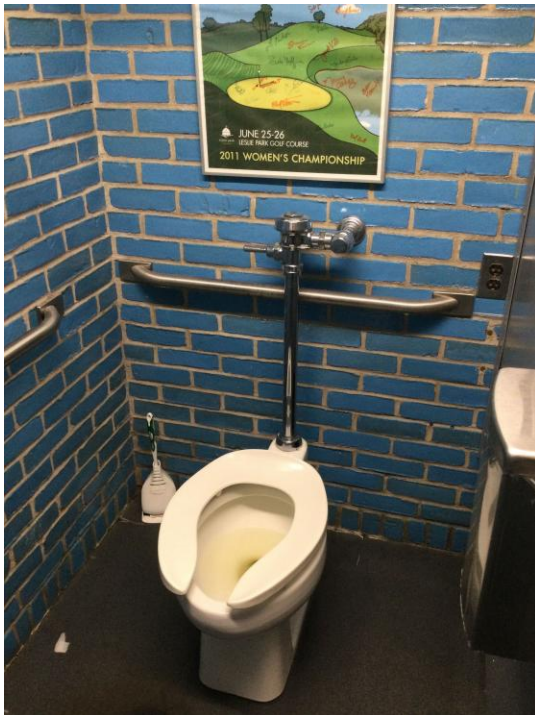
Flush valve not to the open side

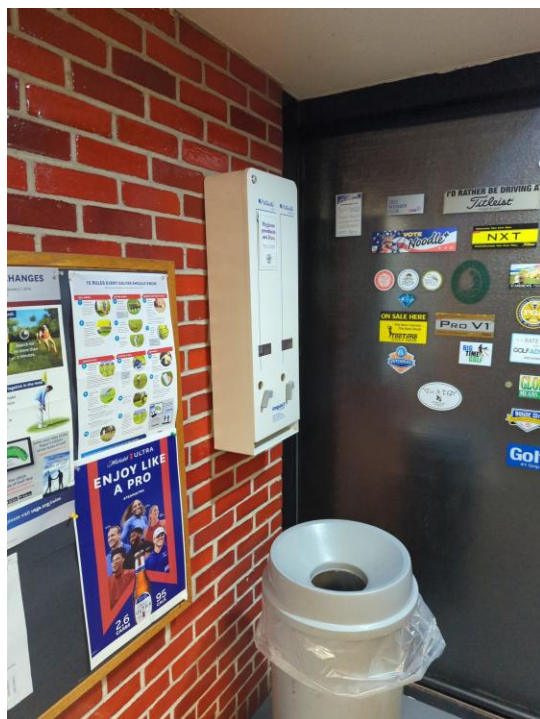
Feminine product dispenser in men's restroom protrudes 6 inches
