Site Accessibility Evaluation

Allmendinger Park
655 Pauline Blvd
Ann Arbor, MI 48104
ADA Only

Inspection Date: 07/11/2022

Report Date: 11/15/2022

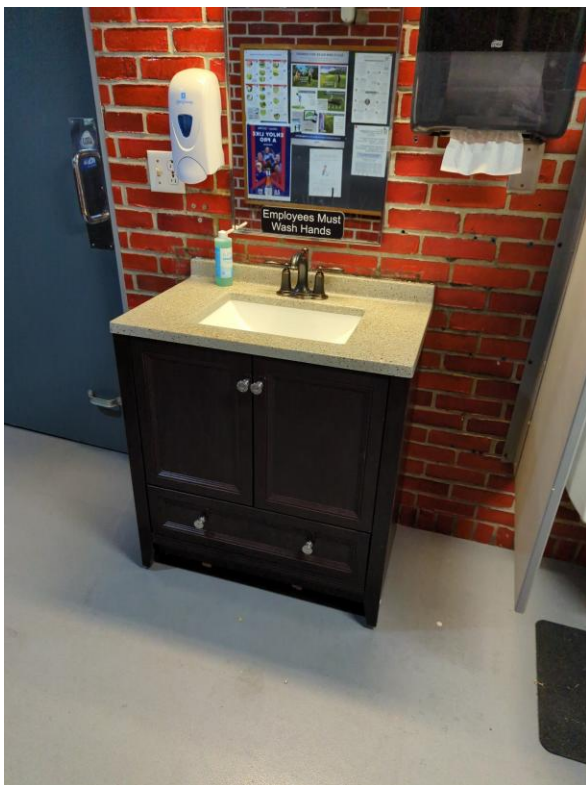
Clear floor space for a forward approach is not provided

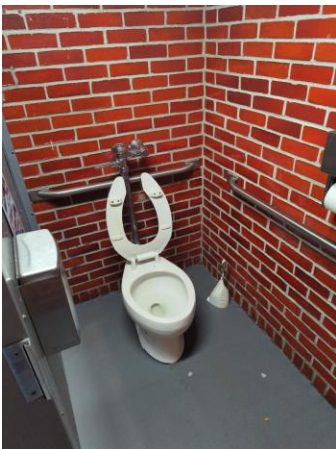
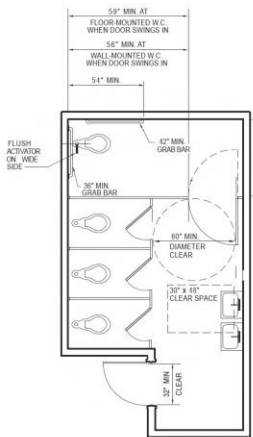
Toilet stall is not accessible

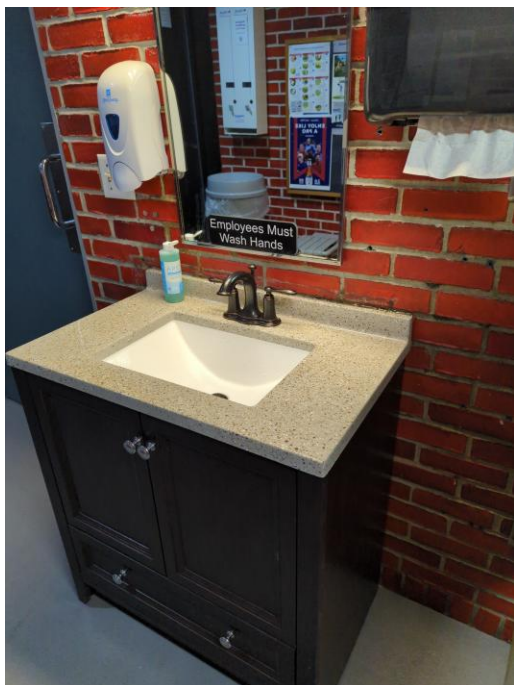
Mirror is 40-1/2 inches high to the reflective surface

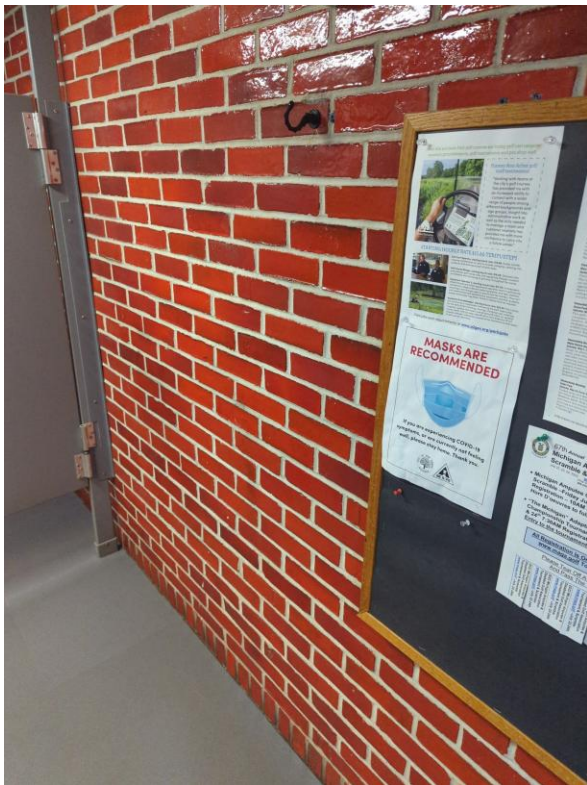
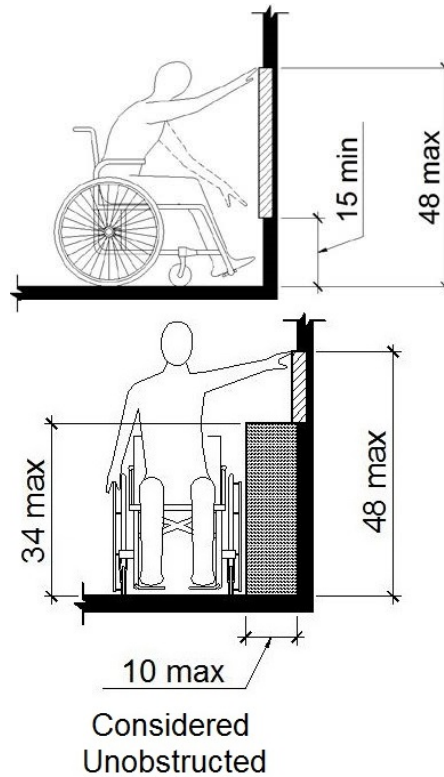
Coat hook is 63 inches high

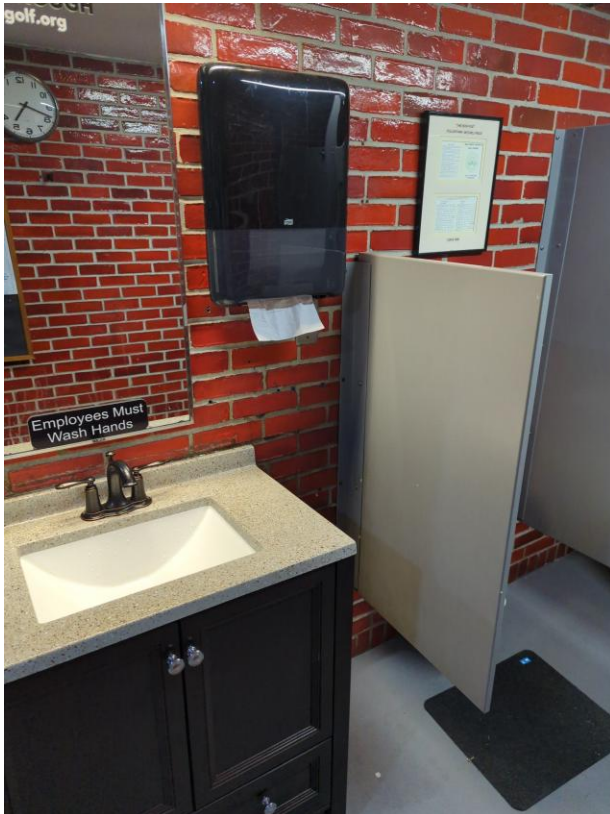
Paper towel dispenser is 50 inches high

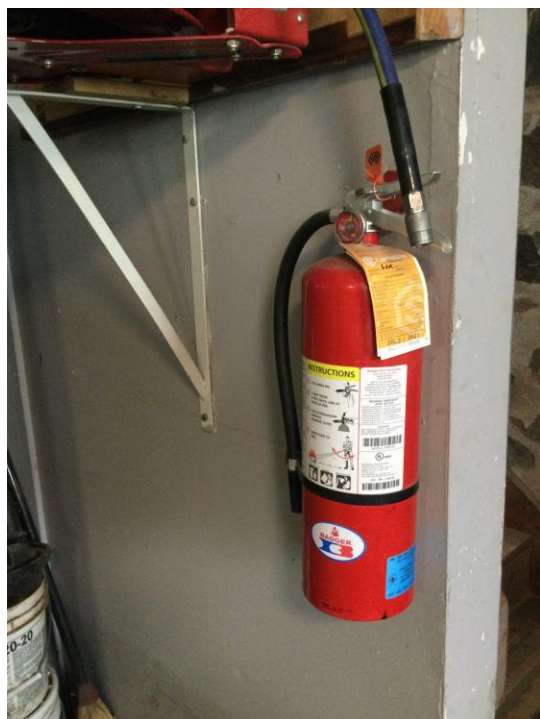
Fire extinguisher protrudes more than 4 inches

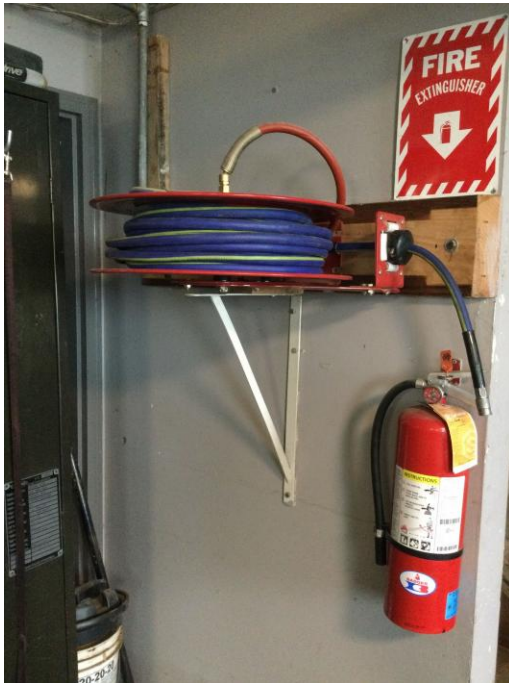
Hose winder protrudes more than 4 inches lower than 80 inches from the floor.

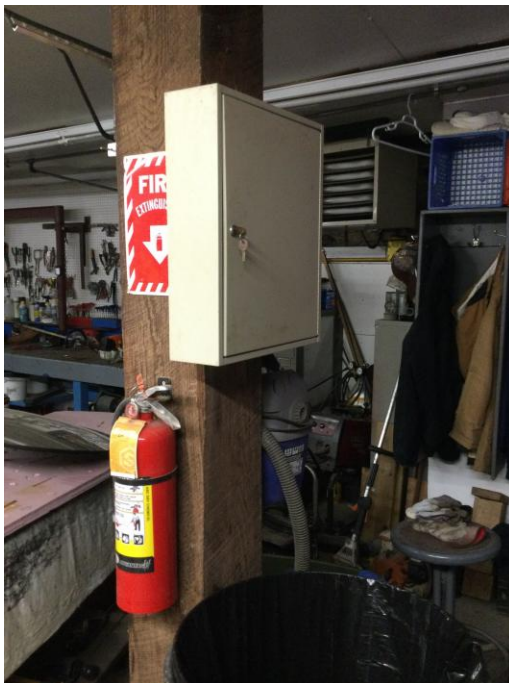
Utility box protrudes more than 4 inches at less than 80 inches from the floor.

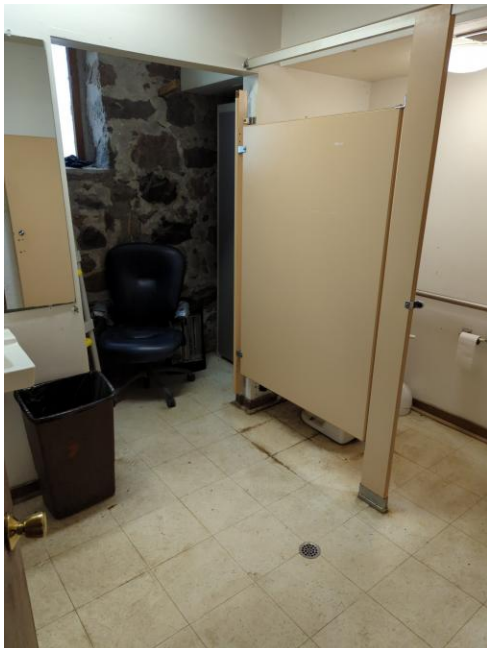
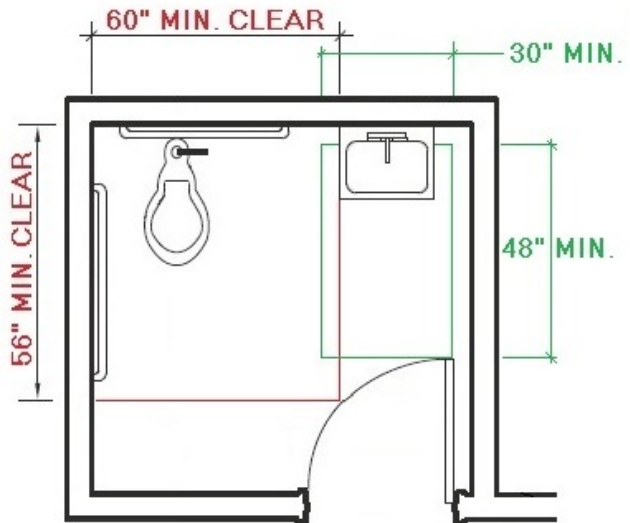
The restroom does not have the required minimum clear floor space or maneuvering clearances for the toilet. The restroom does not have the required minimum clear floor space or maneuvering clearances for the lavatory. The entry door does not contain the required minimum maneuvering spaces on the pull/push sides. The entry door encroach into the required clear floor space for fixtures. Grab bars are missing and/or incorrectly installed. Accessories, such as toilet seat covers, paper towel holders, garbage cans, hand dryers, and mirrors are either too high or without clear floor space or both.

Restroom in workshop is not accessible

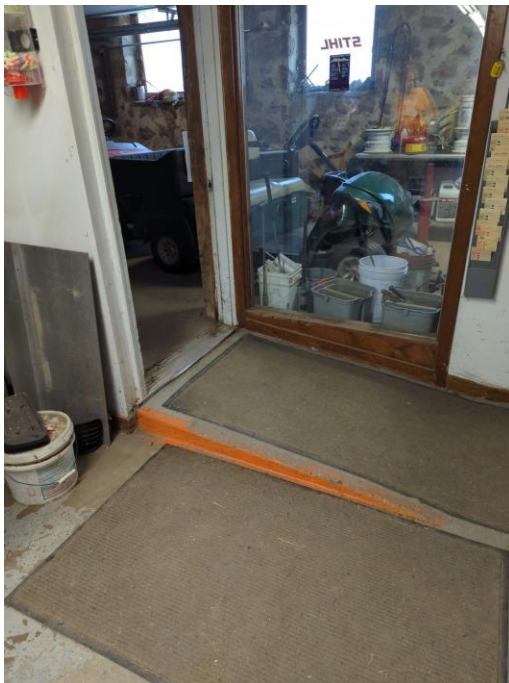
Door has a ramp in the maneuvering clearance

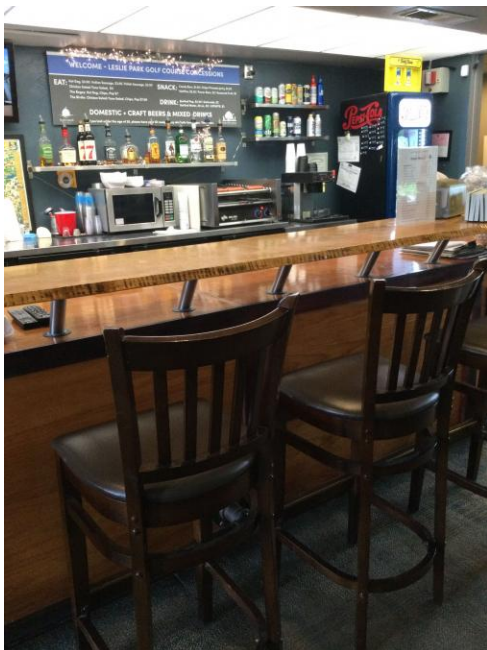
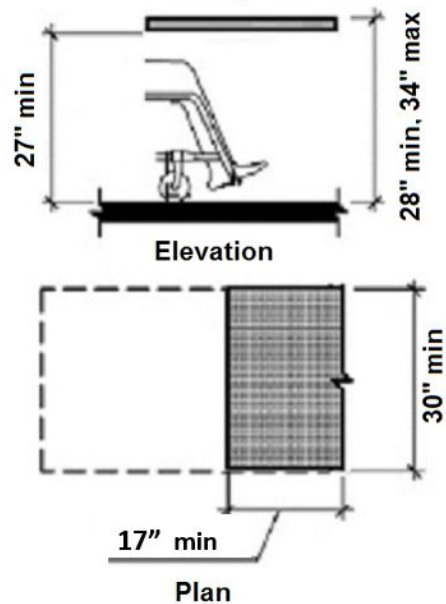
All dining surfaces must have a compliant seating space

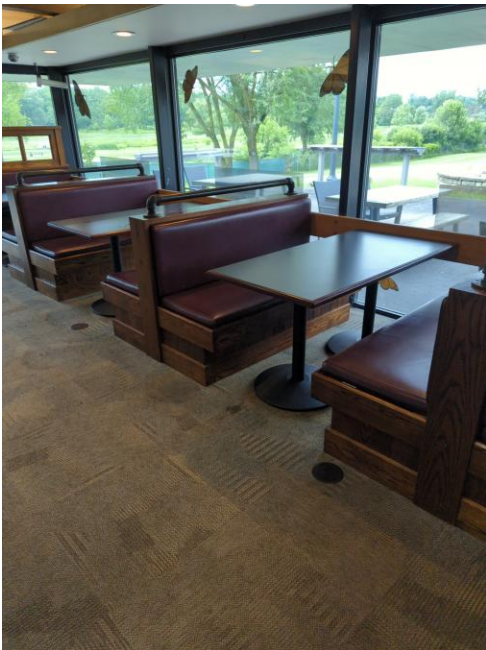
4 dining tables do not provide accessible seating

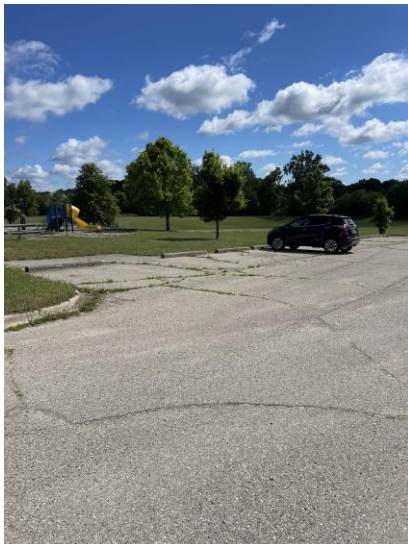
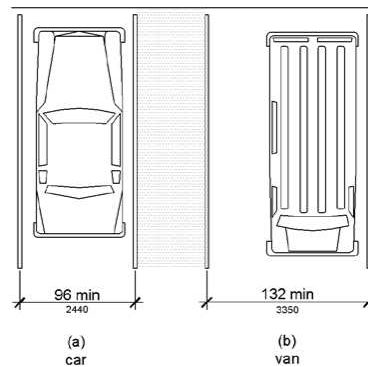
Two accessible spaces provided. Surface slopes greater than 2%, no striping, no signs.

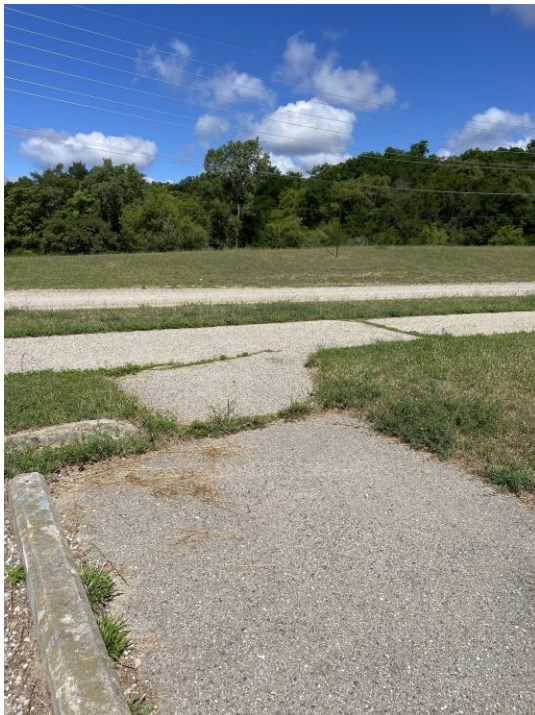
Running slope greater than 5%

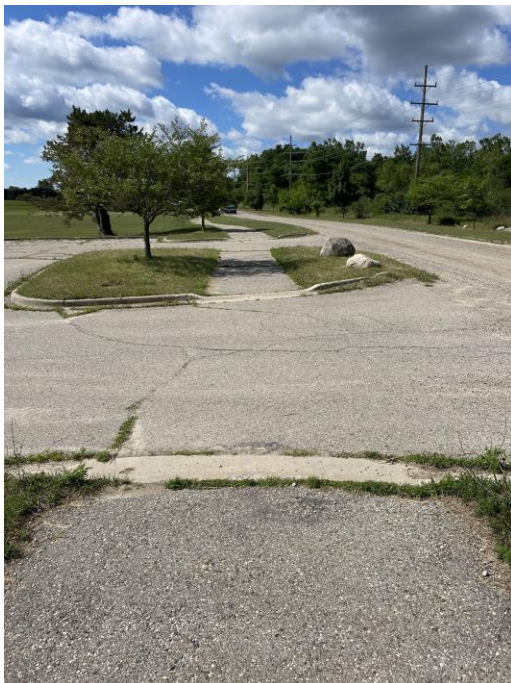
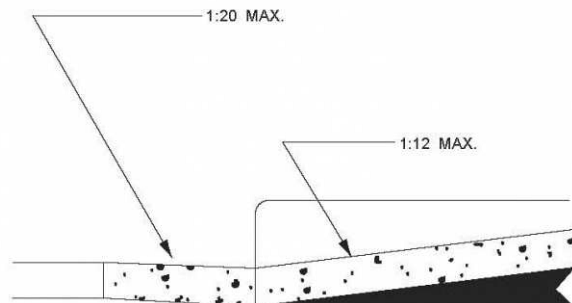
Gutters not flush against the curb ramps

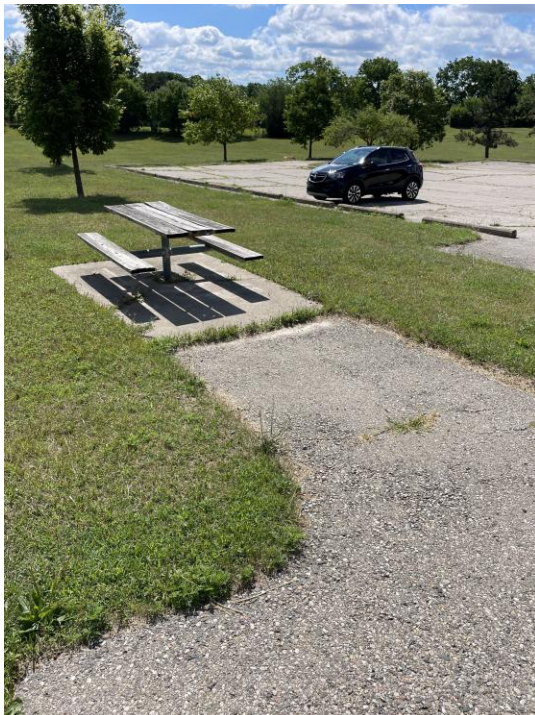
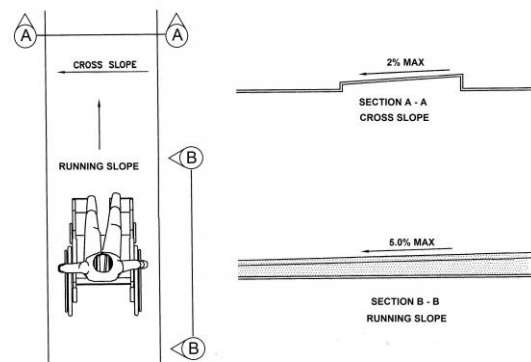
Route to the picnic table has a running slope greater than 5%.

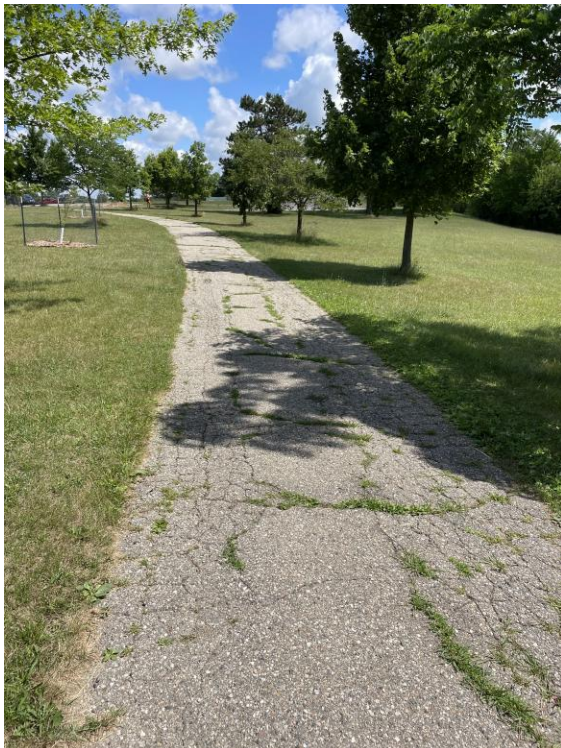
Excessive cross slope; greater than 2%

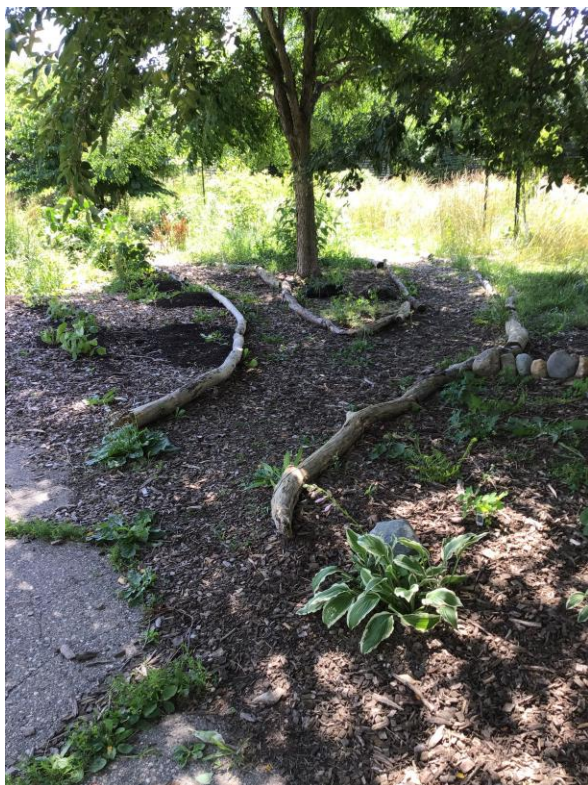
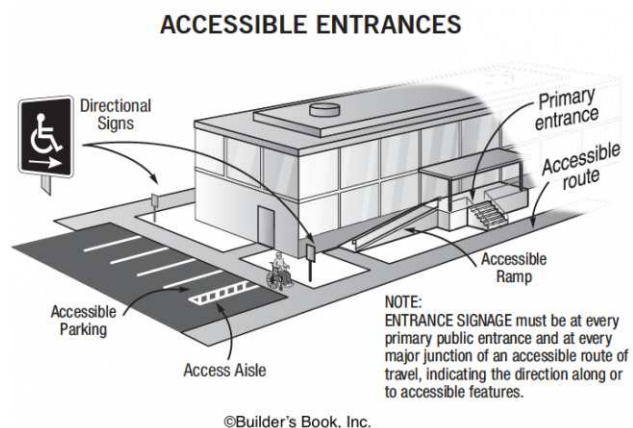
No accessible route to the food forest.

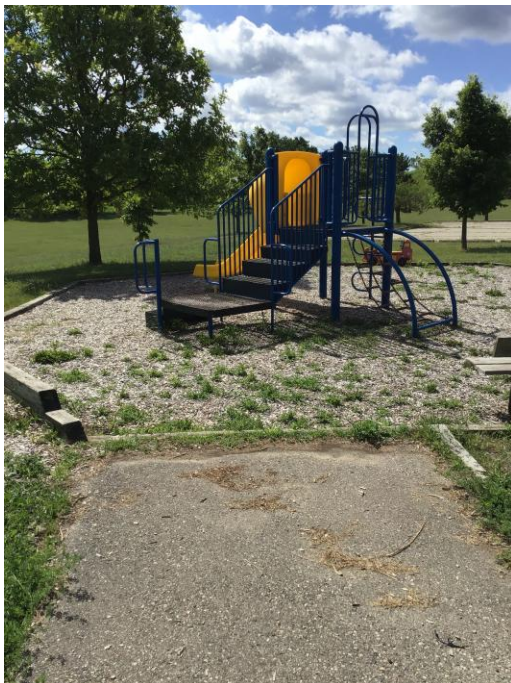
Vertical change greater than 1/2-inch at entrance to play area

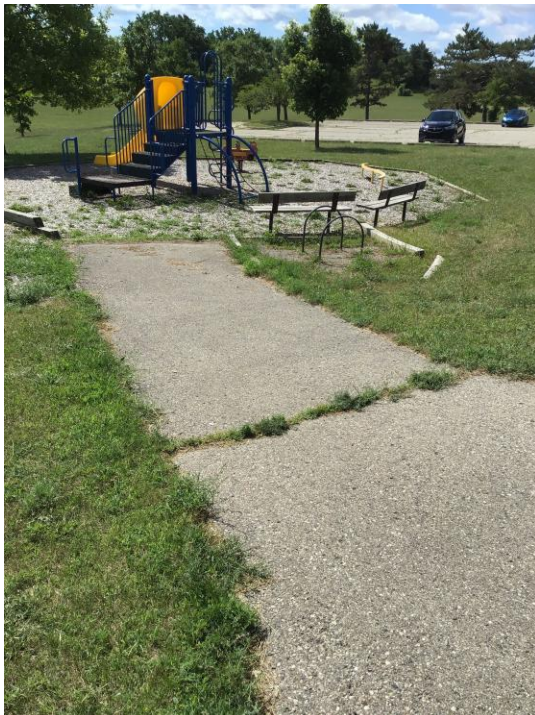
Route to play area has a running slope that exceeds 5%.

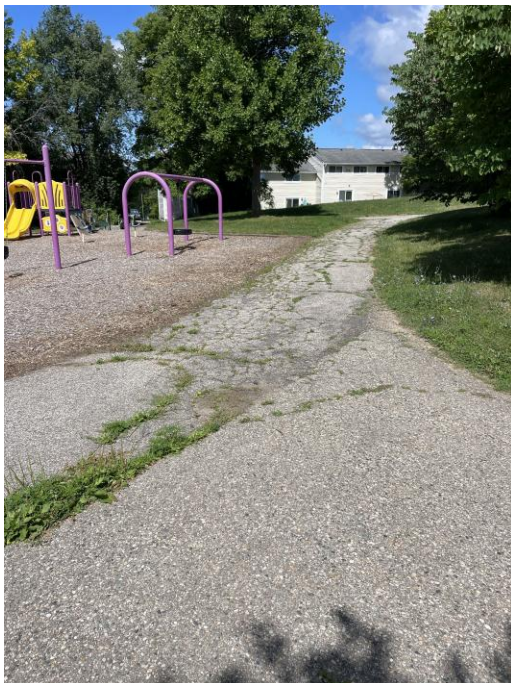
Route around playground has cross slopes greater than 2%, running slopes greater than 5%, and openings greater than 1/2-inch.

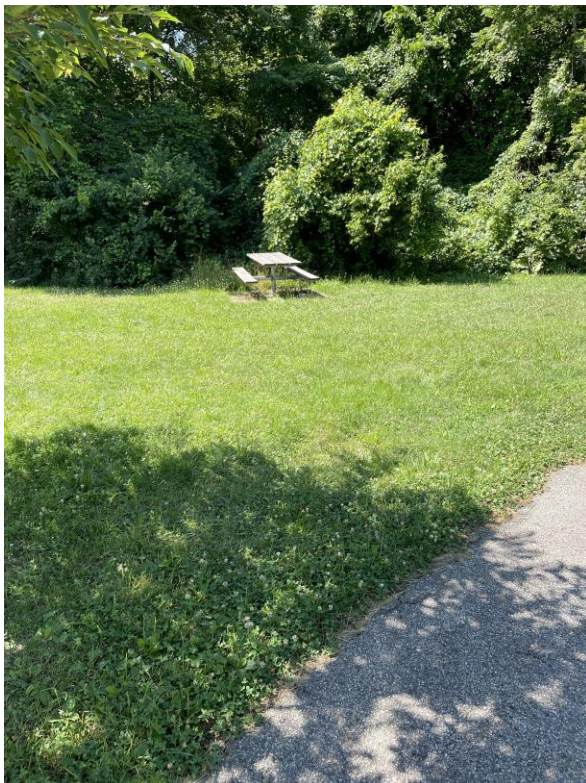
No route to picnic table is provided

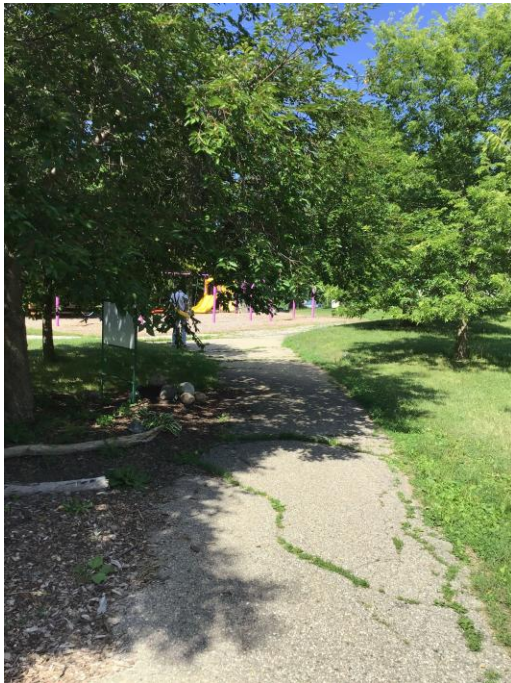
Tree to play area is a protruding object.

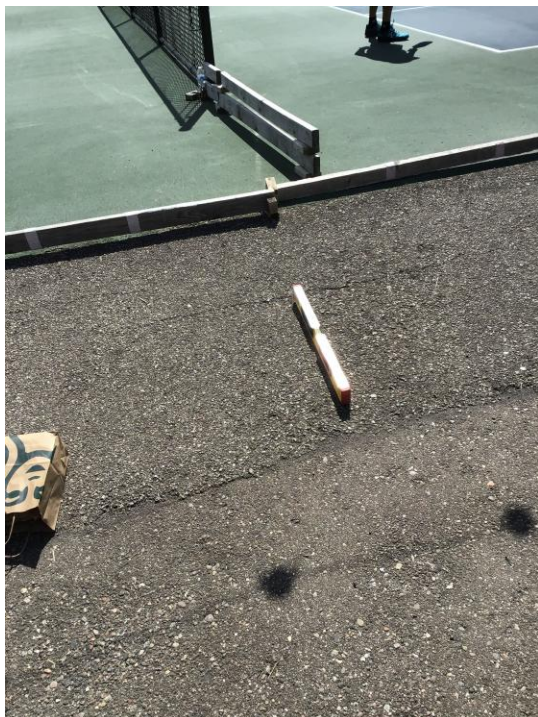
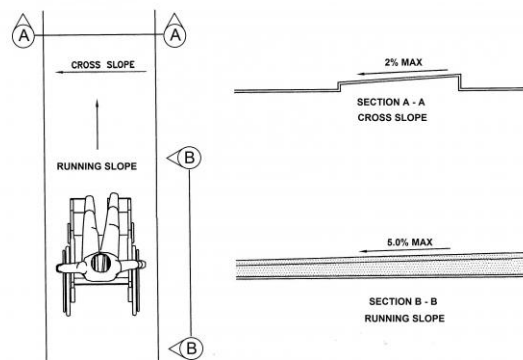
Slope at entrance to courts is approximately 10%.

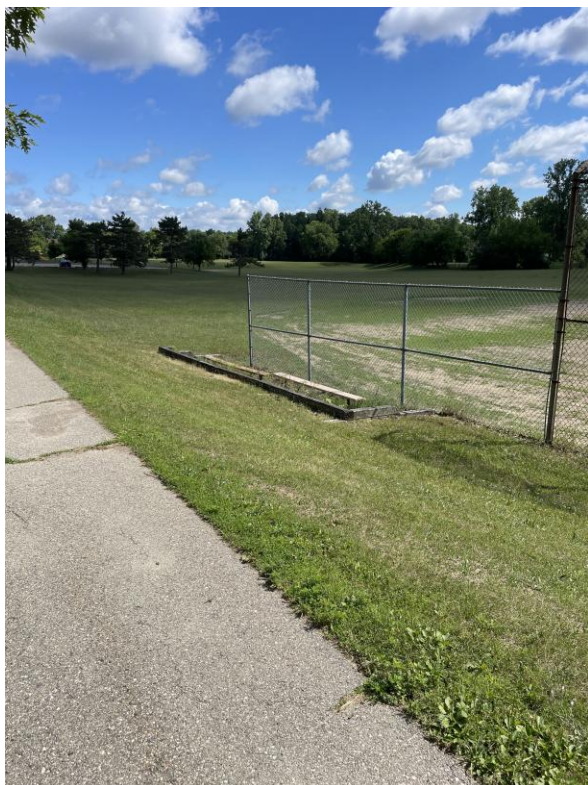
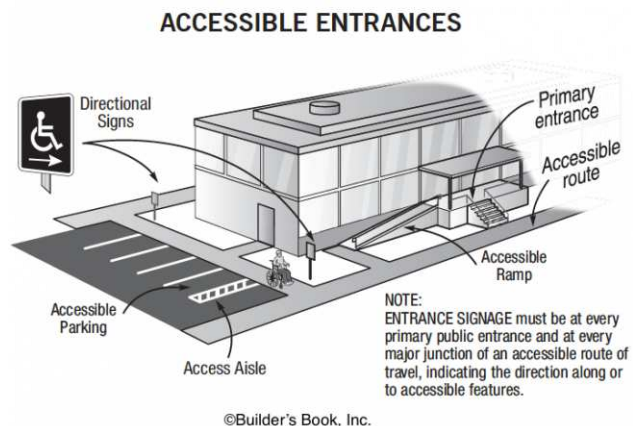
No route to baseball dugout

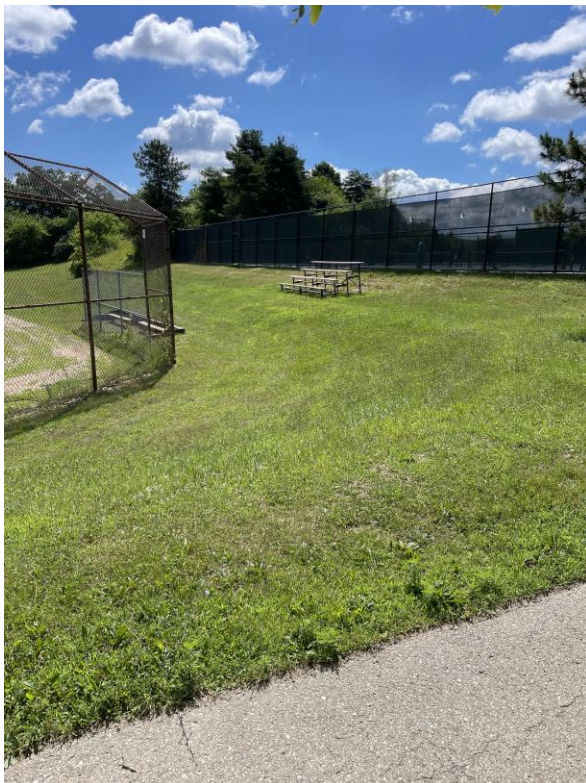
No route to dugout and bleachers

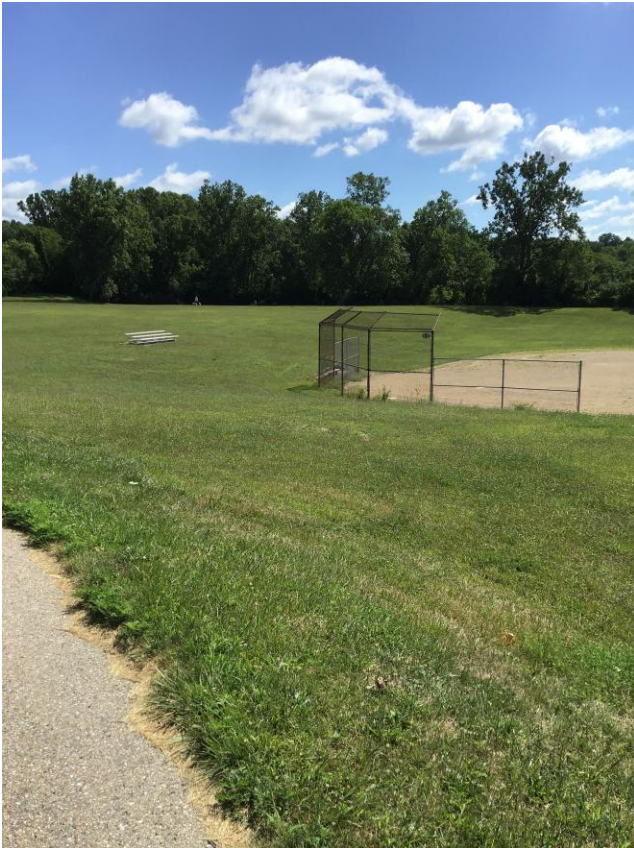
No accessible route to court, seating, dugouts.

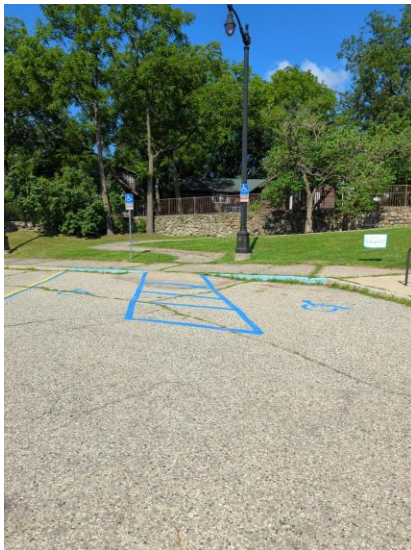
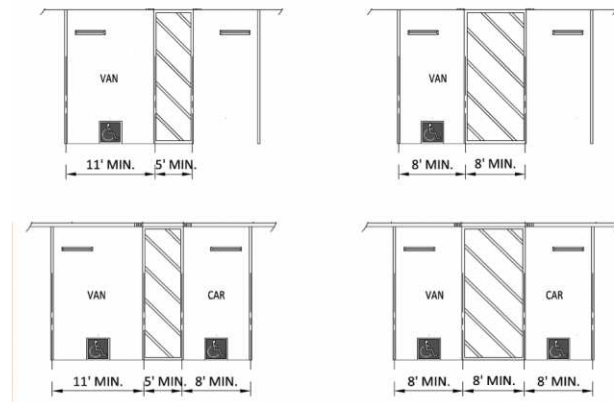
Accessible parking stall on right is only 10 feet wide

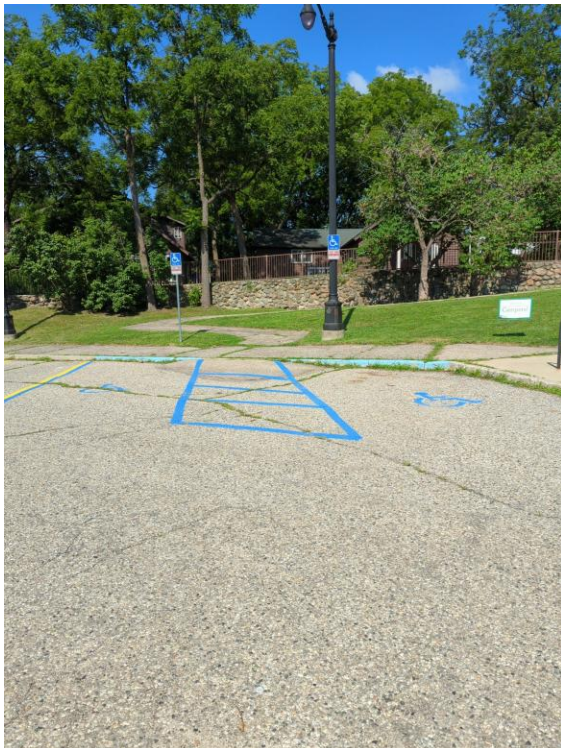
The van stall is missing a sign identifying it as a van accessible stall.

Accessible parking stall on right does not have a van accessible sign

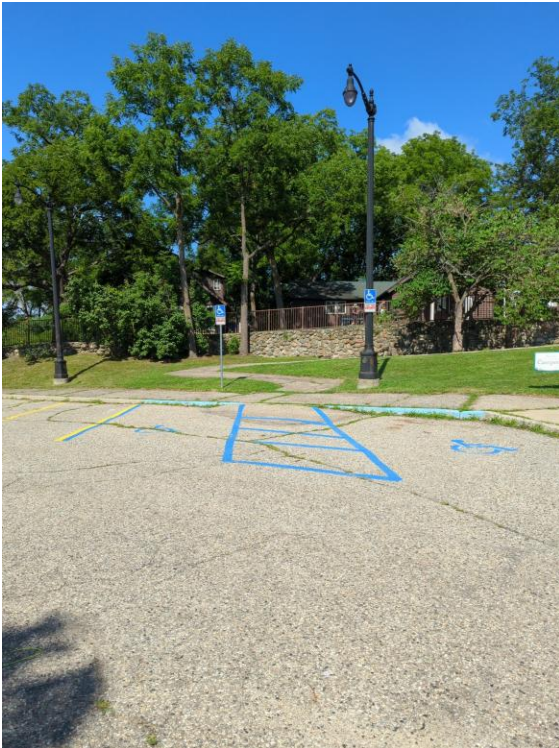
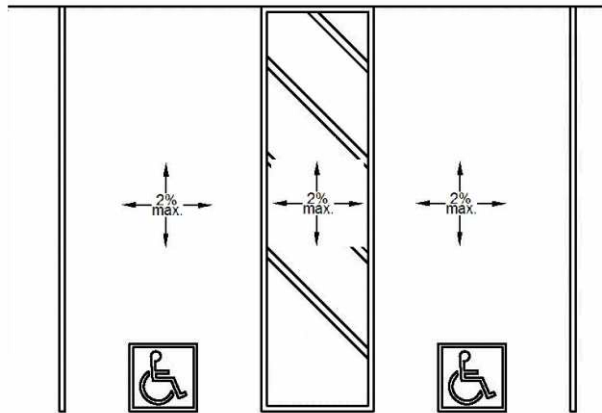
Curb ramp is inside the access aisle

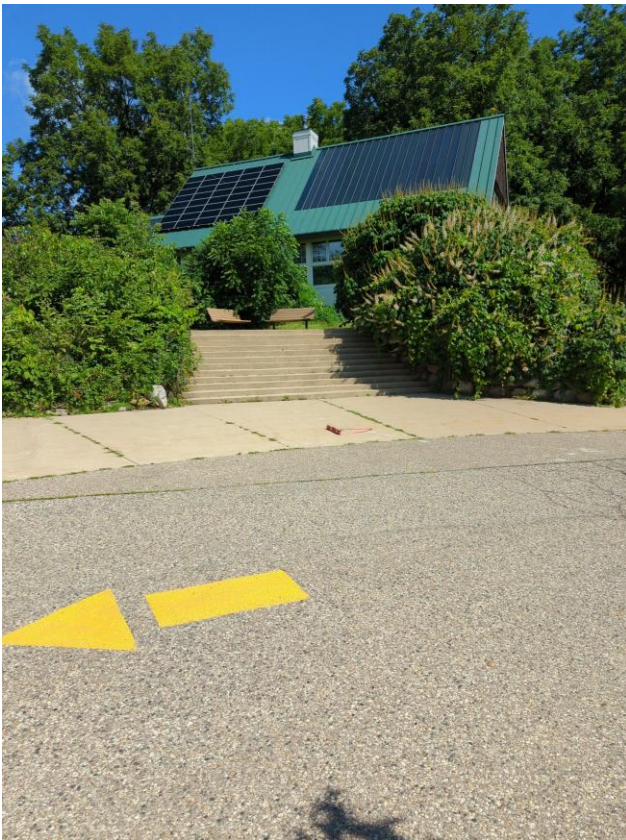
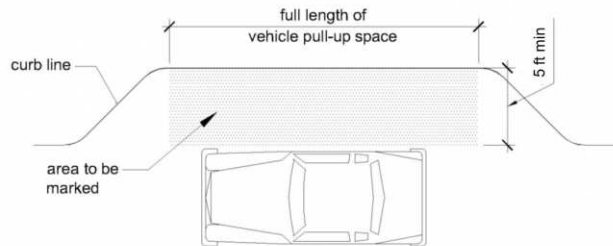
There is no markings at the drop-off zone

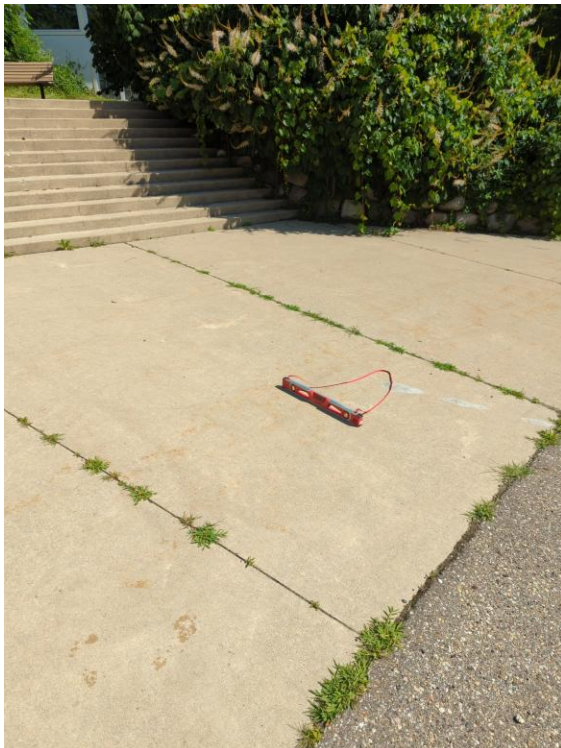
Sidewalk next to drop off zone has a cross slope of up to 5%

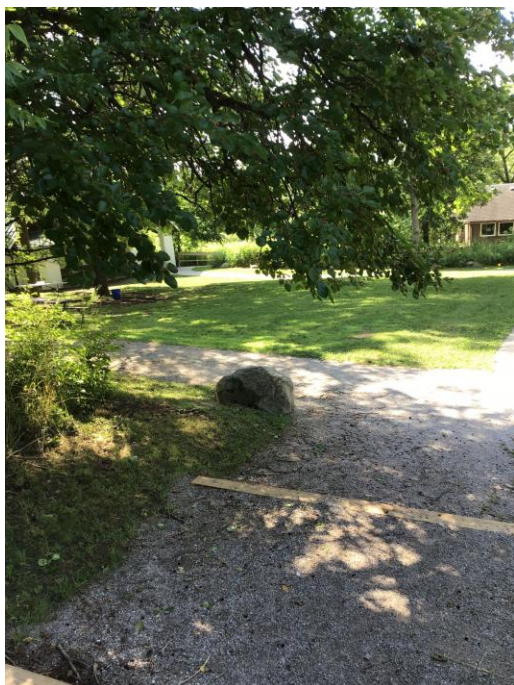
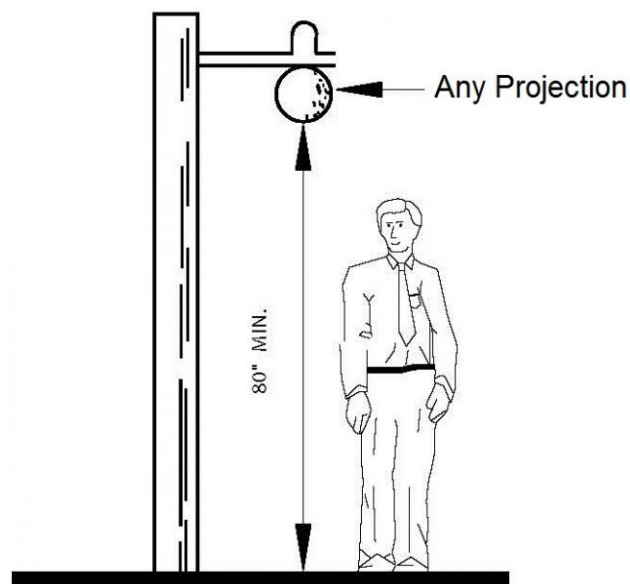
Tree is a protruding object.

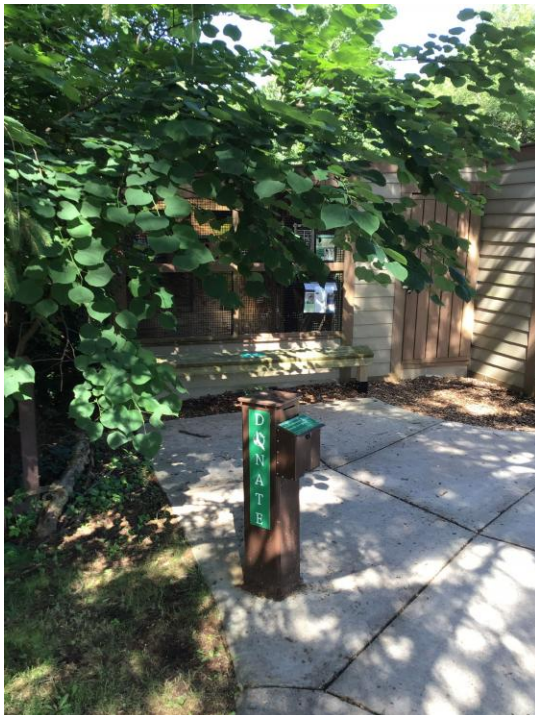
Tree is a protruding object at animal display.

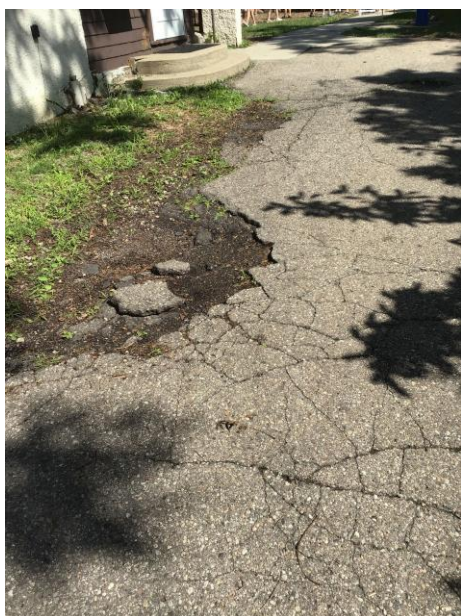
Asphalt surface has areas that are not accessible.

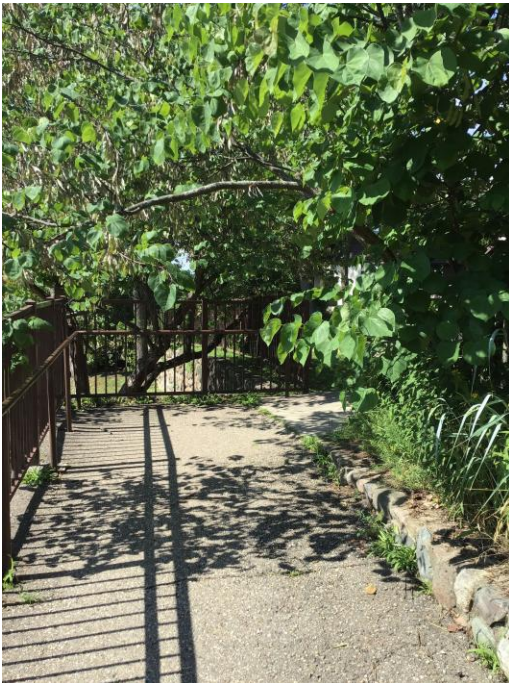
Tree is a protruding object.

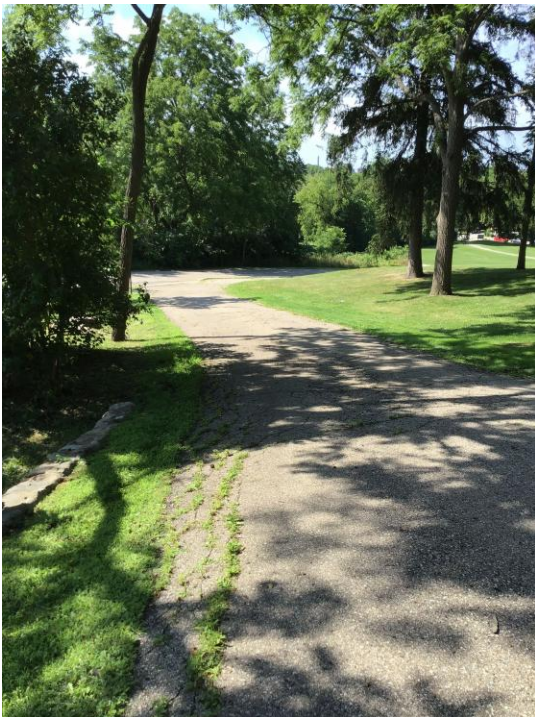
Asphalt trail exceeds 5% from ROW to site.

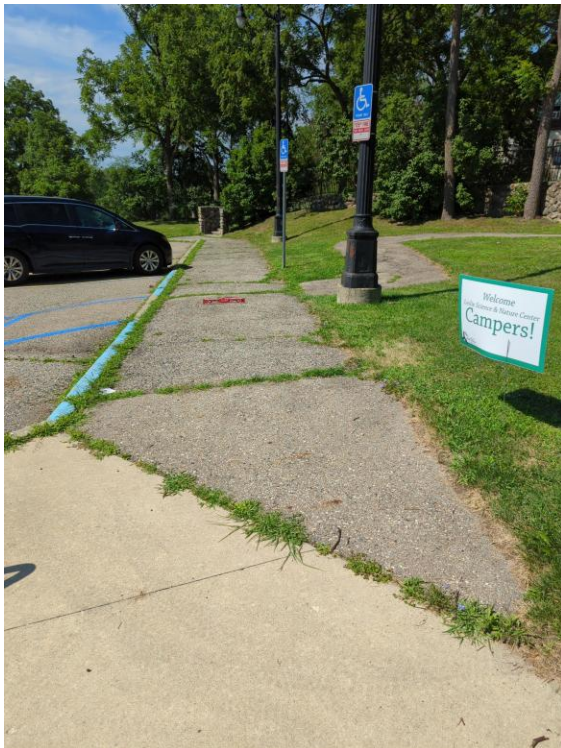
Path in front of accessible parking has a cross slope of up to 7%

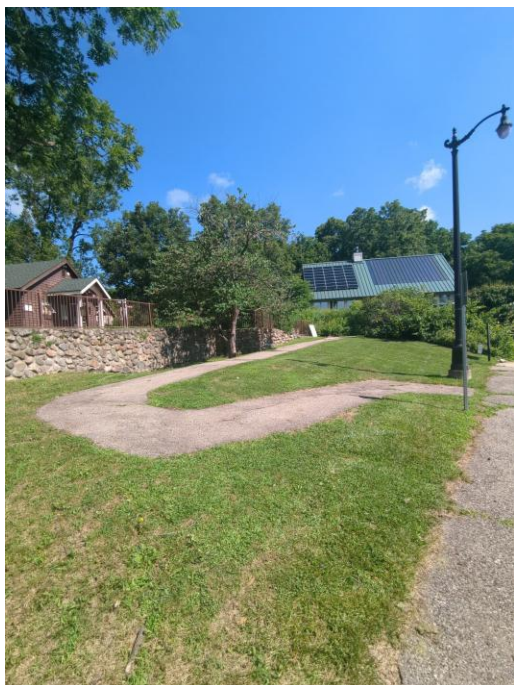
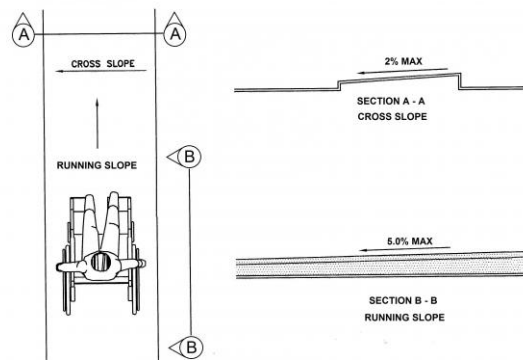
Path from parking to Walnut house has running slopes greater than 5% and cross slopes greater than 2%

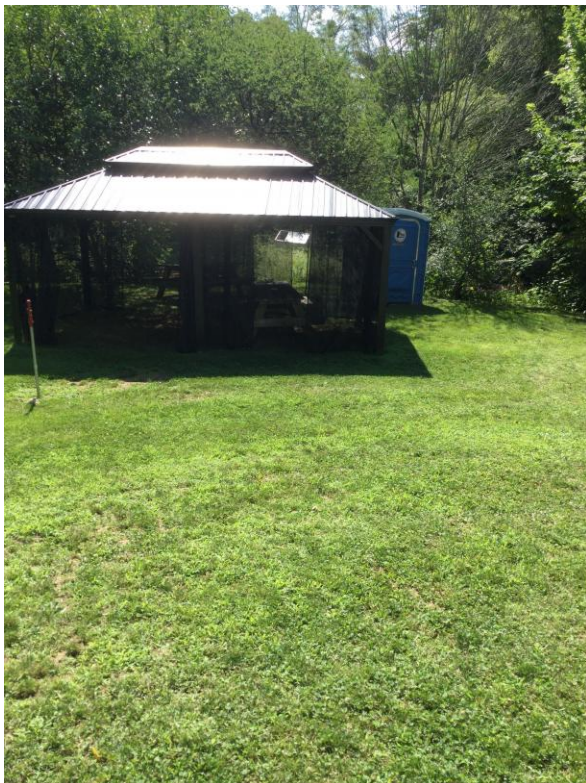
No accessible route to gazebo

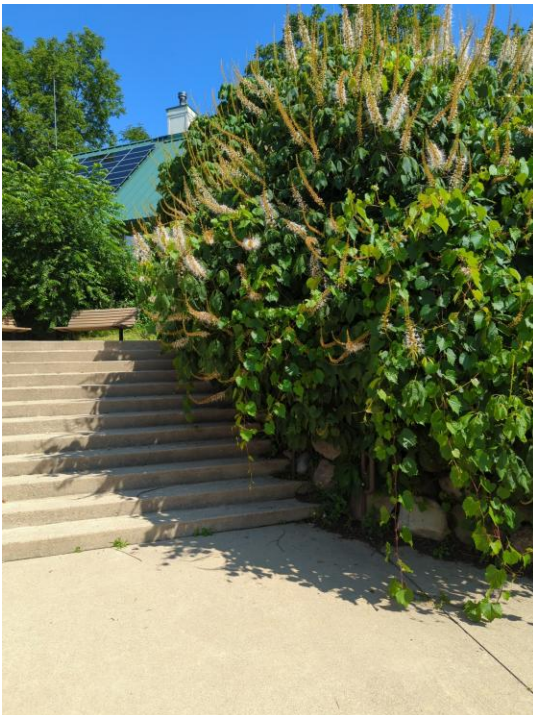
Wall-mounted objects that have leading edges between 27 inches and 80 inches from the floor must not project more than 4 inches into the circulation path. Protruding objects that extend to the floor or within 27 inches of the floor are cane detectable and are therefore not hazardous. Where it is necessary or desirable to have objects protrude from the wall, a manner of cane detection must be provided.

Vegetation protrudes into the main stairs

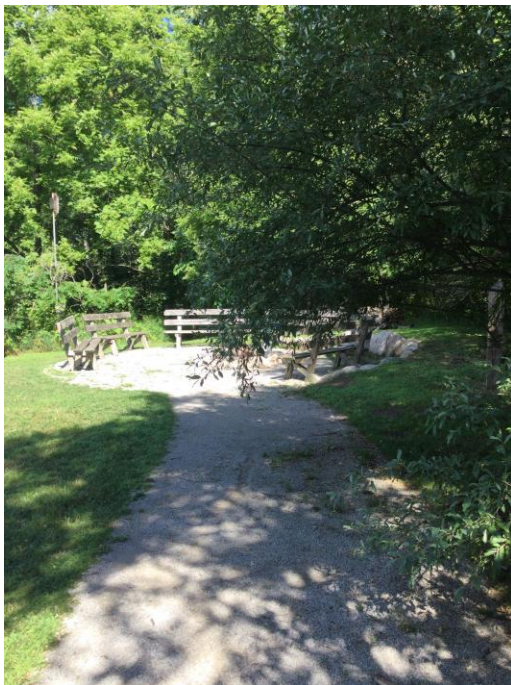
Tree branches obstruct circulation path

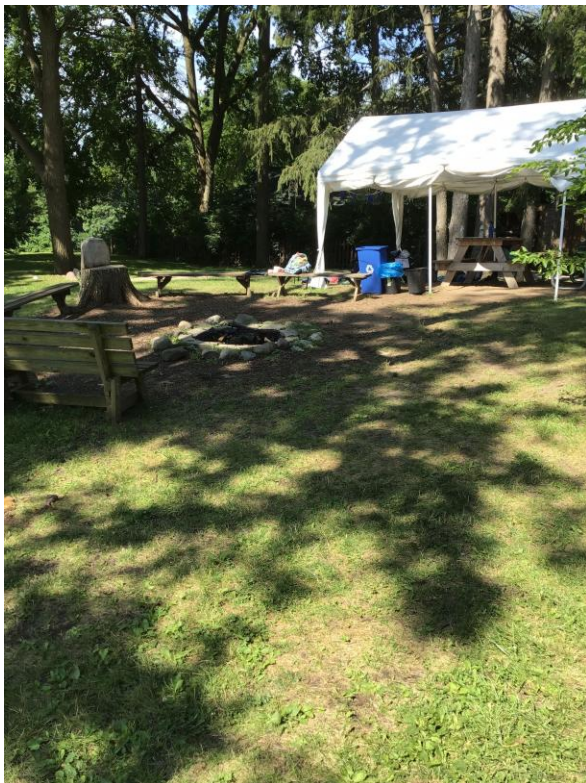
No accessible route to fire pit.

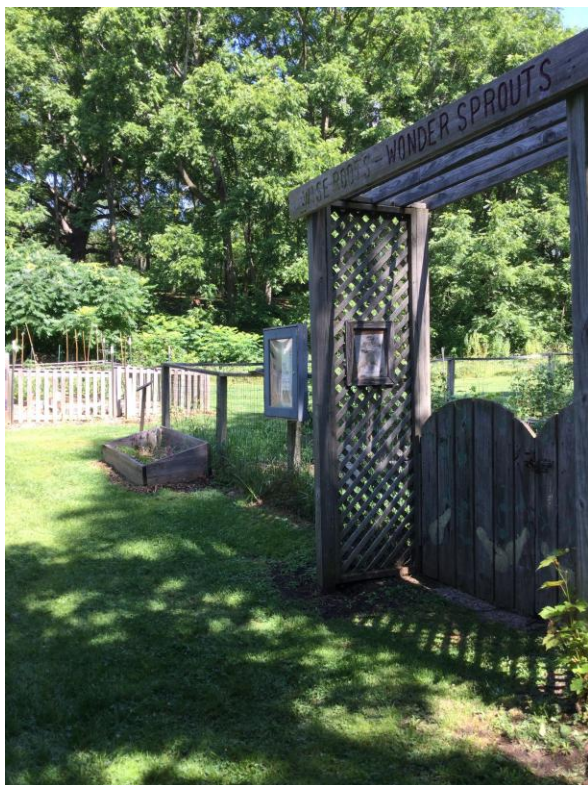
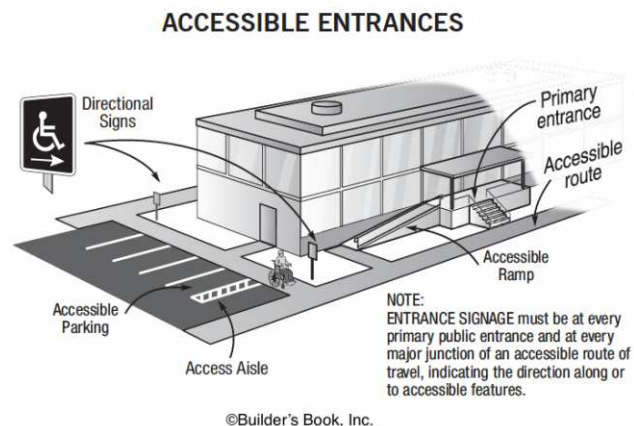
No accessible route to the garden

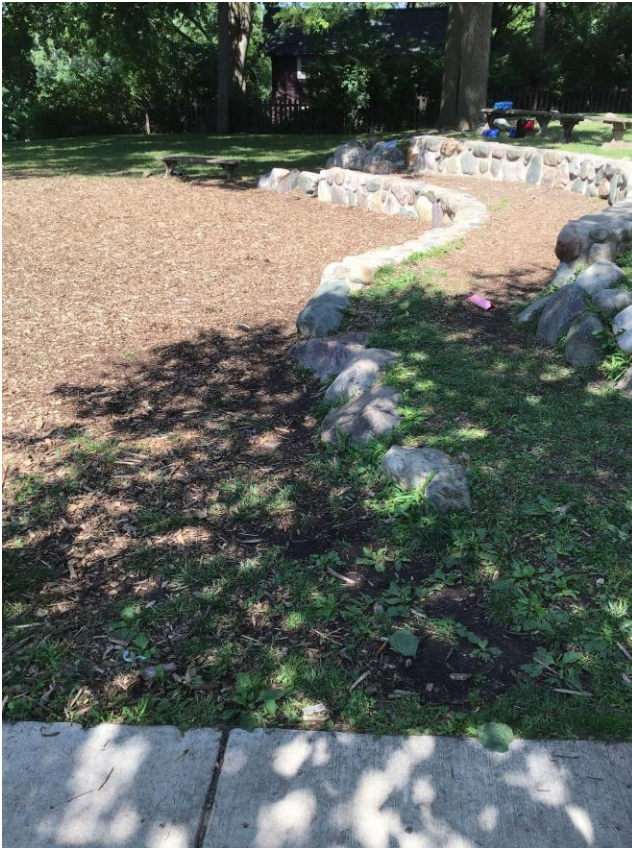
Surface of accessible seating is dirt and mulch.

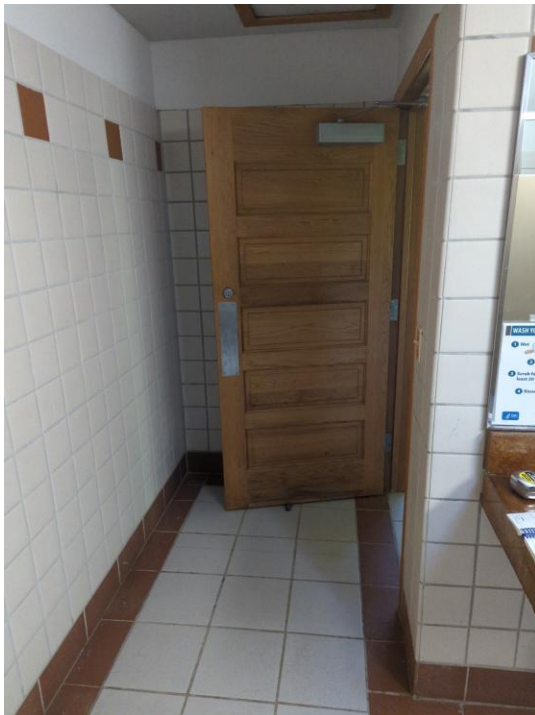
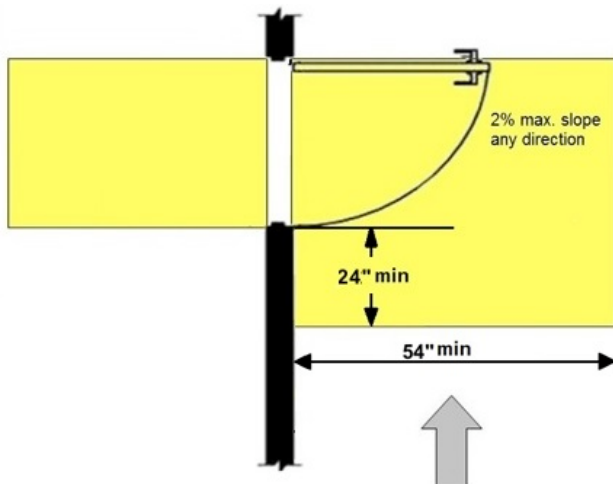
Maneuvering clearance is 47 inches
