Site Accessibility Evaluation

Allmendinger Park
655 Pauline Blvd
Ann Arbor, MI 48104
ADA Only

Inspection Date: 07/11/2022

Report Date: 11/15/2022

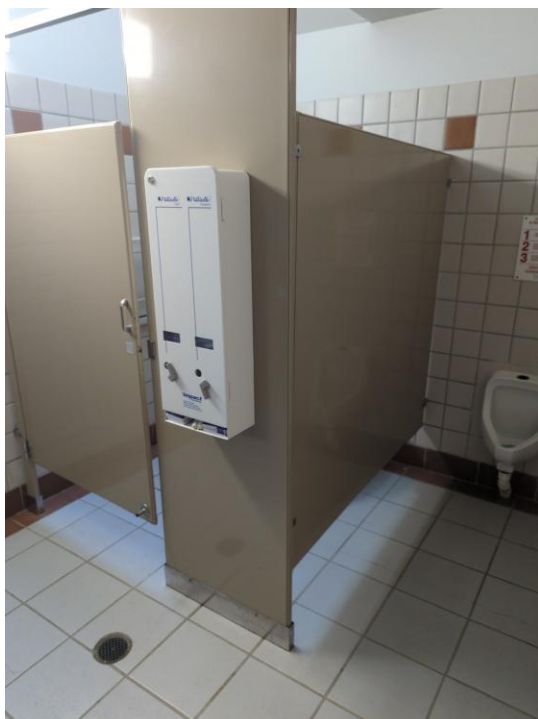
Wall-mounted objects that have leading edges between 27 inches and 80 inches from the floor must not project more than 4 inches into the circulation path. Protruding objects that extend to the floor or within 27 inches of the floor are cane detectable and are therefore not hazardous. Where it is necessary or desirable to have objects protrude from the wall, a manner of cane detection must be provided.

Feminine product dispenser in men's restroom protrudes 6 inches

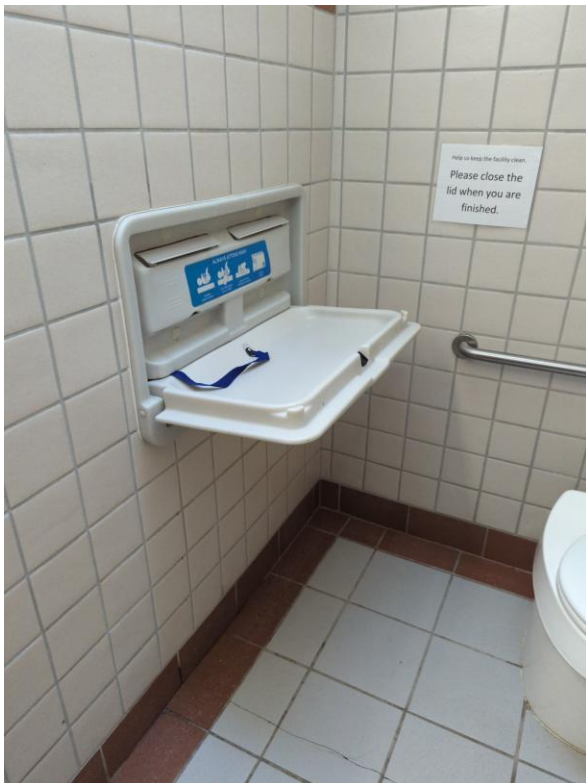
Baby changing table is 40 inches high

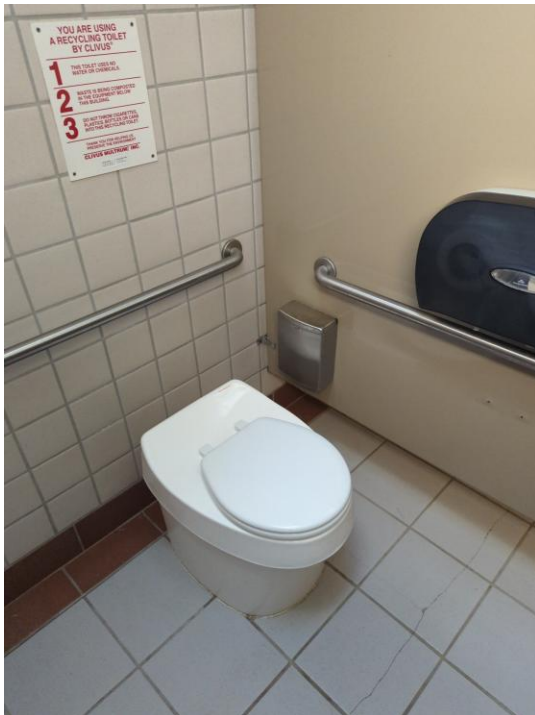
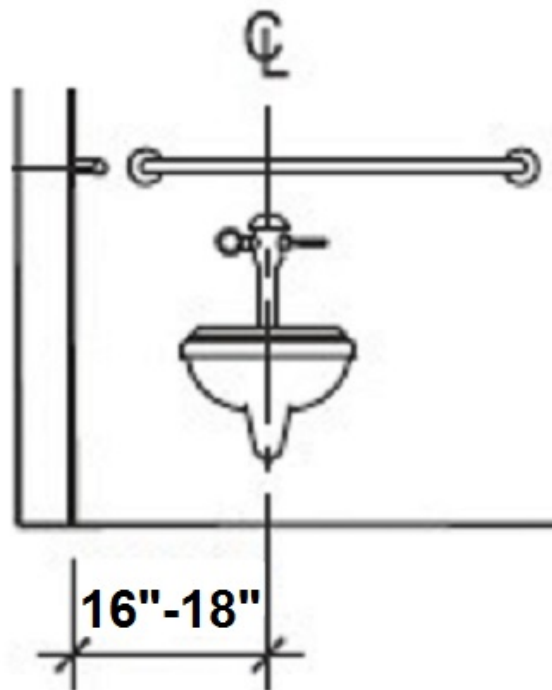
Water closet is centered at 19 inches

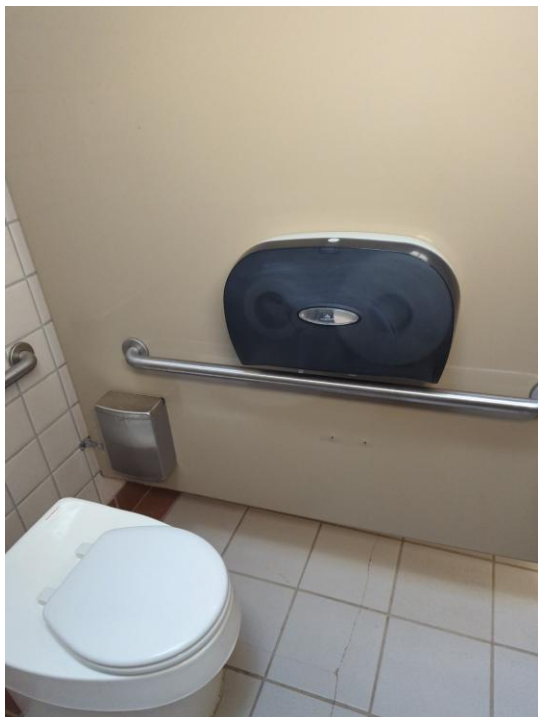
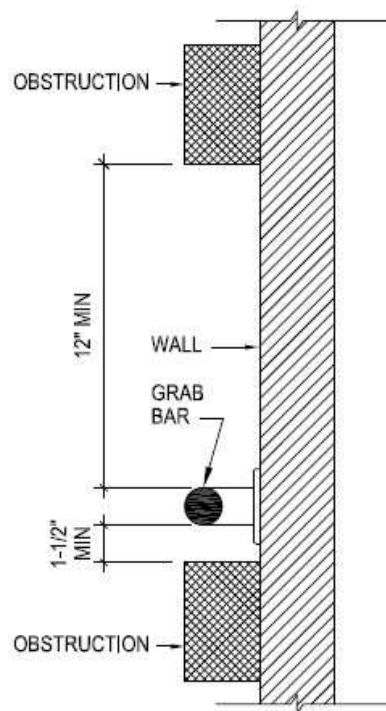
Toilet paper dispenser is 1-1/2 inches above side wall grab bar

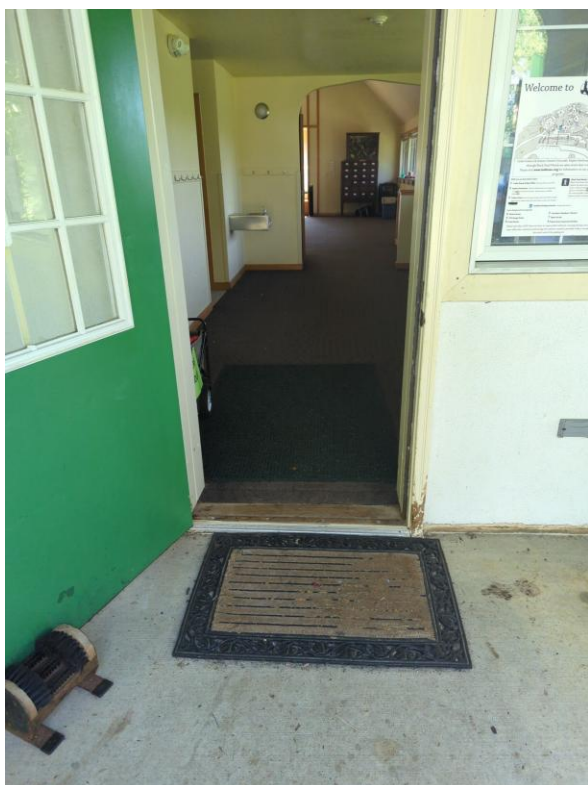
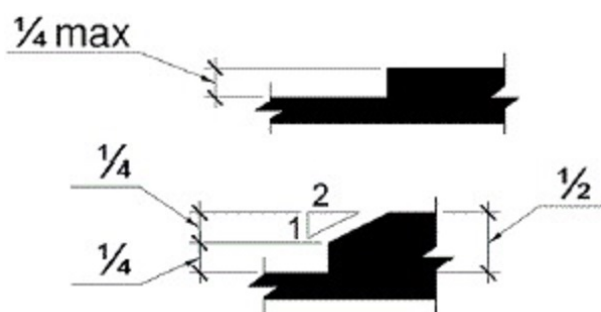
Threshold is 2 inches high

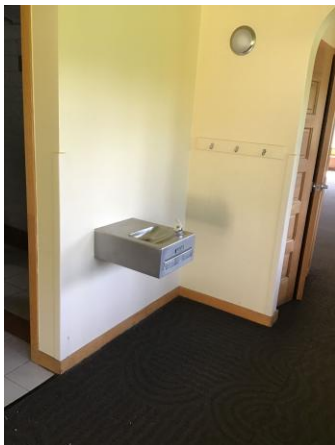
Only one drinking fountain.

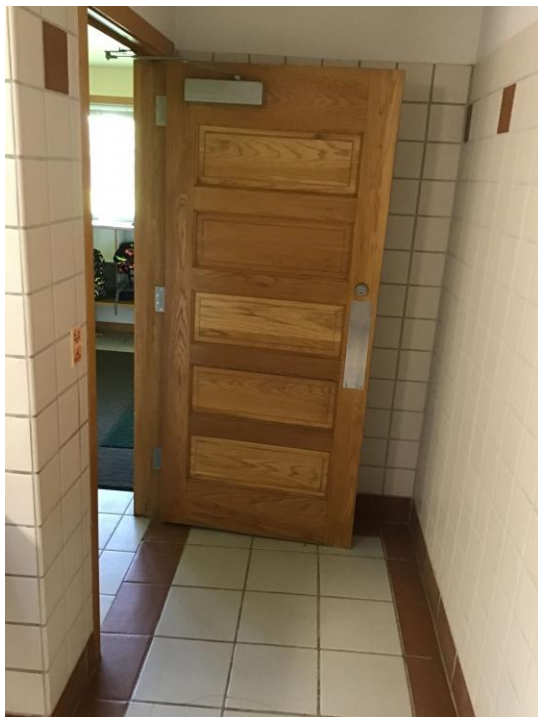
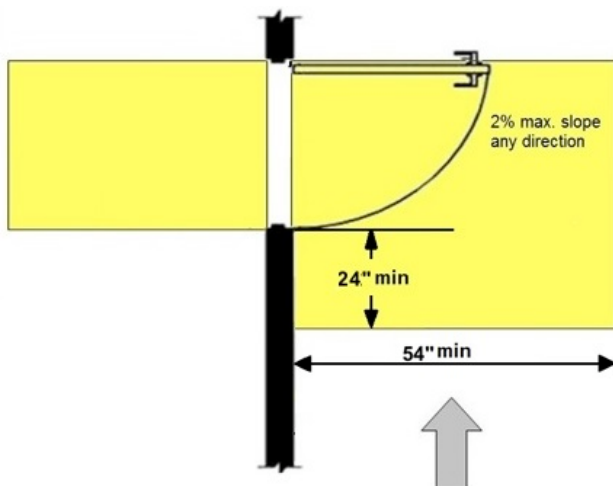
Perpendicular distance of 47 inches.

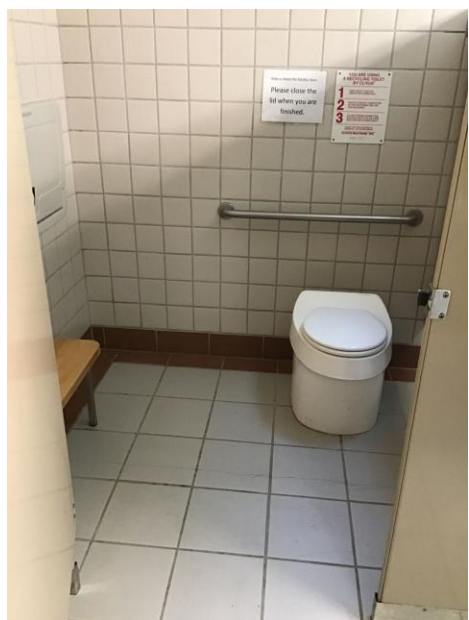
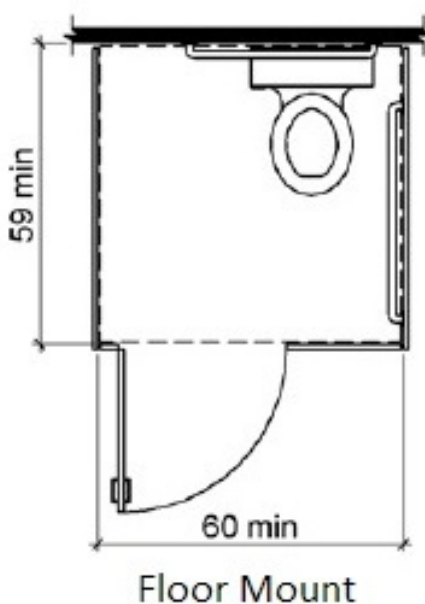
Permanent bench protrudes into clear space.

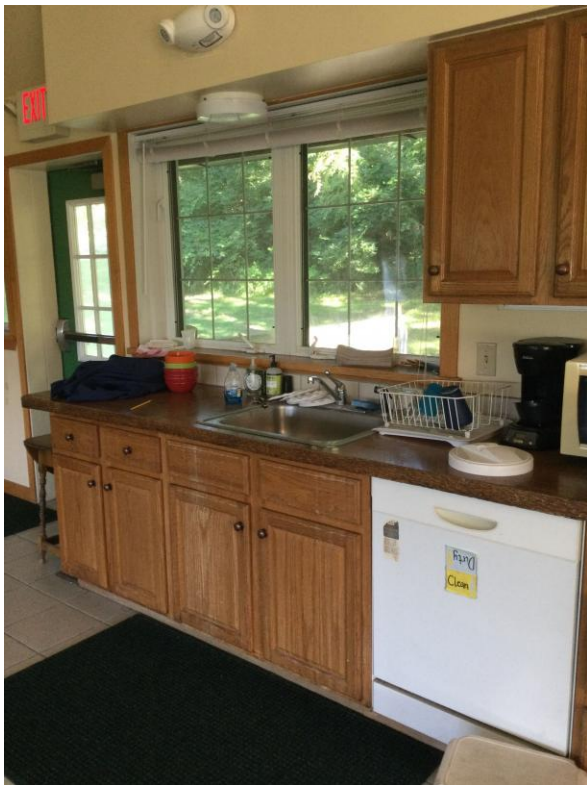
Sink rim is 36" high

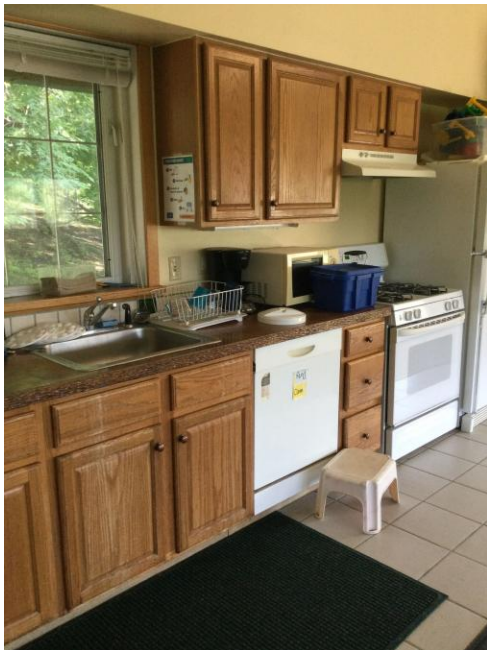
Sink does not have vertical knee clearance

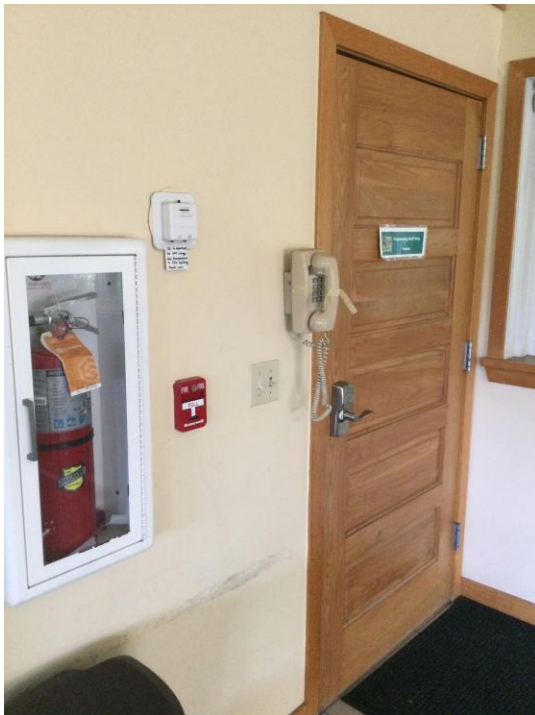
Wall-mounted objects that have leading edges between 27 inches and 80 inches from the floor must not project more than 4 inches into the circulation path. Protruding objects that extend to the floor or within 27 inches of the floor are cane detectable and are therefore not hazardous. Where it is necessary or desirable to have objects protrude from the wall, a manner of cane detection must be provided.

Phone protrudes 7" from wall

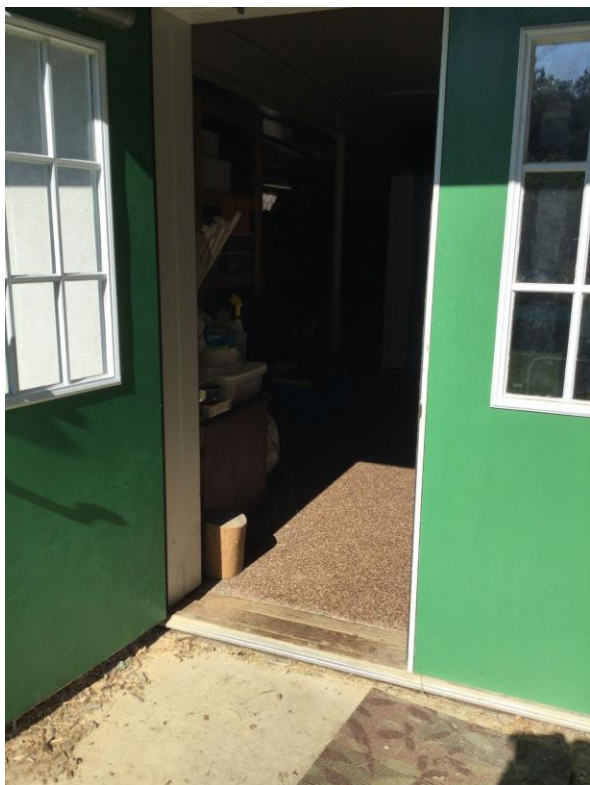
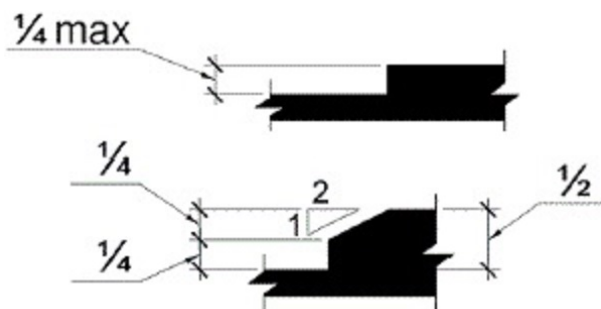
Door has a 2" threshold

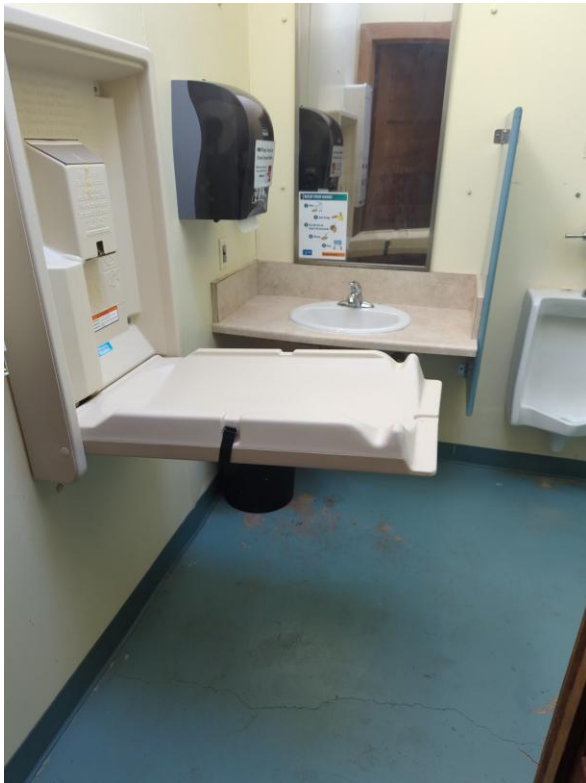
Baby changing table is up to 36 inches high

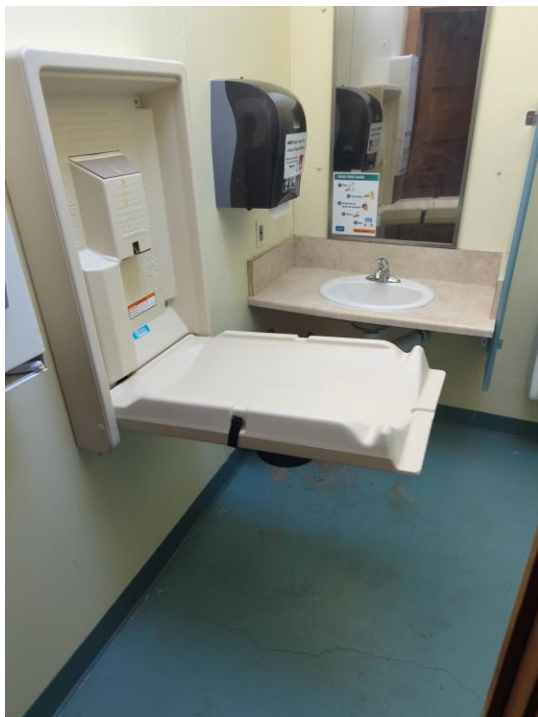
Wall-mounted objects that have leading edges between 27 inches and 80 inches from the floor must not project more than 4 inches into the circulation path. Protruding objects that extend to the floor or within 27 inches of the floor are cane detectable and are therefore not hazardous. Where it is necessary or desirable to have objects protrude from the wall, a manner of cane detection must be provided.

Baby changing table projects 35 inches

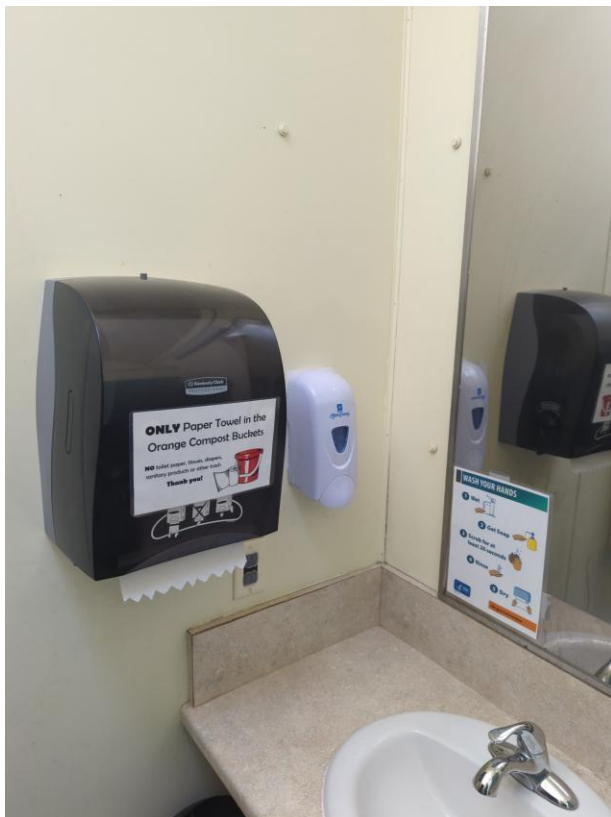
Paper towel dispenser is 49 inches high to the side knob

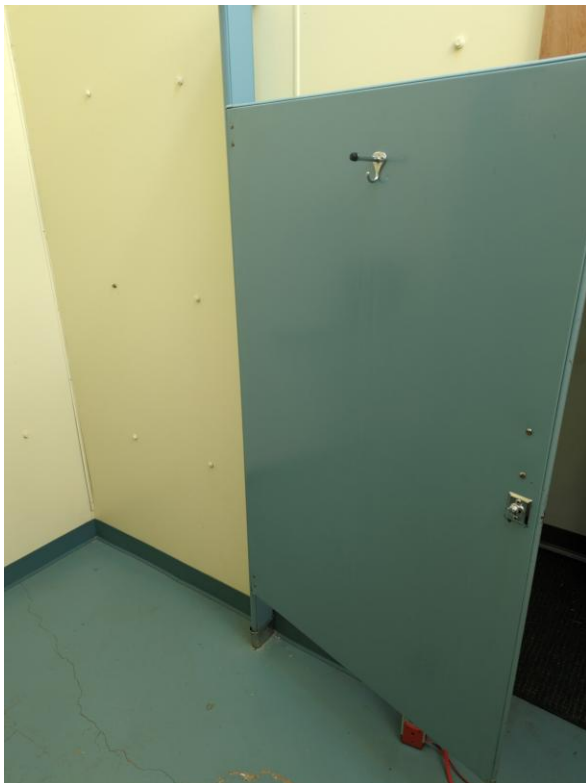
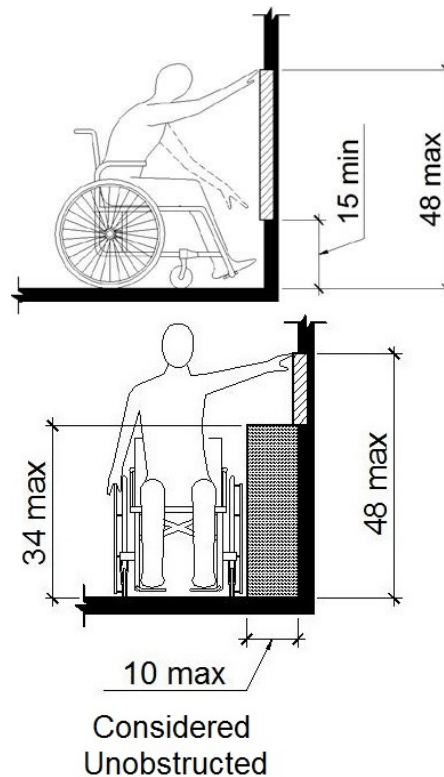
Coat hook is 65 inches high

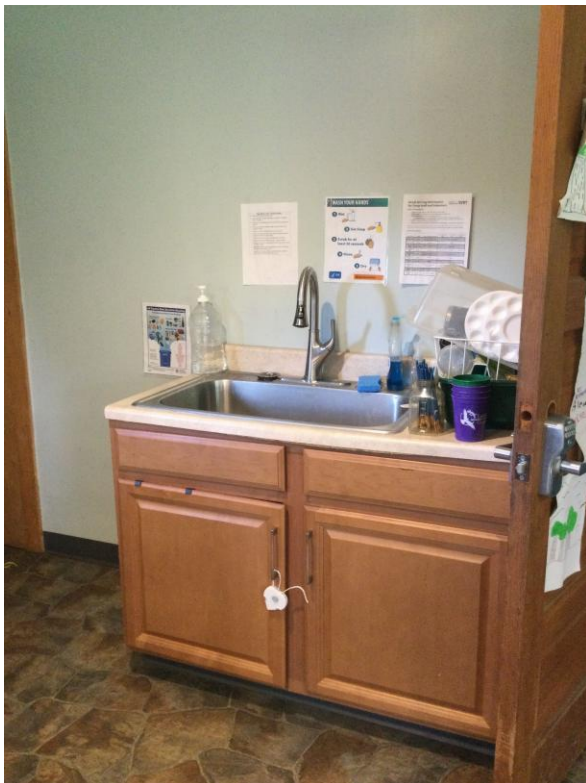
Sink is 36" high to the rim

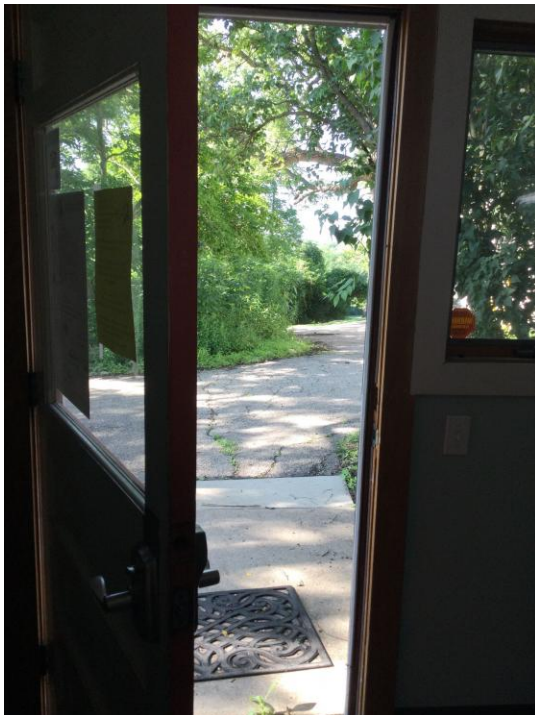
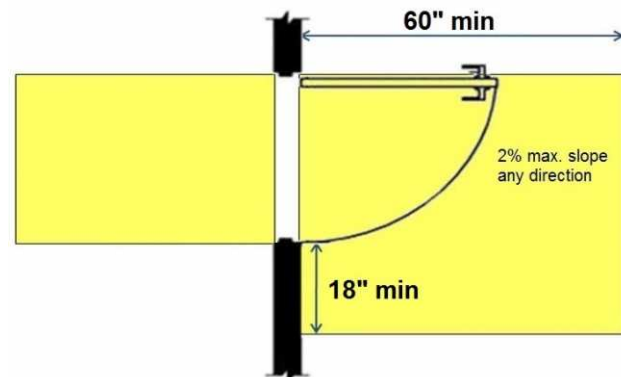
Door has 8" clearance on the pull side

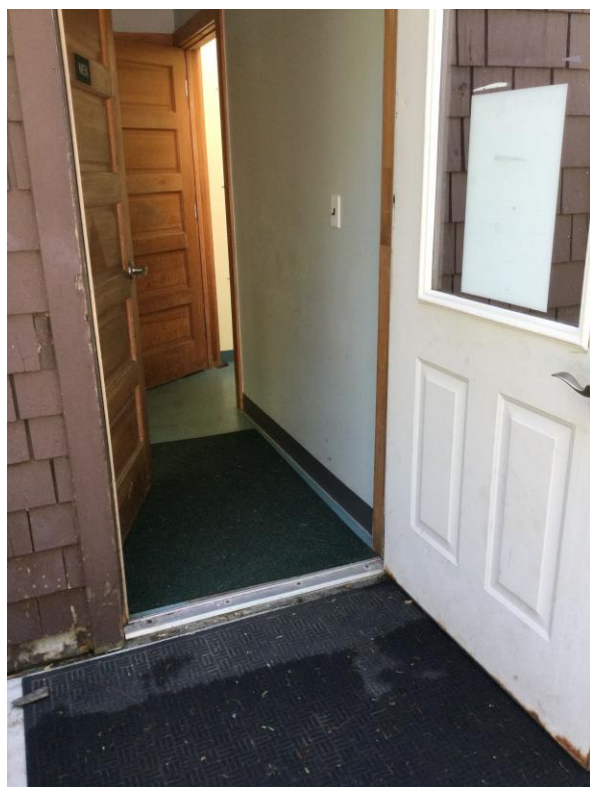
Door has 1" clearance on the pull side

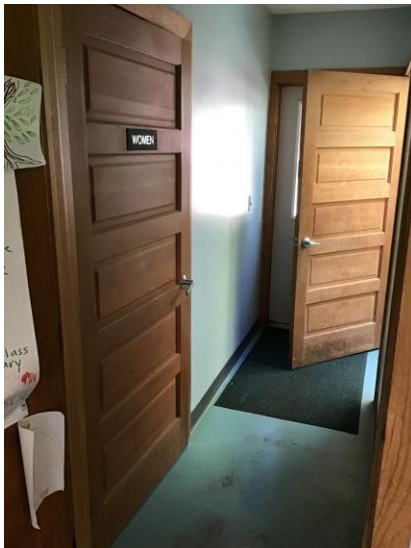
A compliant room identification sign is missing on the strike side of the door.

Door signage is not on the wall adjacent to the strike side of the door

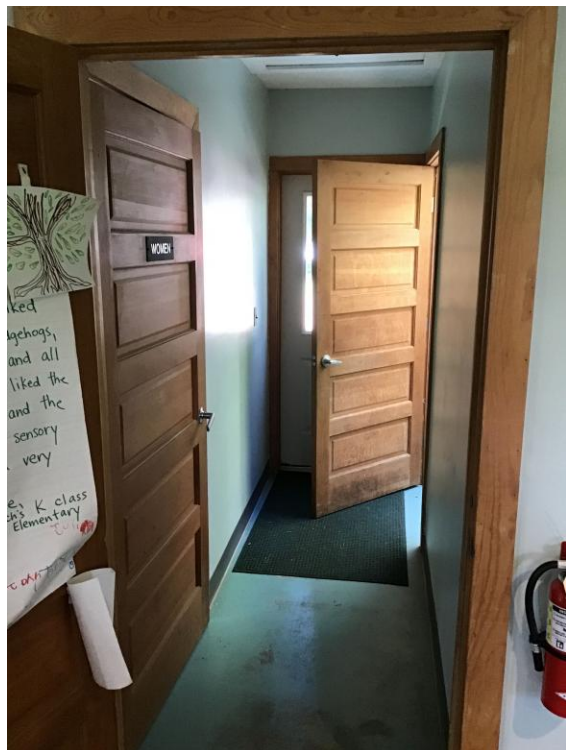
Pull side clearance 39 inches.

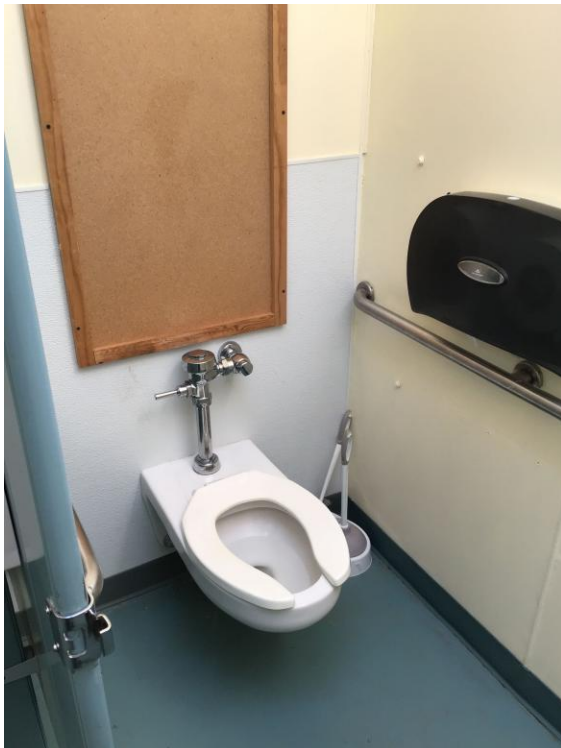
Existing compartment not fully compliant.

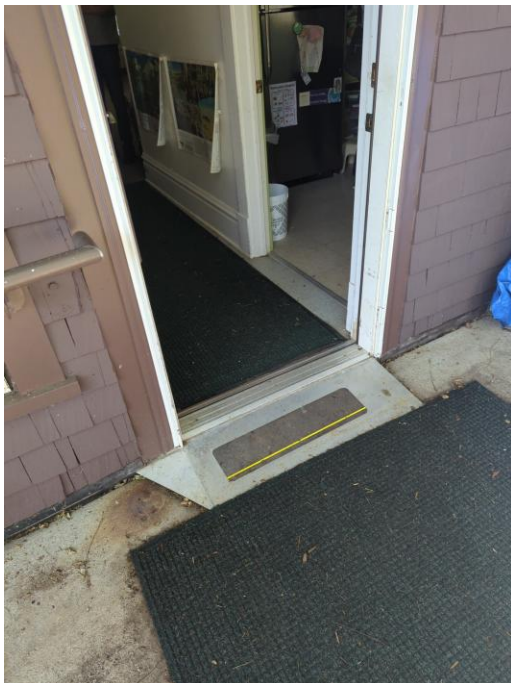
Entrance door has a ramp in the maneuvering clearance

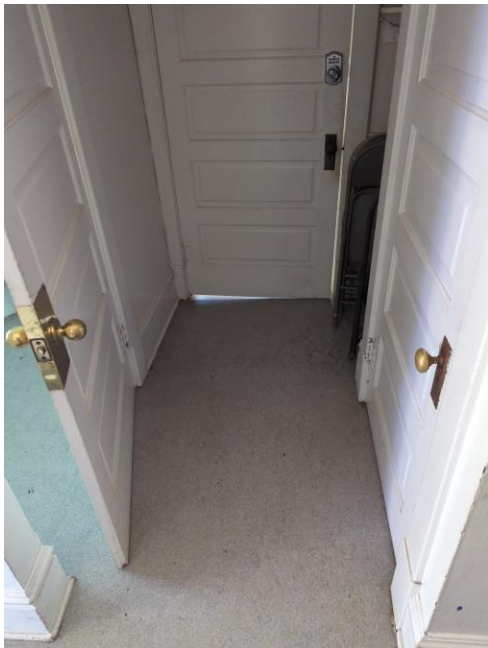
Multiple doors have knobs

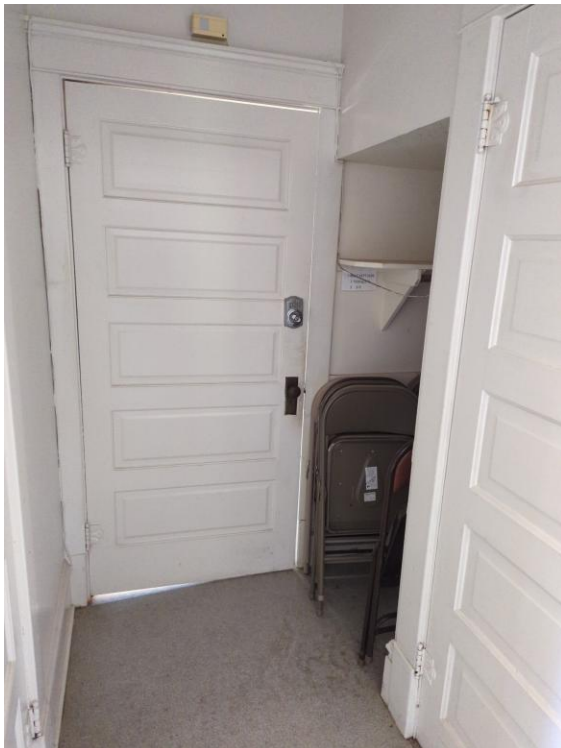
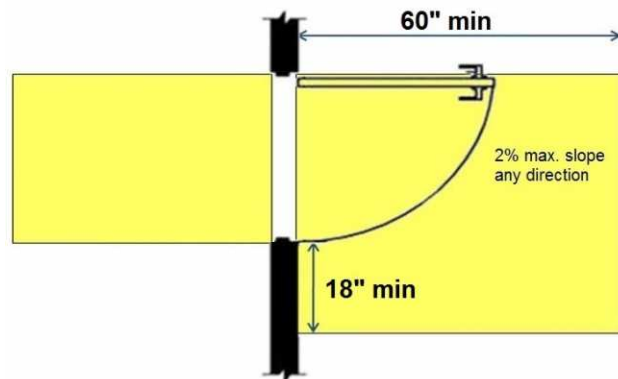
Door has a maneuvering clearance of 32 inches deep

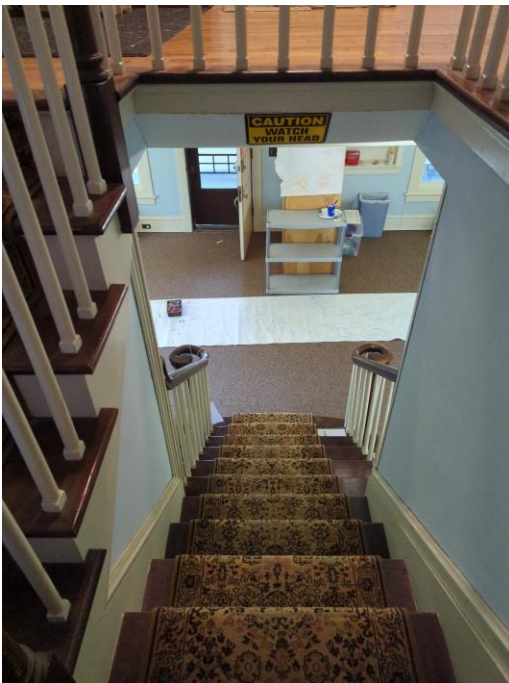
Head clearance is 69 inches high

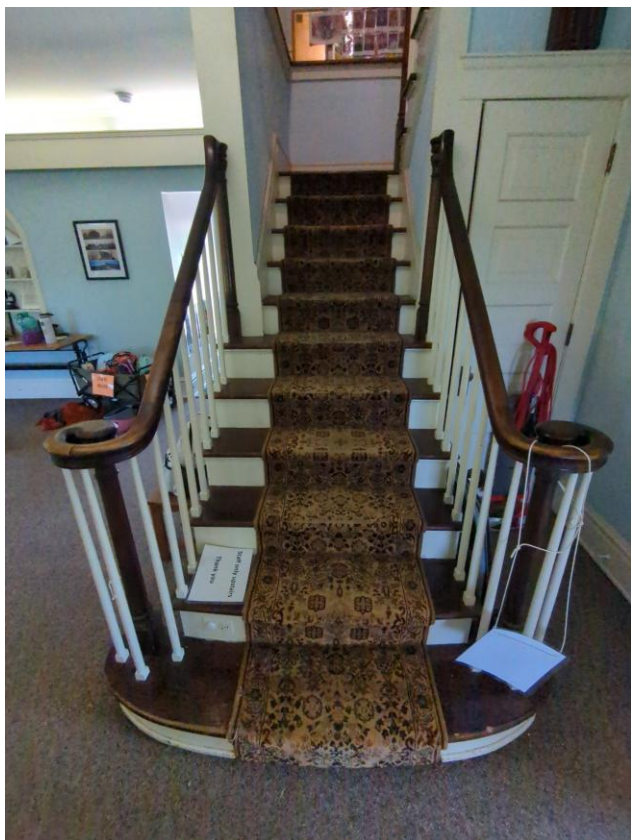
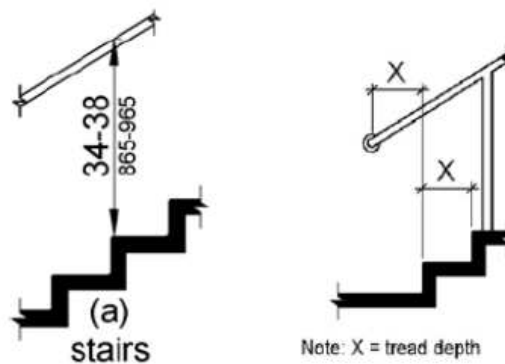
Finding #48 Continued

Stairs from first to second floors do not have compliant handrails

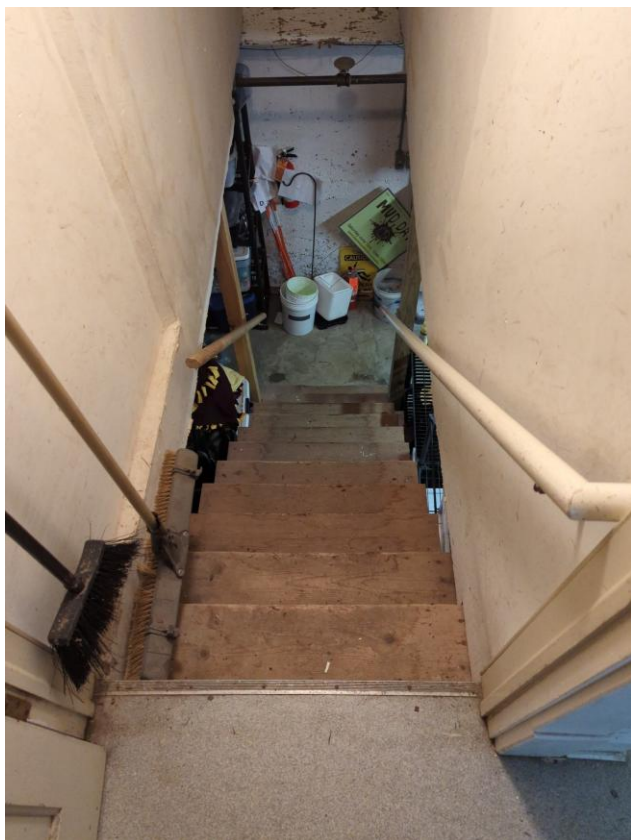
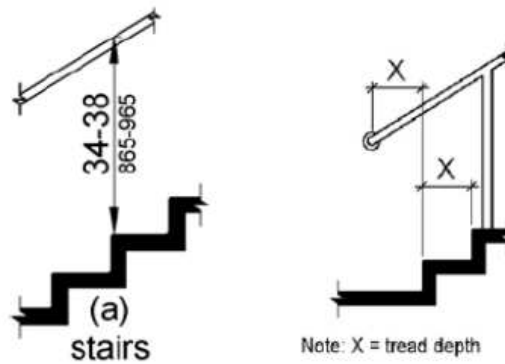
Finding #49 Continued

Stairs have handrails that do not comply

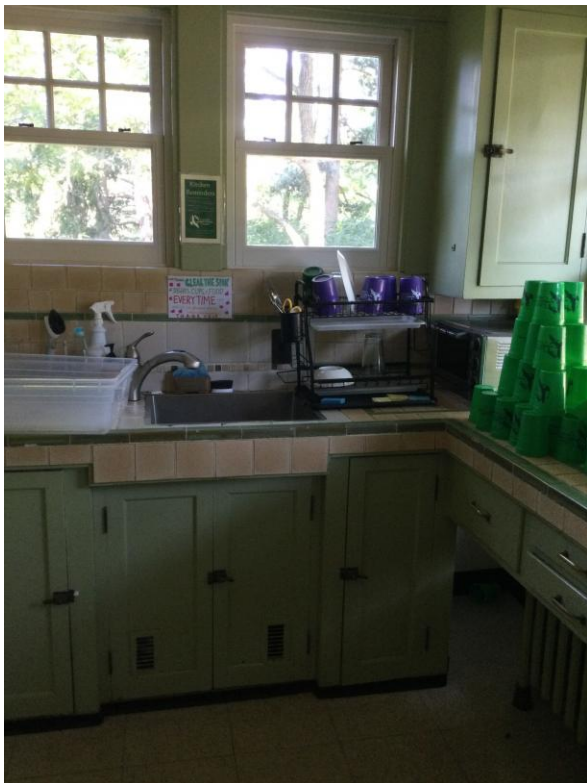
Sink is 35" high to the rim

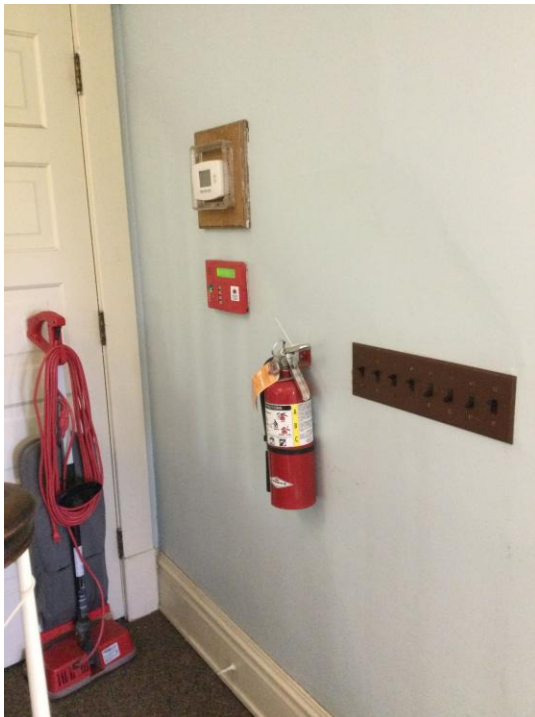
Wall-mounted objects that have leading edges between 27 inches and 80 inches from the floor must not project more than 4 inches into the circulation path. Protruding objects that extend to the floor or within 27 inches of the floor are cane detectable and are therefore not hazardous. Where it is necessary or desirable to have objects protrude from the wall, a manner of cane detection must be provided.

Fire extinguisher protrudes 6"

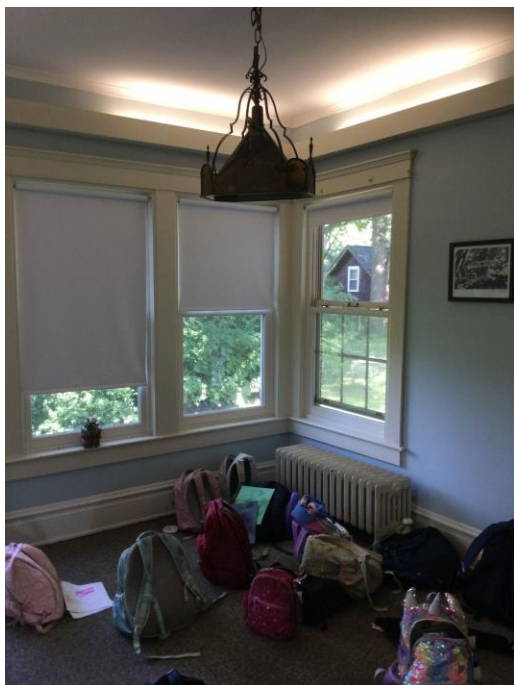
The light fixture is 75" high

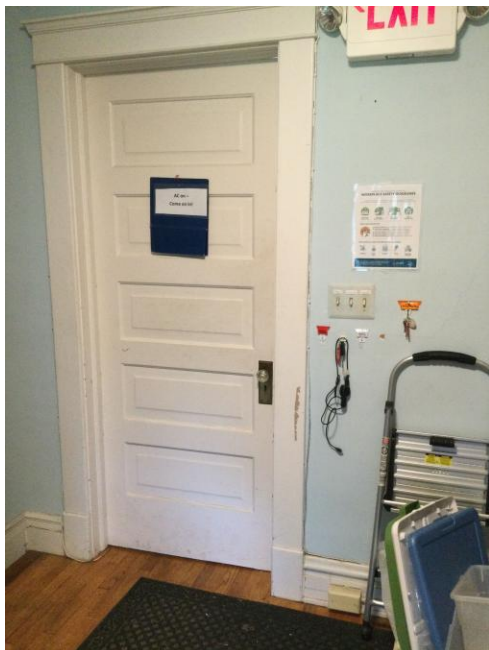
Doors have non-compliant hardware

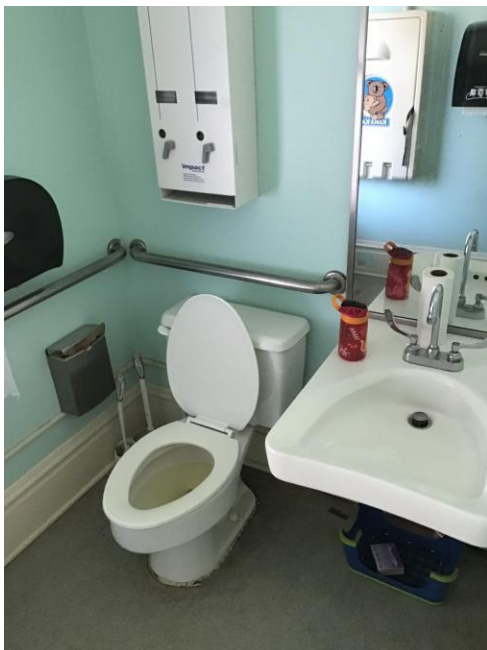
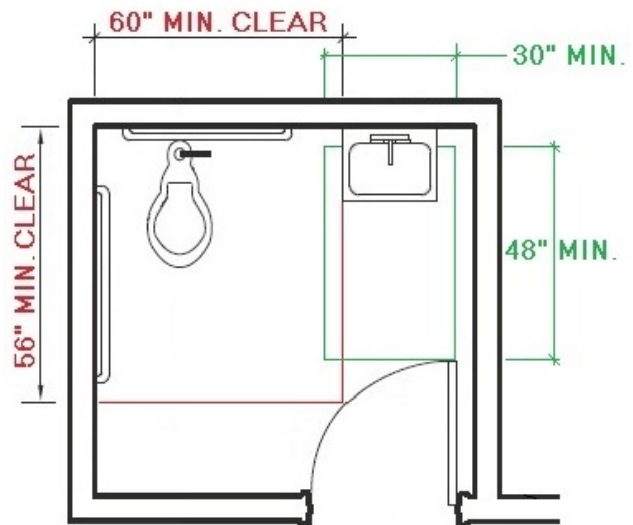
The restroom does not have the required minimum clear floor space or maneuvering clearances for the toilet. The restroom does not have the required minimum clear floor space or maneuvering clearances for the lavatory. The entry door does not contain the required minimum maneuvering spaces on the pull/push sides. The entry door encroach into the required clear floor space for fixtures. Grab bars are missing and/or incorrectly installed. Accessories, such as toilet seat covers, paper towel holders, garbage cans, hand dryers, and mirrors are either too high or without clear floor space or both.

Various barriers including clear space issues.

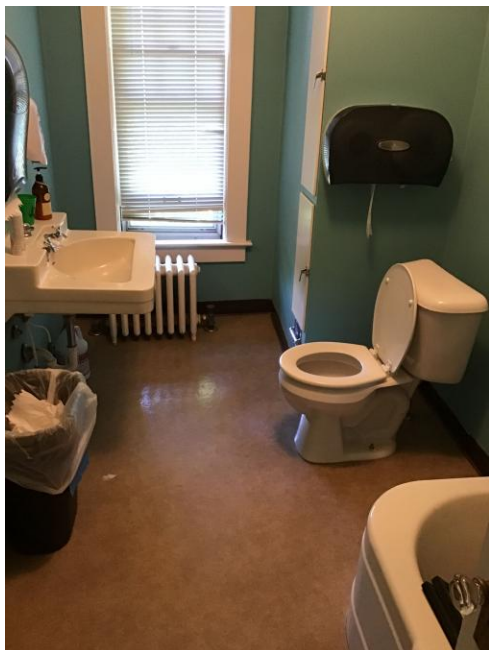
The restroom does not have the required minimum clear floor space or maneuvering clearances for the toilet. The restroom does not have the required minimum clear floor space or maneuvering clearances for the lavatory. The entry door does not contain the required minimum maneuvering spaces on the pull/push sides. The entry door encroach into the required clear floor space for fixtures. Grab bars are missing and/or incorrectly installed. Accessories, such as toilet seat covers, paper towel holders, garbage cans, hand dryers, and mirrors are either too high or without clear floor space or both.

There are various barriers including clear space and tub.

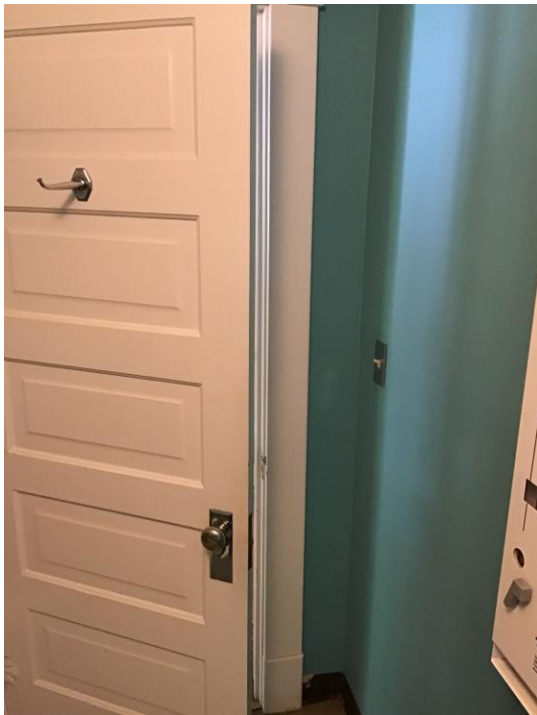
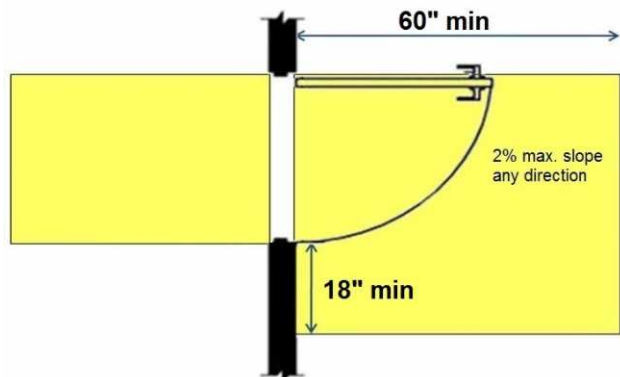
Latch side clearance is 11 inches.

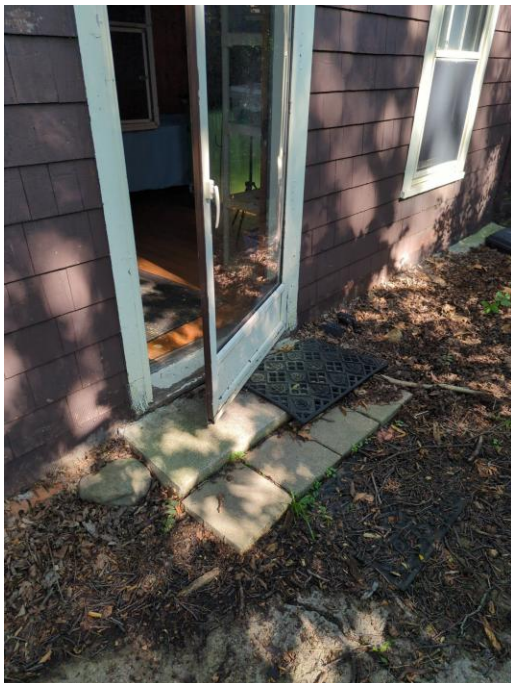
Door has steps in the maneuvering clearance

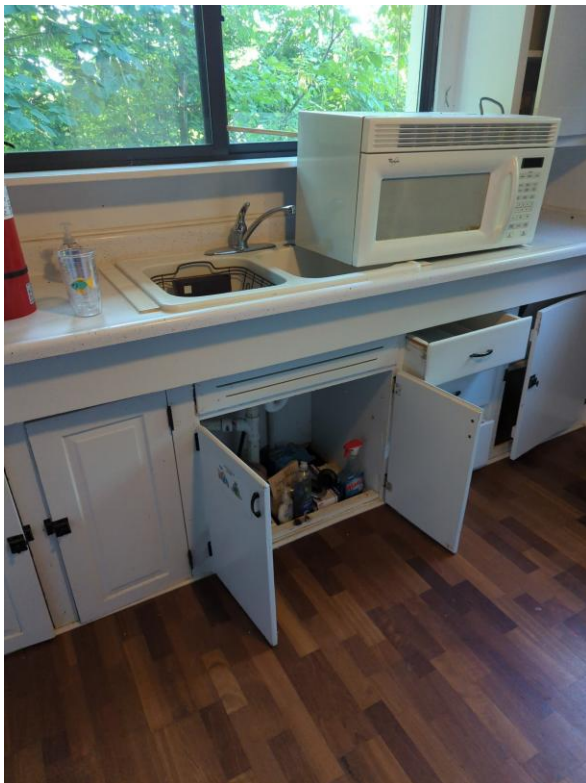
Sink rim is 38 inches high

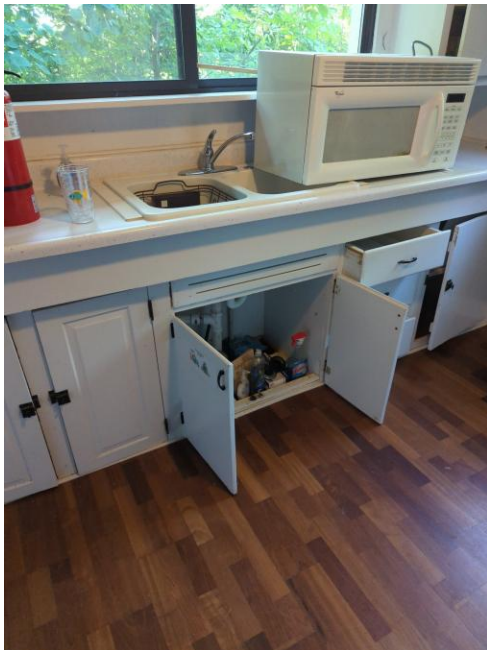
Sink does not have knee and toe clearance

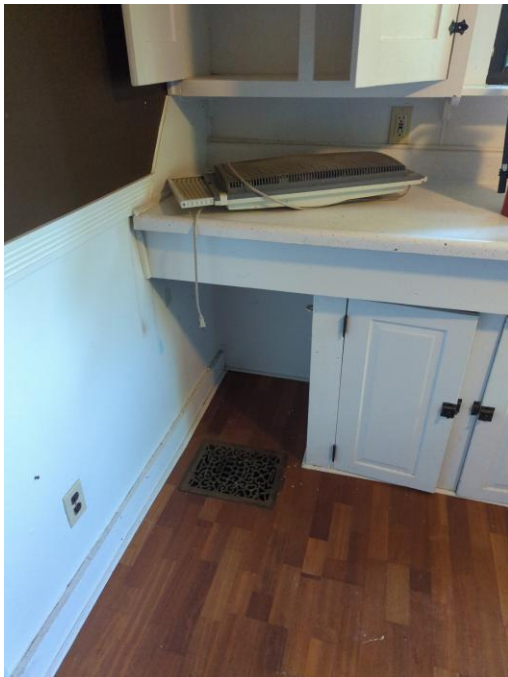
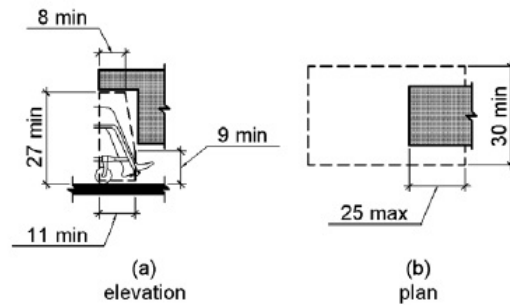
Work surface is only 20 inches wide and 38 inches high

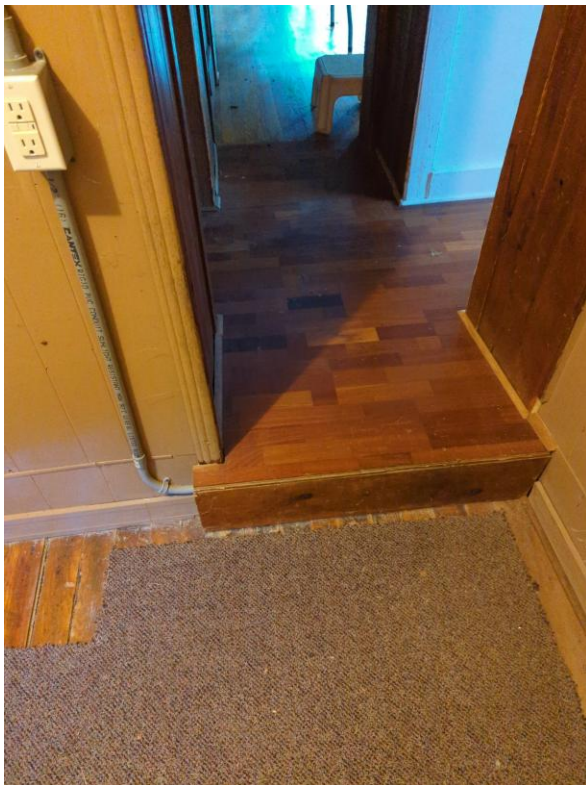
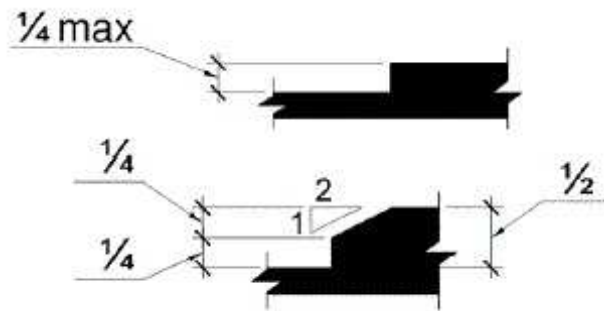
There is a 9 inch step to the laundry room

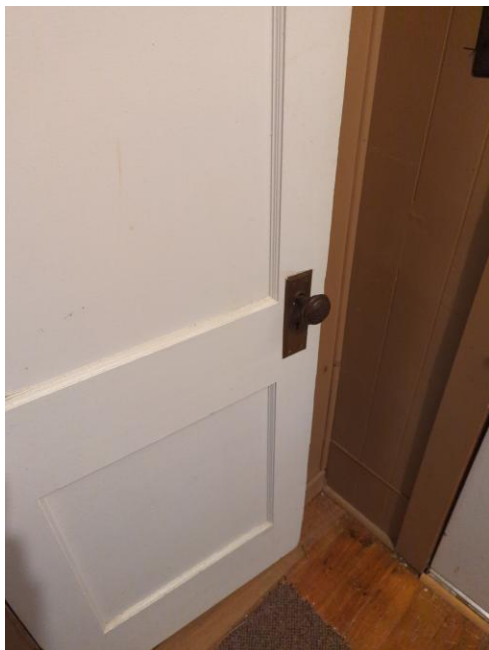
Doors have knobs

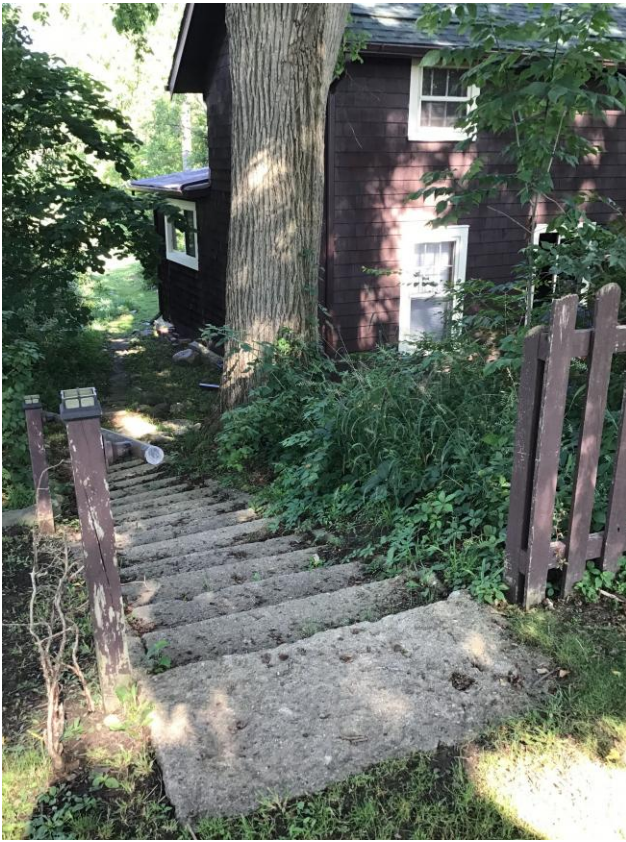
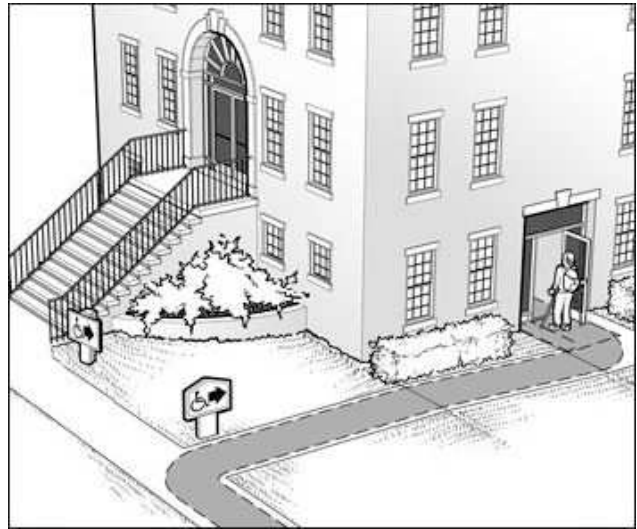
Finding #64 Continued

No accessible route to entrance.

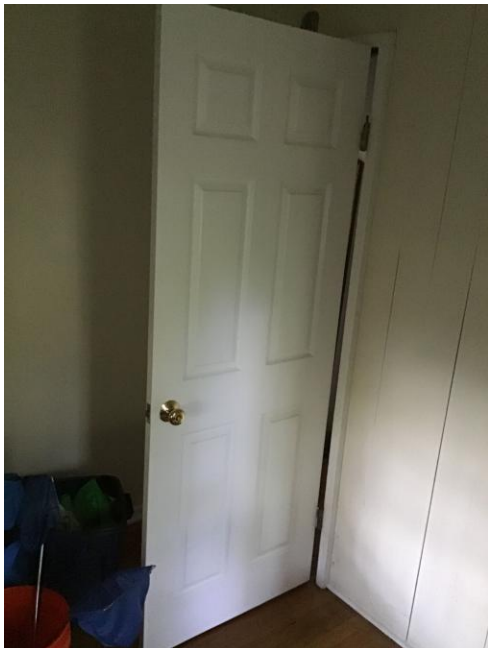
One bedroom door has a knob.

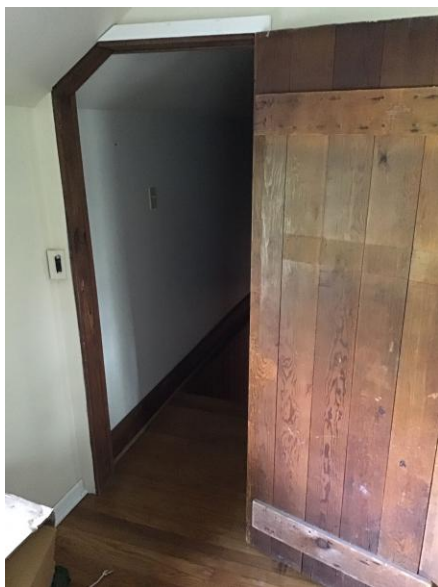
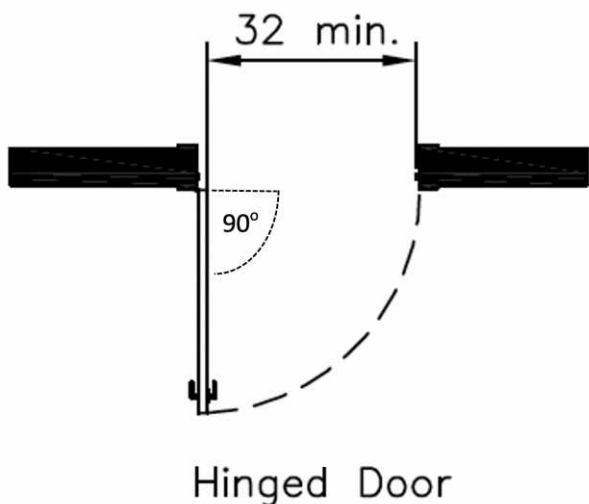
Two bedroom door widths are 29 inches.
