Site Accessibility Evaluation

Allmendinger Park
655 Pauline Blvd
Ann Arbor, MI 48104
ADA Only

Inspection Date: 07/11/2022

Report Date: 11/15/2022

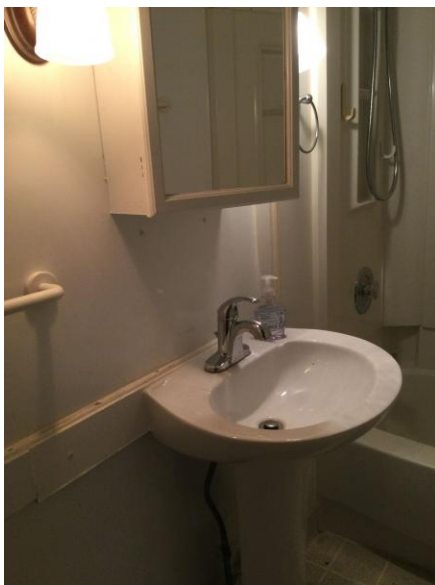
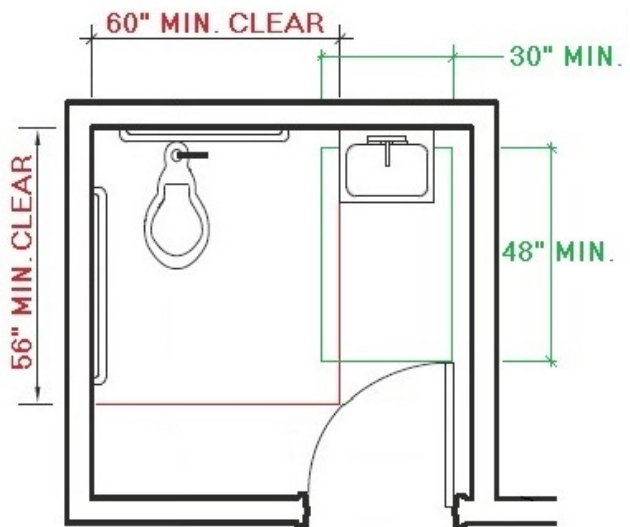
Restroom is not compliant

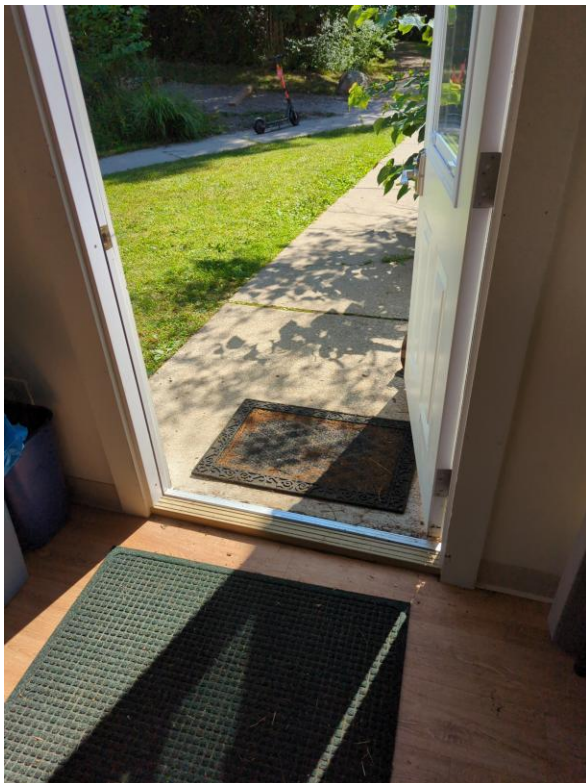
Critter House: Entrance

Threshold is 1-1/2 inches high on the inside

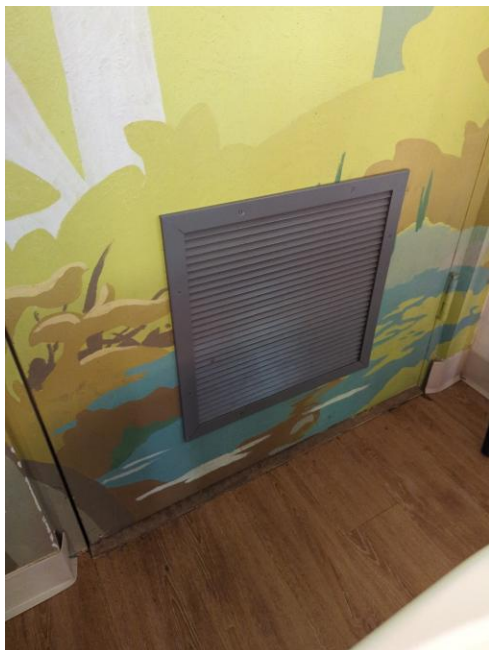
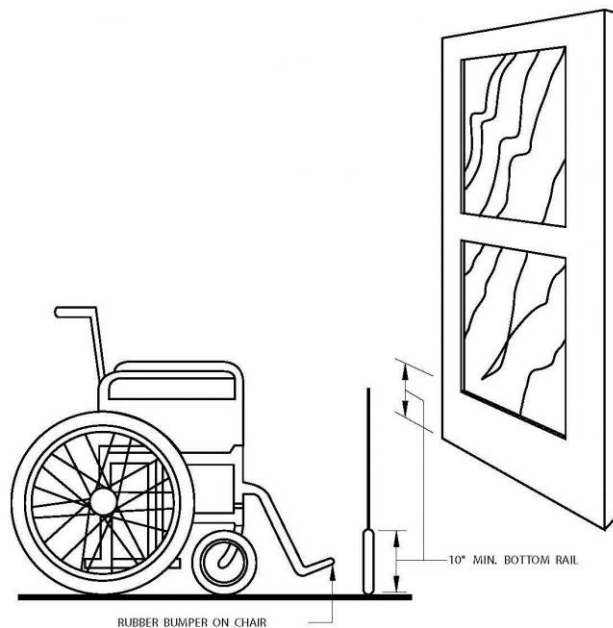
Critter House: Lobby

Door to chemical storage has a louver at 8 inches from the floor

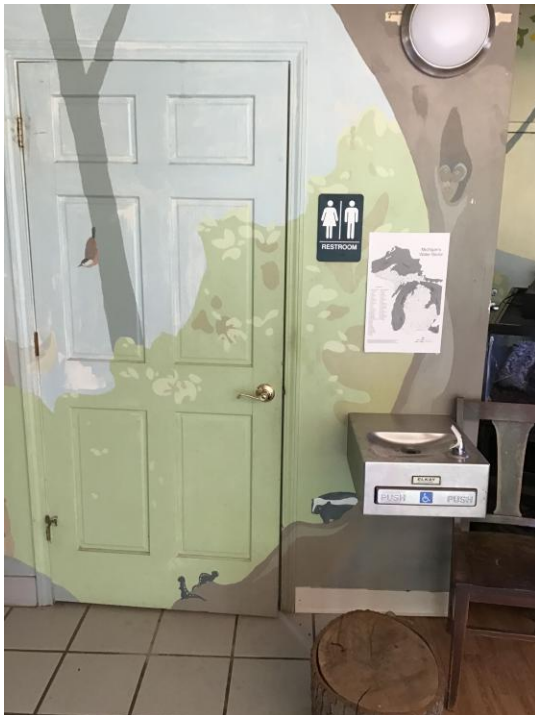
Critter House: Unisex Restroom

Clearance of 9 inches; obstructed by drinking fountain.

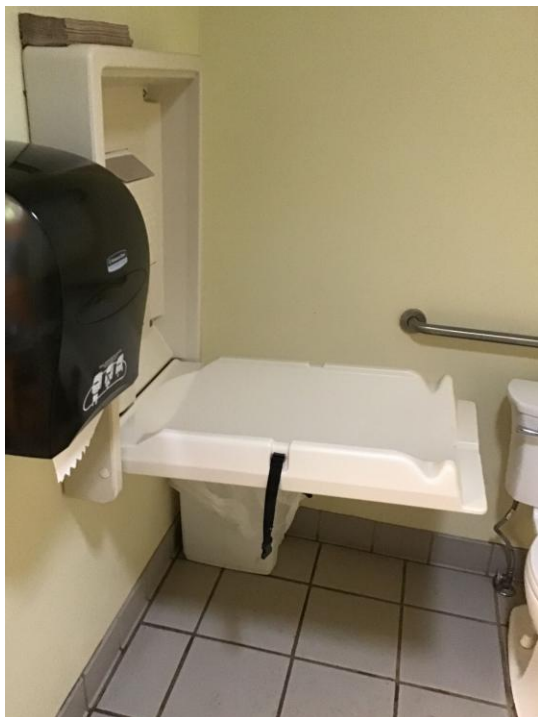
Critter House: Unisex Restroom

Wall-mounted objects that have leading edges between 27 inches and 80 inches from the floor must not project more than 4 inches into the circulation path. Protruding objects that extend to the floor or within 27 inches of the floor are cane detectable and are therefore not hazardous. Where it is necessary or desirable to have objects protrude from the wall, a manner of cane detection must be provided.

Baby changing table is a protruding object.

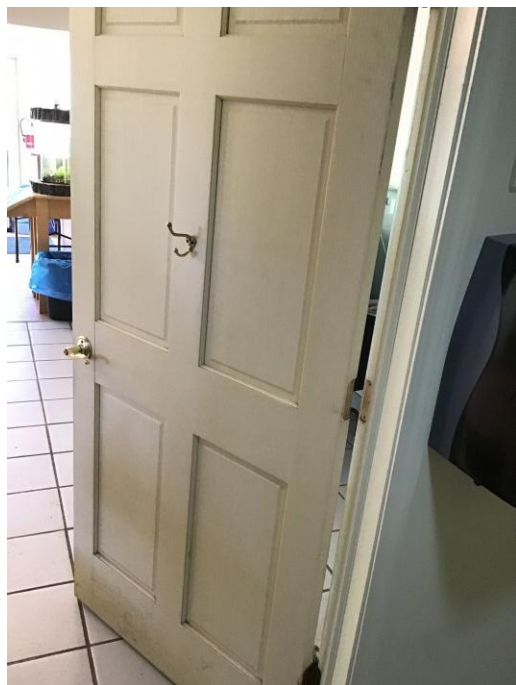
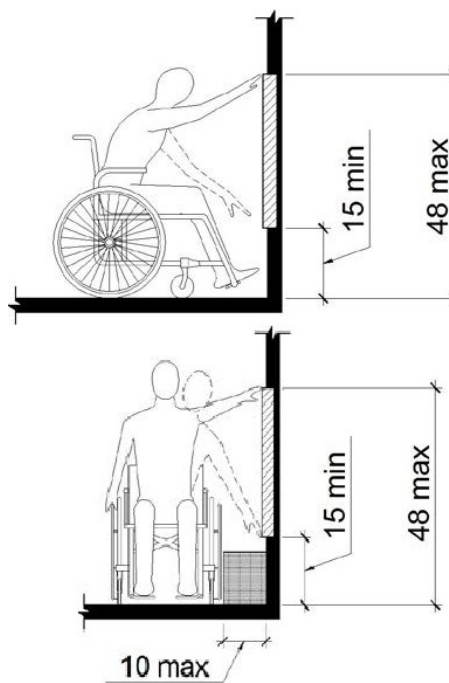
Critter House: Unisex Restroom

Hook at 52 inches.

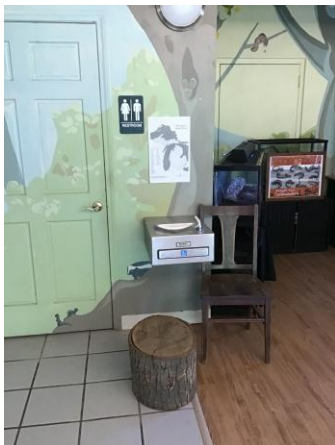
Critter House: Open Space

Only one drinking fountain.

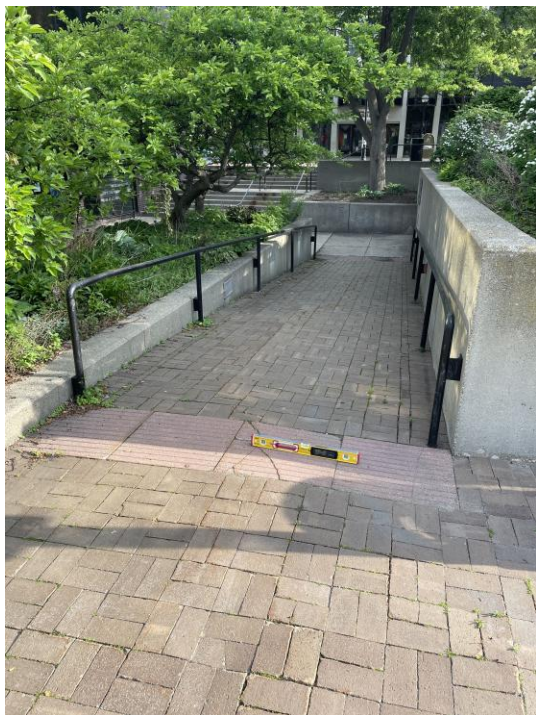
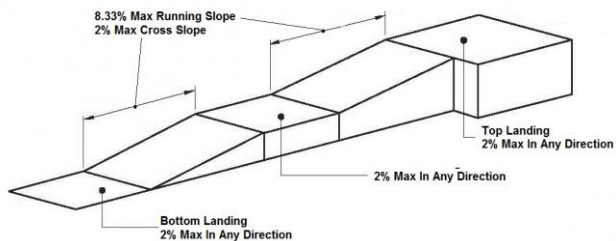
Top landing at ramp has slopes greater than 2%.

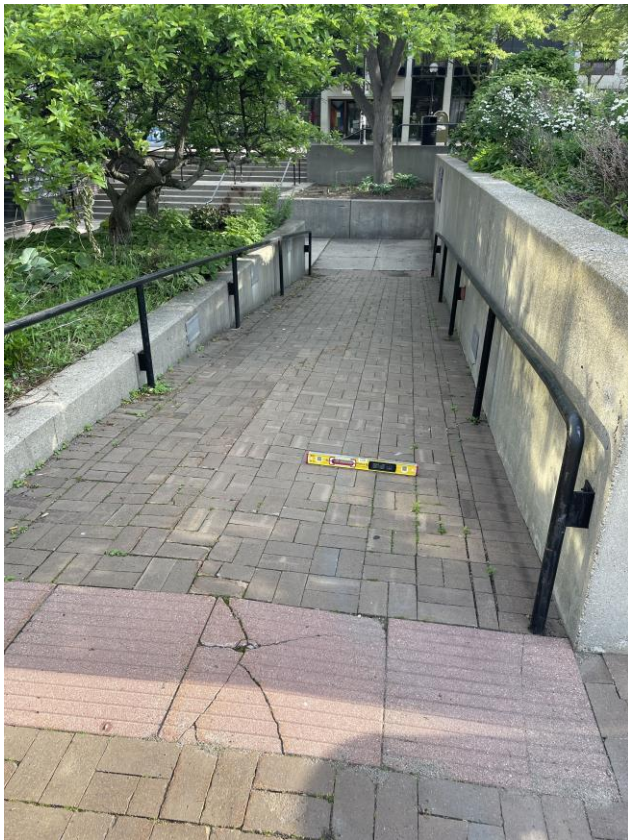
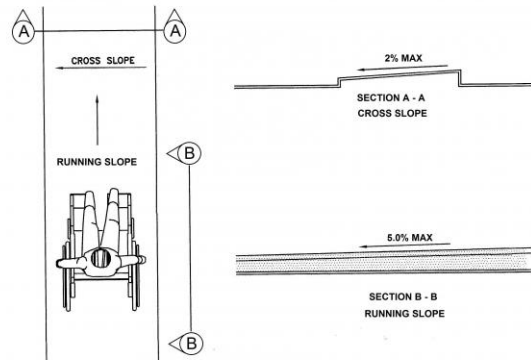
Trail System: Trail

Cross slope at ramp is greater than 2%

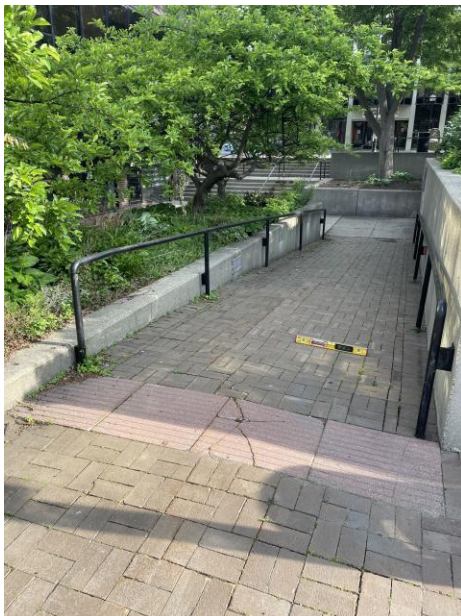
Trail System: Trail

Handrails too low and have no extensions

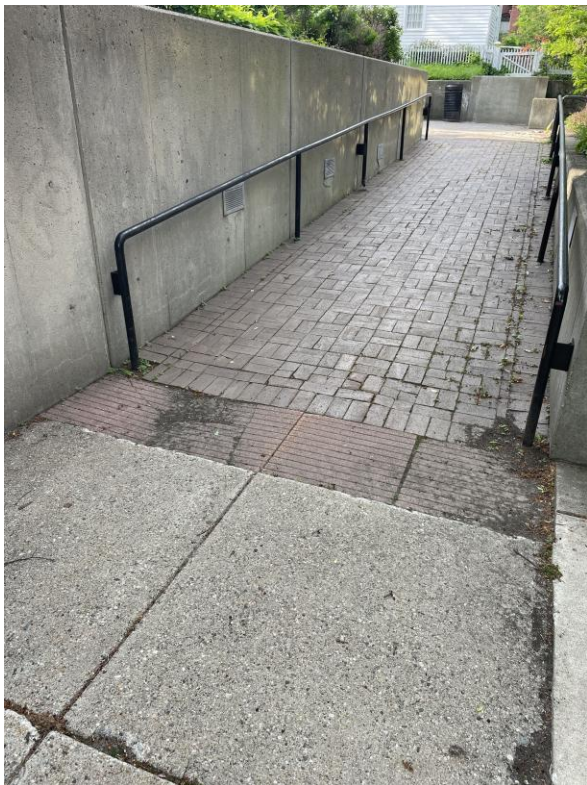
Trail System: Trail

Bottom of ramp has a vertical change in level greater than 1/2-inch.

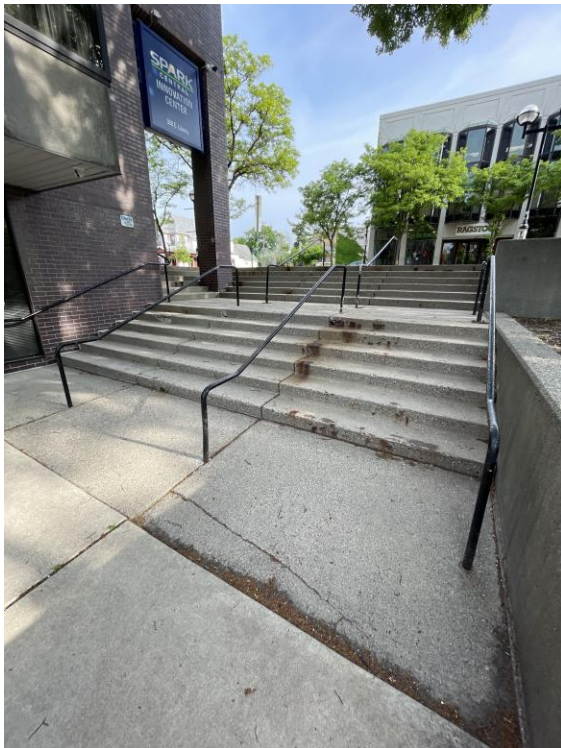
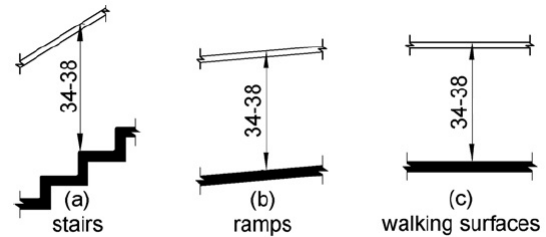
Trail System: Trail

Stair handrails are not 34-38 inches high

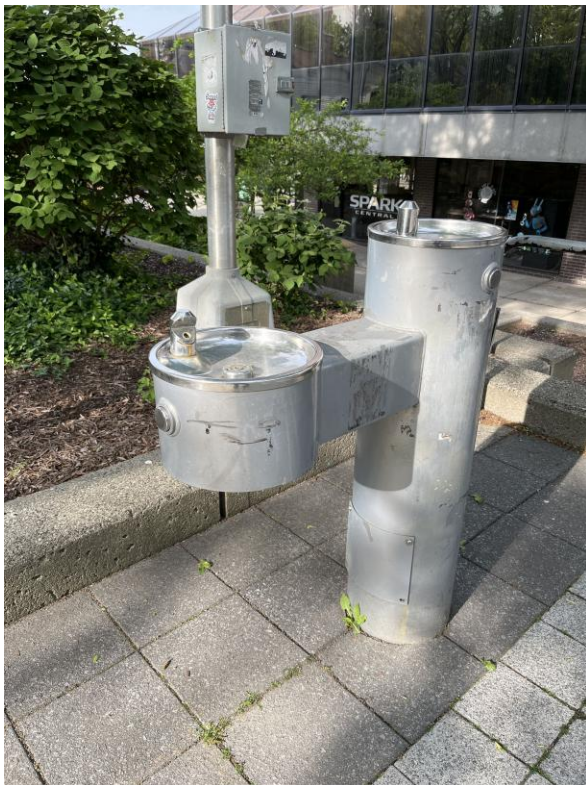
Green Space: Drinking Fountain

Accessible drinking fountain has 26 inches vertical knee clearance

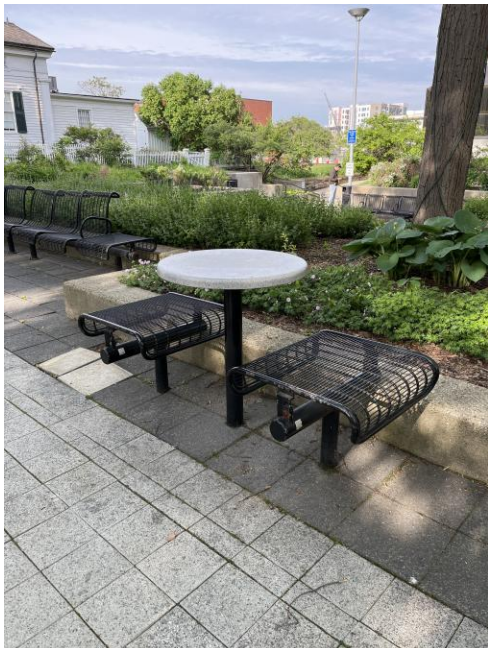
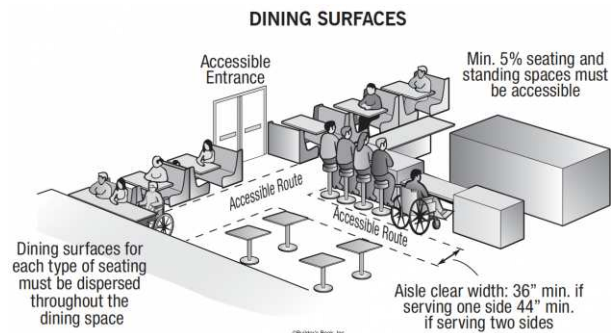
Green Space: Picnic Area

Fixed table does not have an accessible wheelchair space

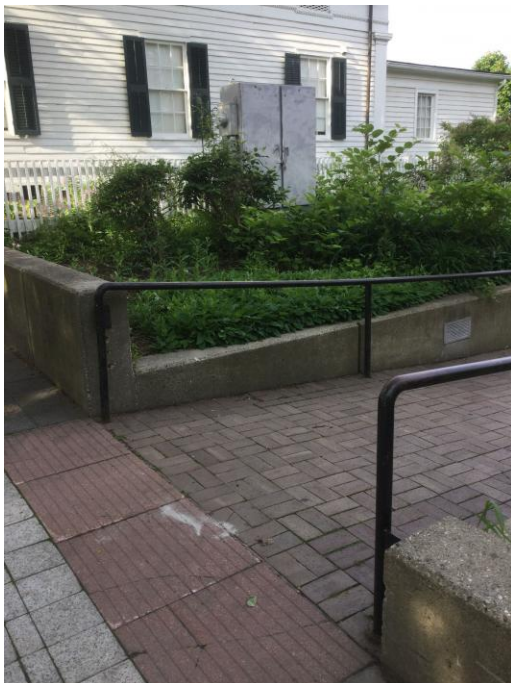
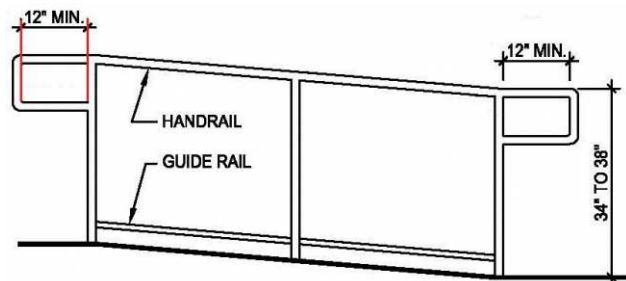
Assembly Area: Ramp

Ramp does not have a top handrail extension

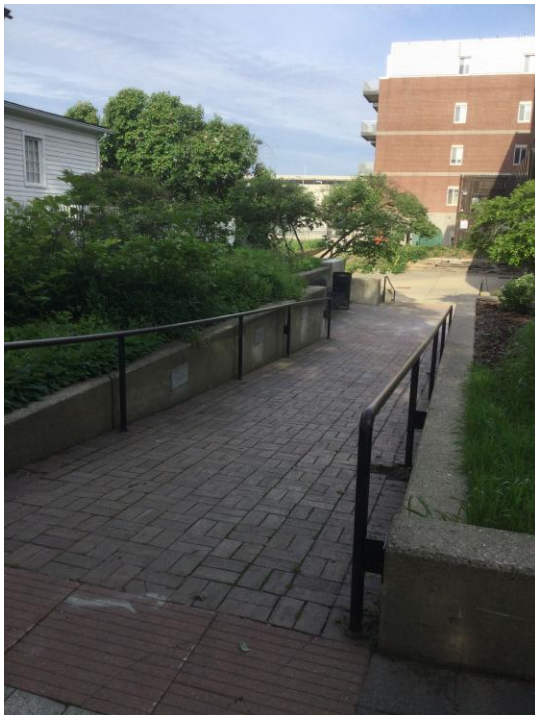
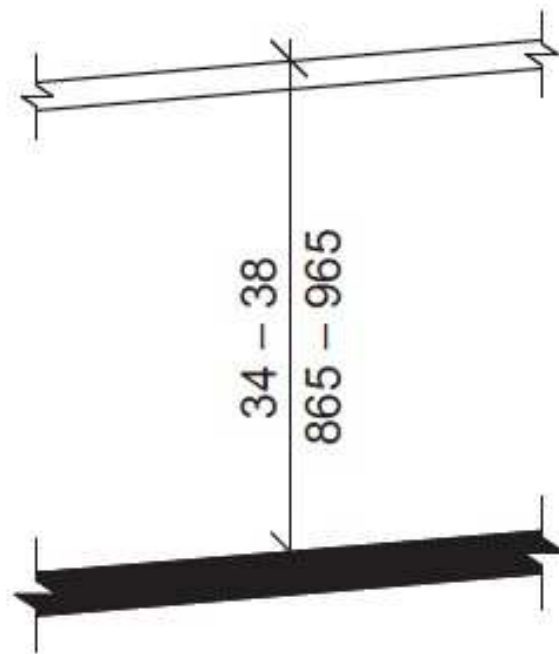
Assembly Area: Ramp

Ramp does not have a top handrail extension

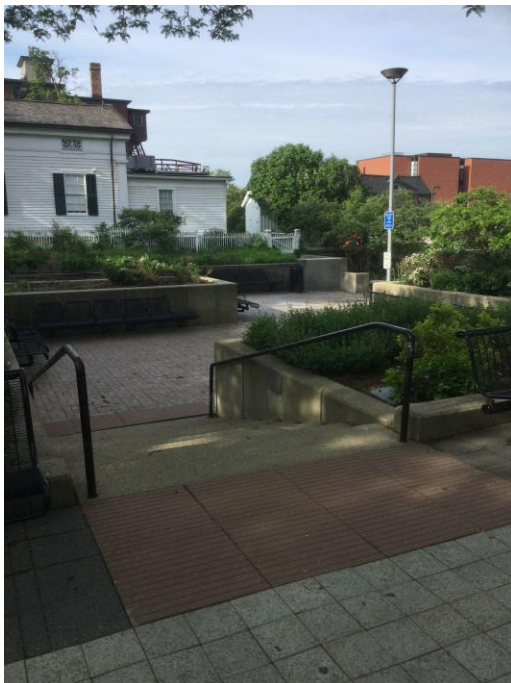
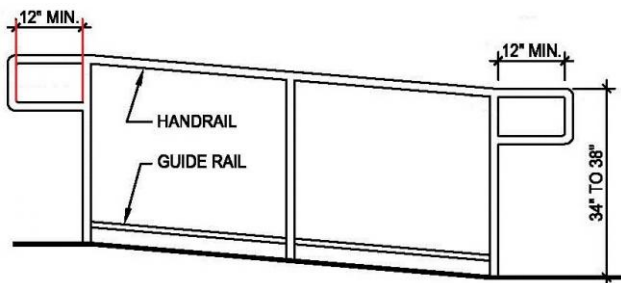
Assembly Area: Ramp

Stair handrails are not compliant

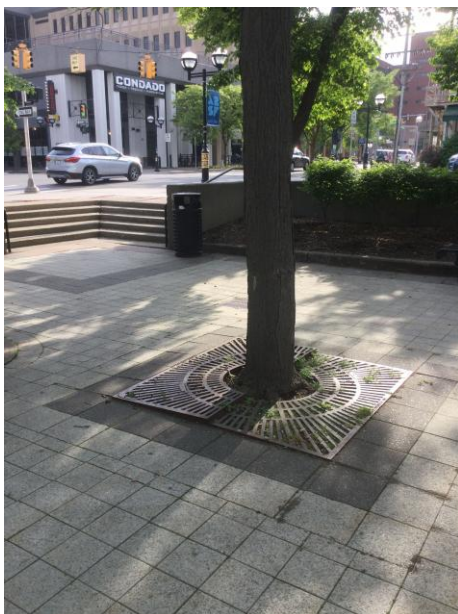
Assembly Area: Plaza

Accessible route has vertical changes in level greater than 1/4-inch, or 1/2-inch unbeveled

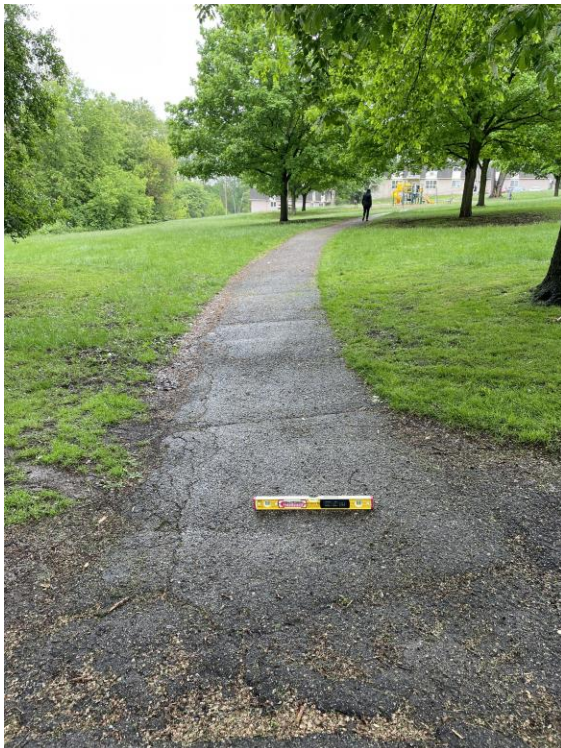
Route has a cross slope greater than 2%

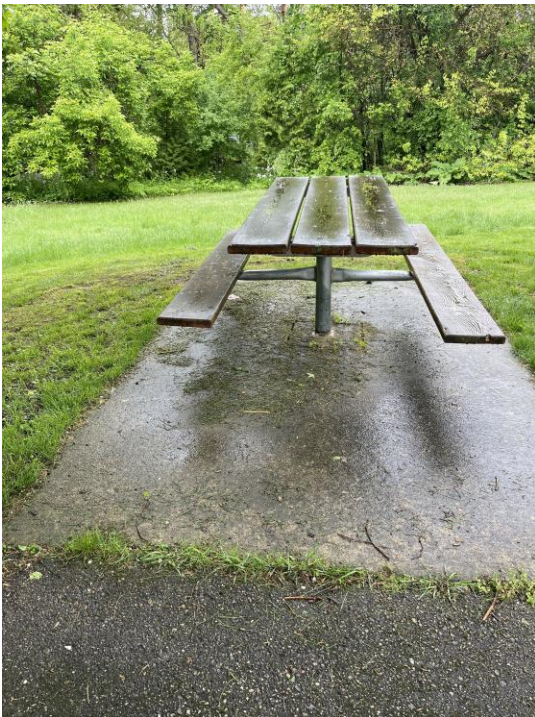
Green Space: Picnic Area

Route to picnic table has a vertical change in level greater than 1/2-inch unbeveled

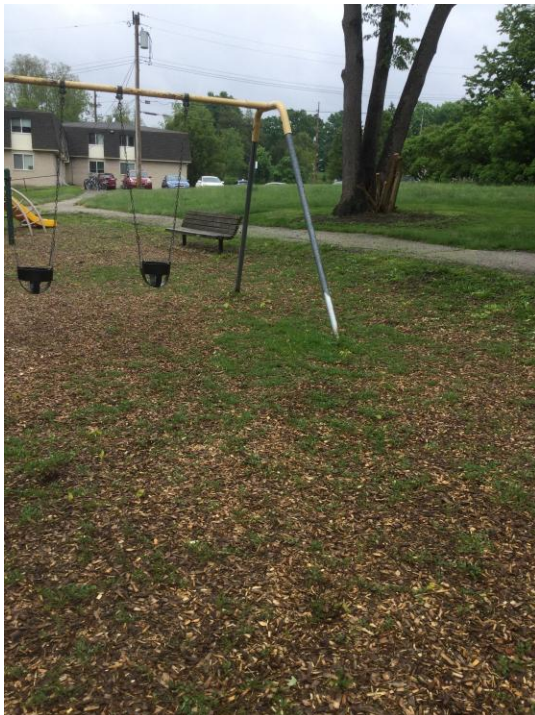
Play area ground surface is not compliant with vegetation growing

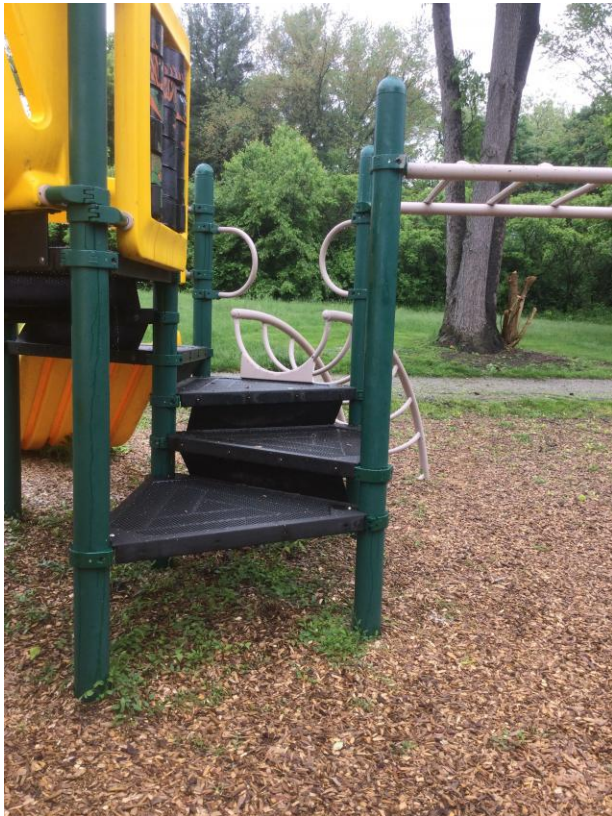
Playground equipment does not have an accessible entrance

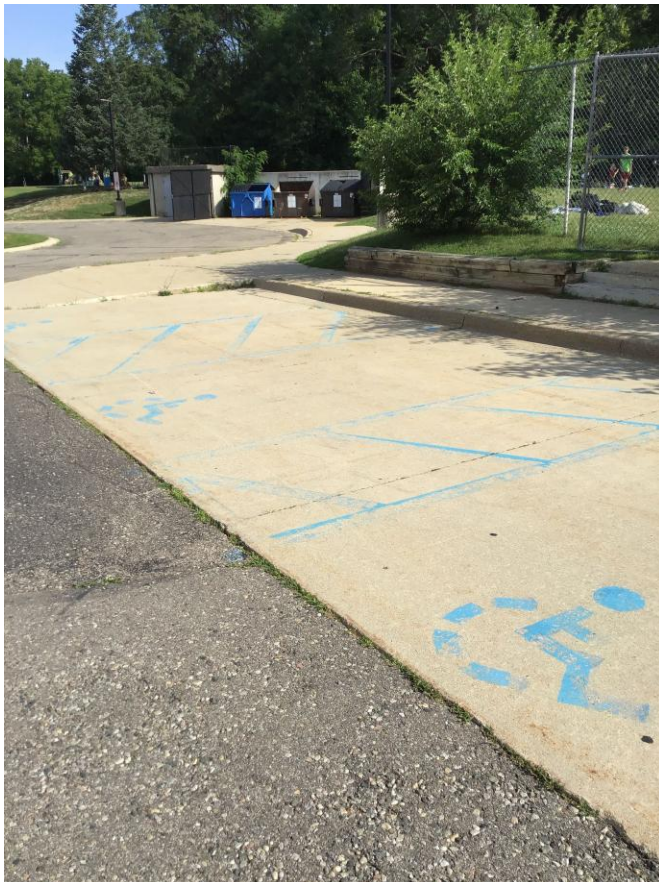
The striping and markings for the accessible parking stall, loading/unloading access aisle are dilapidated and in need of repair and/or maintenance.

Markings are faded.

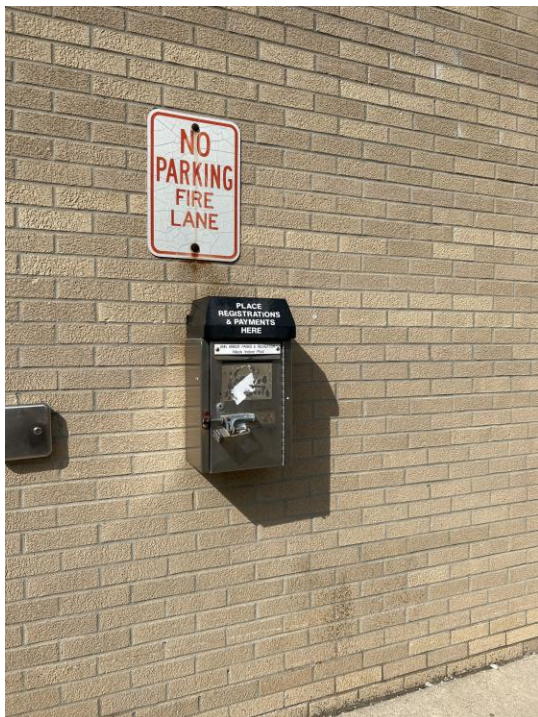
Wall-mounted objects that have leading edges between 27 inches and 80 inches from the floor must not project more than 4 inches into the circulation path. Protruding objects that extend to the floor or within 27 inches of the floor are cane detectable and are therefore not hazardous. Where it is necessary or desirable to have objects protrude from the wall, a manner of cane detection must be provided.

Payment box protrudes more than 4 inches

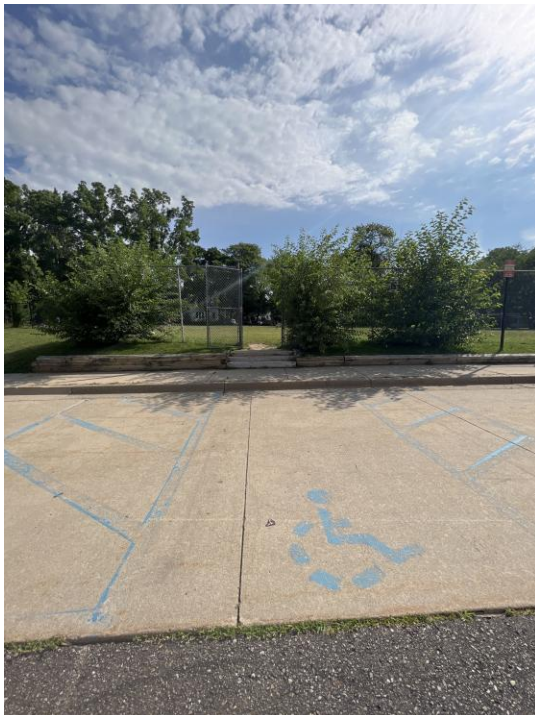
The required parking signage is missing.

Accessible parking spaces do not have a parking sign

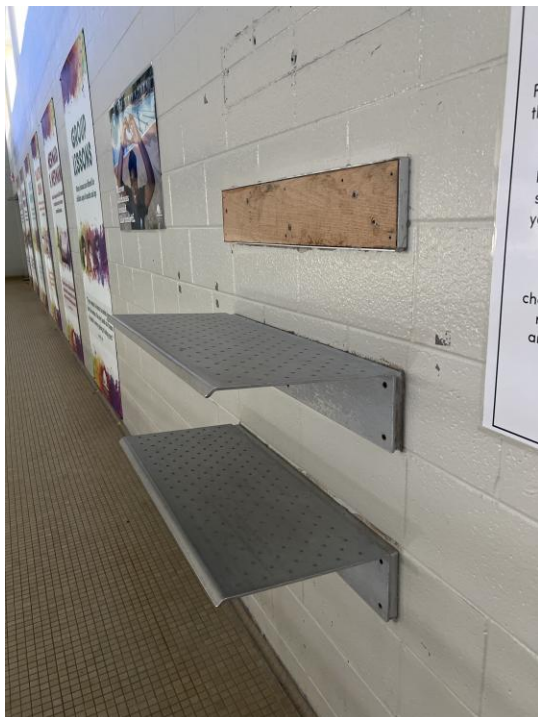
Wall-mounted objects that have leading edges between 27 inches and 80 inches from the floor must not project more than 4 inches into the circulation path. Protruding objects that extend to the floor or within 27 inches of the floor are cane detectable and are therefore not hazardous. Where it is necessary or desirable to have objects protrude from the wall, a manner of cane detection must be provided.

Wall-mounted shelves protrude more than 4 inches

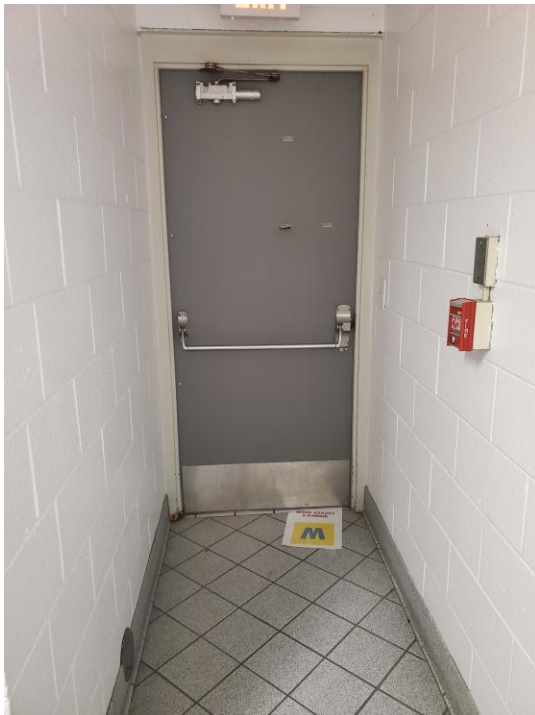
Door to women's locker room does not have 12 inches on push side

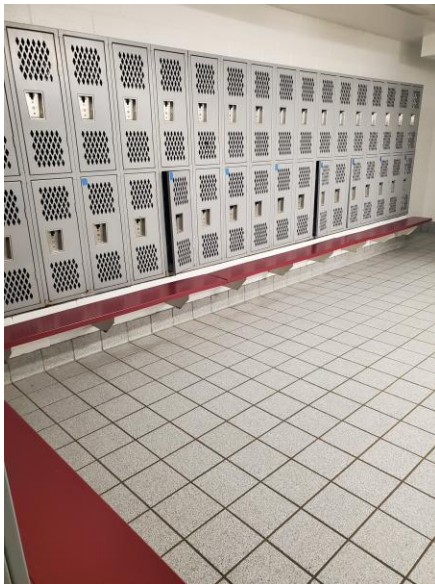
Locker room does not have a compliant bench

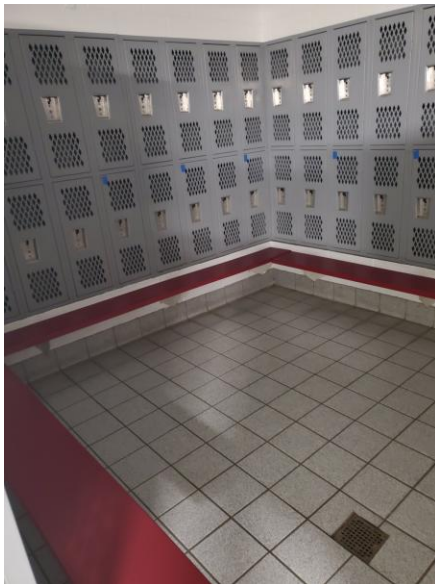
Locker room does not have a compliant bench

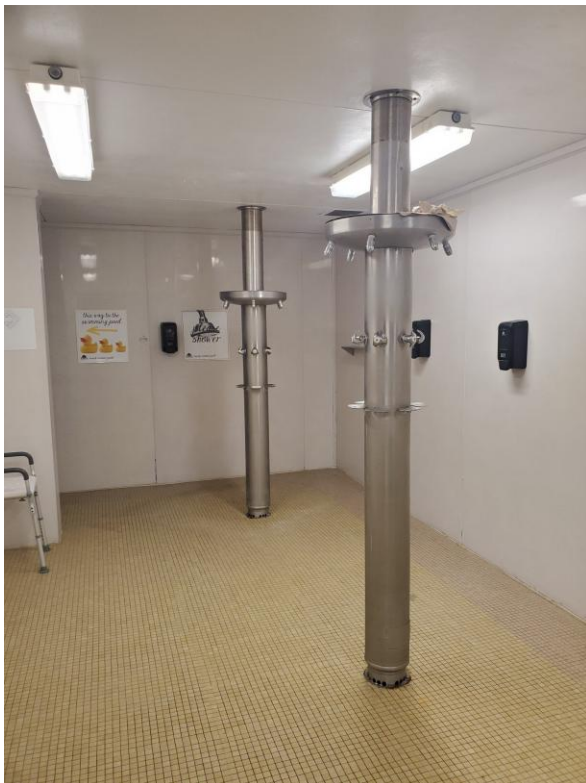
There is no accessible shower

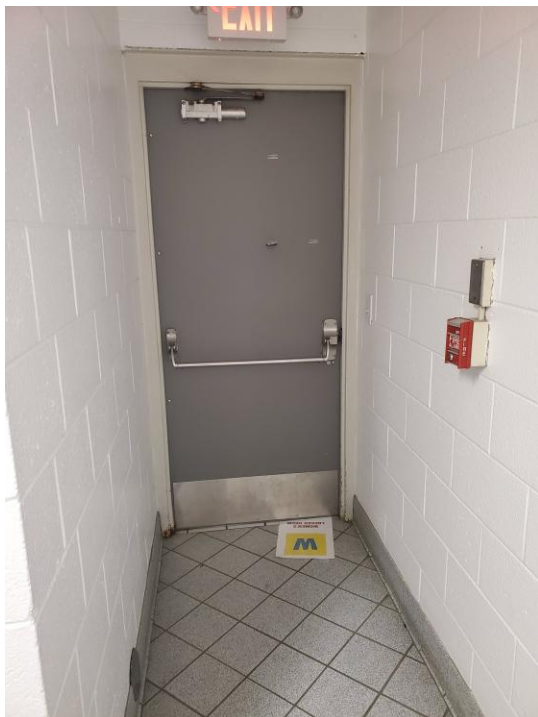
Door to locker room does not have the required clearance on the pull side

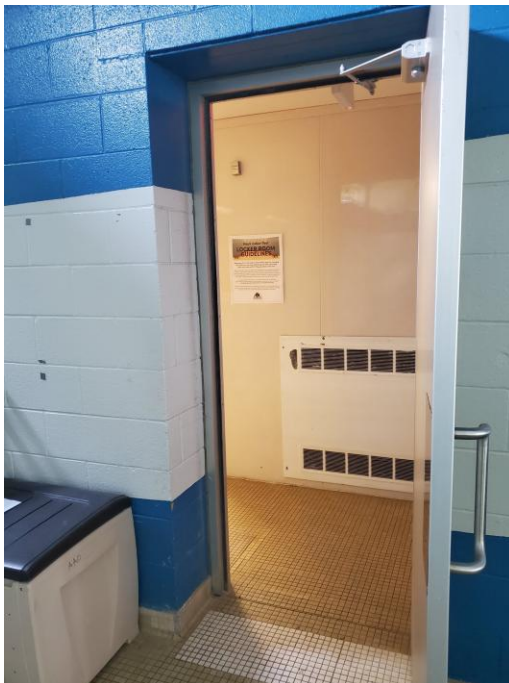
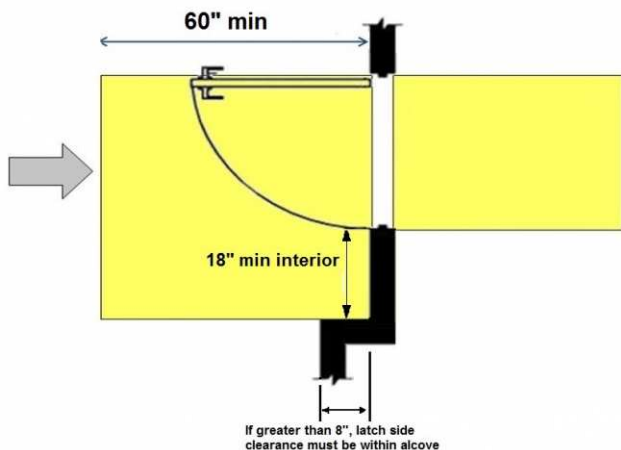
Recessed door does not provide the required maneuvering clearance

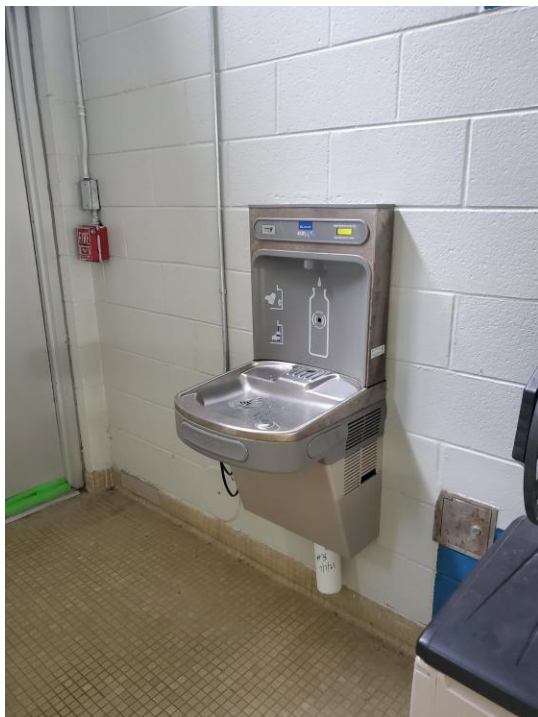
Wall-mounted objects that have leading edges between 27 inches and 80 inches from the floor must not project more than 4 inches into the circulation path. Protruding objects that extend to the floor or within 27 inches of the floor are cane detectable and are therefore not hazardous. Where it is necessary or desirable to have objects protrude from the wall, a manner of cane detection must be provided.

Drinking fountain protrudes more than 4 inches

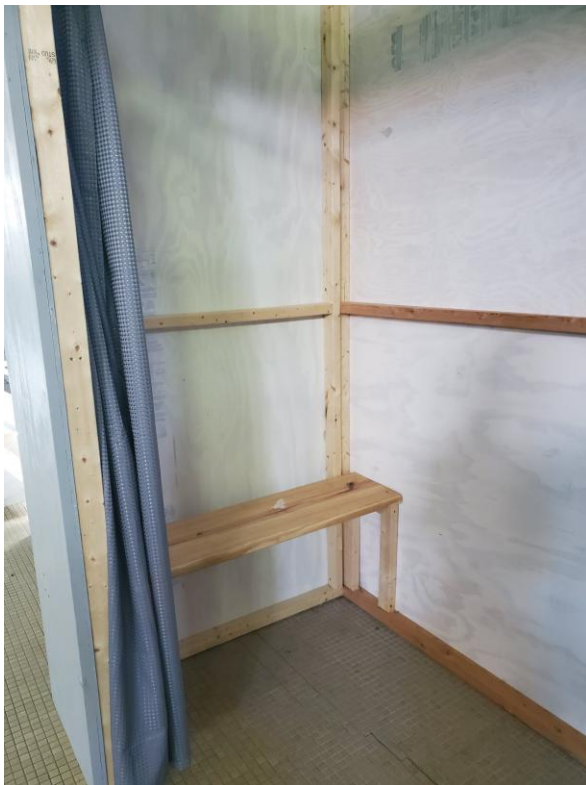
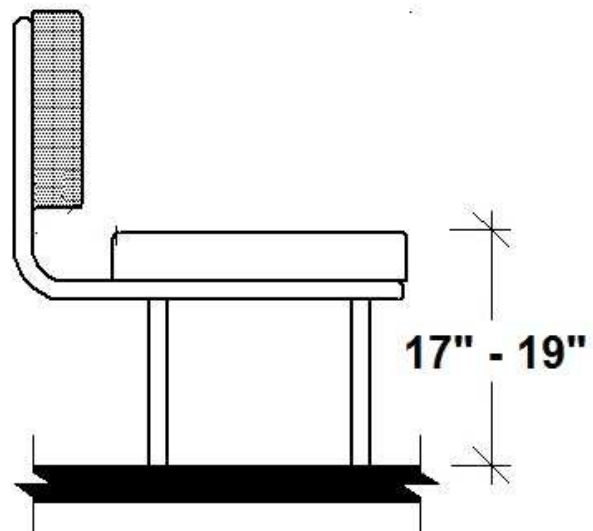
The changing room bench is not compliant, and is 21" high.

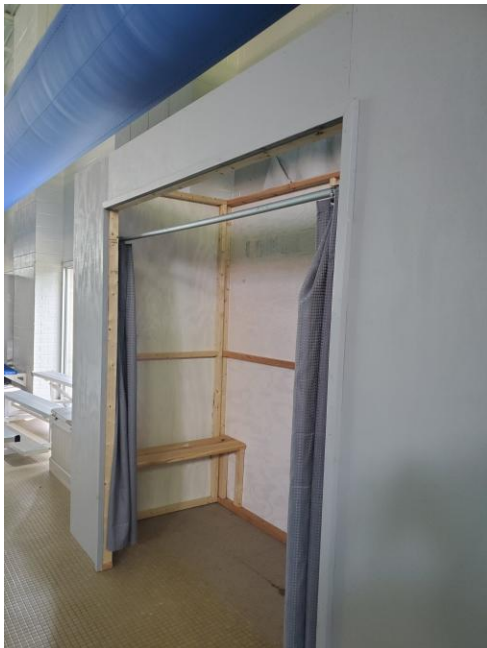
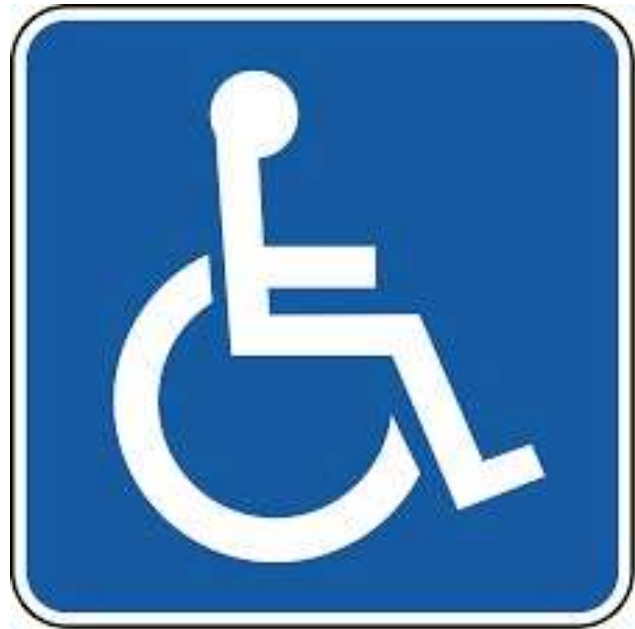
Accessible changing room does not have an identifying sign

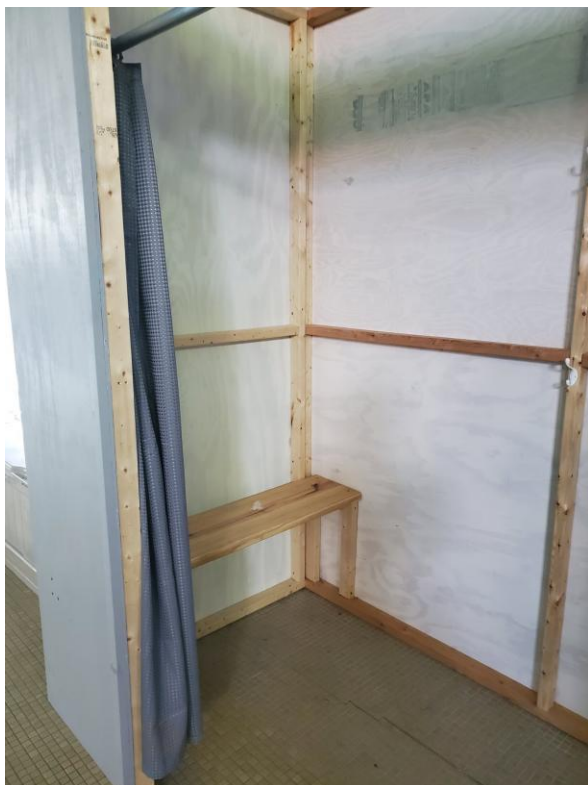
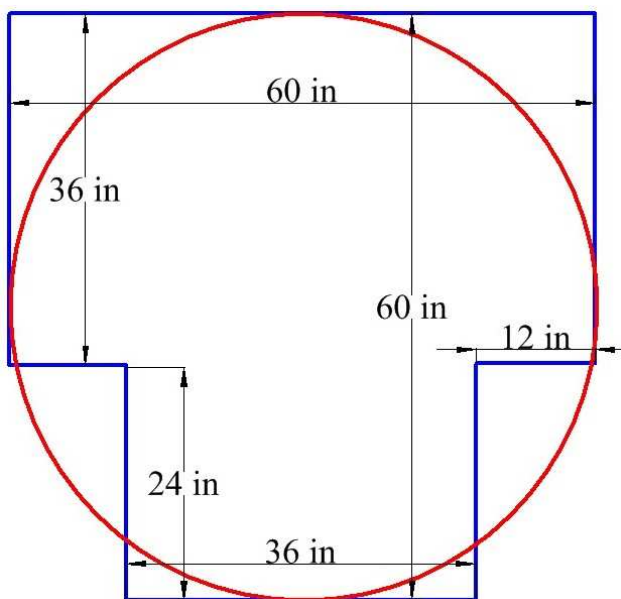
Changing does not have a turning space

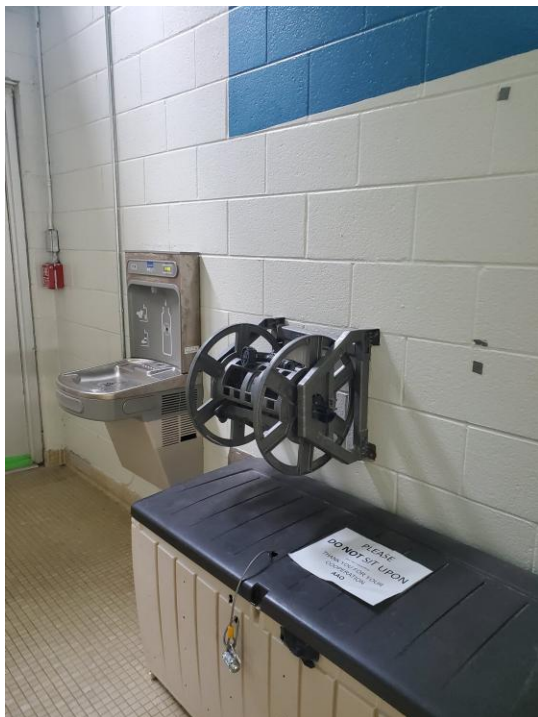
Wall-mounted objects that have leading edges between 27 inches and 80 inches from the floor must not project more than 4 inches into the circulation path. Protruding objects that extend to the floor or within 27 inches of the floor are cane detectable and are therefore not hazardous. Where it is necessary or desirable to have objects protrude from the wall, a manner of cane detection must be provided.

Hose reel protrudes more than 4 inches from wall.

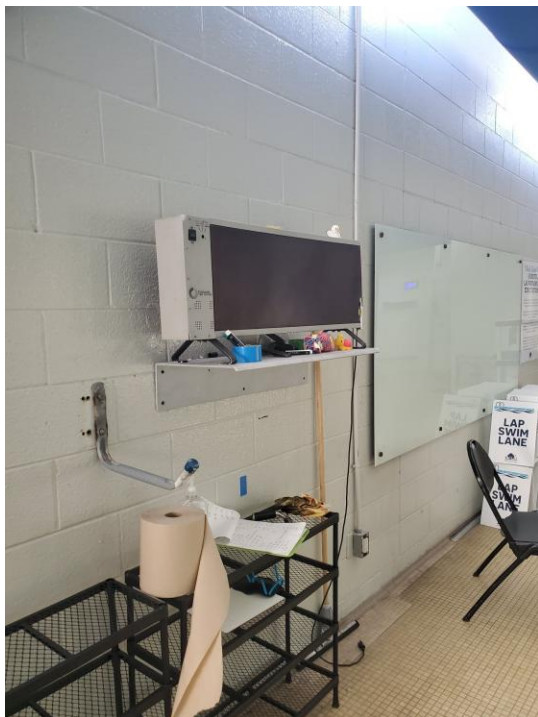
Wall-mounted objects that have leading edges between 27 inches and 80 inches from the floor must not project more than 4 inches into the circulation path. Protruding objects that extend to the floor or within 27 inches of the floor are cane detectable and are therefore not hazardous. Where it is necessary or desirable to have objects protrude from the wall, a manner of cane detection must be provided.

Shelf protrudes 14" from wall

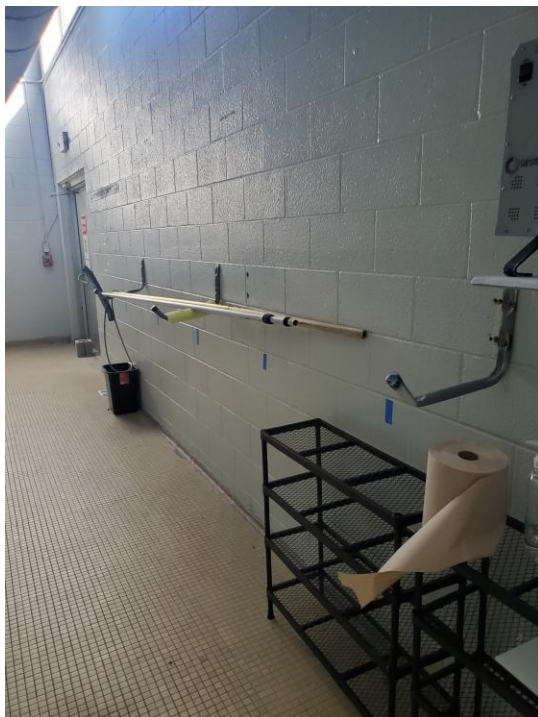
Wall-mounted objects that have leading edges between 27 inches and 80 inches from the floor must not project more than 4 inches into the circulation path. Protruding objects that extend to the floor or within 27 inches of the floor are cane detectable and are therefore not hazardous. Where it is necessary or desirable to have objects protrude from the wall, a manner of cane detection must be provided.

Pool tool hooks protrude 16" from the wall.

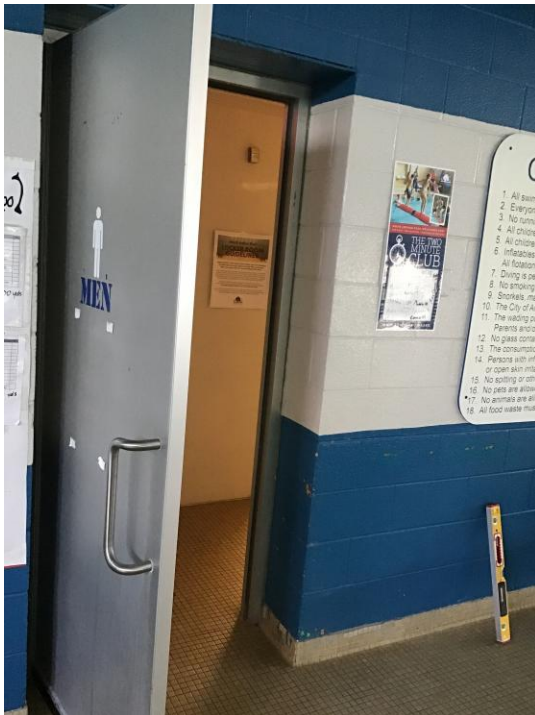
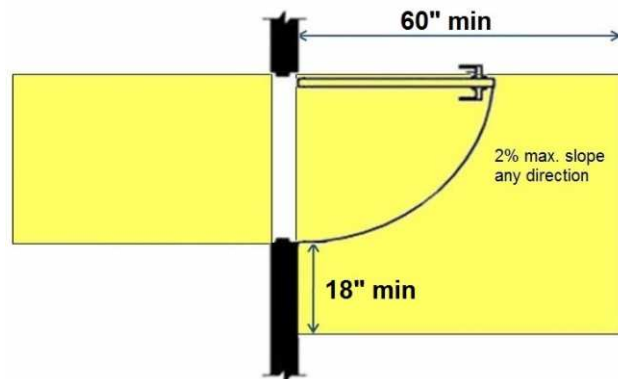
Pull side has wall at 11 inches thick from face of door.

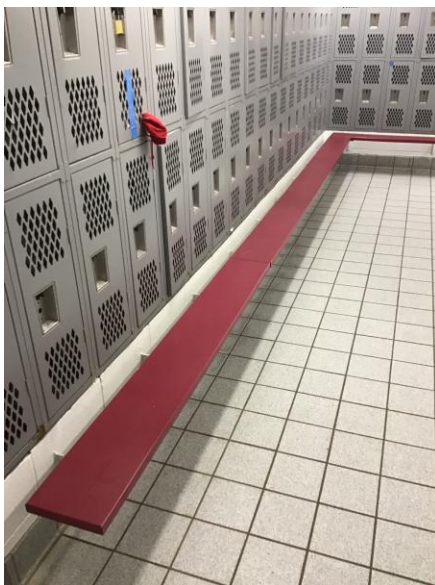
Existing bench at 9 inches deep among other barriers.

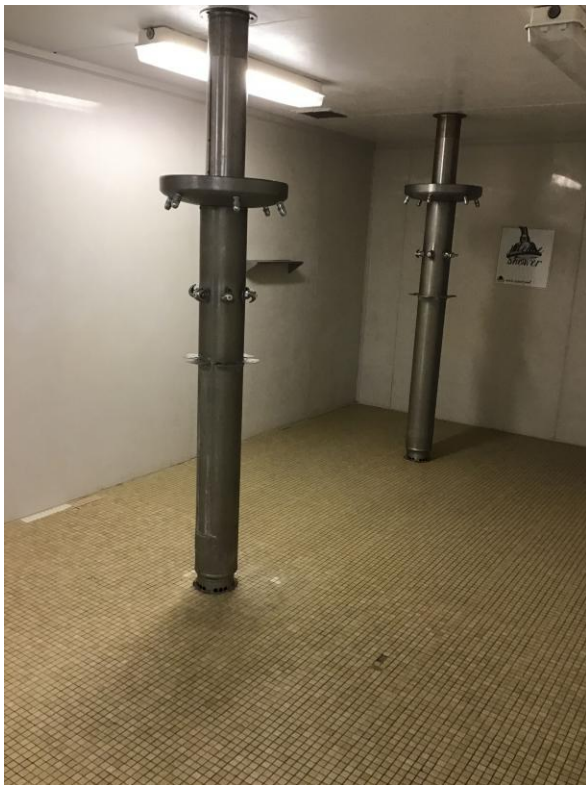
No accessible showers provided.

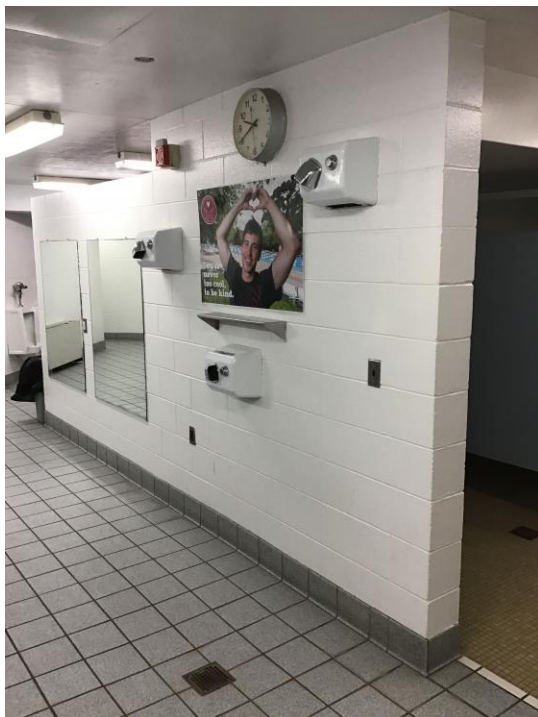
Wall-mounted objects that have leading edges between 27 inches and 80 inches from the floor must not project more than 4 inches into the circulation path. Protruding objects that extend to the floor or within 27 inches of the floor are cane detectable and are therefore not hazardous. Where it is necessary or desirable to have objects protrude from the wall, a manner of cane detection must be provided.

Shelf and dryers are protruding objects.

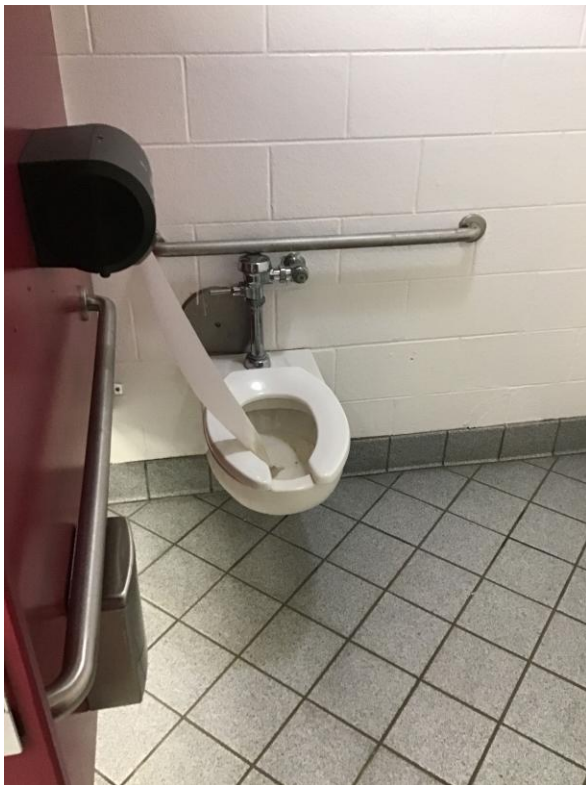
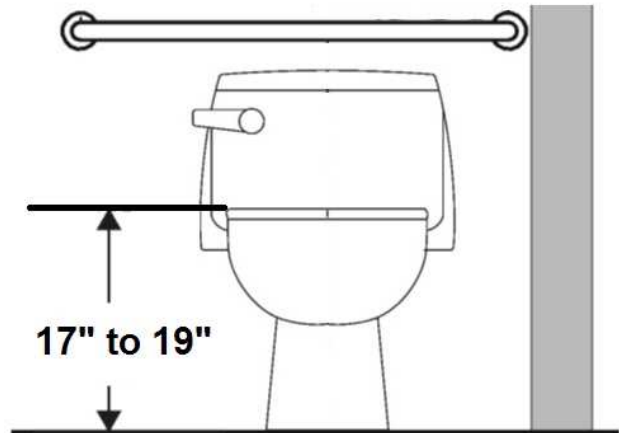
Seat height at 21 inches.

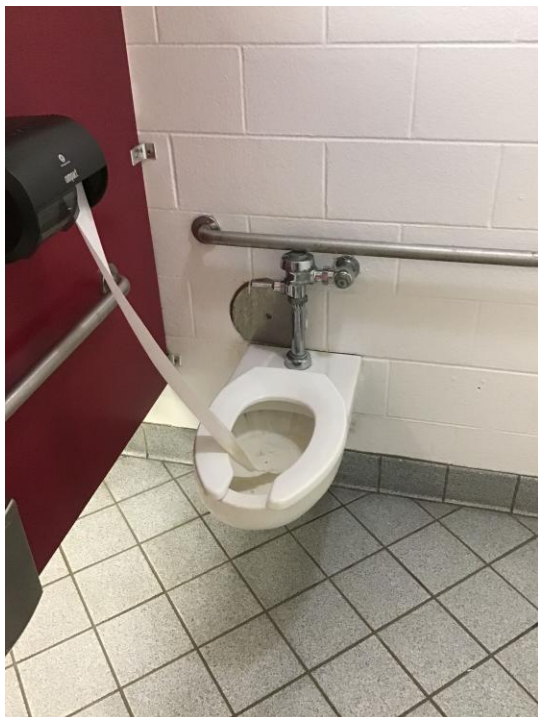
Flush control on closed side.
