Site Accessibility Evaluation

Allmendinger Park
655 Pauline Blvd
Ann Arbor, MI 48104
ADA Only

Inspection Date: 07/11/2022

Report Date: 11/15/2022

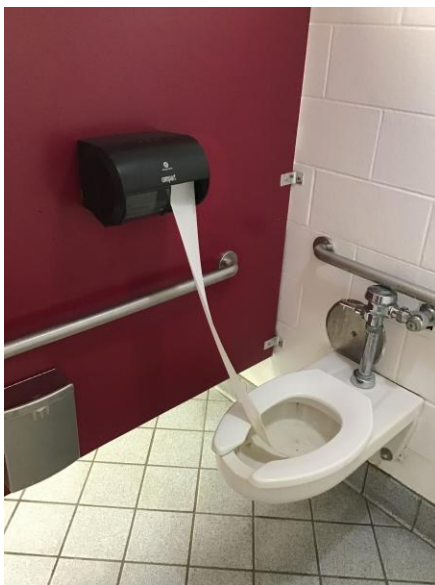
Toilet paper dispenser located 10 inches above grab bars.

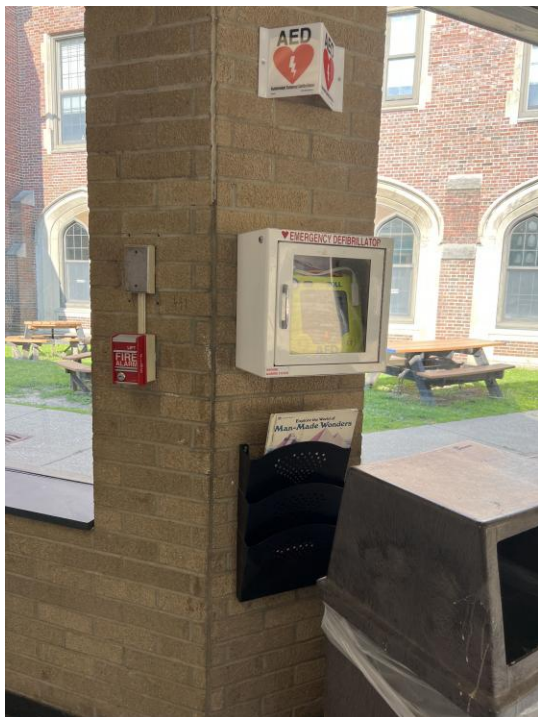
Wall-mounted objects that have leading edges between 27 inches and 80 inches from the floor must not project more than 4 inches into the circulation path. Protruding objects that extend to the floor or within 27 inches of the floor are cane detectable and are therefore not hazardous. Where it is necessary or desirable to have objects protrude from the wall, a manner of cane detection must be provided.

AED box protrudes more than 4 inches from the wall

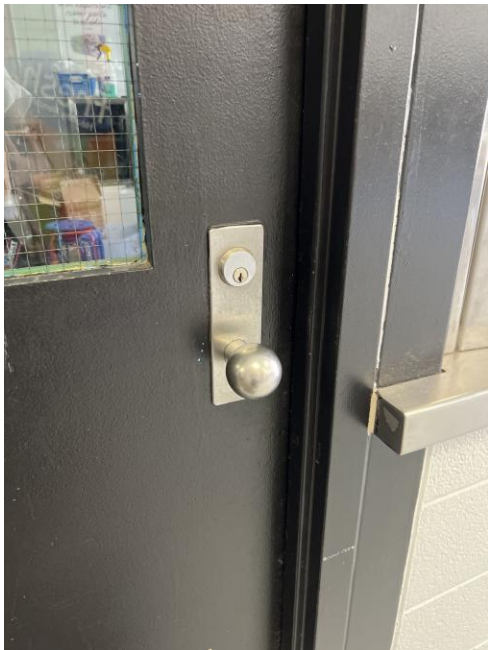
Door has non-compliant hardware

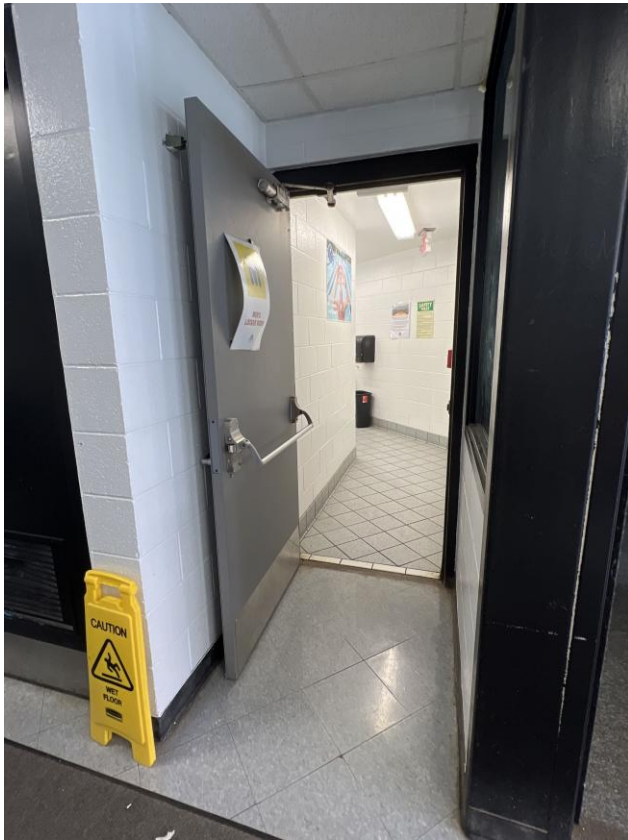
Finding #27 Continued

Door sign is non-compliant and not on the wall adjacent to the strike side of the door.

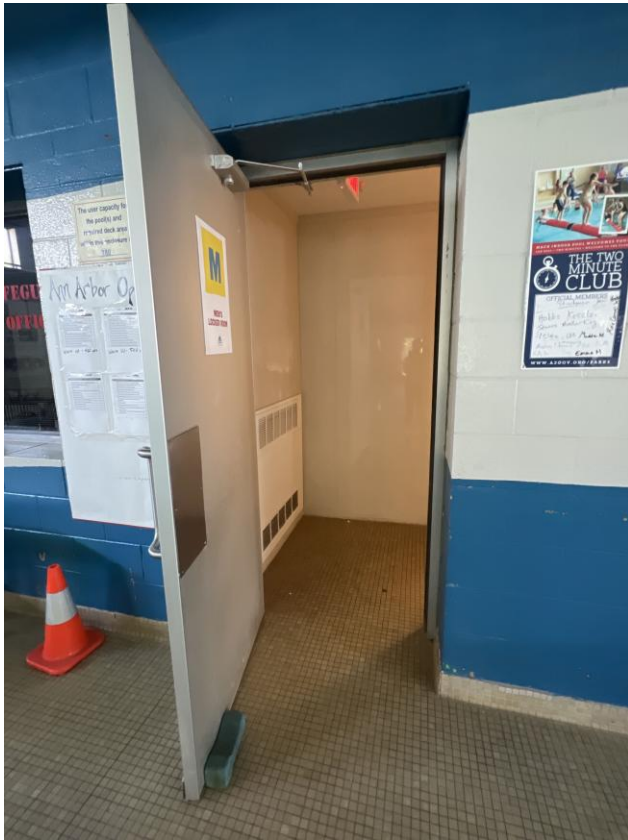
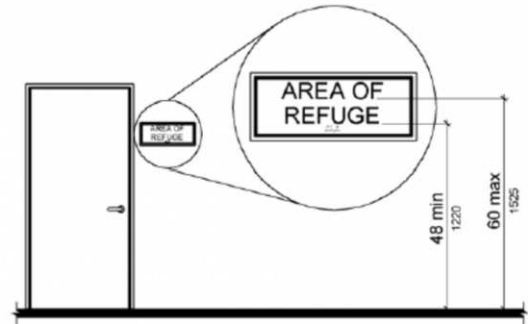
Finding #28 Continued

Door sign is non-compliant and not on the wall adjacent to the strike side of the door.

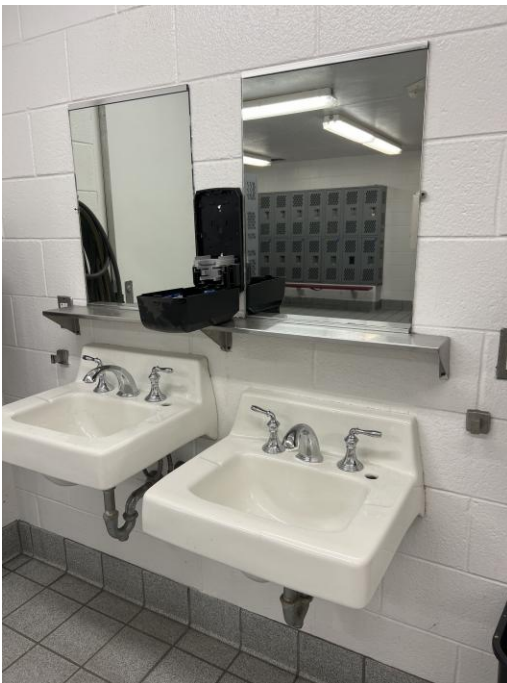
Mirror over lavatory is higher than 40 inches to the edge of the reflective surface

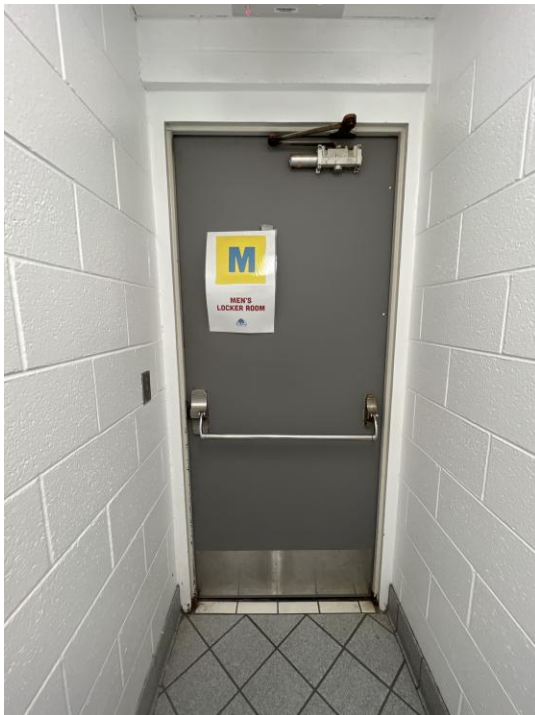
Door does not have the required maneuvering clearance on the push side

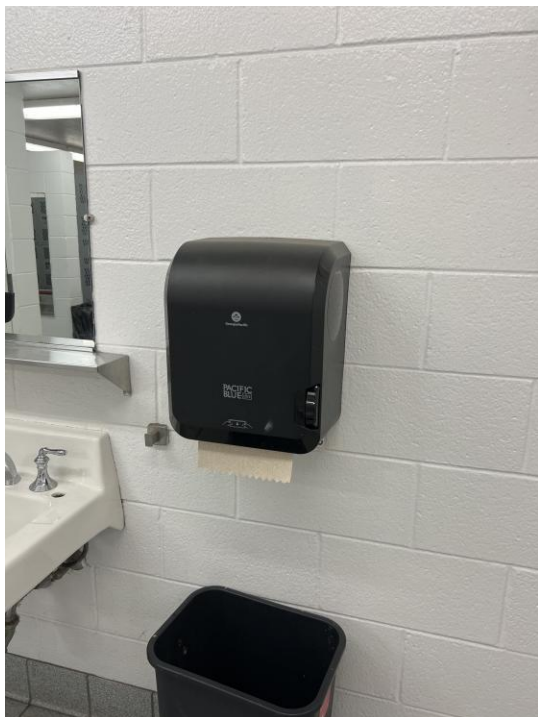
Wall-mounted objects that have leading edges between 27 inches and 80 inches from the floor must not project more than 4 inches into the circulation path. Protruding objects that extend to the floor or within 27 inches of the floor are cane detectable and are therefore not hazardous. Where it is necessary or desirable to have objects protrude from the wall, a manner of cane detection must be provided.

Paper towel dispenser protrudes more than 4 inches from the wall

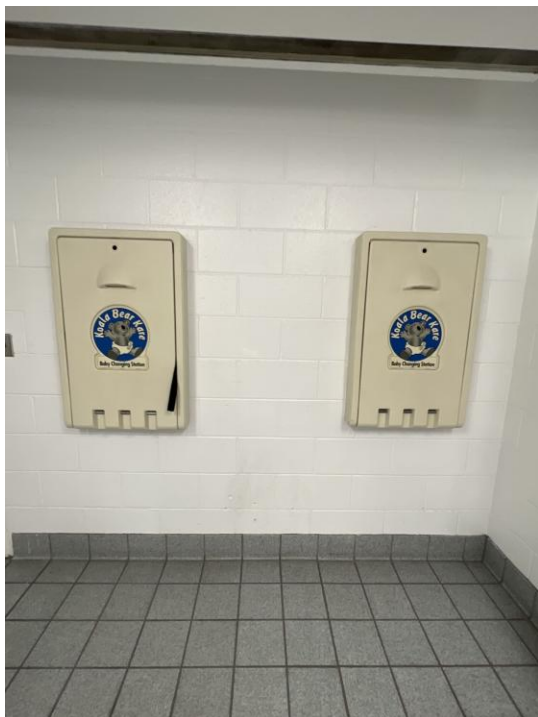
Wall-mounted objects that have leading edges between 27 inches and 80 inches from the floor must not project more than 4 inches into the circulation path. Protruding objects that extend to the floor or within 27 inches of the floor are cane detectable and are therefore not hazardous. Where it is necessary or desirable to have objects protrude from the wall, a manner of cane detection must be provided.

Baby changing station protrude more than 4 inches when open

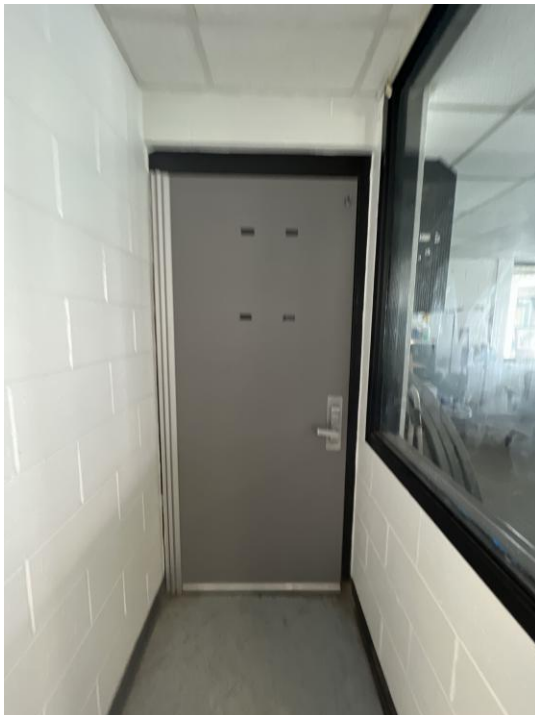
Door does not have the required maneuvering clearance on the pull side

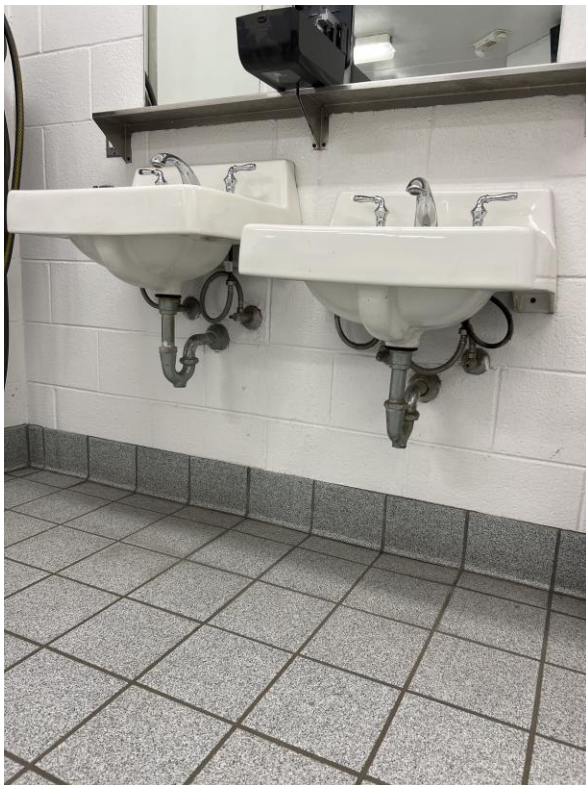
Sinks do not have insulated pipe covers

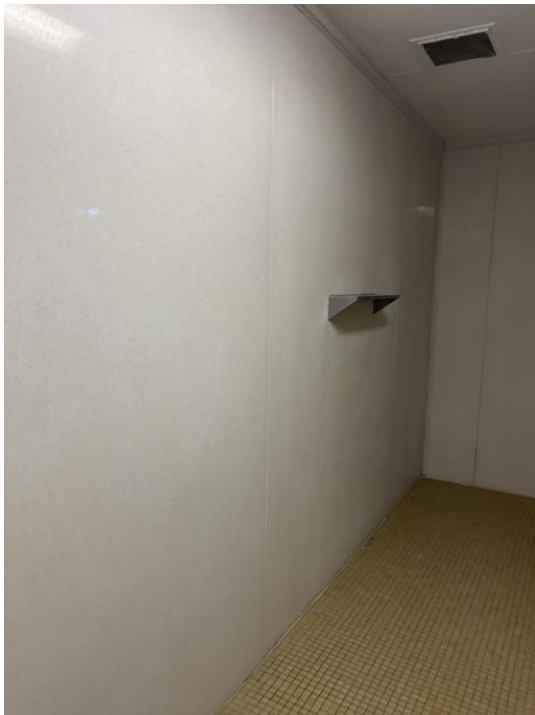
Wall-mounted objects that have leading edges between 27 inches and 80 inches from the floor must not project more than 4 inches into the circulation path. Protruding objects that extend to the floor or within 27 inches of the floor are cane detectable and are therefore not hazardous. Where it is necessary or desirable to have objects protrude from the wall, a manner of cane detection must be provided.

Shelf protrudes more than 4 inches from the wall

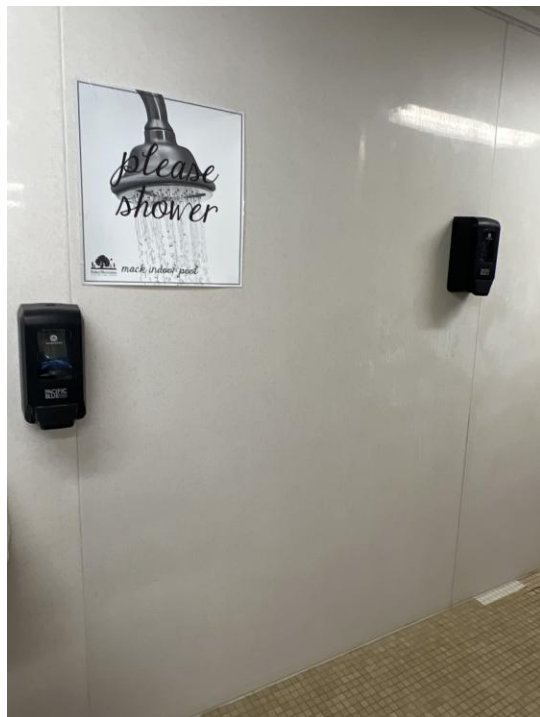
Wall-mounted objects that have leading edges between 27 inches and 80 inches from the floor must not project more than 4 inches into the circulation path. Protruding objects that extend to the floor or within 27 inches of the floor are cane detectable and are therefore not hazardous. Where it is necessary or desirable to have objects protrude from the wall, a manner of cane detection must be provided.

Soap dispensers protrude more than 4 inches from the wall

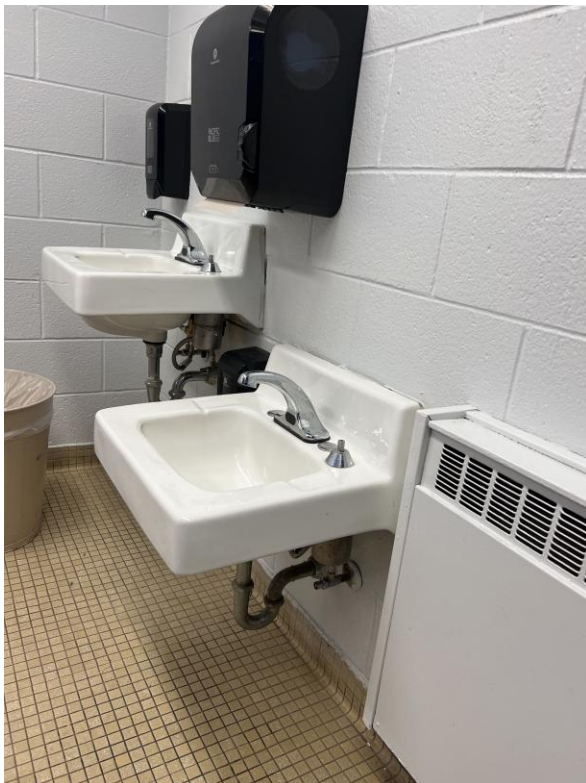
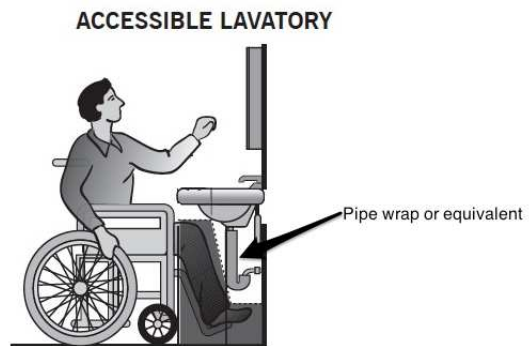
Sinks do not have insulated pipe covers

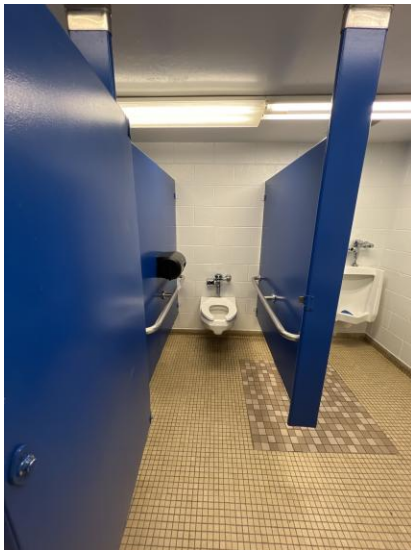
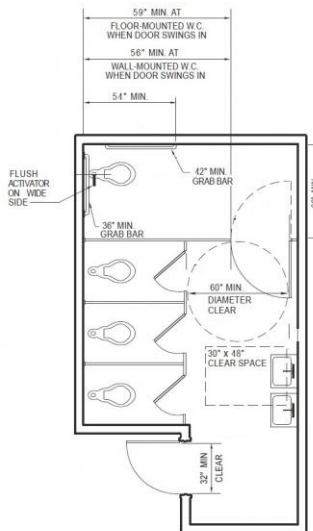
Restroom does not have an accessible stall

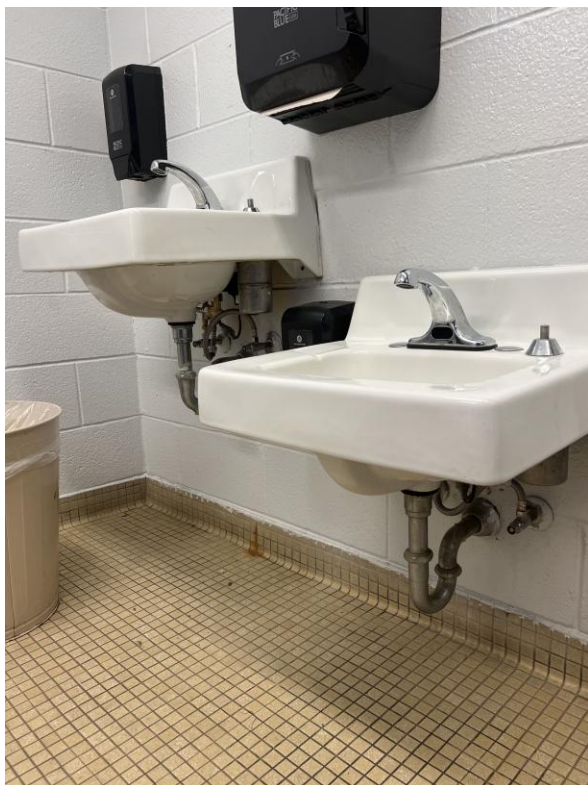
Sinks do not have insulated pipe covers

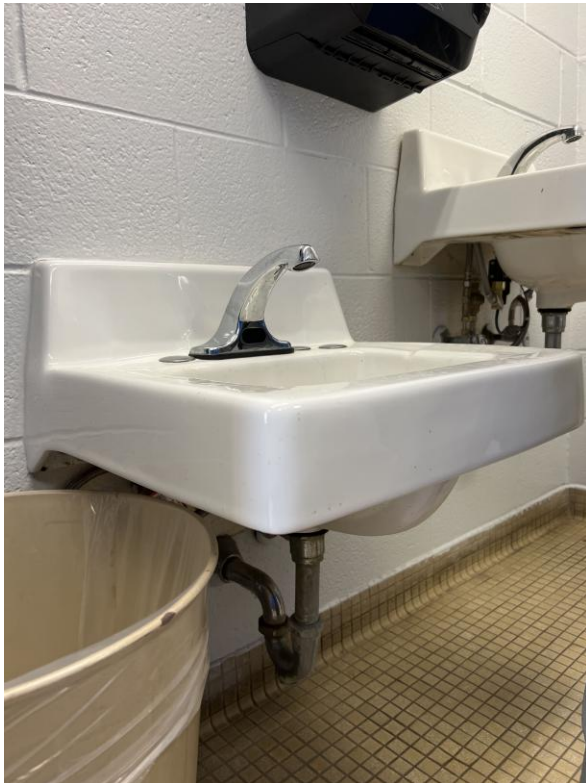
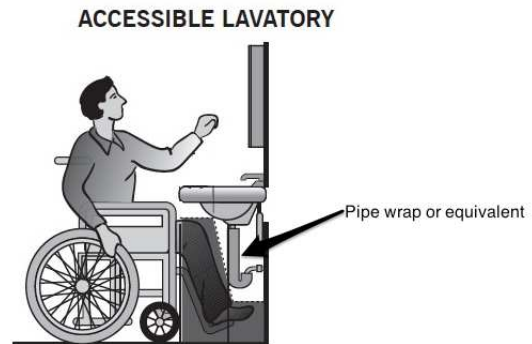
Sinks do not have insulated pipe covers

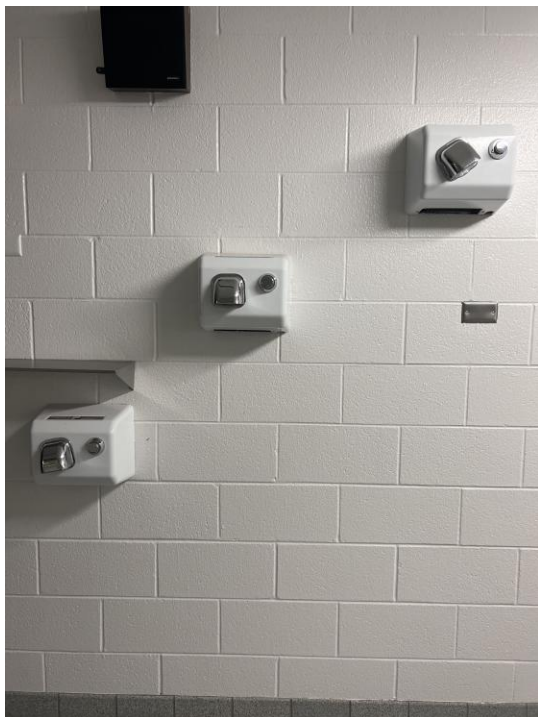
Wall-mounted objects that have leading edges between 27 inches and 80 inches from the floor must not project more than 4 inches into the circulation path. Protruding objects that extend to the floor or within 27 inches of the floor are cane detectable and are therefore not hazardous. Where it is necessary or desirable to have objects protrude from the wall, a manner of cane detection must be provided.

3 hand dryers protrude more than 4 inches from the wall

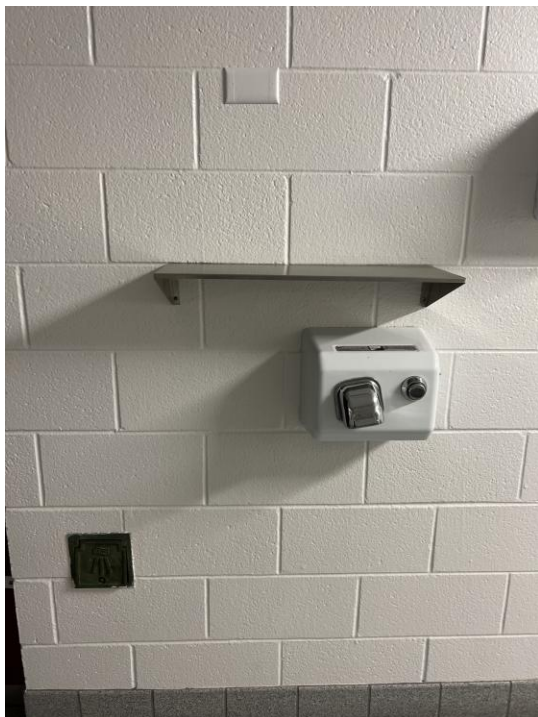
Wall-mounted objects that have leading edges between 27 inches and 80 inches from the floor must not project more than 4 inches into the circulation path. Protruding objects that extend to the floor or within 27 inches of the floor are cane detectable and are therefore not hazardous. Where it is necessary or desirable to have objects protrude from the wall, a manner of cane detection must be provided.

Wall-mounted shelf protrudes more than 4 inches from the wall

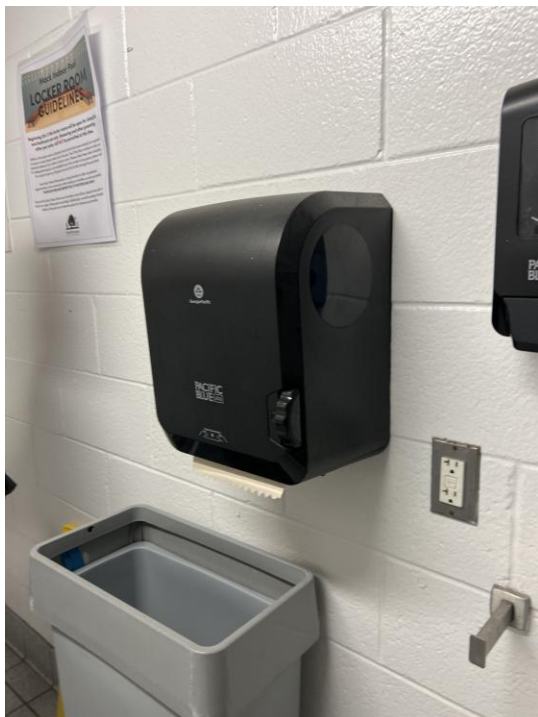
Wall-mounted objects that have leading edges between 27 inches and 80 inches from the floor must not project more than 4 inches into the circulation path. Protruding objects that extend to the floor or within 27 inches of the floor are cane detectable and are therefore not hazardous. Where it is necessary or desirable to have objects protrude from the wall, a manner of cane detection must be provided.

Wall-mounted paper towel dispenser protrudes more than 4 inches from the wall

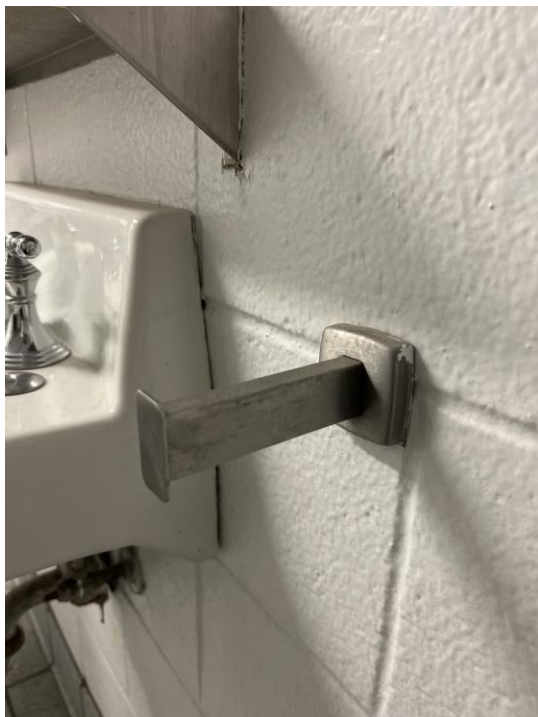
Wall-mounted objects that have leading edges between 27 inches and 80 inches from the floor must not project more than 4 inches into the circulation path. Protruding objects that extend to the floor or within 27 inches of the floor are cane detectable and are therefore not hazardous. Where it is necessary or desirable to have objects protrude from the wall, a manner of cane detection must be provided.

Coat hook protrudes more than 4 inches from the wall

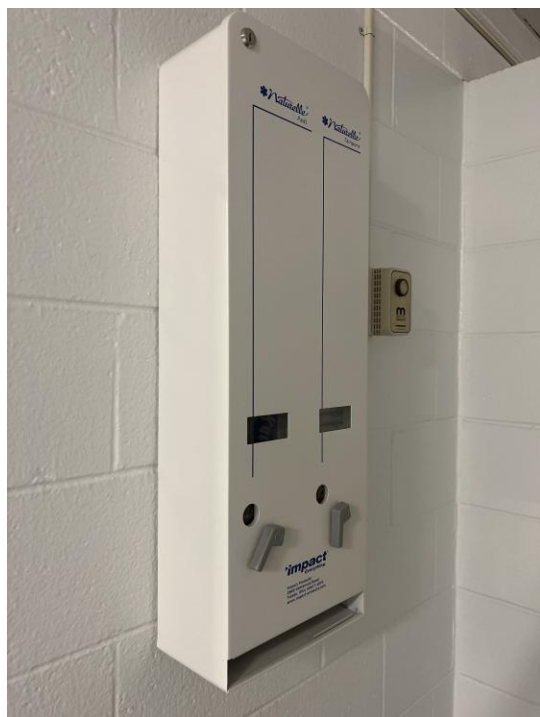
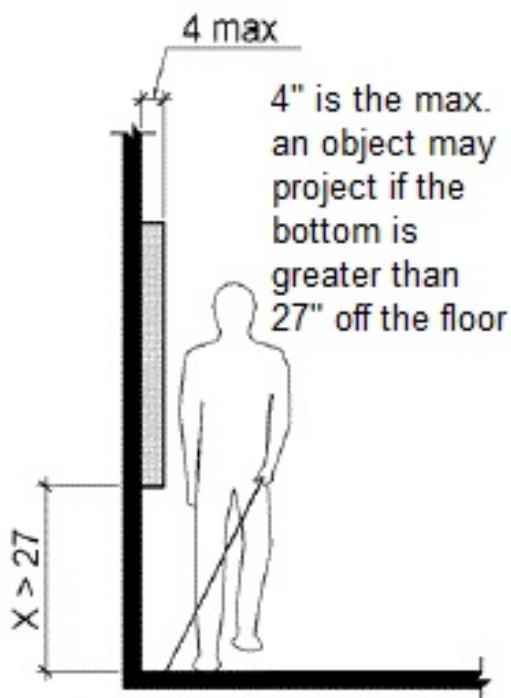
Wall-mounted objects that have leading edges between 27 inches and 80 inches from the floor must not project more than 4 inches into the circulation path. Protruding objects that extend to the floor or within 27 inches of the floor are cane detectable and are therefore not hazardous. Where it is necessary or desirable to have objects protrude from the wall, a manner of cane detection must be provided.

Hygiene dispenser protrudes more than 4 inches from the wall

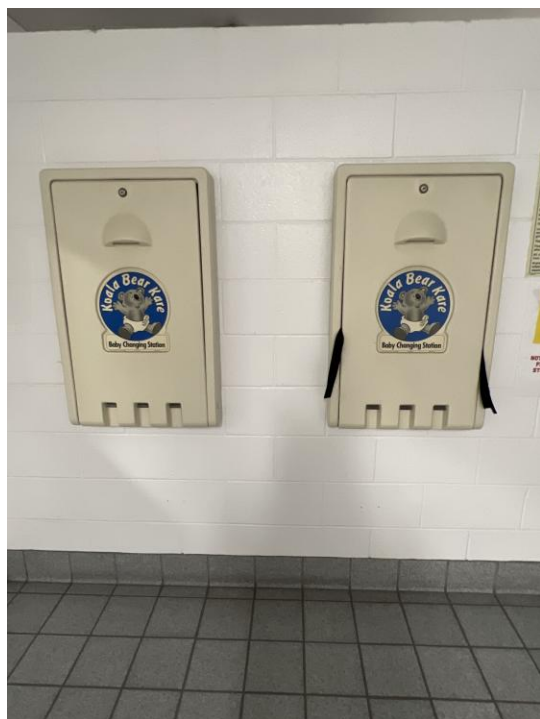
Wall-mounted objects that have leading edges between 27 inches and 80 inches from the floor must not project more than 4 inches into the circulation path. Protruding objects that extend to the floor or within 27 inches of the floor are cane detectable and are therefore not hazardous. Where it is necessary or desirable to have objects protrude from the wall, a manner of cane detection must be provided.

Baby changing stations protrude more than 4 inches when open

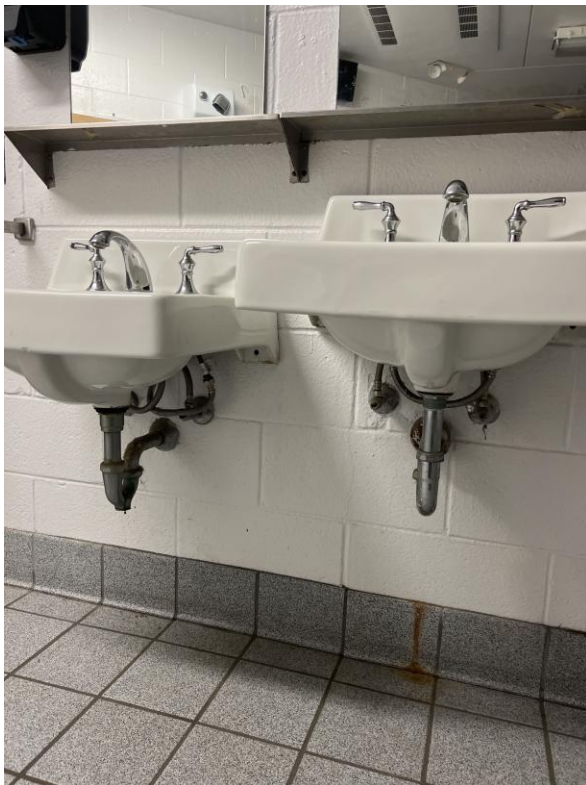
Sinks do not have insulated pipe covers

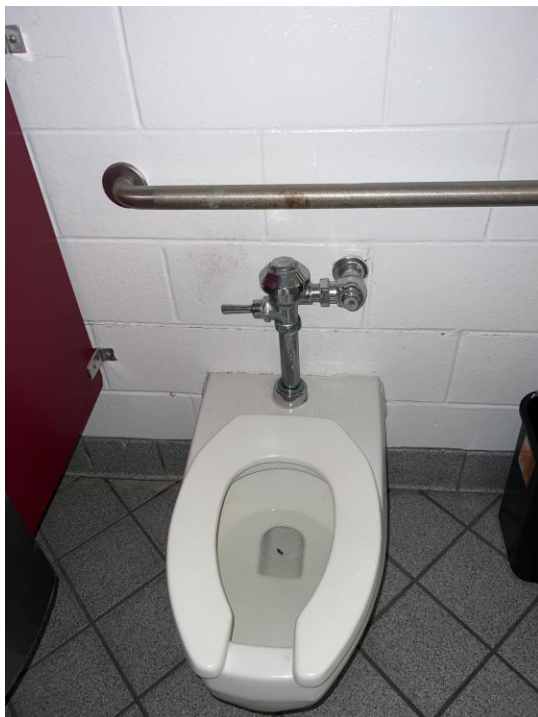
Flush valve is not towards the open side

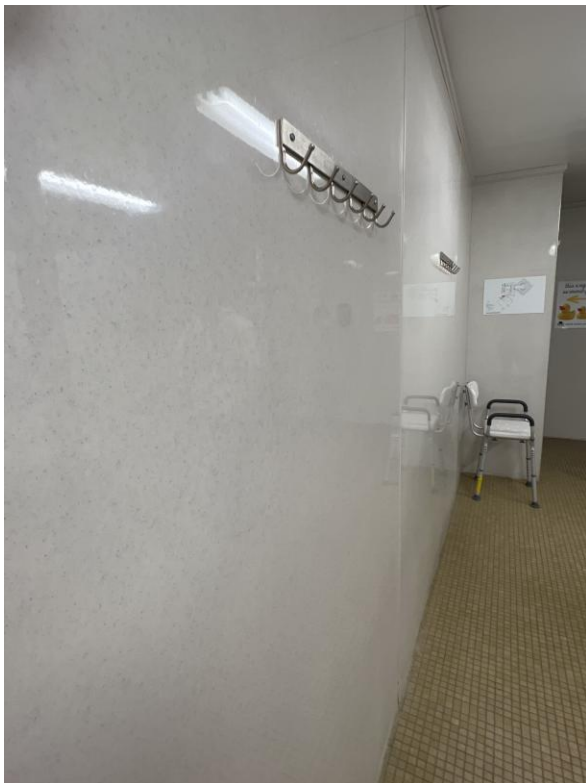
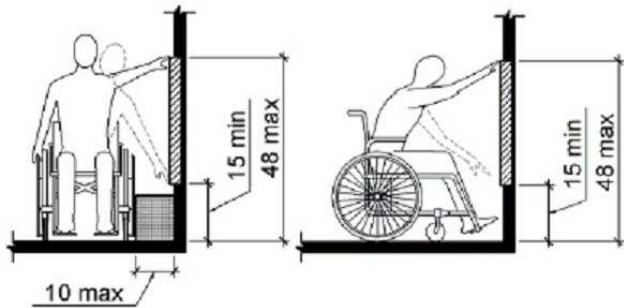
Coat hooks are not within reach range

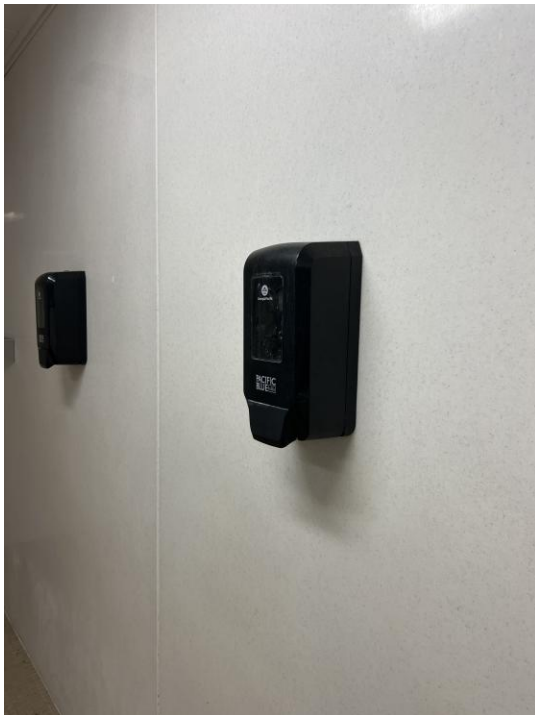
Wall-mounted objects that have leading edges between 27 inches and 80 inches from the floor must not project more than 4 inches into the circulation path. Protruding objects that extend to the floor or within 27 inches of the floor are cane detectable and are therefore not hazardous. Where it is necessary or desirable to have objects protrude from the wall, a manner of cane detection must be provided.

Soap dispensers protrude more than 4 inches from the wall

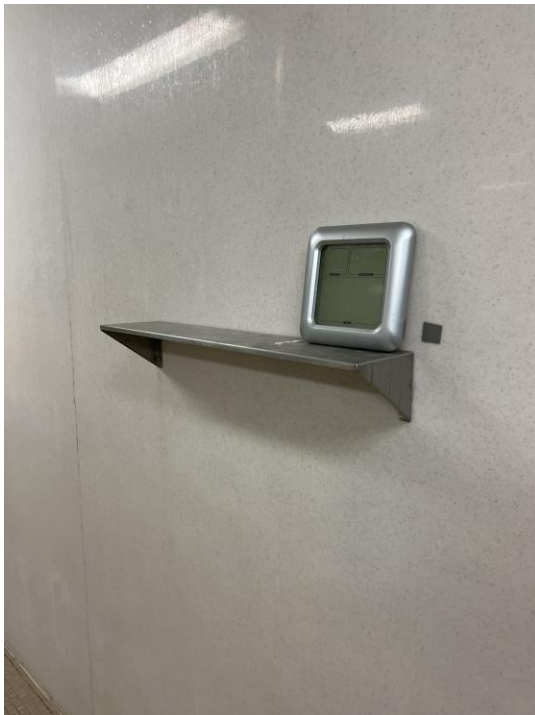
Wall-mounted objects that have leading edges between 27 inches and 80 inches from the floor must not project more than 4 inches into the circulation path. Protruding objects that extend to the floor or within 27 inches of the floor are cane detectable and are therefore not hazardous. Where it is necessary or desirable to have objects protrude from the wall, a manner of cane detection must be provided.

Shelves protrude more than 4 inches from the wall

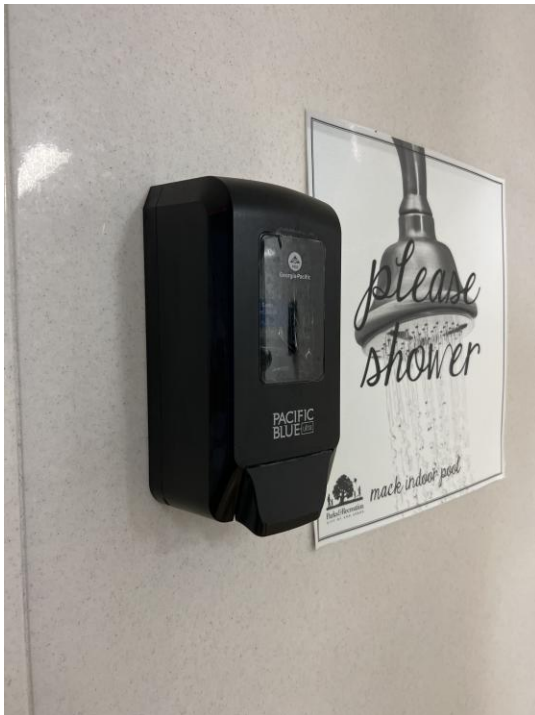
Wall-mounted objects that have leading edges between 27 inches and 80 inches from the floor must not project more than 4 inches into the circulation path. Protruding objects that extend to the floor or within 27 inches of the floor are cane detectable and are therefore not hazardous. Where it is necessary or desirable to have objects protrude from the wall, a manner of cane detection must be provided.

Soap dispenser protrudes more than 4 inches from the wall

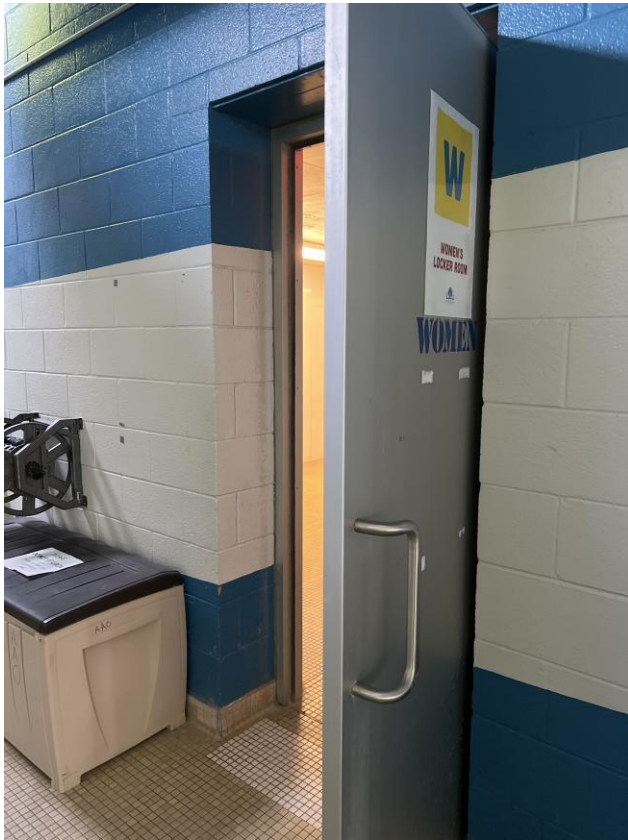
Finding #53 Continued

Door sign is not compliant and not on the wall adjacent to the latch side

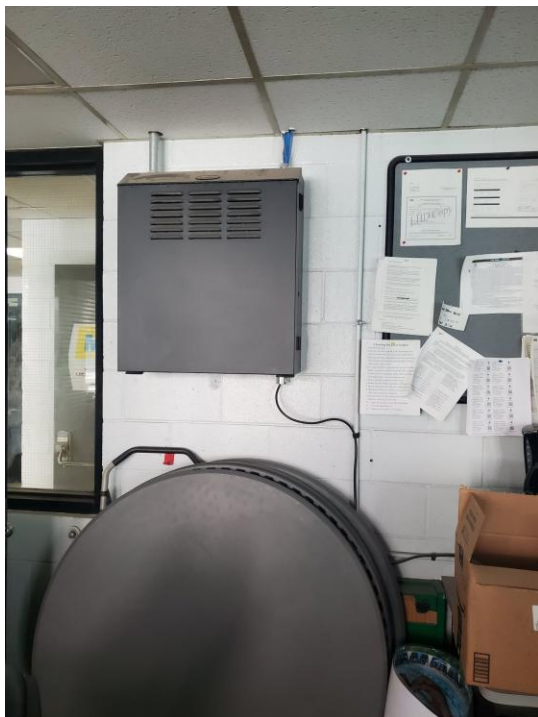
Wall-mounted objects that have leading edges between 27 inches and 80 inches from the floor must not project more than 4 inches into the circulation path. Protruding objects that extend to the floor or within 27 inches of the floor are cane detectable and are therefore not hazardous. Where it is necessary or desirable to have objects protrude from the wall, a manner of cane detection must be provided.

Server in sales office protrudes more than 4 inches from the wall and is less than 80 inches high

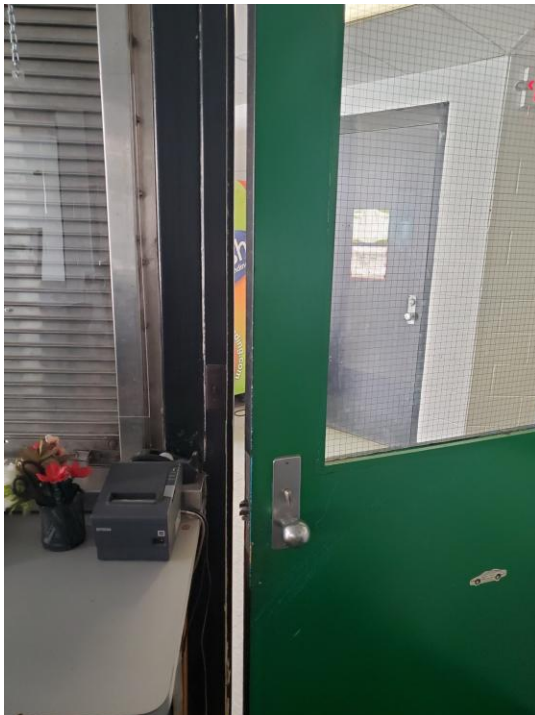
Door does not have the required maneuvering clearance on the pull side

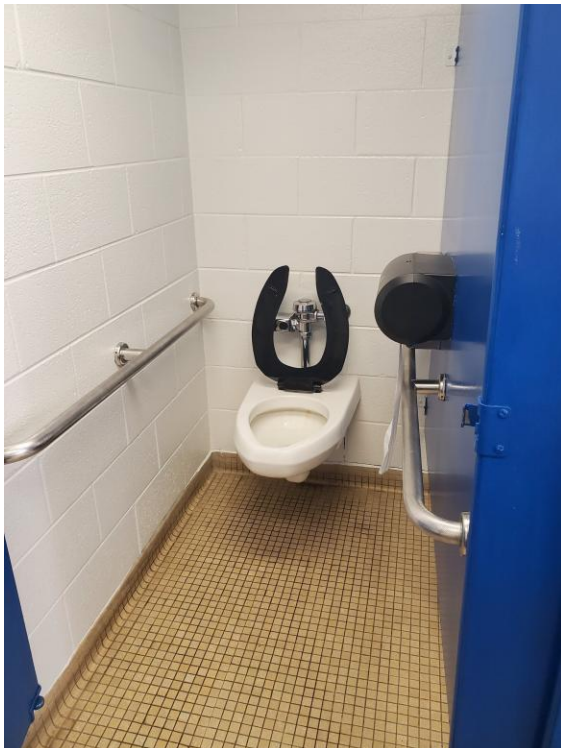
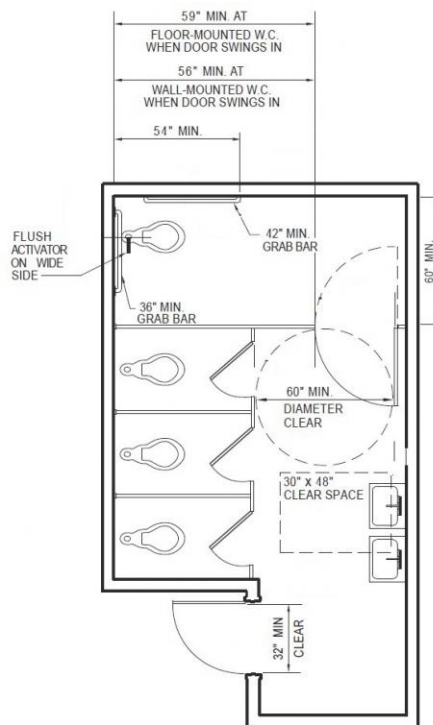
The stall does not have the required minimum clear floor space or maneuvering clearances for the toilet, Grab bars are missing and/or incorrectly installed, accessories, such as toilet seat covers, toilet paper holders, and garbage cans are either too high, without clear floor space or both, the floor level changes greater than a 1/2 inch at the floor drains.

Women's restroom in lobby does not have an accessible stall

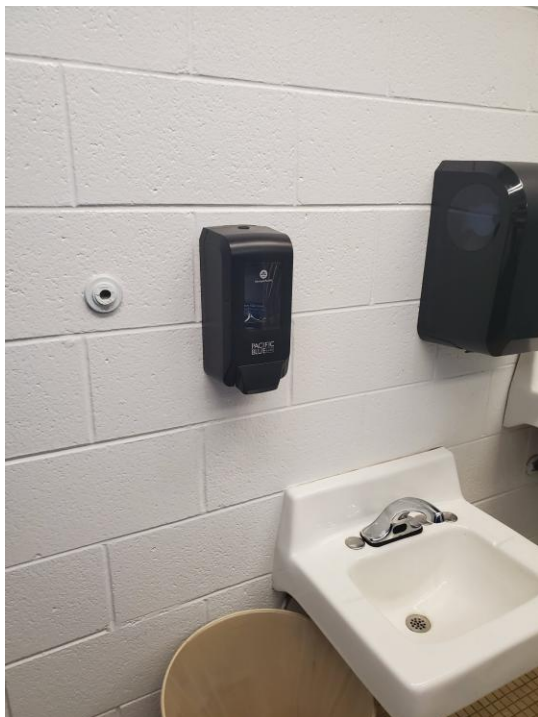
Wall-mounted objects that have leading edges between 27 inches and 80 inches from the floor must not project more than 4 inches into the circulation path. Protruding objects that extend to the floor or within 27 inches of the floor are cane detectable and are therefore not hazardous. Where it is necessary or desirable to have objects protrude from the wall, a manner of cane detection must be provided.

Soap dispensers and paper towel dispensers protrude more than 4 inches

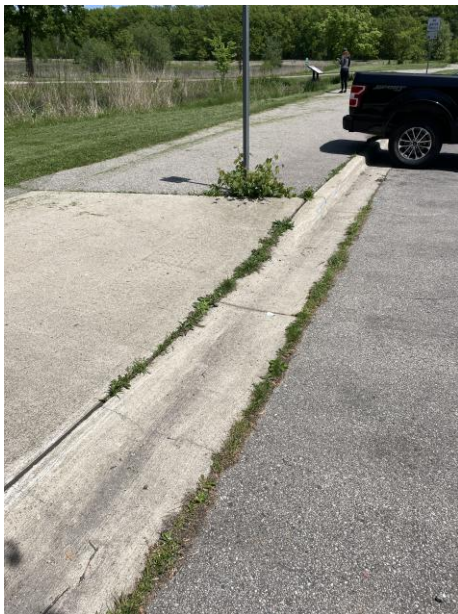
Vegetation at joints produce a change in level greater than 1/2 inch

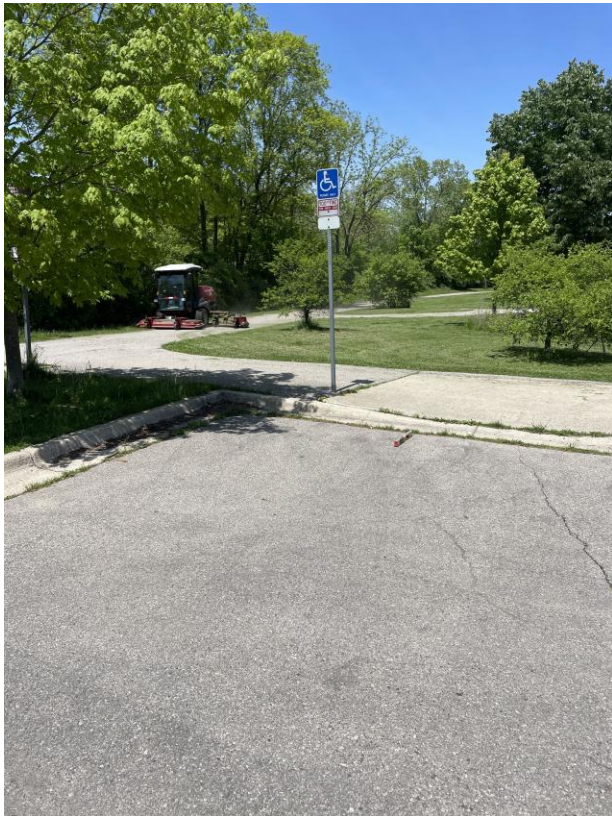
Accessible parking stall has slopes greater than 2%

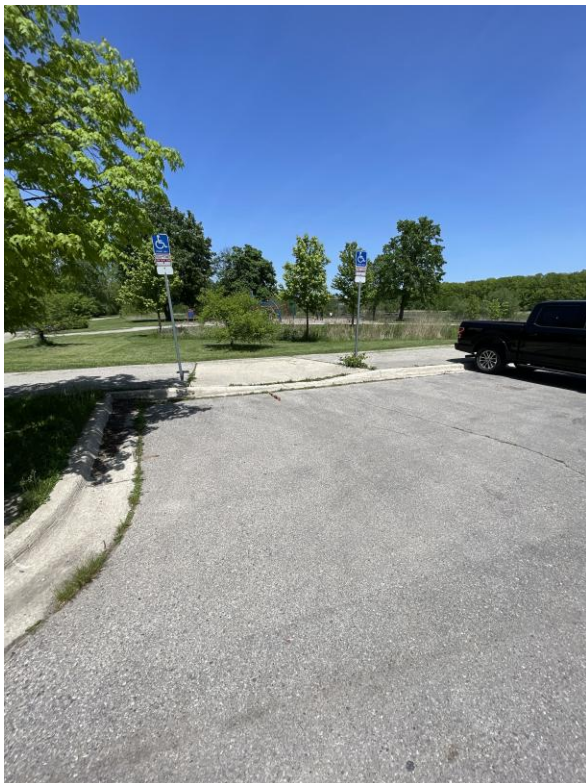
The accessible parking space is missing the required markings.

Accessible parking stall is not marked

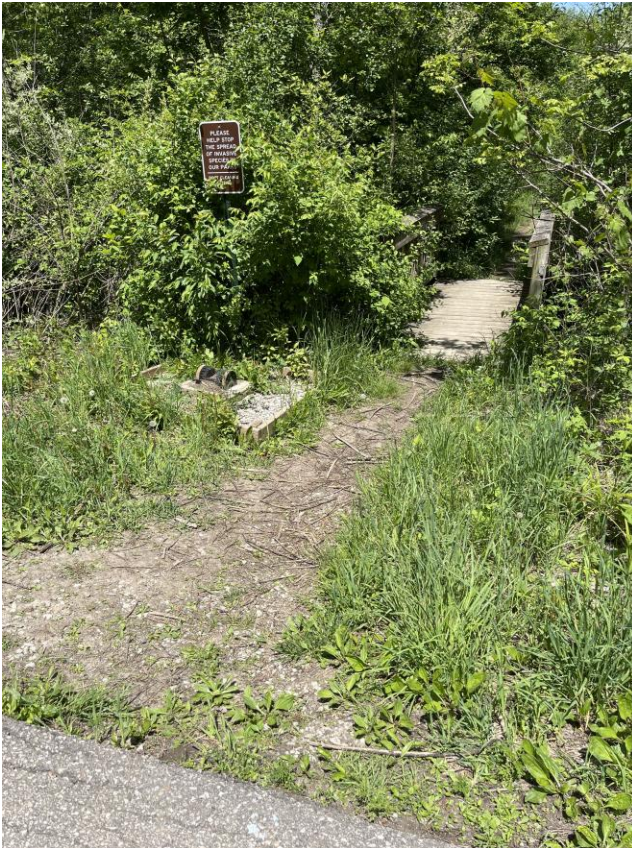
Route has a non-compliant change in level and does not have a stable surface

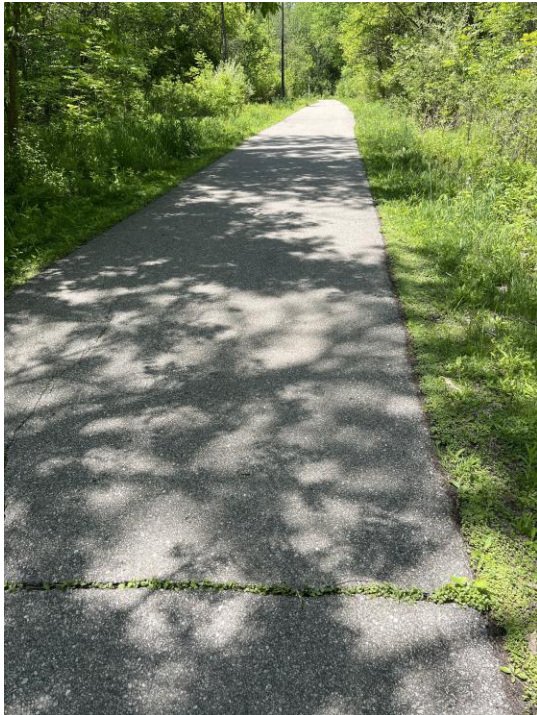
horizontal openings along the trail

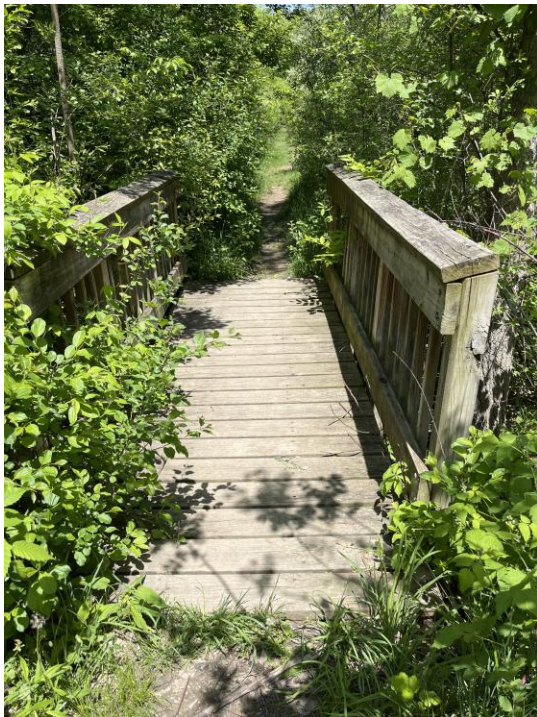
Wooden bridge with openings and change in level

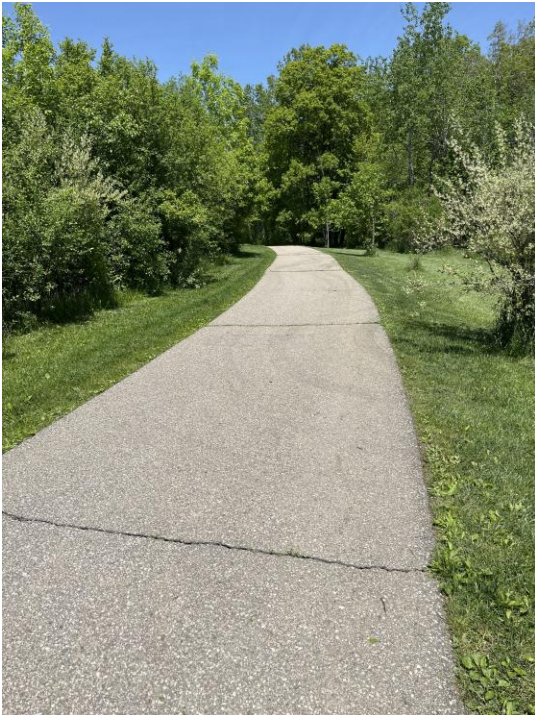
horizontal openings along the trail

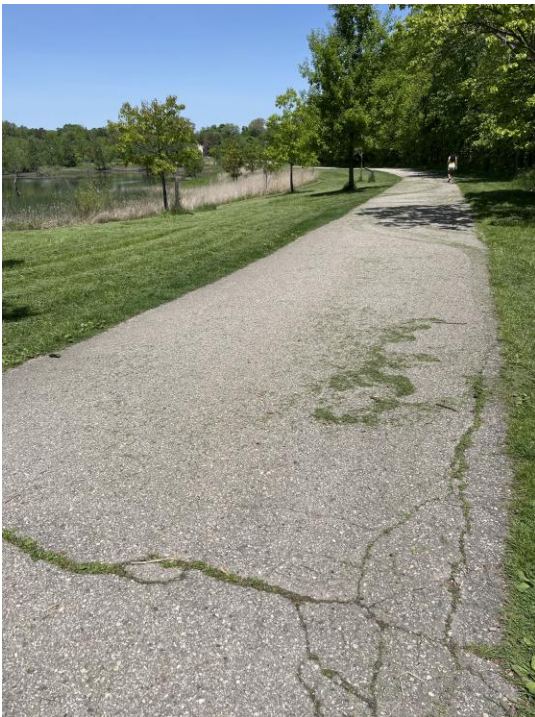
horizontal openings along the trail

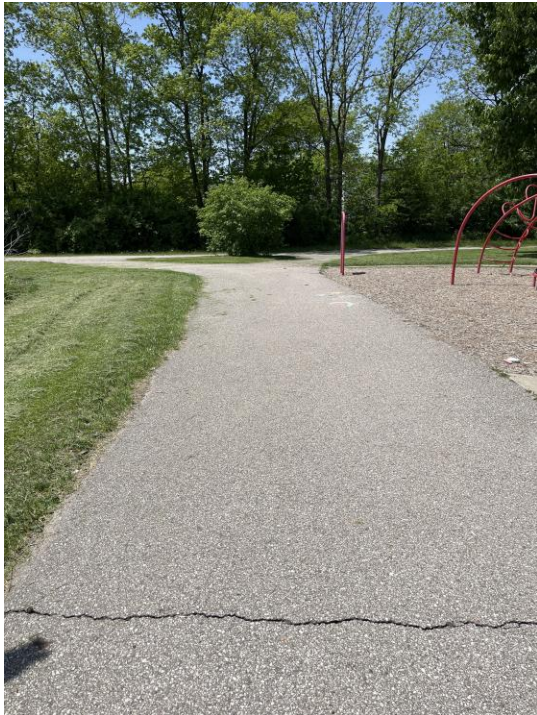
horizontal opening along the trail to the play area

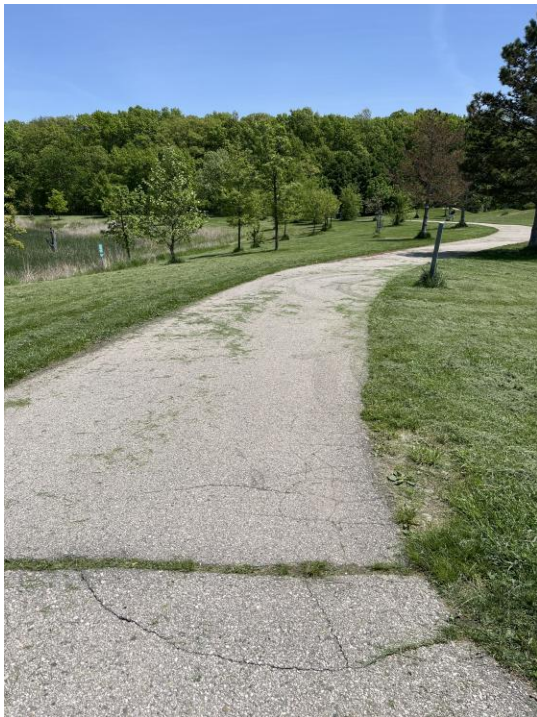
horizontal openings along the trail

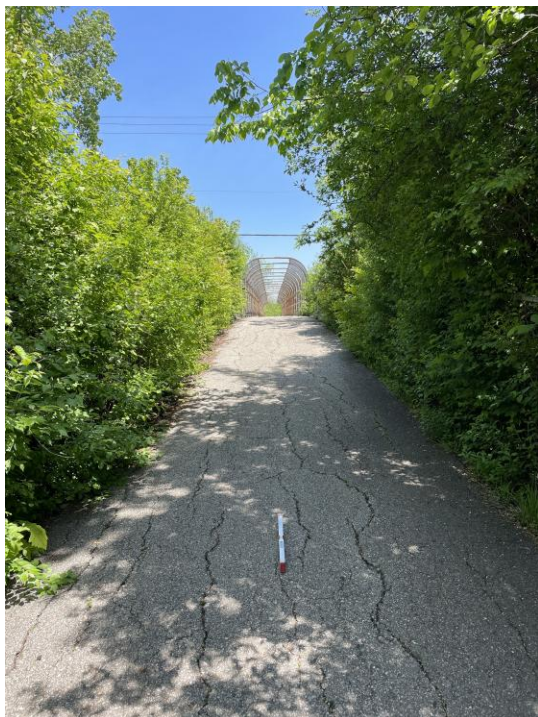
Accessible route has a running slope greater than 5% and is not built as a ramp

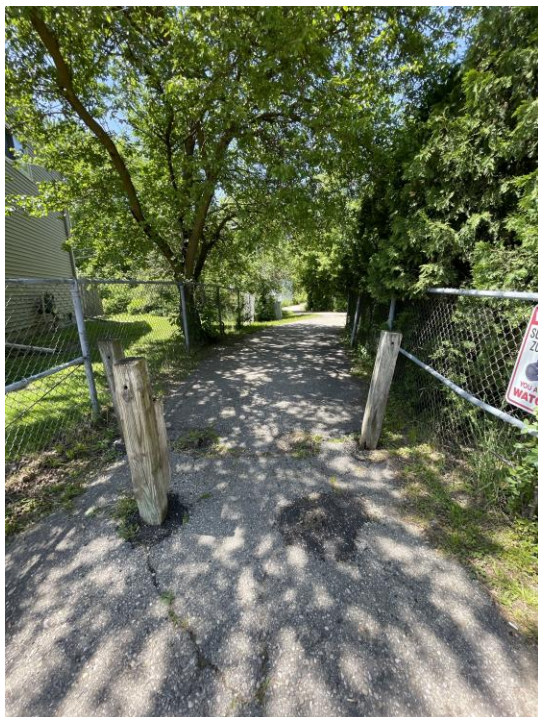
Accessible route has a running slope greater than 5% and is not built as a ramp

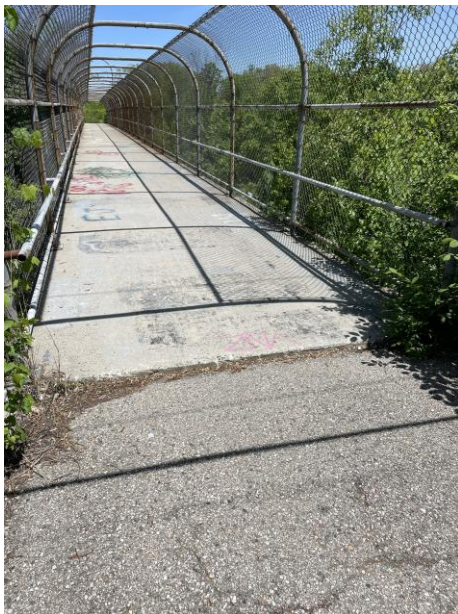
Accessible route has non-compliant vertical changes in level
