Site Accessibility Evaluation

Allmendinger Park
655 Pauline Blvd
Ann Arbor, MI 48104
ADA Only

Inspection Date: 07/11/2022

Report Date: 11/15/2022

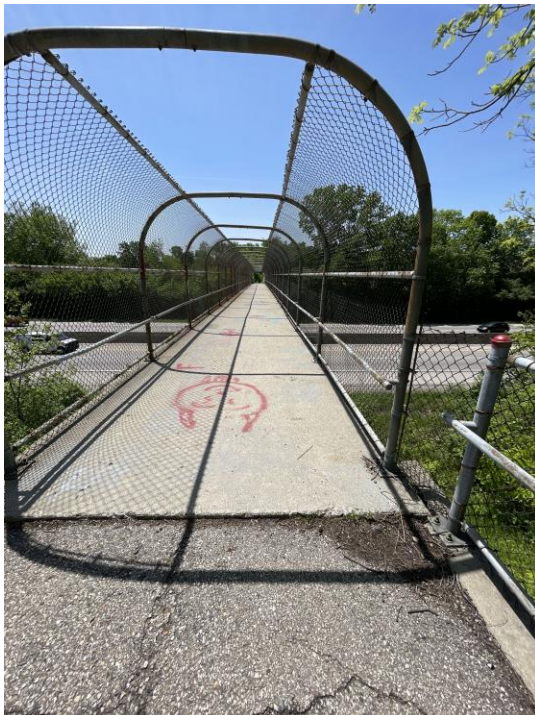
Handrails along accessible route is not compliant with 505

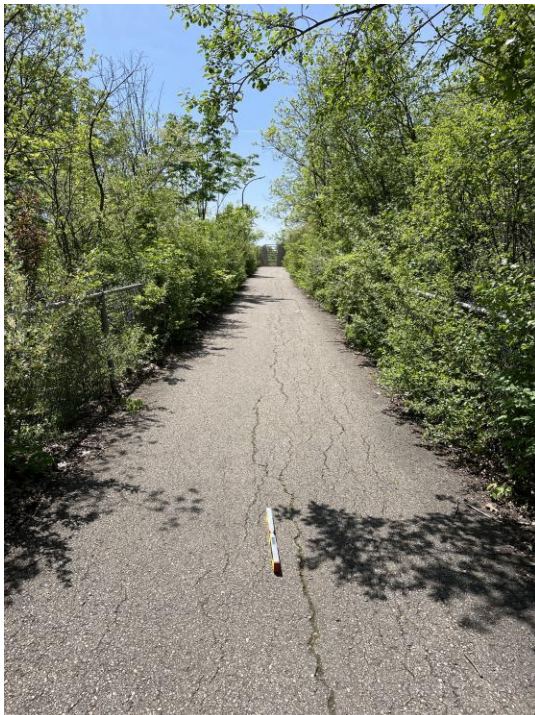
Accessible route has a running slope greater than 5% and is not built as a ramp

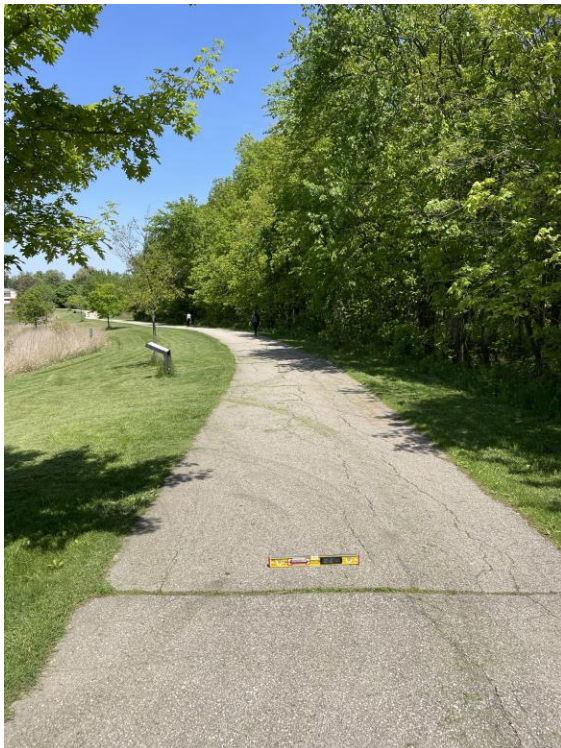
Accessible route has a cross slope greater than 2%

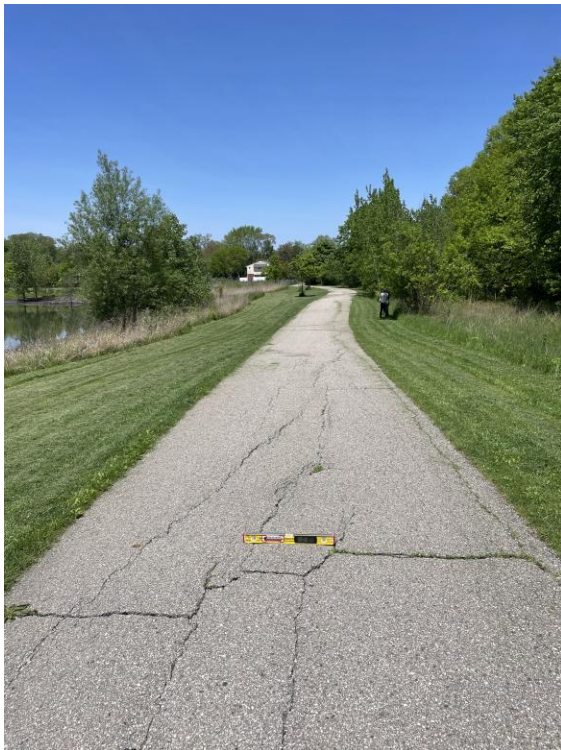
Accessible route has a cross slope greater than 2%

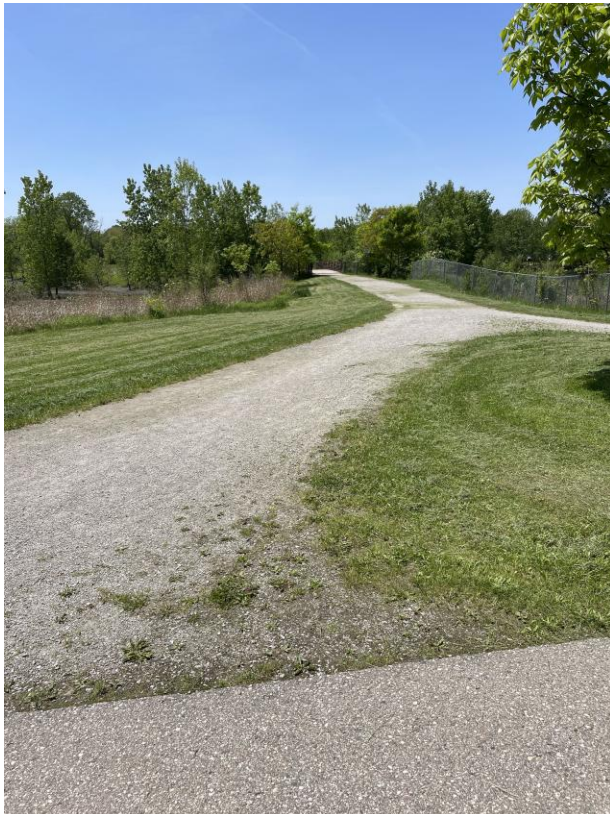
The accessible route contains loose gravel and/or surface materials that do not provide for a stable, firm slip resistant surface.

Route does not have a compliant surface

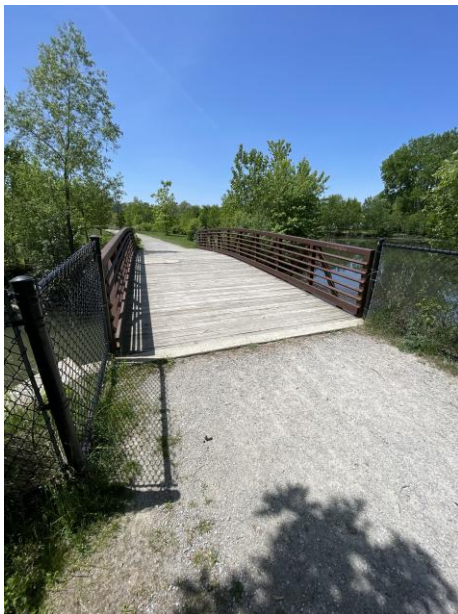
Accessible route has non-compliant changes in level

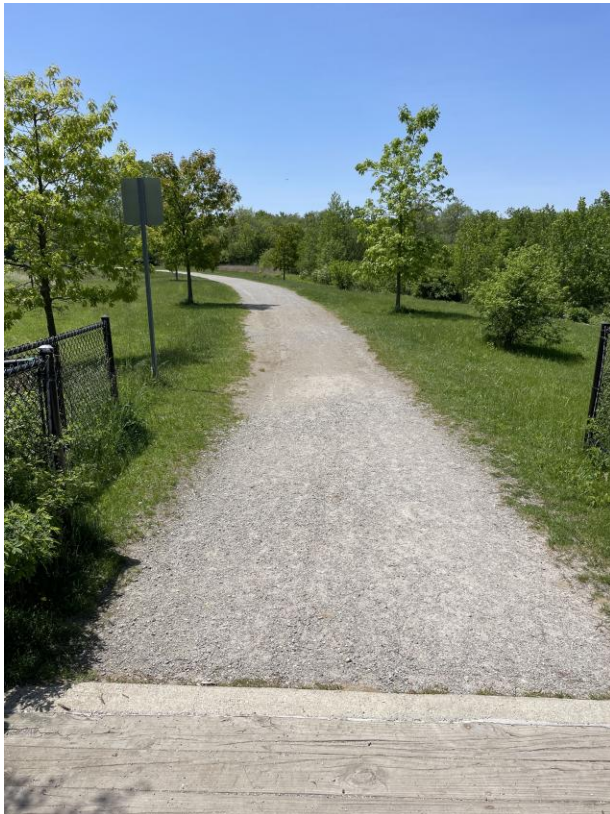
The accessible route contains loose gravel and/or surface materials that do not provide for a stable, firm slip resistant surface.

Route does not have a compliant surface

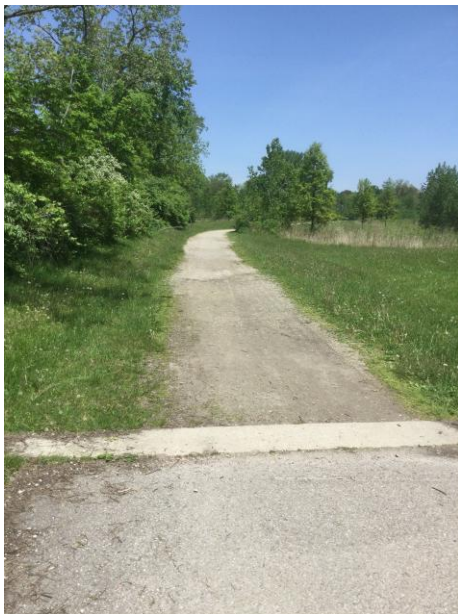
Accessible route has non-compliant changes in level

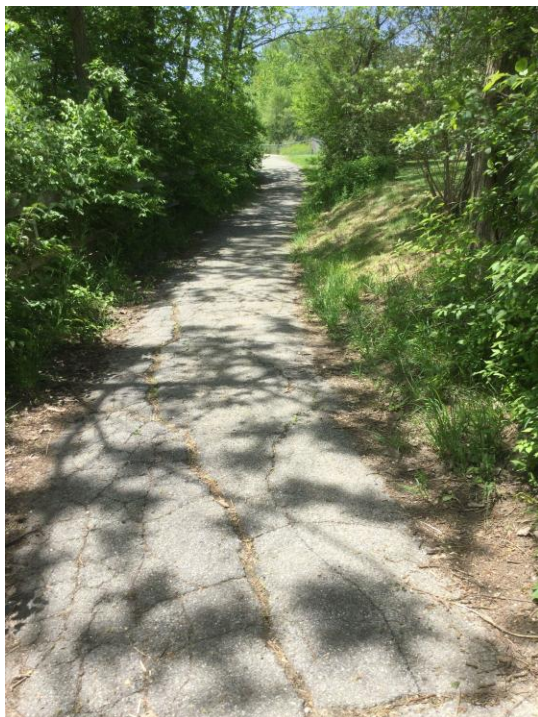
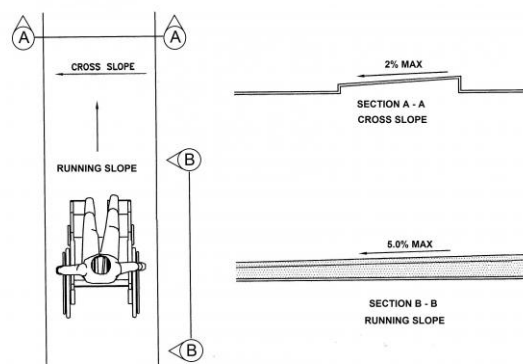
Accessible route has a running slope greater than 5% and is not built as a ramp

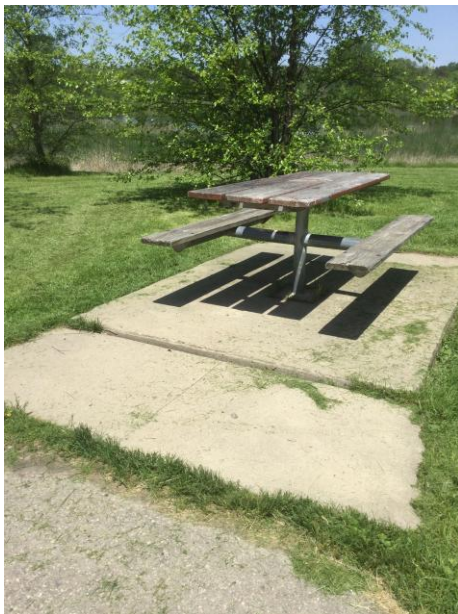
Accessible route has multiple violations

Route to picnic table has non-compliant changes in level

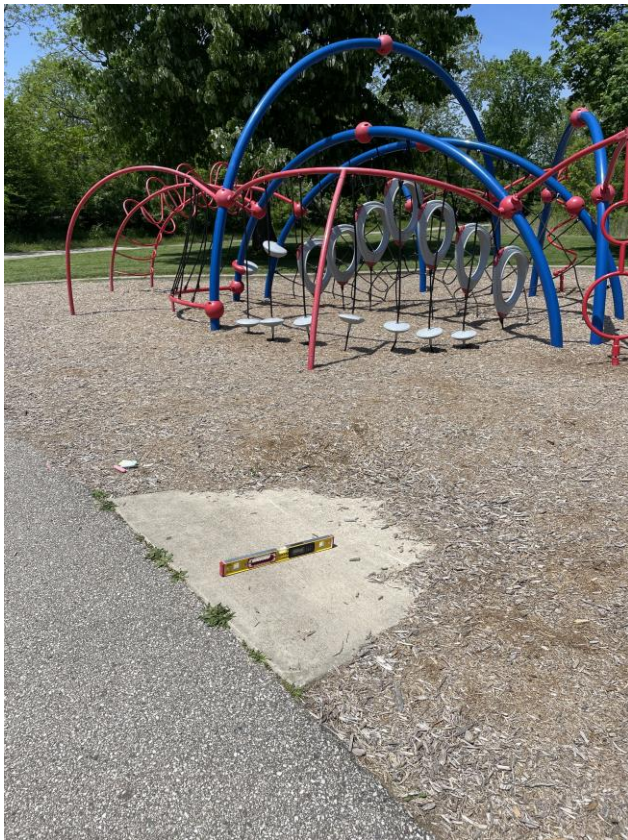
Ramp to play area has a slope greater than 8.33%

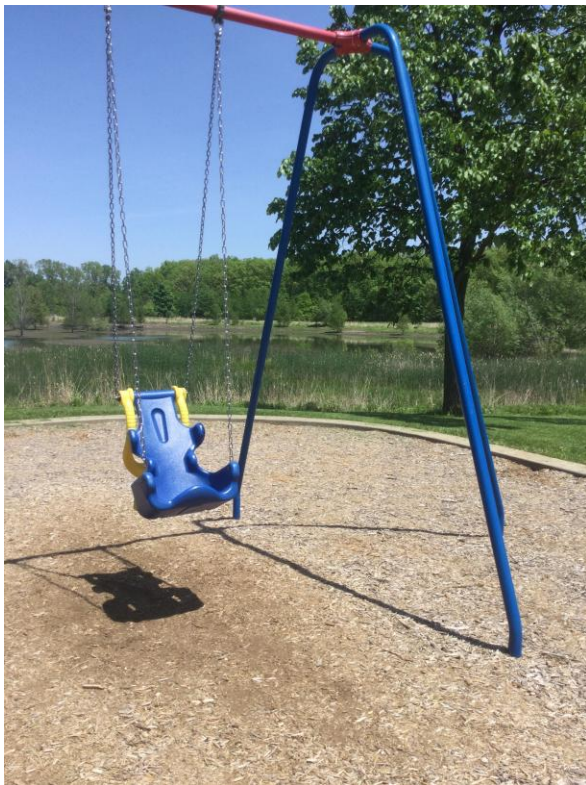
The entry point to the swing is higher than 24 inches

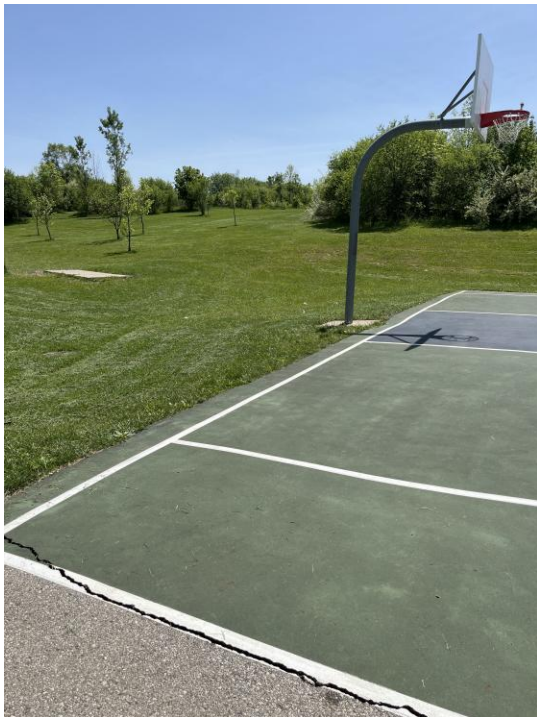
horizontal opening between trail and basketball court

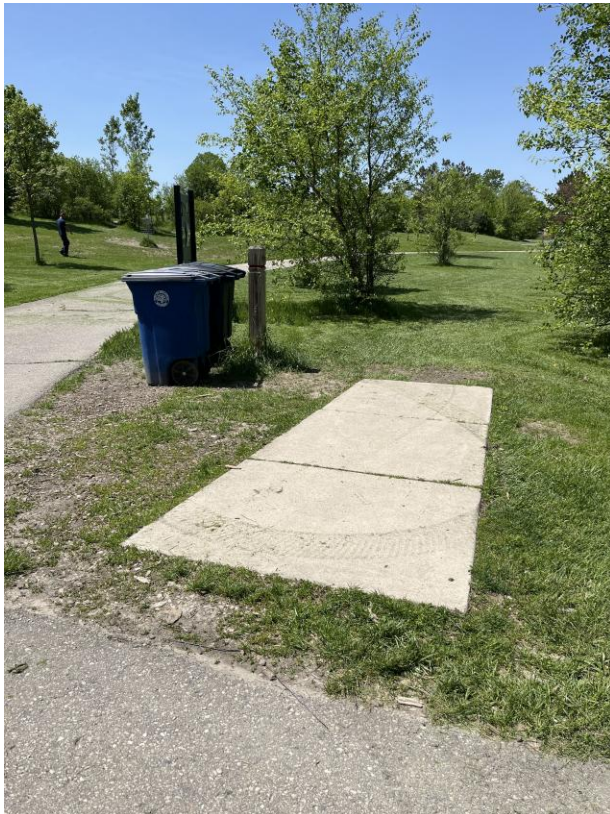
Route does not have a compliant surface; grass is non-compliant

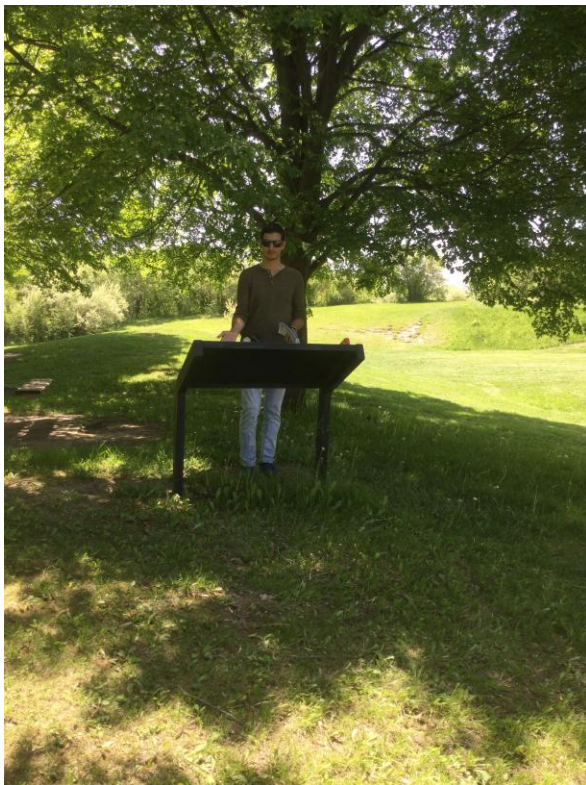
Accessible route not provided to informational sign

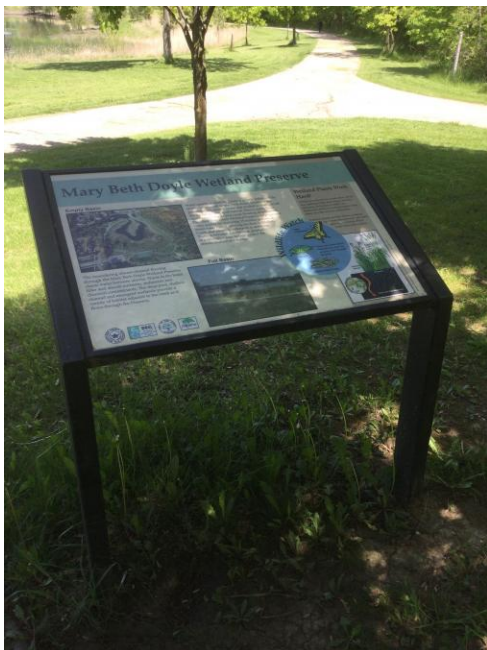
Sign is non-compliant

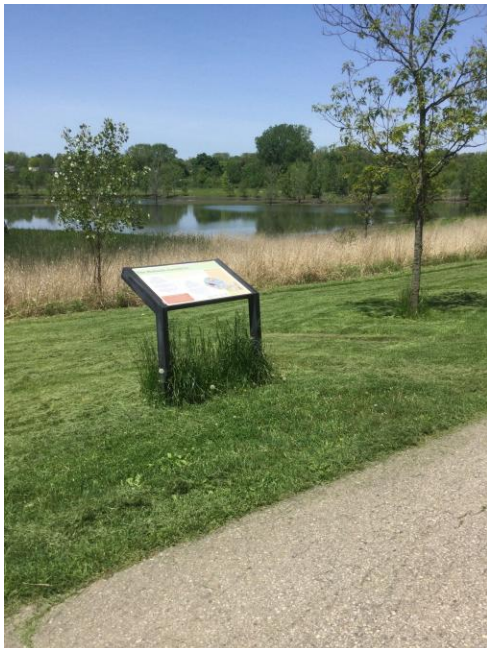
Wetland sign is non-compliant

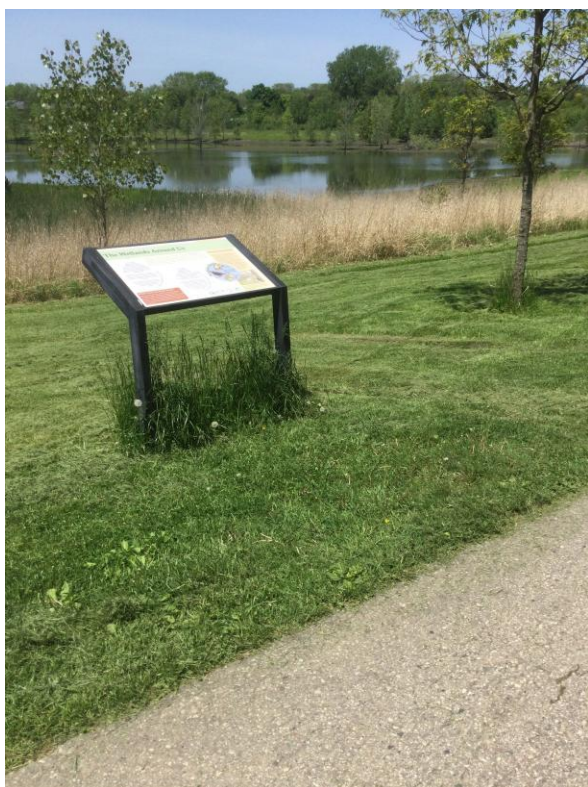
Accessible route not provided to informational sign

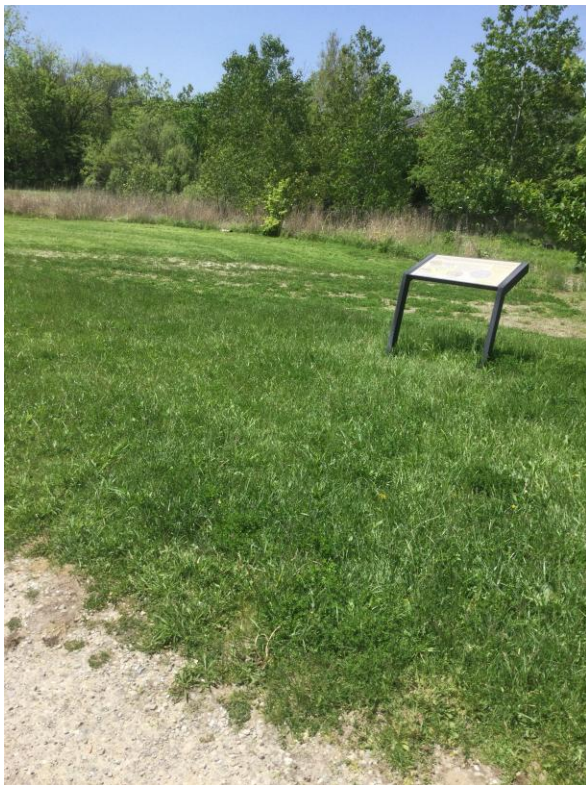
Accessible route not provided to informational sign

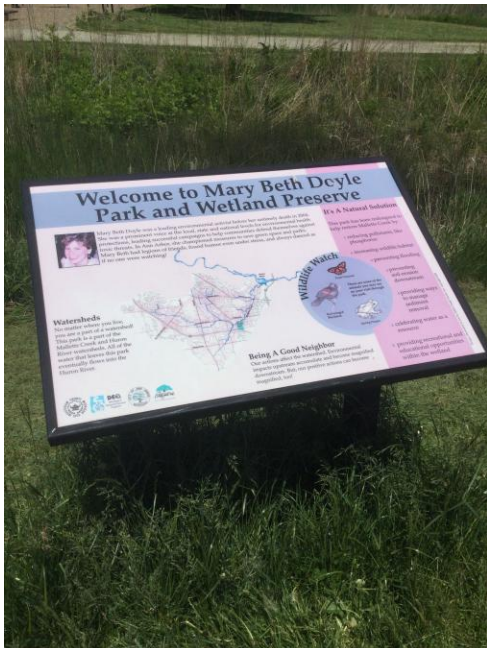
Sign is non-compliant

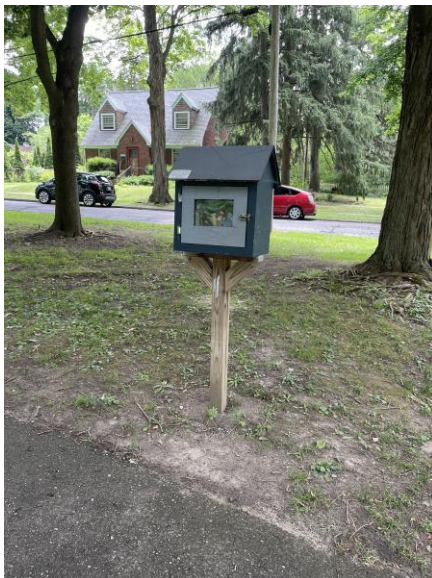
Library box is not installed within reach range

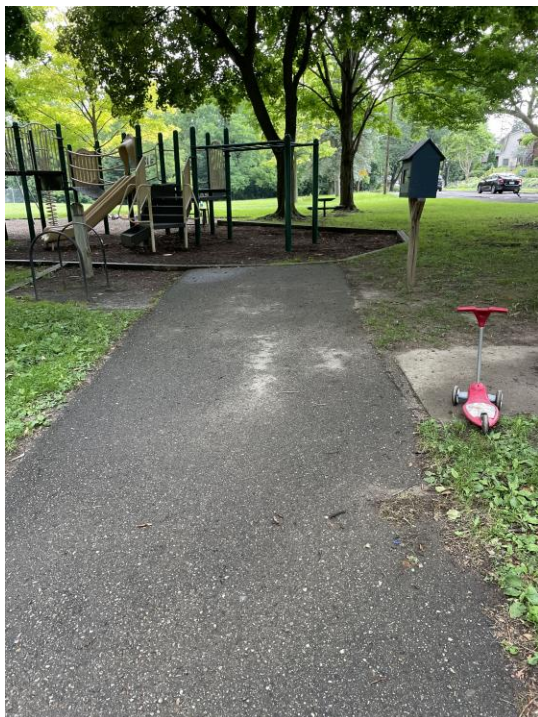
Accessible route has excessive running and cross slope

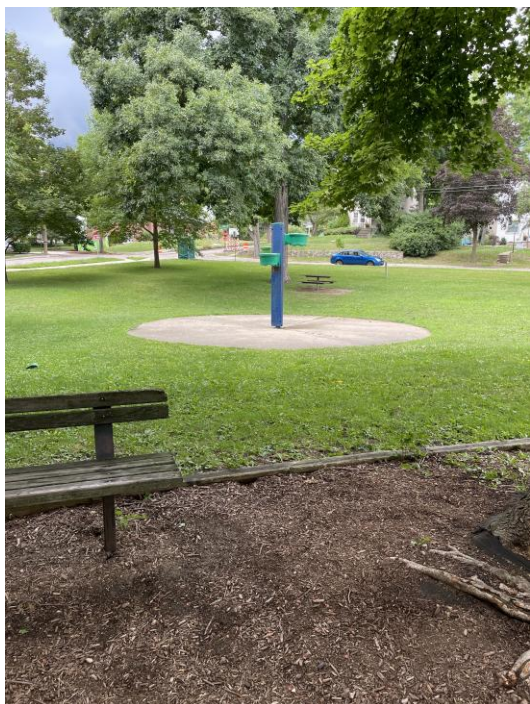
No route to court

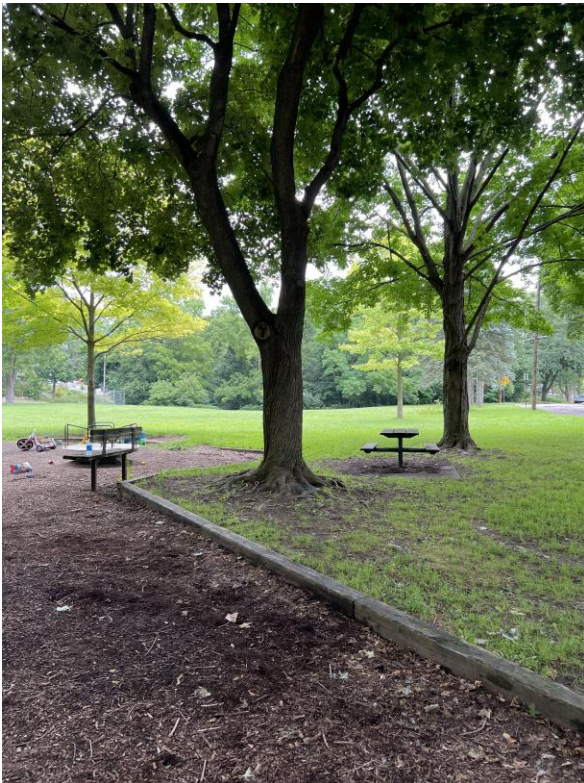
Picnic table is not on an accessible route

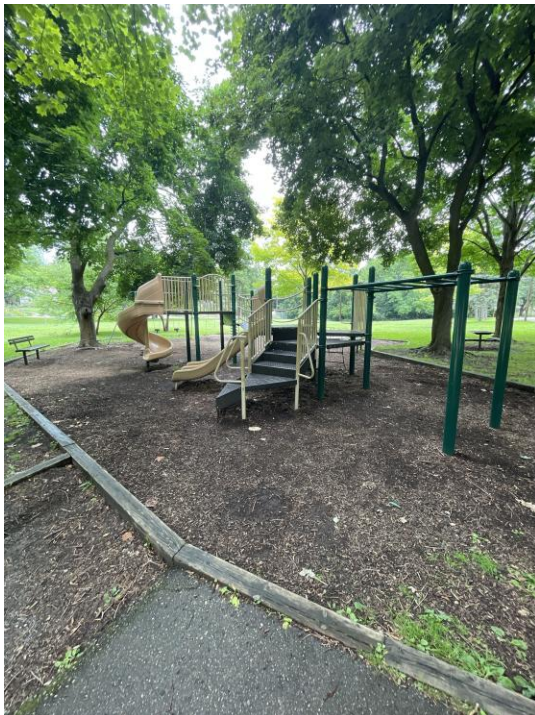
Play area needs proper maintenance and mulch

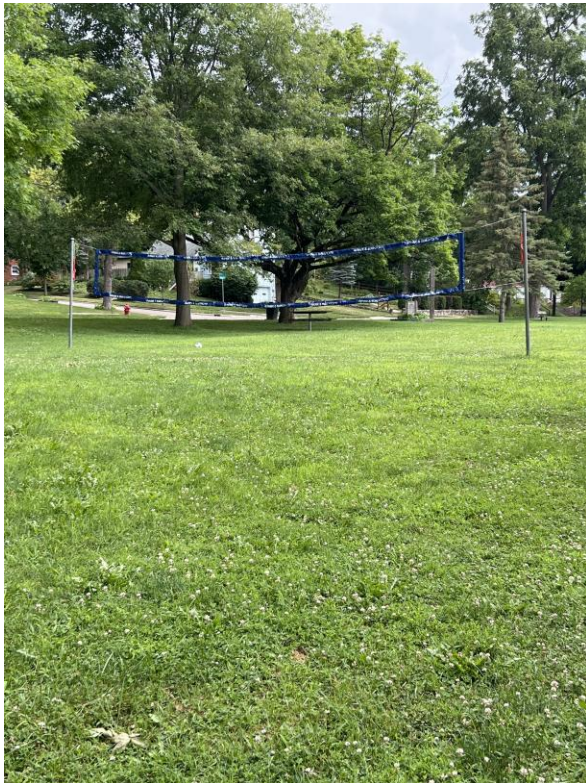
There is no accessible route to the volleyball court

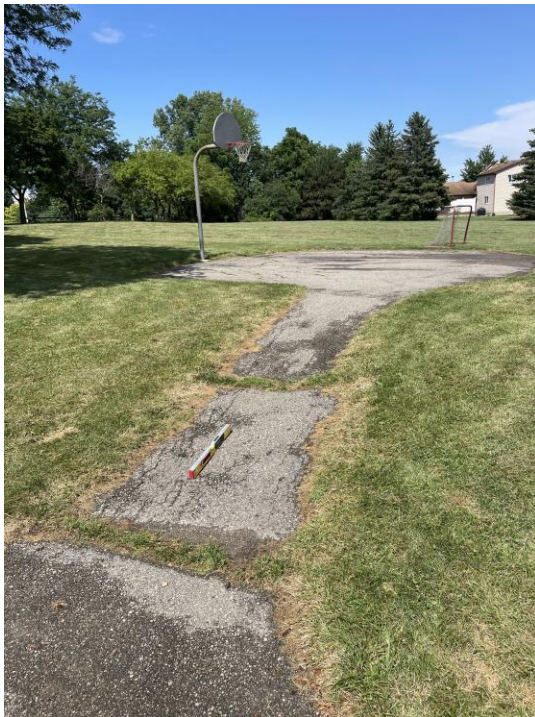
Running slope to basketball court is 10% and greater

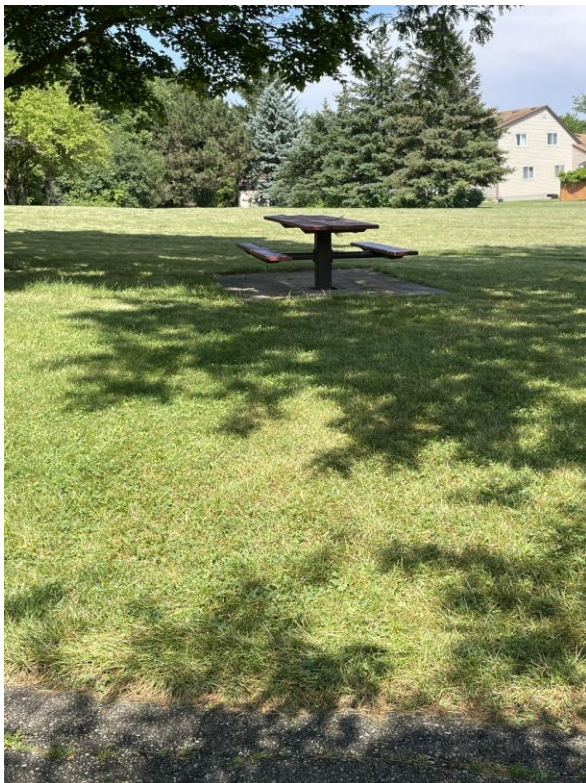
No accessible route provided to picnic table

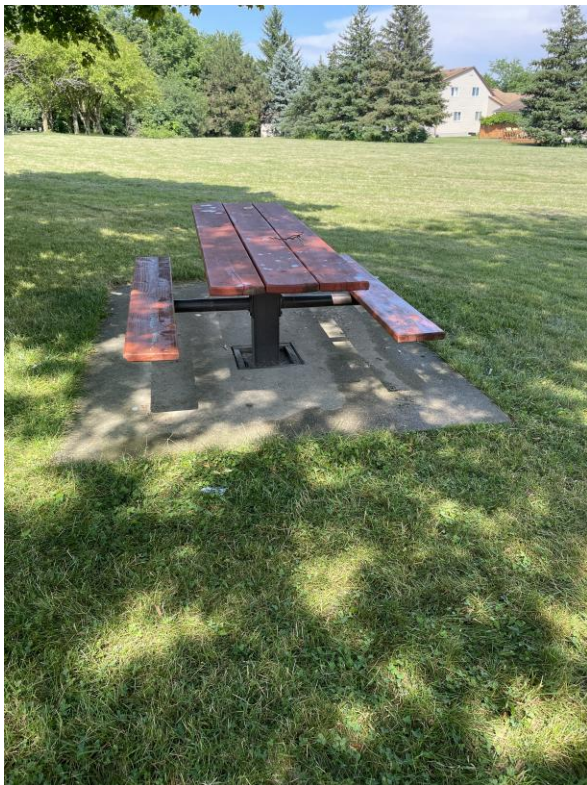
Picnic table does not have a compliant wheelchair space; 26" vertical knee clearance

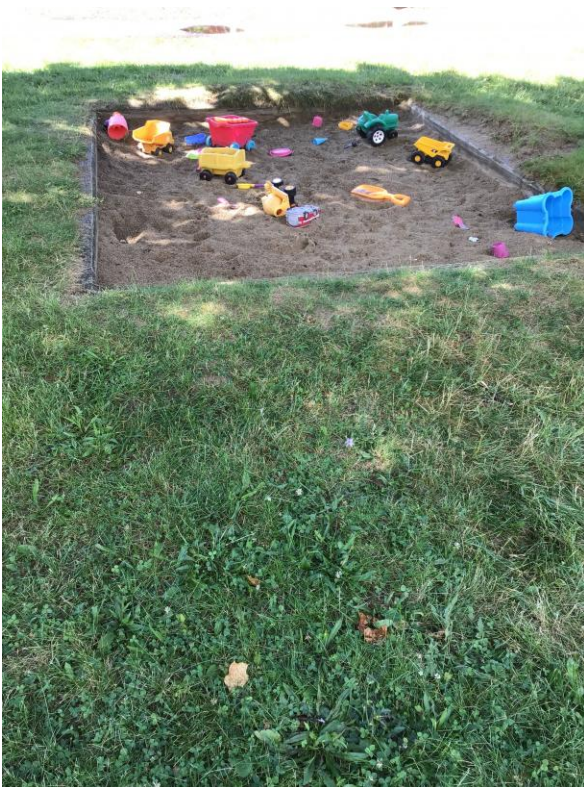
No accessible route to sand pit.

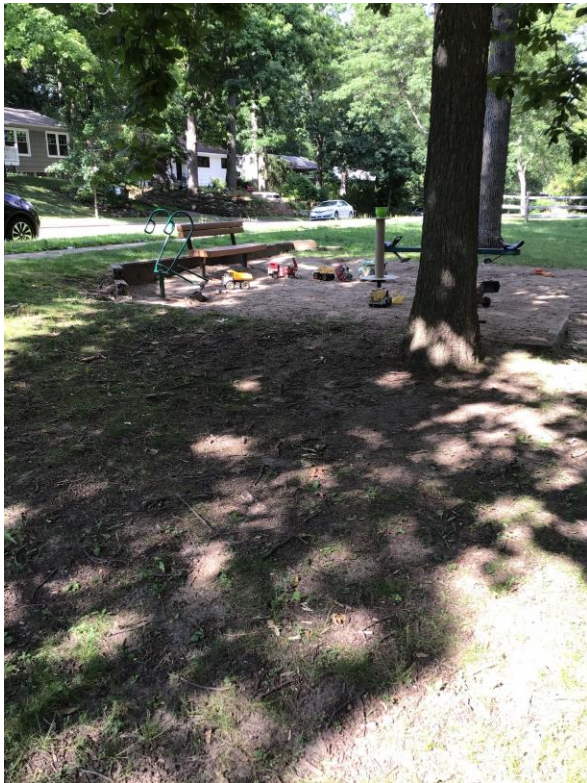
No accessible route to play area.

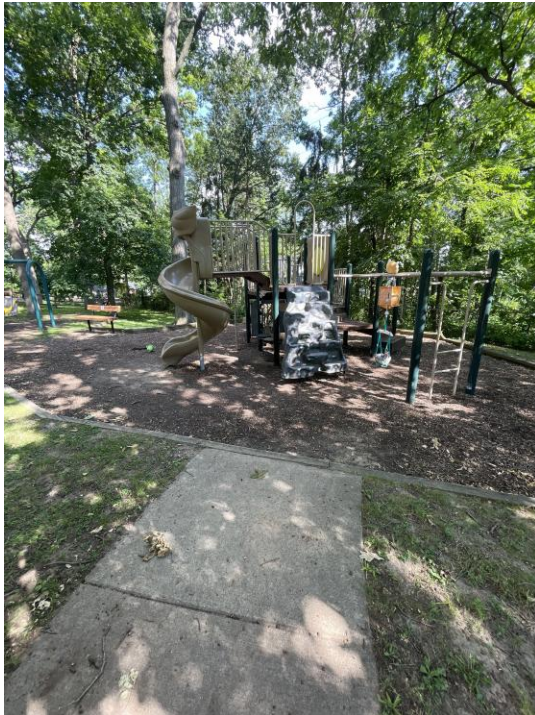
Non compliant surface in play area

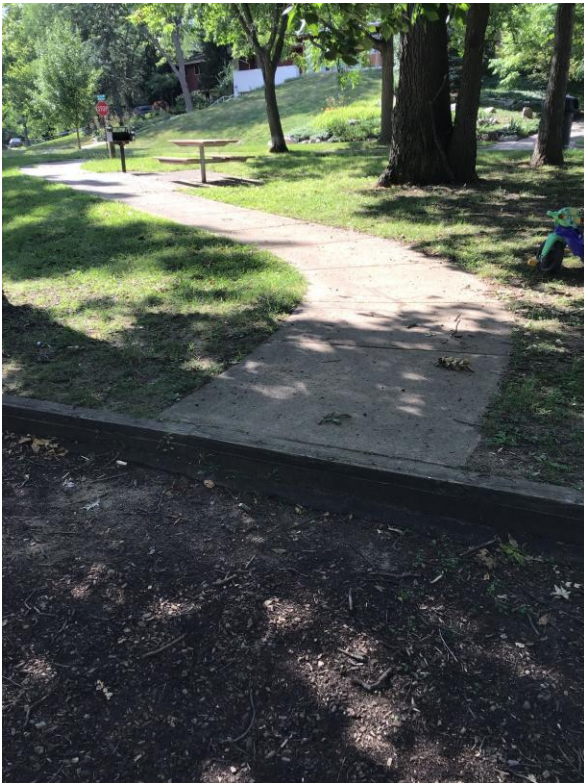
No accessible route to play area; vertical change in level greater than 1/2-inch

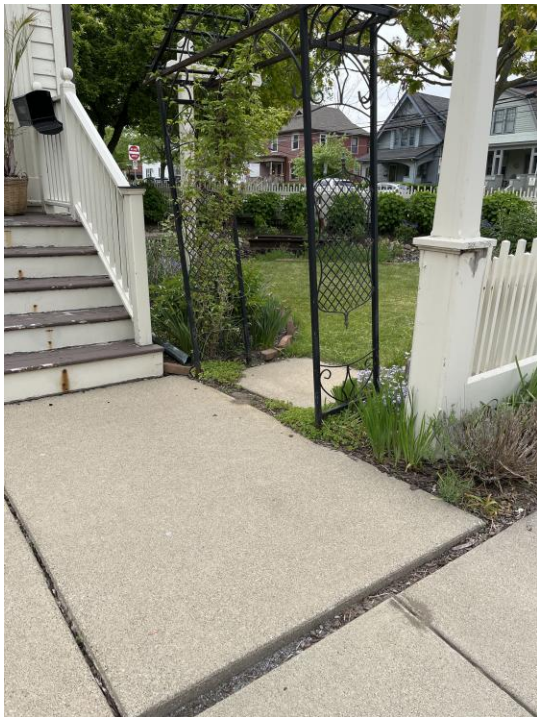
Two surface openings to enter the park

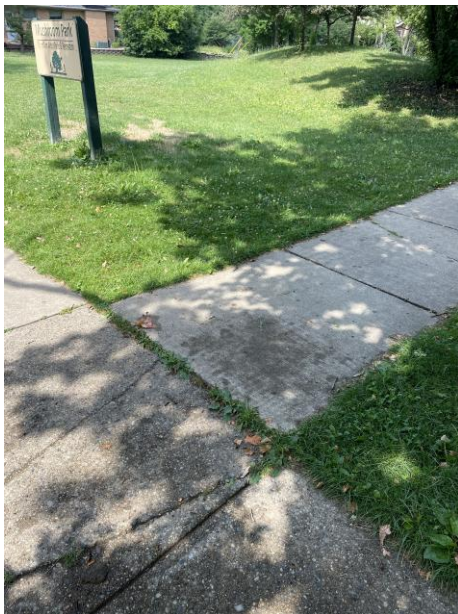
Vegetation on accessible route creates vertical changes in level

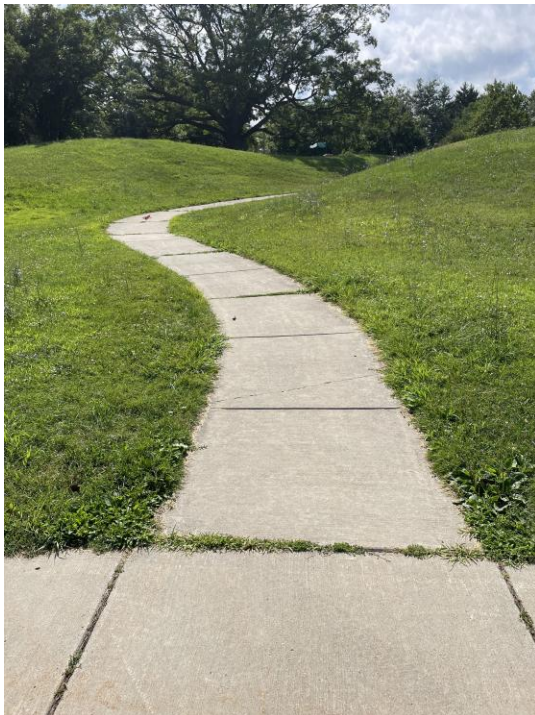
Running slope is up to 13%

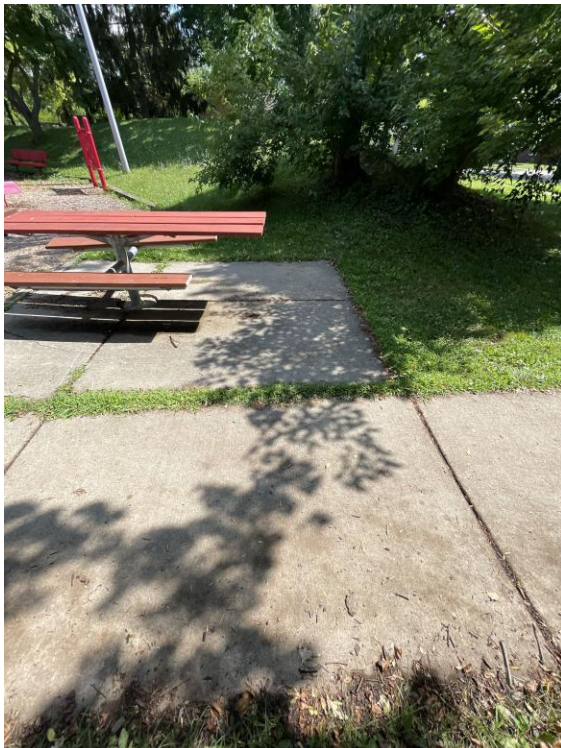
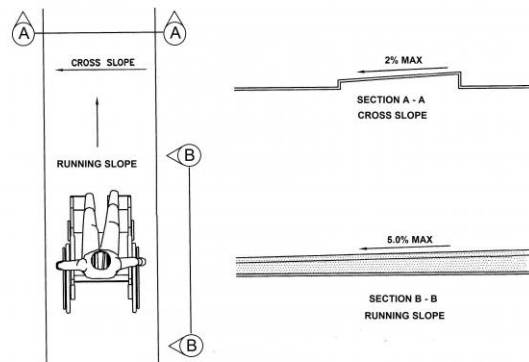
Route to the picnic table and the clear floor space have a slope of 4%

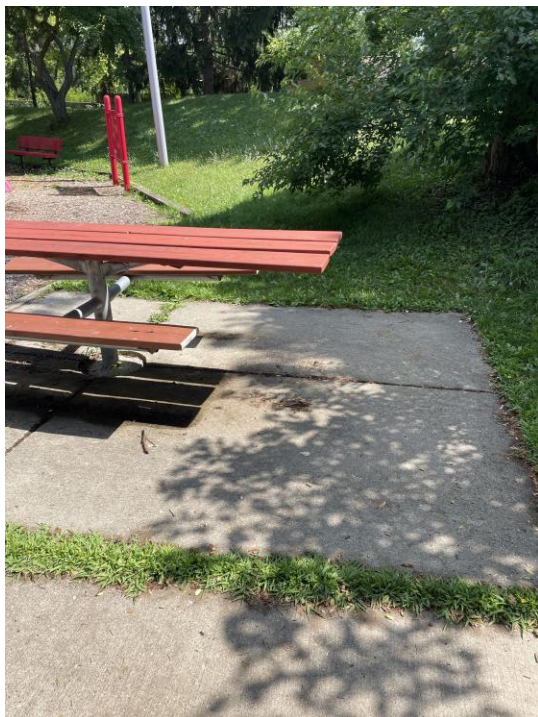
Tabletop is protruding

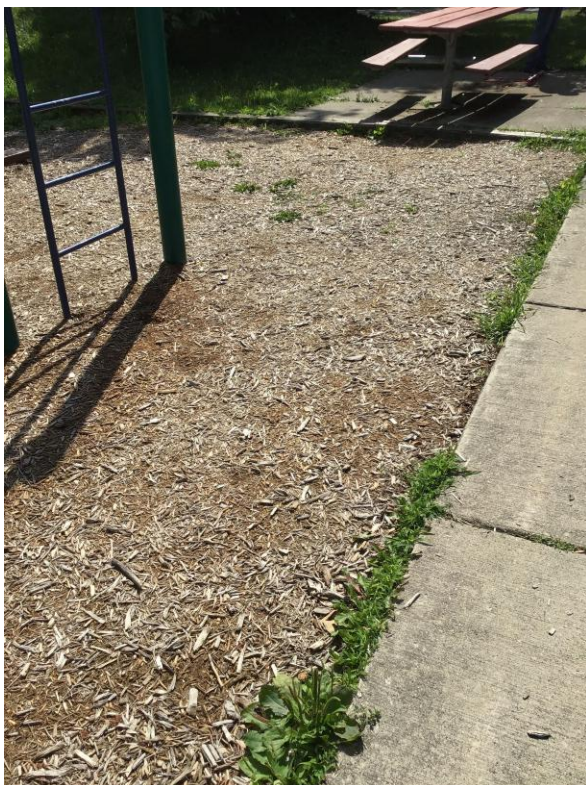
No accessible route to play area.

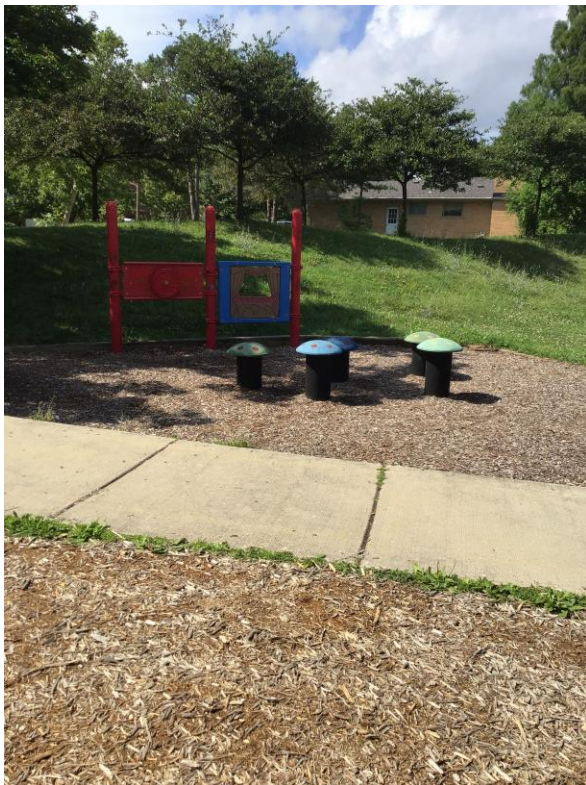
No accessible route to play area.

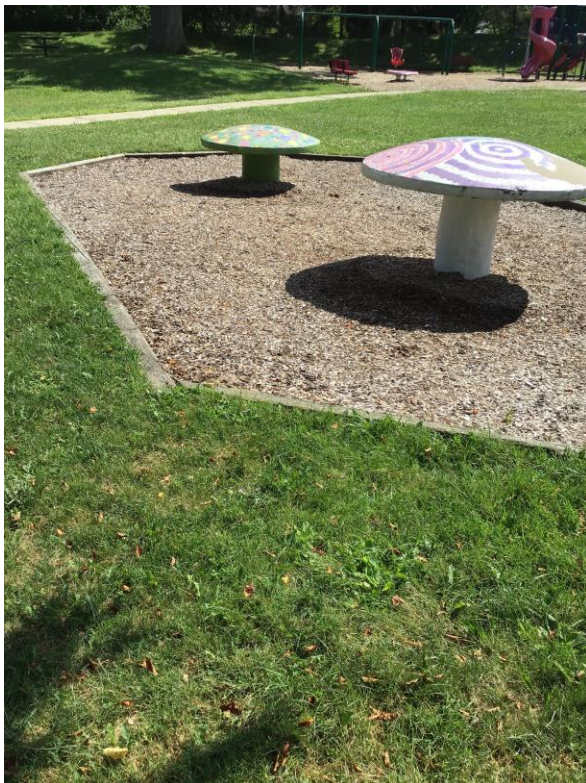
No accessible route to play area.

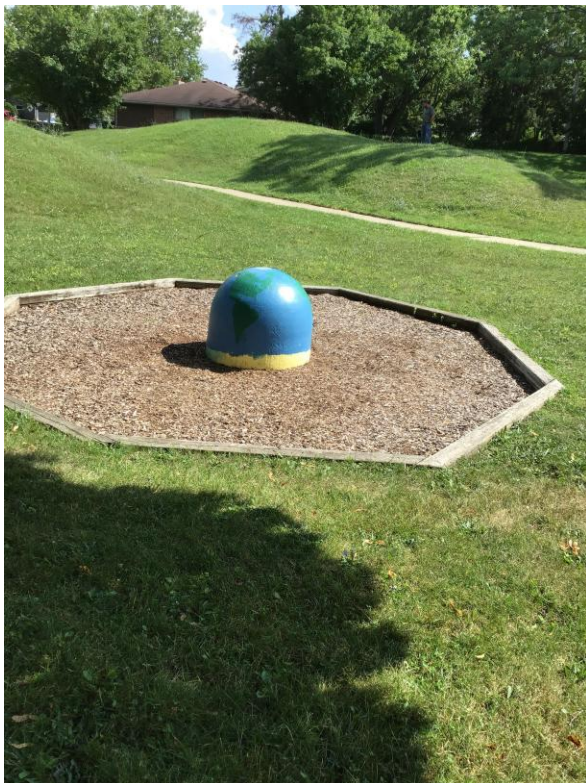
No accessible route to play area.

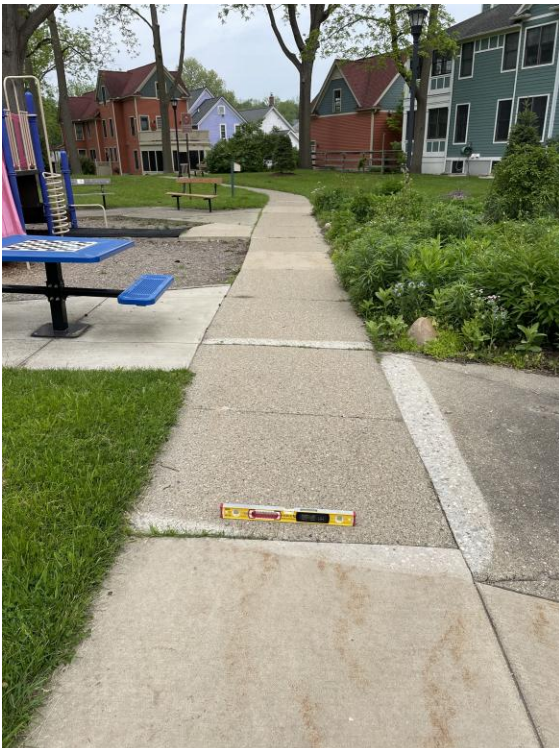
Route has a cross slope greater than 2%

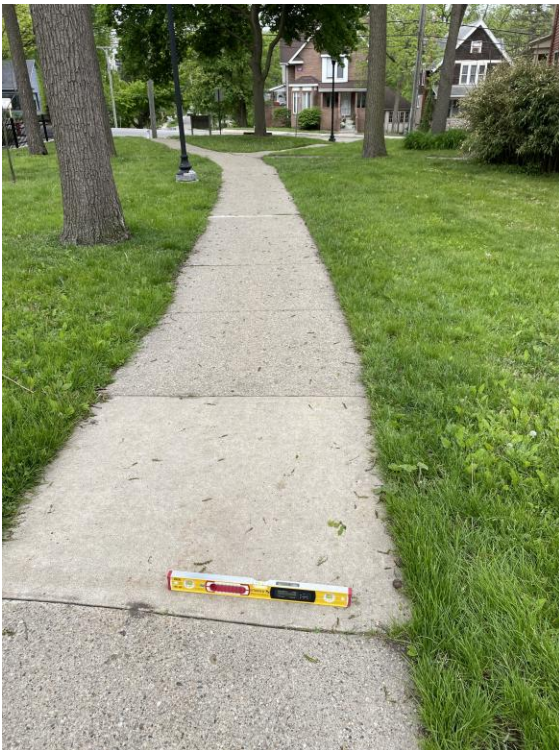
Route has a cross slope greater than 2%

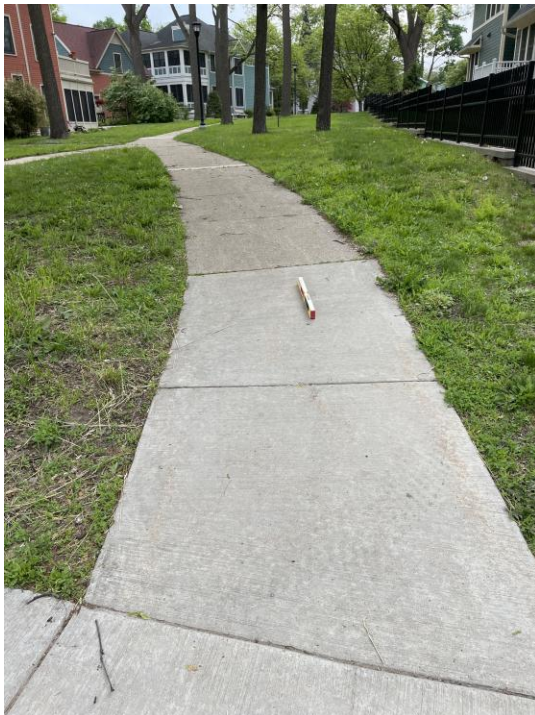
Accessible route has a running slope greater than 5% and is not built as a ramp

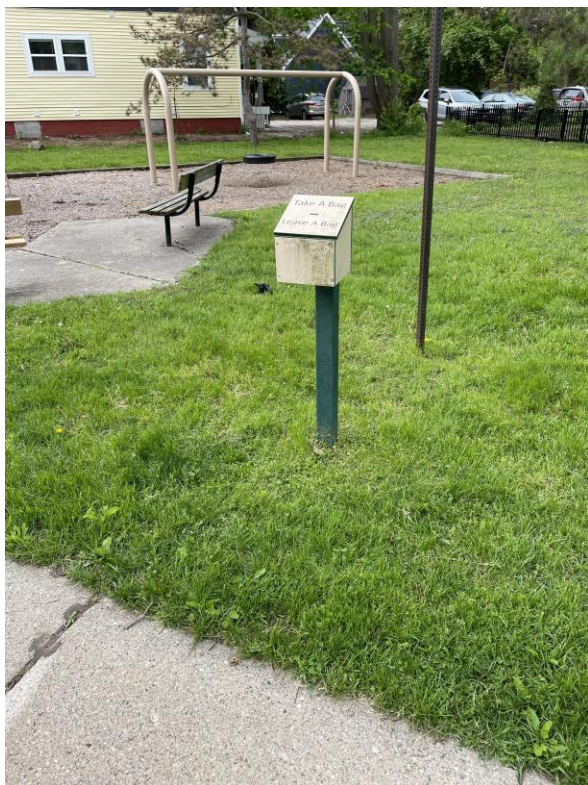
No accessible route to bag dispenser

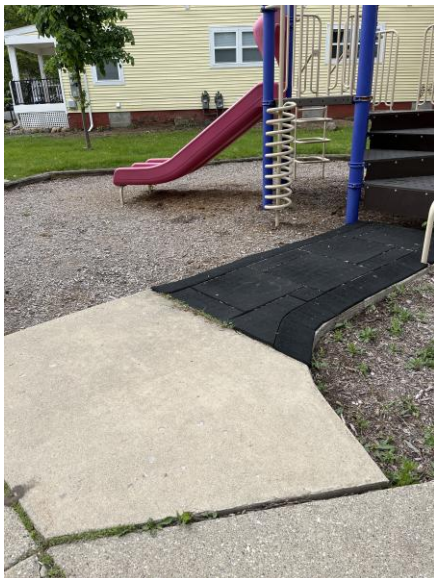
Two changes in level greater than 1/2-inch in the transition from sidewalk to play component

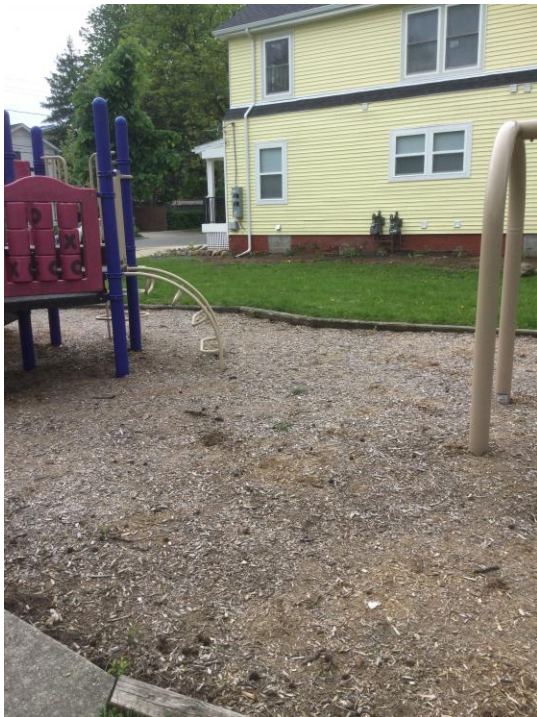
Play area ground surface is non-compliant

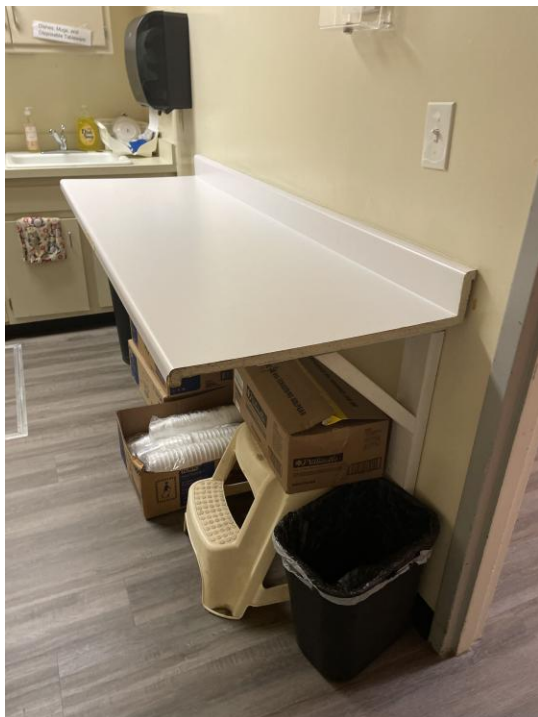
The counter is protruding.

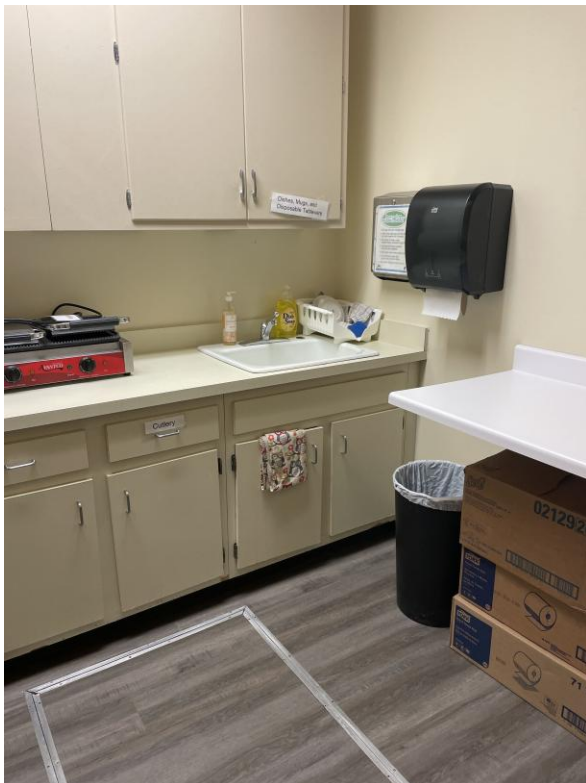
The kitchen sink is at a height of 36”.

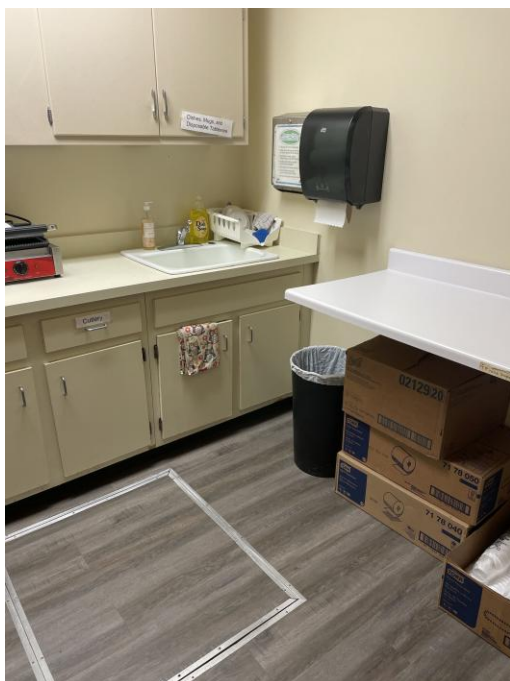
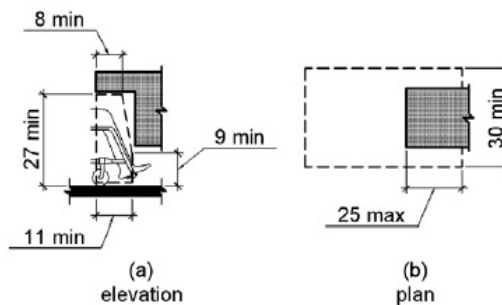
No knee and toe clearance provided at the sink.

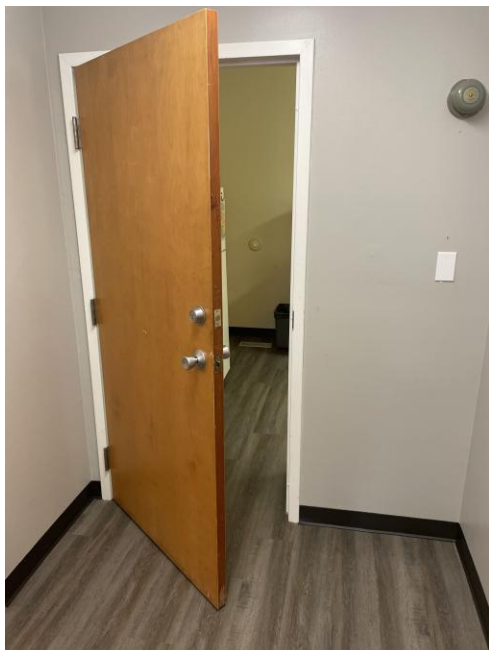
There are 4 doors along the accessible route that have knobs.

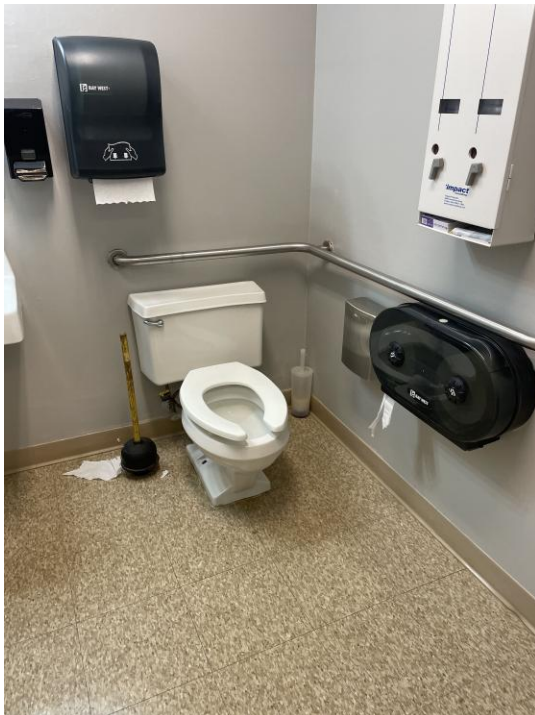
The toilet centerline is 21" from side wall.
