Site Accessibility Evaluation

Allmendinger Park
655 Pauline Blvd
Ann Arbor, MI 48104
ADA Only

Inspection Date: 07/11/2022

Report Date: 11/15/2022

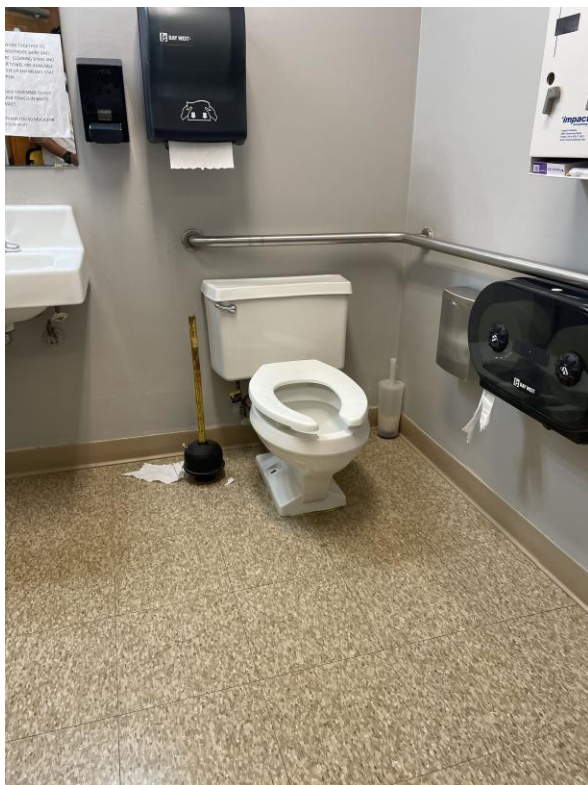
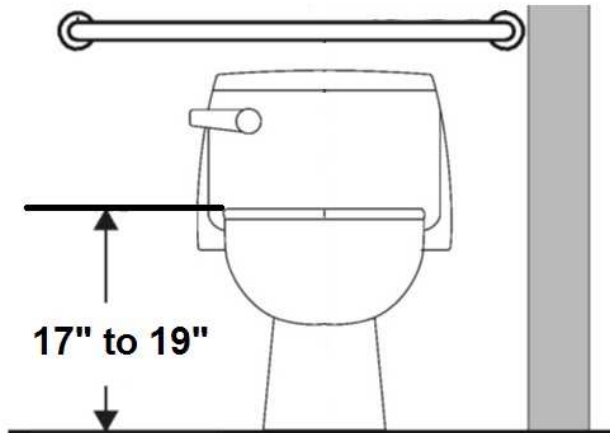
The toilet seat height is 16" above finish floor.

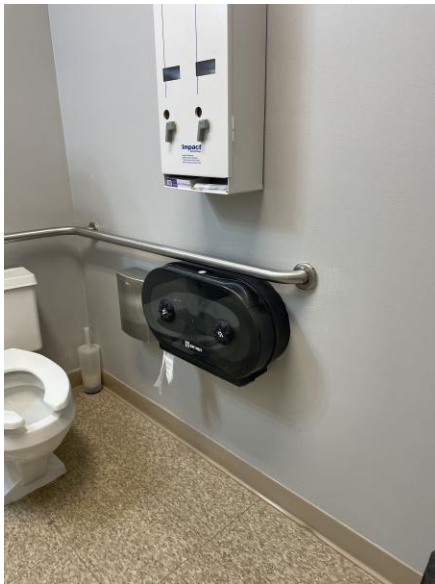
The toilet paper dispenser is not 1 1/2" below grab bar.

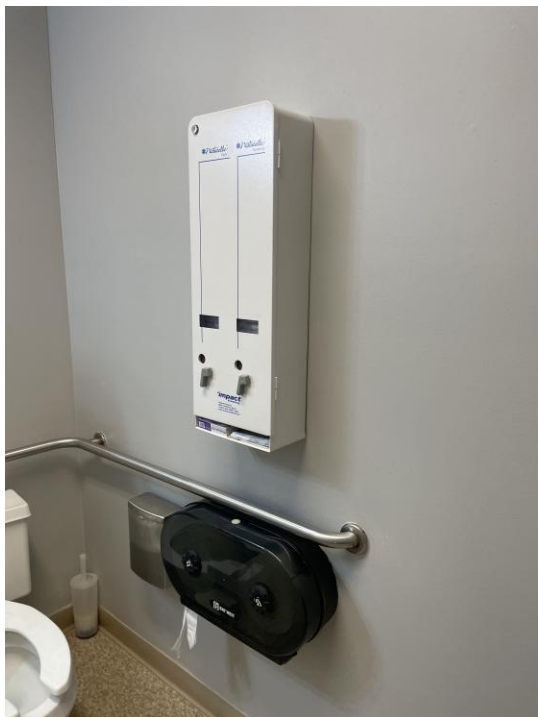
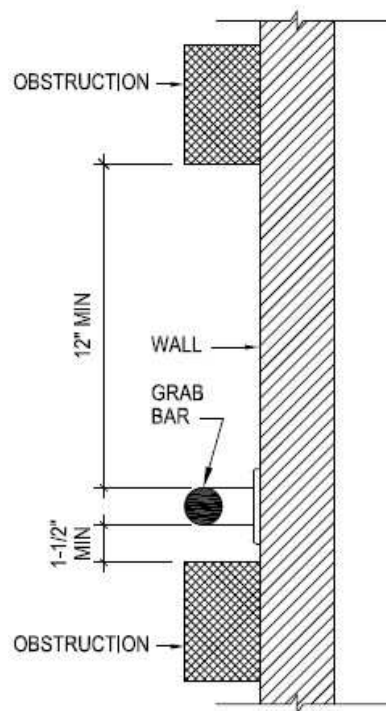
The dispenser is at 9" above side grab bar.

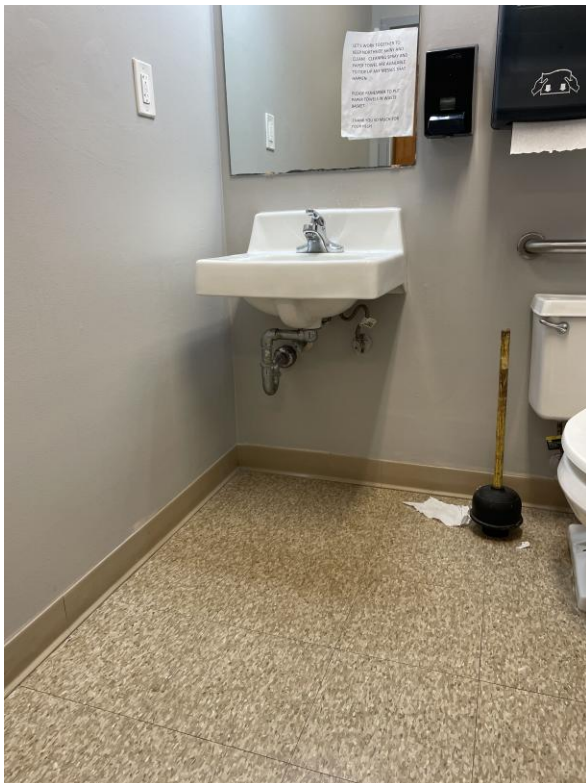
The lavatory pipes are not insulated.

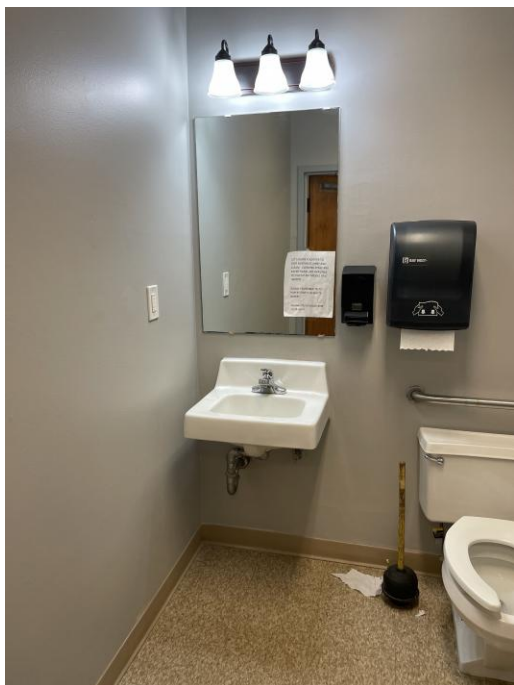
Bottom edge of the mirror is installed at 42" above the finish floor.

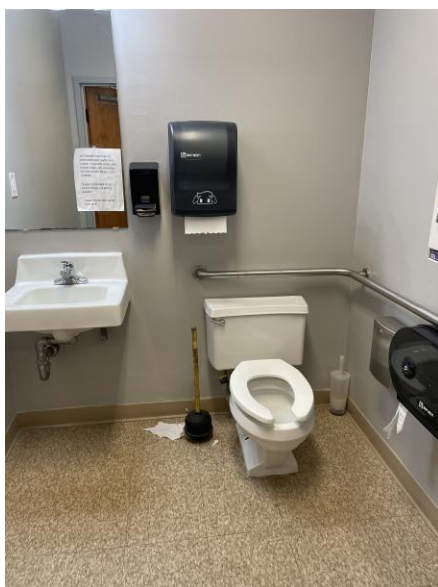
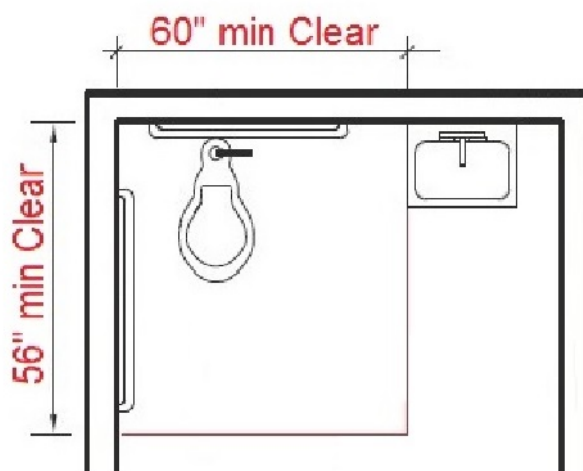
Hallway: Unisex Restroom

The paper towel dispenser, soap dispenser, and lavatory overlap clearance around water closet.

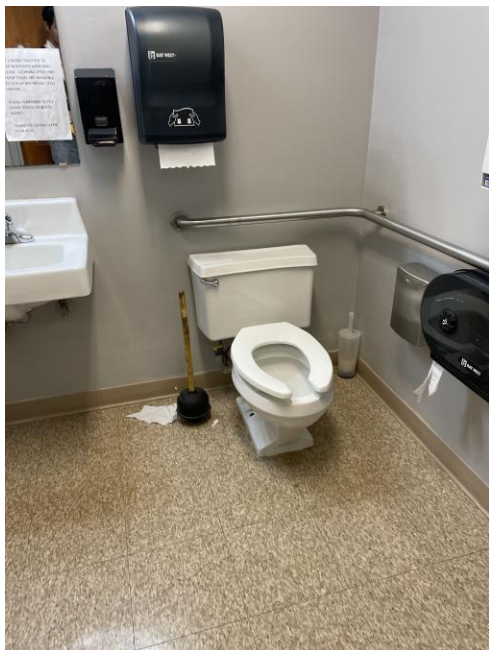
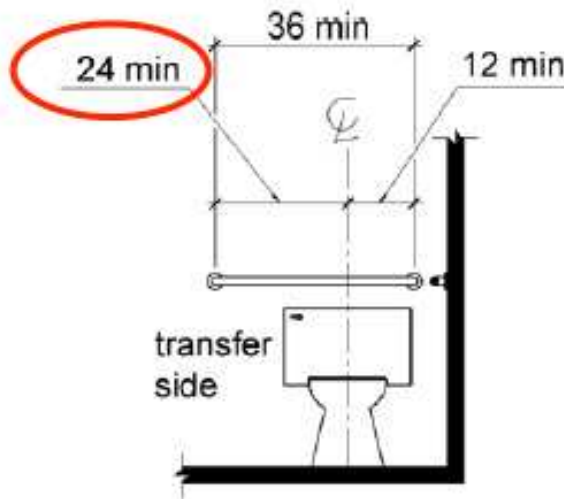
Hallway: Unisex Restroom

The rear grab bar does not extend the minimum 24" on the wide side.

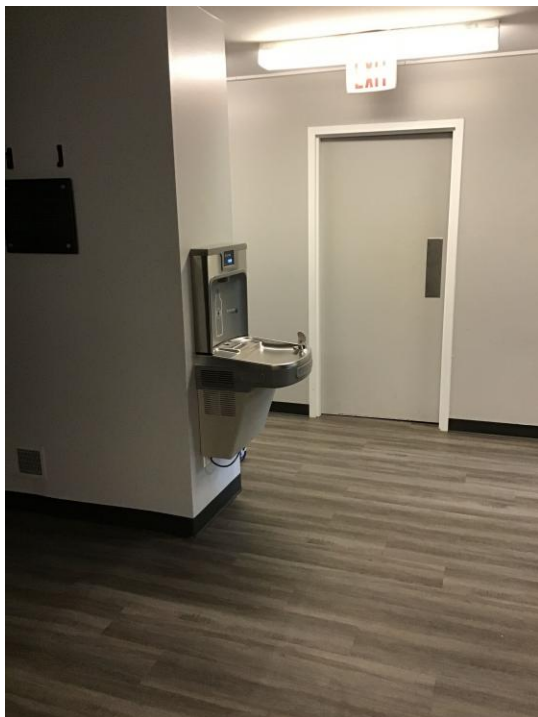
Lobby Area: Main Area

Wall-mounted objects that have leading edges between 27 inches and 80 inches from the floor must not project more than 4 inches into the circulation path. Protruding objects that extend to the floor or within 27 inches of the floor are cane detectable and are therefore not hazardous. Where it is necessary or desirable to have objects protrude from the wall, a manner of cane detection must be provided.

The drinking fountain is a protruding object.

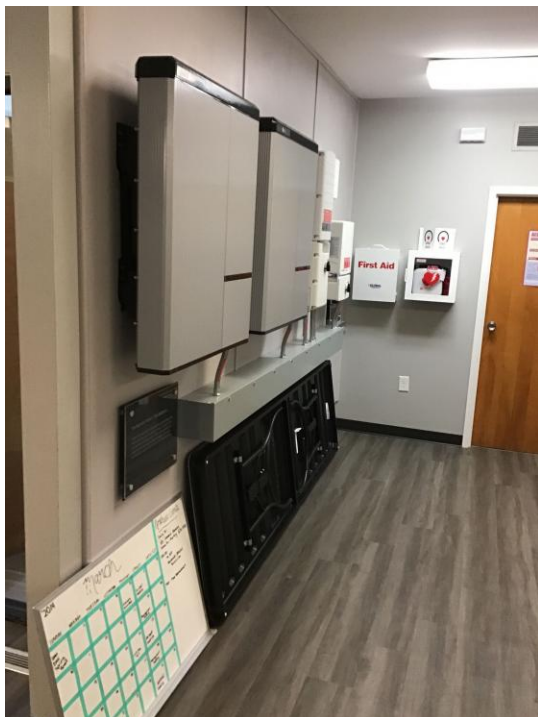
Lobby Area: Main Area

Wall-mounted objects that have leading edges between 27 inches and 80 inches from the floor must not project more than 4 inches into the circulation path. Protruding objects that extend to the floor or within 27 inches of the floor are cane detectable and are therefore not hazardous. Where it is necessary or desirable to have objects protrude from the wall, a manner of cane detection must be provided.

Solar batteries are protruding objects.

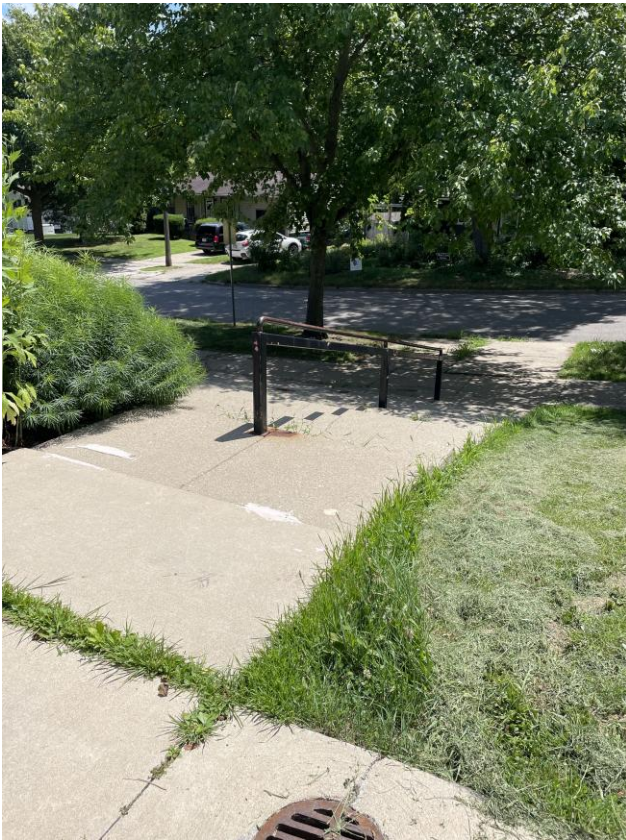
Finding #17 Continued

Handrails not provided on both sides of the stairs.

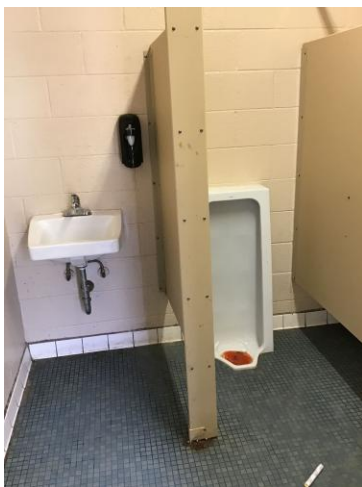
Garage Building: Men's Restroom

Various eements were non-compliant such as the stall size, grab bars missing, and lavatory.

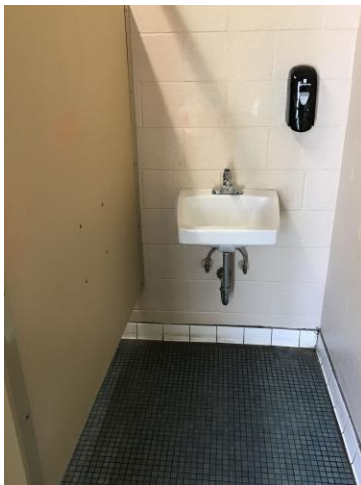
Garage Building: Women's Restroom

Various eements were non-compliant such as the stall size, grab bars missing, and lavatory.

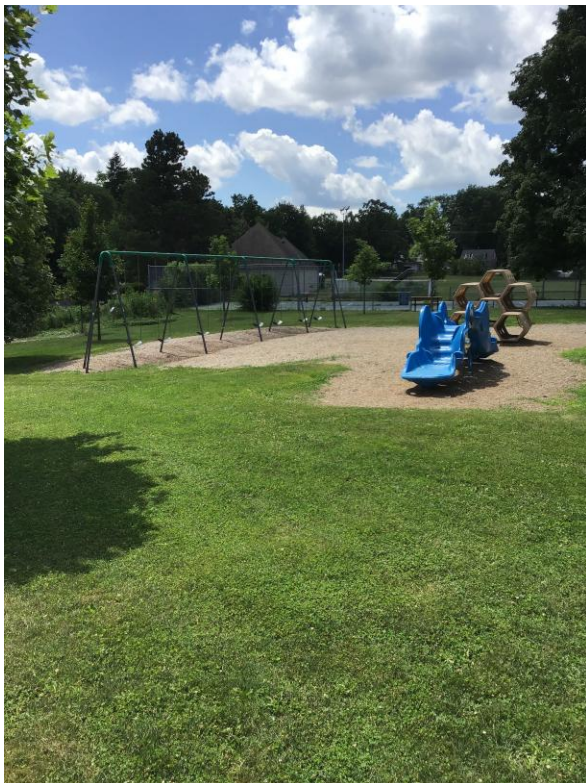
No accessible route to play areas.

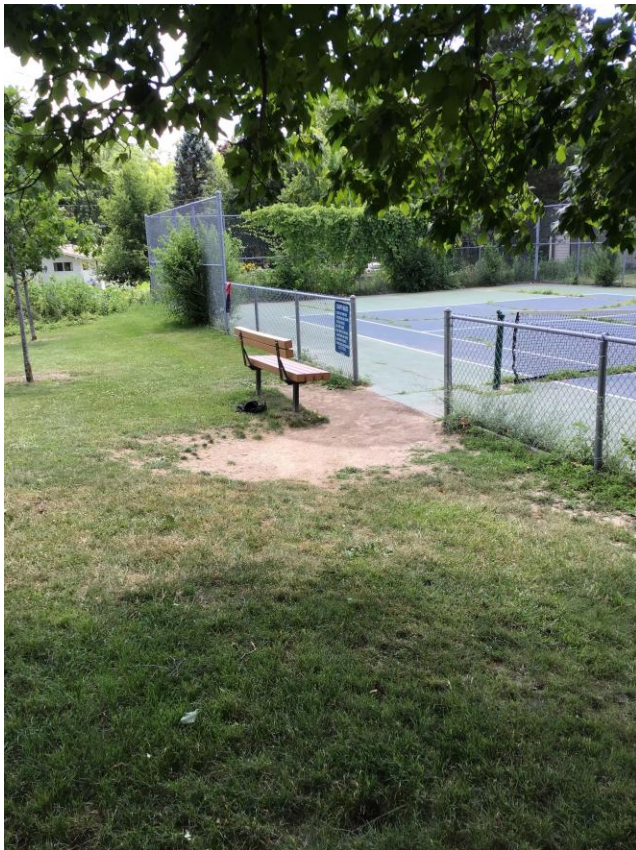
Tennis Court: Entrance

No accessible route to tennis court.

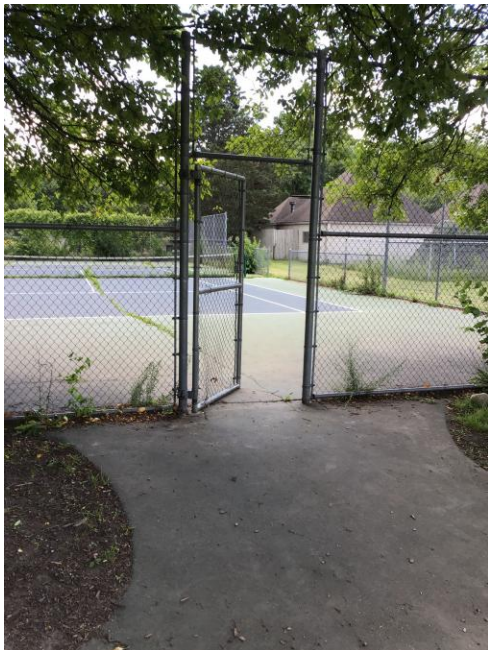
Tennis Court: Entrance

Door from tennis court to basketball court is chain link.

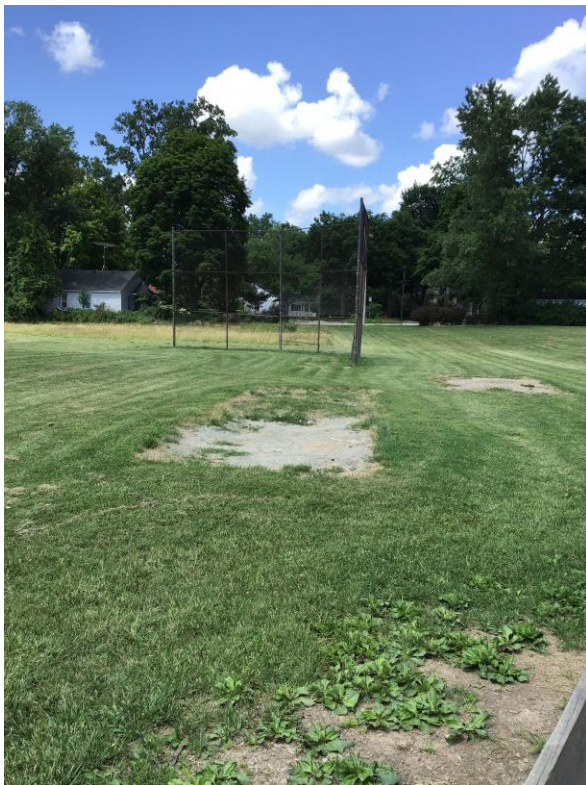
Baseball Field: Seating

No accessible route to baseball field.

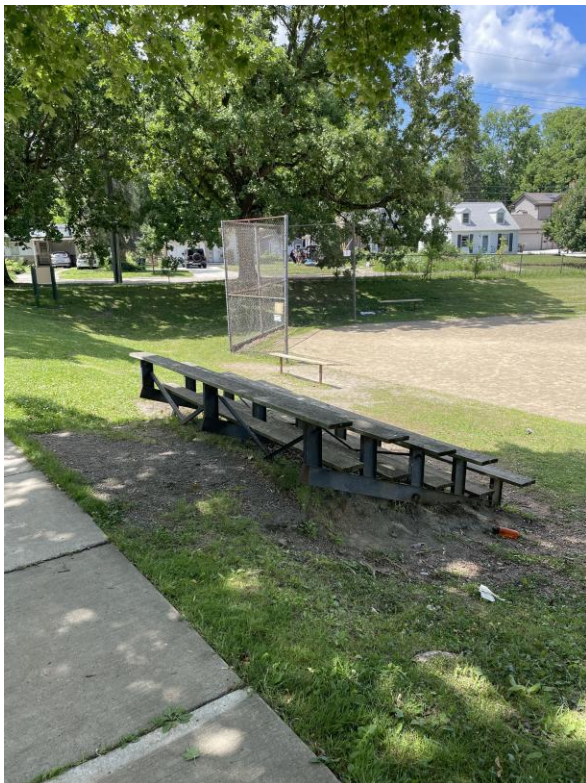
Baseball Field: Seating

Not accessible route provided to bleachers and dugouts

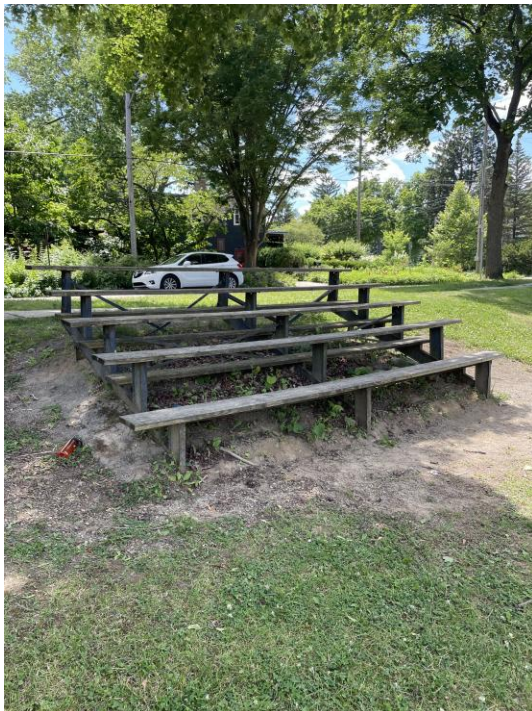
Baseball Field: Seating

No wheelchair spaces are provided at bleachers

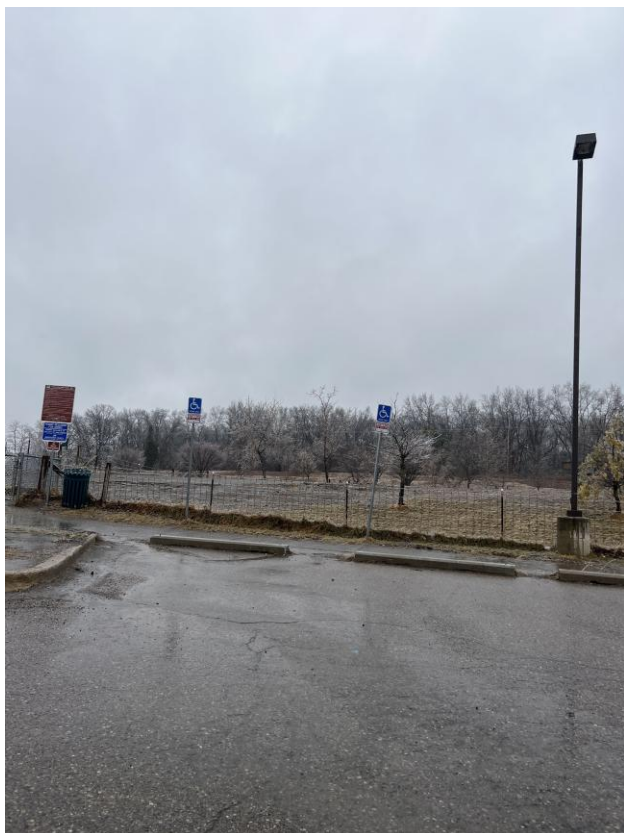
Parking: Parking Lot

The required access aisle is missing.

No access aisle provided

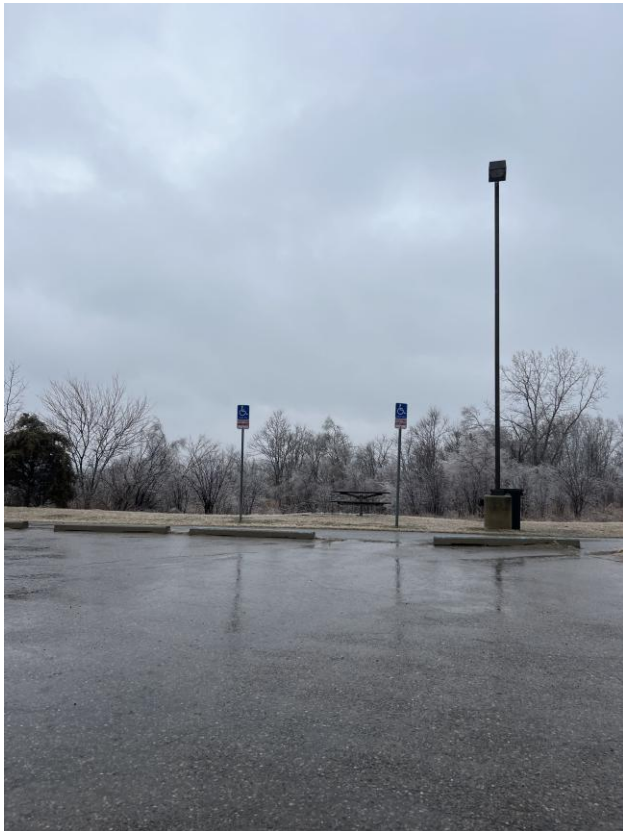
Parking: Parking Lot

The required access aisle is missing.

No access aisle provided

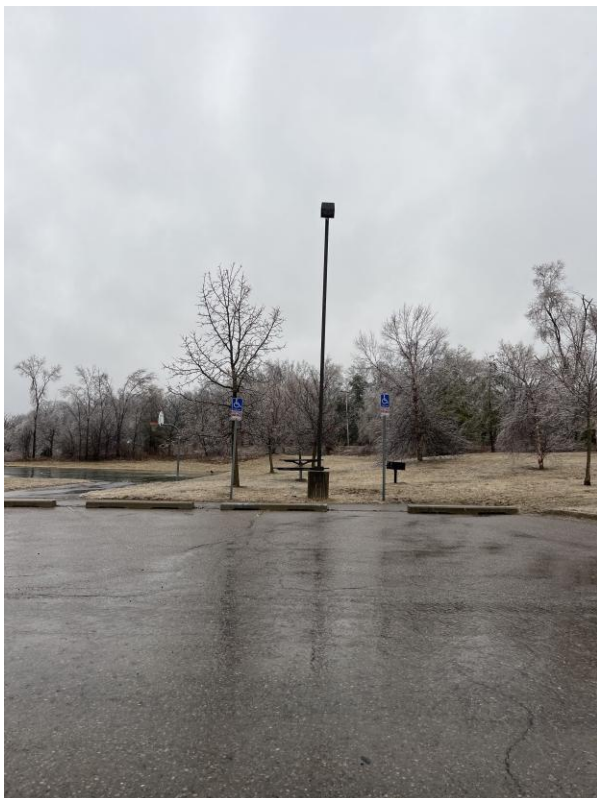
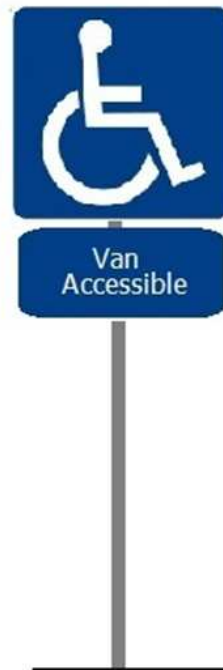
Parking: Parking Lot

The van stall is missing a sign identifying it as a van accessible stall.

2 van stalls needed for whole lot, can share access aisle

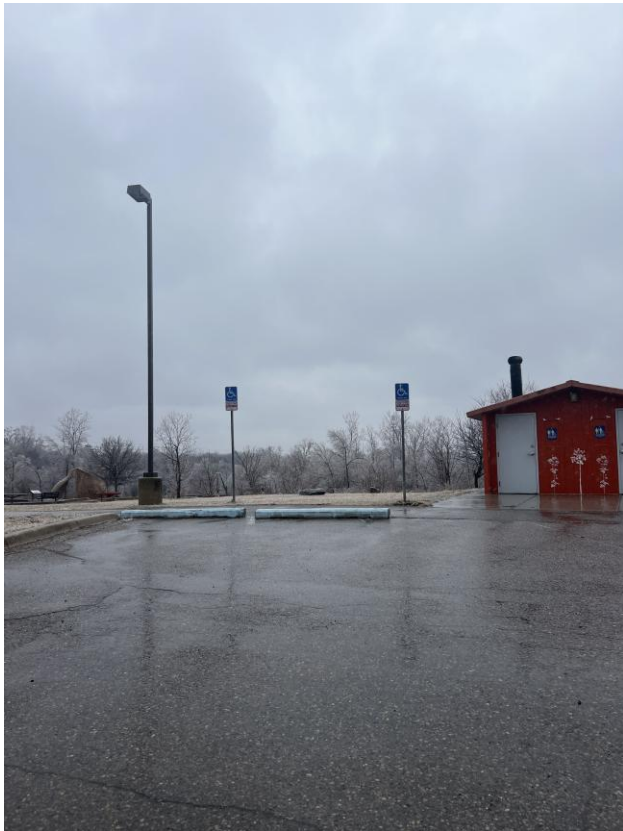
Parking: Parking Lot

The required access aisle is missing.

No access aisle provided

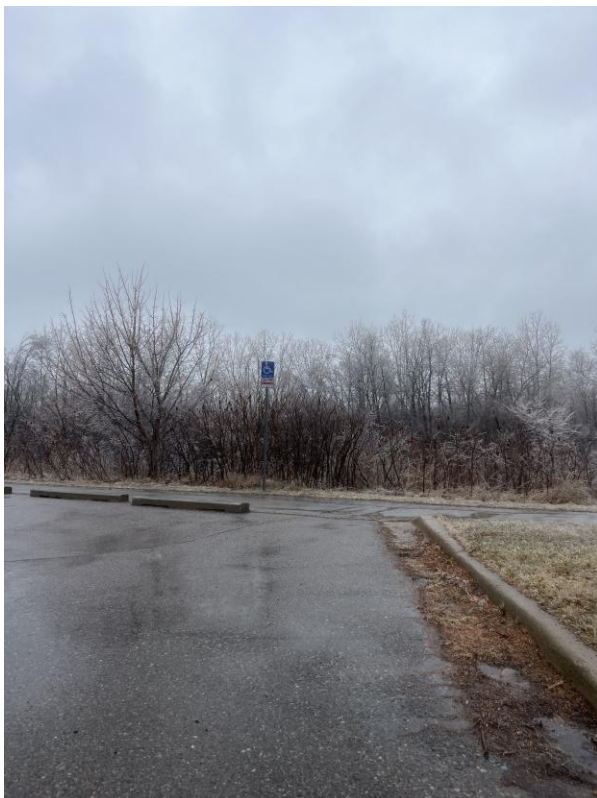
Parking: Parking Lot

The van stall is missing a sign identifying it as a van accessible stall.

2 van stalls needed for whole lot, can share access aisle

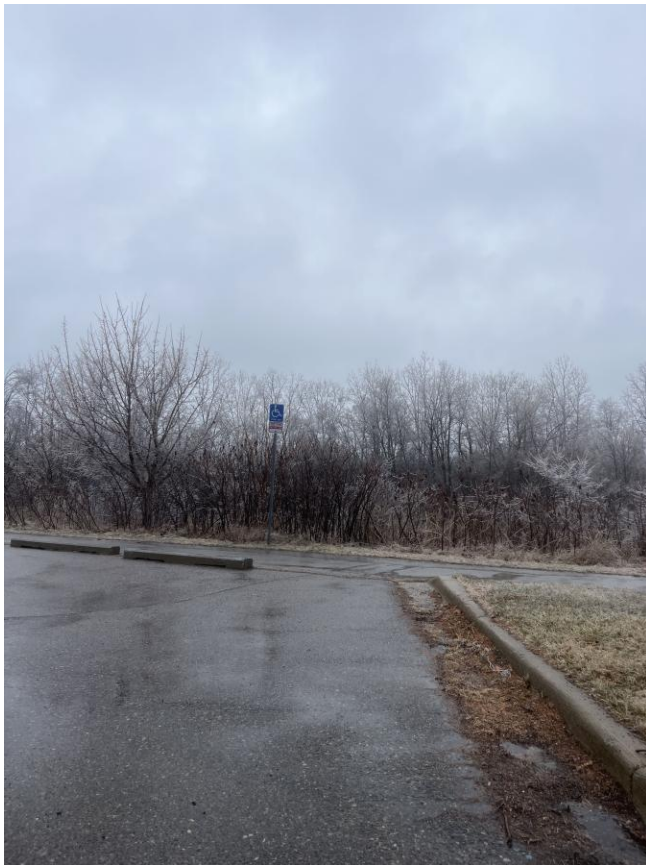
Parking: Parking Lot

The required access aisle is missing.

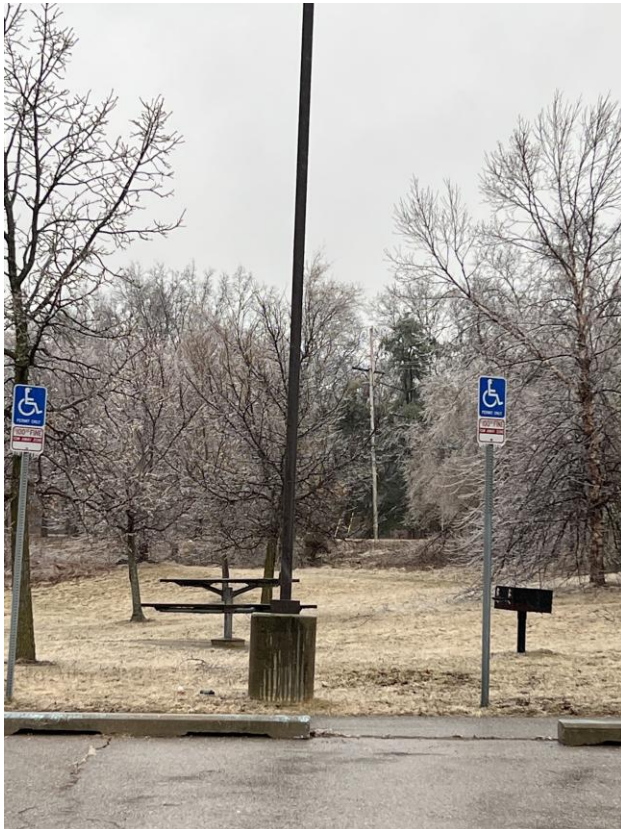
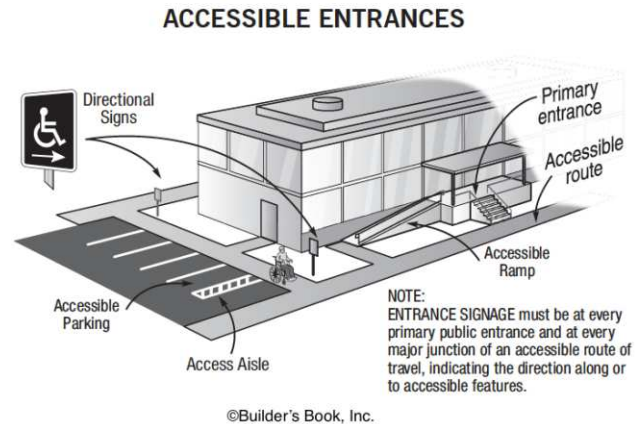
Trail System: Trail

5% of total picnic tables need to be accessible

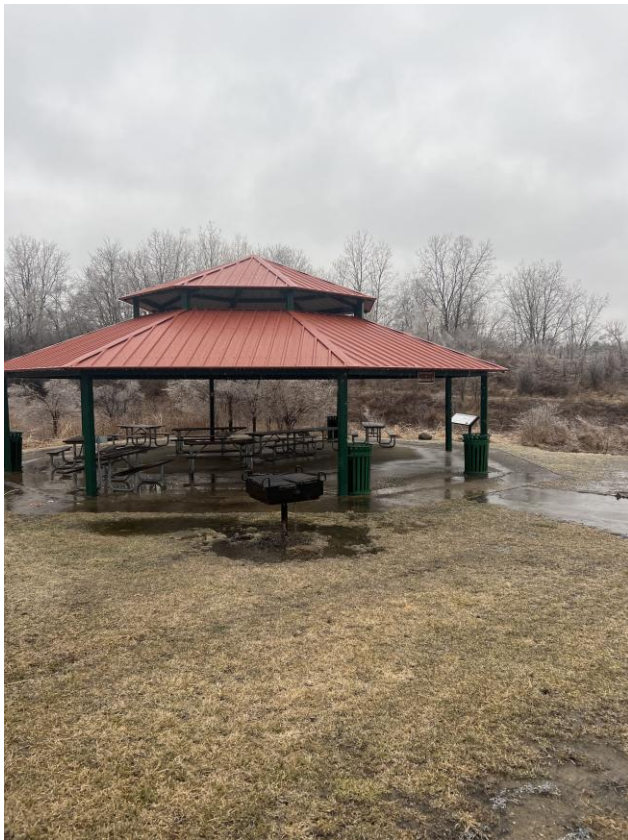
Trail System: Trail

No route to picnic tables and grill

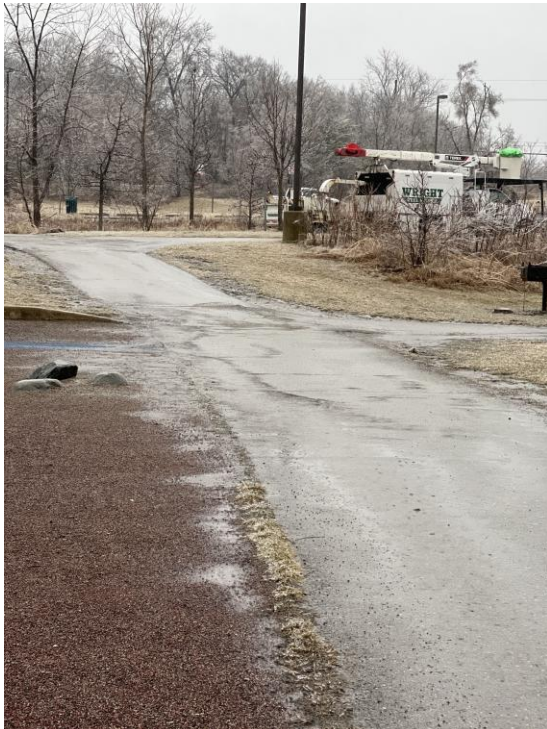
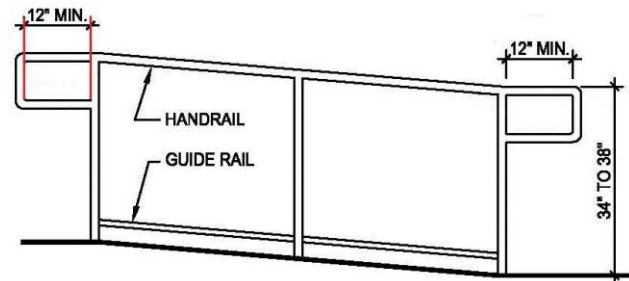
Trail System: Trail

No handrails provided

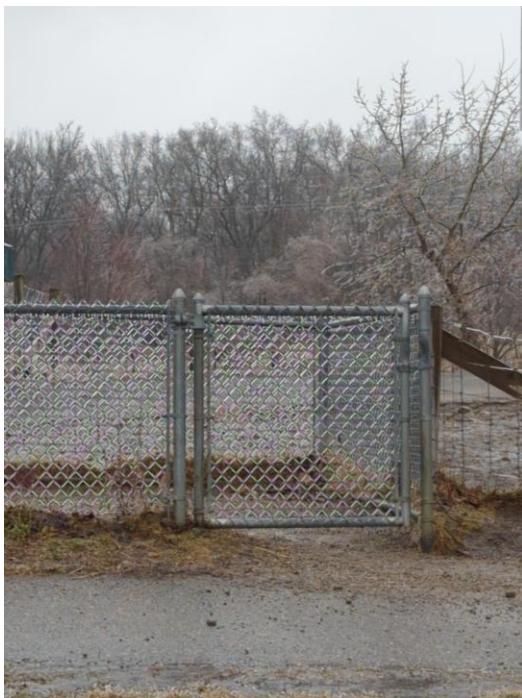
Green Space: Dog Park

Two entry gates to dog park does not have smooth surface

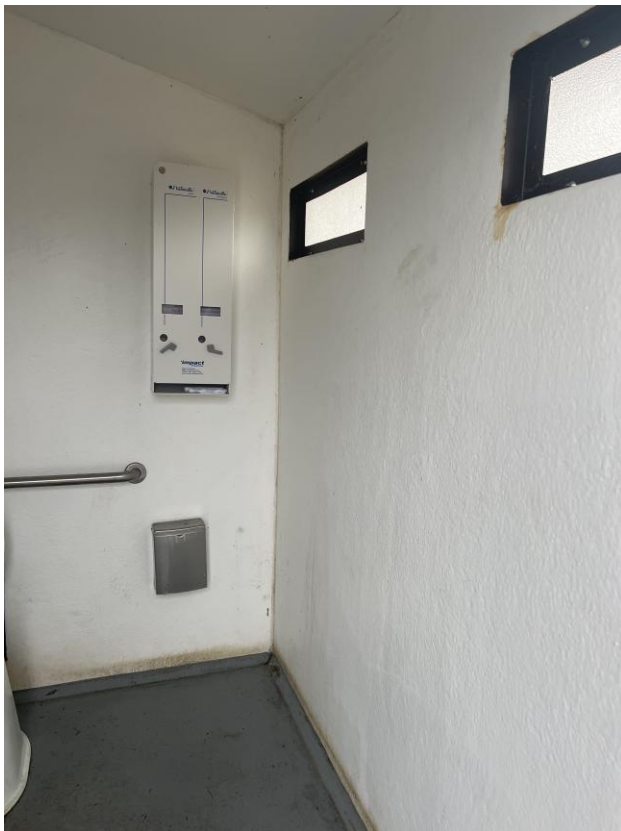
Restrooms: Unisex

Wall-mounted objects that have leading edges between 27 inches and 80 inches from the floor must not project more than 4 inches into the circulation path. Protruding objects that extend to the floor or within 27 inches of the floor are cane detectable and are therefore not hazardous. Where it is necessary or desirable to have objects protrude from the wall, a manner of cane detection must be provided.

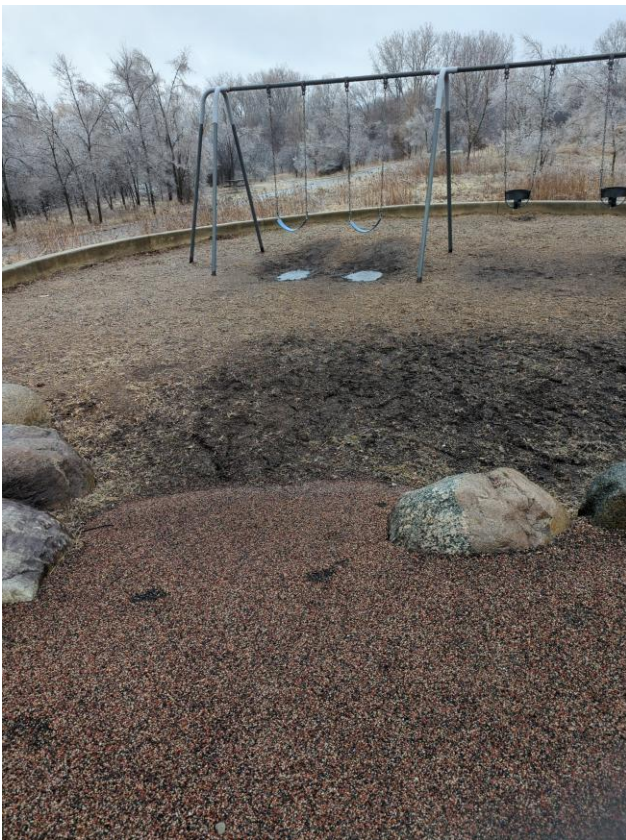
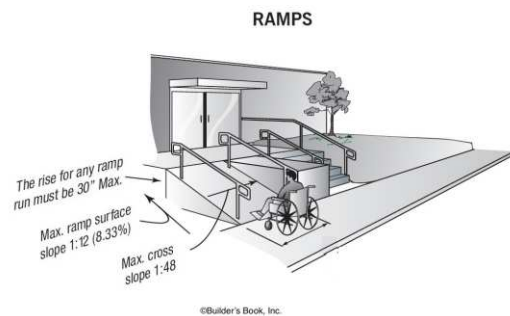
As Built:

Entrance to swings
has a slope of 24%

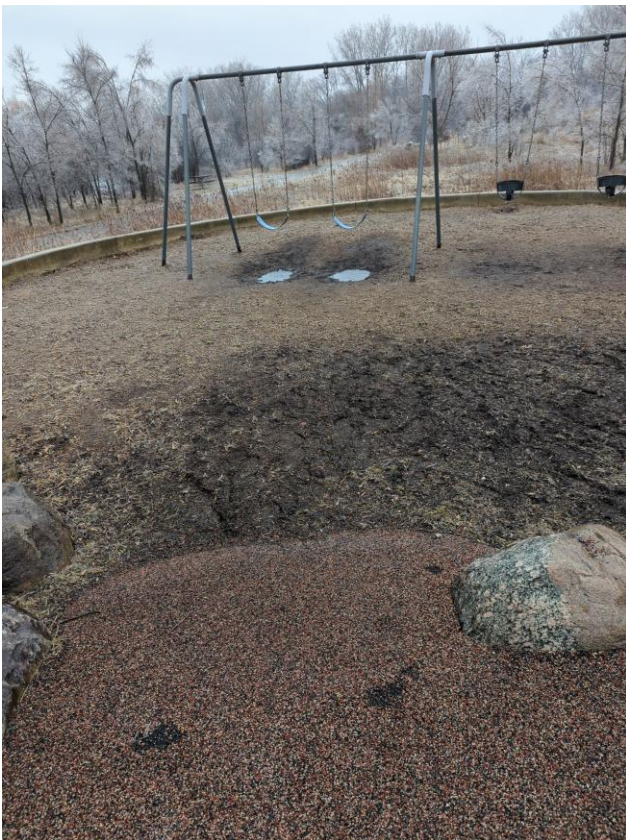
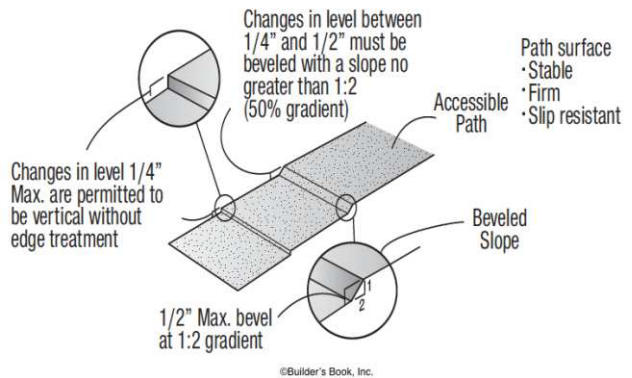
The accessible route contains loose gravel and/or surface materials that do not provide for a stable, firm slip resistant surface.

grass/dirt

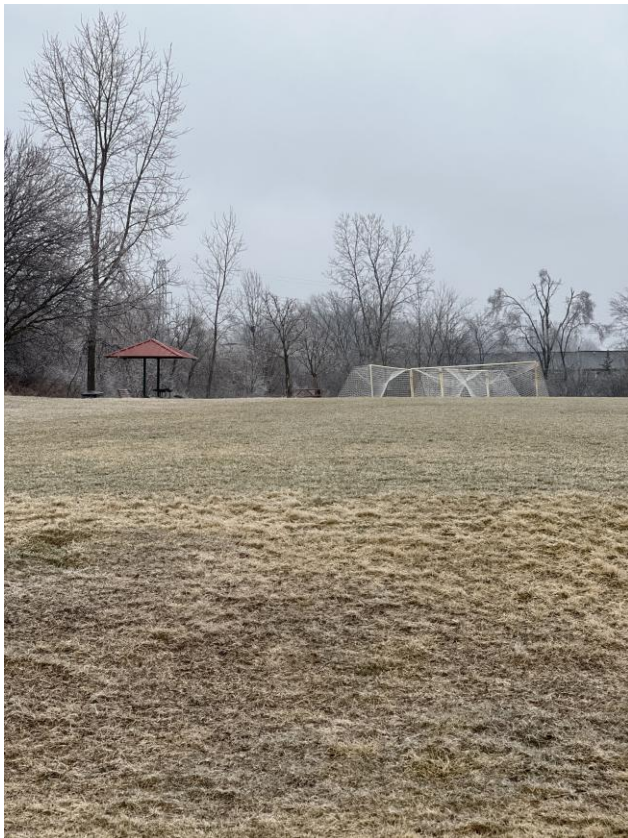
No accessible route to soccer field

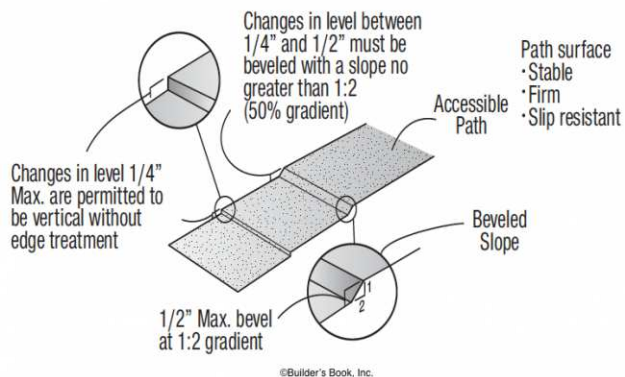
The accessible route contains loose gravel and/or surface materials that do not provide for a stable, firm slip resistant surface.

Surface is asphalt with cracks and excessive cross slope

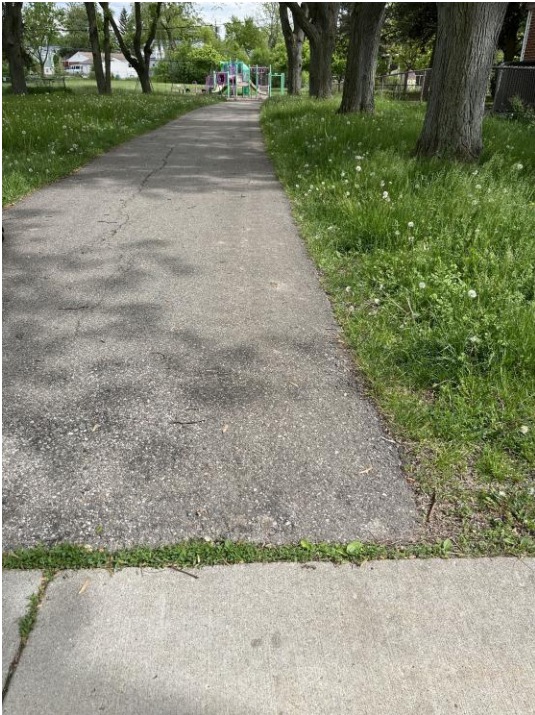
horizontal opening between right of way and trail

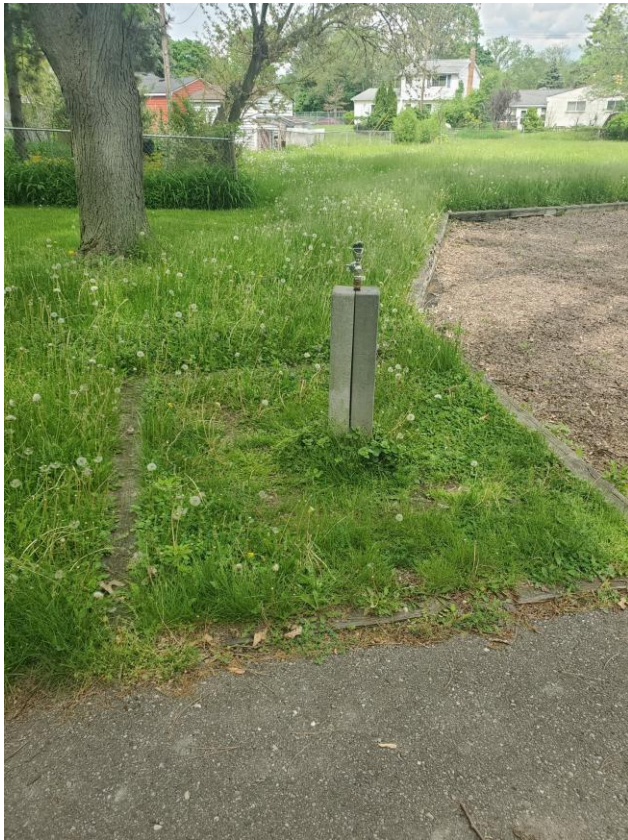
Finding #3 Continued

The drinking fountain has multiple violations.

Non-compliant drinking fountain

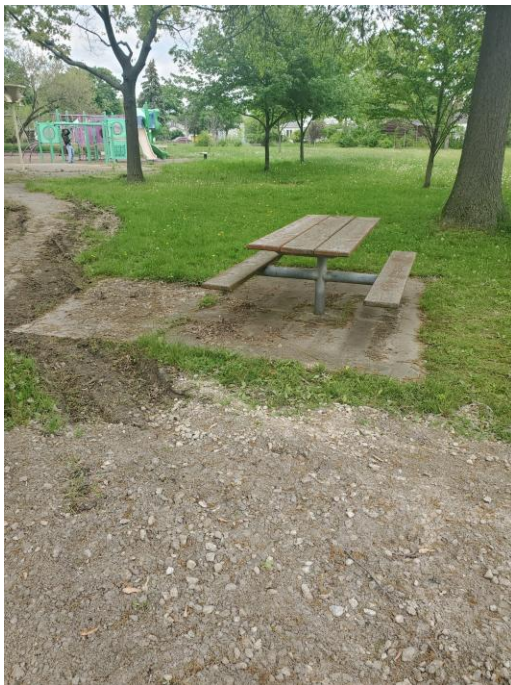
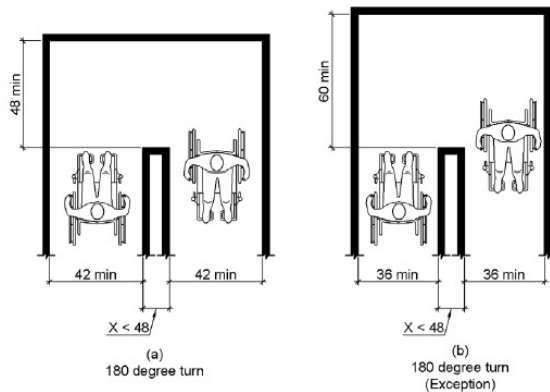
There is no accessible route to the wheelchair seating space of the picnic table

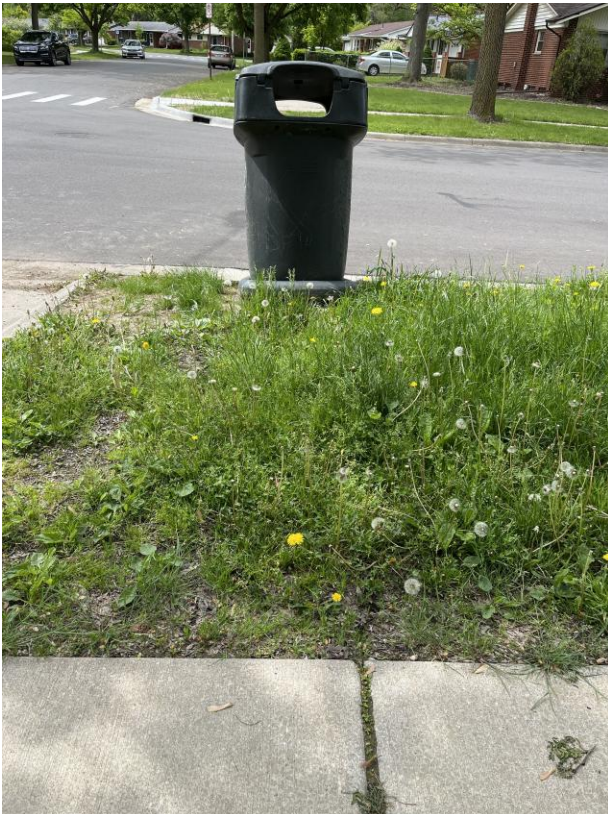
The accessible route contains loose gravel and/or surface materials that do not provide for a stable, firm slip resistant surface.

No accessible route provided to trash can

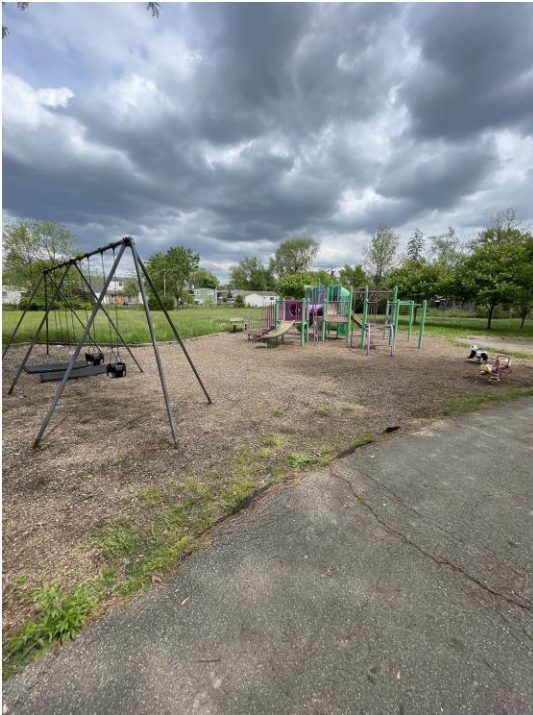
Play area has a non-compliant ground surface

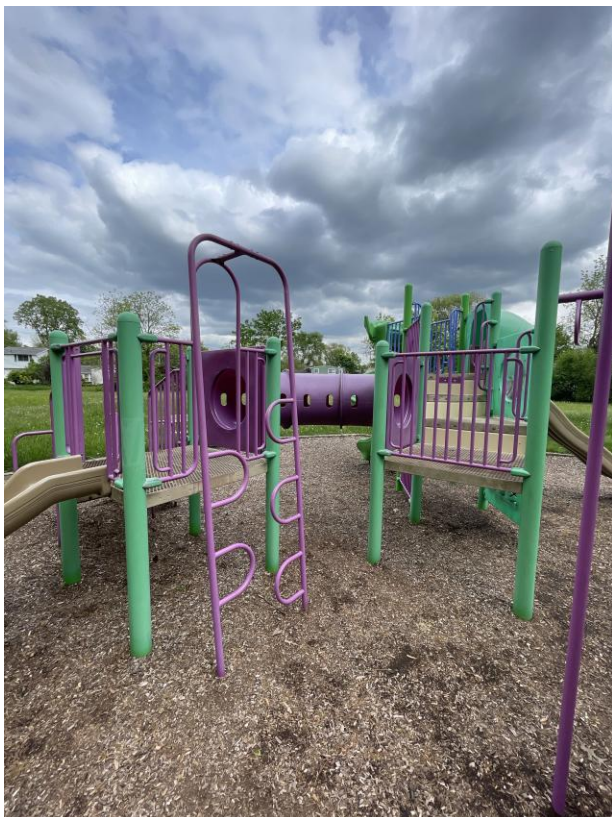
Elevated playground equipment is non-compliant

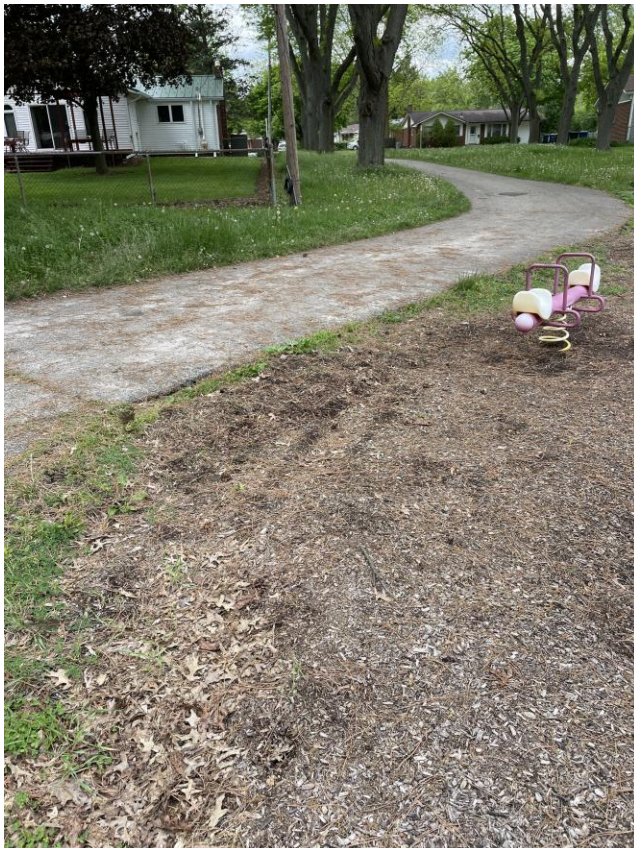
Accessible route has non-compliant changes in level

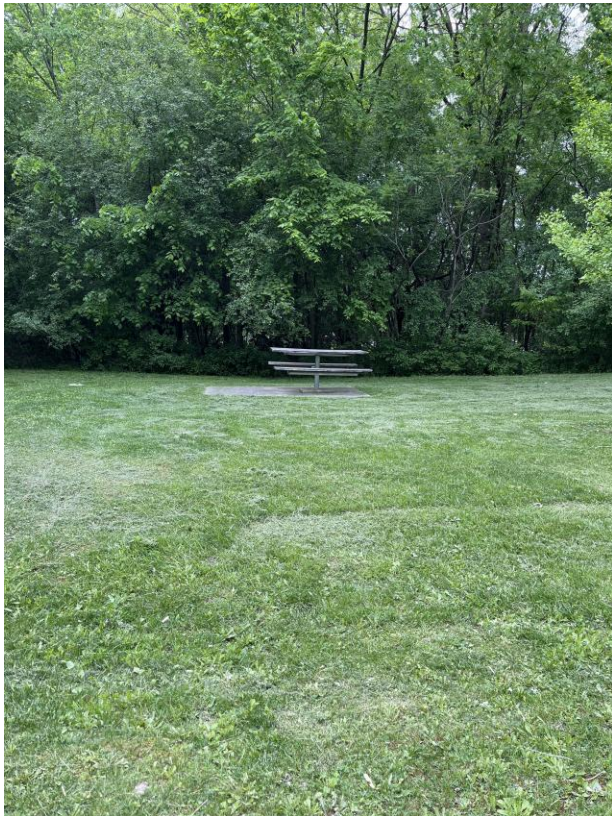
The accessible route contains loose gravel and/or surface materials that do not provide for a stable, firm slip resistant surface.

No accessible route provided to picnic table

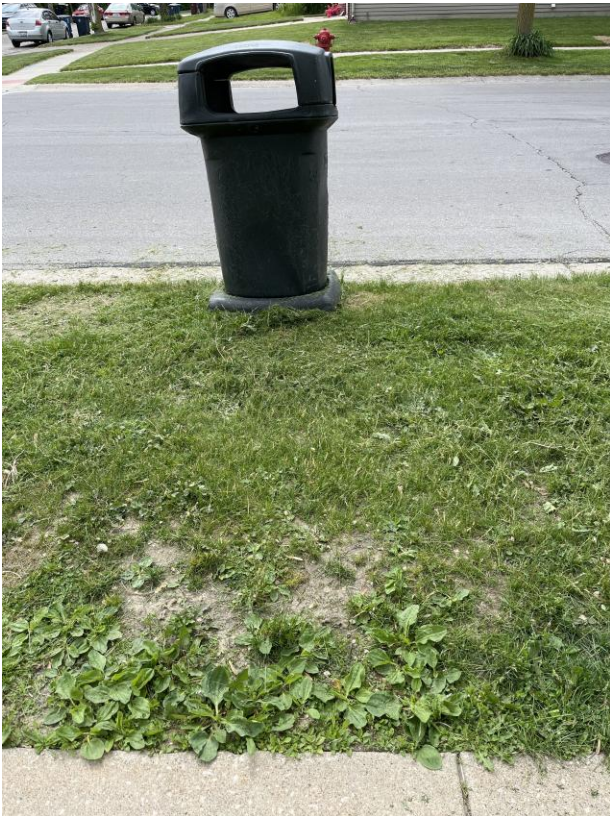
The accessible route contains loose gravel and/or surface materials that do not provide for a stable, firm slip resistant surface.

No accessible route provided to trash can

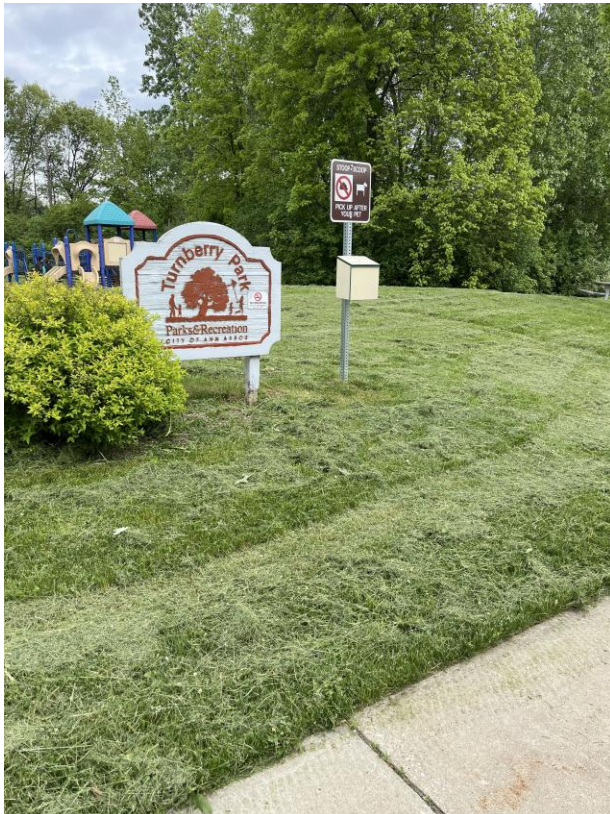
The accessible route contains loose gravel and/or surface materials that do not provide for a stable, firm slip resistant surface.

No accessible route provided to bag dispenser

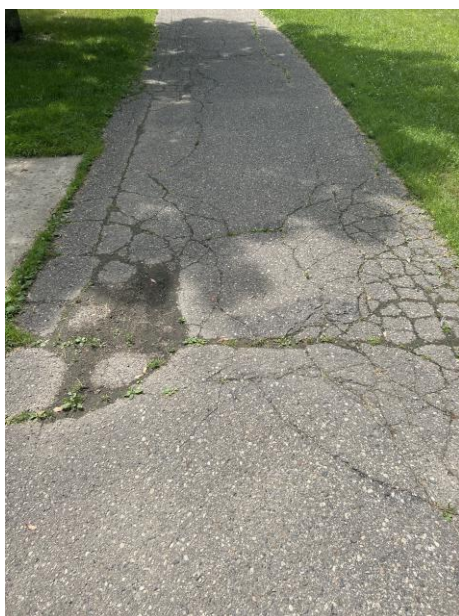
200 linear feet of route is broken

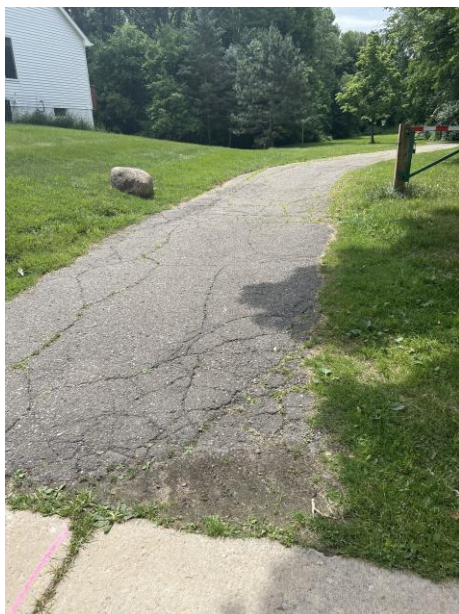
200 linear feet of route is broken

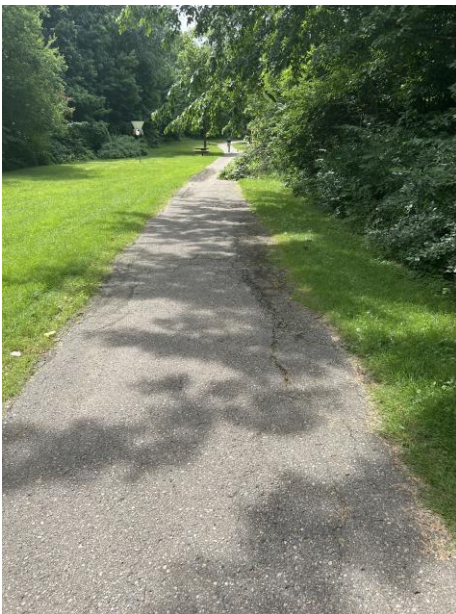
200 linear feet of route is broken
