Site Accessibility Evaluation

Allmendinger Park
655 Pauline Blvd
Ann Arbor, MI 48104
ADA Only

Inspection Date: 07/11/2022

Report Date: 11/15/2022

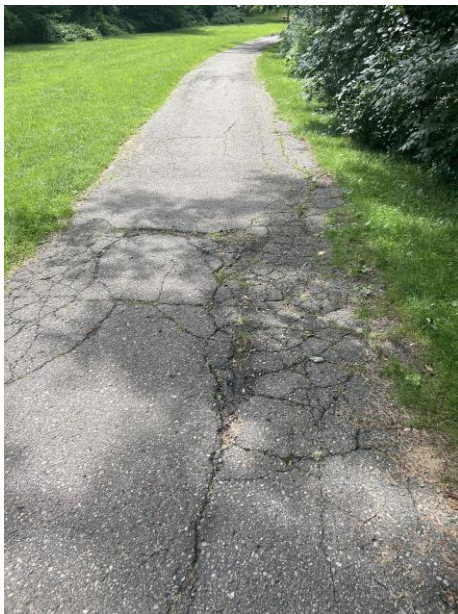
200 linear feet of route is broken

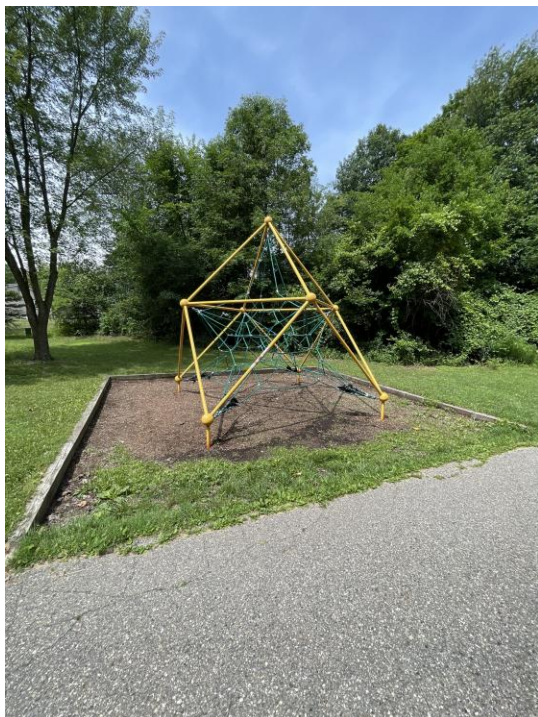
Play area ground surface is non-compliant

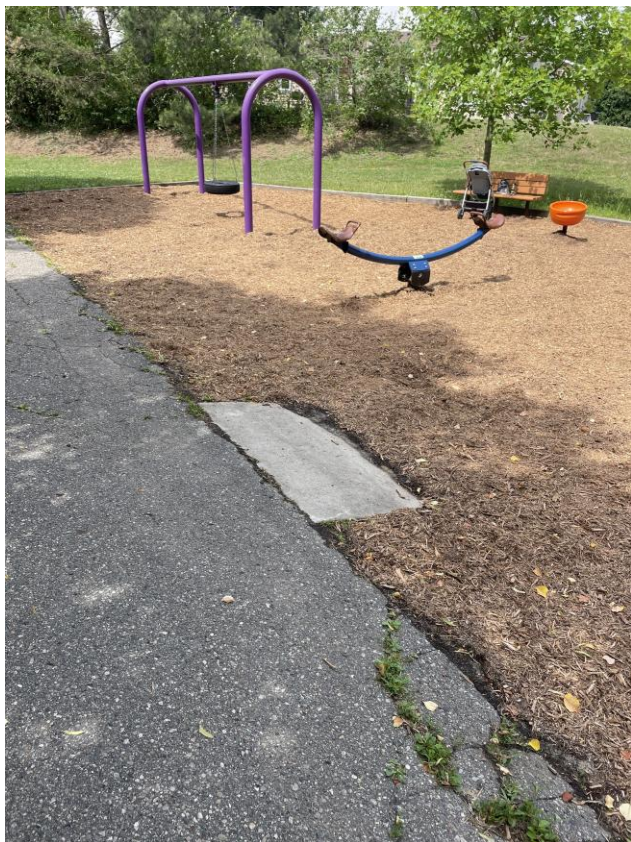
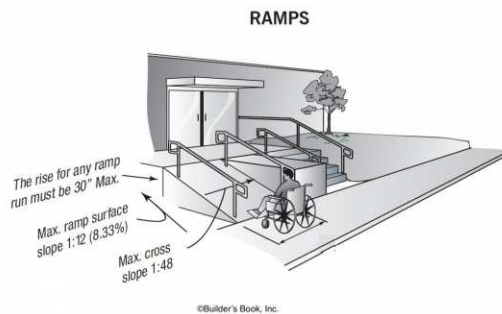
Ramp to play area has a running slope greater than 8.33%

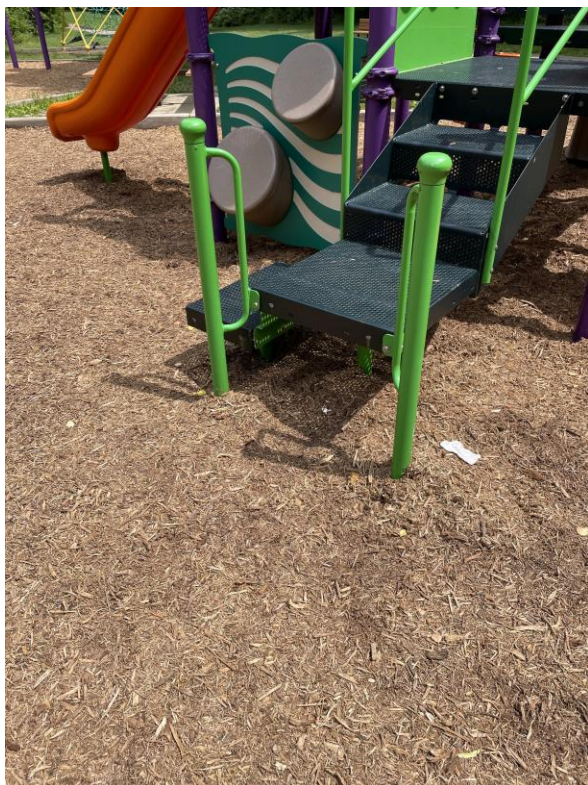
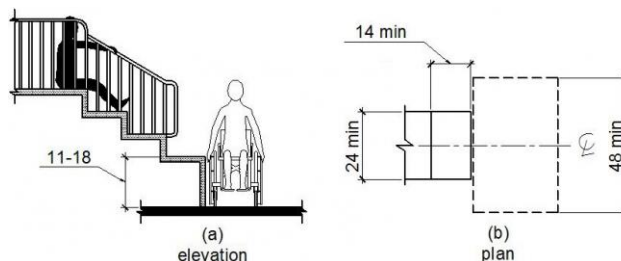
Playground equipment does not have a compliant entry

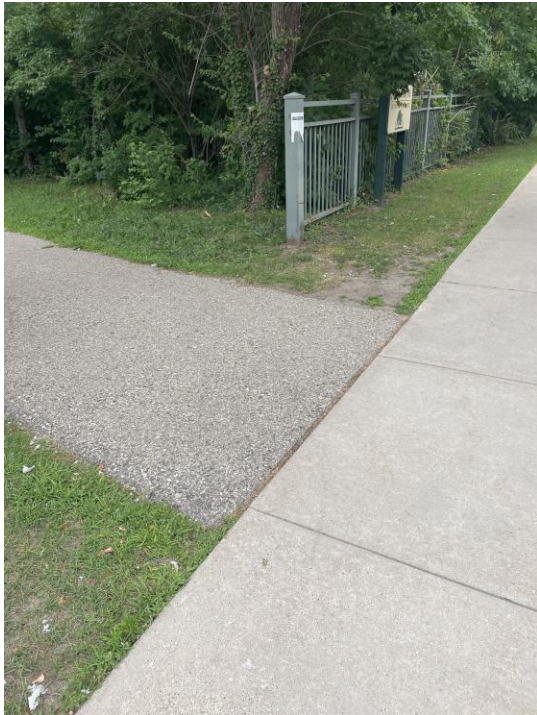
Accessible route has non-compliant changes in level

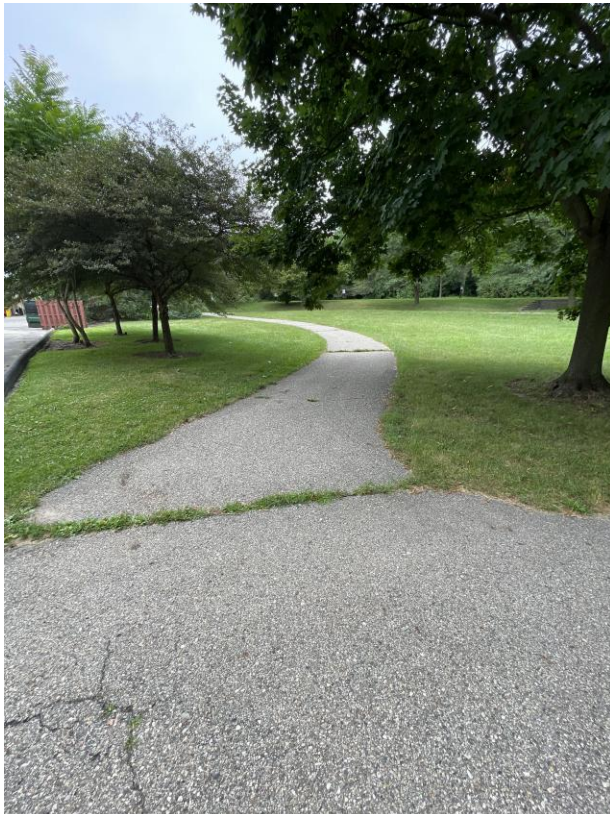
120 LF of non-compliant surface on accessible route

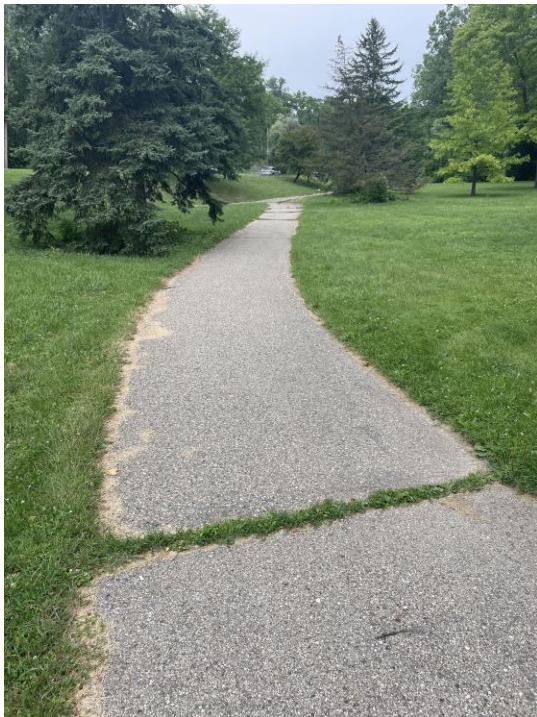
Vegetation on accessible route creates non-compliant changes in level

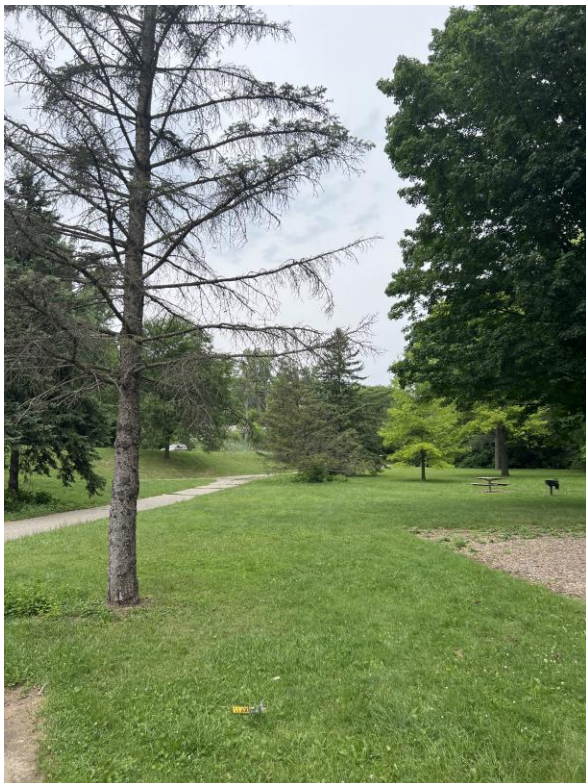
No route to grill

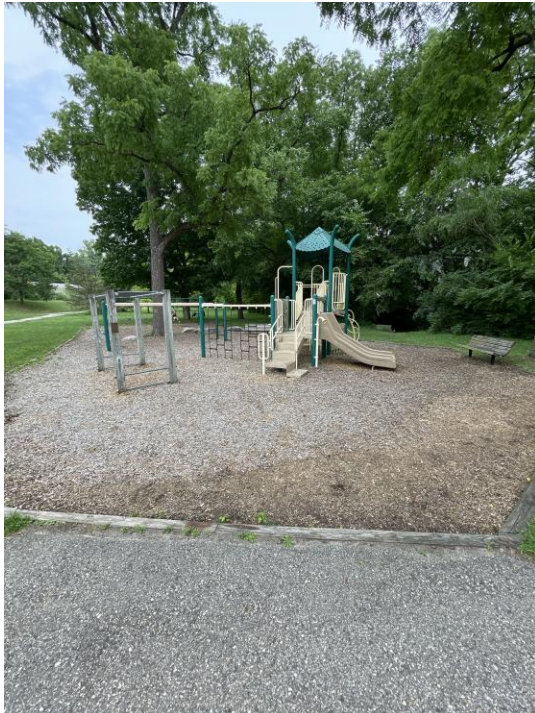
Play area has non-compliant ground surface

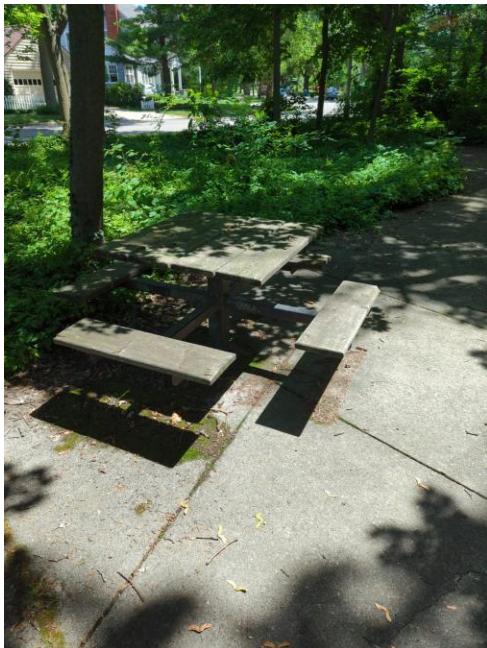
One table provided without an accessible dining surface

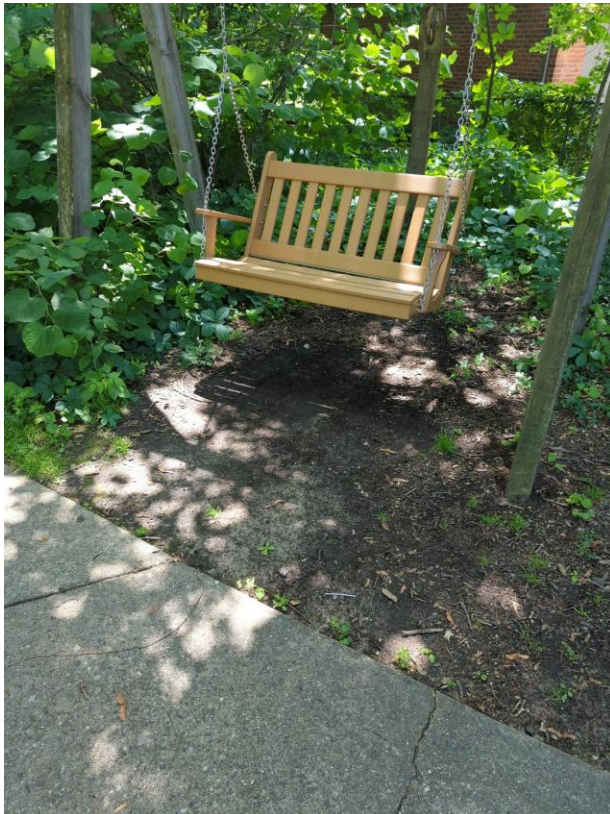
Swing does not have an accessible ground surface

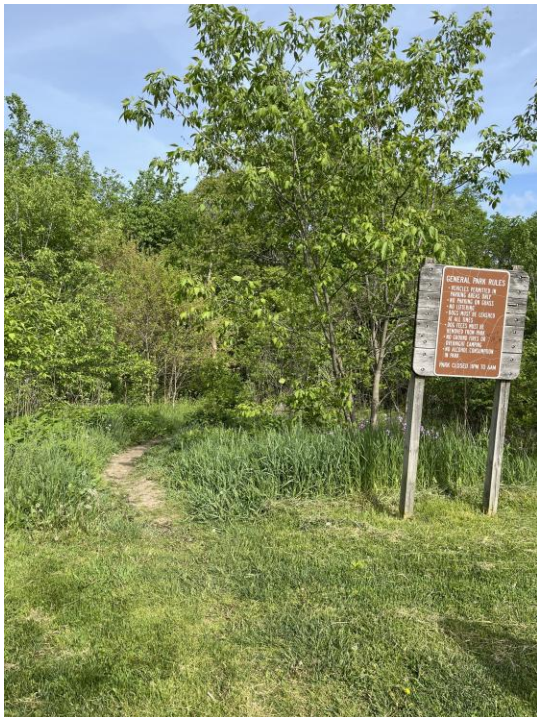
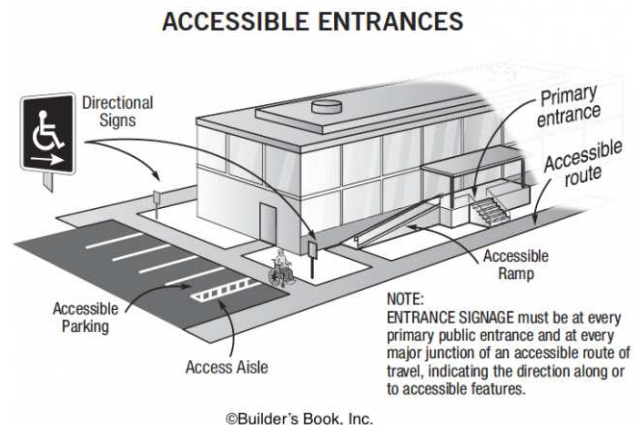
Trail is dirt path, not providing a surface that is firm, stable, and slip resistant.

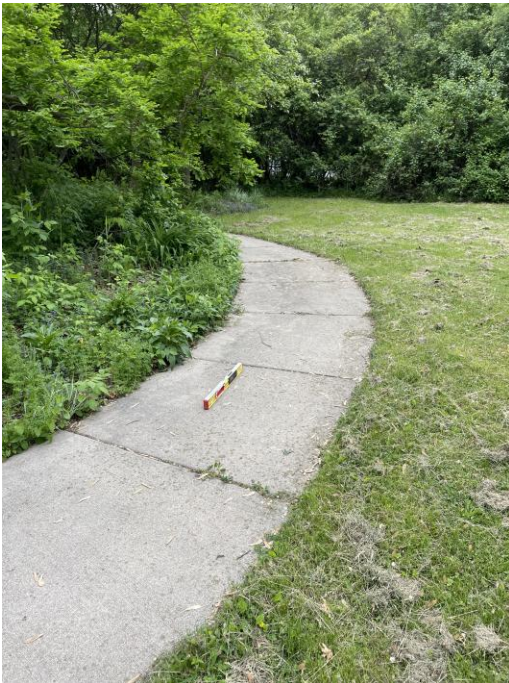
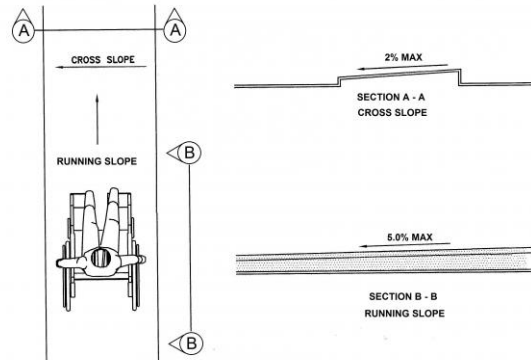
The running slope of the sidewalk is greater than 5%, which is considered a ramp and must comply with the requirements of 406, or must be reduced to less than 5% and comply with 403.

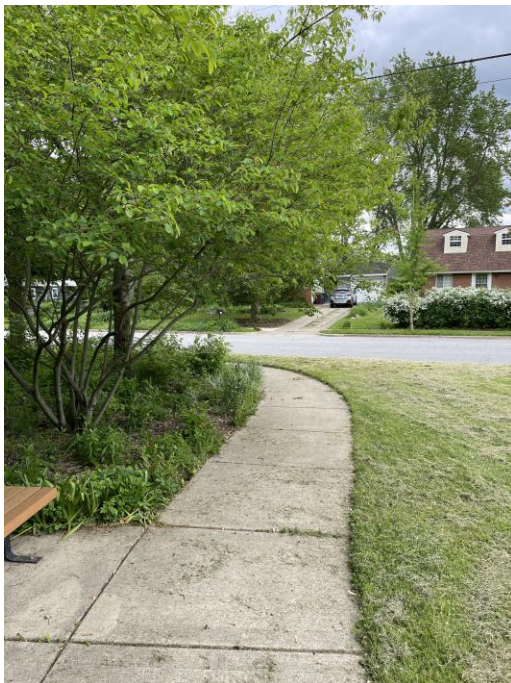
Tree branches protrude more than 4 inches at less than 80 inches high.

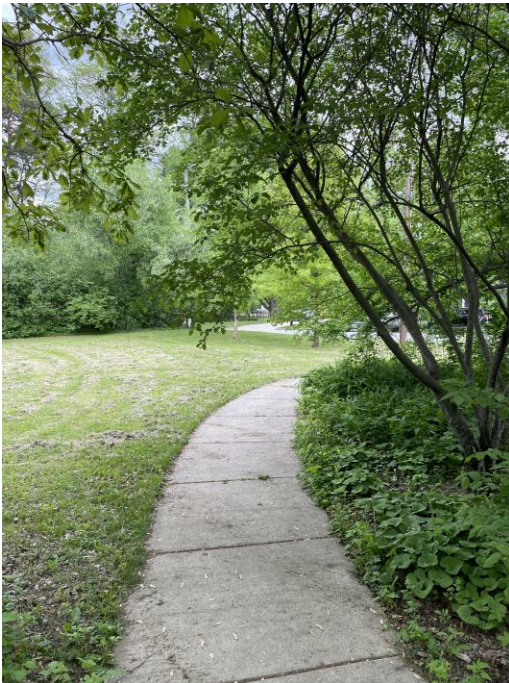
Tree branches protrude more than 4 inches at less than 80 inches high.

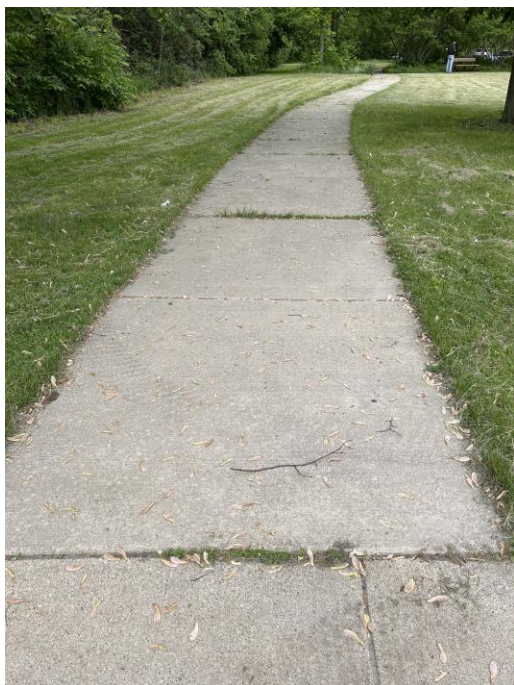
There are horizontal openings along the accessible route that is greater than 1/2-inch and/or deeper than 1/4-inch.

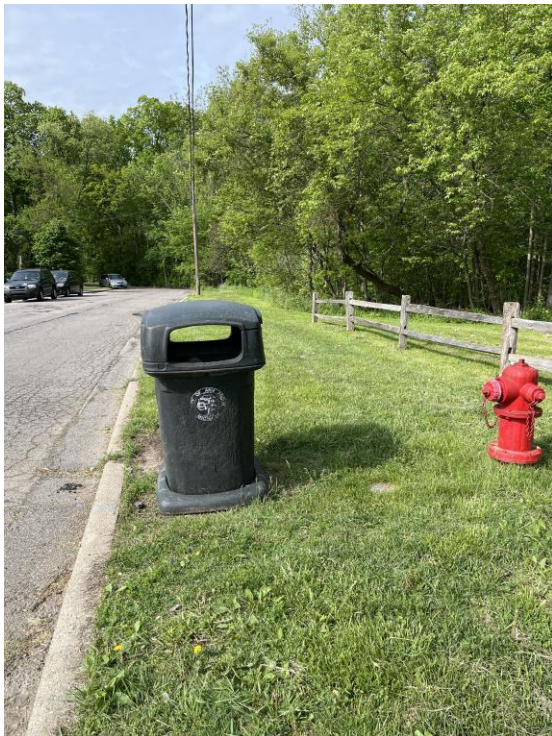
Grass is not a stable, firm, and slip resistant surface.

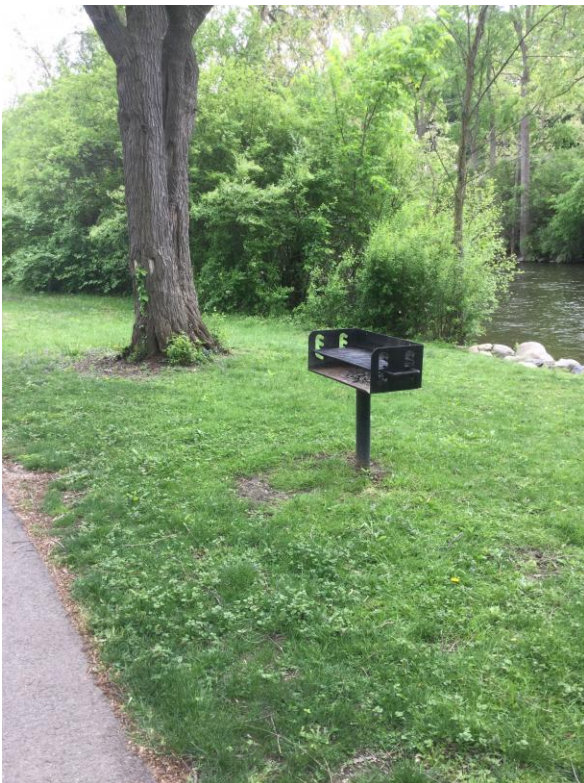
The grill area has grass as the floor surface, which is not firm, stable, and slip resistant.

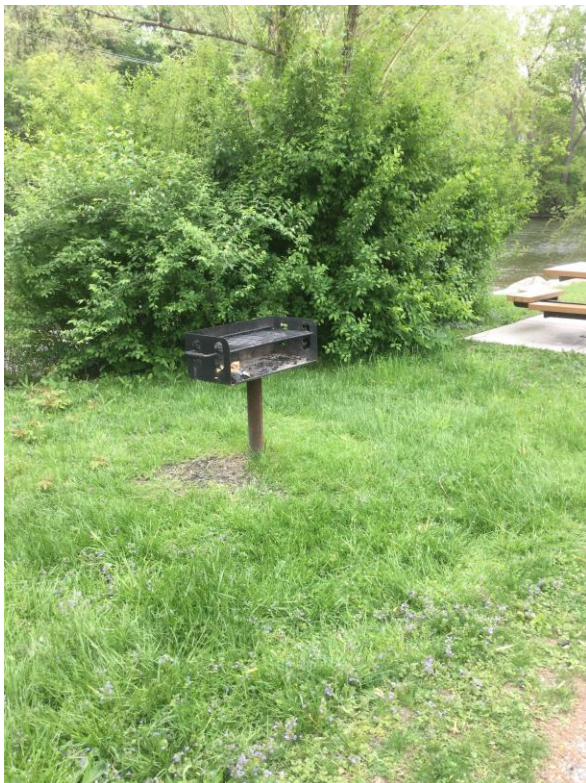
The grill area has grass as the floor surface, which is not firm, stable, and slip resistant.

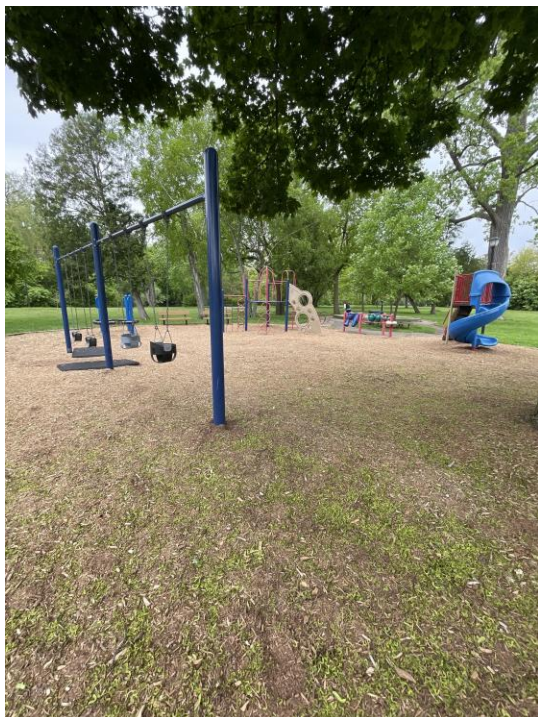
The play area has vegetation on the ground surface, which is not firm, stable, and slip resistant.

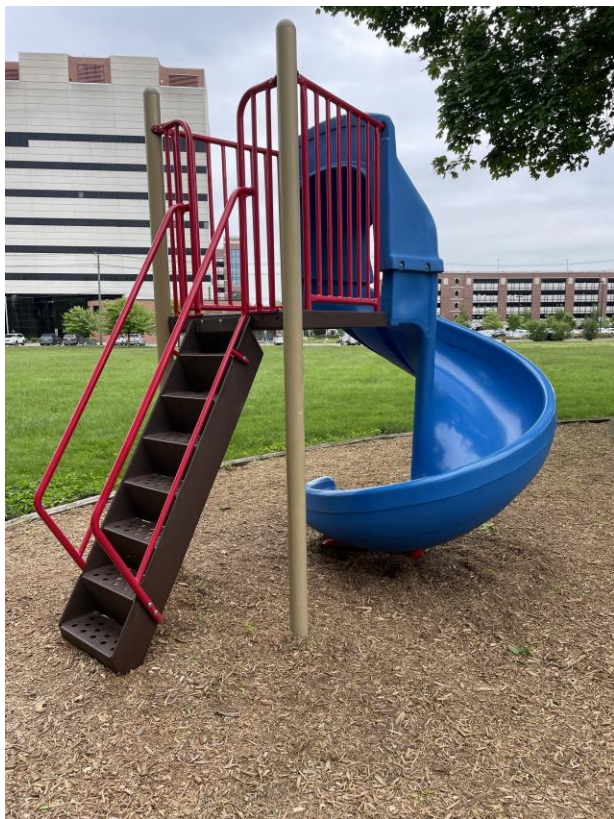
No transfer platform and steps are provided to the slide

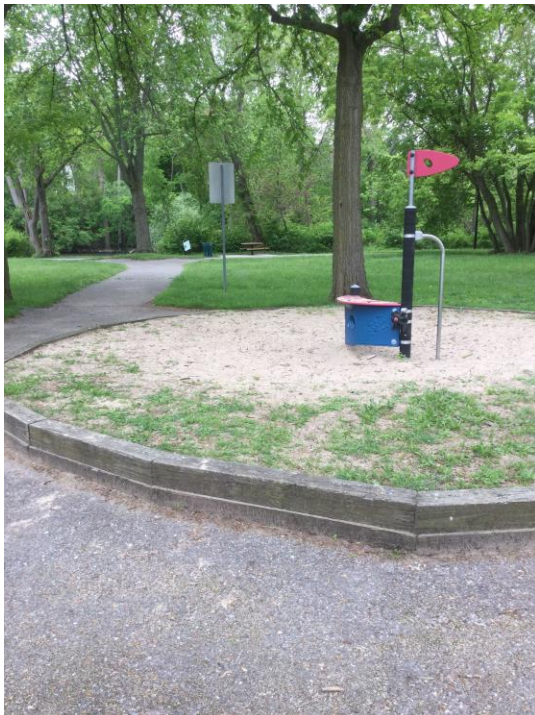
Small play area has sand, which is not firm, stable, or slip resistant.

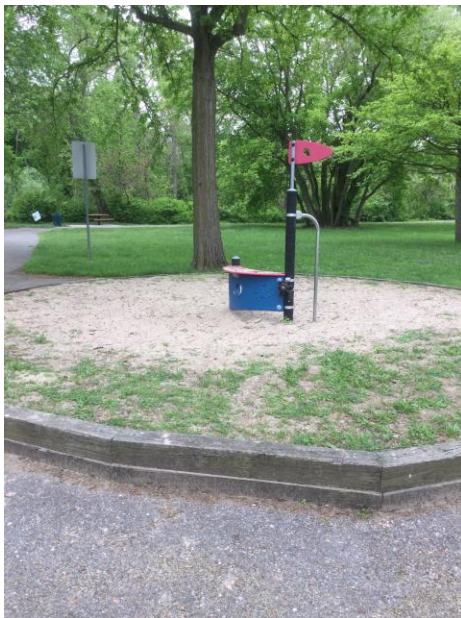
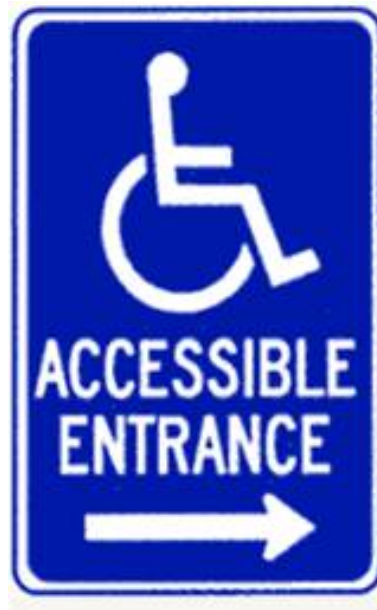
There is no accessible route to the small play area, with an 8-inch change in level.

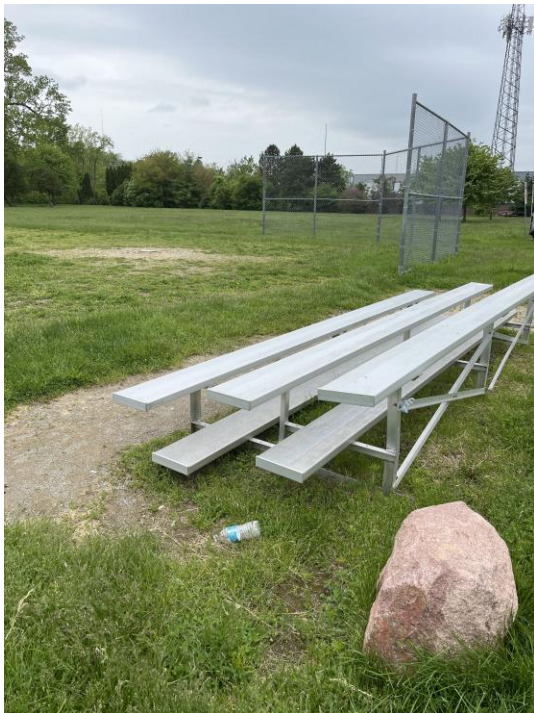
There are no wheelchair spaces provided at the bleachers

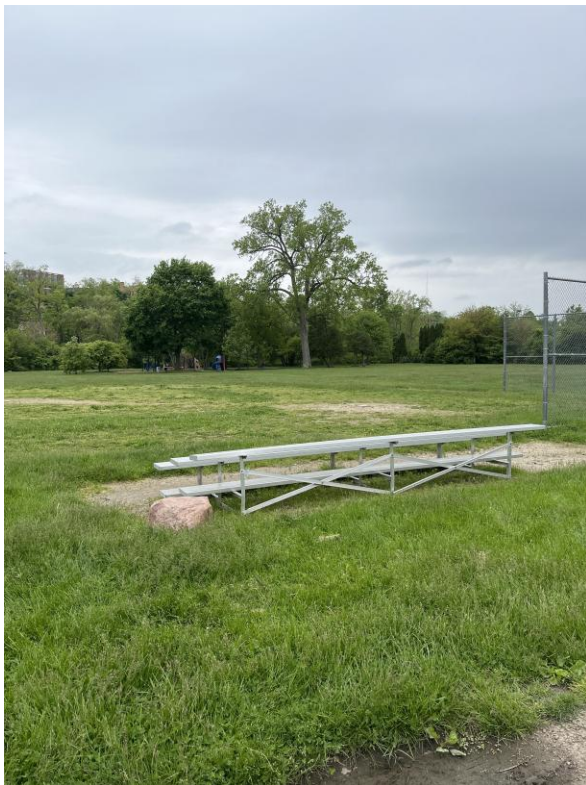
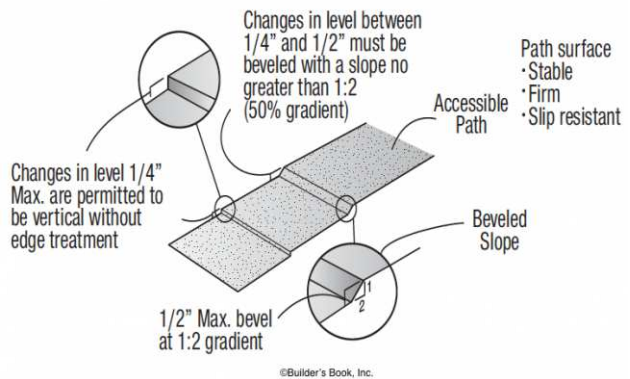
There is no accessible route to the baseball field; the route has grass with is not firm, stable, and slip resistant.

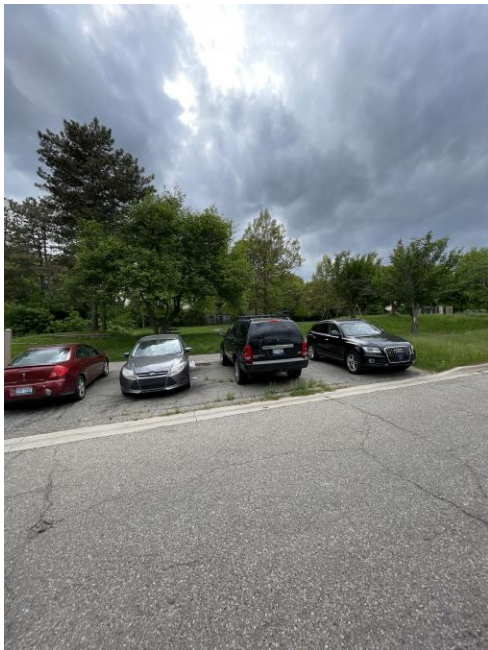
There are no accessible parking spaces provided.

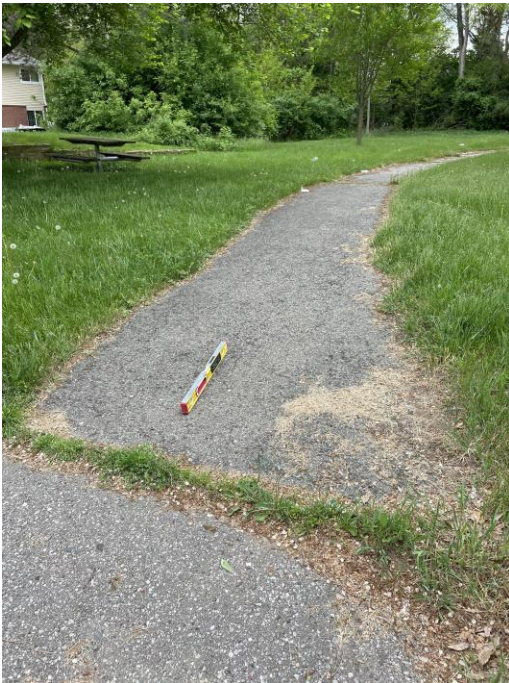
Portions of the accessible routes have running slopes greater than 5%, which are considered ramps and must comply with the requirements of 405, or must be modified to have a running slope less than 5%.

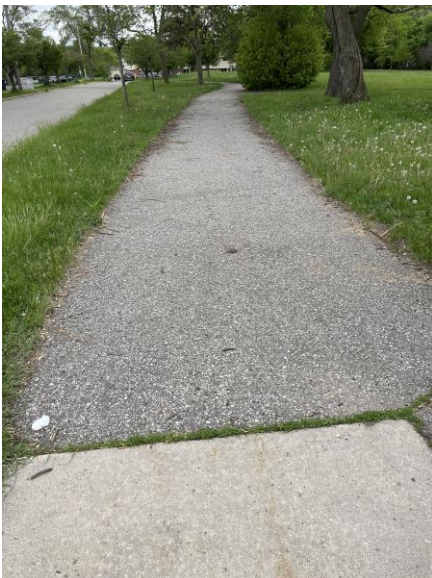
There is a vertical change in level greater than 1/4-inch (or 1/2-inch if beveled) between public sidewalk and park sidewalk

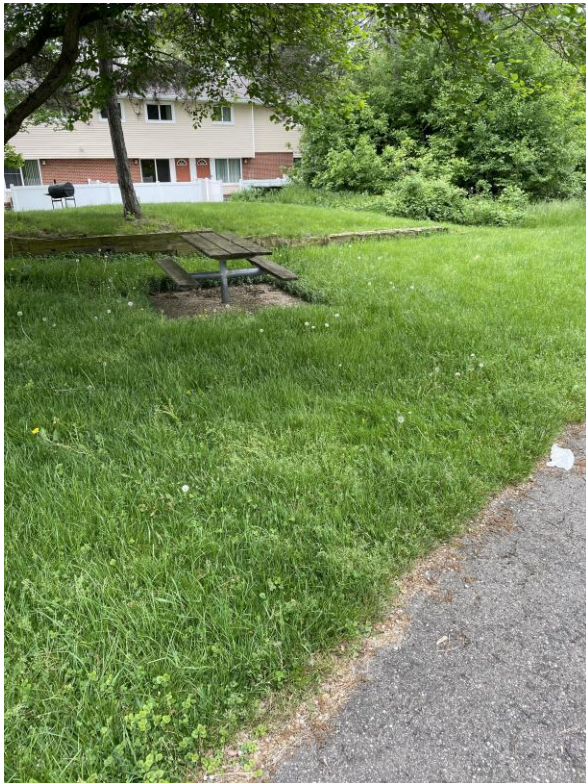
There is no accessible route to the picnic table; grass is not a firm, stable, and slip resistant surface.

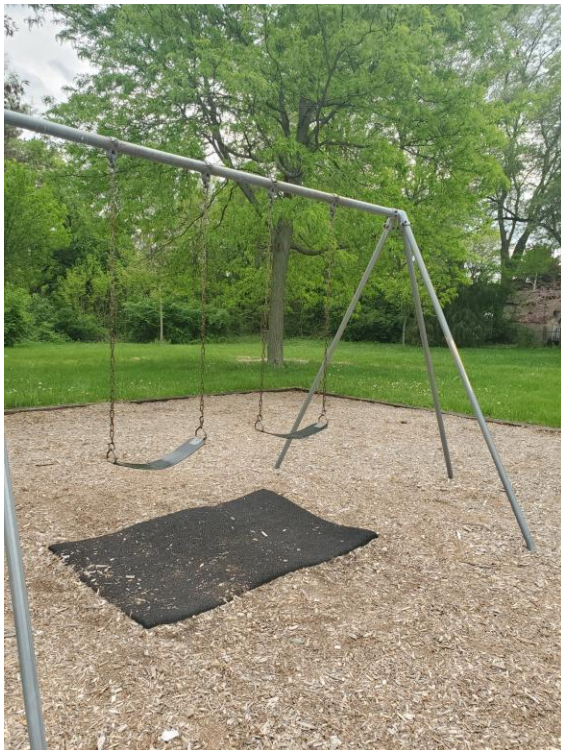
The swing seats are higher than 24 inches from the ground. Lower seats or raise the ground surface with more compliant wood mulch.

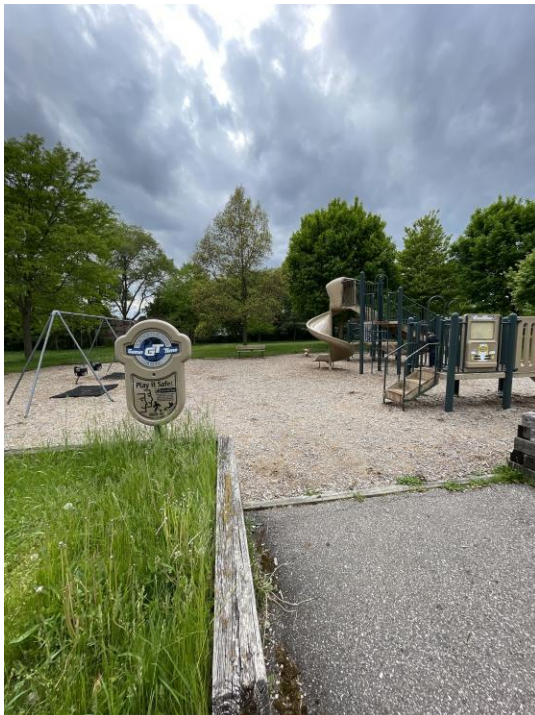
The play area does not provide a ground surface that is firm, stable, and slip resistant.

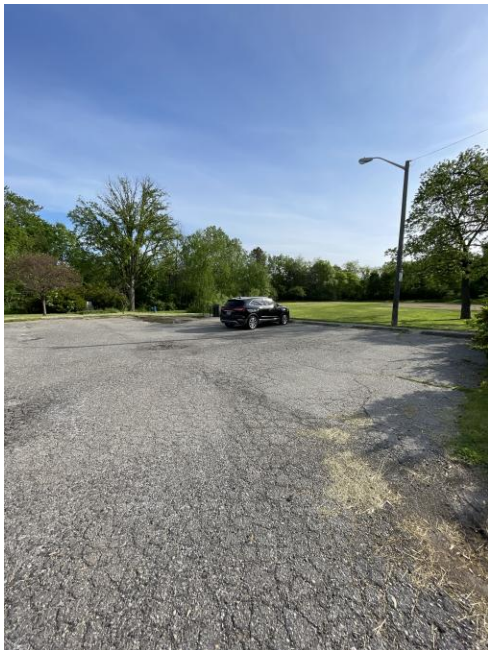
There are no accessible parking stalls provided

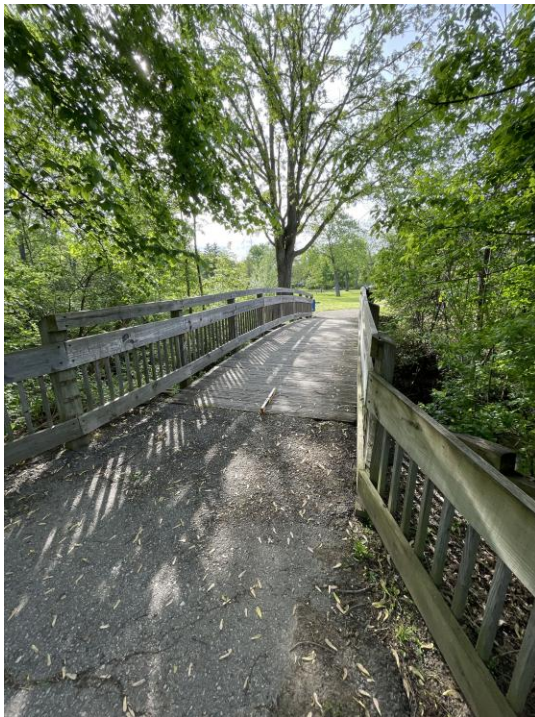
Running slope of wooden bridge is 10.3%

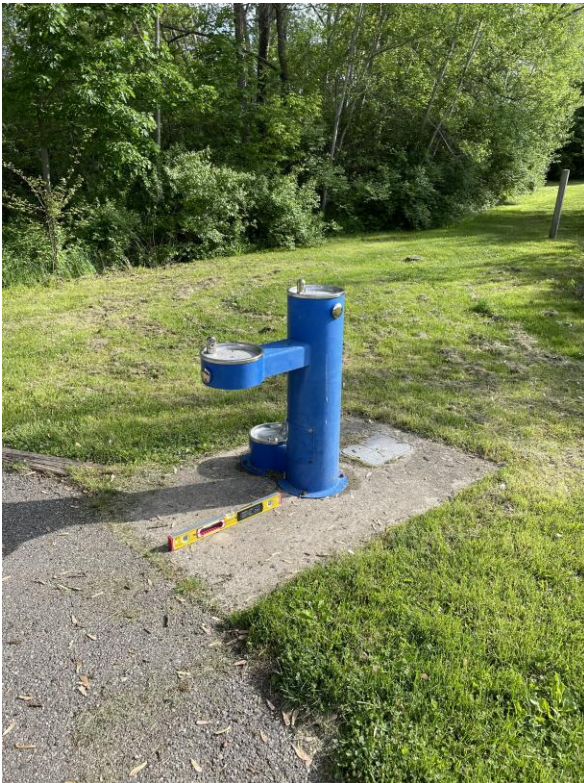
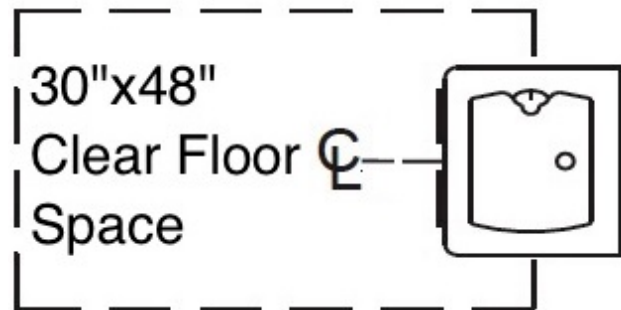
Slope of drinking fountain clear floor space is 3.7%

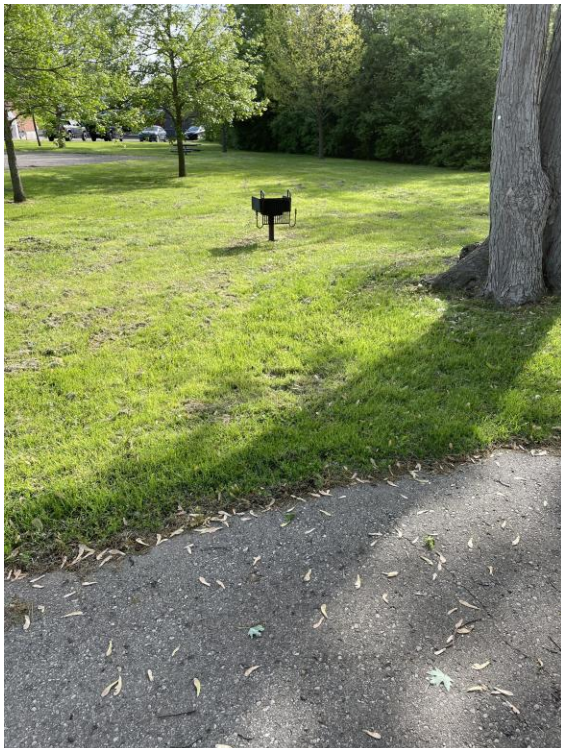
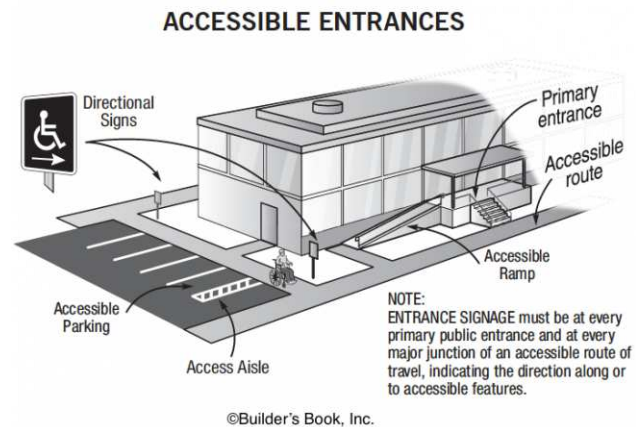
There is no accessible route to the grill; approximately 30 linear feet away. Grass is not an accessible ground surface.

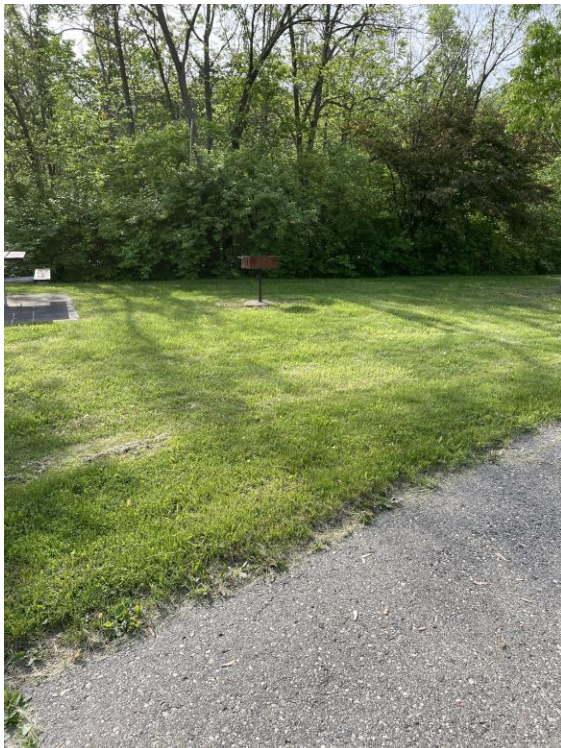
There is no accessible route to the grill; approximately 30 linear feet away. Grass is not an accessible ground surface.

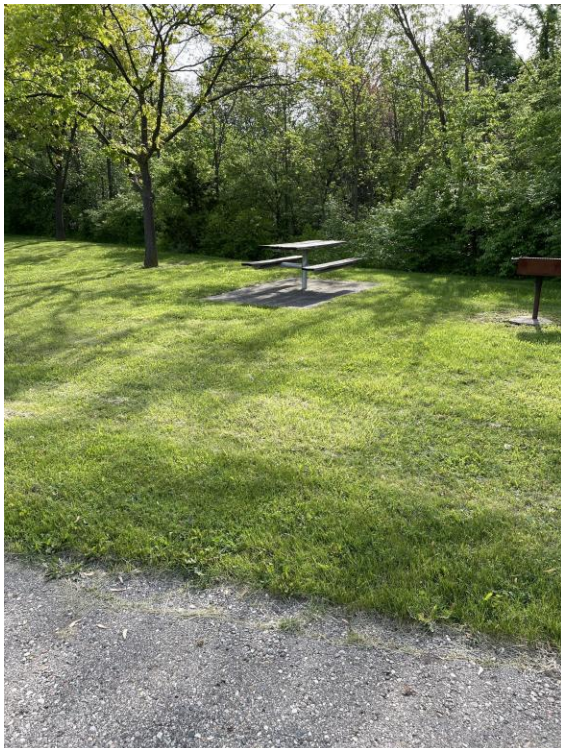
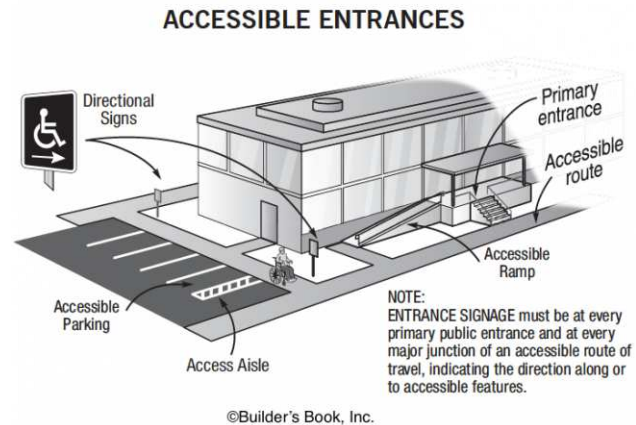
There is no accessible route to the picnic; approximately 30 linear feet away. Grass is not an accessible ground surface.

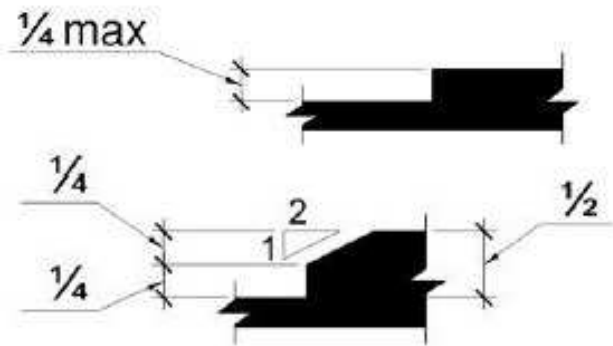
There is vegetation growing in the cracks of the sidewalk creating a vertical change in level greater than 1/4-inch to the trash bin.

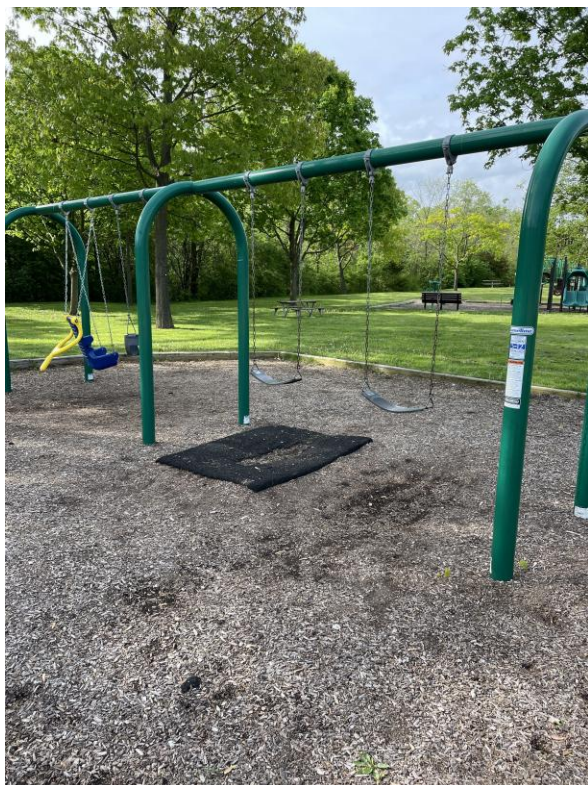
The swing seat is higher than 24 inches

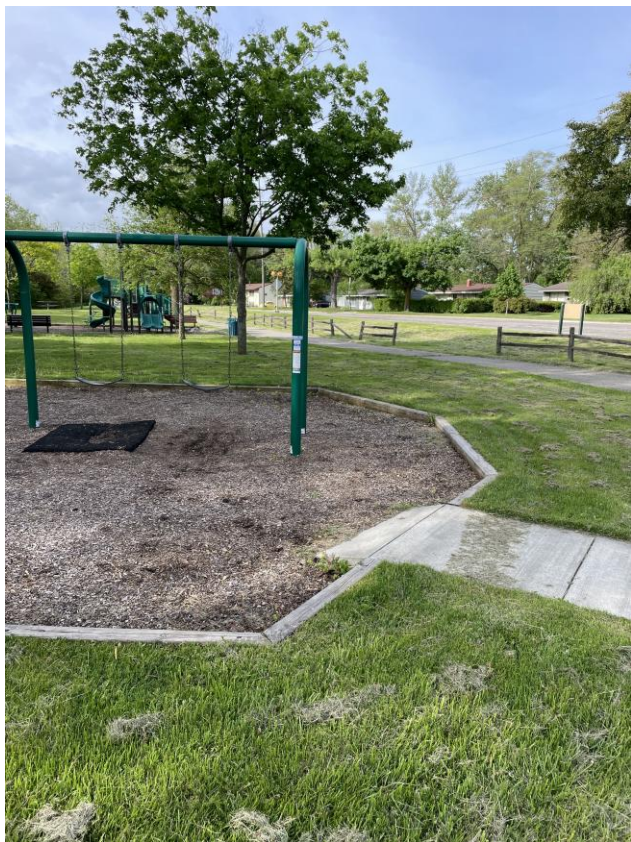
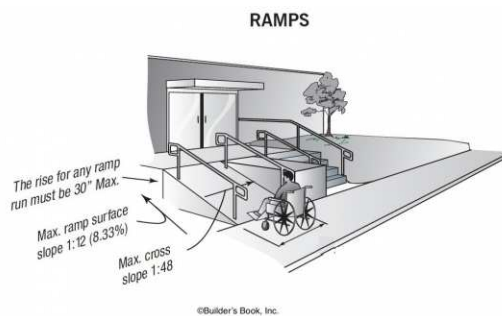
The ramp to the swing play area has a slope greater than 8.33%.

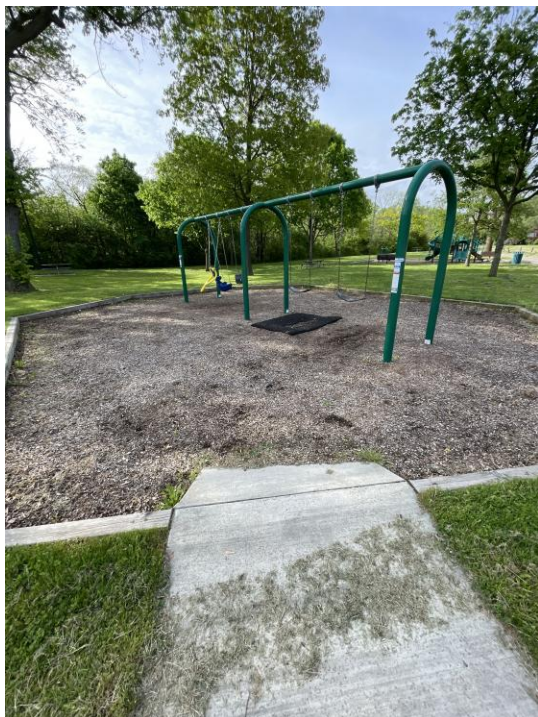
The ground surface at the swing play area is not accessible; sand is not an accessible surface.

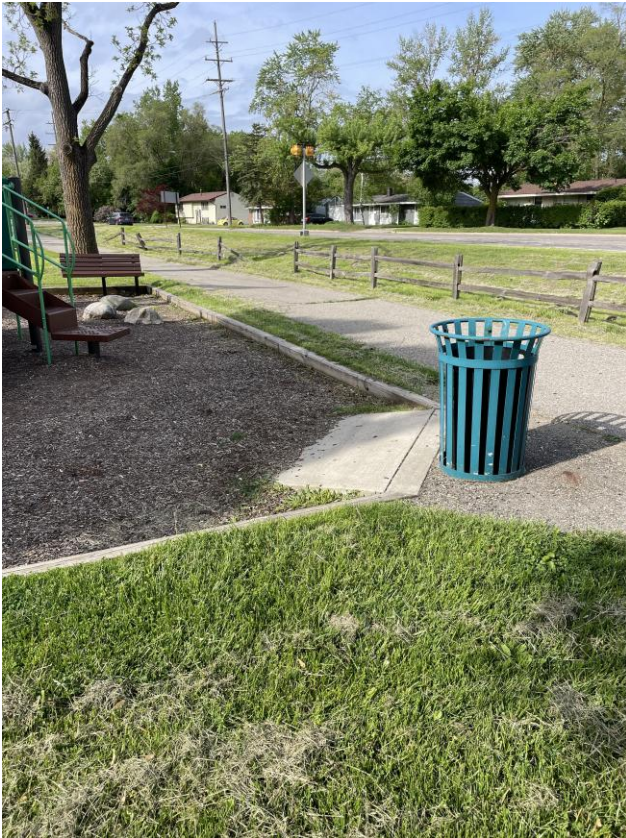
The ramp to the play area has a running slope greater than 8.33%.

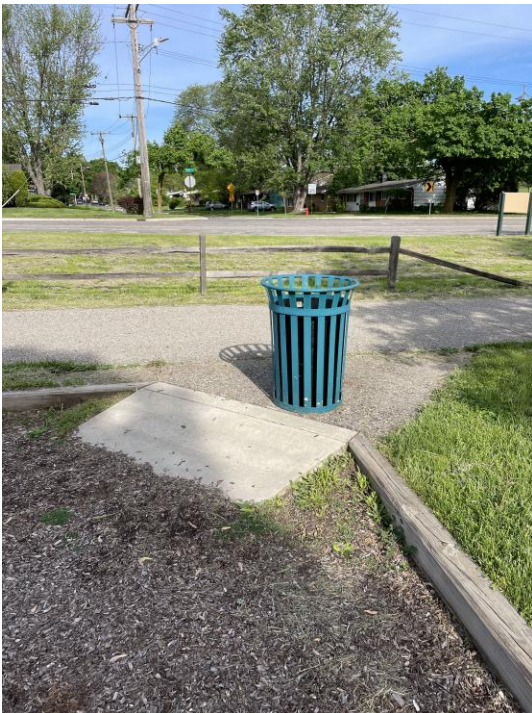
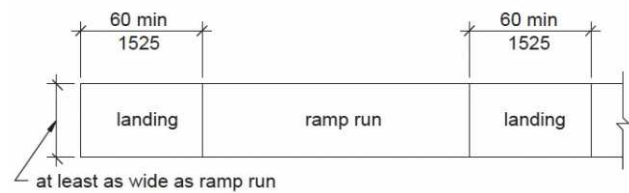
The top landing of the ramp is not clear; trash bin obstructs top landing.

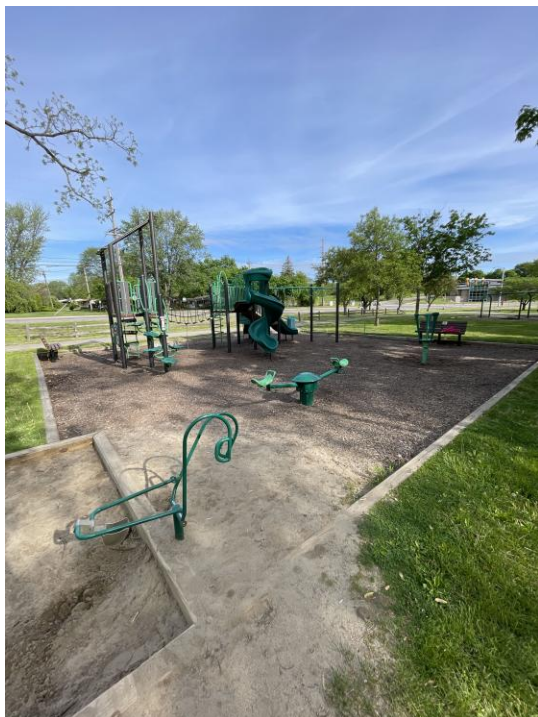
The ground surface at the play area is not accessible; sand is not an accessible surface.

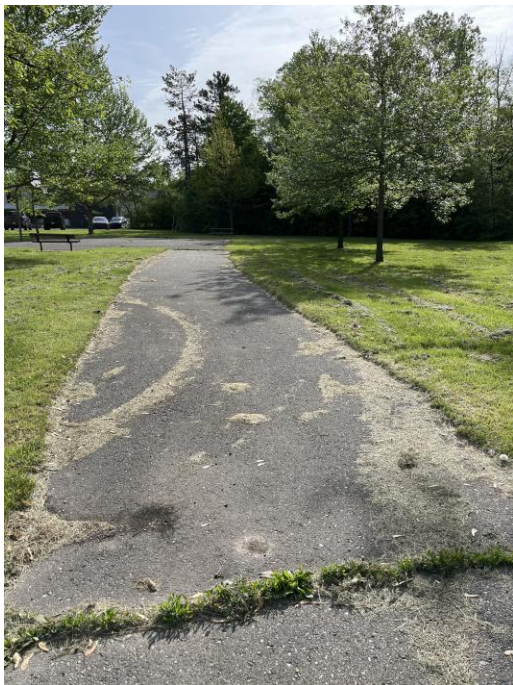
The accessible route has horizontal openings greater than 1/2-inch, or deeper than 1/4-inch, or with vegetation creating vertical changes in level greater than 1/4-inch.

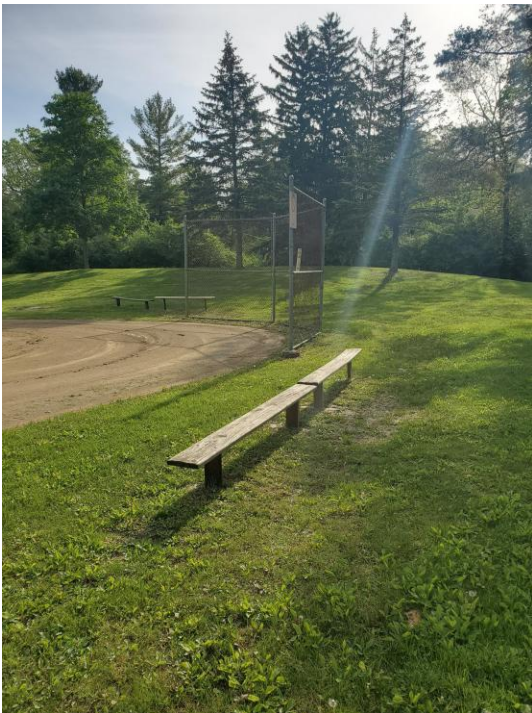
There is no accessible route to the seating area; grass is not an accessible surface.

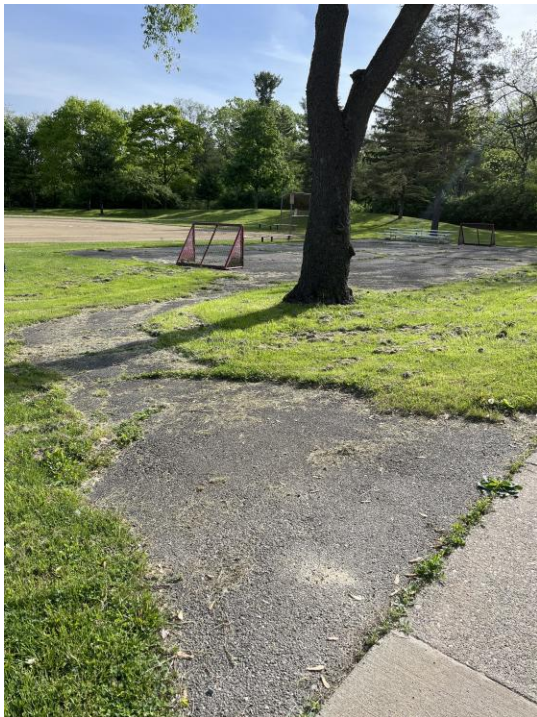
Route has a running slope greater than 8.33%, and firm and stable walking surface.

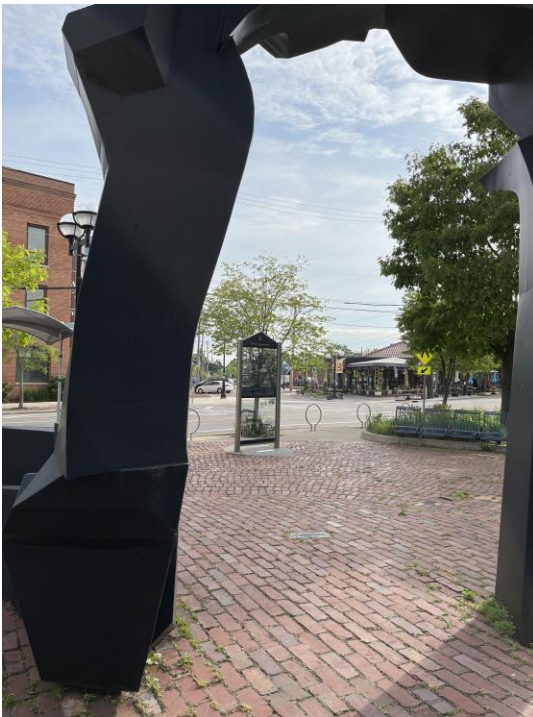
The interior of one of the sculpture's columns protrudes more than 4 inches.

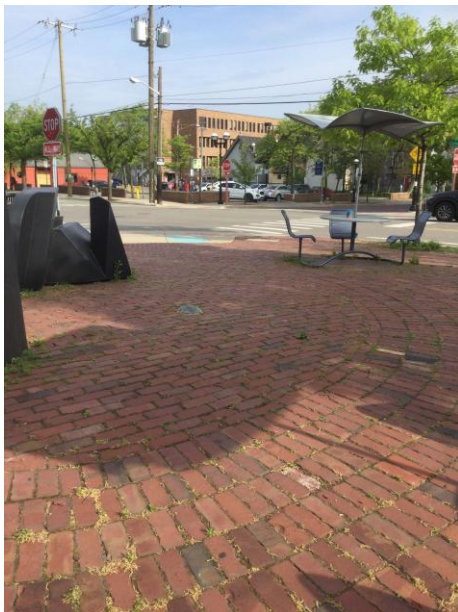
The surface material consists of pavers. The pavers have a change in elevation greater than 1/4 inch.

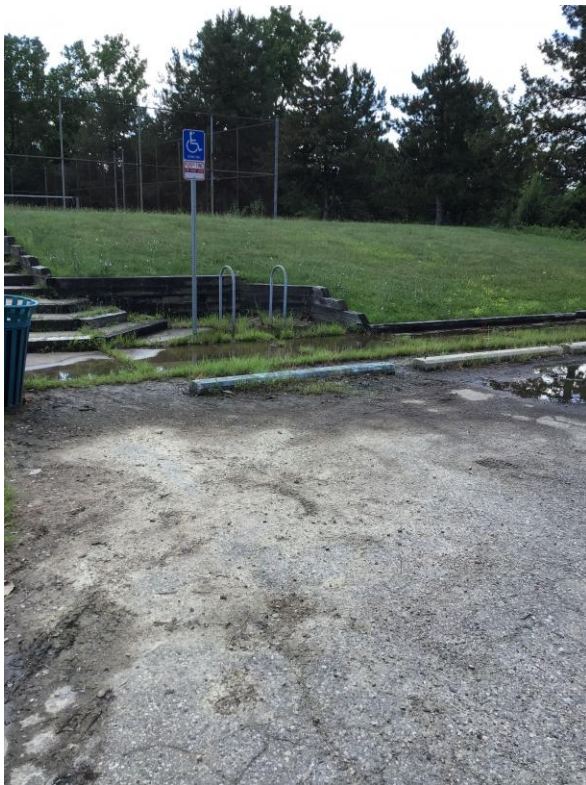
The accessible parking space is missing the required markings.

Existing parking space needs markings.
