Site Accessibility Evaluation

Allmendinger Park
655 Pauline Blvd
Ann Arbor, MI 48104
ADA Only

Inspection Date: 07/11/2022

Report Date: 11/15/2022

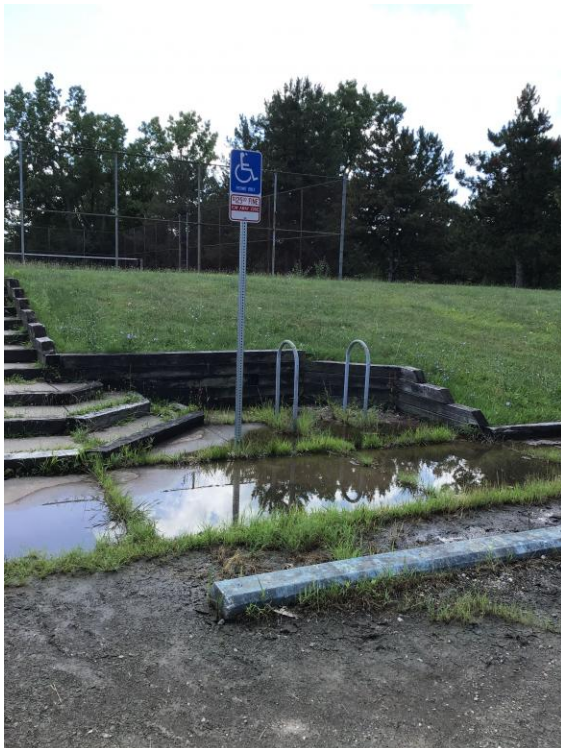
The van stall is missing a sign identifying it as a van accessible stall.

Existing space should be van accessible; at least 1 in every six must be "Van Accessible"

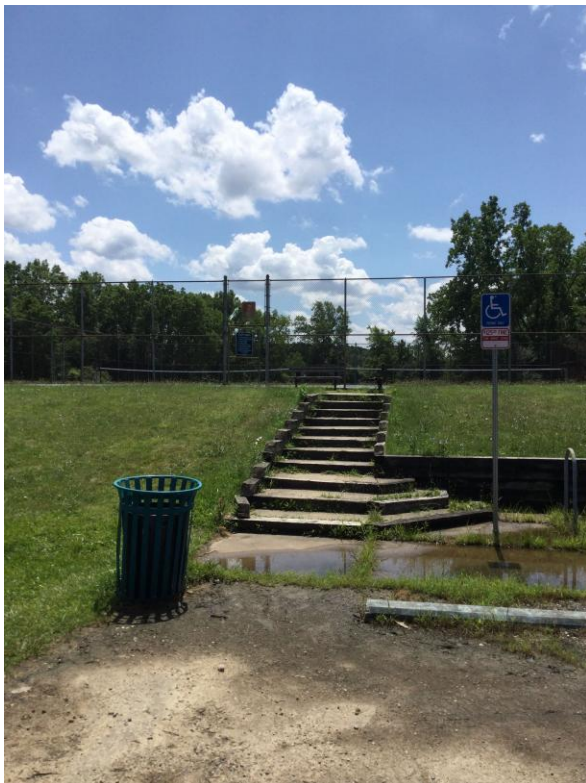
Tennis Court: Entrance

There is no accessible route to the tennis court

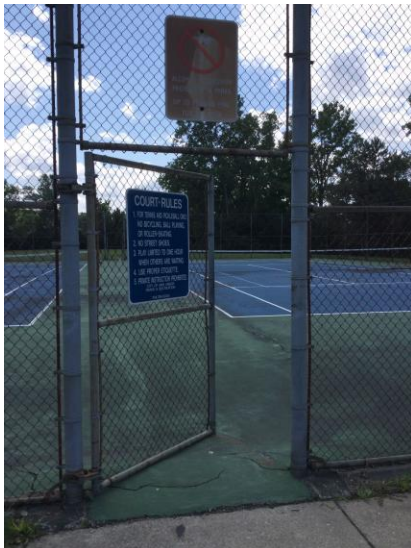
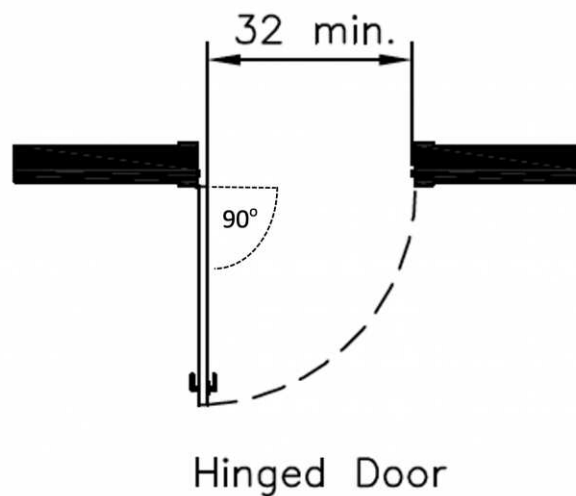
Tennis Court: Entrance

The gate to the tennis court must comply with all the requirements of 404, including a clear opening of at least 32 inches wide and a smooth bottom surface of at least 10 inches high from the finish floor.

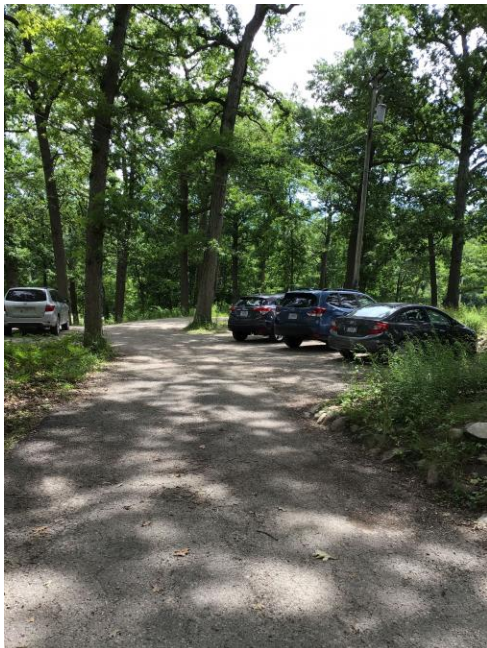
No accessible parking.

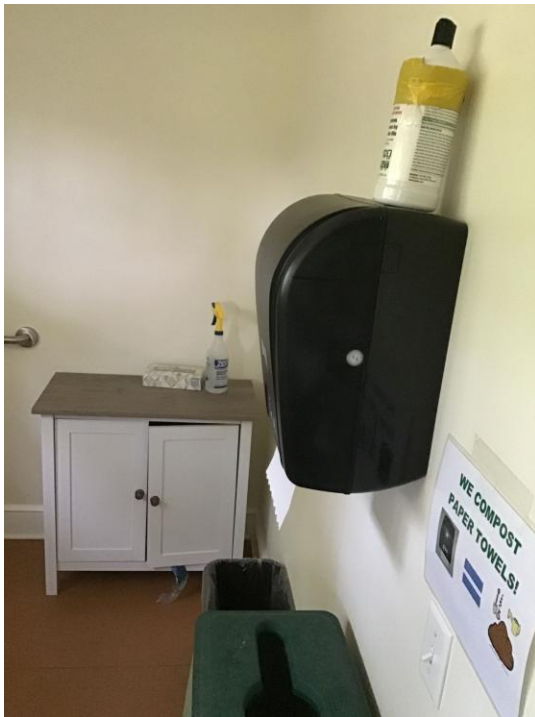
Paper towel dispenser is a protruding object.

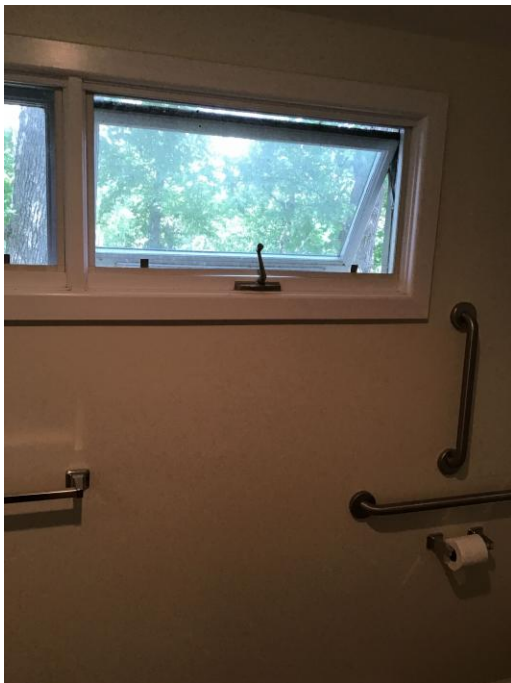
Operable windows controls above reach range.

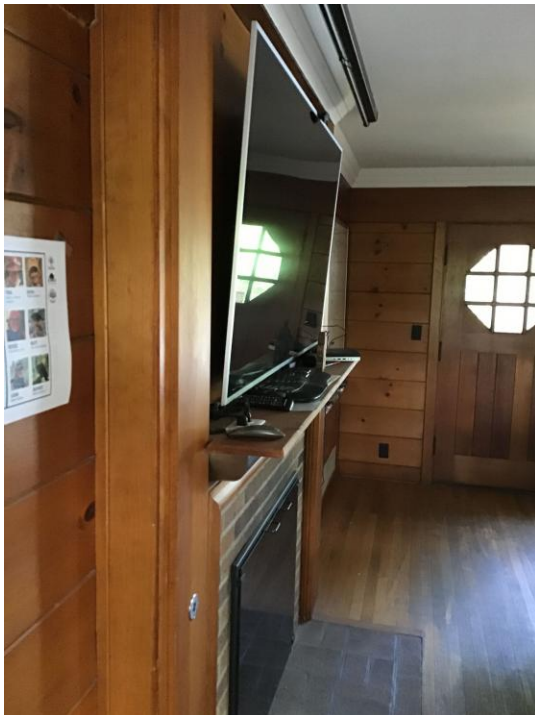
Wooden shelf adjacent to digital display is protruding.

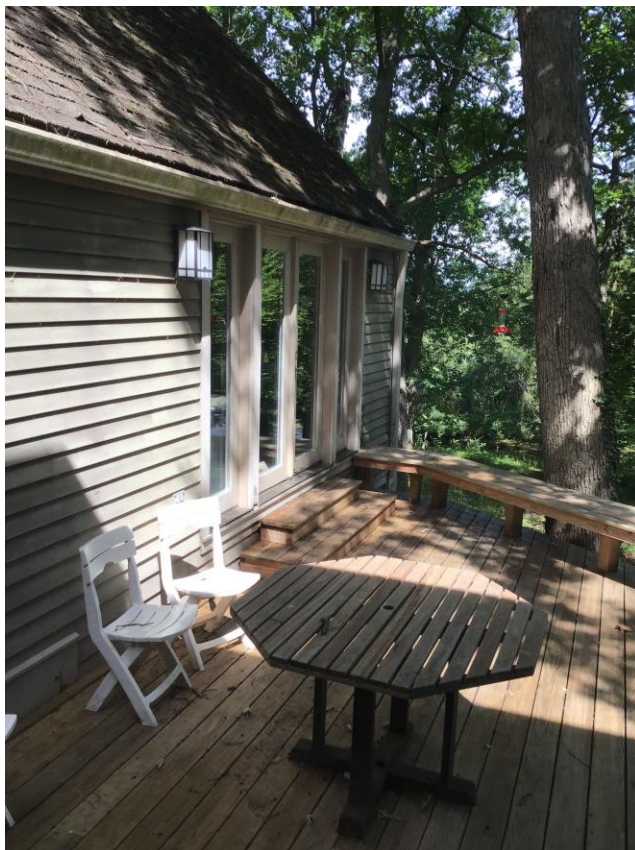
Two steps are only route to exterior deck.

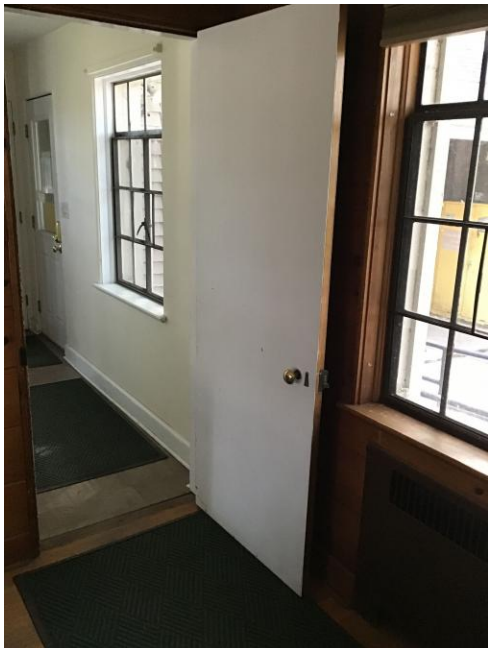
Several doors use knobs.

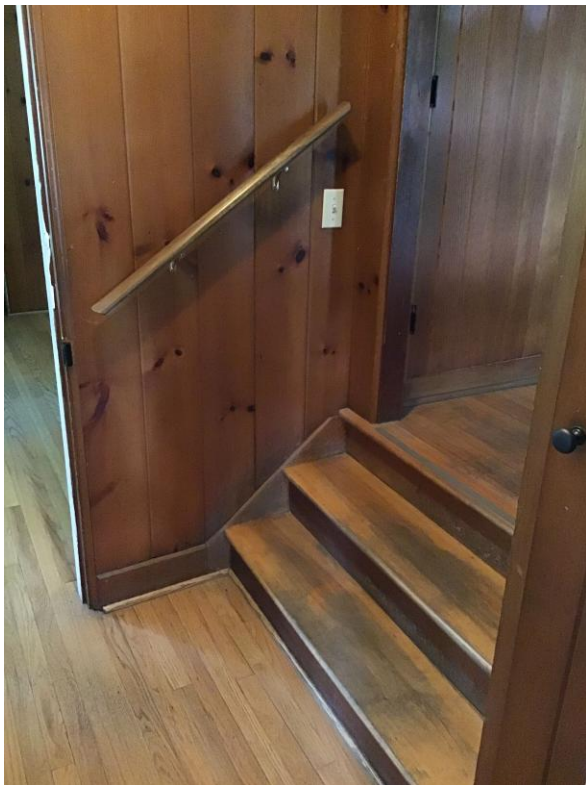
Three steps are the only route to two employees offices.

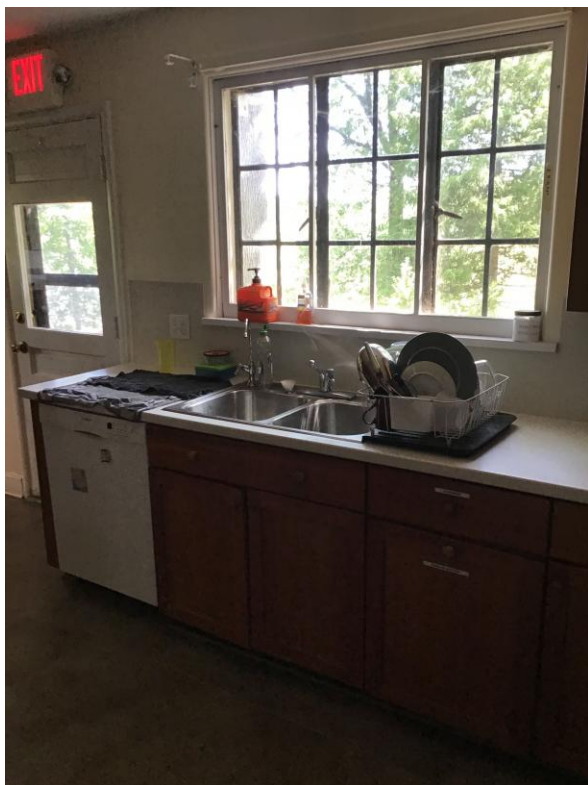
Sink height at 36" with no knee space.

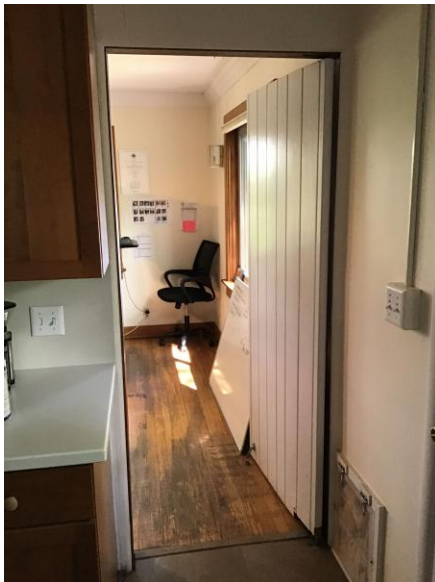
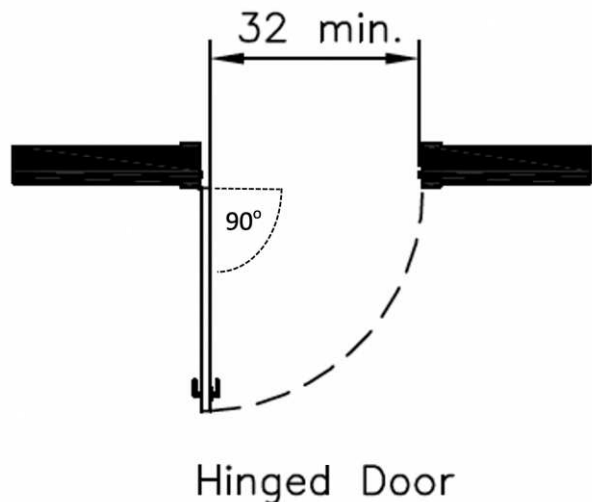
Door width to office is 31".

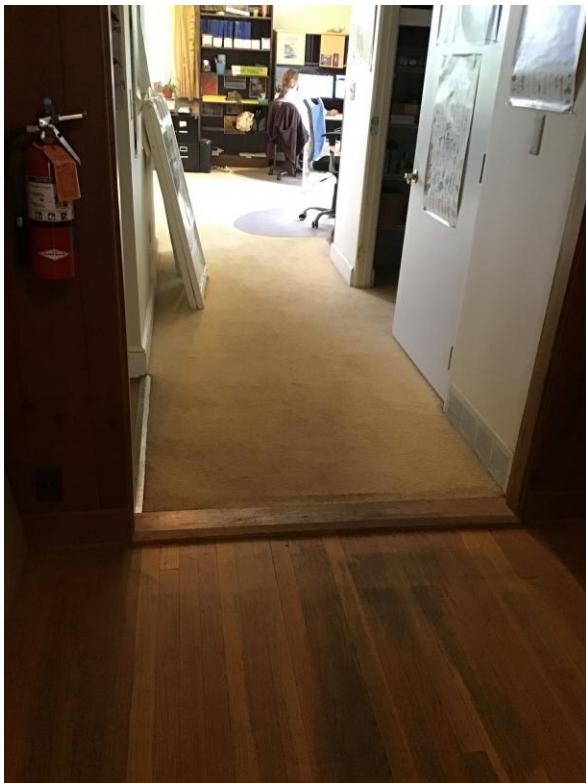
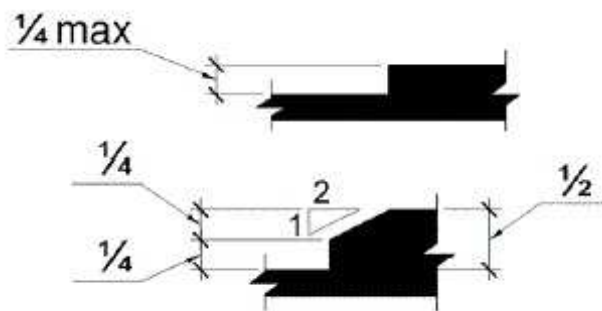
Threshold to employee office from copy area has a level change.

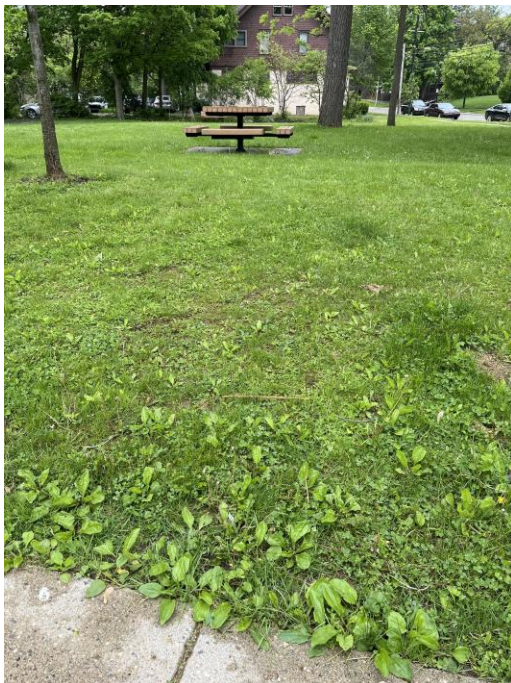
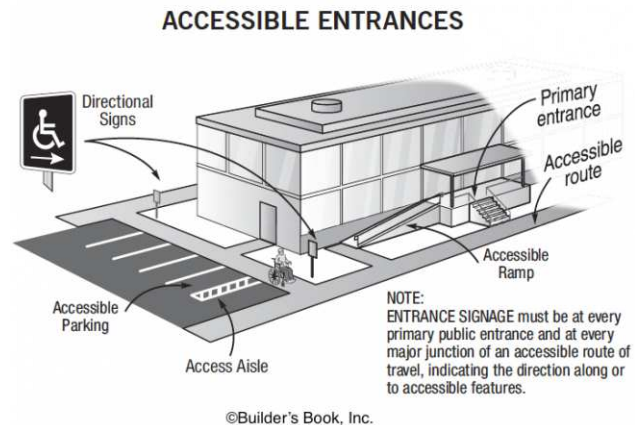
There is no accessible route to the picnic table; existing route is grass with is not an accessible surface and has a slope greater than 5%.

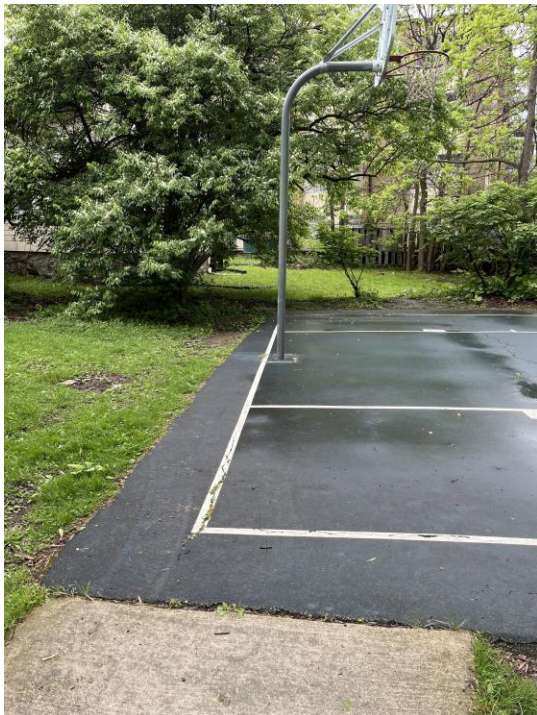
There is an opening greater than 1/2-inch on the route leading to the basketball court.

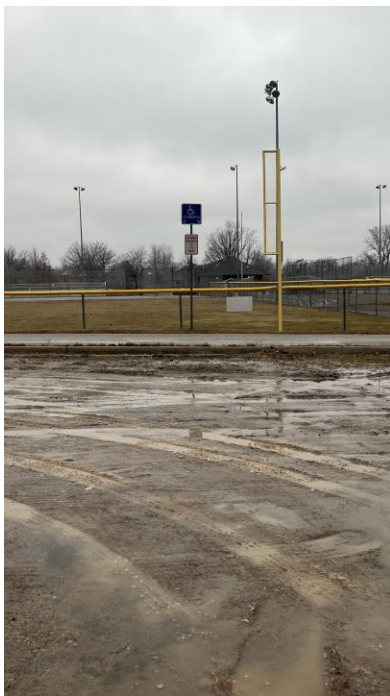
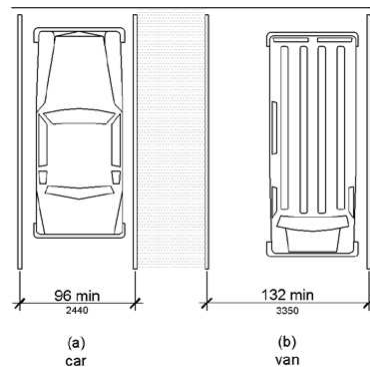
Not accessible

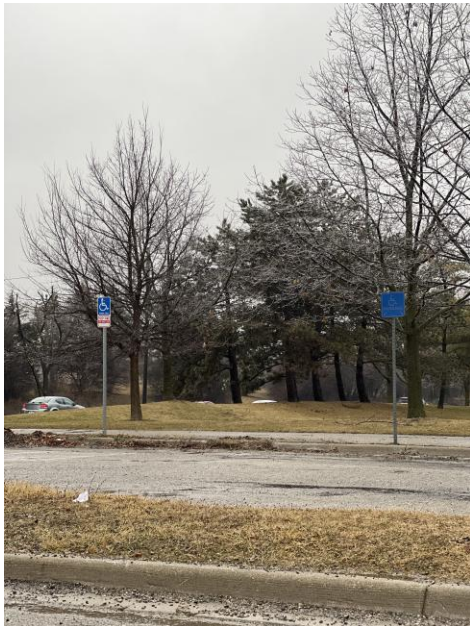
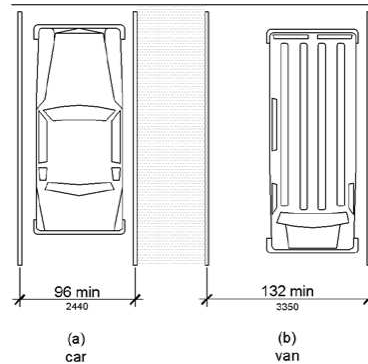
None of the parking spaces in both lots are compliant

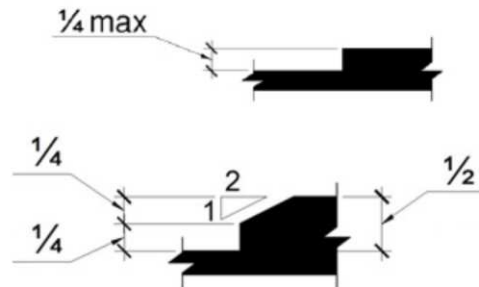
Vegetation on crack creates a change in level greater than 1/2 inch

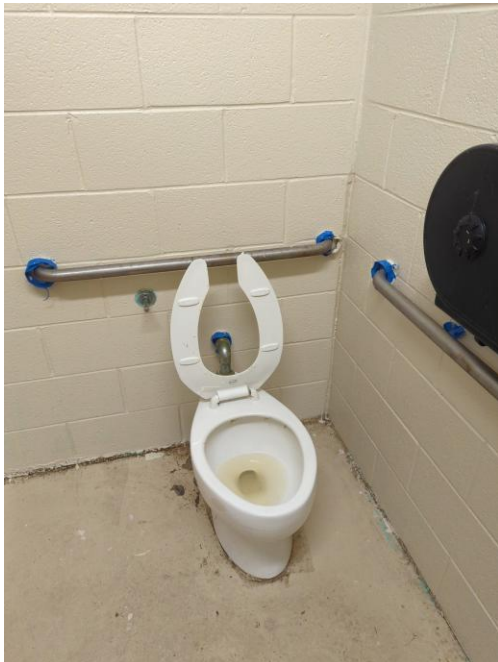
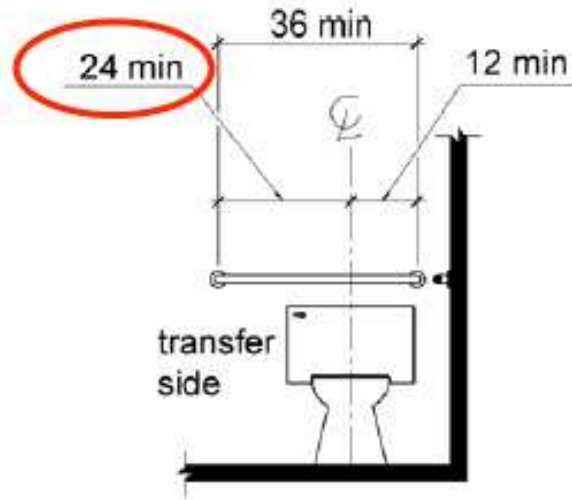
Rear grab bar extends only 21 inches from the centerline of the toilet

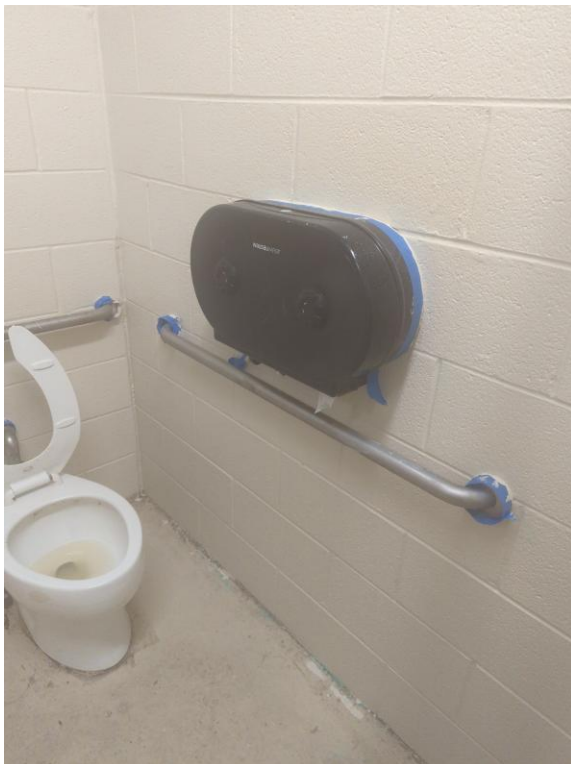
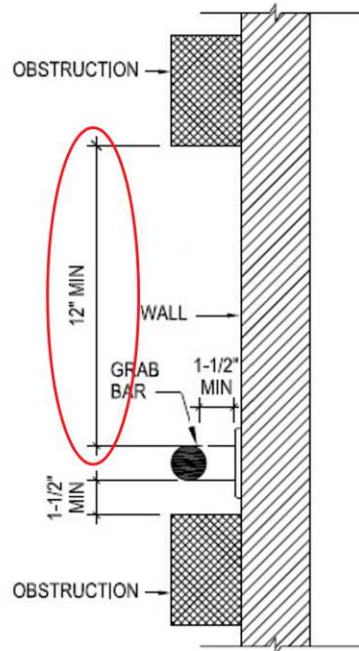
Toilet paper dispenser is 4 inches above the side grab bar

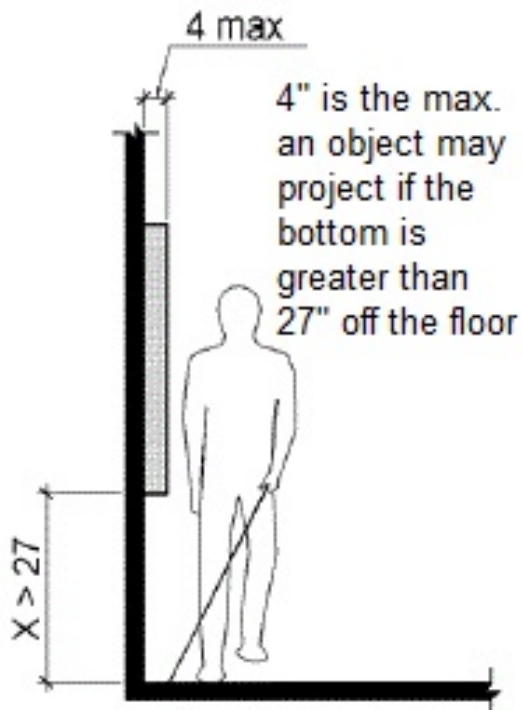
Sanitary napkin
dispenser protrudes
5-1/2 inches at 37
inches high

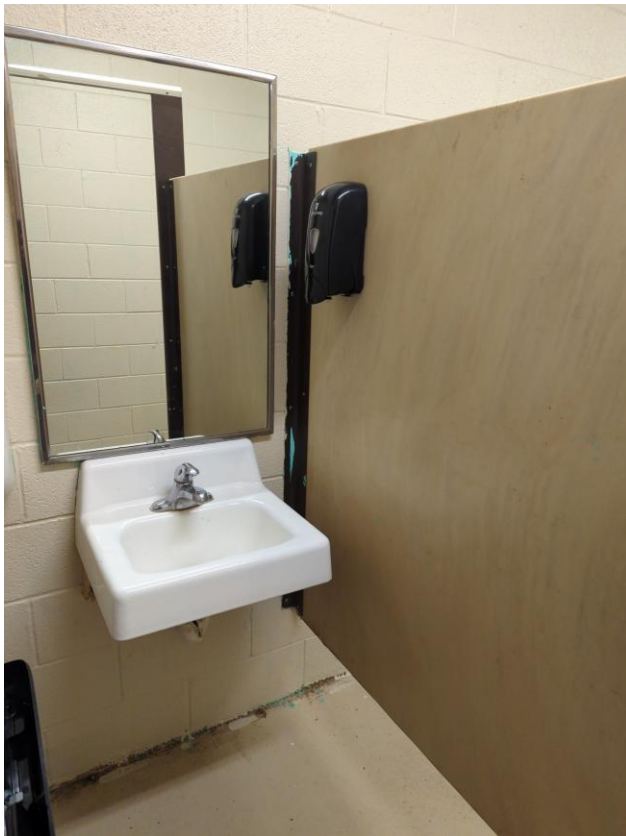
Soap dispenser is 56 inches high

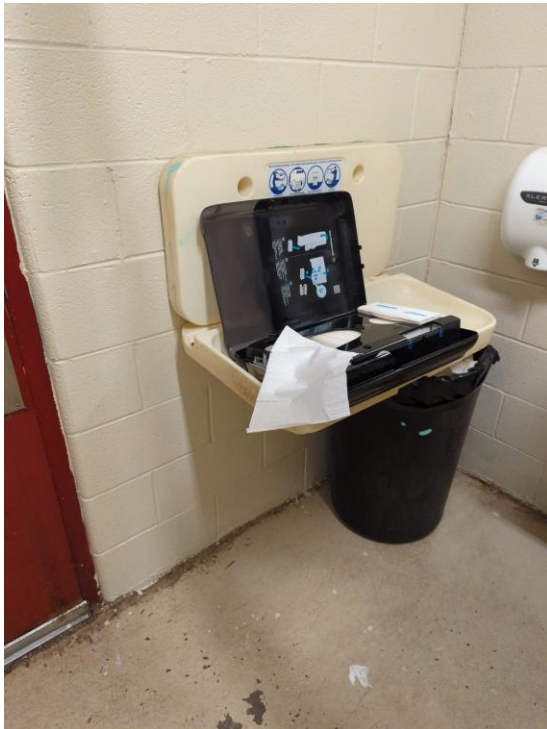
The baby changing table protrudes 19 inches at 30 inches high

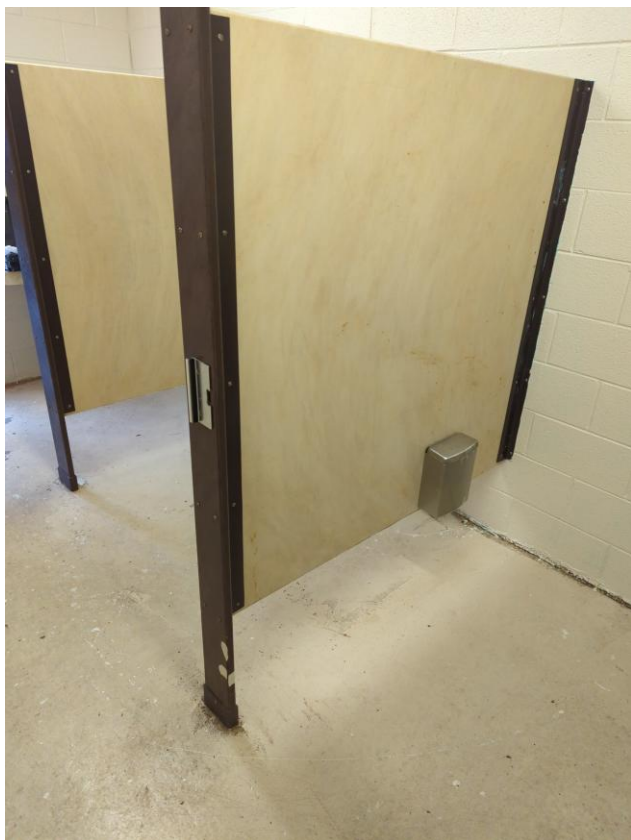
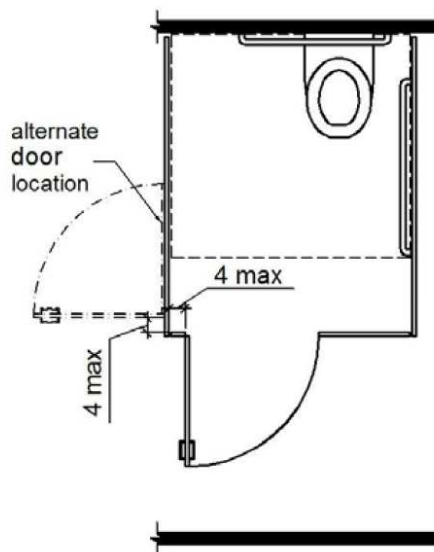
Door encroaches into the required space at 56 inches from the back wall

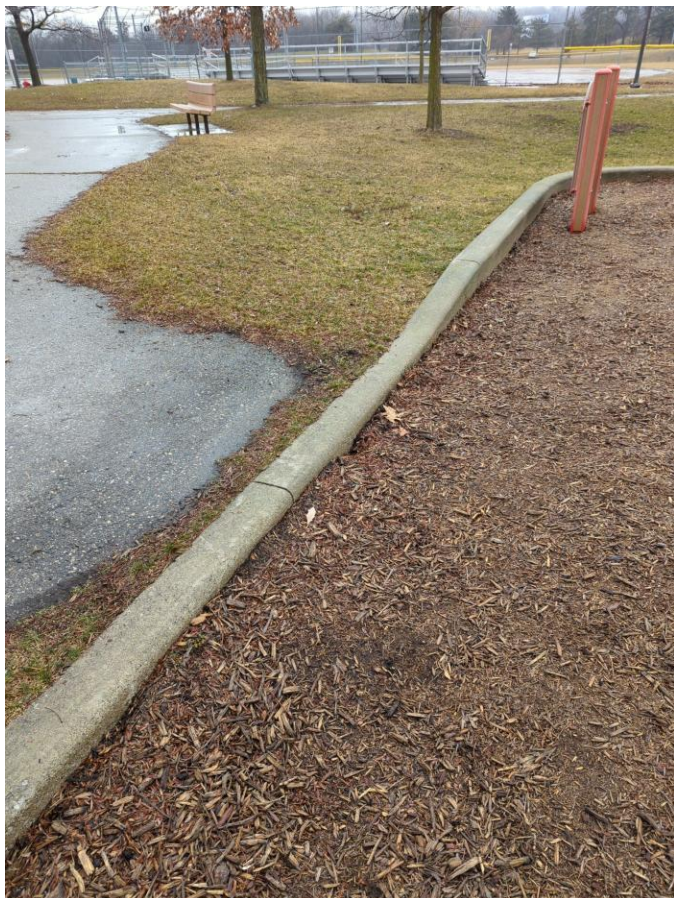
**Entrance to swings
has a 3 inch change in
level**

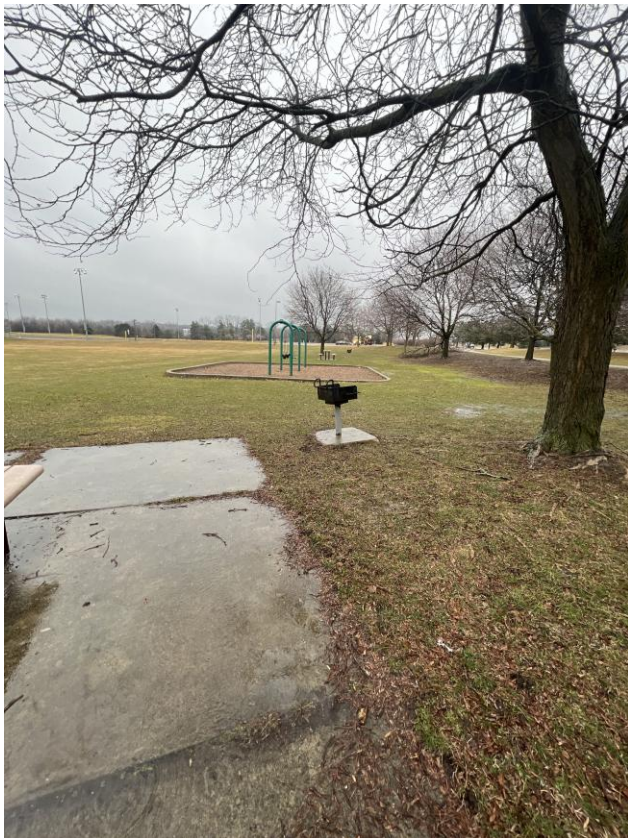
No route to grill

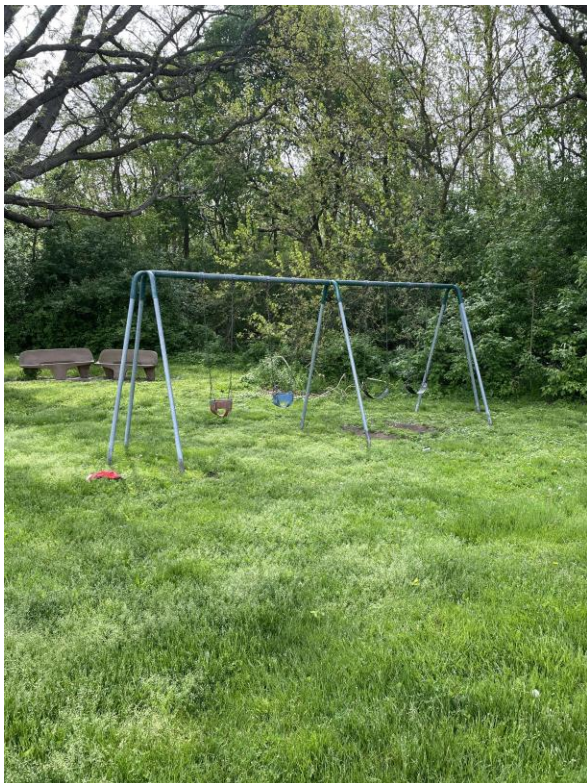
The swings have the seats greater than 24 inches from the ground surface.

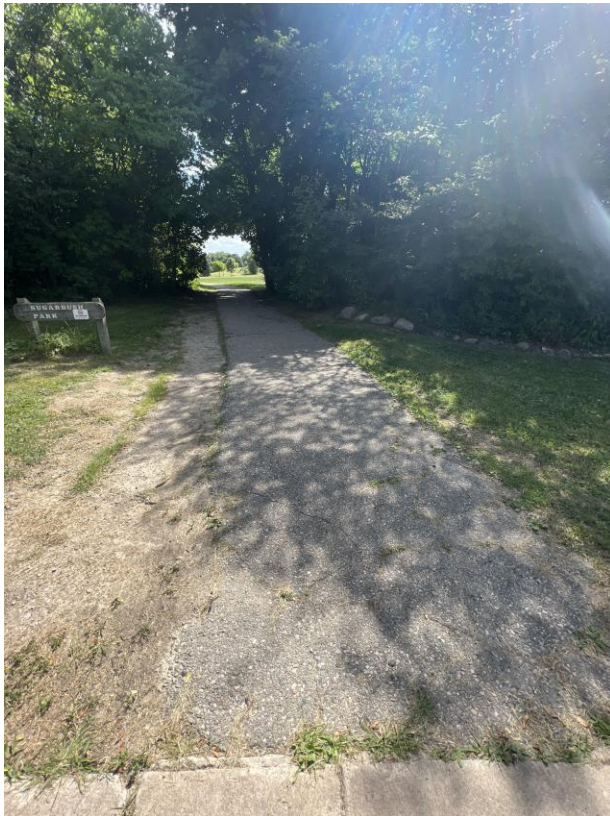
Approximately 30 linear feet of accessible route to the park has a cross slope greater than 2%.

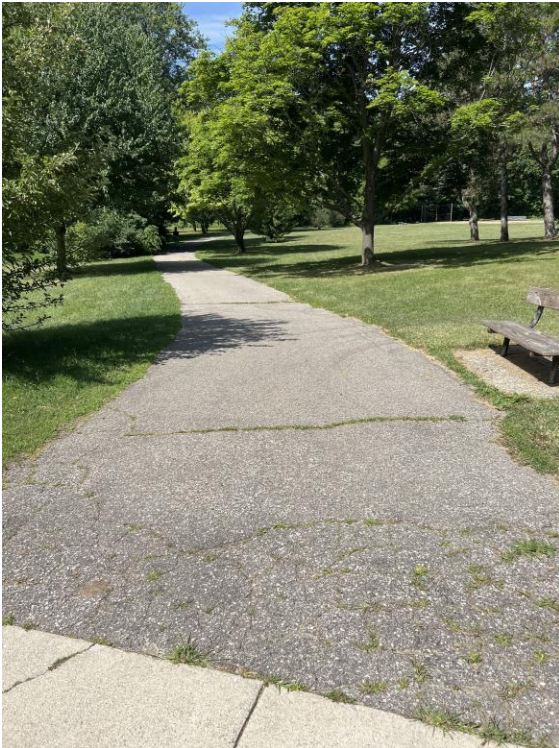
Accessible route has a cross slope greater than 2%.

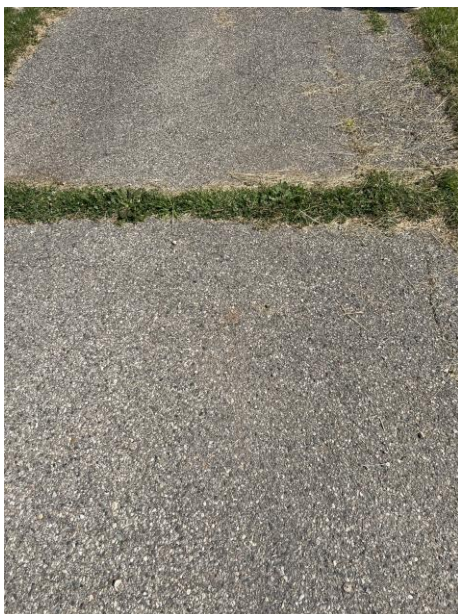
Vegetation is growing on the cracks of the trail creating vertical changes in level greater than 1/2-inch.

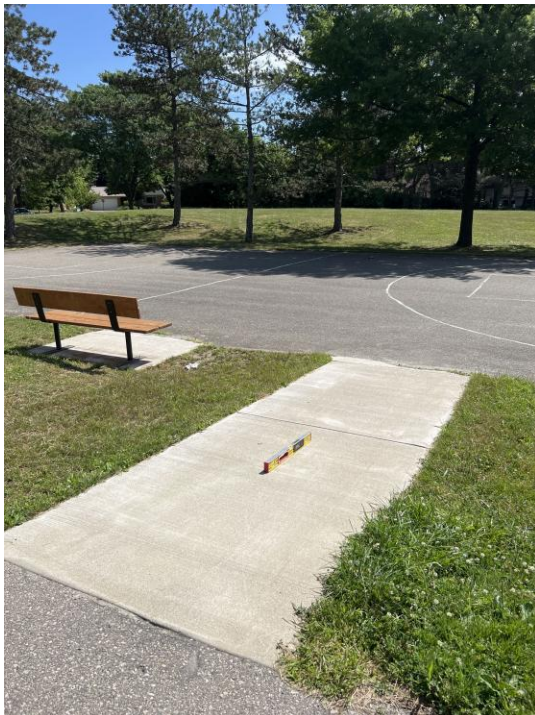
A portion of sidewalk has a running slope greater than 5%.

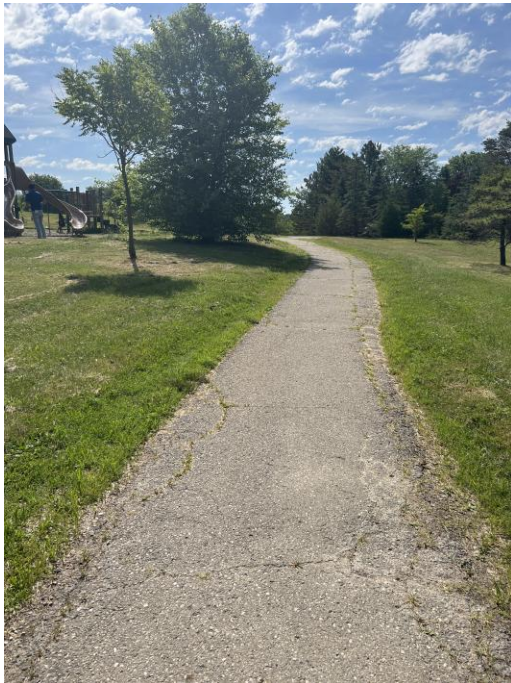
Approximately 200 linear feet of sidewalk has running slopes greater than 5% and/or cross slopes greater than 2%.

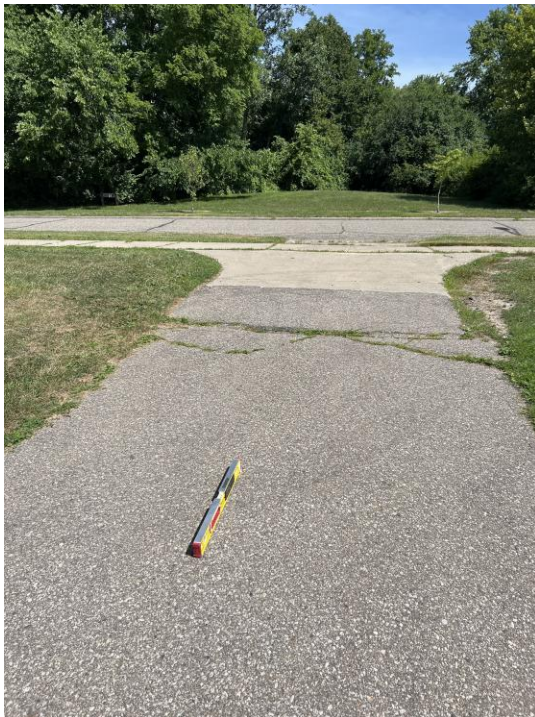
Portion of accessible route has a running slope greater than 5%

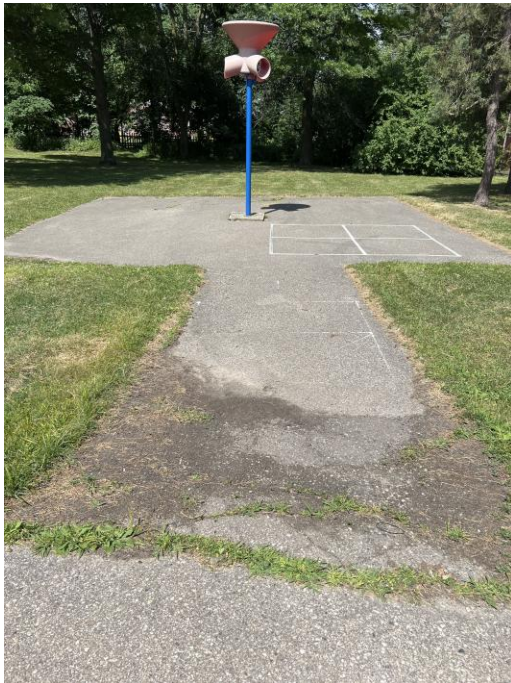
Approximately 25 linear feet of route has a running slope greater than 5% and/or a cross slope greater than 2%.

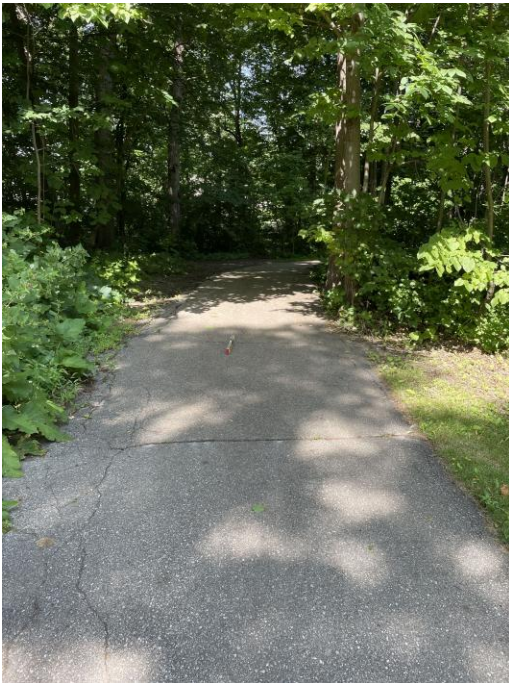
Approximately 45 linear feet of route has a running slope greater than 5% and/or a cross slope greater than 2%.

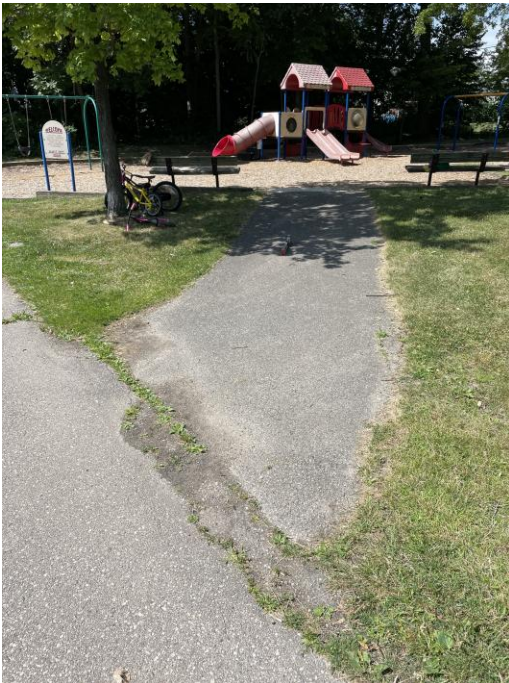
Approximately 50 linear feet of route has a running slope greater than 5% and/or a cross slope greater than 2%.

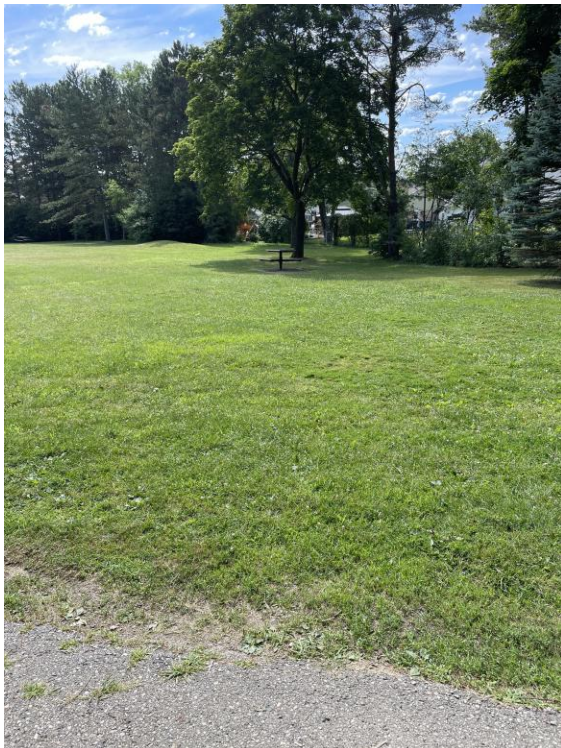
Approximately 100 linear feet of route has a running slope greater than 5% and/or a cross slope greater than 2%.

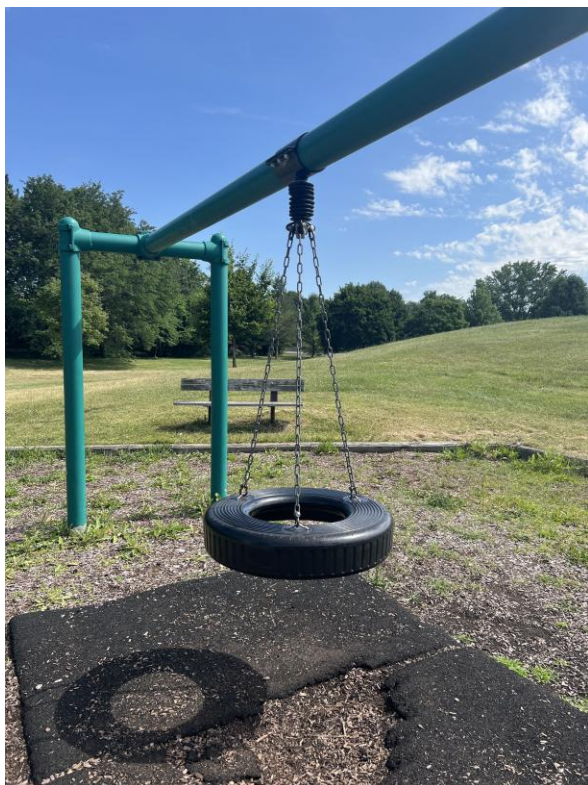
The tire swing seat is higher than 24 inches from the ground surface.

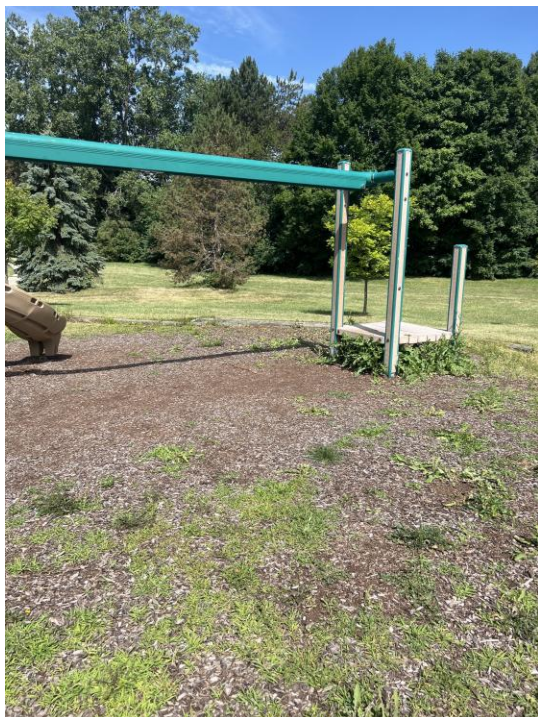
The play area ground surface is not compliant; surface is not firm, stable, and slip resistant.

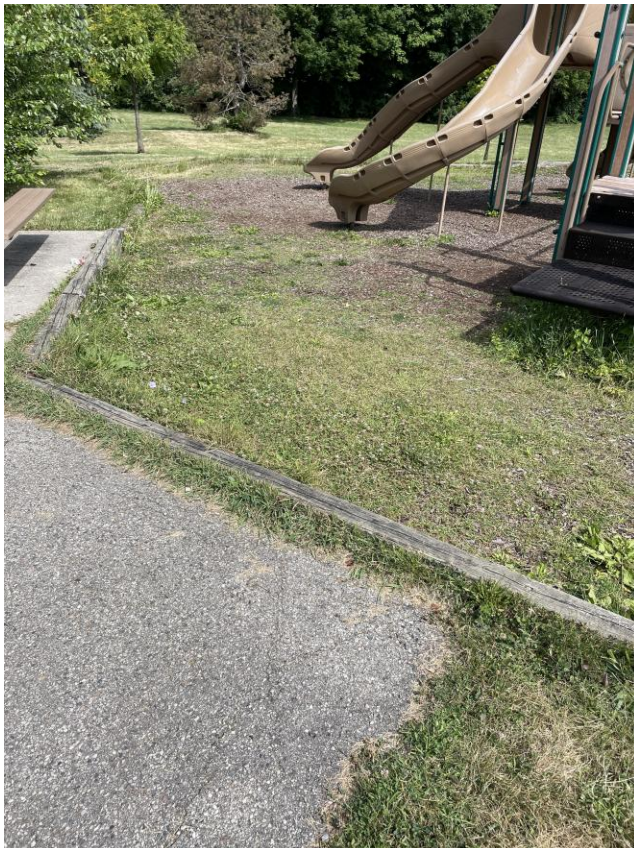
There is a vertical change in level greater than 1/2-inch leading to the play area.

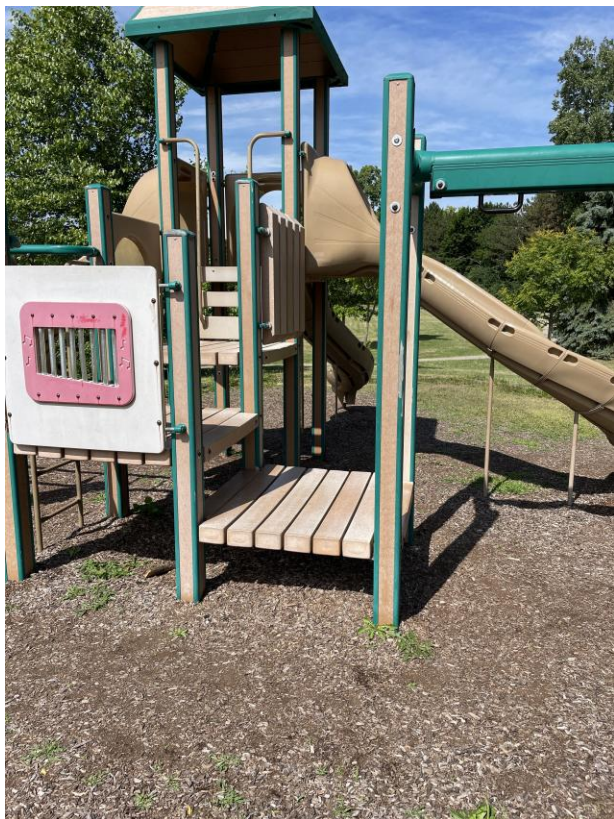
The play area does not have an accessible entry point, a transfer platform is not provided.

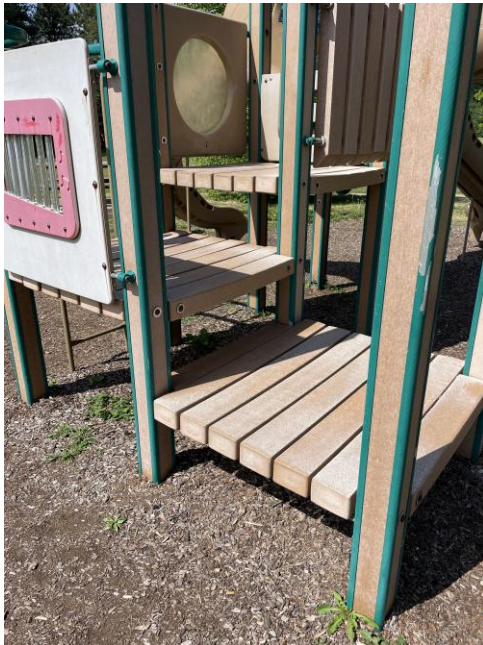
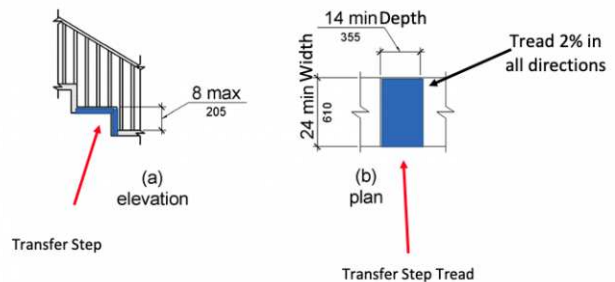
The transfer steps are greater than 8 inches high

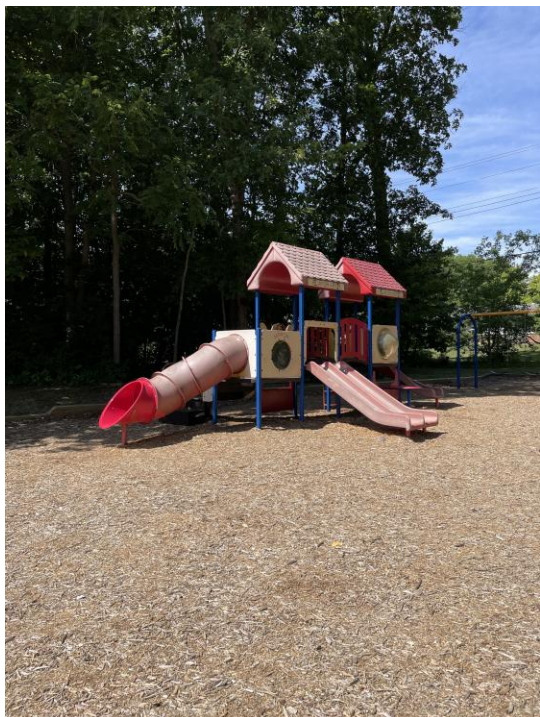
The play area ground surface is not compliant; surface is not firm, stable, and slip resistant.

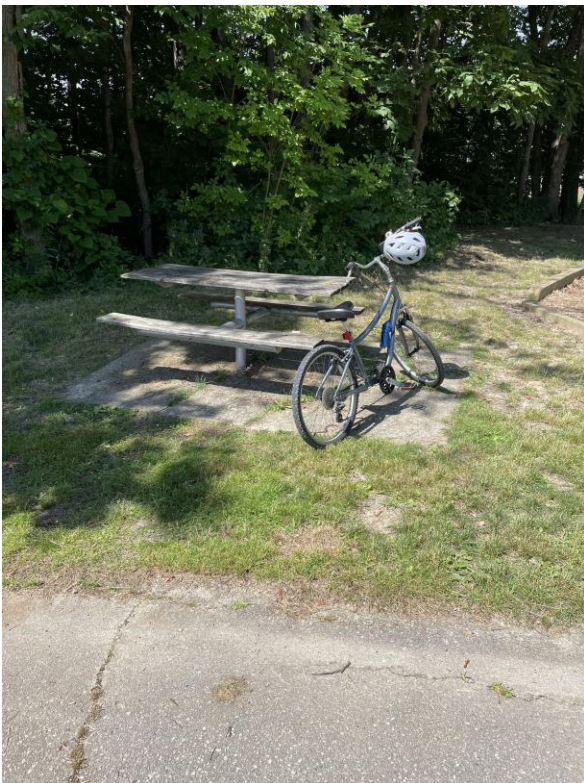
There is no accessible route to the picnic table.

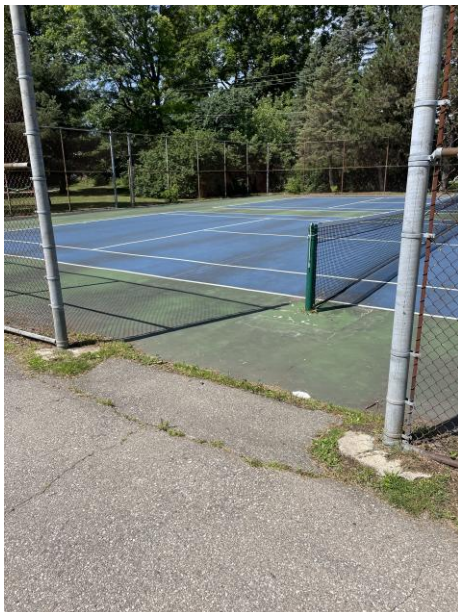
The route to the tennis court has vertical changes in level greater than 1/4-inch

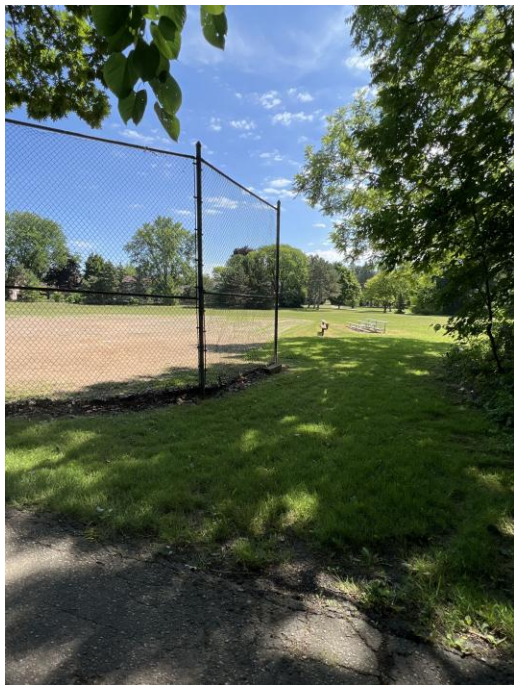
There is no accessible route to seating area of the playing field.

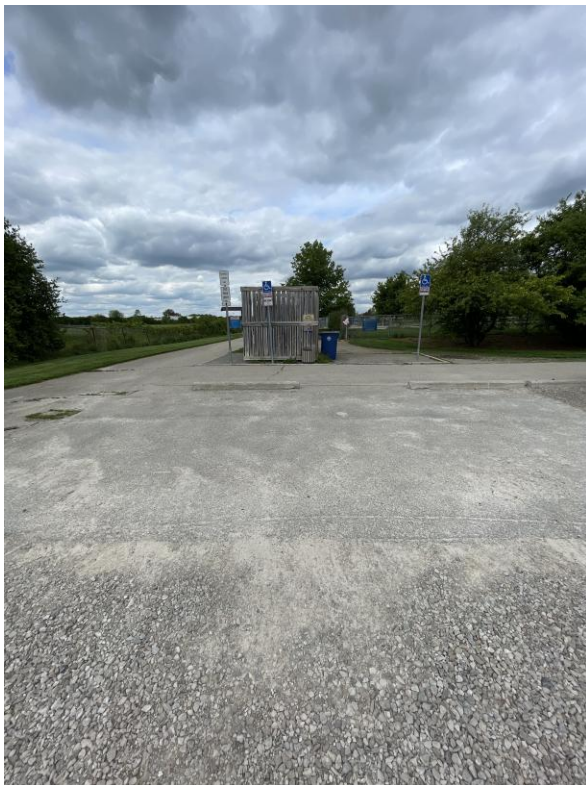
There is no accessible parking space provided.

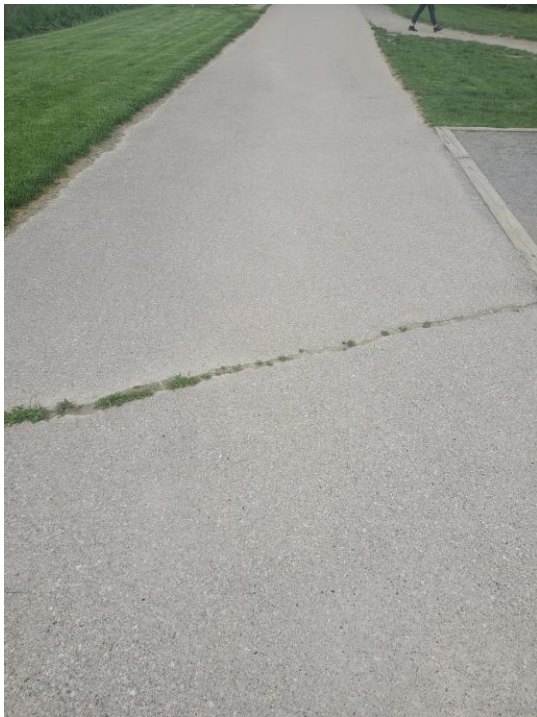
The accessible route has openings greater than 1/2-inch

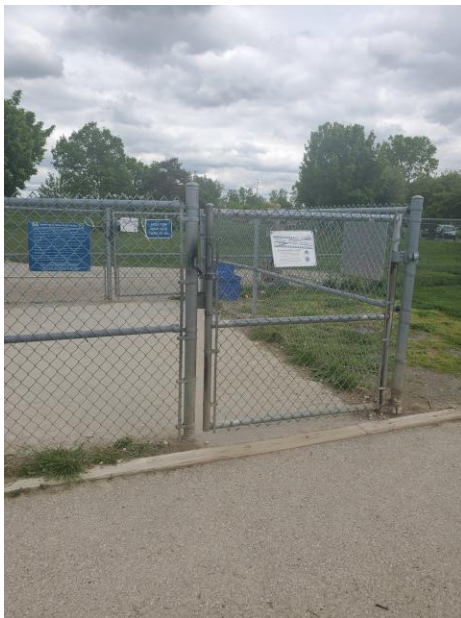
The gate to the play area does not have a bottom smooth surface at least 10 inches high from the finish floor.

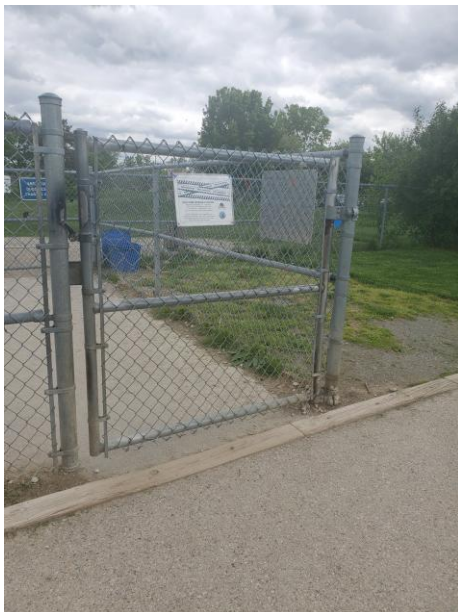
There is a vertical change in level greater than 1/4-inch (or up to 1/2-inch if beveled) at the gate entrance.

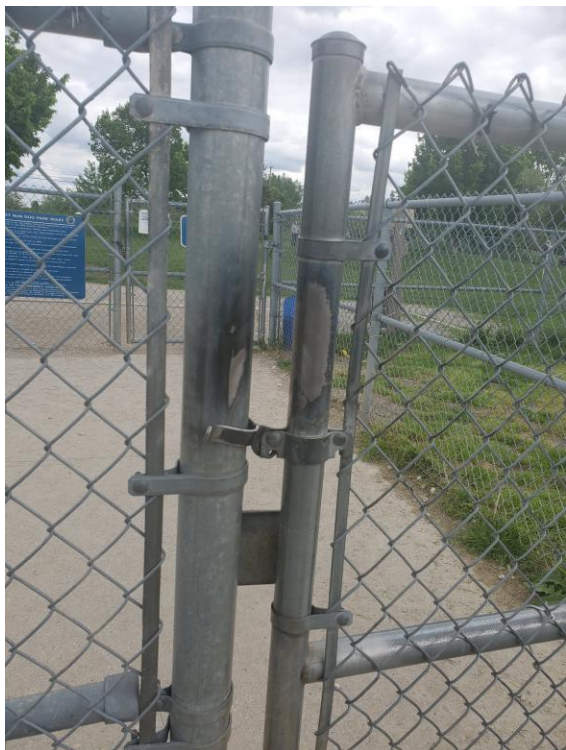
The gate hardware is not compliant, requiring pinching, tight grasping, or turning of the wrist to operate.
