Site Accessibility Evaluation

Allmendinger Park
655 Pauline Blvd
Ann Arbor, MI 48104
ADA Only

Inspection Date: 07/11/2022

Report Date: 11/15/2022

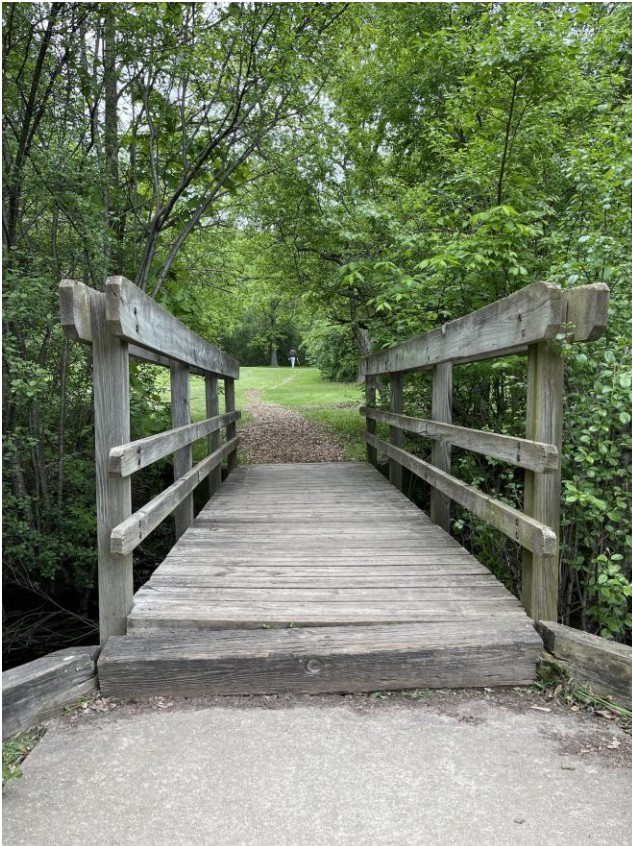
There is no accessible route at the bridge; There is a step at the wooden bridge

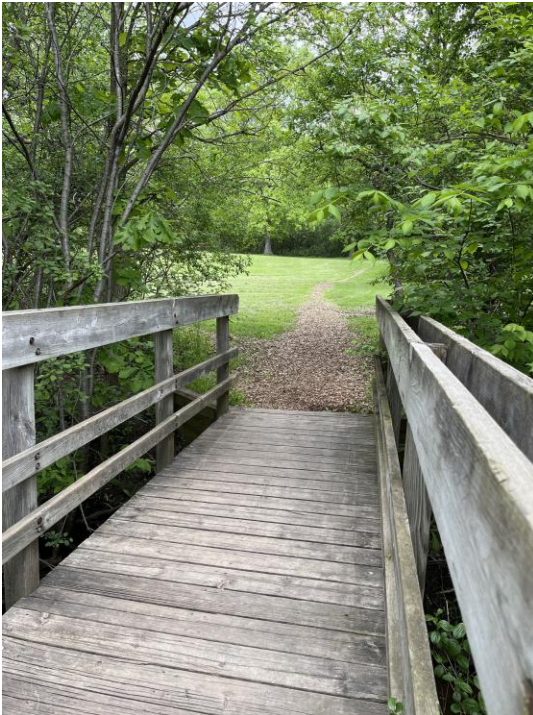
The wooden bridge has openings greater than 1/2-inch

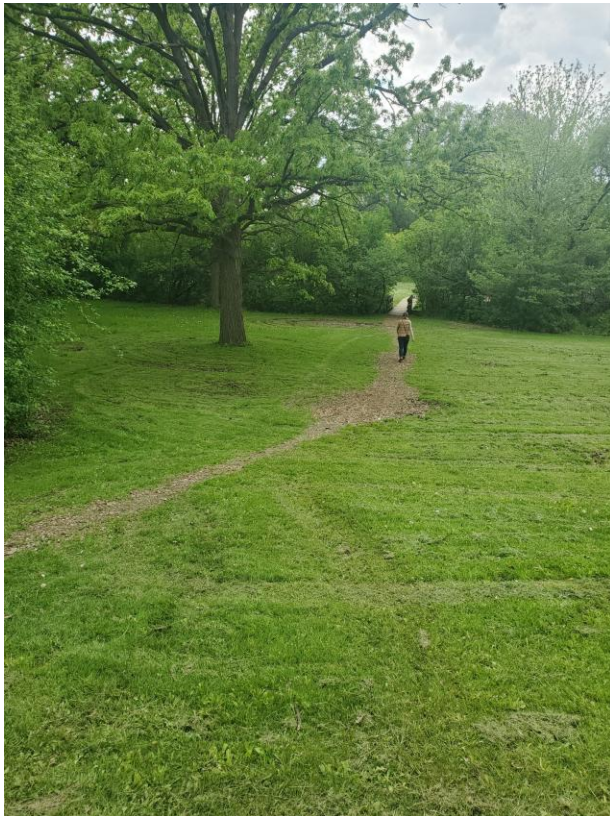
There is no accessible route through the park; route has grass which is not an accessible surface.

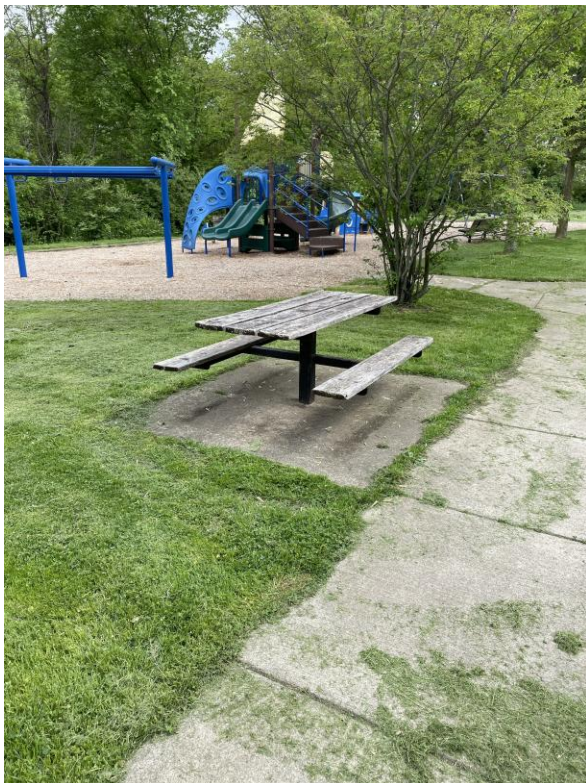
There is no accessible route to the picnic table; existing route is grass with is not an accessible surface.

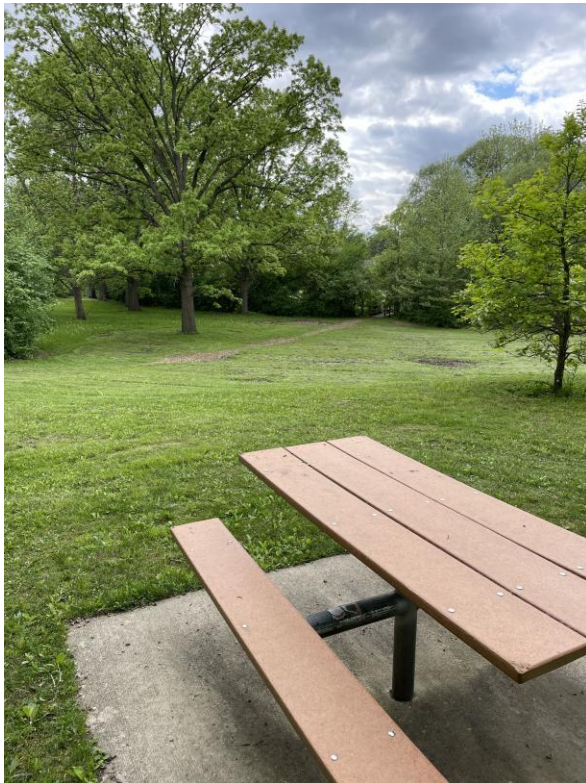
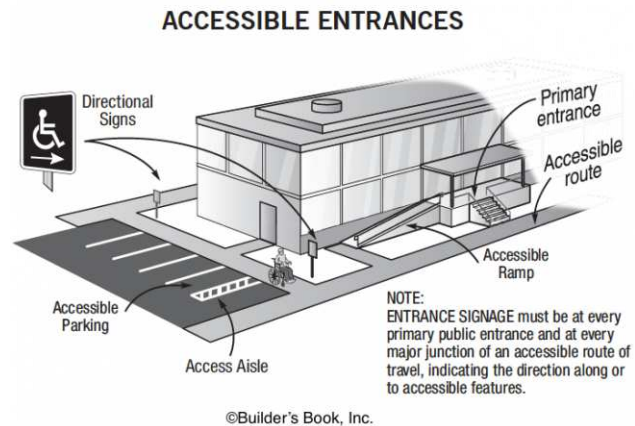
There is no accessible route to the picnic table; existing route is grass with is not an accessible surface.

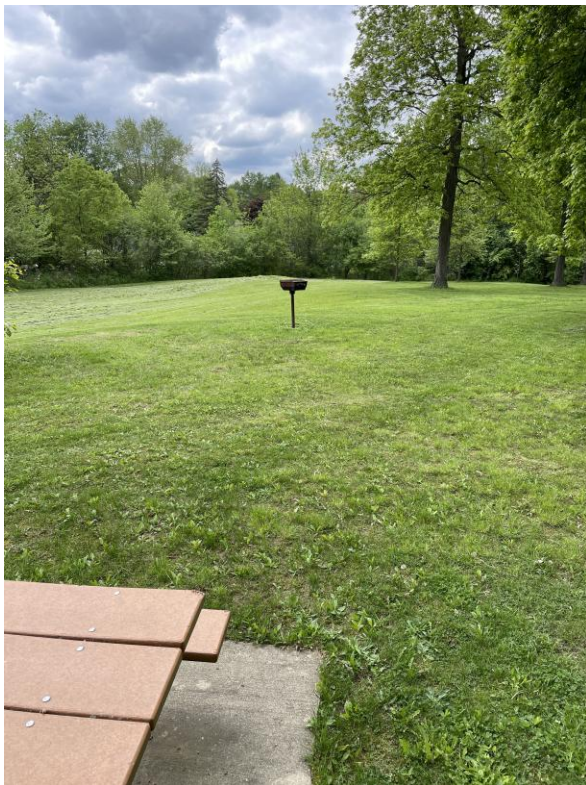
There is no accessible route to the grill; existing route is grass with is not an accessible surface

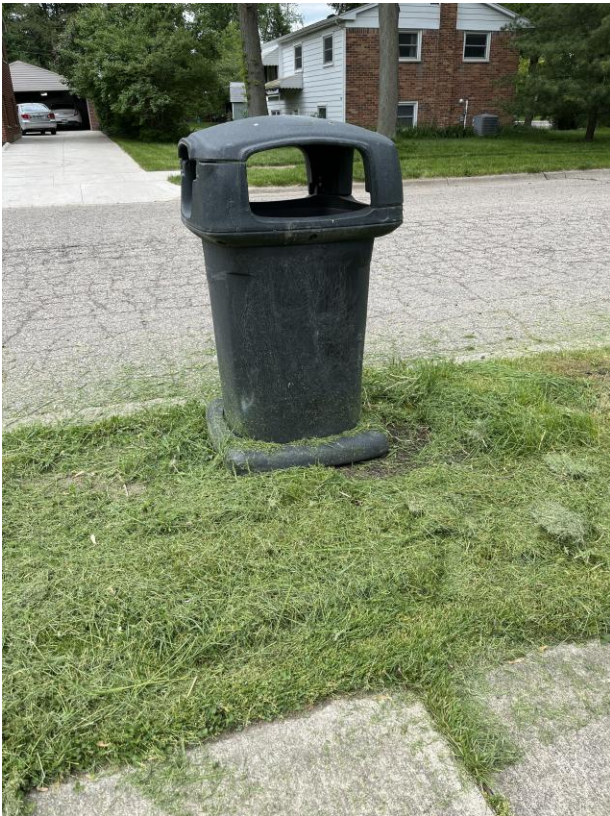
There is no accessible route to the trash bin; existing route is grass with is not an accessible surface.

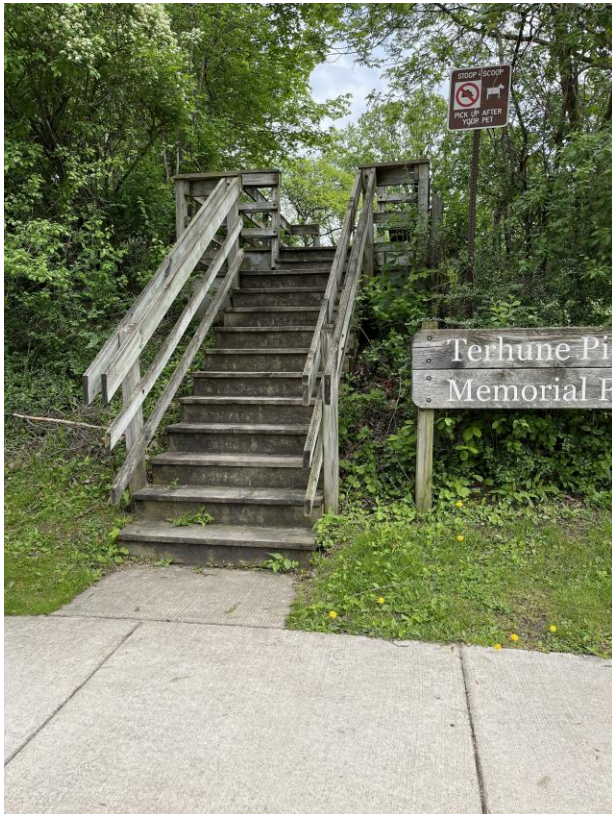
There is no accessible route to the top area of the park; Wooden stairs with 14 steps is not an accessible route.

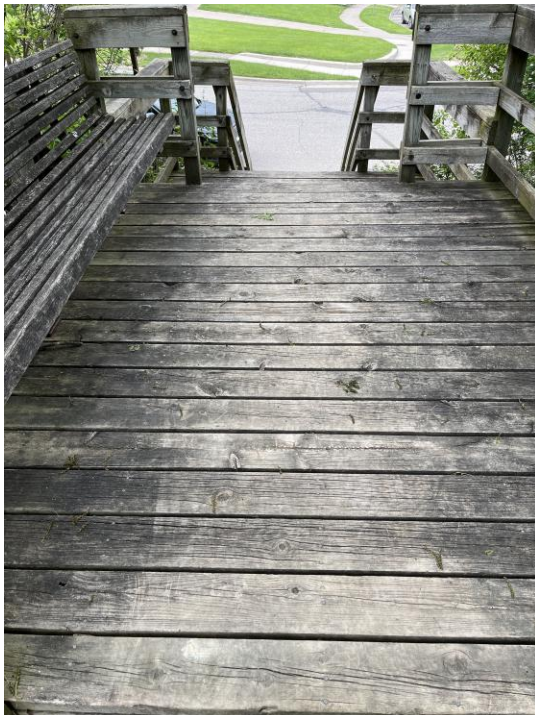
Wooden bridge has ground openings greater than 1/2-inch

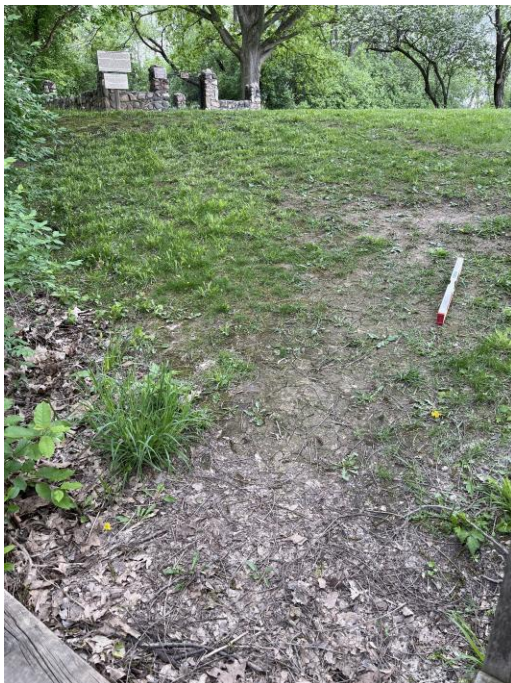
There is no accessible route to the higher area of the park; the hill has slopes greater than 8.33% and the grass is not an accessible surface.

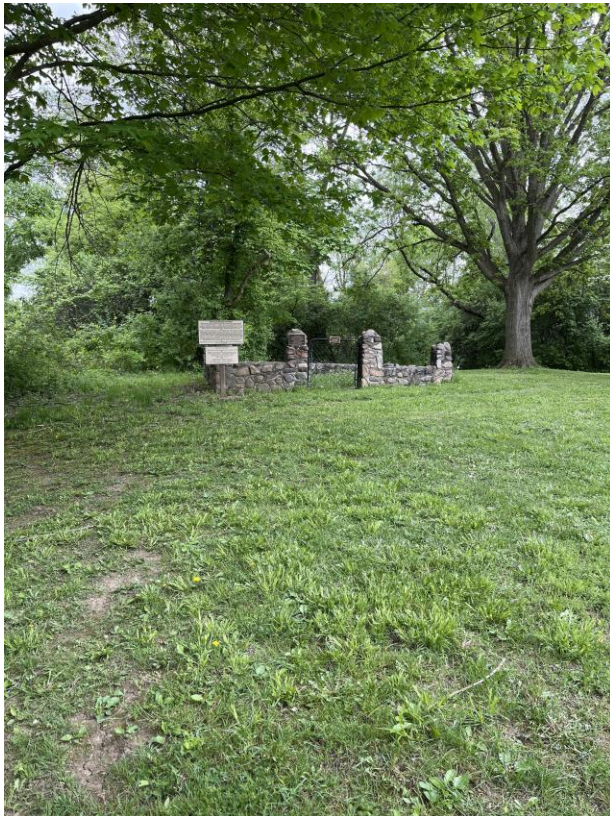
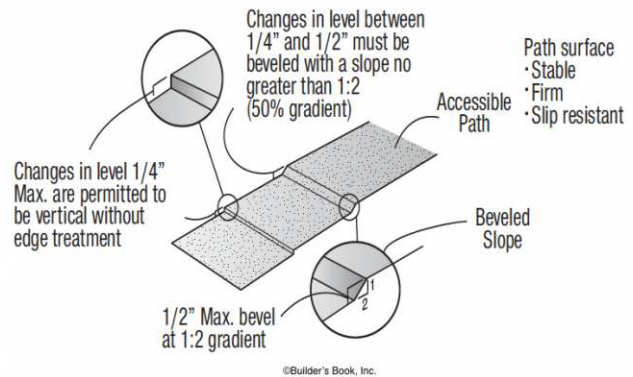
There is no accessible route in the park; grass is not an accessible surface.

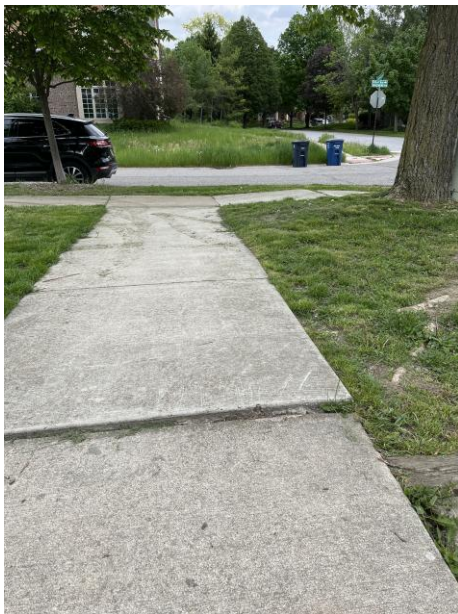
Sidewalk has vertical changes in level greater than 1/2-inch

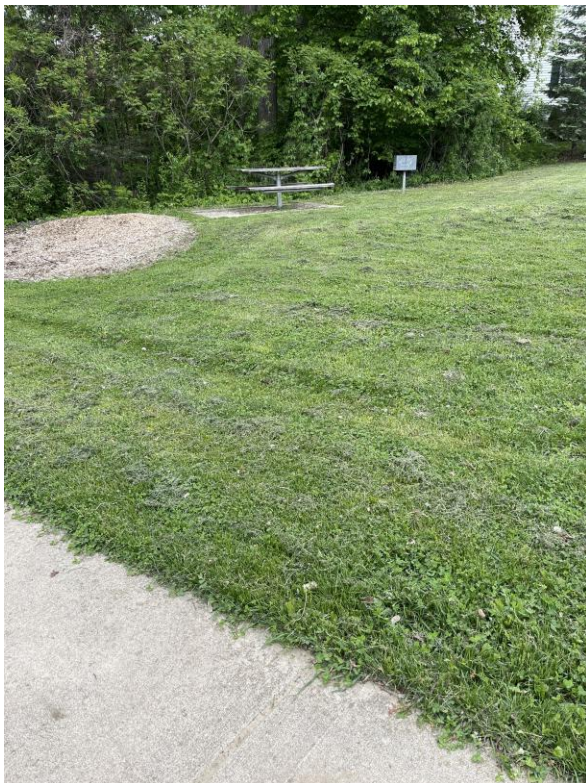
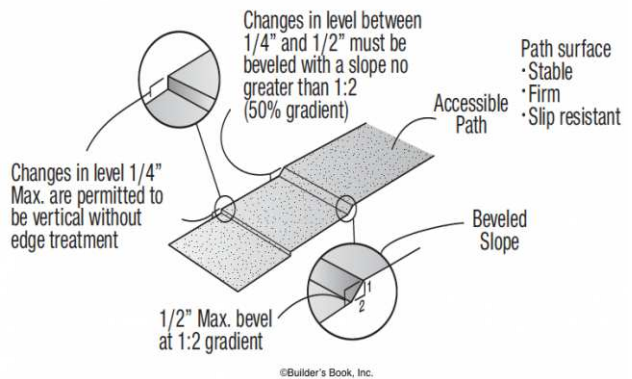
The route ground surface is grass which is not an accessible surface; route has a slope greater than 8.33%.

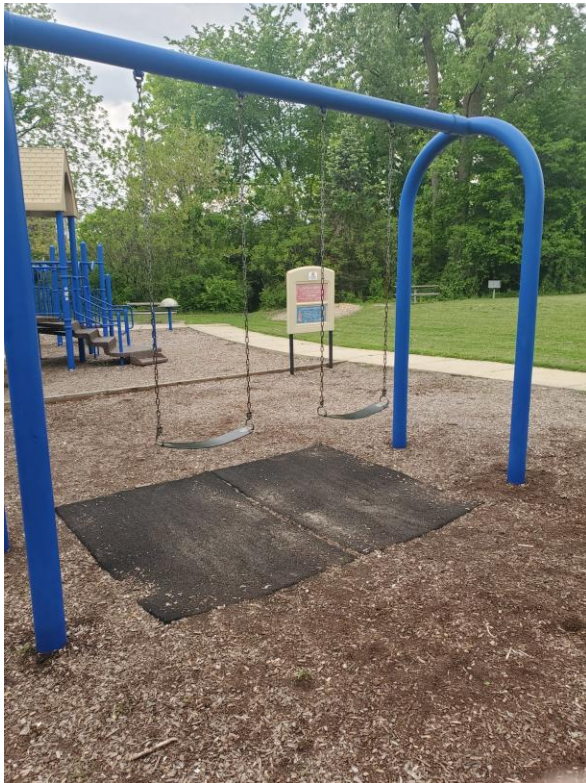
The swing seat is higher than 24 inches

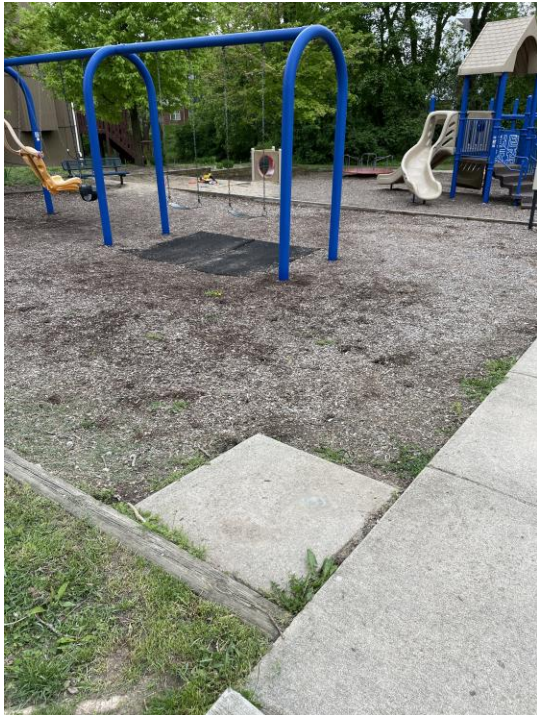
The accessible route to the swing play area has an opening greater than 1/2-inch.

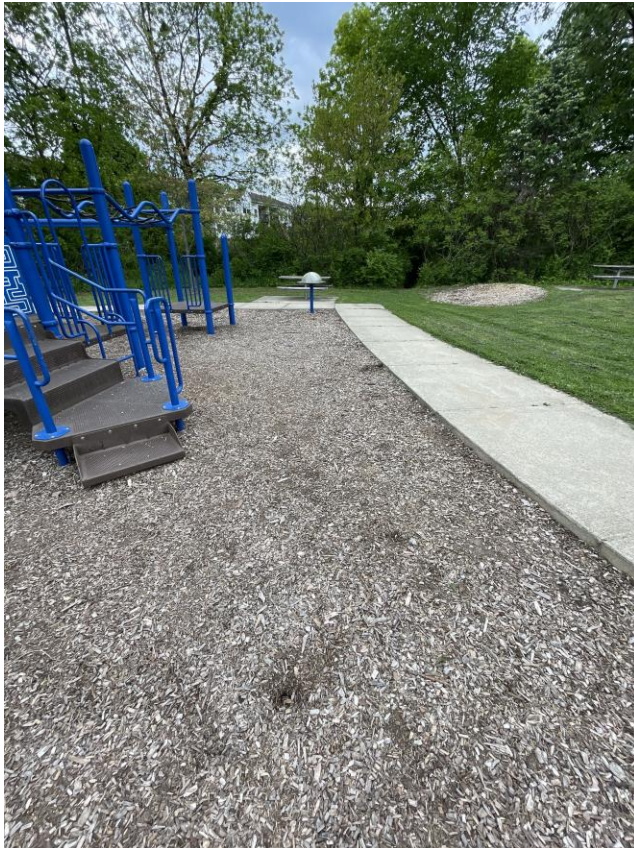
The accessible route to the play area has a vertical change in level greater than 1/2-inch beveled.

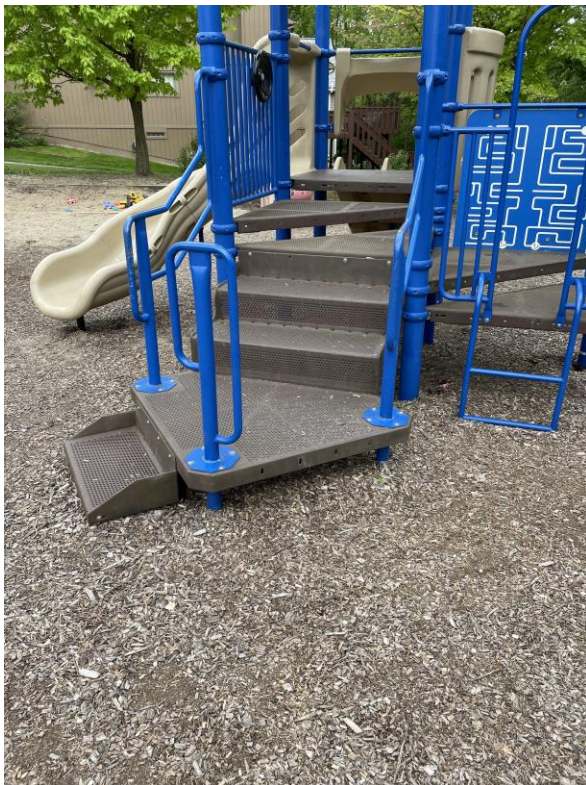
The transfer platform is 10" above ground.

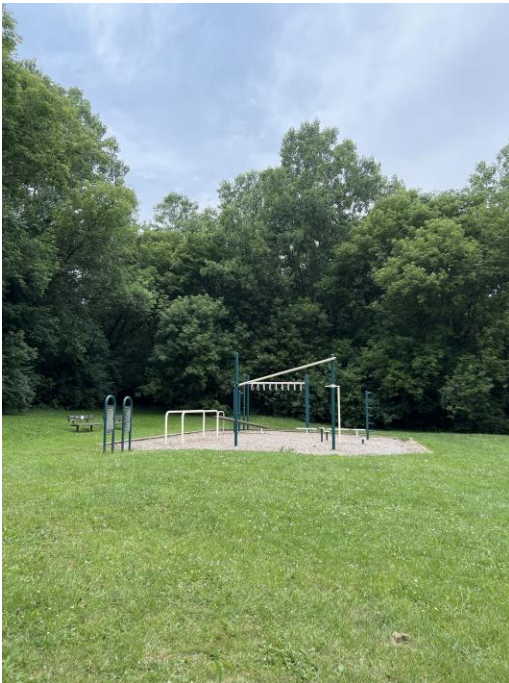
There is no accessible route to the play area; grass is not an accessible surface.

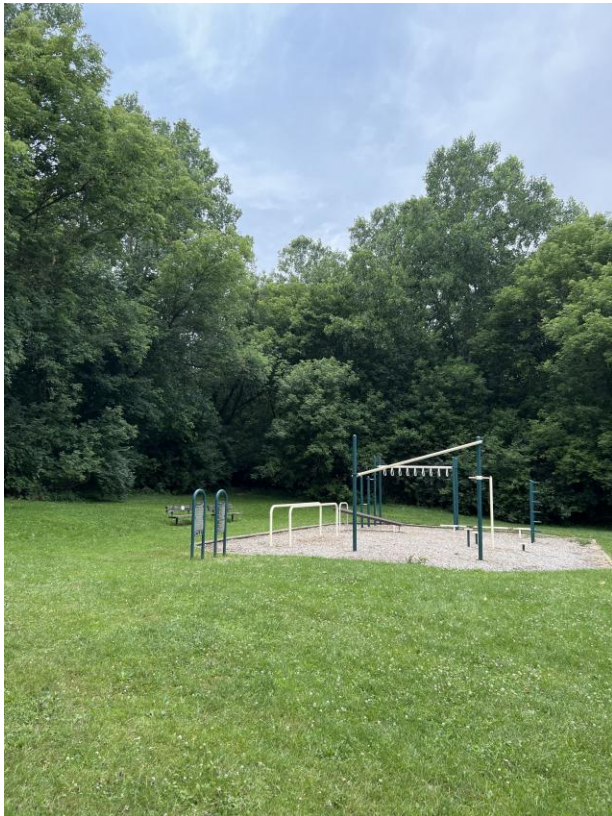
There is no accessible route to the exercise area; grass is not an accessible surface.

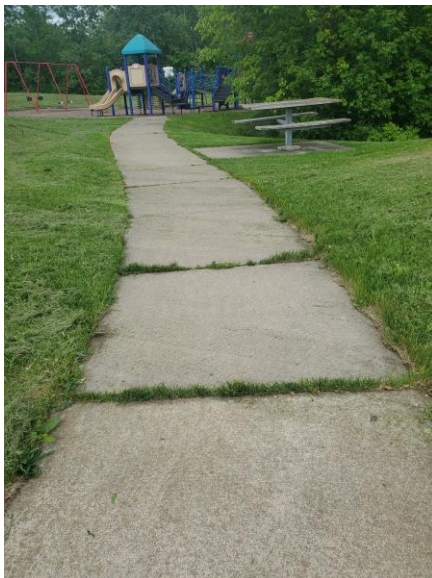
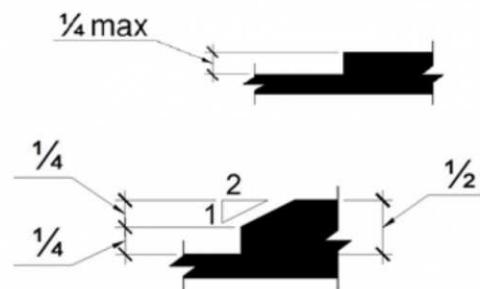
There is vegetation growing on the accessible route which creates vertical changes in level greater than 1/2-inch.

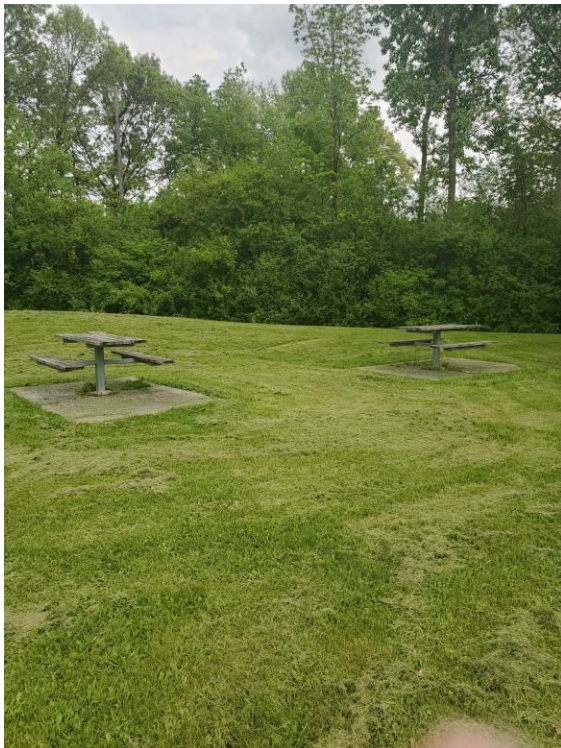
There is no accessible route to the picnic tables. At least 5% of the picnic tables must be compliant and on an accessible route.

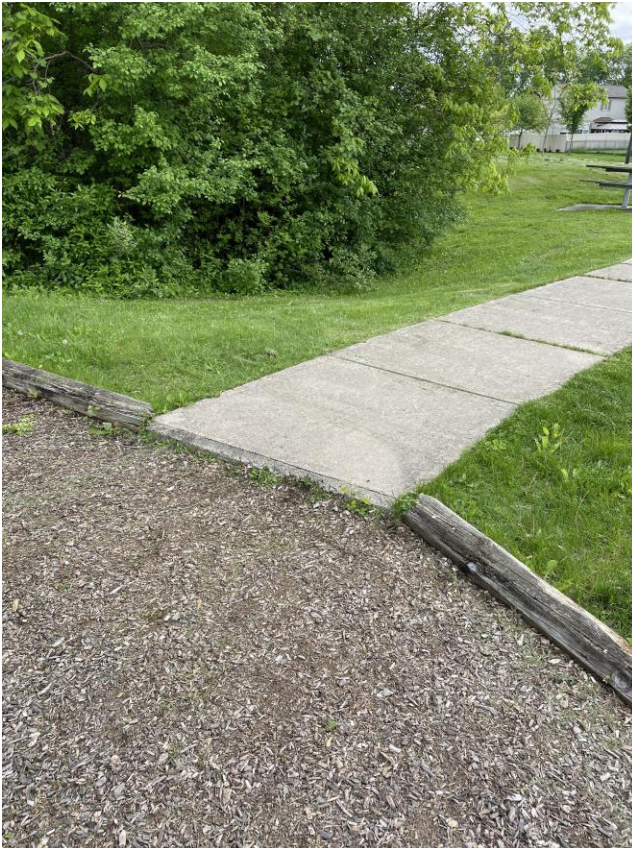
The entrance to the play area has a vertical change in level greater than 1/2-inch

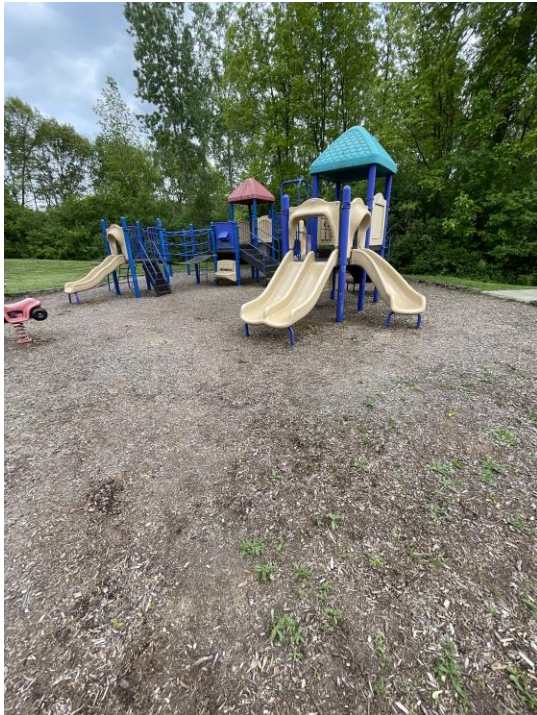
The play area ground surface is not firm, stable, and slip resistant.

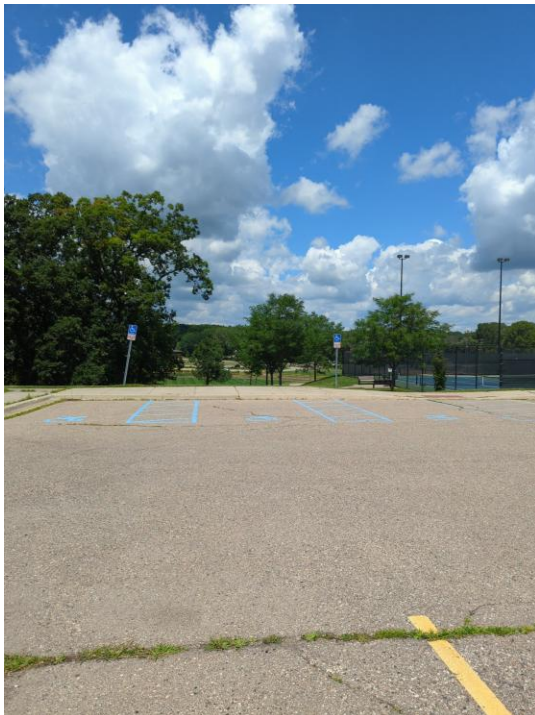
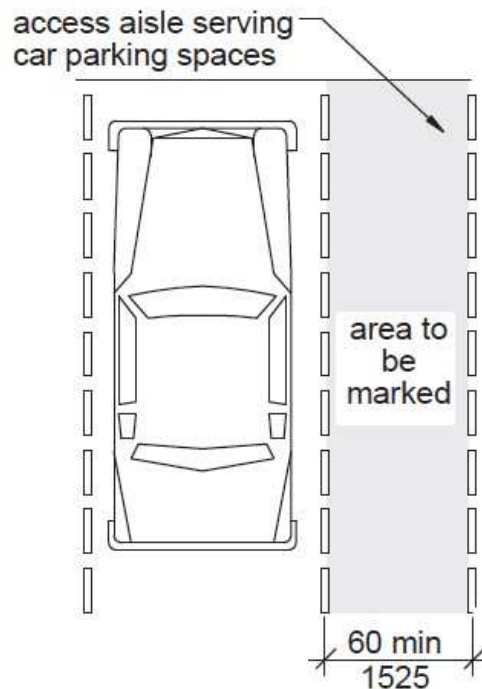
Three accessible parking stalls facing the park, first two access aisles are 54-56 inches wide

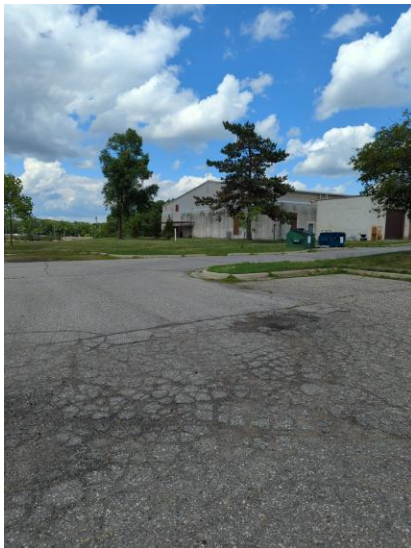
No accessible stalls on west side parking lot

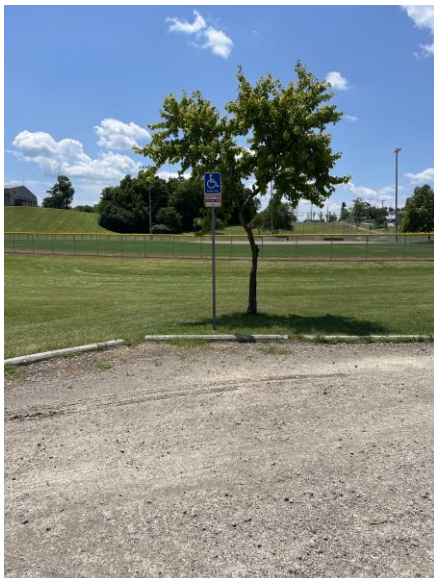
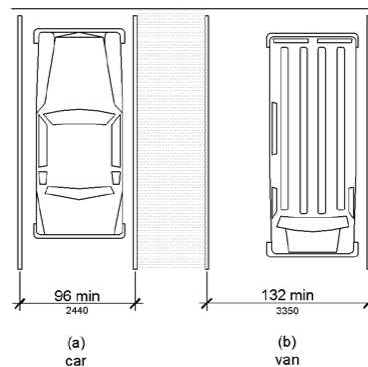
Gravel parking space

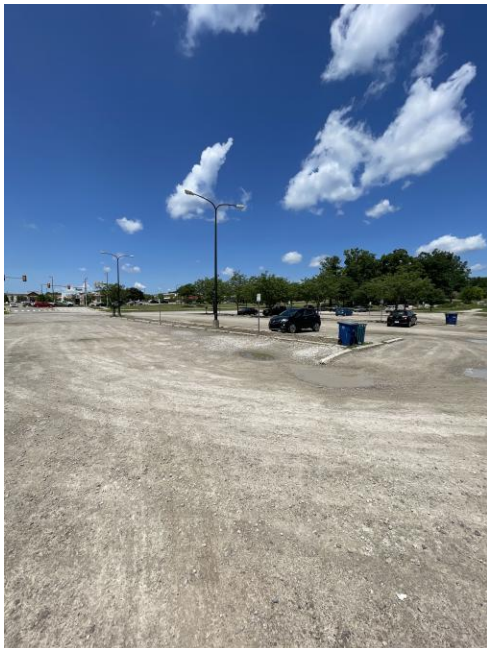
Gravel parking lot

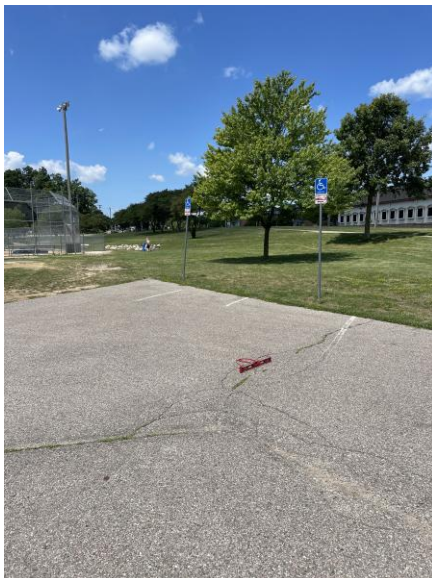
Slope of both spaces exceeds 2%. No marked access aisles are provided. Not ISA painted

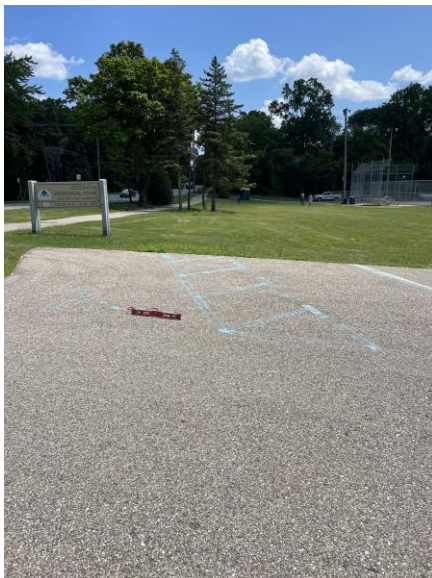
Slope of both spaces exceeds 2%. No signs.

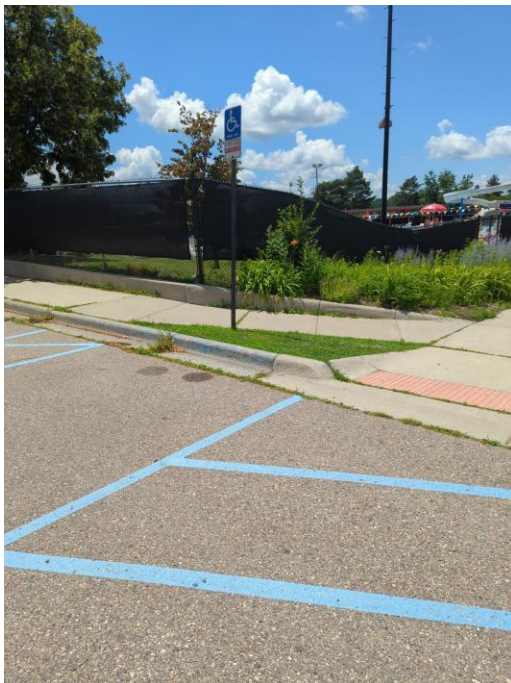
Sidewalk in front of accessible parking by NE corner of pool area has a running slope of 8.2-9.0% workout handrails

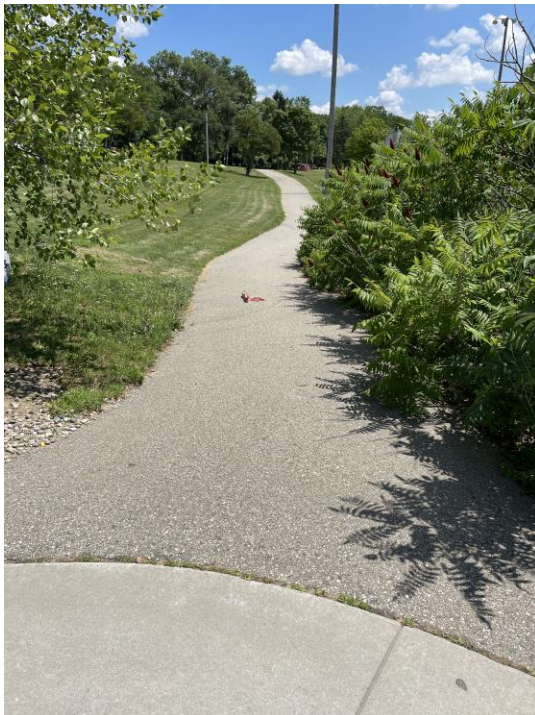
Route to skate park slope is 8%

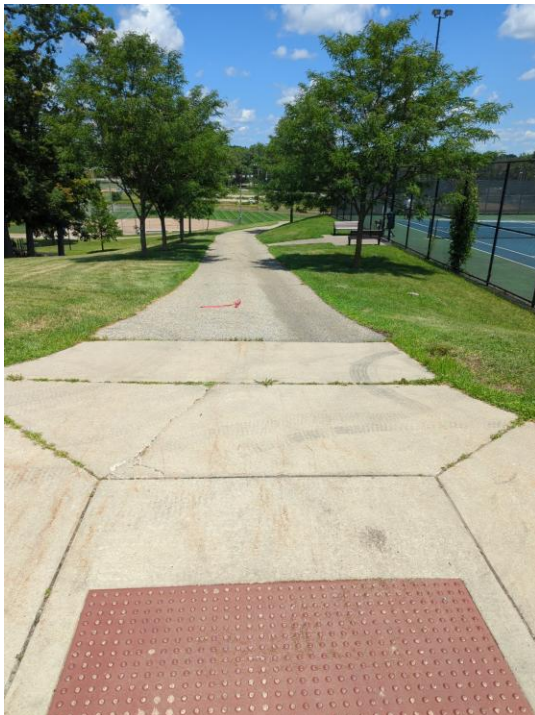
Path from pool parking to tennis courts has a running slope of up to 14%

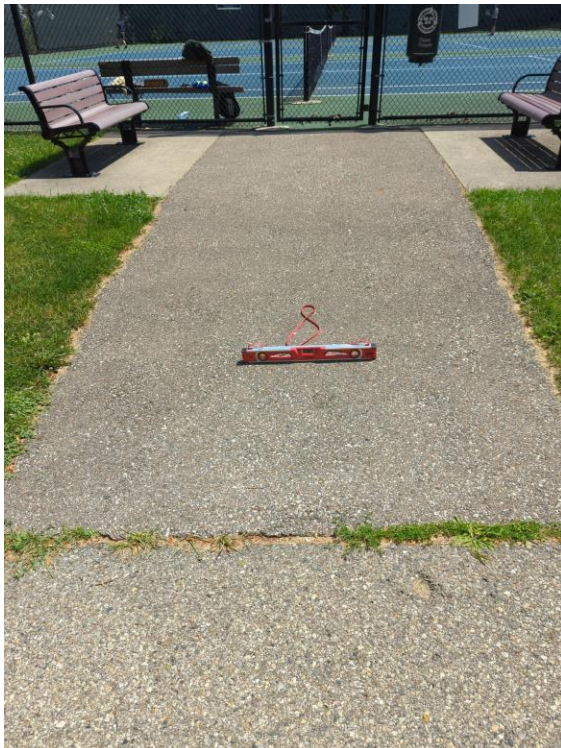
Path to tennis courts has a cross slope of up to 6.3%

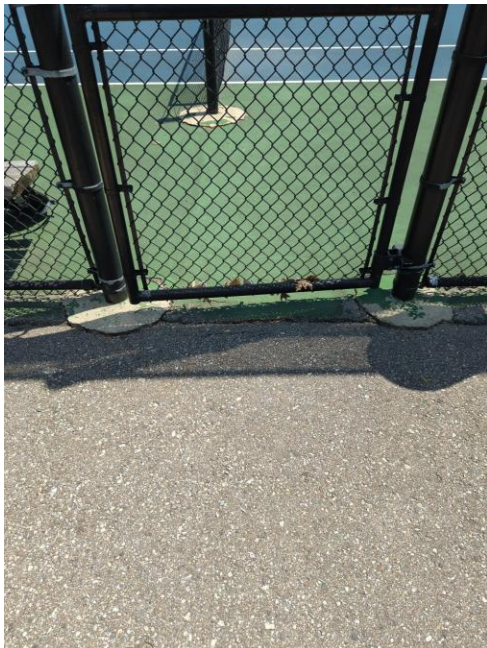
Gate to tennis courts does not have a smooth surface

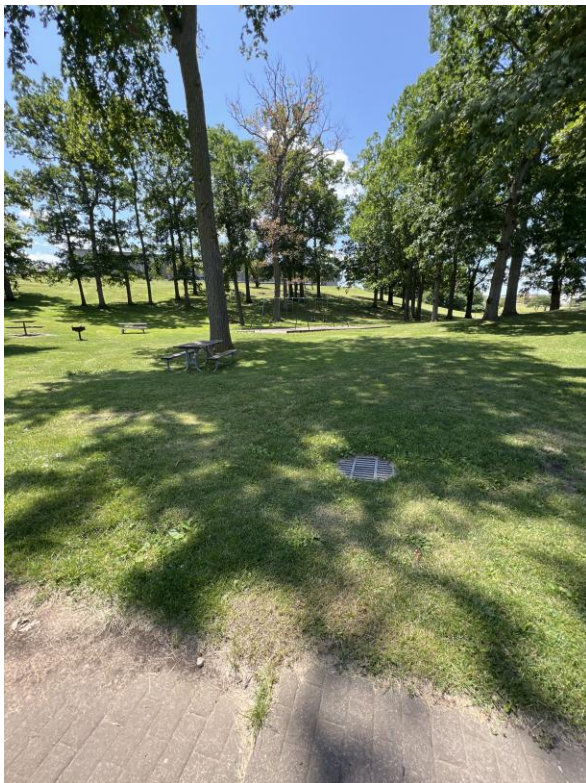
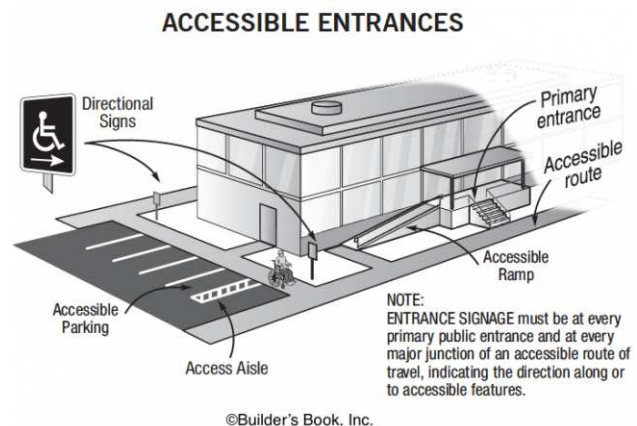
Grass surface. No accessible route to swings.

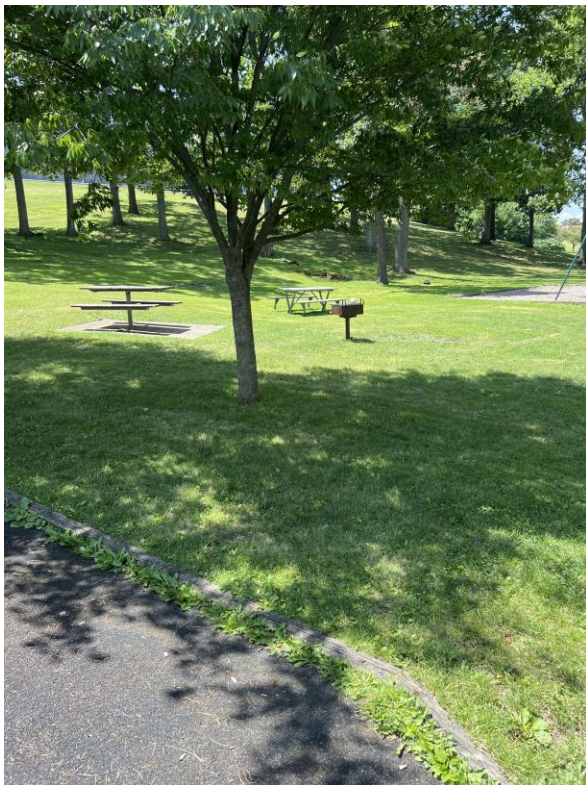
Grass surface. There is no accessible route to the grill.

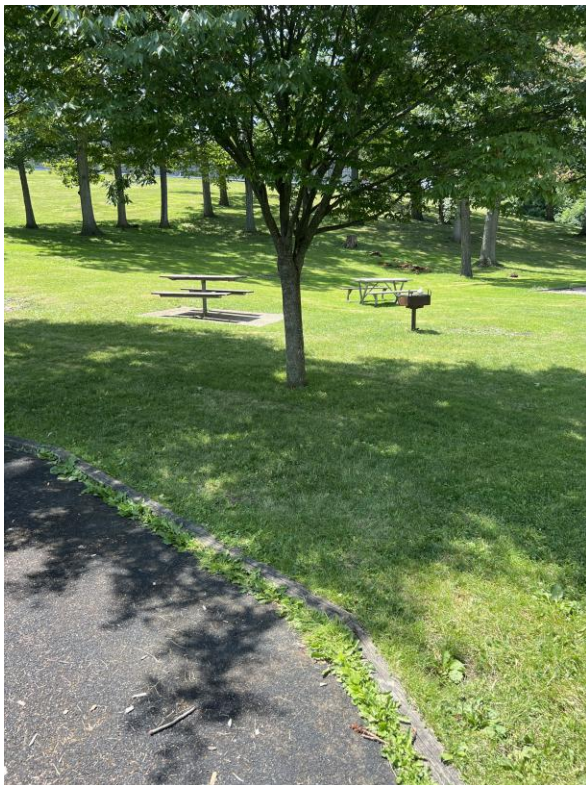
Grass surface. There is no accessible route to the picnic table.

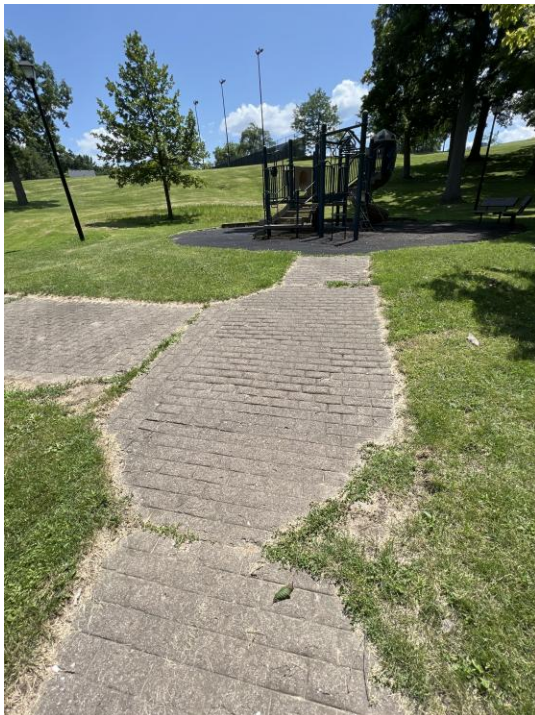
Running slope exceeds 5%.

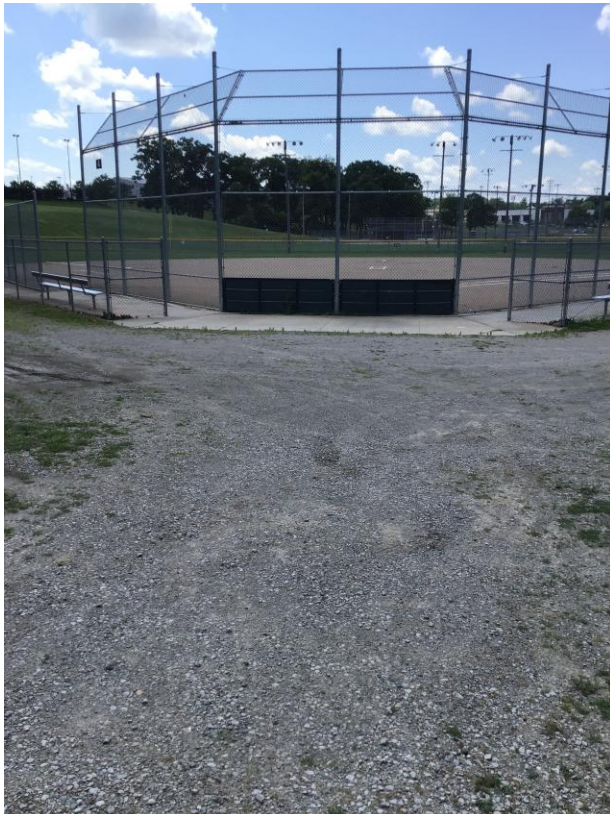
Field 4 has no accessible route to it.

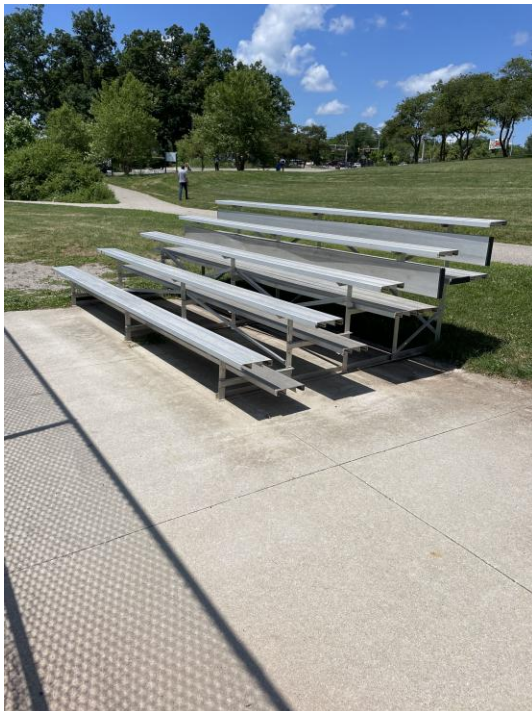
Only one wheelchair space is provided

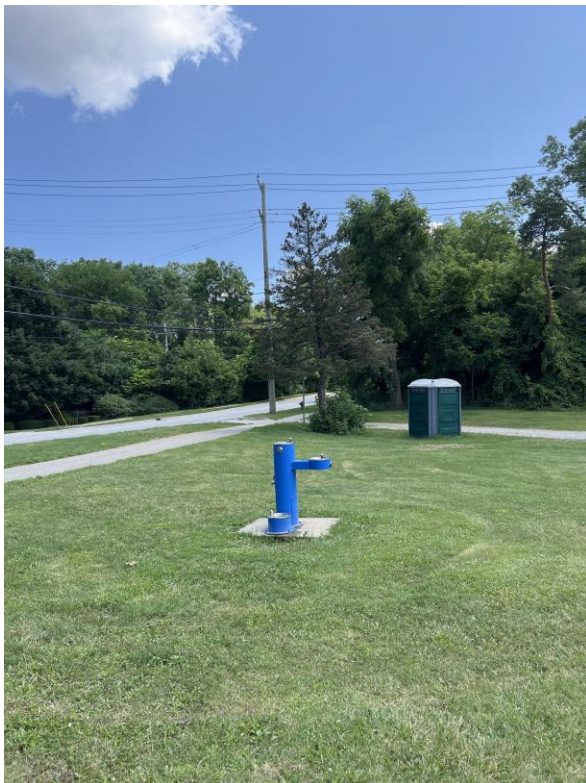
Grass surface existing. Need 15 feet paved surface.

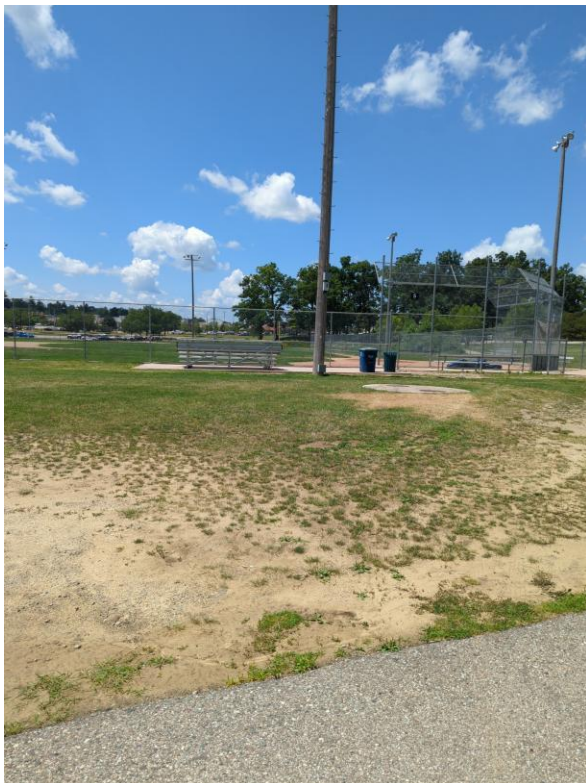
No path from parking to field #5

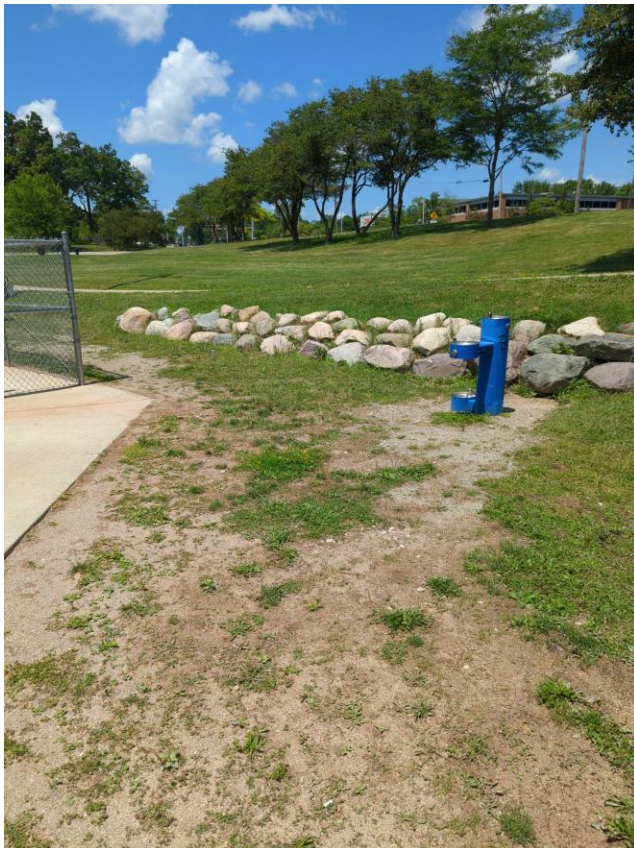
No path to drinking fountain at field #5

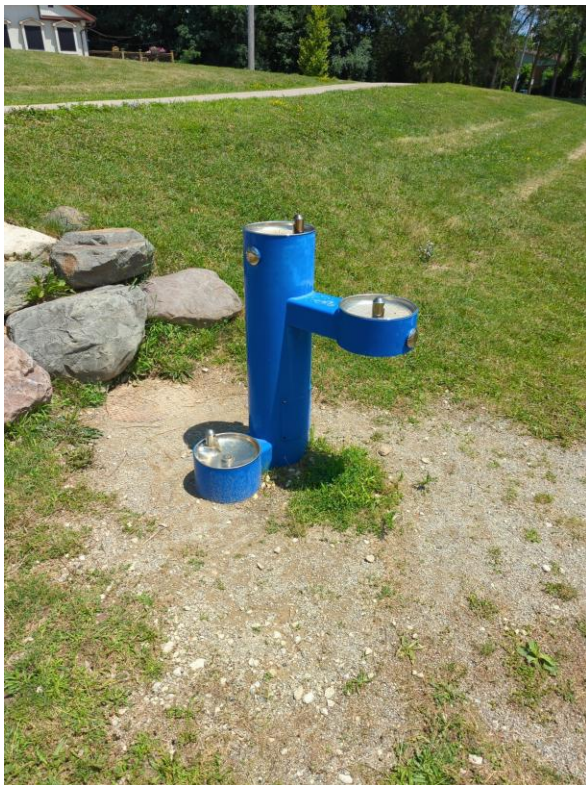
Knee clearance under drinking fountain by field #5 is 26 inches

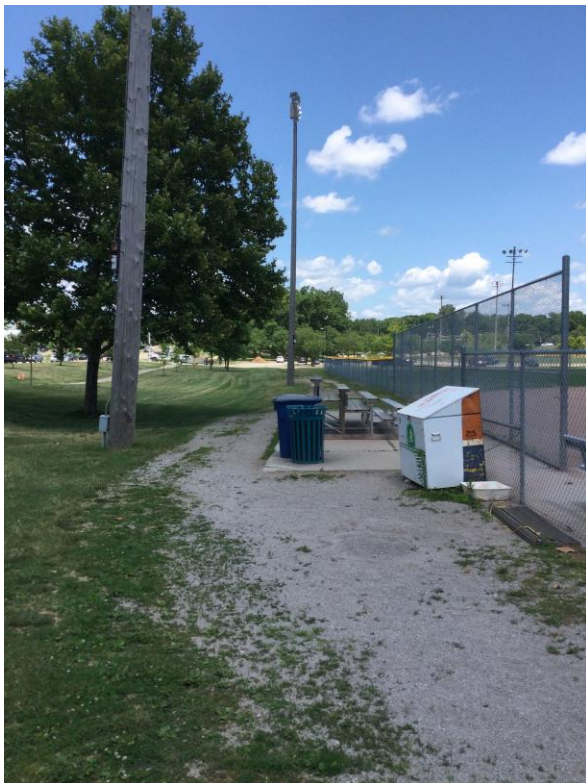
Grass and dirt surface existing.

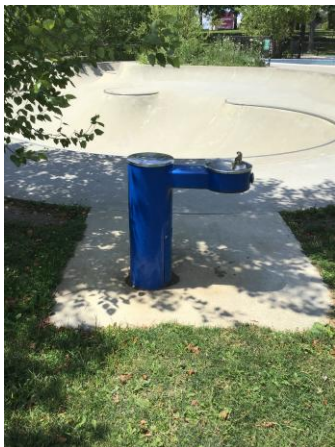
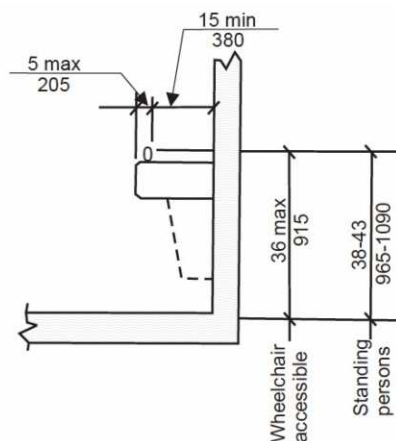
Only low drinking fountain provided.

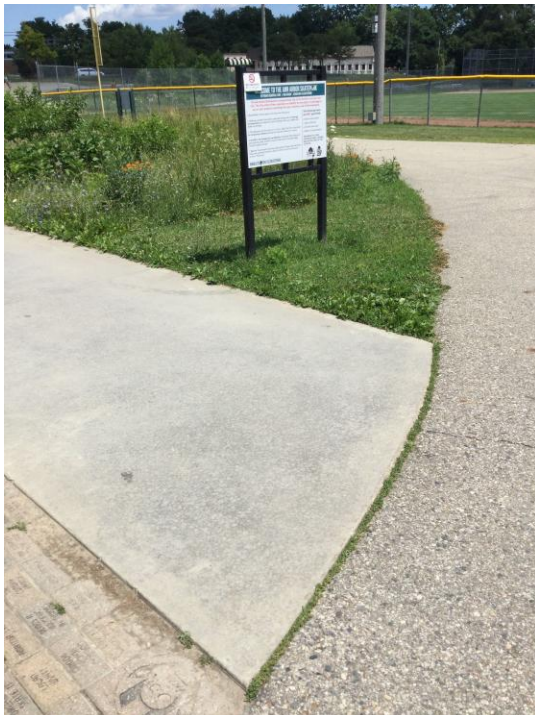
Sidewalk pavement opening is 1", grass is growing in opening.

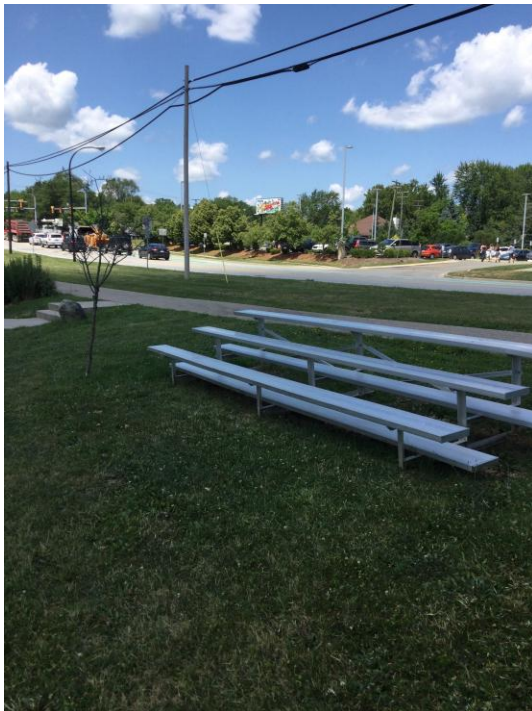
Spectator seating does not include accessible seating option.

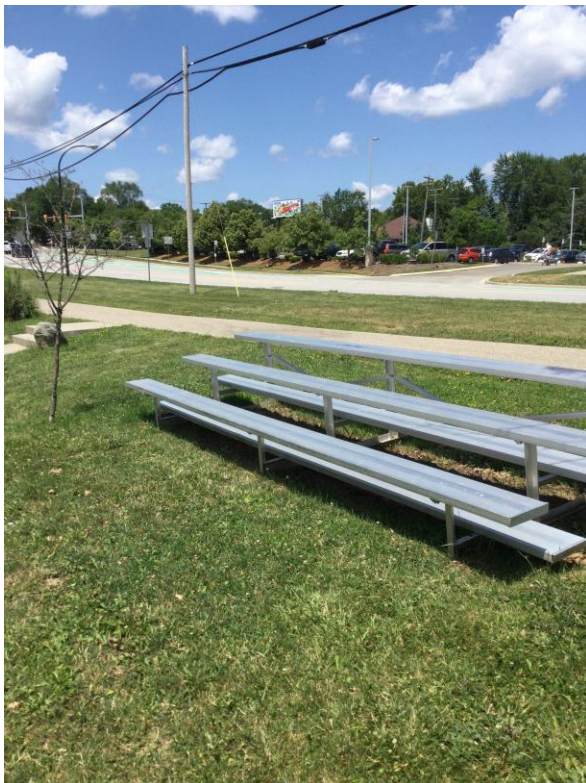
Spectator seating is located in grass surface area away from paved sidewalk/trail routes.

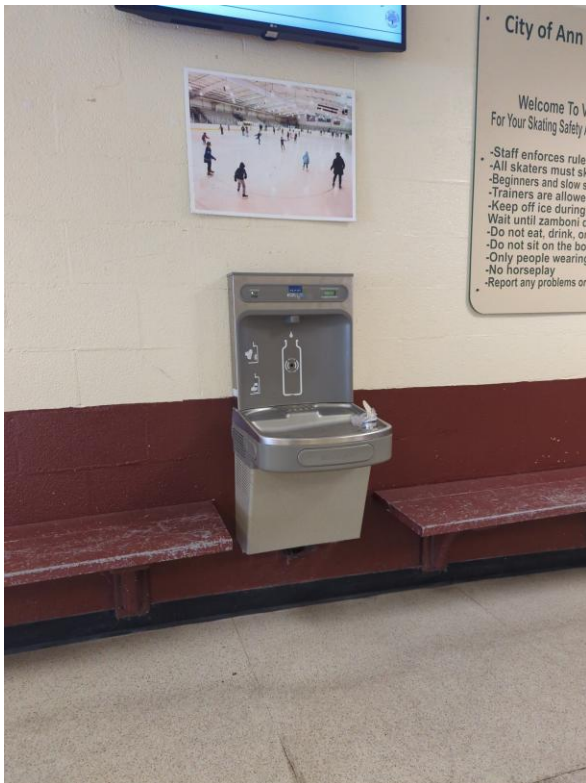
The forward approach to the drinking fountain is 26 inches wide
