Site Accessibility Evaluation

Allmendinger Park
655 Pauline Blvd
Ann Arbor, MI 48104
ADA Only

Inspection Date: 07/11/2022

Report Date: 11/15/2022

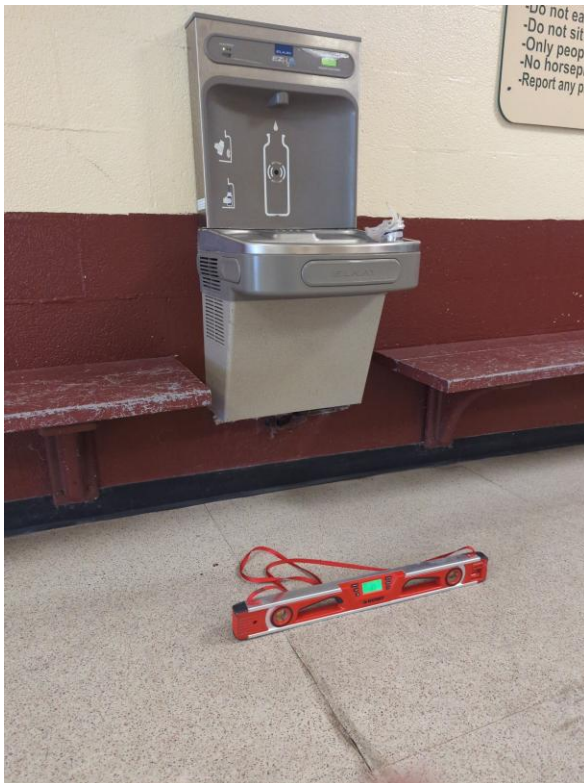
The clear floor area must be level. Existing clear floor space has a slope of 3.9%

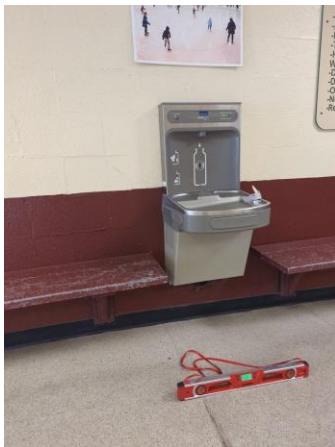
No high drinking fountain provided

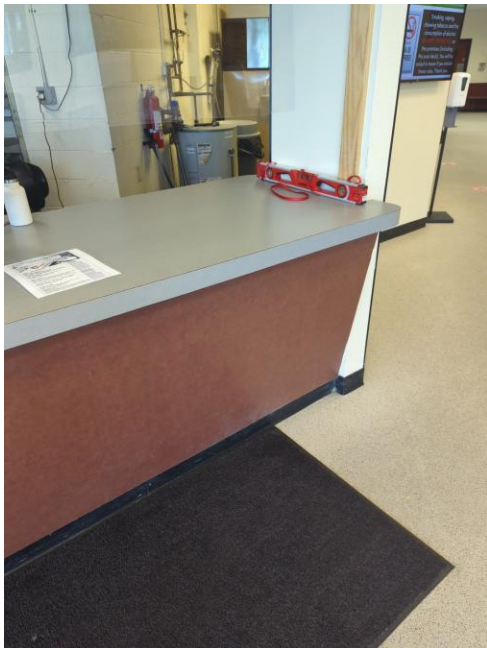
Counter height is 36-1/2 inches

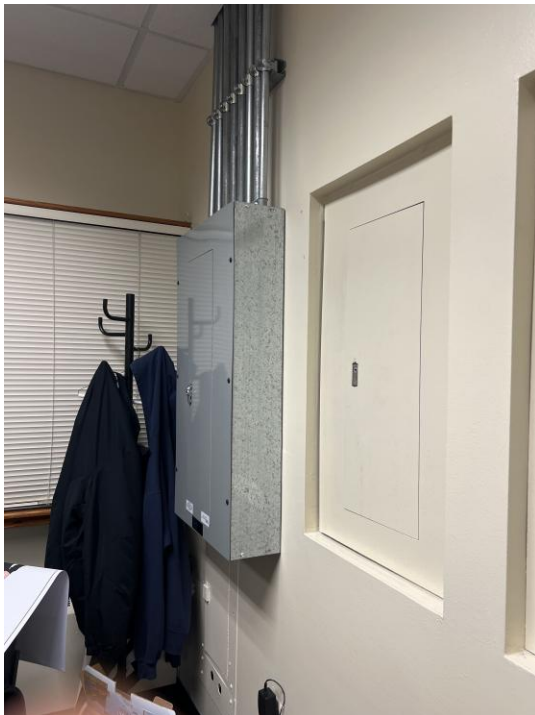
Wall-mounted objects that have leading edges between 27 inches and 80 inches from the floor must not project more than 4 inches into the circulation path. Protruding objects that extend to the floor or within 27 inches of the floor are cane detectable and are therefore not hazardous. Where it is necessary or desirable to have objects protrude from the wall, a manner of cane detection must be provided.

Existing utility box is protruding 6" from wall.

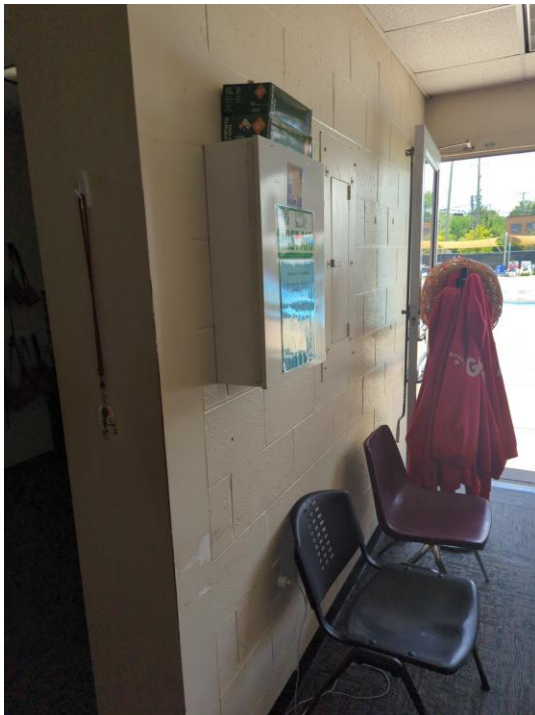
Wall-mounted objects that have leading edges between 27 inches and 80 inches from the floor must not project more than 4 inches into the circulation path. Protruding objects that extend to the floor or within 27 inches of the floor are cane detectable and are therefore not hazardous. Where it is necessary or desirable to have objects protrude from the wall, a manner of cane detection must be provided.

First-aid box protrudes 5-1/2 inches

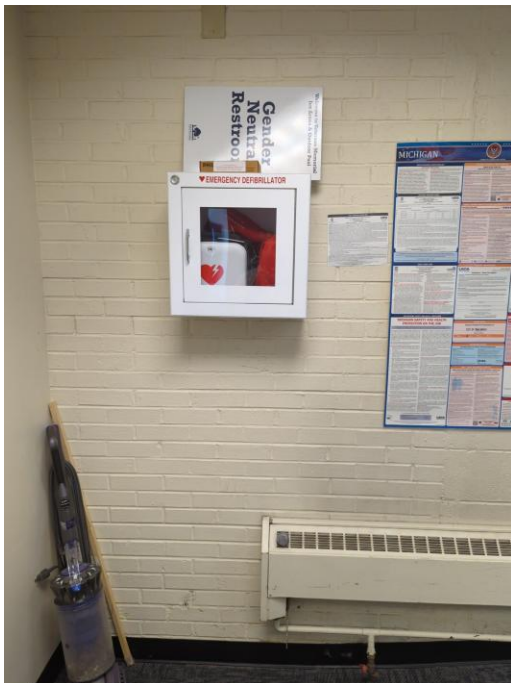
AED box is 65 inches high to the centerline of the handle

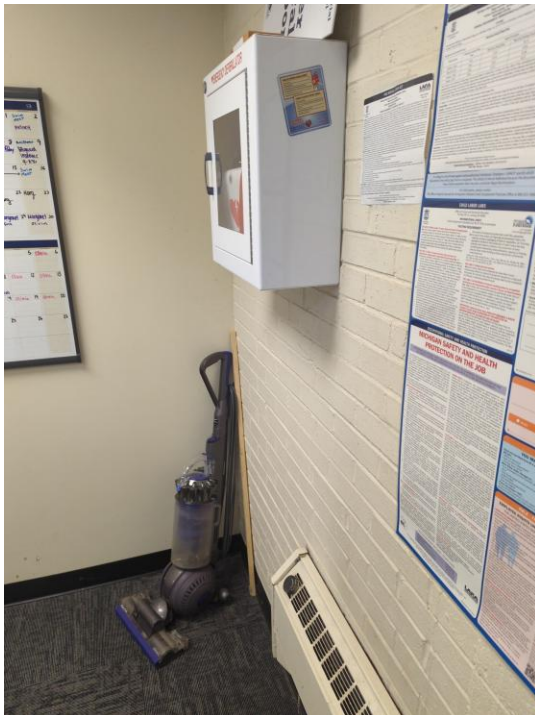
Wall-mounted objects that have leading edges between 27 inches and 80 inches from the floor must not project more than 4 inches into the circulation path. Protruding objects that extend to the floor or within 27 inches of the floor are cane detectable and are therefore not hazardous. Where it is necessary or desirable to have objects protrude from the wall, a manner of cane detection must be provided.

AED box protrudes 7 inches from wall.

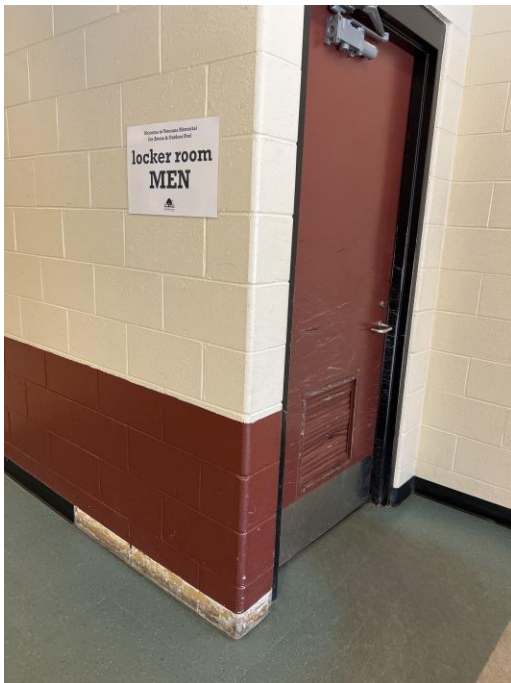
The sign is missing raised characters.

Signage is printed lettering on paper/metal.

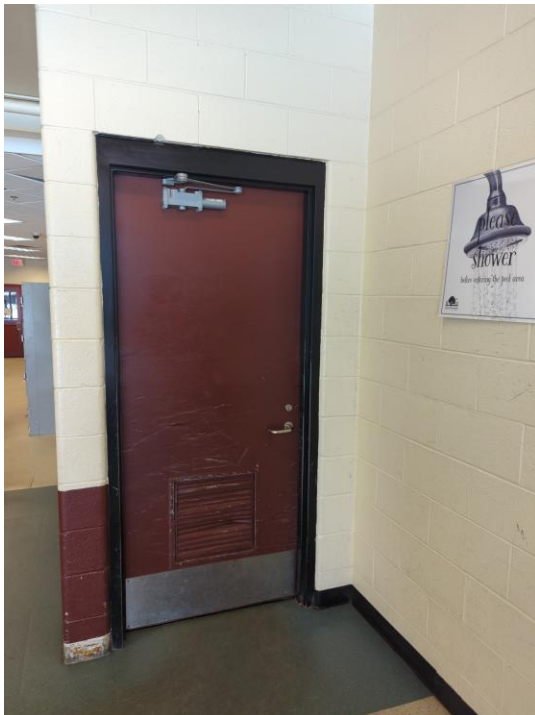
Door has 10 inches maneuvering clearance on the push side

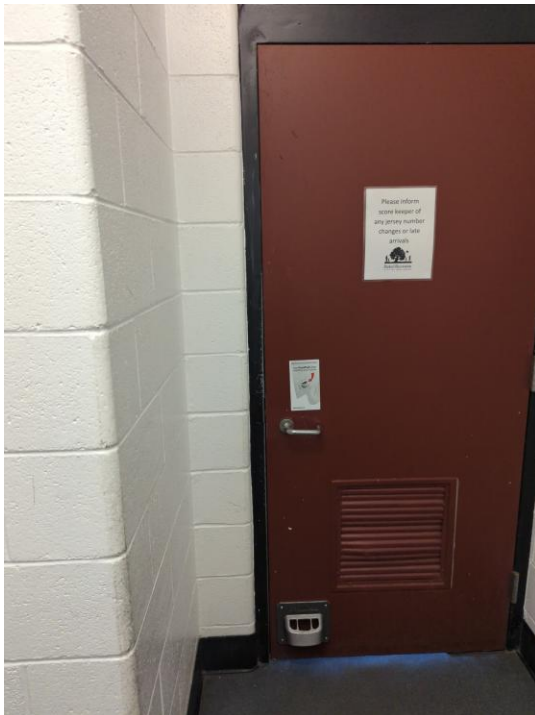
Door has 10 inches maneuvering clearance on the pull side

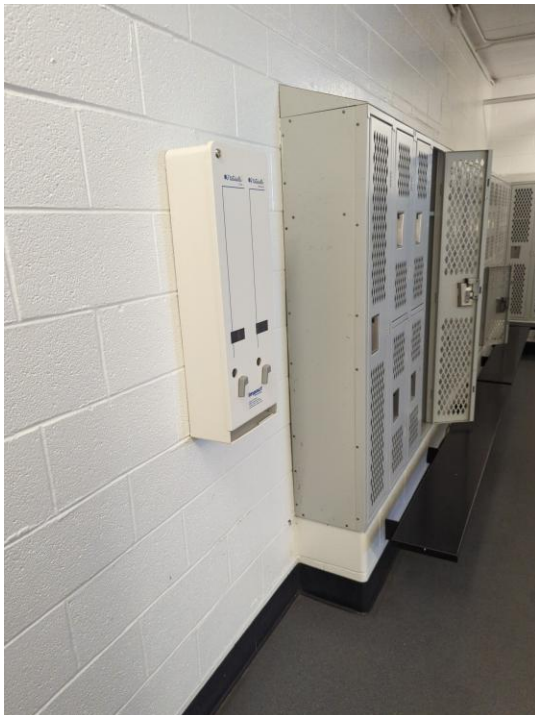
Wall-mounted objects that have leading edges between 27 inches and 80 inches from the floor must not project more than 4 inches into the circulation path. Protruding objects that extend to the floor or within 27 inches of the floor are cane detectable and are therefore not hazardous. Where it is necessary or desirable to have objects protrude from the wall, a manner of cane detection must be provided.

Dispenser protrudes 6 inches from wall.

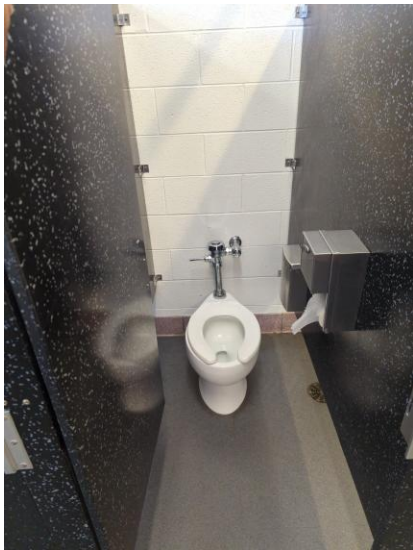
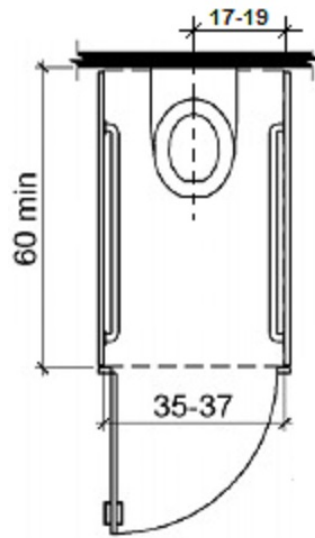
3 urinals and 3 water closets existing; one stall must be ambulatory

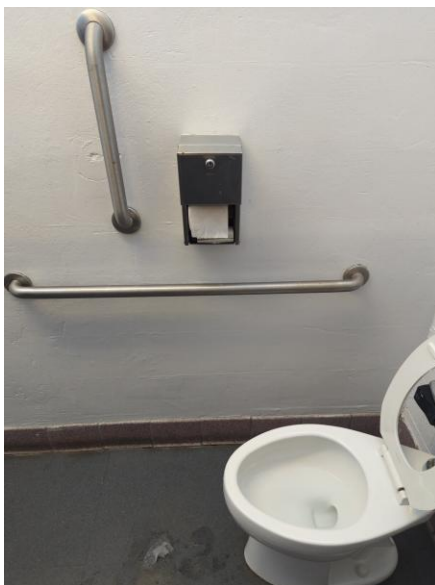
Toilet paper dispenser is 1 inch in front of water closet edge

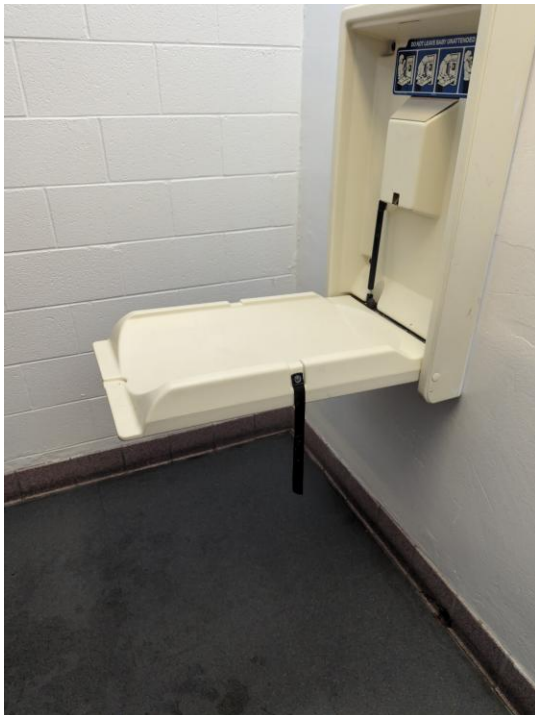
Wall-mounted objects that have leading edges between 27 inches and 80 inches from the floor must not project more than 4 inches into the circulation path. Protruding objects that extend to the floor or within 27 inches of the floor are cane detectable and are therefore not hazardous. Where it is necessary or desirable to have objects protrude from the wall, a manner of cane detection must be provided.

Baby changing table projects 20 inches from the wall

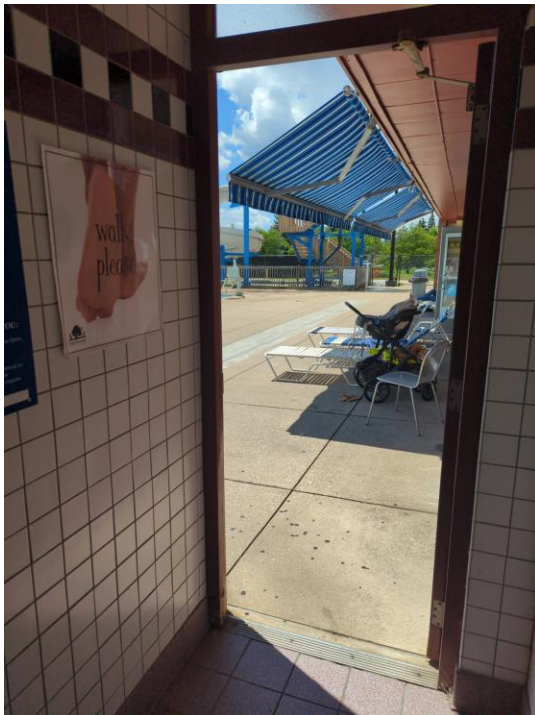
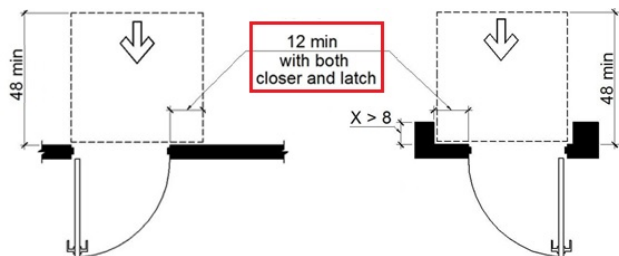
Door with closer and latch has 2 inches on the push side of the door

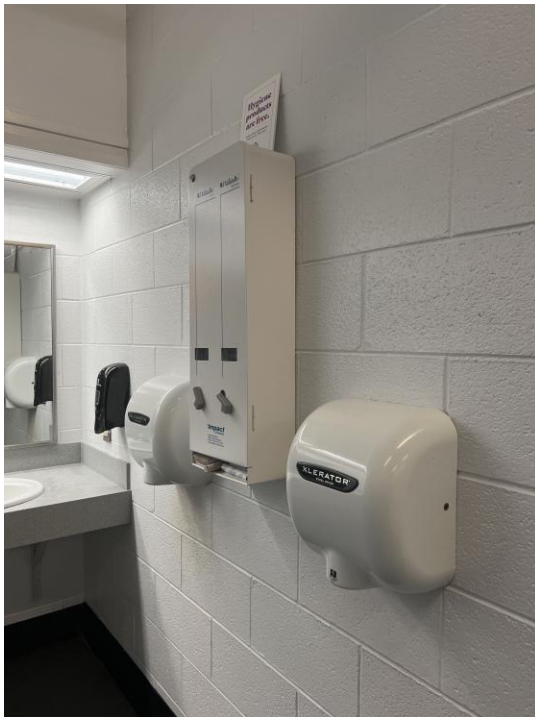
Wall-mounted objects that have leading edges between 27 inches and 80 inches from the floor must not project more than 4 inches into the circulation path. Protruding objects that extend to the floor or within 27 inches of the floor are cane detectable and are therefore not hazardous. Where it is necessary or desirable to have objects protrude from the wall, a manner of cane detection must be provided.

Existing hand dryers and dispenser protrude 7" and 5" from wall.

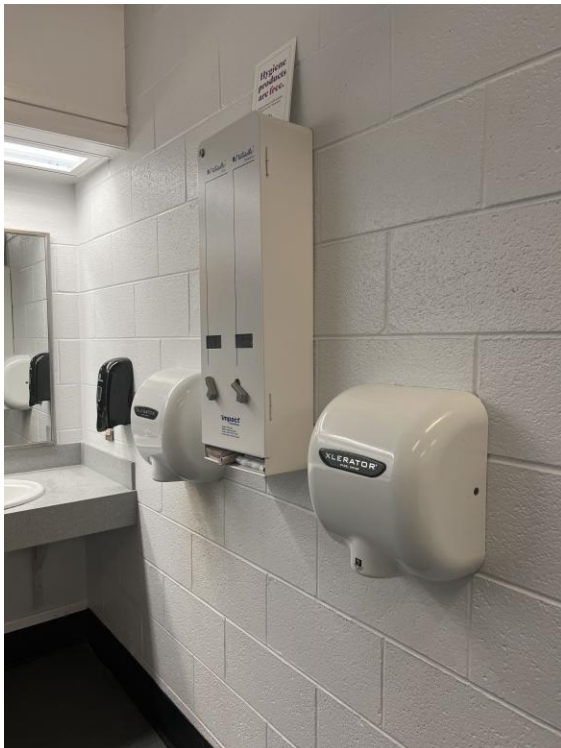
Dispenser operating parts greater than 48" tall.

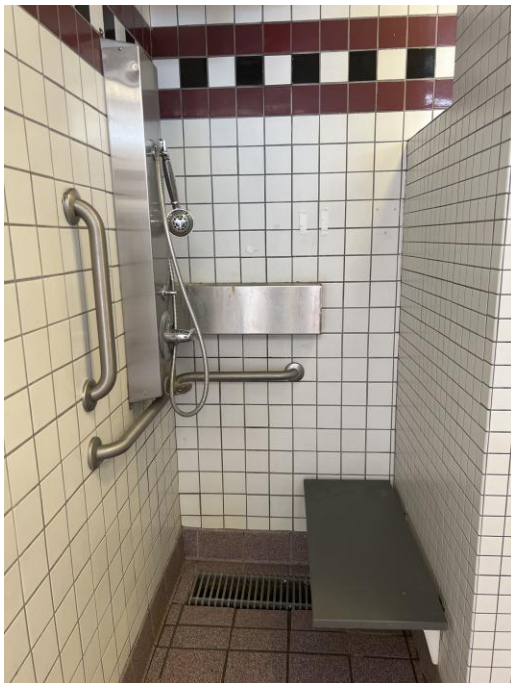
Shower compartment depth exceeds 36".

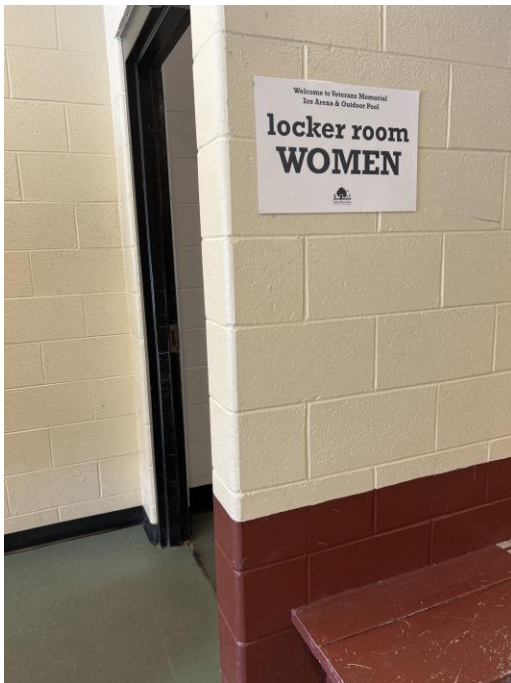
Signage is printed on paper/metal.

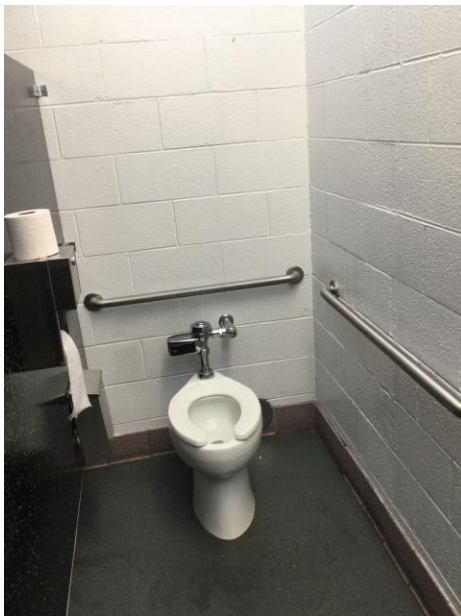
Locker Room: Women's Locker Room

Toilet compartment is 42" wide.

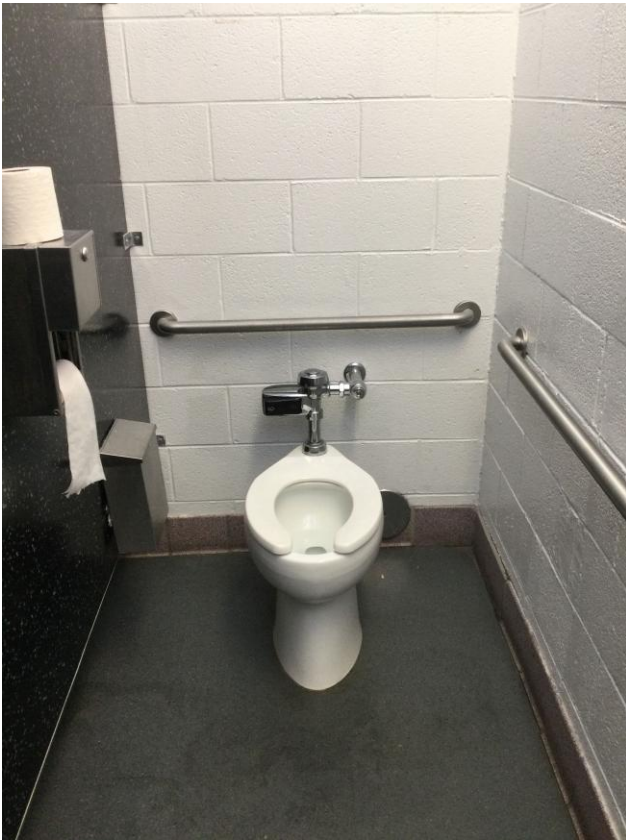
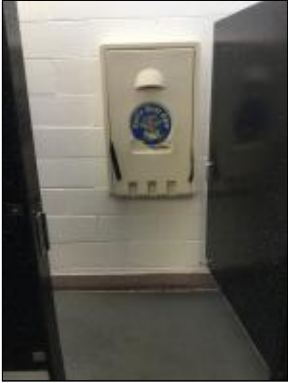
Finding #55 Continued

Door swings in to compartment.

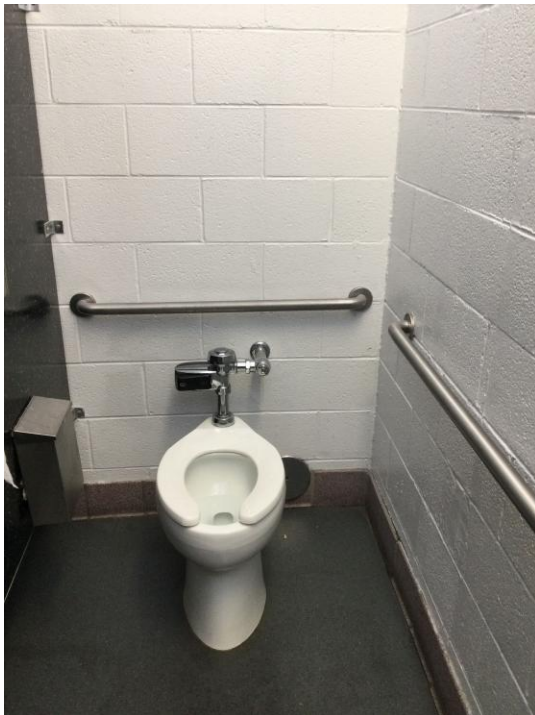
Locker Room: Women's Locker Room

Toilet is installed more than 18" from wall.

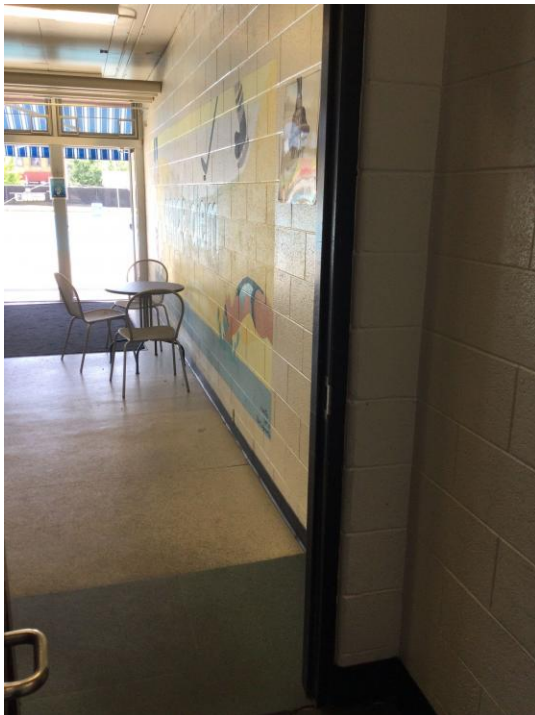
Locker Room: Women's Locker Room

12" latch side

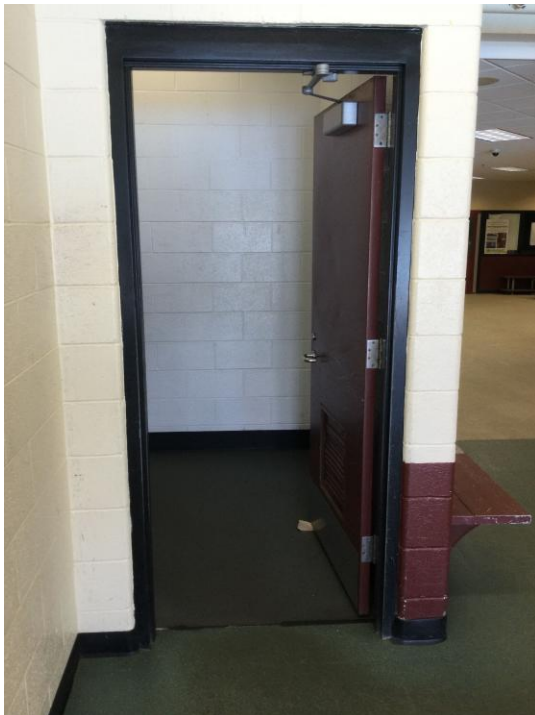
Locker Room: Women's Locker Room

12" latch side

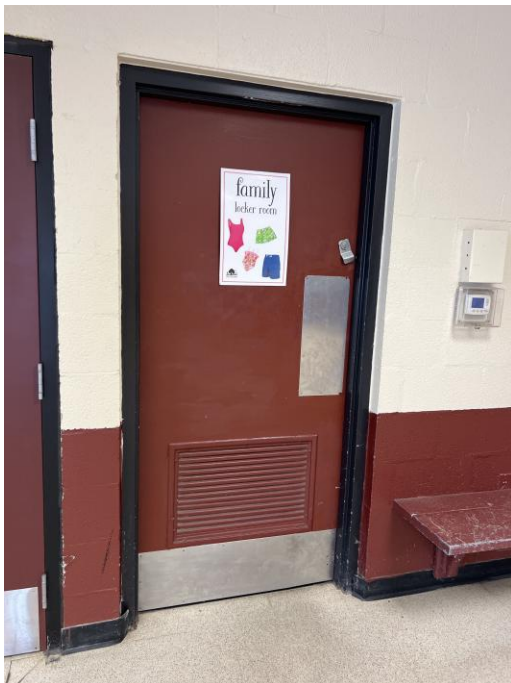
Locker Room: Unisex Locker Room

The sign is missing raised characters.

Signage printed on paper/metal.

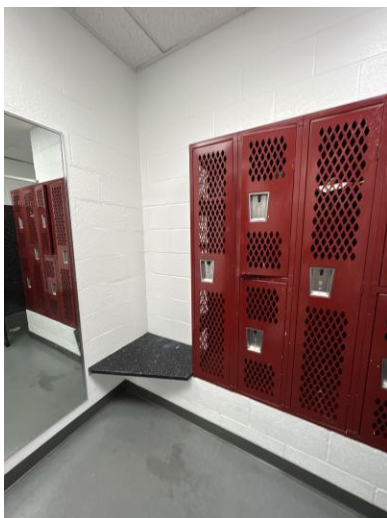
Locker Room: Unisex Locker Room

Bench does not comply.

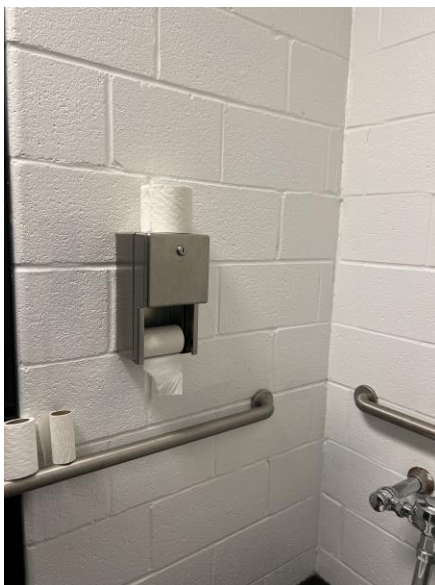
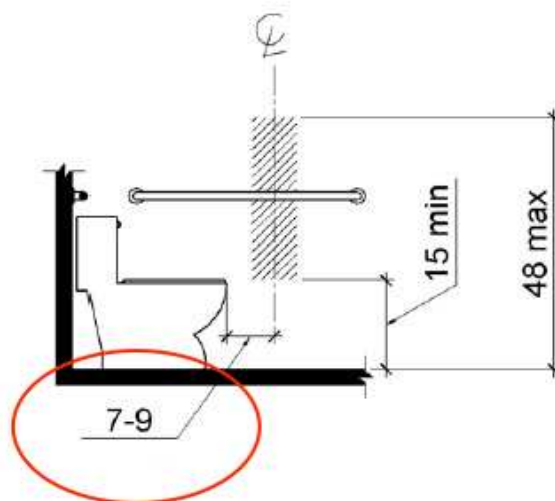
Locker Room: Unisex Locker Room

Paper dispenser is less than 12" above grab bar.

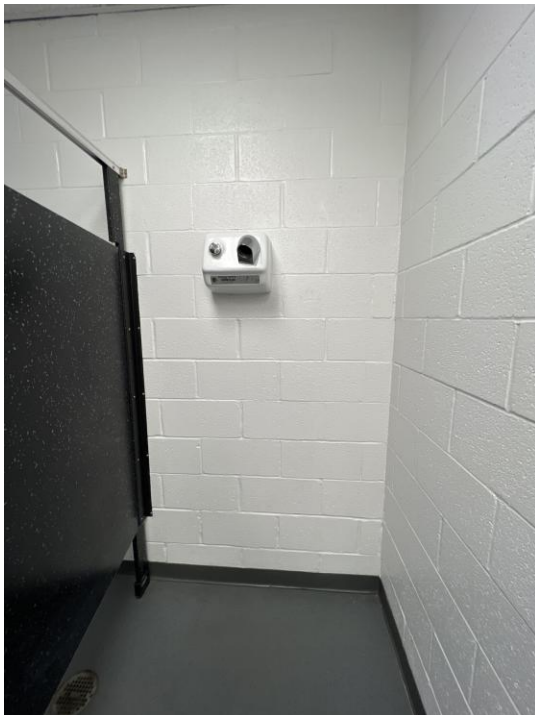
Locker Room: Unisex Locker Room

Wall-mounted objects that have leading edges between 27 inches and 80 inches from the floor must not project more than 4 inches into the circulation path. Protruding objects that extend to the floor or within 27 inches of the floor are cane detectable and are therefore not hazardous. Where it is necessary or desirable to have objects protrude from the wall, a manner of cane detection must be provided.

Hand dryer protrudes 7" from wall.

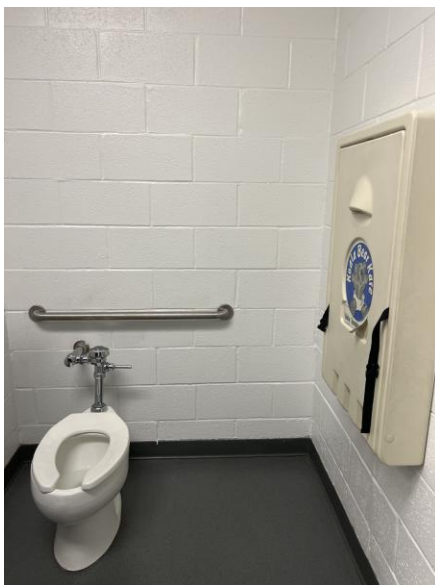
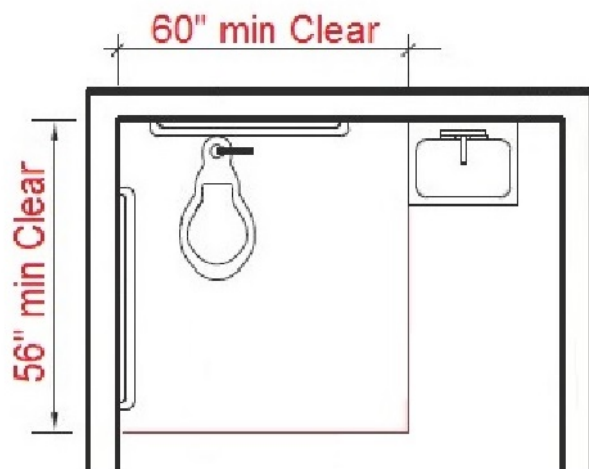
Locker Room: Unisex Locker Room

Baby changing table location conflicts with toilet clear floor space.

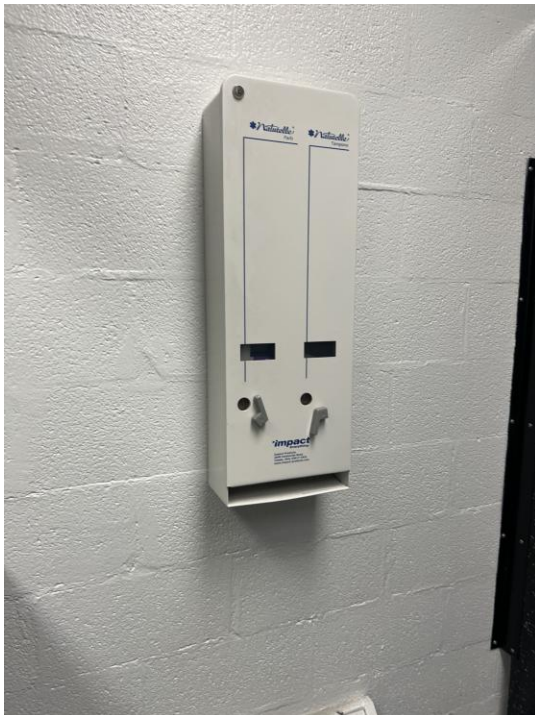
Locker Room: Unisex Locker Room

Wall-mounted objects that have leading edges between 27 inches and 80 inches from the floor must not project more than 4 inches into the circulation path. Protruding objects that extend to the floor or within 27 inches of the floor are cane detectable and are therefore not hazardous. Where it is necessary or desirable to have objects protrude from the wall, a manner of cane detection must be provided.

Dispenser protrudes 5" from wall.

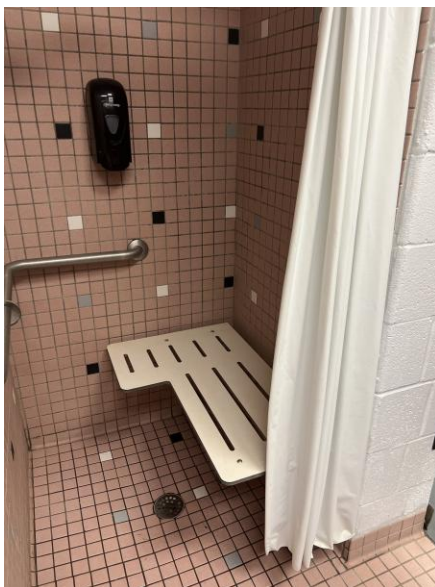
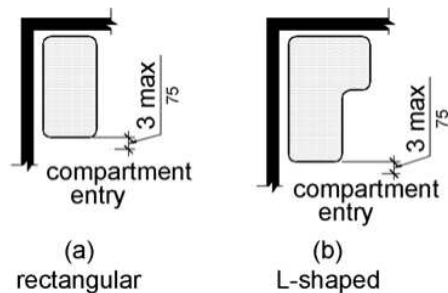
Locker Room: Unisex Locker Room

Shower seat has incorrect spacing from compartment walls.

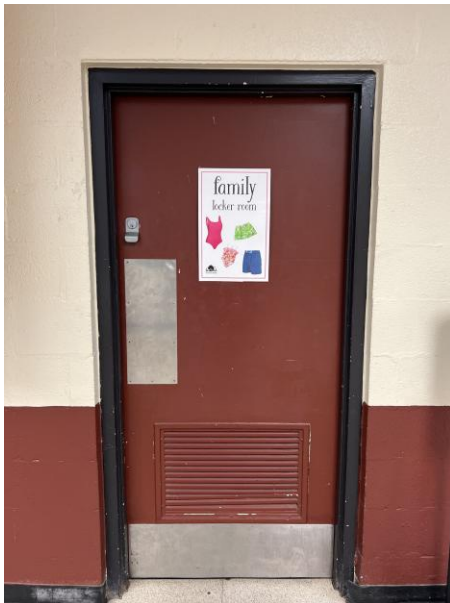
Locker Room: Unisex Locker Room

The sign is missing raised characters.

Signage is printed on paper/metal.

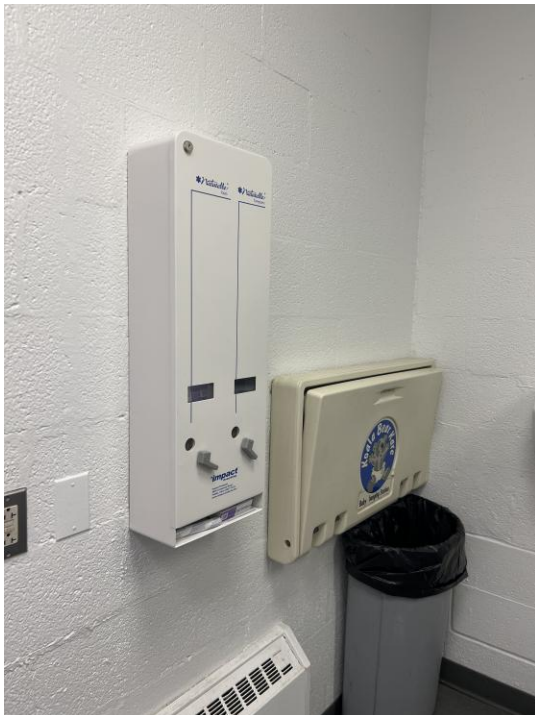
Locker Room: Unisex Locker Room

Wall-mounted objects that have leading edges between 27 inches and 80 inches from the floor must not project more than 4 inches into the circulation path. Protruding objects that extend to the floor or within 27 inches of the floor are cane detectable and are therefore not hazardous. Where it is necessary or desirable to have objects protrude from the wall, a manner of cane detection must be provided.

Dispenser protrudes 6" from wall.

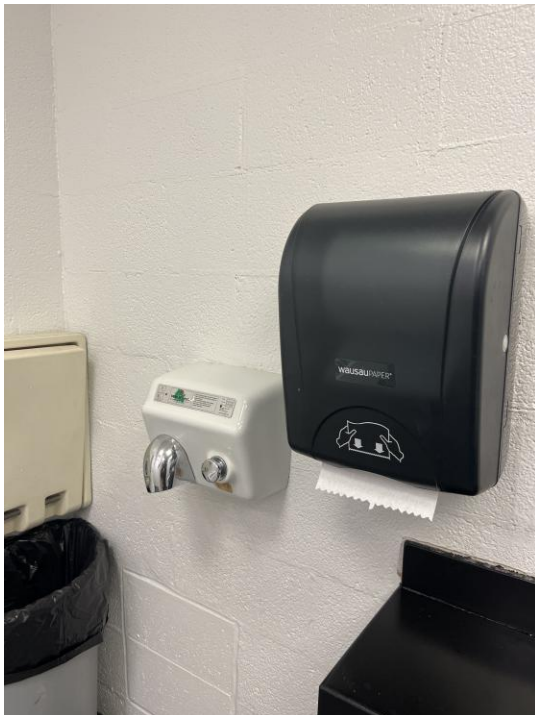
Locker Room: Unisex Locker Room

Wall-mounted objects that have leading edges between 27 inches and 80 inches from the floor must not project more than 4 inches into the circulation path. Protruding objects that extend to the floor or within 27 inches of the floor are cane detectable and are therefore not hazardous. Where it is necessary or desirable to have objects protrude from the wall, a manner of cane detection must be provided.

Hand dryer protrudes 7" from wall.

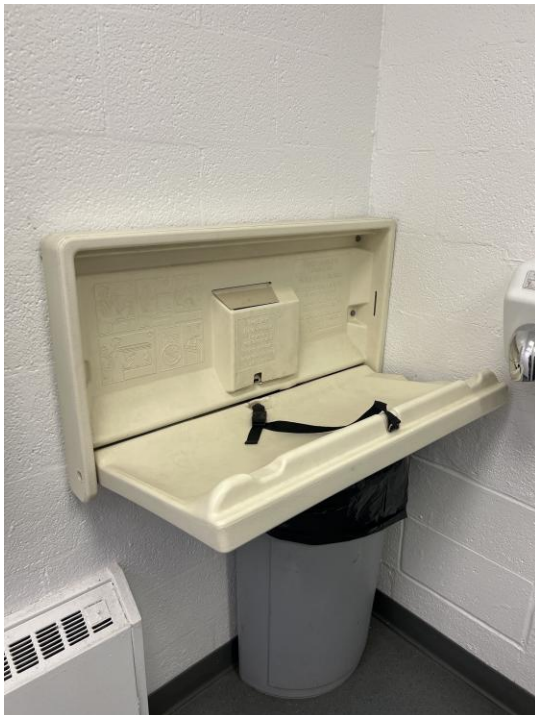
Locker Room: Unisex Locker Room

Wall-mounted objects that have leading edges between 27 inches and 80 inches from the floor must not project more than 4 inches into the circulation path. Protruding objects that extend to the floor or within 27 inches of the floor are cane detectable and are therefore not hazardous. Where it is necessary or desirable to have objects protrude from the wall, a manner of cane detection must be provided.

Baby changing table protrudes more than 20" from wall.

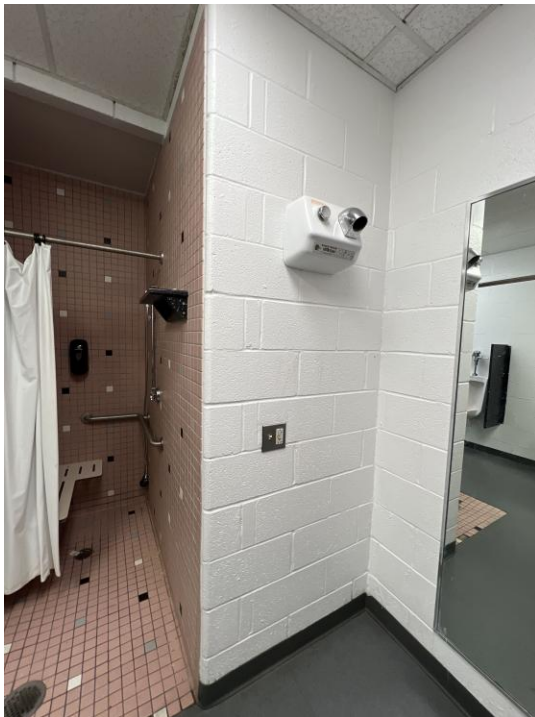
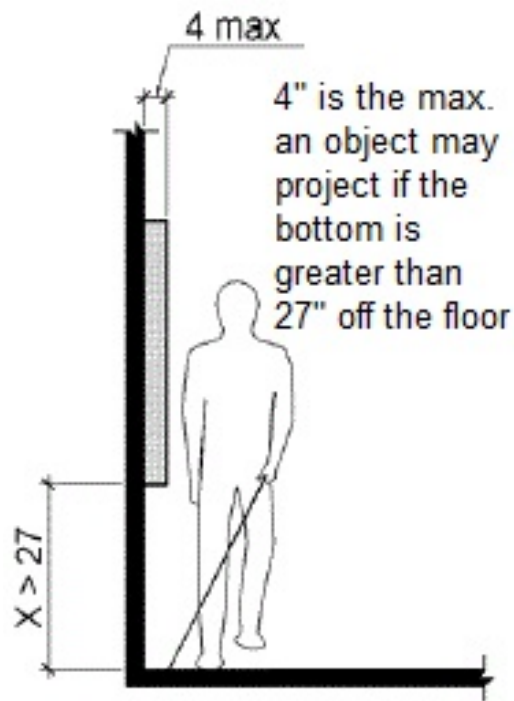
Locker Room: Unisex Locker Room

Wall-mounted objects that have leading edges between 27 inches and 80 inches from the floor must not project more than 4 inches into the circulation path. Protruding objects that extend to the floor or within 27 inches of the floor are cane detectable and are therefore not hazardous. Where it is necessary or desirable to have objects protrude from the wall, a manner of cane detection must be provided.

Hand dryer protrudes 7" from wall.

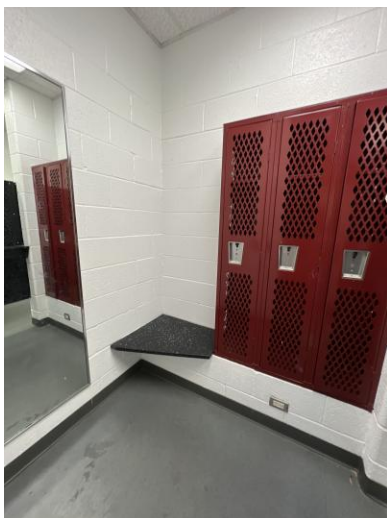
Locker Room: Unisex Locker Room

Bench seat does not comply.

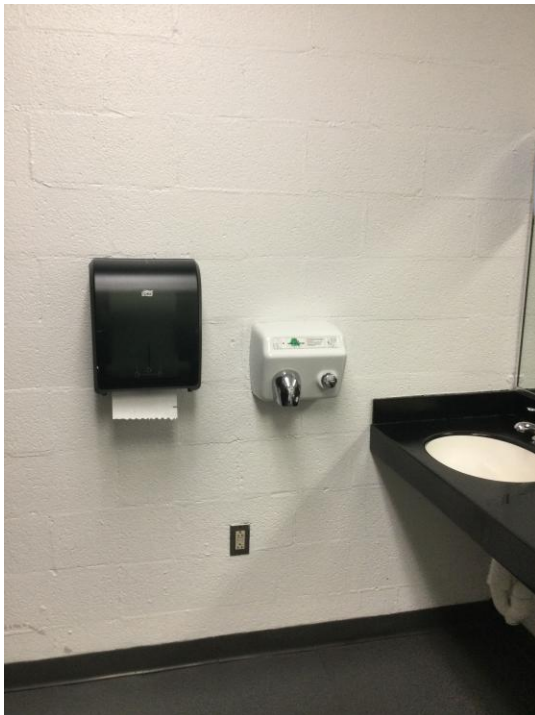
Locker Room: Unisex Locker Room

Wall-mounted objects that have leading edges between 27 inches and 80 inches from the floor must not project more than 4 inches into the circulation path. Protruding objects that extend to the floor or within 27 inches of the floor are cane detectable and are therefore not hazardous. Where it is necessary or desirable to have objects protrude from the wall, a manner of cane detection must be provided.

Dispenser protrudes 7" from wall.

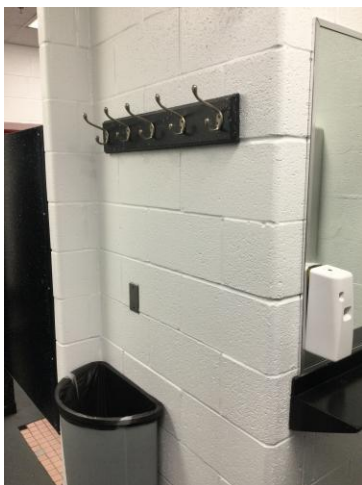
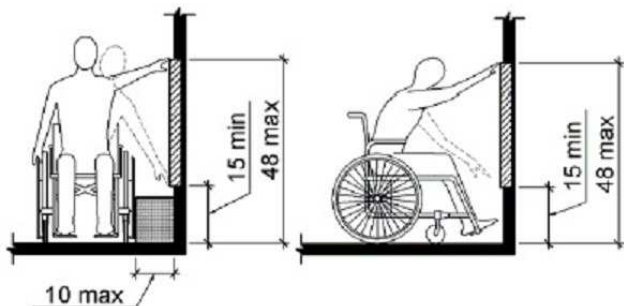
Locker Room: Unisex Locker Room

Coat hooks mounted at 67" from floor.

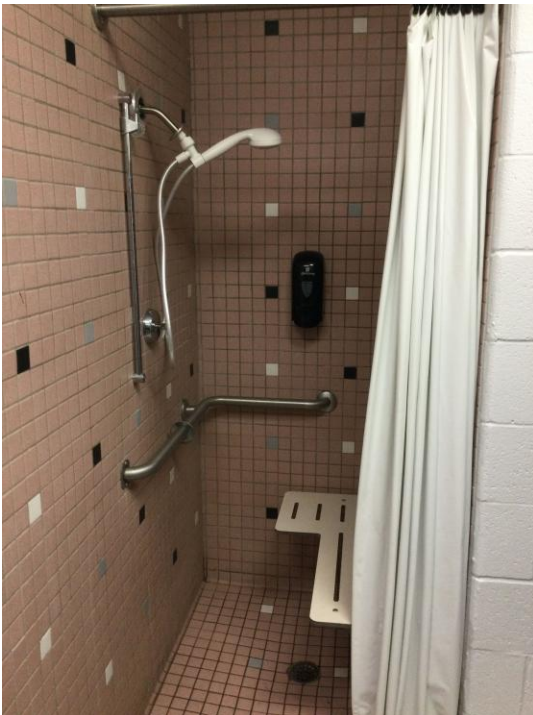
Locker Room: Unisex Locker Room

The shower is missing the hand-held spray unit.

Shower head is not adjustable.

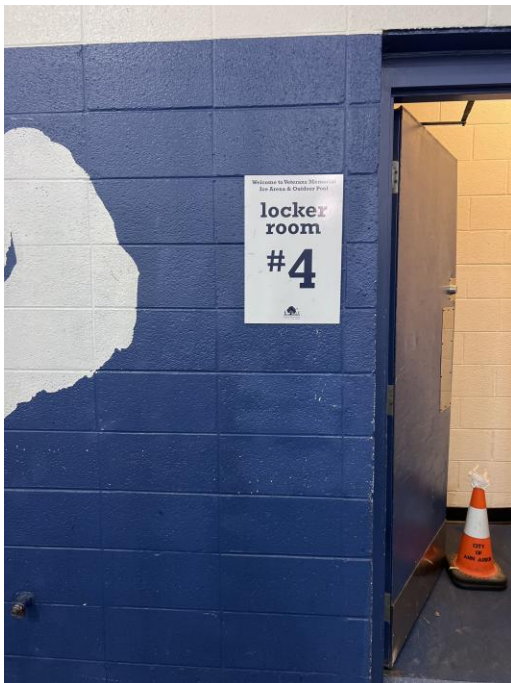
Locker Room: Unisex Locker Room

The sign is missing raised characters.

Signage is printed on paper/metal.

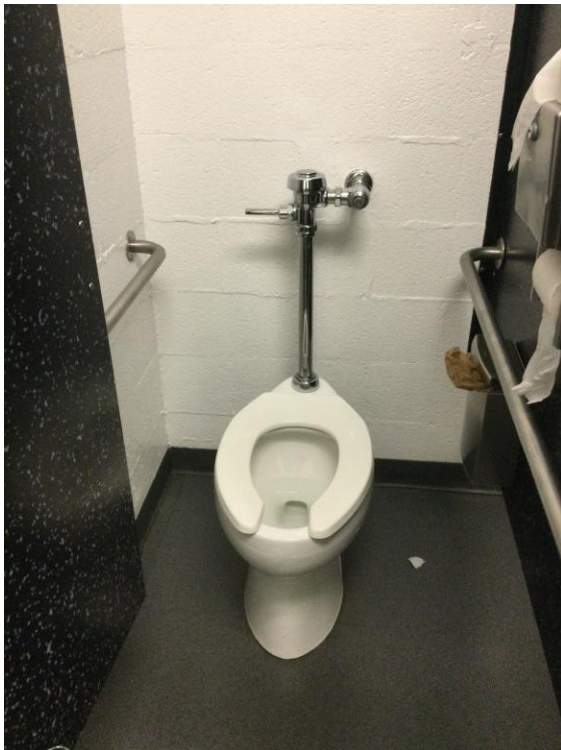
Locker Room: Unisex Locker Room Mens

The stall does not have the required minimum clear floor space or maneuvering clearances for the toilet, Grab bars are missing and/or incorrectly installed, accessories, such as toilet seat covers, toilet paper holders, and garbage cans are either too high, without clear floor space or both, the floor level changes greater than a 1/2 inch at the floor drains.

Toilet compartment does not meet standards.

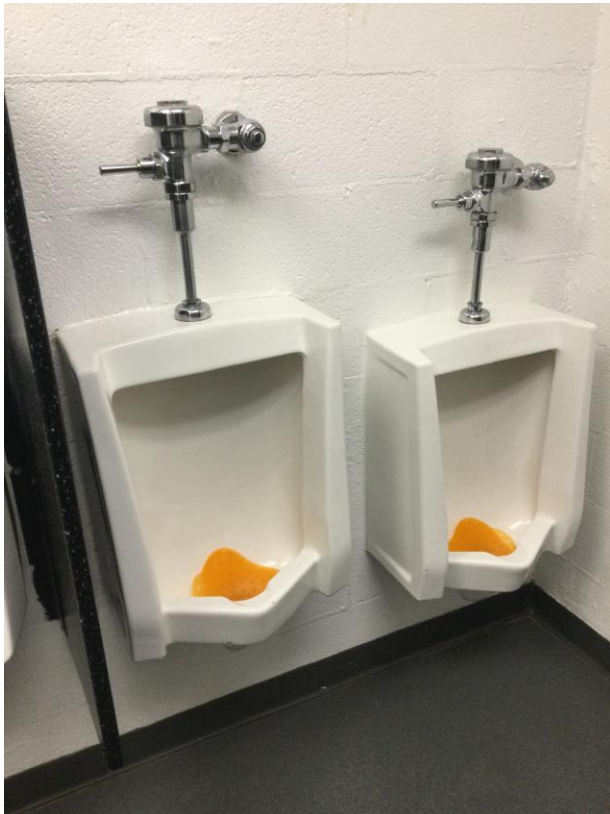
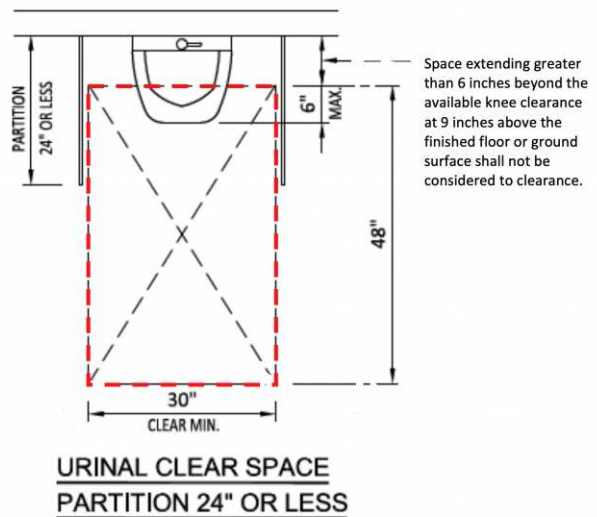
Locker Room: Unisex Locker Room Mens

Urinal clear floor space is 26”.

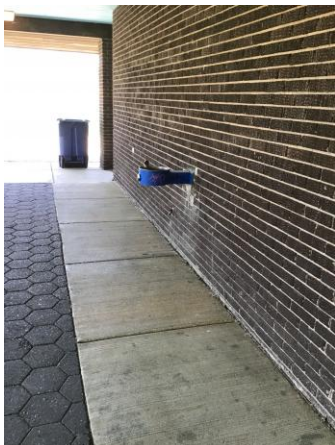
There are two low drinking fountains.

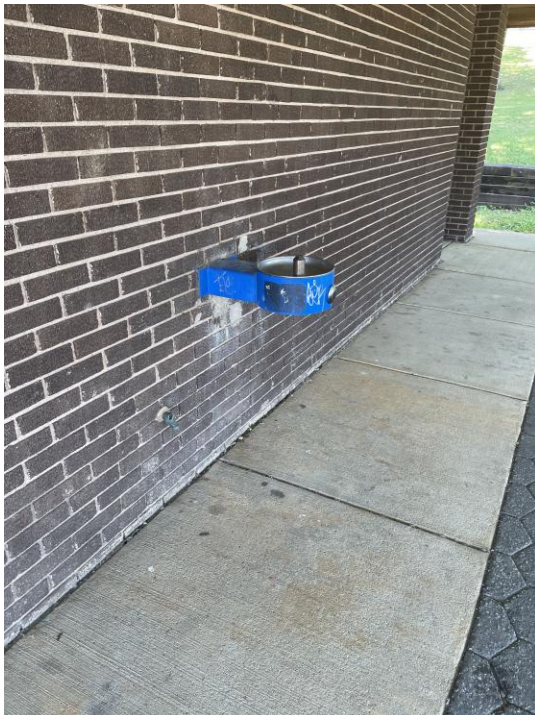
Concessions Area: Concessions

2 fountains in concessions area are at 29" above the ground

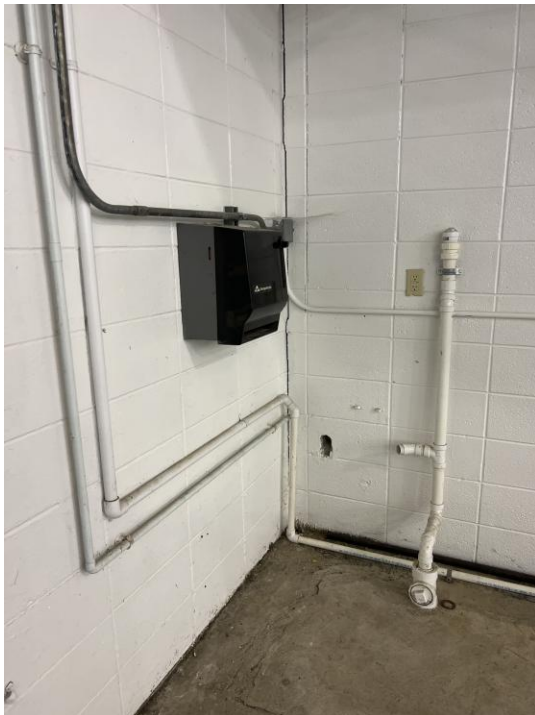
Ice Rink Area: Ice Rink

Wall-mounted objects that have leading edges between 27 inches and 80 inches from the floor must not project more than 4 inches into the circulation path. Protruding objects that extend to the floor or within 27 inches of the floor are cane detectable and are therefore not hazardous. Where it is necessary or desirable to have objects protrude from the wall, a manner of cane detection must be provided.

Dispenser protrudes 8" from wall.

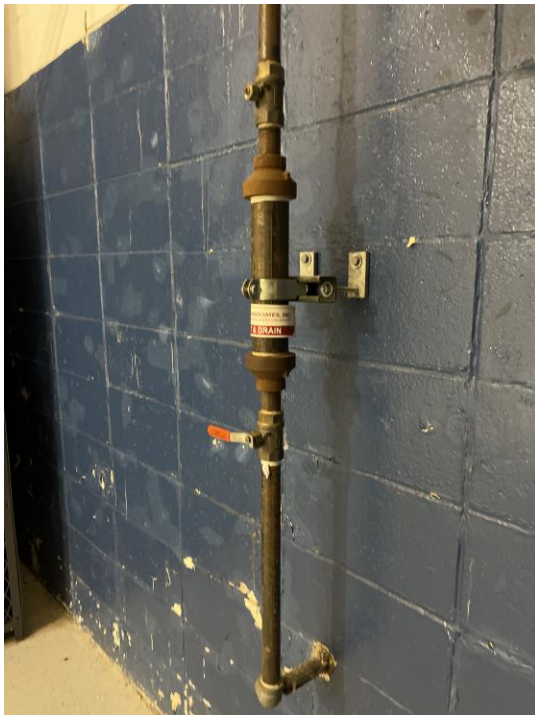
Ice Rink Area: Ice Rink

Wall-mounted objects that have leading edges between 27 inches and 80 inches from the floor must not project more than 4 inches into the circulation path. Protruding objects that extend to the floor or within 27 inches of the floor are cane detectable and are therefore not hazardous. Where it is necessary or desirable to have objects protrude from the wall, a manner of cane detection must be provided.

Pipes protrude 6" from wall.

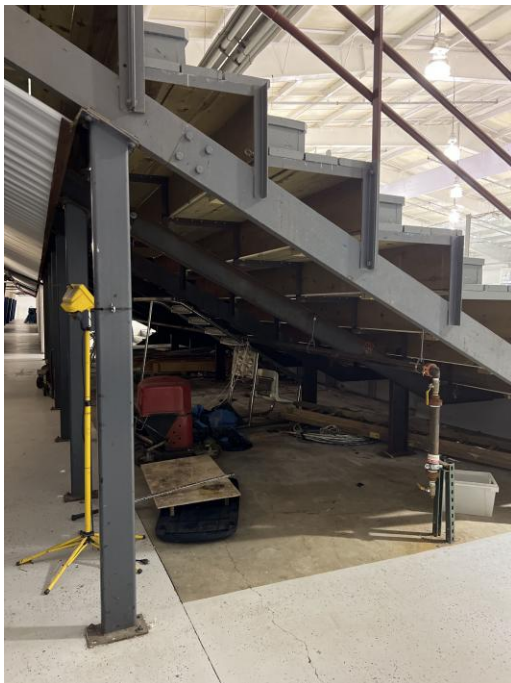
Ice Rink Area: Ice Rink

Spectator seating rail is less than 80".

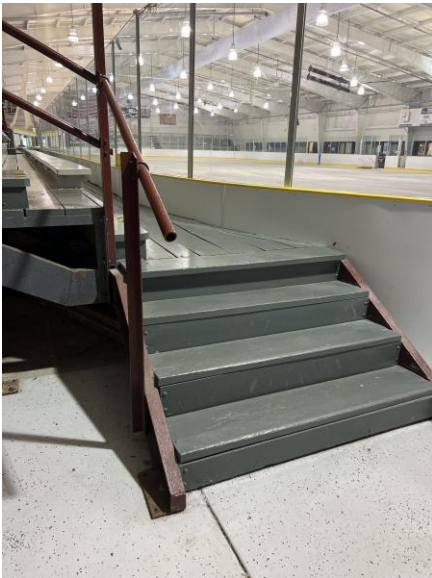
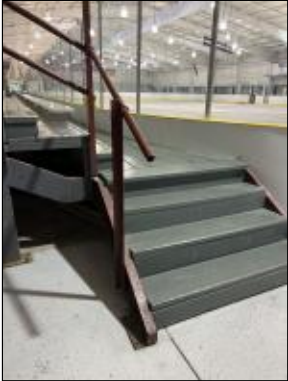
Ice Rink Area: Ice Rink

No hand rail extension

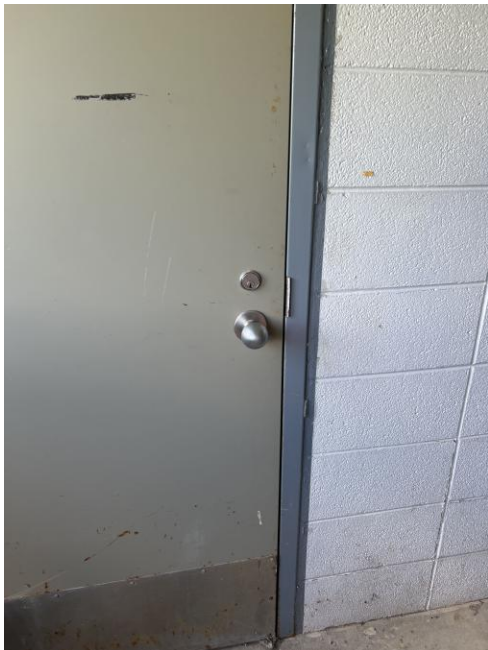
Ice Rink Area: Ice Rink

Door has existing knob

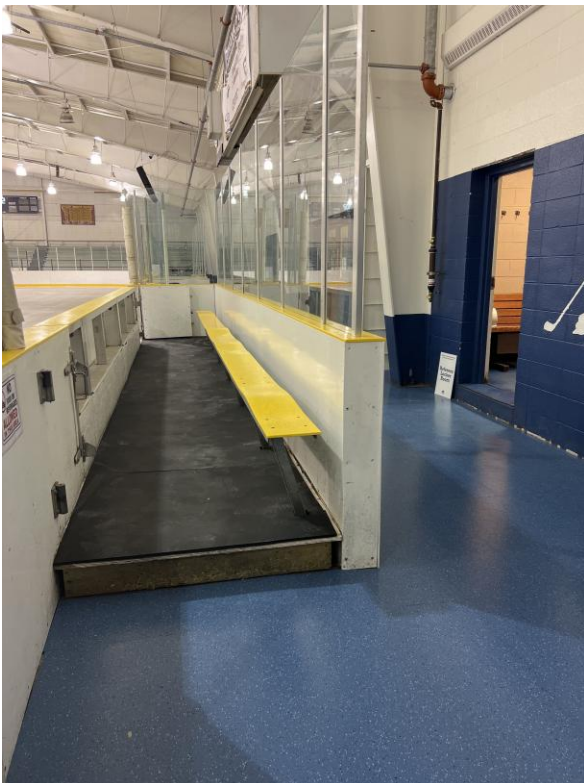
Step/riser is 6"

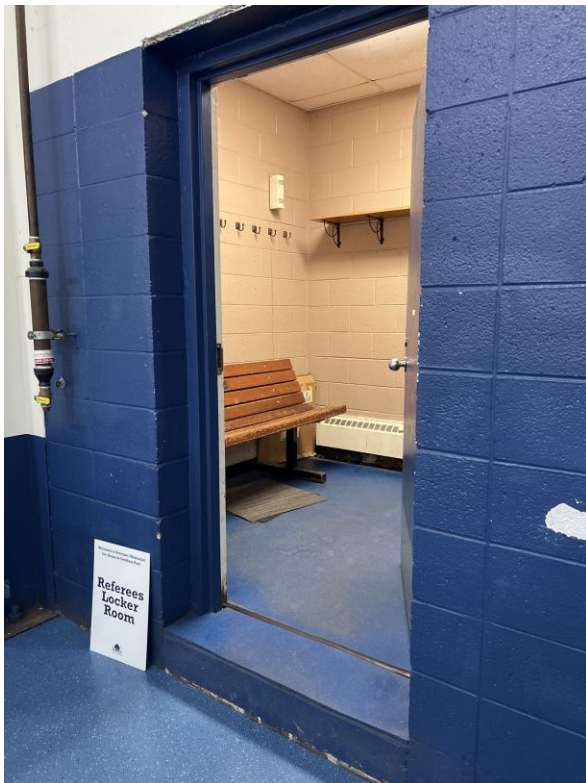
Step/riser is 6"
