Site Accessibility Evaluation

Allmendinger Park
655 Pauline Blvd
Ann Arbor, MI 48104
ADA Only

Inspection Date: 07/11/2022

Report Date: 11/15/2022

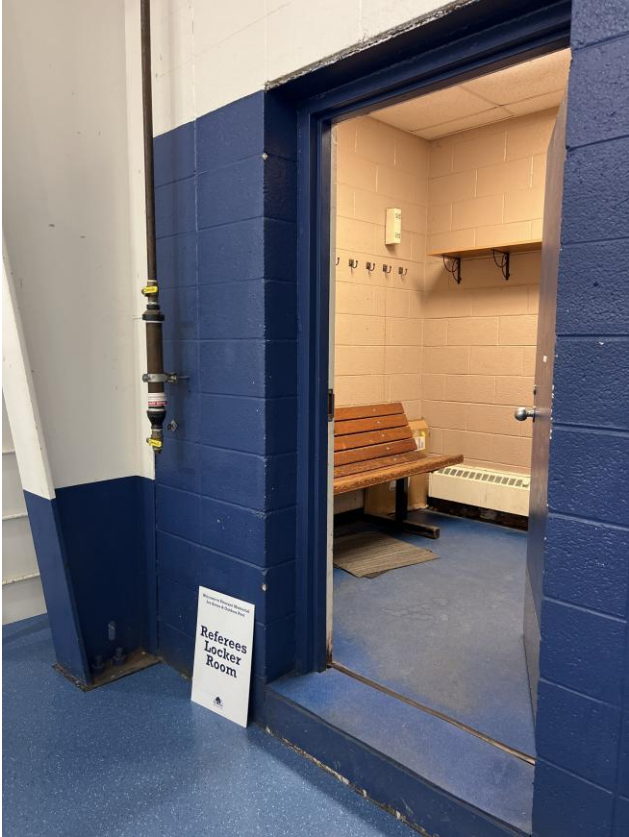
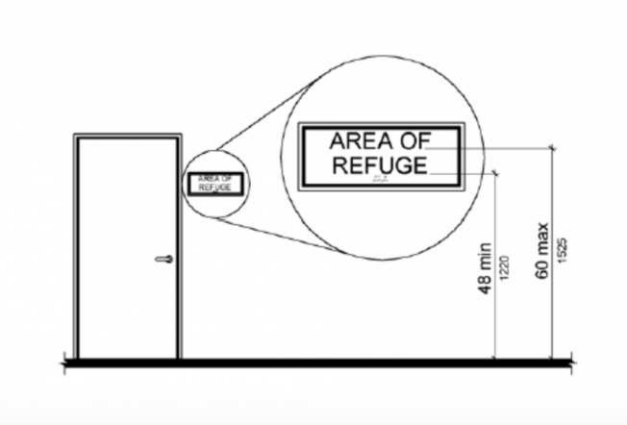
Finding #90 Continued

Compliant room identification signs are missing.

Signage is printed on paper/metal

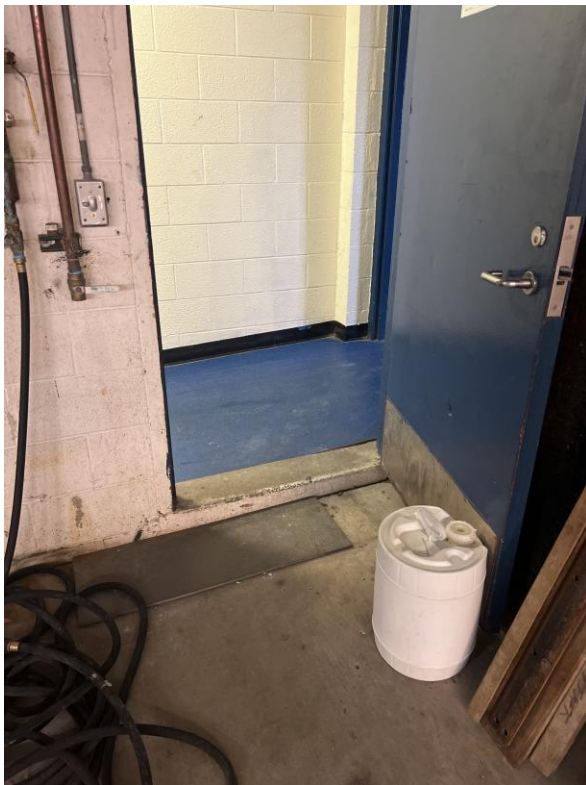
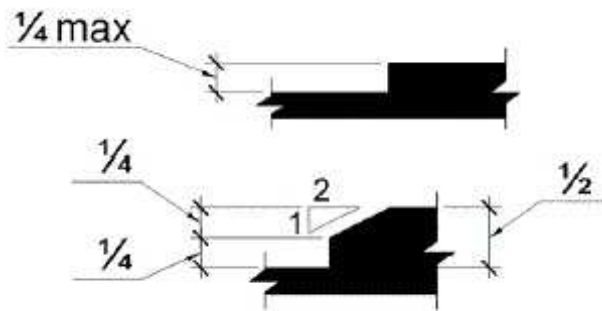
Step/riser is 3"

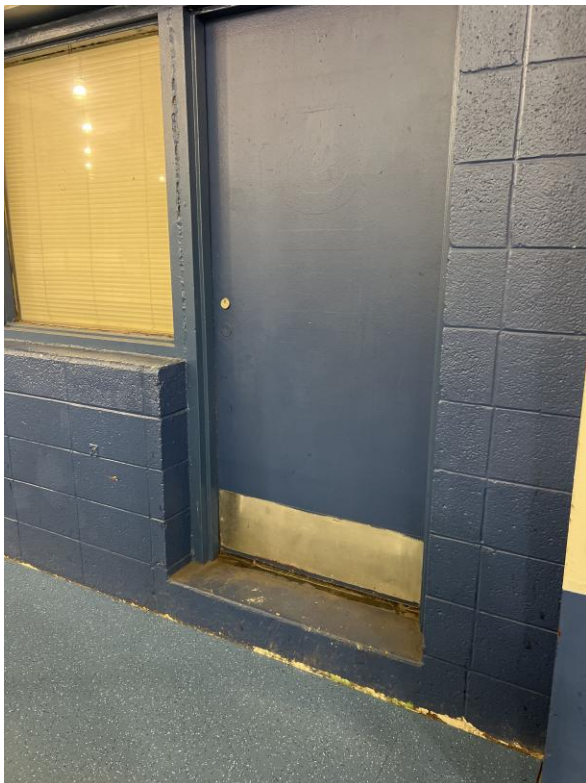
Step/riser is 4"

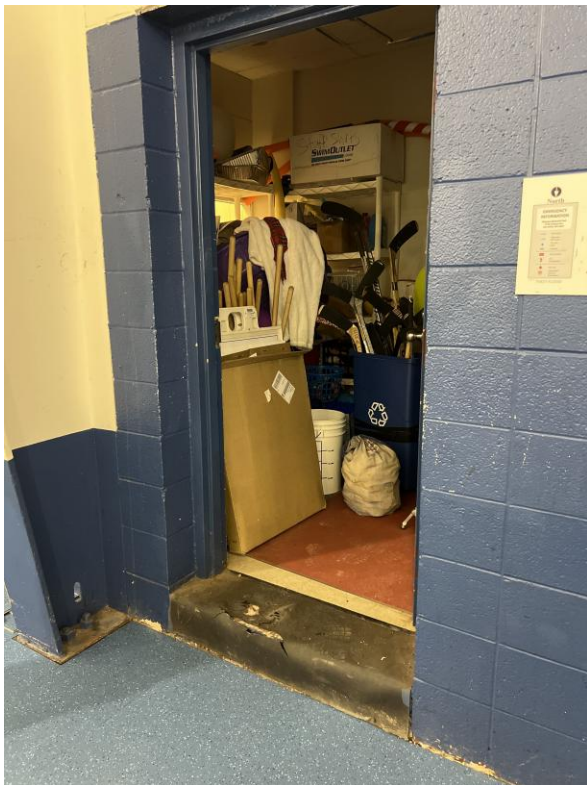
Step/riser is 4"

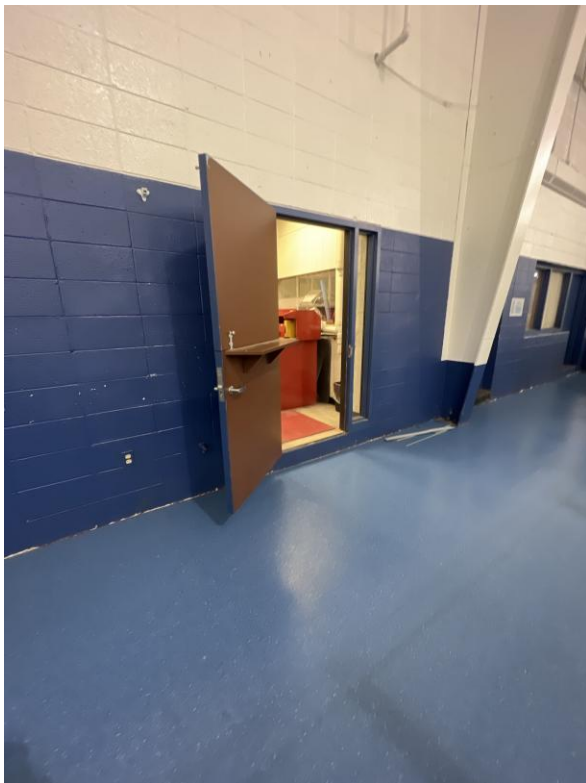
Step/riser is 5"

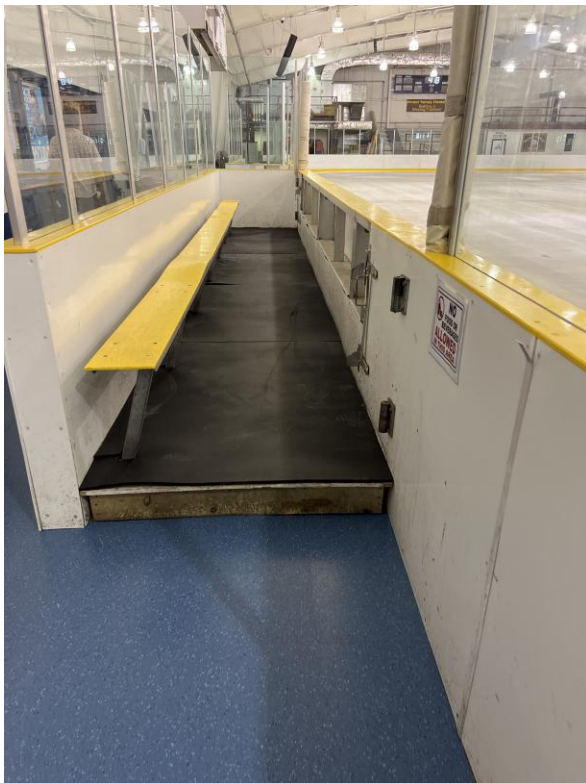
Step/riser is 6"

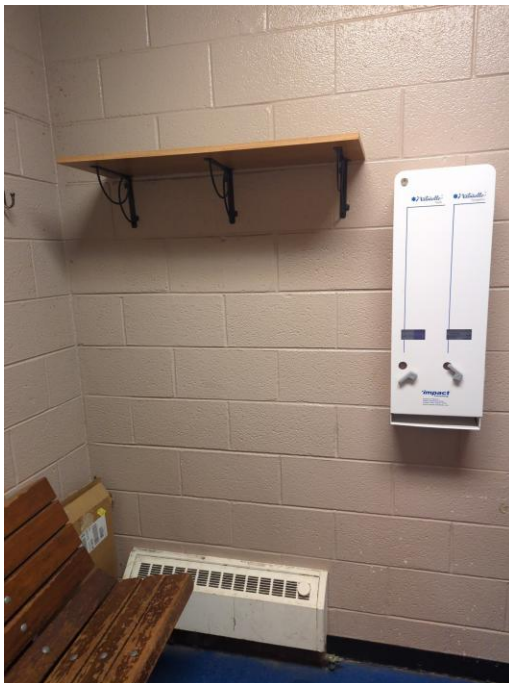
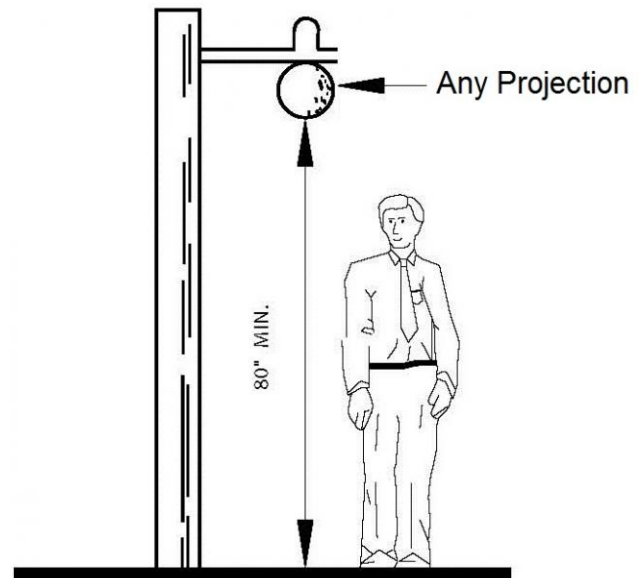
Wall-mounted shelf is 76 inches high

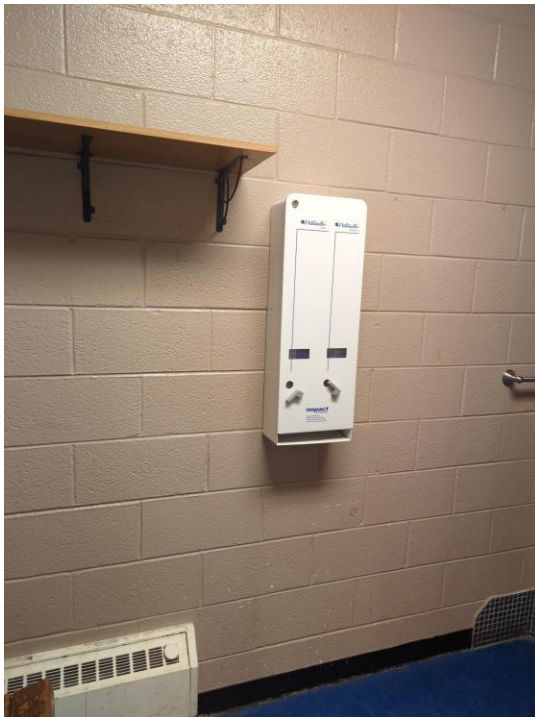
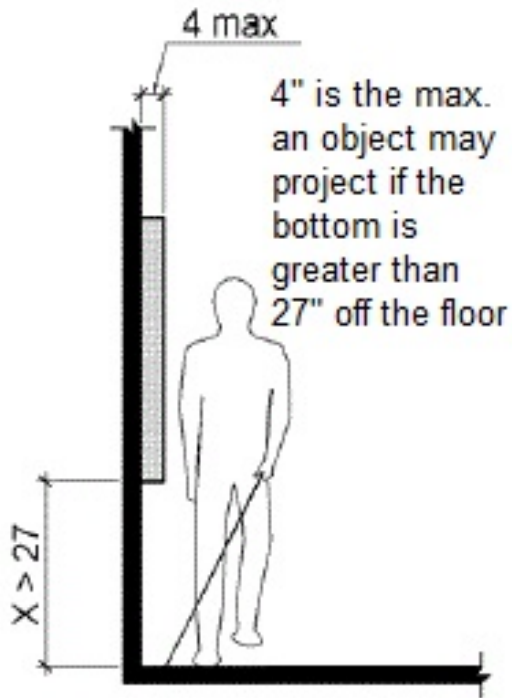
Wall-mounted objects that have leading edges between 27 inches and 80 inches from the floor must not project more than 4 inches into the circulation path. Protruding objects that extend to the floor or within 27 inches of the floor are cane detectable and are therefore not hazardous. Where it is necessary or desirable to have objects protrude from the wall, a manner of cane detection must be provided.

Feminine product dispenser protrudes 6 inches

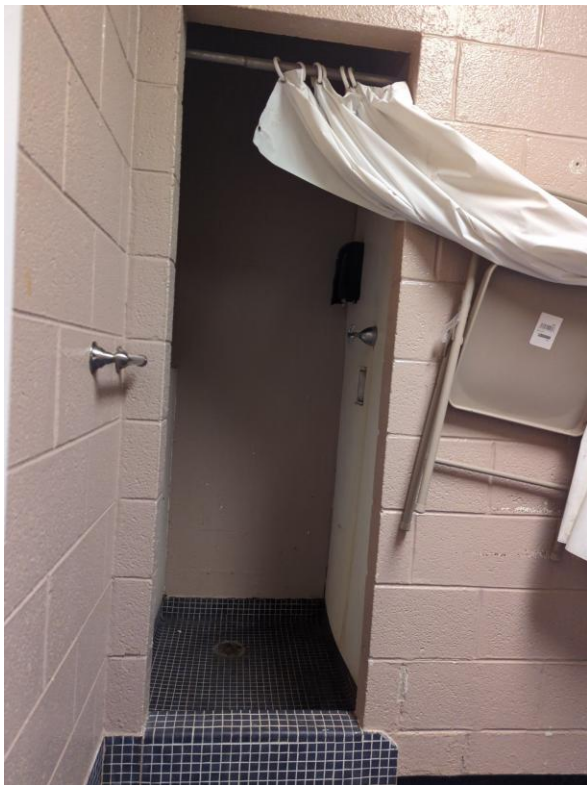
Shower is not accessible

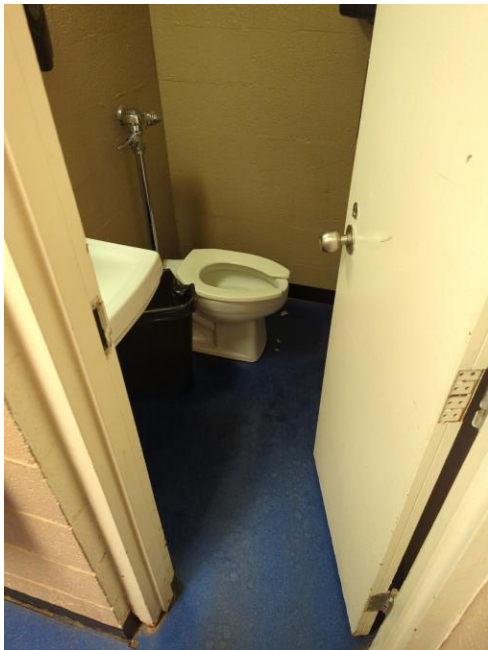
The restroom does not have the required minimum clear floor space or maneuvering clearances for the toilet. The restroom does not have the required minimum clear floor space or maneuvering clearances for the lavatory. The entry door does not contain the required minimum maneuvering spaces on the pull/push sides. The entry door encroach into the required clear floor space for fixtures. Grab bars are missing and/or incorrectly installed. Accessories, such as toilet seat covers, paper towel holders, garbage cans, hand dryers, and mirrors are either too high or without clear floor space or both.

Restroom is not accessible

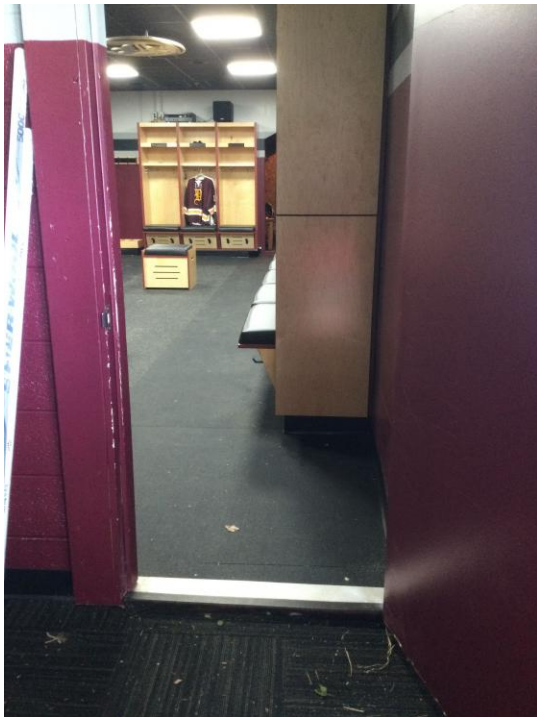
1.5"

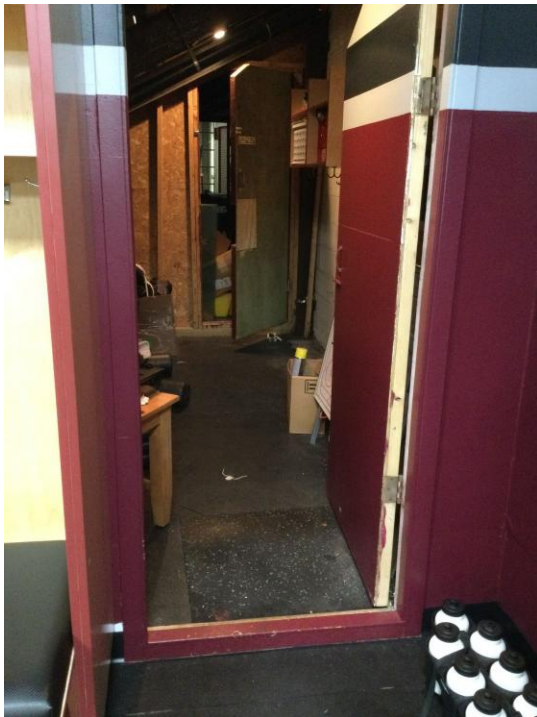
2.25"

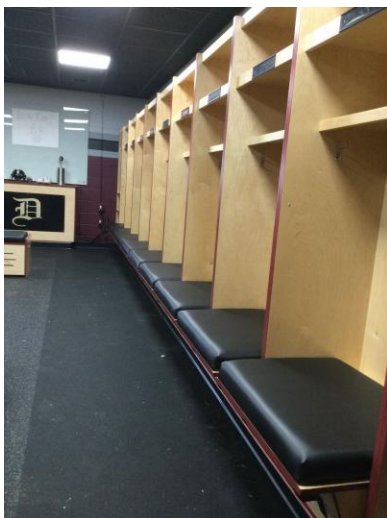
Bench seats are less than 42" long.

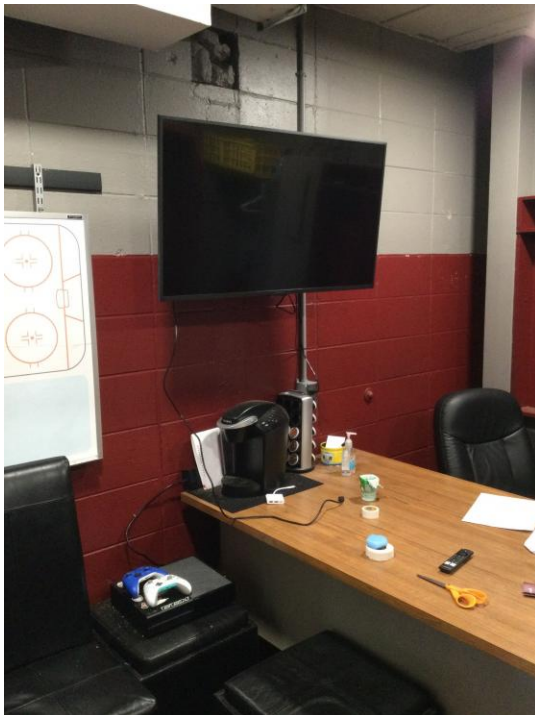
Wall-mounted objects that have leading edges between 27 inches and 80 inches from the floor must not project more than 4 inches into the circulation path. Protruding objects that extend to the floor or within 27 inches of the floor are cane detectable and are therefore not hazardous. Where it is necessary or desirable to have objects protrude from the wall, a manner of cane detection must be provided.

Screen protrudes 12" from wall

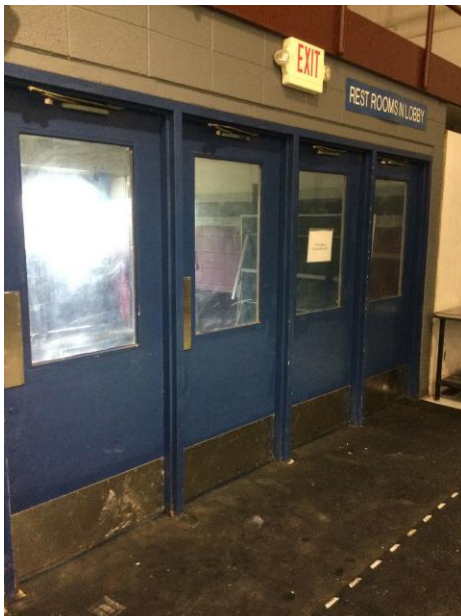
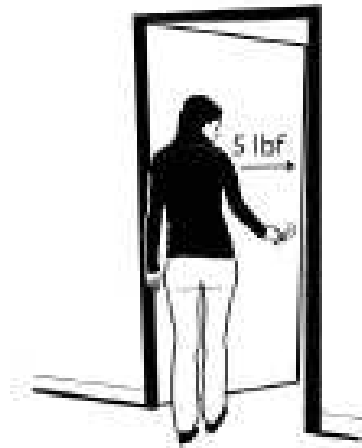
Doors require excess pressure to open

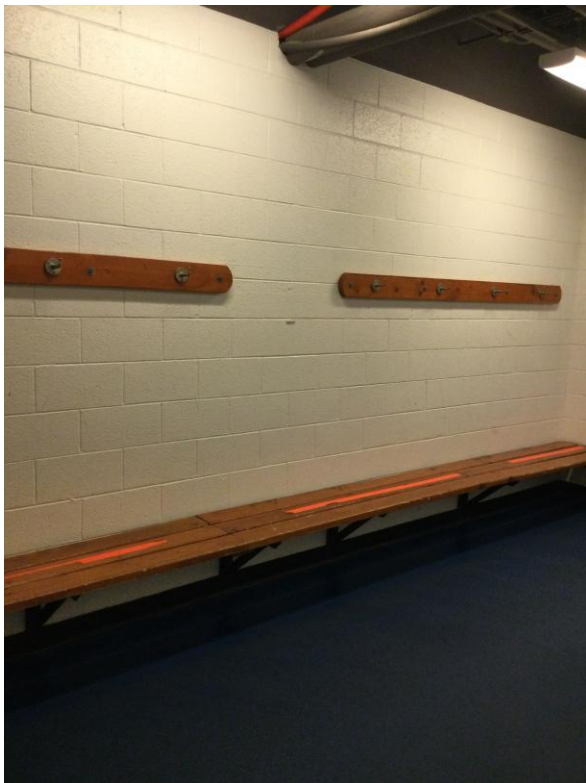
Hooks mounted 65"

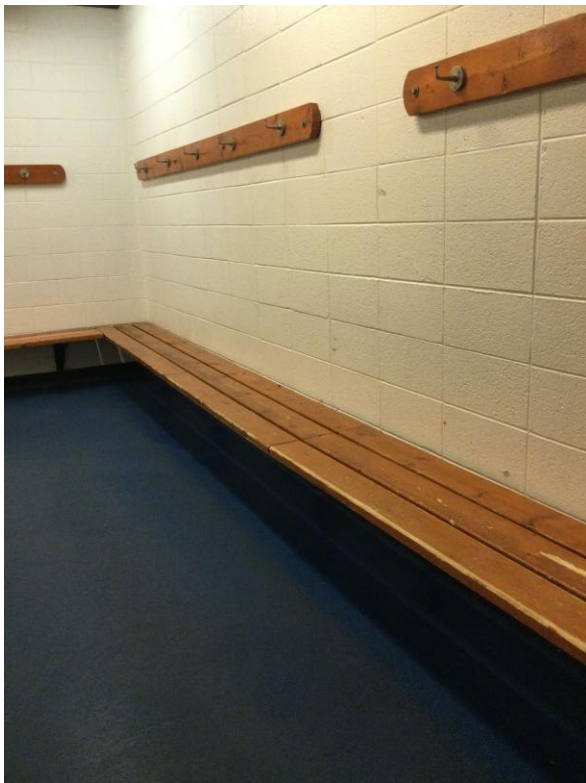
Bench depth is 18"

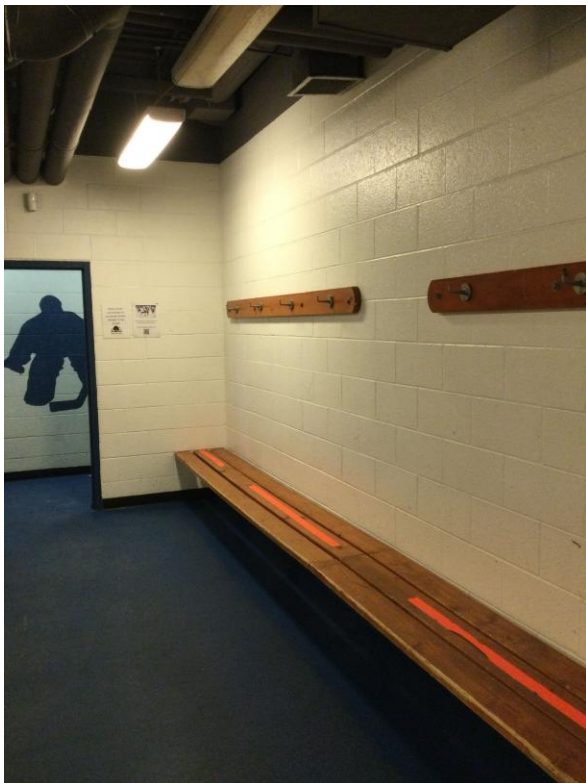
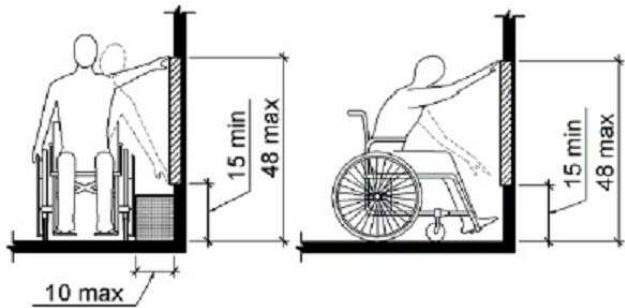
Hooks mounted 65"

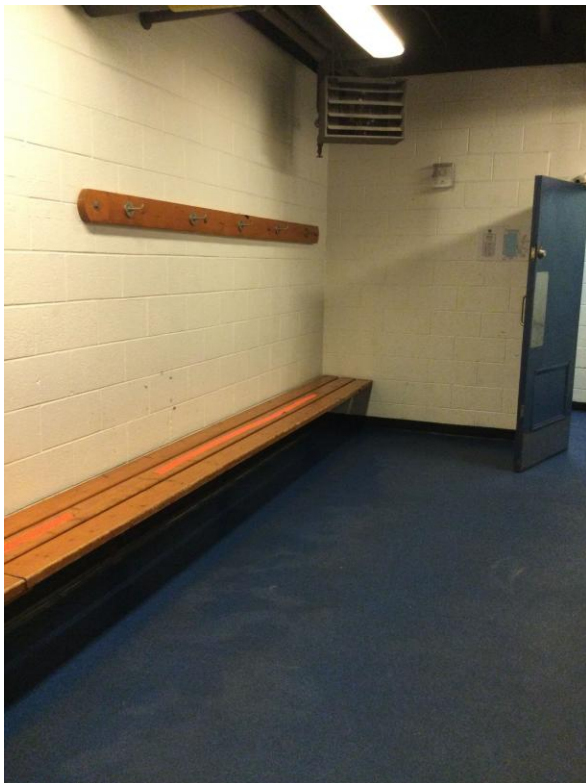
Bench depth is 18"

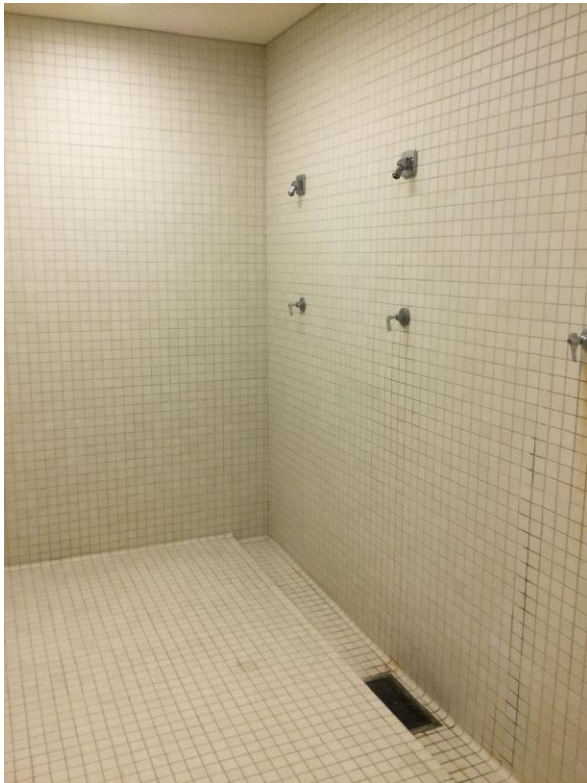
Shower space is not accessible

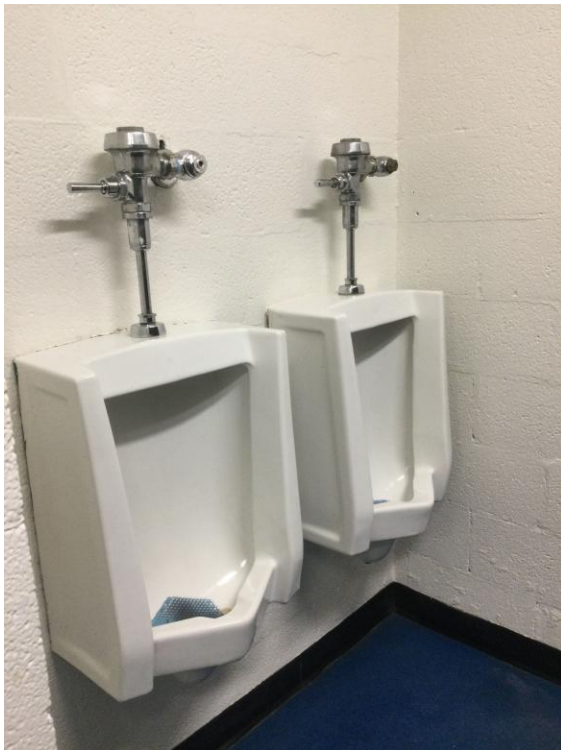
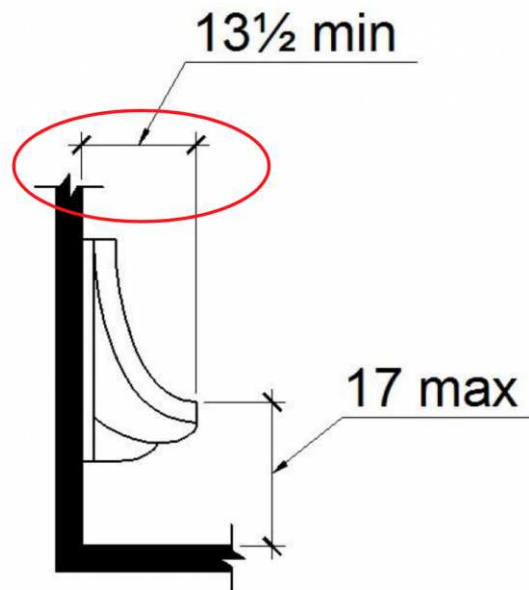
22" rim height

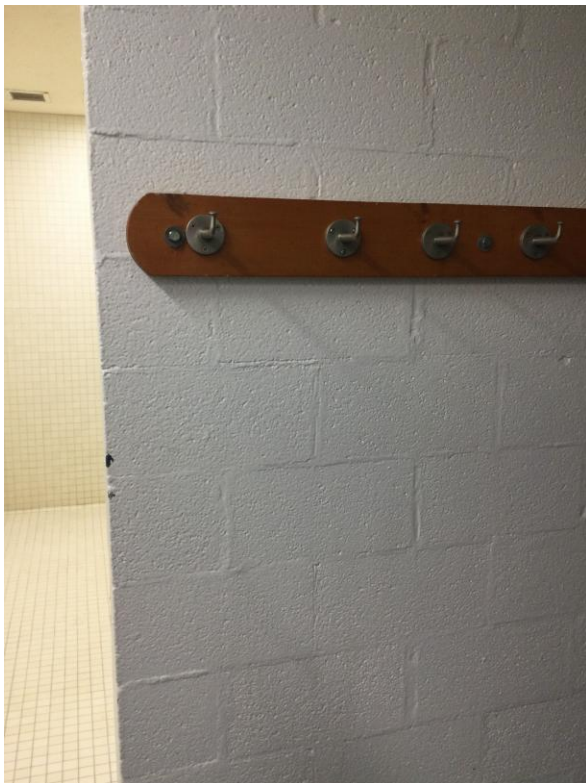
Hooks mounted 65"

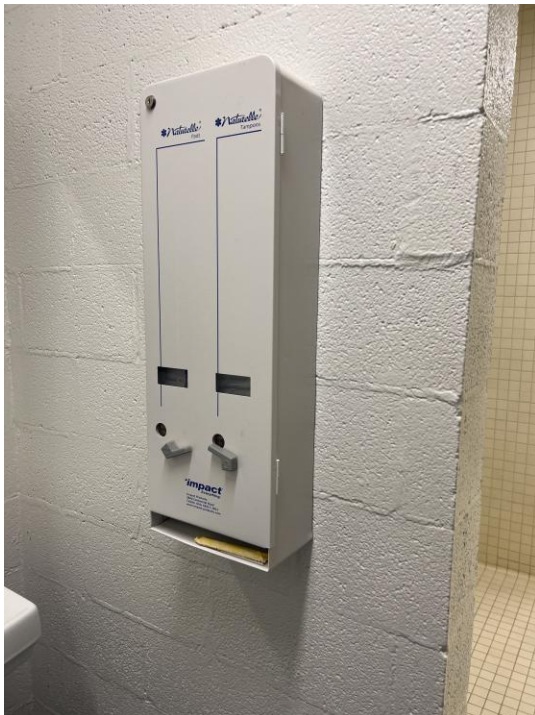
Wall-mounted objects that have leading edges between 27 inches and 80 inches from the floor must not project more than 4 inches into the circulation path. Protruding objects that extend to the floor or within 27 inches of the floor are cane detectable and are therefore not hazardous. Where it is necessary or desirable to have objects protrude from the wall, a manner of cane detection must be provided.

Dispenser protrudes 6" from wall

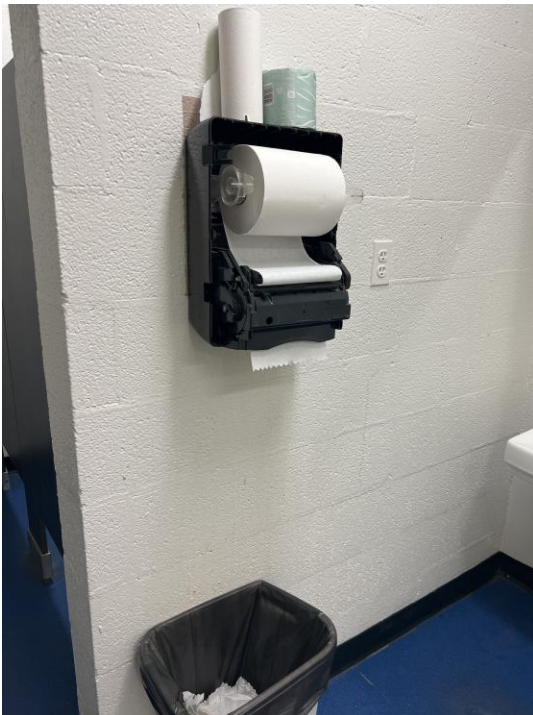
Wall-mounted objects that have leading edges between 27 inches and 80 inches from the floor must not project more than 4 inches into the circulation path. Protruding objects that extend to the floor or within 27 inches of the floor are cane detectable and are therefore not hazardous. Where it is necessary or desirable to have objects protrude from the wall, a manner of cane detection must be provided.

Dispenser protrudes 7" from wall

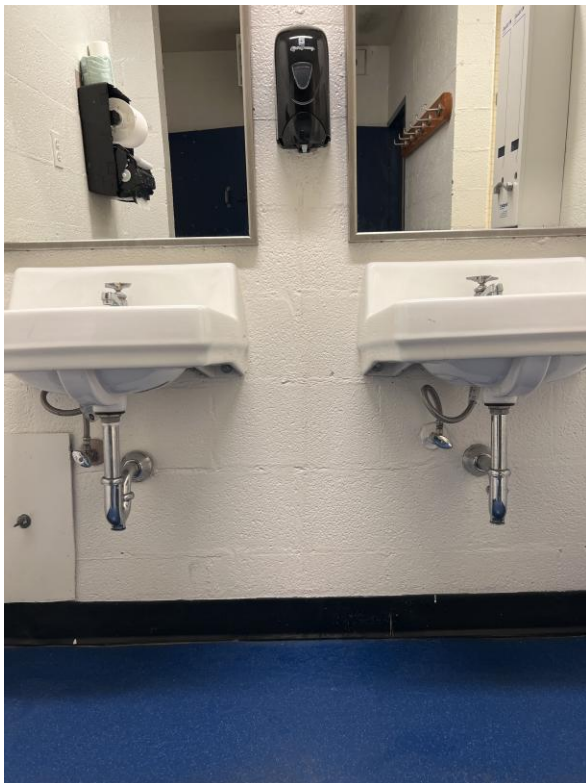
Lavatory pipes are not insulated

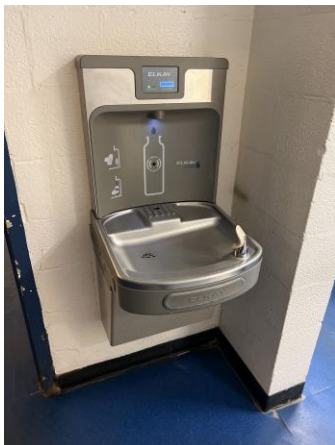
Missing standing drinking fountain

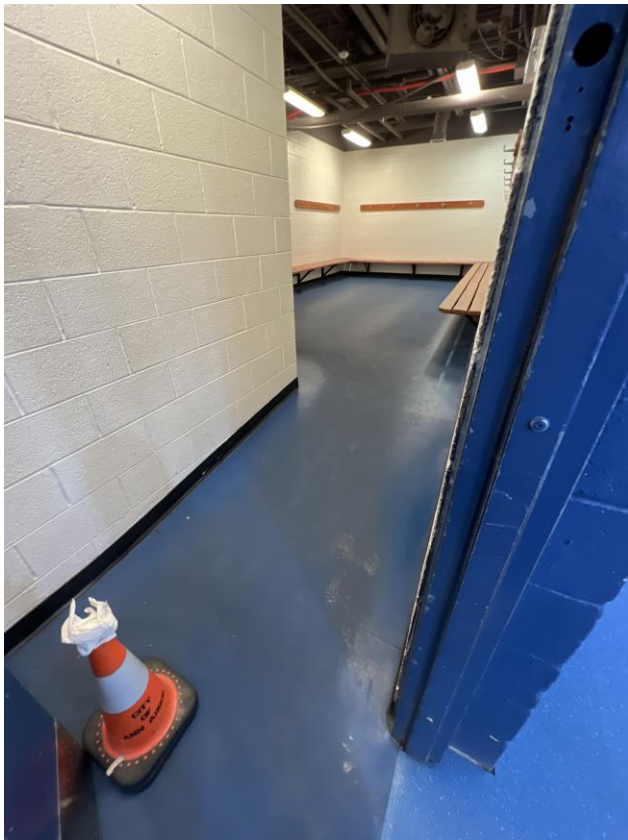
Ramp slope exceeds minimum

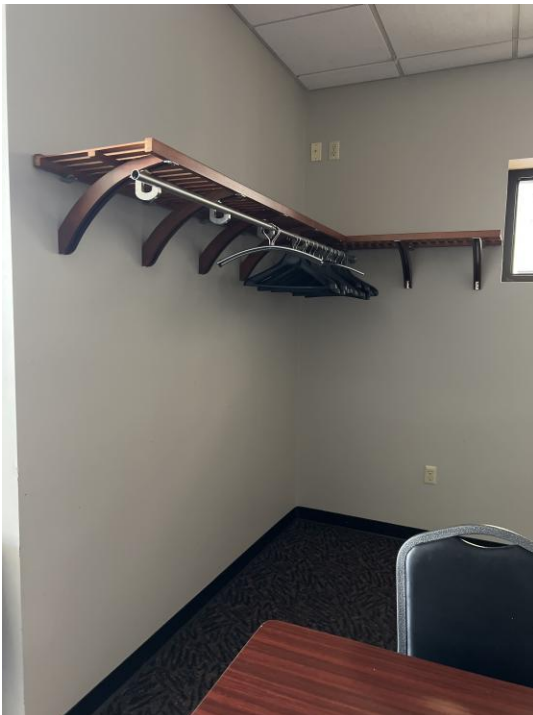
Wall-mounted objects that have leading edges between 27 inches and 80 inches from the floor must not project more than 4 inches into the circulation path. Protruding objects that extend to the floor or within 27 inches of the floor are cane detectable and are therefore not hazardous. Where it is necessary or desirable to have objects protrude from the wall, a manner of cane detection must be provided.

Rack protrudes 12" from wall

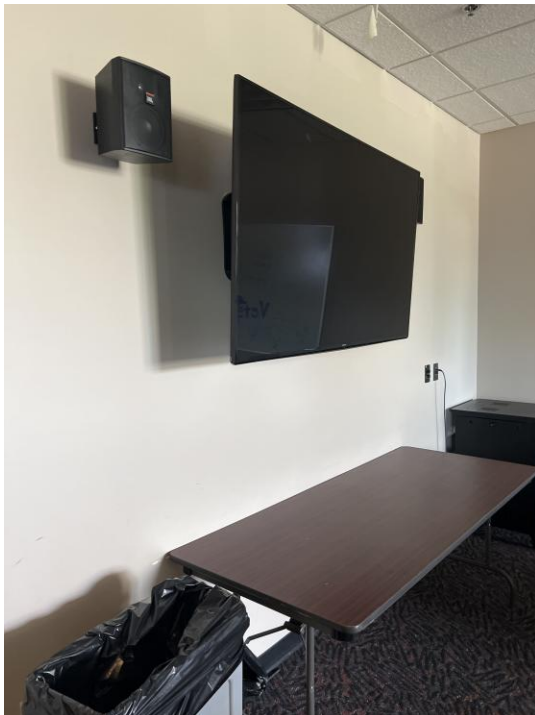
Wall-mounted objects that have leading edges between 27 inches and 80 inches from the floor must not project more than 4 inches into the circulation path. Protruding objects that extend to the floor or within 27 inches of the floor are cane detectable and are therefore not hazardous. Where it is necessary or desirable to have objects protrude from the wall, a manner of cane detection must be provided.

Digital display protrudes 12" from wall

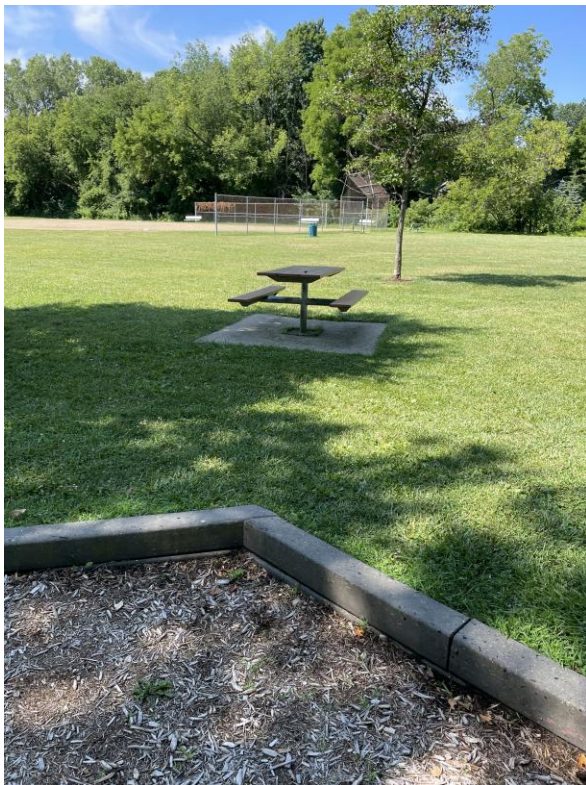
There is no accessible route provided to the picnic table

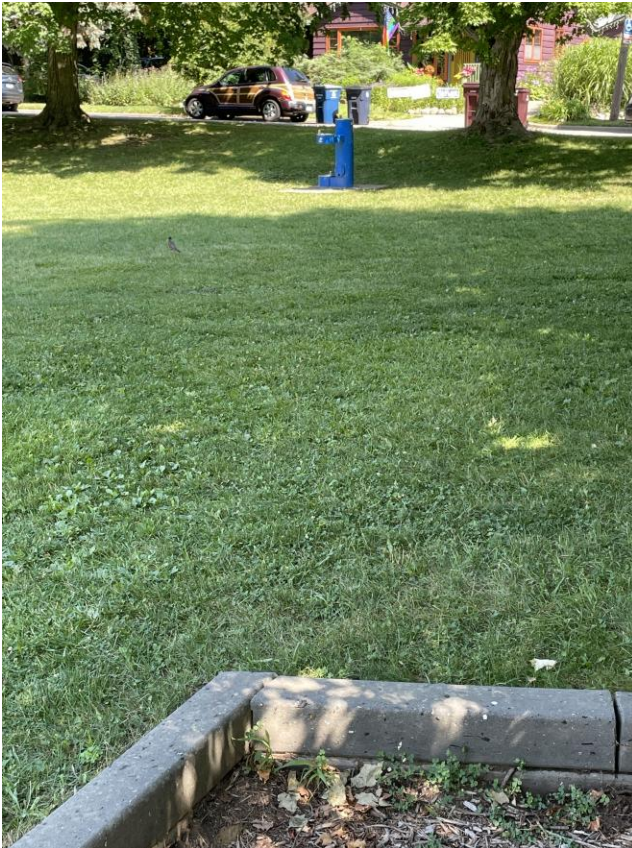
There is no accessible route provided to the drinking fountain

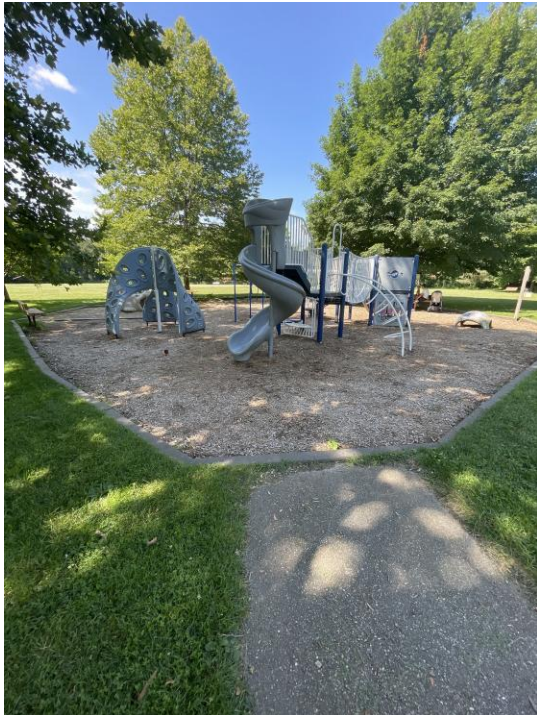
Play Area: Playground

The play area ground surface is not compliant

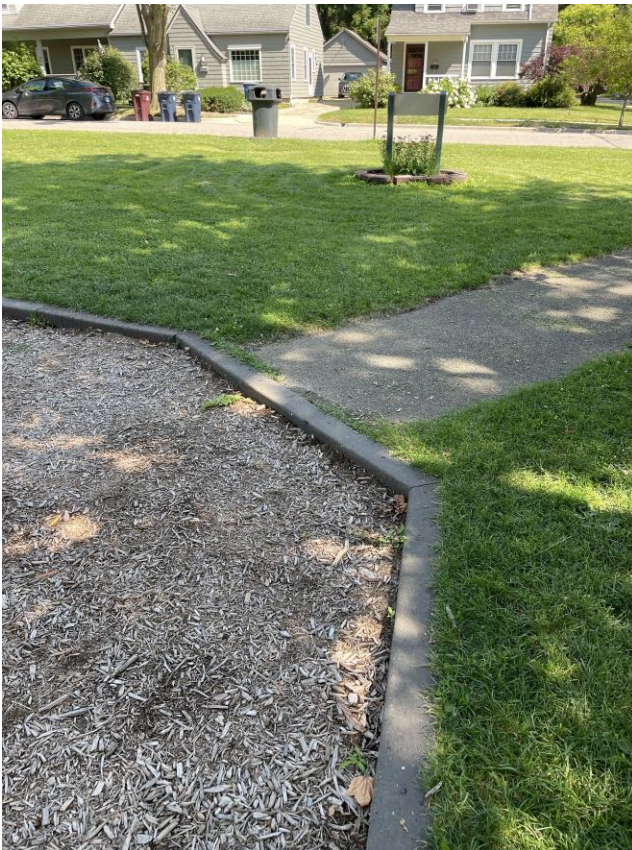
Play Area: Playground

There is a vertical change in level greater than 1/2-inch to the play area; ramp is required.

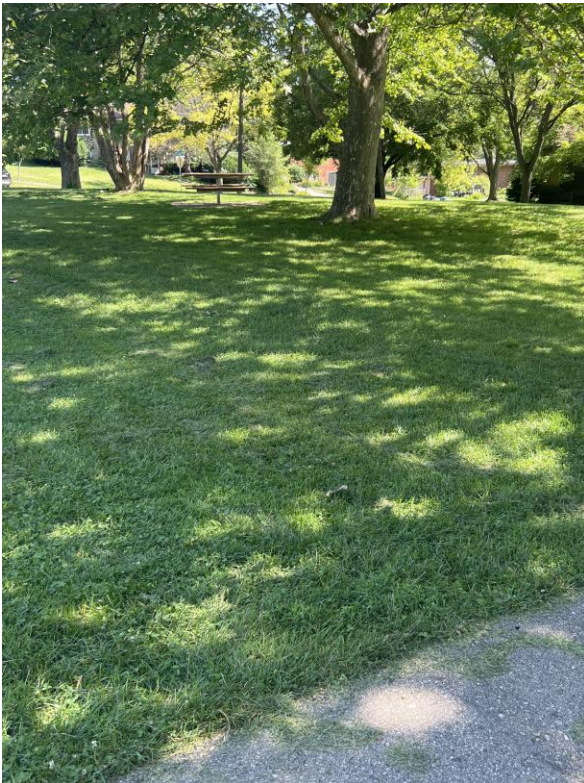
Basketball Court: Picnic Area

There is no accessible route provided to the picnic table from basketball court

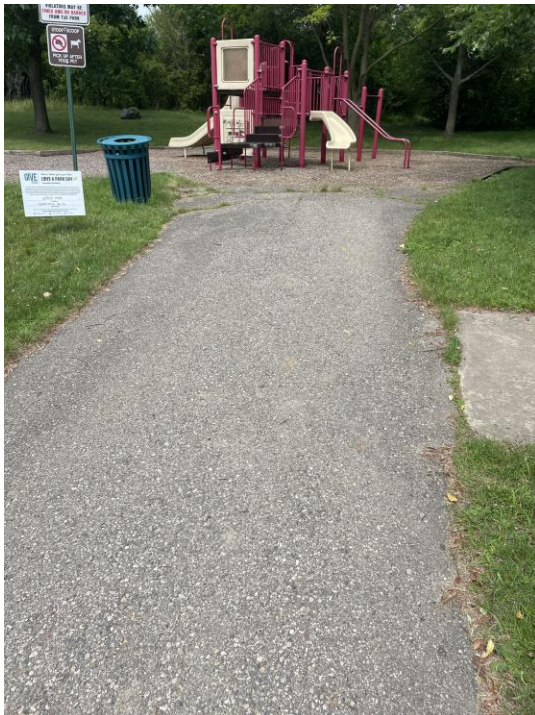
Approximately 30 linear feet of sidewalk has a running slope greater than 5%.

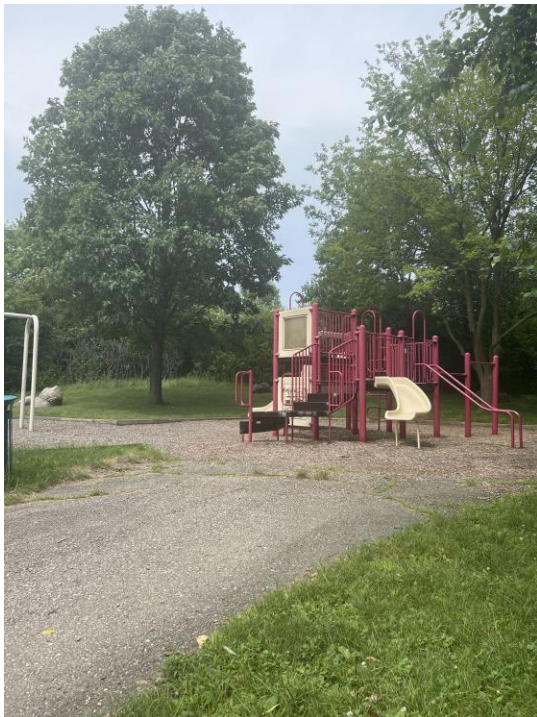
Play Area: Playground

The play area does not have a compliant ground surface.

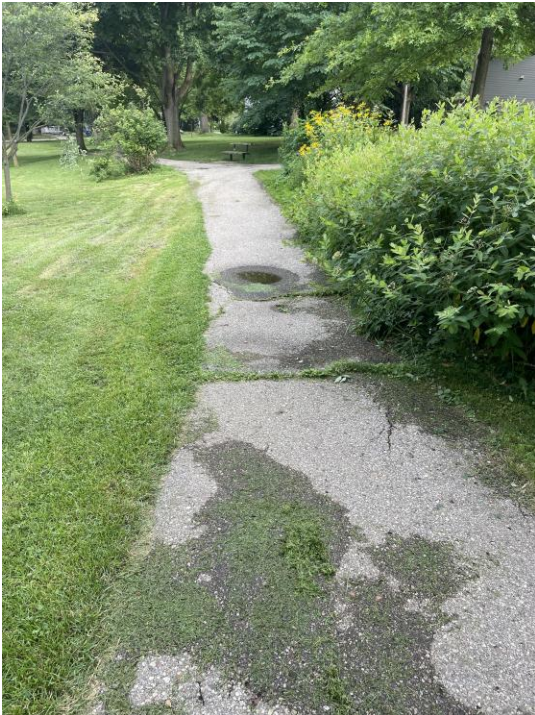
The accessible route has running slopes greater than 5% and vertical changes in level greater than 1/2-inch.

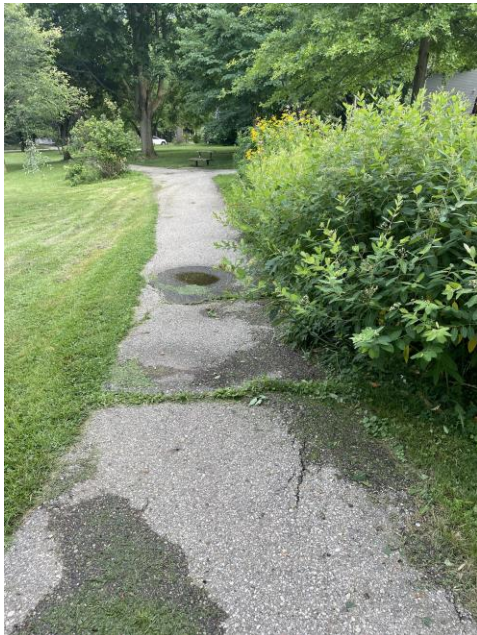
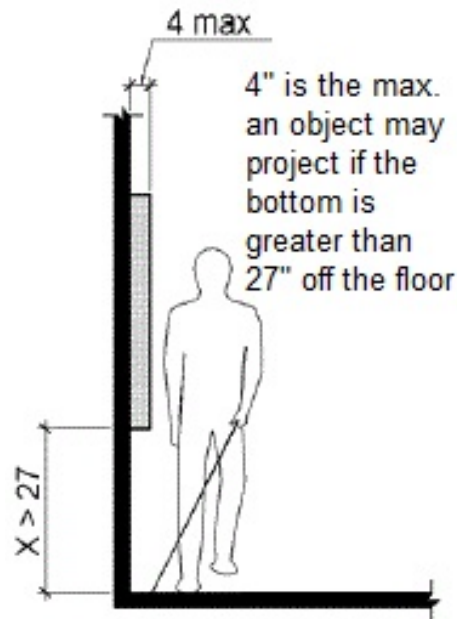
Trail System: Trail

Vegetation protrudes over the trail more than 4 inches

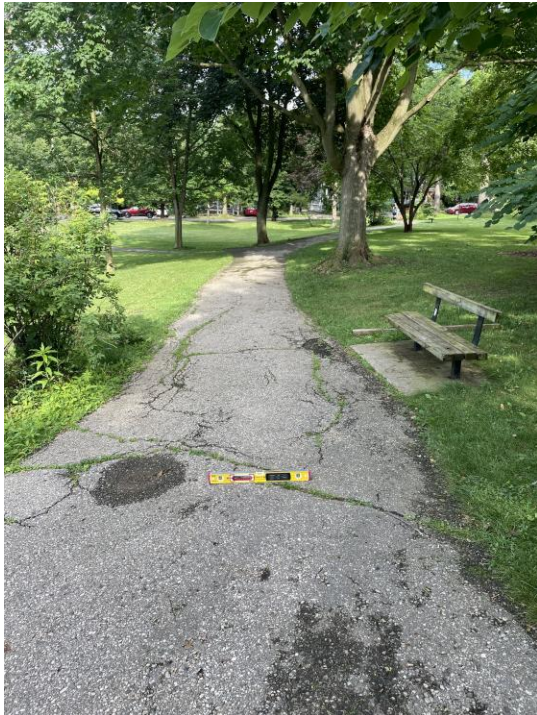
Trail System: Trail

The accessible route has running slopes greater than 5% and vertical changes in level greater than 1/2-inch.

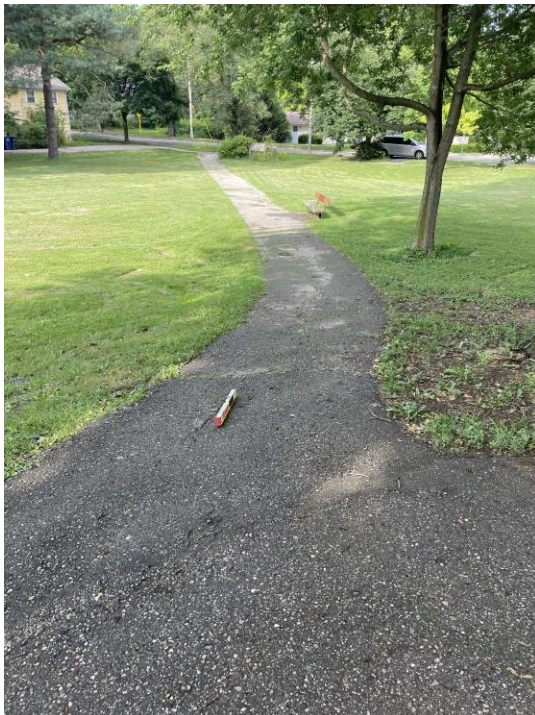
Trail System: Trail

The accessible route has running slopes greater than 5% and cross slopes greater than 2%.

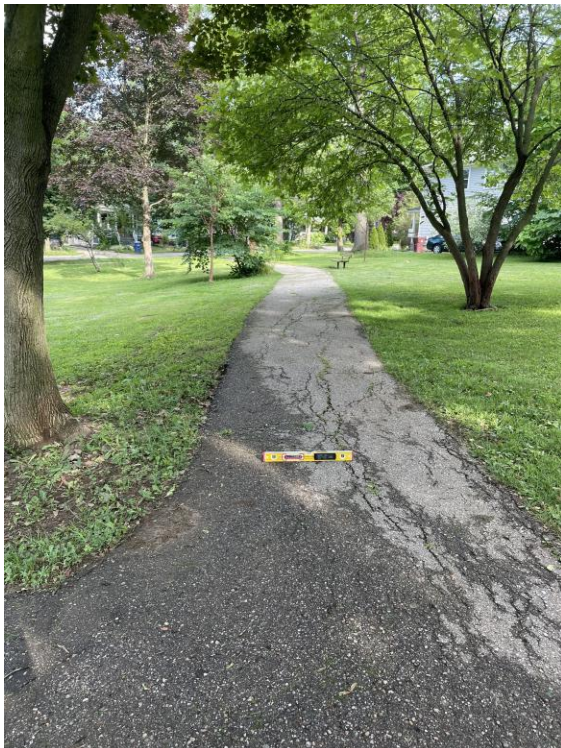
Trail System: Trail

The accessible route has cross slopes greater than 2%

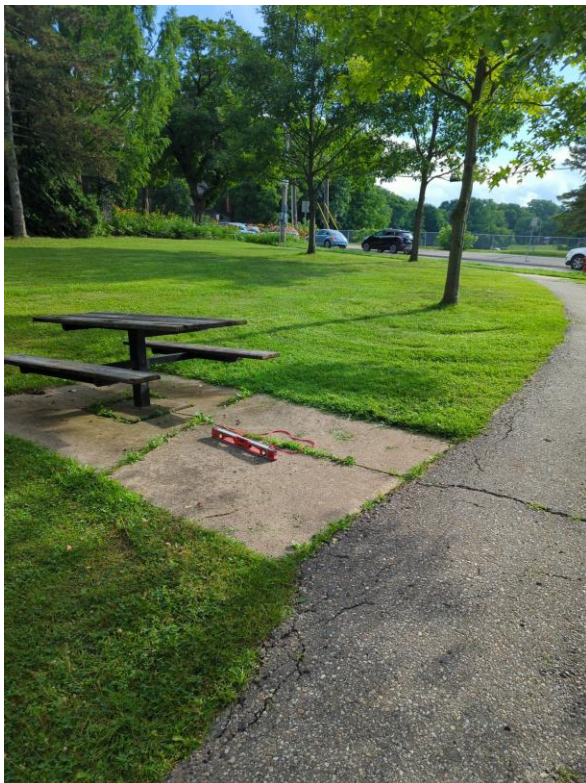
Trail System: Trail

Clear floor space at accessible picnic table has a slope of 3%

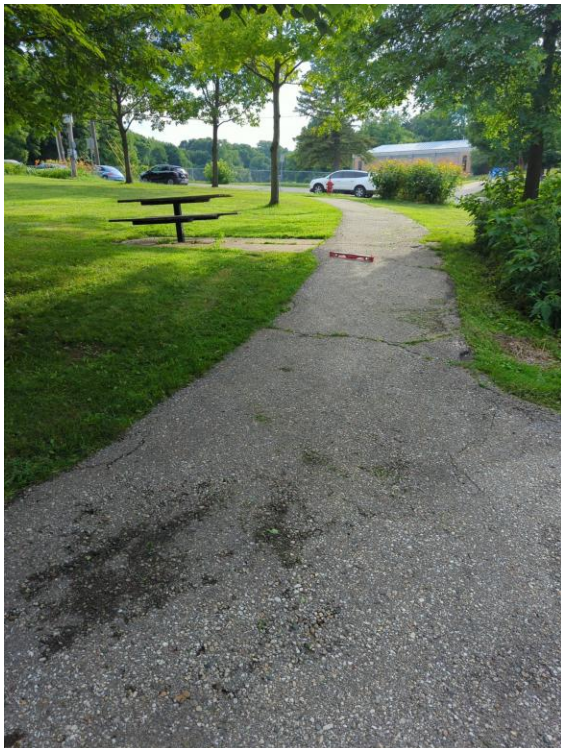
Trail System: Trail

Path leading to accessible table has a cross slope of up to 11%

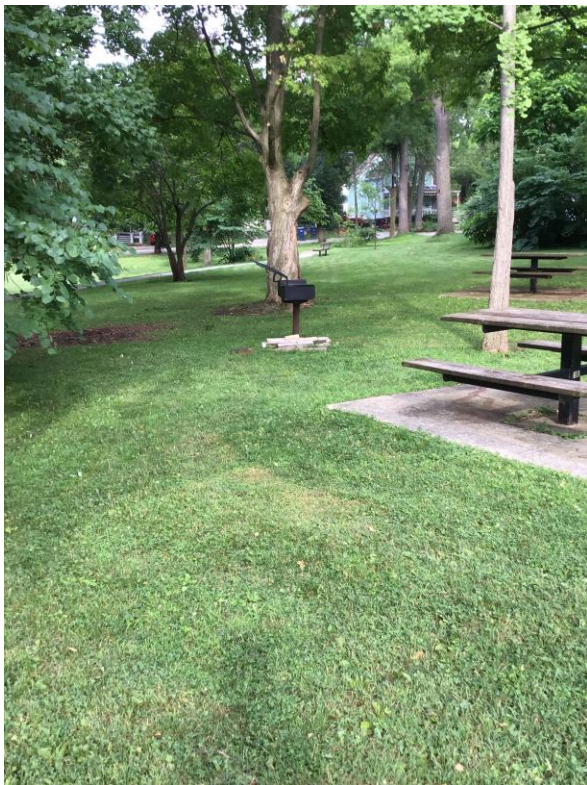
Green Space: Picnic Area

There is no accessible route provided to the grill.

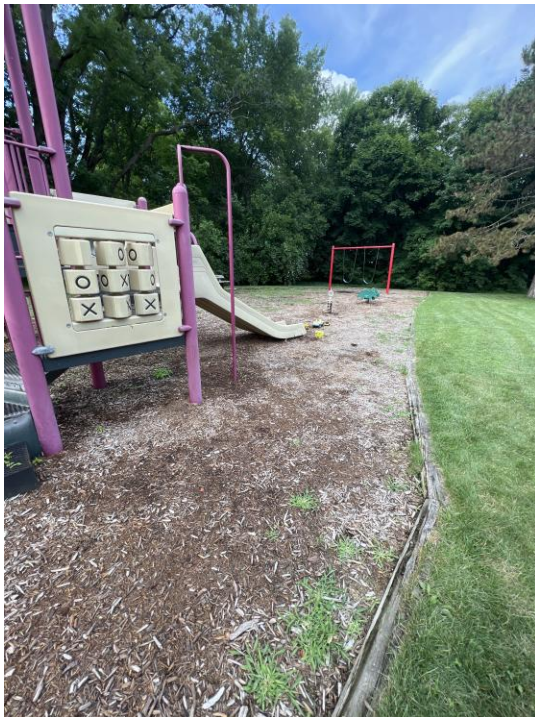
Play Area: Playground

The play area ground surface is not compliant; the surface is not firm, stable, and slip resistant.

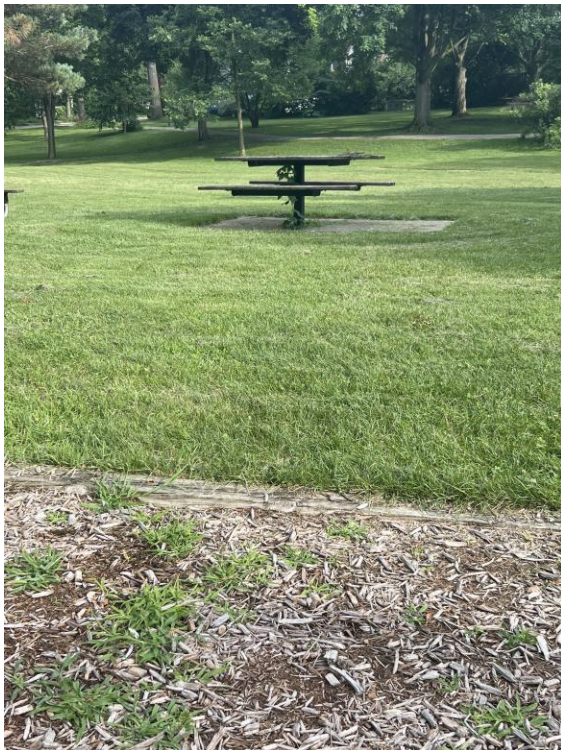
Play Area: Playground

There is no accessible route provided to the picnic table; at least 5% of the picnic tables must be accessible and on an accessible route.

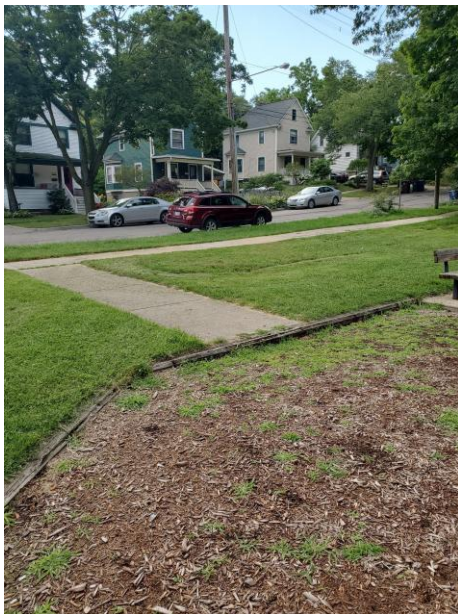
Play Area: Large Playground

The play area entrance has a vertical change in level greater than 1/2-inch which requires a ramp.
