Site Accessibility Evaluation

Allmendinger Park
655 Pauline Blvd
Ann Arbor, MI 48104
ADA Only

Inspection Date: 07/11/2022

Report Date: 11/15/2022

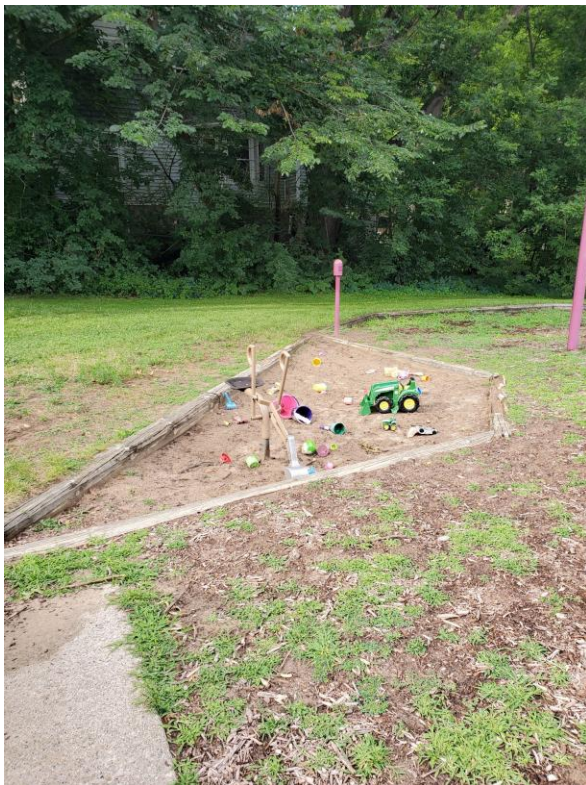
Play Area: Large Playground

There is no accessible route provided to the sand box.

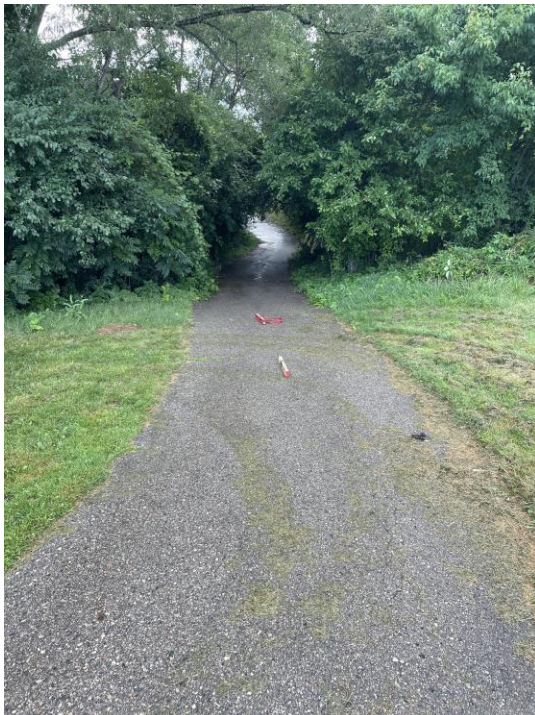
Running slope of trail is 10% and greater

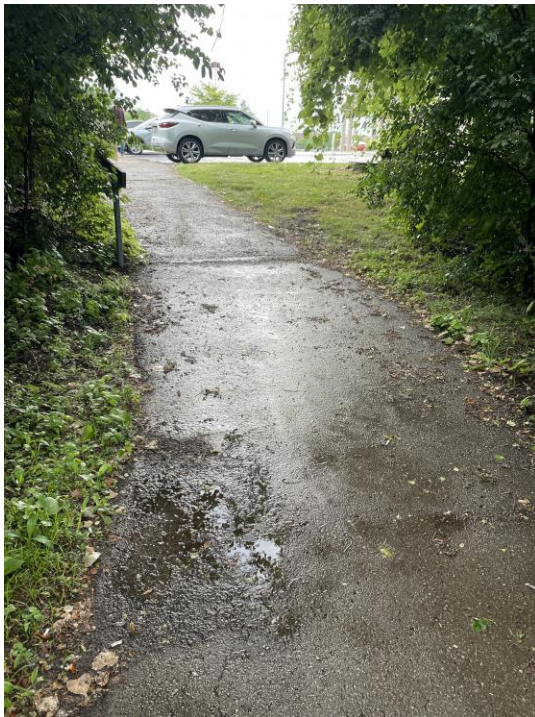
Trail System: Trail

Running slope of trail is 10% and greater

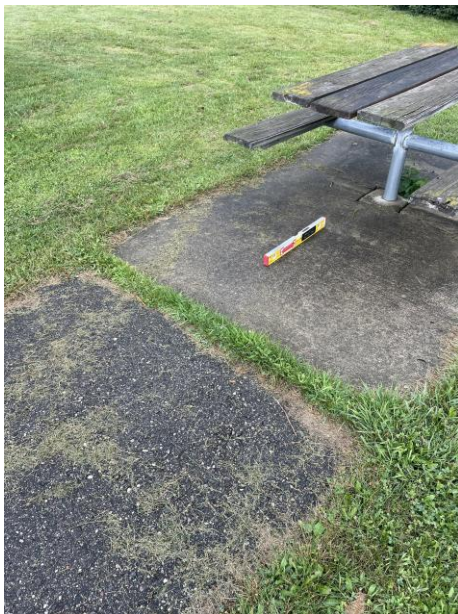
Vegetation between asphalt and concrete create a vertical change in level greater than 1/2-inch.

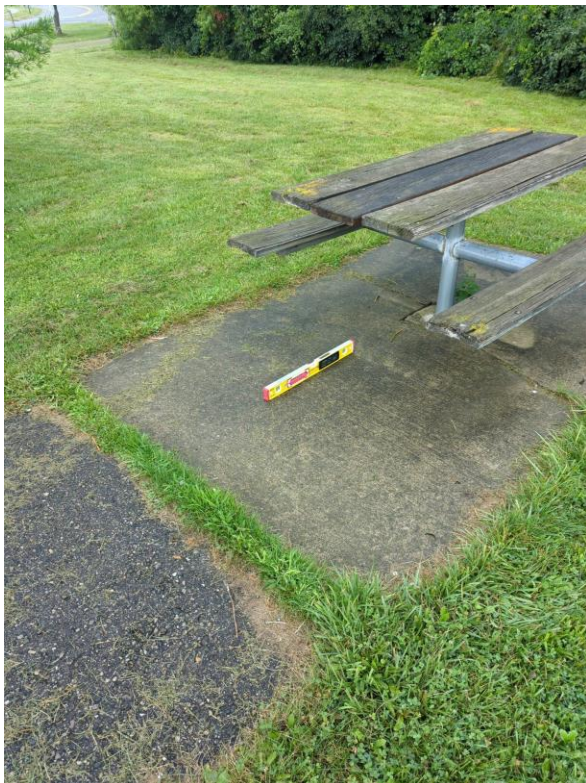
Green Space: Picnic Area

Table clear floor space has a slope of up to 4%

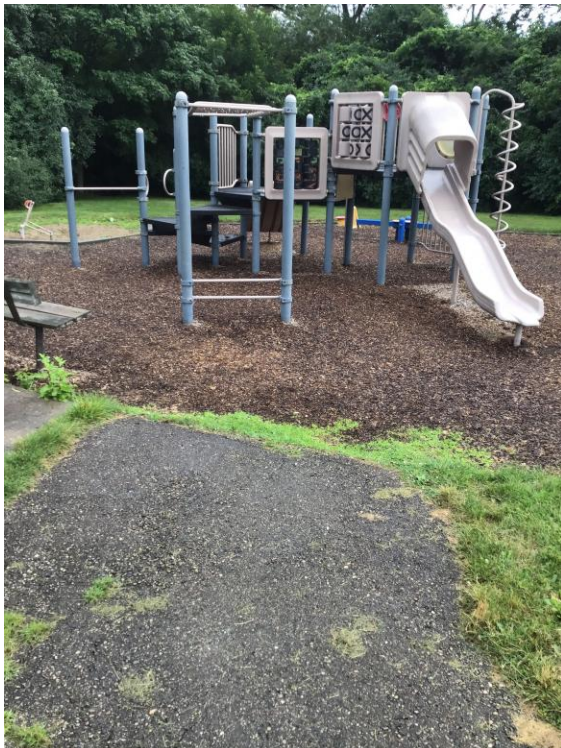
Play Area: Play Area

There is no accessible route to play area; route to the play area has a vertical change in level greater than 1/2-inch which requires a ramp.

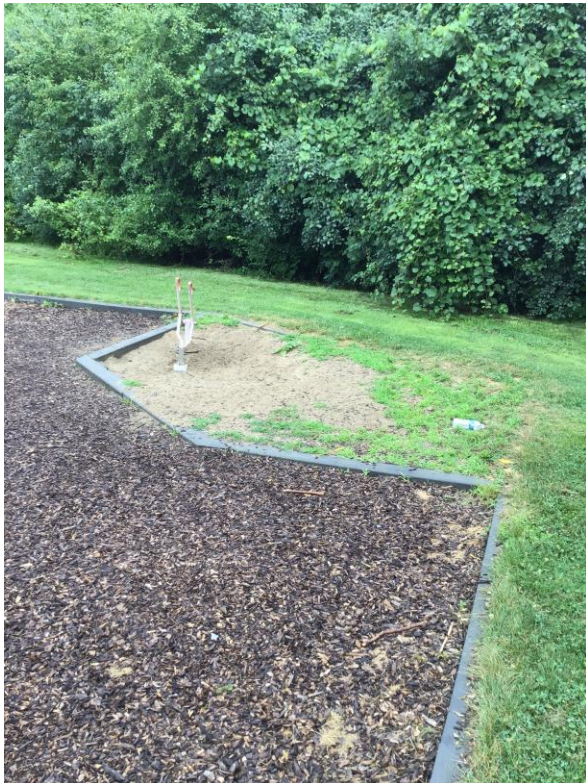
Play Area: Sand Pit

There is no accessible route to the sand pit.

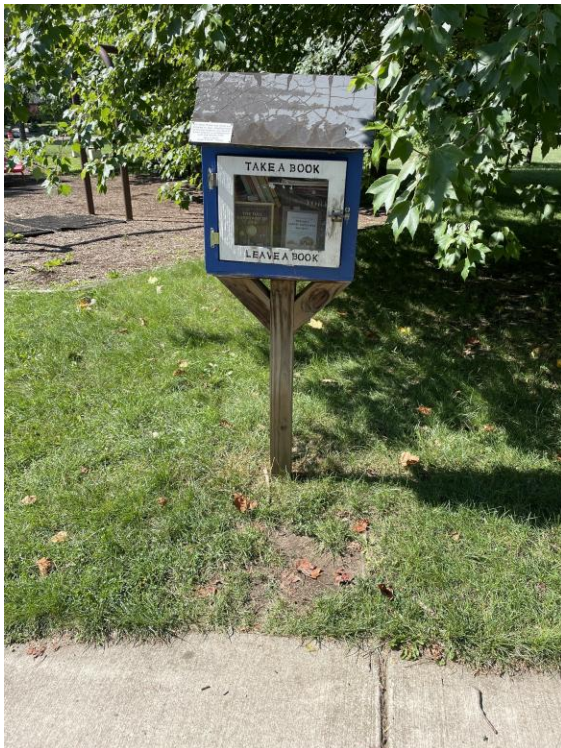
There is no accessible route to little library; the little library is not within reach range from the accessible route.

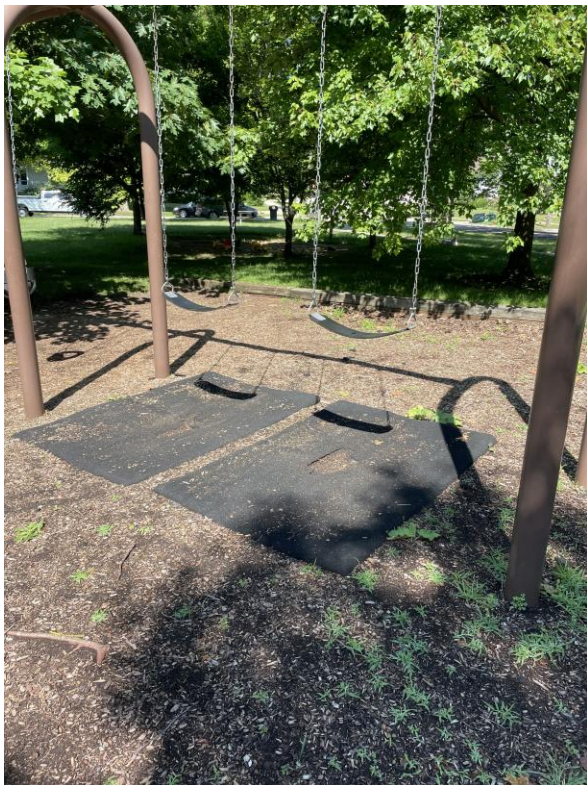
Play Area: Playground

Swings seats are 30" above the ground

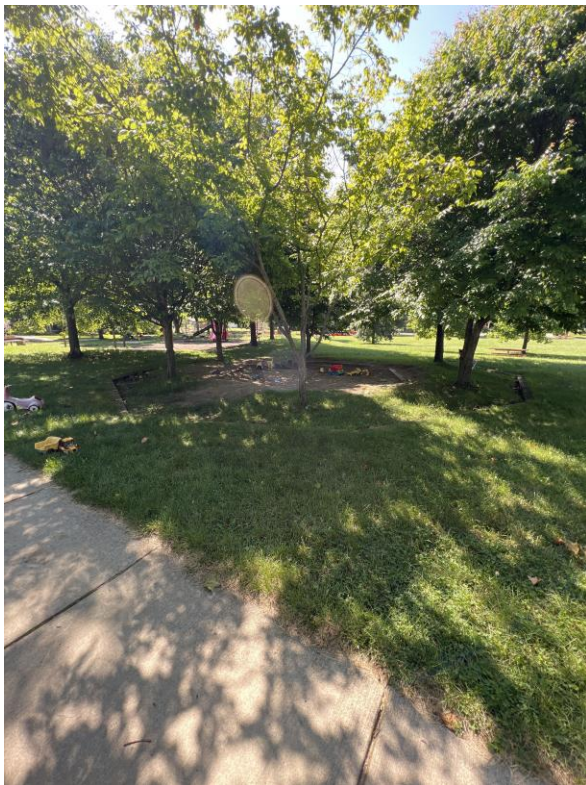
Play Area: Sandbox

There is no accessible route provided to the sandbox

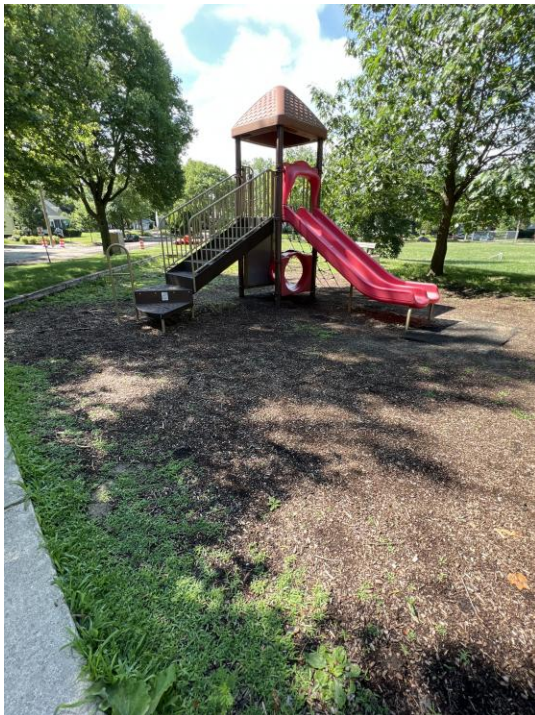
Play Area: Playground

Play area ground surface is not compliant; ground surface is not firm, stable, and slip resistant.

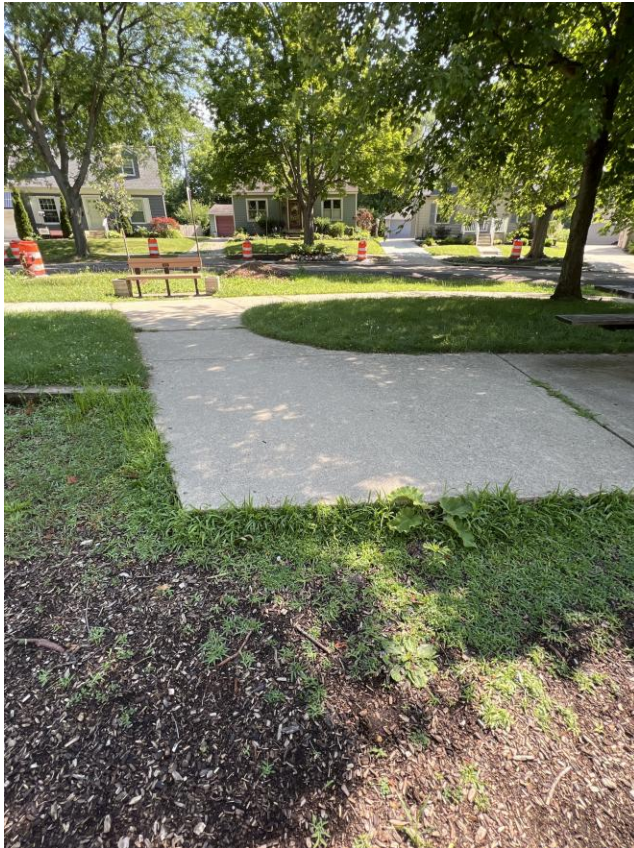
The sidewalk contains vertical changes in level greater than 1/2-inch

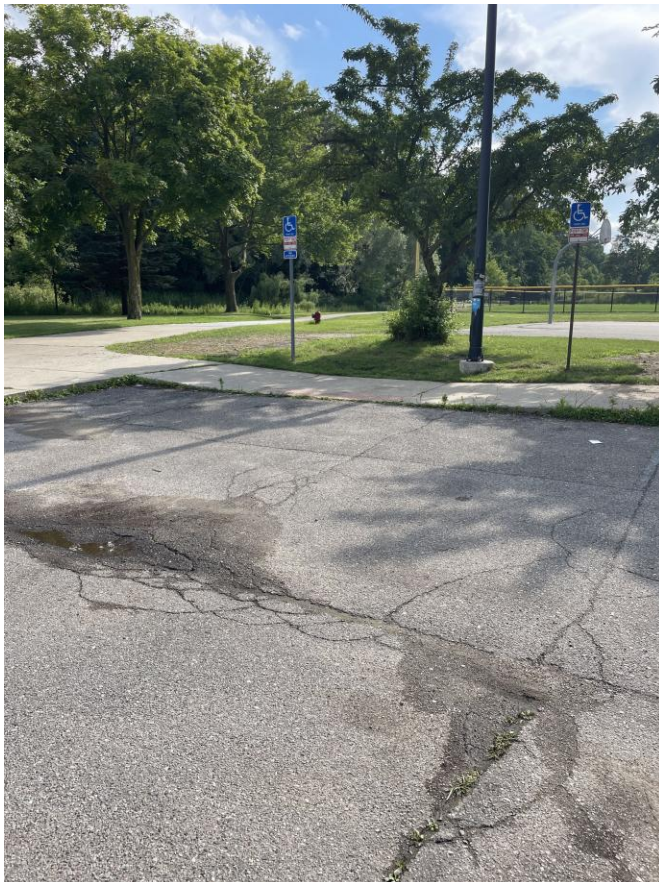
The striping and markings for the accessible parking stall, loading/unloading access aisle are dilapidated and in need of repair and/or maintenance.

The accessible parking spaces are not properly marked; existing markings are faded.

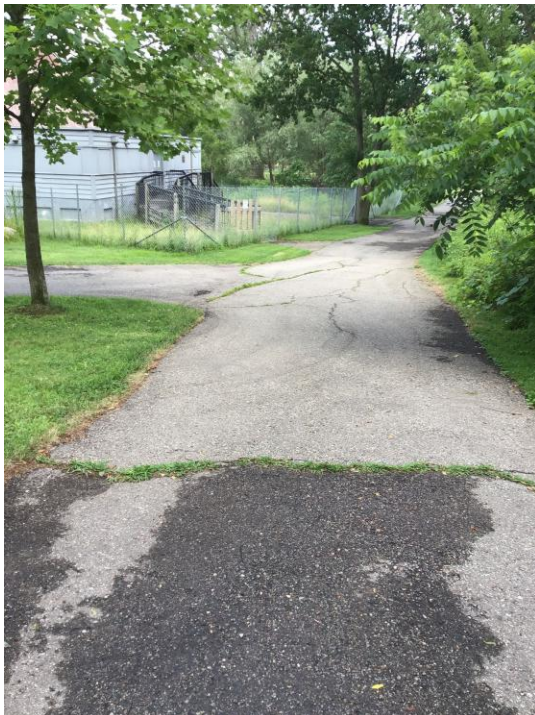
The trail has running slopes greater than 5%

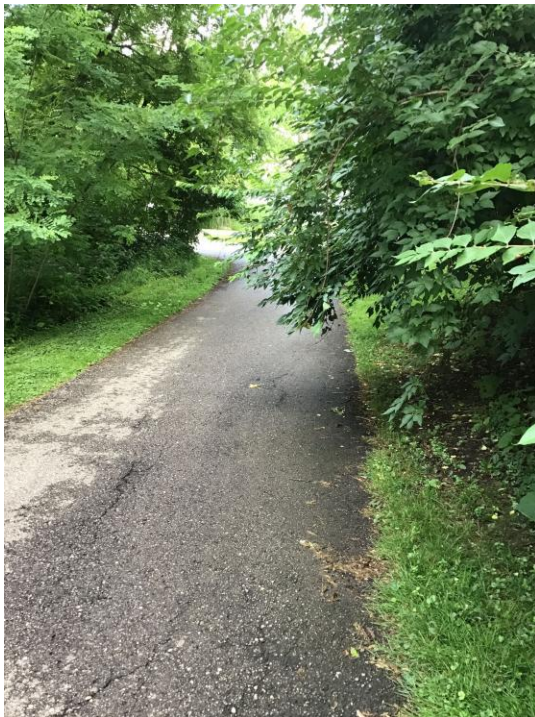
The tree branches protrude more than 4 inches into the sidewalk between 27 and 80 inches high.

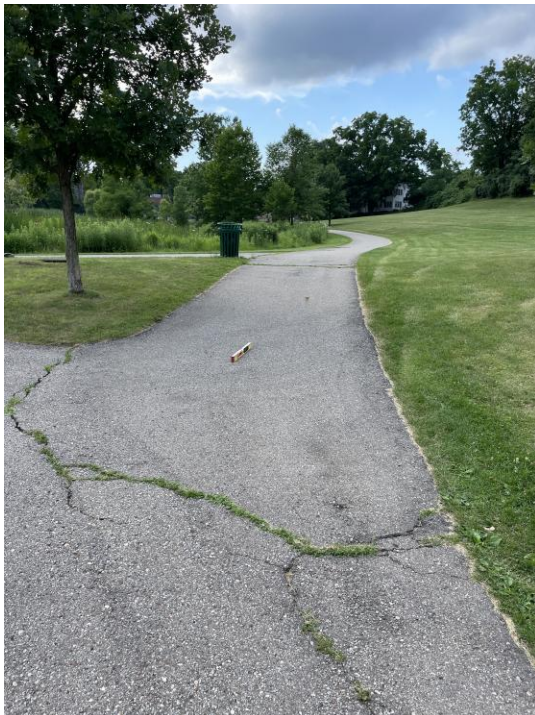
The trail has running slopes of 6.5% or greater.

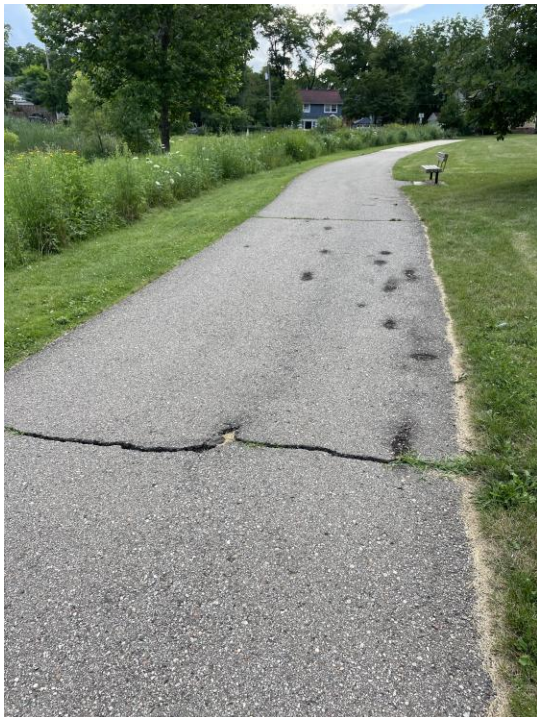
The trail has openings greater than 1/2-inch

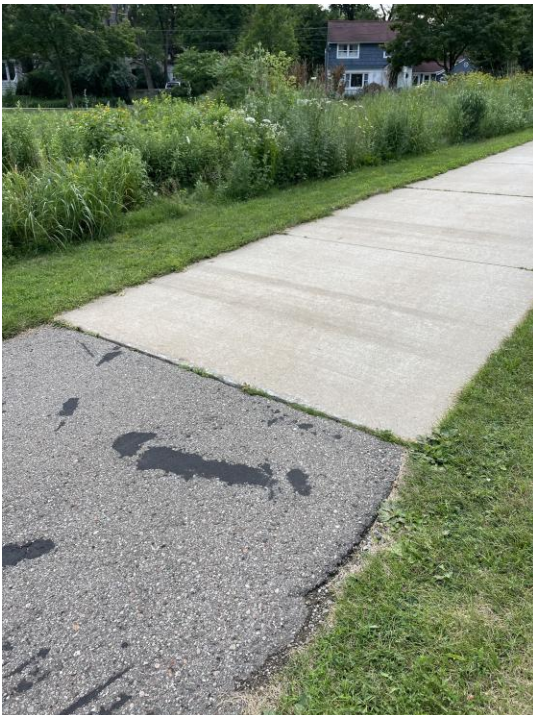
The trail has an opening greater than 1/2-inch where the asphalt and concrete trails meet

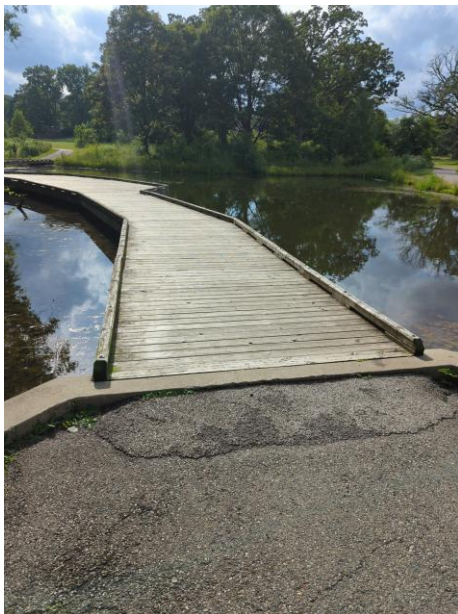
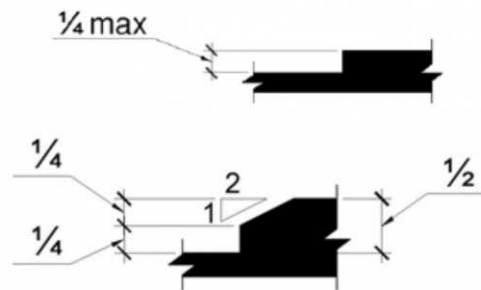
There is a 1-inch vertical change in level to cross bridge on both ends

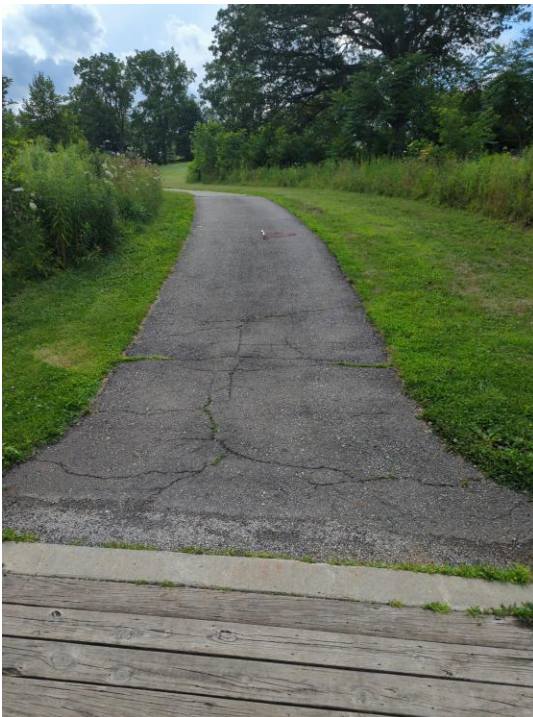
Path past bridge has running short of up to 9%

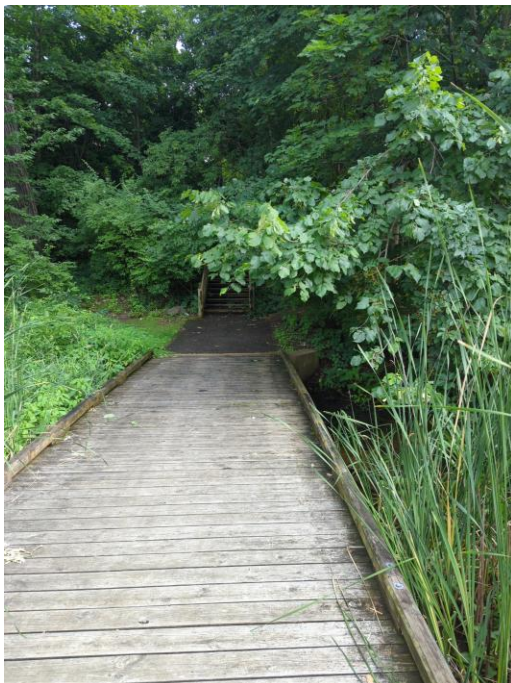
There is vegetation protruding more than 4 inches over the bridge

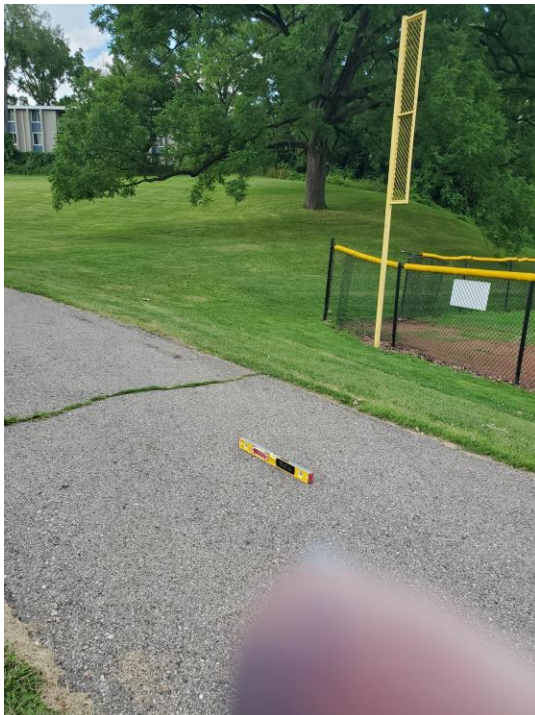
The trail has a running slope greater than 5%

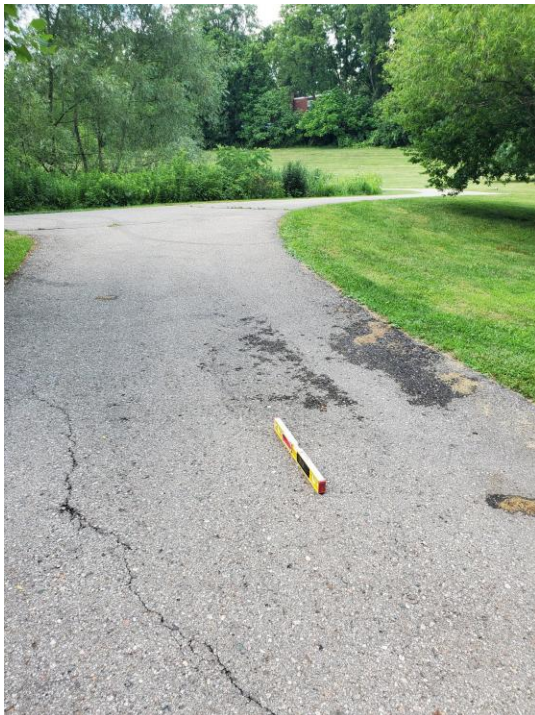
The trail has a running slope greater than 5%

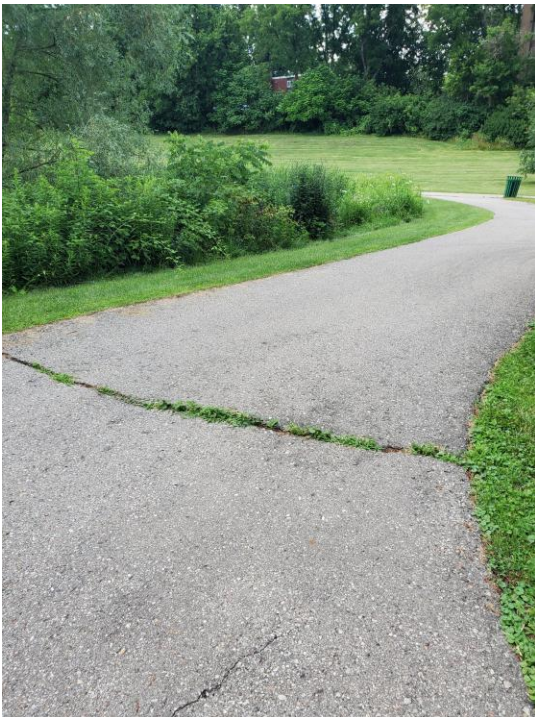
The trail has an opening greater than 1/2-inch approximately 10 feet long

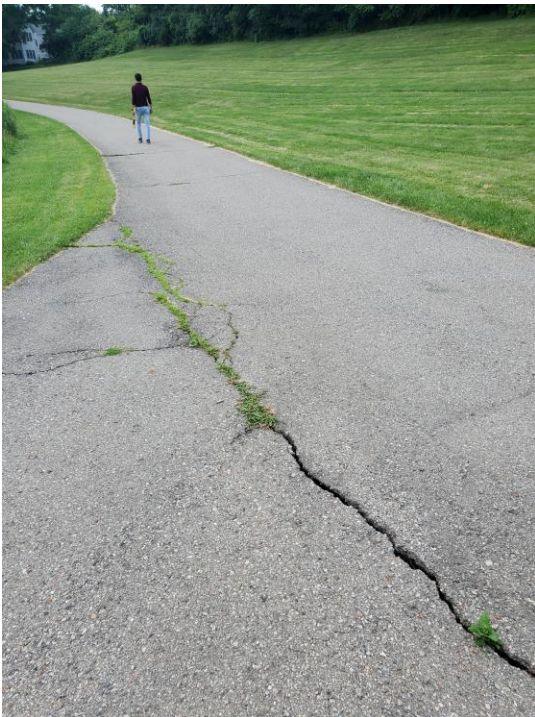
The trail has an opening greater than 1/2-inch approximately 10 feet long

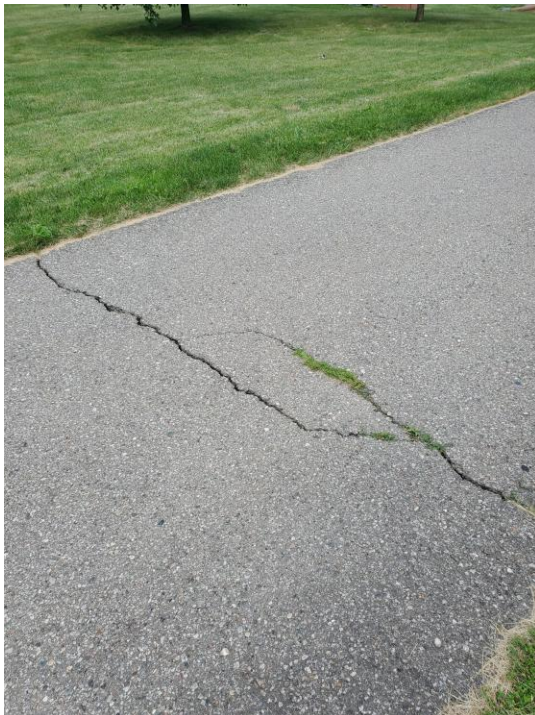
The trail has an opening greater than 1/2-inch approximately 10 feet long

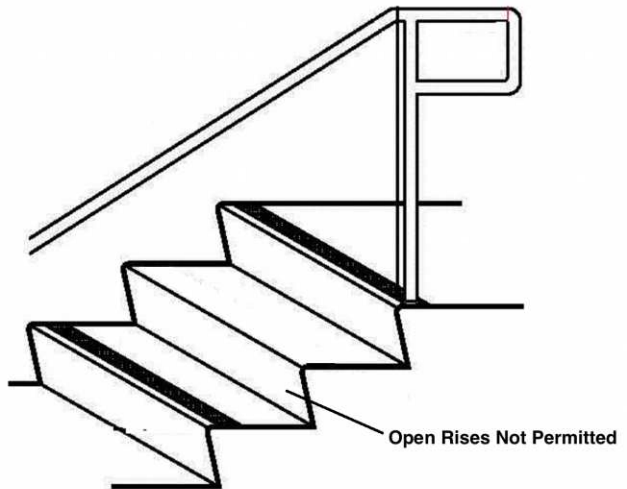
The exterior stairs have open risers which are not permitted.

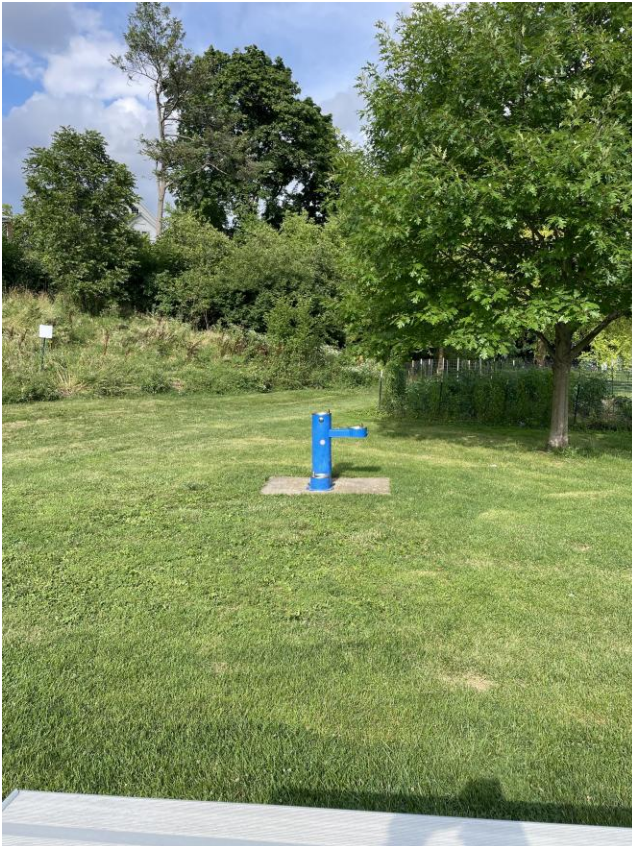
There is no accessible route provided to the drinking fountain

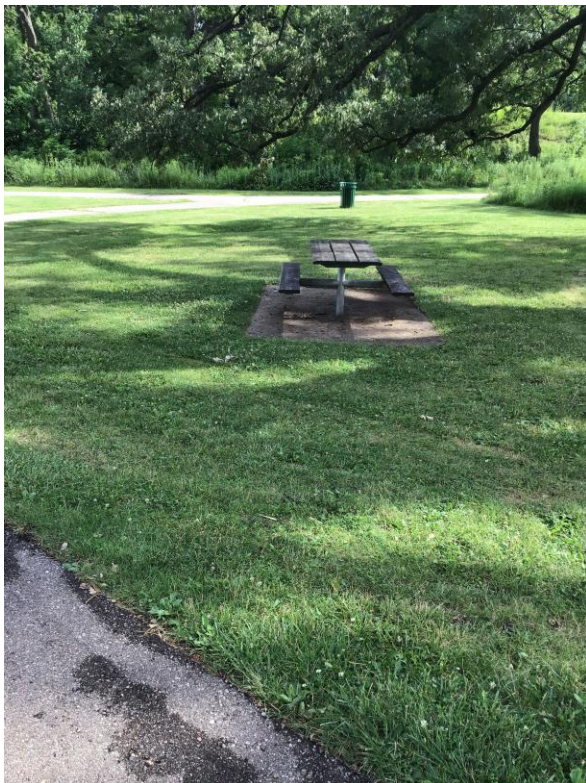
There is no accessible route provided to the picnic table.

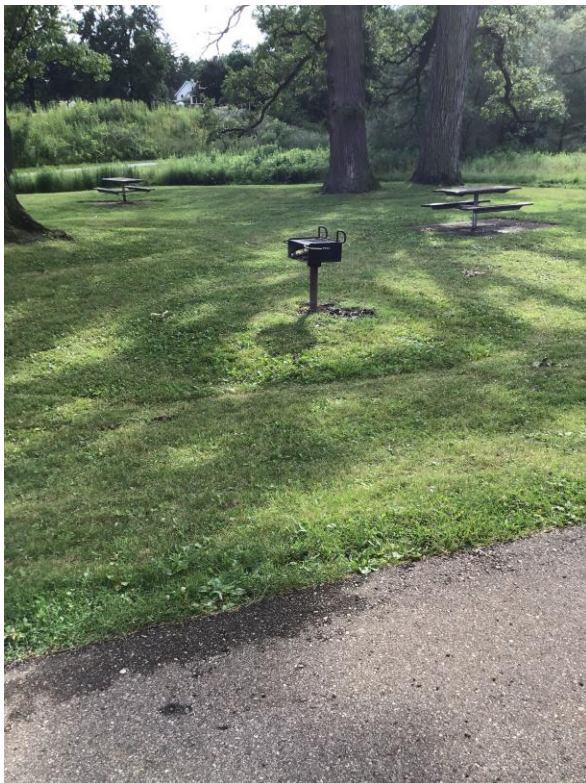
There is no accessible route provided to the grill.

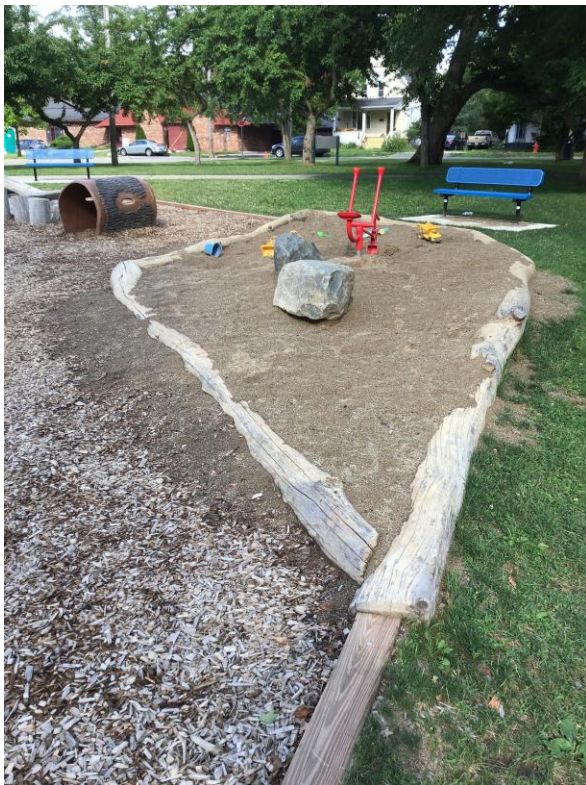
There is no accessible route provided to the sand pit.

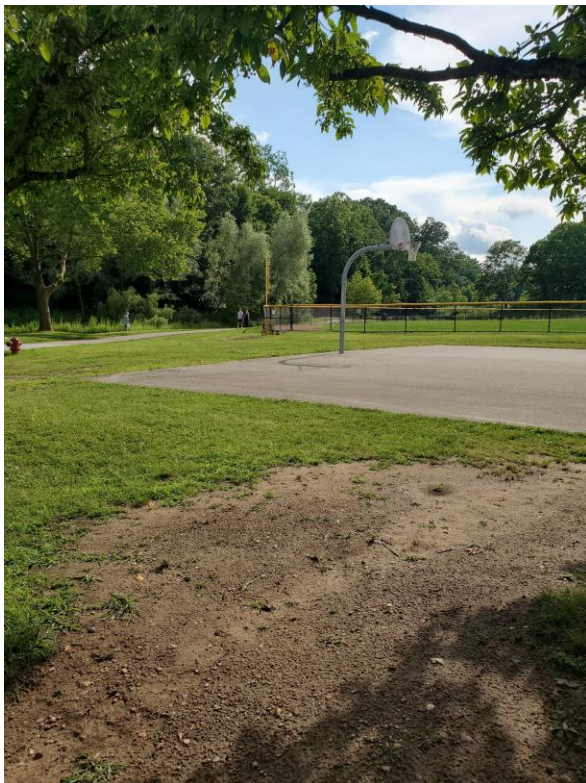
There is no accessible route provided to the basketball court.

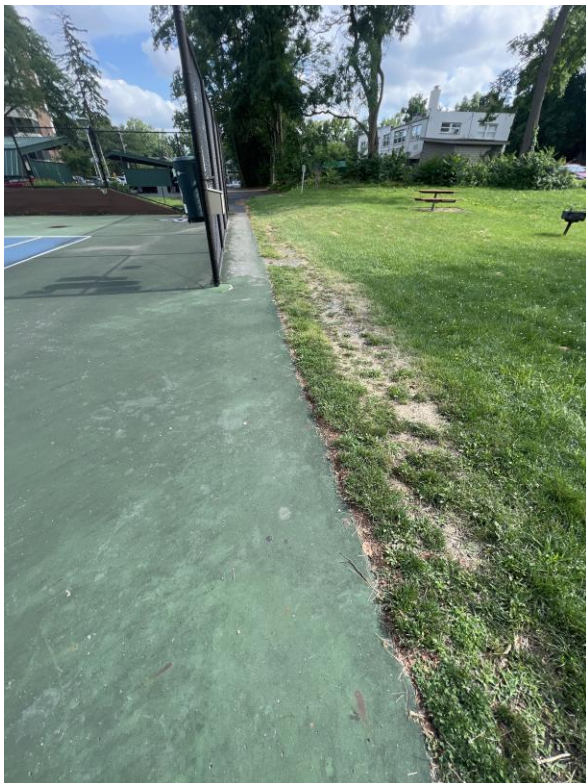
There is no accessible route provided to the picnic area by the basketball court.

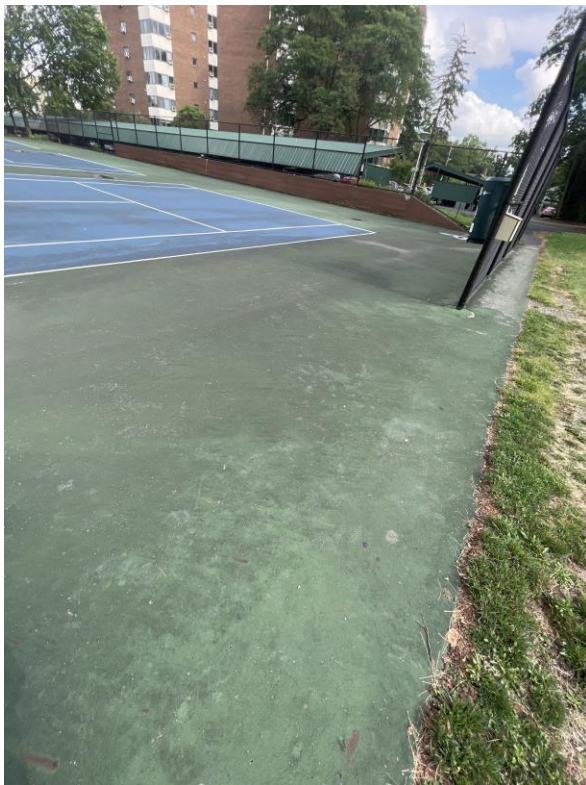
There is no accessible route to the tennis court.

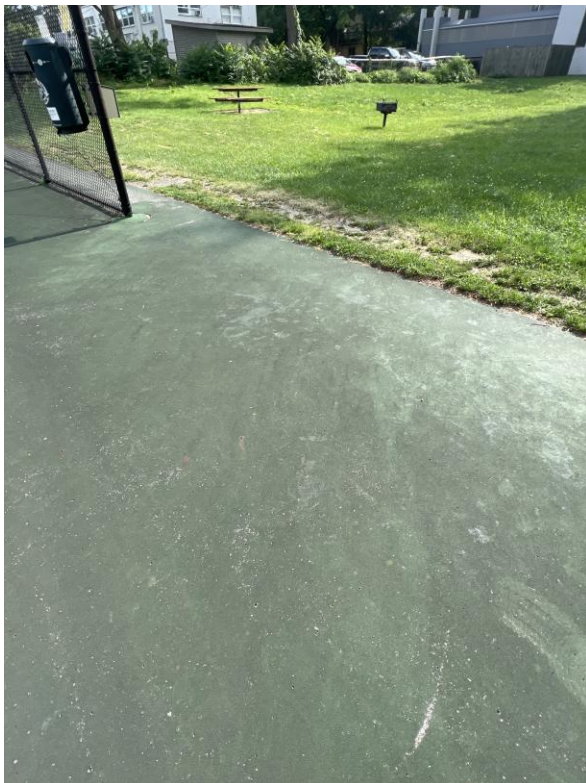
There is no accessible route to the grill.

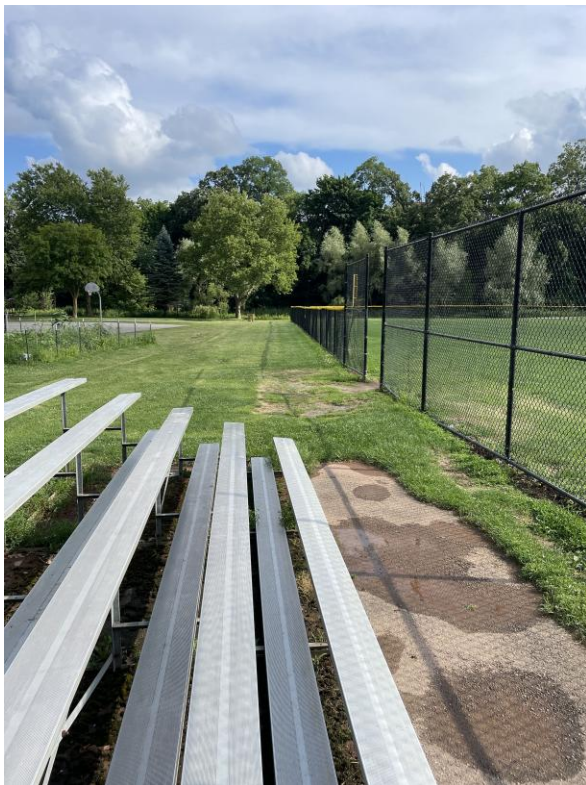
There is no accessible route provided to baseball field, dugouts and seating area

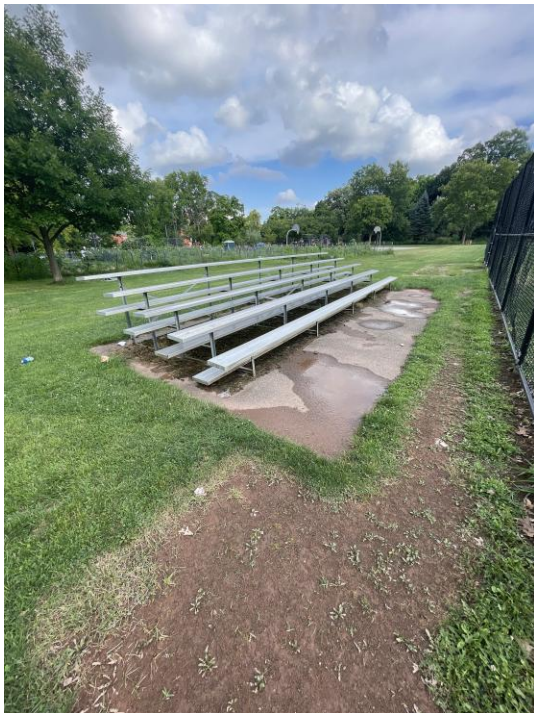
There are no wheelchair seating spaces are provided at the bleachers

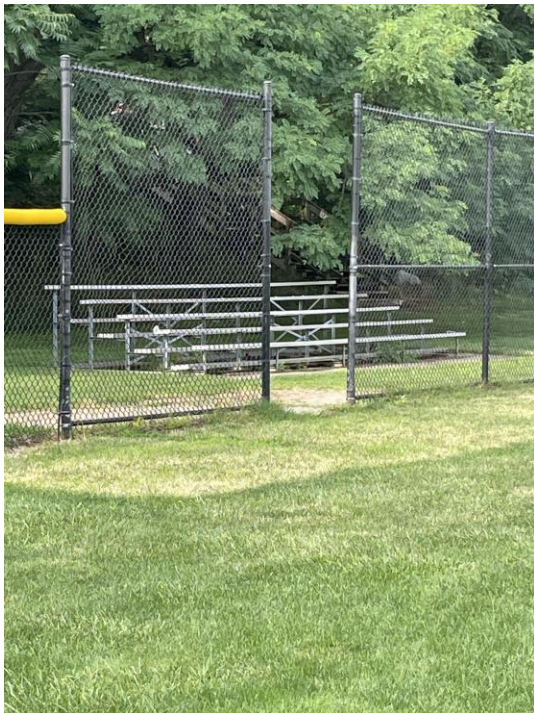
There are no wheelchair seating spaces are provided at the bleachers

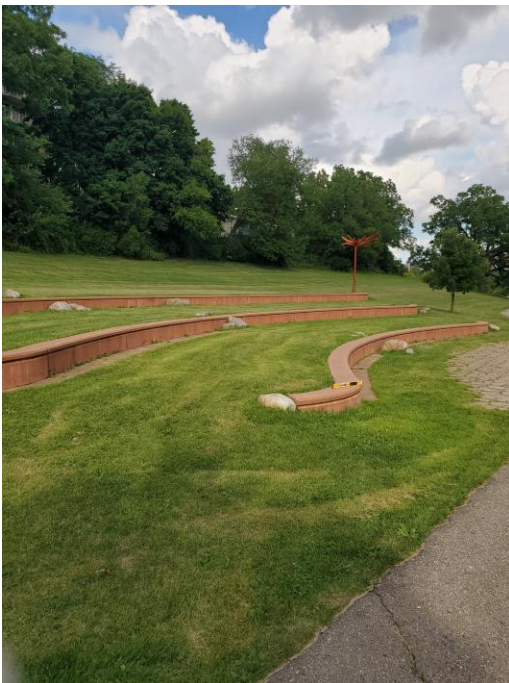
There is no accessible route between the performance area and the assembly seating area.

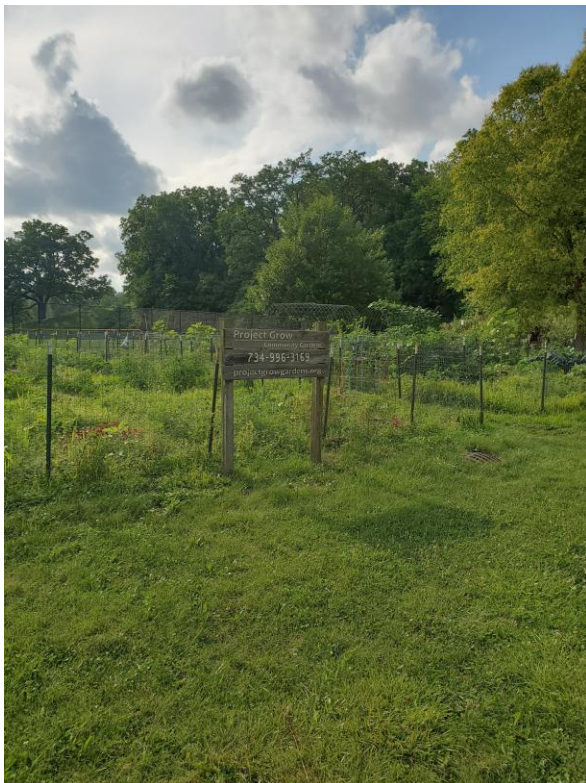
There is no accessible route provided to the food garden

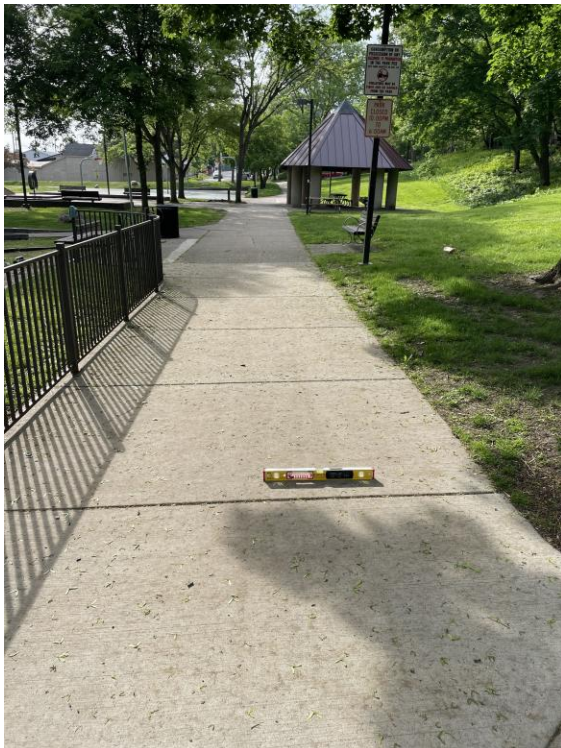
The trail has a cross slope greater than 2%

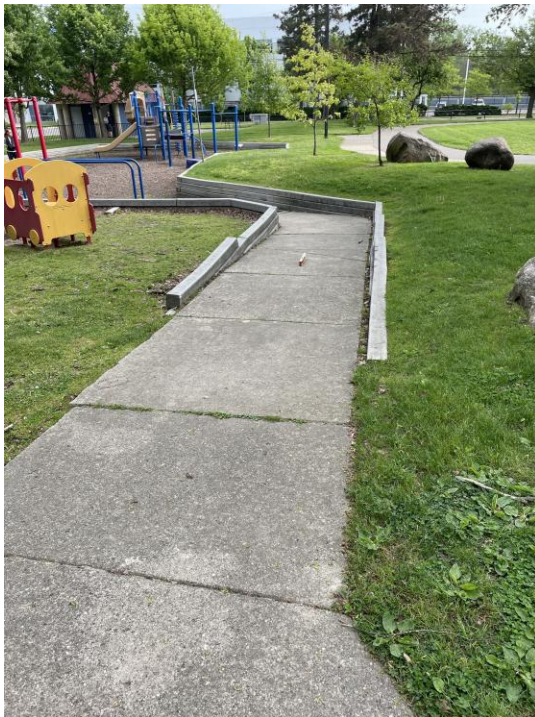
The trail has a running slope greater than 5%

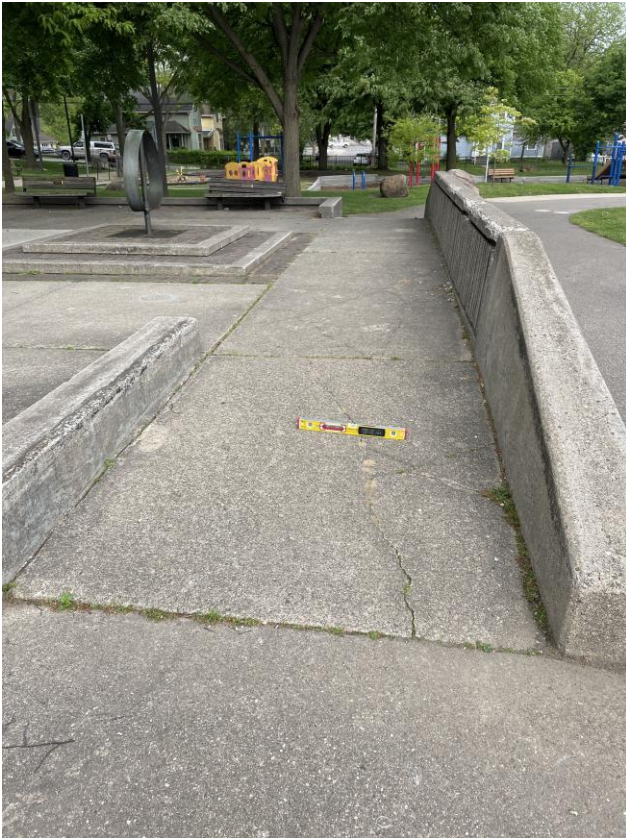
The ramp has a cross slope greater than 2%

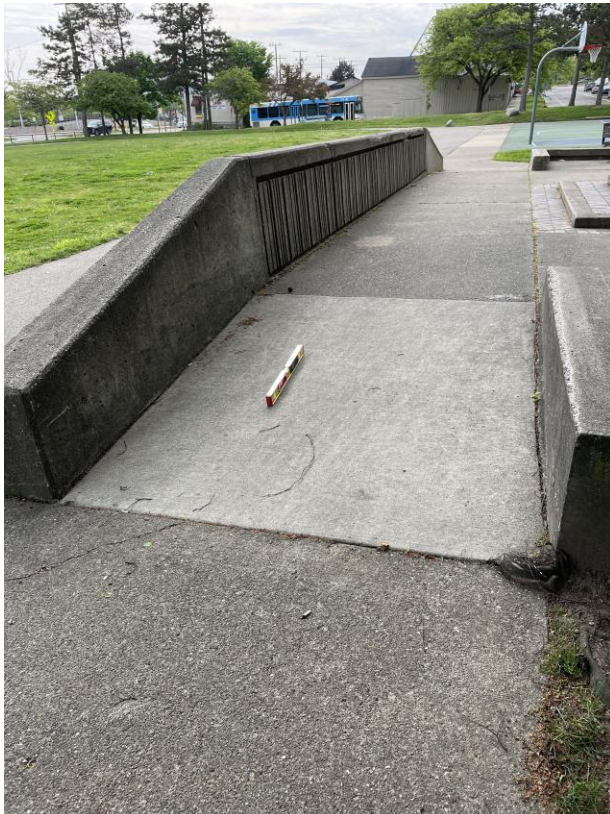
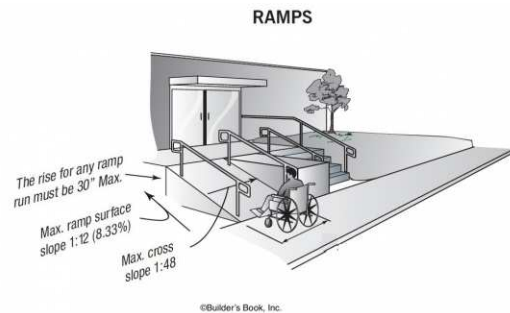
The trail has a running slope greater than 5% and a cross slope greater than 2%. Trails with a running slope greater than 5% are considered ramps and must comply with 405 including handrails.

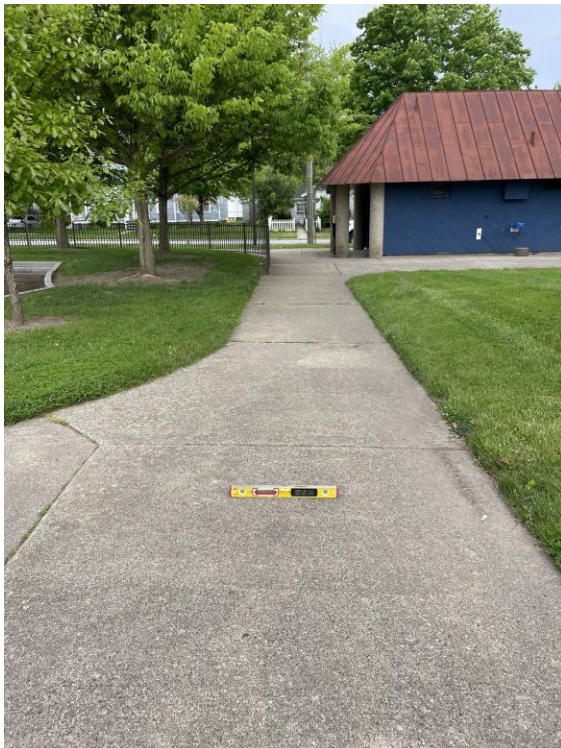
The trail has a cross slope greater than 2%

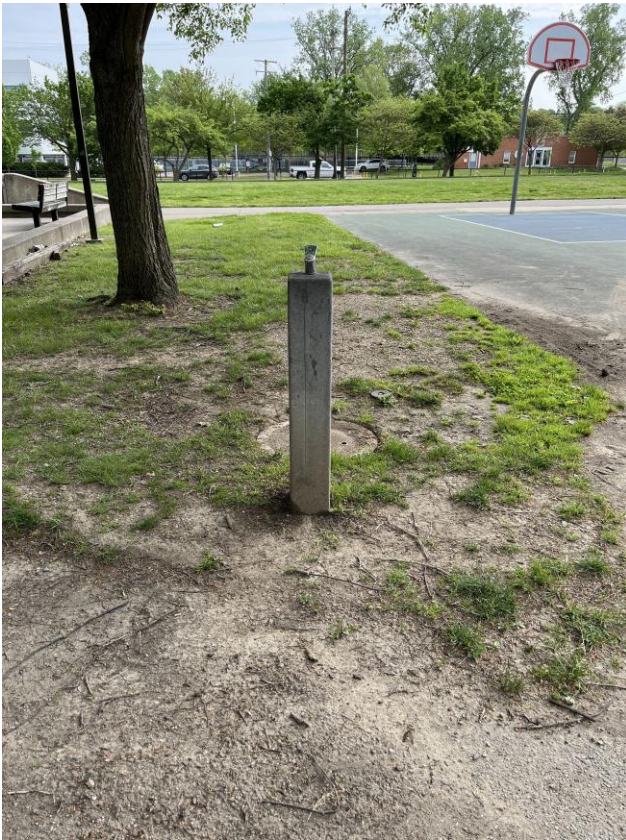
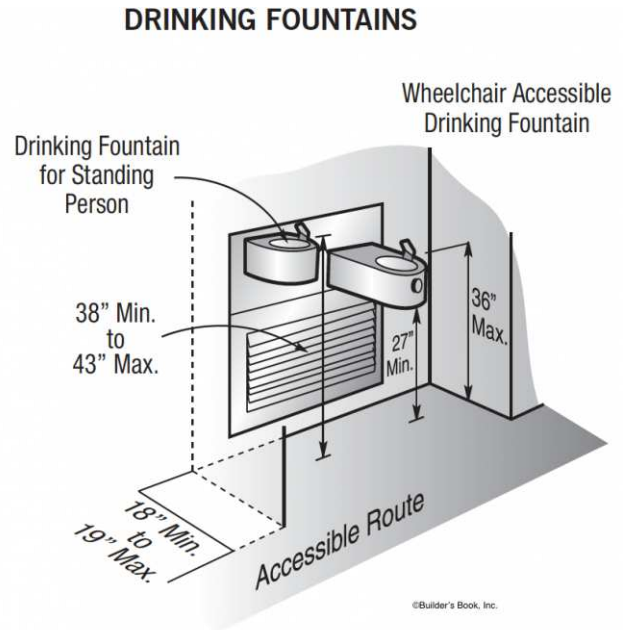
Finding #6 Continued

The drinking fountain has multiple violations.

Both "high" and "low" drinking fountains must be provided compliant with 602, including a clear floor space on the "low" drinking fountain.

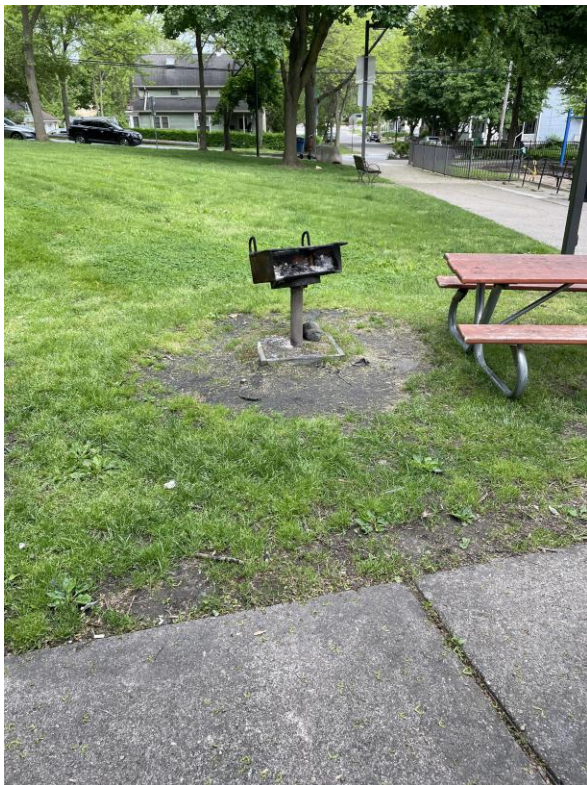
There is no accessible route provided to the grill

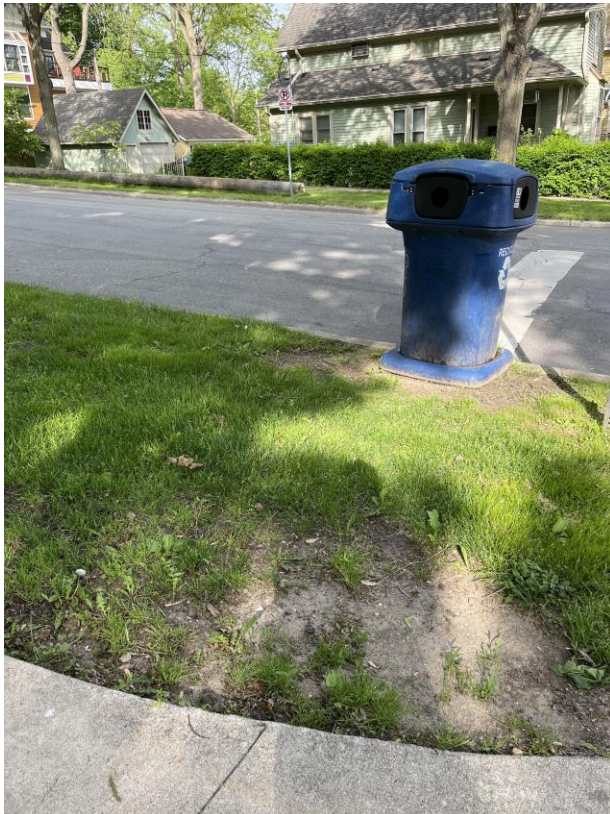
There is no accessible route provided to the trash bin; grass is not a compliant surface.

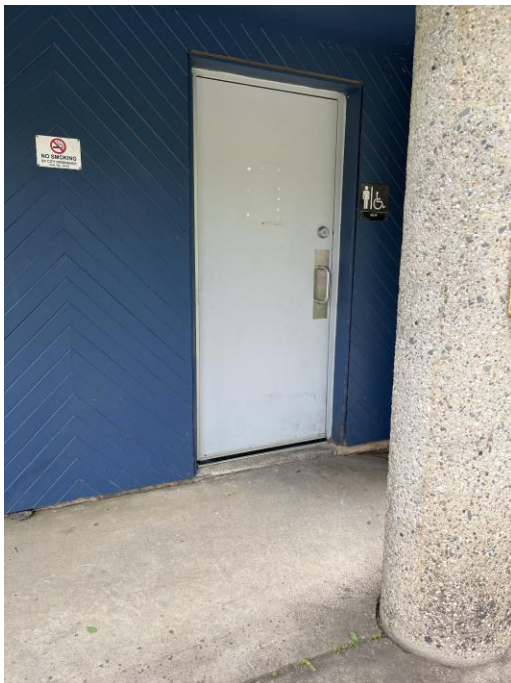
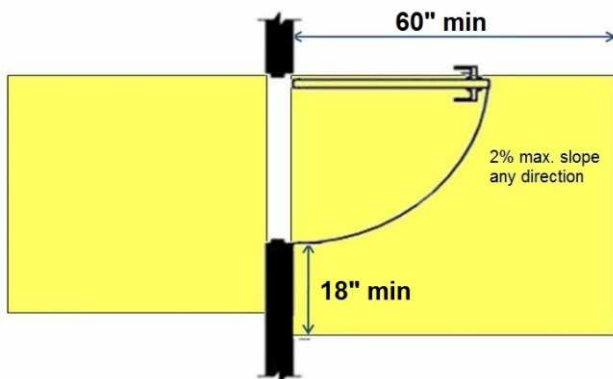
The maneuvering clearance at the door has a slope that is greater than 2%

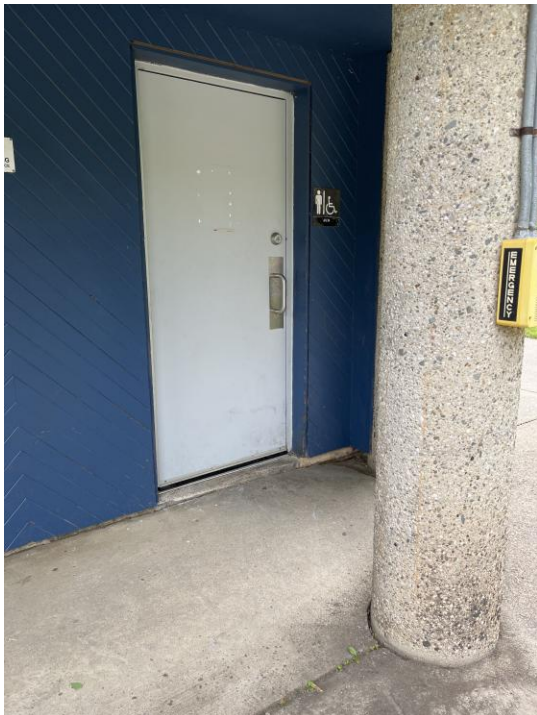
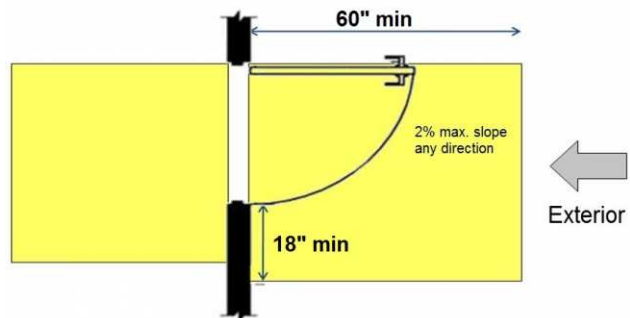
The door's maneuvering clearance is obstructed by a column
