Site Accessibility Evaluation

Allmendinger Park
655 Pauline Blvd
Ann Arbor, MI 48104
ADA Only

Inspection Date: 07/11/2022

Report Date: 11/15/2022

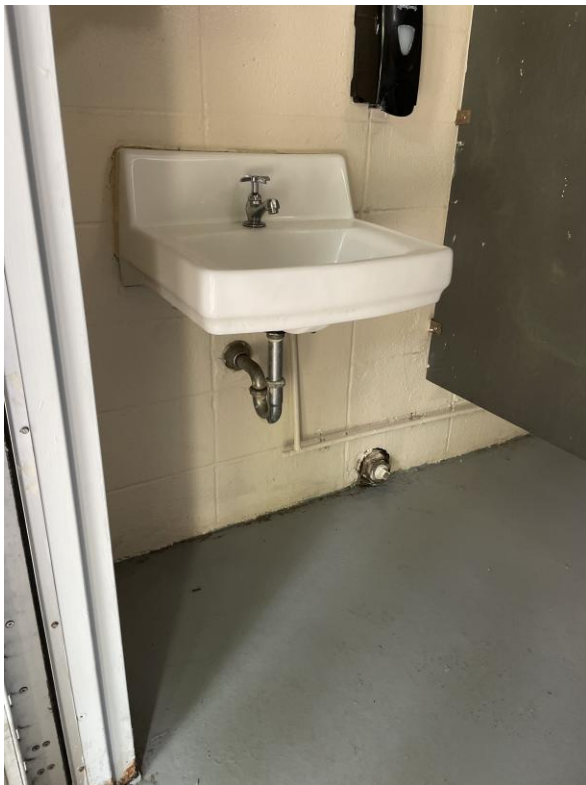
The lavatory does not have insulated water and sewer lines

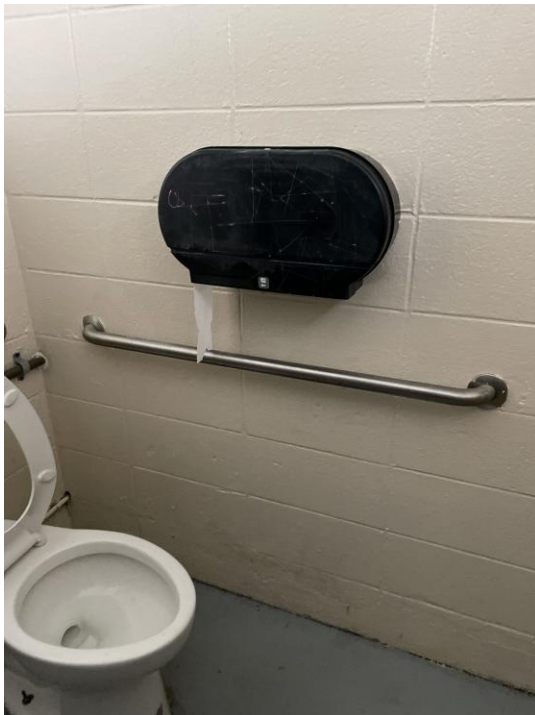
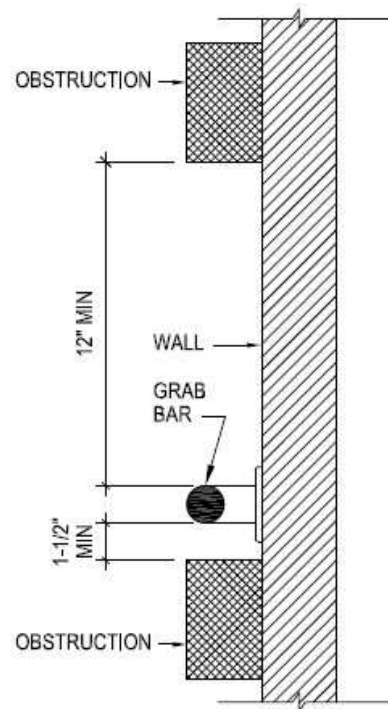
The toilet paper dispenser is closer than 12 inches above the grab bar

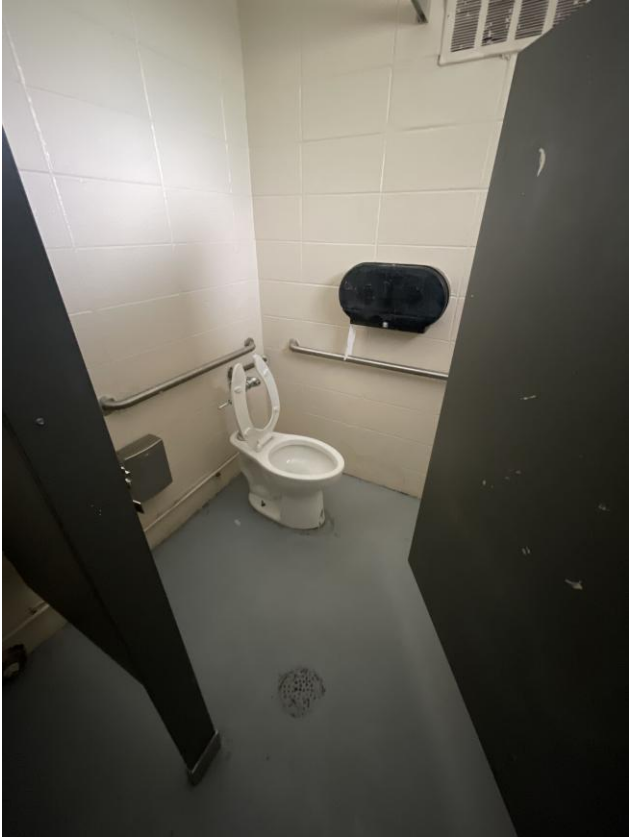
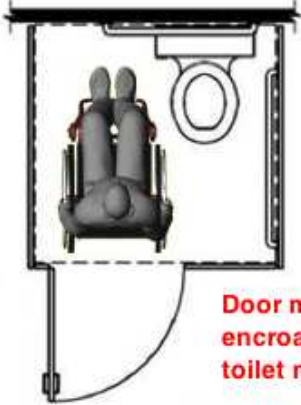
Finding #13 Continued

Door swings into minimum required WC clearance

Door must swing out or not encroach into the required toilet maneuvering space.

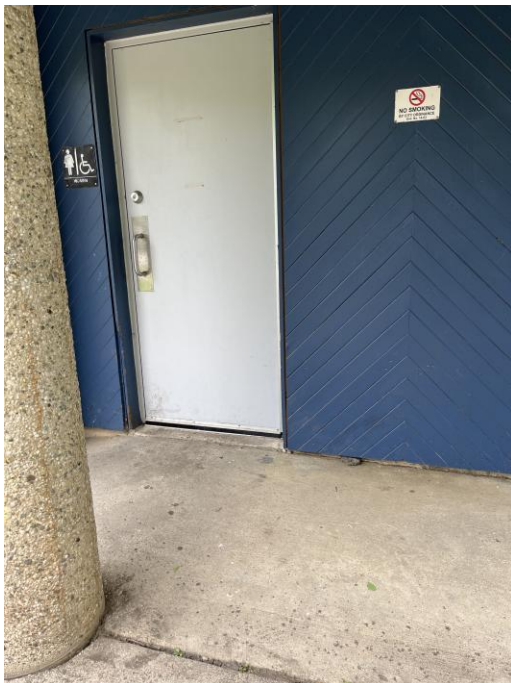
The maneuvering clearance at the door has a slope that is greater than 2%

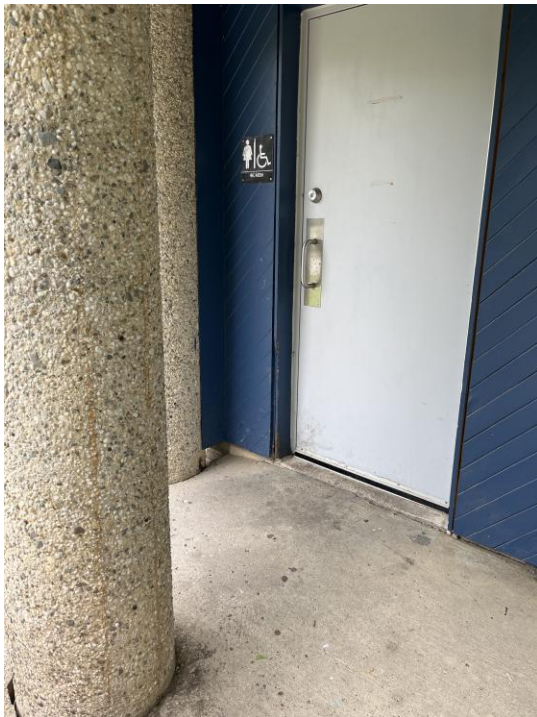
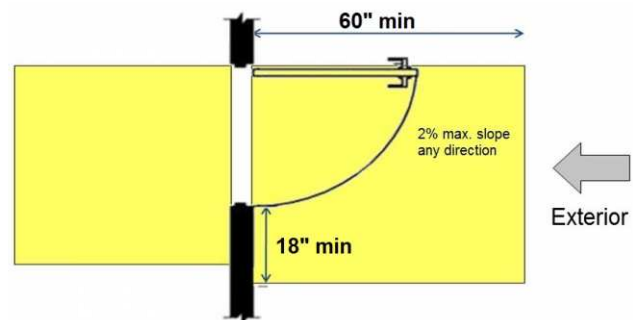
The door's maneuvering clearance is obstructed by a column

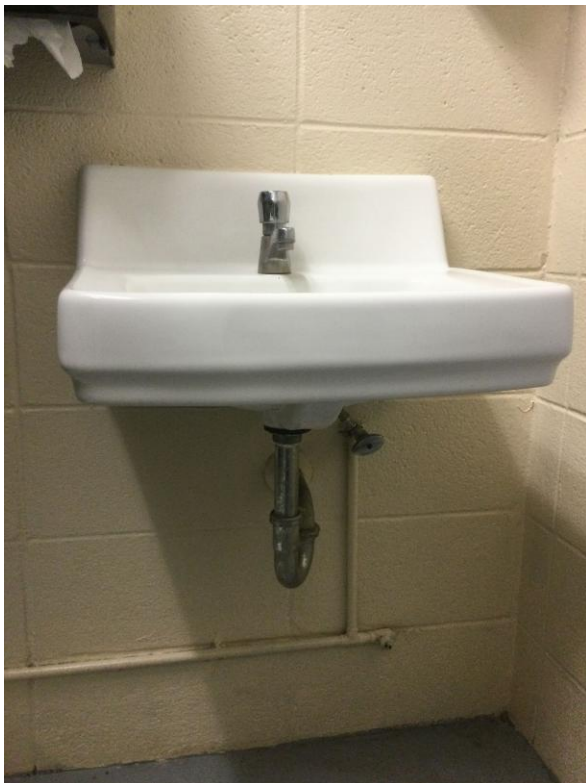
The lavatory does not have insulated water and sewer lines

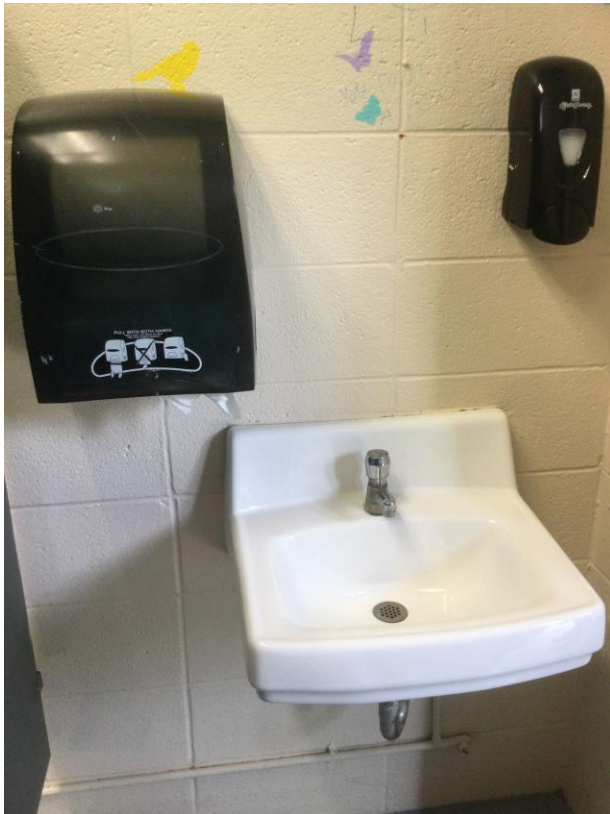
The paper towel dispenser is located higher than 48 inches to the operable part.

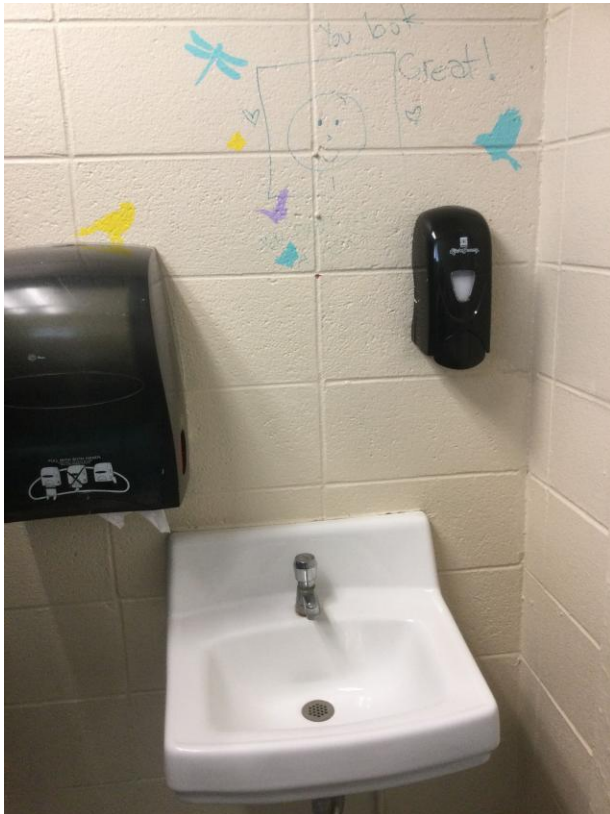
The soap dispenser is mounted higher than 48 inches to the operable part

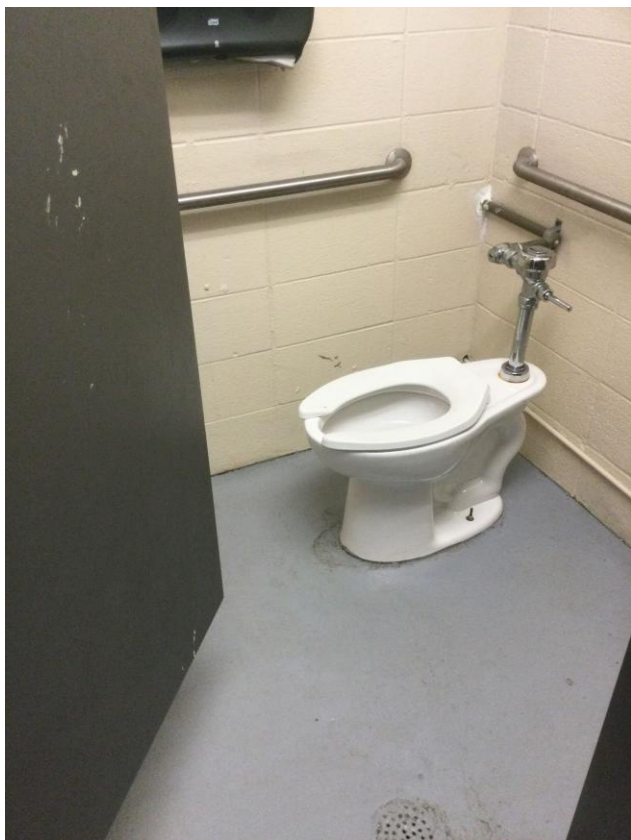
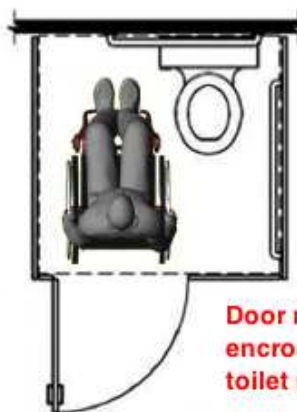
Finding #19 Continued

The toilet partition door swings into the toilet's required maneuvering clearance

Door must swing out or not encroach into the required toilet maneuvering space.

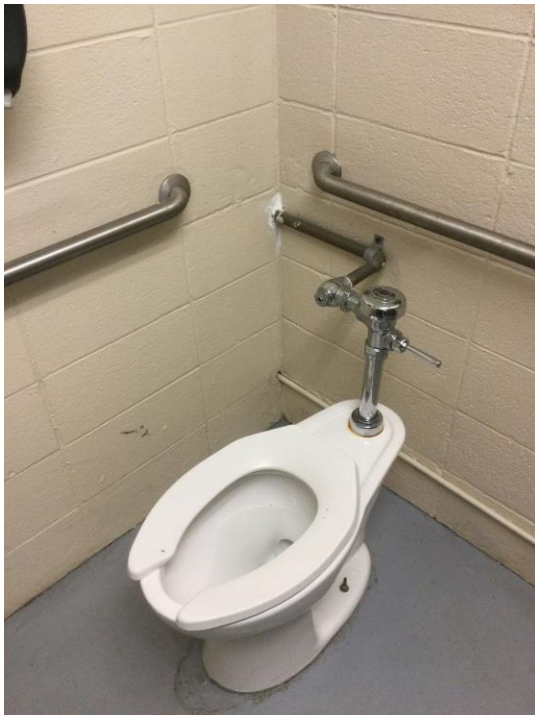
The accessible toilet is not centered at 16-18 inches to the centerline from the side wall.

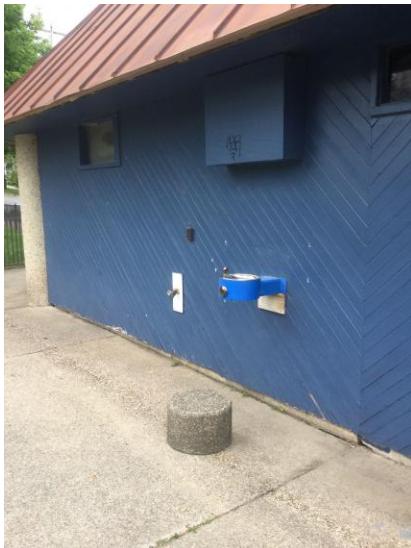
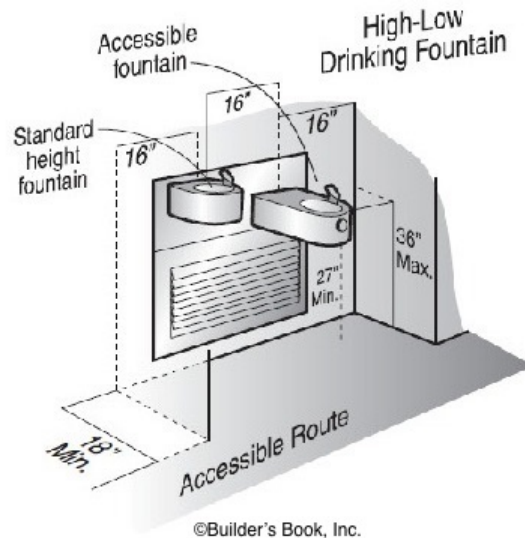
The drinking fountains must comply with 602, including having both a "high" and "low" drinking fountain

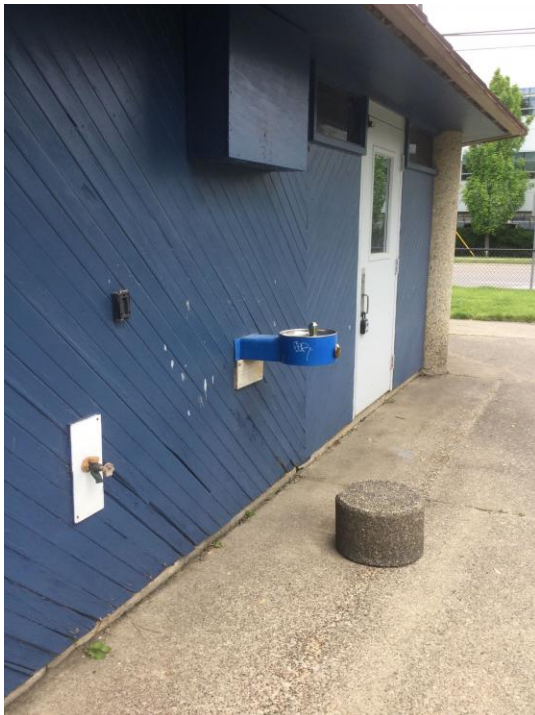
The drinking fountain protrudes more than 4 inches from the wall at a height greater than 27 inches

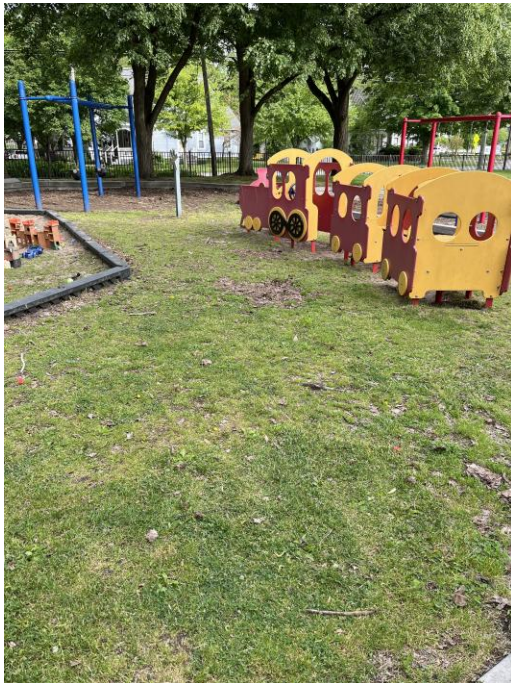
The ground surface of the play area is not compliant; grass does not provide a firm, stable, and slip resistant surface.

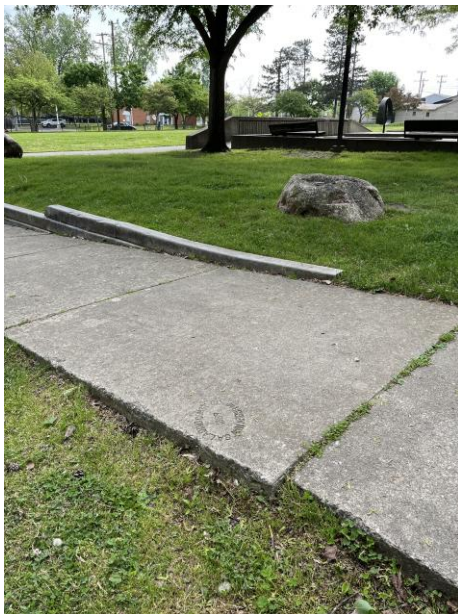
There is a vertical change in level greater than 1/4-inch leading from the trail to the play area

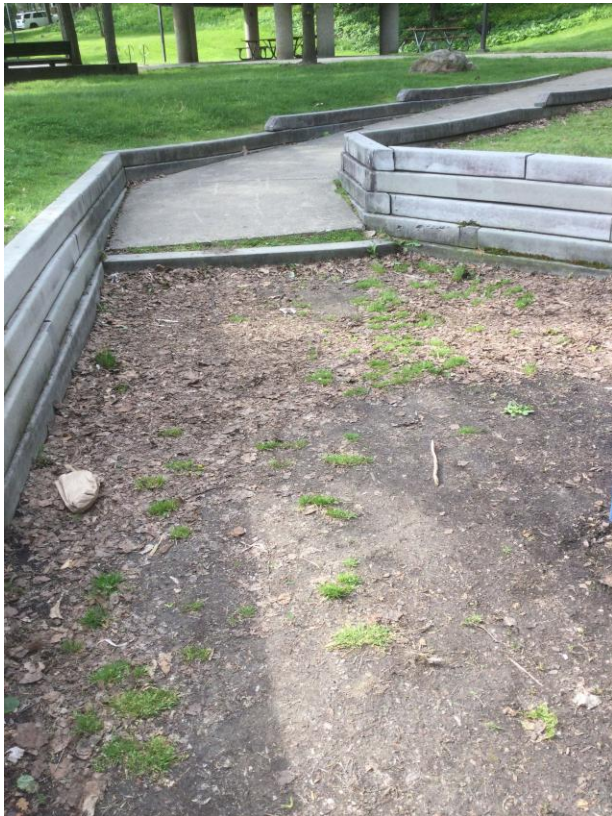
The ground surface of the play area is not compliant; surface is not firm, stable, and slip resistant.

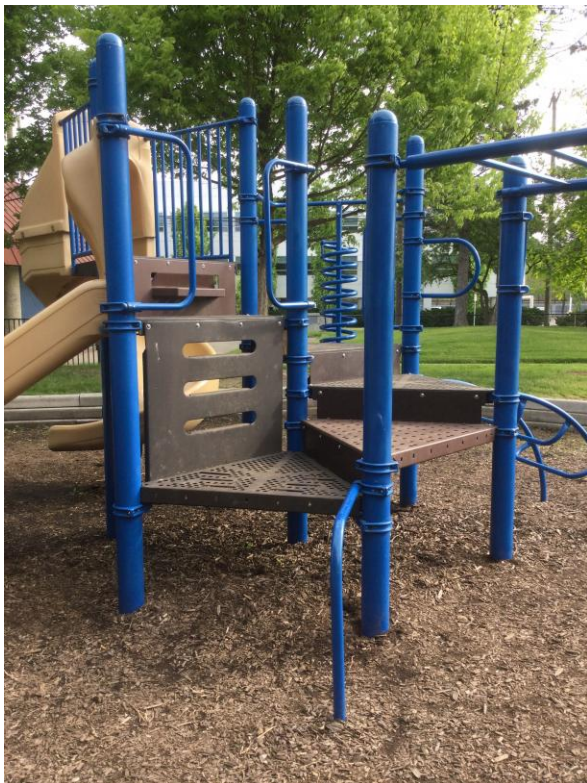
There is no compliant entry point to the play area

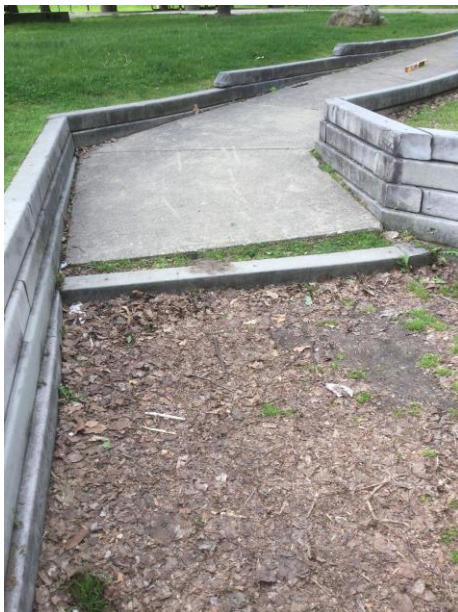
There is a vertical change in level greater than 1/2-inch at the entry of the play area

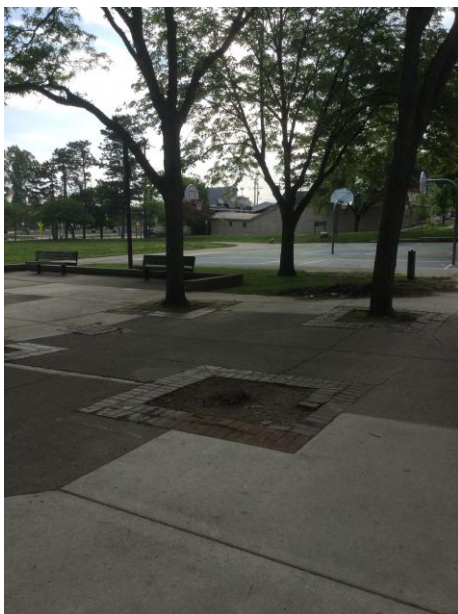
There are vertical changes in level greater than 1/2-inch at the plaza

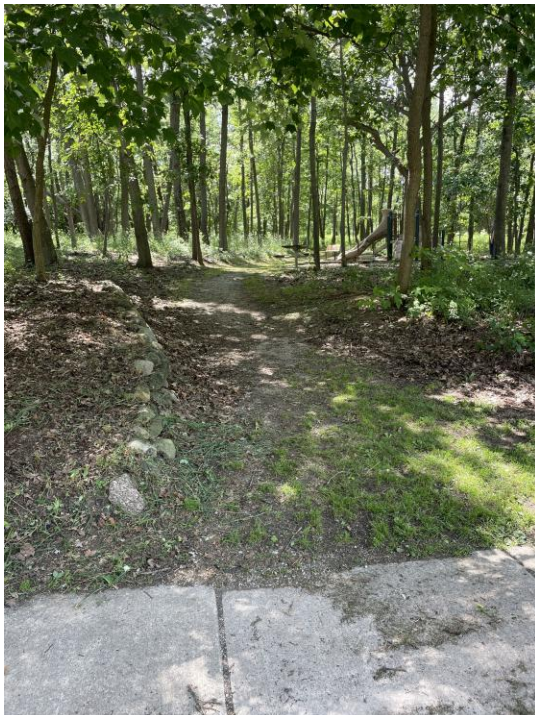
There is no accessible route provided from public sidewalk to park amenities

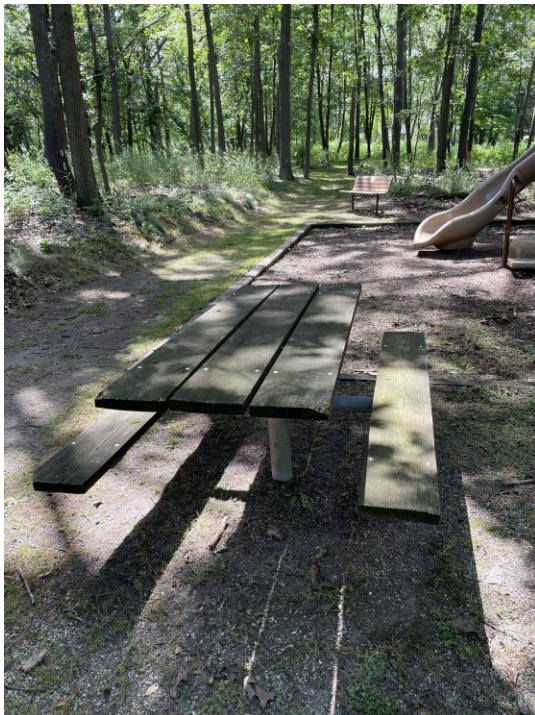
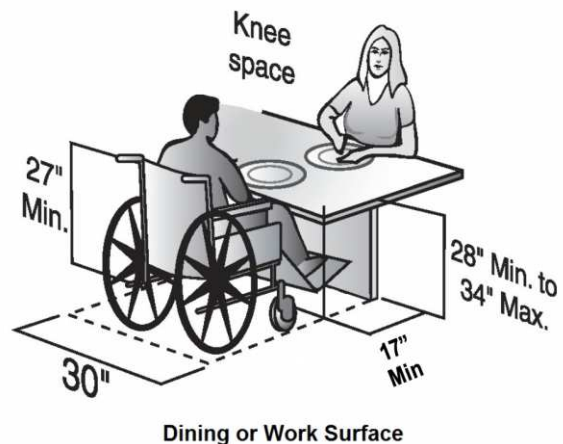
Accessible picnic table does not provide an accessible clear floor space with vertical knee and toe clearance

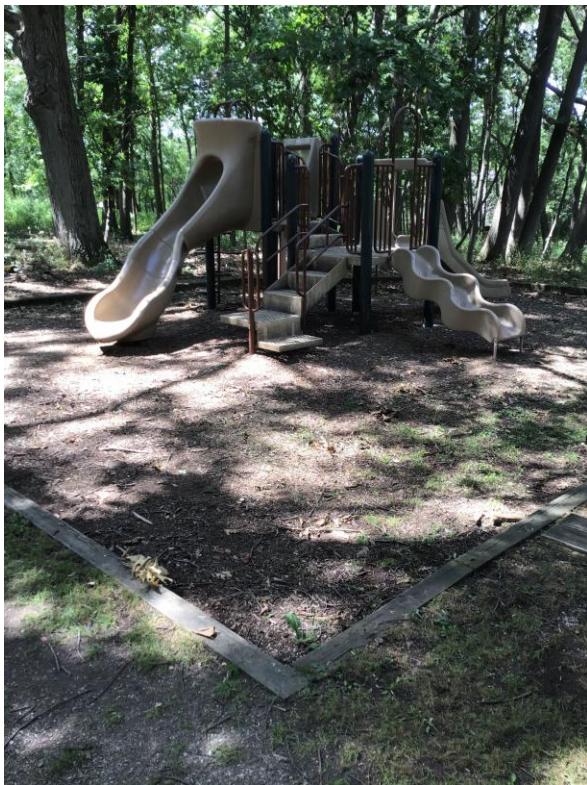
No accessible route from the trail to the play area.

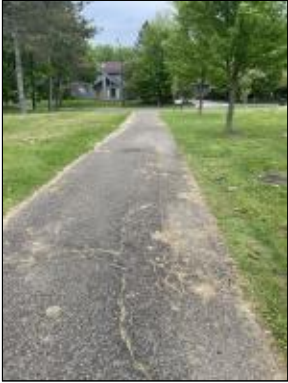
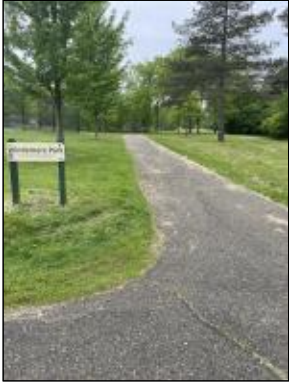
Finding #1 Additional Finding Photos

The sidewalk that forms part of the accessible route has loose gravel

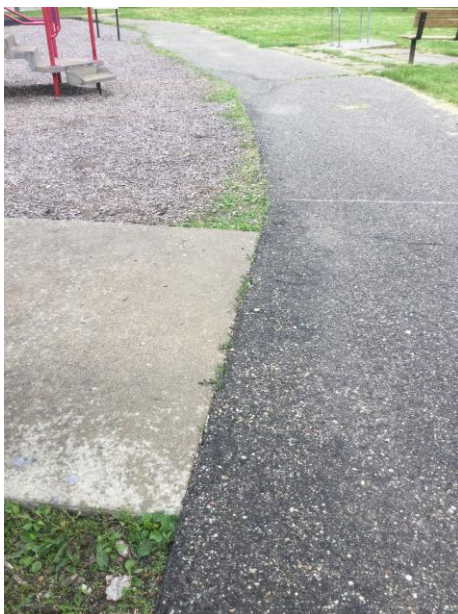
The route to the picnic table has a vertical change in level greater than 1/2-inch

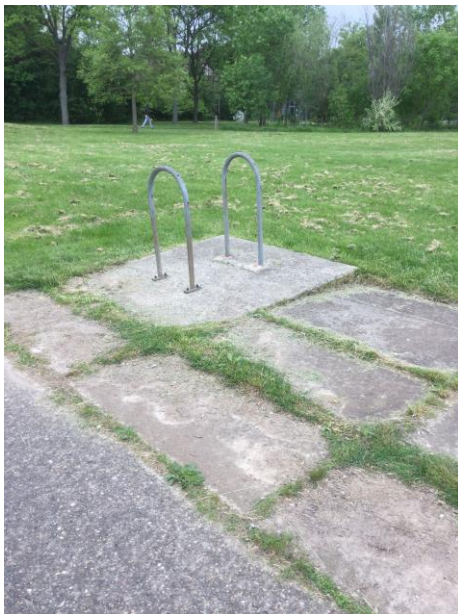
The accessible route to the bike rack area has vertical changes in level greater than 1/2-inch

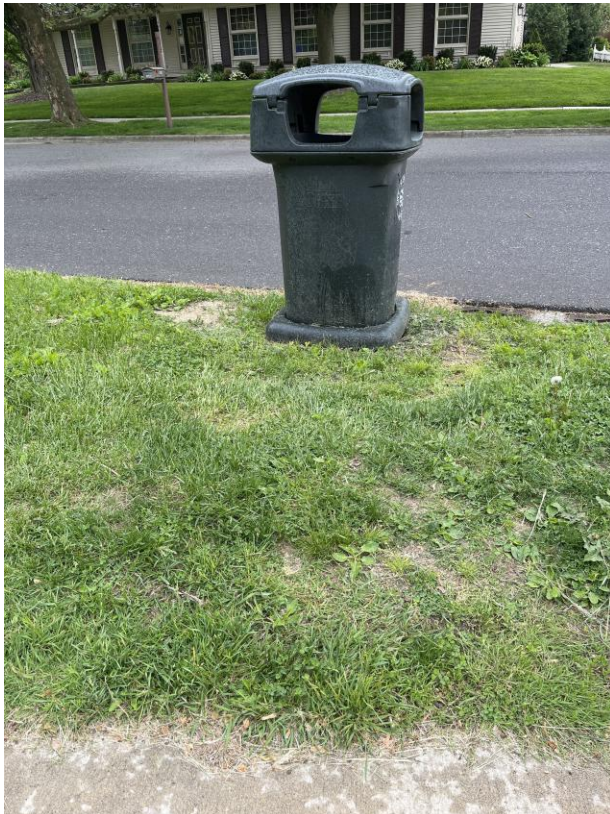
There is no accessible route to the trash bin; grass is not an accessible surface.

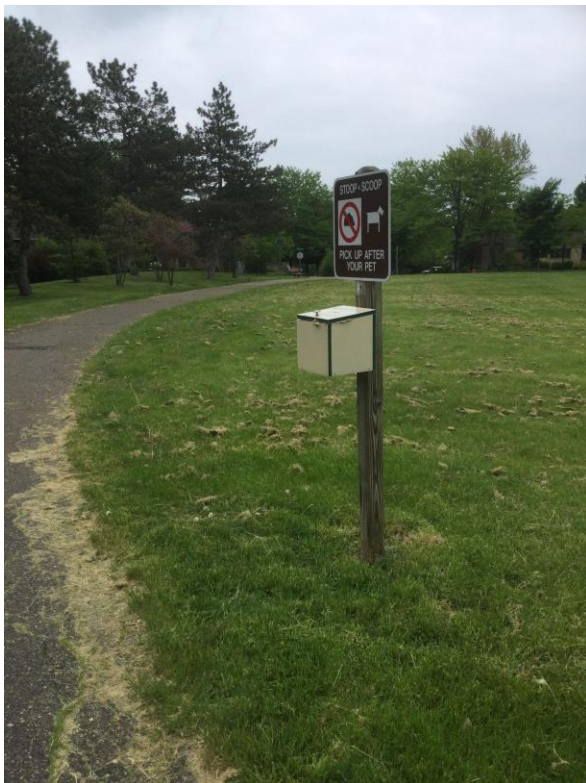
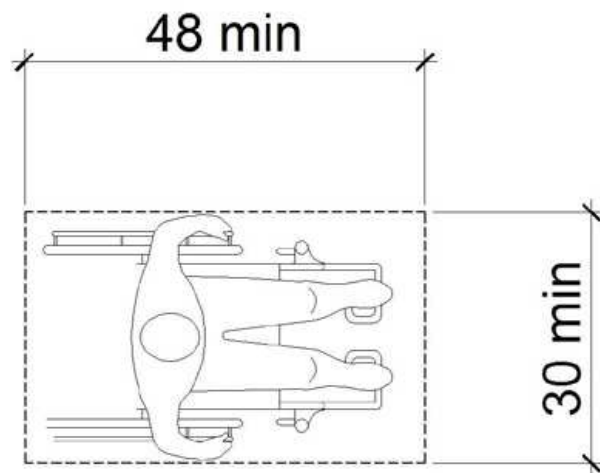
The dog waste station is not on an accessible route; station is not located within the reach range from the accessible route.

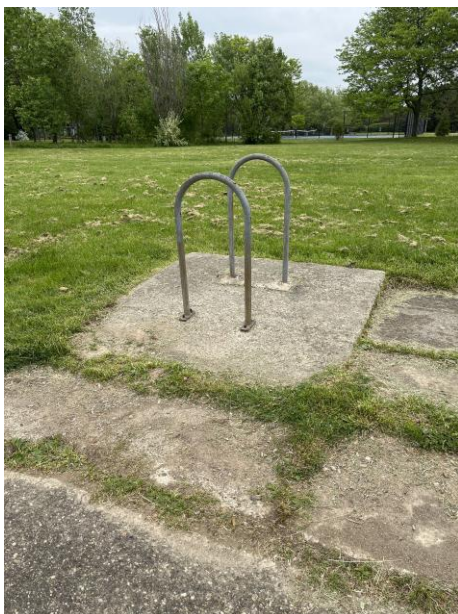
There are vertical changes in level greater than 1/2-inch from the sidewalk to the bike rack

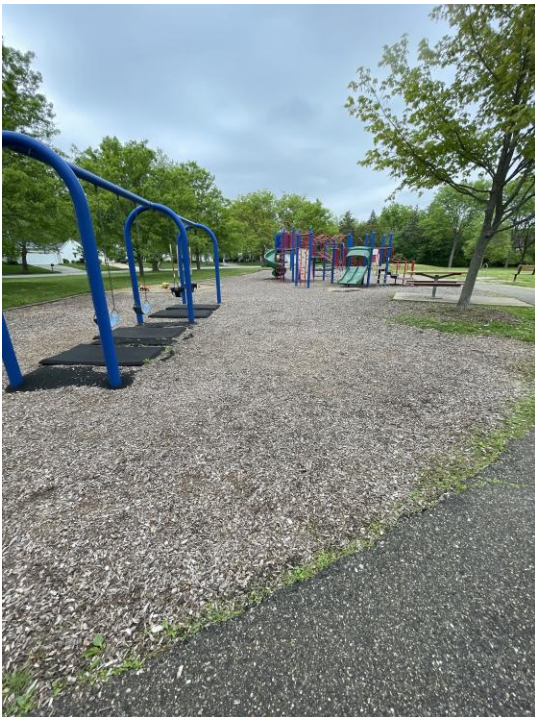
Play area ground surface is not compliant; surface is not firm, stable, and slip resistant.

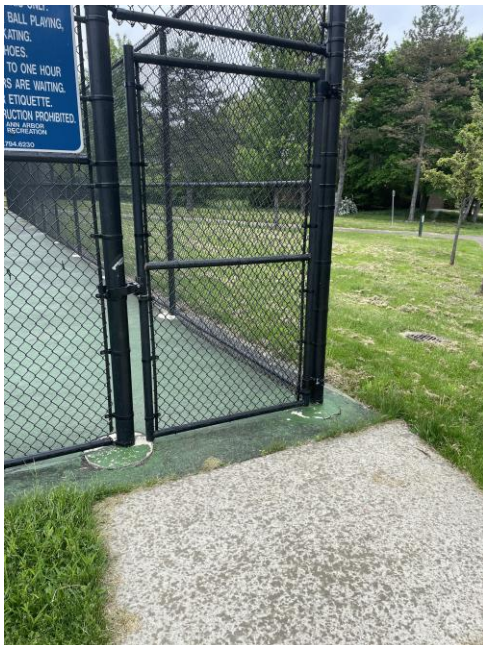
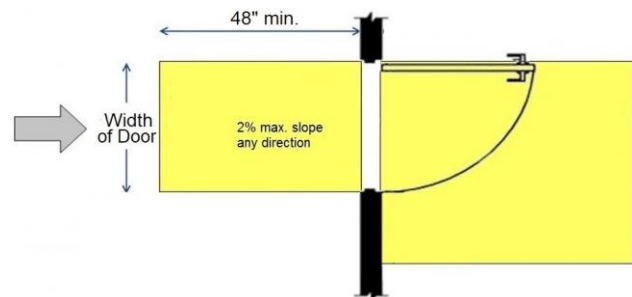
The gate has a maneuvering clearance with slopes greater than 2%.

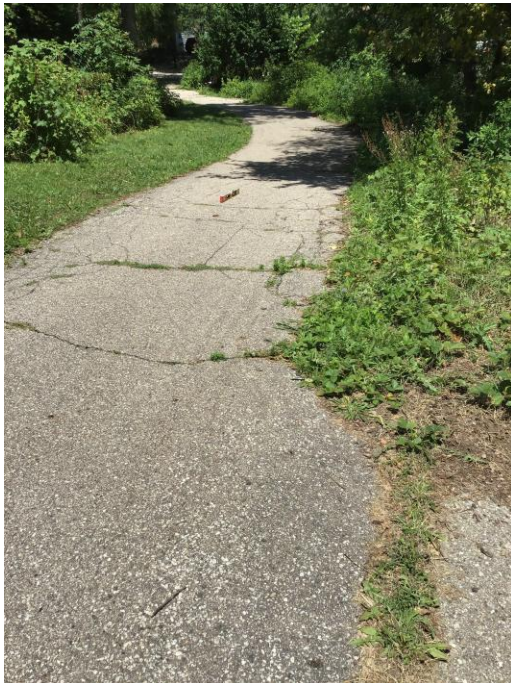
The accessible route has running slopes greater than 7%, which is considered a ramp and must comply with the requirements of 406, and a cross slope of 4%.

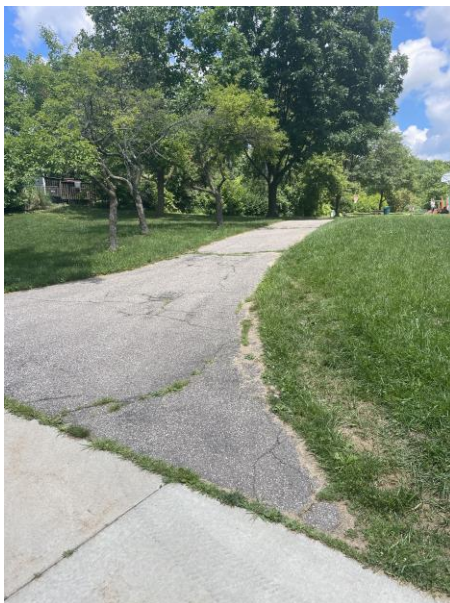
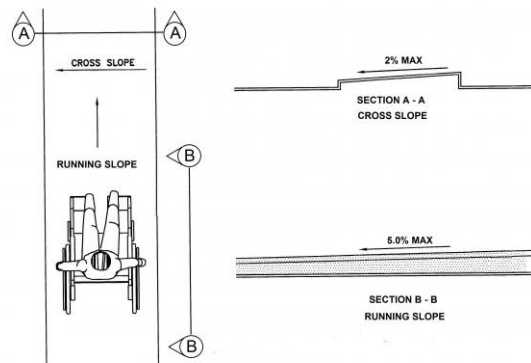
The accessible route has a running slope greater than 5% which is considered a ramp and must comply with 405.

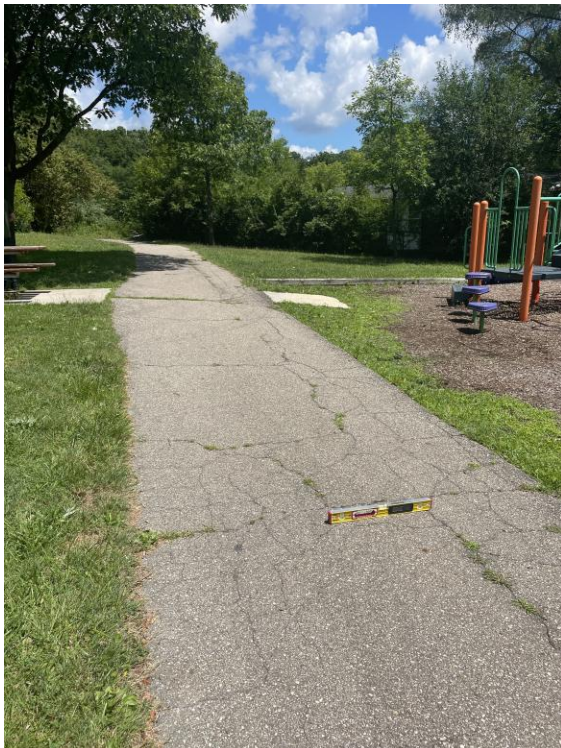
The accessible route has a cross slope of 4%.

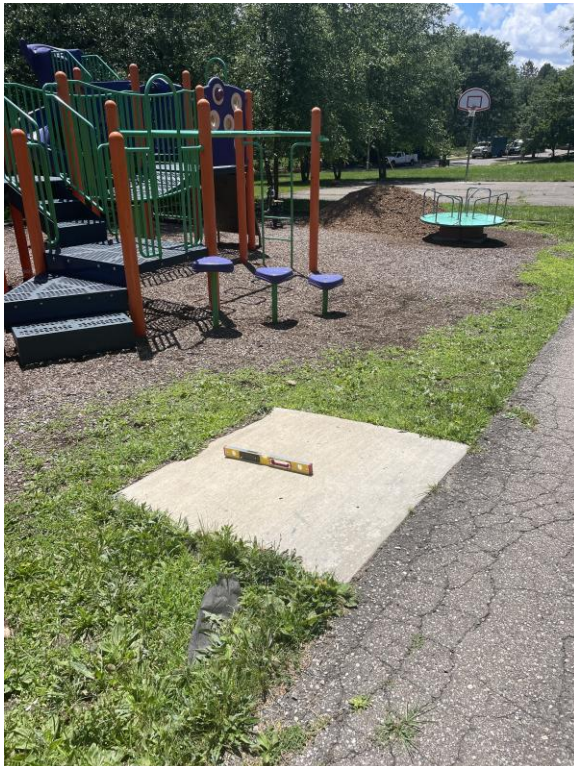
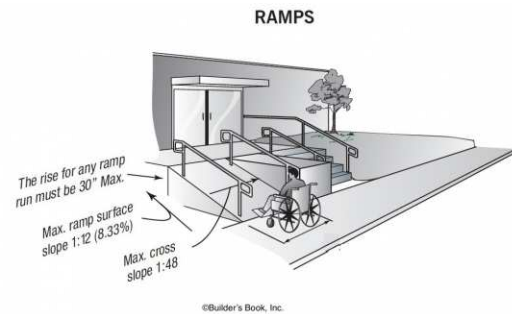
The ramp to the play area has a running slope of 12%.

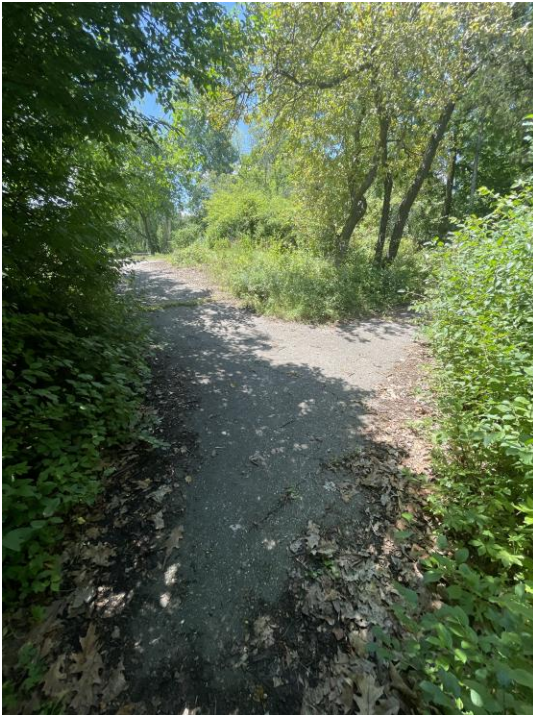
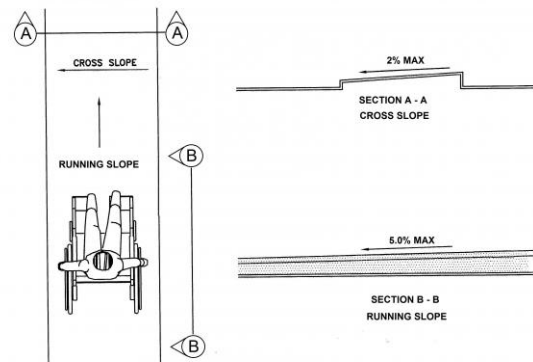
The trails have running slopes greater than 5% and cross slopes greater than 2%

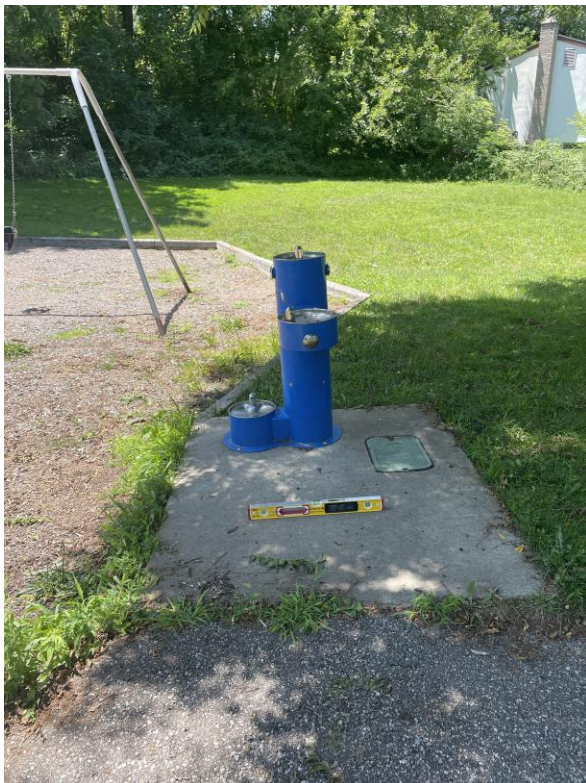
The clear floor space of the drinking fountain has a slope of 7.3%

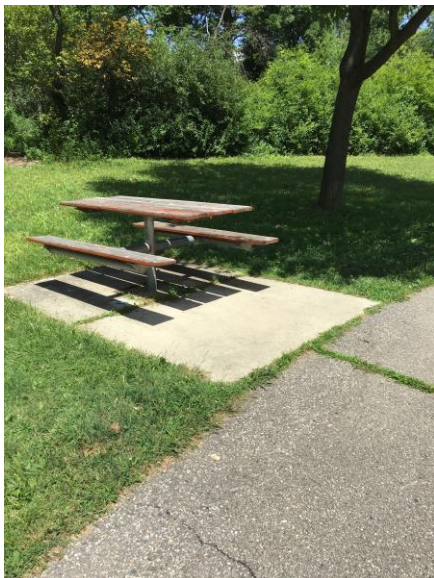
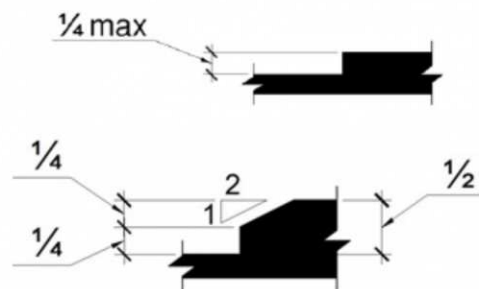
The accessible route to the picnic table has vegetation growing on the cracks which create vertical changes in level greater than 1/2-inch.

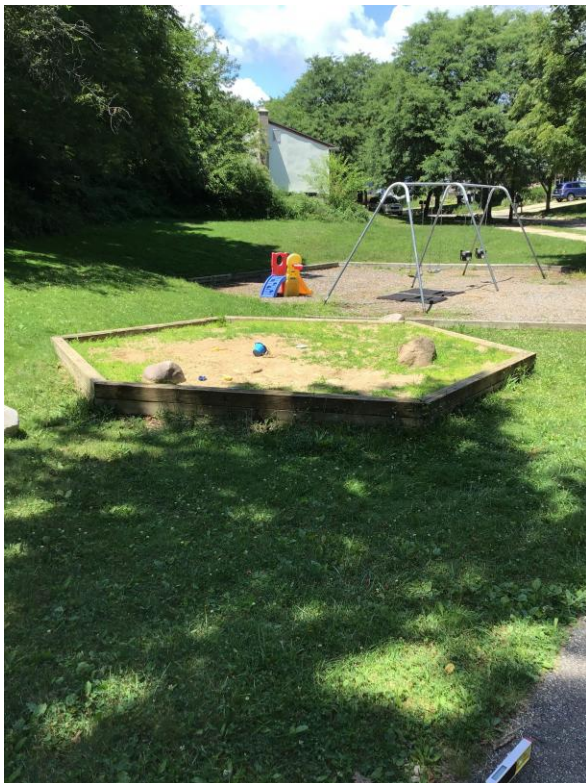
There is no accessible route provided to sand pit.

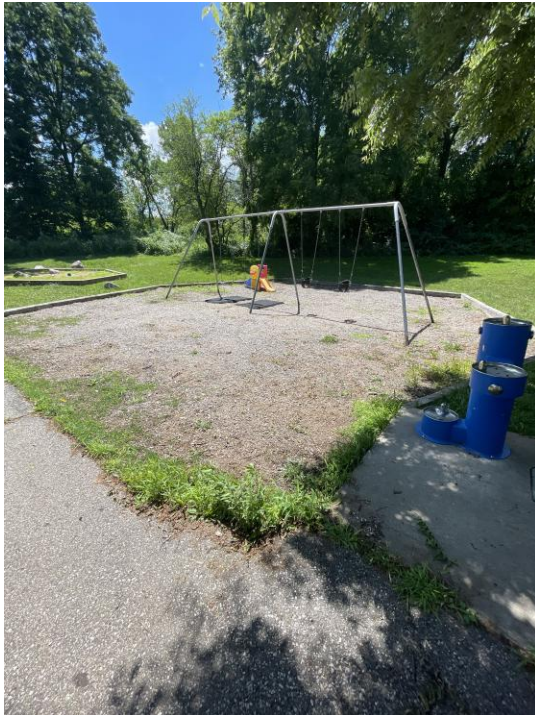
The play area ground surface is not compliant; surface is not firm, stable, and slip resistant.

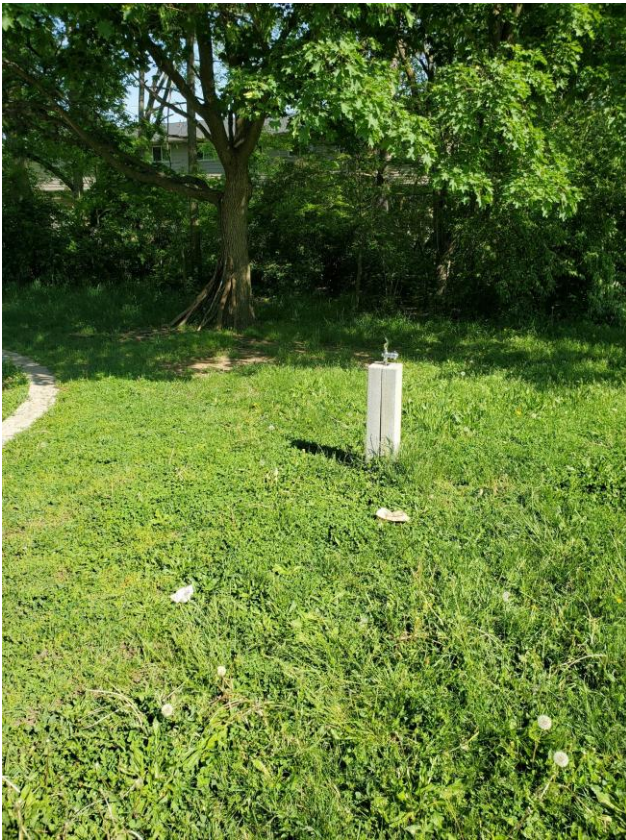
Finding #1 Continued

The drinking fountain has multiple violations.

At least one "low" and one "high" drinking fountains complying with all the requirements of 602 must be provided along an accessible route

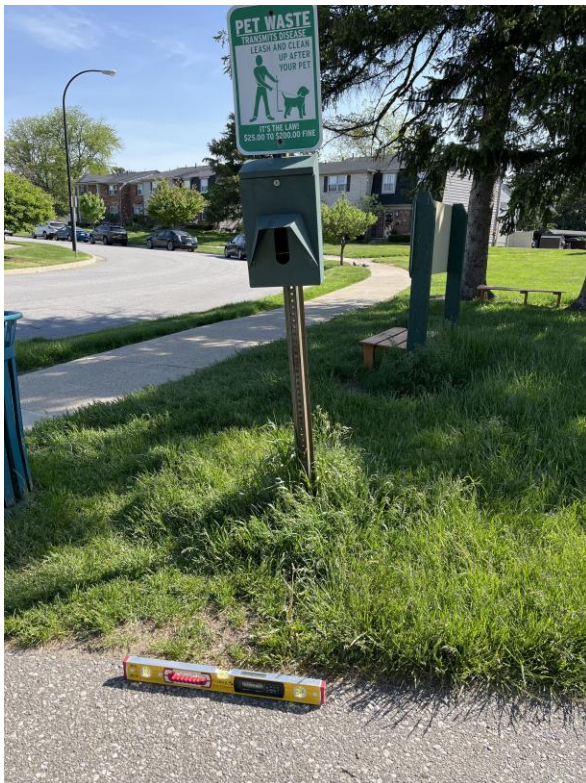
The slope at the dog waste station clear floor space is 4%.

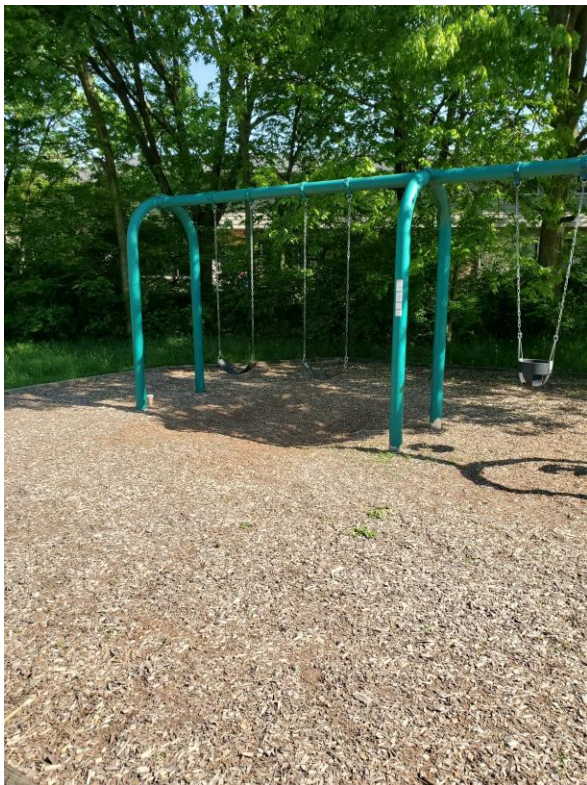
The swing seat is higher than 24 inches from the finish floor.

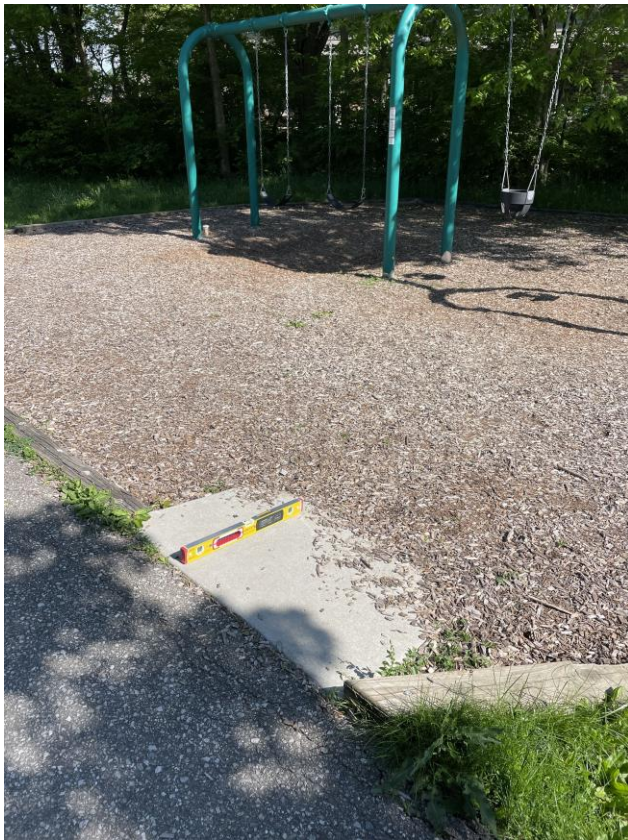
The ramp to the swing play area has a running slope greater than 8.33%.

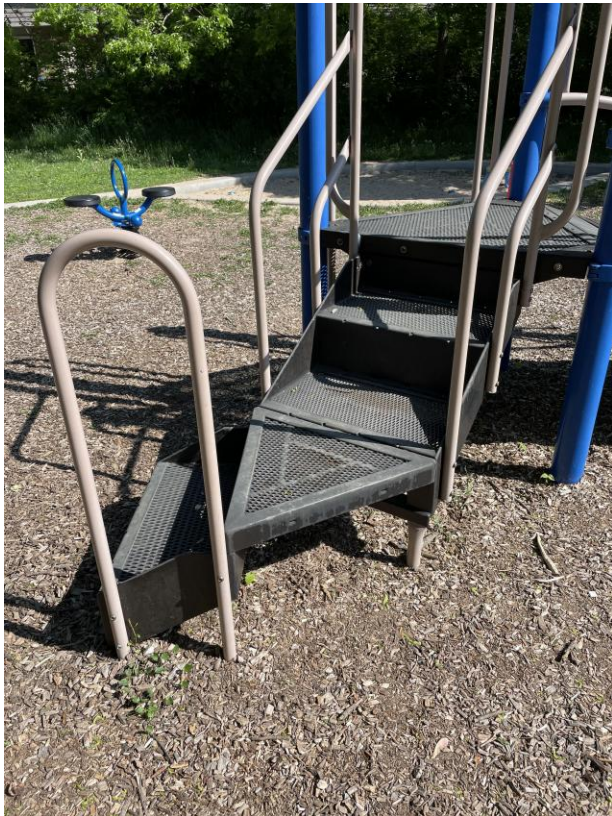
The transfer platform at the play area is not compliant

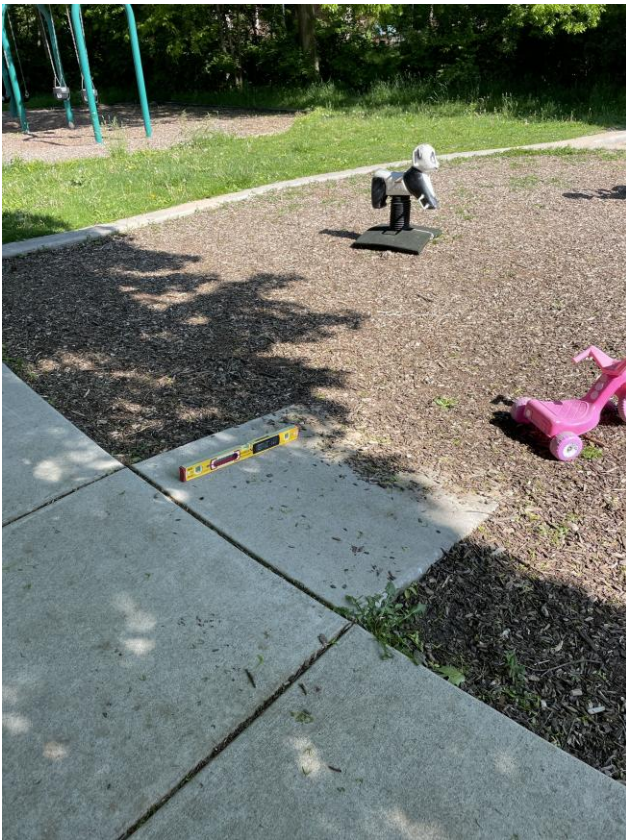
The running slope at the ramp to the play area is greater than 8.33%.

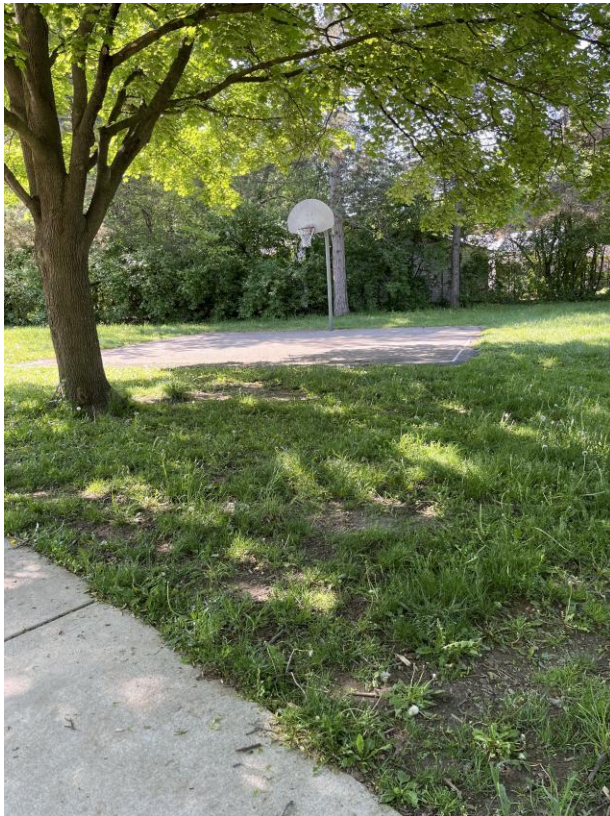
There is no accessible route provided to the basketball court; grass is not an accessible surface.

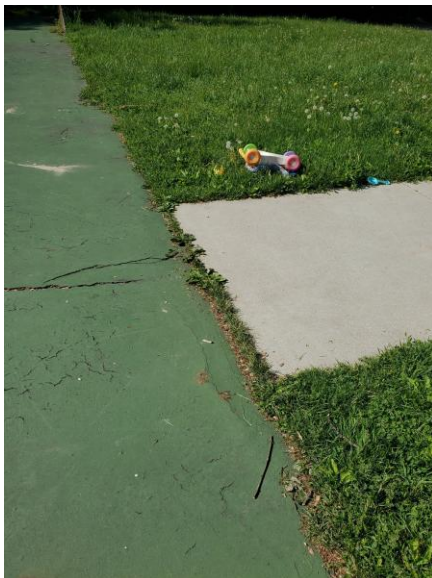
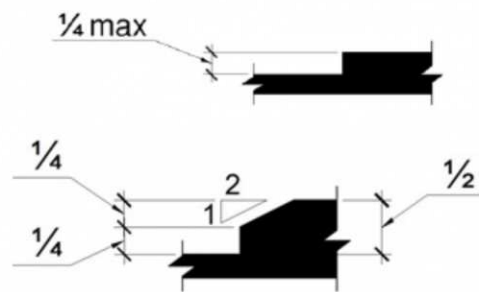
The accessible route to the tennis court has grass growing on the cracks creating vertical changes in level greater than 1/2-inch.

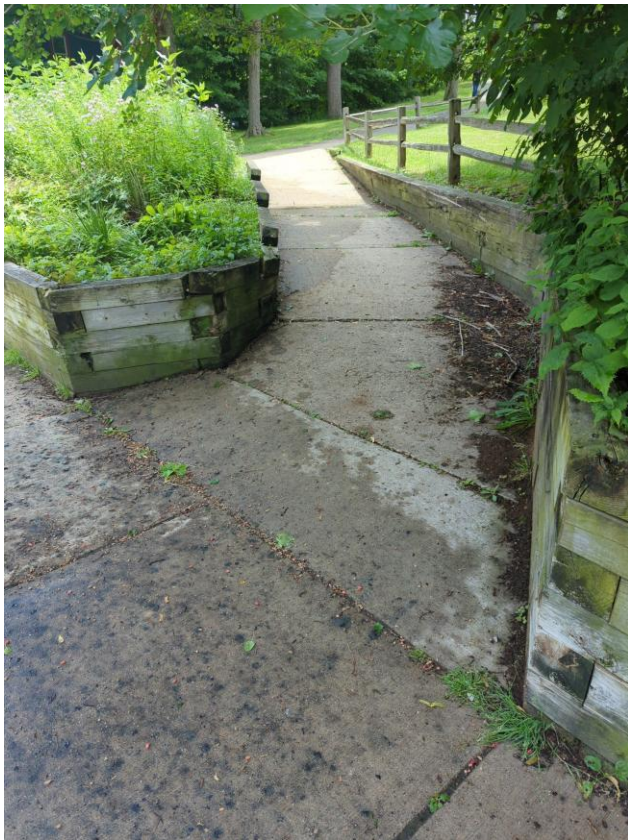
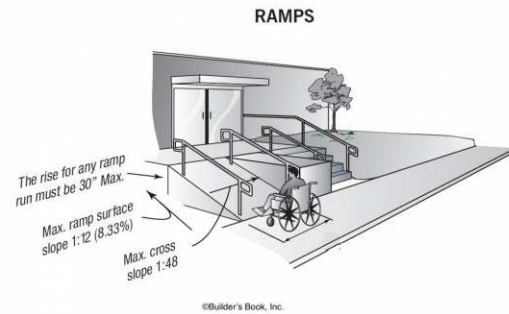
Ramp connecting to public sidewalk has a running slope of up to 15%
